FUSELAGE

757-200 STRUCTURAL REPAIR MANUAL

CHAPTER 53 FUSELAGE

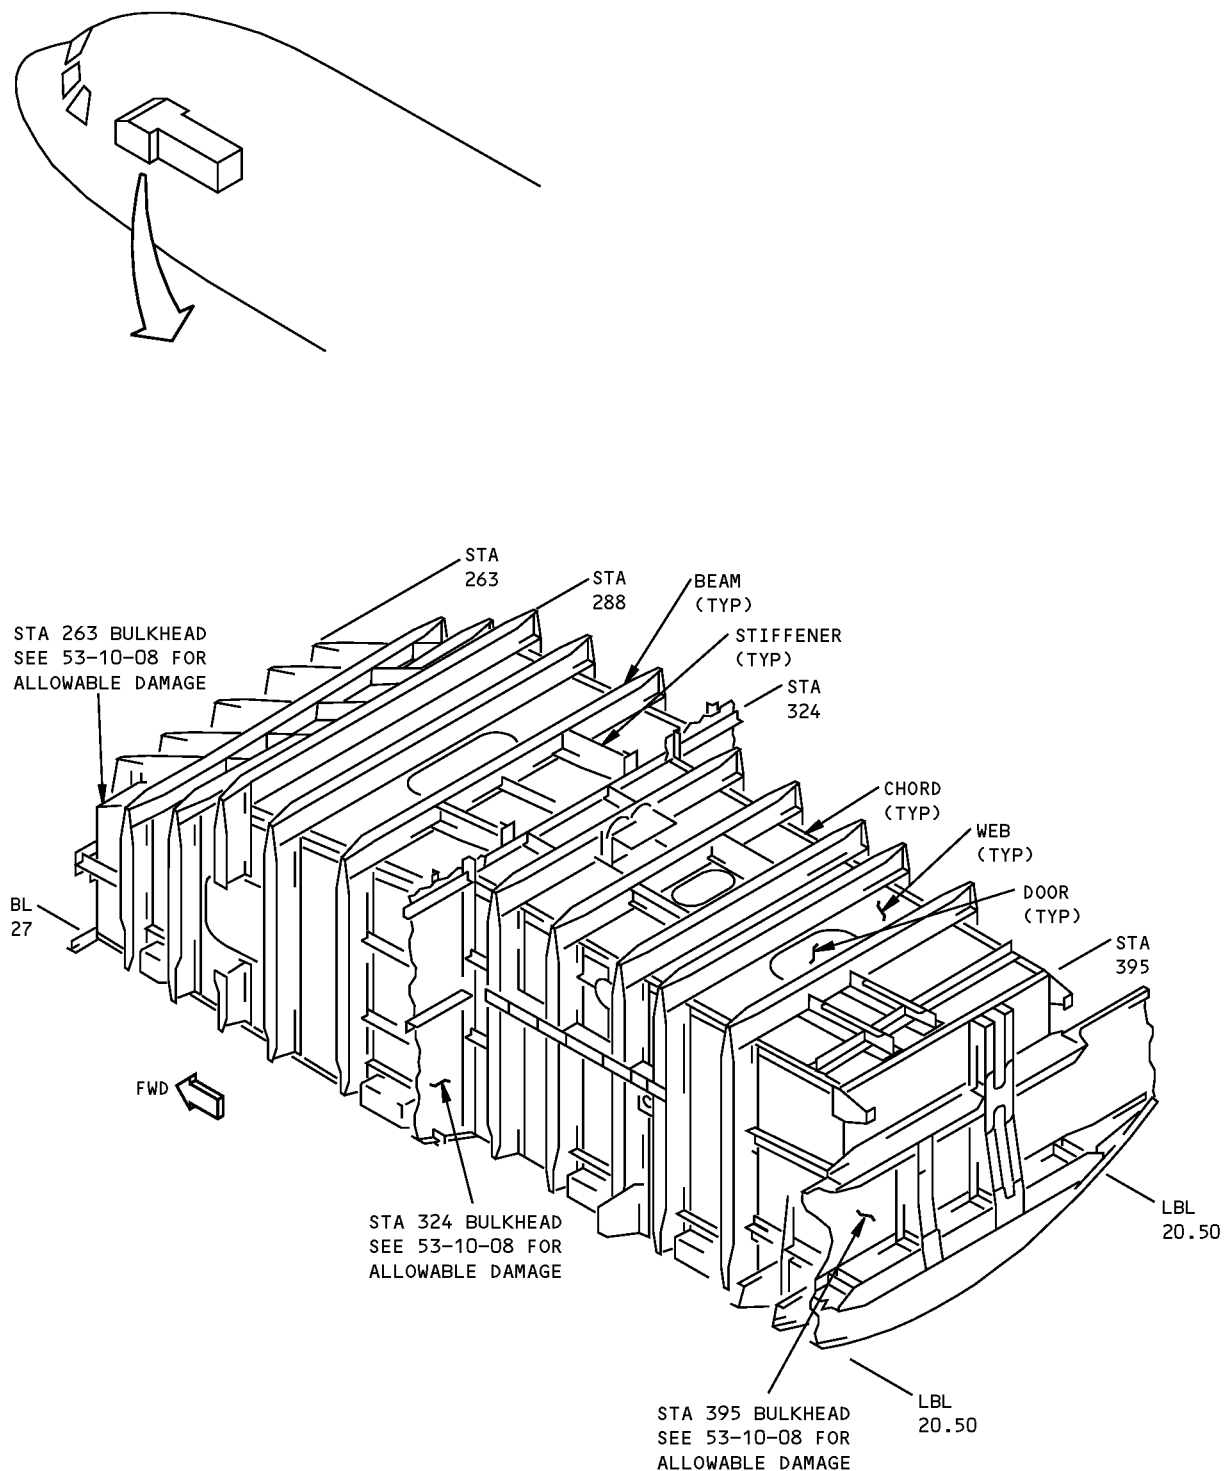
ALLOWABLE DAMAGE 1 - NOSE WHEEL WELL STRUCTURE

**Nose Wheel Well Structure Allowable Damage
Figure 101 (Sheet 1 of 5)**

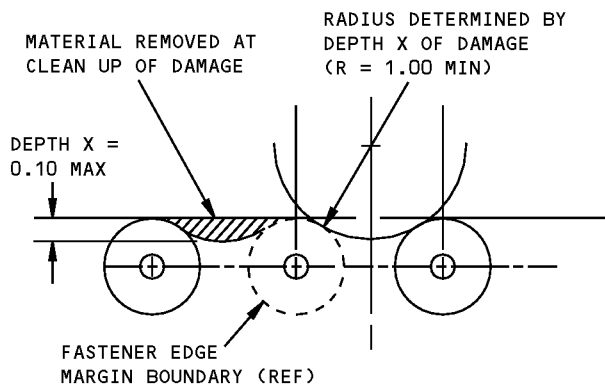
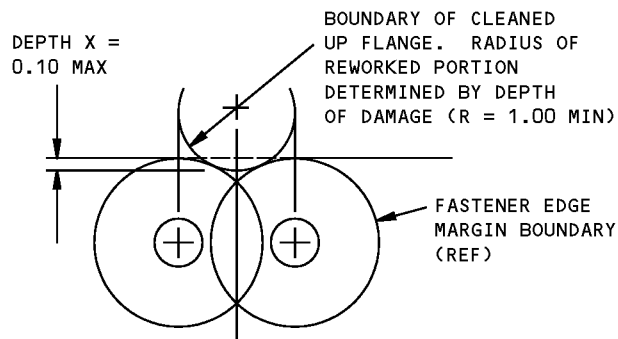
DETAIL I

DAMAGE CLEAN UP OF EDGES WHERE FASTENER EDGE MARGINS DO NOT OVERLAP

DAMAGE CLEAN UP OF EDGES WHERE FASTENER EDGE MARGINS OVERLAP

- A** CRACKS NOT ALLOWED EXCEPT FOR EDGE CRACKS WHICH MUST BE REMOVED PER DETAILS I AND VI
- B** CRACKS NOT ALLOWED EXCEPT FOR EDGE CRACKS WHICH MUST BE REMOVED PER DETAILS I AND VII
- C** REMOVE DAMAGE PER DETAILS I, II, IV, AND VI
- D** CLEAN OUT DAMAGE UP TO 0.25 MAX DIA AND NOT CLOSER THAN 1.0 INCH TO FASTENER HOLE OR OTHER DAMAGE. MAINTAIN MINIMUM EDGE MARGIN OF 1.5 D. FILL HOLE WITH A 2117-T3 OR T4 ALUMINUM RIVET INSTALLED WET WITH BMS 5-95 SEALANT. ALL OTHER HOLES TO BE REPAIRED

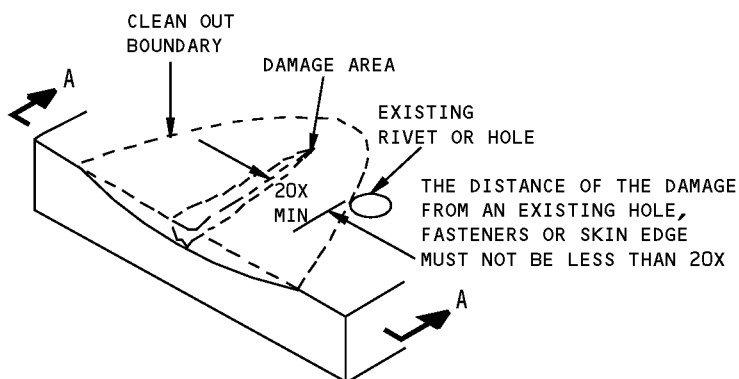
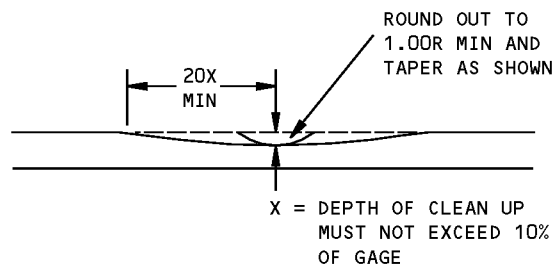
DETAIL II

SECTION A-A

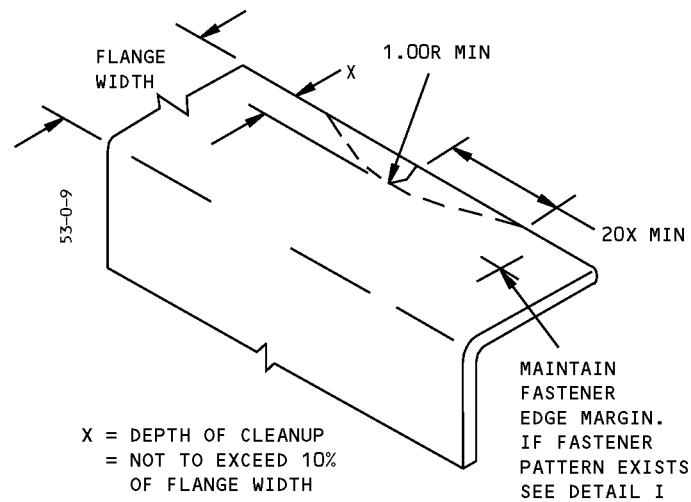
DETAIL VI

**REMOVAL OF NICK OR CRACK
DAMAGE ON AN EDGE**

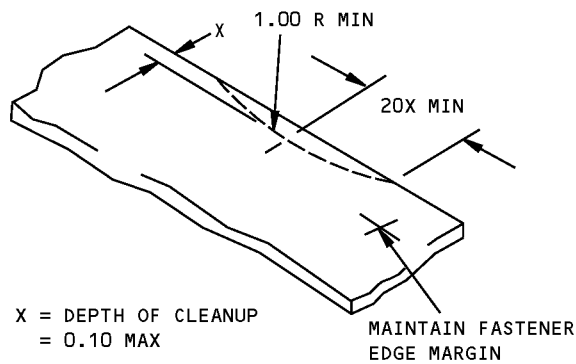
DETAIL VII

**REMOVAL OF NICK OR CRACK
DAMAGE ON AN EDGE**

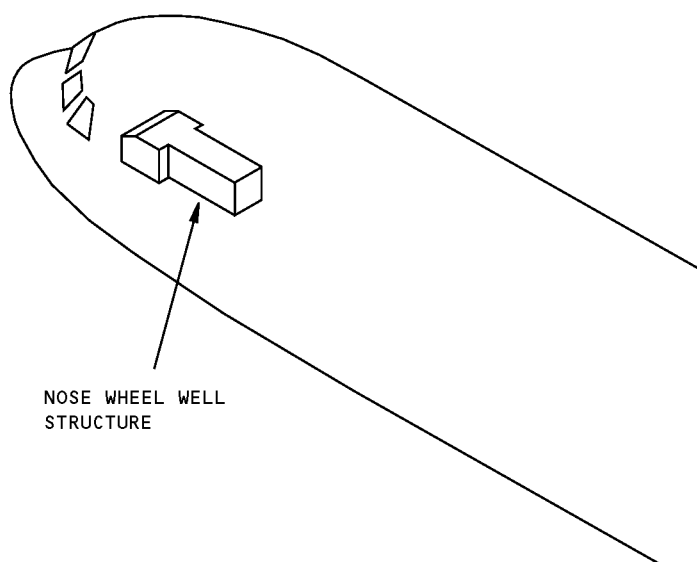
| APPLICABILITY |
|--|
| THIS REPAIR DOES NOT APPLY TO PRESSURE WEBS, BULKHEAD WEBS AT STA 263, STA 324, AND STA 395, AND THE EXTRUDED WEB STIFFENERS |

- SEE 51-70-11 FOR FORMED SECTION REPAIR
- SEE 51-70-12 FOR EXTRUDED SECTION REPAIR
- SEE 51-70-13 FOR WEB REPAIRS TO CONSTANT THICKNESS WEB SECTION
- NO REPAIRS ALLOWED TO FITTINGS

**Nose Wheel Well Structure Repair
Figure 201**

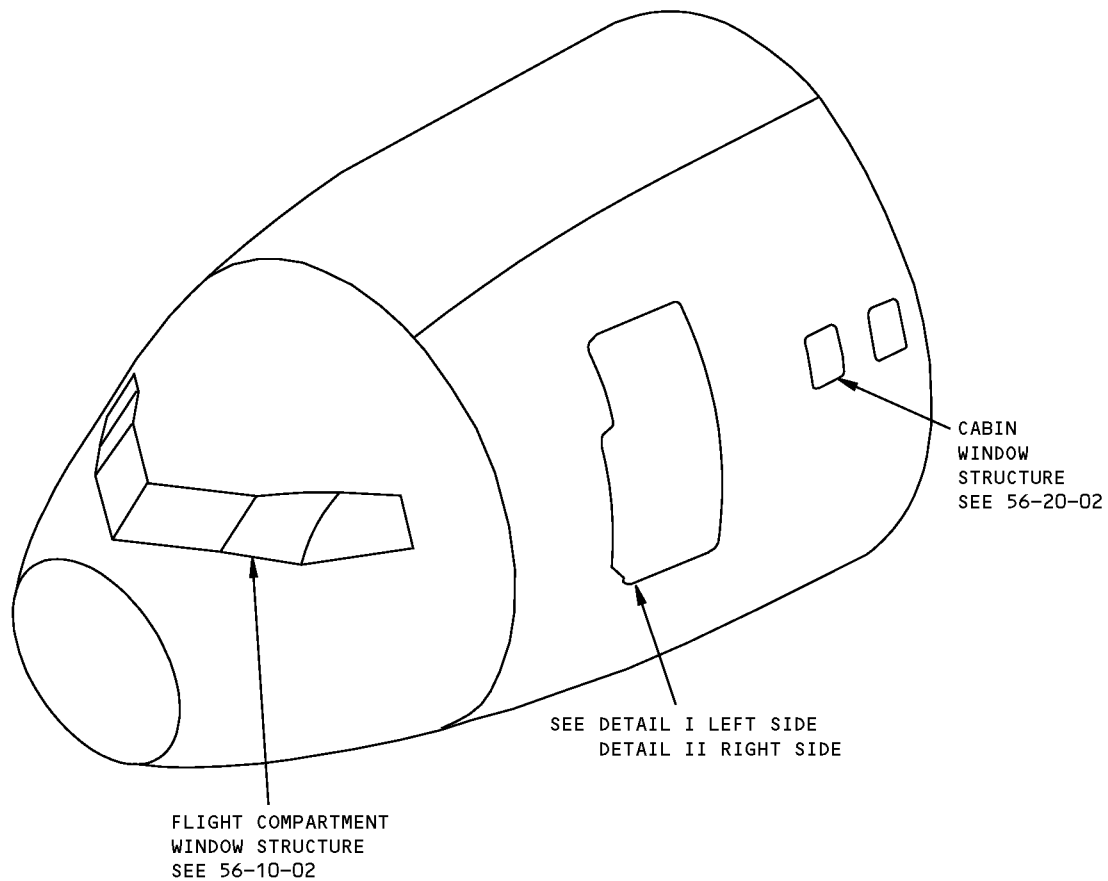
IDENTIFICATION 1 - SECTION 41 - DOOR SURROUND STRUCTURE

Section 41 Door Surround Structure Identification
Figure 1 (Sheet 1 of 5)

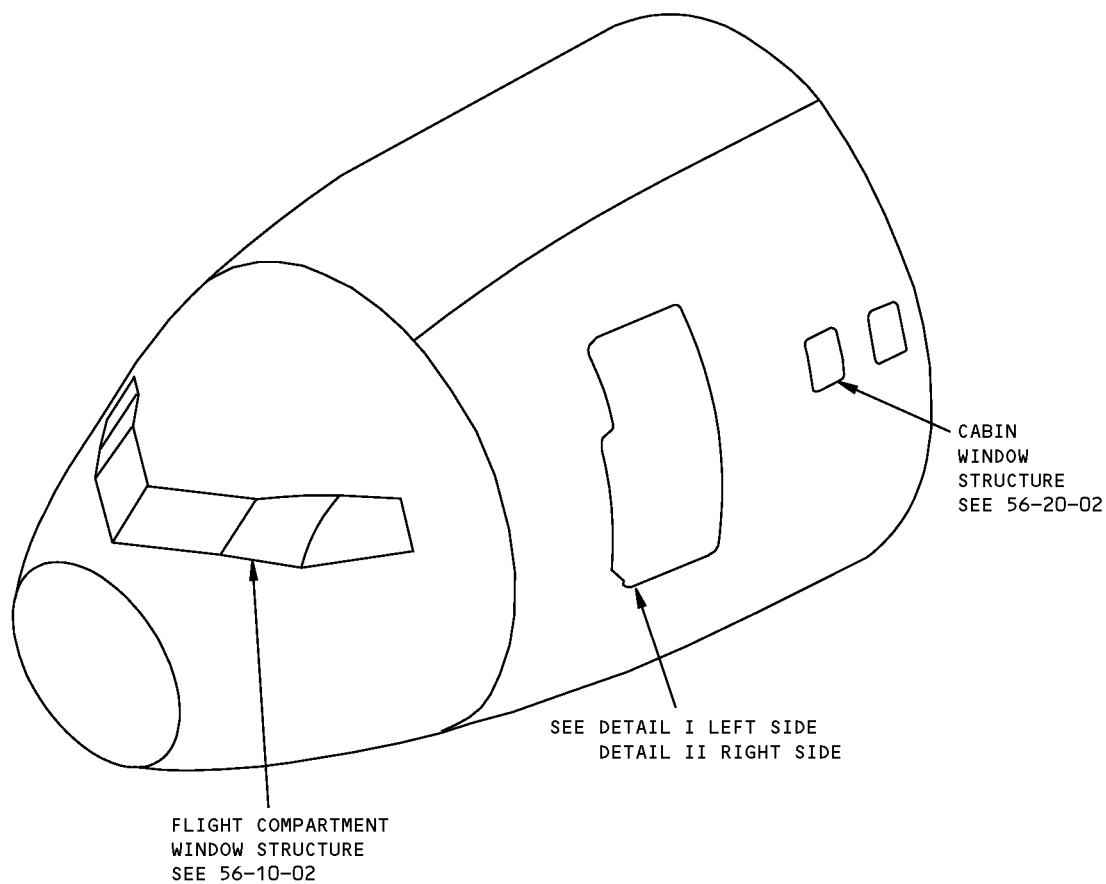
ALLOWABLE DAMAGE 1 - SECTION 41 - DOOR SURROUND STRUCTURE

Section 41 Door Surround Structure Allowable Damage
Figure 101 (Sheet 1 of 5)

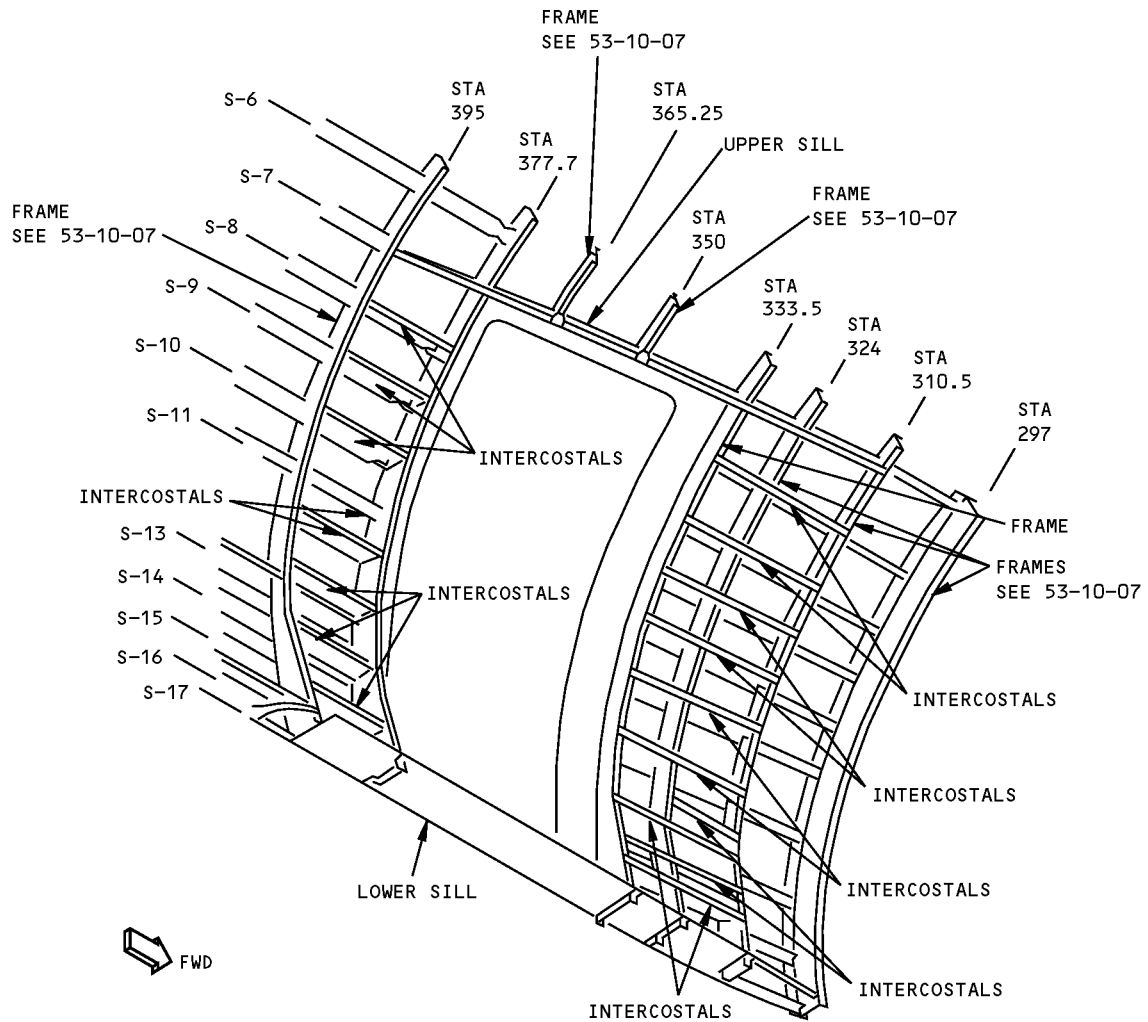
MATERIAL: ALUMINUM

LEFT SIDE
DETAIL I

Section 41 Door Surround Structure Allowable Damage
Figure 101 (Sheet 2 of 5)

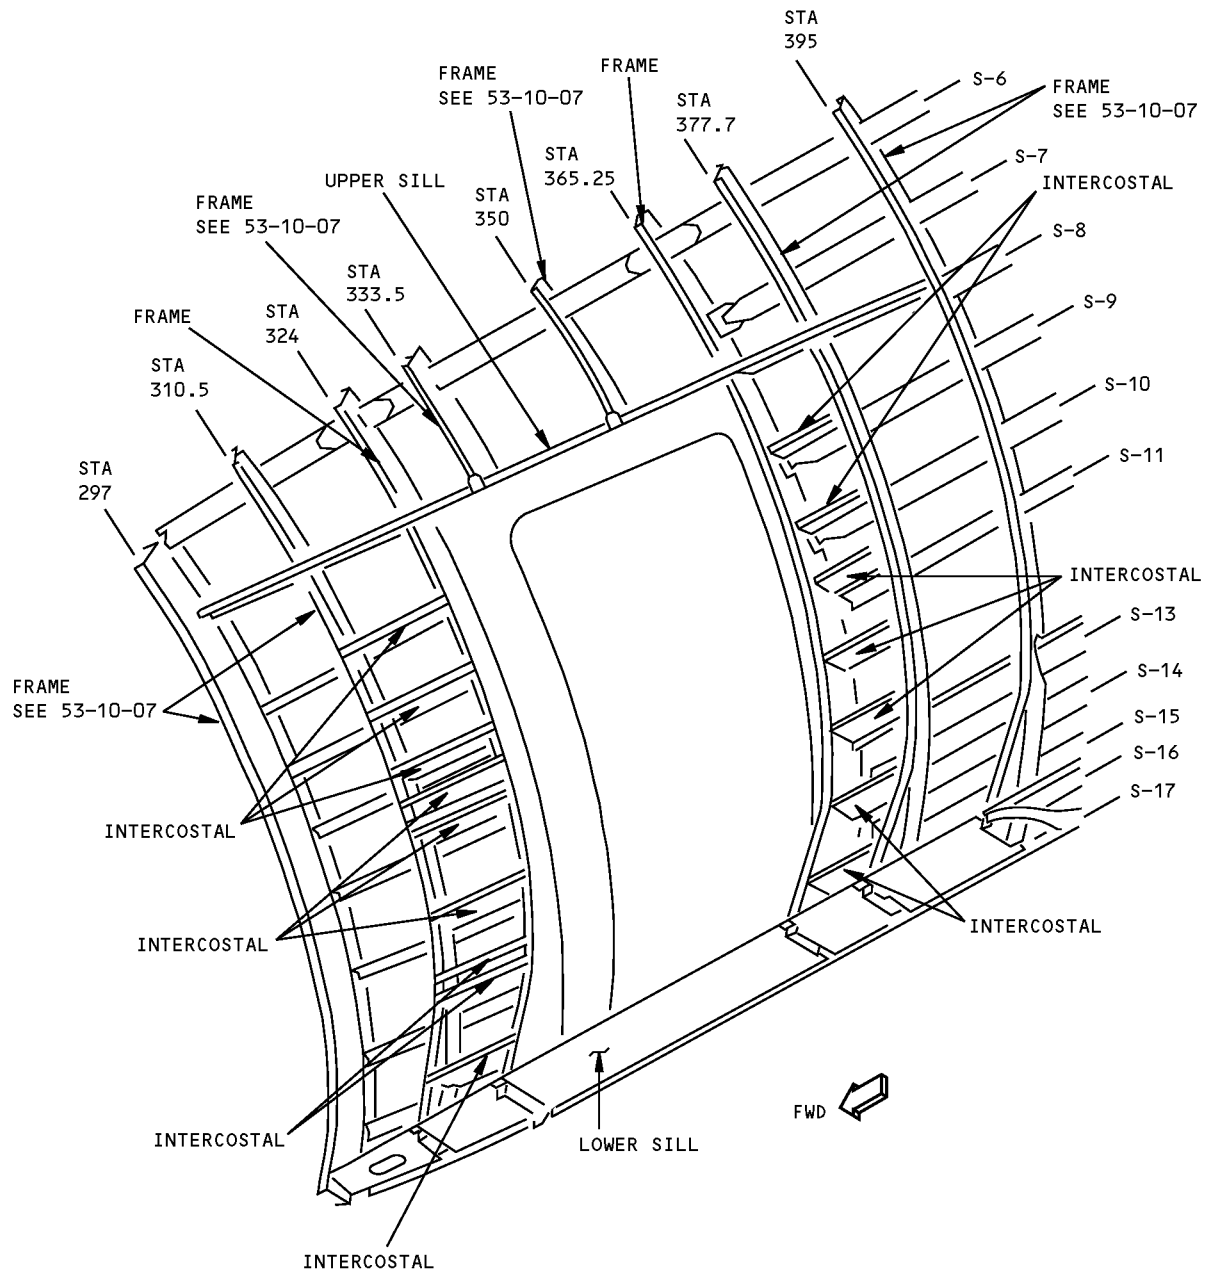
MATERIAL: ALUMINUM

RIGHT SIDE
DETAIL II

**Section 41 Door Surround Structure Allowable Damage
Figure 101 (Sheet 3 of 5)**

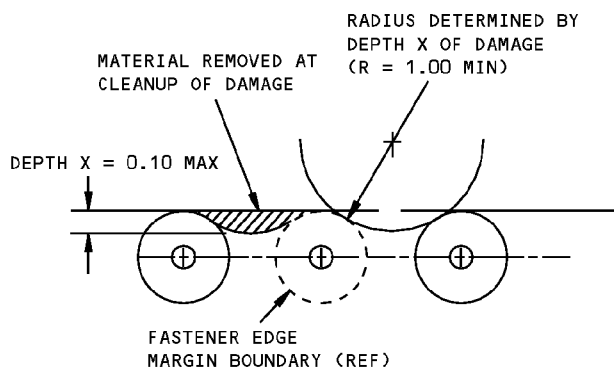
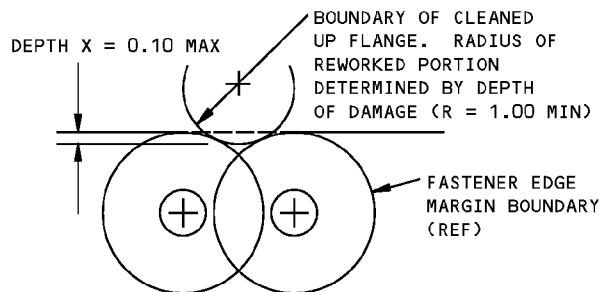
DETAIL III

DAMAGE CLEANUP OF EDGES WHERE FASTENER EDGE MARGINS DO NOT OVERLAP

DAMAGE CLEANUP OF EDGES WHERE FASTENER EDGE MARGINS OVERLAP

CRACKS NOT PERMITTED EXCEPT FOR EDGE CRACKS WHICH MUST BE REMOVED AS SHOWN IN DETAILS III AND VIII
- B

REMOVE DAMAGE AS SHOWN IN DETAILS III, IV, AND VI
- C

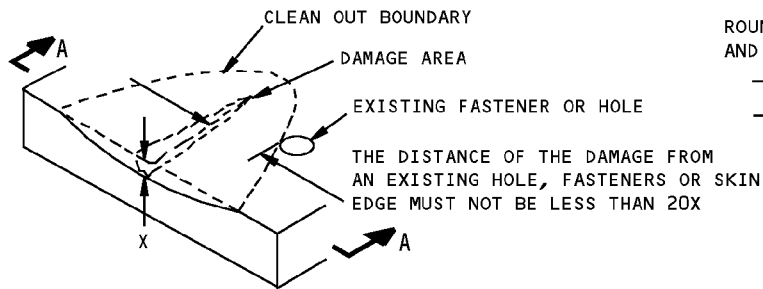
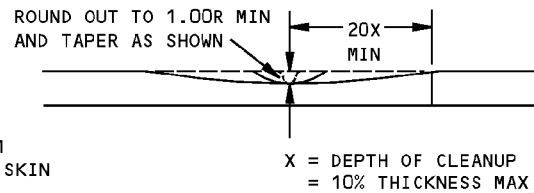
SECTION A-A

REMOVAL OF NICK, GOUGE AND SCRATCH DAMAGE ON A SURFACE
DETAIL IV

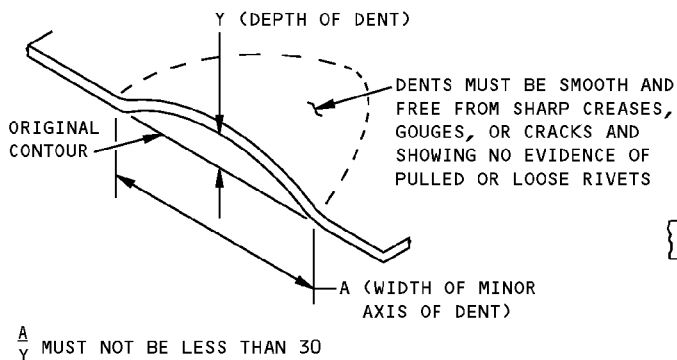
ALLOWABLE DAMAGE FOR DENT
DETAIL V

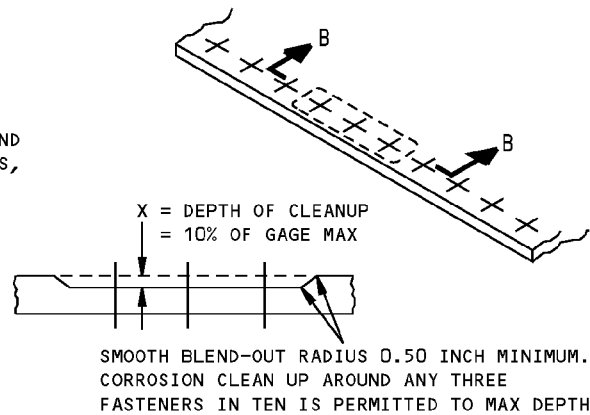
SECTION B-B
CORROSION CLEANUP
DETAIL VI

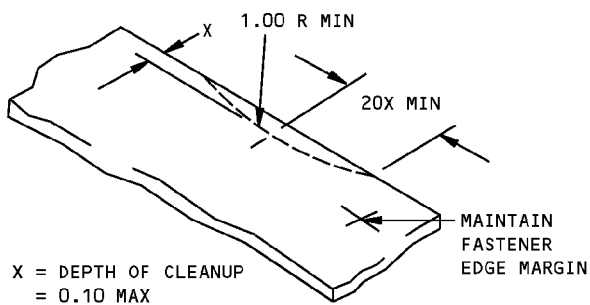
REMOVAL OF NICK OR CRACK
DAMAGE ON AN EDGE
DETAIL VII

CRACKS NOT PERMITTED EXCEPT FOR EDGE CRACKS WHICH MUST BE REMOVED AS SHOWN IN DETAILS III AND VII
- D

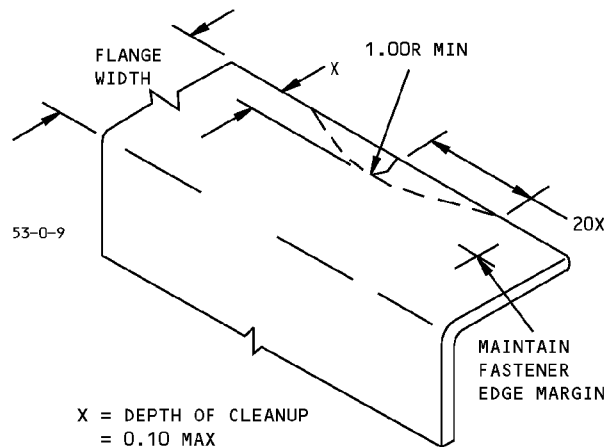
REMOVAL OF NICK OR CRACK
DAMAGE ON AN EDGE
DETAIL VIII

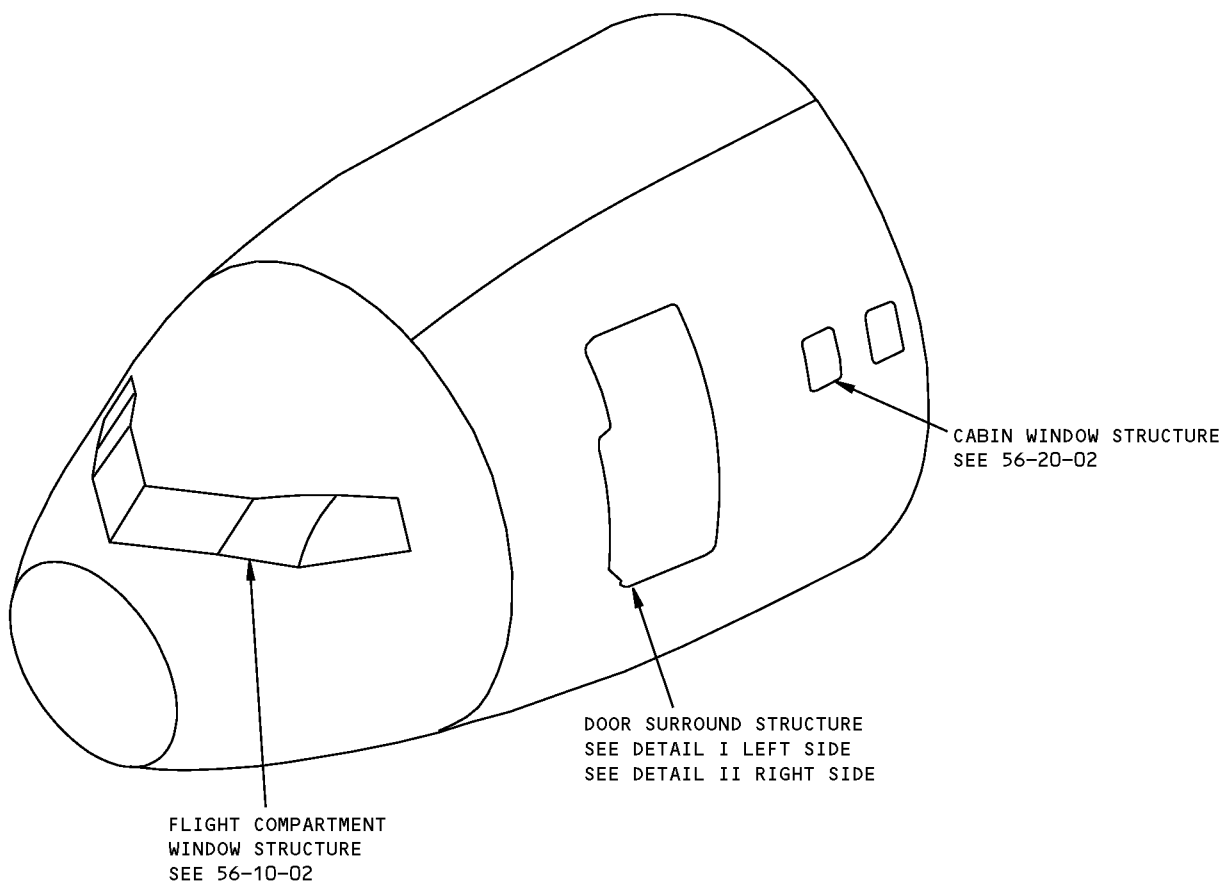
- THIS REPAIR DATA IS APPLICABLE TO PASSENGER AIRPLANES ONLY.
- DAMAGED COMPONENTS IN DOOR SURROUND STRUCTURE MAY BE REPLACED OR REPAIRED. IF REPAIRS ARE TO BE MADE, SEE 51-70 FOR TYPICAL WEB, AND EXTRUDED SECTION REPAIRS.

Section 41 Door Surround Structure Repair
Figure 201 (Sheet 1 of 3)

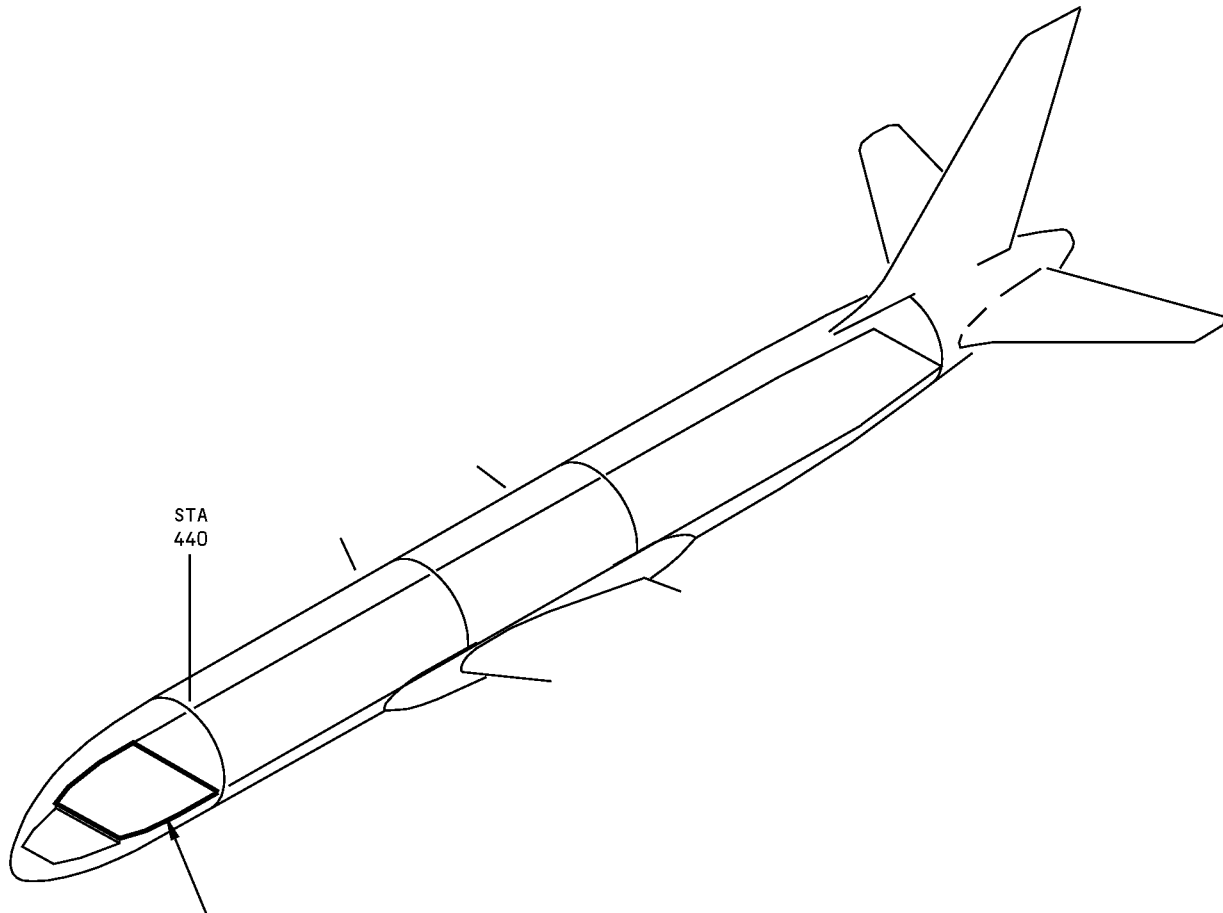
FOR FLOOR PANEL IDENTIFICATION
THIS SECTION SEE 53-00-50

Section 41 Main Deck Floor Panel Identification
Figure 1

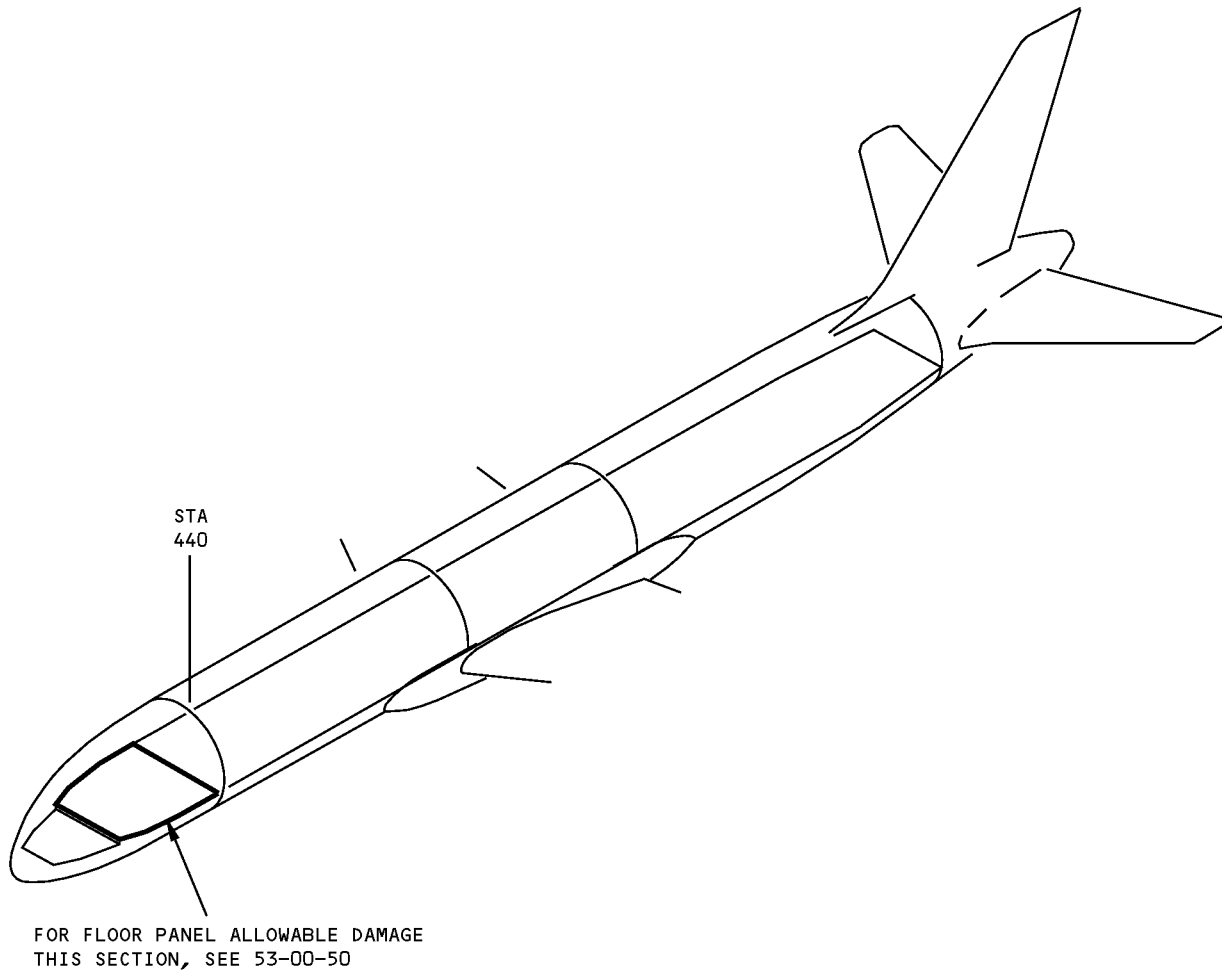
Section 41 Main Deck Floor Panel Allowable Damage
Figure 101

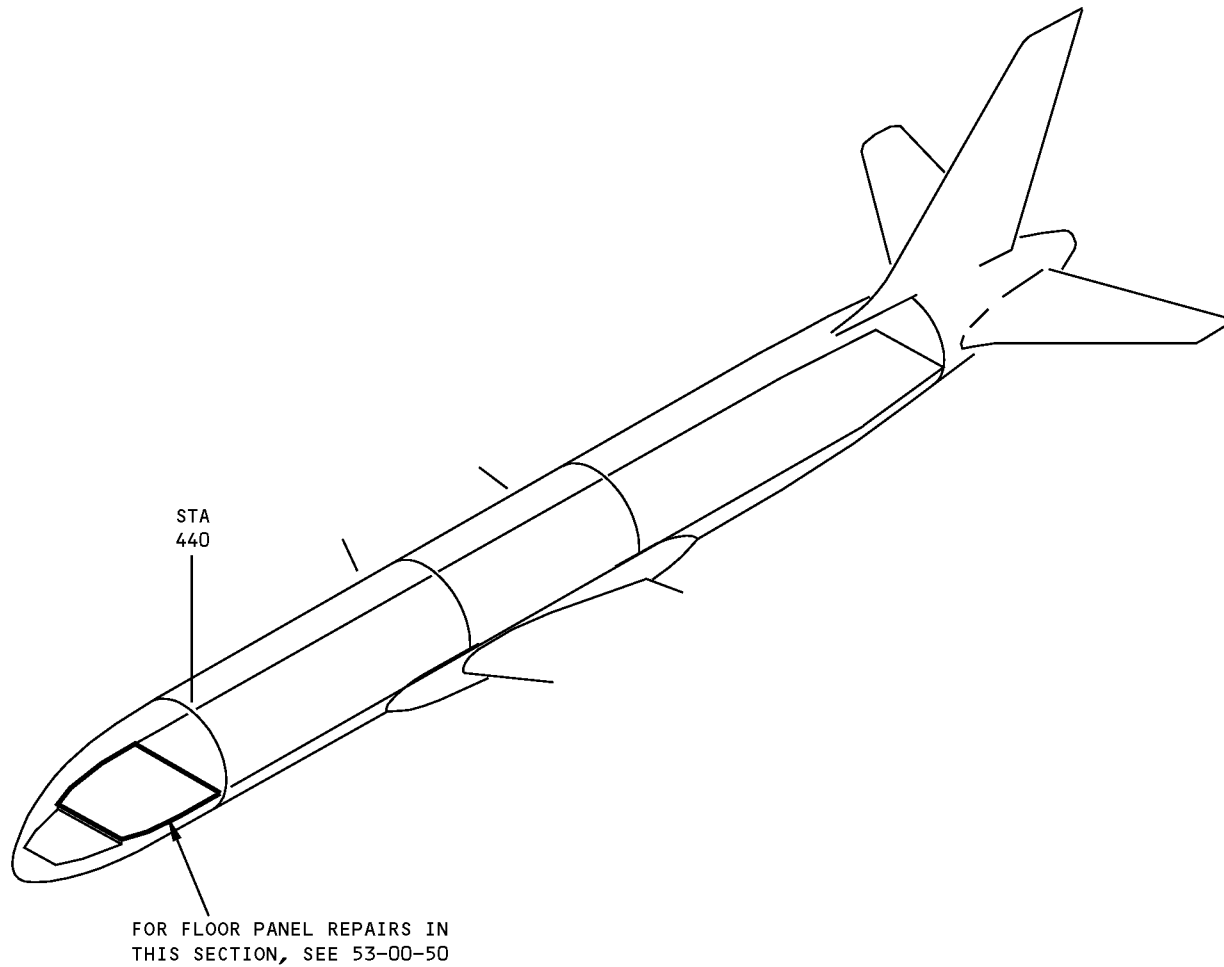
Section 41 Main Deck Floor Panel Repairs
Figure 201

REPAIR GENERAL - SECTION 41 - MAIN DECK FLOOR PANEL REPAIRS

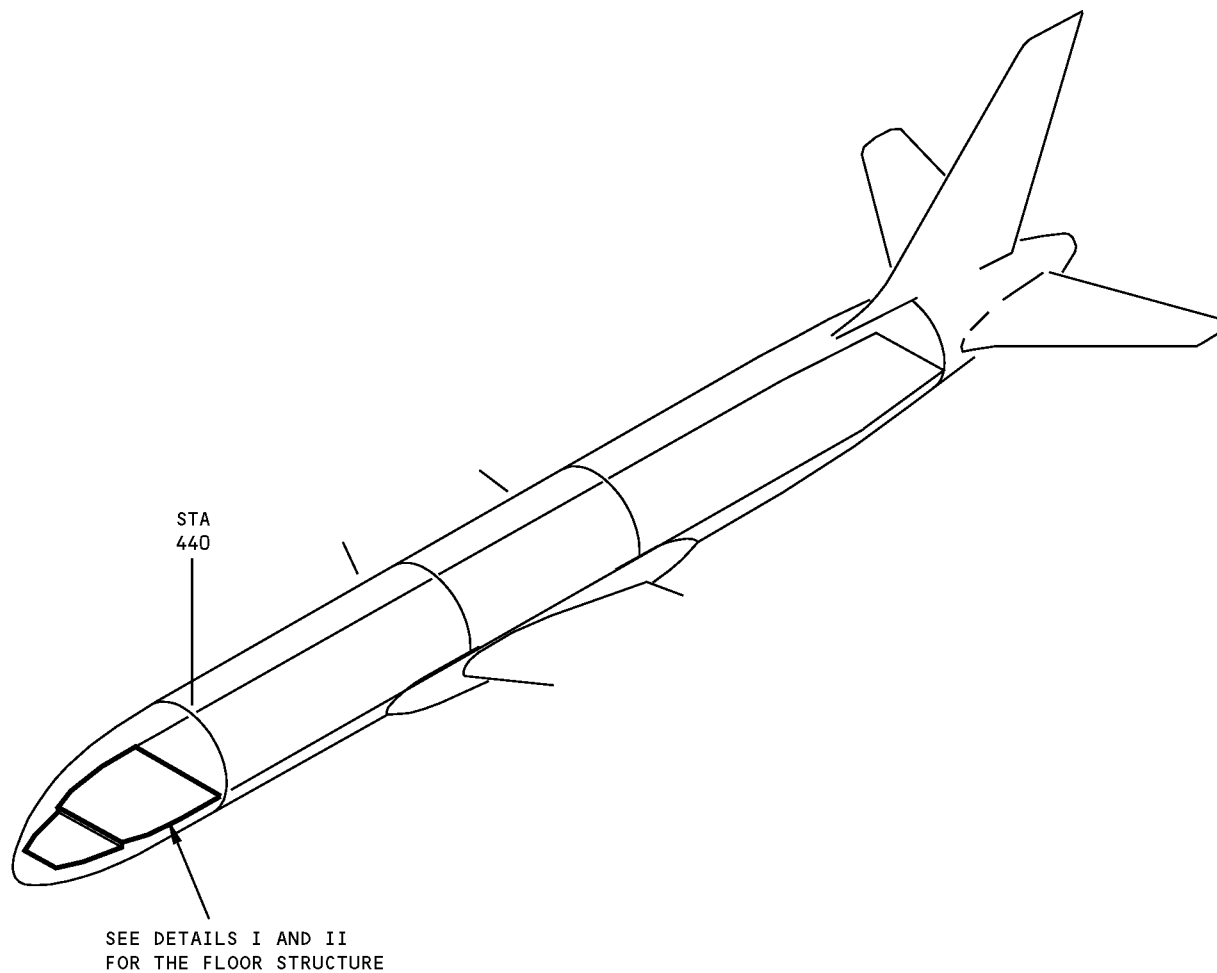
IDENTIFICATION 1 - SECTION 41 - MAIN DECK FLOOR STRUCTURE

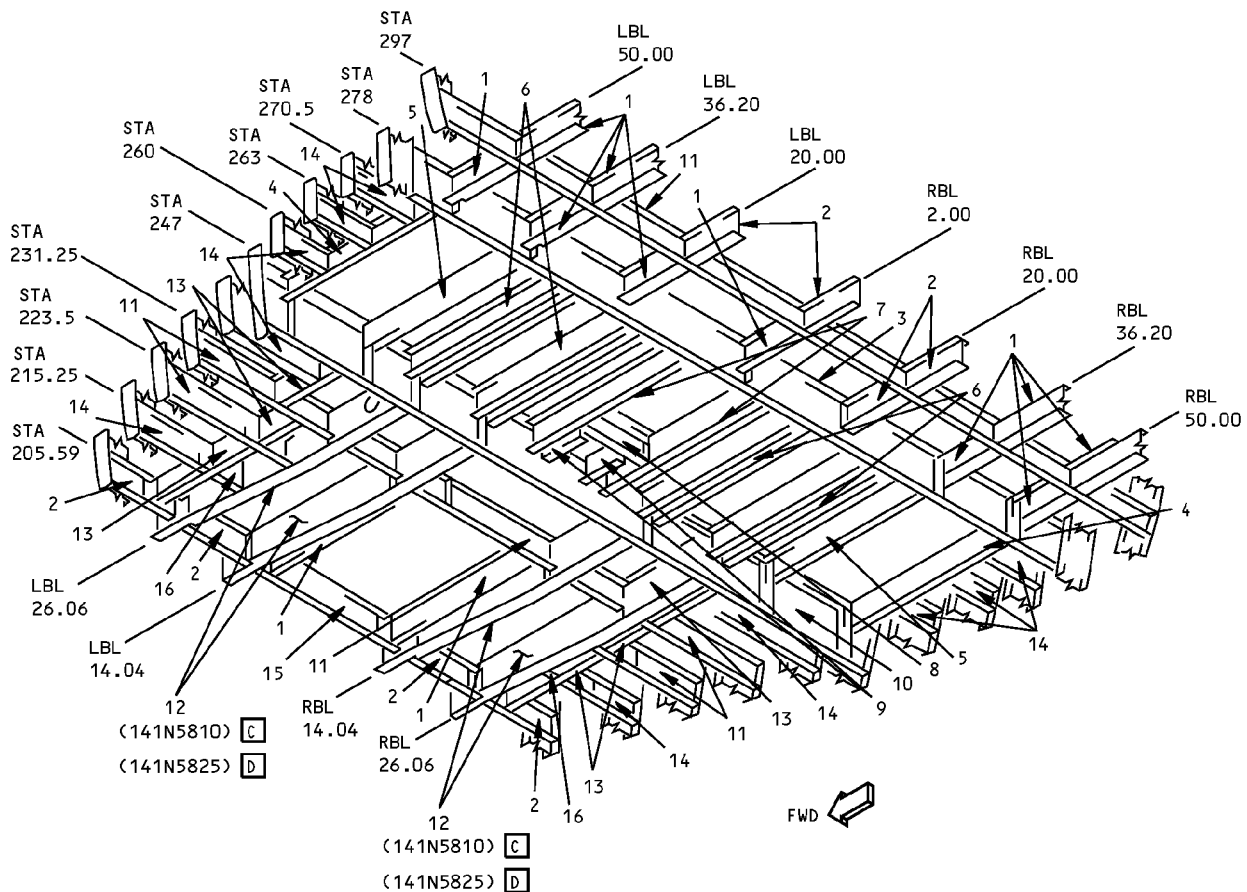
VIEW LOOKING UP AND FORWARD
DETAIL I

REFERENCE DRAWING
141N5810
141N5825

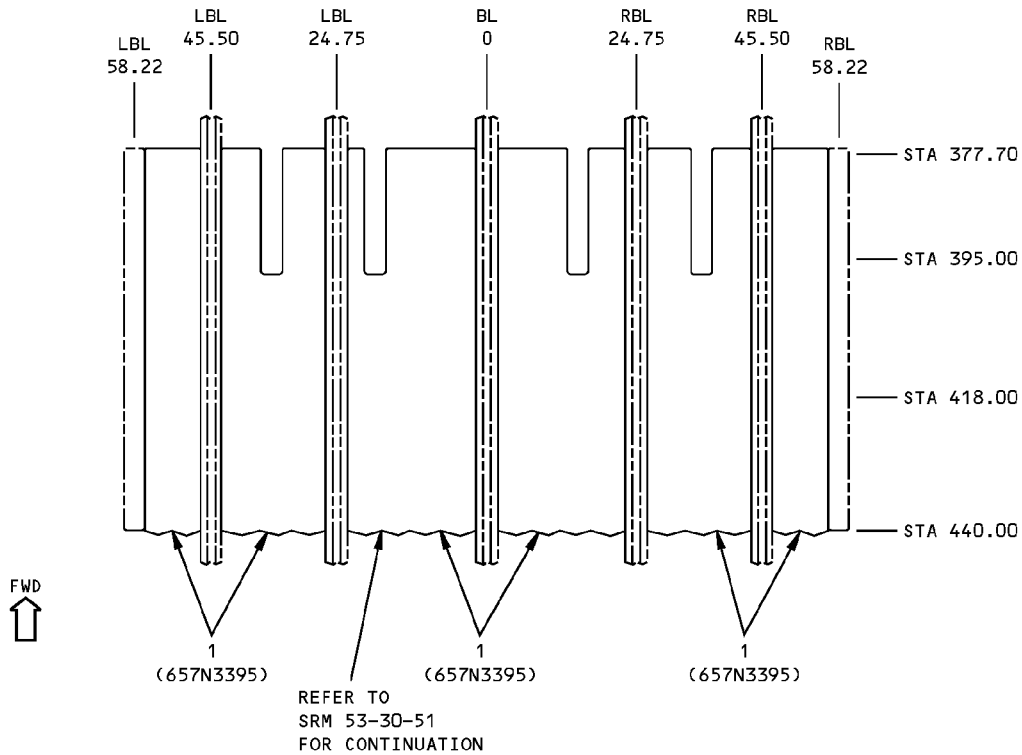
SHEAR WEB IDENTIFICATION
DETAIL III
(757-SF AIRPLANES ONLY)

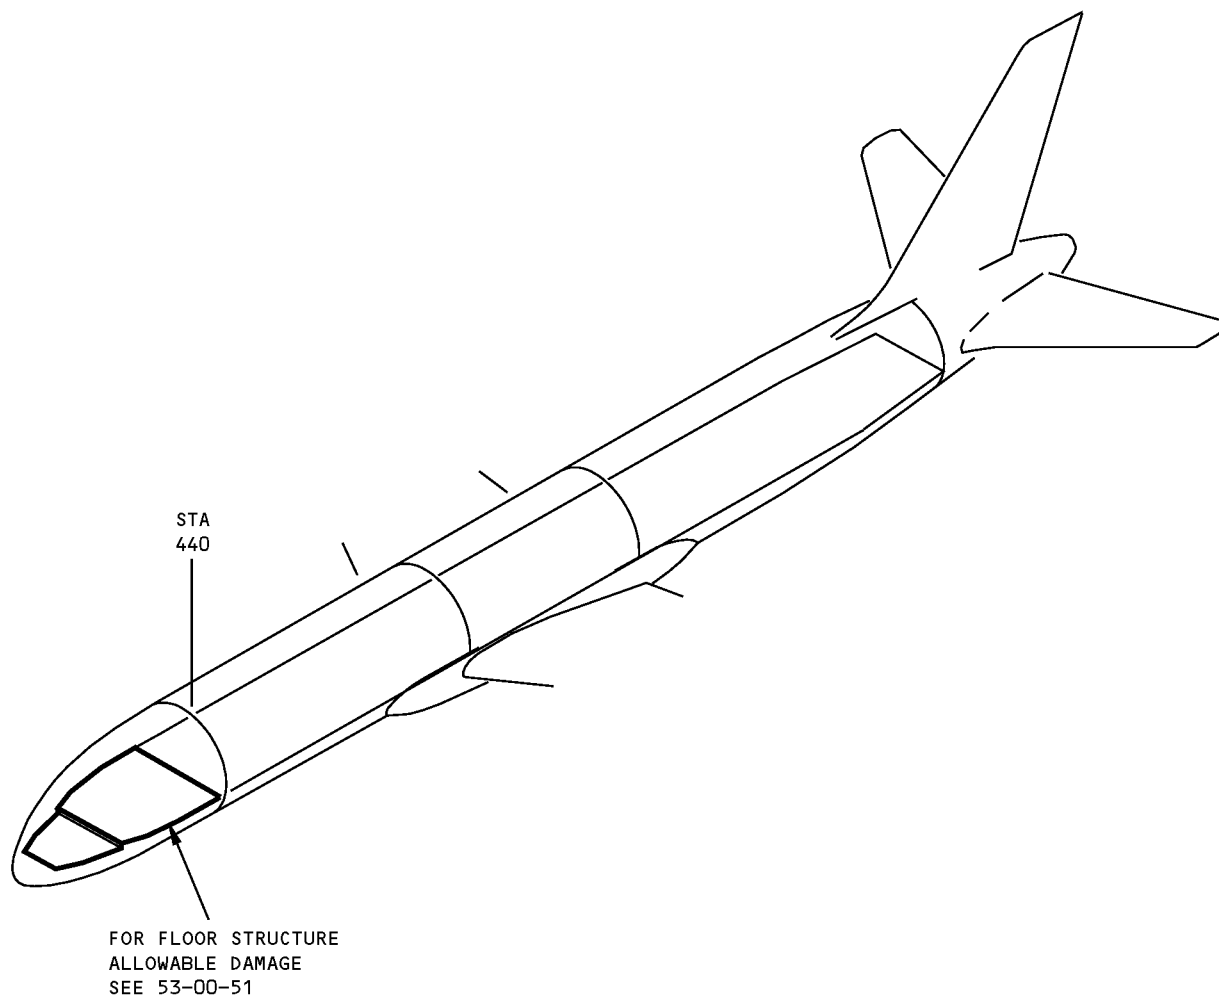
Section 41 Main Deck Floor Structure Allowable Damage
Figure 101

ALLOWABLE DAMAGE GENERAL - SECTION 41 - MAIN DECK FLOOR STRUCTURE

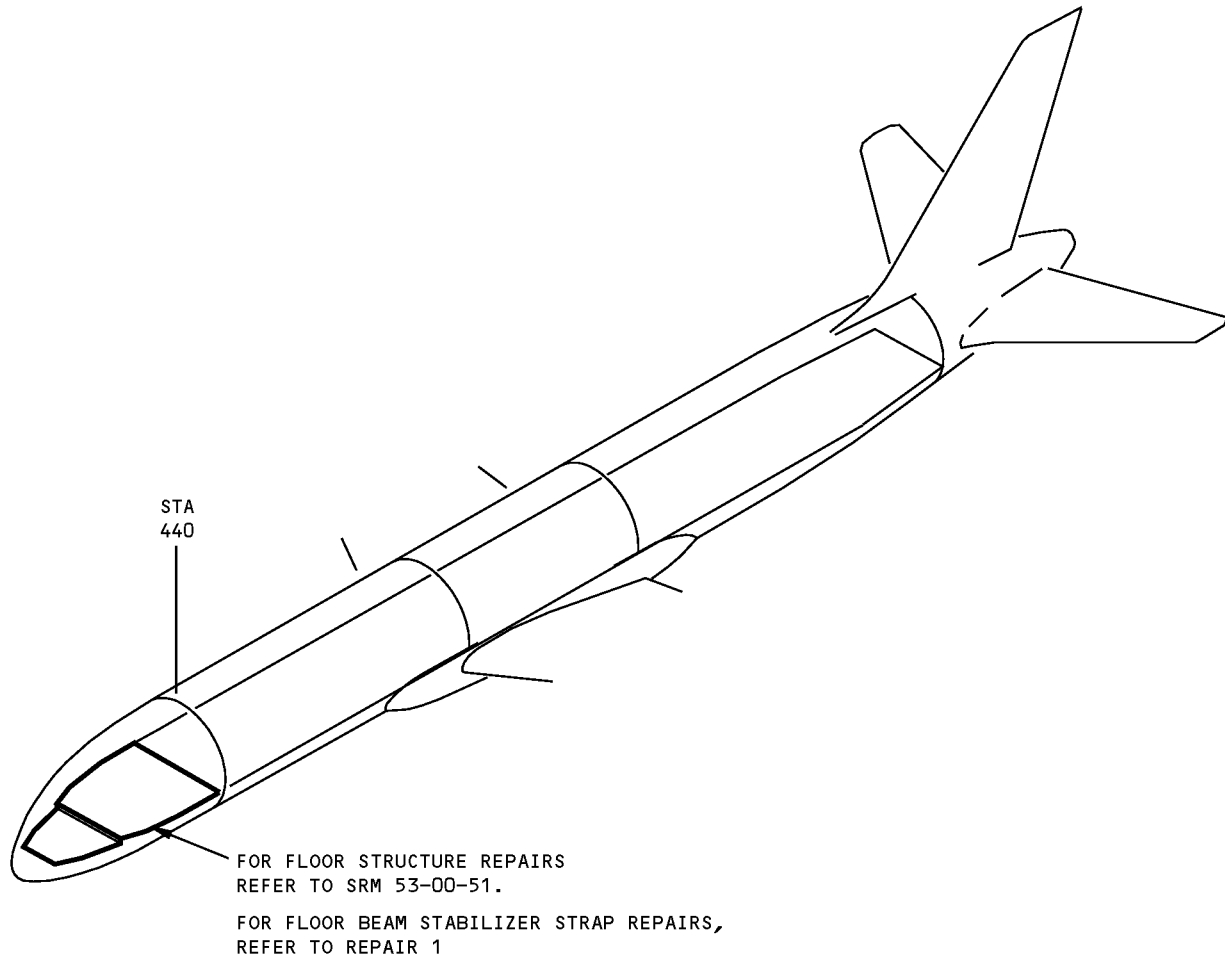
Section 41 Main Deck Floor Structure Repair
Figure 201

REPAIR GENERAL - SECTION 41 - MAIN DECK FLOOR STRUCTURE

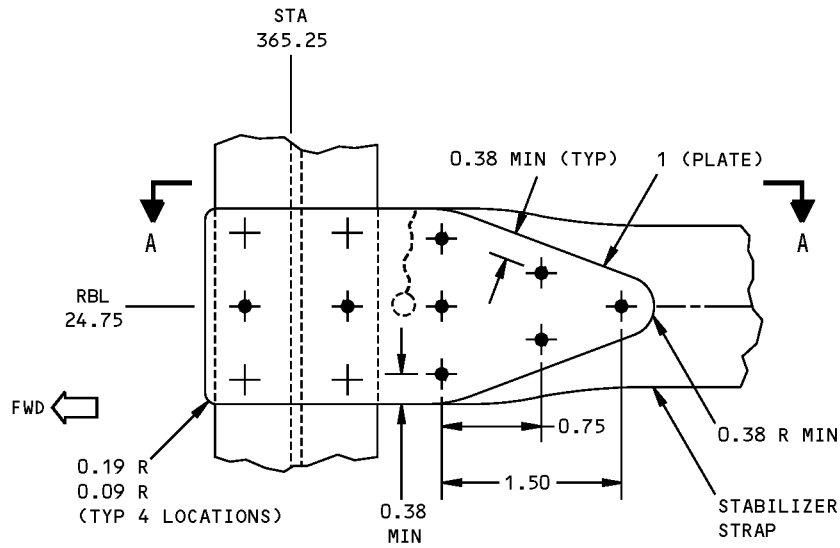
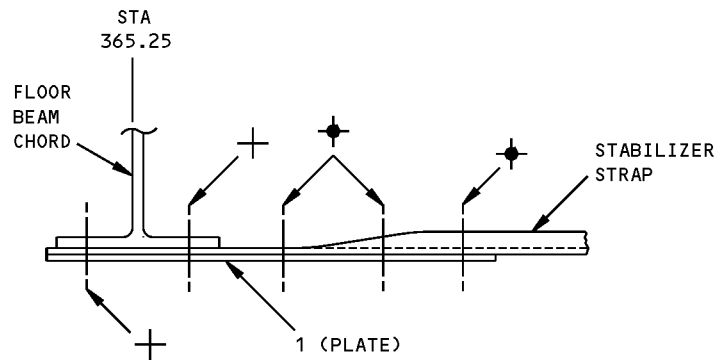
Section 41 Floor Structure Stabilizer Strap Crack Repair
Figure 201 (Sheet 2 of 7)

VIEW IN THE UP DIRECTION

SECTION A-A

DETAIL I

3. Make the part 1 plate. See Table I. See Details I thru V for a repair near the end of a stabilizer strap. See Detail VI for a repair at floor beam locations between the ends of a stabilizer strap.

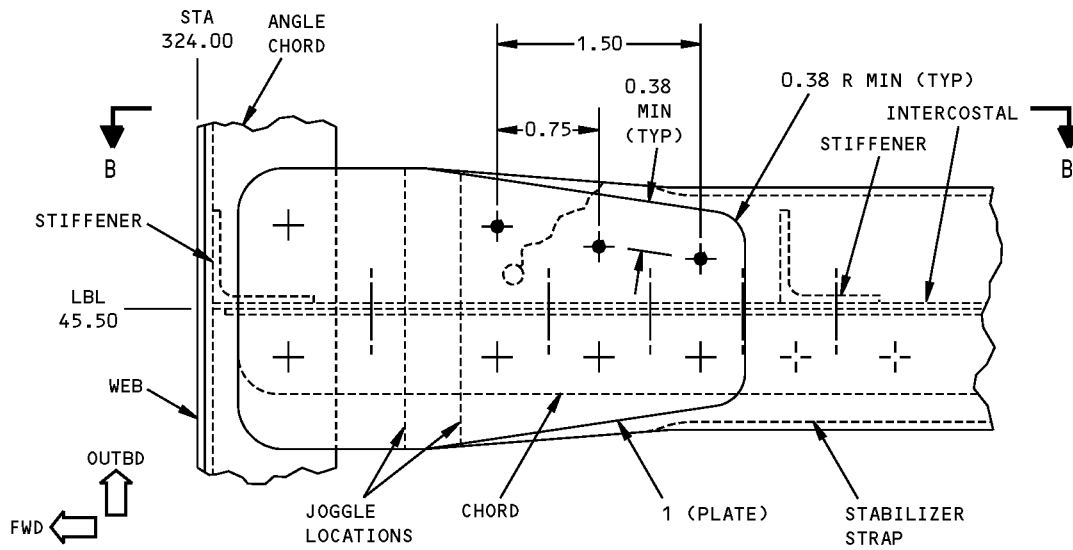
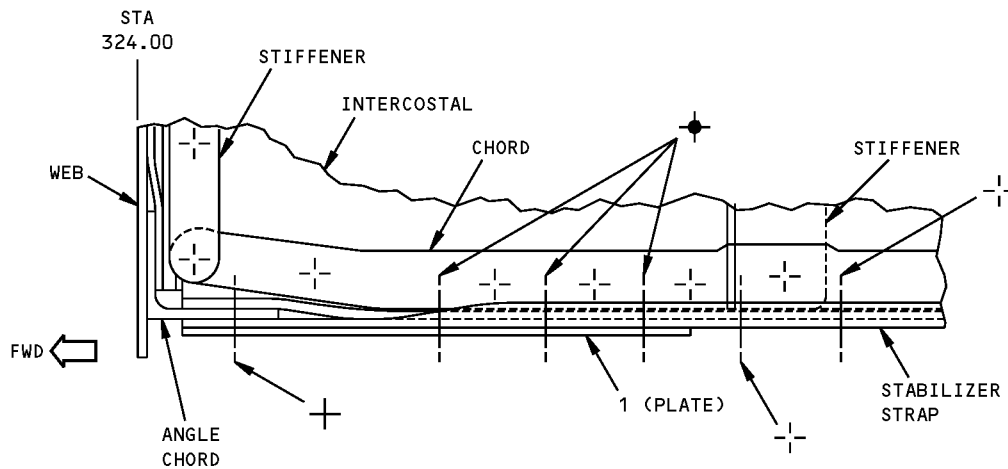
Section 41 Floor Structure Stabilizer Strap Crack Repair
Figure 201 (Sheet 3 of 7)

VIEW IN THE UP DIRECTION

SECTION B-B

DETAIL II
