FUSELAGE

757-200 STRUCTURAL REPAIR MANUAL

CHAPTER 53 FUSELAGE

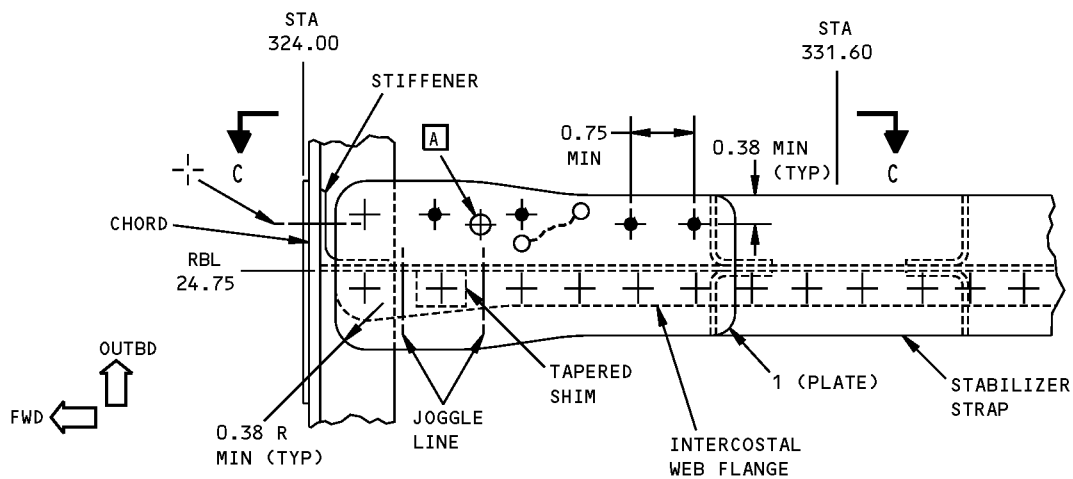
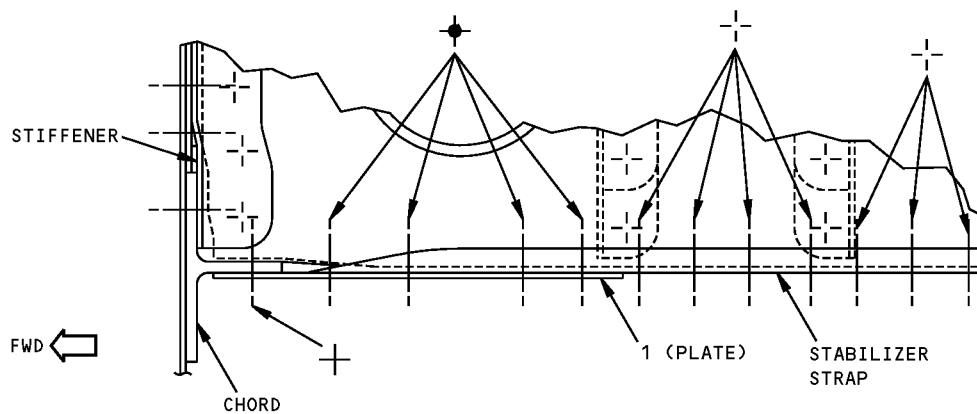
Section 41 Floor Structure Stabilizer Strap Crack Repair
Figure 201 (Sheet 4 of 7)

VIEW IN THE UP DIRECTION

SECTION C-C

DETAIL III

3. Make the part 1 plate. See Table I. See Details I thru V for a repair near the end of a stabilizer strap. See Detail VI for a repair at floor beam locations between the ends of a stabilizer strap.

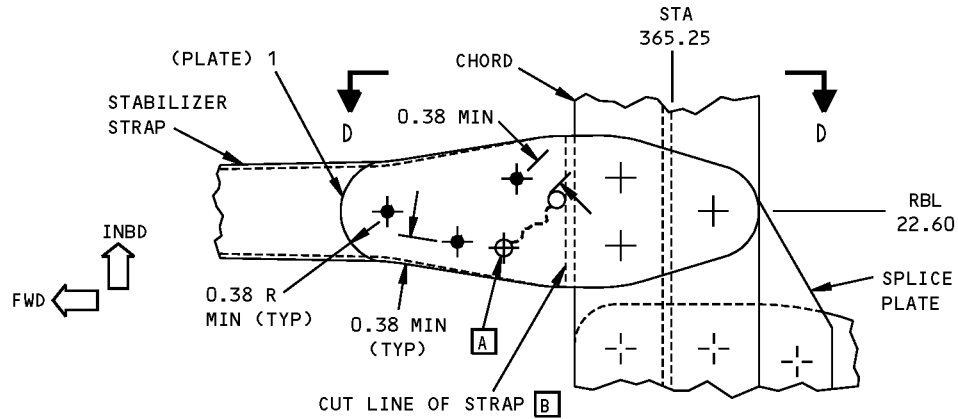
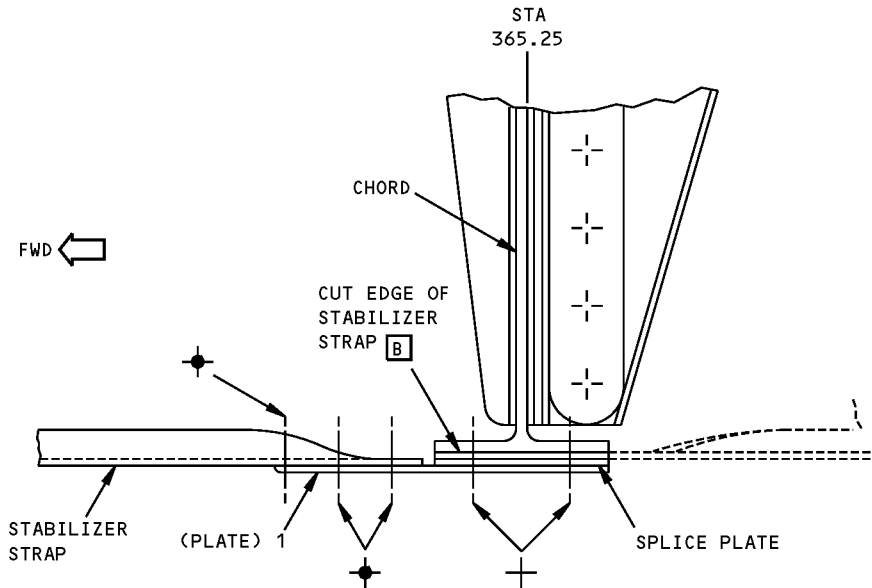
Section 41 Floor Structure Stabilizer Strap Crack Repair
Figure 201 (Sheet 5 of 7)

VIEW IN THE UP DIRECTION

SECTION D-D

DETAIL IV

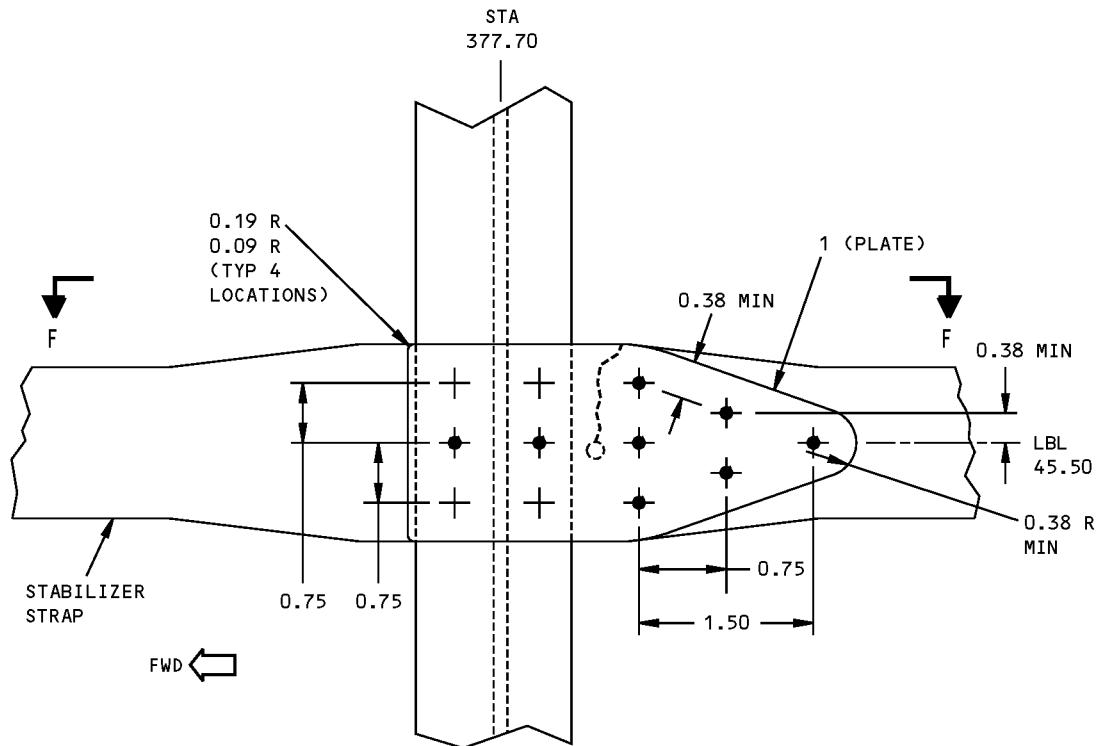
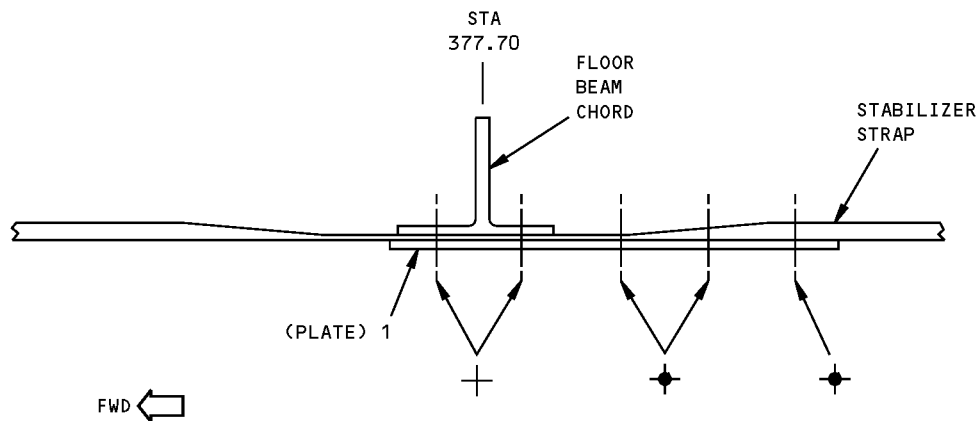
Section 41 Floor Structure Stabilizer Strap Crack Repair
Figure 201 (Sheet 7 of 7)

VIEW IN THE UP DIRECTION

SECTION F-F

DETAIL VI

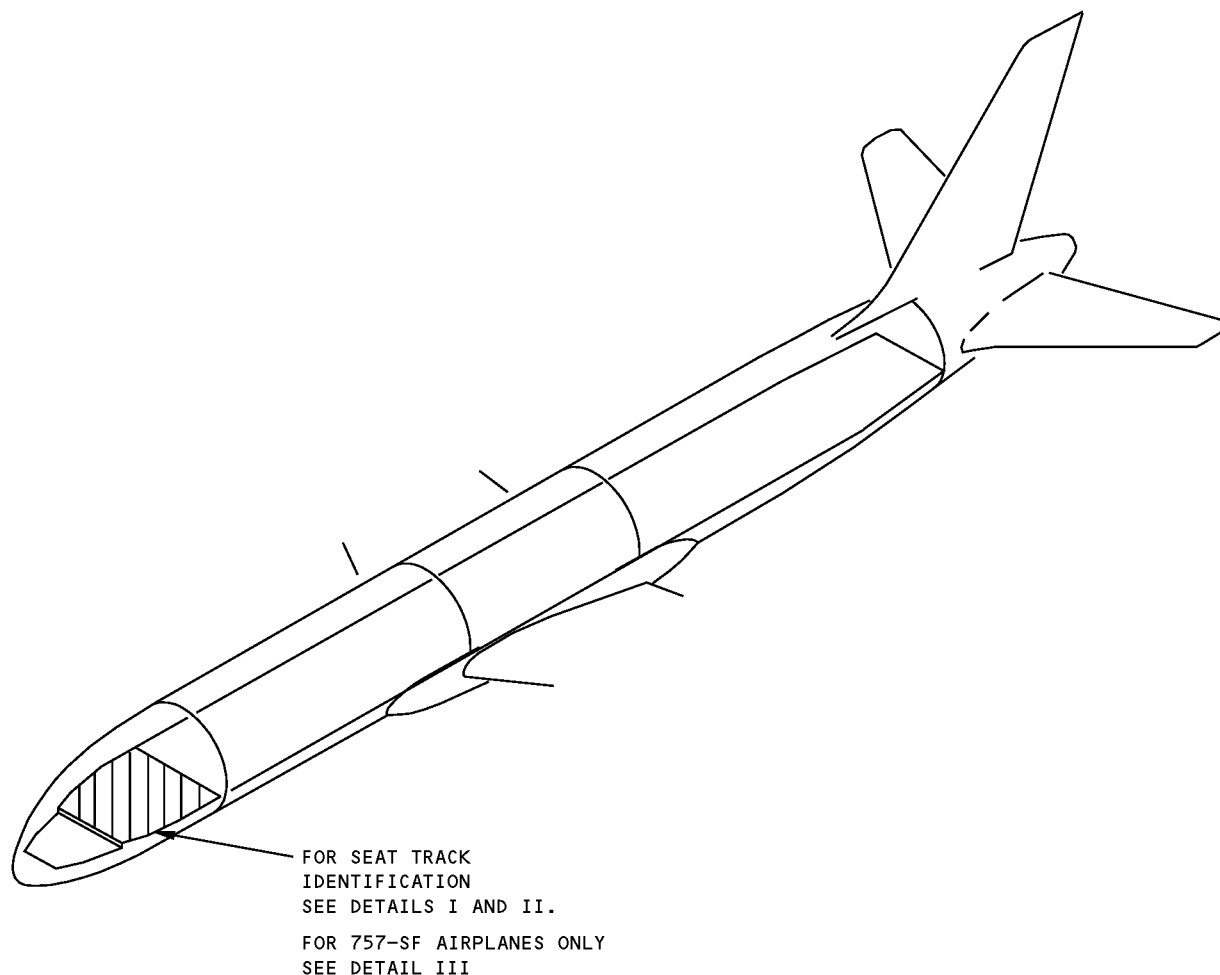
IDENTIFICATION 1 - SECTION 41 - SEAT TRACKS

A SEAT TRACK CONFIGURATION DIFFER FROM BASIC IN AREAS SHOWN TO SUIT OPERATOR REQUIREMENTS. SEE DWG 141N5130 FOR INDIVIDUAL OPERATOR VARIABLE

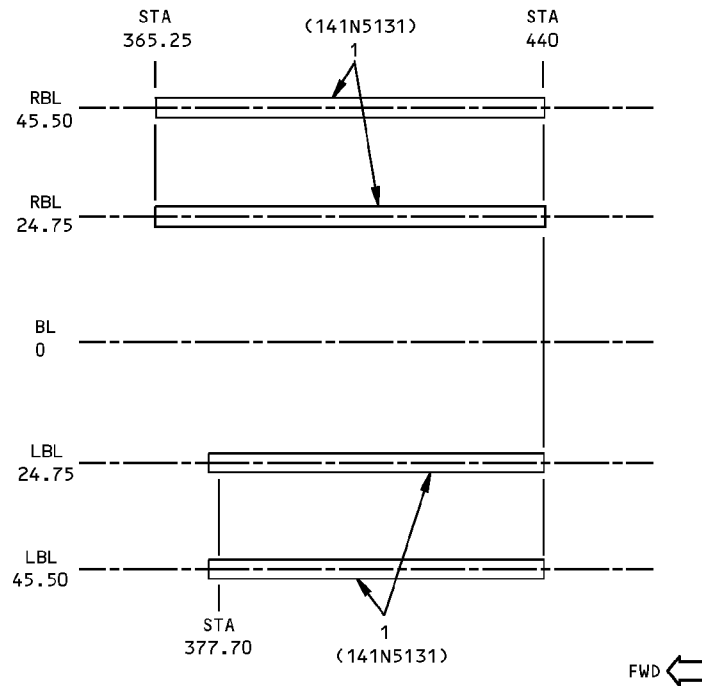
**BASIC CONFIGURATION
DETAIL I**

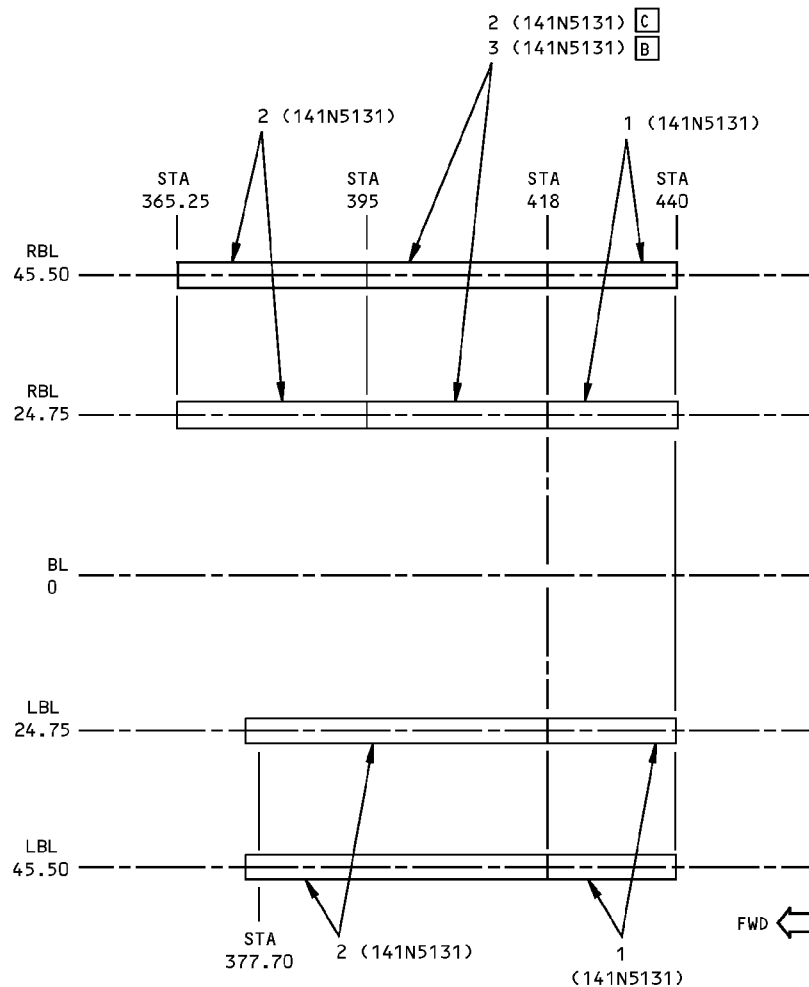
VARIABLE CONFIGURATION A
DETAIL II

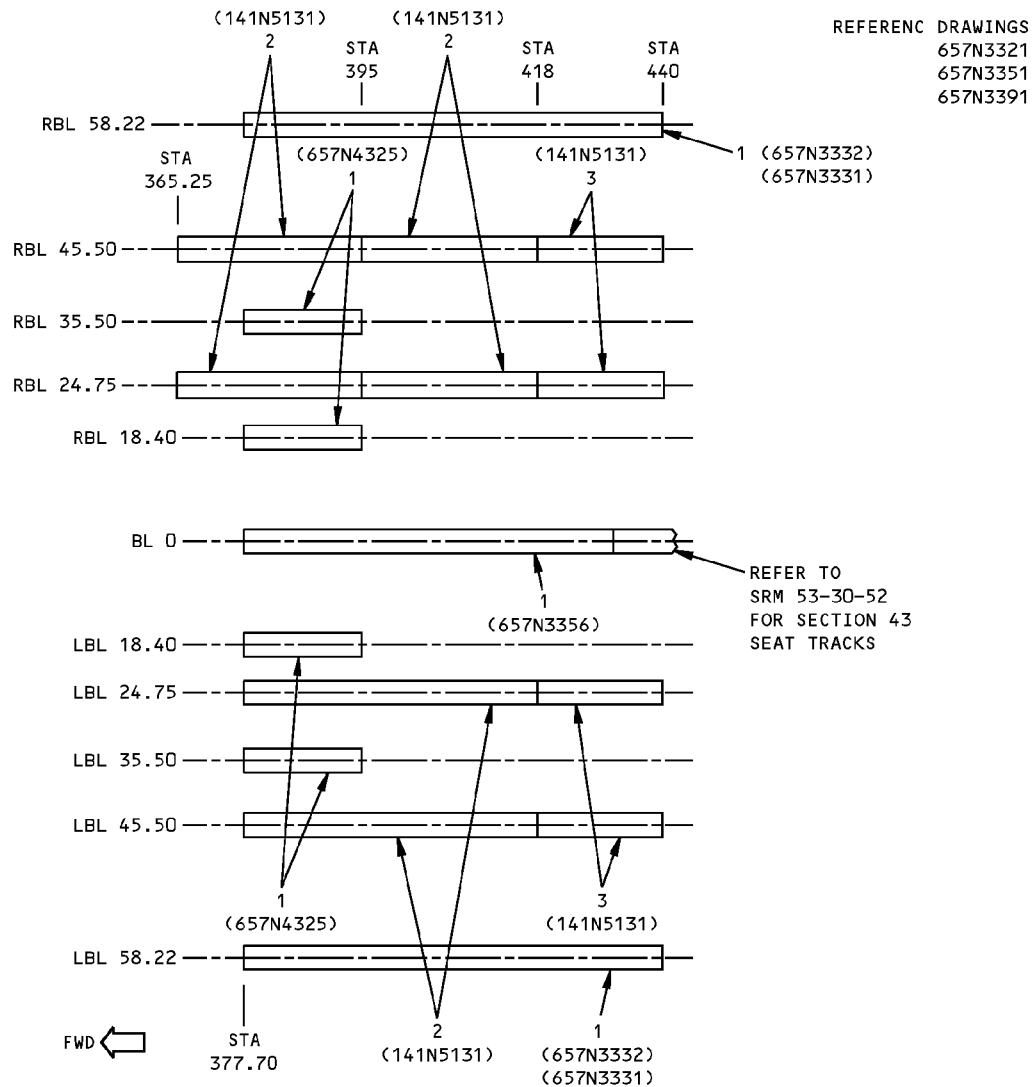
757-SF AIRPLANES ONLY
 DETAIL III

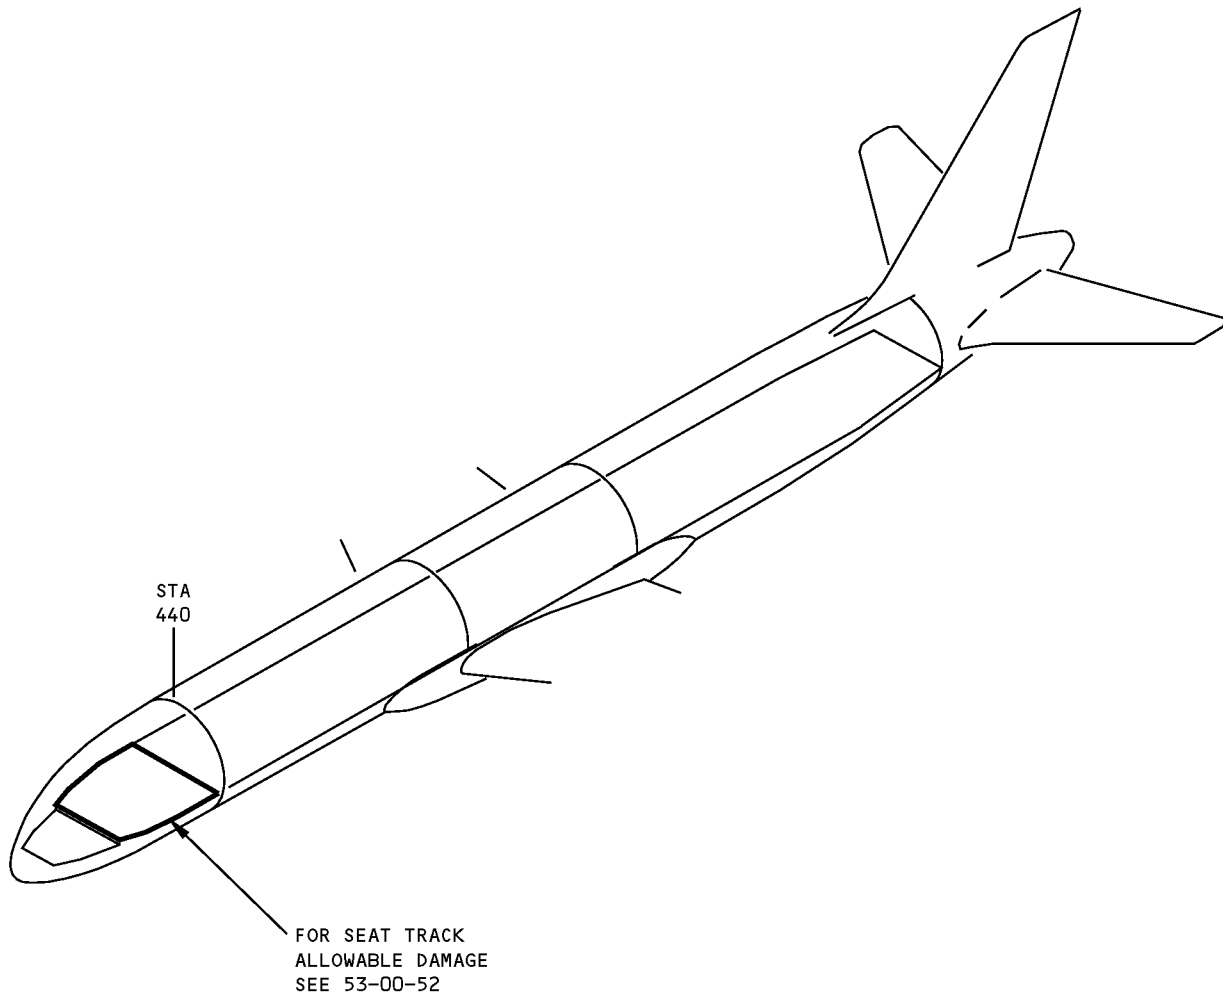
Section 41 Seat Track Allowable Damage
Figure 101

ALLOWABLE DAMAGE GENERAL - SECTION 41 - SEAT TRACKS

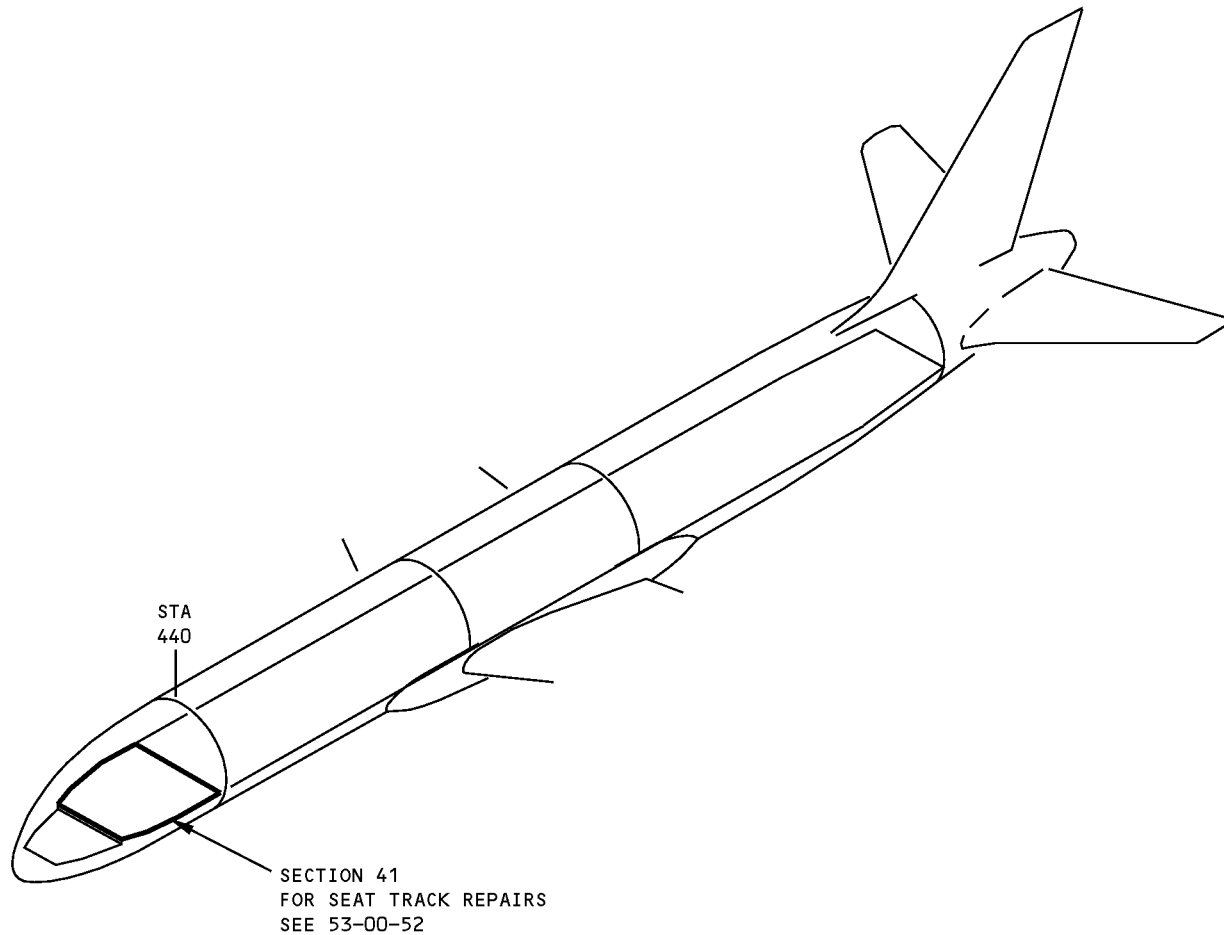
Section 41 Seat Track Repairs
Figure 201

REPAIR GENERAL - SECTION 41 - SEAT TRACKS

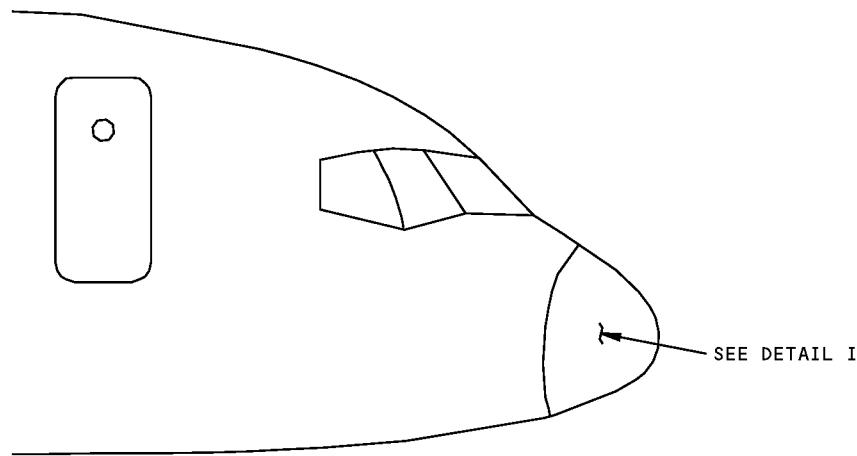
IDENTIFICATION 1 - NOSE RADOME

- REFER TO FIGURE 201, 202, 203, AND 204 FOR NONMETALLIC HONEYCOMB CORE RADOME REPAIR.
- REFER TO SRM 53-11-72, REPAIR GENERAL FOR FLUTED CORE RADOME REPAIR.
- REFER TO SRM 53-10-72, REPAIR GENERAL FOR RADOME THICKNESS INFORMATION.

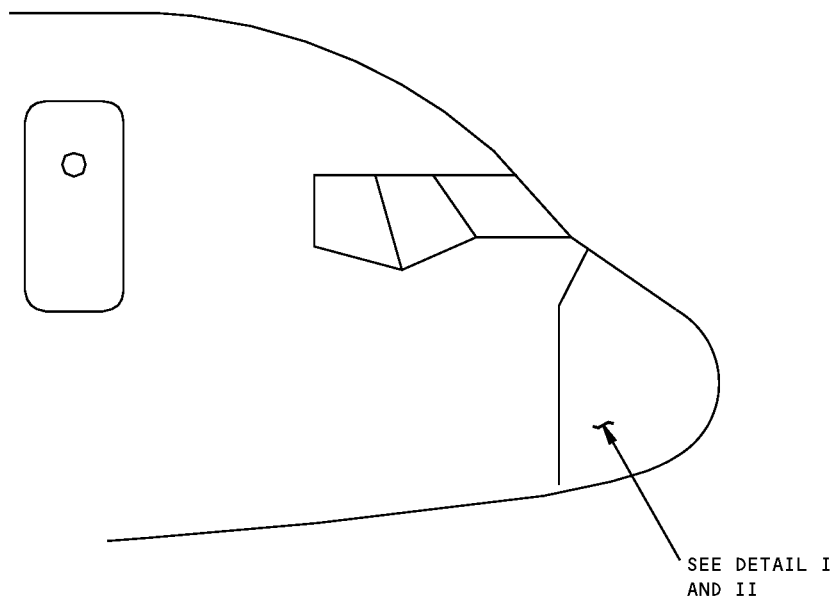
Nose Radome Allowable Damage
Figure 101 (Sheet 1 of 3)

ALLOWABLE DAMAGE 1 - NOSE RADOME

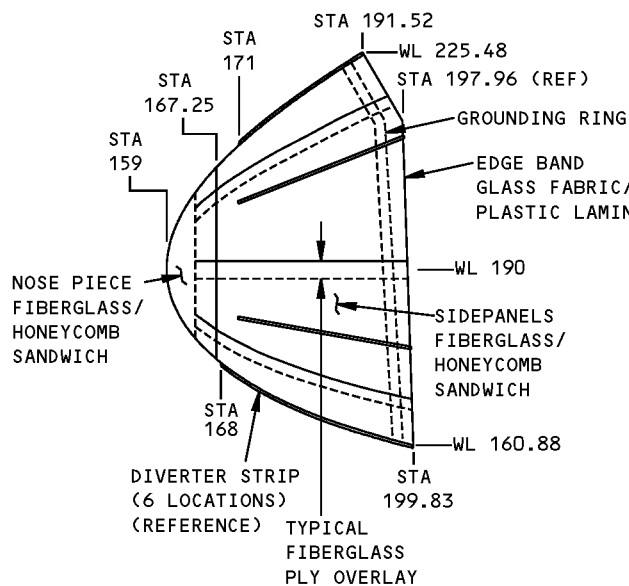
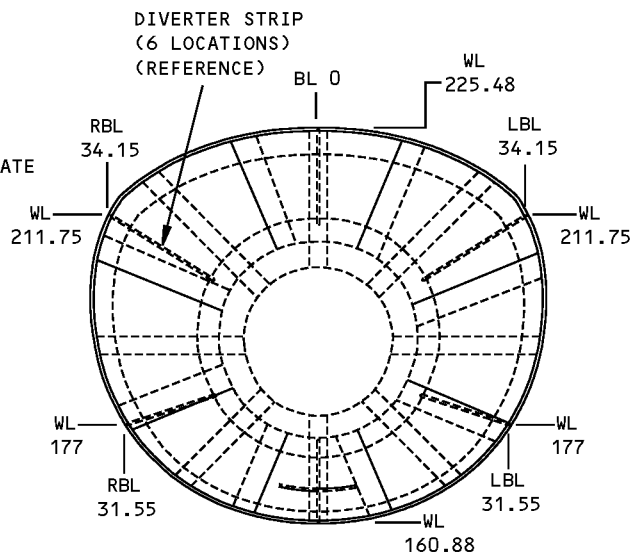
SIDE VIEW

REAR VIEW

FIBERGLASS SKIN WITH NOMEX HONEYCOMB CORE
RADOME
DETAIL I

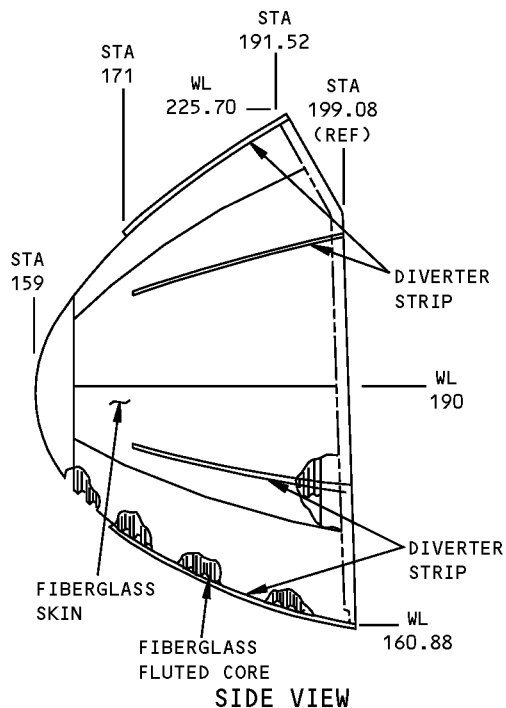
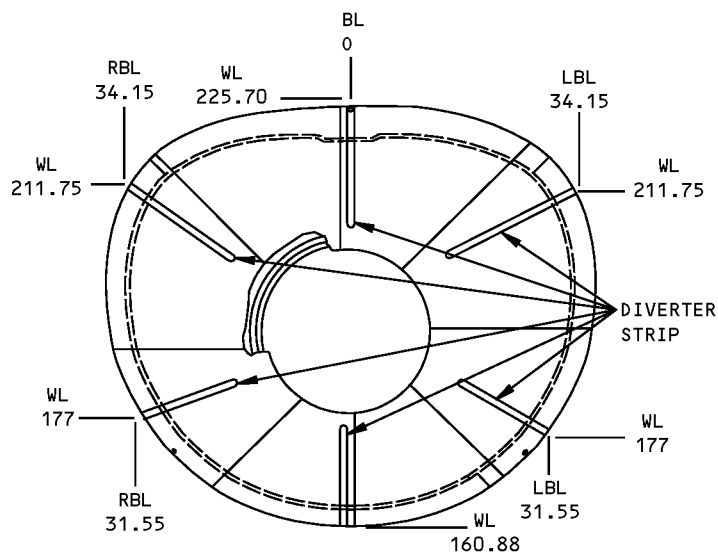
SIDE VIEW

REAR VIEW

FIBERGLASS SKIN AND FLUTED CORE RADOME
DETAIL II

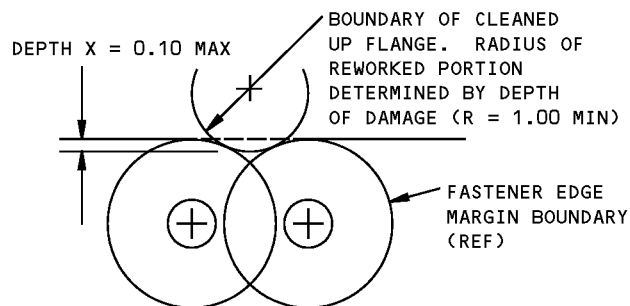
Nose Radome Allowable Damage
Figure 101 (Sheet 3 of 3)

DAMAGE CLEAN UP OF EDGES WHERE FASTENER EDGE MARGINS DO NOT OVERLAP

DAMAGE CLEAN UP OF EDGES WHERE FASTENER EDGE MARGINS OVERLAP

DETAIL III

| DESCRIPTION | CRACKS | NICKS, GOUGES AND CORROSION | DENTS | HOLES AND PUNCTURES |
|---|---|---|---|---|
| NOSE RADOME | CLEAN UP EDGE CRACKS PER DETAIL III. OTHER CRACKS ARE NOT PERMITTED | A B | A B | A B |
| GROUNDING RING | CLEAN UP EDGE CRACKS PER DETAIL III. OTHER CRACKS ARE NOT PERMITTED | A C | A C | A C |

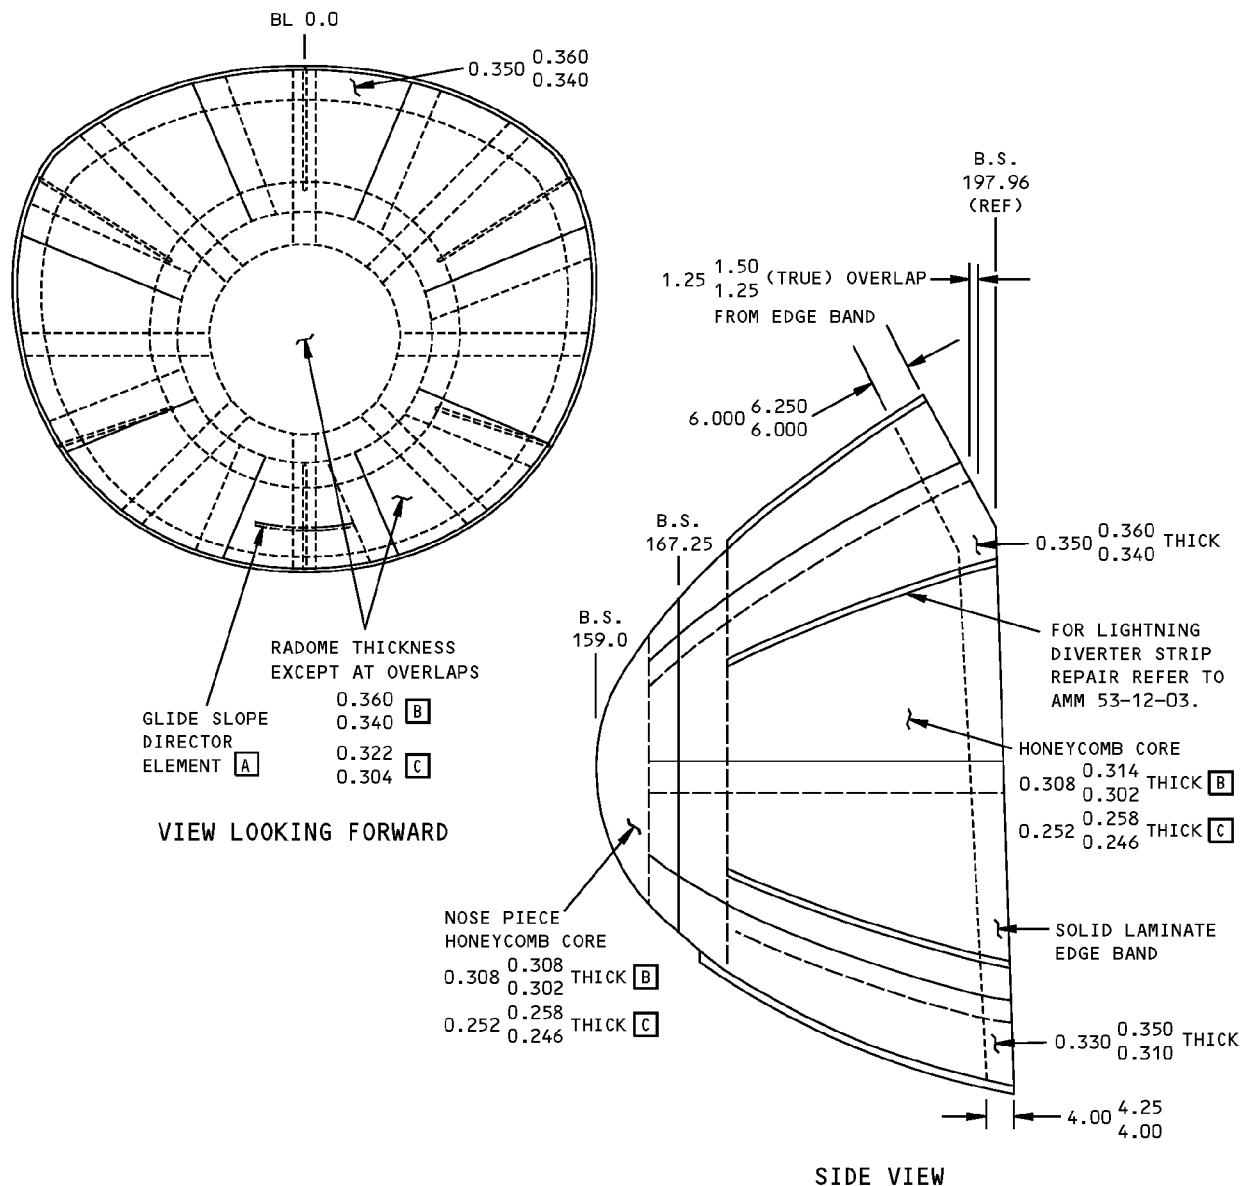
Thicknesses for Nose Radome
Figure 201

- THICKNESSES ARE BASED ON CURED SANDWICH THICKNESS BEFORE APPLICATION OF FINISHES OR RAIN EROSION COATINGS.
- RADOME THICKNESS AFTER REPAIR MAY BE MEASURED USING THE EDDY CURRENT METHOD DESCRIBED IN THE NONDESTRUCTIVE TESTING MANUAL, D634N301, PART 6.

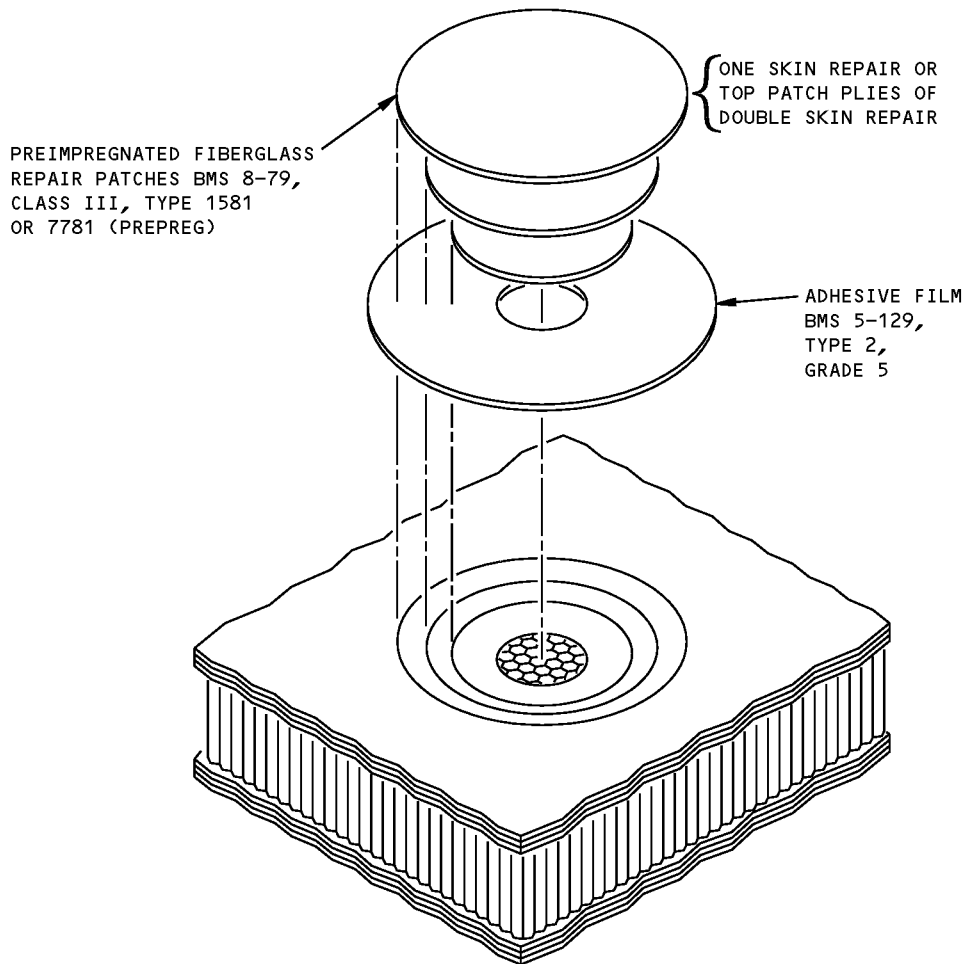
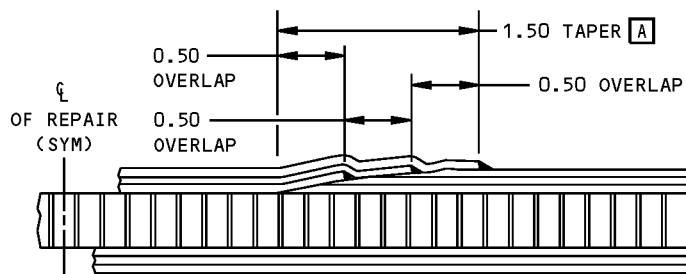
Nose Radome Prepreg Repairs Figure 202

SECTION THROUGH REPAIR
LAYUP "A"

- H. For repairs that use preimpregnated (prepreg) material, see Paragraph 8./REPAIR GENERAL and Figure 201/REPAIR GENERAL Figure 202/REPAIR GENERAL Figure 203/REPAIR GENERAL Figure 204/REPAIR GENERAL and Figure 205/REPAIR GENERAL.

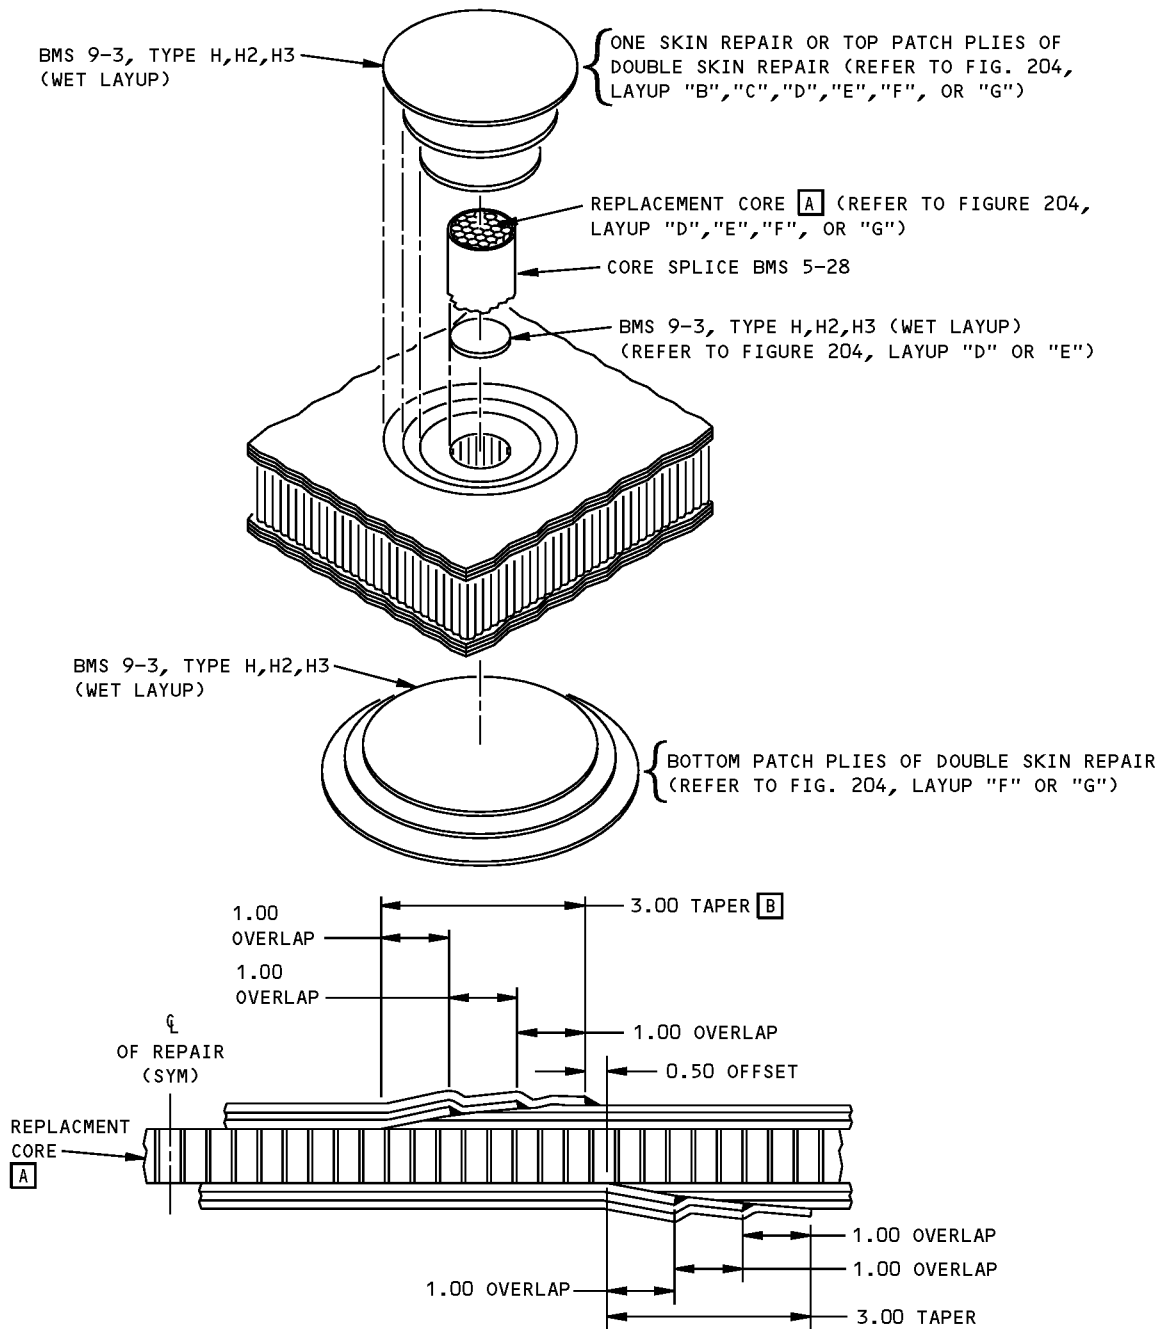
SECTION THROUGH REPAIR

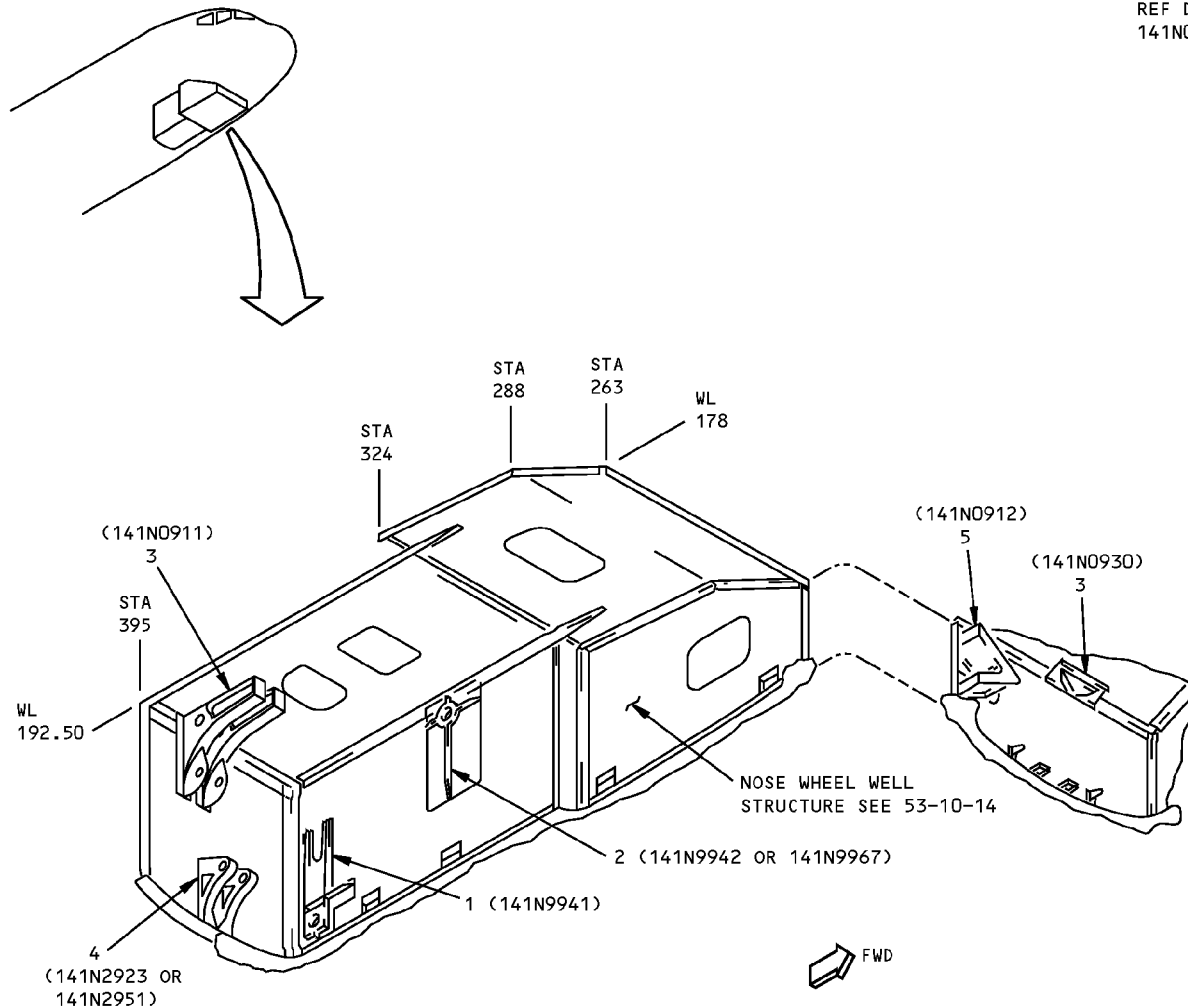
IDENTIFICATION 1 - NOSE LANDING GEAR ATTACHMENT FITTINGS

| ITEM | DESCRIPTION | GAGE | MATERIAL | EFFECTIVITY |
|---|---|---|--|---|
| 1 | TRUNNION FITTING | | FORGED BLOCK 7075-T73 | |

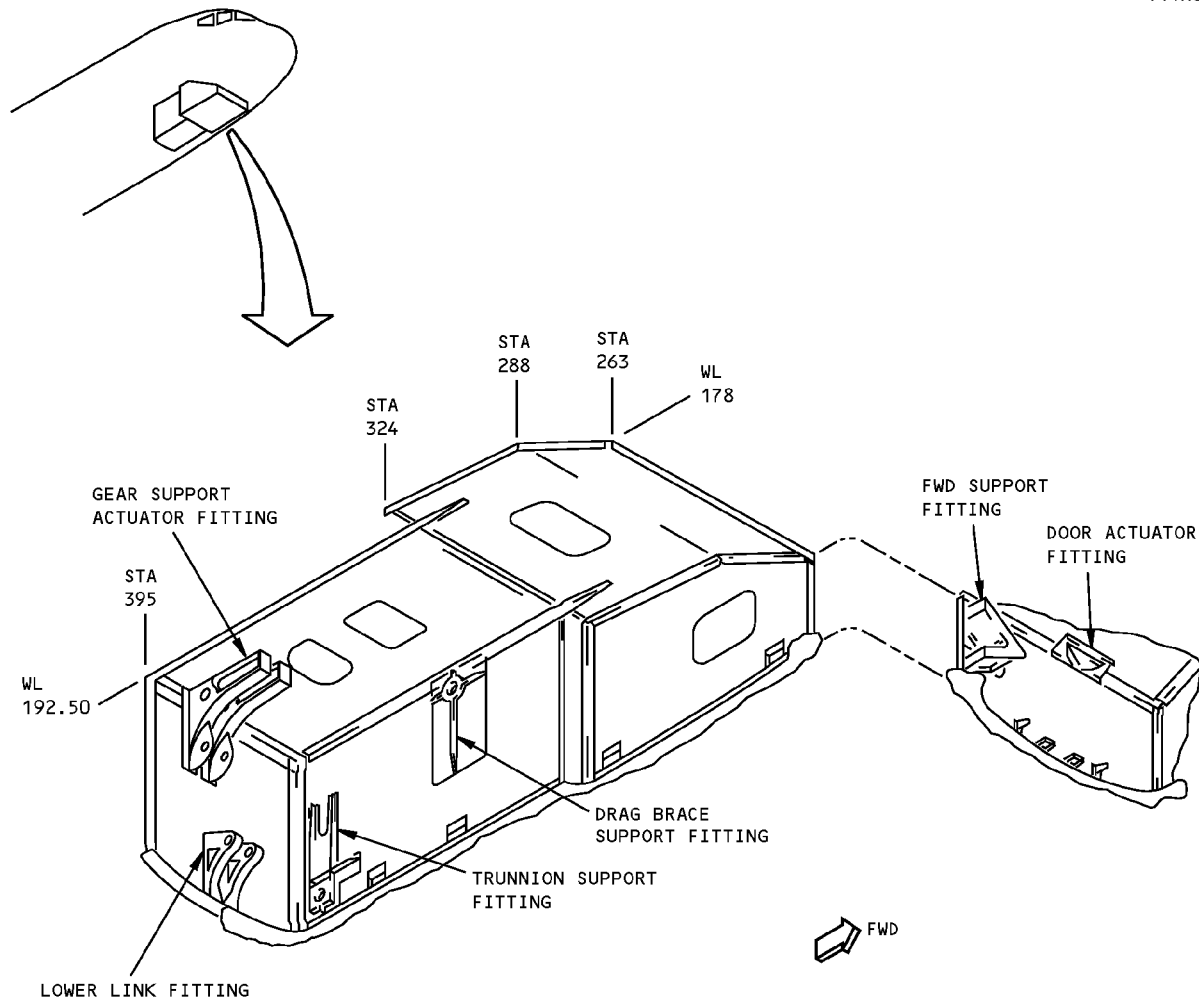
ALLOWABLE DAMAGE 1 - NOSE LANDING GEAR ATTACHMENT FITTINGS

MATERIAL: ALUMINUM FORGED BLOCK

- SHOT PEEN ALL REWORKED AREAS PER 51-20-06
 - REFINISH REWORKED AREAS PER 51-20 OF THE MAINTENANCE MANUAL
- A** CLEAN UP EDGE CRACKS PER DETAILS I AND IV. OTHER CRACKS NOT ALLOWED
- B** CLEAN UP EDGE DAMAGE PER DETAILS I AND IV. FOR OTHER DAMAGE SEE DETAILS II AND V. FOR LUG DAMAGE SEE DETAIL III
- C** CLEAN UP EDGE DAMAGE PER DETAILS I AND IV. FOR OTHER DAMAGE SEE DETAIL II. FOR LUG DAMAGE SEE DETAIL III
- D** CLEAN UP EDGE DAMAGE PER DETAILS I AND IV. FOR OTHER DAMAGE SEE DETAILS II AND VI
- E** CLEAN UP EDGE DAMAGE PER DETAILS I AND IV. FOR OTHER DAMAGE SEE DETAILS II AND V

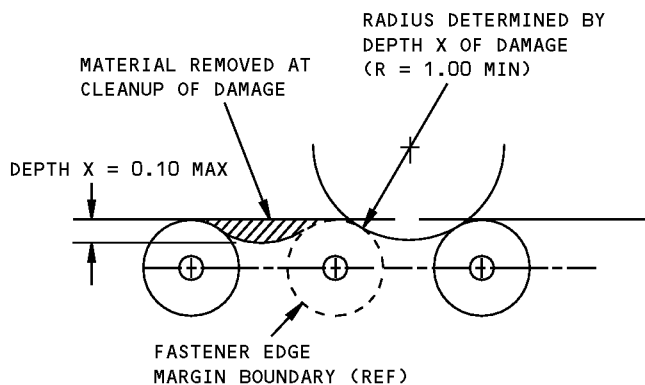
DETAIL I

DAMAGE CLEANUP OF EDGES WITH FASTENERS
WHERE EDGE MARGINS DO NOT OVERLAP

DAMAGE CLEANUP OF EDGES WITH FASTENERS
WHERE EDGE MARGINS OVERLAP

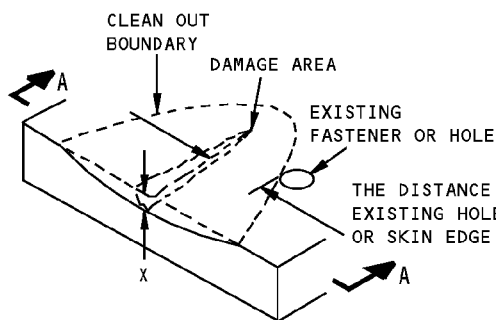
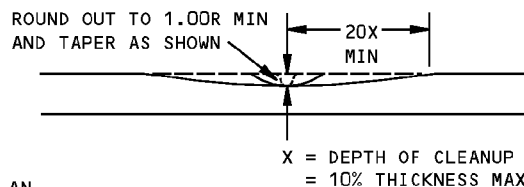
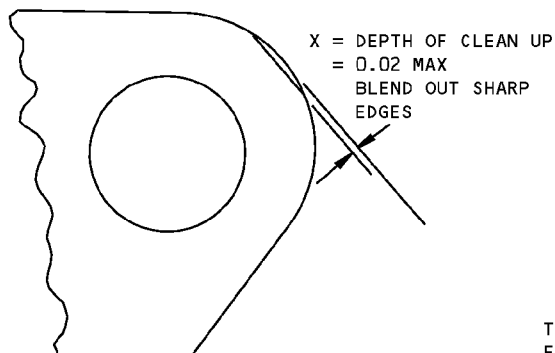
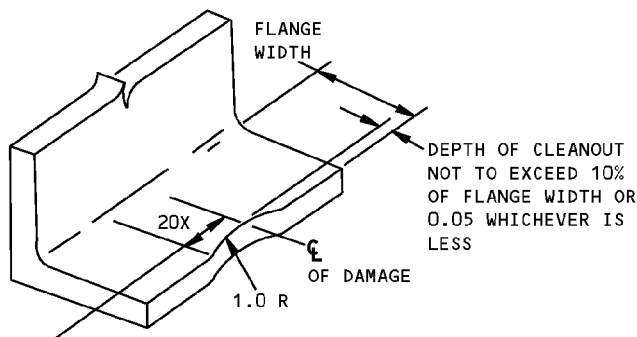
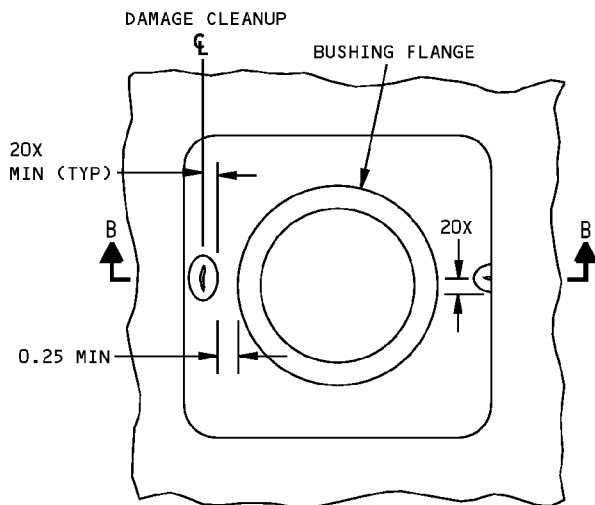
Nose Landing Gear Attachment Fittings Allowable Damage
Figure 101 (Sheet 3 of 4)

REMOVAL OF NICK, GOUGE AND SCRATCH DAMAGE ON A SURFACE
DETAIL II

THE AREA REMOVED FOR CLEANUP
MUST NOT EXCEED 4% OF THE CROSS
SECTIONAL AREA

SECTION A-A

DAMAGE CLEANUP FOR EDGES OF LUG
DETAIL III

THE DISTANCE OF THE DAMAGE FROM AN
EXISTING HOLE, FASTENERS, OTHER DAMAGE
OR EDGE MUST NOT BE LESS THAN 20X

REMOVAL OF EDGE DAMAGE FROM
FREE FLANGE WITHOUT FASTENERS
DETAIL IV

DETAIL V

SECTION B-B

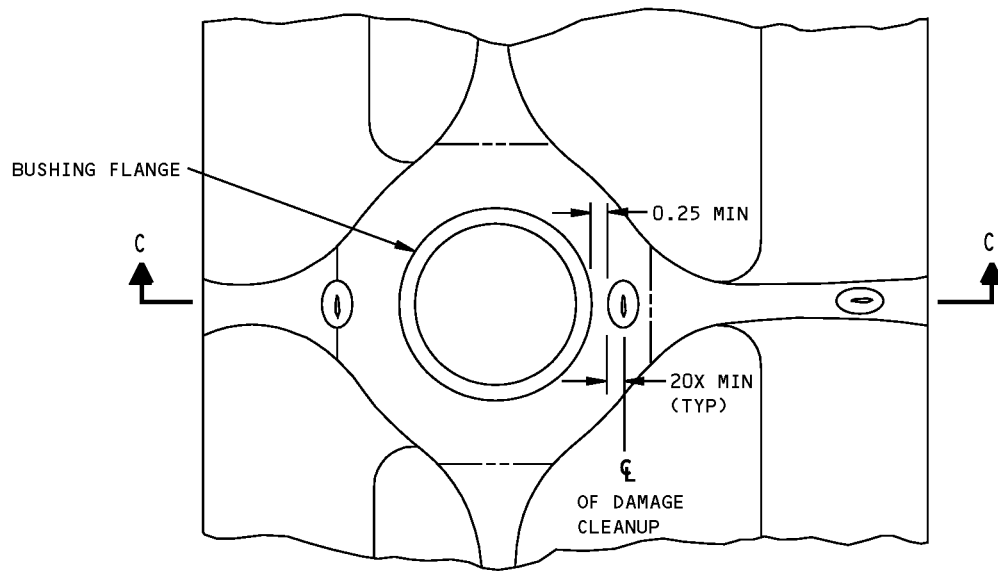
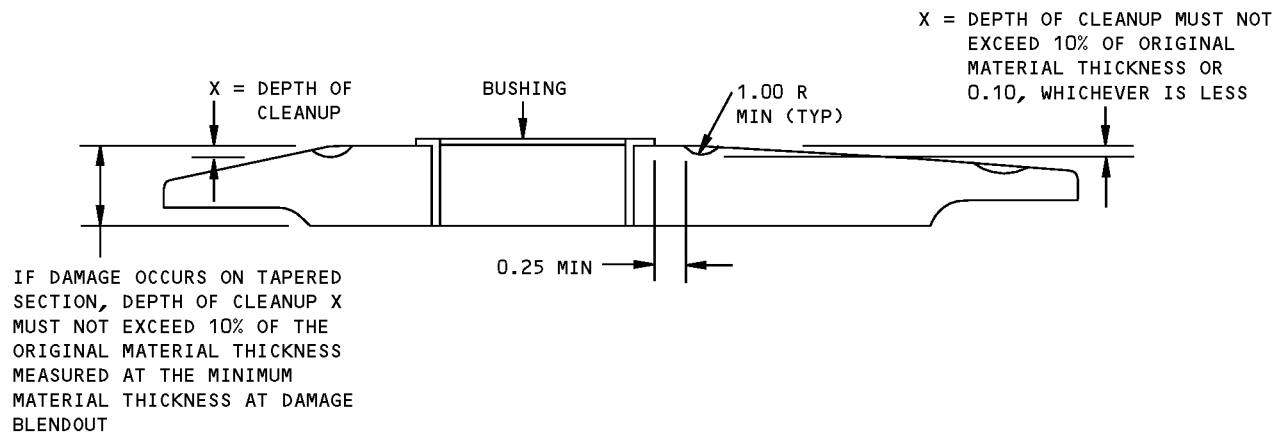
Nose Landing Gear Attachment Fittings Allowable Damage
Figure 101 (Sheet 4 of 4)

SECTION C-C

DETAIL VI

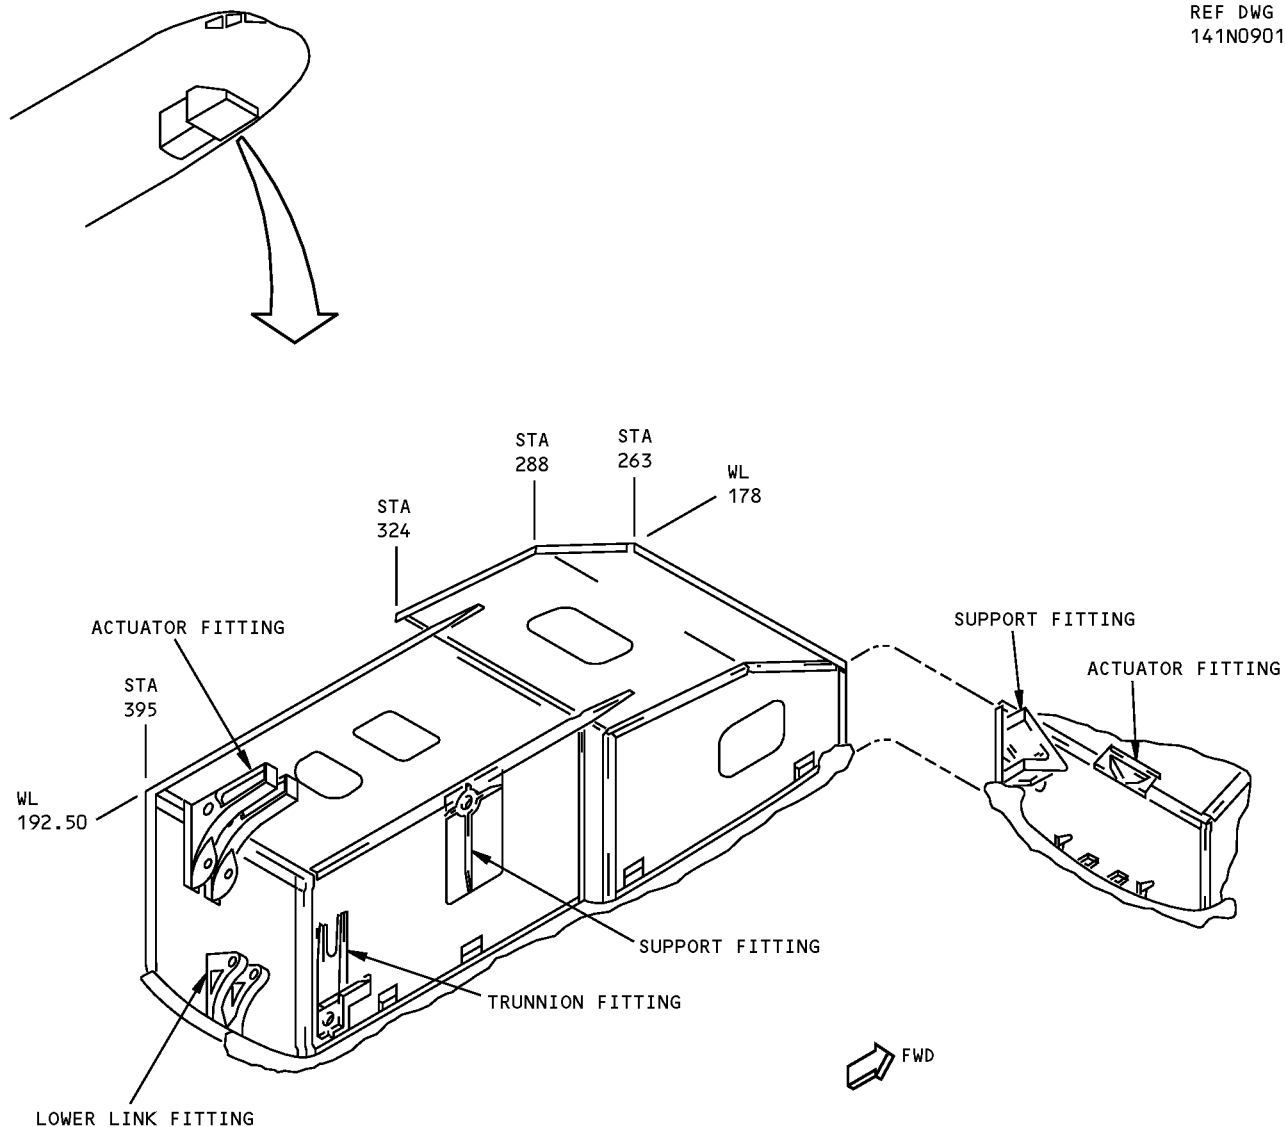
Nose Landing Gear Attachment Fitting Repair
Figure 201

REPAIR GENERAL - NOSE LANDING GEAR ATTACHMENT FITTINGS

REF DWG
141N0901

- NO TYPICAL REPAIR TO FITTINGS APPLICABLE.
SPECIFIC REPAIRS TO FITTINGS WILL BE
PROVIDED BASED ON SERVICE EXPERIENCE
