FUSELAGE

757-200 STRUCTURAL REPAIR MANUAL

CHAPTER 53 FUSELAGE

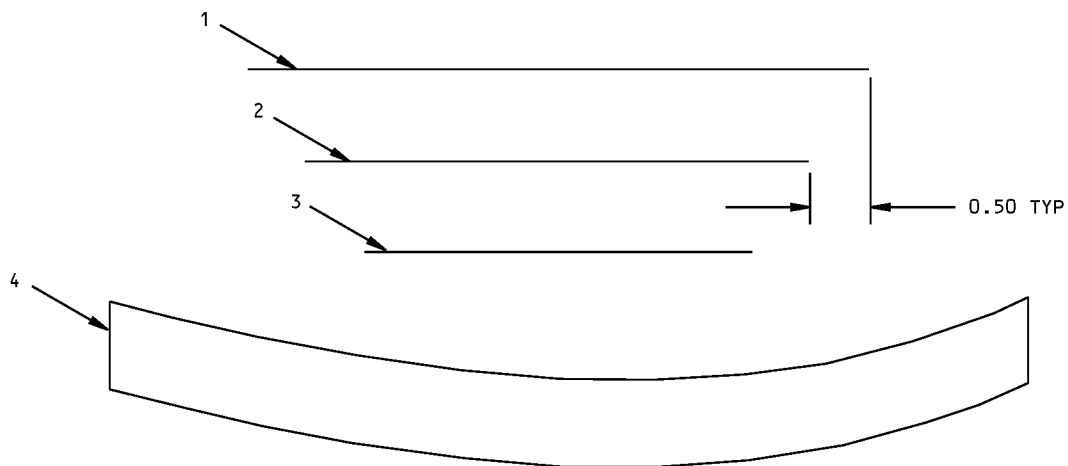
**Layup Diagram - Precured Patch
Figure 201**

| ITEM | MATERIAL |
|---|---|
| 1 | PREPREG PER BMS 8-79 TYPE 1581 |

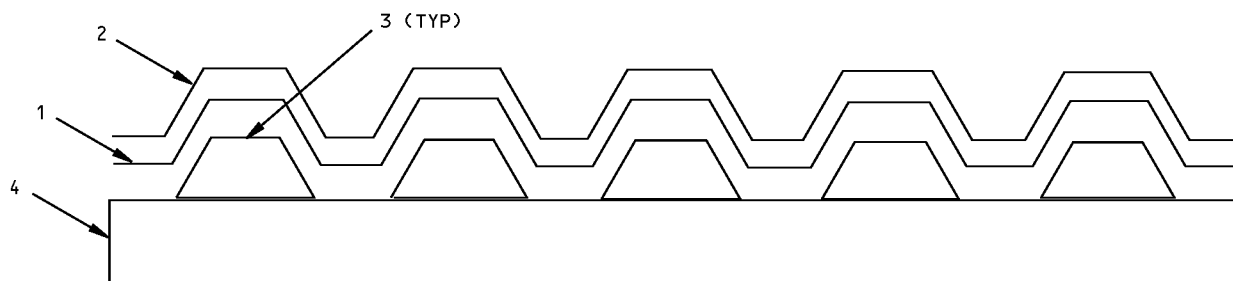
**Core Patch Layup
Figure 202**

| ITEM | MATERIAL |
|---|---|
| 1 | PREPREG PER BMS 8-79 TYPE 120 |

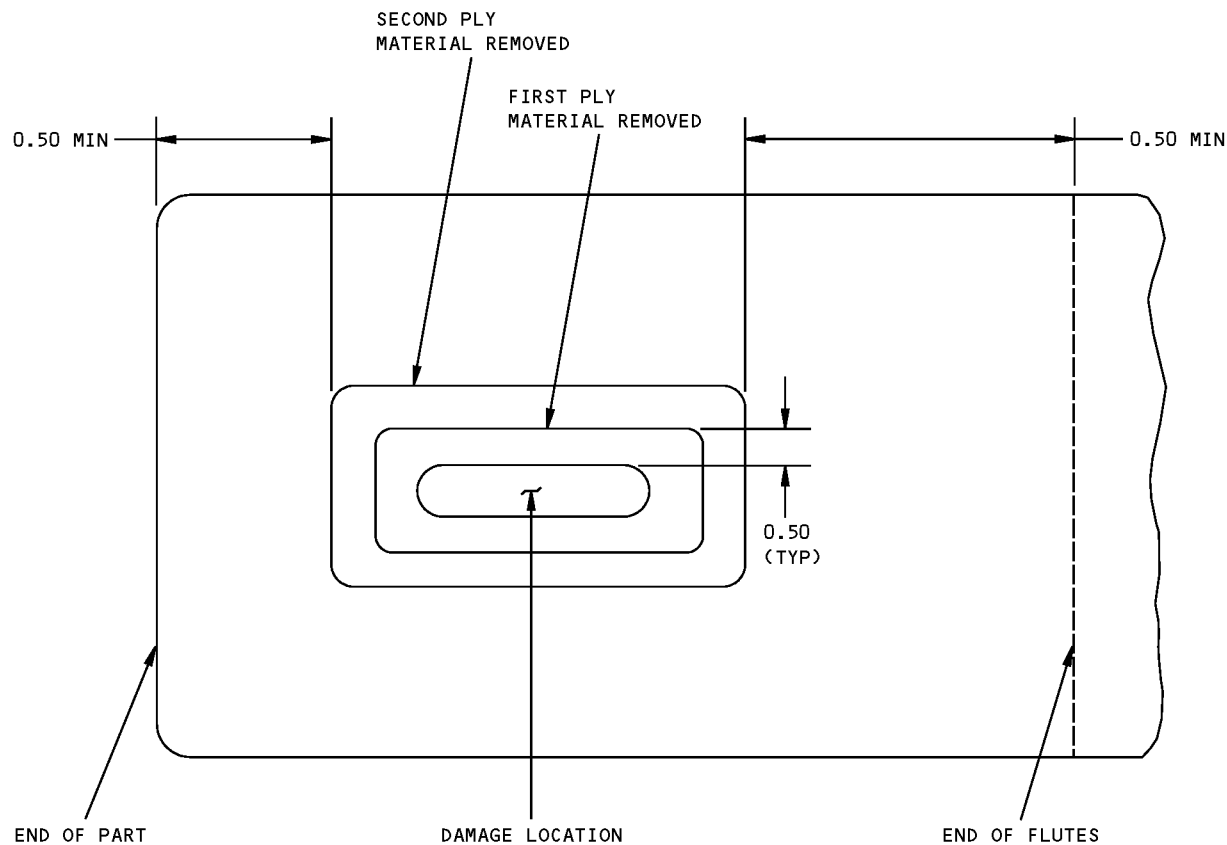
**2 Ply Damage Repair
Figure 204 (Sheet 1 of 2)**

**MATERIAL REMOVAL PROCEDURE
DETAIL I**

- (1) Mark off the area required for ply replacement.
- (2) Prepare glass fabric patches in accordance with Paragraph 6.B.(2)/REPAIR GENERAL.
- (3) Cut glass fabric patches using the same fabric and warp orientation as specified on the engineering drawing. There shall be a glass fabric patch applied for every ply removed plus one extra ply. Cut all patches 0.50 inch larger on all edges than the ply that was removed. The extra ply shall be 1.0 inch larger on all edges than the first ply removed and shall be glass fabric per specification BMS 9-3, Type D (Figure 204/REPAIR GENERAL and Figure 208/REPAIR GENERAL).

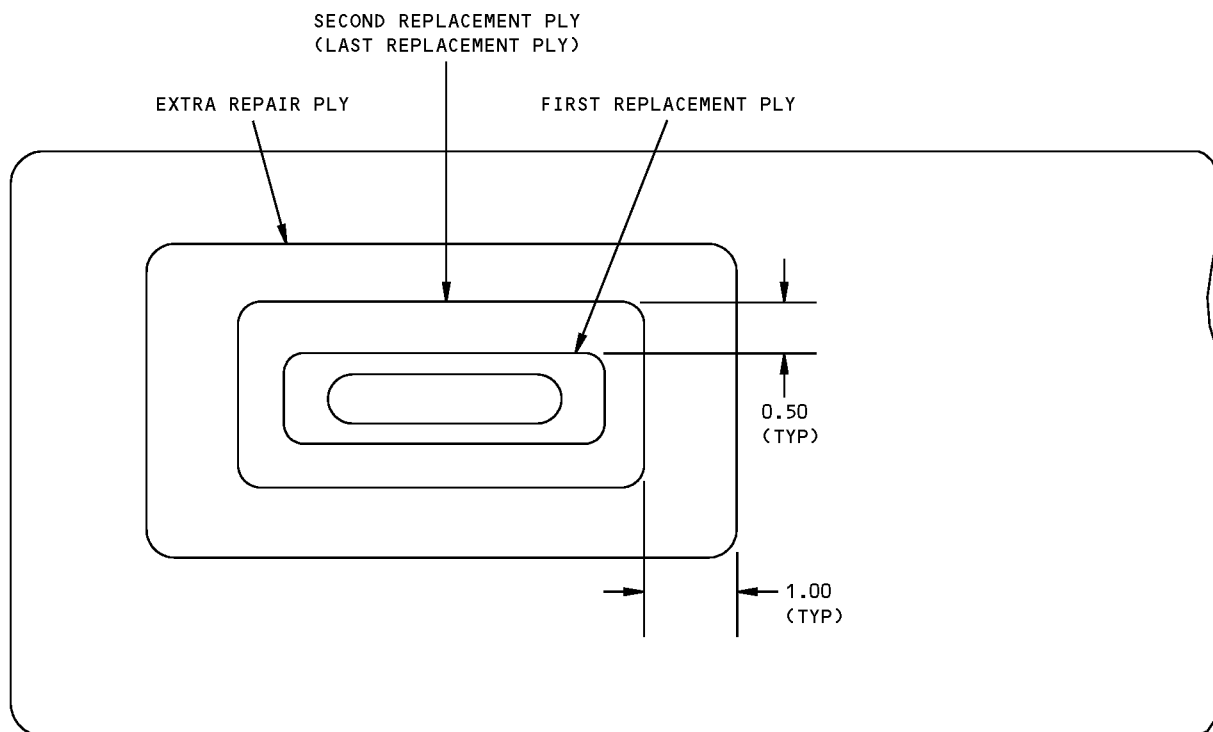
2 Ply Damage Repair
Figure 204 (Sheet 2 of 2)

DETAIL II

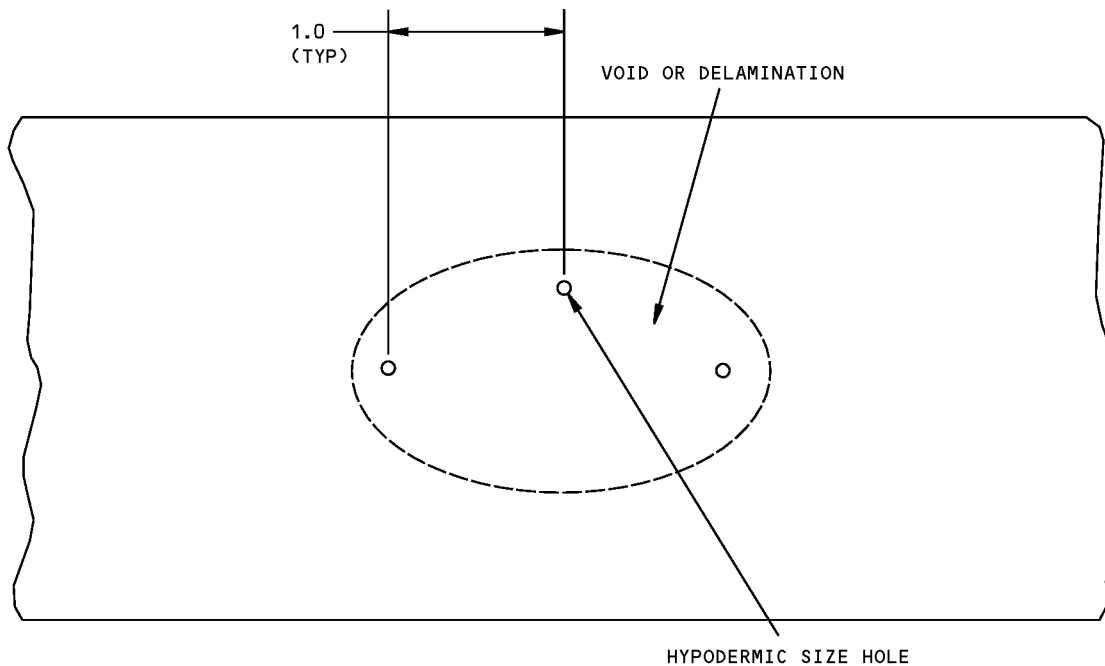
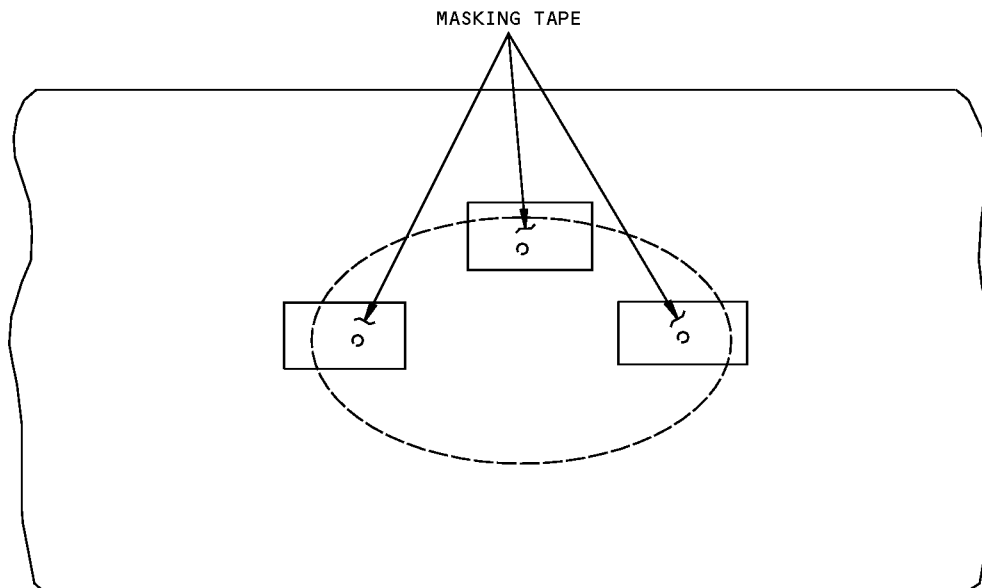
Repair Of Voids And Delaminations
Figure 205

STEP 1
DETAIL I

STEP 2
DETAIL II

- (1) Drill small holes into void about 1.0 inch apart. Drill at least two holes at both ends of void. Select hole size to ensure tight fit of hypodermic needle that will be used in filling the holes. Outline void area as shown in Figure 205/REPAIR GENERAL, Detail I.

- (3) Observe resin flow, continue to inject resin until void is filled.
- (4) When the voids have been filled, cover the holes with masking tape (Detail II, Figure 205/REPAIR GENERAL).

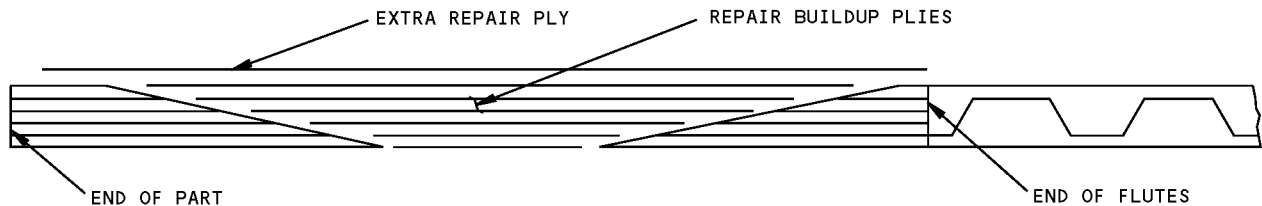
Repair of Mislocated Hole or Puncture Larger than 0.50 Inch
Figure 207

MISLOCATED HOLE OR PUNCTURE LARGER THAN 0.50 INCH

- REMOVE MATERIAL TO OBTAIN 10° SLOPE MAXIMUM
- HIGHER SLOPE IS PERMITTED ONLY IN AREAS WHERE 0.50 MINIMUM REQUIREMENTS PER FIGURE 203 CANNOT BE MET
- MATERIAL SHALL BE REMOVED IN OVAL SHAPE TO MEET 10° SLOPE MAXIMUM IN REMAINING AREA

- (a) Puncture is 0.50 inch or smaller in any direction.
 - 1) Mark off area to be repaired.
 - 2) Countersink both sides of hole per Figure 206/REPAIR GENERAL.
 - 3) Remove all finishes 0.25 inch minimum beyond the edge of the countersink.
 - 4) Prepare resin mix in accordance with Paragraph 6.B.(1)/REPAIR GENERAL.
 - 5) Add 20 percent by weight of the milled glass fiber to the catalysed resin mix. Mix to the milled glass fiber evenly dispersed.
 - 6) Fill the hole with mixture prepared per par. (5) above.
 - 7) Cure per requirements of Figure 209/REPAIR GENERAL.
 - 8) Refinish per requirements of par. Paragraph 10./REPAIR GENERAL.
- (b) Puncture is larger than 0.50 inch in any direction. Repair in accordance with Paragraph 7.A.(1)/REPAIR GENERAL and Figure 207/REPAIR GENERAL.

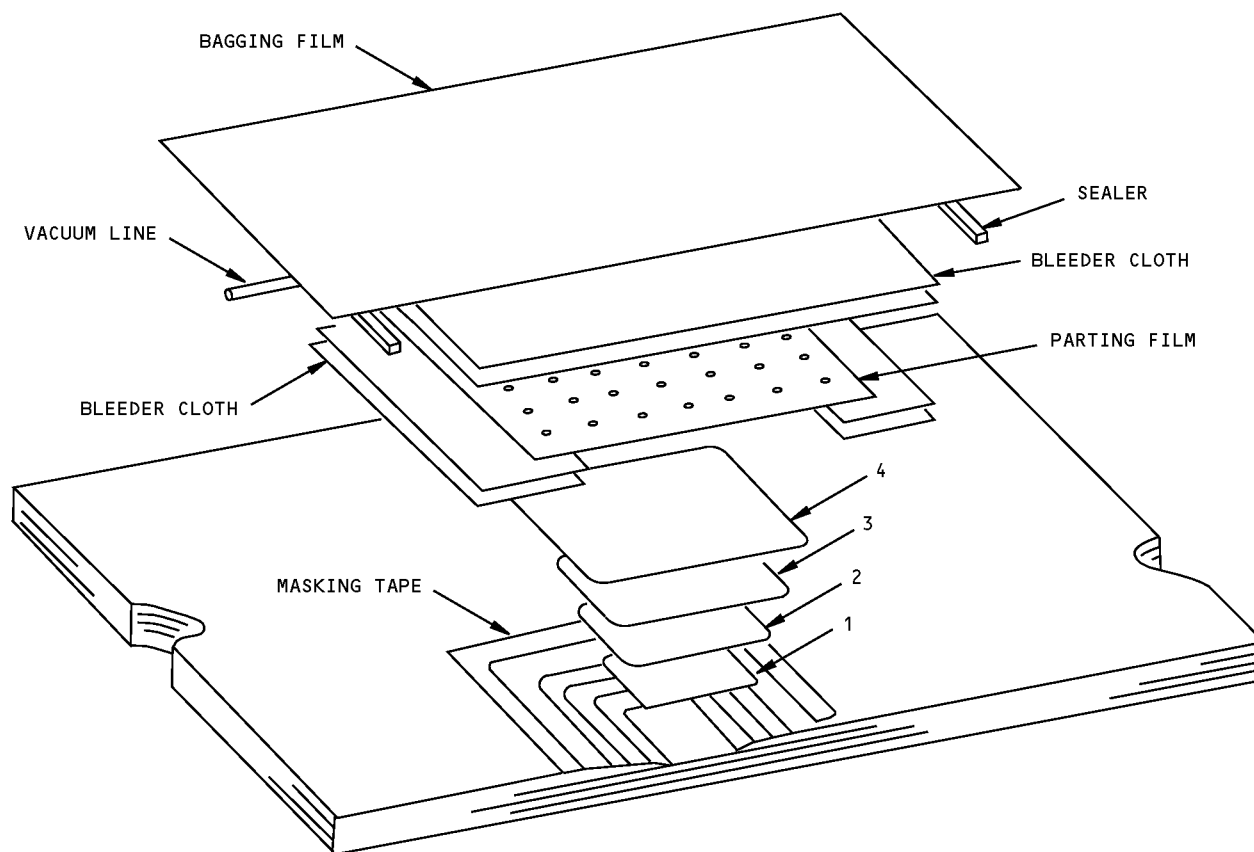
3 Ply Replacement or Repair of Solid Laminate Structure
Figure 208 (Sheet 1 of 2)

DETAIL I

- (6) Place layer of perforated parting film over the repaired area.
- (7) Lay bleeder cloth over parting film. Edge bleeder may be used as an option (ply for ply) or in addition (Figure 208/REPAIR GENERAL).

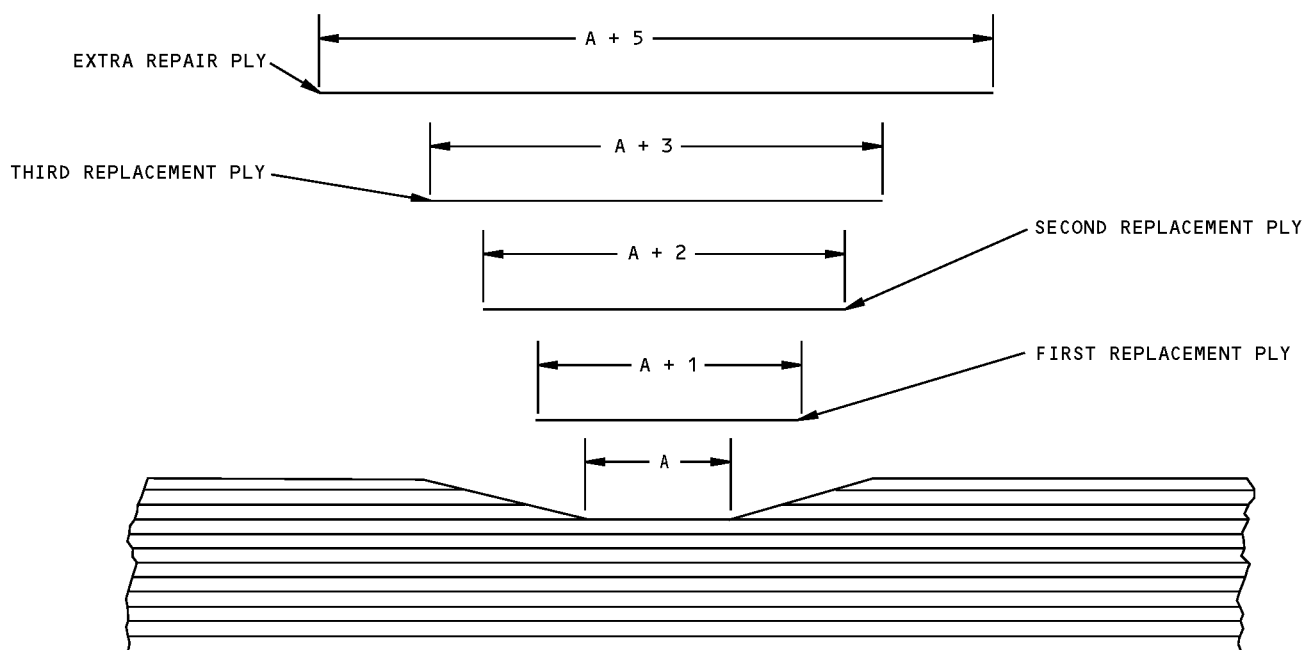
3 Ply Replacement or Repair of Solid Laminate Structure
Figure 208 (Sheet 2 of 2)

DETAIL II

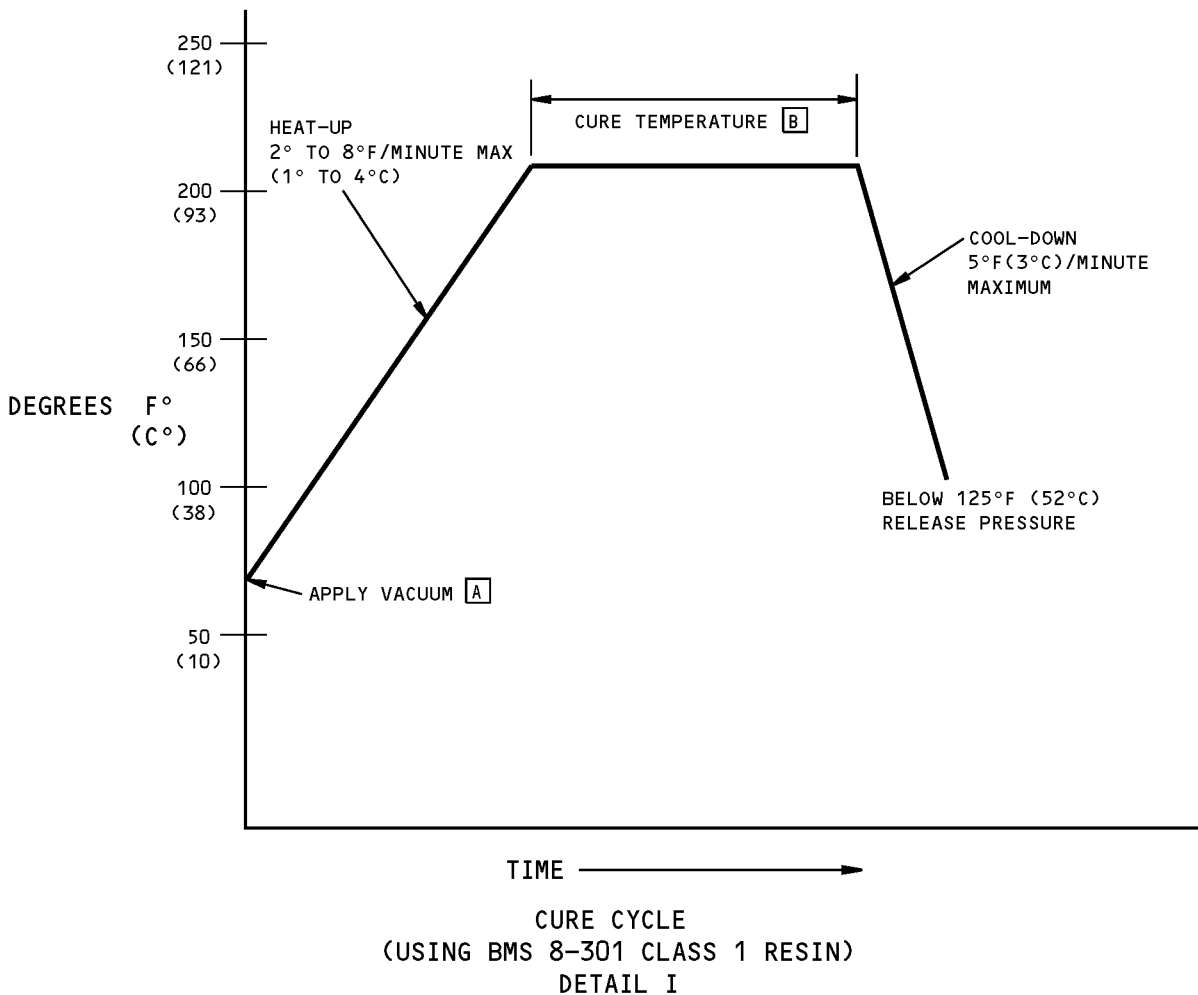
Resin Cure Cycle
Figure 209 (Sheet 1 of 2)

- WHEN USING BMS 8-301 CLASS 2, OR EA 9330 RESINS, SURFACE TEMPERATURE SHOULD NOT EXCEED 160°F (71°C)
 - FOR OPTIMUM PROPERTIES, CURE BMS 8-301 CLASS 2 FOR 180 MINUTES AT 150°F (66°C)
 - SEE DETAIL I FOR CURING BMS 8-301 CLASS I
 - SEE DETAIL II FOR CURING EA 9330
- [A] MAINTAIN 22 INCHES VACUUM MINIMUM DURING ENTIRE CURE CYCLE

- (5) Apply a minimum of 2 psi pressure.
- (6) Cure per Figure 209/REPAIR GENERAL.
- (7) When voids occur in fluted core sandwich, extreme care should be exercised to prevent flow of resin into flutes. This may be realized as follows:

- (9) Evacuate to a minimum vacuum of 20 inches of mercury and force excess resin from patch with teflon squeegee.
- (10) Cure the repair. Maintain a minimum of 20 inches of mercury during the entire cure cycle. See Figure 209/REPAIR GENERAL for the minimum time and temperature requirements.

- (d) Prepare repair surface in accordance with Paragraph 6.C./REPAIR GENERAL. Extreme care should be exercised to prevent damage to the bond ply. Do not sand into fabric of the bond ply.
- (e) Lay up glass fabric patches.
- (f) Place layer of perforated parting film over the repaired area.
- (g) Apply pressure 2 psi minimum and 5 psi maximum, and force excess resin from patch with a teflon squeegee.
- (h) Cure the repair at room temperature as given in Figure 209/REPAIR GENERAL.
- (i) Refinish in accordance with Paragraph 10./REPAIR GENERAL.

- (j) Cure the repair as given in Figure 209/REPAIR GENERAL.

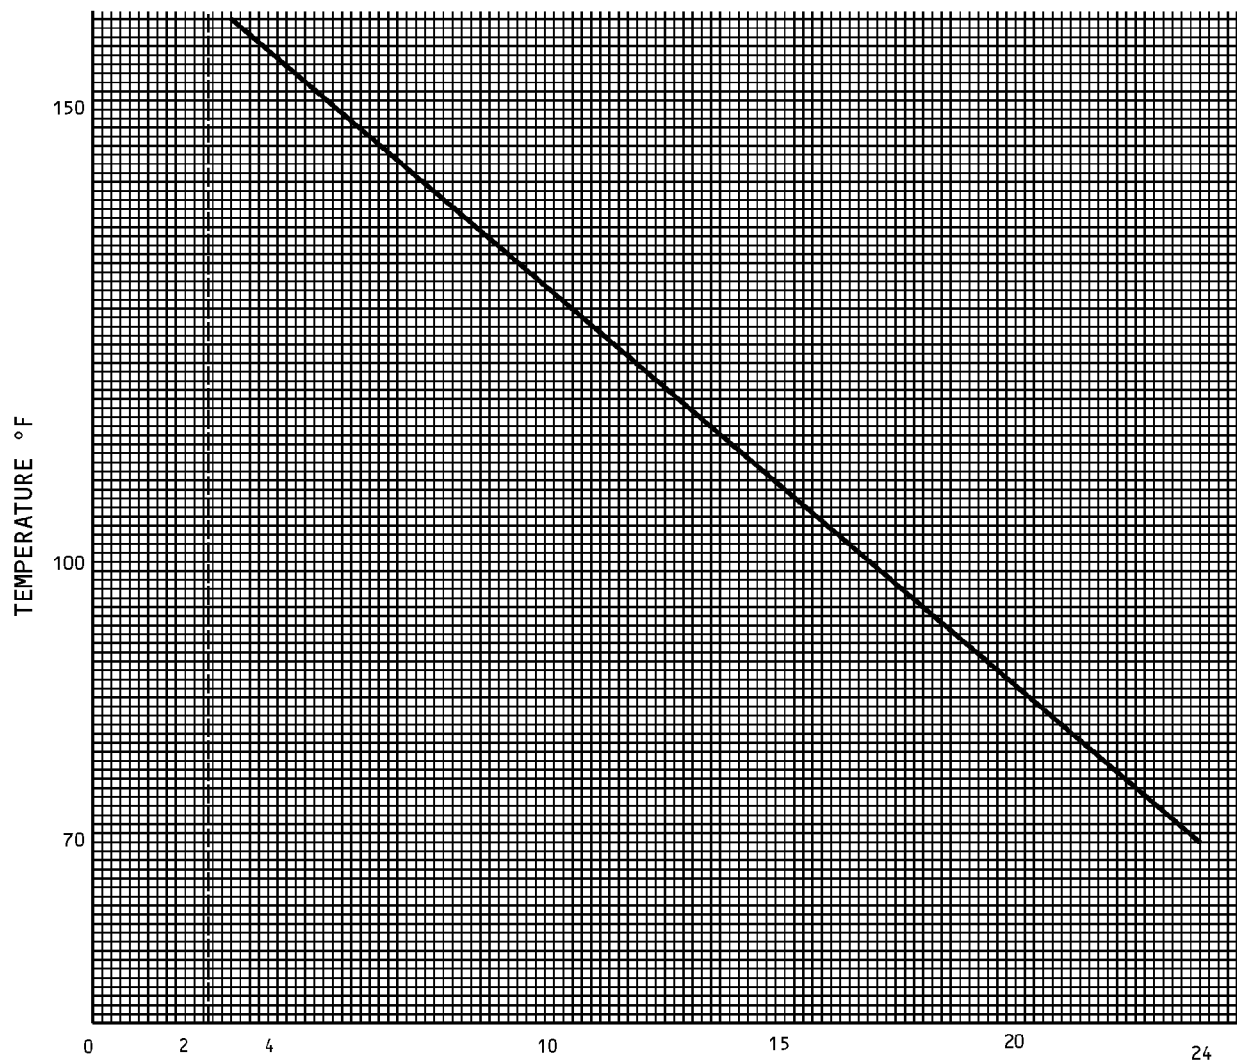
Resin Cure Cycle
Figure 209 (Sheet 2 of 2)

TIME IN HOURS
(CURE CURVE FOR EA 9330 A/B ADHESIVE)

DETAIL II

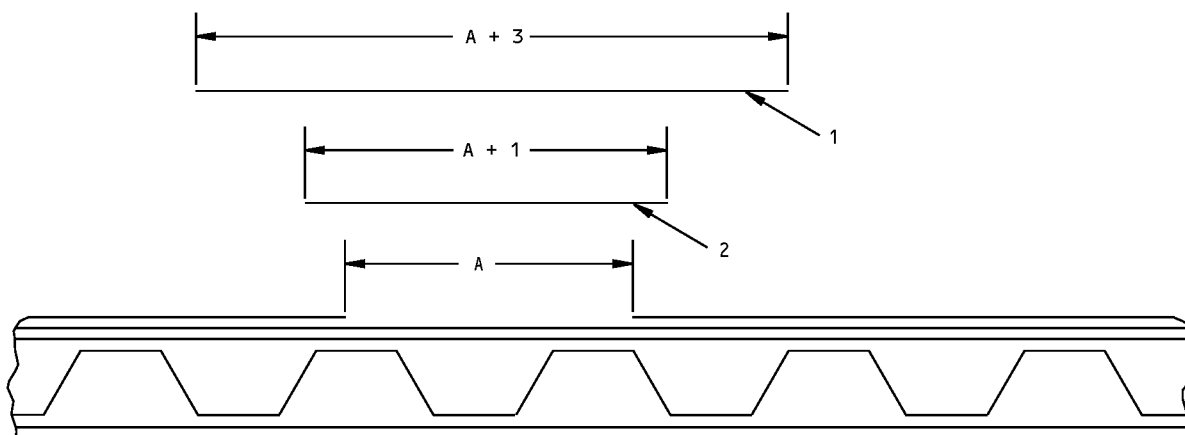
**One Ply Repair or Replacement of Fluted Core Sandwich Structure
Figure 210**

| ITEM | MATERIAL |
|---|--|
| 1 | REPLACEMENT PLY, GLASS FABRIC PER BMS 9-3 TYPE H OR H2 |

- (1) Replacement of Skin (One Ply)
 - (a) Mark off area requiring ply replacement.
 - (b) Prepare glass fabric in accordance with Paragraph 6.B.(2)/REPAIR GENERAL and Figure 210/REPAIR GENERAL.
 - (c) Cut glass fabric patches using the same fabric and warp orientation as required on the engineering drawing. There shall be a glass fabric patch applied for the ply removed, plus one extra ply. The patch will be cut 0.50 inch larger on all edges than the ply that was removed. The extra ply shall be 1.0 inch larger on all edges than the ply (Figure 210/REPAIR GENERAL) and shall be glass fabric per specification BMS 9-3, Type D.

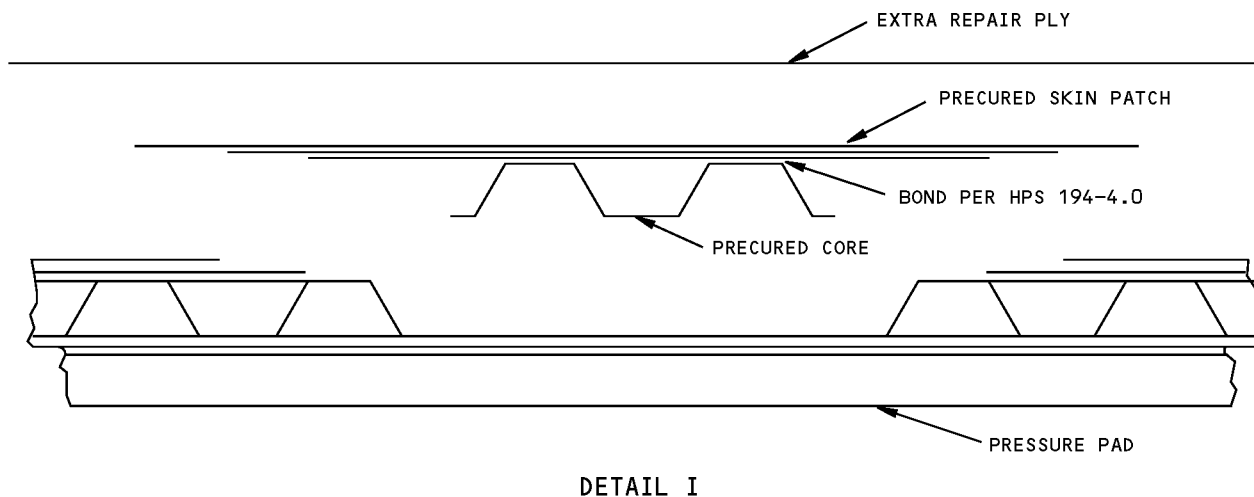
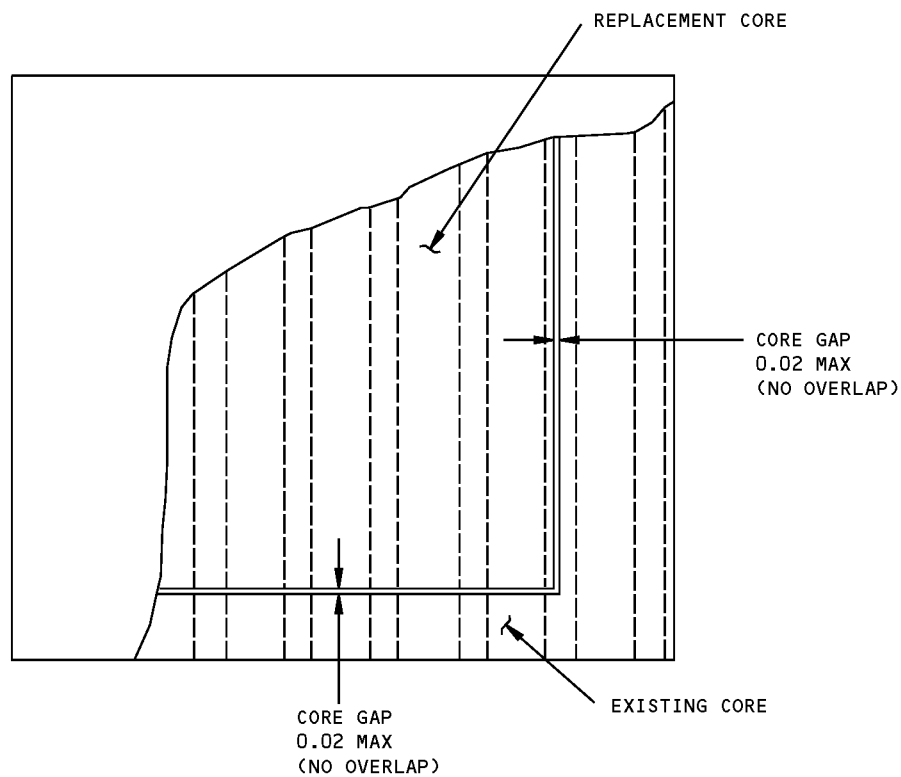
Replacement of Core and One Skin
Figure 213

| ITEM | MATERIAL |
|---|---|
| 1 | PRECURED PATCH |

CORE GAP
DETAIL II

Core gap shall not exceed 0.020 in. (0.051 cm) (Figure 213/REPAIR GENERAL, Detail II).

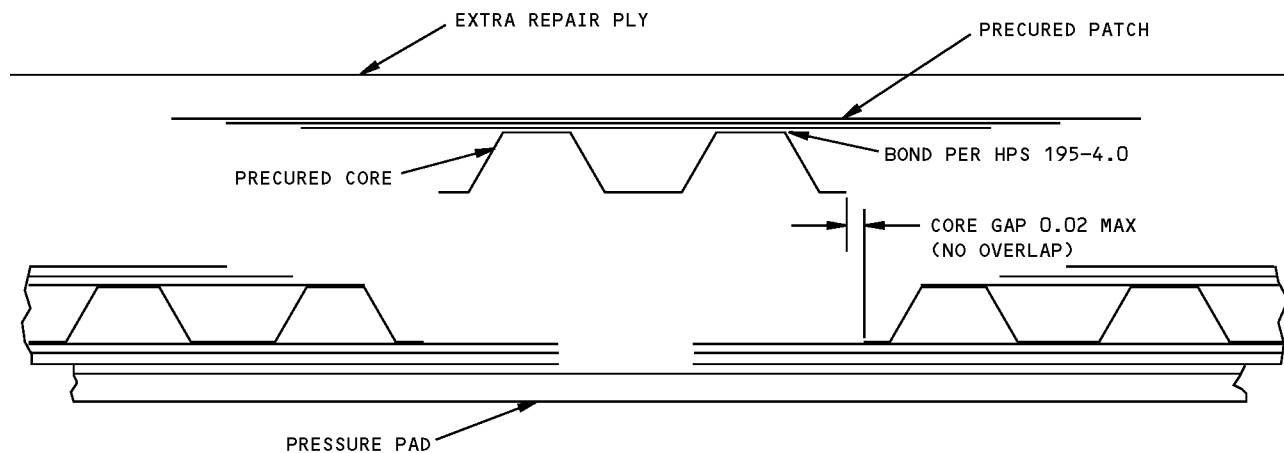
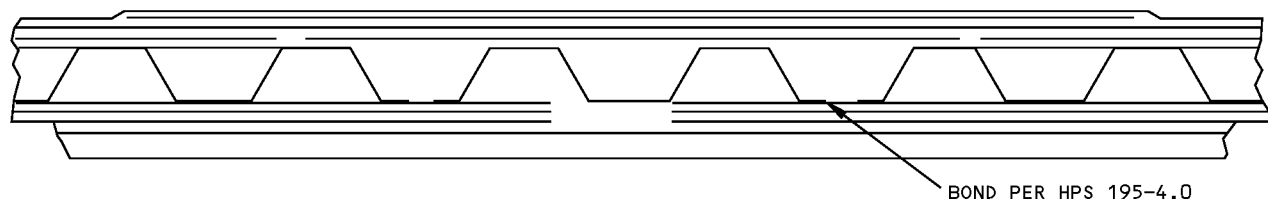
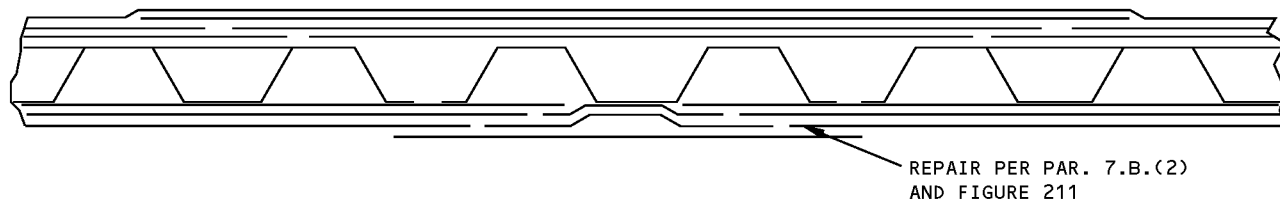
Replacment of Core and Both Skins
Figure 214

STEP 1

STEP 2

STEP 3

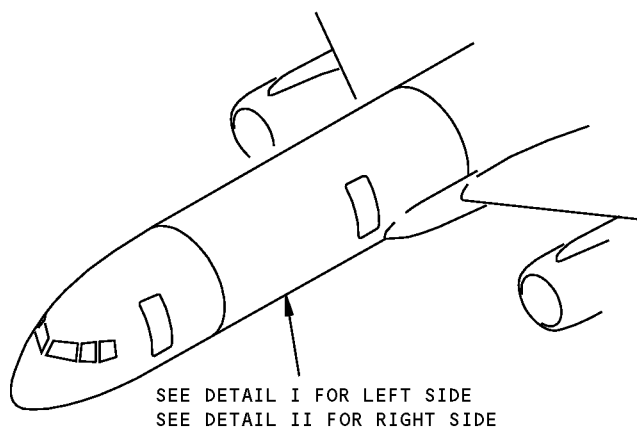
Section 43 Skin Identification
Figure 1 (Sheet 1 of 5)

IDENTIFICATION 1 - SECTION 43 - SKINS

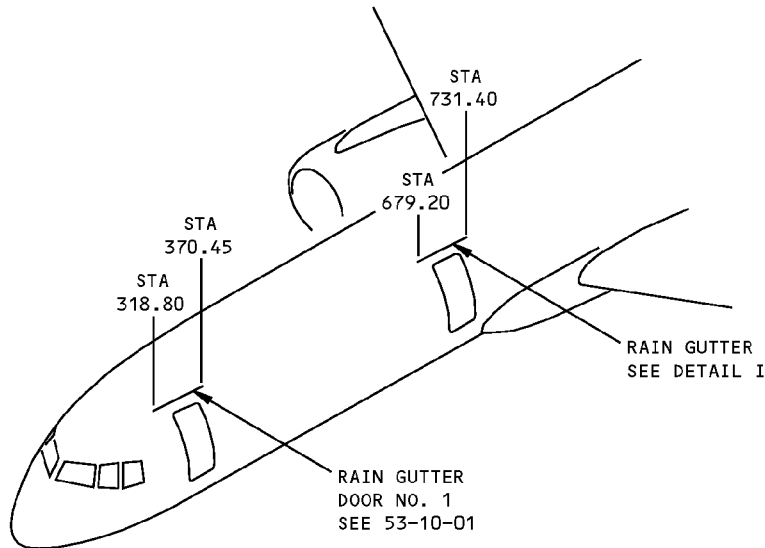
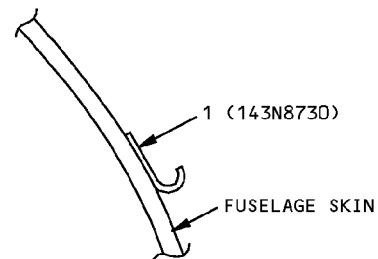
IDENTIFICATION 2 - RAIN GUTTER

SECTION THRU RAIN GUTTER
DETAIL I

| ITEM | DESCRIPTION | GAGE | MATERIAL | EFFECTIVITY | | |
|---|---|---|--|---|---|---|
| 1 | GUTTER | | BAC1498-356 CLAD 7075-T6 BAC1498-356 CLAD 2024-T3 | <table><tr><td>A</td></tr><tr><td>B</td></tr></table> | A | B |
| A | | | | | | |
| B | | | | | | |

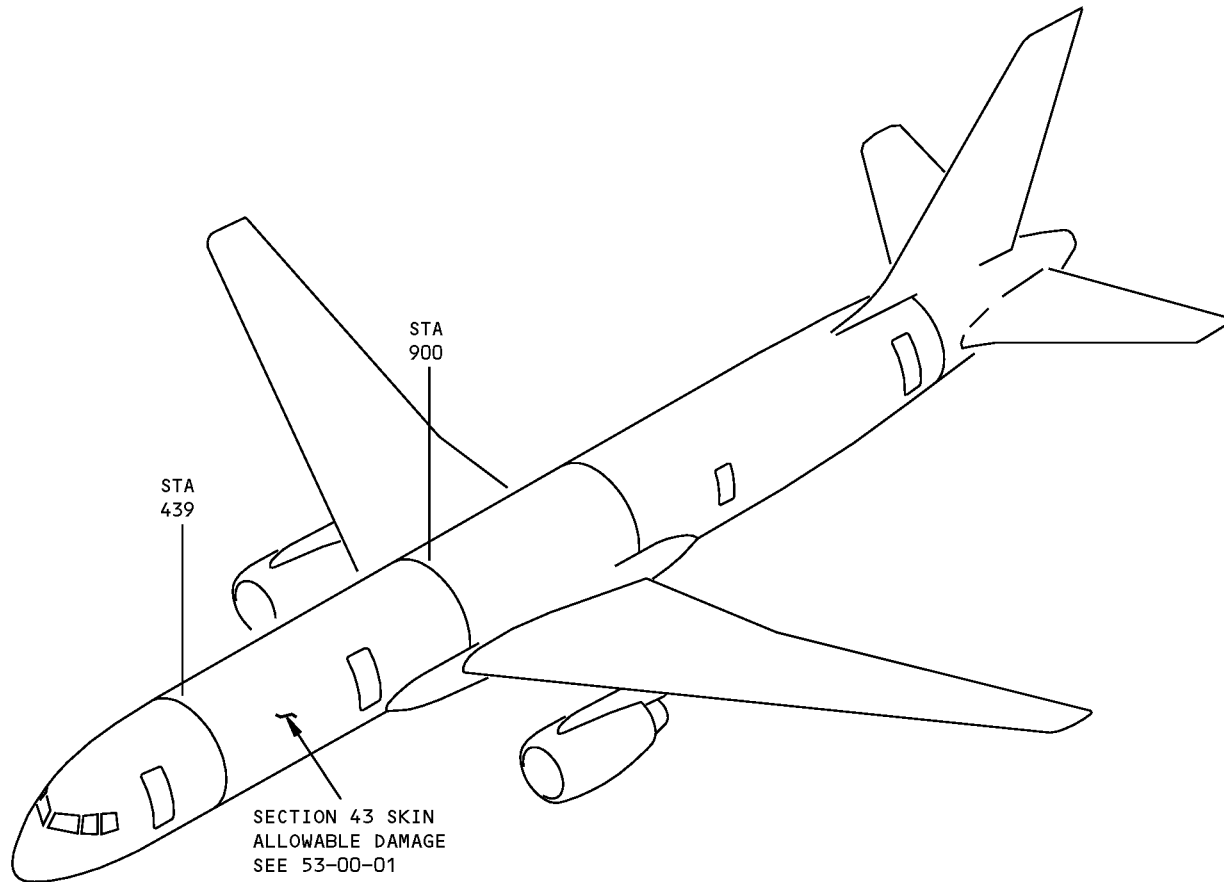
Section 43 Skin Allowable Damage
Figure 101

ALLOWABLE DAMAGE 1 - SECTION 43 - SKINS

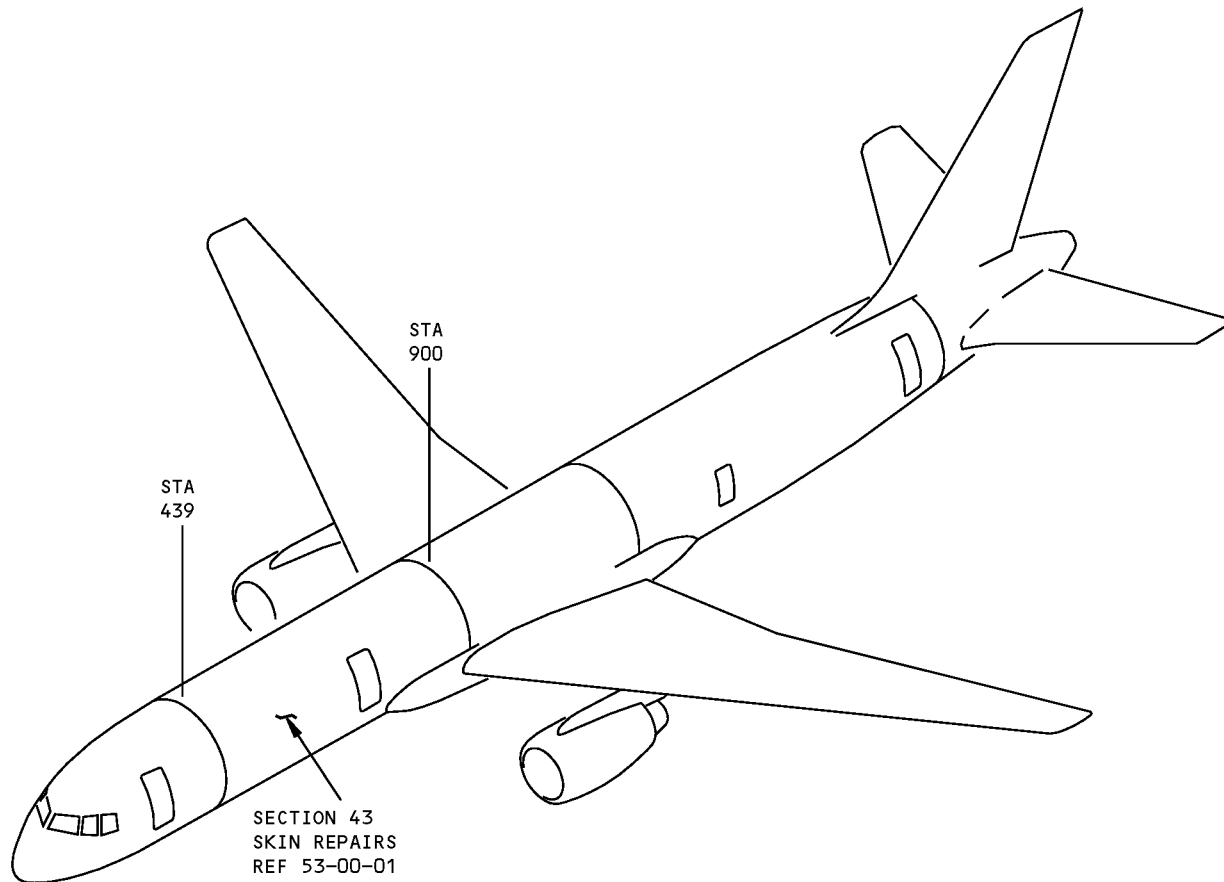
Section 43 Skin Repairs
Figure 201

REPAIR 1 - SECTION 43 - SKINS

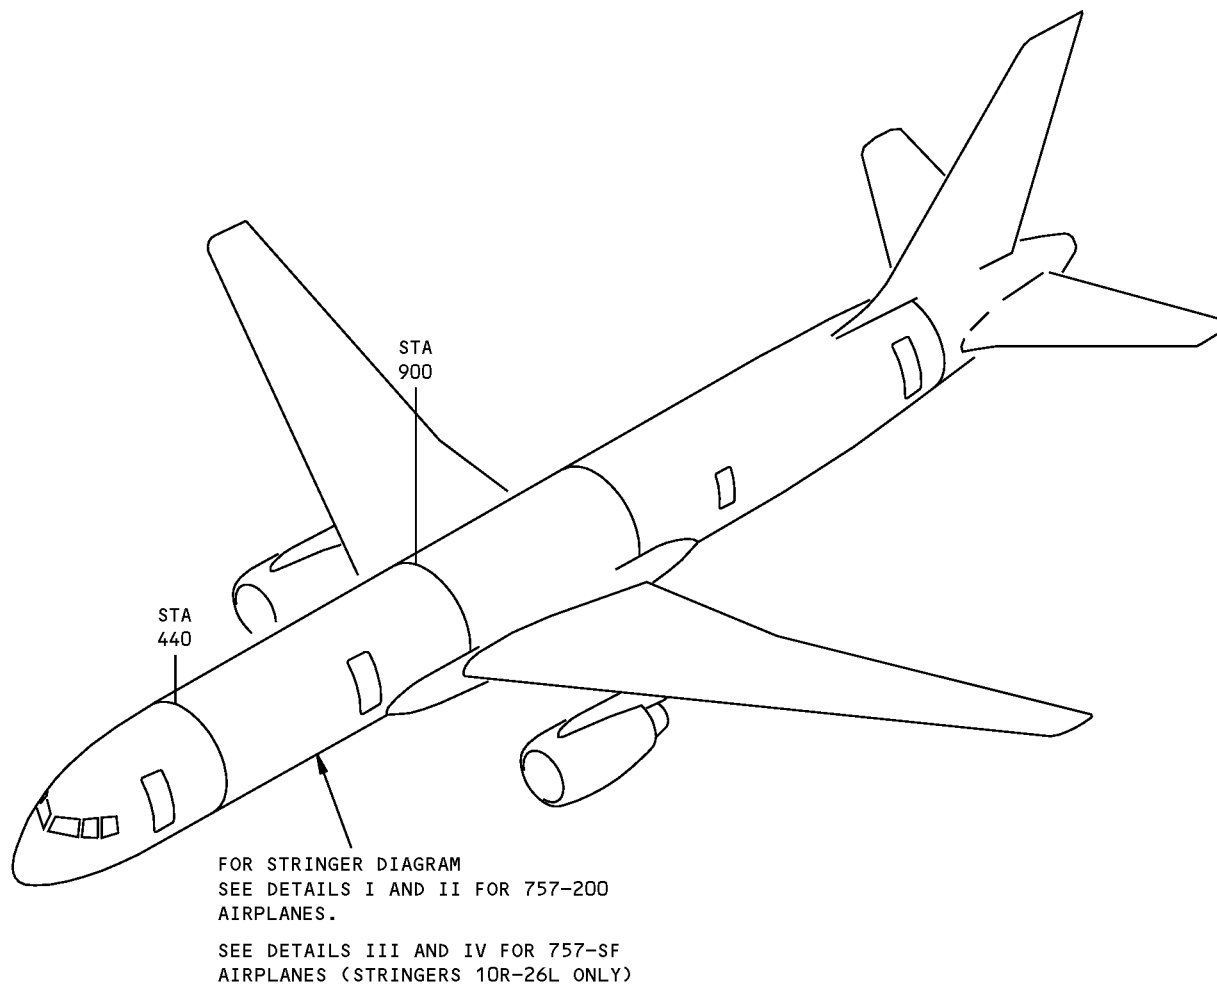
Section 43 Stringer Identification
Figure 1 (Sheet 1 of 4)

IDENTIFICATION 1 - SECTION 43 - STRINGERS

- A** GAGES VARY THROUGHOUT THE LENGTH OF THE STRINGER. MAXIMUM GAGES ARE SHOWN.
- B** FOR CUM LINE NUMBERS 209 AND ON
- C** FOR CUM LINE NUMBERS 232 AND ON
- D** FOR AIRPLANES WITH CUM LINE NUMBERS 210 THRU 231 BETWEEN BS 509 AND 610

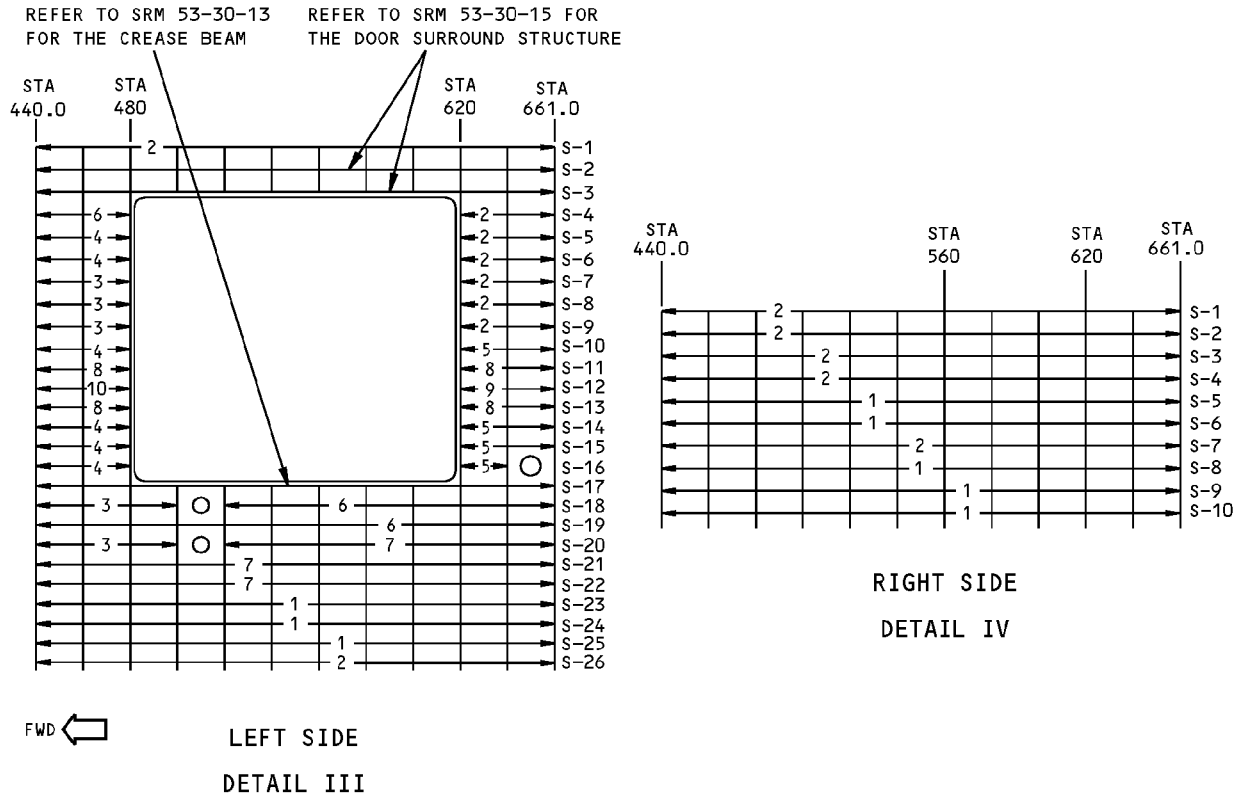
REFERENCE DRAWINGS
657N3240
657N3241
657N3242

| ITEM | DESCRIPTION | GAGE A | MATERIAL | STRINGER TYPE | REF DWG | EFFECTIVITY |
|---|---|---|---|---|---|---|
| 1 | STRINGER | 0.063 | 7075-T6 | U | 143N3110 | |

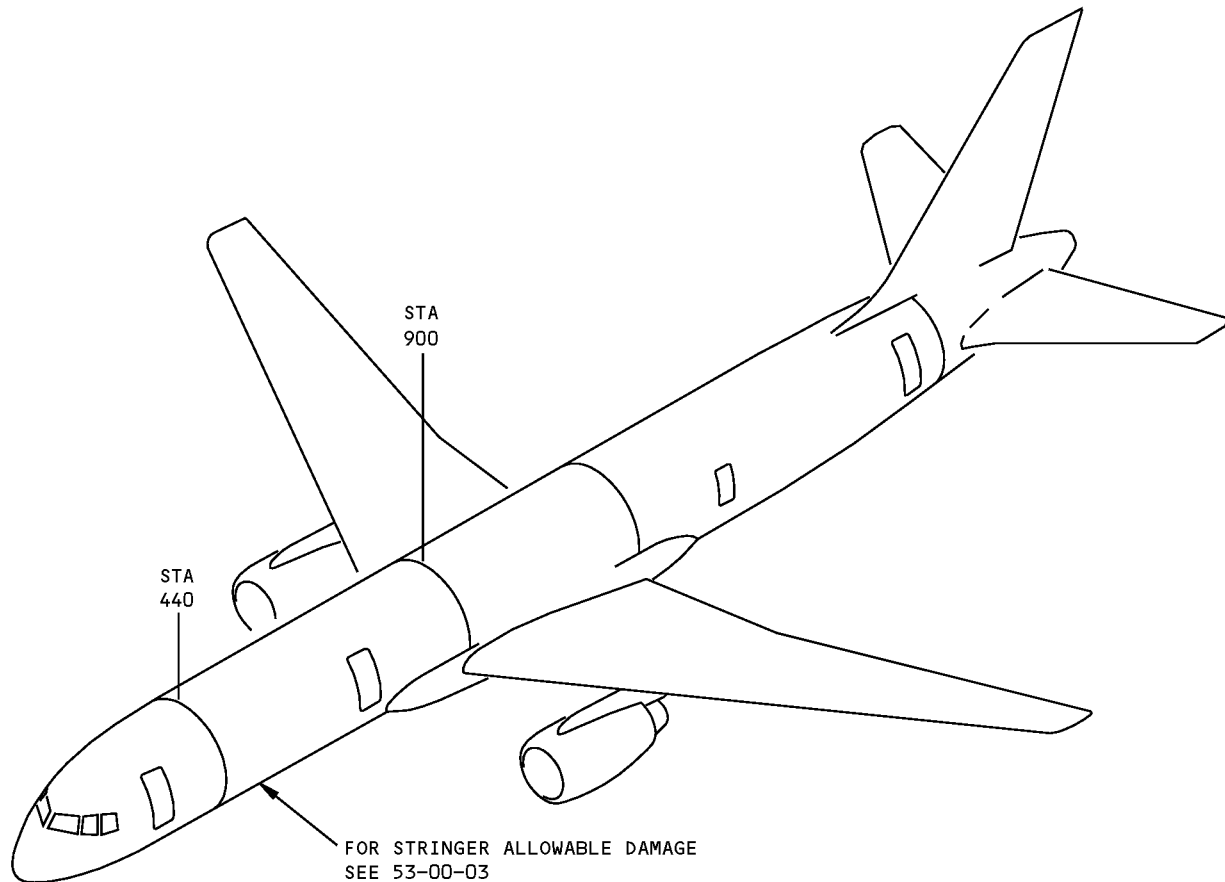
Section 43 Stringer Allowable Damage
Figure 101

ALLOWABLE DAMAGE GENERAL - SECTION 43 - STRINGERS

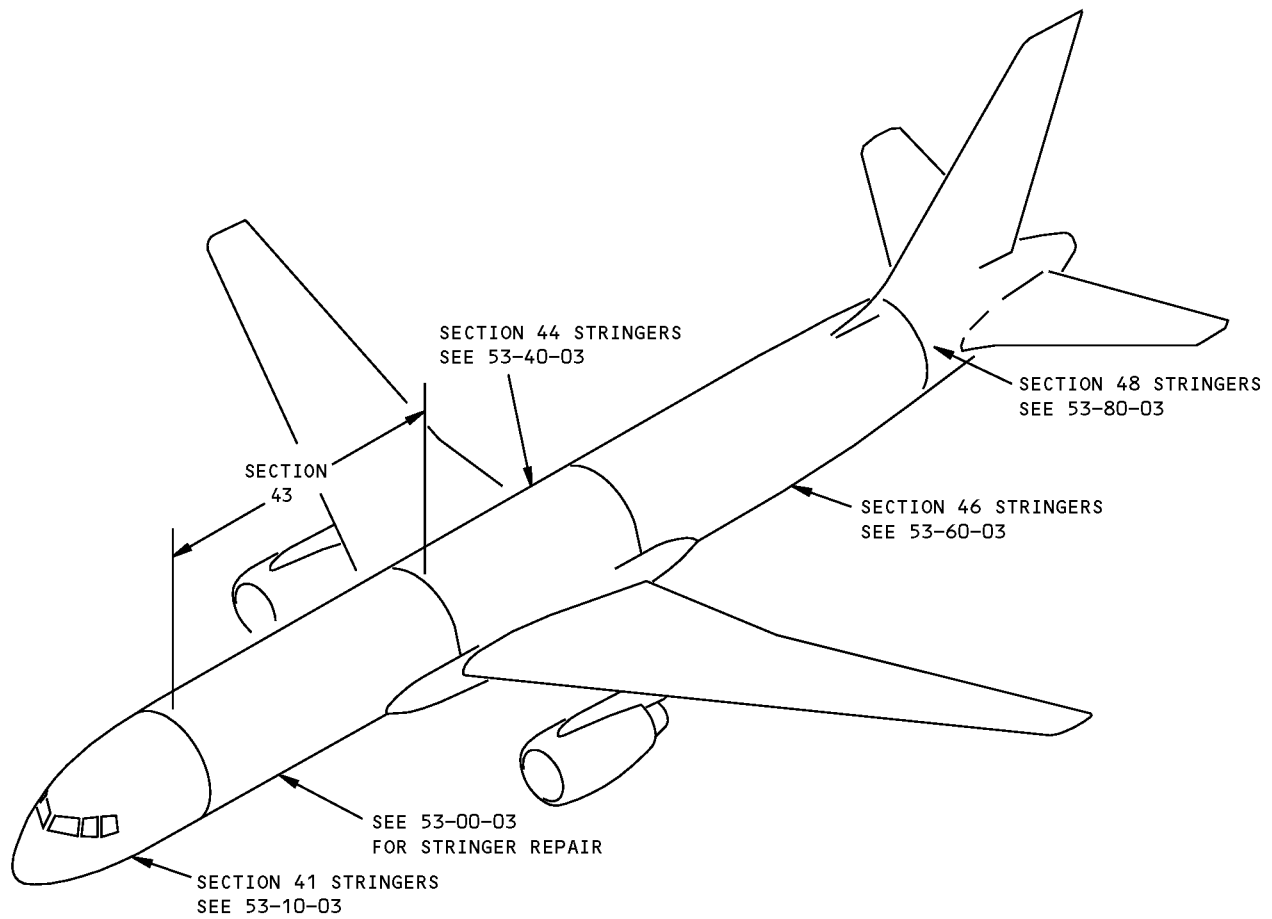
Section 43 Stringer Repair
Figure 201

REPAIR GENERAL - SECTION 43 - STRINGERS

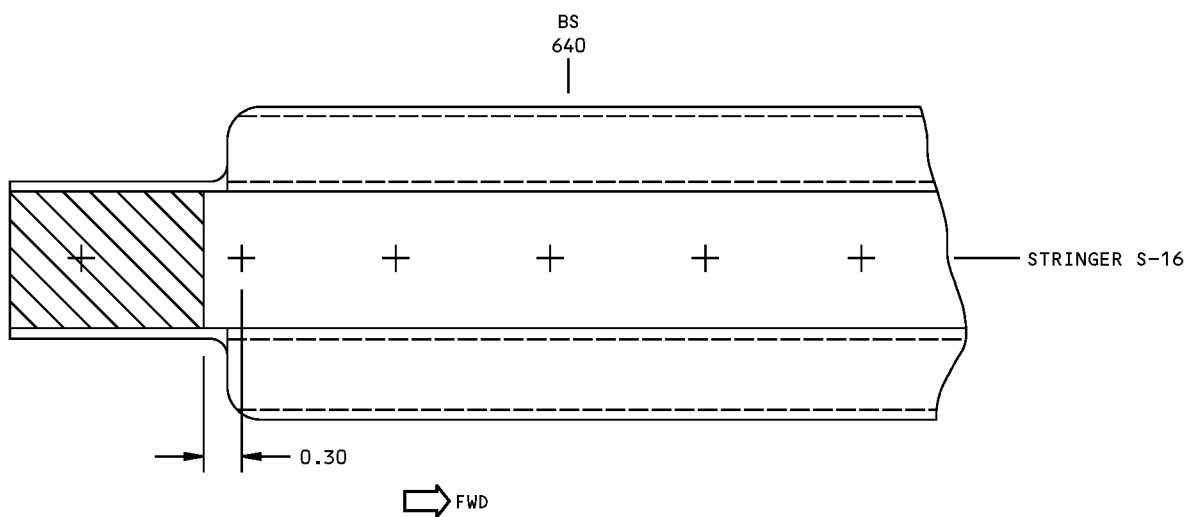
DETAIL I

**Stringer Repair - Stringer S-16 at the Wing Scanning Light
Figure 201 (Sheet 2 of 5)**

1. Get access to the left and right stringer (S-16L and S-16R) between BS 640 and BS 645.
2. Make a visual inspection of the stringers for cracks. Refer to SRM 51-10-02.
 - A. If there are cracks in the shaded area shown in Detail I, then repair the stringer as given in Part 2.
 - B. If a crack goes outside of the shaded area shown in Detail I, then:
 - (1) Cut and remove the aft part of the stringer at BS 630.
 - (2) Repair the stringer from BS 630 to BS 645 as given in SRM 53-00-03, Figure 201.
 - (3) Do the modification given in Service Bulletin 757-53-0016.

1. Cut and remove the damaged part of the stringer.
 - A. You must remove a minimum of the structure as shown in Detail II.
 - B. Cut and remove any damaged part of the stringer that remains. Remove the material only in the shaded area shown in Detail I. Cut out only the structure that is cracked.

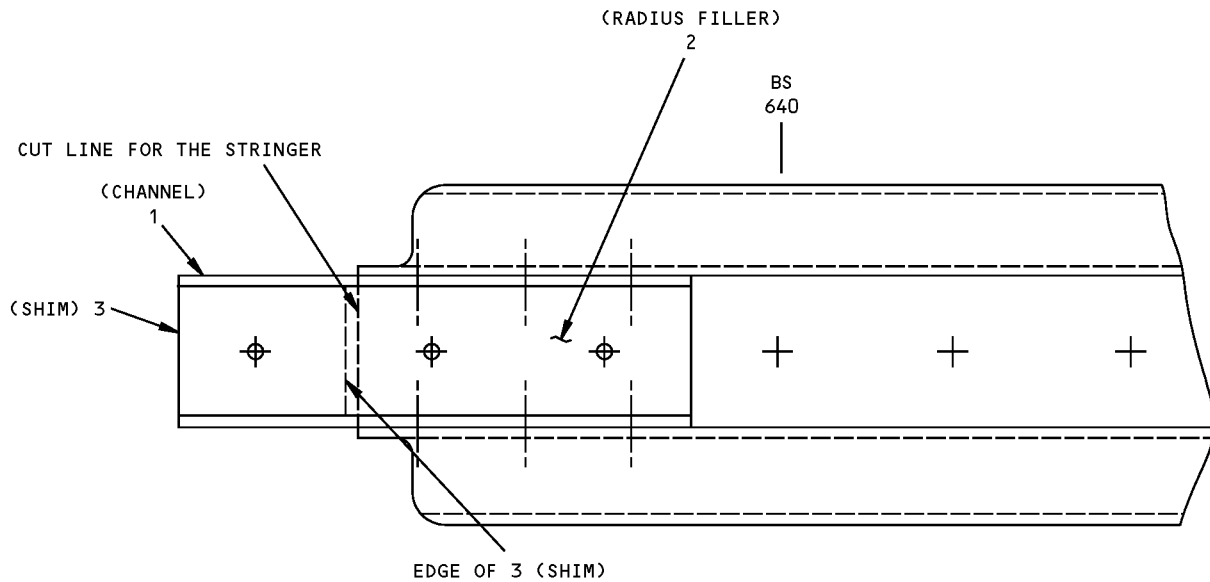
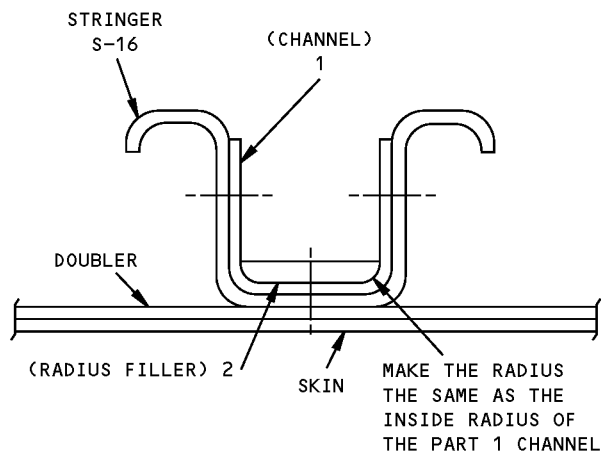
Stringer Repair - Stringer S-16 at the Wing Scanning Light
Figure 201 (Sheet 4 of 5)

VIEW A-A

LEFT SIDE STRINGER

RIGHT SIDE STRINGER

SECTION B-B
