FUSELAGE

757-200 STRUCTURAL REPAIR MANUAL

CHAPTER 53 FUSELAGE

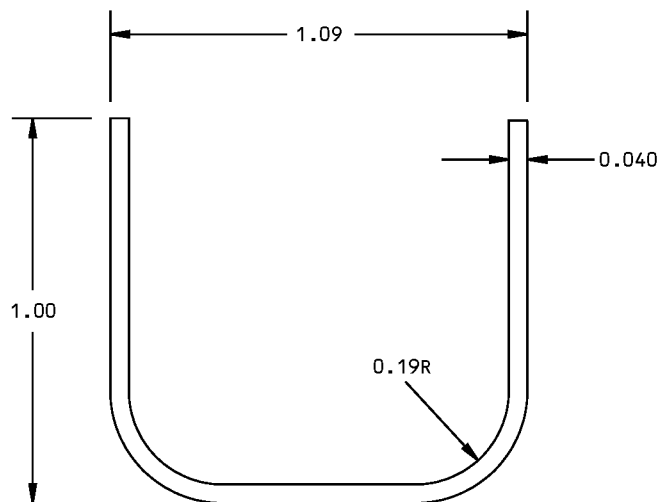
Stringer Repair - Stringer S-16 at the Wing Scanning Light
Figure 201 (Sheet 5 of 5)

PART 1 CHANNEL
DETAIL IV

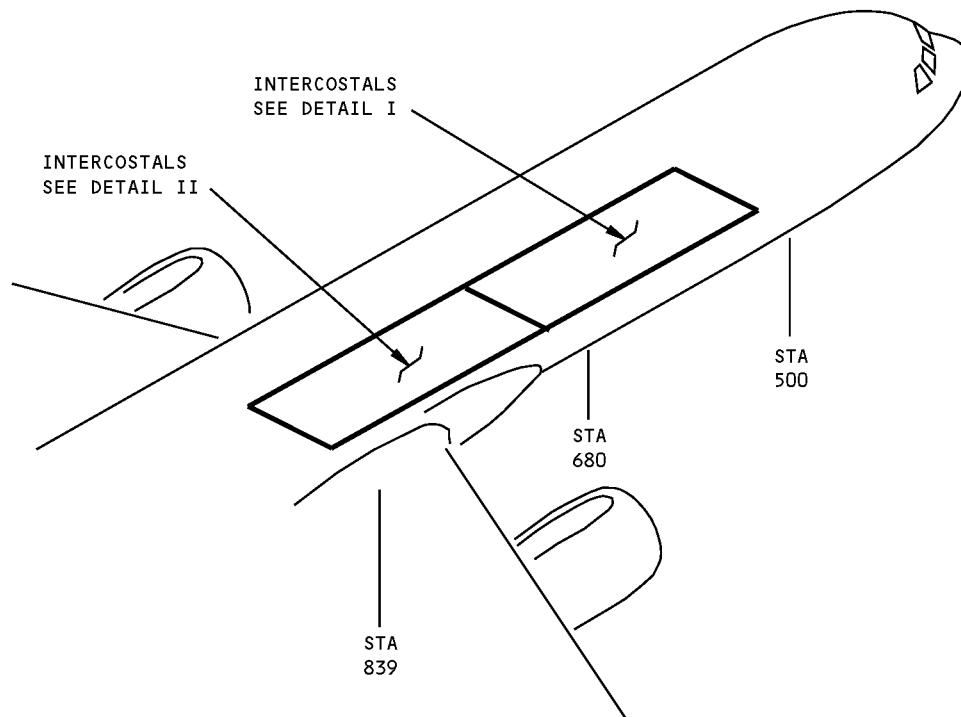
Section 43 Intercostal Allowable Damage
Figure 101 (Sheet 1 of 2)

ALLOWABLE DAMAGE GENERAL - SECTION 43 - INTERCOSTALS

- REFER TO 53-00-04 FOR INTERCOSTAL ALLOWABLE DAMAGE DATA

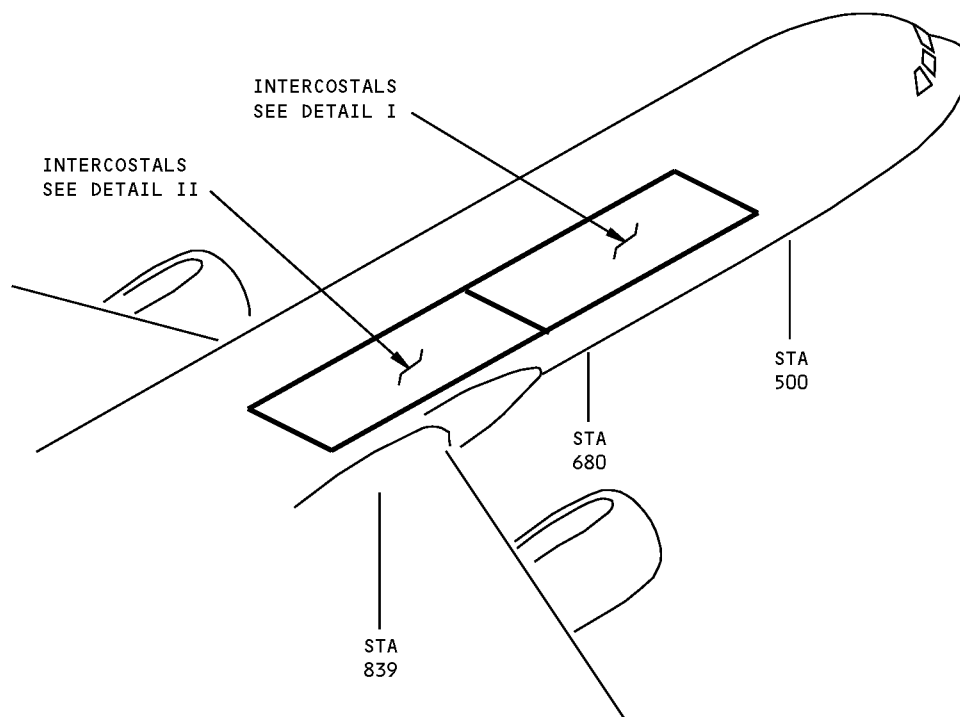
Section 43 Intercostal Repair
Figure 201 (Sheet 1 of 2)

REPAIR GENERAL - SECTION 43 - INTERCOSTALS

- DAMAGED INTERCOSTAL COMPONENTS MAY BE REPLACED OR REPAIRED. IF REPAIRS ARE TO BE MADE, SEE 51-70 FOR TYPICAL WEB, FORMED SECTION, OR EXTRUDED SECTION REPAIRS

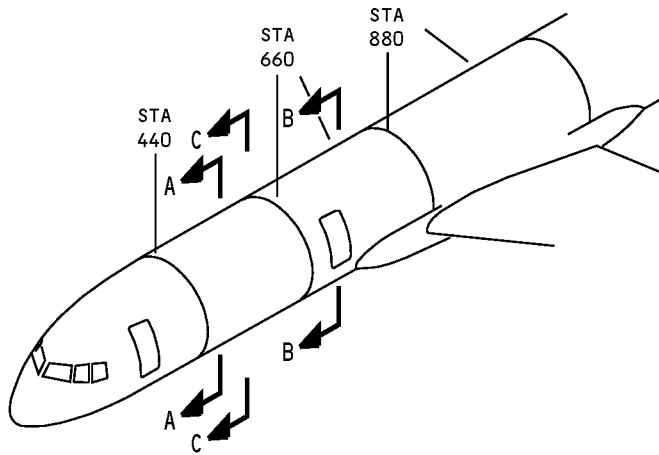
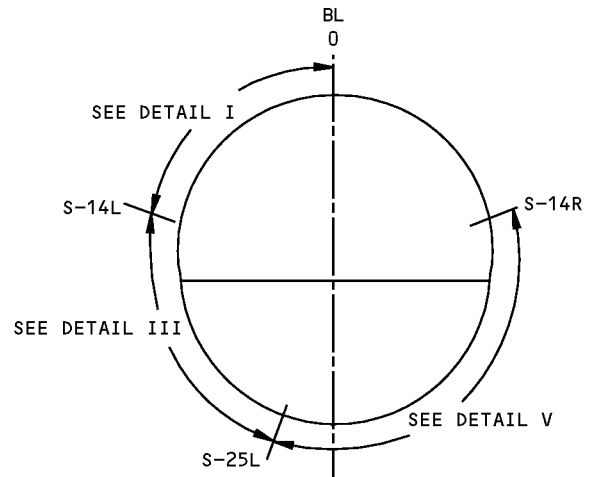
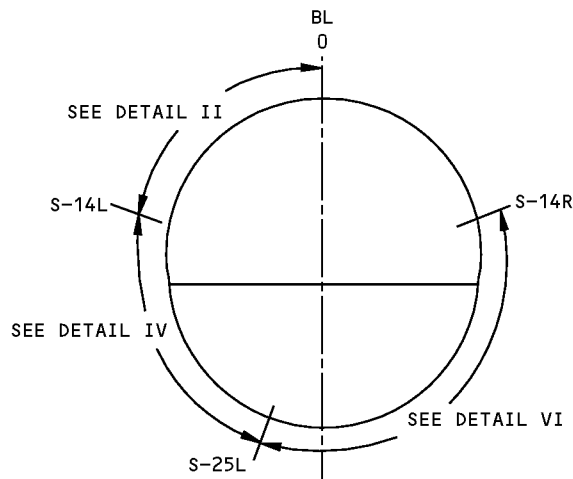
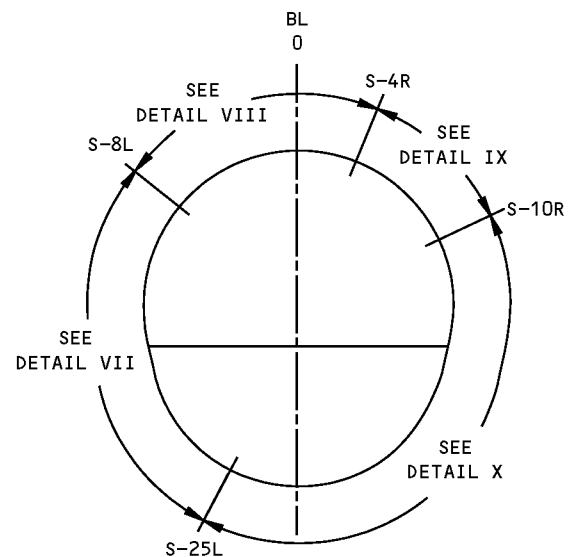
IDENTIFICATION 1 - SECTION 43 - FRAMES

DETAIL INDEX
STA 440-660
SECTION A-A

DETAIL INDEX
STA 660-880
SECTION B-B

DETAIL INDEX
STA 440-660
SECTION C-C [C]

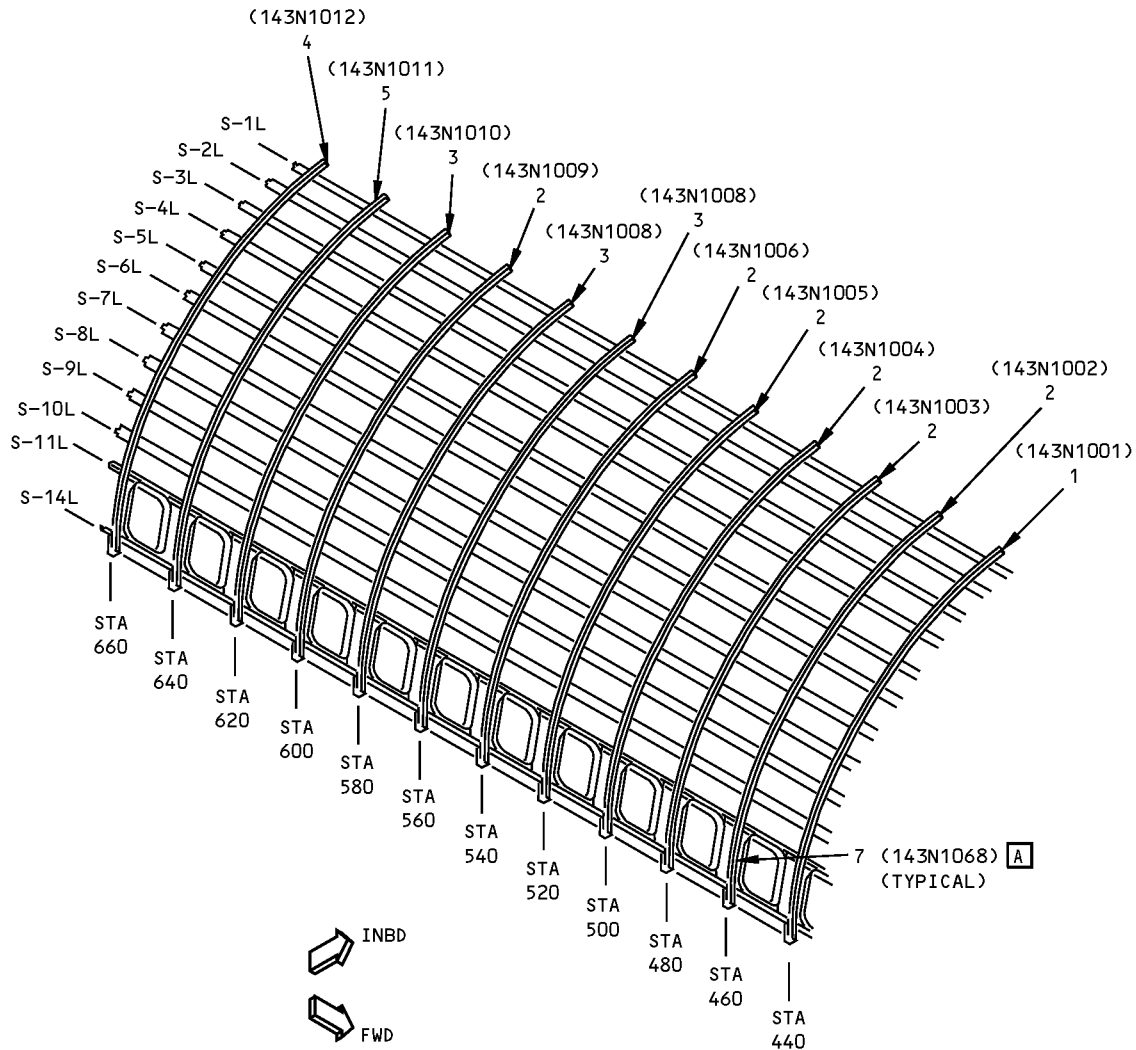
LEFT SIDE IS SHOWN, RIGHT SIDE IS OPPOSITE
DETAIL I

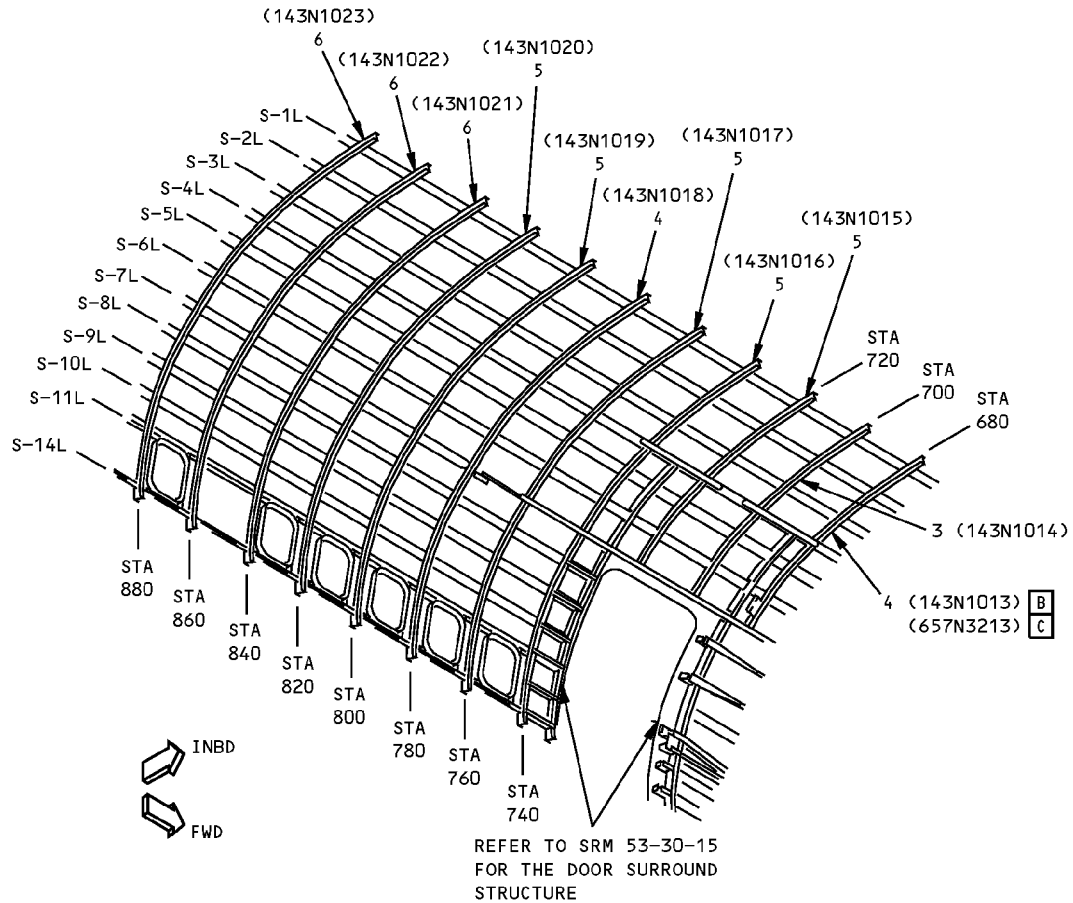
LEFT SIDE IS SHOWN, RIGHT SIDE OPPOSITE
DETAIL II

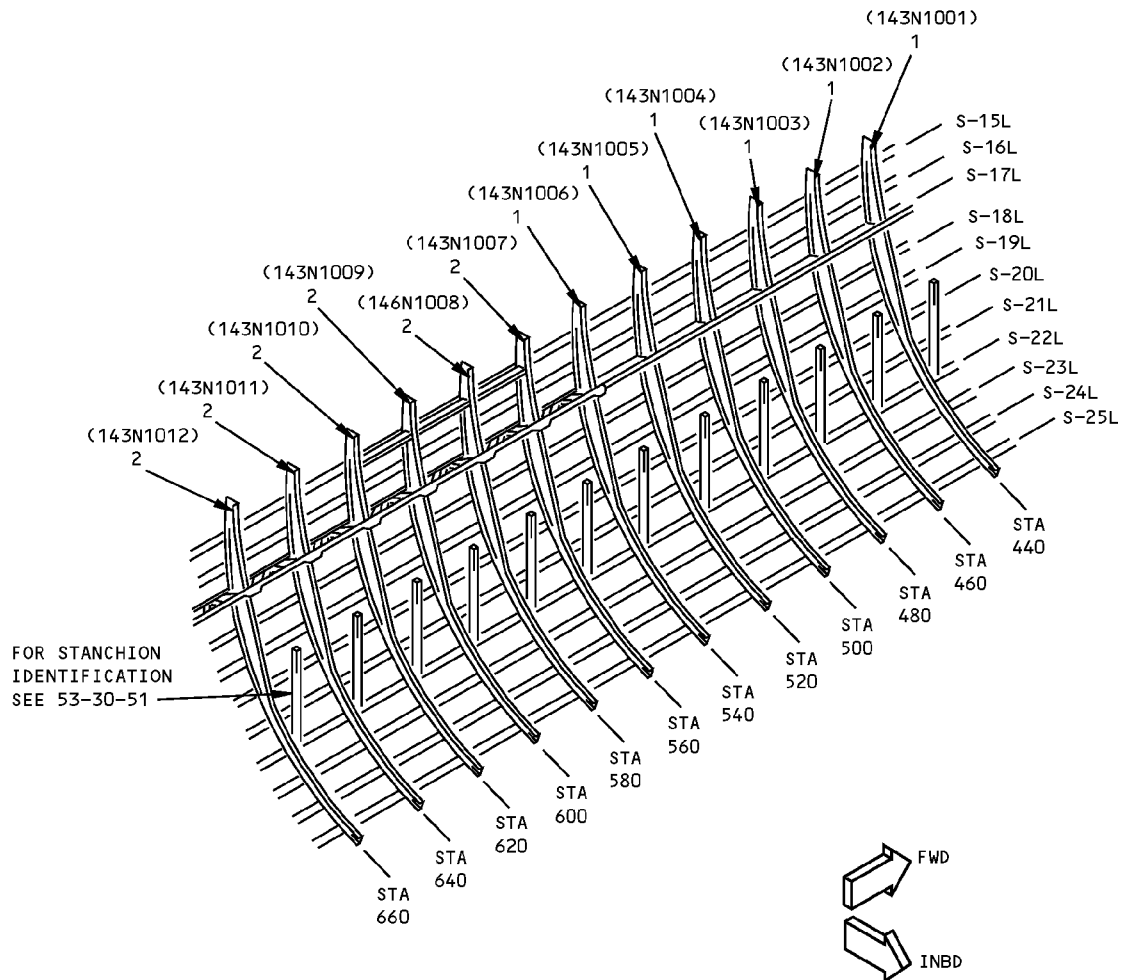
LEFT SIDE VIEW
DETAIL III

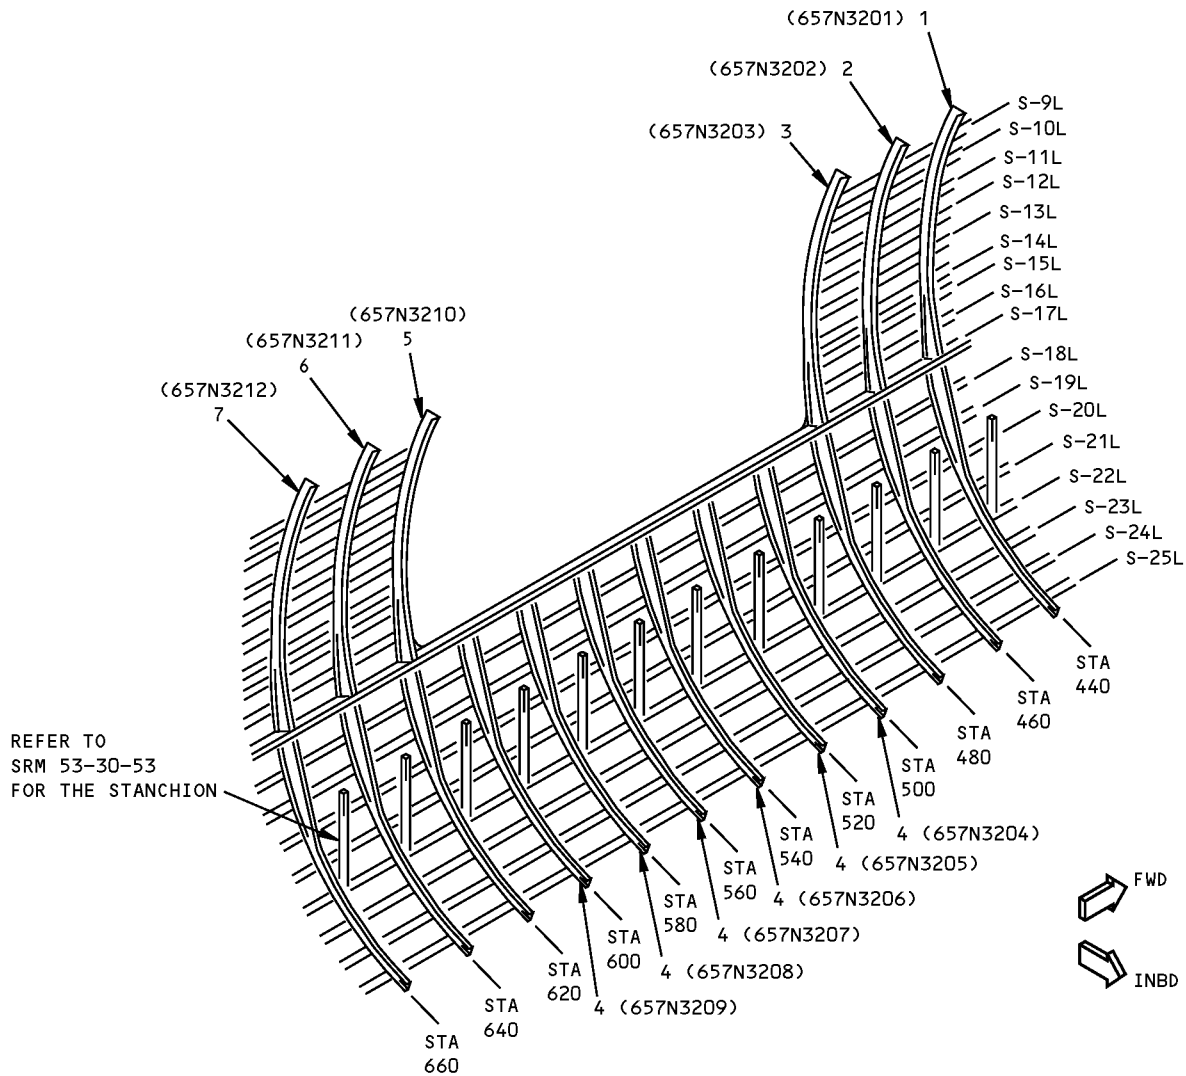
Section 43 Frame Identification Figure 1 (Sheet 8 of 16)

LEFT SIDE IS SHOWN
DETAIL VII

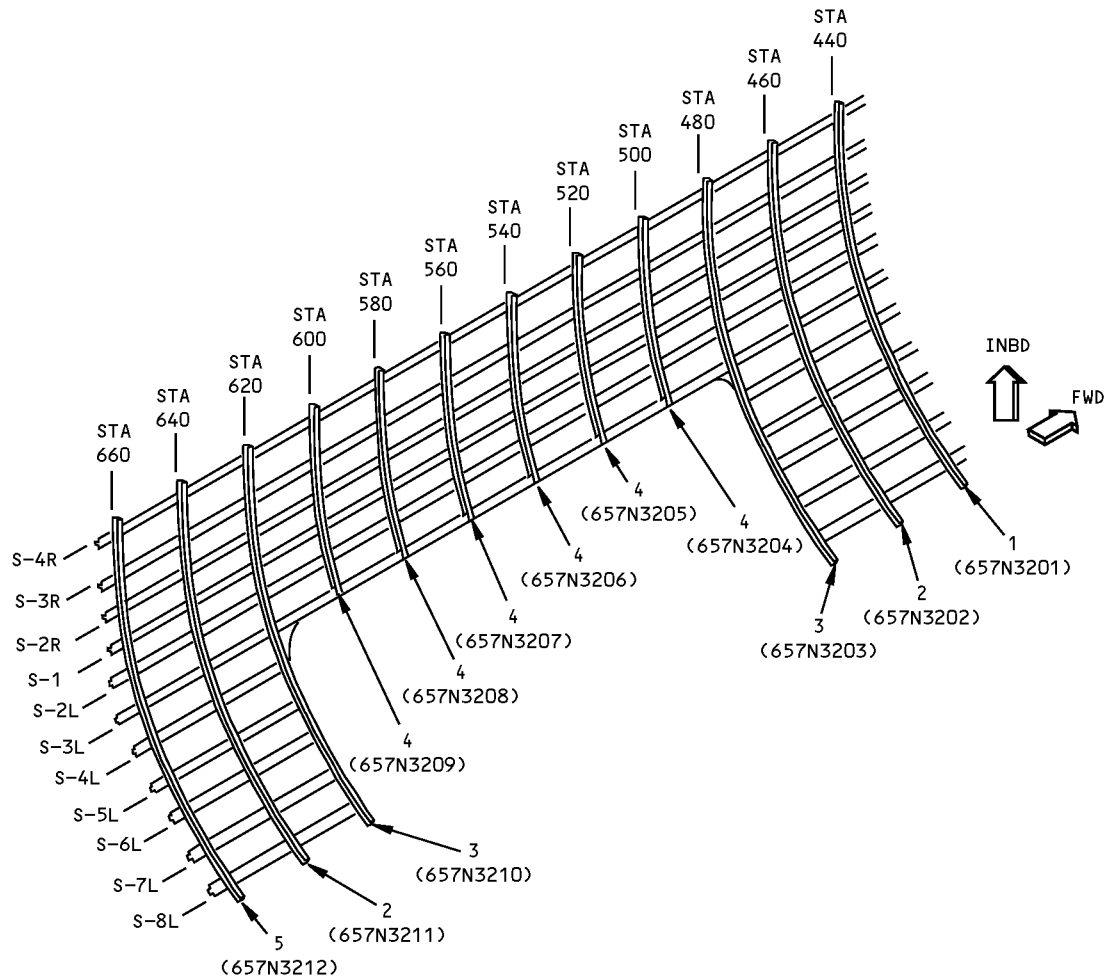
Section 43 Frame Identification
Figure 1 (Sheet 10 of 16)

CROWN FRAMES
LEFT AND RIGHT SIDE IS SHOWN
DETAIL VIII

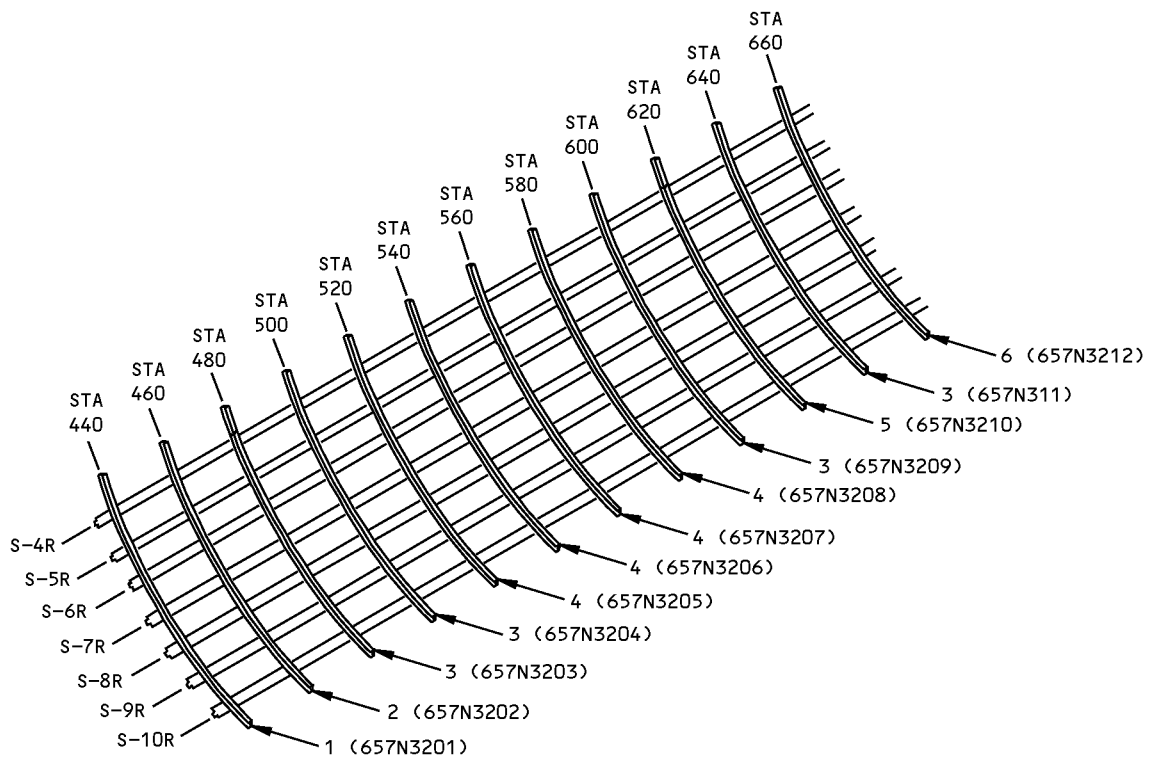
RIGHT SIDE IS SHOWN

CROWN FRAMES
DETAIL IX

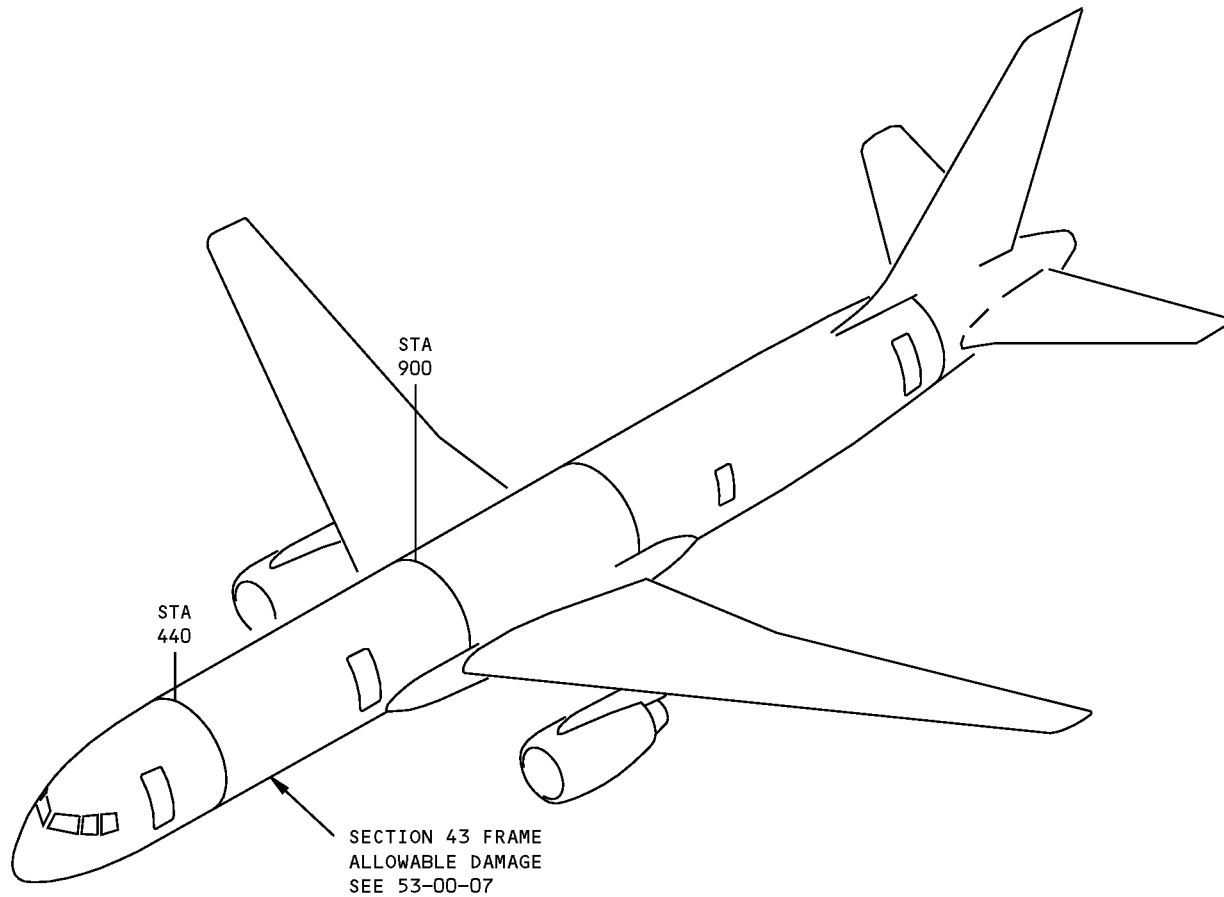
Section 43 Frame Allowable Damage
Figure 101

ALLOWABLE DAMAGE GENERAL - SECTION 43 - FRAMES

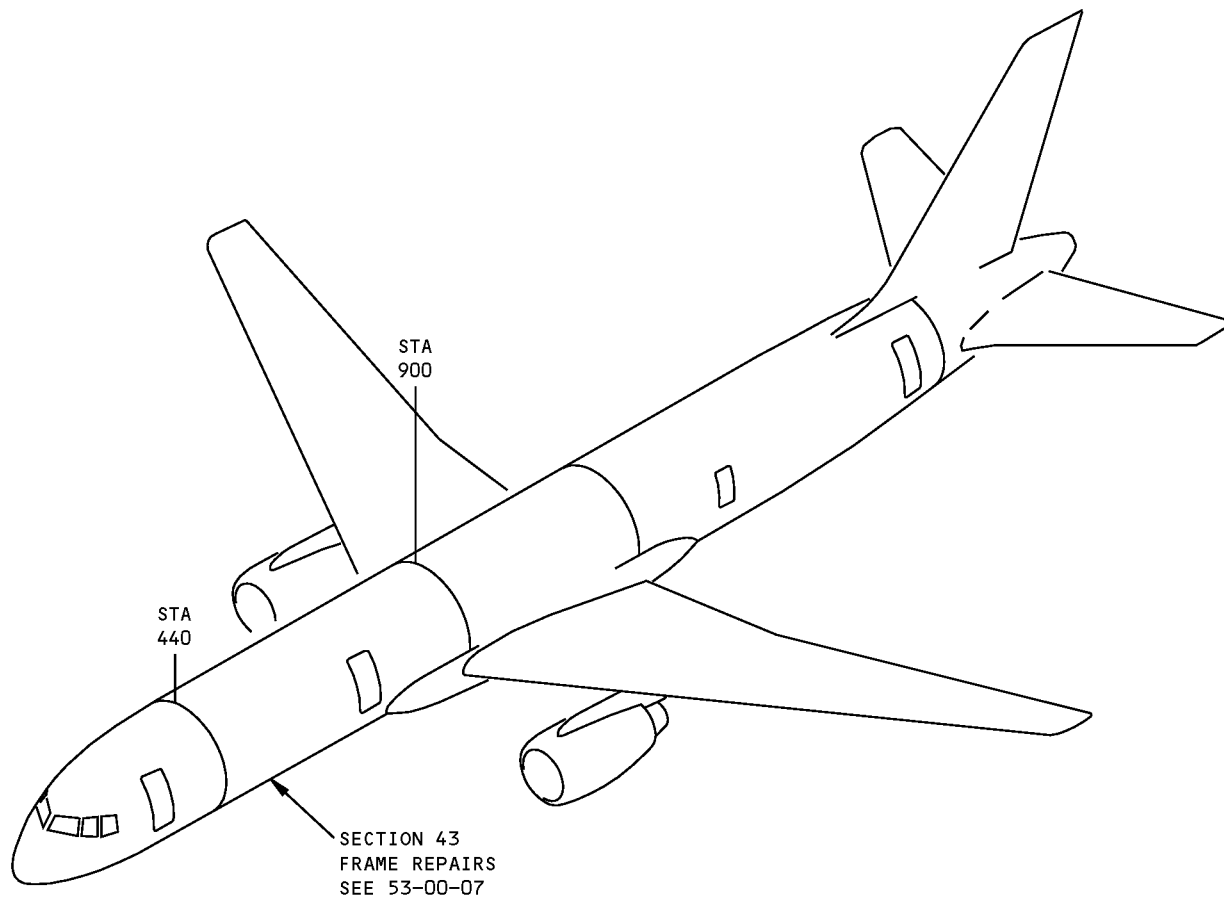
Section 43 Frame Repairs
Figure 201

REPAIR GENERAL - SECTION 43 - FRAMES

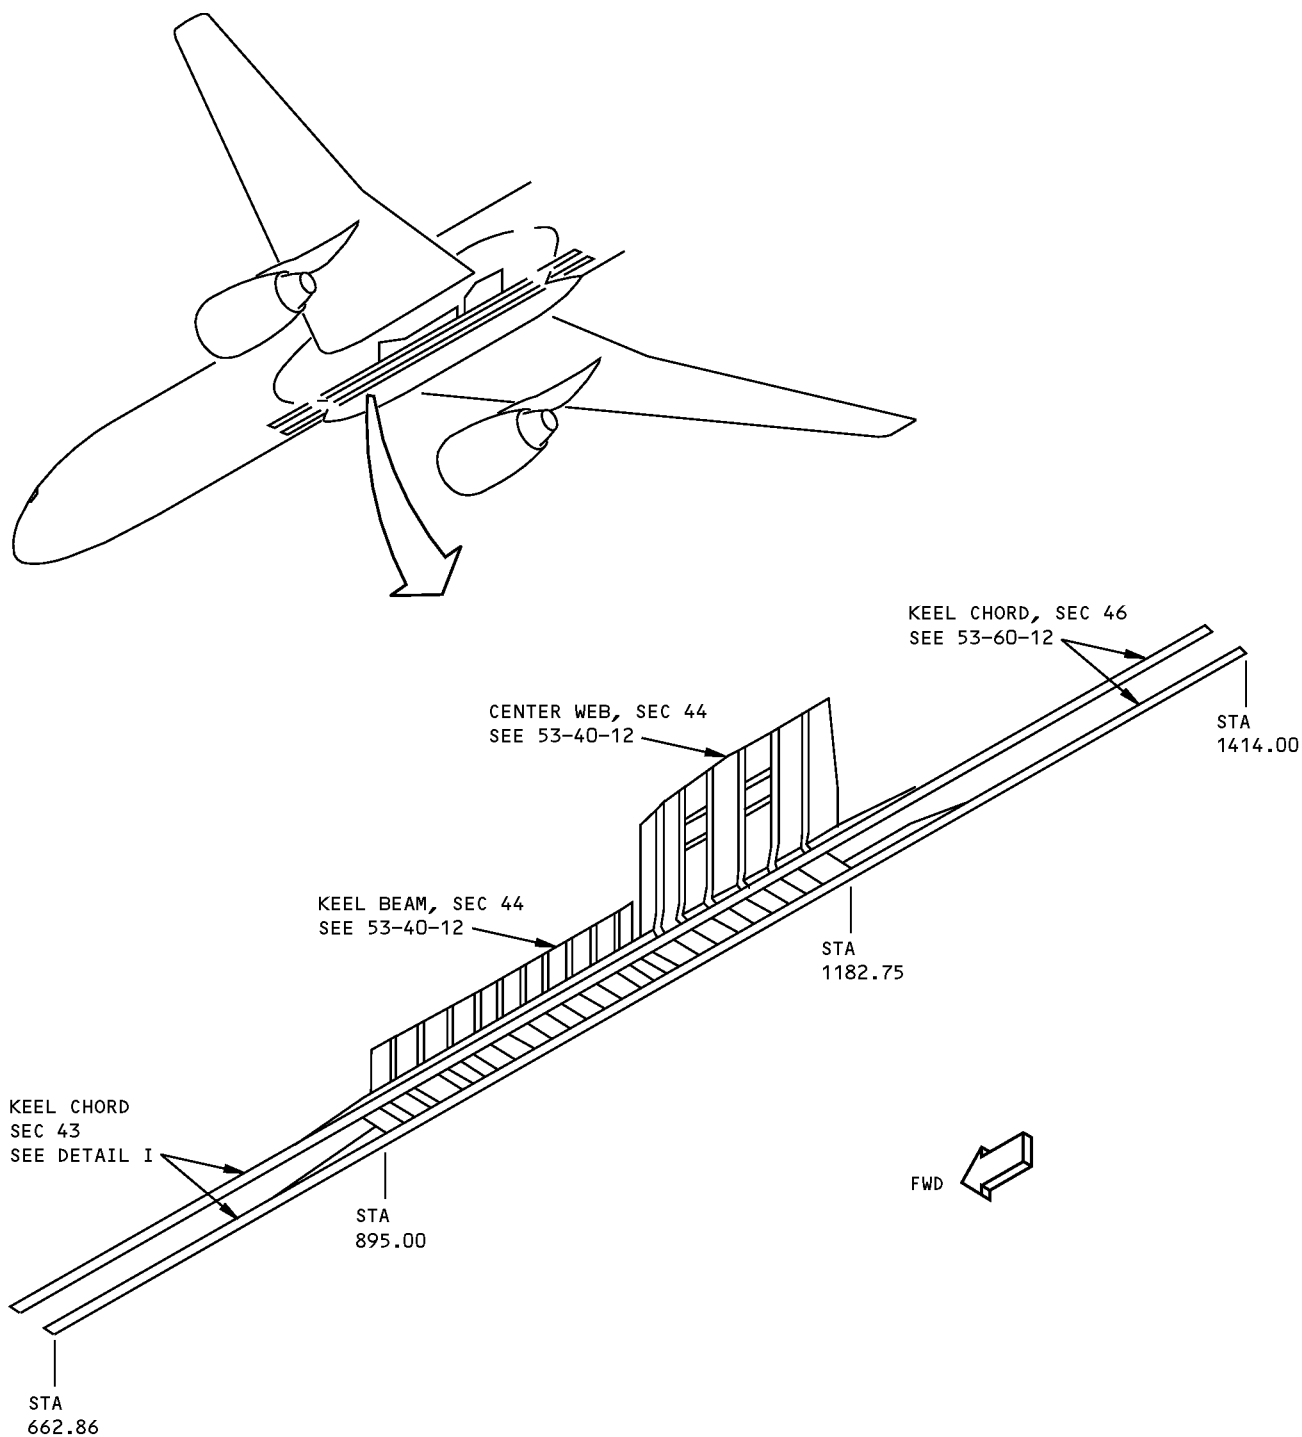
**Section 43 Keel Beam Structure Identification
Figure 1 (Sheet 1 of 2)**

IDENTIFICATION 1 - SECTION 43 - KEEL BEAM STRUCTURE

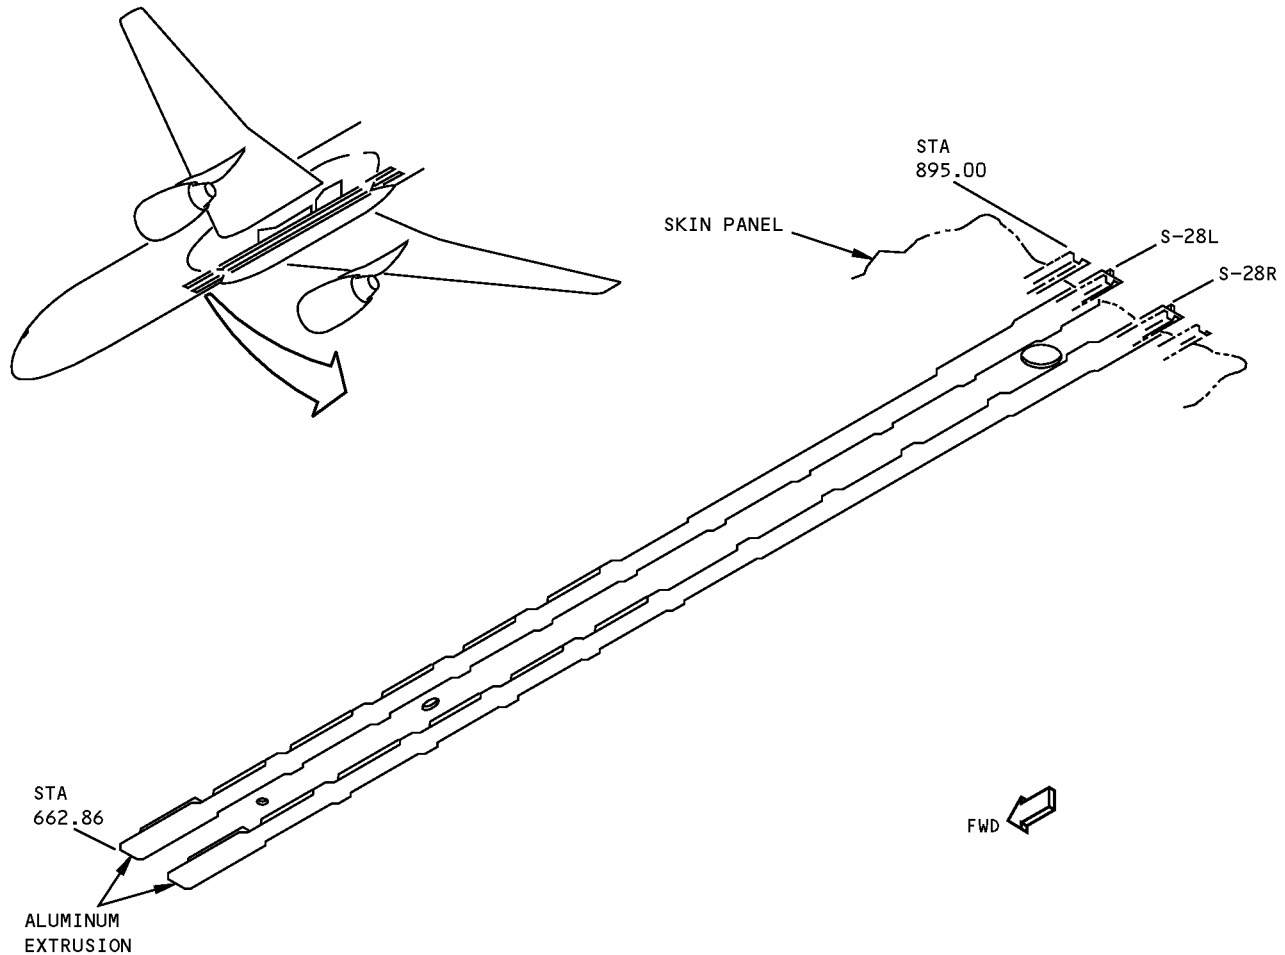
**Section 43 Keel Beam Structure Allowable Damage
Figure 101 (Sheet 1 of 2)**

ALLOWABLE DAMAGE 1 - SECTION 43 - KEEL BEAM STRUCTURE

- A** CRACKS NOT ALLOWED. EDGE CRACKS MUST BE REMOVED PER DETAILS I AND III. ELSEWHERE THE AFFECTED PART MUST BE REPLACED OR REPAIRED
- B** REMOVE DAMAGE PER DETAILS I,II,III AND IV. THE TOTAL CROSS-SECTIONAL AREA REMOVED MUST NOT EXCEED 10% OF THE ORIGINAL CROSS-SECTIONAL AREA OF THE FLANGE

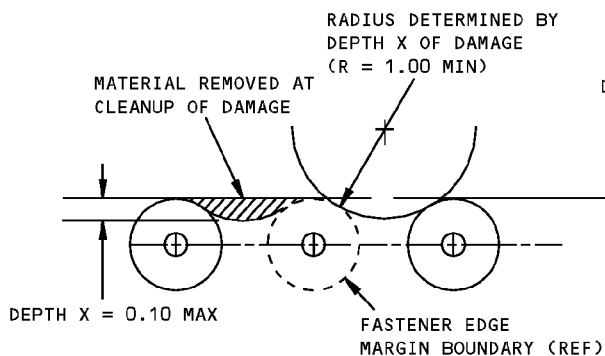
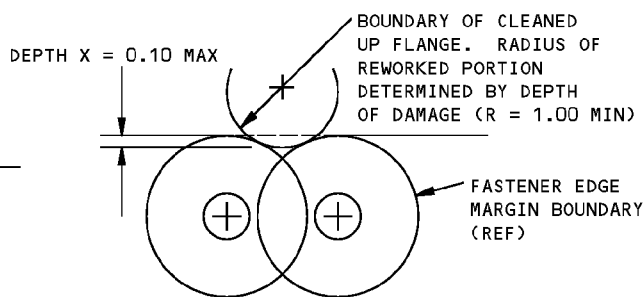
DETAIL I

DAMAGE CLEANUP OF EDGES WHERE FASTENER EDGE MARGINS DO NOT OVERLAP

DAMAGE CLEANUP OF EDGES WHERE FASTENER EDGE MARGINS OVERLAP

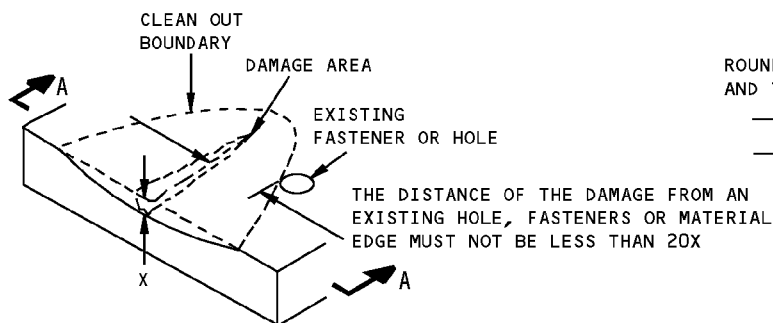
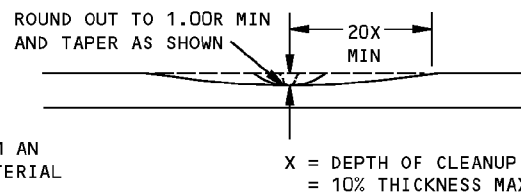
SECTION A-A

REMOVAL OF NICK, GOUGE AND SCRATCH DAMAGE ON A SURFACE

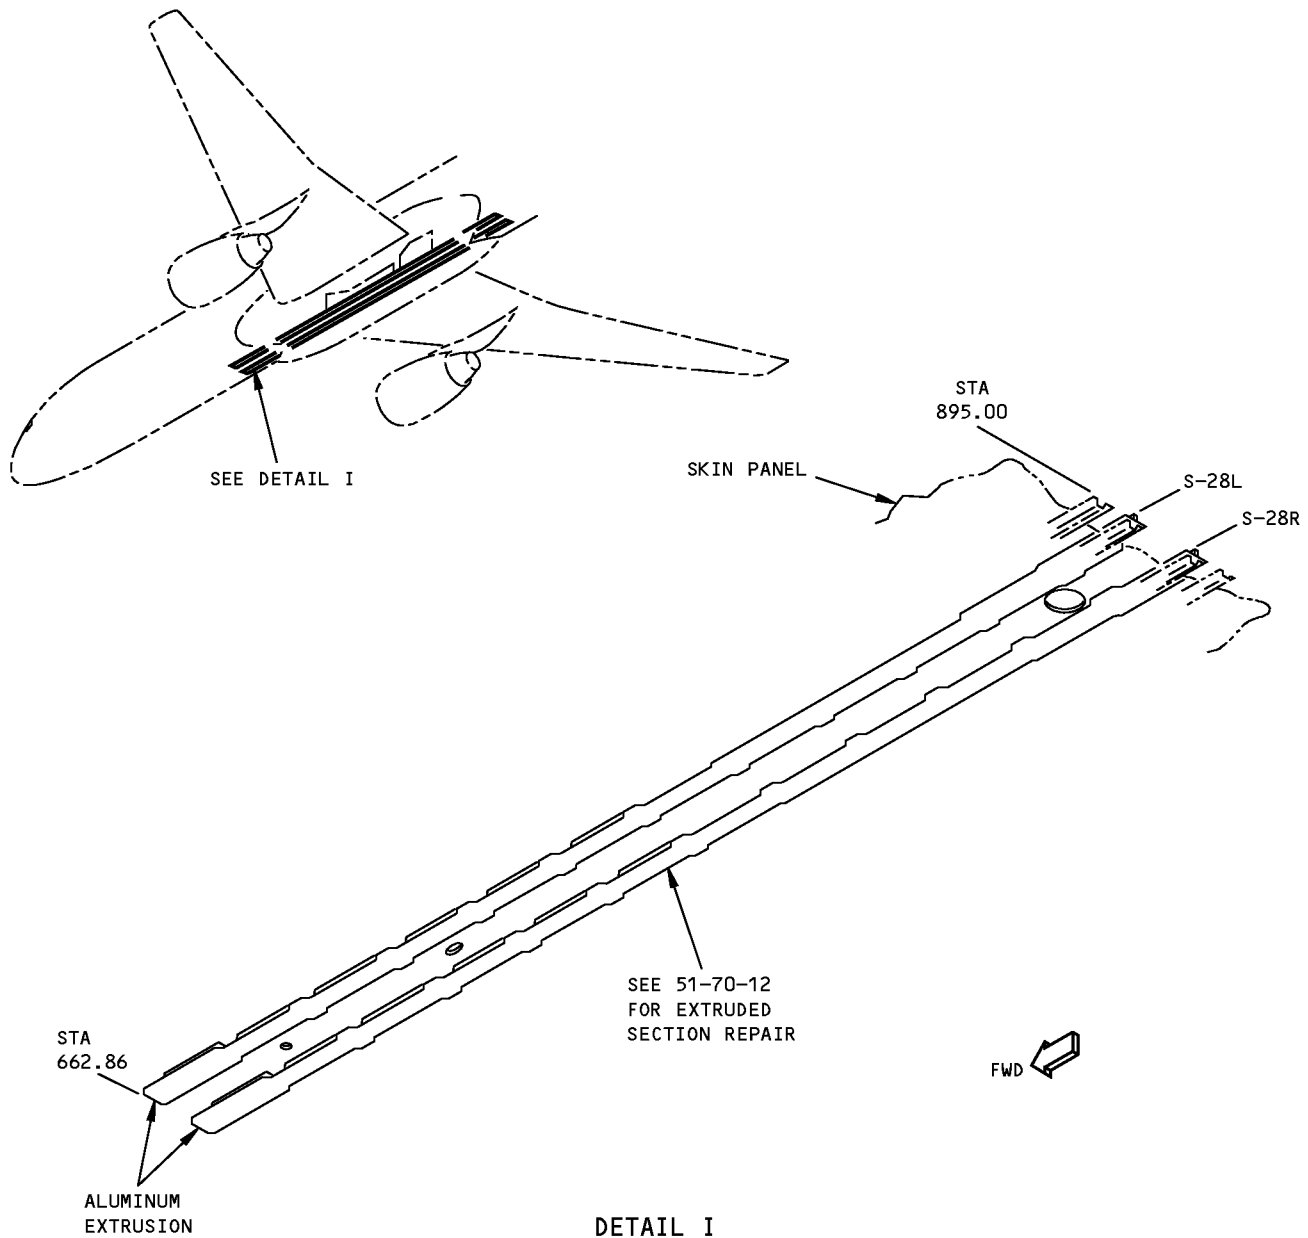
Section 43 Keel Chord Repair
Figure 201

REPAIR GENERAL - SECTION 43 - KEEL BEAM STRUCTURE

- THIS IS A CATEGORY A REPAIR. THE INSPECTIONS GIVEN IN THE MAINTENANCE PLANNING DATA (MPD) ARE SUFFICIENT TO MAINTAIN THE DAMAGE TOLERANCE OF THE INITIAL STRUCTURE WITH THIS REPAIR INSTALLED. REFER TO SRM 51-00-06 FOR REPAIR CATEGORIES AND DEFINITIONS.

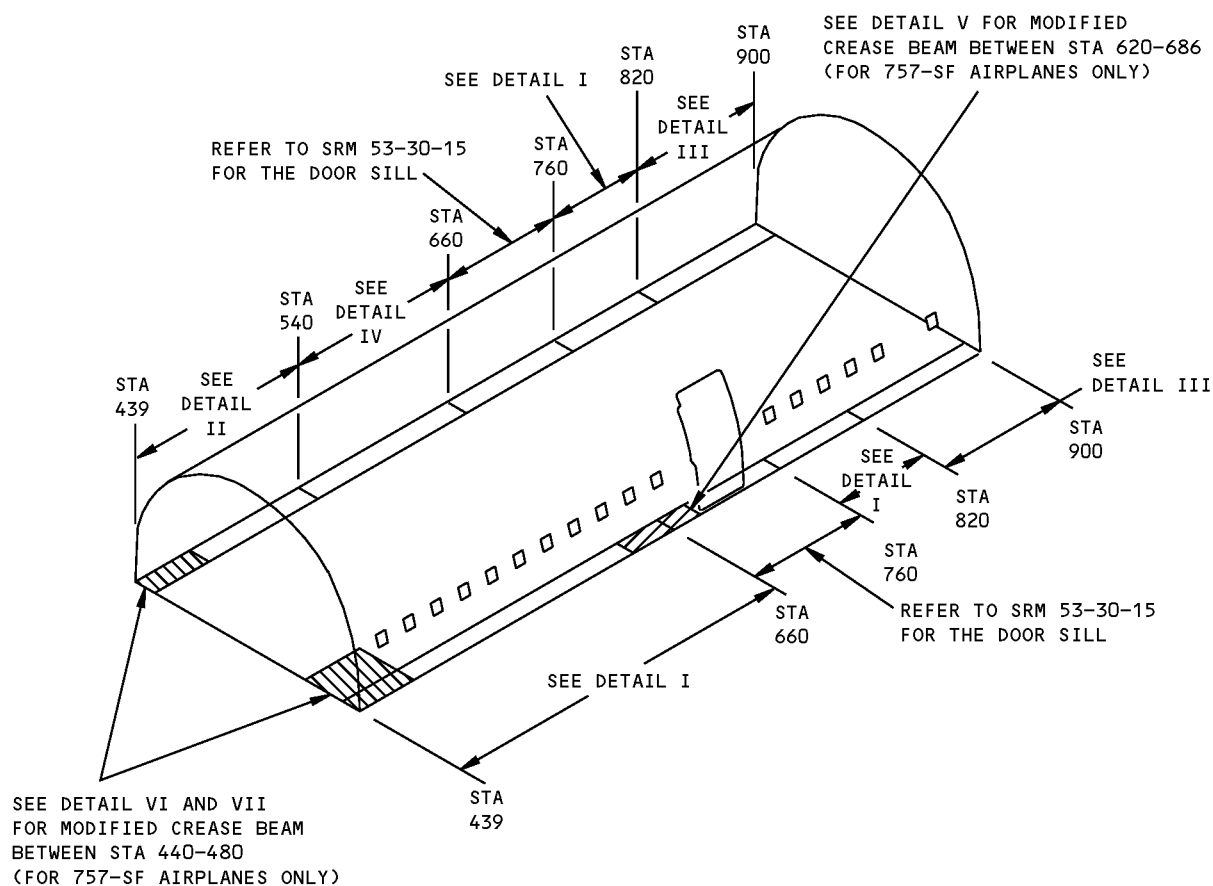
IDENTIFICATION 1 - SECTION 43 - CREASE BEAM

REFERENCE DRAWING
143N5520

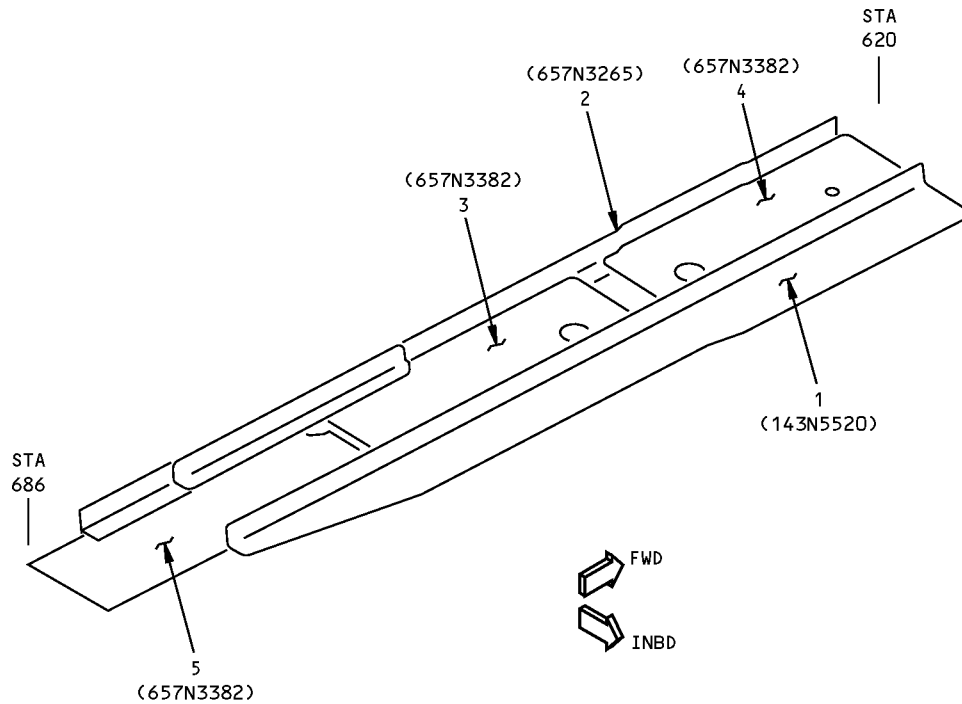
MODIFIED CREASE BEAM FOR 757-SF AIRPLANES ONLY
DETAIL V

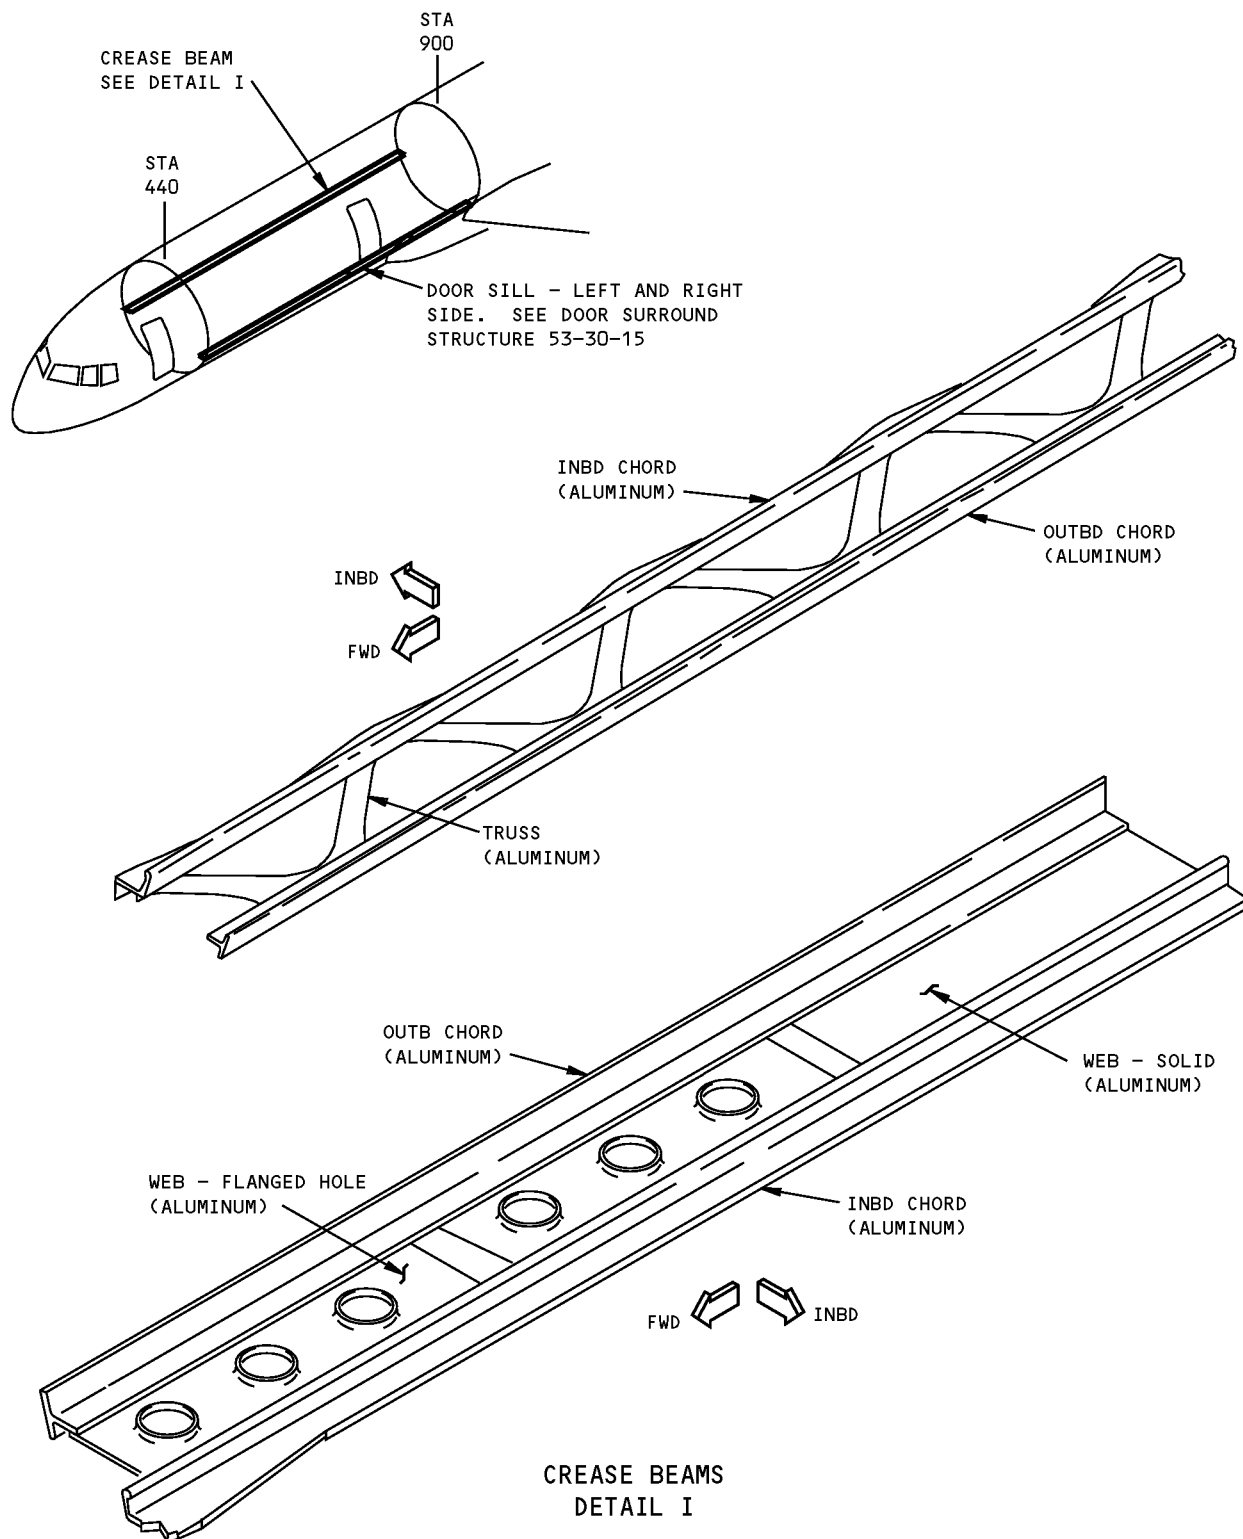
Section 43 Crease Beam Allowable Damage
Figure 101 (Sheet 1 of 5)

ALLOWABLE DAMAGE 1 - SECTION 43 - CREASE BEAM

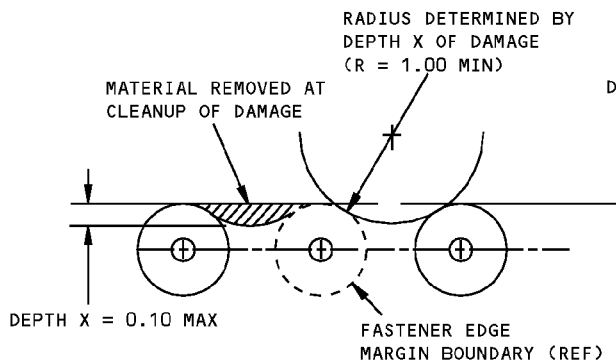
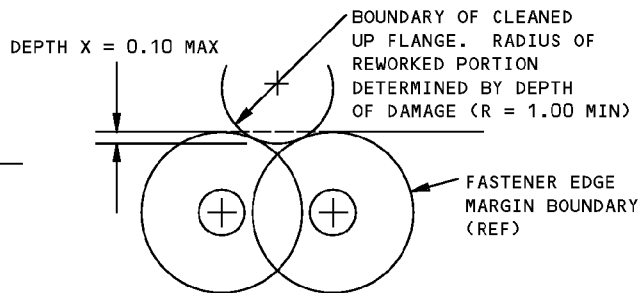
DETAIL II

DAMAGE CLEANUP OF EDGES WHERE
FASTENER EDGE MARGINS DO NOT OVERLAP

DAMAGE CLEANUP OF EDGES WHERE
FASTENER EDGE MARGINS OVERLAP

- [A]** REMOVE DAMAGE AS SHOWN IN DETAILS II, III, AND V
- [B]** FOR EDGE CRACKS SEE DETAILS II AND V. FOR LIGHTENING HOLE EDGE CRACKS SEE DETAIL VI
- [C]** REMOVE DAMAGE AS SHOWN IN DETAILS III, V, AND VI
- [D]** CLEAN OUT DAMAGE UP TO 0.25 INCH (6 mm) MAX DIA AND NOT CLOSER THAN 1.5 INCH (38 mm) TO FASTENER HOLE, MATERIAL EDGE, OR OTHER DAMAGE. FILL HOLE WITH 2117-T3 OR T4 ALUMINUM RIVET INSTALLED WET WITH BMS 5-95 SEALANT. ALL OTHER HOLES TO BE REPAIRED
- [E]** CRACKS NOT PERMITTED EXCEPT FOR EDGE CRACKS WHICH CAN BE REMOVED AS SHOWN IN DETAILS II AND V

- [F]** REMOVE DAMAGE AS SHOWN IN DETAILS II AND III
- [G]** CRACKS NOT PERMITTED EXCEPT FOR EDGE CRACKS WHICH MUST BE REMOVED AS SHOWN IN DETAILS II AND VII
- [H]** CRACKS NOT PERMITTED EXCEPT FOR EDGE CRACKS WHICH MUST BE REMOVED AS SHOWN IN DETAILS II AND III
- [J]** REMOVE EDGE DAMAGE AS SHOWN IN DETAILS II AND V. BLEND OUT SURFACE DAMAGE AS SHOWN IN DETAIL VII
- [K]** CLEAN OUT DAMAGE TO WEB PORTION OF TRUSS ONLY UP TO 0.25 INCH (6 mm) DIA AND NOT CLOSER THAN 1.0 INCH (25 mm) TO FASTENER HOLE, MATERIAL EDGE, OR OTHER DAMAGE. FILL HOLE WITH 2117-T3 OR T4 ALUMINUM RIVET INSTALLED WET WITH BMS 5-95 SEALANT. ALL OTHER HOLES TO BE REPAIRED

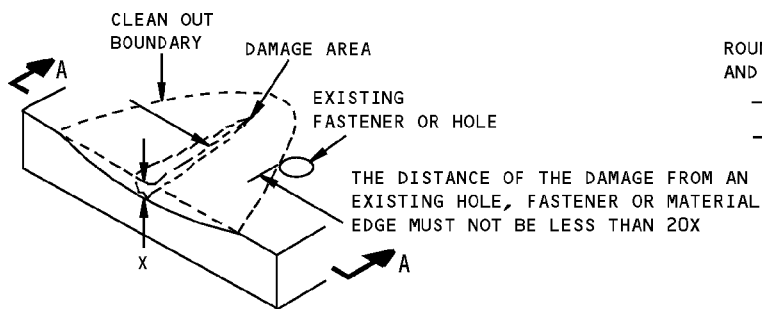
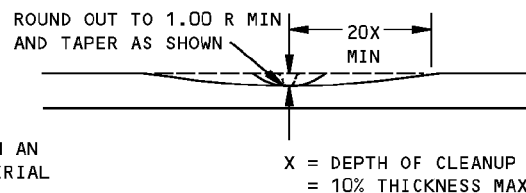
SECTION A-A

REMOVAL OF NICK, GOUGE AND SCRATCH DAMAGE ON A SURFACE
DETAIL III

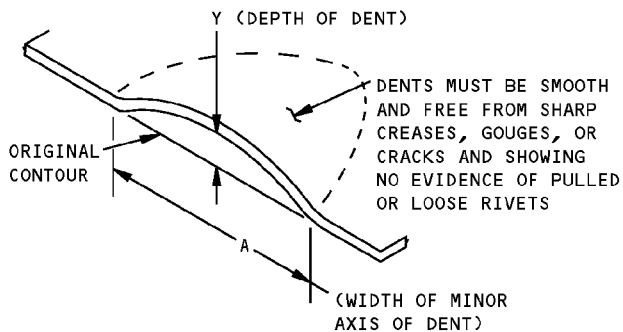
$\frac{A}{Y}$ MUST NOT BE LESS THAN 30
 Y (MAX) = 0.125

ALLOWABLE DAMAGE FOR DENT
DETAIL IV
