FUSELAGE

757-200 STRUCTURAL REPAIR MANUAL

CHAPTER 53 FUSELAGE

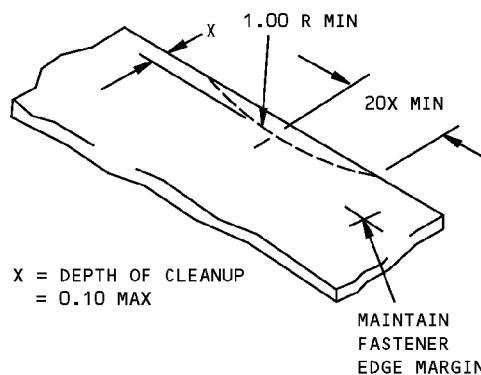
REMOVAL OF NICK OR CRACK
DAMAGE ON AN EDGE
DETAIL V

- [A]** REMOVE DAMAGE AS SHOWN IN DETAILS II, III, AND V
- [B]** FOR EDGE CRACKS SEE DETAILS II AND V. FOR LIGHTENING HOLE EDGE CRACKS SEE DETAIL VI
- [C]** REMOVE DAMAGE AS SHOWN IN DETAILS III, V, AND VI
- [D]** CLEAN OUT DAMAGE UP TO 0.25 INCH (6 mm) MAX DIA AND NOT CLOSER THAN 1.5 INCH (38 mm) TO FASTENER HOLE, MATERIAL EDGE, OR OTHER DAMAGE. FILL HOLE WITH 2117-T3 OR T4 ALUMINUM RIVET INSTALLED WET WITH BMS 5-95 SEALANT. ALL OTHER HOLES TO BE REPAIRED
- [E]** CRACKS NOT PERMITTED EXCEPT FOR EDGE CRACKS WHICH CAN BE REMOVED AS SHOWN IN DETAILS II AND V

- [F]** REMOVE DAMAGE AS SHOWN IN DETAILS II AND III
- [G]** CRACKS NOT PERMITTED EXCEPT FOR EDGE CRACKS WHICH MUST BE REMOVED AS SHOWN IN DETAILS II AND VII
- [H]** CRACKS NOT PERMITTED EXCEPT FOR EDGE CRACKS WHICH MUST BE REMOVED AS SHOWN IN DETAILS II AND III
- [J]** REMOVE EDGE DAMAGE AS SHOWN IN DETAILS II AND V. BLEND OUT SURFACE DAMAGE AS SHOWN IN DETAIL VII
- [K]** CLEAN OUT DAMAGE TO WEB PORTION OF TRUSS ONLY UP TO 0.25 INCH (6 mm) DIA AND NOT CLOSER THAN 1.0 INCH (25 mm) TO FASTENER HOLE, MATERIAL EDGE, OR OTHER DAMAGE. FILL HOLE WITH 2117-T3 OR T4 ALUMINUM RIVET INSTALLED WET WITH BMS 5-95 SEALANT. ALL OTHER HOLES TO BE REPAIRED

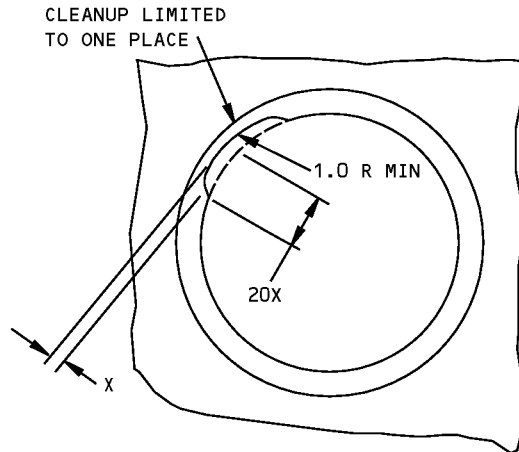
X = DEPTH OF CLEANUP = 0.10 MAX OR
1/2 FLANGE WIDTH WHICHEVER IS LESS

**FLANGED HOLE EDGE DAMAGE CLEANUP
DETAIL VI**

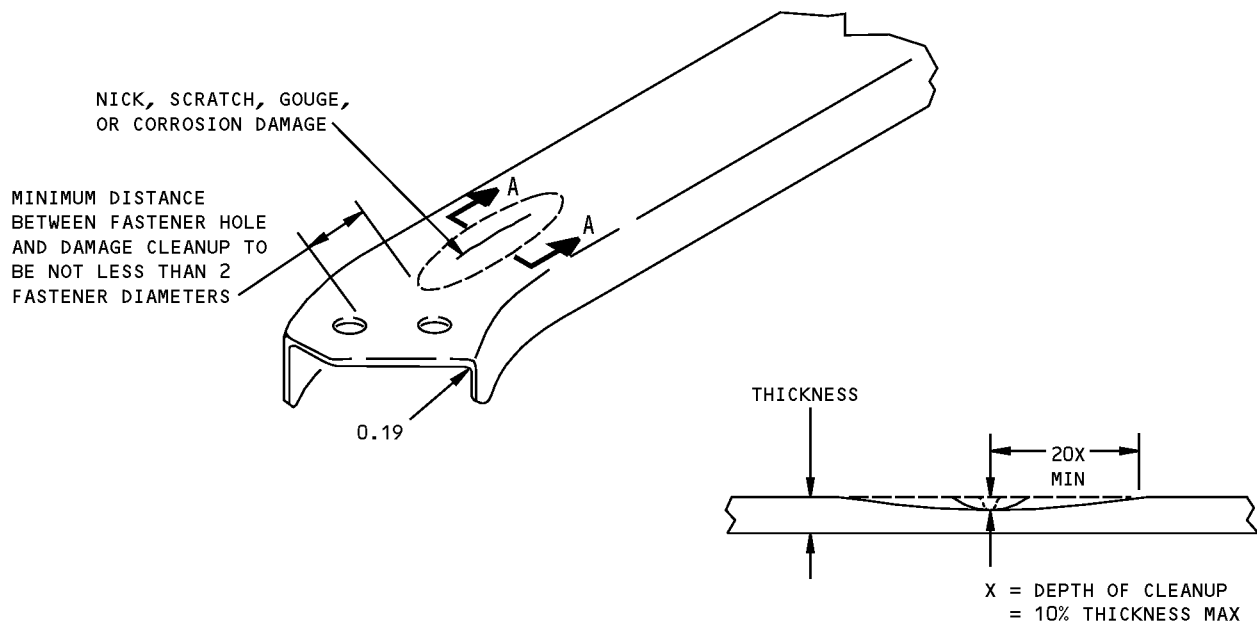
SECTION A-A

**NICK, GOUGE, AND SCRATCH REMOVAL
FROM SURFACE OF CREASE BEAM TRUSS
DETAIL VII**

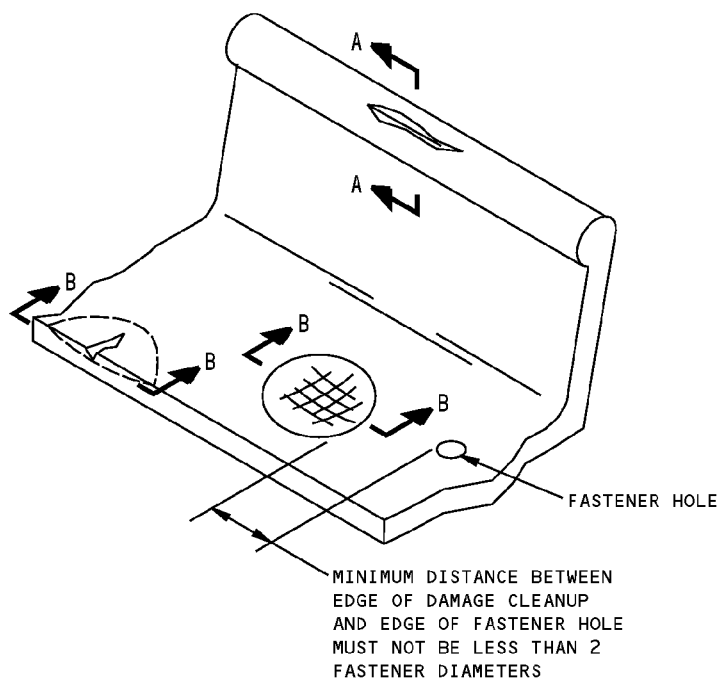
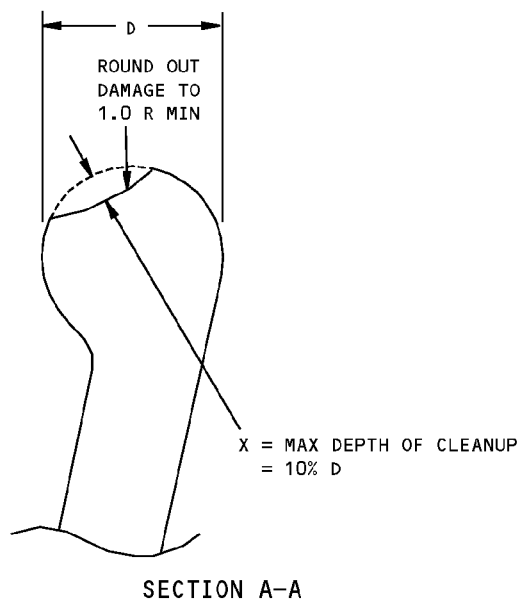
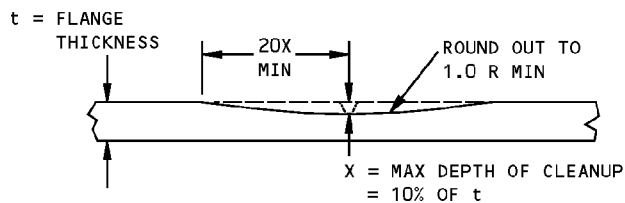
DAMAGE CLEANUP MUST NOT
REDUCE CROSS-SECTIONAL
AREA BY MORE THAN 10%

SECTION THRU EXTRUSION

DAMAGE CLEANUP OF BULB ANGLE
DETAIL VIII

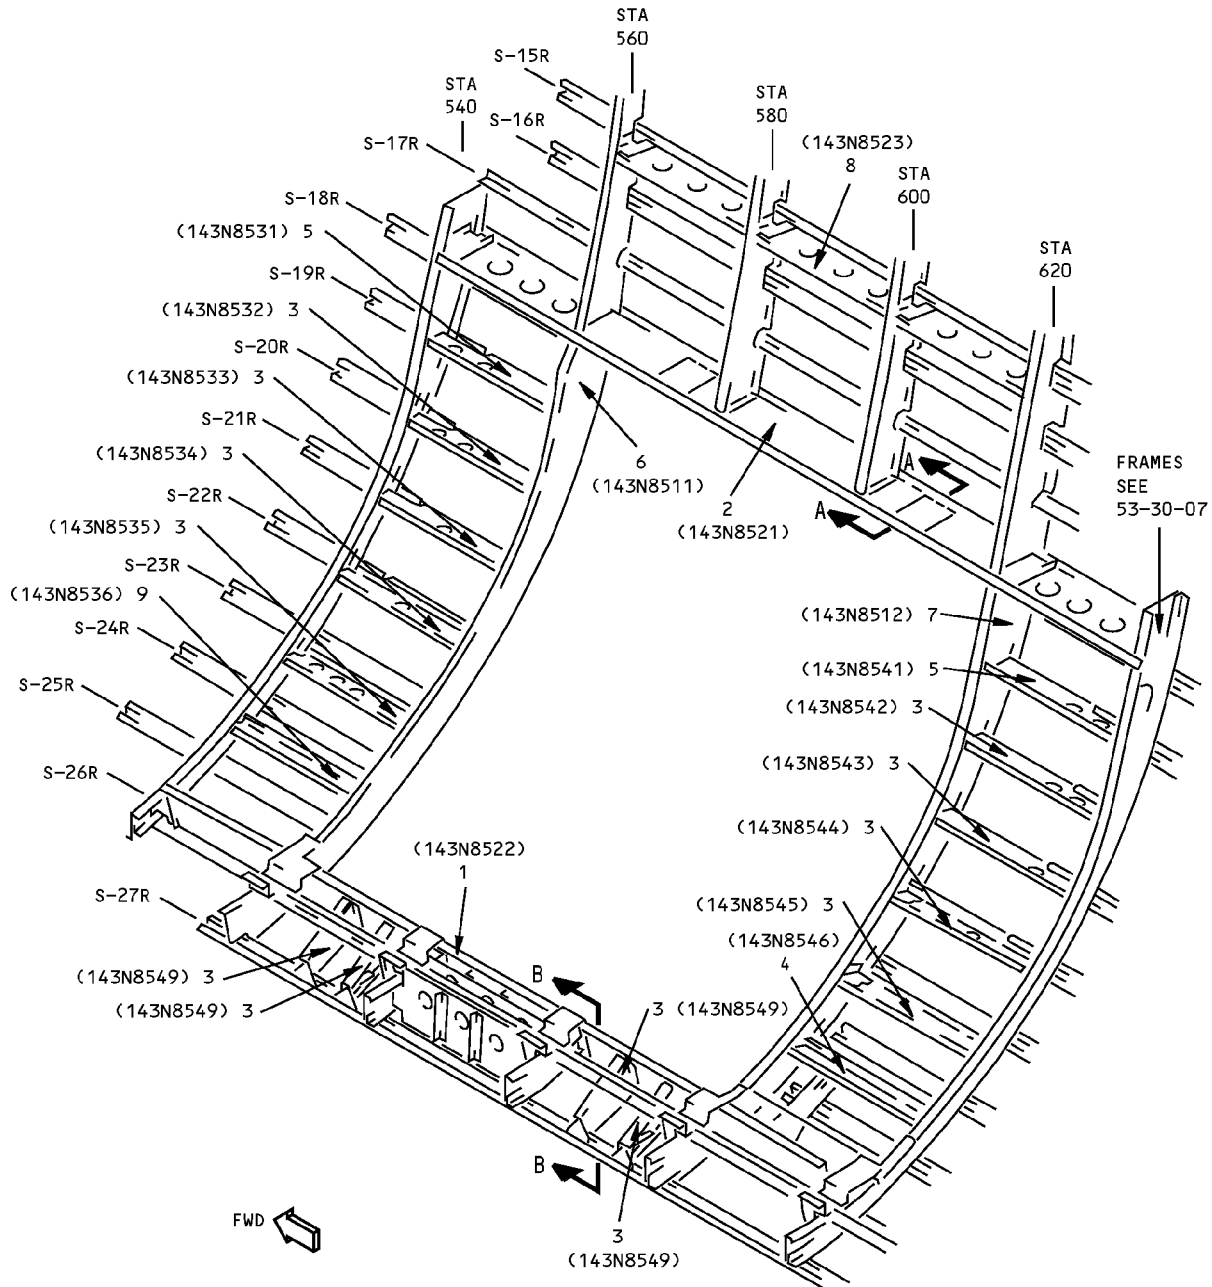
FORWARD CARGO COMPARTMENT DOOR SURROUND STRUCTURE
DETAIL I

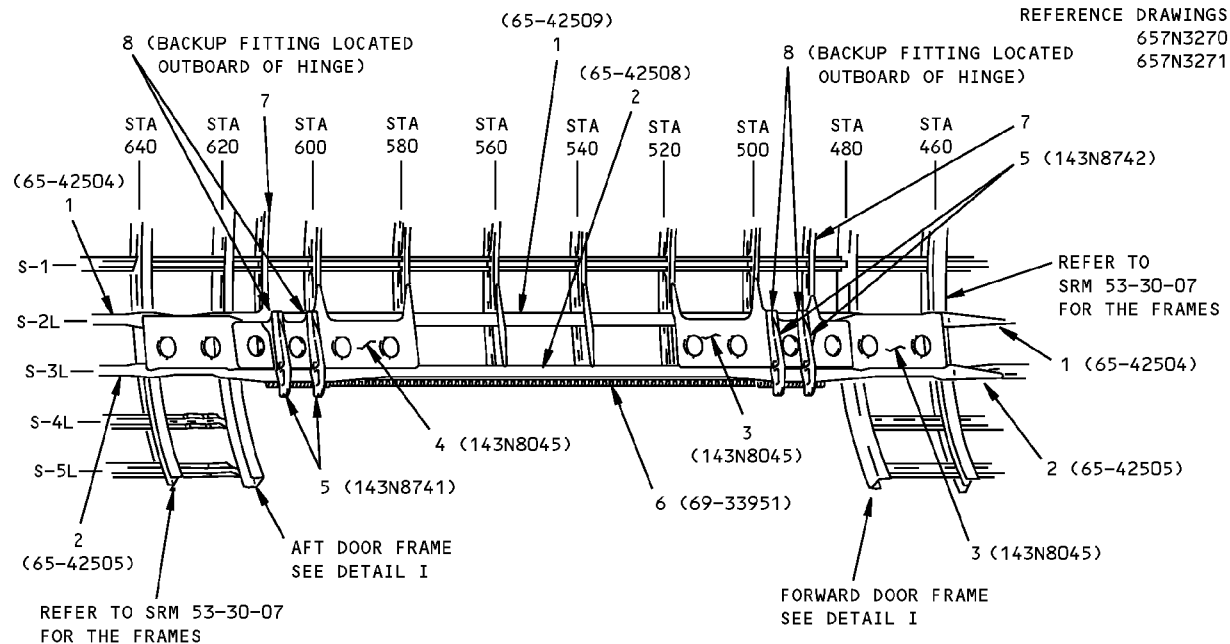
MAIN CARGO DOOR
UPPER SILL
DETAIL IV **E**

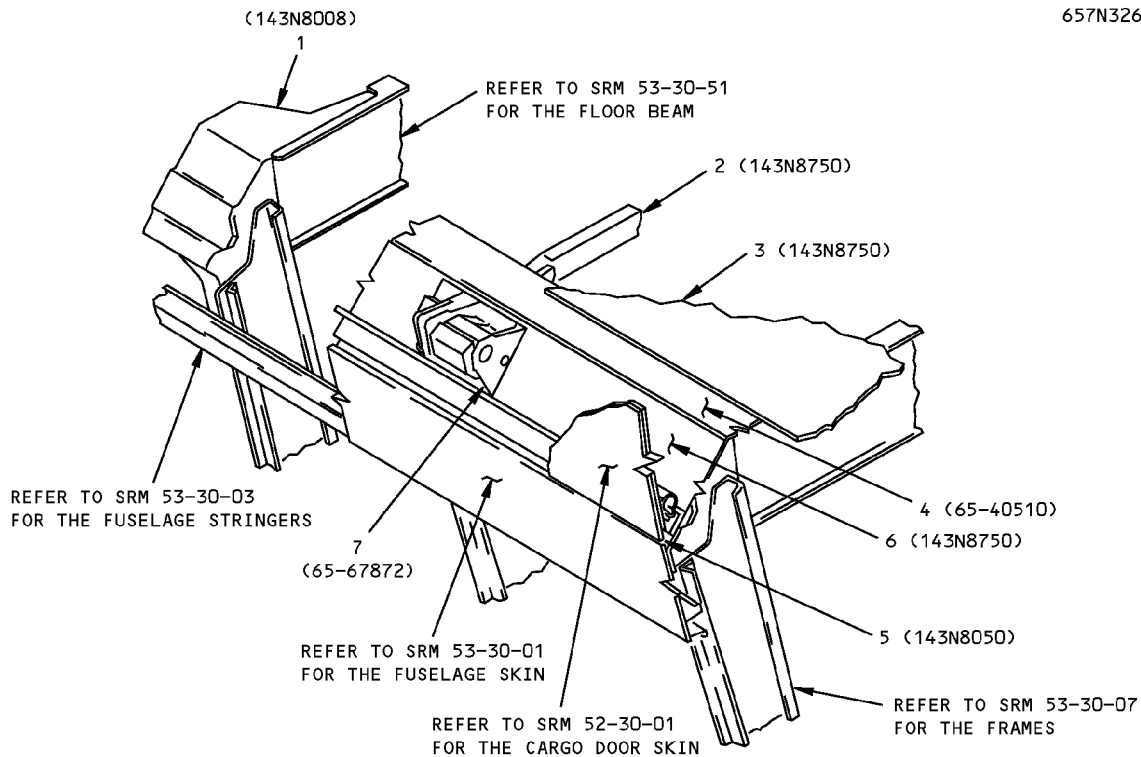
MAIN CARGO DOOR
LOWER DOOR SILL
DETAIL V E

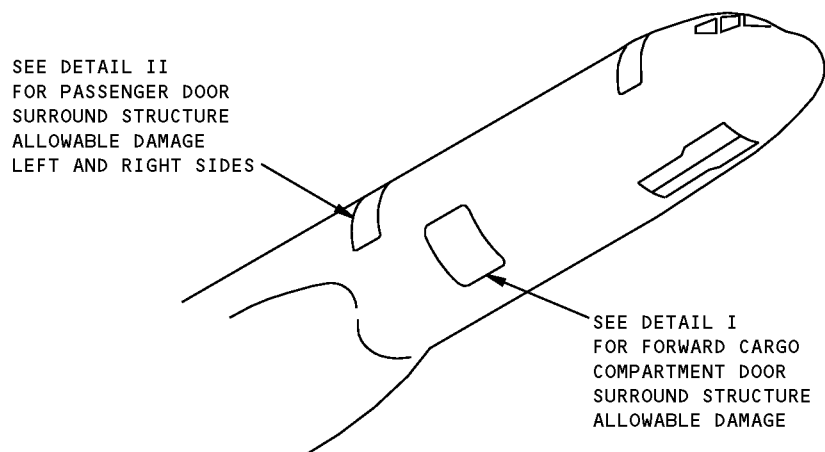
Section 43 Door Surround Structure Allowable Damage
Figure 101 (Sheet 1 of 7)

ALLOWABLE DAMAGE 1 - SECTION 43 - DOOR SURROUND STRUCTURE

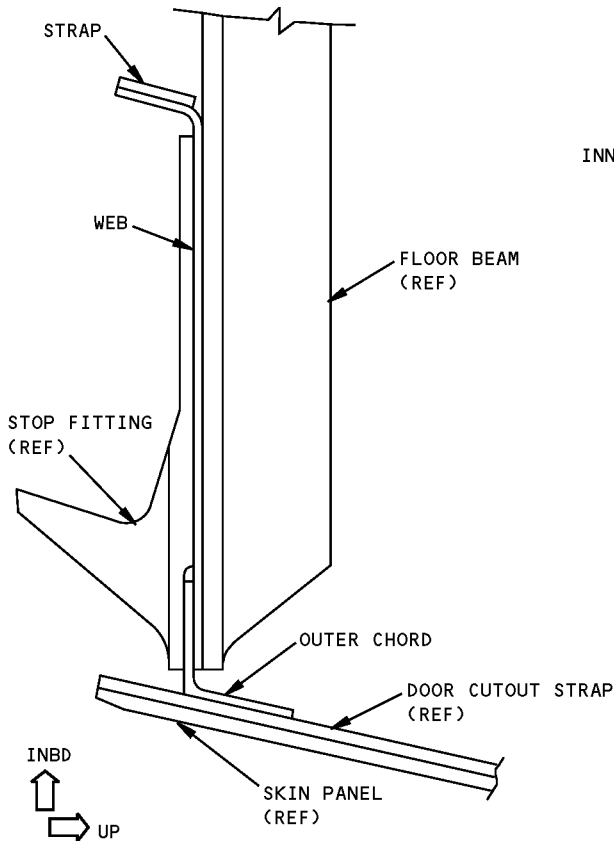
**UPPER SILL
SECTION A-A**

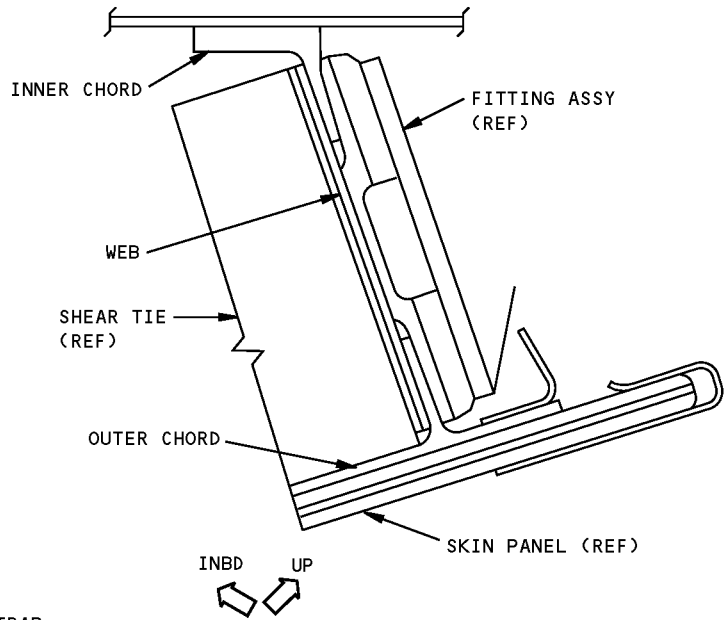
**LOWER SILL
SECTION B-B**

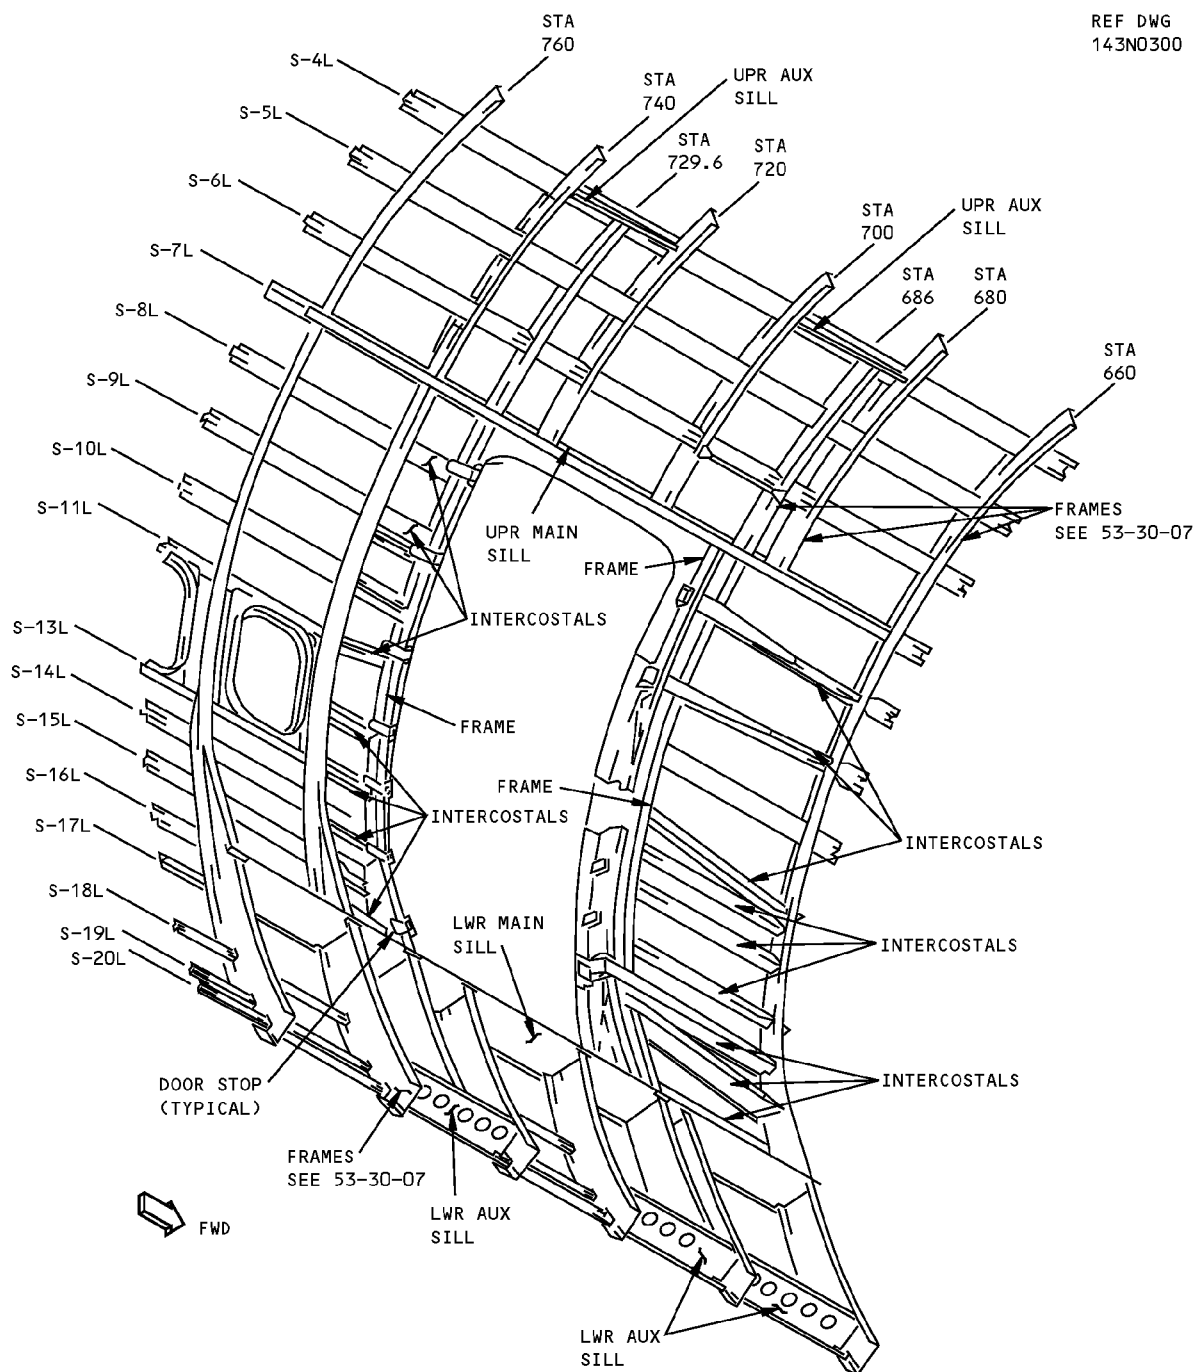
LEFT SIDE SHOWN
RIGHT SIDE OPPOSITE
PASSENGER DOOR SURROUND STRUCTURE
DETAIL II

MATERIAL: ALUMINUM

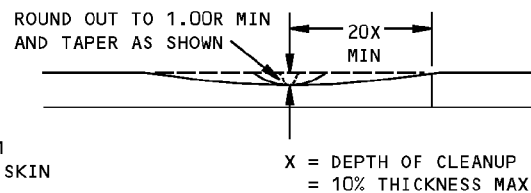
SECTION A-A

REMOVAL OF NICK, GOUGE AND SCRATCH DAMAGE ON A SURFACE
DETAIL IV

- A CRACKS NOT ALLOWED EXCEPT FOR EDGE CRACKS WHICH MUST BE REMOVED PER DETAILS III AND VIII
- B REMOVE DAMAGE PER DETAILS III, IV AND VI
- C CRACKS NOT ALLOWED EXCEPT FOR EDGE CRACKS WHICH MUST BE REMOVED PER DETAILS III AND VII
- D CLEAN OUT DAMAGE UP TO 0.25 MAX DIA AND NOT CLOSER THAN 1.0 INCH TO FASTENER HOLE OR OTHER DAMAGE. FILL HOLE WITH A 2117-T3 OR T4 ALUMINUM RIVET INSTALLED WET WITH BMS 5-95 SEALANT. ALL OTHER HOLES TO BE REPAIRED

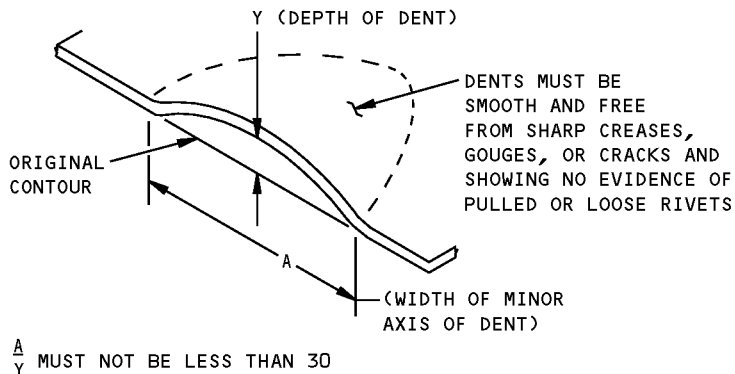
ALLOWABLE DAMAGE FOR DENT
DETAIL V

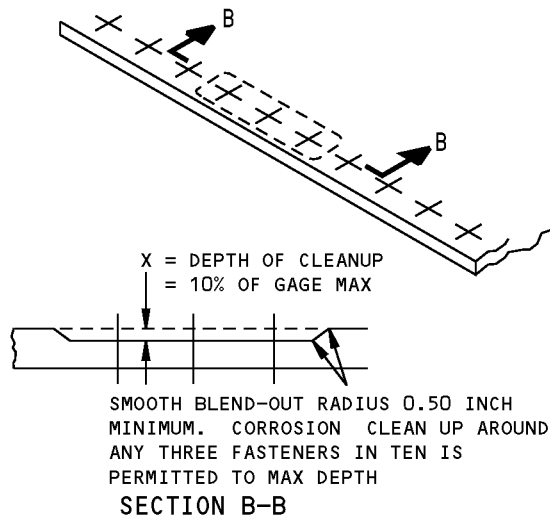
CORROSION CLEANUP
DETAIL VI

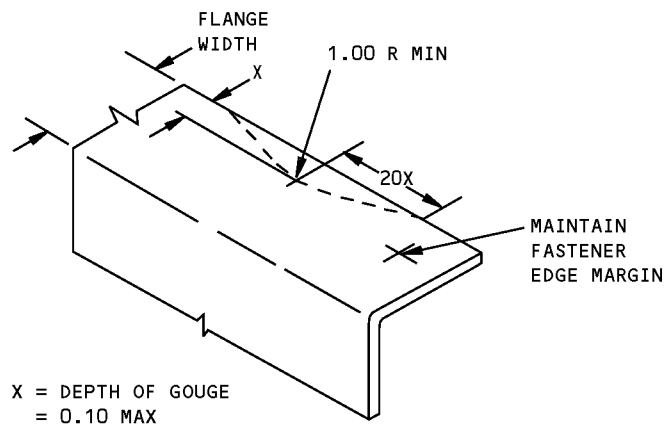
DETAIL VII

REMOVAL OF NICK OR CRACK DAMAGE ON AN EDGE
DETAIL VIII

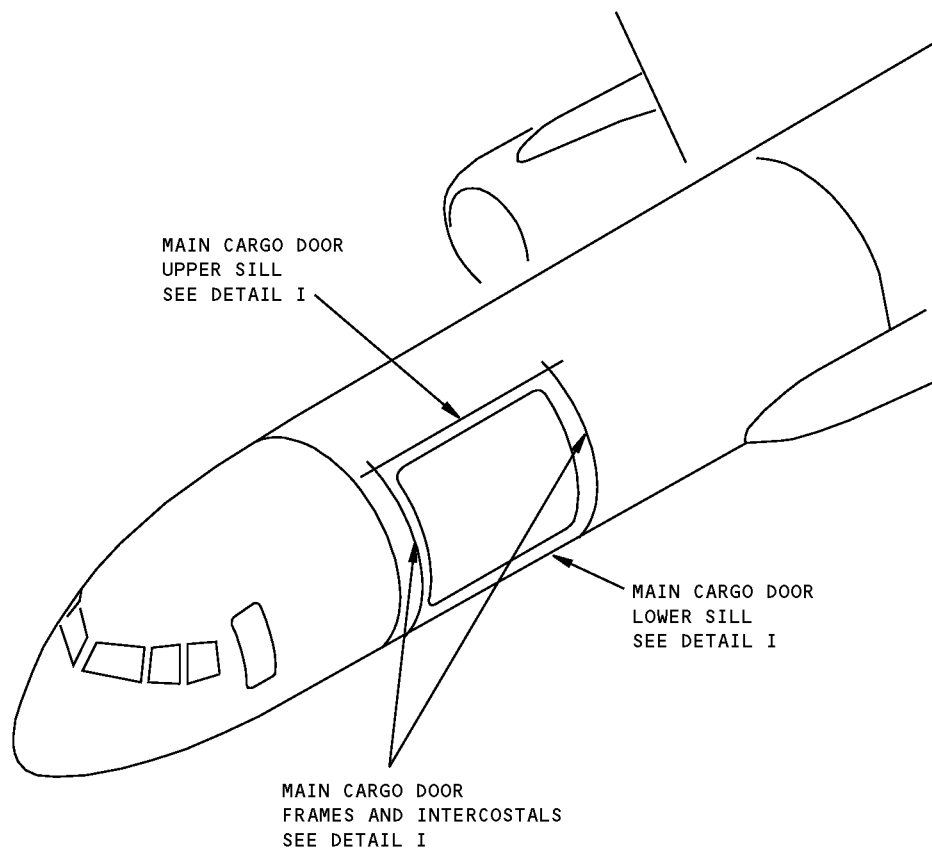
ALLOWABLE DAMAGE 2 - MAIN DECK CARGO DOOR - DOOR SURROUND STRUCTURE - 757-SF

Main Deck Cargo Door - Door Surround Structure Allowable Damage - 757-SF
Figure 101 (Sheet 1 of 5)

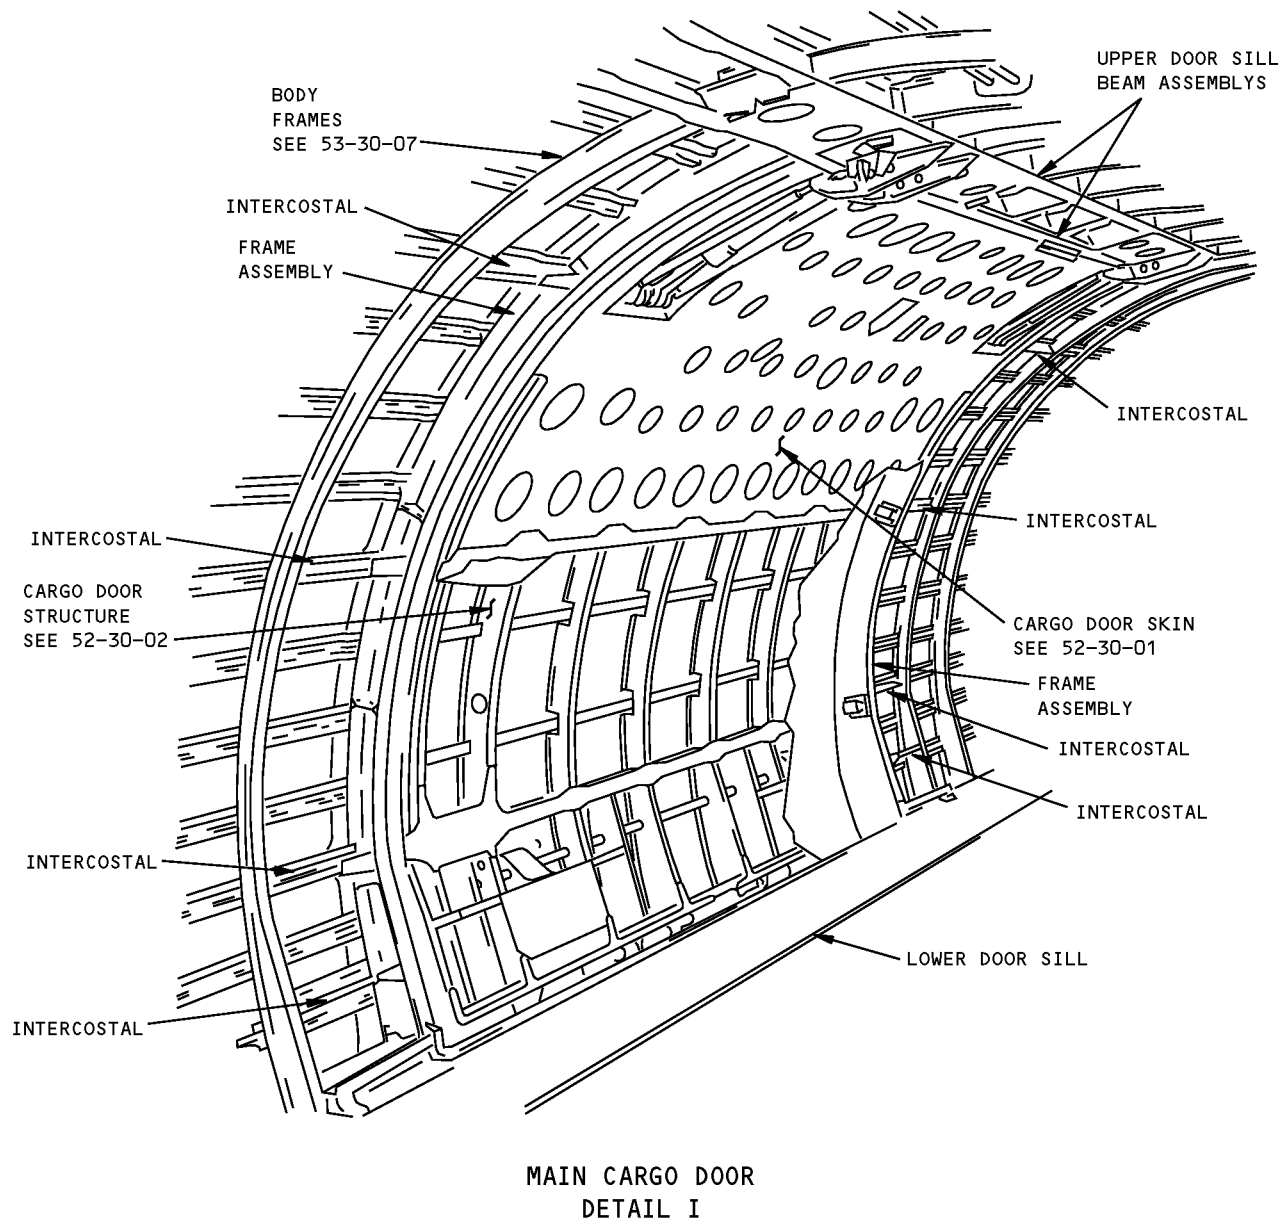
MATERIAL: ALUMINUM

**Main Deck Cargo Door - Door Surround Structure Allowable Damage - 757-SF
Figure 101 (Sheet 2 of 5)**

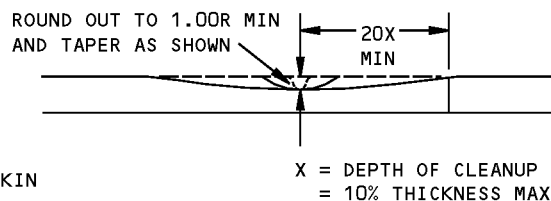
SECTION A-A

REMOVAL OF NICK, GOUGE AND SCRATCH DAMAGE ON A SURFACE
DETAIL III

- A** CRACKS NOT PERMITTED EXCEPT FOR EDGE CRACKS WHICH MUST BE REMOVED. SEE DETAILS II AND VII.
- B** REMOVE DAMAGE. SEE DETAILS II, III AND V.
- C** CRACKS NOT PERMITTED EXCEPT FOR EDGE CRACKS WHICH MUST BE REMOVED. SEE DETAILS II AND VI.
- D** CLEAN OUT DAMAGE UP TO 0.25 MAXIMUM DIAMETER AND NOT CLOSER THAN 1.0 INCH TO FASTENER HOLE OR OTHER DAMAGE. FILL HOLE WITH A 2771-T3 OR T4 ALUMINUM RIVET INSTALLED WET WITH BMS 5-95 SEALANT. ALL OTHER HOLES TO BE REPAIRED.
- E** MAXIMUM EDGE TRIM IS 0.05 INCH FOR STRINGER 3L DOOR SILL INNER CHORD BETWEEN STA. 590 AND STA. 640.

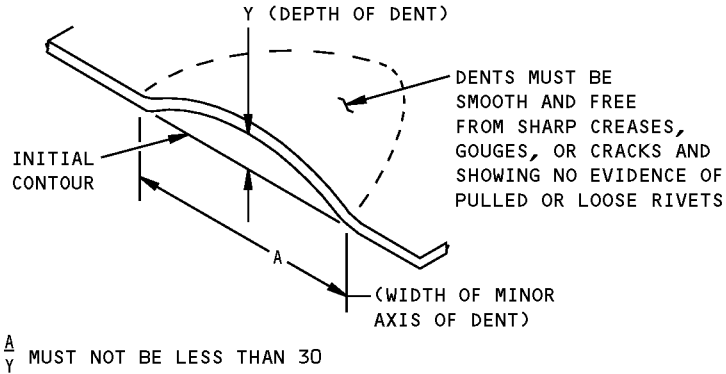
ALLOWABLE DAMAGE FOR DENT
DETAIL IV

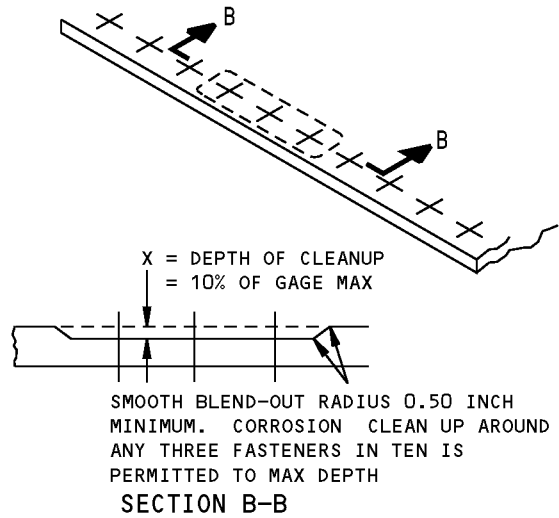
CORROSION CLEANUP
DETAIL V

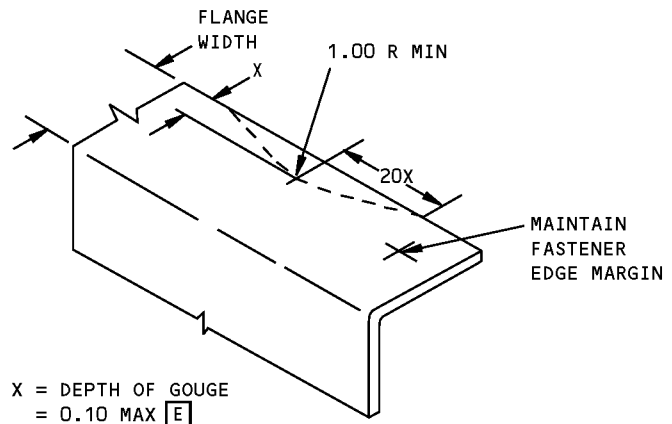
REMOVAL OF NICK OR CRACK DAMAGE ON AN EDGE
DETAIL VII

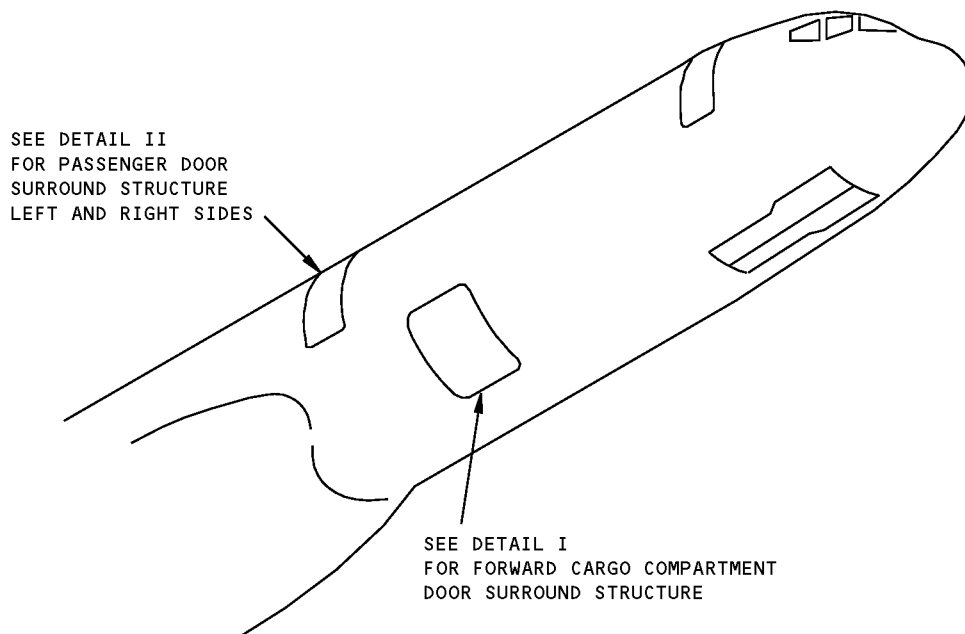
- DAMAGED COMPONENTS IN DOOR SURROUND STRUCTURE MAY BE REPLACED OR REPAIRED. IF REPAIRS ARE TO BE MADE, SEE 51-70 FOR TYPICAL WEB, AND EXTRUDED SECTION REPAIRS

Section 43 Door Surround Structure Repair
Figure 201 (Sheet 1 of 3)

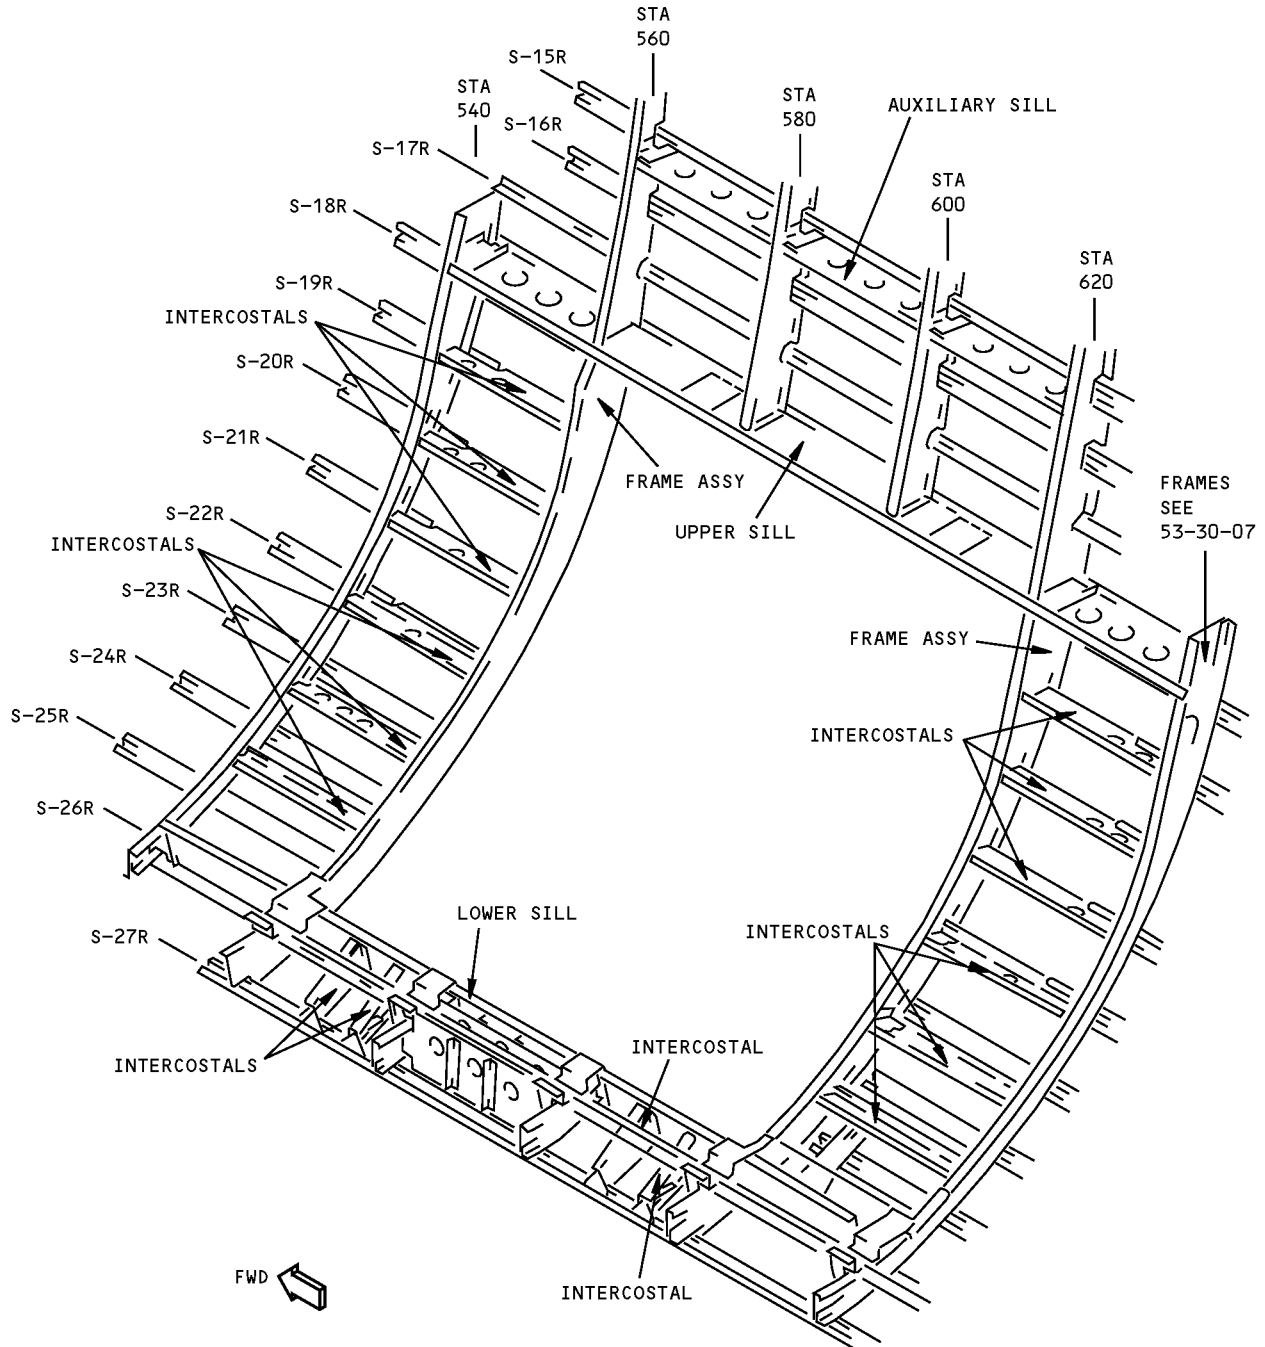
**FORWARD CARGO COMPARTMENT DOOR SURROUND STRUCTURE
DETAIL I**

**Section 43 Door Surround Structure Repair
Figure 201 (Sheet 2 of 3)**

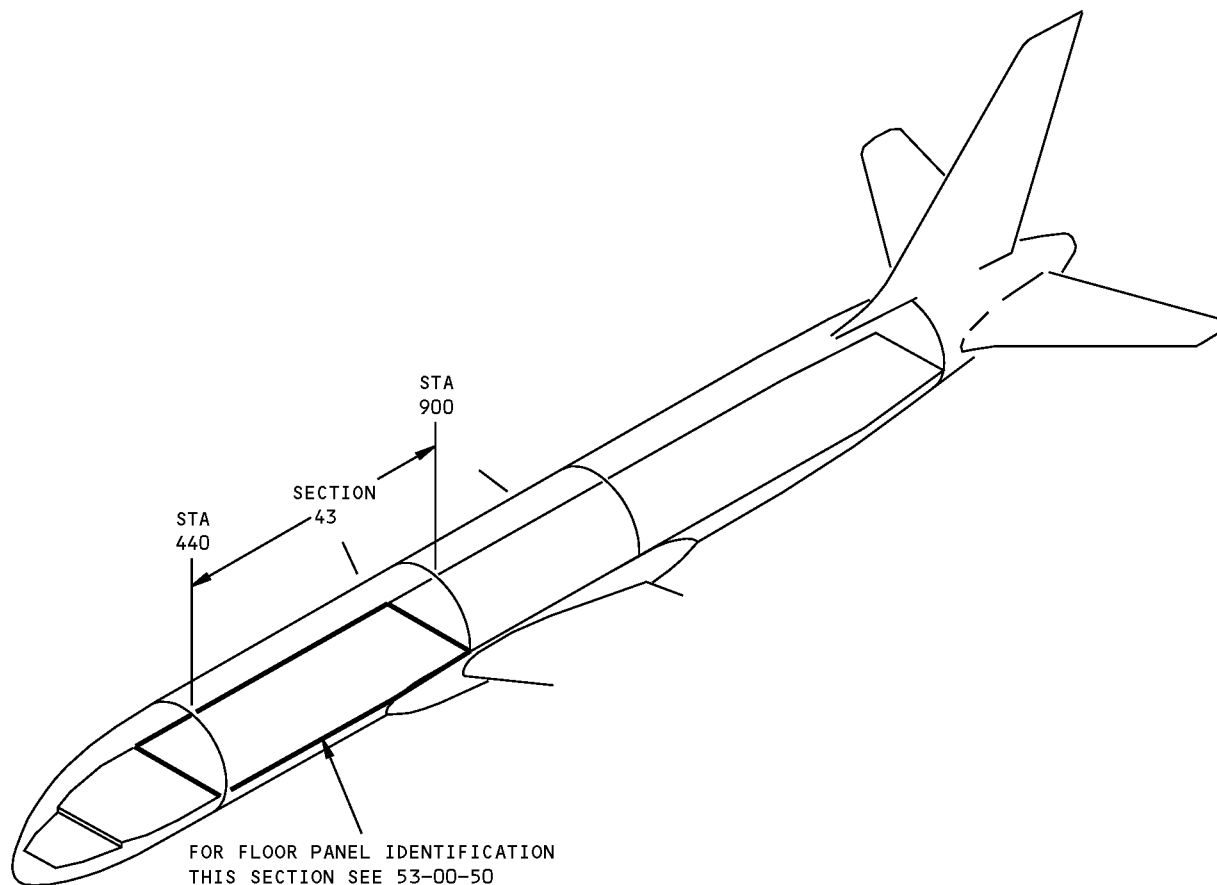
Section 43 Main Deck Floor Panel Identification
Figure 1

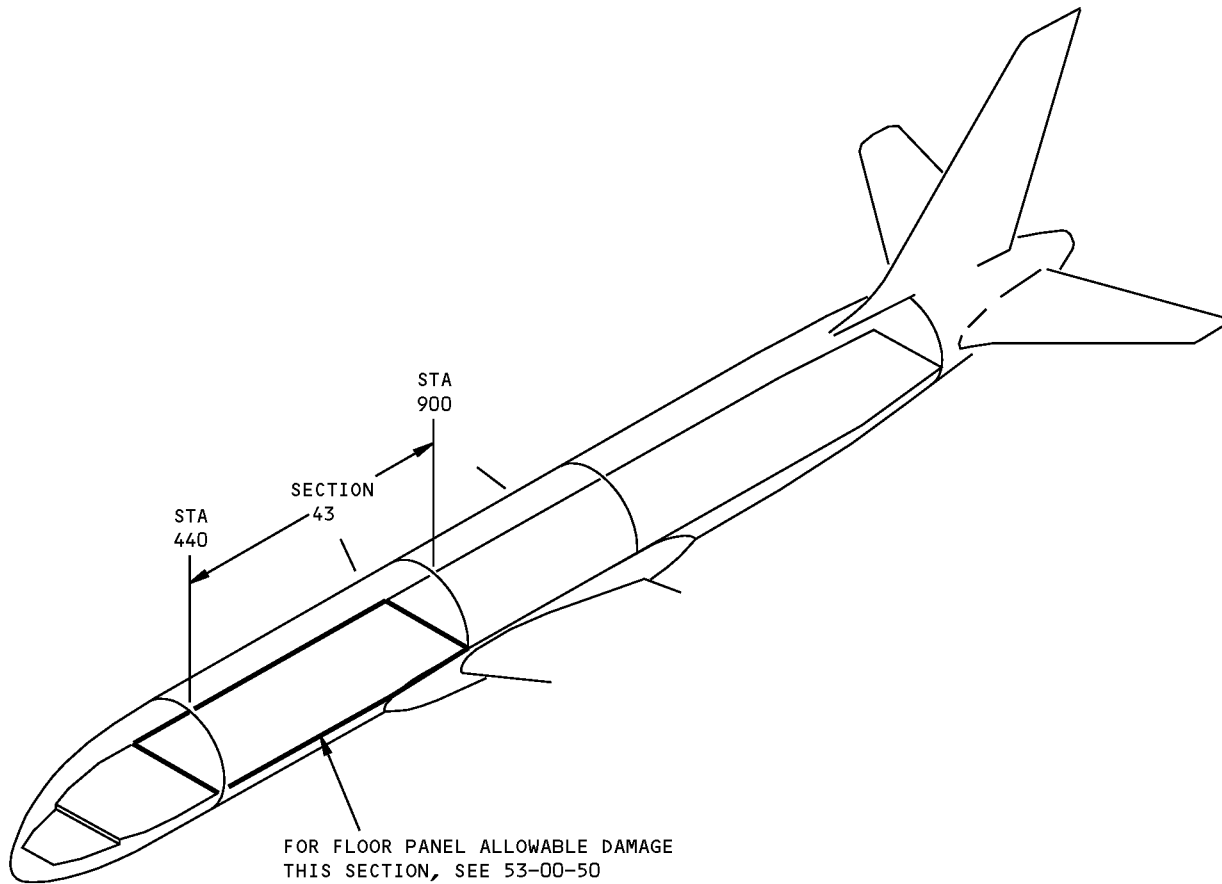
Section 43 Main Deck Floor Panel Allowable Damage
Figure 101

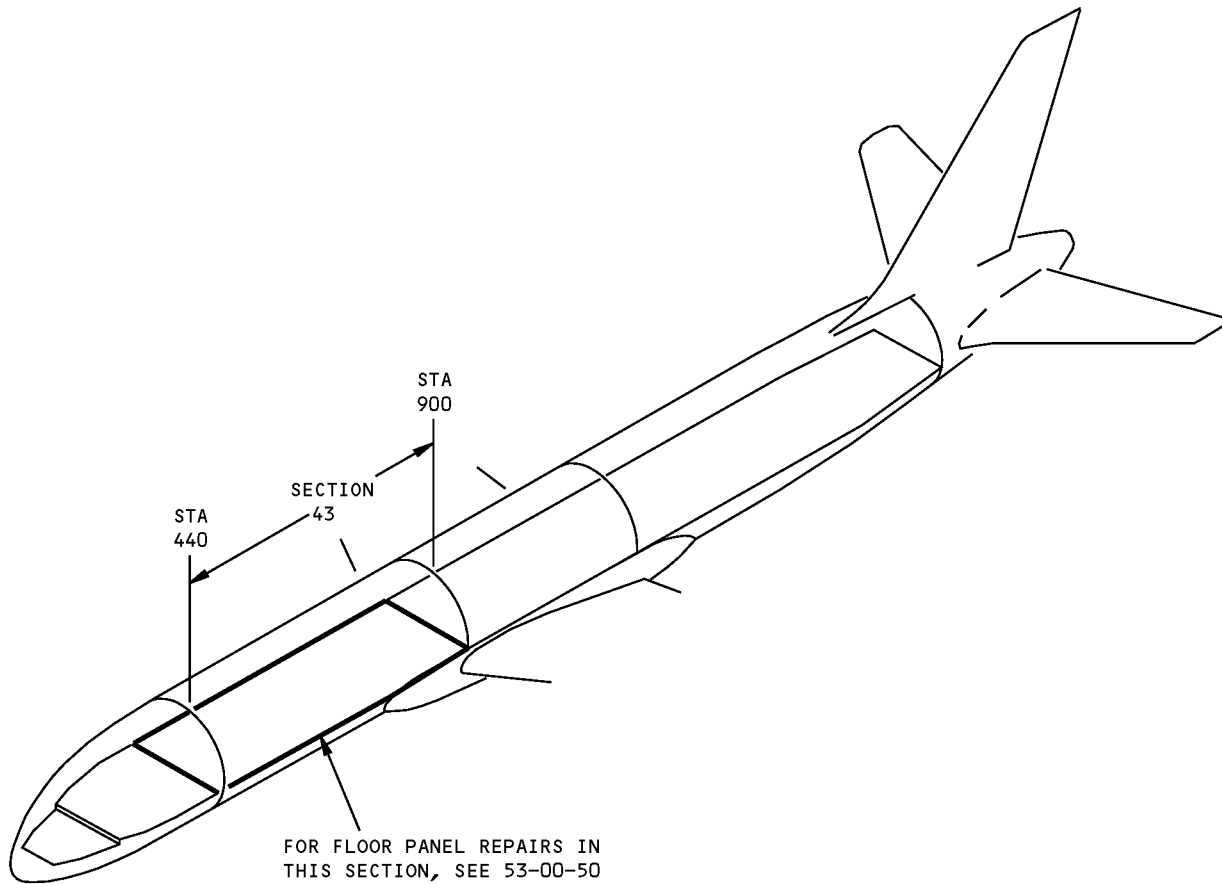
Section 43 Main Deck Floor Panel Repairs
Figure 201

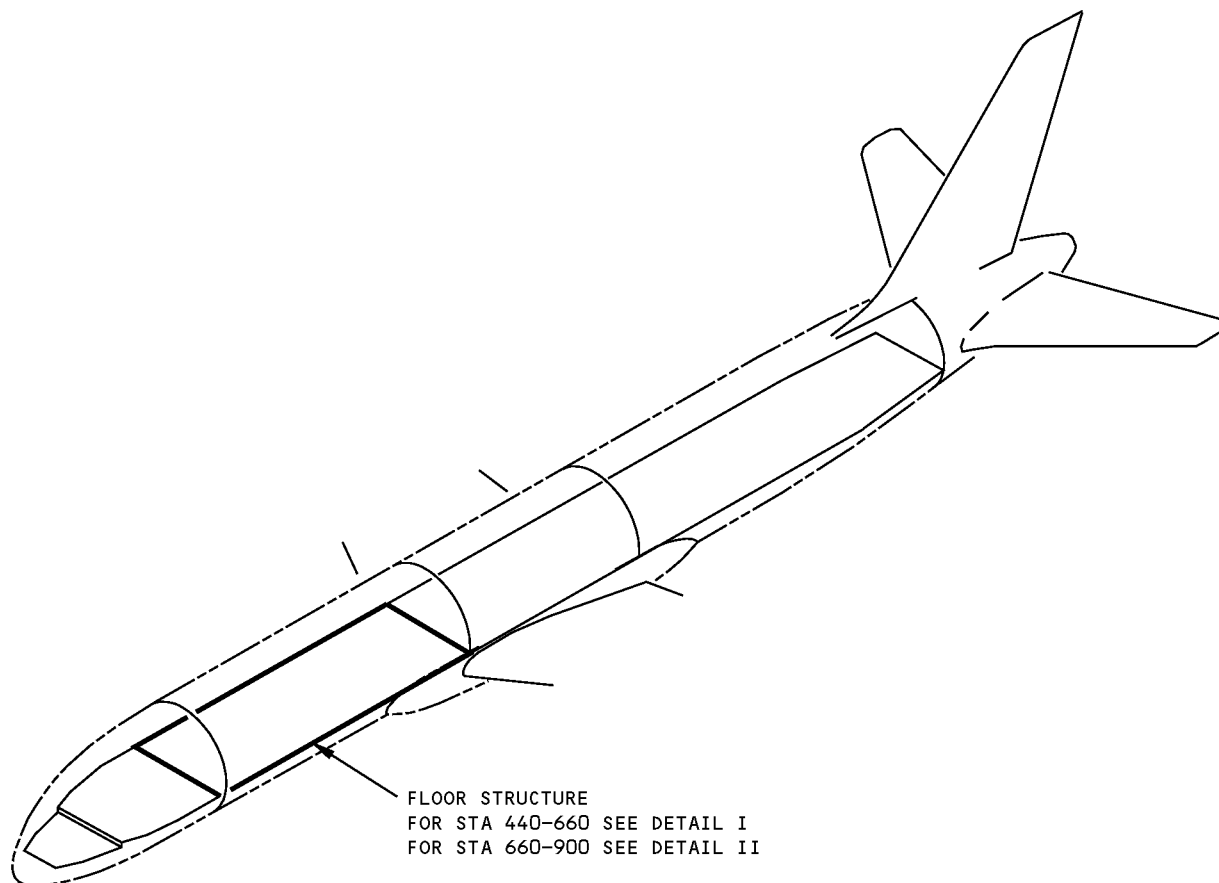
IDENTIFICATION 1 - SECTION 43 - MAIN DECK FLOOR STRUCTURE

- TOP OF FLOOR BEAM WL 208.10
- [A]** FOR CUM LINE NUMBERS:
2 THRU 5
- [B]** FOR 757-SF AIRPLANES ONLY
- [C]** FOR 757 PASSENGER AIRPLANES

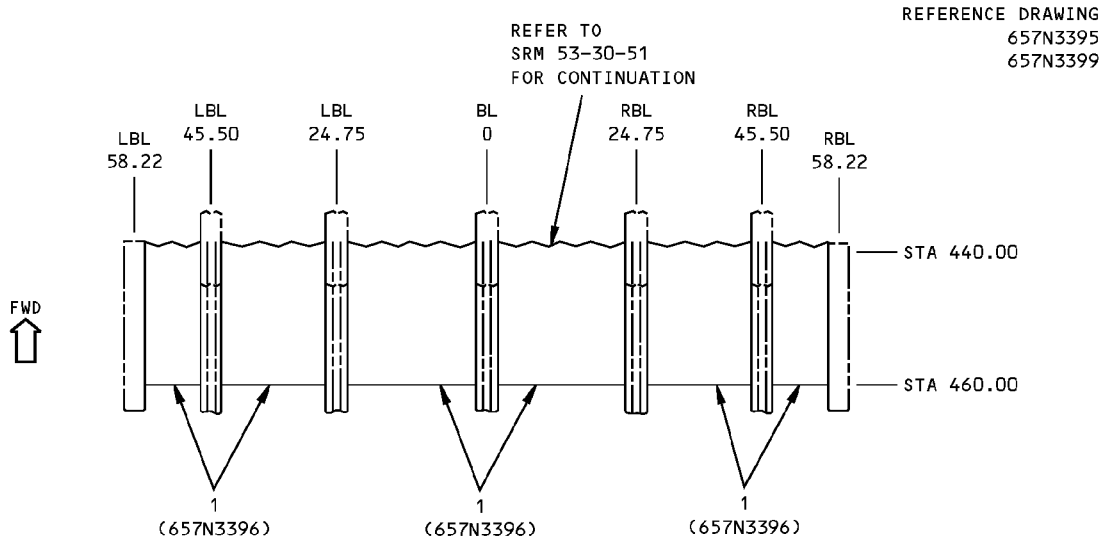
SHEAR WEB IDENTIFICATION

DETAIL III B

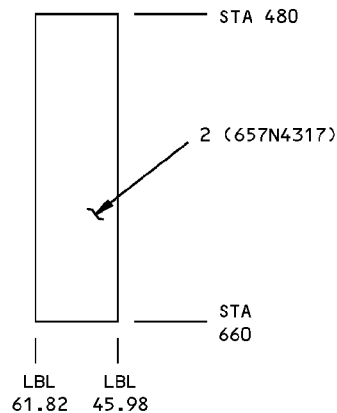
SHEAR WEB IDENTIFICATION

DETAIL IV B

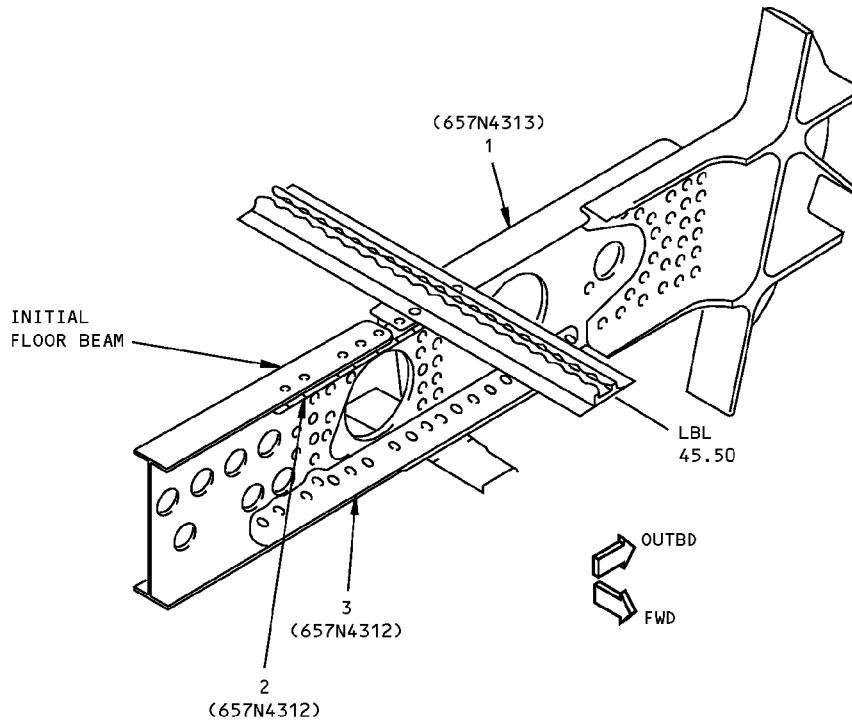
TYPICAL BEAM SPLICE AT STA. 480-620
DETAIL V B

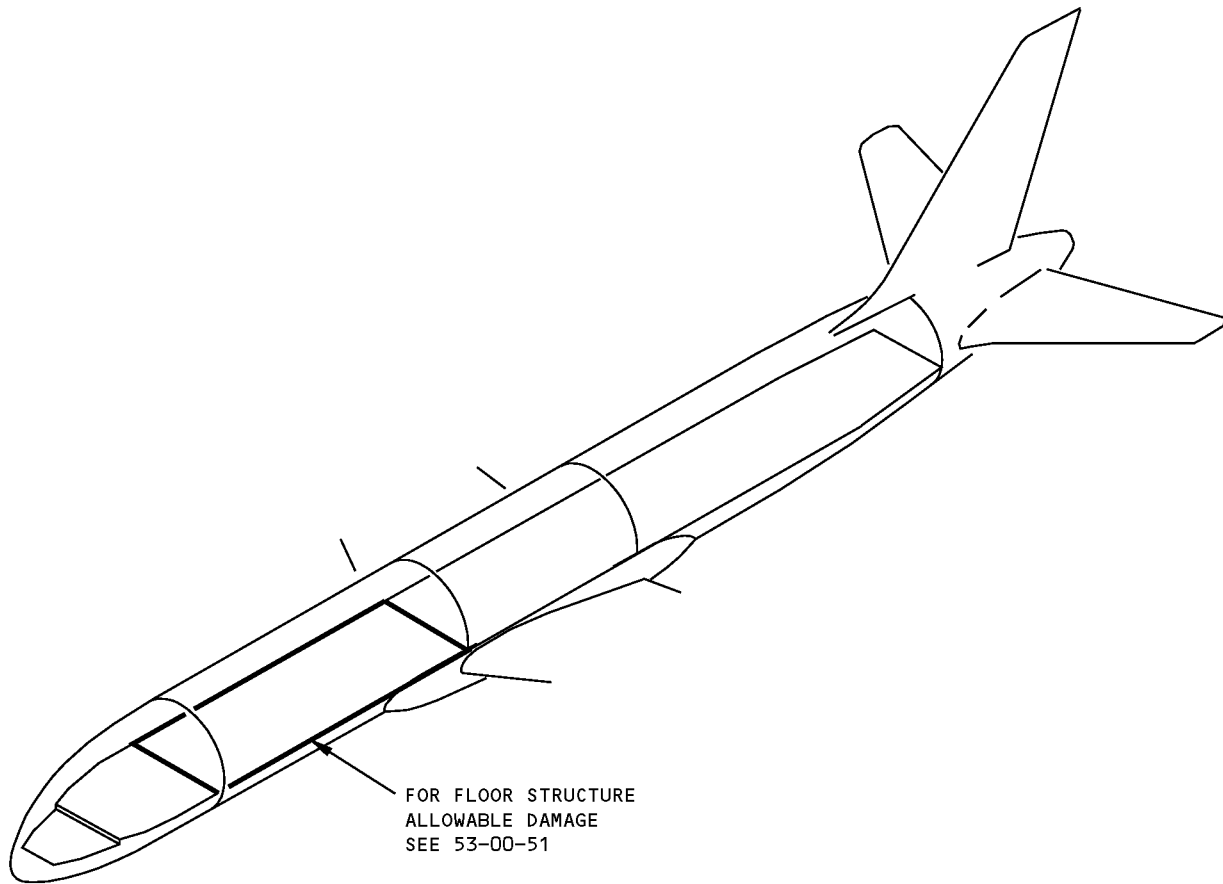
Section 43 Main Deck Floor Structure Allowable Damage
Figure 101
