FUSELAGE

757-200 STRUCTURAL REPAIR MANUAL

CHAPTER 53 FUSELAGE

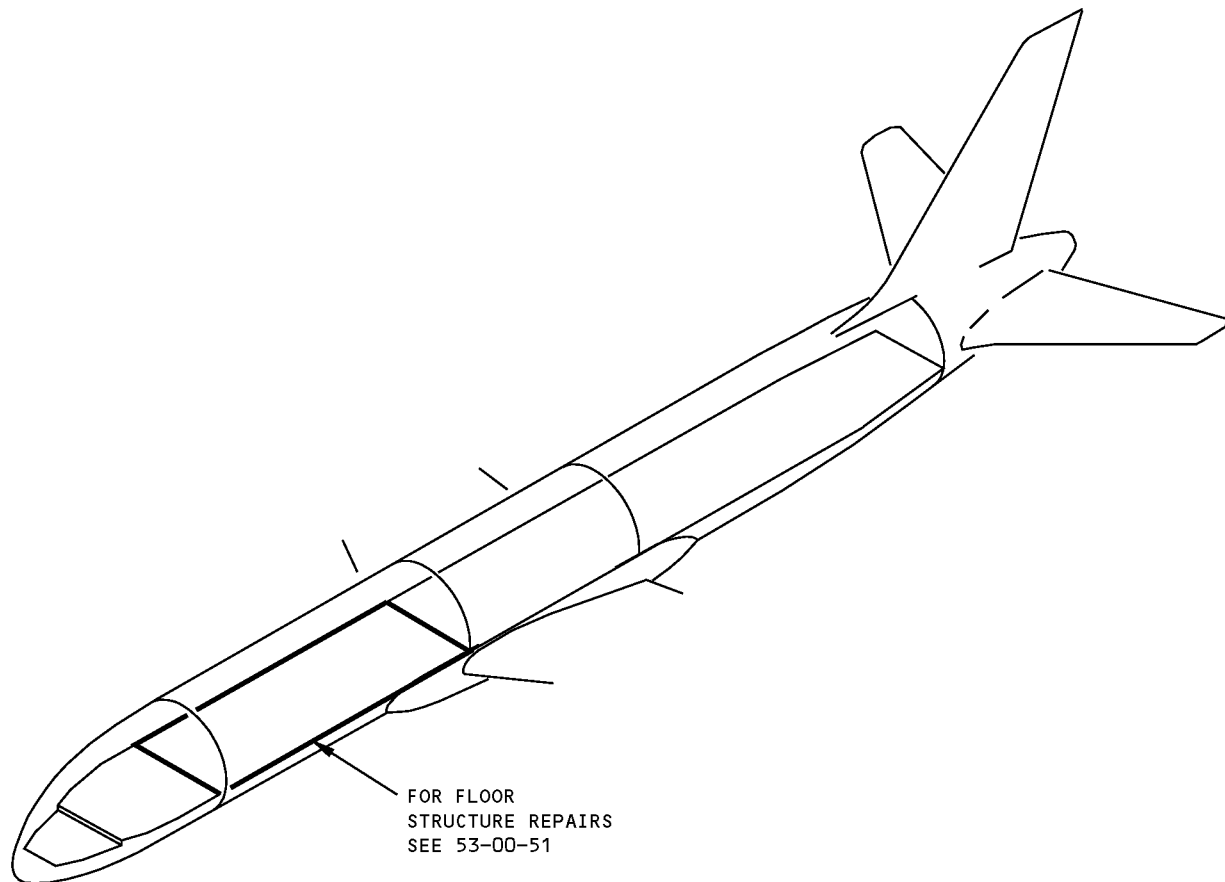
Section 43 Main Deck Floor Structure Repairs and Service Bulletin Repair Chart
Figure 201 (Sheet 2 of 2)

The following service bulletins contain floor structure repairs which are available for use where specific damage has been encountered. Usually, the service bulletin also covers preventive modification data which operators are encouraged to use to eliminate the need for repair.

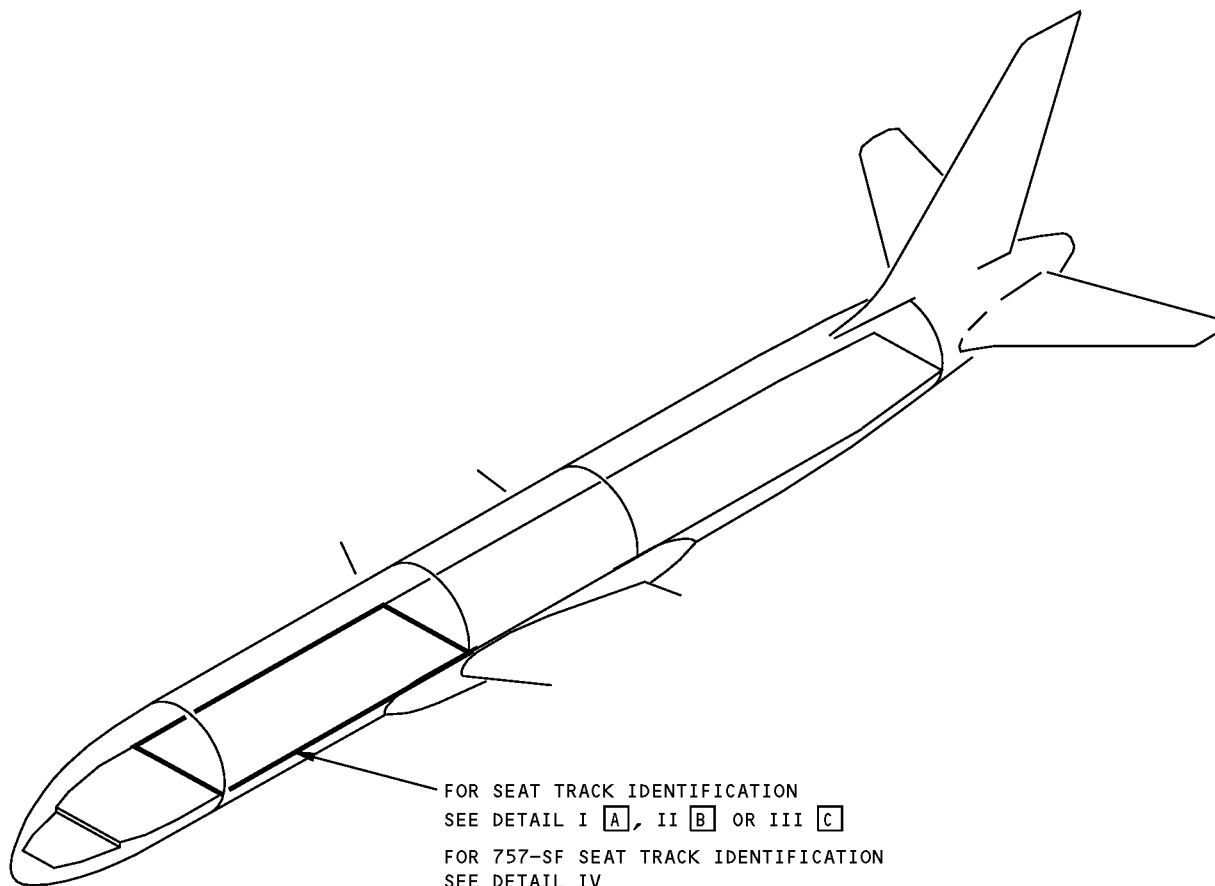
IDENTIFICATION 1 - SECTION 43 - SEAT TRACKS

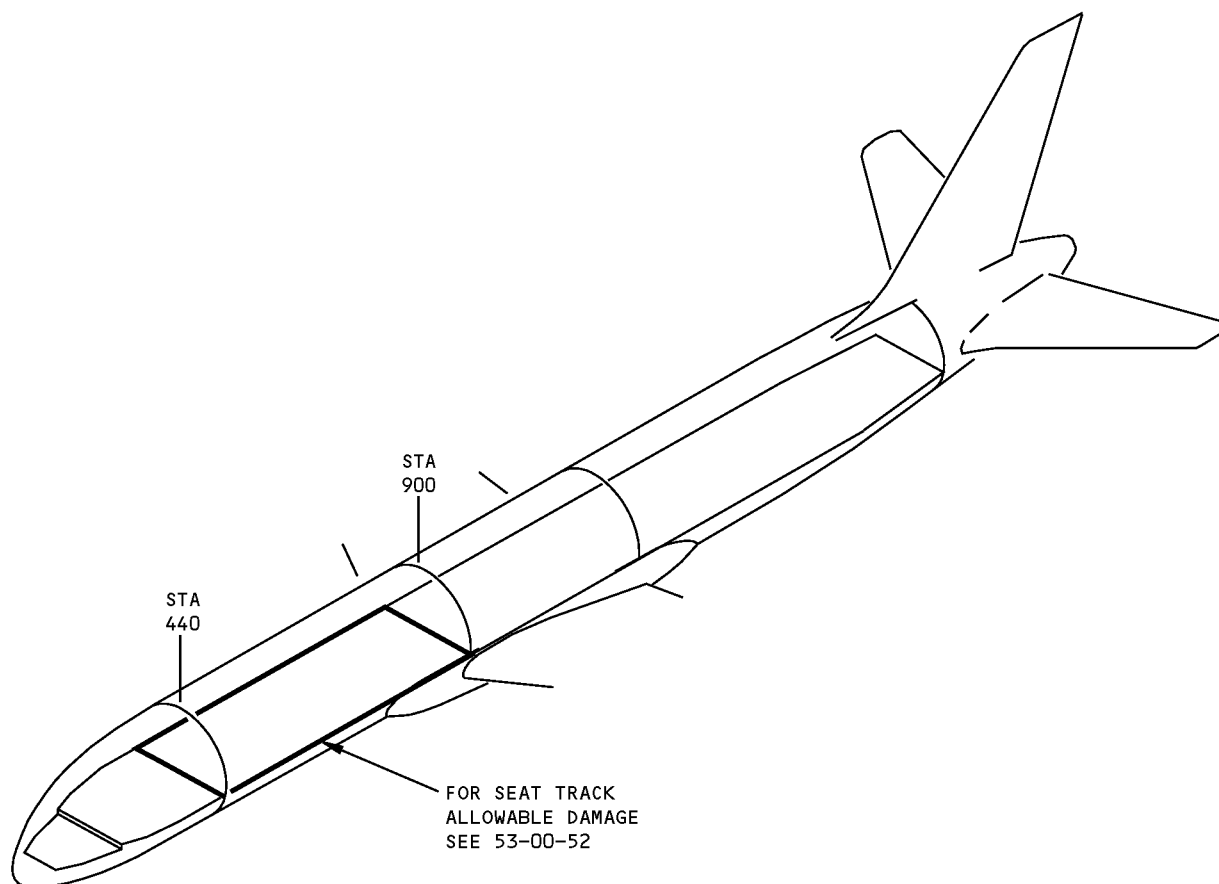
Section 43 Seat Track Allowable Damage
Figure 101

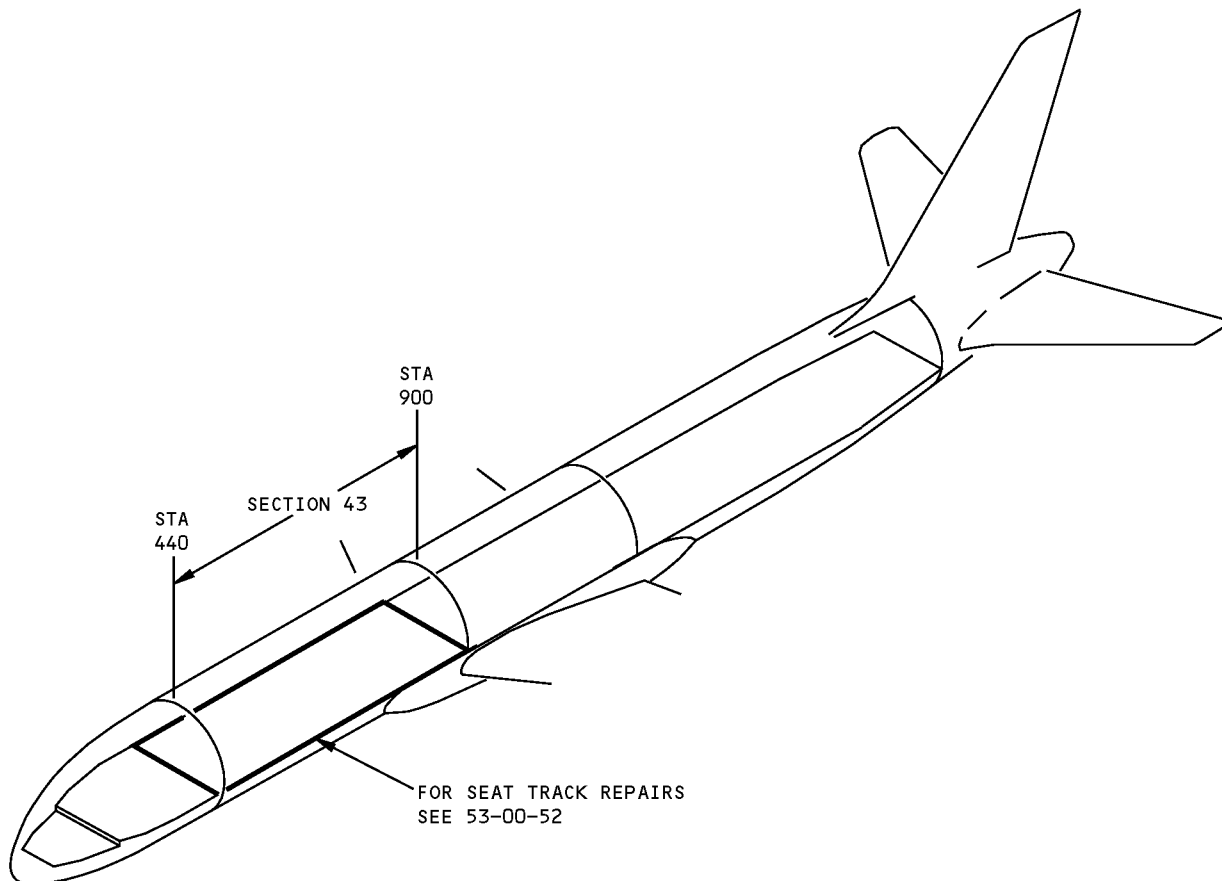
Section 43 Seat Track Repair
Figure 201

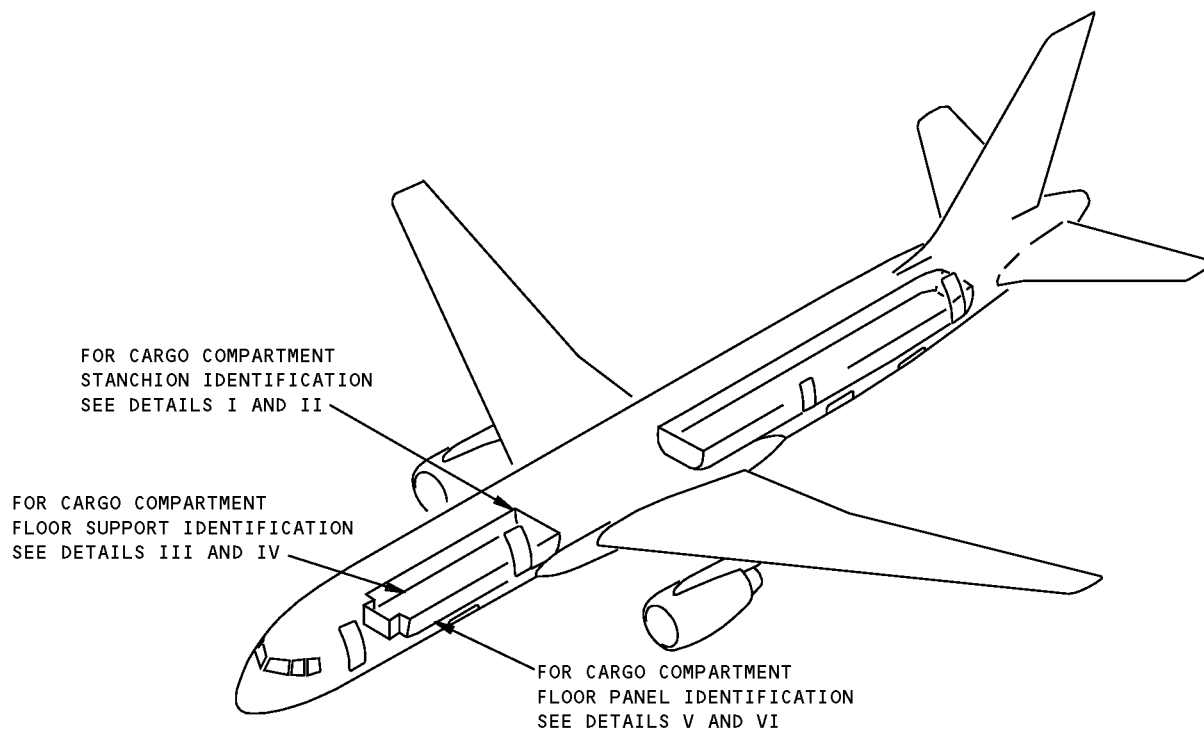
IDENTIFICATION 1 - SECTION 43 - CARGO COMPARTMENT STRUCTURE

- [A]** CARGO COMPARTMENT FLOOR STRUCTURE HAS MANY CONFIGURATIONS. SEE ENGINEERING DRAWINGS FOR APPROPRIATE CONFIGURATION
- [B]** THICKER DECK PLATES AVAILABLE AS AN OPERATOR OPTION

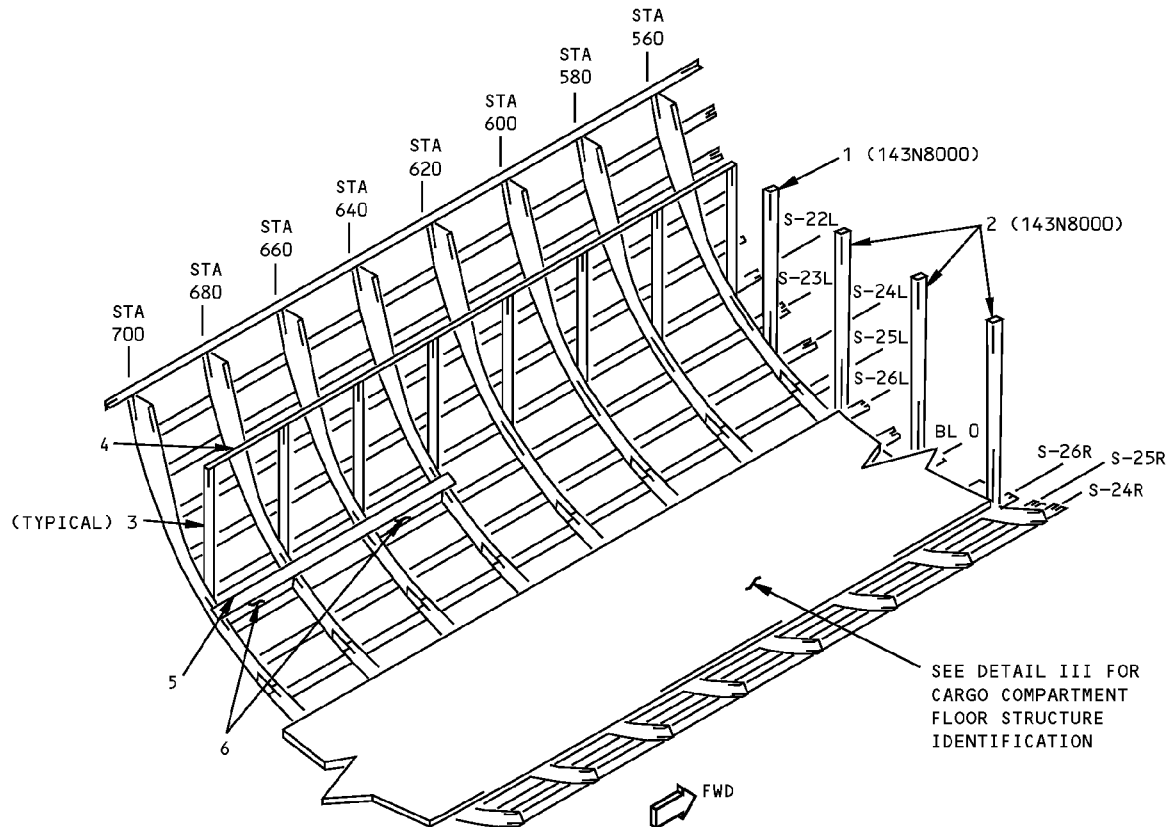
CARGO COMPARTMENT STANCHION IDENTIFICATION
(SYMMETRICAL ABOUT BL 0)
DETAIL I

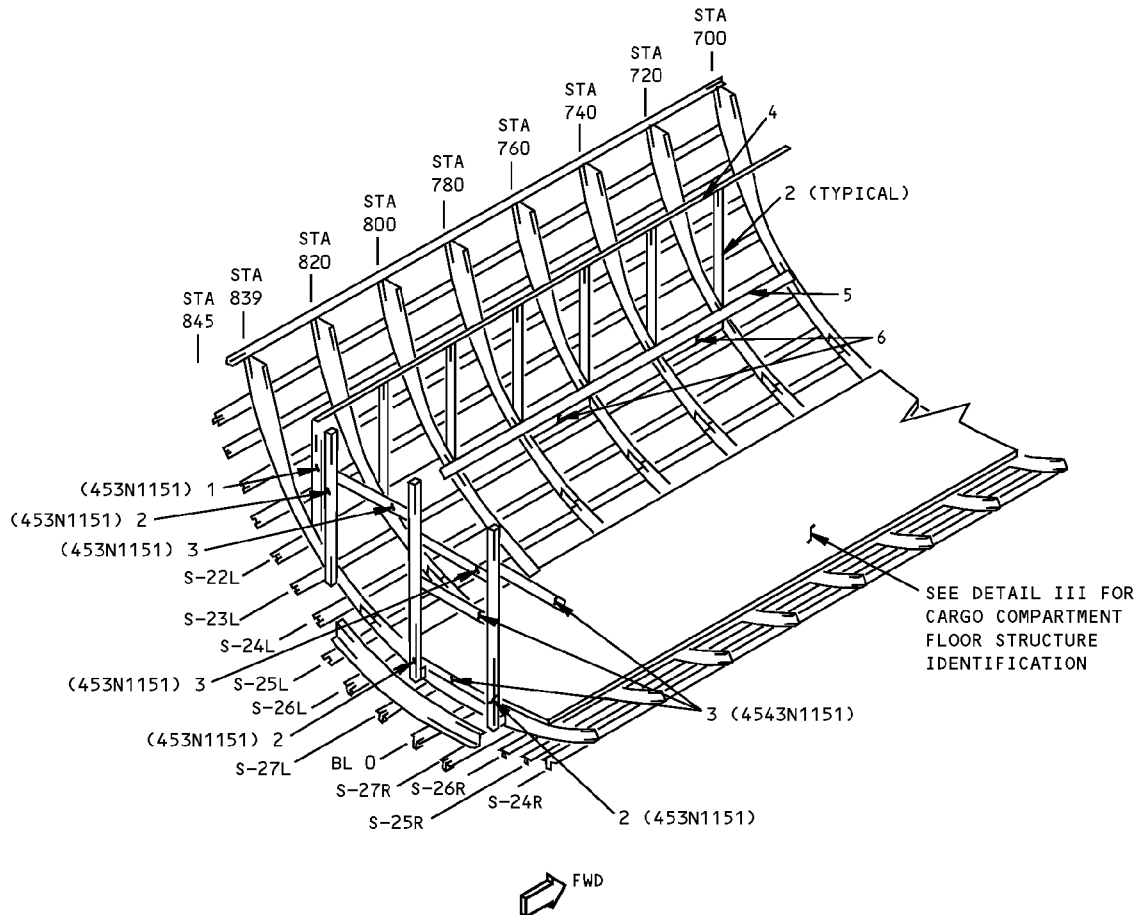
CARGO COMPARTMENT STANCHION IDENTIFICATION
(SYMMETRICAL ABOUT BL 0 EXCEPT WHERE NOTED)
DETAIL II

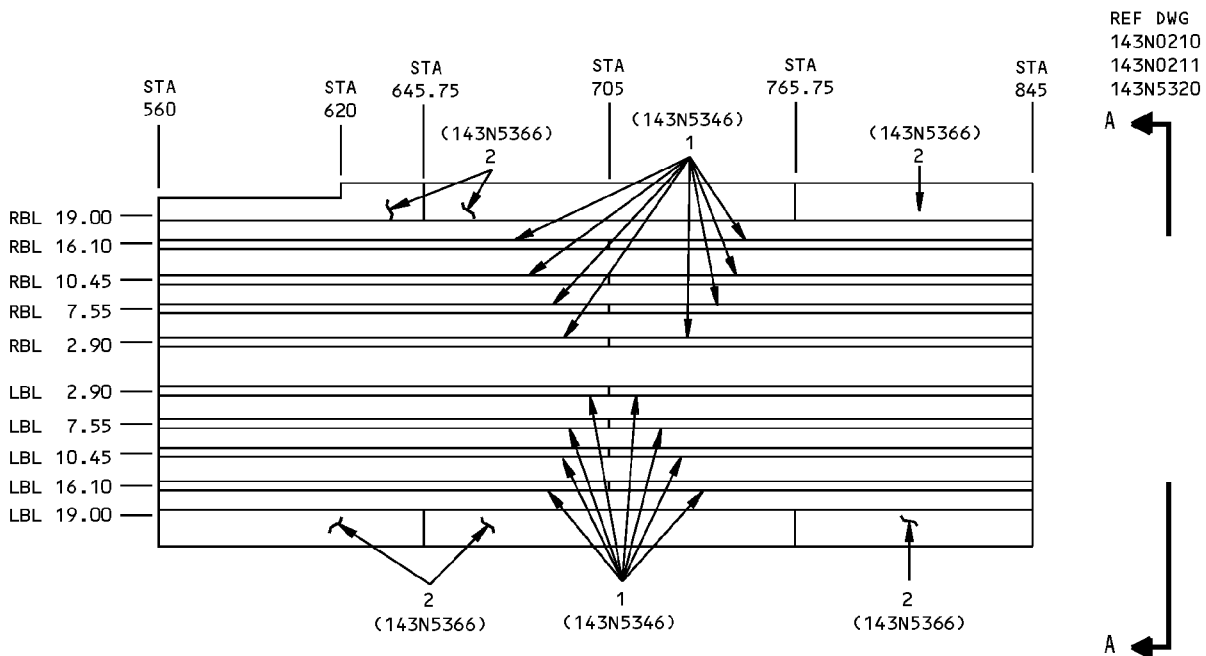
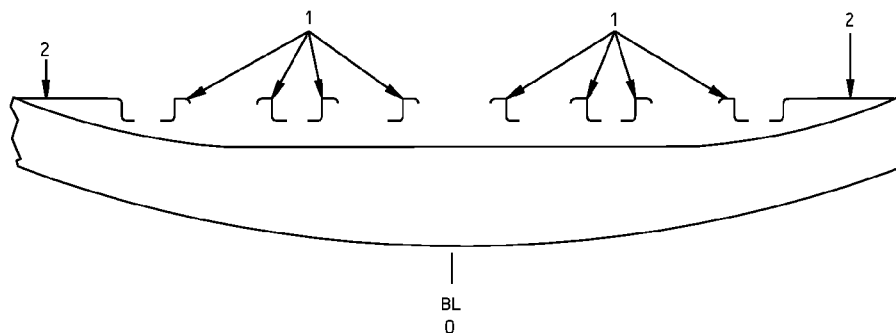
SECTION A-A (ROTATED 90°)

Section 43 Cargo Compartment Structure Identification Figure 1 (Sheet 4 of 7)

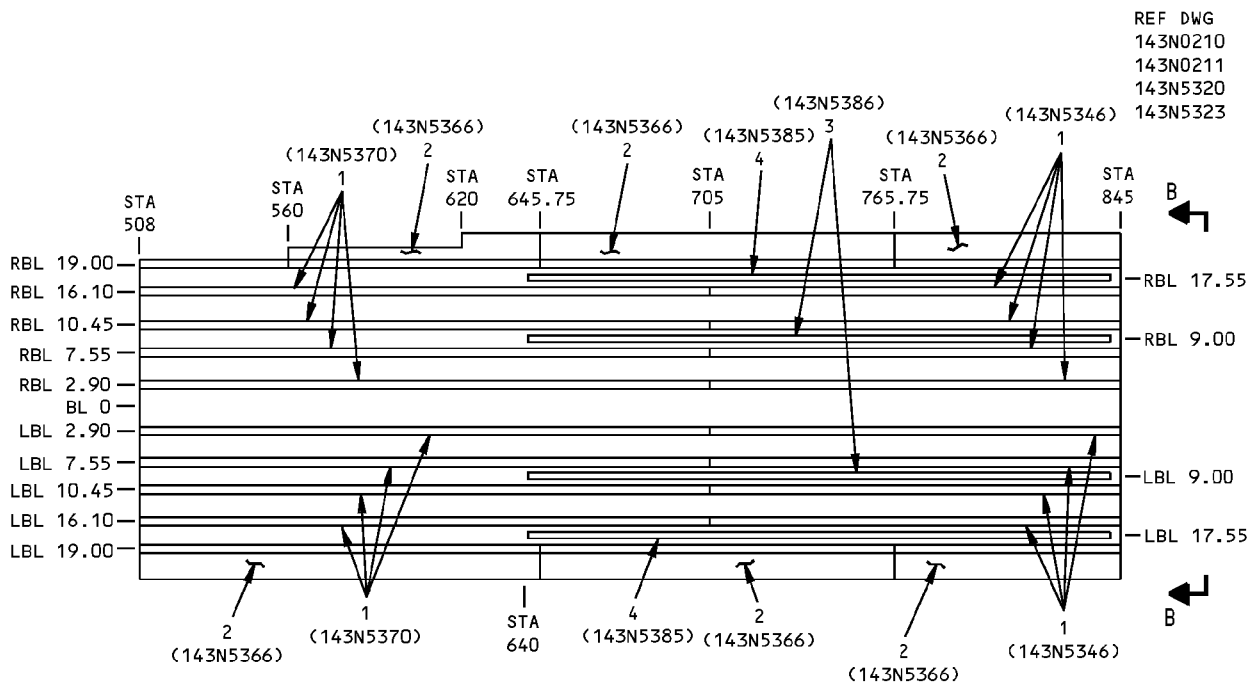
CARGO COMPARTMENT FLOOR SUPPORT IDENTIFICATION
DETAIL IV **A**

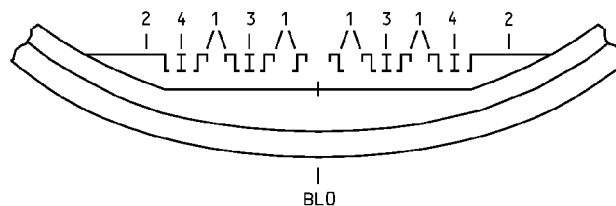
SECTION B-B (ROTATED 90°)

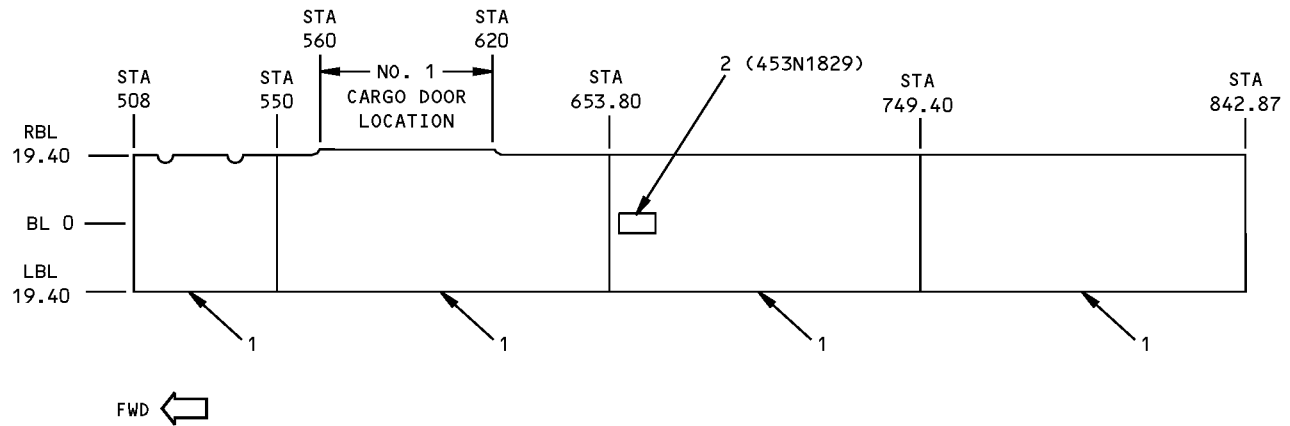
DECK PLATE LOCATIONS FOR AIRPLANES WITHOUT ACE BAGGAGE LOADER
DETAIL V

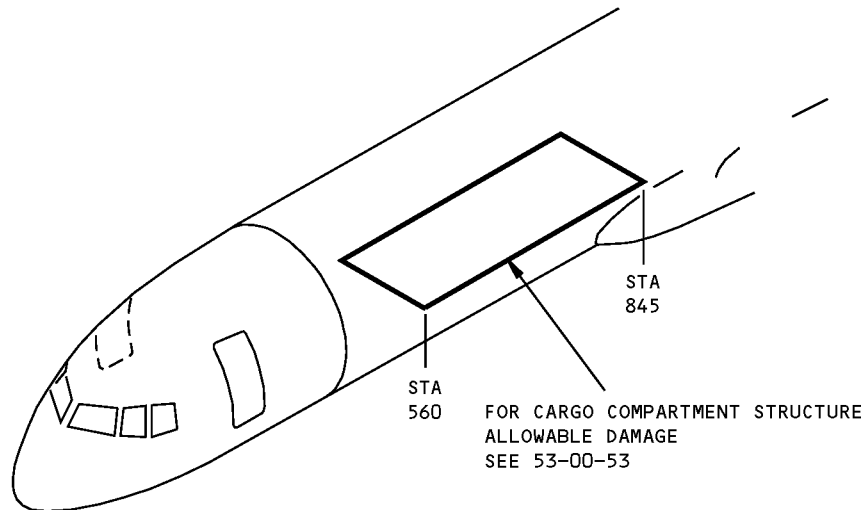
Section 43 Cargo Compartment Structure Allowable Damage
Figure 101

ALLOWABLE DAMAGE GENERAL - SECTION 43 - CARGO COMPARTMENT STRUCTURE

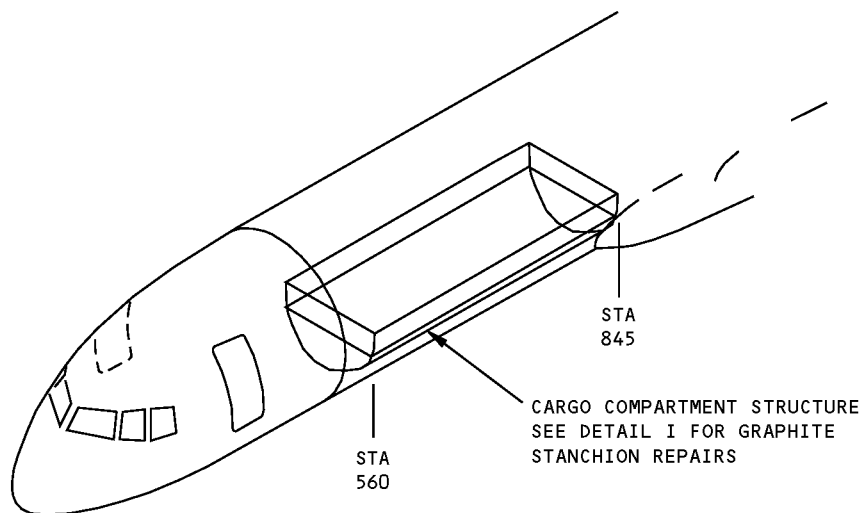
Section 43 Cargo Compartment Structure Repair Figure 201 (Sheet 1 of 2)

- THIS IS A CATEGORY A REPAIR FOR 757-SF AIRPLANES. THE INSPECTIONS GIVEN IN THE MAINTENANCE PLANNING DATA (MPD) ARE SUFFICIENT TO MAINTAIN THE DAMAGE TOLERANCE OF THE INITIAL STRUCTURE WITH THIS REPAIR INSTALLED. REFER TO SRM 51-00-06 FOR REPAIR CATEGORIES AND DEFINITIONS.

- REFER TO AMM 25-50-09 FOR REPAIRS TO THE CARGO SIDEWALL LINER. THE LINERS PROVIDE A FIRE AND SMOKE BARRIER
- REFER TO SRM 51-70-11 FOR FORMED SECTION REPAIR

- REFER TO SRM 51-70-12 FOR EXTRUDED SECTION REPAIR
- REFER TO SRM 51-70-13 FOR WEB REPAIRS
- FITTING REPAIRS ARE NOT PERMITTED
- A CRACK REPAIR TO GRAPHITE STANCHIONS IS PERMITTED IF, THE CRACK IS LOCATED IN A CORNER AND THE CRACK LENGTH DOES NOT EXCEED A MAXIMUM OF 3.0 INCHES (75 mm)

- REPAIR GRAPHITE STANCHIONS AS GIVEN IN SRM 51-70-03, PARAGRAPH 5.P. ONLY IF THESE CONDITIONS ARE MET
- AT THE NEXT "C" CHECK, REPLACE ANY DAMAGED GRAPHITE STANCHION WITH A NEW STANCHION MADE OF GRAPHITE OR ALUMINUM MATERIAL

- STANCHIONS WITH DAMAGE EXCEEDING THE LIMITS AS GIVEN MUST BE REPLACED

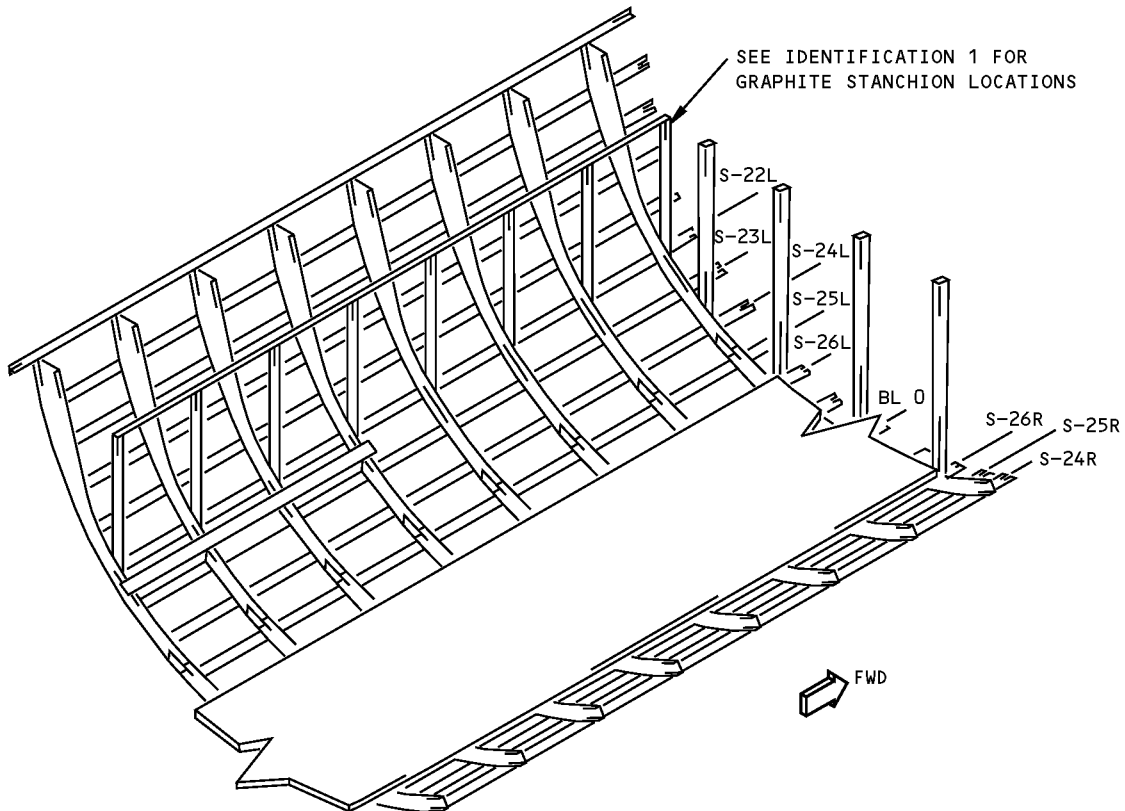
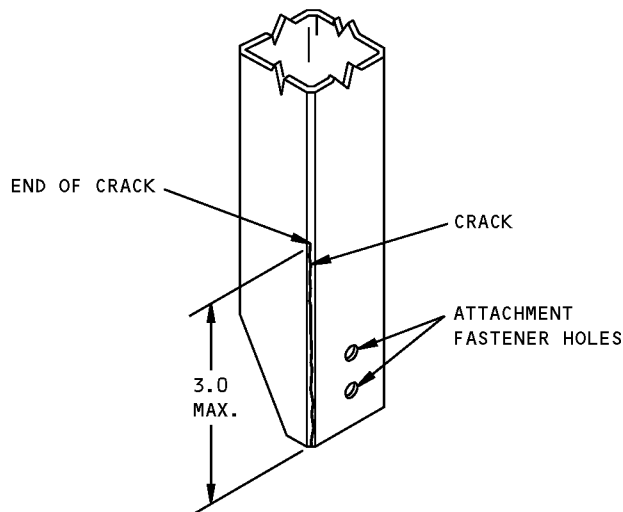
Section 43 Cargo Compartment Structure Repair Figure 201 (Sheet 2 of 2)

TYPICAL CARGO COMPARTMENT STRUCTURE

TYPICAL GRAPHITE STANCHION

GRAPHITE STANCHION REPAIR
DETAIL I

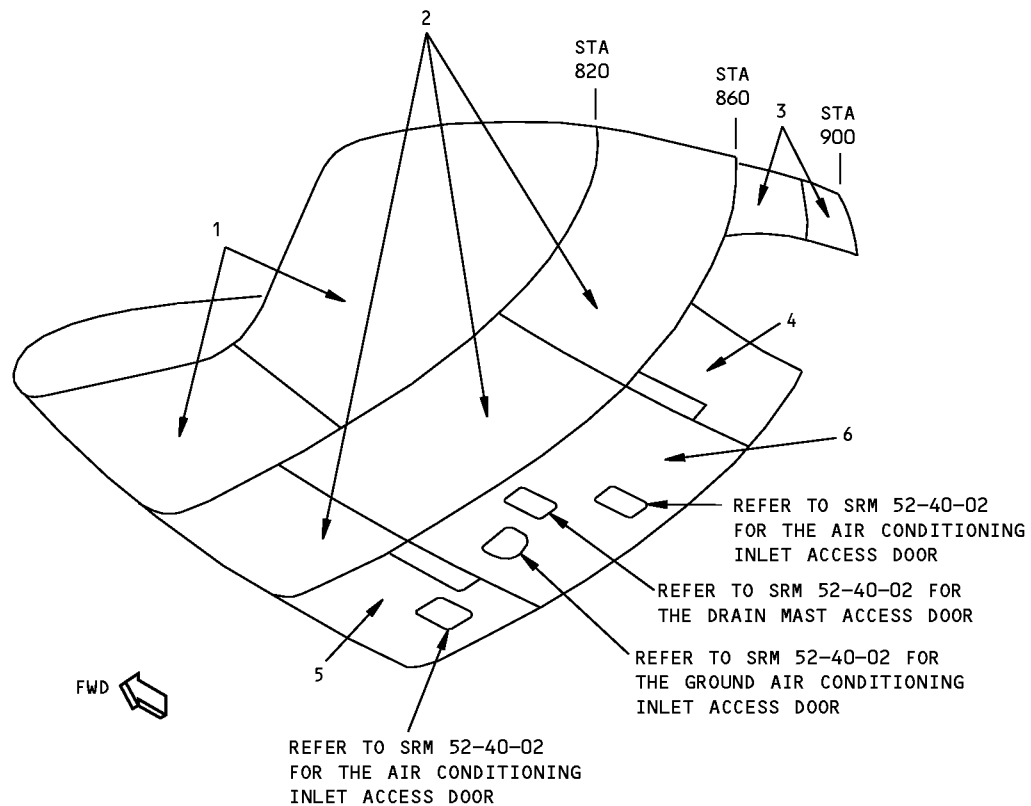
Section 43 Wing-to-Body Fairing Skin Identification Figure 1 (Sheet 2 of 12)

DETAIL I 0

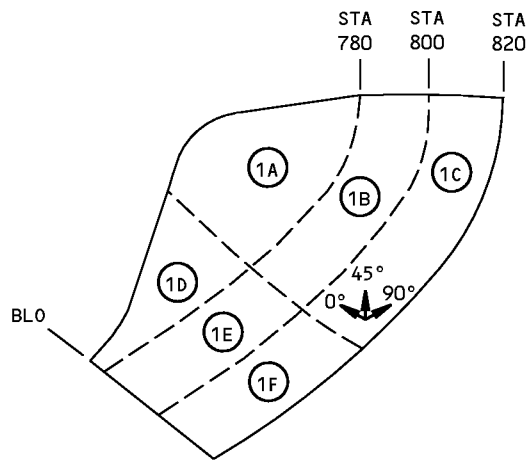
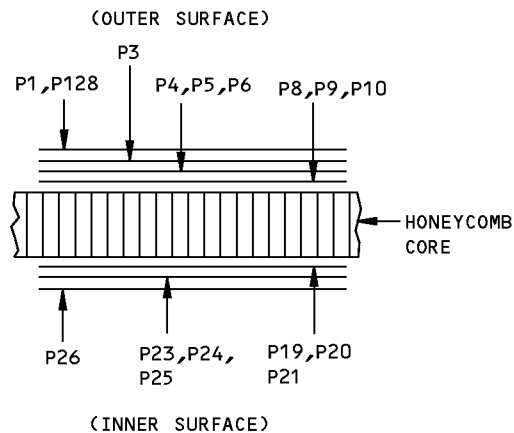
LEFT SIDE SHOWN
RIGHT SIDE SIMILAR
VIEW ON PANELS **C**

SECTION THRU HONEYCOMB PANEL

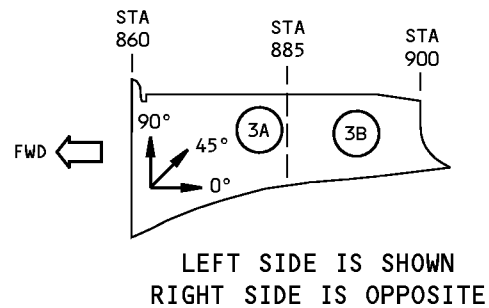
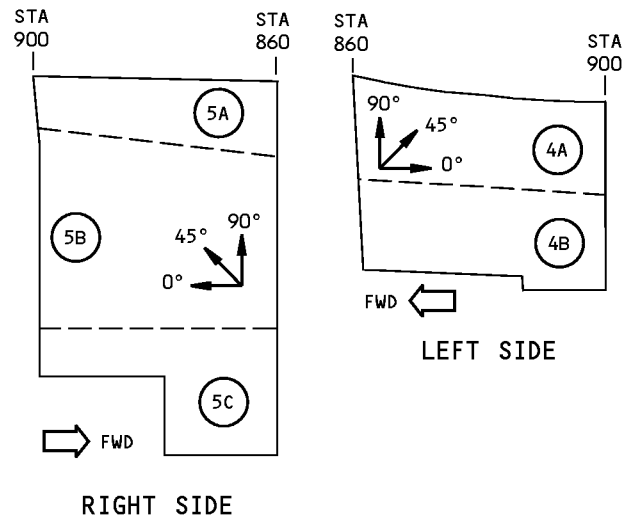
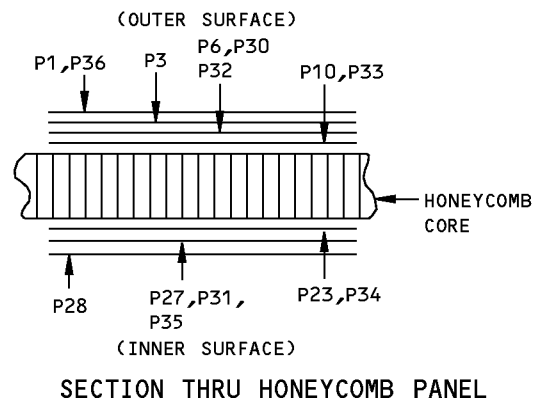
Section 43 Wing-to-Body Fairing Skin Identification Figure 1 (Sheet 6 of 12)

DETAIL IV D

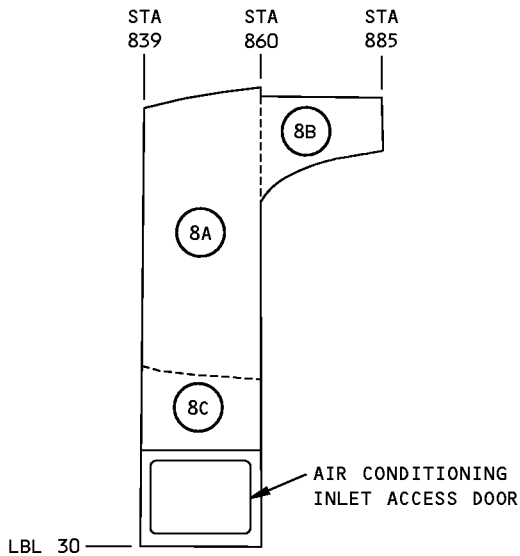
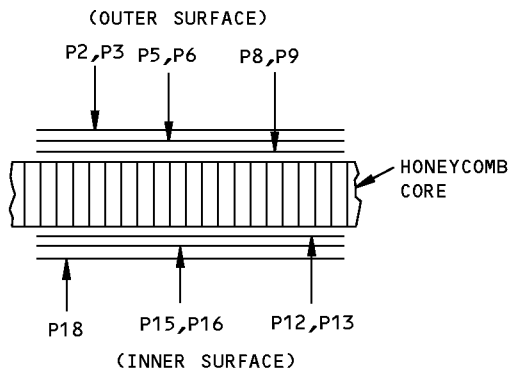
LEFT SIDE IS SHOWN
RIGHT SIDE IS OPPOSITE
VIEW ON PANELS [C]

SECTION THRU HONEYCOMB PANEL

DETAIL VIII [P]

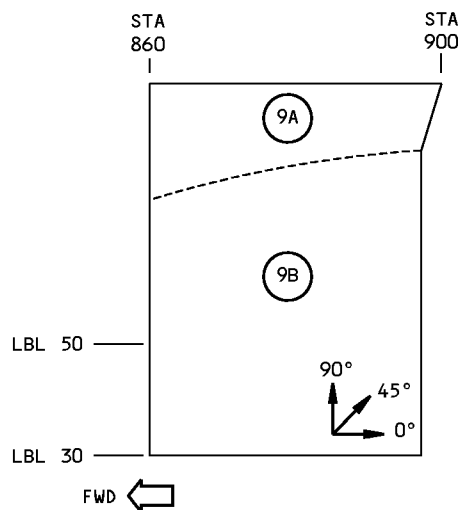
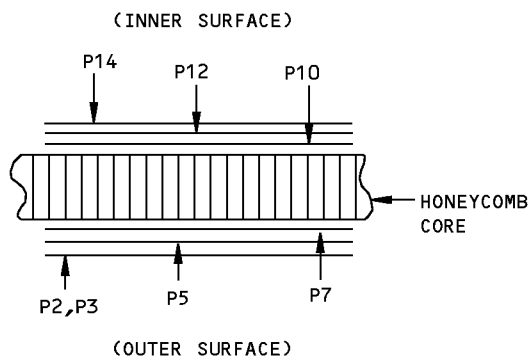
VIEW ON PANELS C

SECTION THRU HONEYCOMB PANEL

DETAIL IX P

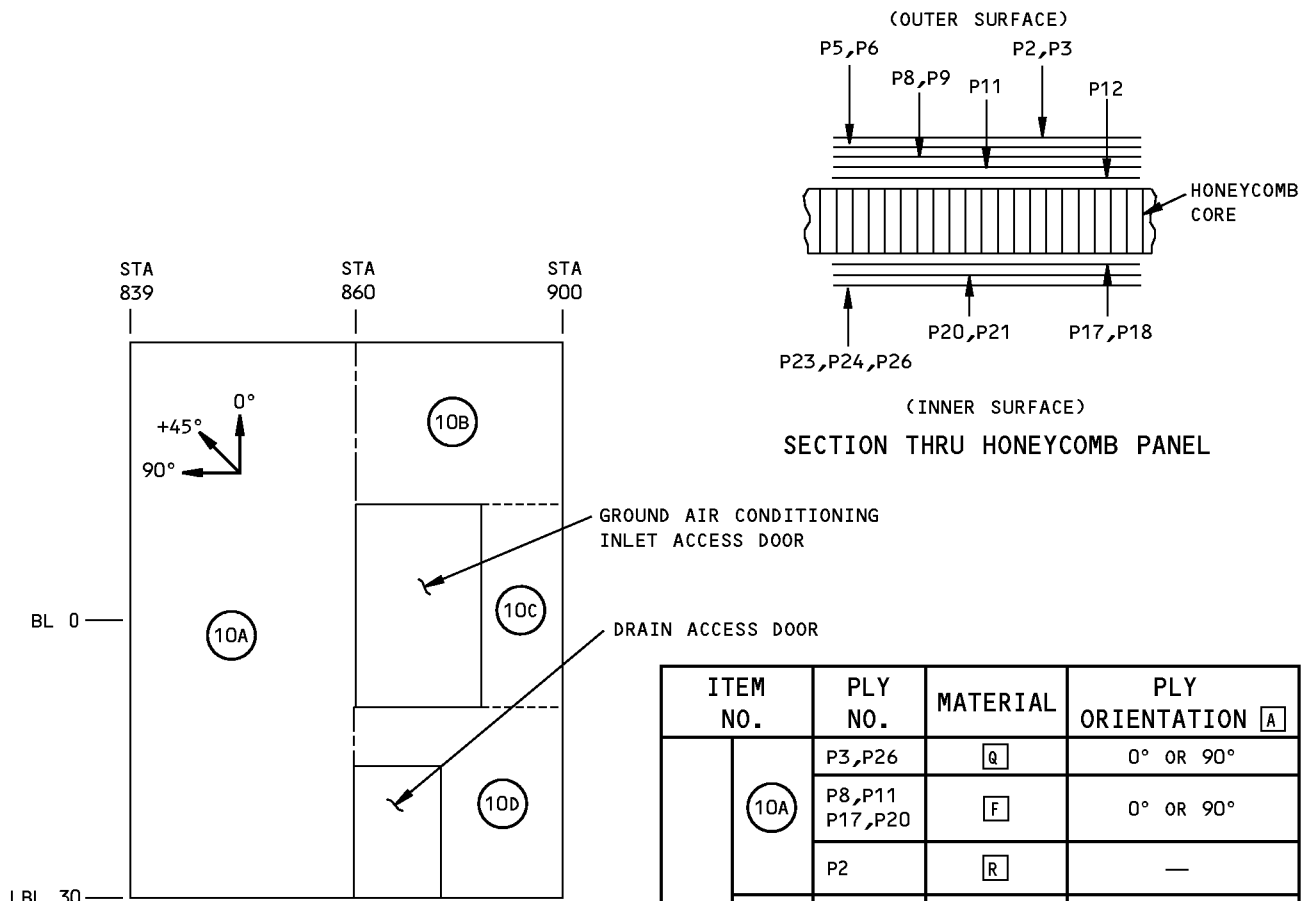
VIEW ON PANEL C

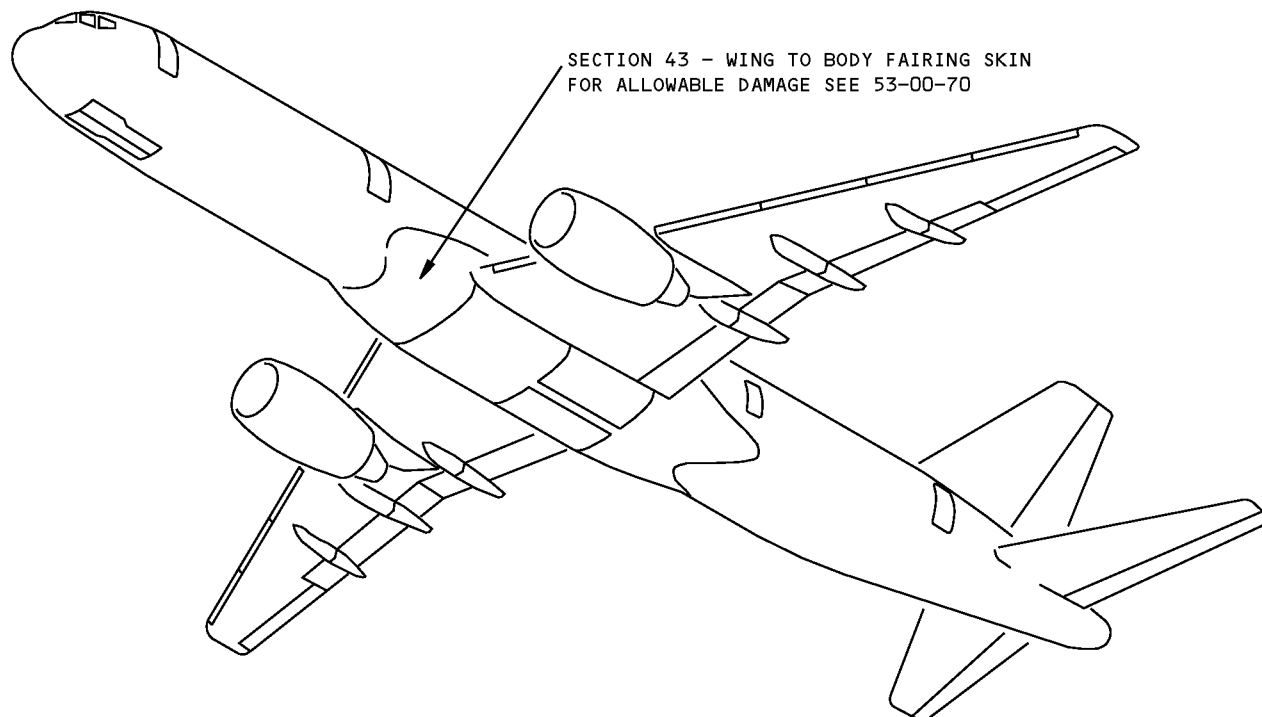
Section 43 Wing-to-Body Fairing Skin Allowable Damage
Figure 101

ALLOWABLE DAMAGE GENERAL - SECTION 43 - WING-TO-BODY FAIRING SKINS

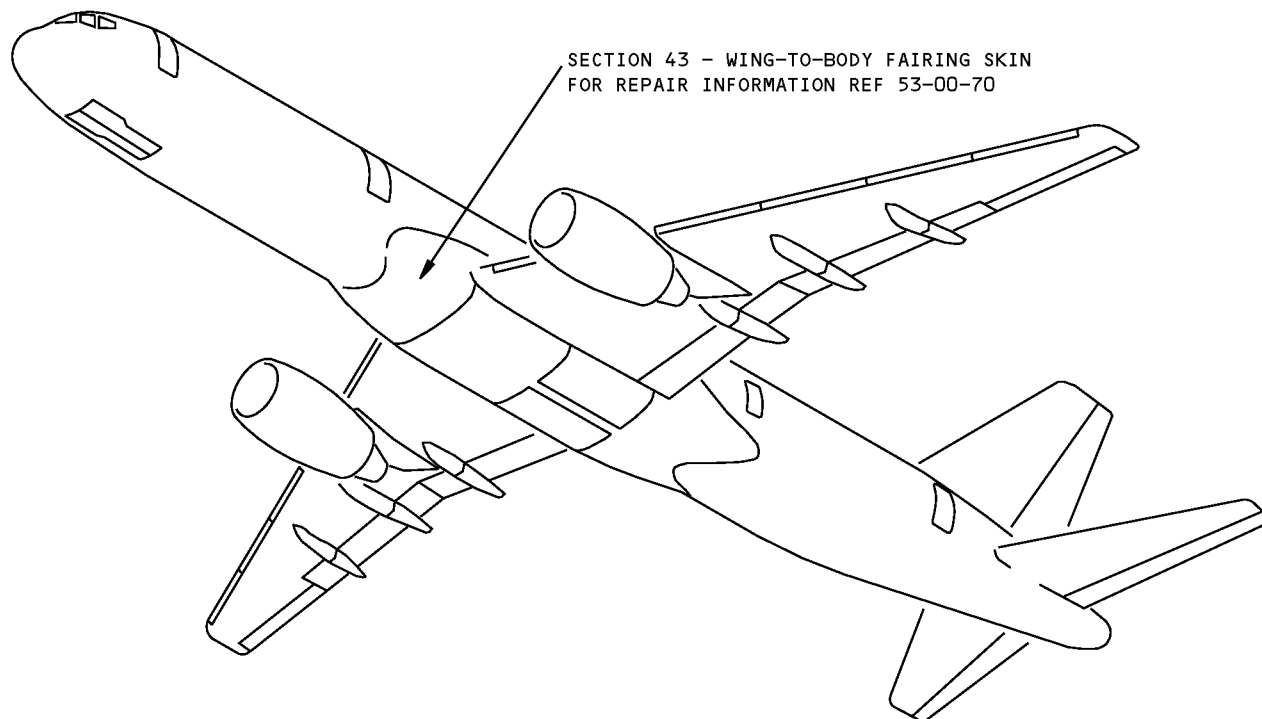
Section 43 Wing-to-Body Fairing Skin Repairs
Figure 201

REPAIR GENERAL - SECTION 43 - WING-TO-BODY FAIRING SKINS

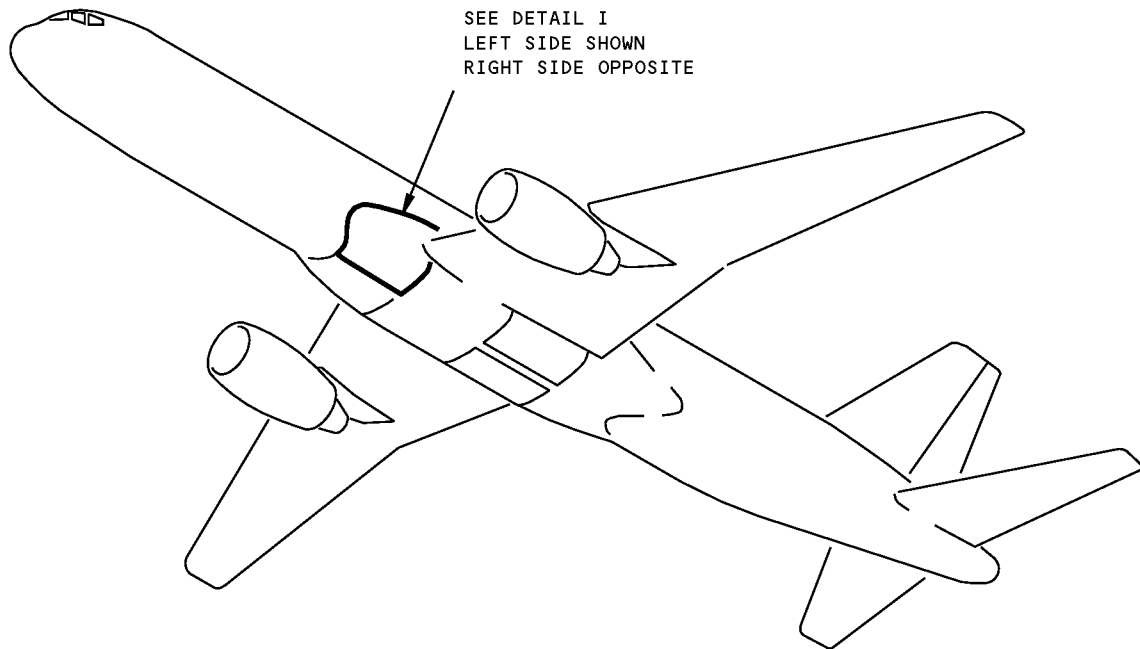
Section 43 Wing-to-Body Fairing Structure Identification
Figure 1 (Sheet 1 of 3)

IDENTIFICATION 1 - SECTION 43 - WING-TO-BODY FAIRING STRUCTURE

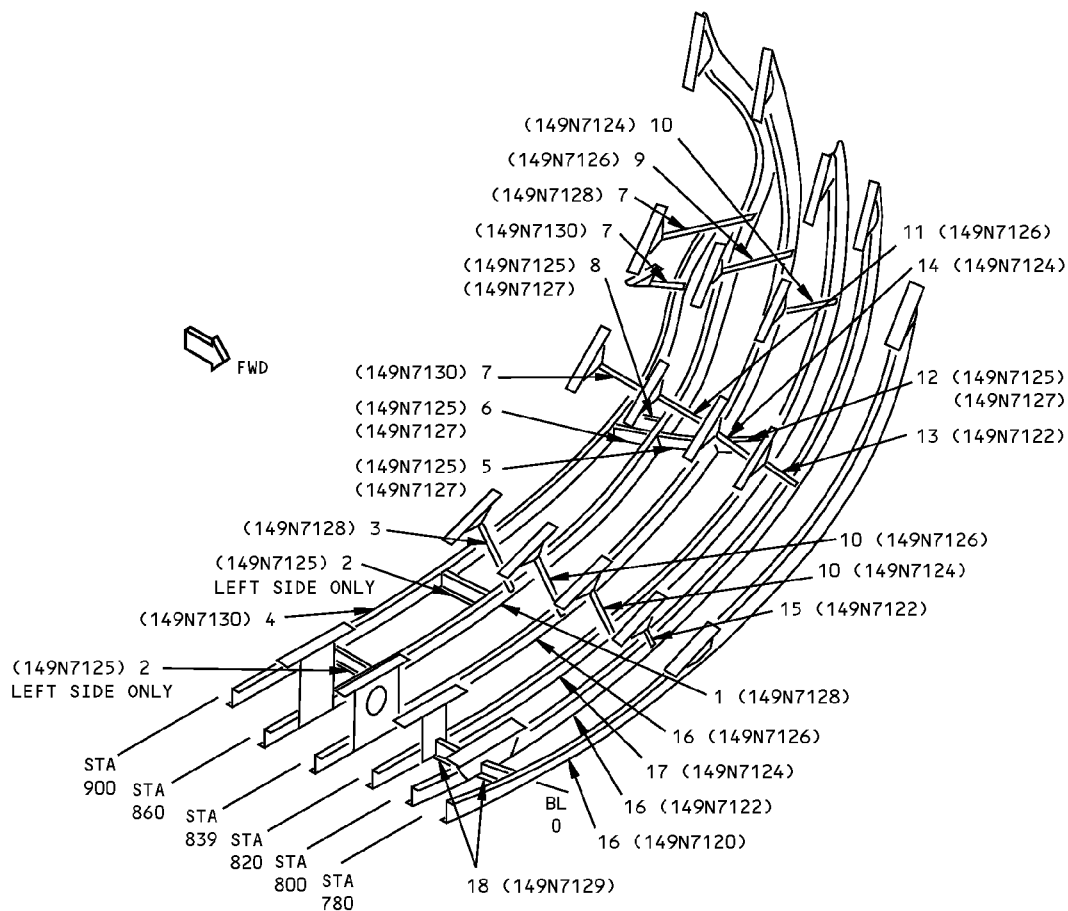
LEFT SIDE SHOWN
RIGHT SIDE OPPOSITE EXCEPT AS NOTED
DETAIL I

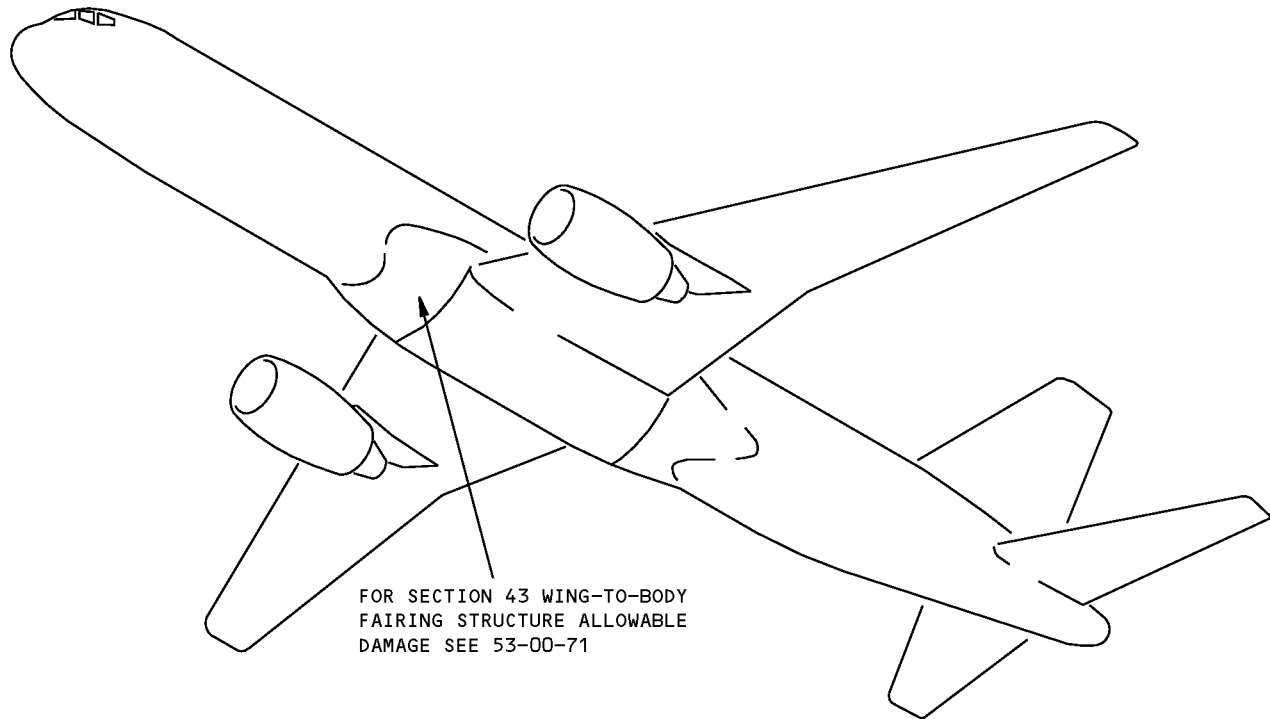
Section 43 Wing-to-Body Fairing Structure Allowable Damage
Figure 101

ALLOWABLE DAMAGE GENERAL - SECTION 43 - WING-TO-BODY FAIRING STRUCTURE

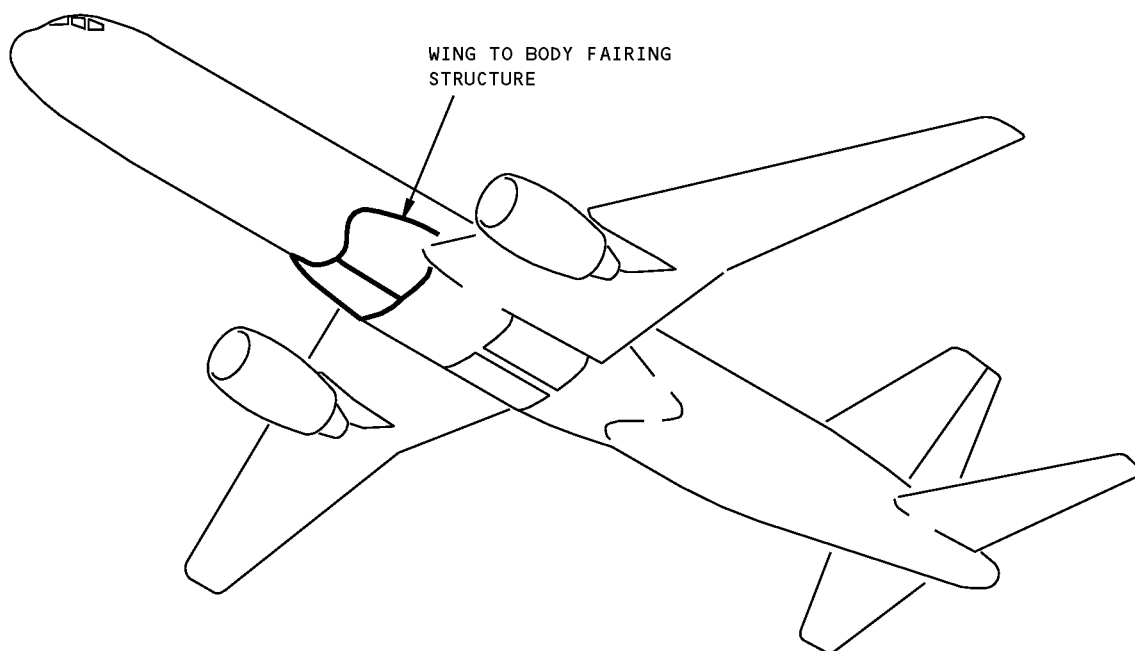
Section 43 Wing-to-Body Fairing Structure Repair
Figure 201

- SEE 51-70-11 FOR FORMED SECTION REPAIR
- SEE 51-70-12 FOR EXTRUDED SECTION REPAIR
- SEE 51-70-13 FOR WEB REPAIRS
