FUSELAGE

757-200 STRUCTURAL REPAIR MANUAL

CHAPTER 53 FUSELAGE

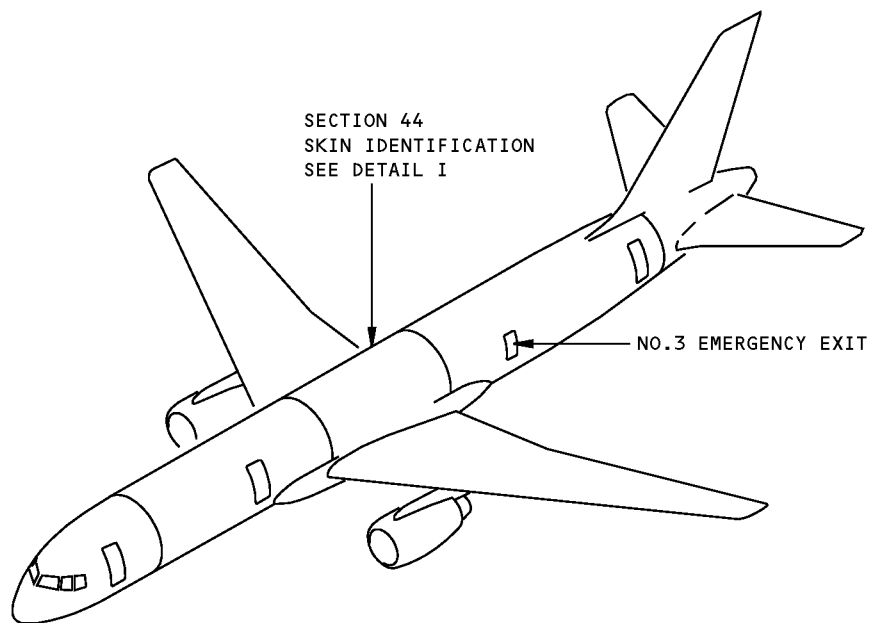
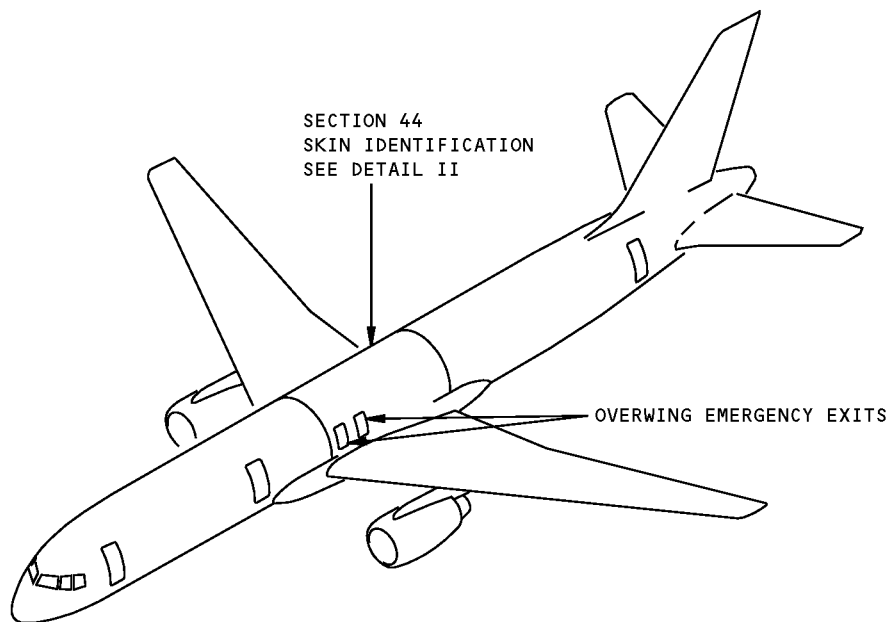
**Section 44 Skin Identification
Figure 1 (Sheet 1 of 3)**

**AIRPLANES WITH NO. 3 EMERGENCY EXIT
BASIC CONFIGURATION**

**AIRPLANES WITH OVERWING EMERGENCY EXITS
BASIC CONFIGURATION**

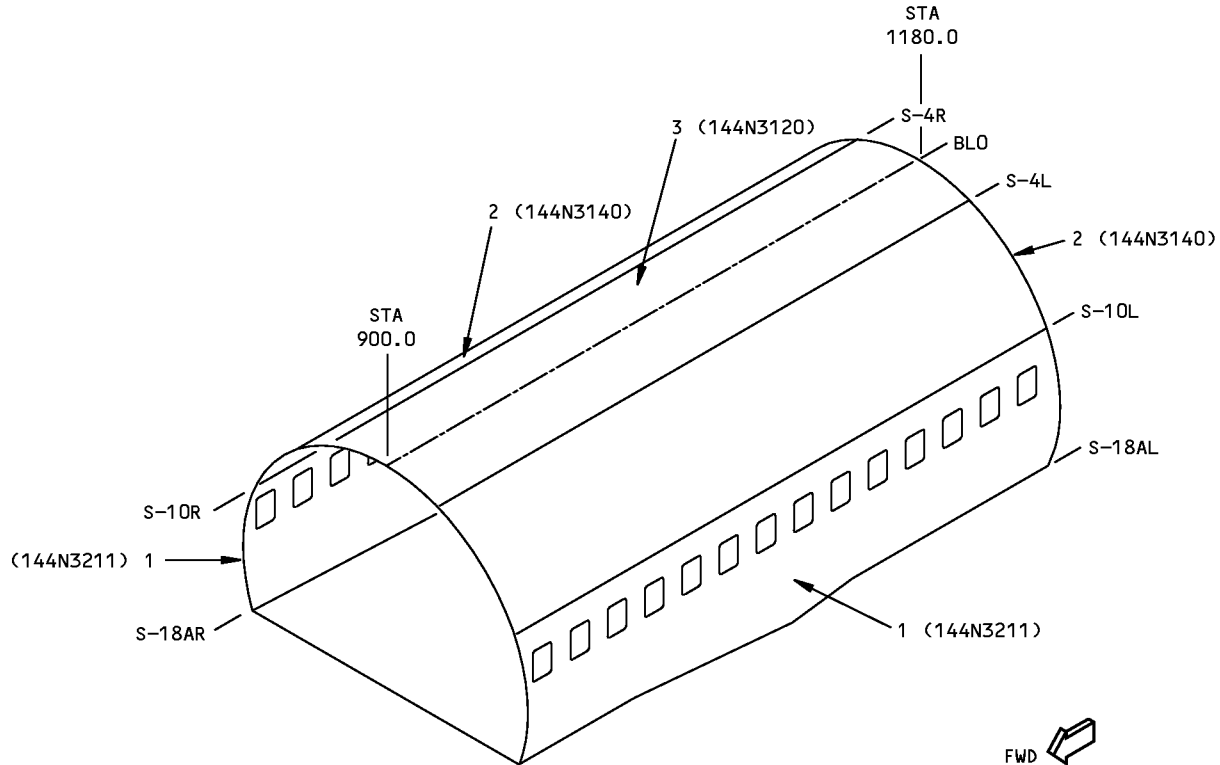
AIRPLANES WITHOUT OVERWING EMERGENCY EXITS
DETAIL I

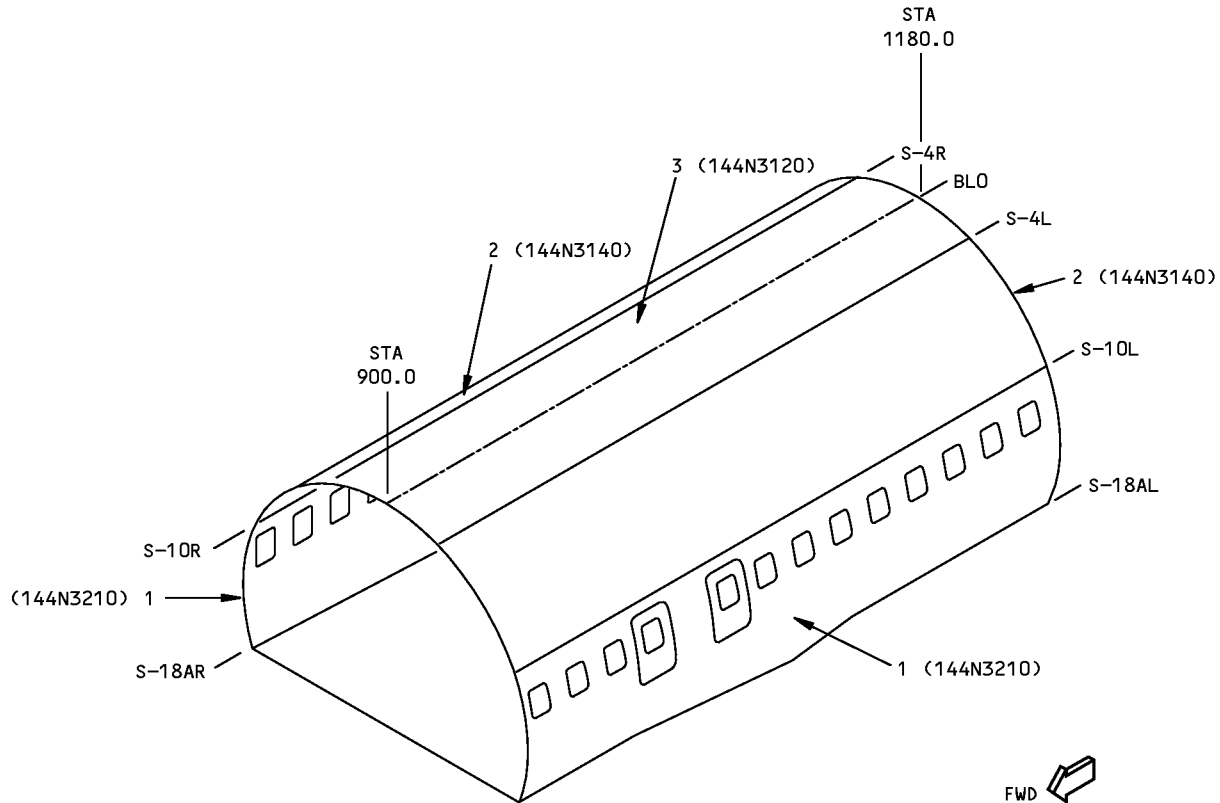
AIRPLANES WITH OVERWING EMERGENCY EXITS
DETAIL II

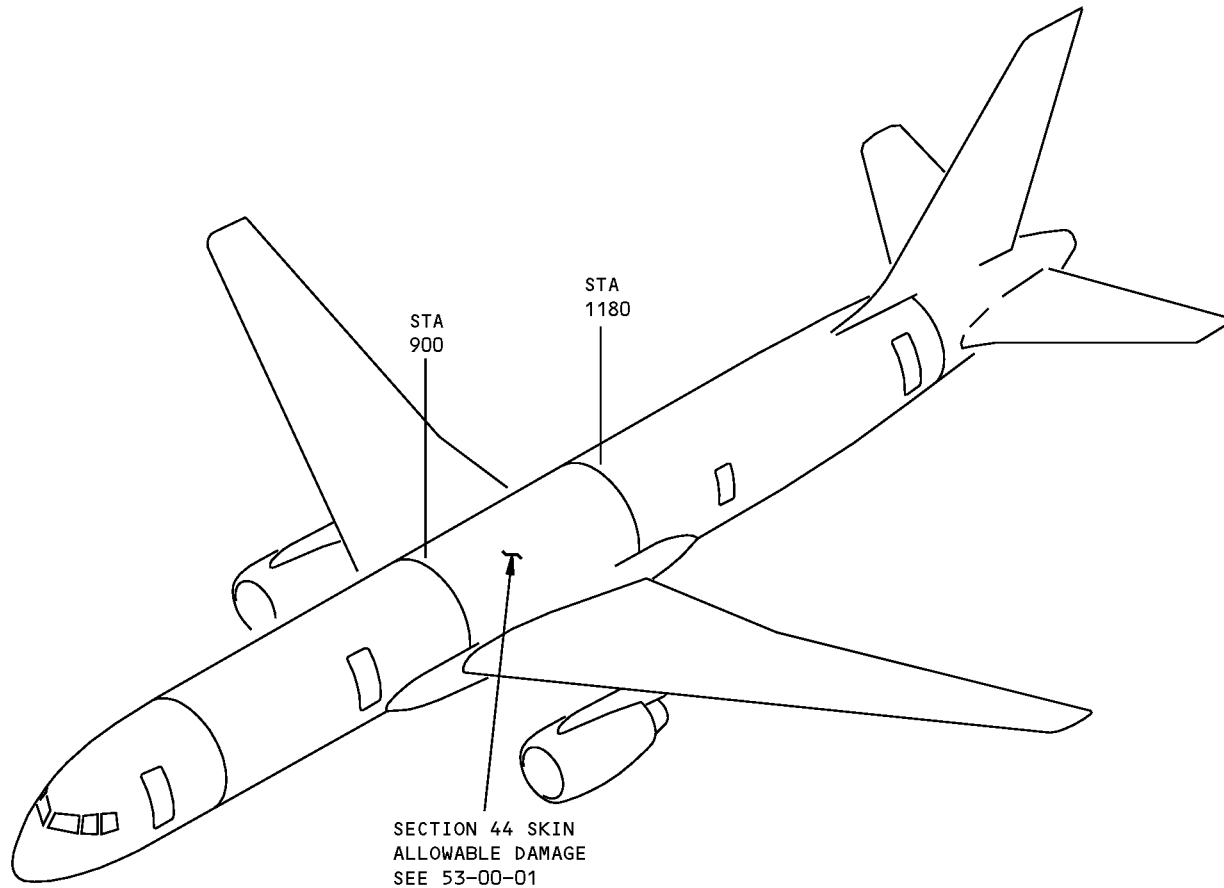
Section 44 Skin Allowable Damage
Figure 101

ALLOWABLE DAMAGE GENERAL - SECTION 44 - SKINS

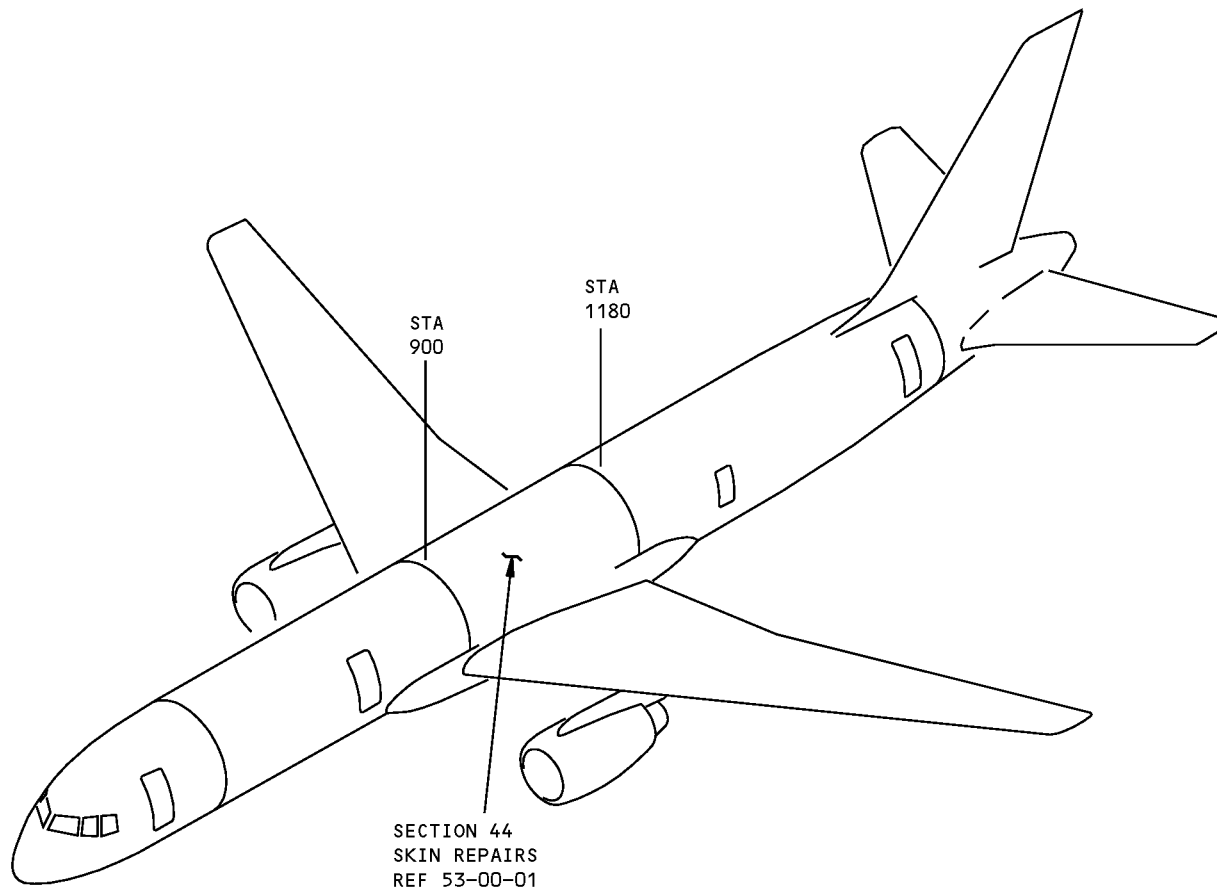
Section 44 Skin Repair
Figure 201

REPAIR GENERAL - SECTION 44 - SKINS

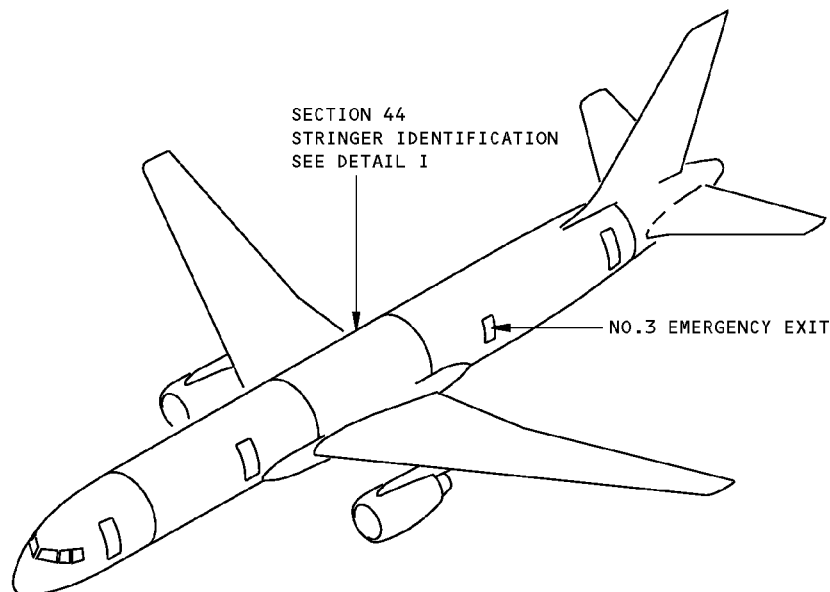
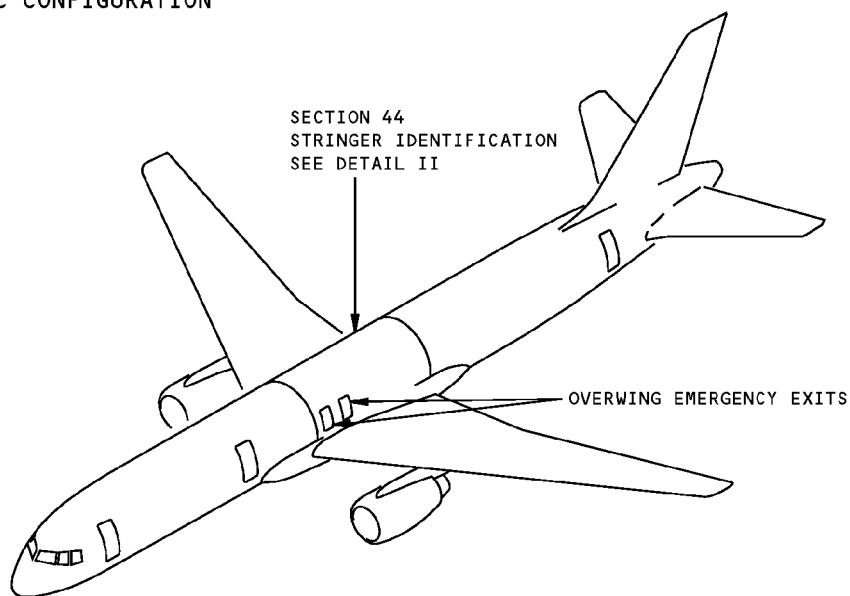
AIRPLANES WITH NO. 3 EMERGENCY EXIT
BASIC CONFIGURATION

AIRPLANES WITH OVERWING EMERGENCY EXITS
BASIC CONFIGURATION

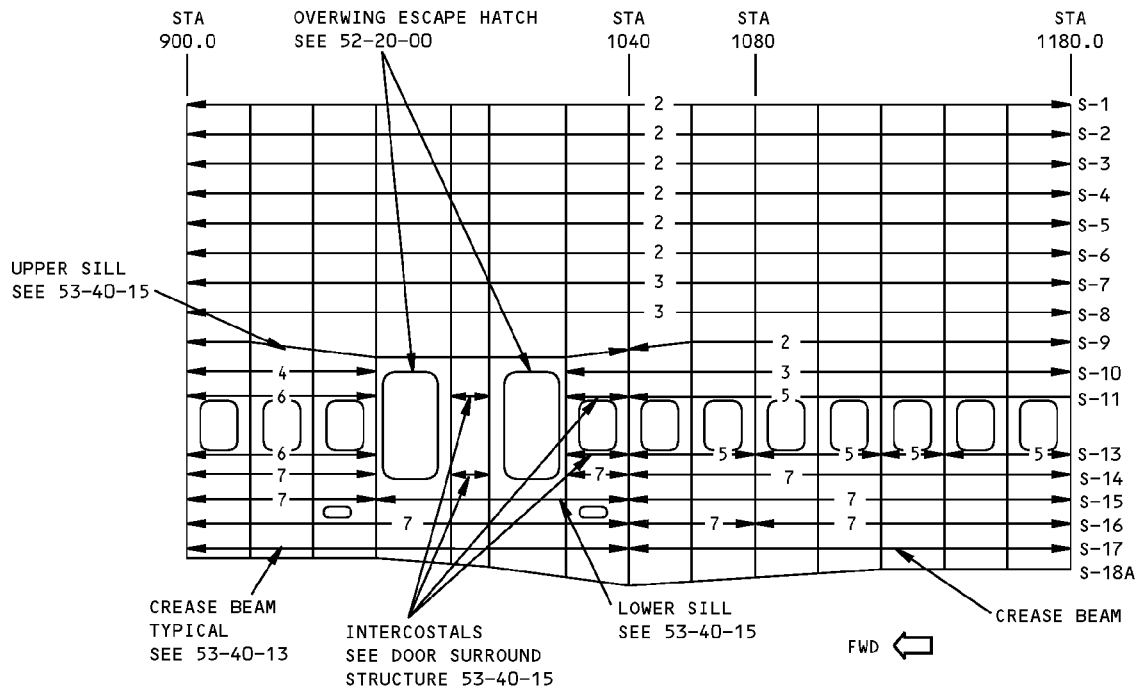
AIRPLANES WITH OVERWING ESCAPE HATCHES
DETAIL II

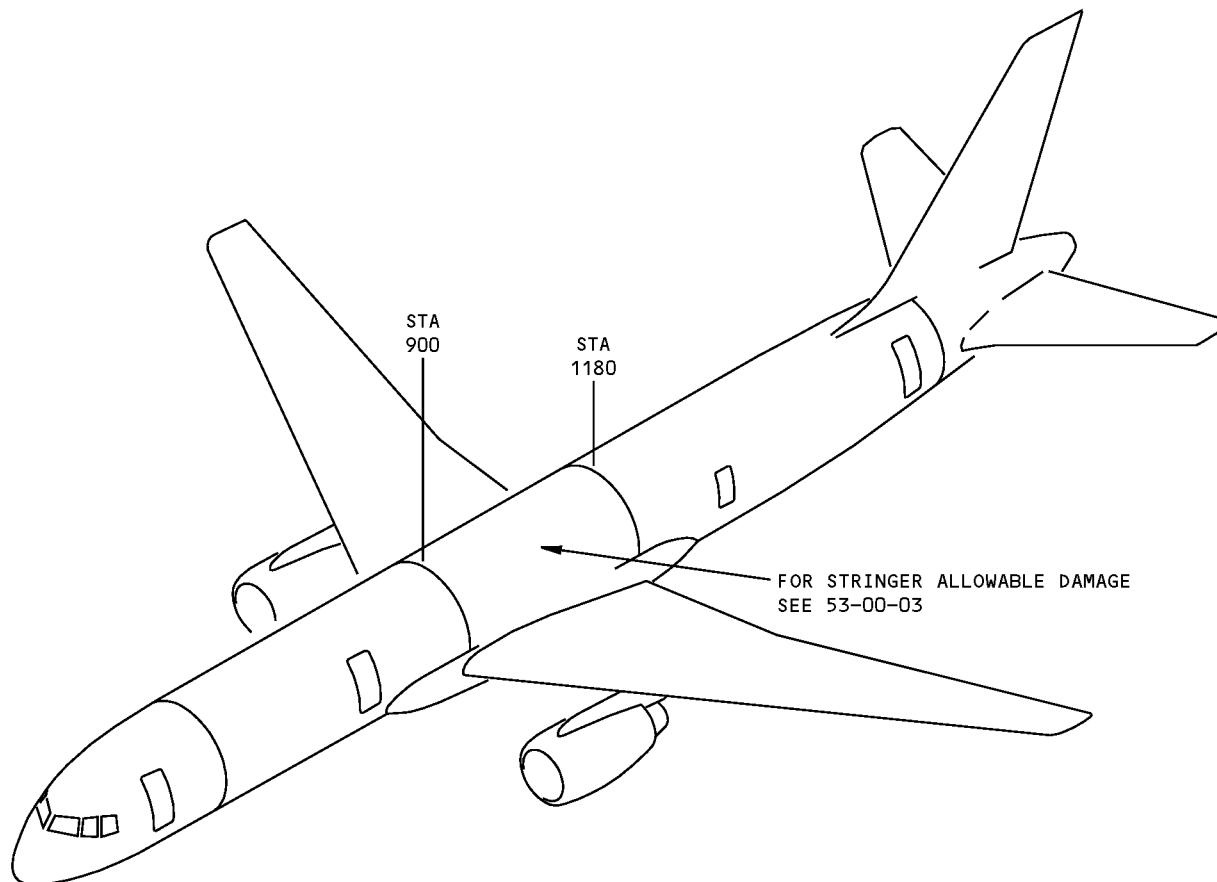
Section 44 Stringer Allowable Damage
Figure 101

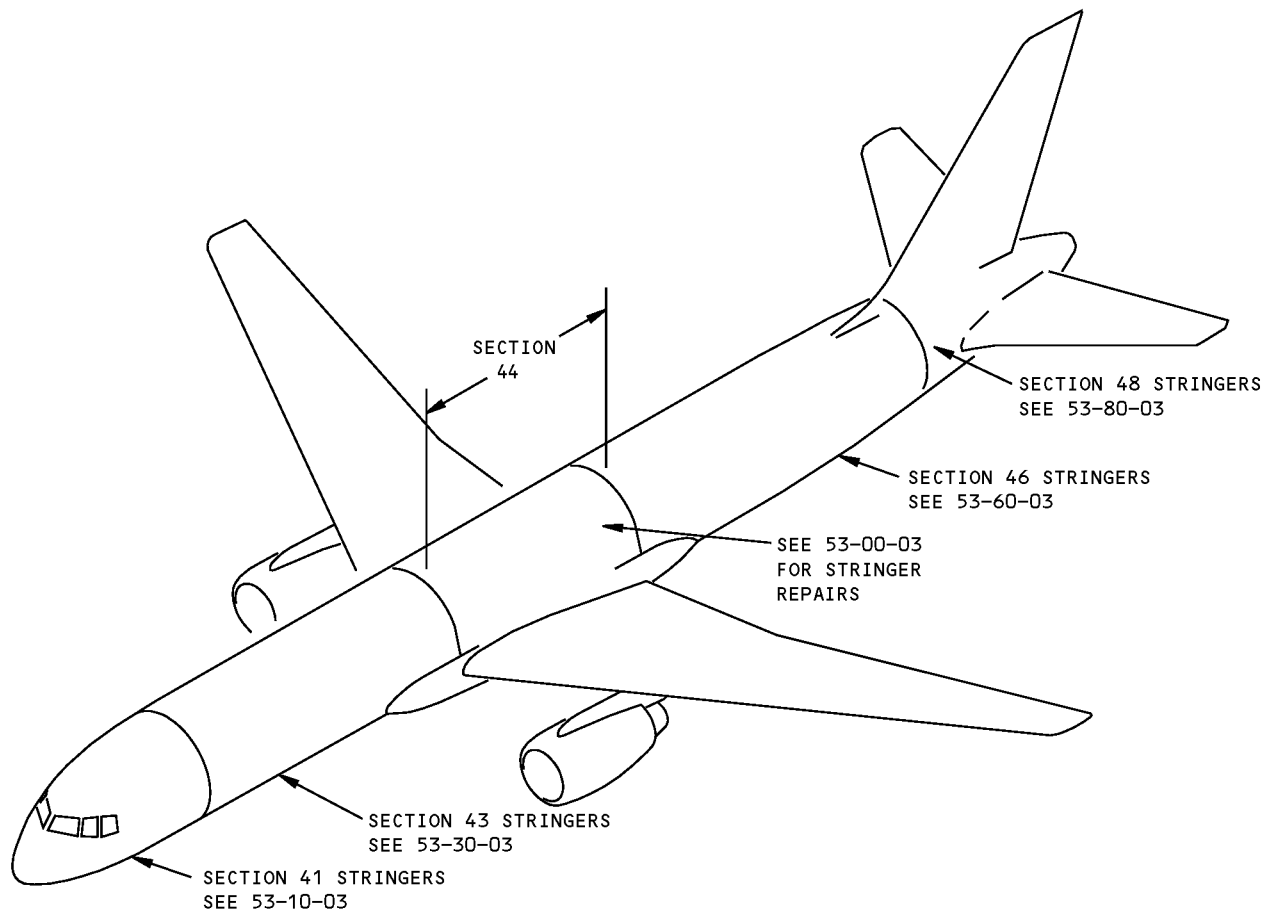
Section 44 Fuselage Stringer Repair
Figure 201

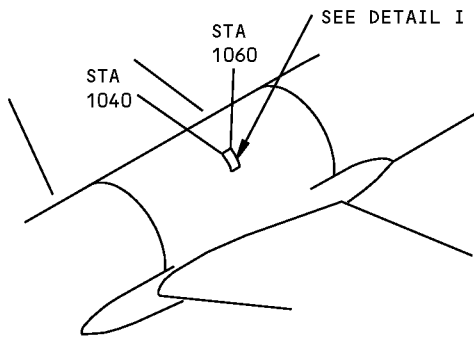
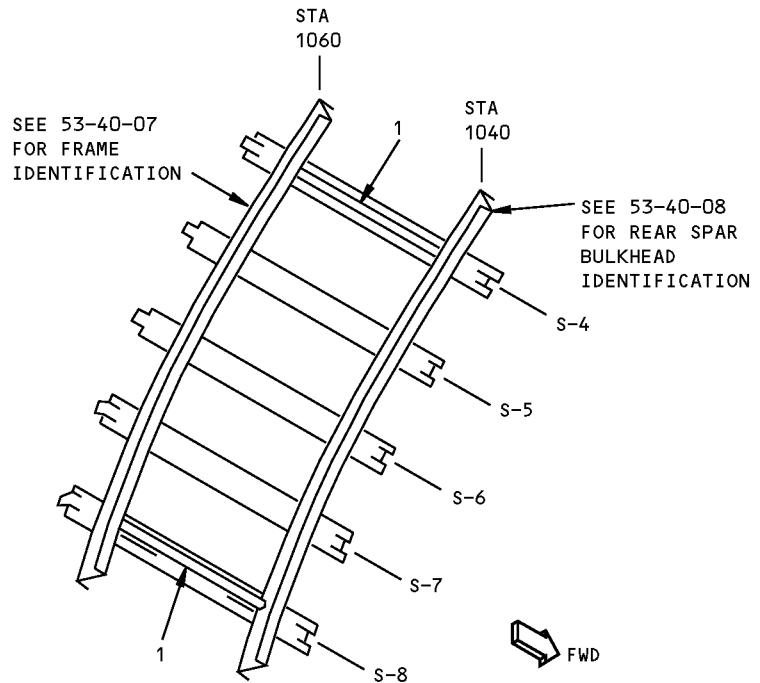
IDENTIFICATION 1 - SECTION 44 - INTERCOSTALS

LEFT SIDE IS SHOWN, RIGHT SIDE IS OPPOSITE
DETAIL I

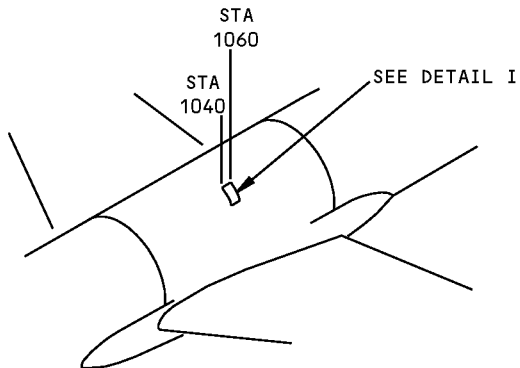
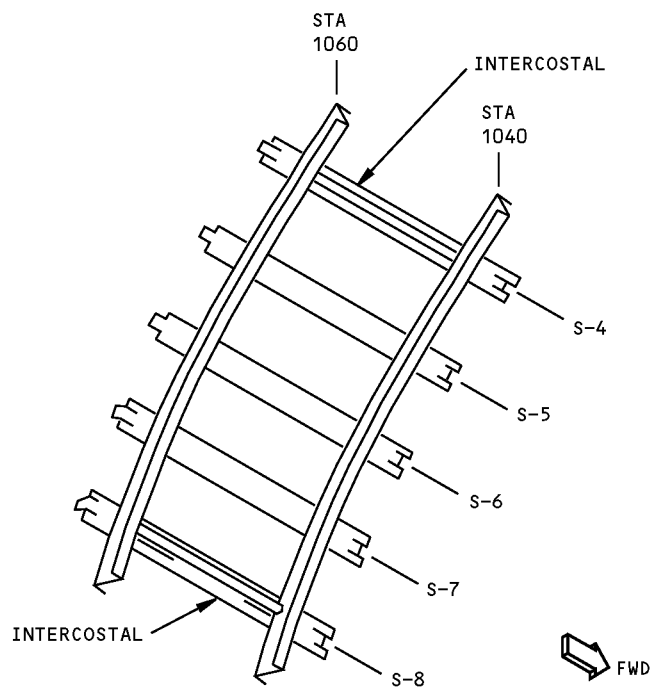
LEFT SIDE SHOWN
RIGHT SIDE OPPOSITE
DETAIL I

- REFER TO 53-00-04 FOR INTERCOSTAL ALLOWABLE DAMAGE DATA

Section 44 Intercostal Allowable Damage
Figure 101

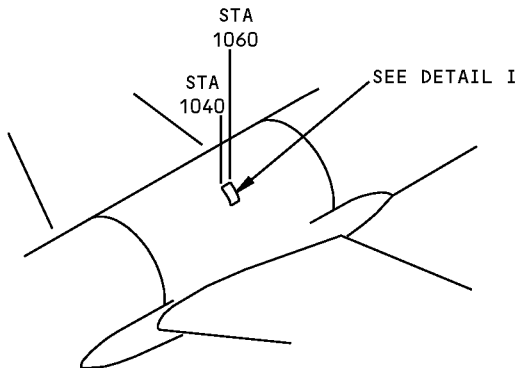
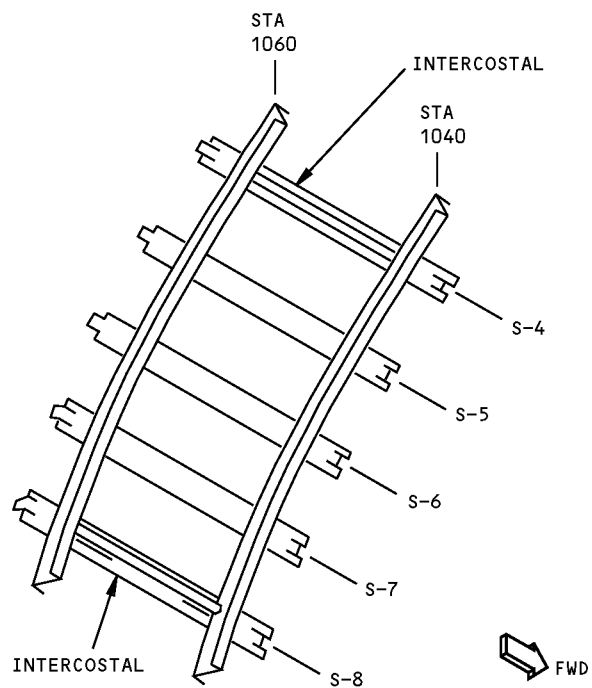
LEFT SIDE SHOWN
RIGHT SIDE OPPOSITE
DETAIL I

- DAMAGED COMPONENTS MAY BE REPLACED OR REPAIRED. IF REPAIRS ARE TO BE MADE, SEE 51-70 FOR TYPICAL WEB, FORMED SECTION, OR EXTRUDED SECTION REPAIRS

Section 44 Intercostal Repair
Figure 201

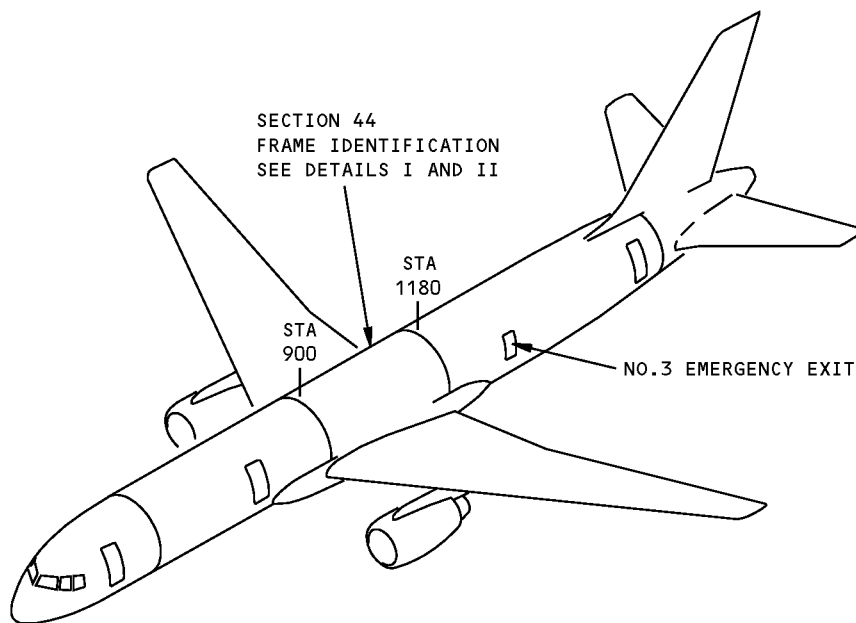
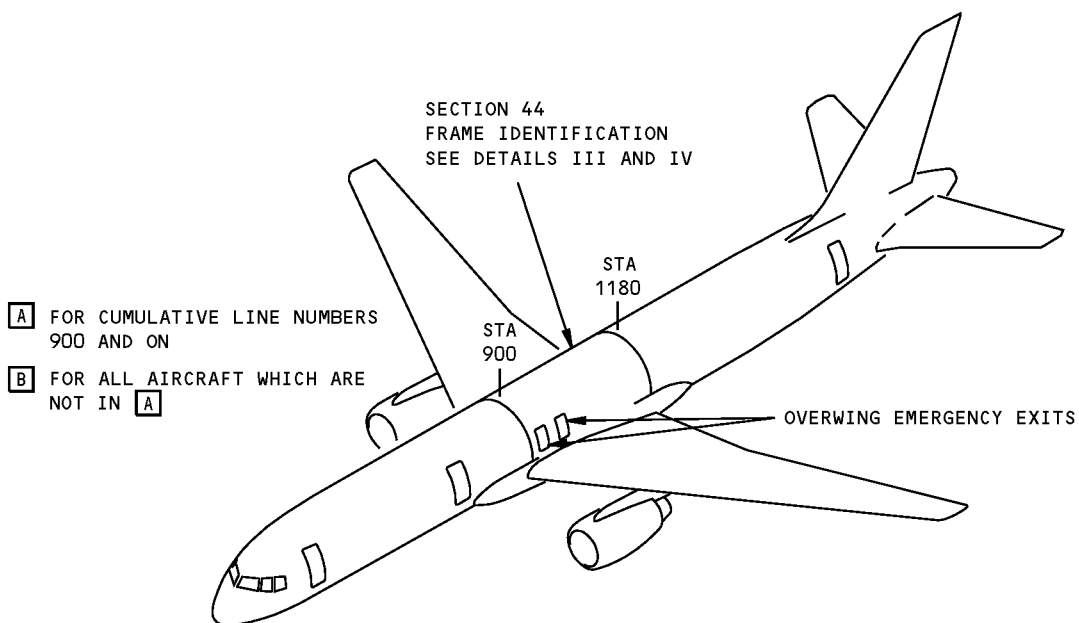
**Section 44 Frame Identification
Figure 1 (Sheet 1 of 7)**

AIRPLANES WITH NO. 3 EMERGENCY EXIT
BASIC CONFIGURATION

AIRPLANES WITH OVERWING EMERGENCY EXITS
BASIC CONFIGURATION

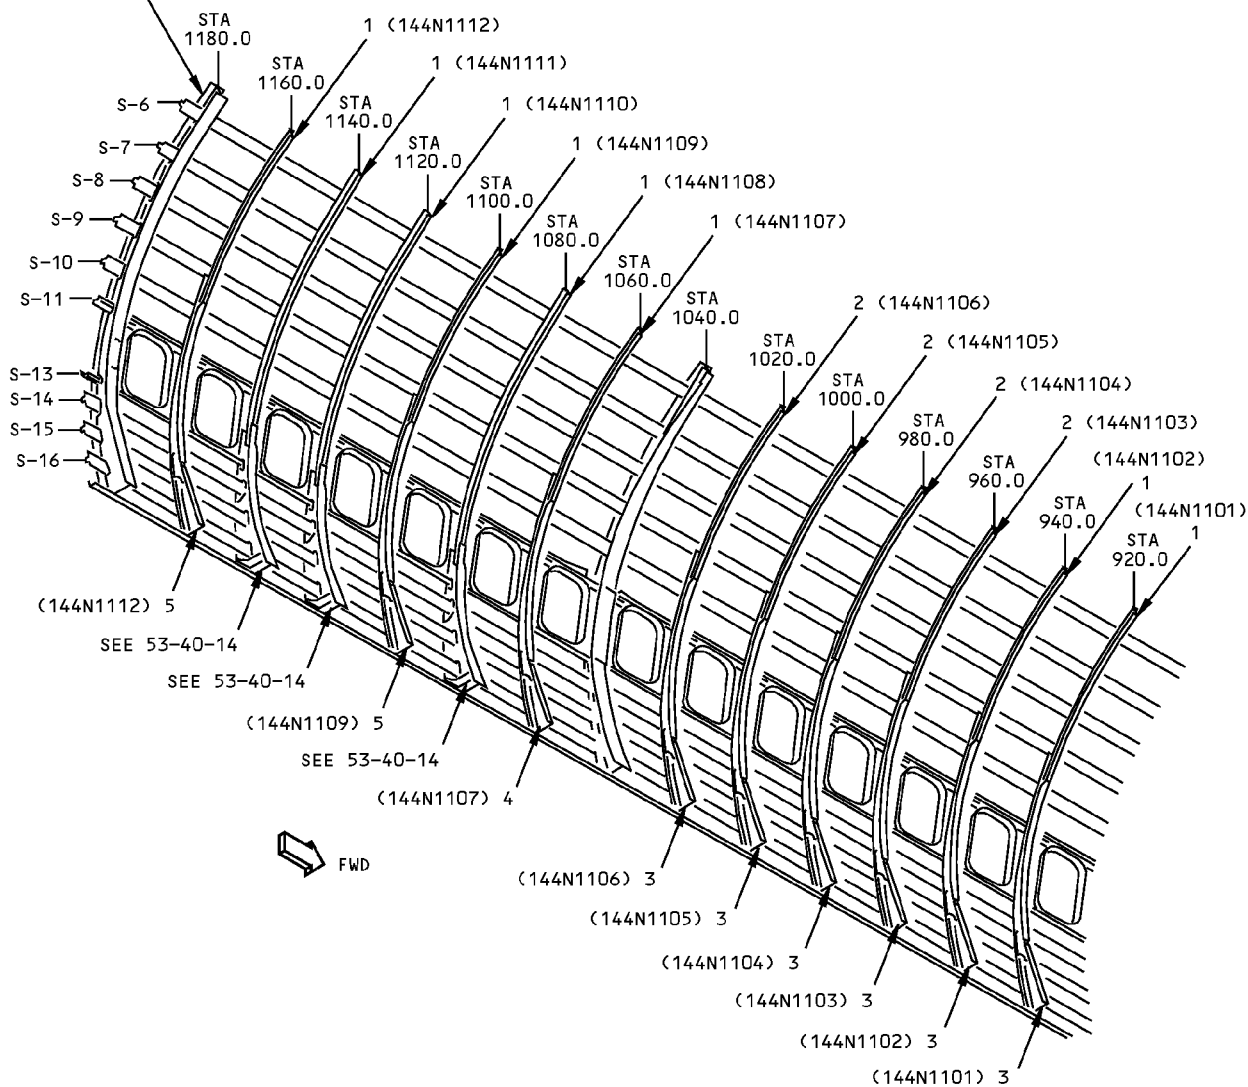
AIRPLANES WITH NO. 3 EMERGENCY EXIT
LEFT SIDE SHOWN RIGHT SIDE OPPOSITE
DETAIL I

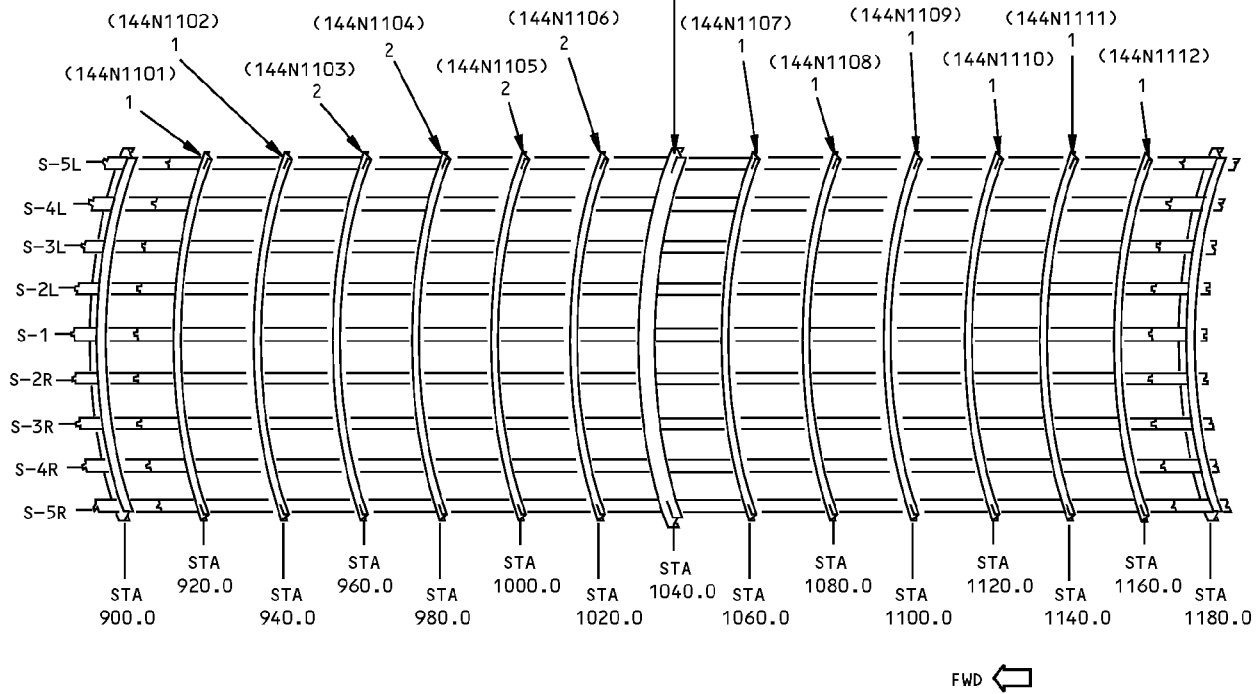
AIRPLANES WITH NO. 3 EMERGENCY EXIT
CROWN FRAMES
DETAIL II

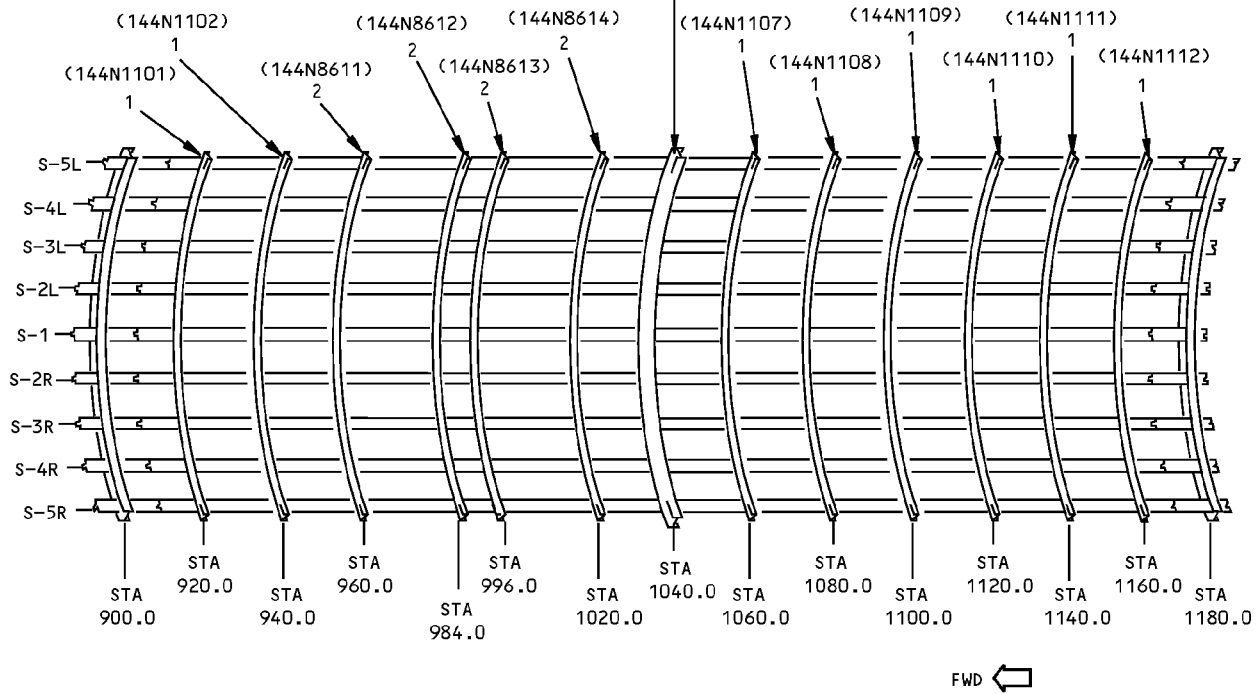
AIRPLANES WITH OVERWING EMERGENCY EXITS
CROWN FRAMES
DETAIL III

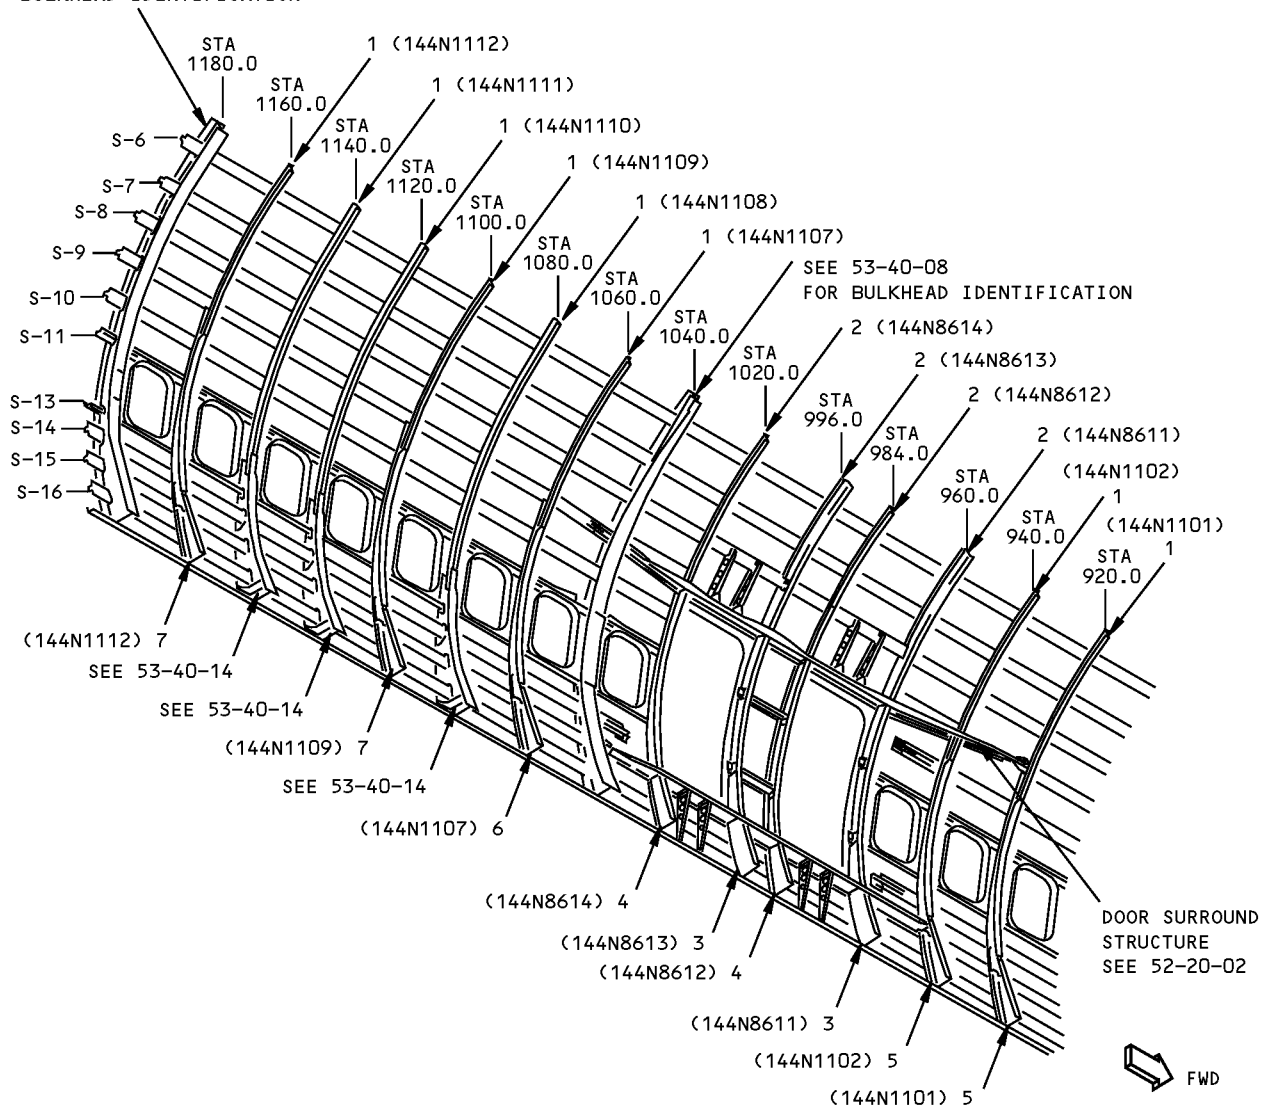
AIRPLANES WITH OVERWING EMERGENCY EXITS
LEFT SIDE SHOWN RIGHT SIDE OPPOSITE
DETAIL IV

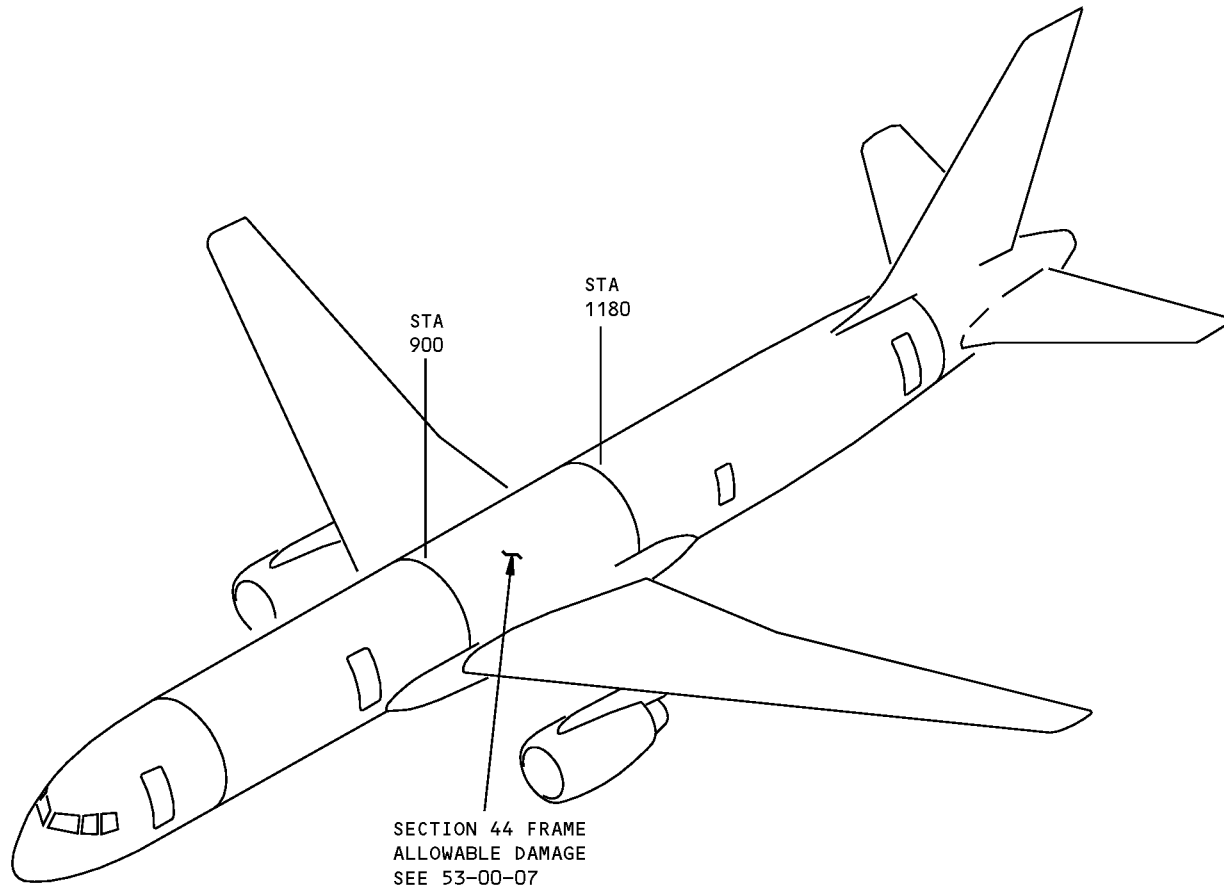
Section 44 Frame Allowable Damage
Figure 101

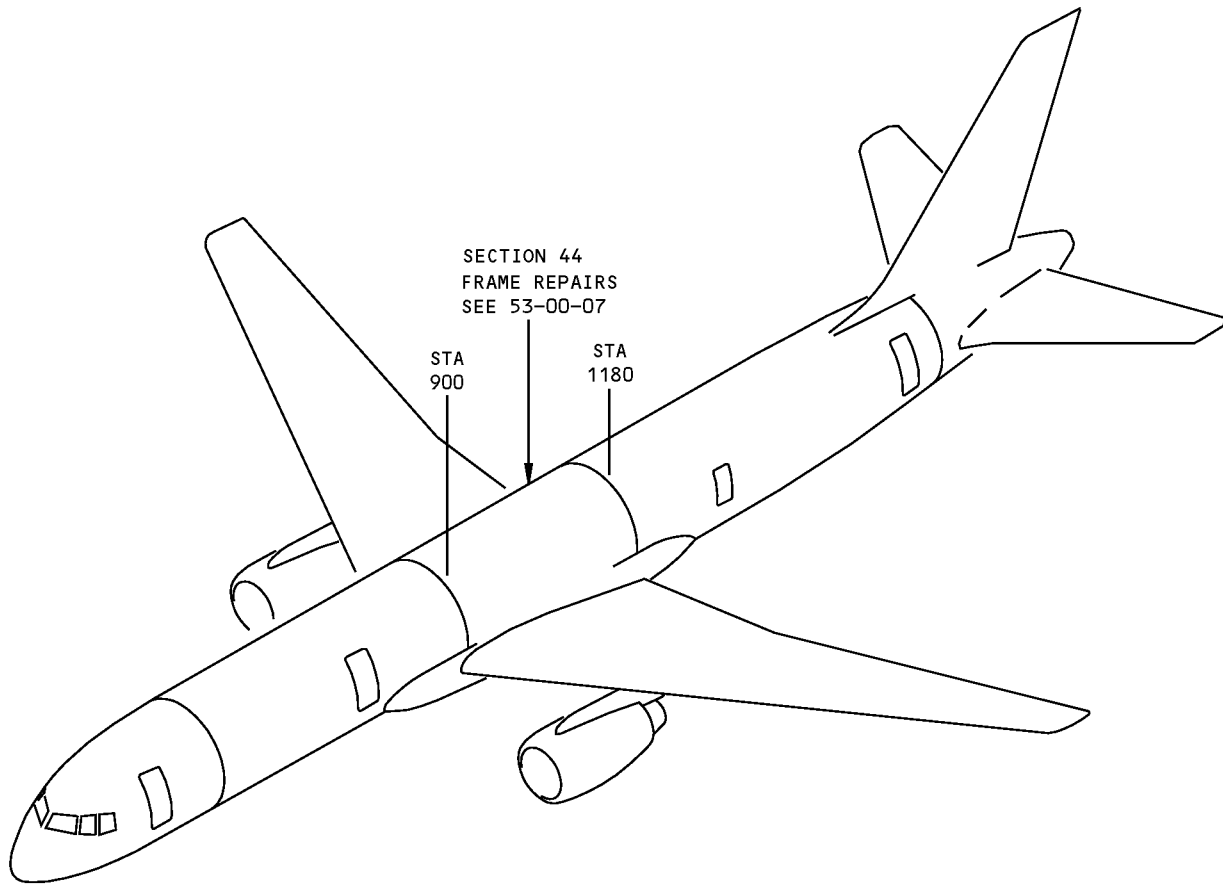
Section 44 Fuselage Frame Repairs
Figure 201

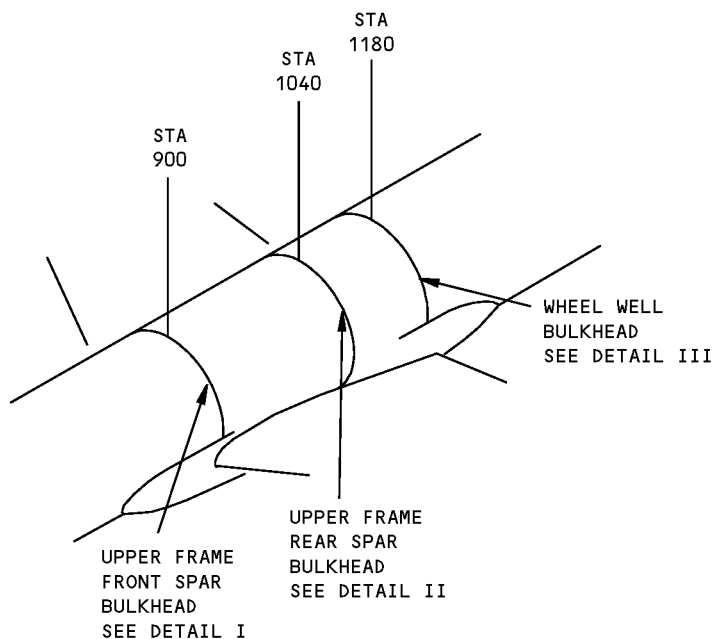
IDENTIFICATION 1 - SECTION 44 - BULKHEAD STRUCTURE

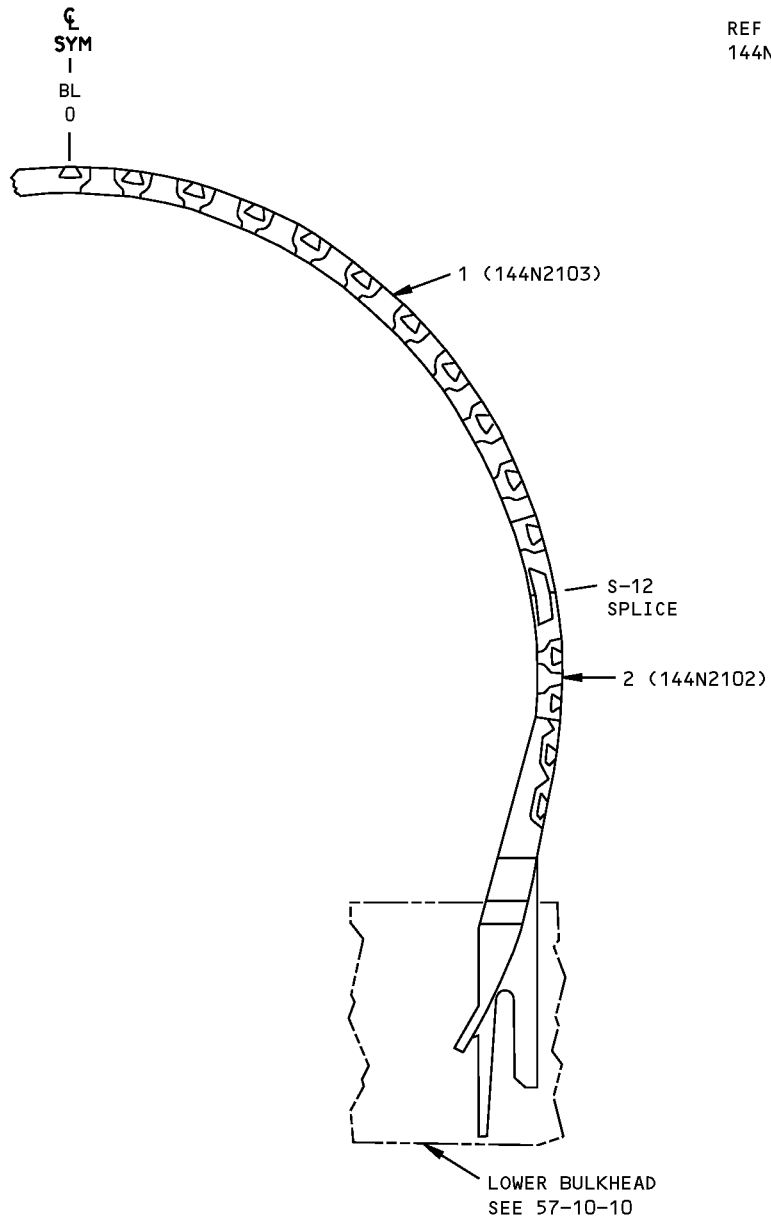
FRONT VIEW STA 900
LEFT SIDE IS SHOWN, RIGHT SIDE IS OPPOSITE
DETAIL I

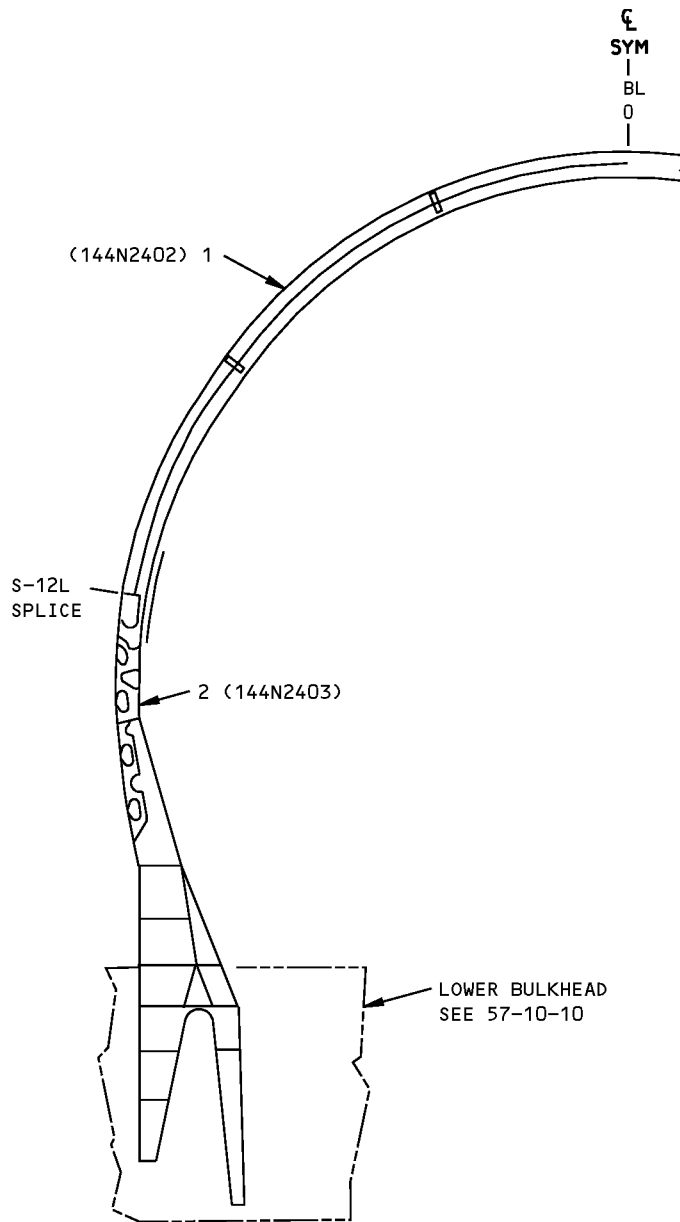
REAR VIEW STA 1140
LEFT SIDE IS SHOWN, RIGHT SIDE IS OPPOSITE
DETAIL II

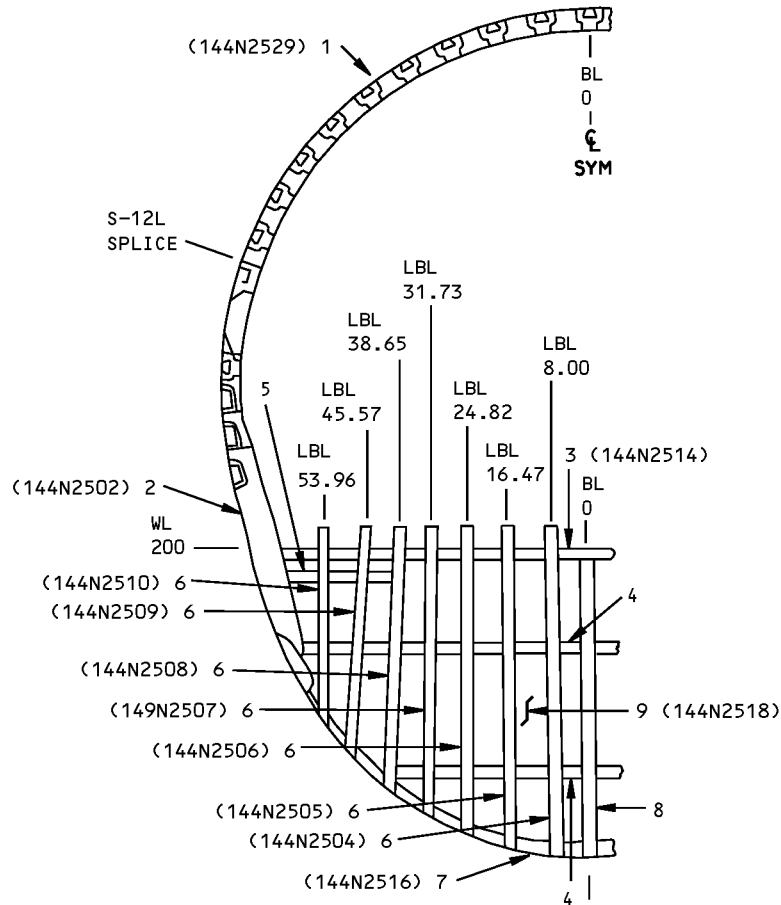
MLG WHEEL WELL BULKHEAD STA 1180

REAR VIEW

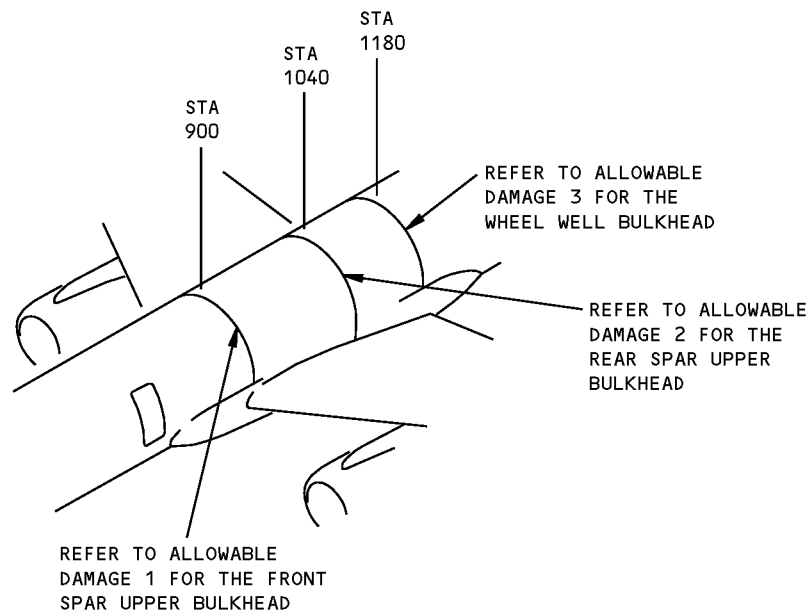
Section 44 Bulkhead Structure Allowable Damage Index
Figure 101
