FUSELAGE

757-200 STRUCTURAL REPAIR MANUAL

CHAPTER 53 FUSELAGE

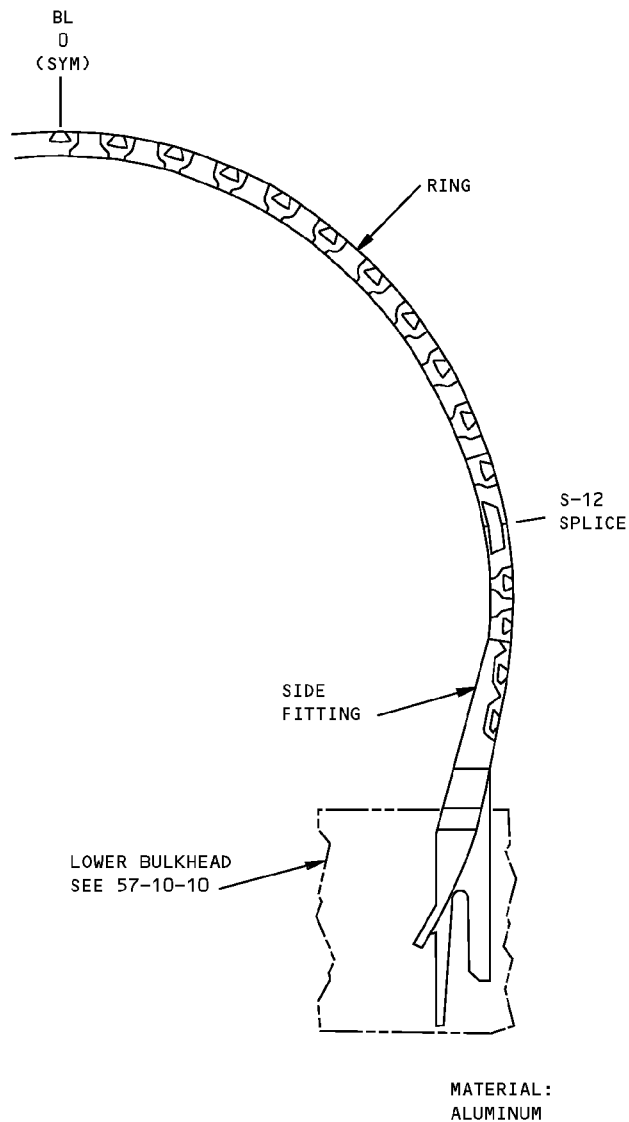
FRONT VIEW

Station 900 Front Spar Bulkhead Allowable Damage
Figure 101 (Sheet 1 of 3)

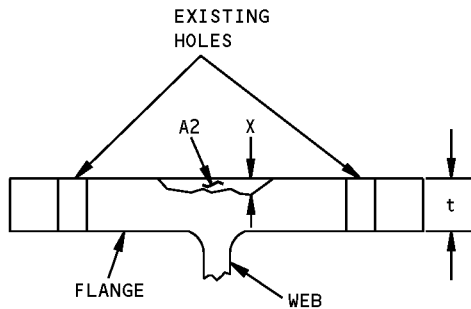
CROSS-SECTIONAL VIEW

A1 = NET AREA (NOT INCLUDING WEB)
= TOTAL AREA - EXISTING HOLES

A2 = AREA REMOVED FOR NICKS,
GOUGES OR CORROSION

[B] REMOVE DAMAGE PER DETAILS II, III, IV, OR V. THE TOTAL CROSS-SECTIONAL AREA REMOVED MUST NOT EXCEED 10% OF THE ORIGINAL CROSS-SECTIONAL AREA OF THE FLANGE OR WEB AS APPROPRIATE. SEE DETAIL I. SHOT PEEN REWORKED AREAS PER 20-10-03 OF THE COMPONENT MAINTENANCE MANUAL WITH SHOT NO. 230-550, INTENSITY .008A. **[C]**

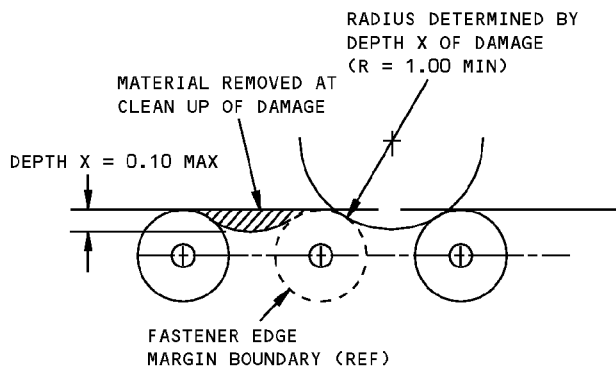
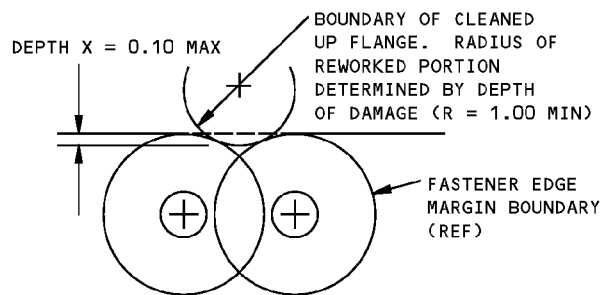
DETAIL II

DAMAGE CLEAN UP OF EDGES WHERE FASTENER EDGE MARGINS DO NOT OVERLAP

DAMAGE CLEAN UP OF EDGES WHERE FASTENER EDGE MARGINS OVERLAP

[A] CRACKS NOT ALLOWED EXCEPT FOR EDGE CRACKS, WHICH MUST BE REMOVED PER DETAILS II AND IV. MAX DEPTH 0.10 INCH. SHOT PEEN REWORKED AREAS PER 20-10-03 OF THE COMPONENT MAINTENANCE MANUAL WITH SHOT NO. 230-550, INTENSITY .008A. **[C]**

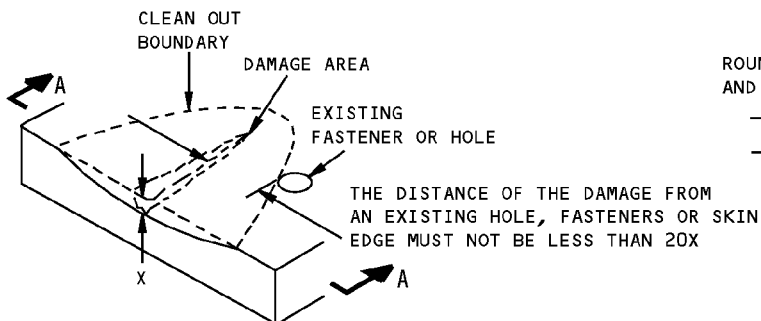
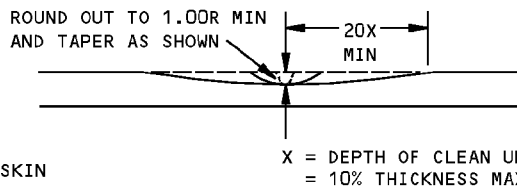
SECTION A-A

REMOVAL OF NICK, GOUGE AND SCRATCH DAMAGE ON A SURFACE
DETAIL III

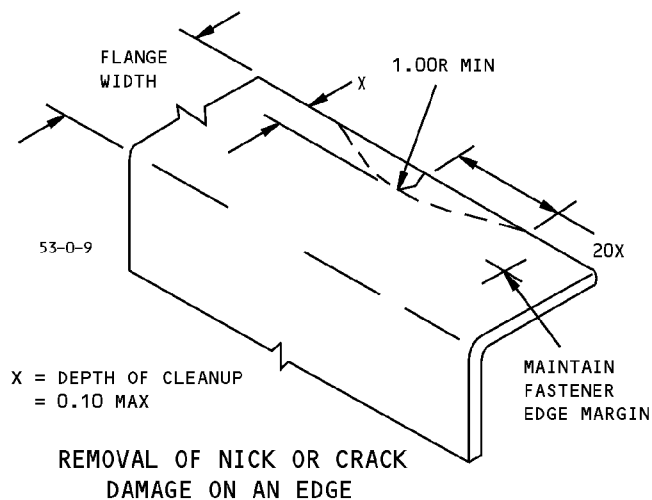
DETAIL IV

REMOVAL OF NICK OR CRACK DAMAGE ON AN EDGE

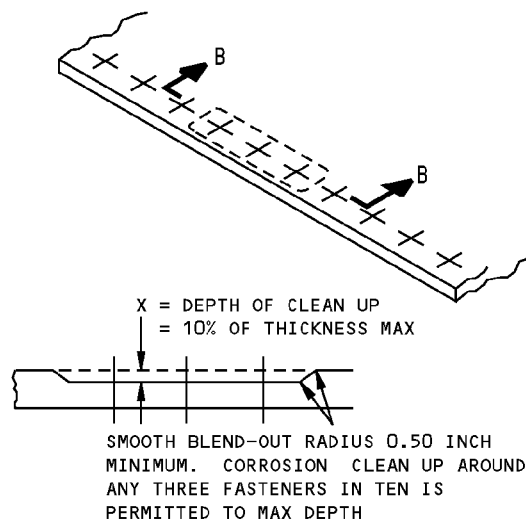
CORROSION CLEANUP
DETAIL V

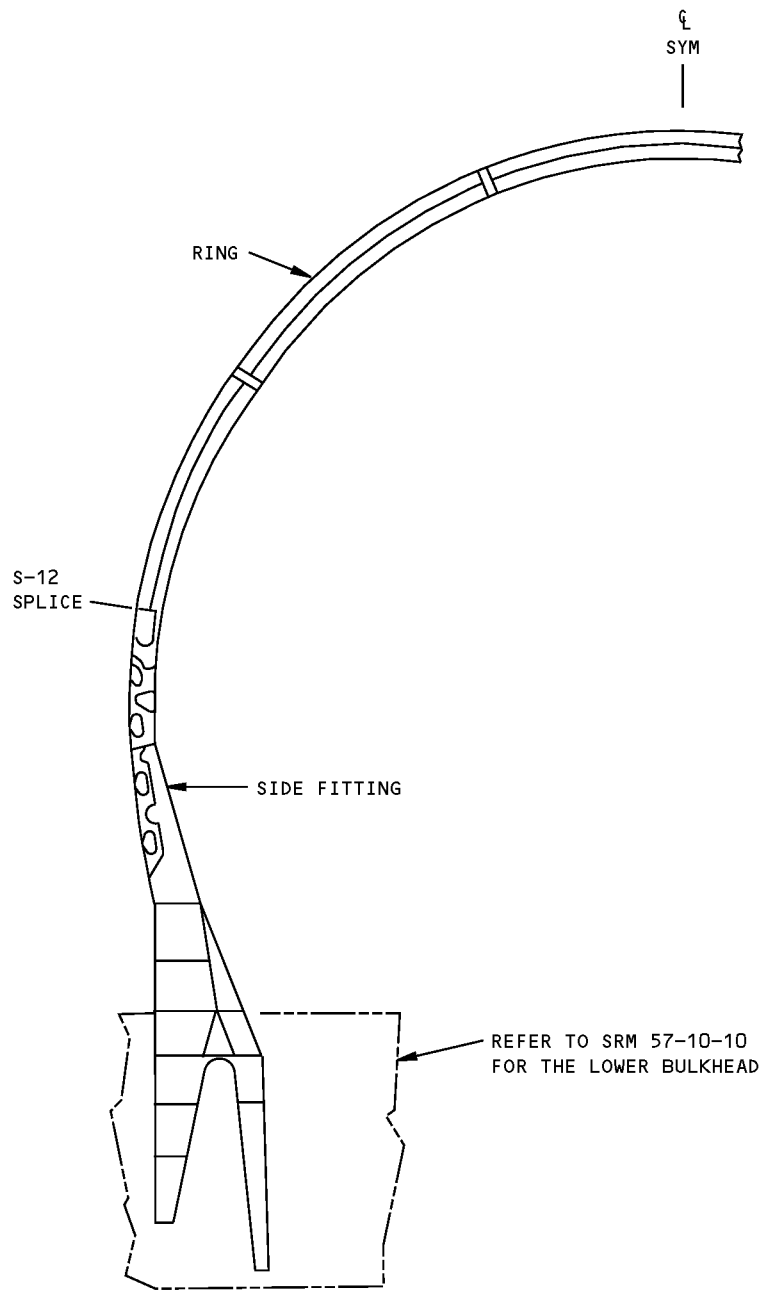
REAR VIEW

MATERIAL: ALUMINUM

Sta 1040 Rear Spar Bulkhead Allowable Damage
Figure 101 (Sheet 1 of 3)

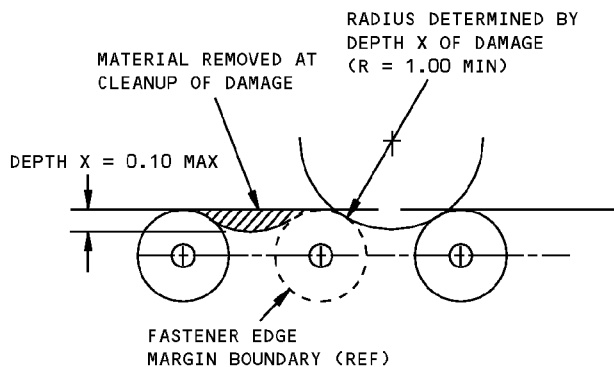
DETAIL I

DAMAGE CLEANUP OF EDGES WHERE
FASTENER EDGE MARGINS DO NOT OVERLAP

A CRACKS NOT ALLOWED EXCEPT FOR EDGE CRACKS WHICH MUST BE REMOVED PER DETAILS I AND III. MAX DEPTH 0.10 INCH. SHOT PEEN REWORKED AREAS PER 20-10-03 OF THE COMPONENT MAINTENANCE MANUAL WITH SHOT NO. 230-550, INTENSITY .008A **E**

C REMOVE DAMAGE PER DETAILS I,II, III AND IV. THE TOTAL CROSS-SECTIONAL AREA REMOVED MUST NOT EXCEED 10% OF THE ORIGINAL CROSS-SECTIONAL AREA OF THE FLANGE. SHOT PEEN REWORKED AREAS PER 20-10-03 OF THE COMPONENT MAINTENANCE MANUAL WITH SHOT NO. 230-550, INTENSITY .008A **E**

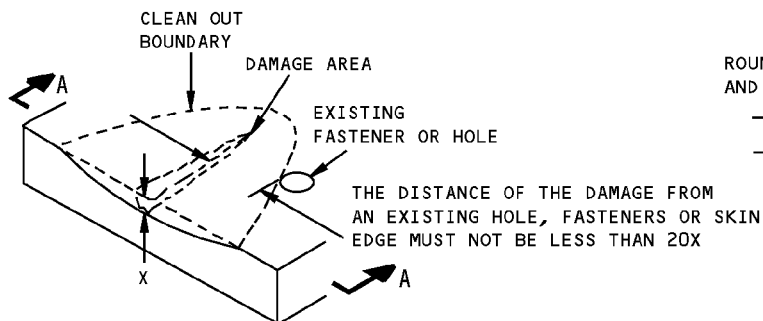
REMOVAL OF NICK, GOUGE AND SCRATCH DAMAGE ON A SURFACE
DETAIL II

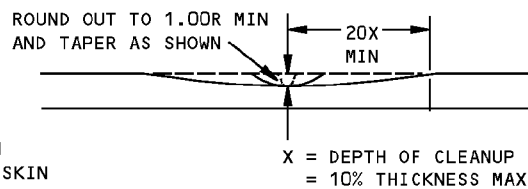
SECTION A-A

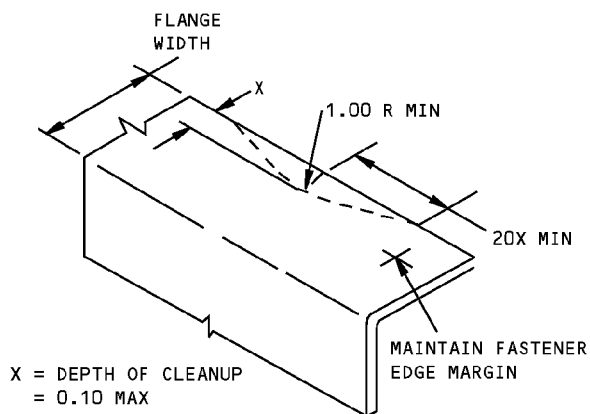
REMOVAL OF NICK OR CRACK
DAMGE ON AN EDGE
DETAIL III

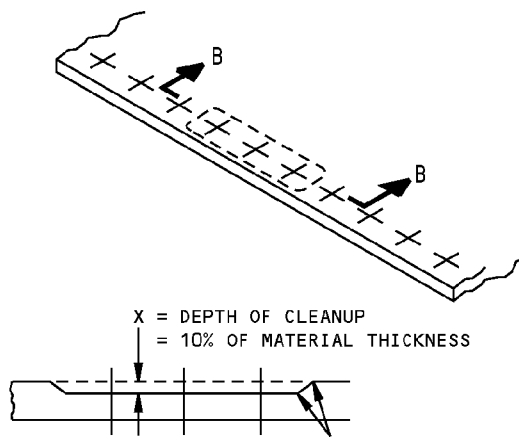
SECTION B-B
CORROSION CLEANUP
DETAIL IV

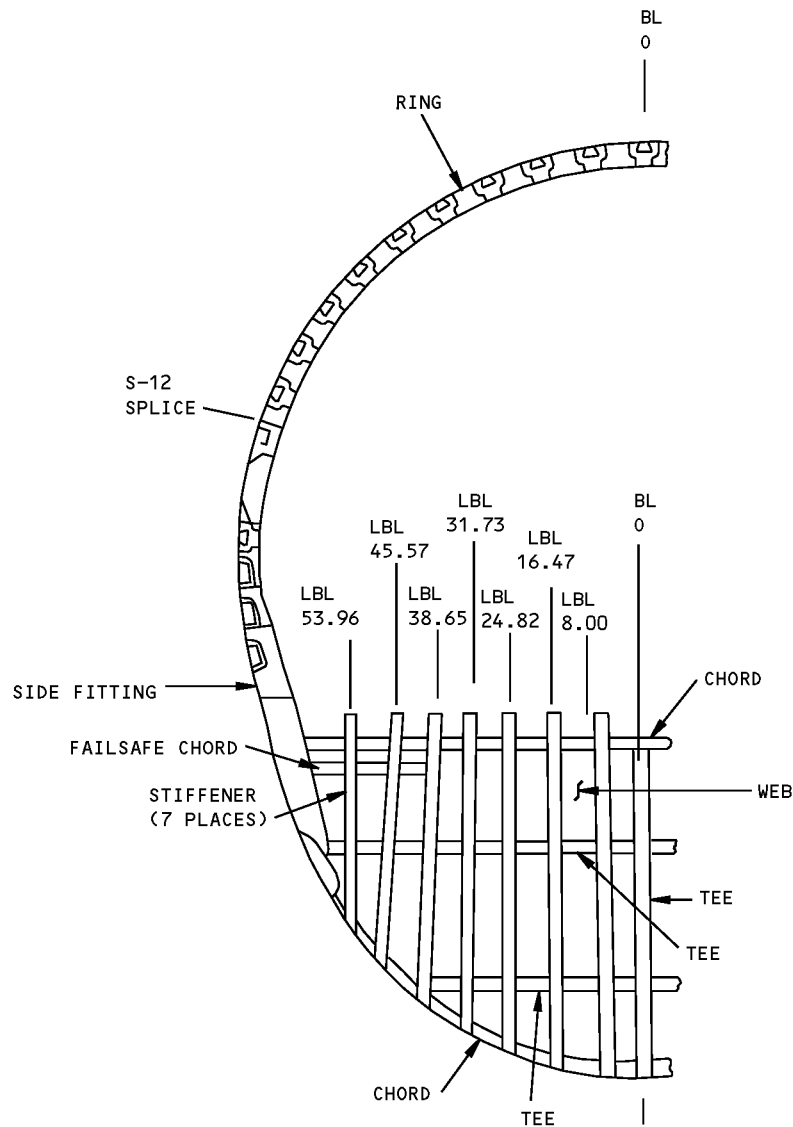
MATERIAL: ALUMINUM

**Sta 1180 Wheel Well Bulkhead Allowable Damage
Figure 101 (Sheet 1 of 3)**

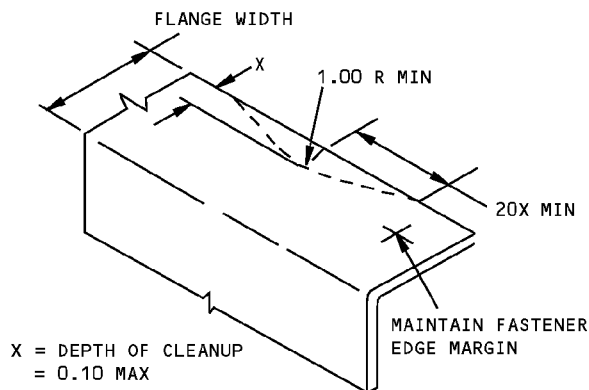
REMOVAL OF NICK OR CRACK DAMAGE ON AN EDGE
DETAIL I

- REFINISH REWORKED AREAS PER 51-20 OF THE MAINTENANCE MANUAL
- A** CRACKS NOT ALLOWED EXCEPT FOR EDGE CRACKS, WHICH MUST BE REMOVED PER DETAILS I AND II. SHOT PEEN REWORKED AREAS PER 20-10-03 OF THE COMPONENT MAINTENANCE MANUAL WITH SHOT NO. 230-550.

- B** CRACKS NOT ALLOWED EXCEPT FOR EDGE CRACKS WHICH MUST BE REMOVED PER DETAILS I AND II.
- C** REMOVE DAMAGE PER DETAILS I, II, III AND V. SHOT PEEN REWORKED AREAS PER 20-10-03 OF THE COMPONENT MAINTENANCE MANUAL WITH SHOT NO. 230-550. **G**

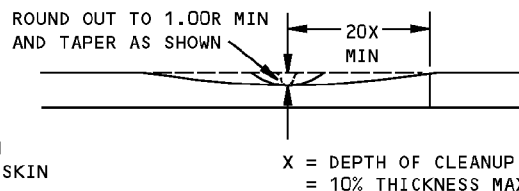
SECTION A-A

REMOVAL OF NICK, GOUGE AND SCRATCH DAMAGE ON A SURFACE
DETAIL III

- D** REMOVE DAMAGE PER DETAILS I, II AND III
- E** REMOVE DAMAGE PER DETAILS I, II, III AND V
- F** CLEAN OUT DAMAGE UP TO 0.25 MAX DIA AND NOT CLOSER THAN 1.0 INCH TO FASTENER HOLE, MATERIAL EDGE OR OTHER DAMAGE. FILL HOLE WITH A 2117-T3 OR T4 ALUMINUM RIVET INSTALLED WET WITH BMS 5-95 SEALANT. ALL OTHER HOLES TO BE REPAIRED

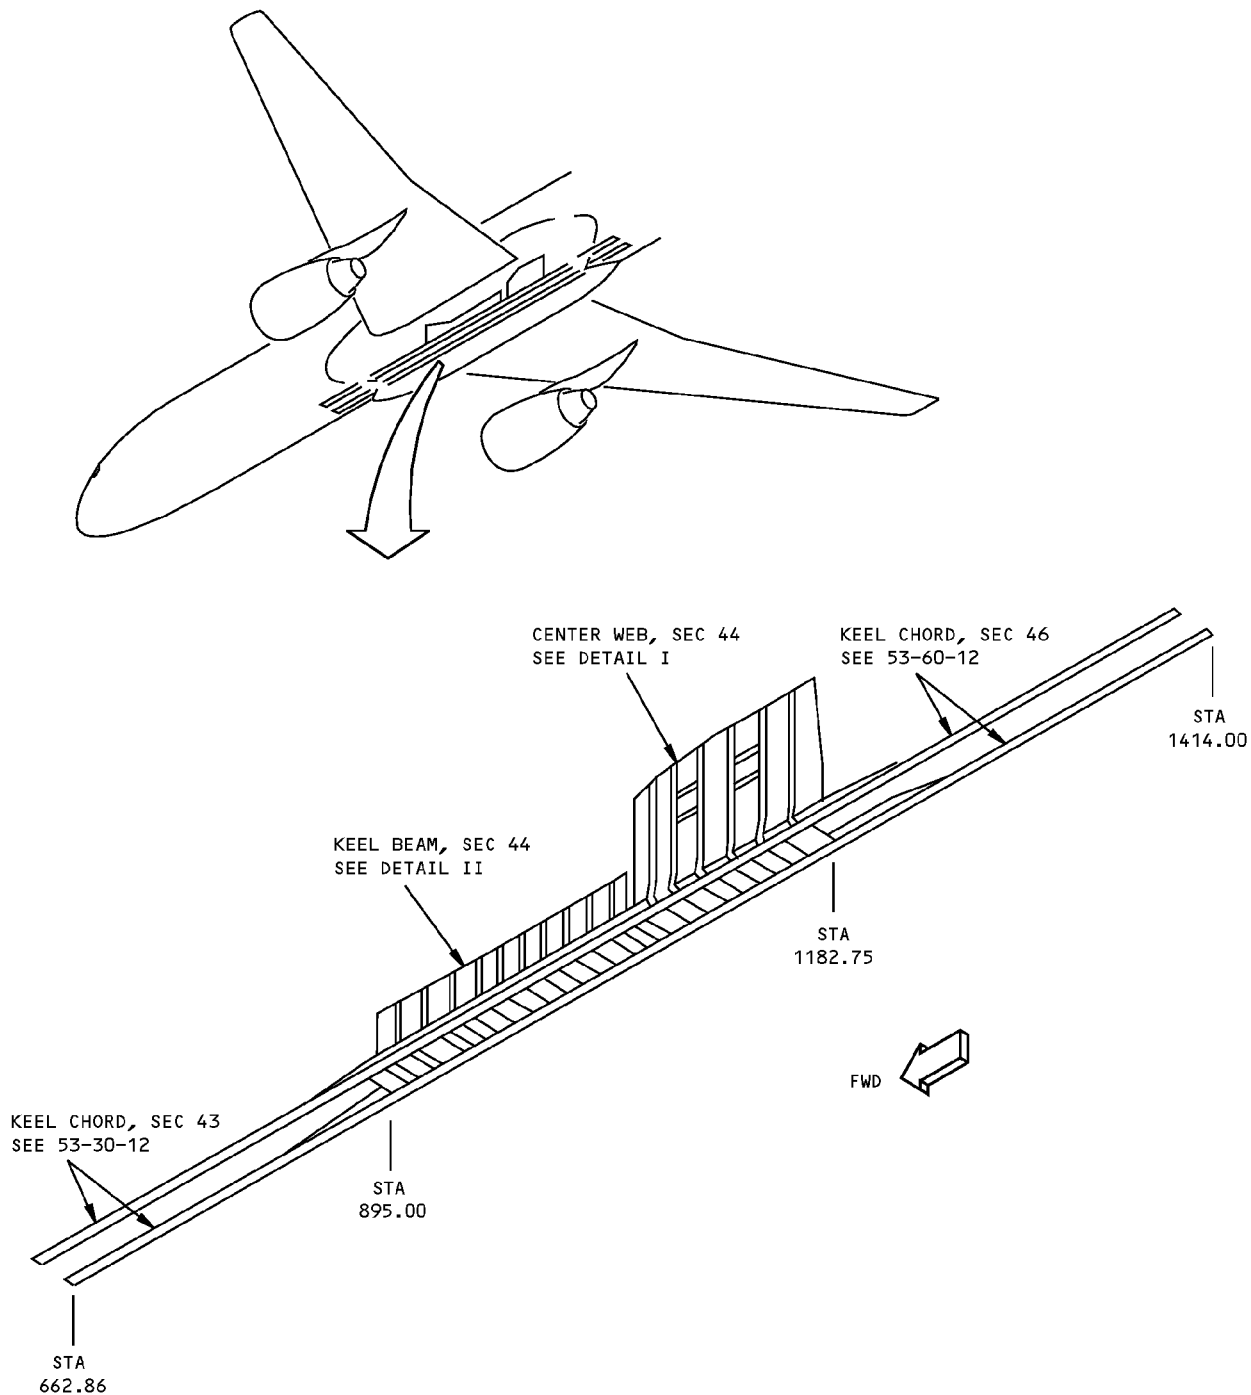
Section 44 - Keel Beam Structure Allowable Damage
Figure 101 (Sheet 1 of 7)

ALLOWABLE DAMAGE 1 - SECTION 44 - KEEL BEAM STRUCTURE

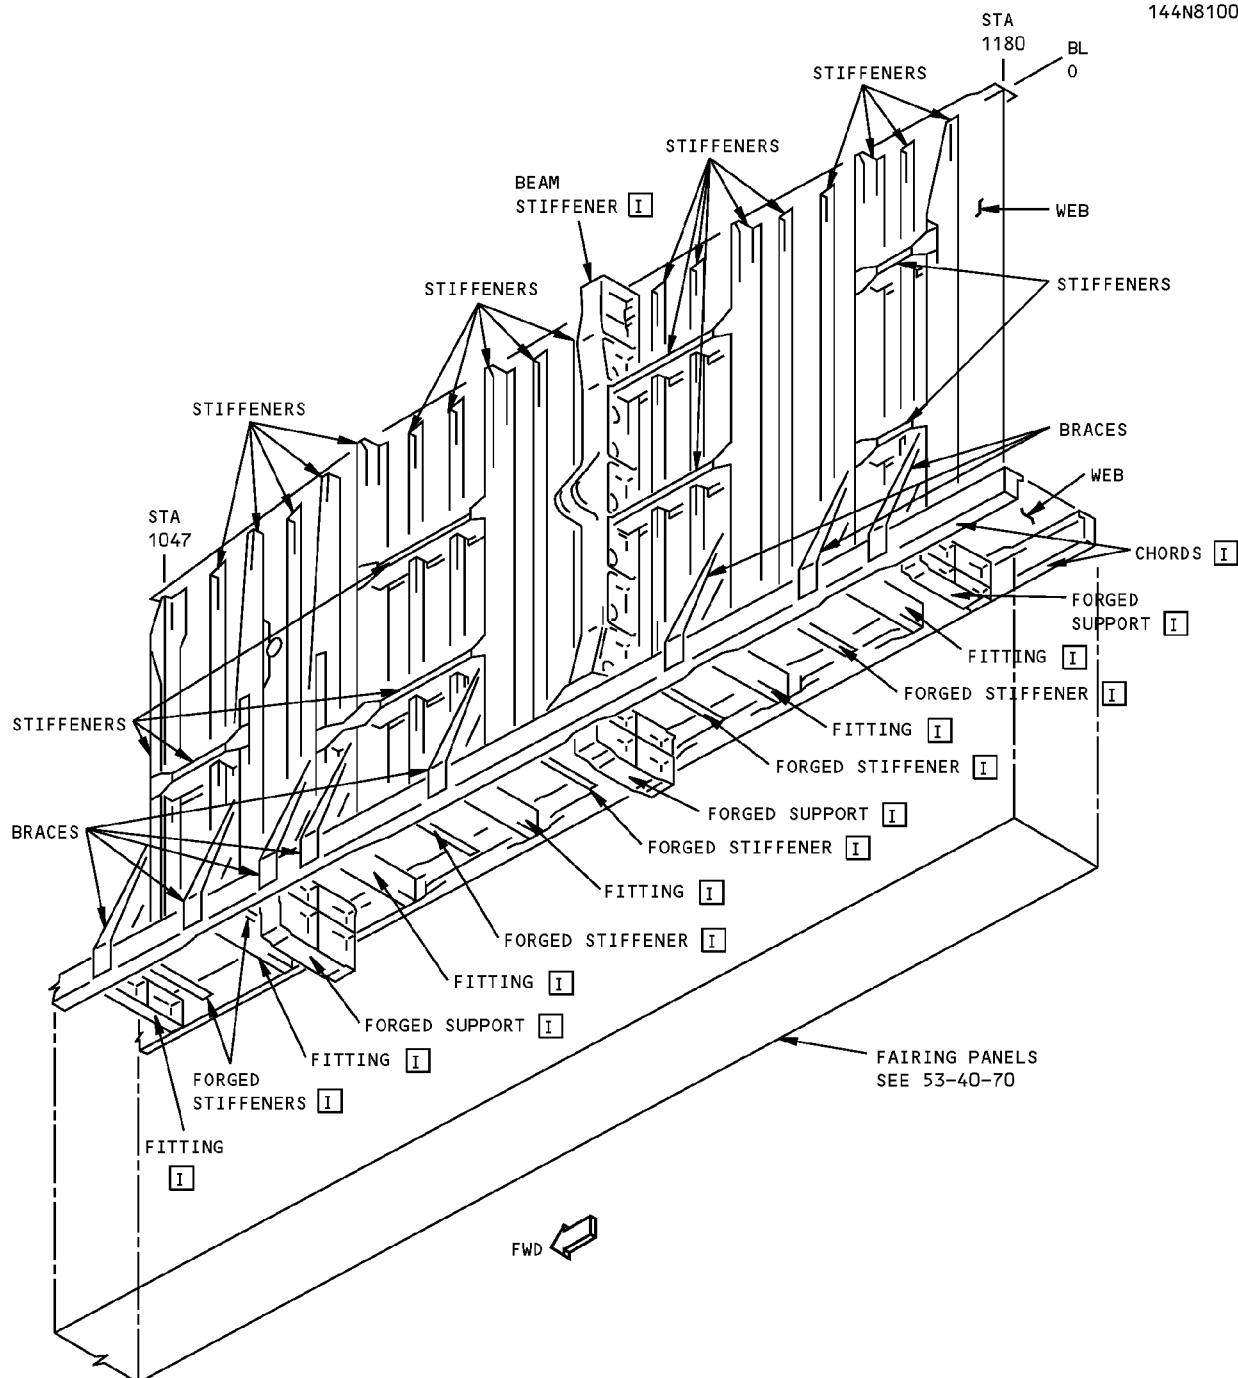
DETAIL I

MATERIAL: ALUMINUM

Section 44 - Keel Beam Structure Allowable Damage
Figure 101 (Sheet 2 of 7)

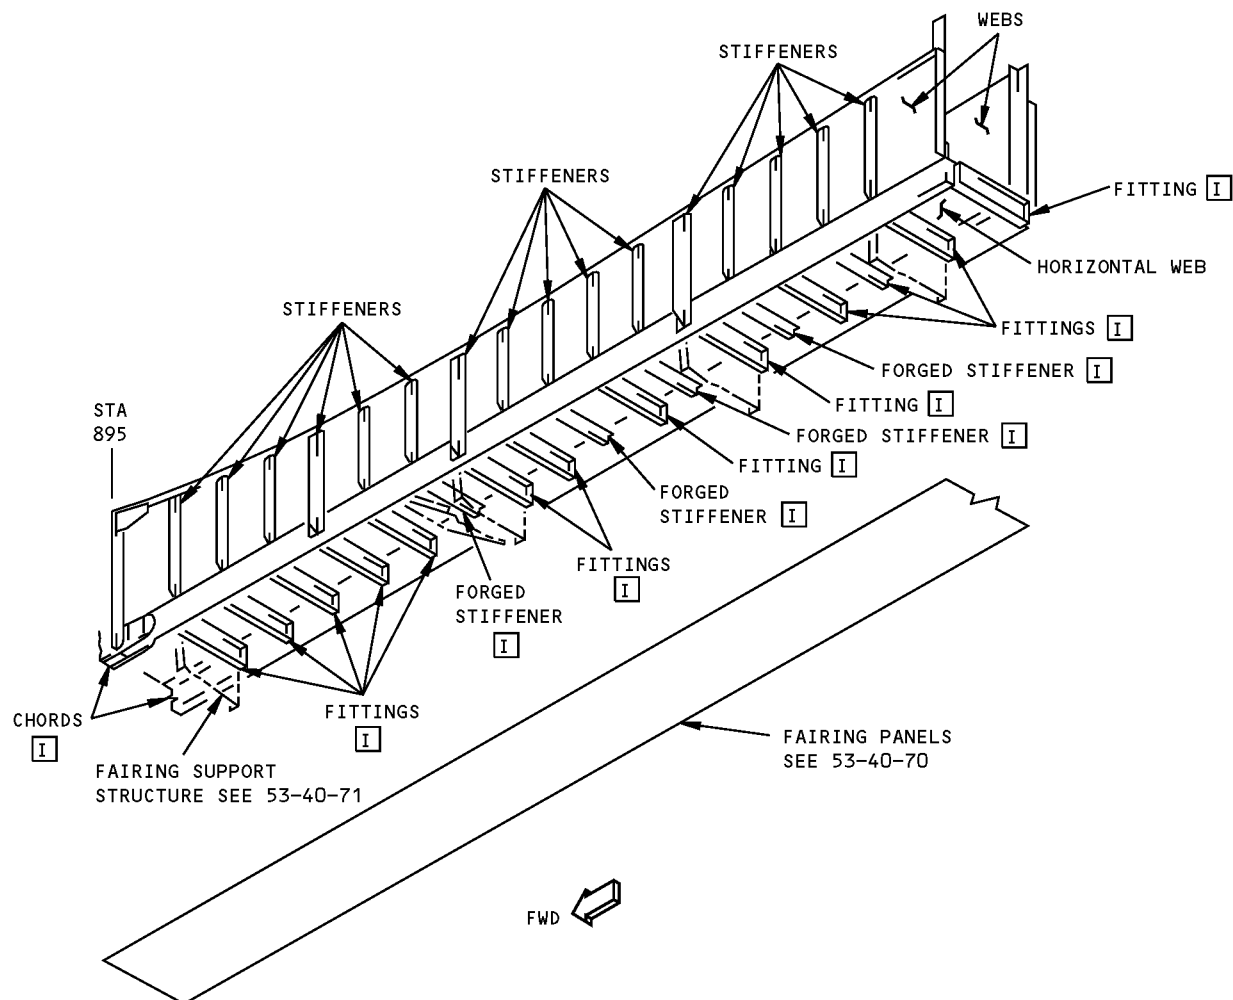
DETAIL II

MATERIAL: ALUMINUM

**Section 44 - Keel Beam Structure Allowable Damage
Figure 101 (Sheet 3 of 7)**

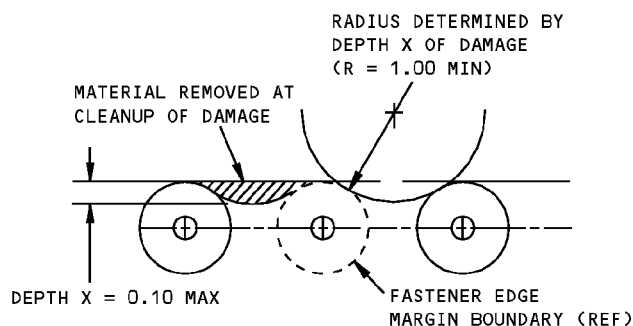
DAMAGE CLEANUP OF EDGES WHERE FASTENER EDGE MARGINS DO NOT OVERLAP

- B** REMOVE DAMAGE PER DETAILS IV, VIII AND XI. SEE DETAILS I, II FOR APPLICABLE SHOT PEEN REQUIREMENTS
- C** CRACKS NOT ALLOWED EXCEPT FOR EDGE CRACKS WHICH MUST BE REMOVED PER DETAILS III AND VIII. SEE DETAILS I, II FOR APPLICABLE SHOT PEEN REQUIREMENTS

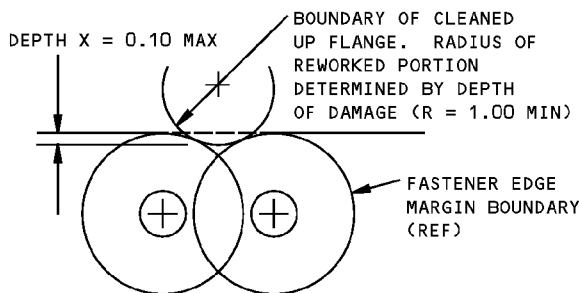
DETAIL III

DAMAGE CLEANUP OF EDGES WHERE FASTENER EDGE MARGINS OVERLAP

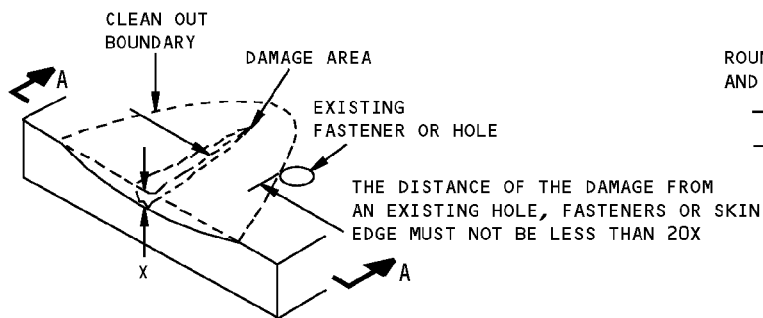
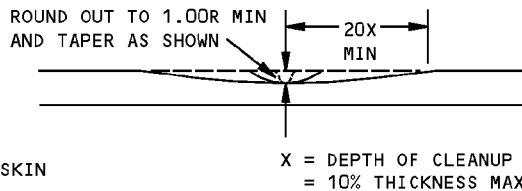
SECTION A-A

REMOVAL OF NICK, GOUGE AND SCRATCH DAMAGE ON A SURFACE
DETAIL IV

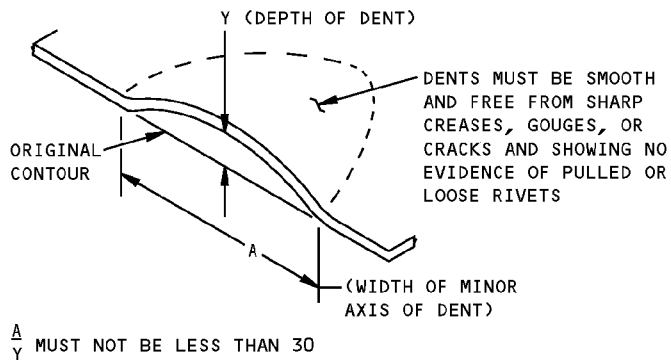
ALLOWABLE DAMAGE FOR DENT
DETAIL V

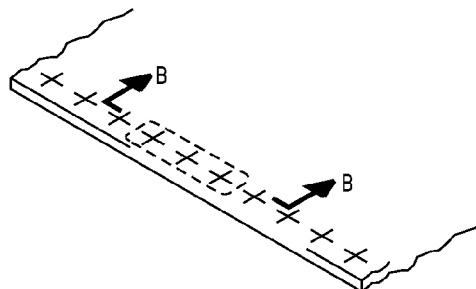
SMOOTH BLEND-OUT RADIUS 0.50 INCH MINIMUM. CORROSION CLEANUP AROUND ANY THREE FASTENERS IN TEN IS PERMITTED TO MAX DEPTH

SECTION B-B
CORROSION CLEANUP
DETAIL VI

- F** REMOVE DAMAGE PER DETAILS III, IV, AND VI
- G** CRACKS NOT ALLOWED EXCEPT FOR EDGE CRACKS WHICH MUST BE REMOVED PER DETAILS III AND VIII
- H** FOR EDGE DAMAGE SEE DETAIL XI. FOR LUG DAMAGE SEE DETAIL X. FOR OTHER DAMAGE SEE DETAIL IV. DAMAGE NOT ALLOWED IN VICINITY OF BUSHINGS. SEE DETAIL I FOR APPLICABLE SHOT PEEN REQUIREMENTS

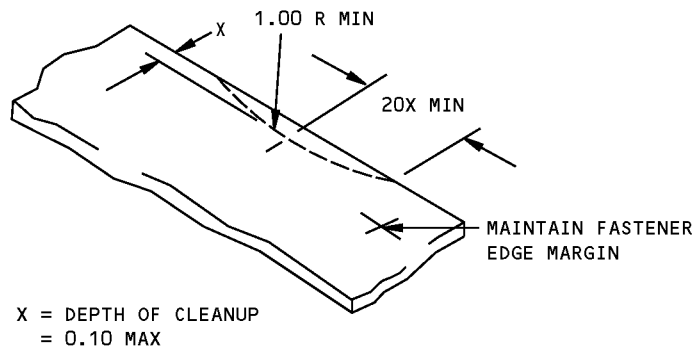
**REMOVAL OF NICK OR CRACK
DAMAGE ON AN EDGE
DETAIL VII**

- D** CRACKS NOT ALLOWED EXCEPT FOR EDGE CRACKS WHICH MUST BE REMOVED PER DETAILS III AND VII
- E** CLEAN OUT DAMAGE UP TO 0.25 MAX DIA AND NOT CLOSER THAN 1.0 INCH TO FASTENER HOLE OR OTHER DAMAGE. MAINTAIN 2.0D EDGE MARGIN ON PART EDGE. FILL HOLE WITH A 2117-T3 OR T4 ALUMINUM RIVET INSTALLED WET WITH BMS 5-95 SEALANT. ALL OTHER HOLES TO BE REPAIRED

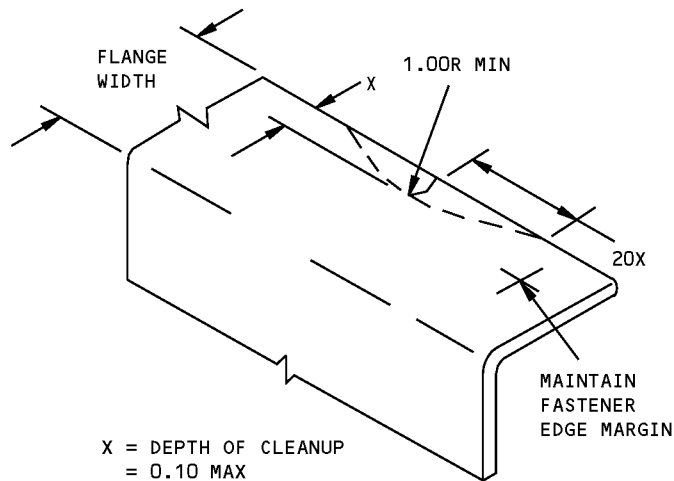
**REMOVAL OF NICK OR CRACK
DAMAGE ON AN EDGE
DETAIL VIII**

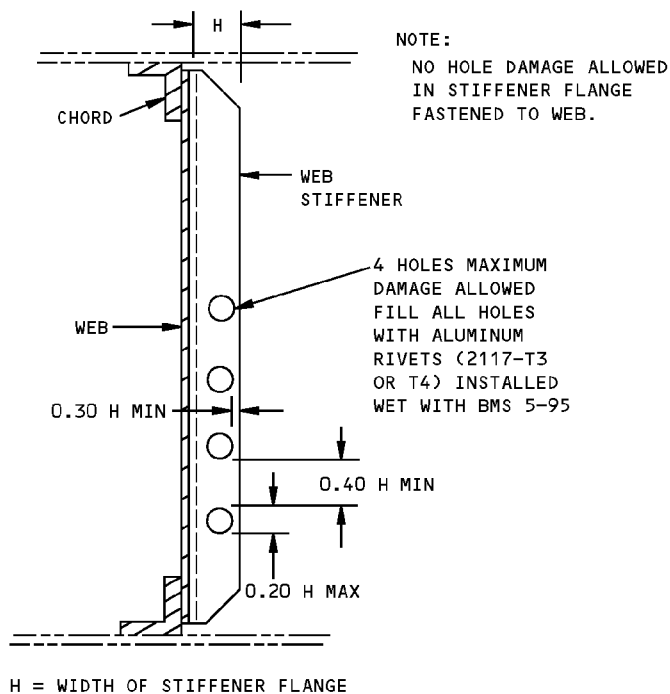
ALLOWABLE DAMAGE LIMITS FOR
HOLES IN WEB STIFFENERS
DETAIL IX

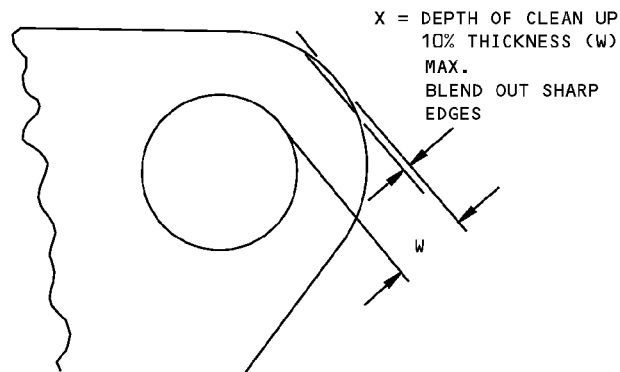
DAMAGE CLEAN UP FOR EDGES OF LUG
DETAIL X

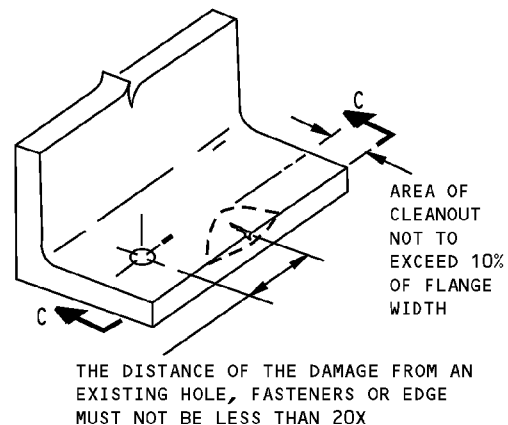
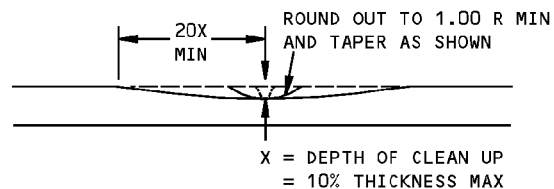
SECTION C-C
REMOVAL OF NICK OR CRACK
DAMAGE ON AN EDGE
DETAIL XI

- REFINISH REWORKED AREAS PER 51-20 OF THE MAINTENANCE MANUAL
- A** CRACKS NOT ALLOWED EXCEPT FOR EDGE CRACKS WHICH MUST BE REMOVED PER DETAIL XI. SEE DETAILS I, II FOR APPLICABLE SHOT PEEN REQUIREMENTS

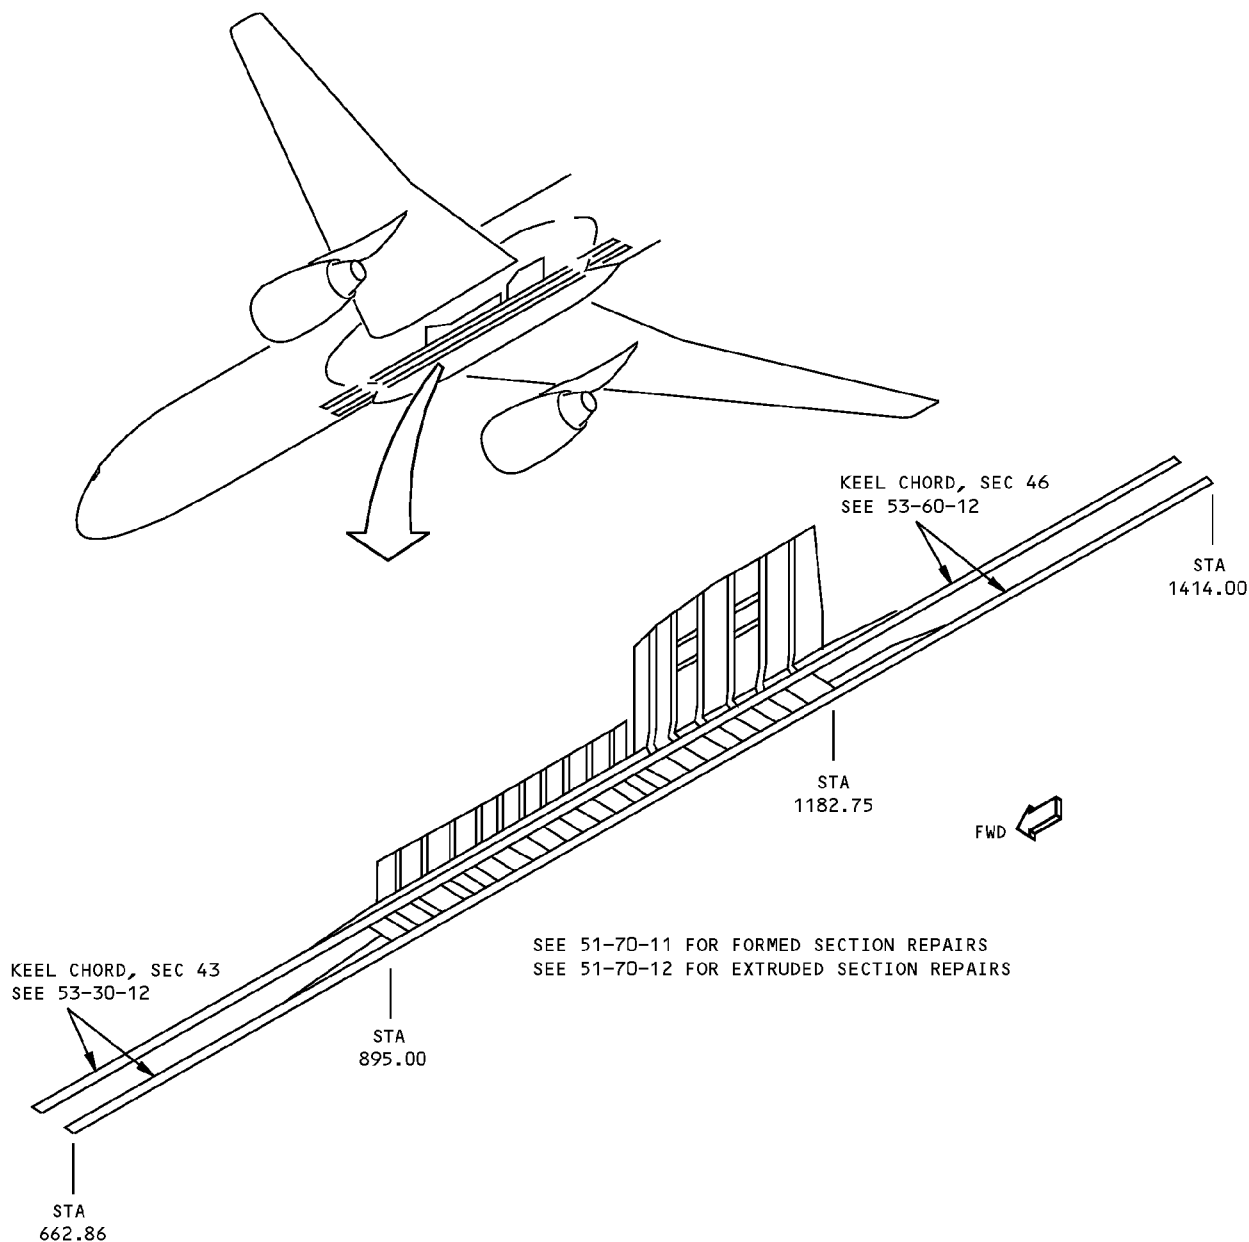
Section 44 Keel Beam Structure Repair Figure 201

REPAIR GENERAL - SECTION 44 - KEEL BEAM STRUCTURE

- WEB REPAIR IN 51-70-13 DOES NOT APPLY TO KEEL BEAM WEBS
- REPAIRS NOT ALLOWED TO FORGINGS

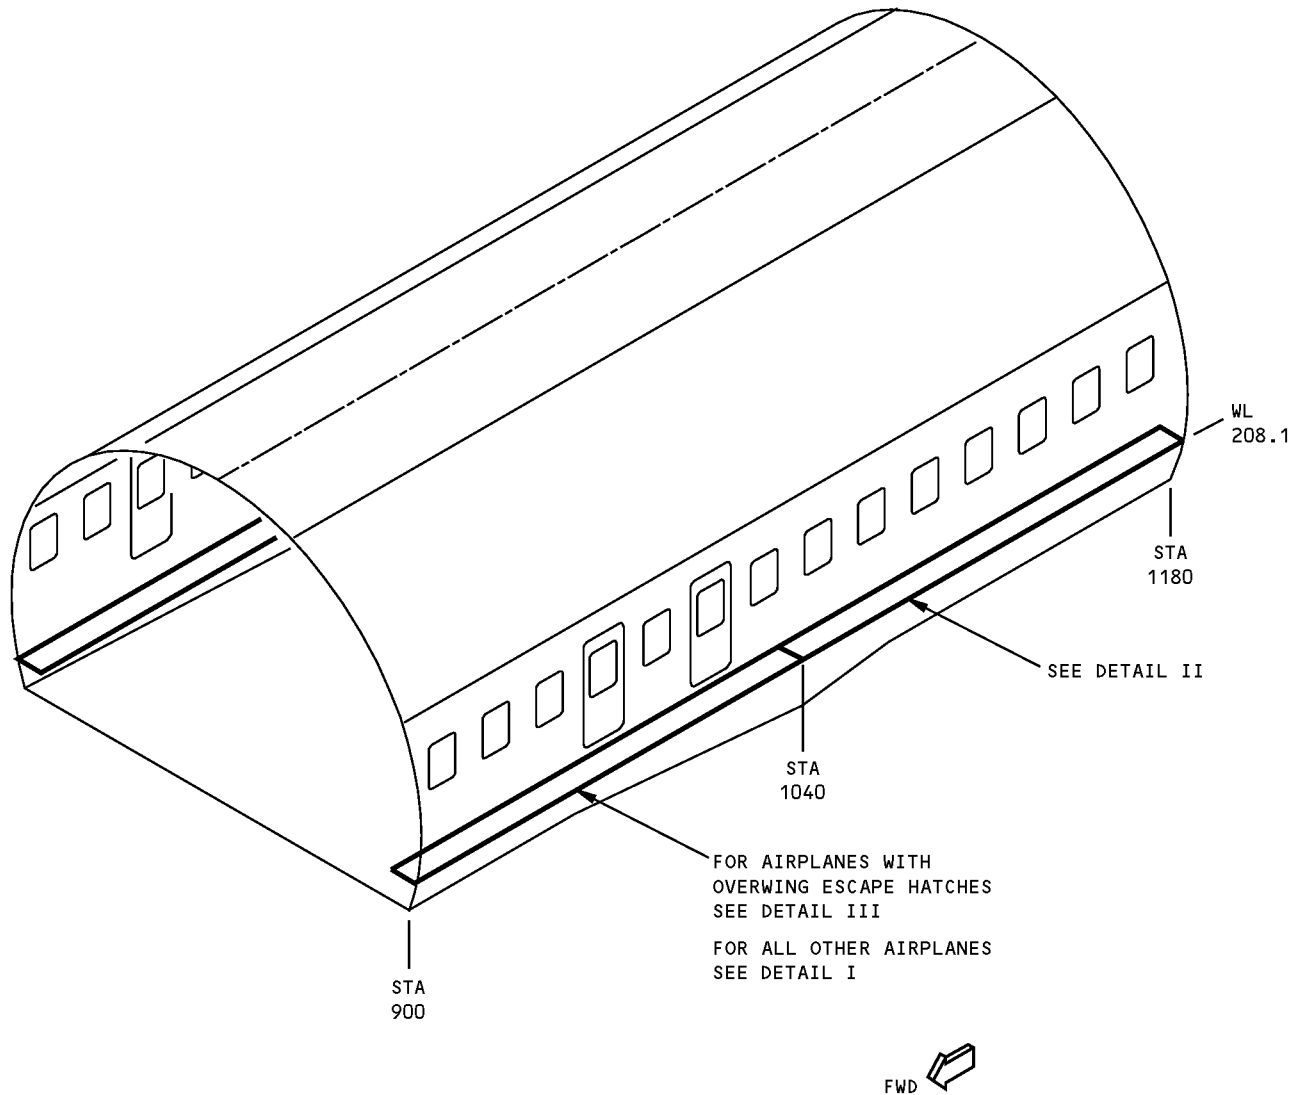
Section 44 Crease Beam Identification
Figure 1 (Sheet 1 of 4)

IDENTIFICATION 1 - SECTION 44 - CREASE BEAM

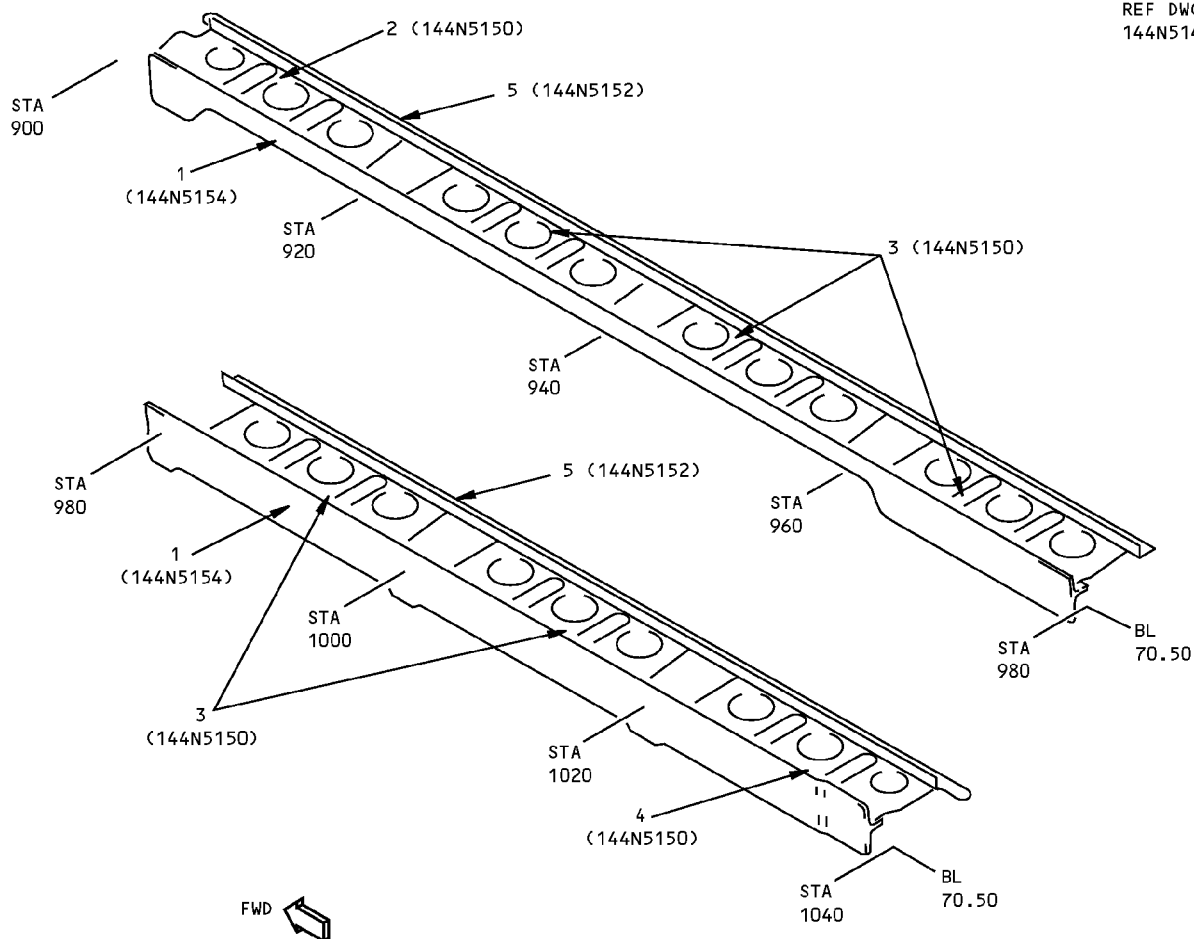
REF DWG
144N5140

LEFT SIDE SHOWN
RIGHT SIDE OPPOSITE
DETAIL I

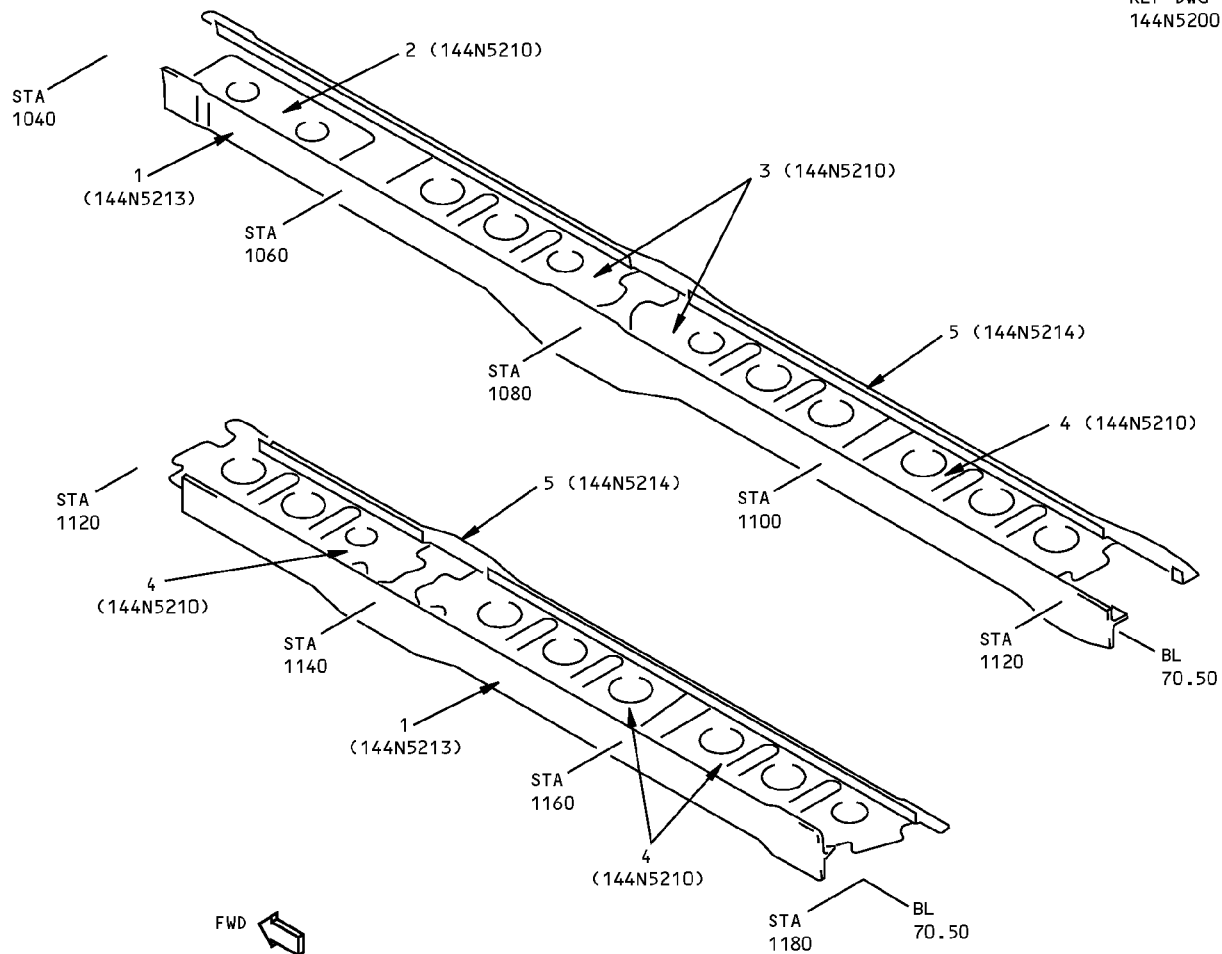
REF DWG
144N5200

LEFT SIDE SHOWN
RIGHT SIDE OPPOSITE
DETAIL II

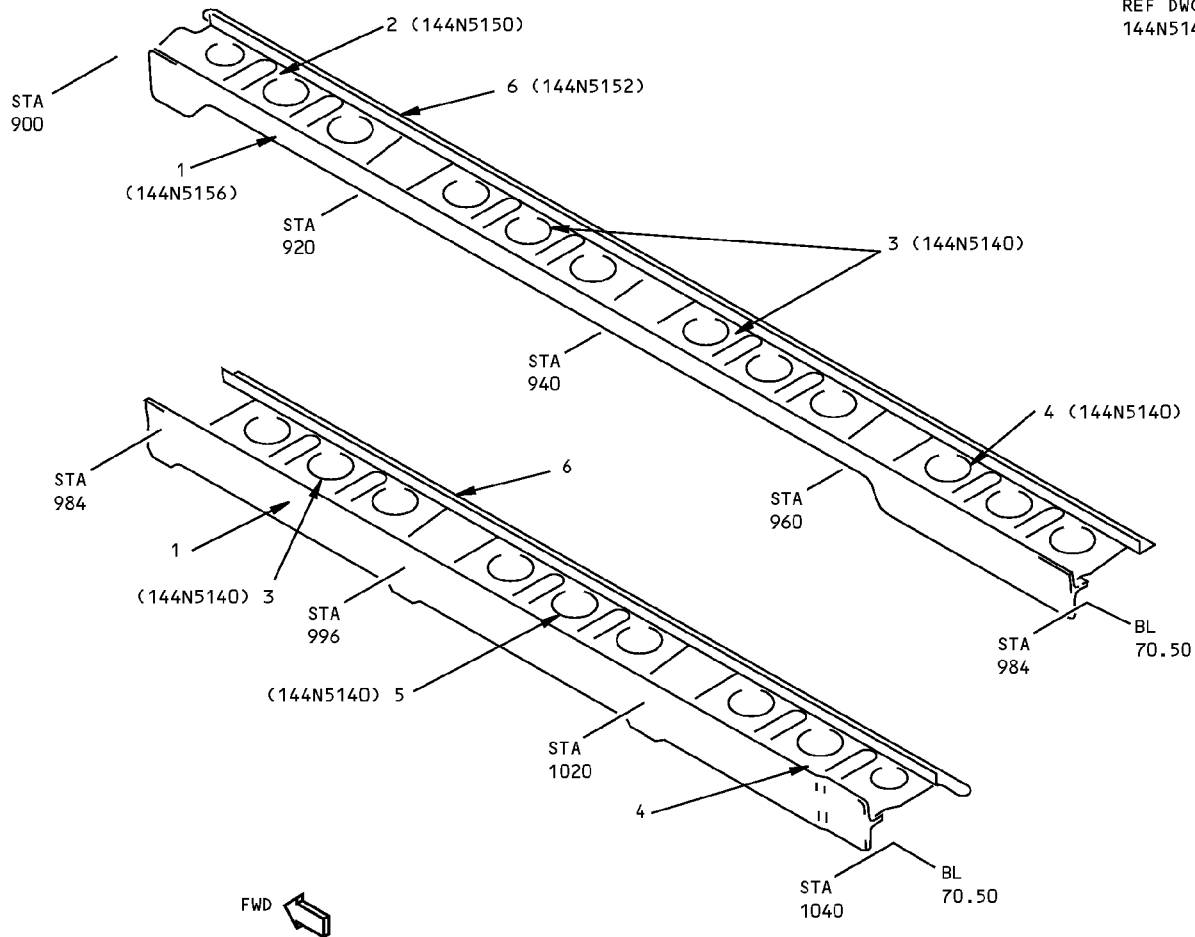
REF DWG
144N5140

AIRPLANES WITH OVERWING ESCAPE HATCHES
LEFT SIDE SHOWN
RIGHT SIDE OPPOSITE
DETAIL III

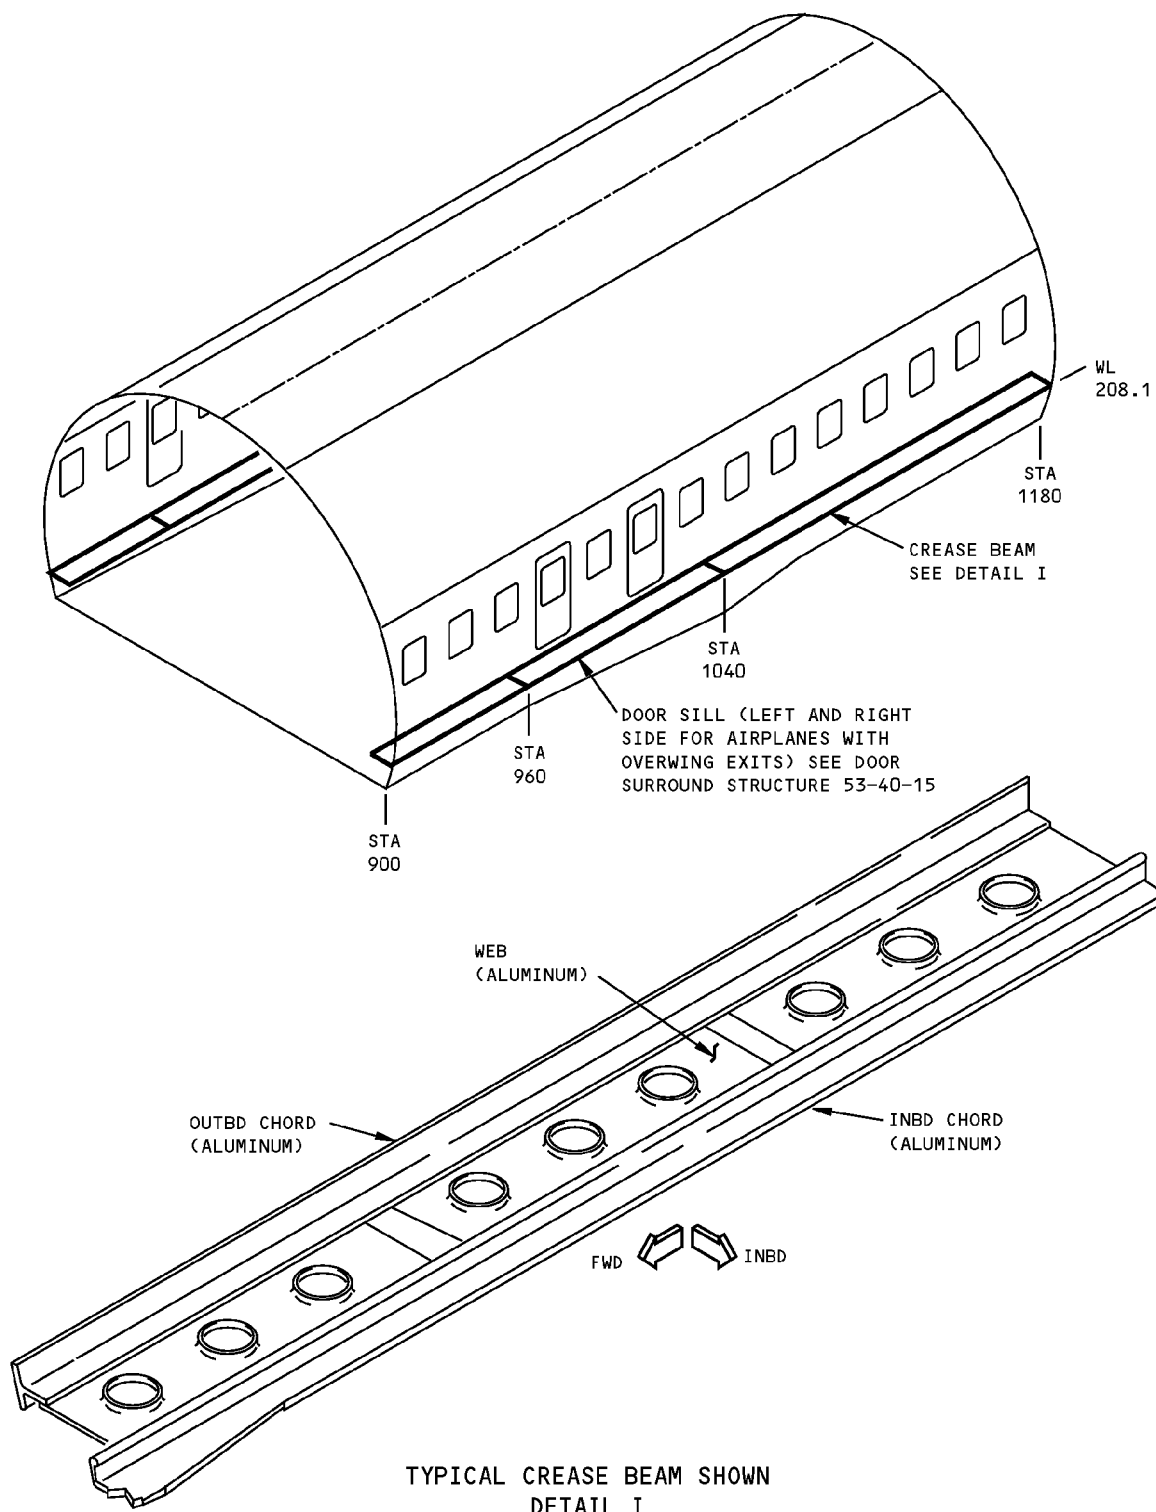
Section 44 Crease Beam Allowable Damage
Figure 101 (Sheet 1 of 4)

ALLOWABLE DAMAGE 1 - SECTION 44 - CREASE BEAM

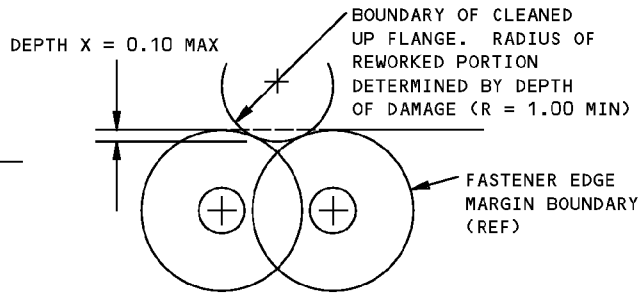
DETAIL II

DAMAGE CLEANUP OF EDGES WHERE
FASTENER EDGE MARGINS OVERLAP

- [D]** CRACKS ARE NOT PERMITTED EXCEPT FOR EDGE CRACKS WHICH MUST BE REMOVED AS SHOWN IN DETAILS II AND III
- [E]** REMOVE EDGE DAMAGE AS SHOWN IN DETAILS II AND III
- [F]** CRACKS ARE NOT PERMITTED EXCEPT FOR EDGE CRACKS WHICH MAY BE REMOVED AS SHOWN IN DETAILS II AND VII
