FUSELAGE

757-200 STRUCTURAL REPAIR MANUAL

CHAPTER 53 FUSELAGE

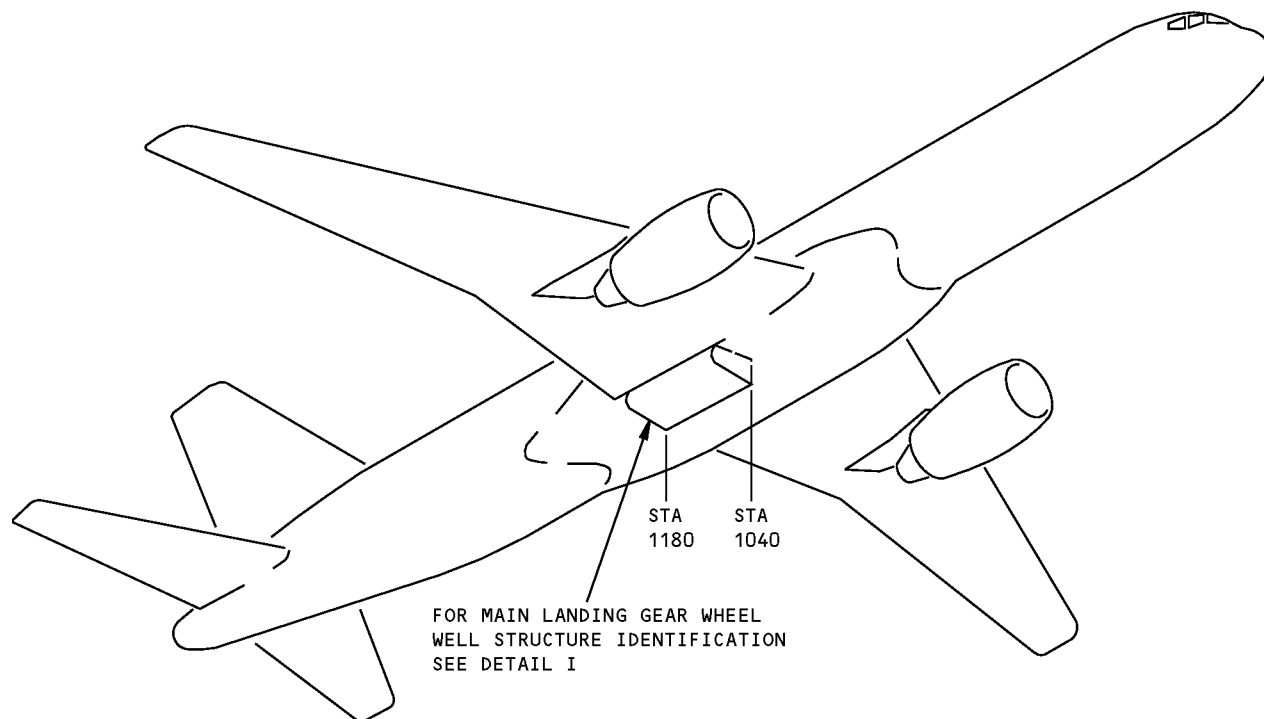
IDENTIFICATION 1 - SECTION 44 - MAIN LANDING GEAR WHEEL WELL STRUCTURE

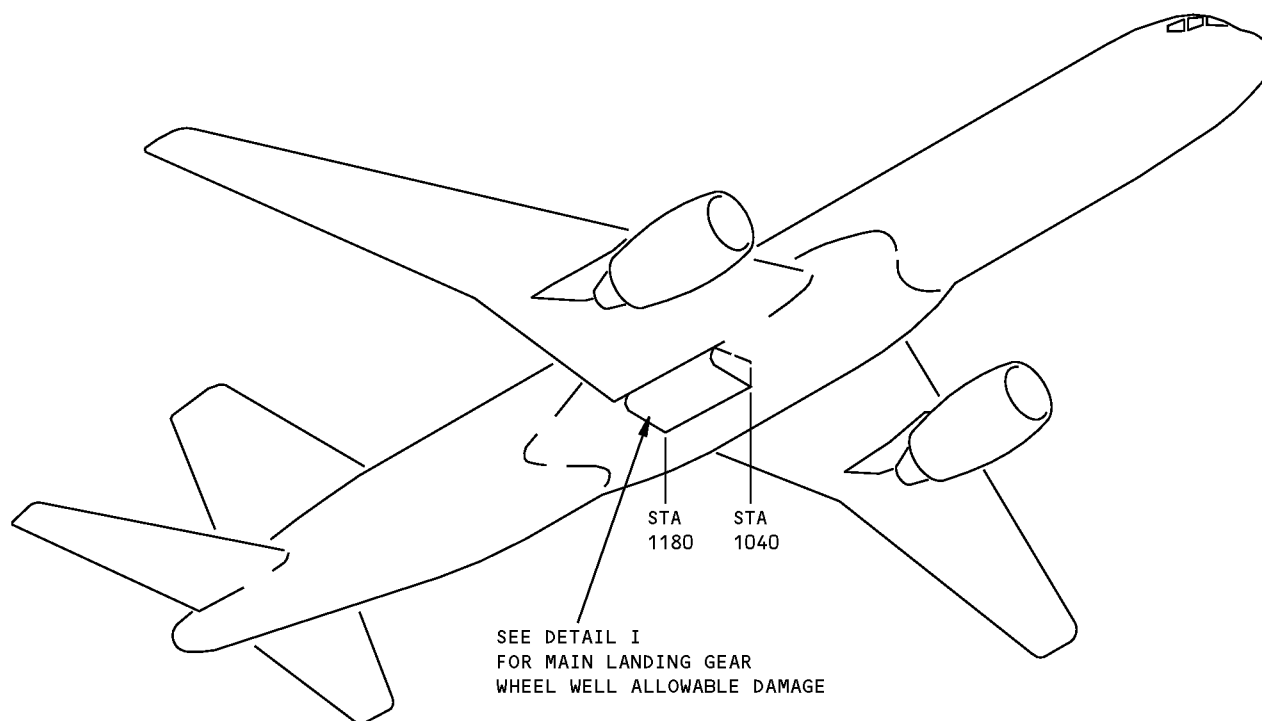
Section 44 Main Landing Gear Wheel Well Structure Allowable Damage
Figure 101 (Sheet 1 of 6)

ALLOWABLE DAMAGE 1 - SECTION 44 - MAIN LANDING GEAR WHEEL WELL STRUCTURE

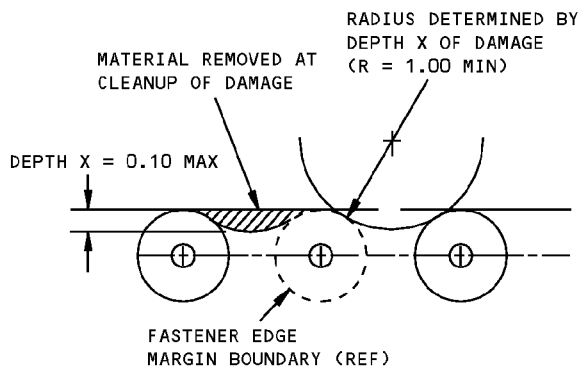
DAMAGE CLEANUP OF EDGES WHERE
FASTENER EDGE MARGINS DO NOT OVERLAP

A CRACKS NOT ALLOWED EXCEPT FOR EDGE CRACKS WHICH MUST BE REMOVED PER DETAILS II AND VII

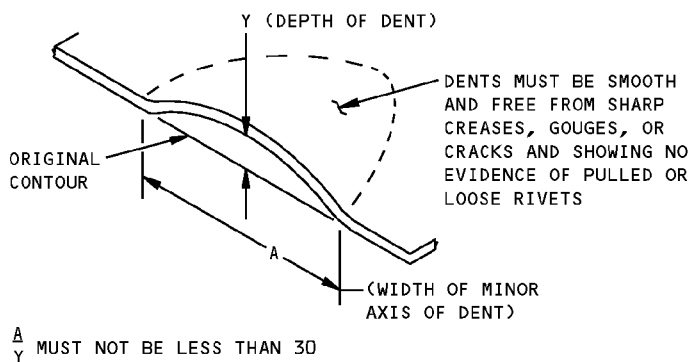
ALLOWABLE DAMAGE FOR DENT
DETAIL IV

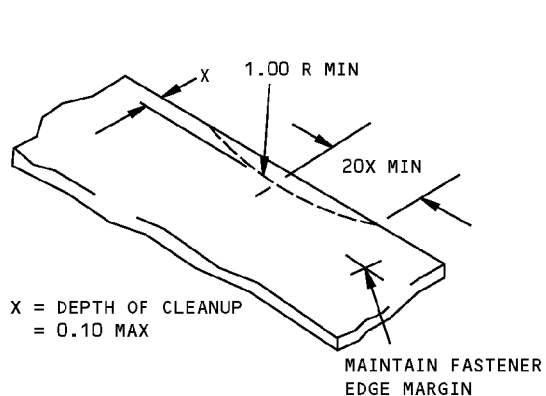
REMOVAL OF NICK OR CRACK
DAMAGE ON AN EDGE
DETAIL VI

D CRACKS NOT ALLOWED EXCEPT FOR EDGE CRACKS WHICH MUST BE REMOVED PER DETAILS II AND VI

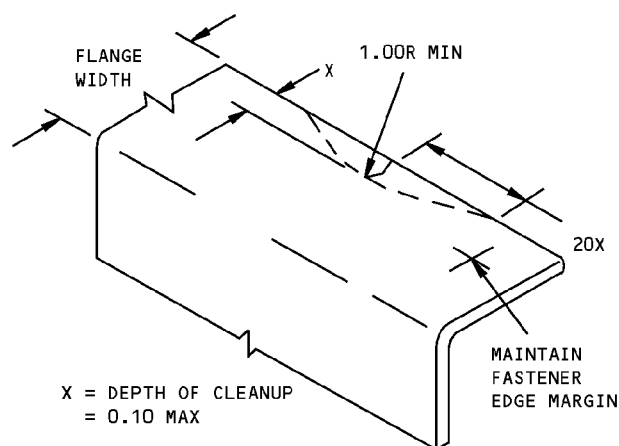
REMOVAL OF NICK OR CRACK
DAMAGE ON AN EDGE
DETAIL VII

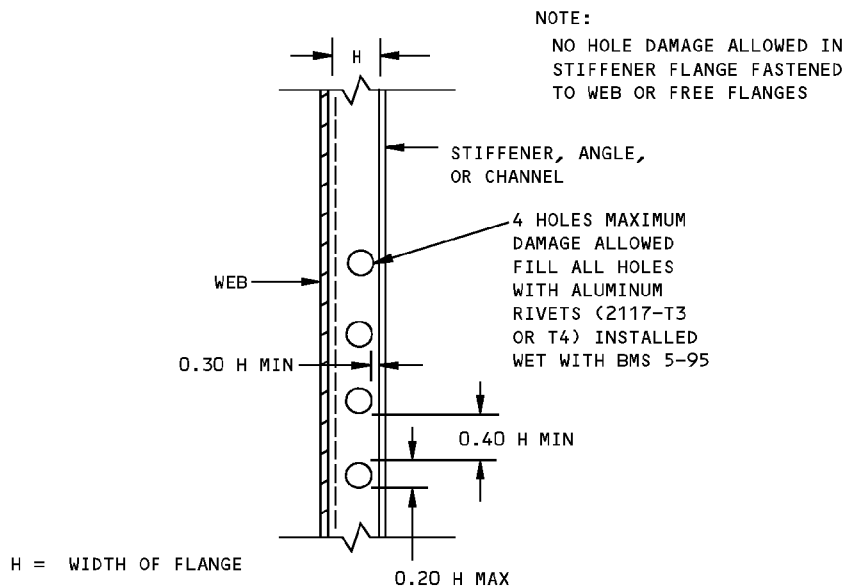
ALLOWABLE DAMAGE LIMITS FOR
HOLES IN STIFFENERS, ANGLES, AND CHANNELS
DETAIL VIII

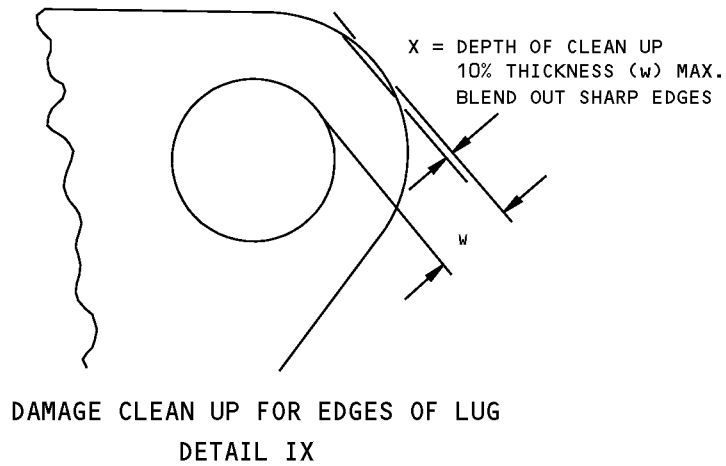
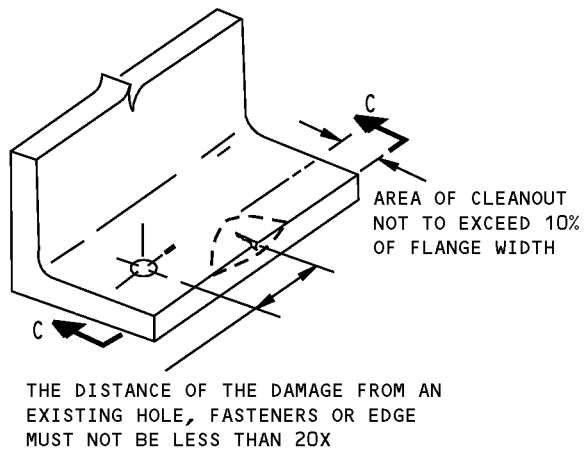
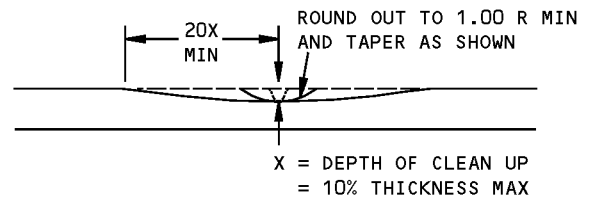
DETAIL X

REMOVAL OF NICK OR CRACK
DAMAGE ON AN EDGE
SECTION C-C

Section 44 Main Landing Gear Wheel Well Structure Allowable Damage
Figure 101 (Sheet 6 of 6)

C FOR EDGE DAMAGE SEE DETAIL X. FOR LUG DAMAGE SEE DETAIL IX. FOR OTHER DAMAGE SEE DETAIL III. DAMAGE NOT ALLOWED IN VICINITY OF BUSHINGS. SEE DETAIL I FOR APPLICABLE SHOT PEEN REQUIREMENTS

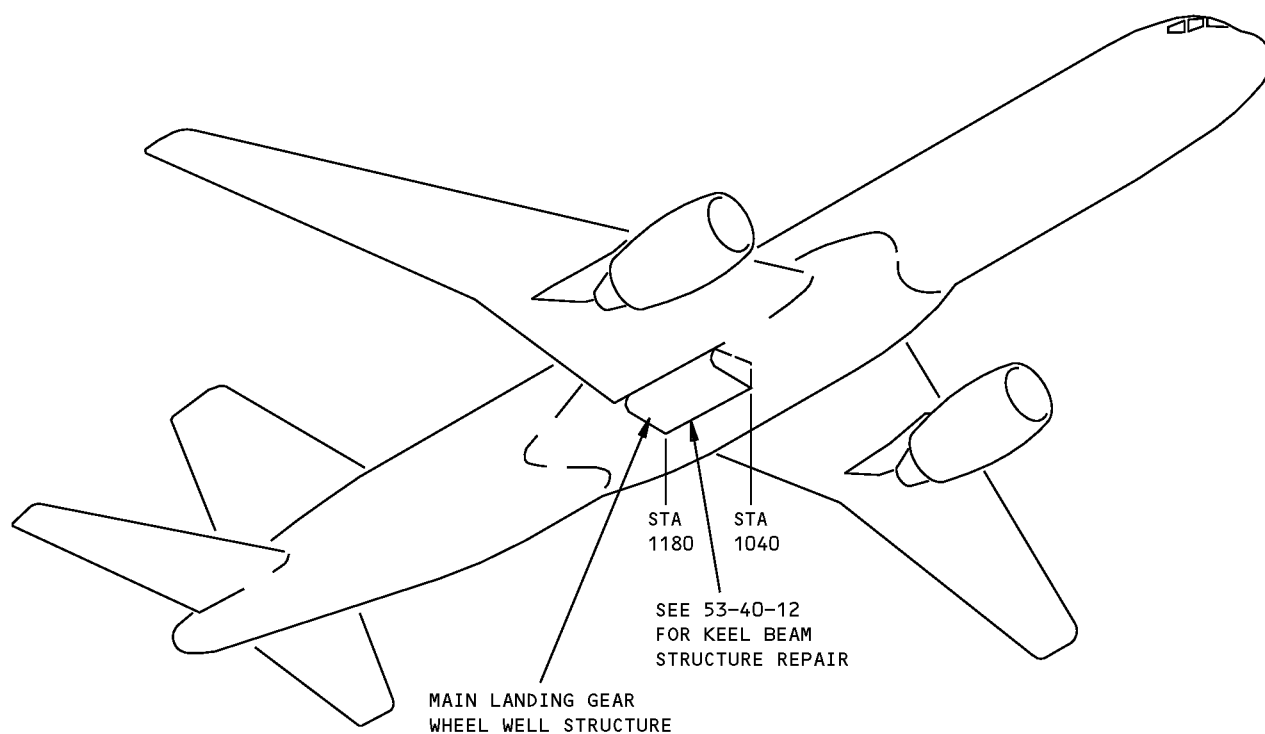
Section 44 Main Landing Gear Wheel Well Structure Repair
Figure 201

| APPLICABILITY |
|--|
| THIS REPAIR DOES NOT APPLY TO PRESSURE DECK WEBS, B.S. 1180 BULKHEAD WEBS, WING CENTER SECTION REAR SPAR STRUCTURE AND EXTRUDED WEB STIFFENERS |

- SEE 51-70-11 FOR FORMED SECTION REPAIR
- SEE 51-70-12 FOR EXTRUDED SECTION REPAIR
- SEE 51-70-13 FOR WEB REPAIR
- NO REPAIRS ALLOWED TO FITTINGS

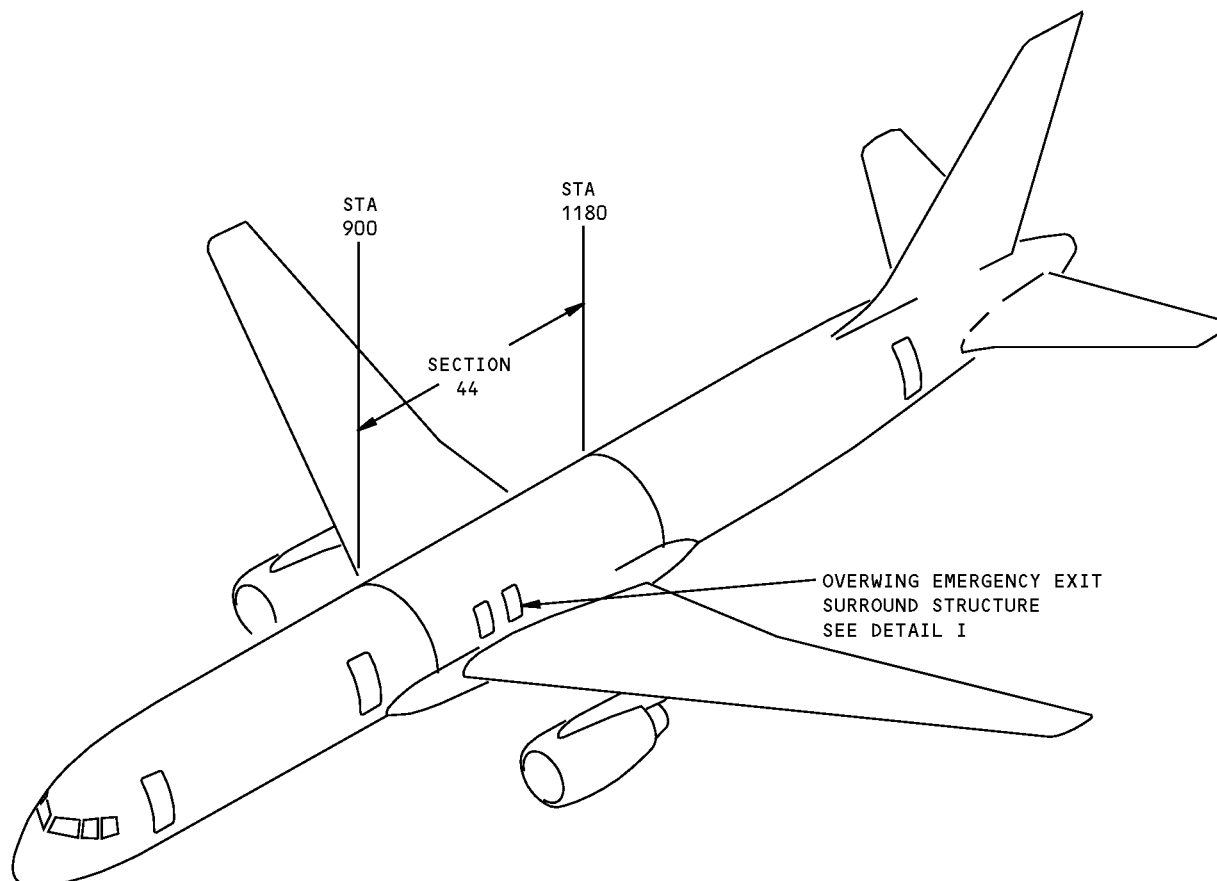
IDENTIFICATION 1 - SECTION 44 - DOOR SURROUND STRUCTURE

- [A]** FOR CUM LINE NUMBERS:
37,39,41,43 THRU 49
- [B]** SILL WEB THICKNESSES VARY.
THIS THICKNESS IS USED BETWEEN
STA 996 AND STA 1020
- [C]** SILL WEB THICKNESSES VARY.
THIS THICKNESS IS USED AT STATIONS
NOT IN **[B]**

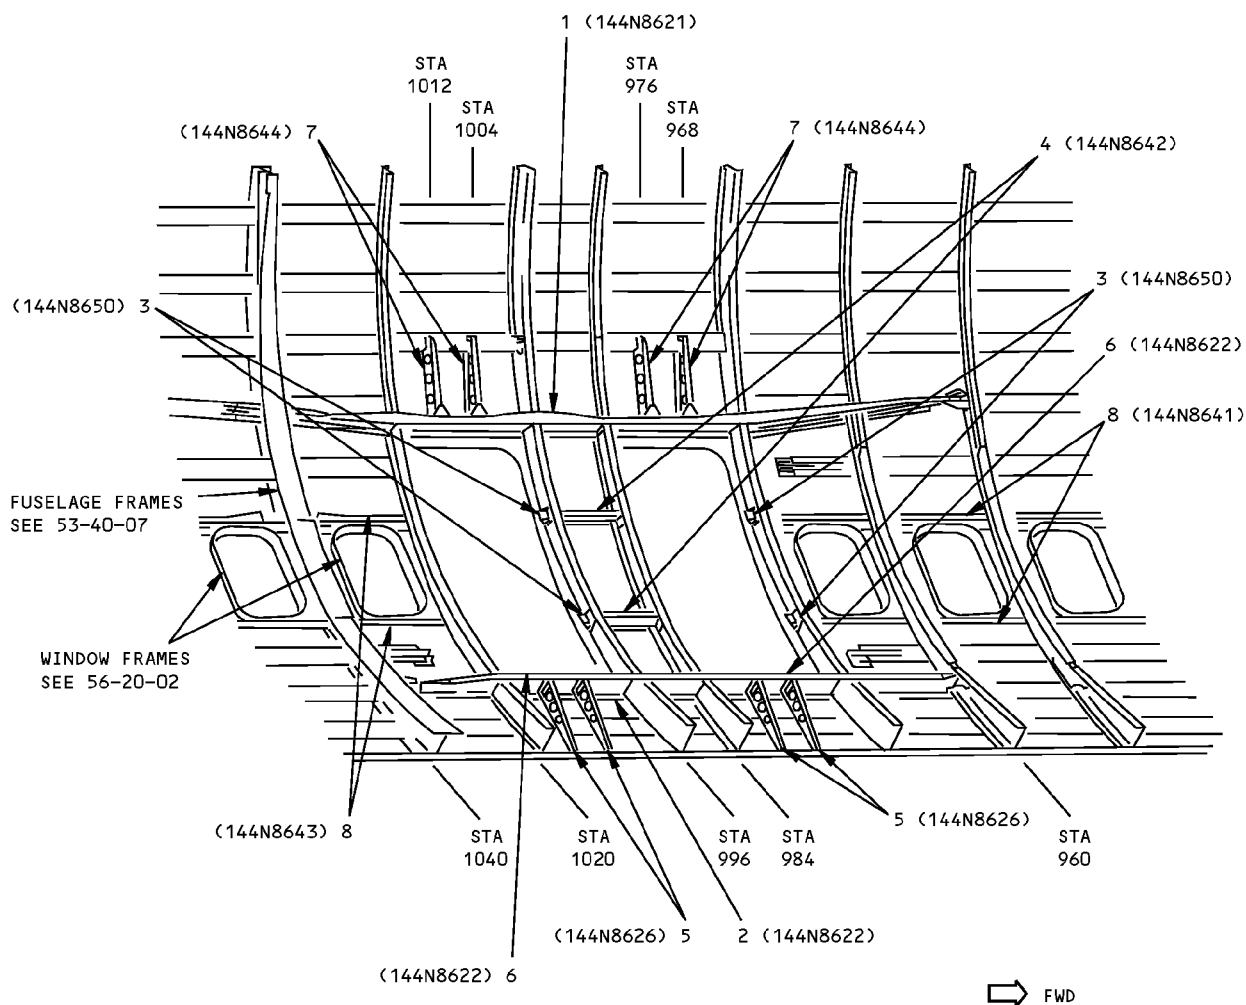
LEFT SIDE SHOWN
RIGHT SIDE OPPOSITE
DETAIL I

**Section 44 Door Surround Structure Identification
Figure 1 (Sheet 2 of 3)**

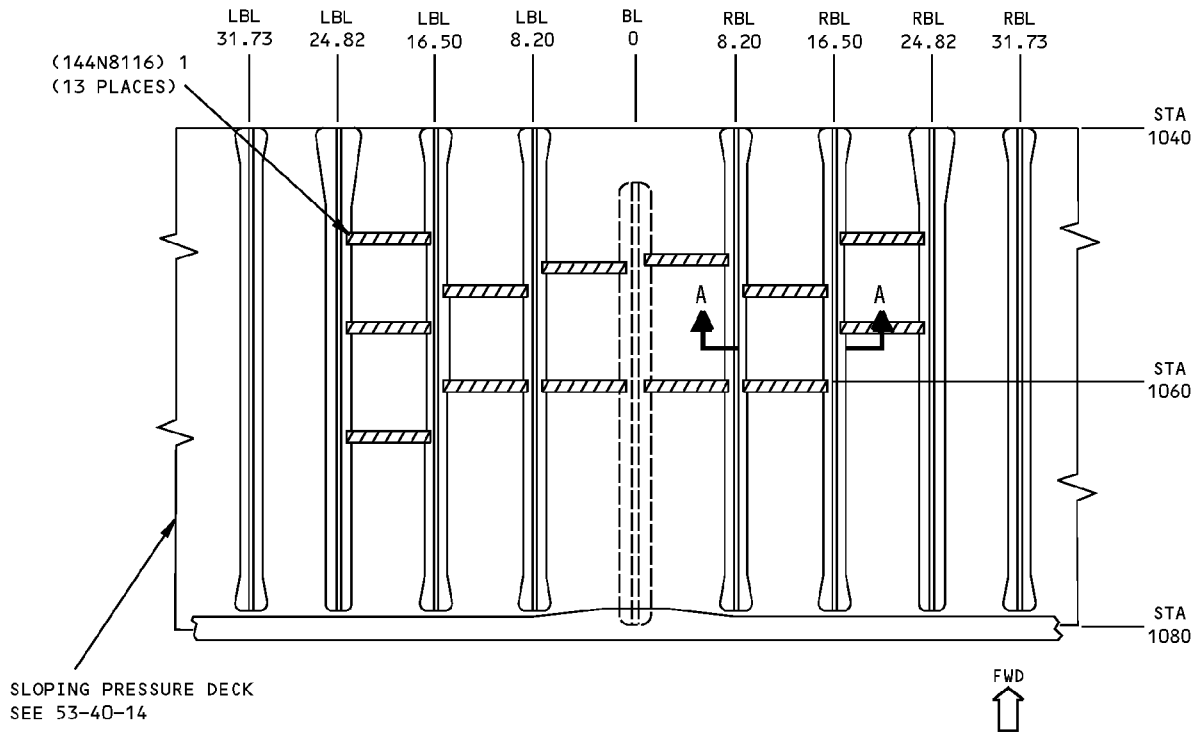
INTERCOSTAL LOCATIONS - WEB SUPPORT

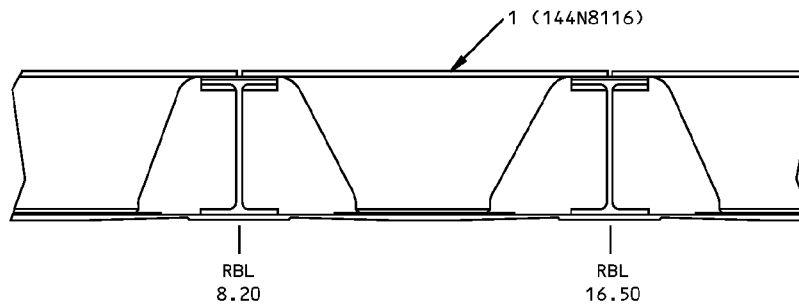
TYPICAL WEB SUPPORT INTERCOSTAL
(INTERCOSTAL SHAPES VARY)

SECTION A-A DETAIL II

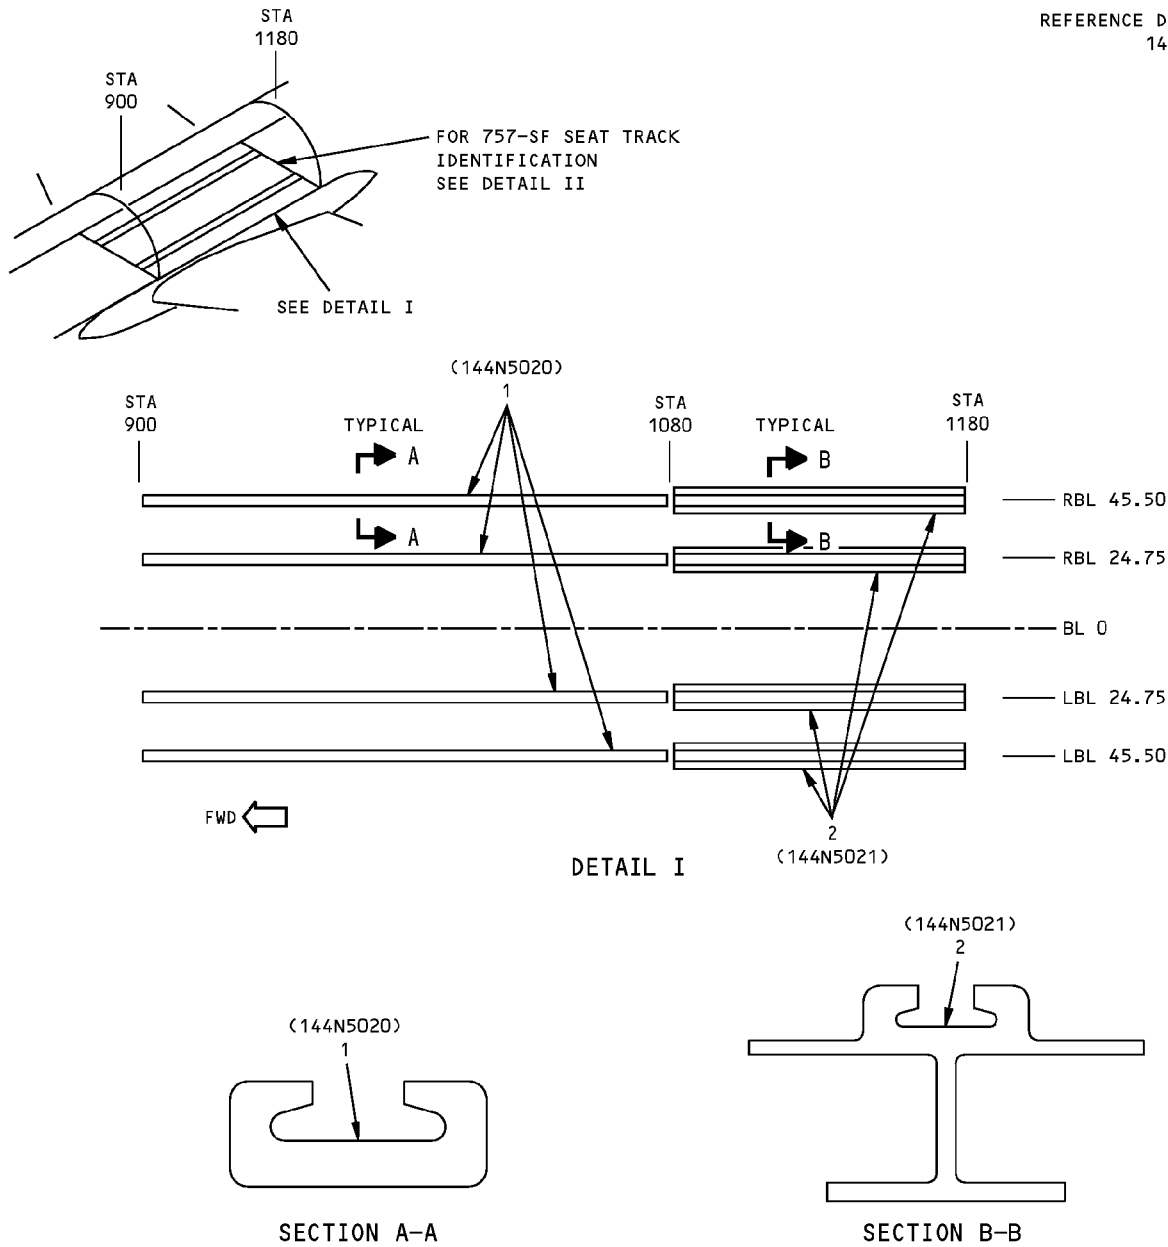
IDENTIFICATION 1 - SECTION 44 - SEAT TRACKS

| ITEM | DESCRIPTION | GAGE | MATERIAL | EFFECTIVITY |
|---|---|---|---|---|
| 1 | SEAT TRACK | | BAC1520-841 7178-T6511 | |

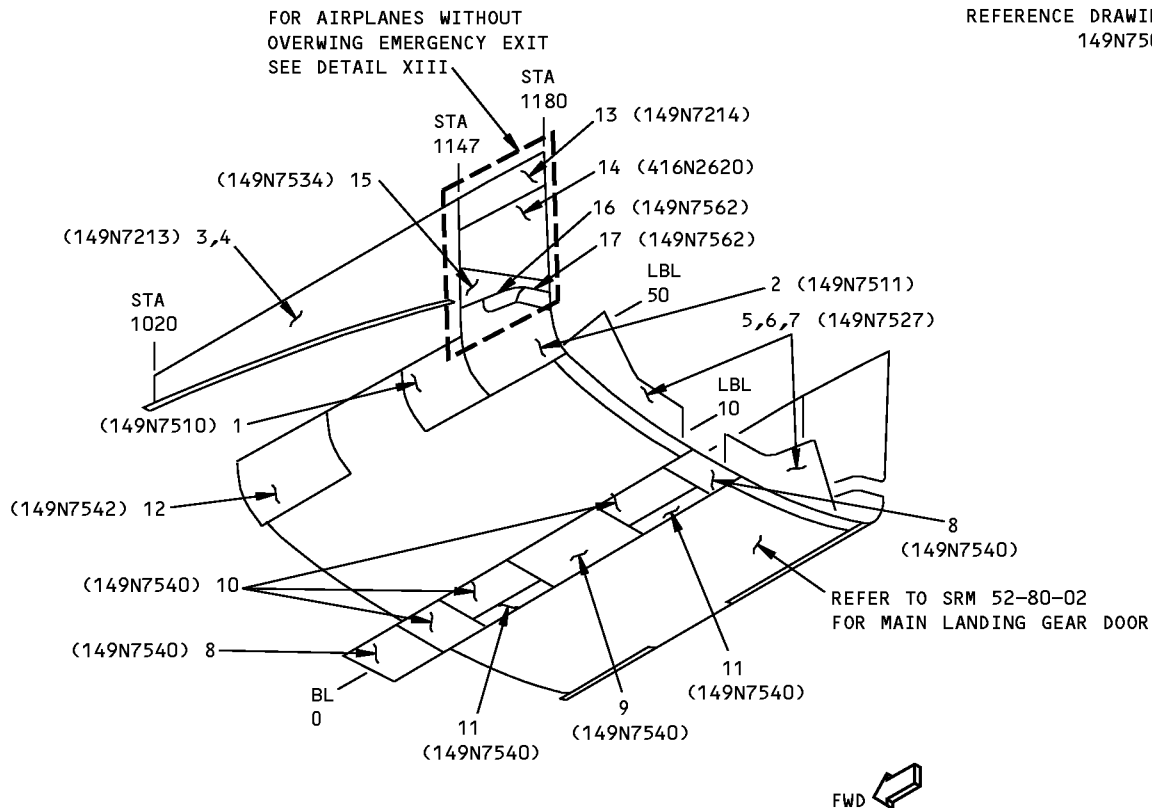
| ITEM | DESCRIPTION | GAGE | MATERIAL | EFFECTIVITY | | |
|---|--|---|--|--|---|---|
| 1 | SKIN PANEL SKIN PANEL SKIN CORE | | ARAMID/GRAPHITE/EPOXY HONEYCOMB SANDWICH, FIBERGLASS/GRAPHITE/EPOXY HONEYCOMB SANDWICH, SEE DETAIL VII ARAMID HONEYCOMB PER BMS 8-124, CLASS 4, TYPE V, GRADE 3.0 | <table><tr><td>Z</td></tr><tr><td>AA</td></tr></table> | Z | AA |

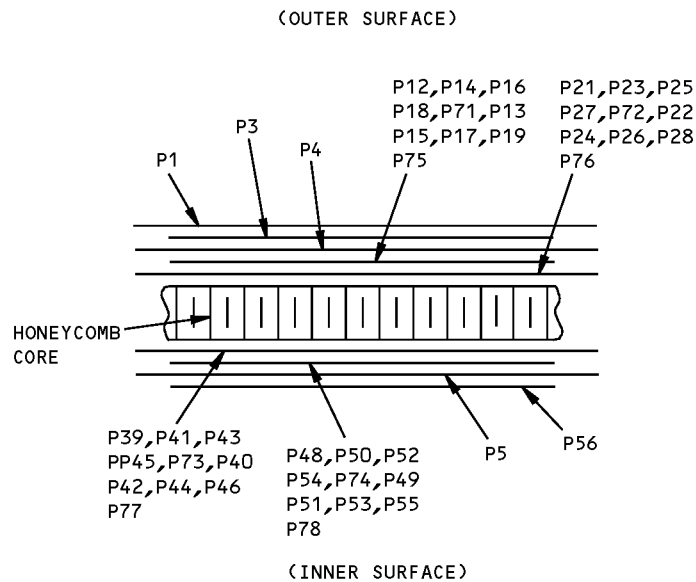
SECTION THRU HONEYCOMB PANELS
DETAIL IV

Section 44 Wing-to-Body Fairing Skin Identification Figure 1 (Sheet 8 of 18)

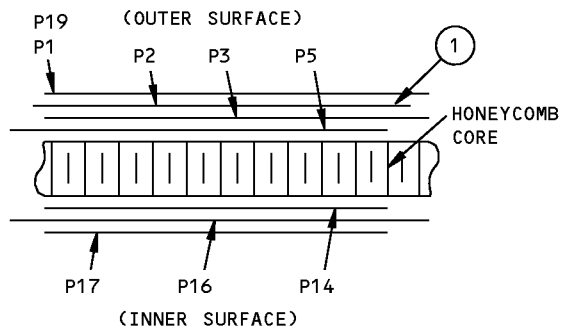
SECTION THRU HONEYCOMB PANEL
DETAIL VII

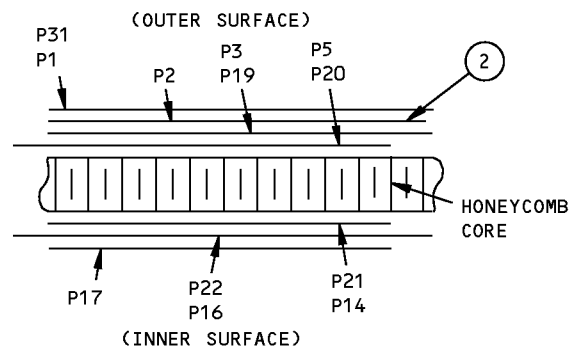
DETAIL VIII

SECTION THRU HONEYCOMB PANEL

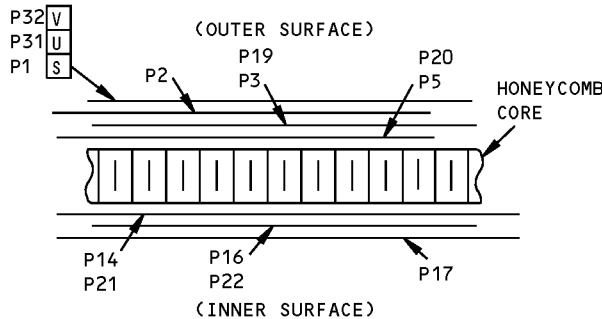
DETAIL XII

SECTION THRU HONEYCOMB PANEL

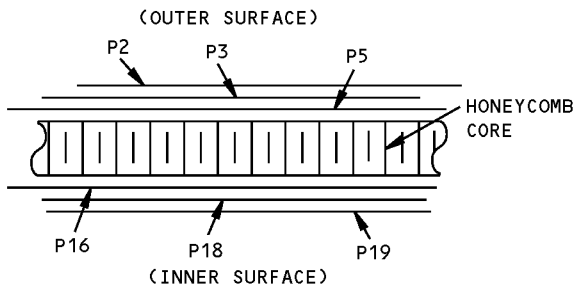
DETAIL XIII

SECTION THRU HONEYCOMB PANEL

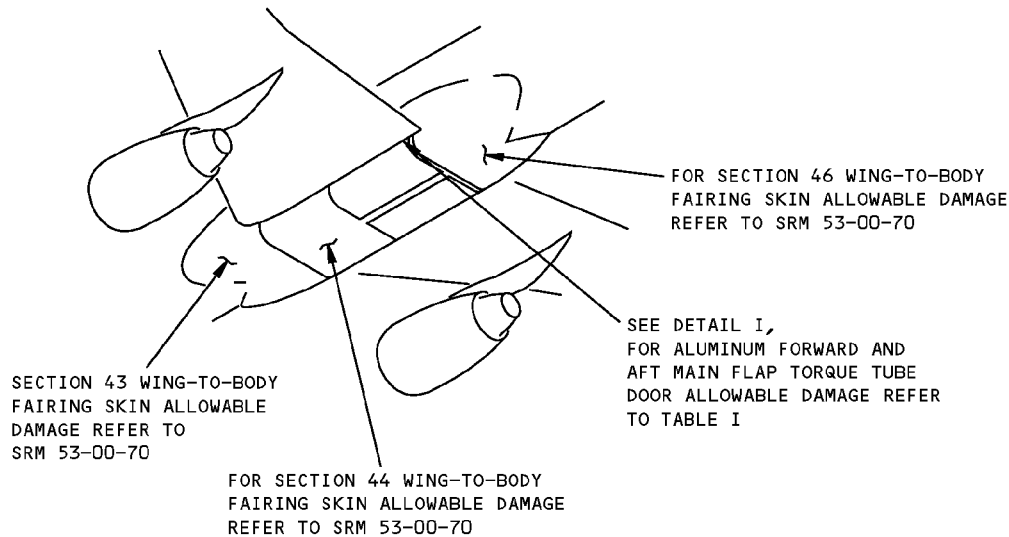
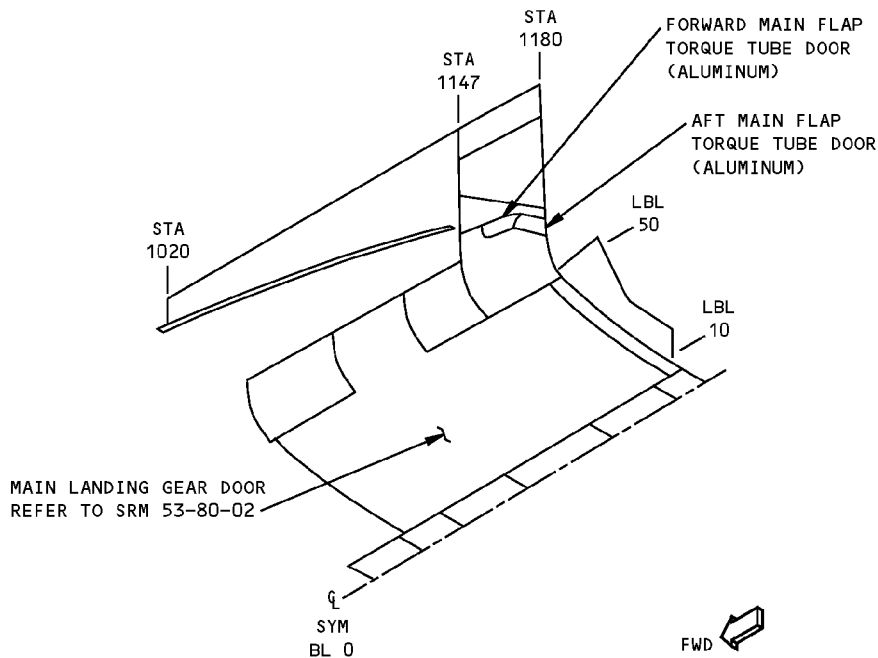
Section 44 Wing-to-Body Fairing Torque Tube Door Allowable Damage
Figure 101 (Sheet 1 of 4)

ALLOWABLE DAMAGE GENERAL - SECTION 44 - WING-TO-BODY FAIRING TORQUE TUBE DOORS

LEFT SIDE IS SHOWN, RIGHT SIDE IS OPPOSITE

DETAIL I

- REFER TO AMM 51-20 FOR INTERNAL AND EXTERNAL FINISHES.
- REFER TO SRM 51-10-01 FOR AERODYNAMIC SMOOTHNESS REQUIREMENTS. IF THE DAMAGE IS LARGER THAN THE LIMITS GIVEN IN SRM 51-10-01, AERODYNAMIC PERFORMANCE WILL DECREASE.
- REFER TO SRM 51-10-02 FOR INSPECTION AND REMOVAL OF DAMAGE

- A** EDGE CRACKS ARE PERMITTED. REMOVE EDGE CRACKS AS SHOWN IN DETAILS II AND VI. REPAIR ALL OTHER CRACKS AS SHOWN IN DETAIL VII.
- B** REMOVE THE DAMAGE AS SHOWN IN DETAILS II, III, V AND VI. YOU CAN DRILL OUT DAMAGE CAUSED BY CORROSION TO A MAXIMUM DIAMETER 0.50 INCH (12.7 mm) IF THE FASTENER EDGE MARGINS ARE KEPT. SEE DETAIL VII.
- C** REMOVE THE DAMAGE UP TO 0.25 INCH (6 mm) IN DIAMETER THAT IS NOT NEARER THAN 1.0 INCH (25 mm) TO A FASTENER HOLE, MATERIAL EDGE, OR OTHER DAMAGE. INSTALL A 2117-T3 OR T4 ALUMINUM RIVET IN THE HOLE WITH BMS 5-95 SEALANT. REPAIR ALL OTHER HOLES.

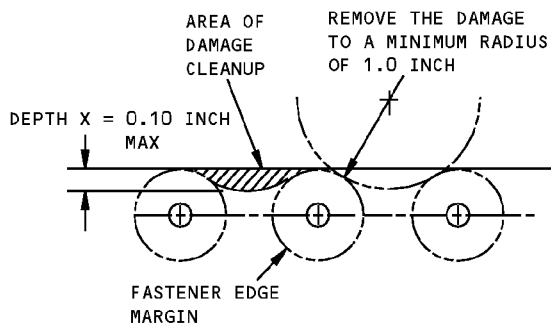
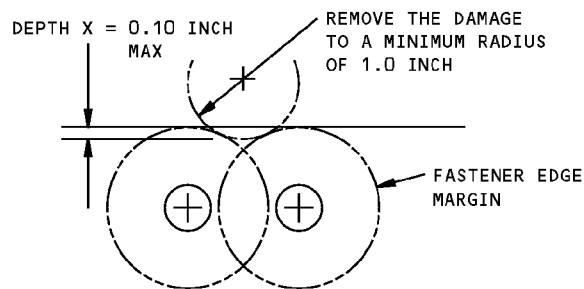
DETAIL II

REMOVAL OF DAMAGE AT EDGES WHERE
FASTENER EDGE MARGINS DO NOT OVERLAP

REMOVAL OF DAMAGE AT EDGES WHERE
FASTENER EDGE MARGINS OVERLAP

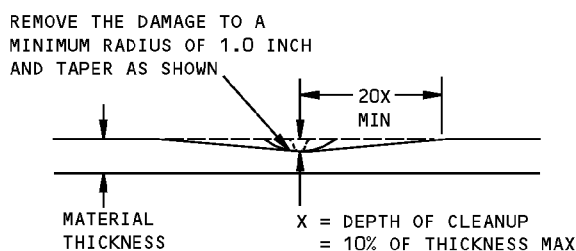
SECTION A-A

REMOVAL OF DAMAGE ON A SURFACE
DETAIL III

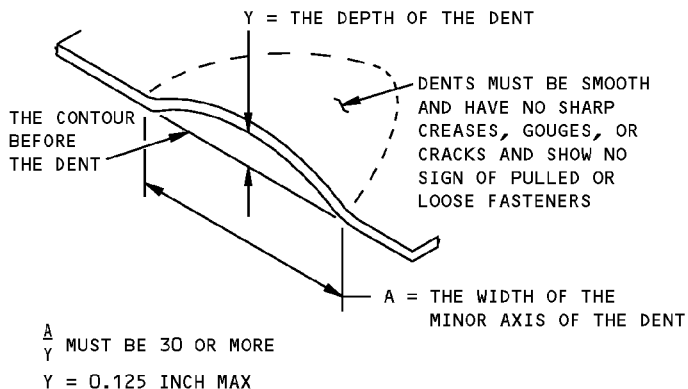
DENT DAMAGE PERMITTED
DETAIL IV

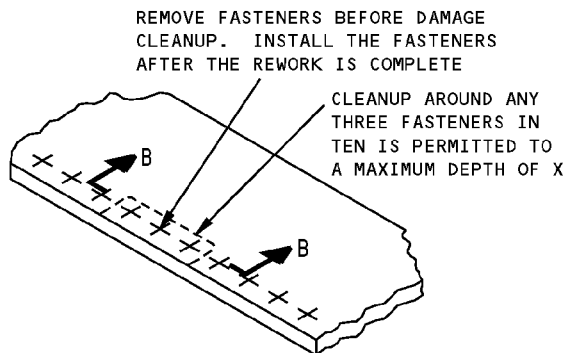
SECTION B-B

REMOVAL OF CORROSION DAMAGE
DETAIL V

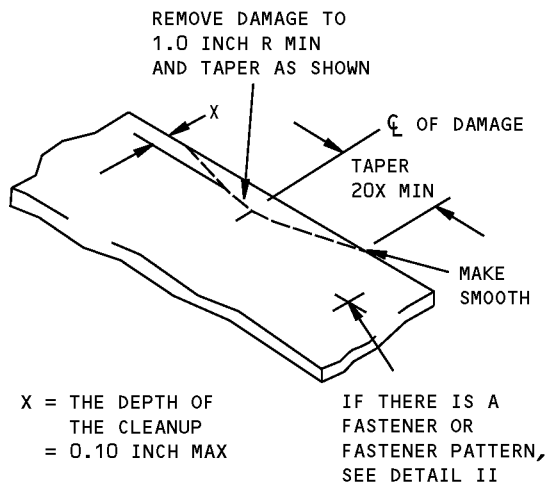
REMOVAL OF DAMAGE ON AN EDGE DETAIL VI

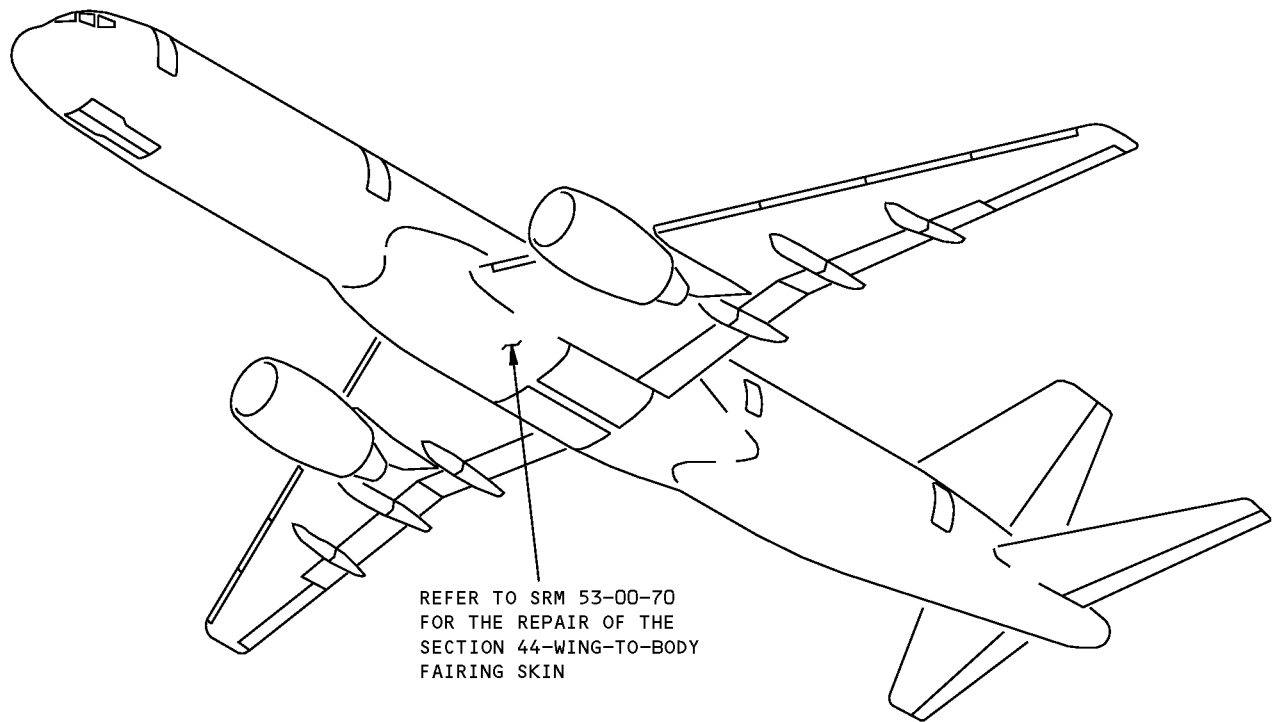
Section 44 Wing-to-Body Fairing Skin Repairs
Figure 201

REPAIR GENERAL - SECTION 44 - WING-TO-BODY FAIRING SKINS

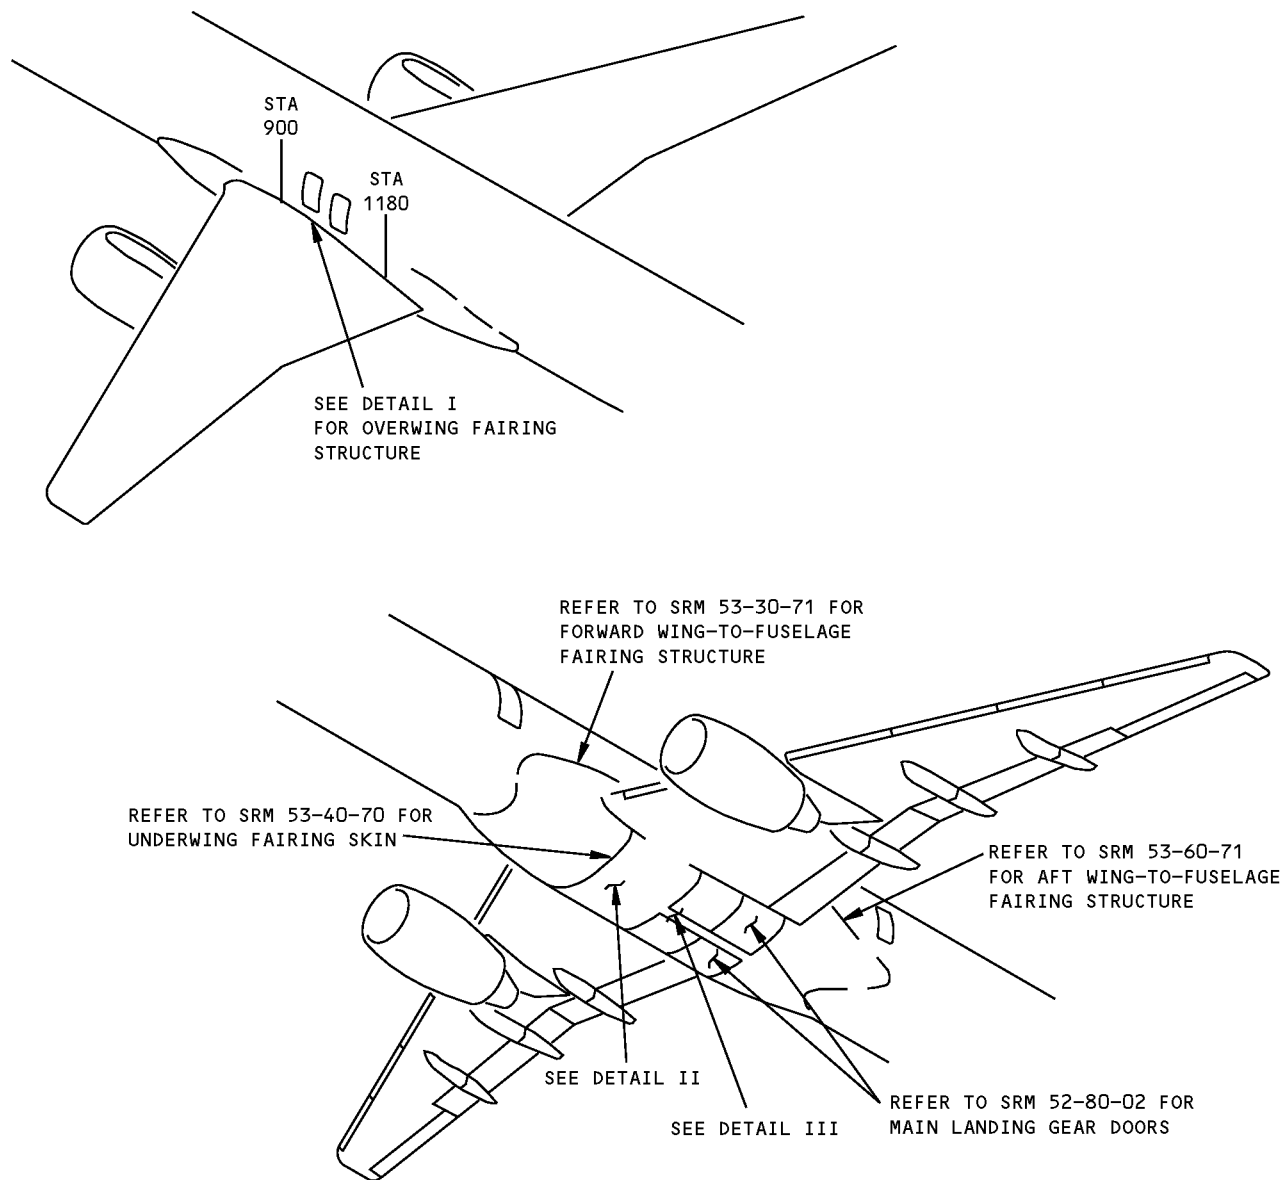
IDENTIFICATION 1 - SECTION 44 - FAIRING STRUCTURE

- A** FOR CUM LINE NUMBERS:
1 THRU 520
- B** FOR AIRPLANES NOT LISTED IN **A**.

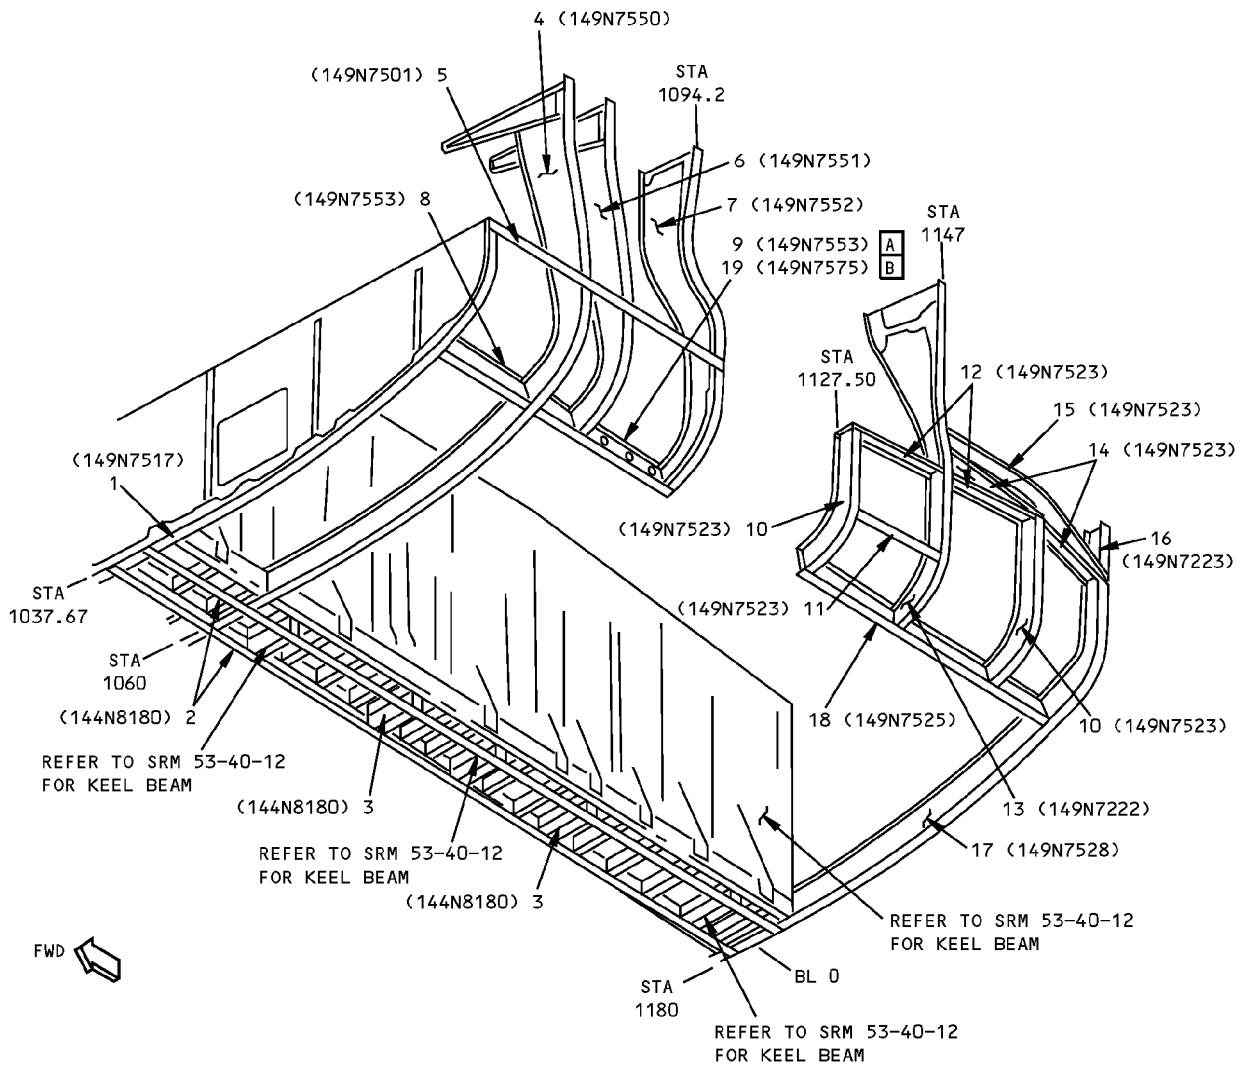
DETAIL IV

REFERENCE DRAWING
149N7201
149N7501

UNDERWING FAIRING SUPPORT STRUCTURE

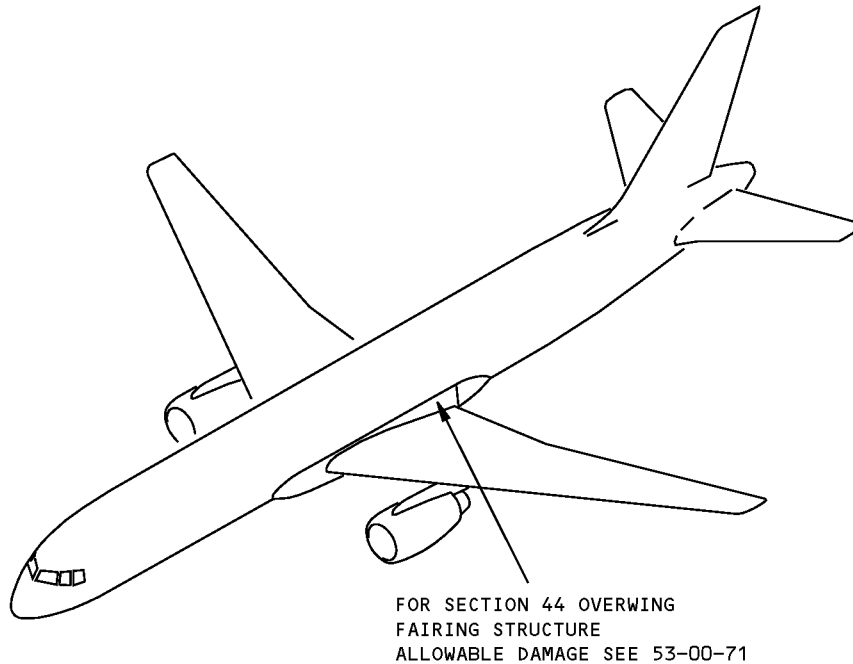
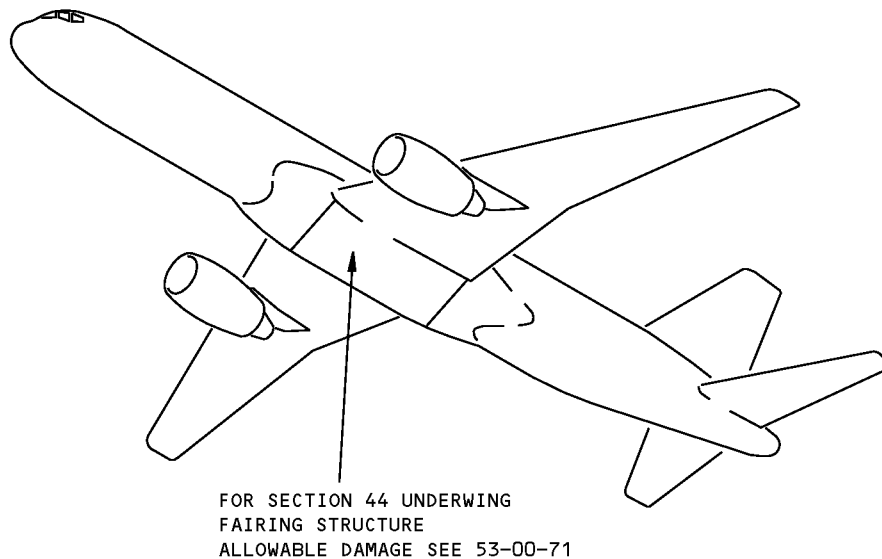
Section 44 Wing-to-Body Fairing Structure Allowable Damage
Figure 101

ALLOWABLE DAMAGE GENERAL - SECTION 44 - WING-TO-BODY FAIRING STRUCTURE

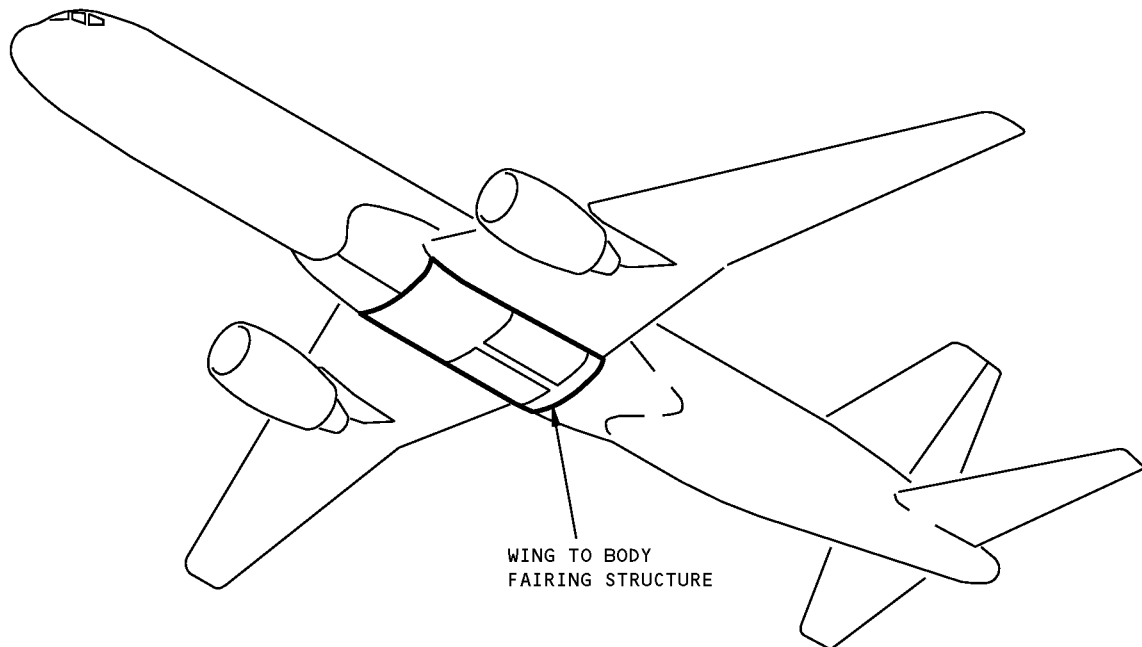
Section 44 Wing-to-Body Fairing Structure Repair
Figure 201 (Sheet 2 of 2)

- REFER TO SRM 51-70-11 FOR FORMED SECTION REPAIR
- REFER TO SRM 51-70-12 FOR EXTRUDED SECTION REPAIR
- REFER TO SRM 51-70-13 FOR WEB REPAIRS

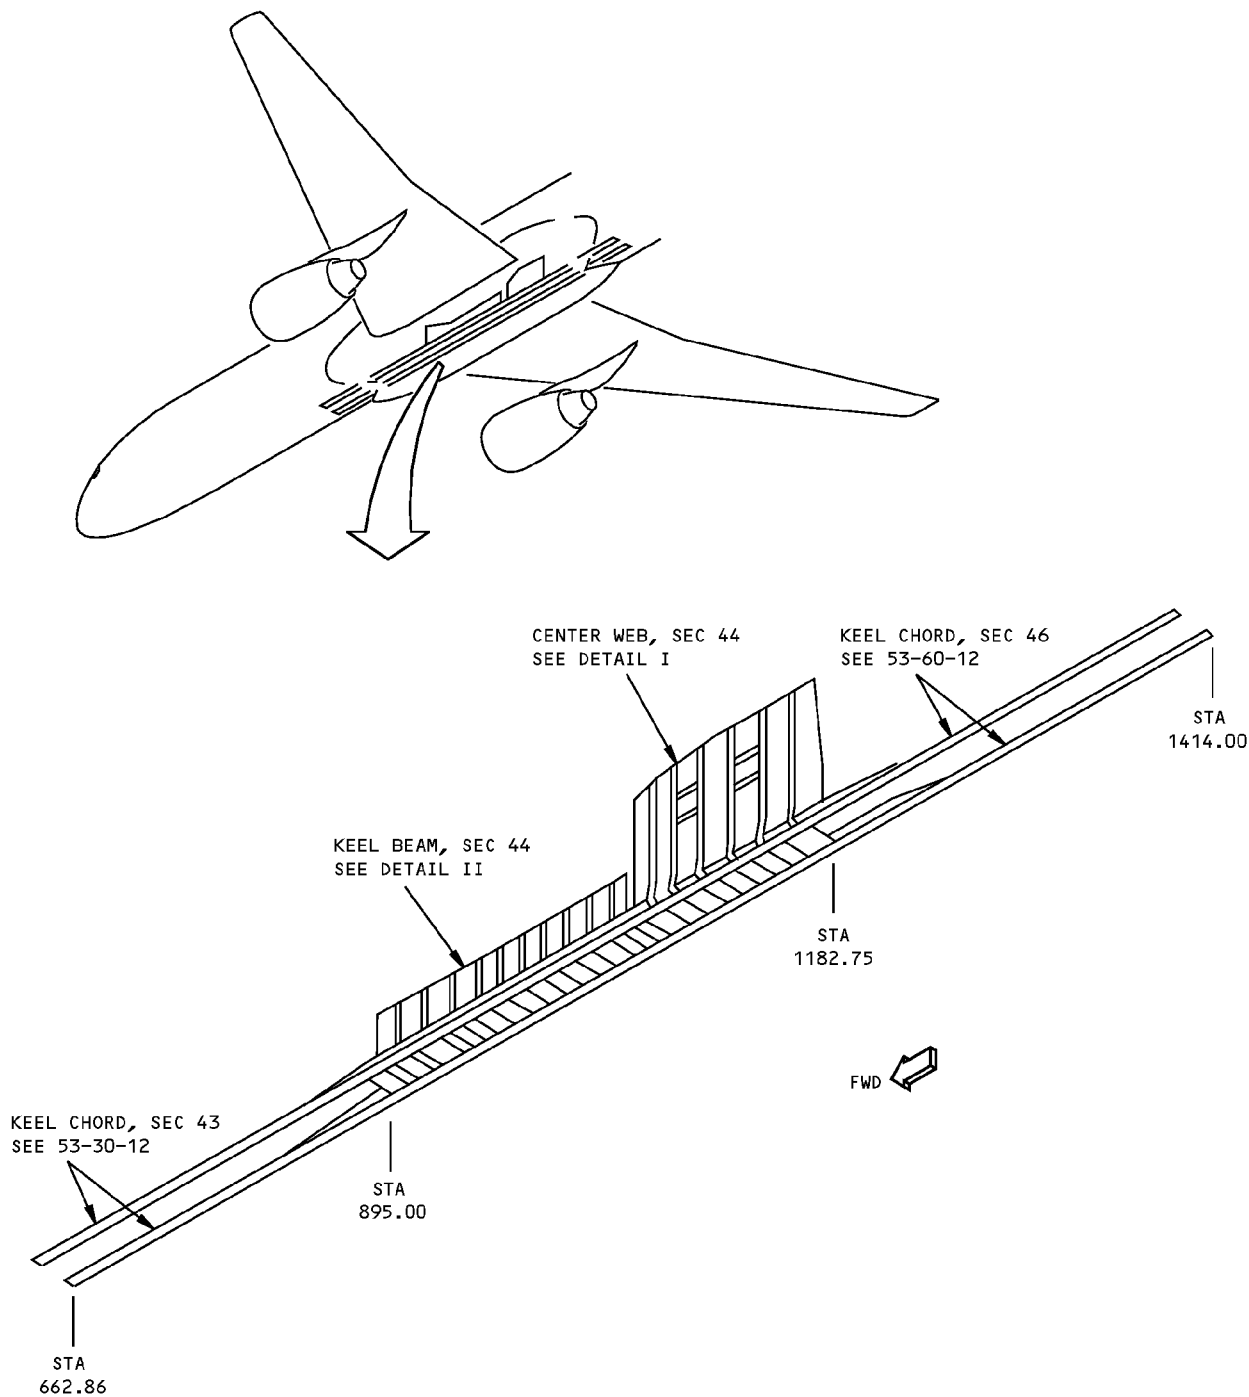
**Section 44 Keel Beam Fitting Repair
Figure 201 (Sheet 1 of 2)**

REPAIR 1 - SECTION 44 - KEEL BEAM FITTINGS
