FUSELAGE

757-200 STRUCTURAL REPAIR MANUAL

CHAPTER 53 FUSELAGE

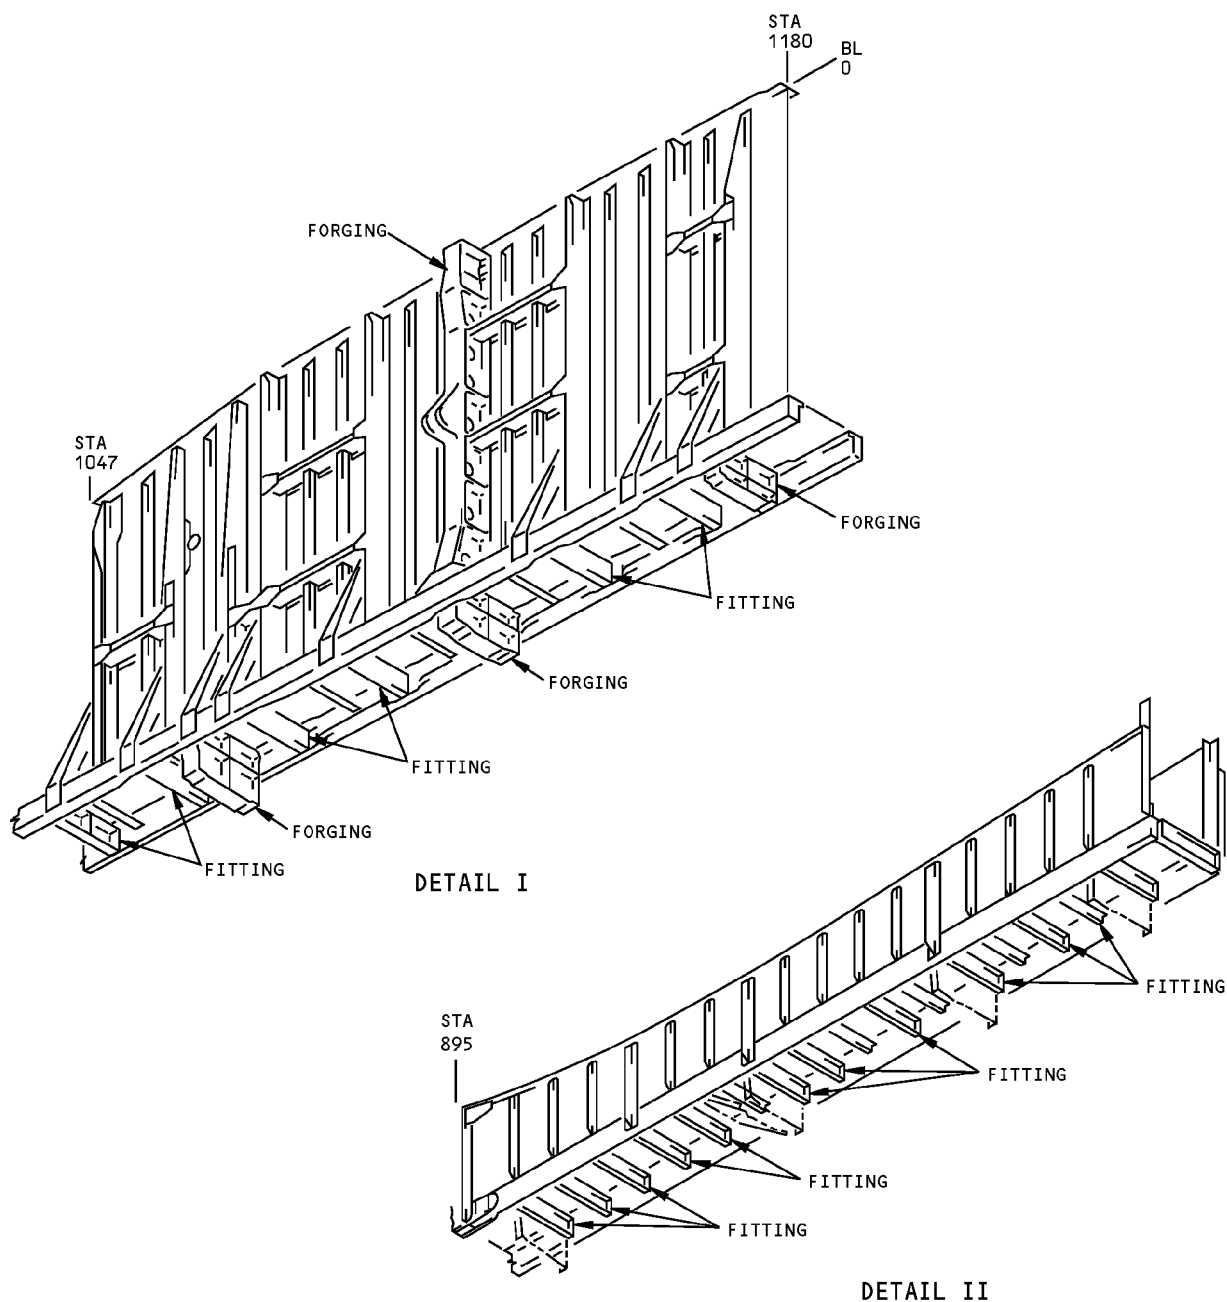
Section 44 Keel Beam Fitting Repair Figure 201 (Sheet 2 of 2)

- SEE 53-40-12 FOR STRUCTURE IDENTIFICATION AND ALLOWABLE DAMAGE INFORMATION
- NO TYPICAL REPAIR TO FITTINGS APPLICABLE. SPECIFIC REPAIRS TO FITTINGS WILL BE PROVIDED BASED ON SERVICE EXPERIENCE

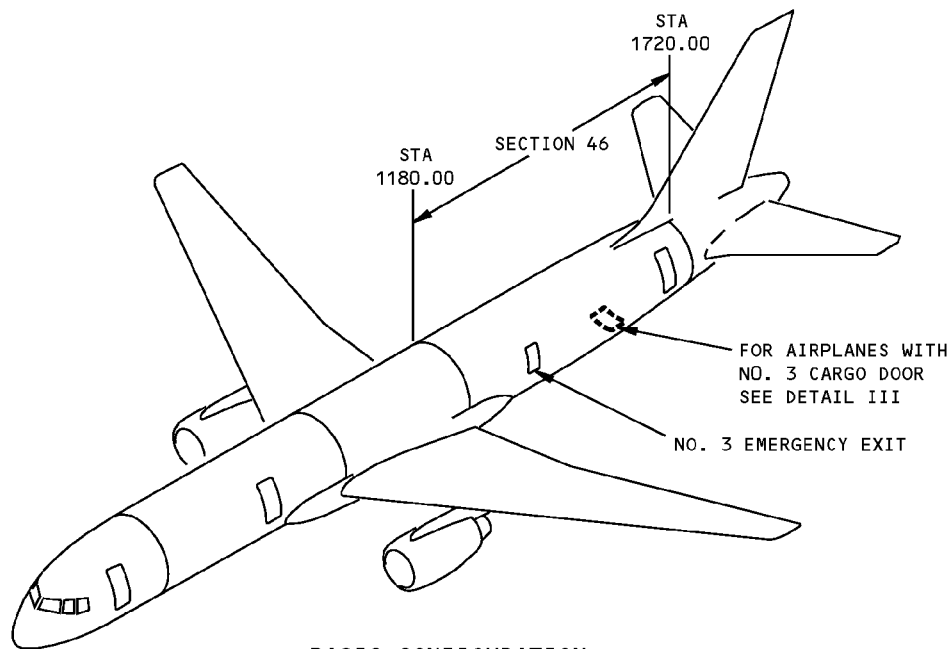
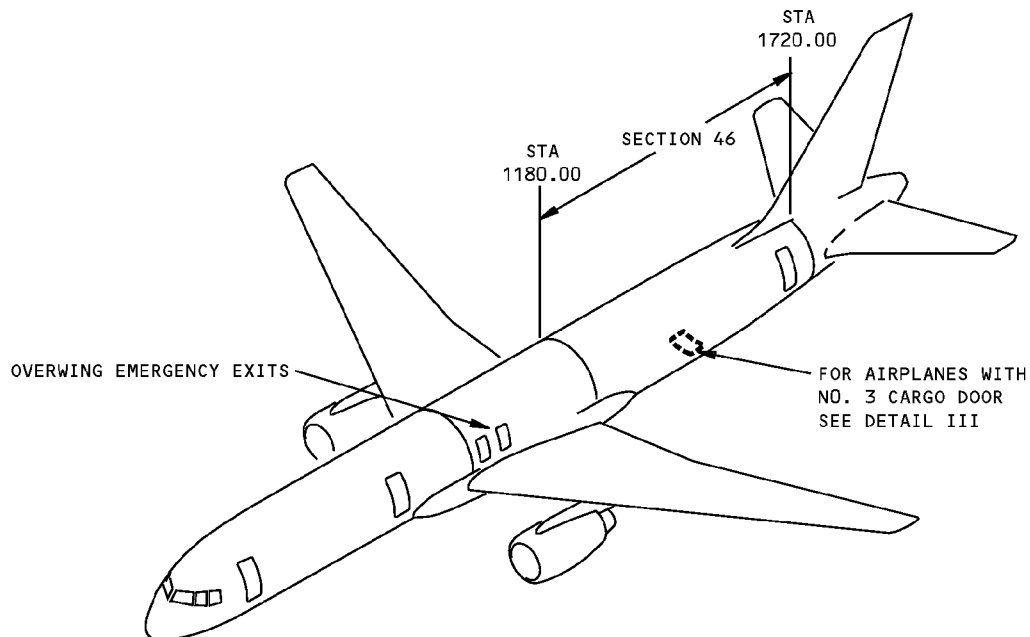
Section 46 Skin Identification
Figure 1 (Sheet 1 of 7)

IDENTIFICATION 1 - SECTION 46 - SKINS

BASIC CONFIGURATION
AIRPLANES WITH NO. 3 EMERGENCY EXIT
SEE DETAILS I AND II

BASIC CONFIGURATION
AIRPLANES WITH OVERWING EMERGENCY EXITS
SEE DETAILS IV AND V

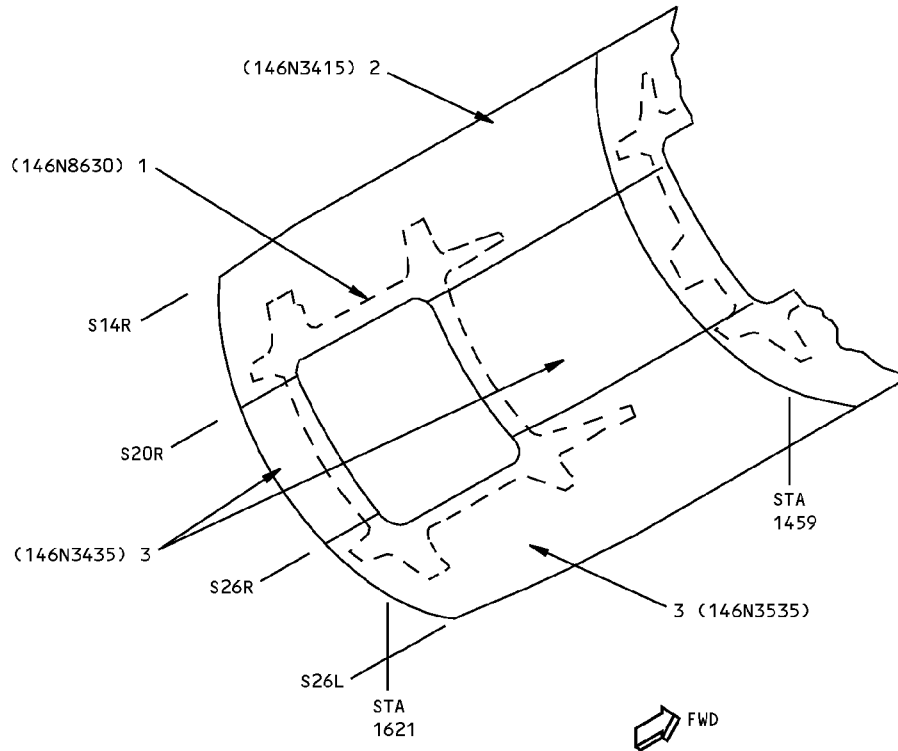
AIRPLANES WITH NO. 3 CARGO DOOR
DETAIL III

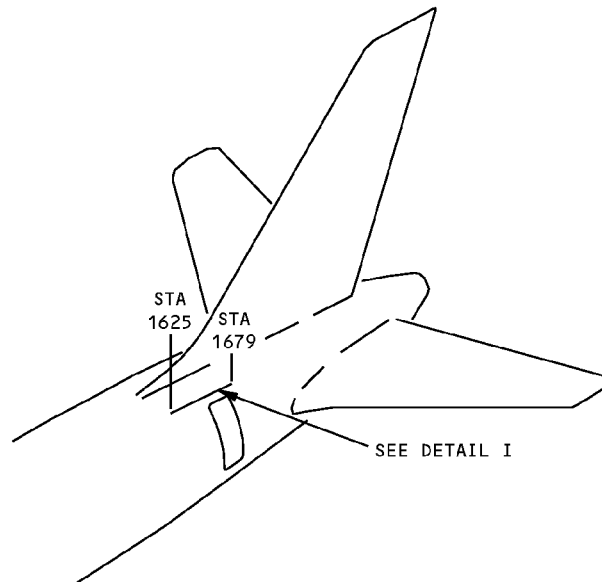
IDENTIFICATION 2 - SECTION 46 - RAIN GUTTER

- A** FOR CUM LINE NUMBERS: 1 THRU 23,
GUTTER IS BETWEEN STA 1640 AND STA 1679
FOR CUM LINE NUMBERS: 24 AND ON,
GUTTER IS BETWEEN STA 1625 AND STA 1679

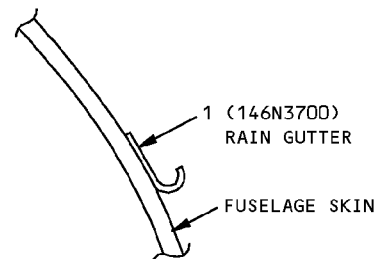
SECTION THRU RAIN GUTTER
DETAIL I

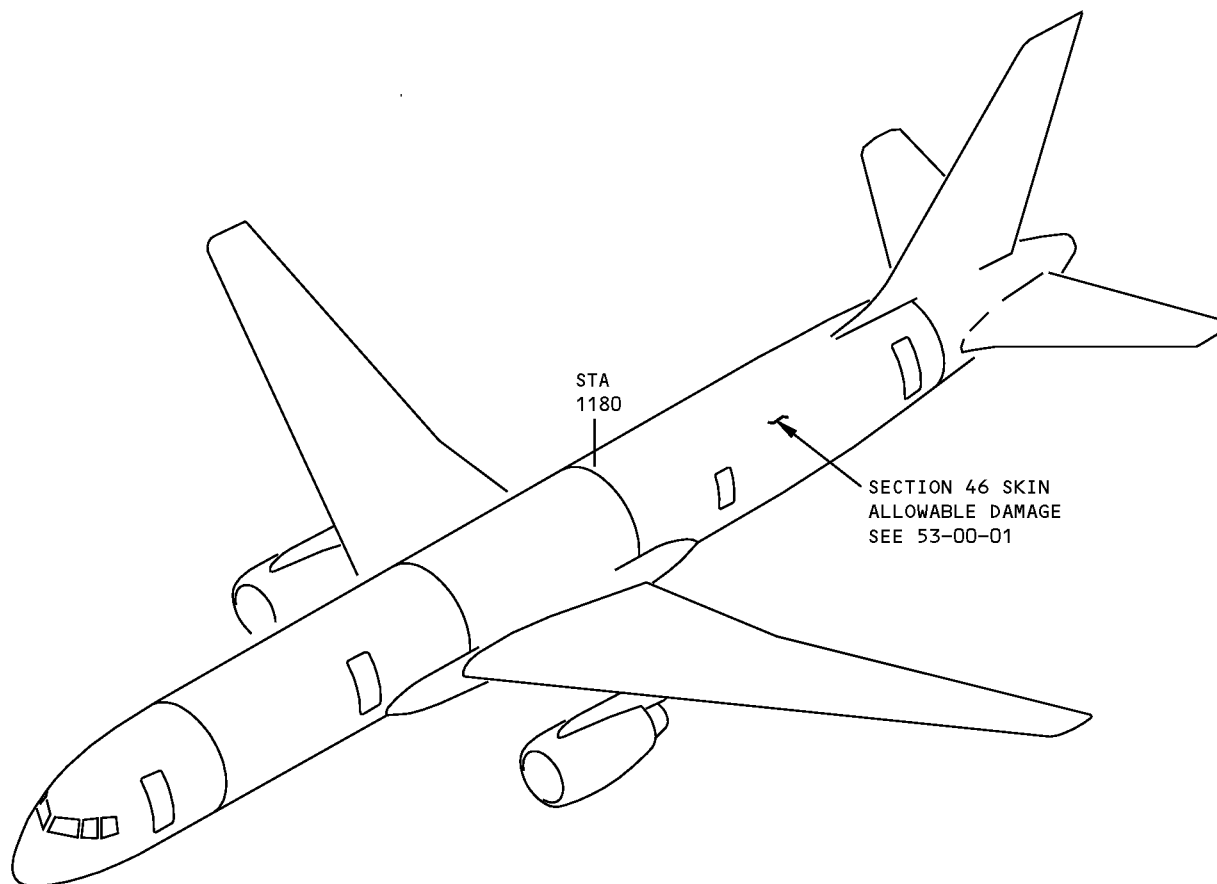
Section 46 Skin Allowable Damage
Figure 101

ALLOWABLE DAMAGE GENERAL - SECTION 46 - SKINS

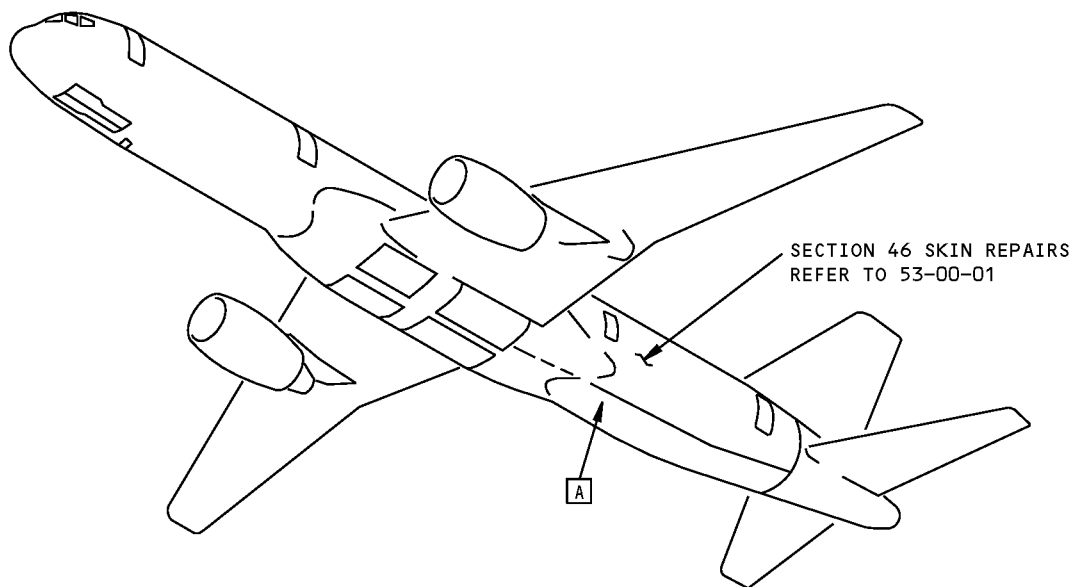
Section 46 Skin Repairs
Figure 201 (Sheet 2 of 2)

- A** FOR CUM LINE NUMBERS 257 THRU 280:
FOR REPAIRS INVOLVING SKIN REPLACEMENT
COMMON TO THE STRINGER 26L LAP SPLICE,
SEE REPAIR DRAWING 691N0015.

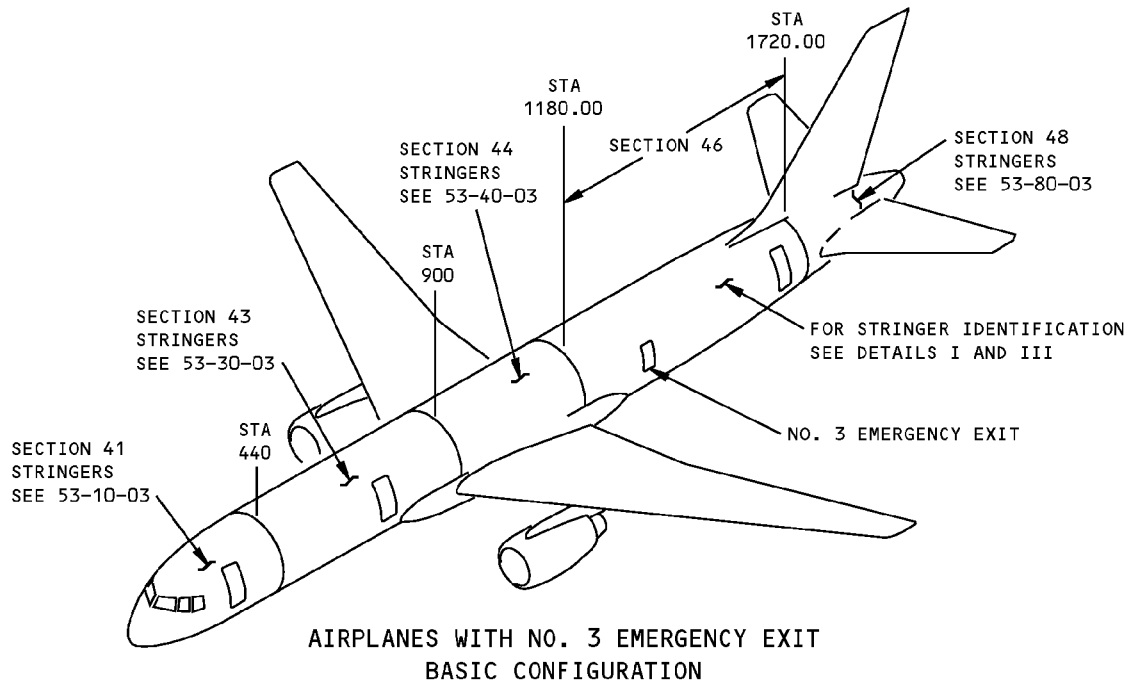
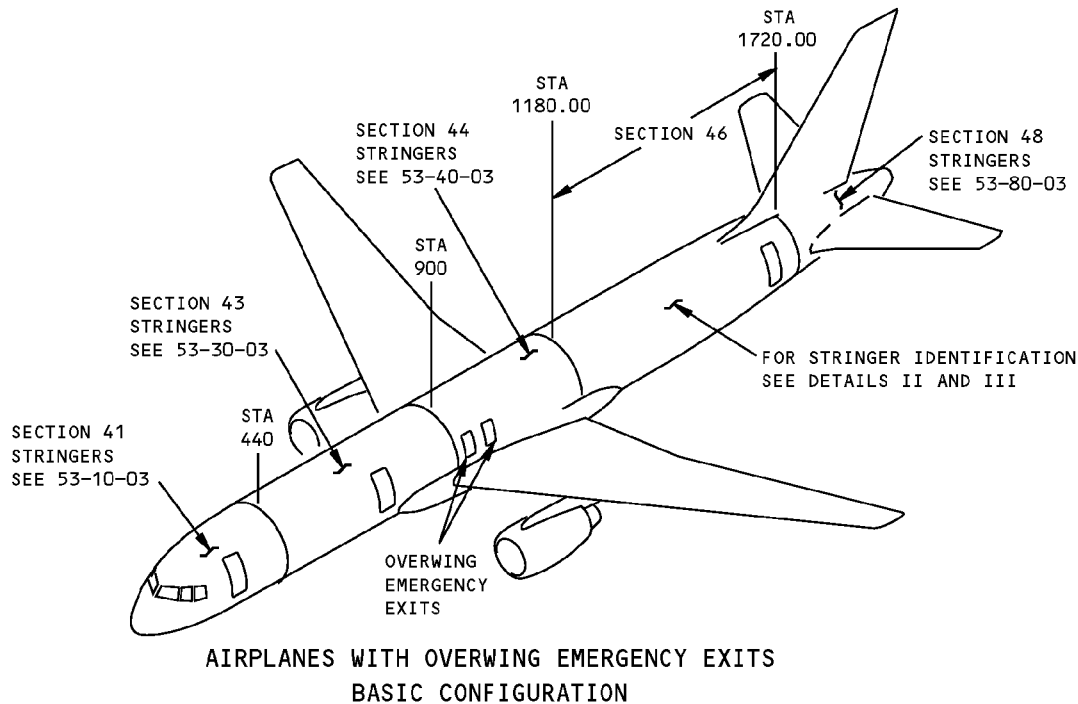
IDENTIFICATION 1 - SECTION 46 - STRINGERS

- [A] GAGES VARY THROUGHOUT LENGTH OF THE STRINGER; MAXIMUM GAGE GIVEN
- [B] STRINGER SPLICE - REF DWG 146N3821

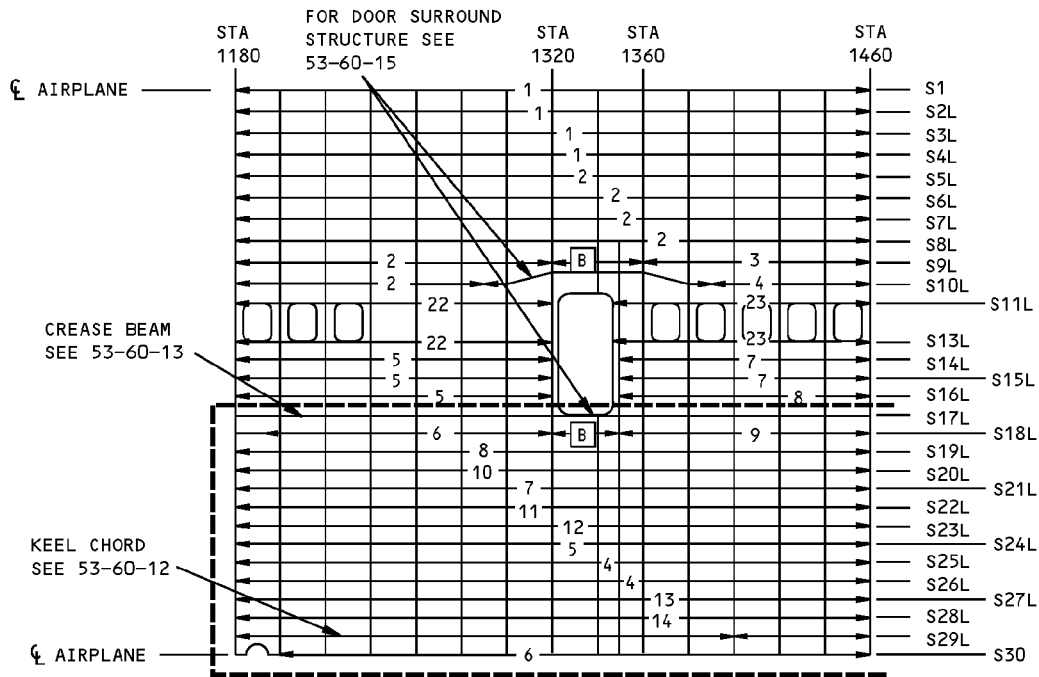
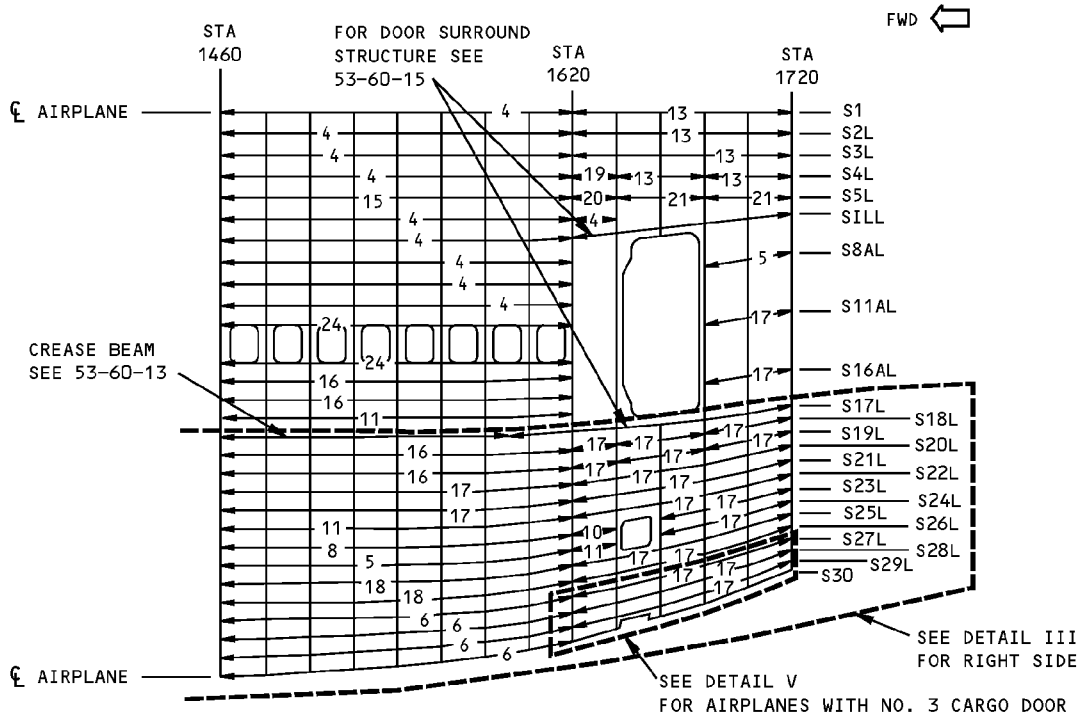
Section 46 Stringer Identification Figure 1 (Sheet 1 of 8)

FOR AIRPLANES WITH NO. 3 EMERGENCY EXIT
LEFT SIDE SHOWN, RIGHT SIDE OPPOSITE EXCEPT AS NOTED
DETAIL I

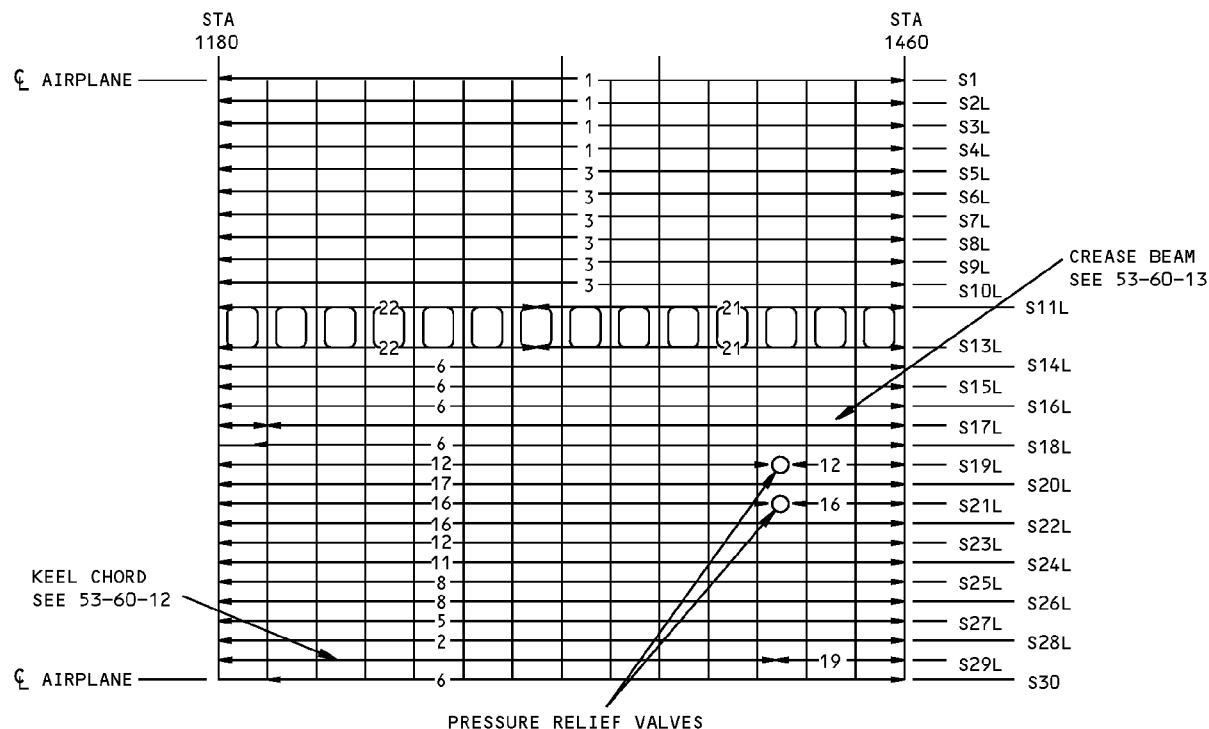
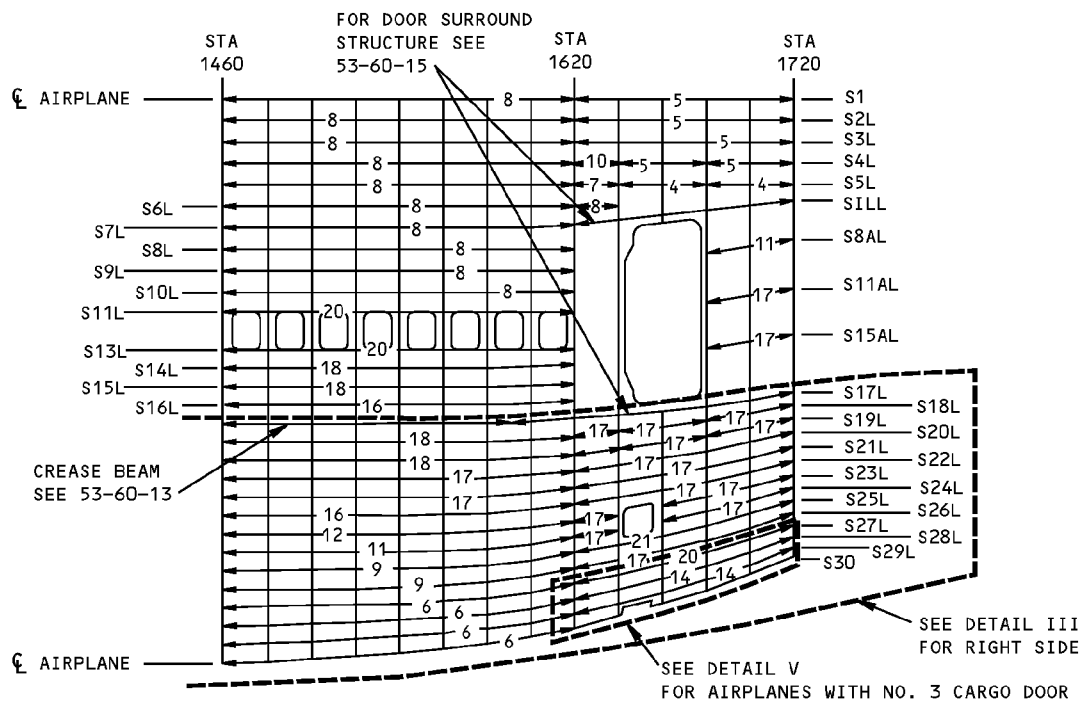
Section 46 Stringer Identification Figure 1 (Sheet 4 of 8)

DETAIL II

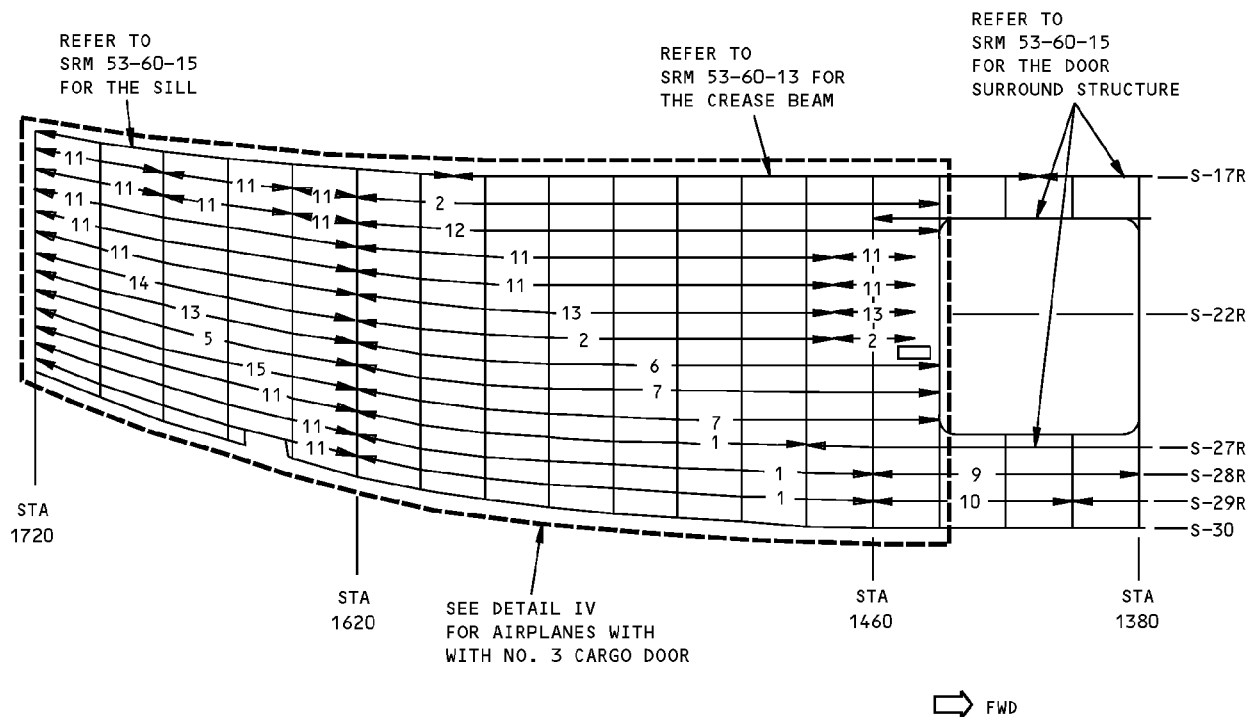
RIGHT SIDE
DETAIL III

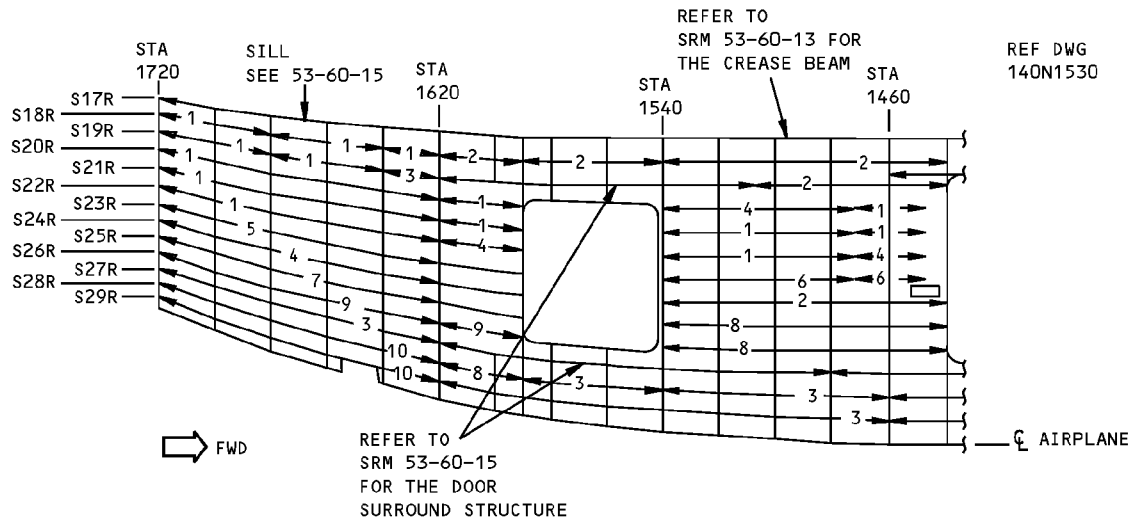
AIRPLANES WITH NO. 3 CARGO DOOR
DETAIL IV

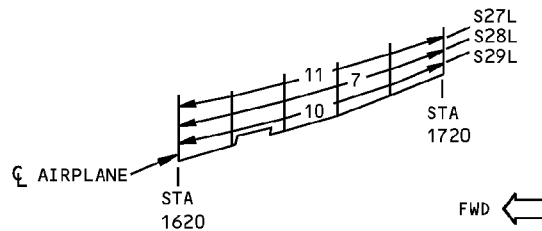
AIRPLANES WITH NO. 3 CARGO DOOR
DETAIL V

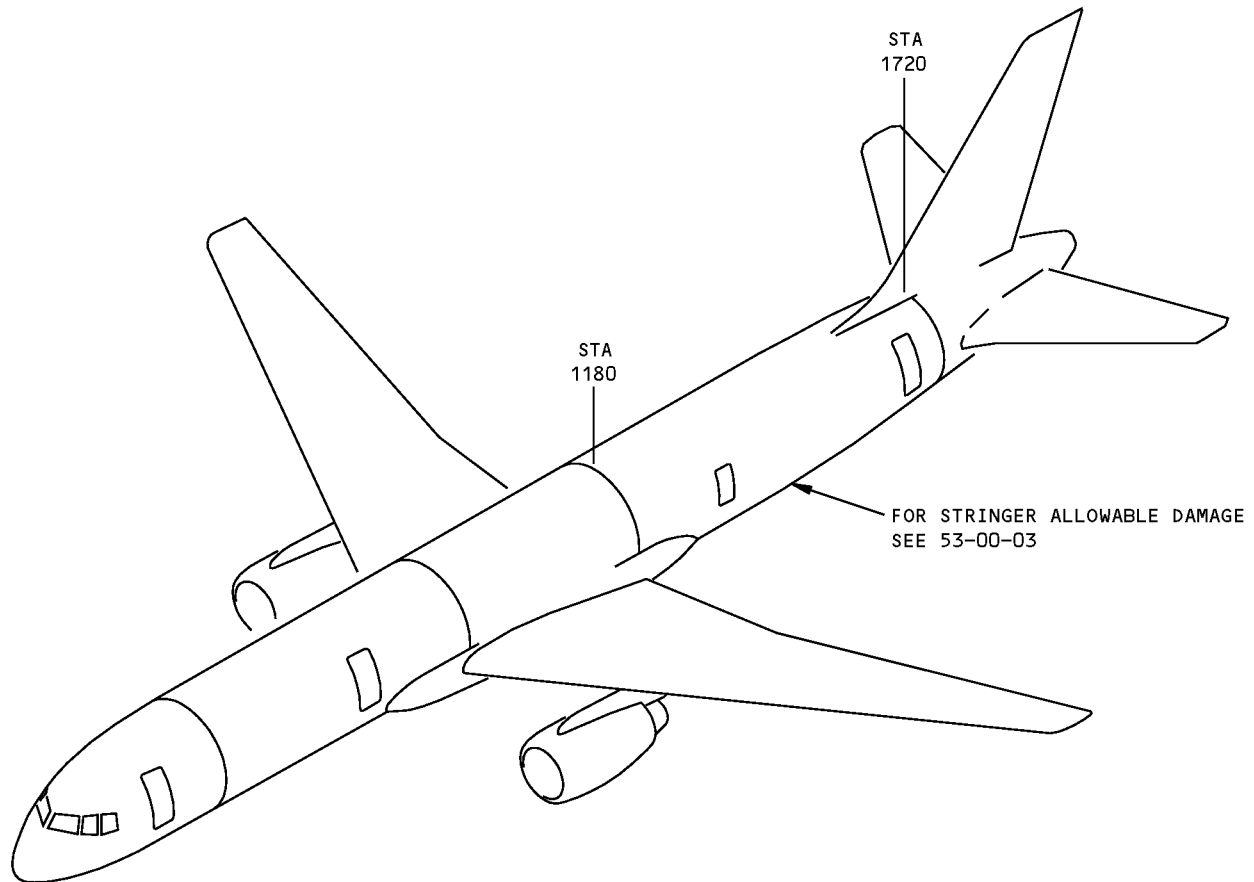
Section 46 Stringer Allowable Damage
Figure 101

ALLOWABLE DAMAGE GENERAL - SECTION 46 - STRINGERS

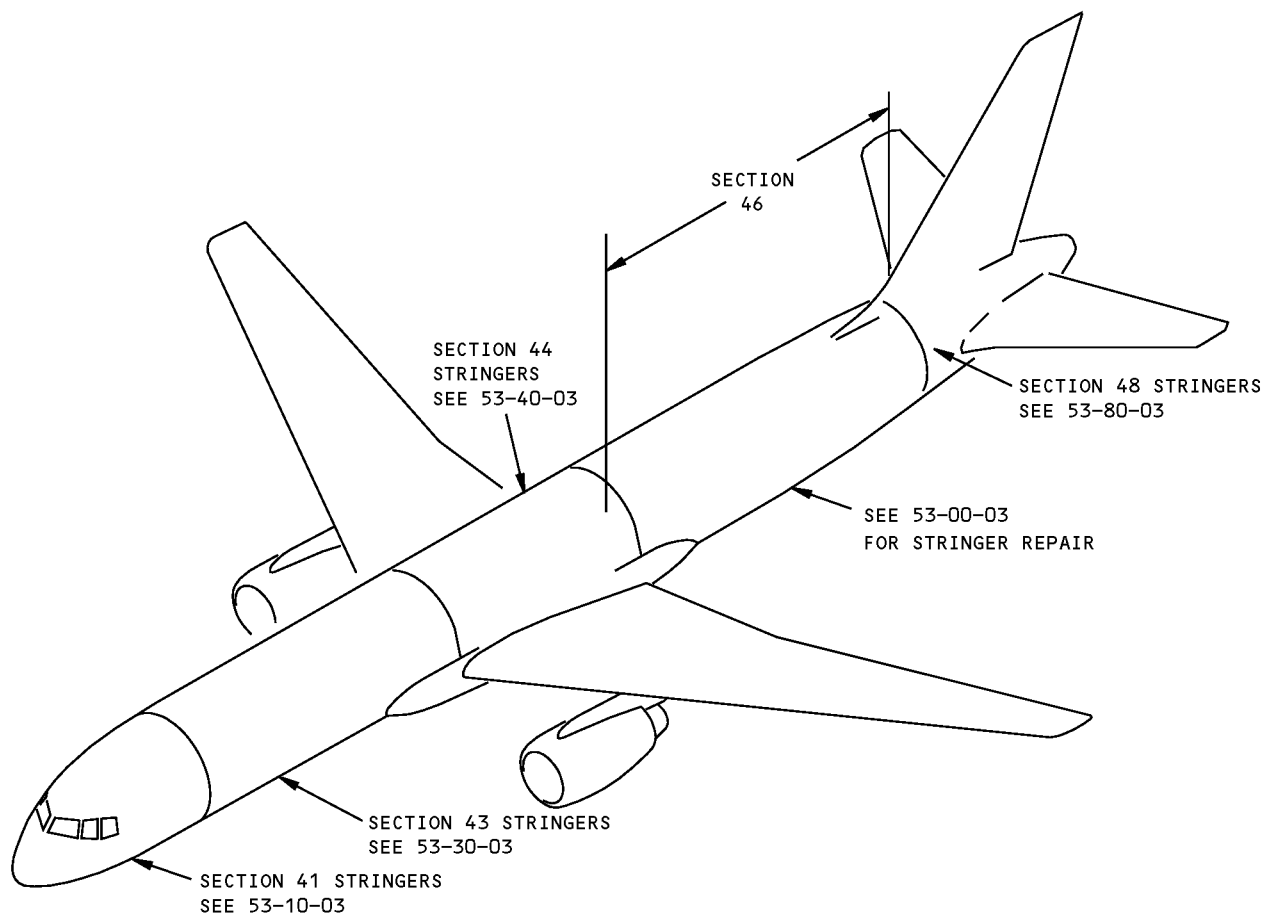
Section 46 Stringer Repair
Figure 201

REPAIR GENERAL - SECTION 46 - STRINGERS

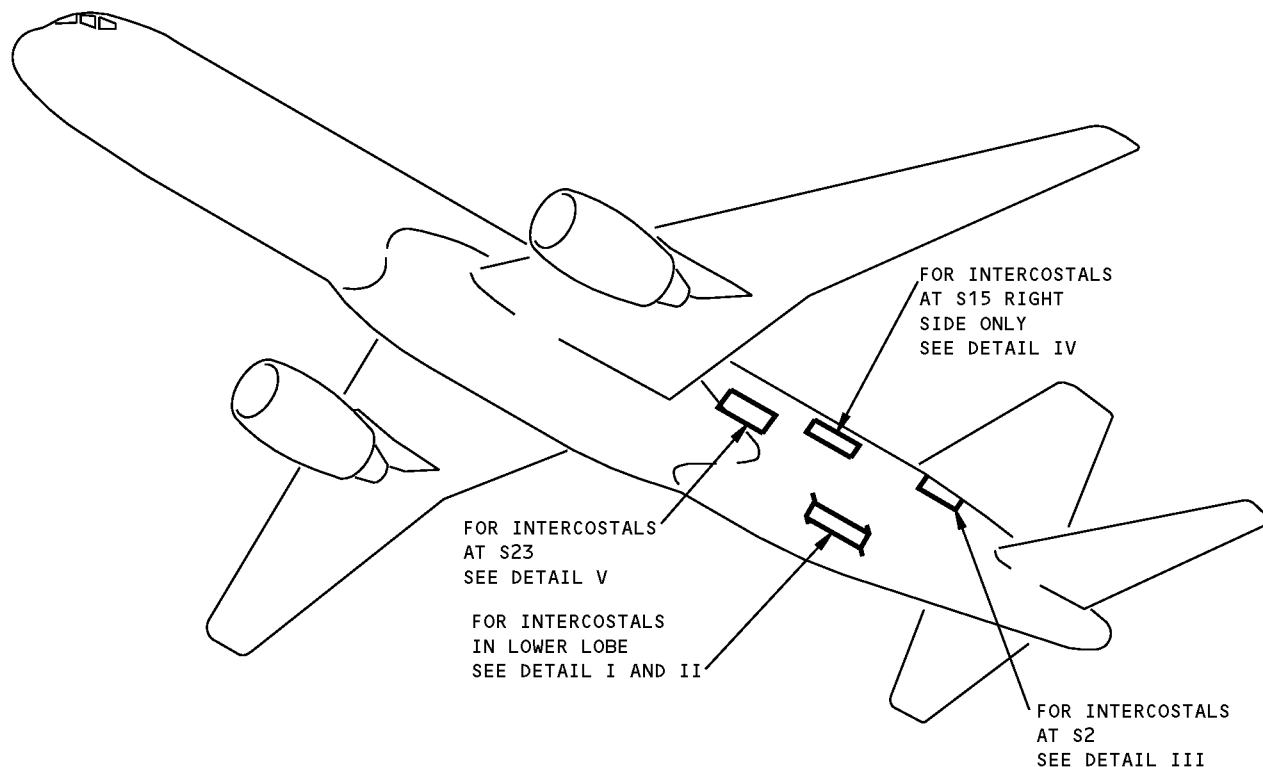
IDENTIFICATION 1 - SECTION 46 - INTERCOSTALS

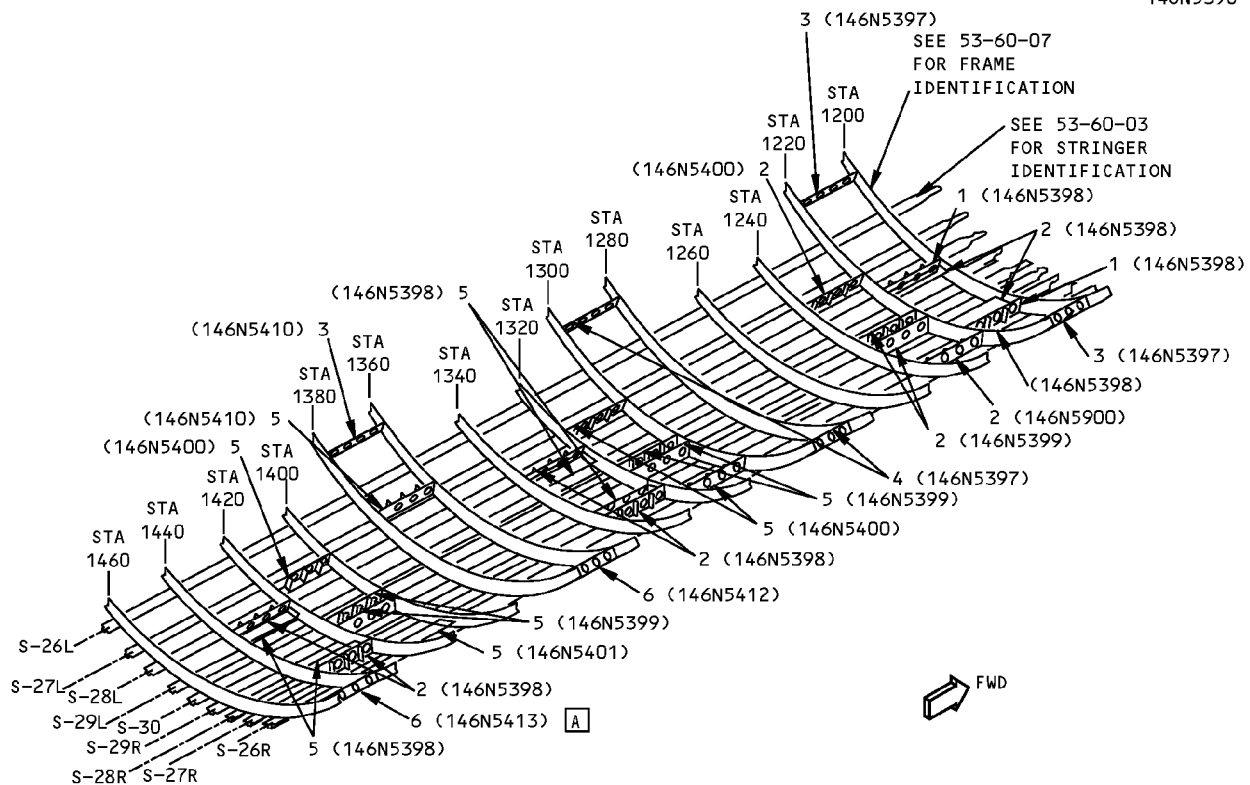
DETAIL I

REF DWG
146N5390

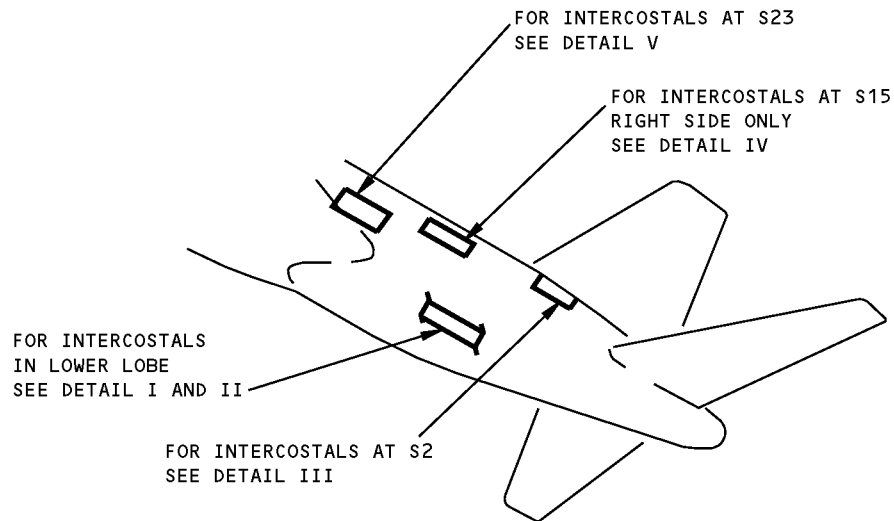
Section 46 Intercostal Allowable Damage
Figure 101 (Sheet 1 of 3)

ALLOWABLE DAMAGE GENERAL - SECTION 46 - INTERCOSTALS

- REFER TO 53-00-04 FOR INTERCOSTAL
ALLOWABLE DAMAGE DATA

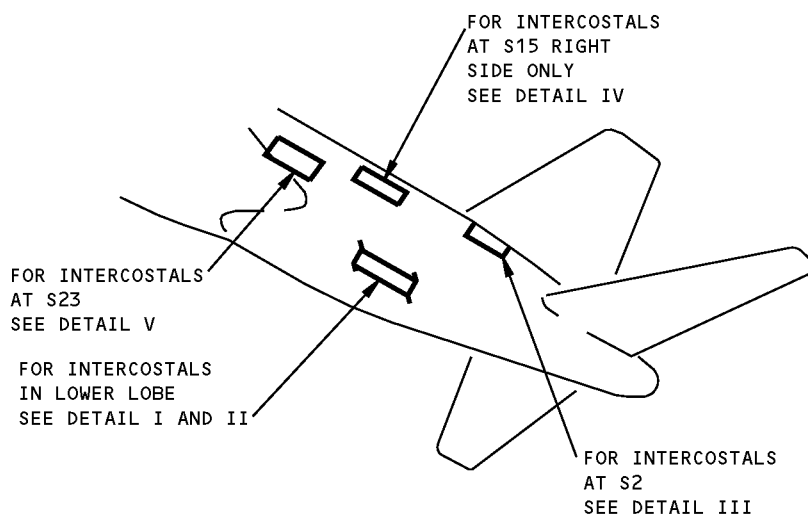
Section 46 Intercostals Repair
Figure 201 (Sheet 1 of 3)

REPAIR GENERAL - SECTION 46 - INTERCOSTALS

- DAMAGED INTERCOSTAL COMPONENTS MAY BE REPLACED OR REPAIRED. IF REPAIRS ARE TO BE MADE, SEE 51-70 FOR TYPICAL WEB, FORMED SECTION, OR EXTRUDED SECTION REPAIRS.

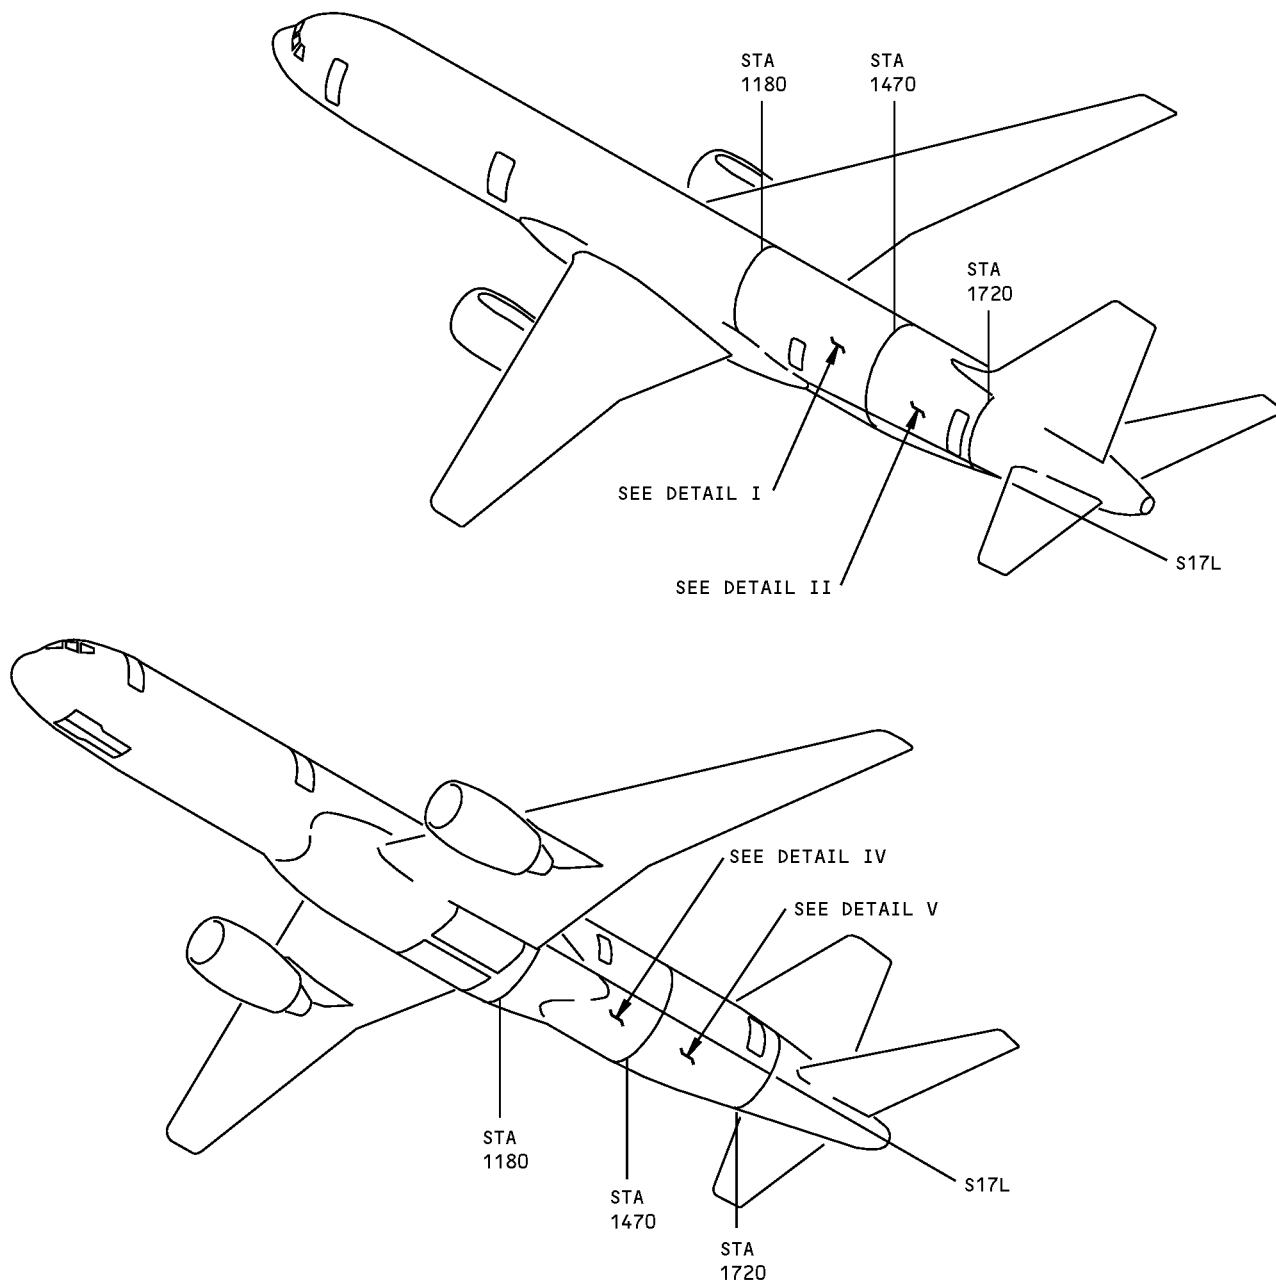
**Section 46 Frame Identification
Figure 1 (Sheet 1 of 11)**

IDENTIFICATION 1 - SECTION 46 - FRAMES

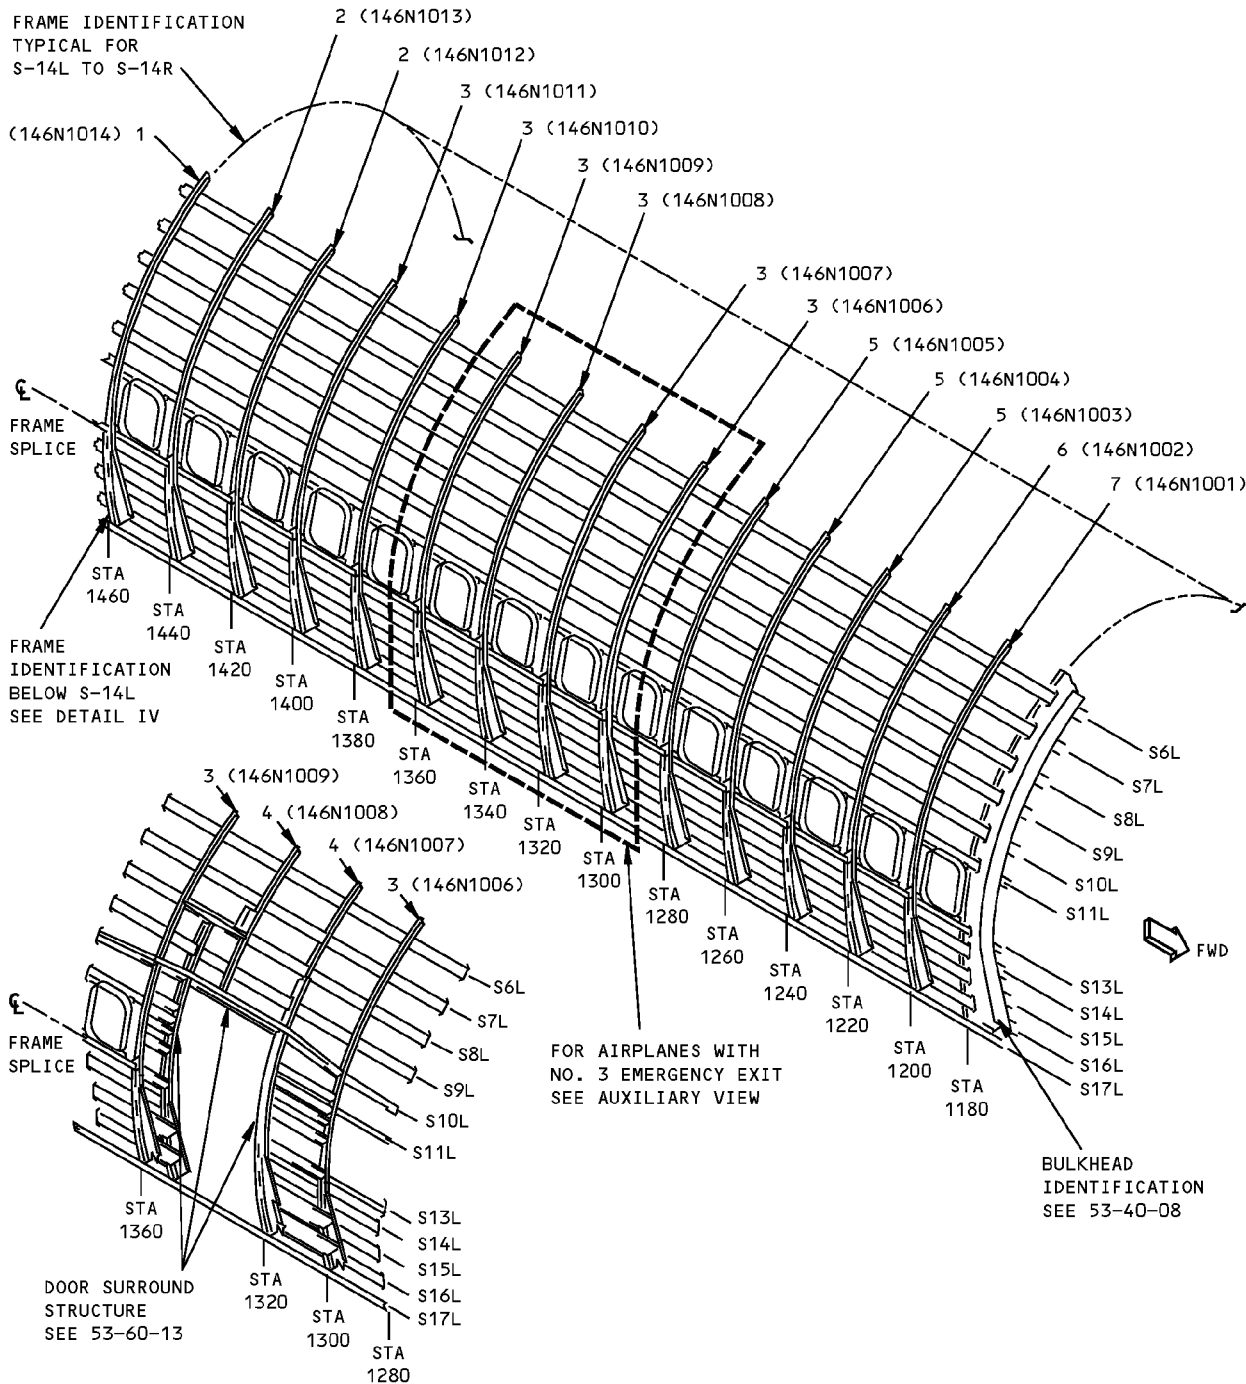
AIRPLANES WITH NO. 3 EMERGENCY EXIT
AUXILIARY VIEW

LEFT SIDE SHOWN RIGHT SIDE OPPOSITE
DETAIL I

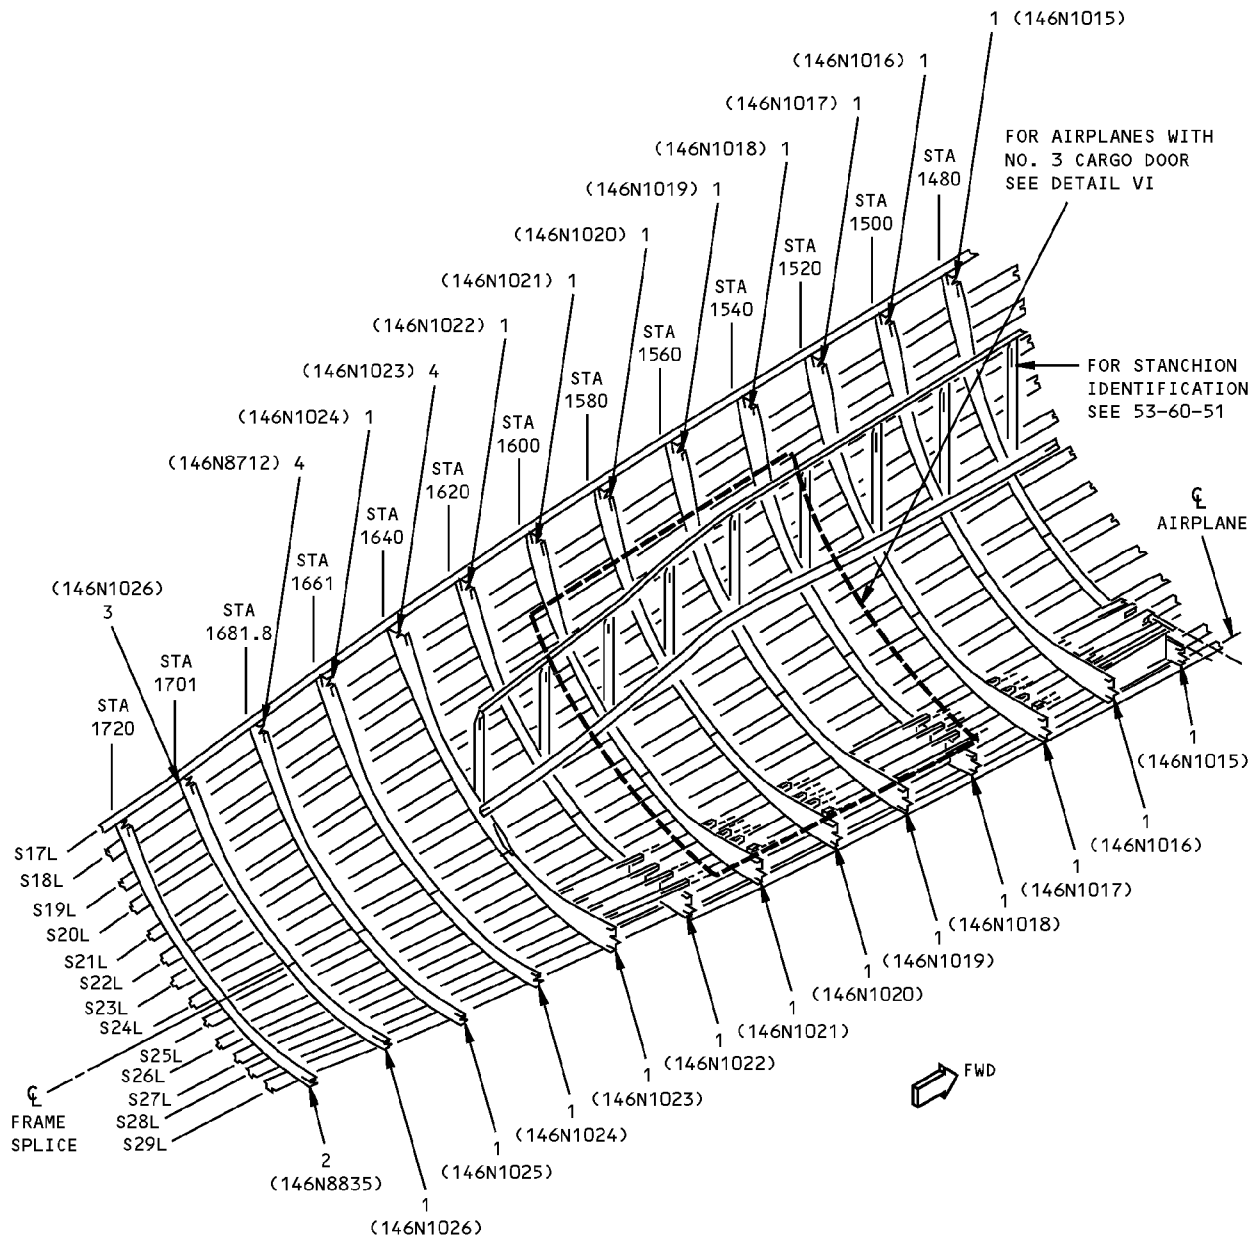
DETAIL V

LEFT SIDE SHOWN
RIGHT SIDE OPPOSITE EXCEPT AS NOTED
