FUSELAGE

757-200 STRUCTURAL REPAIR MANUAL

CHAPTER 53 FUSELAGE

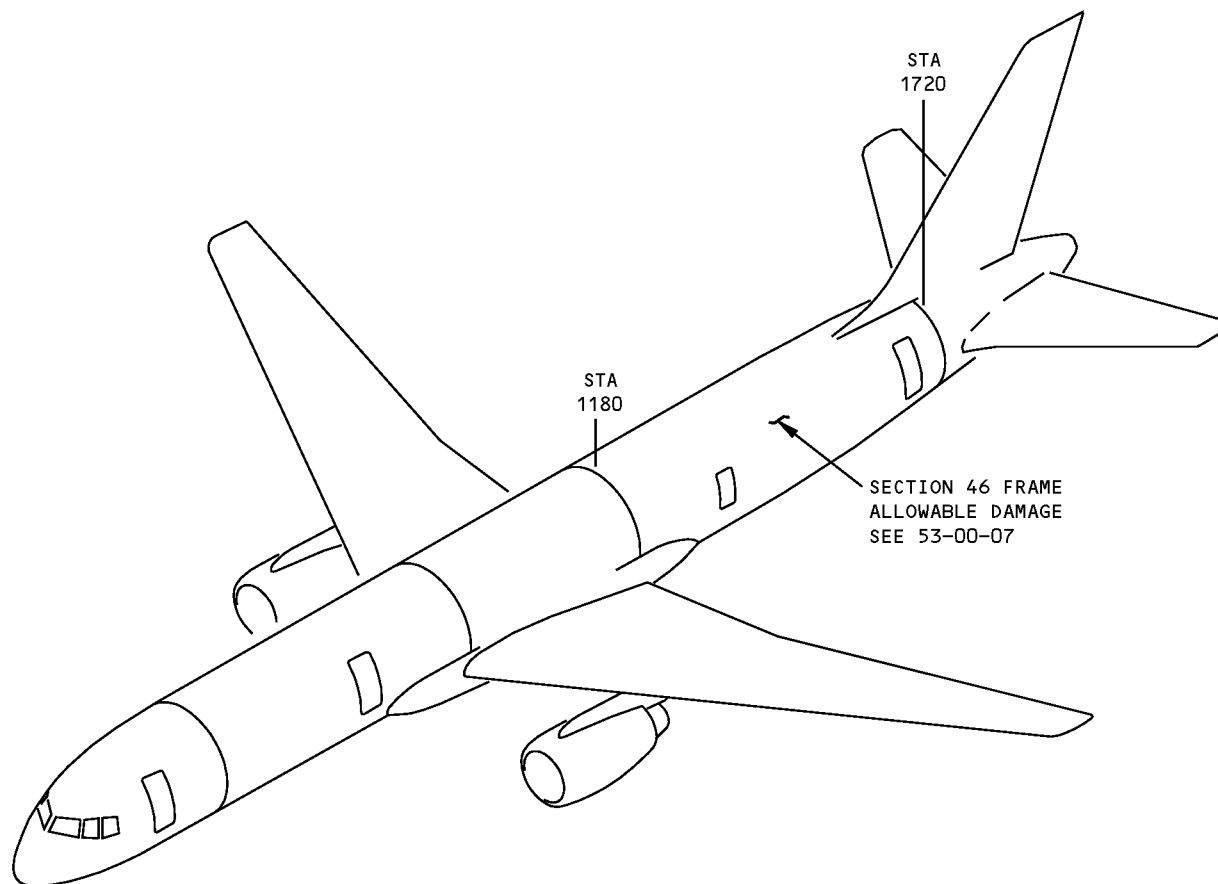
Section 46 Frame Allowable Damage
Figure 101

ALLOWABLE DAMAGE GENERAL - SECTION 46 - FRAMES

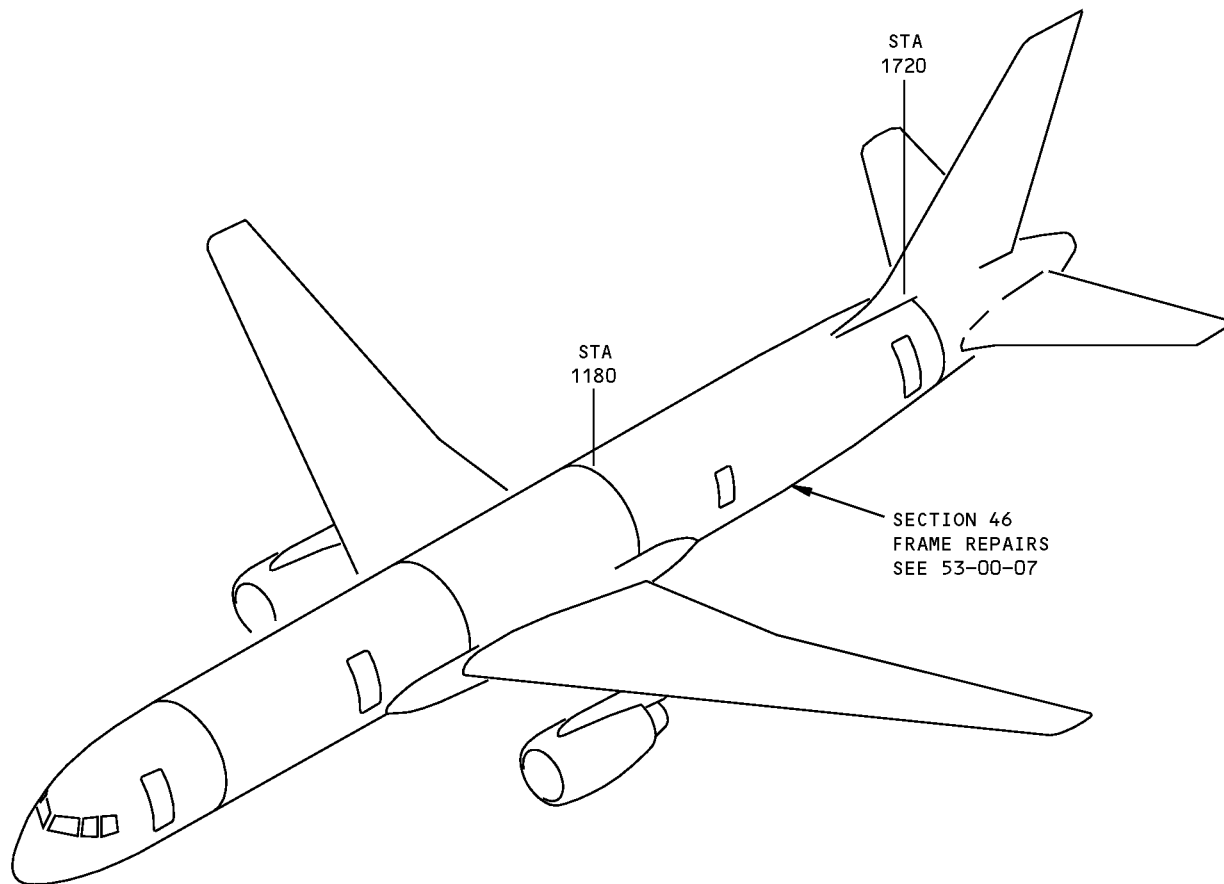
Section 46 Fuselage Frame Repairs
Figure 201

REPAIR GENERAL - SECTION 46 - FRAMES

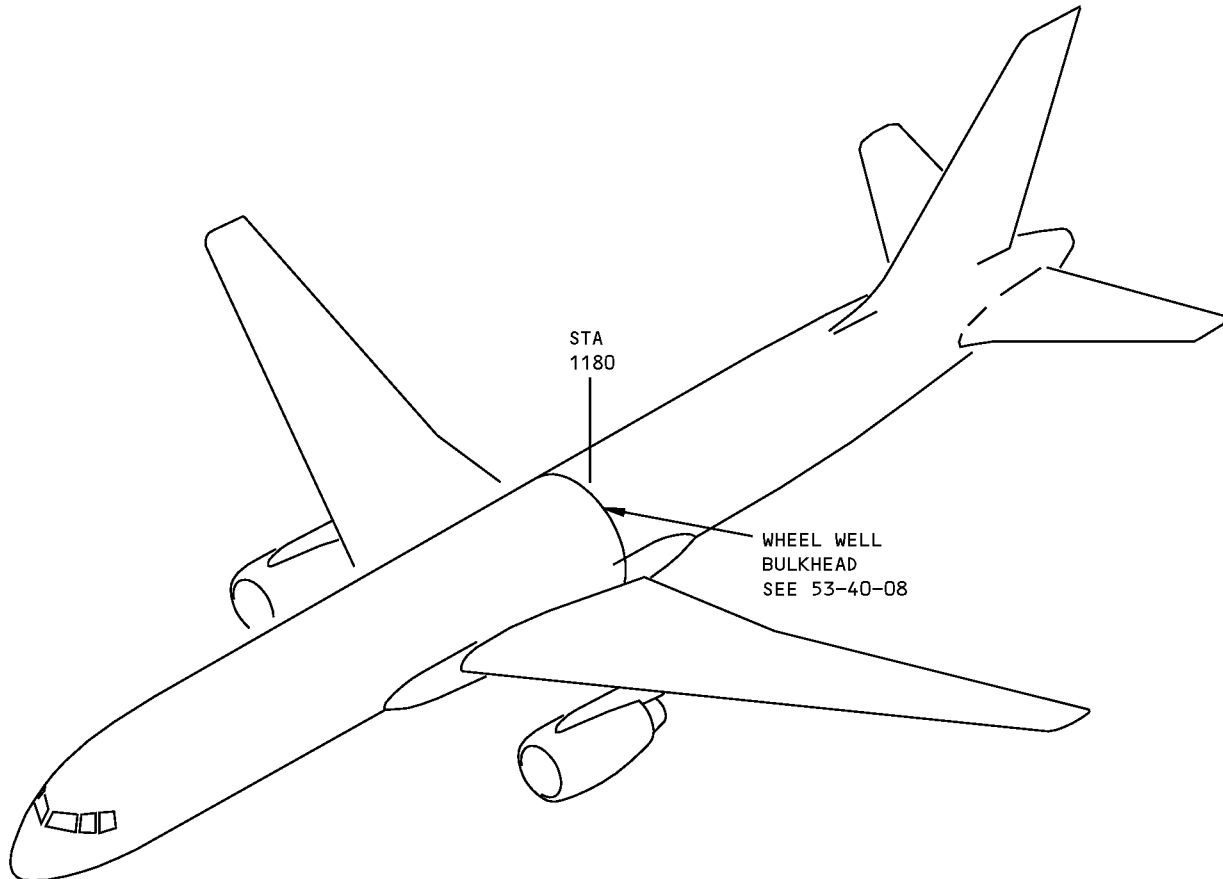
Section 46 Bulkhead Structure Identification
Figure 1

IDENTIFICATION 1 - SECTION 46 - BULKHEAD STRUCTURE

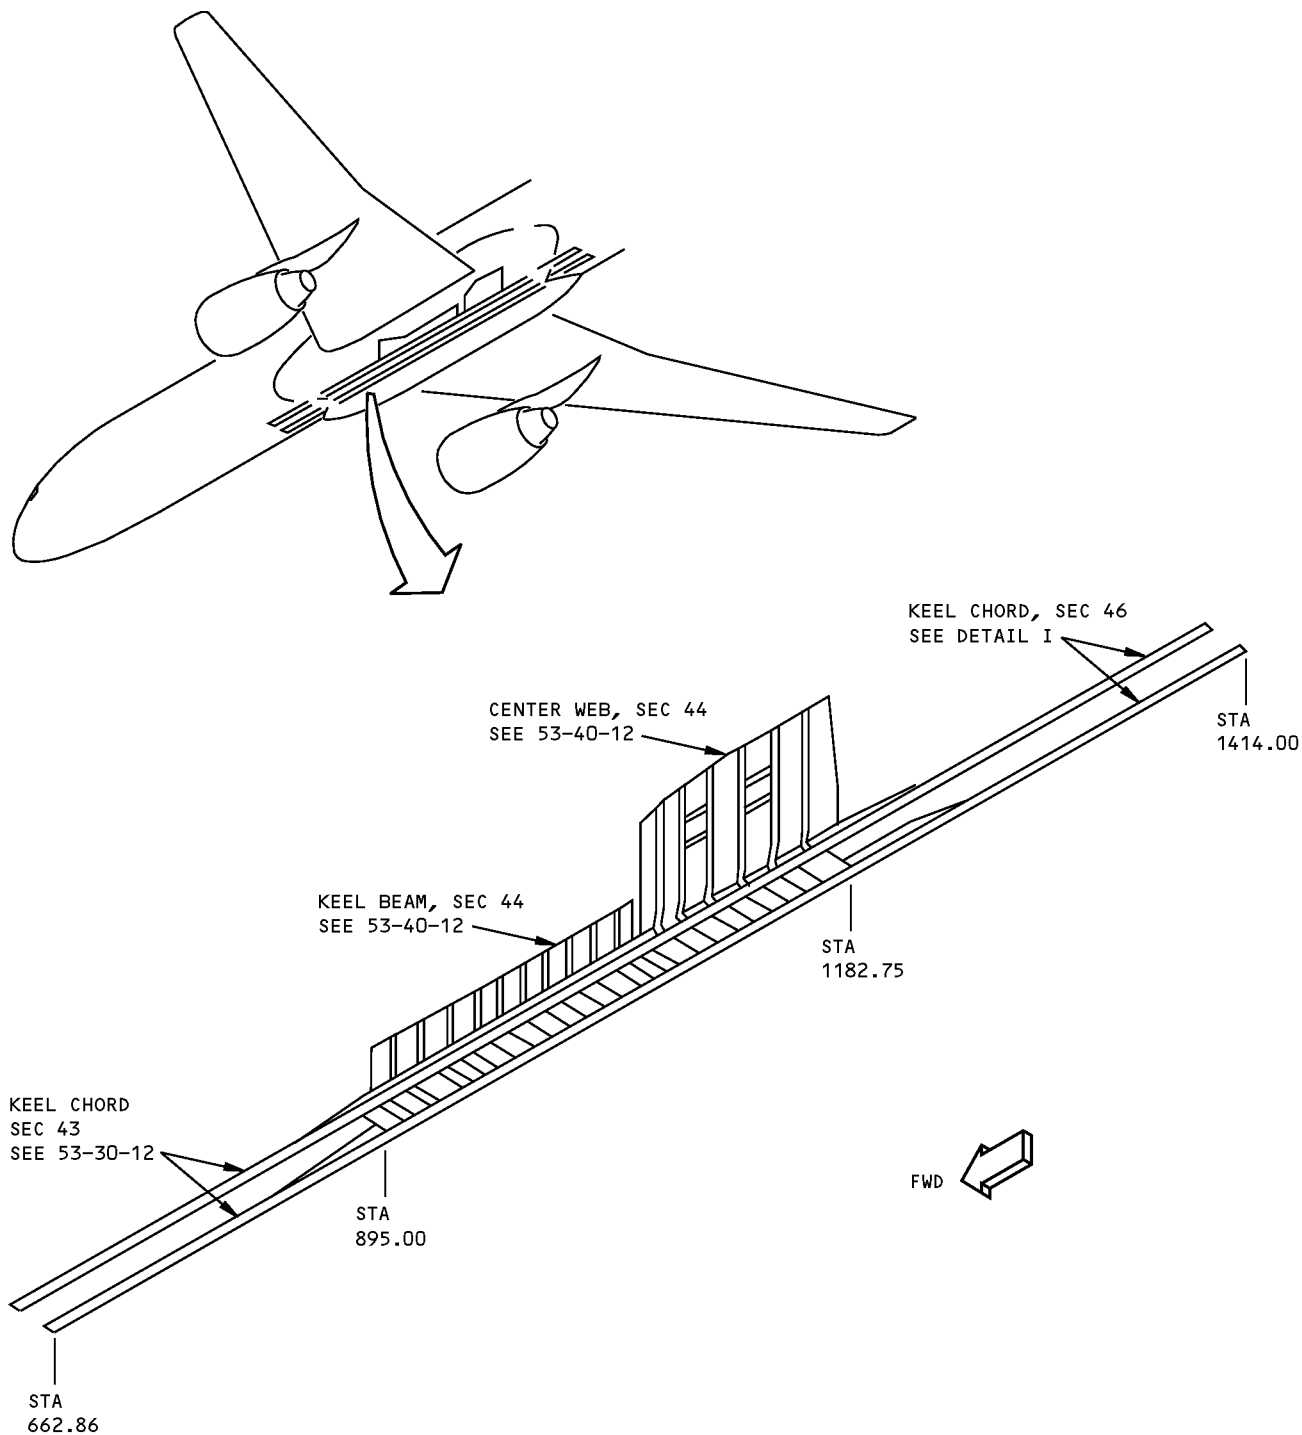
**Section 46 - Keel Beam Structure Identification
Figure 1 (Sheet 1 of 2)**

IDENTIFICATION 1 - SECTION 46 - KEEL BEAM STRUCTURE

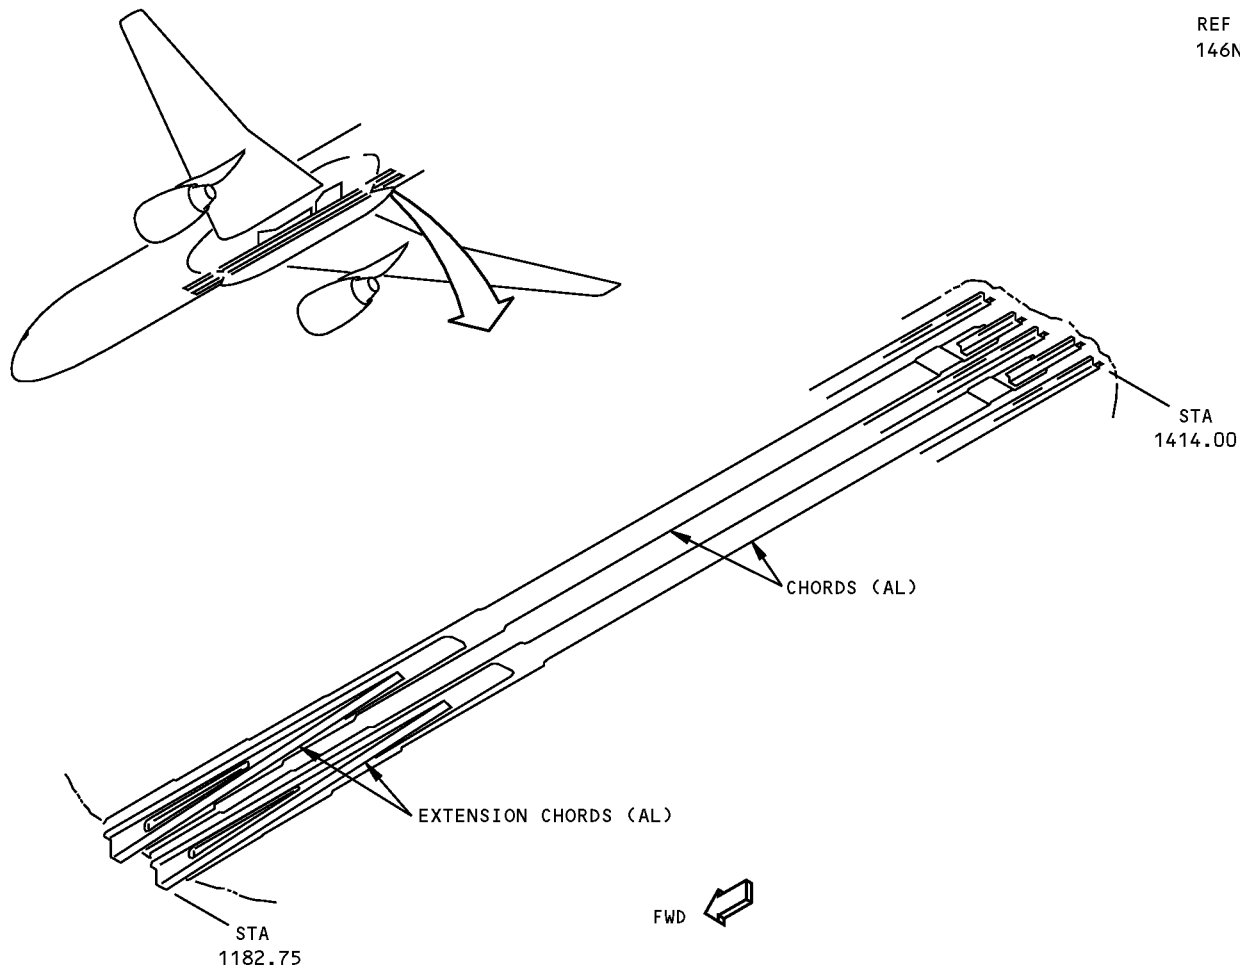
Section 46 - Keel Beam Structure Allowable Damage
Figure 101 (Sheet 1 of 2)

ALLOWABLE DAMAGE 1 - SECTION 46 - KEEL BEAM STRUCTURE

A CRACKS NOT ALLOWED. EDGE CRACKS MUST BE REMOVED PER DETAILS I AND III. ELSEWHERE THE AFFECTED PART MUST BE REPLACED OR REPAIRED

B REMOVE DAMAGE PER DETAILS I, II, III AND IV. THE TOTAL CROSS-SECTIONAL AREA REMOVED MUST NOT EXCEED 10% OF THE ORIGINAL CROSS-SECTIONAL AREA OF THE FLANGE

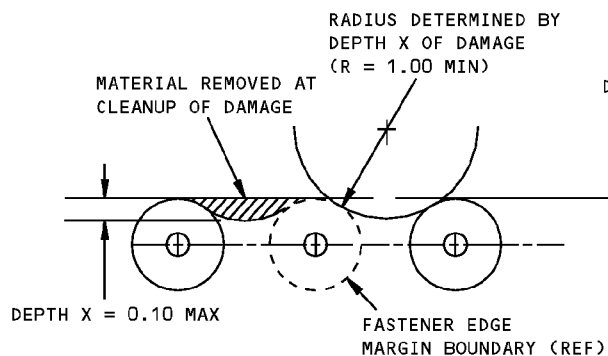
DETAIL I

DAMAGE CLEANUP OF EDGES WHERE FASTENER EDGE MARGINS DO NOT OVERLAP

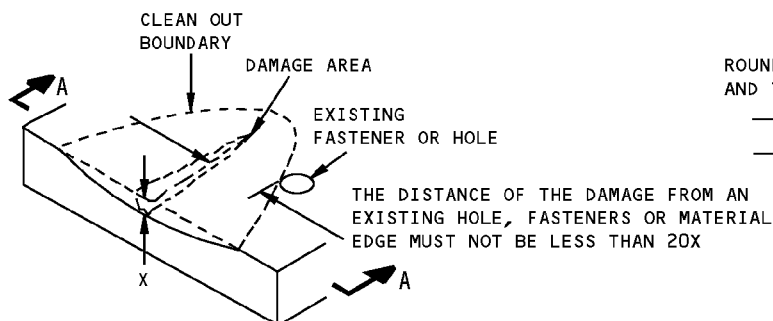
SECTION A-A

REMOVAL OF NICK, GOUGE AND SCRATCH DAMAGE ON A SURFACE
DETAIL II

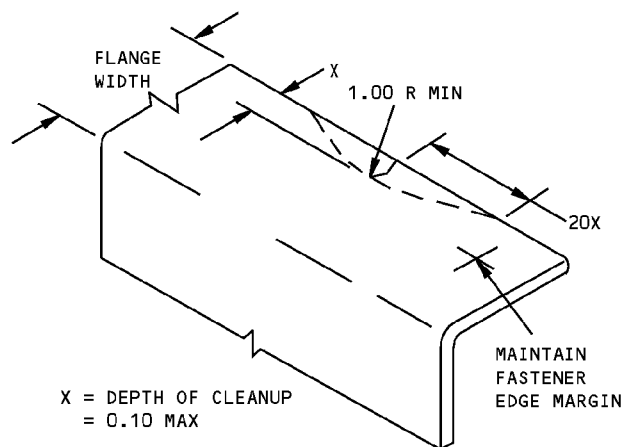
REMOVAL OF NICK OR CRACK DAMAGE ON AN EDGE
DETAIL III

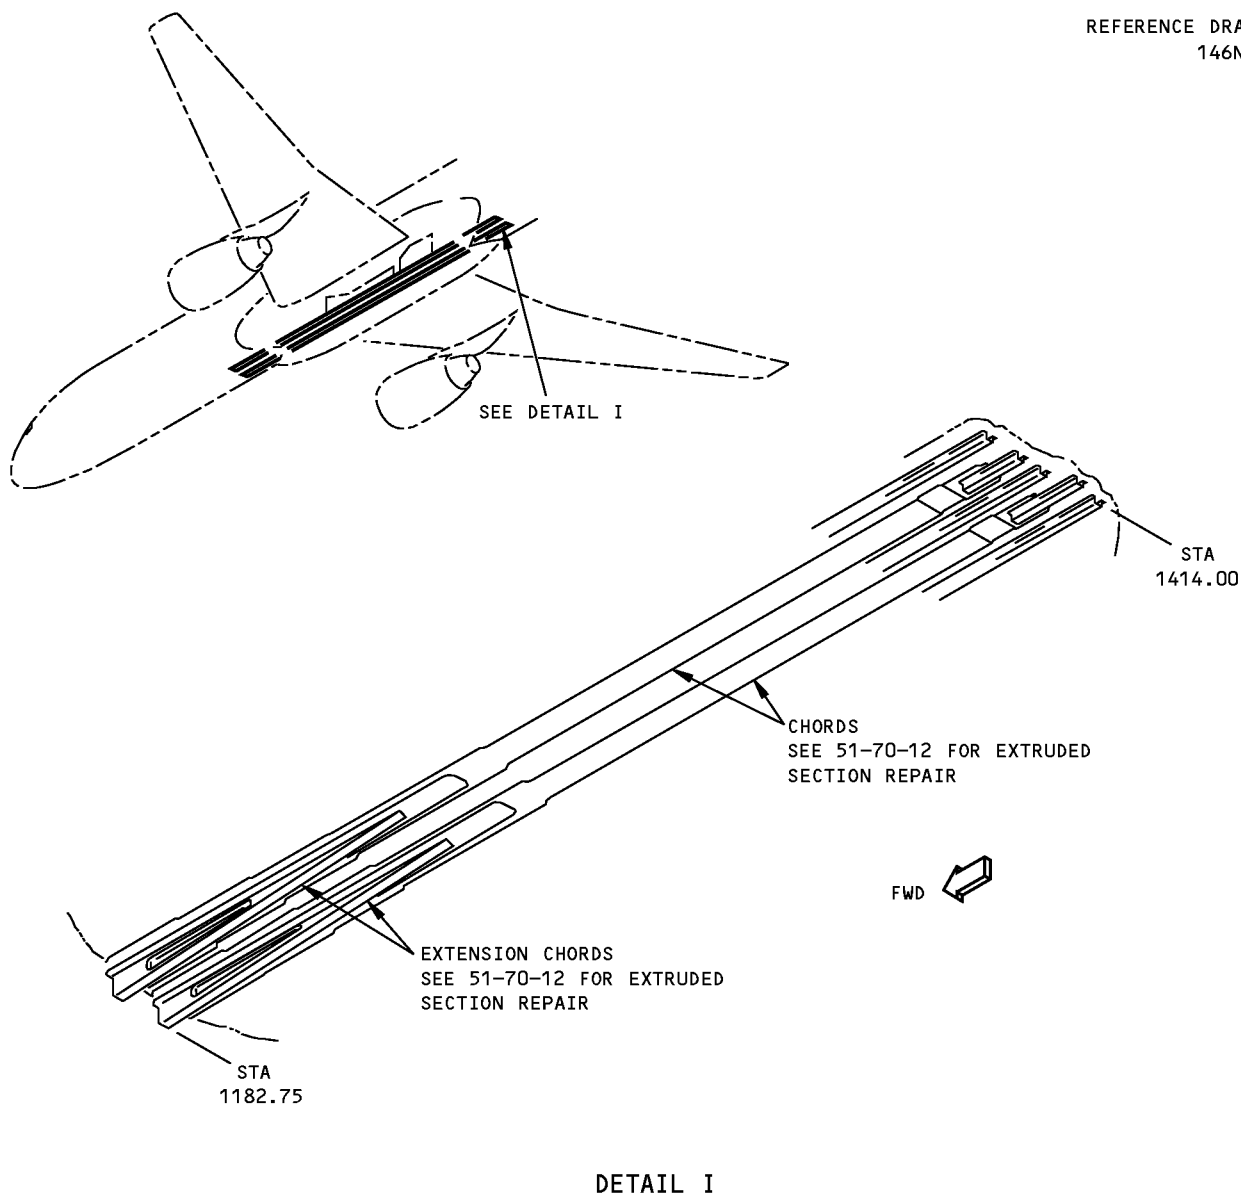
Section 46 - Keel Chord Repair Figure 201

REPAIR GENERAL - SECTION 46 - KEEL CHORD REPAIR

- THIS IS A CATEGORY A REPAIR. THE INSPECTIONS GIVEN IN THE MAINTENANCE PLANNING DATA (MPD) ARE SUFFICIENT TO MAINTAIN THE DAMAGE TOLERANCE OF THE INITIAL STRUCTURE WITH THIS REPAIR INSTALLED. REFER TO SRM 51-00-06 FOR REPAIR CATEGORIES AND DEFINITIONS.

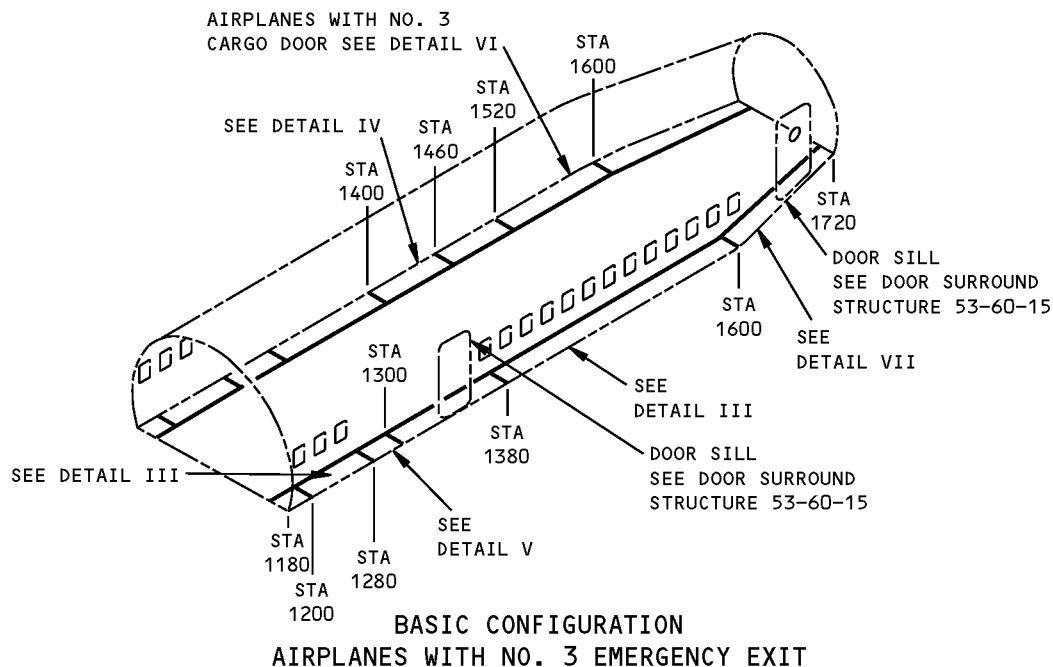
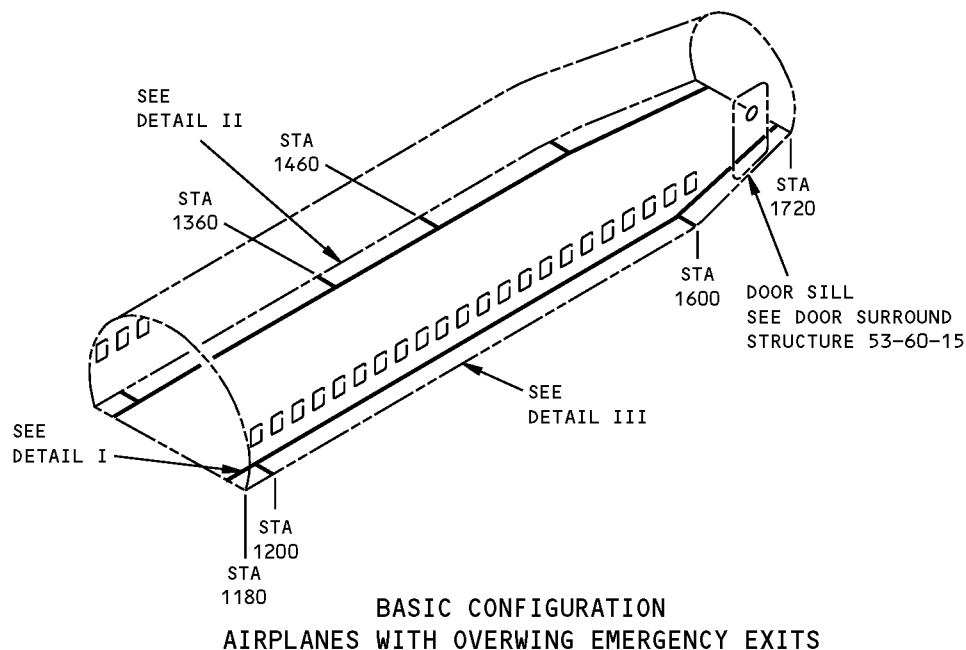
IDENTIFICATION 1 - SECTION 46 - CREASE BEAM

- RIGHT SIDE OPPOSITE LEFT SIDE EXCEPT WHERE NOTED

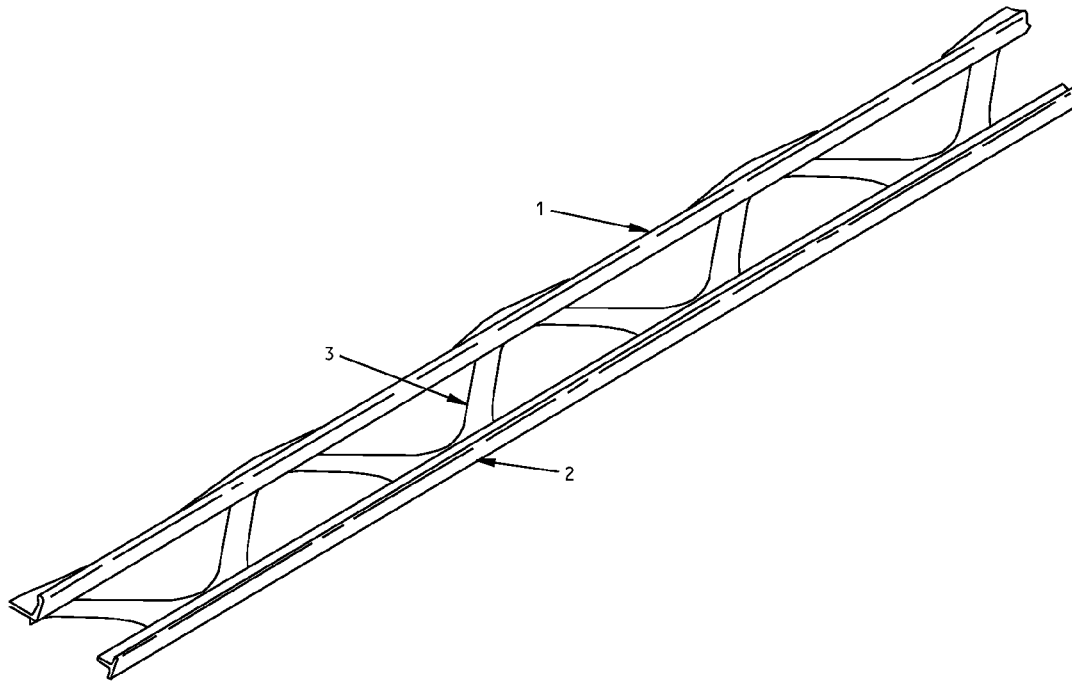
TYPICAL TRUSS CREASE BEAM INSTALLATION
DETAIL III

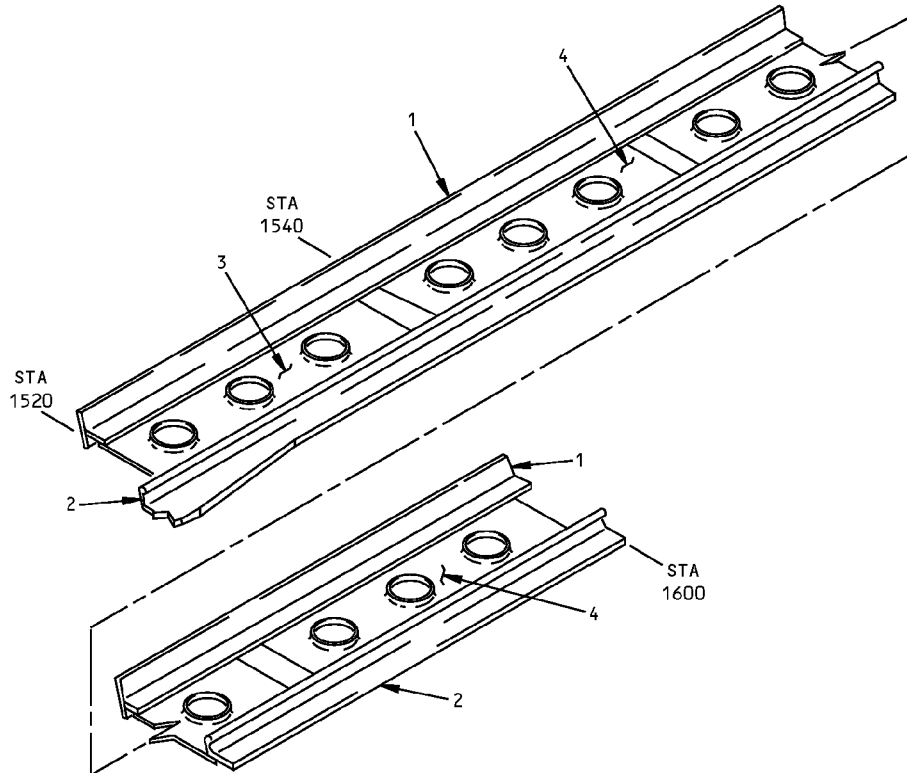
DETAIL VI

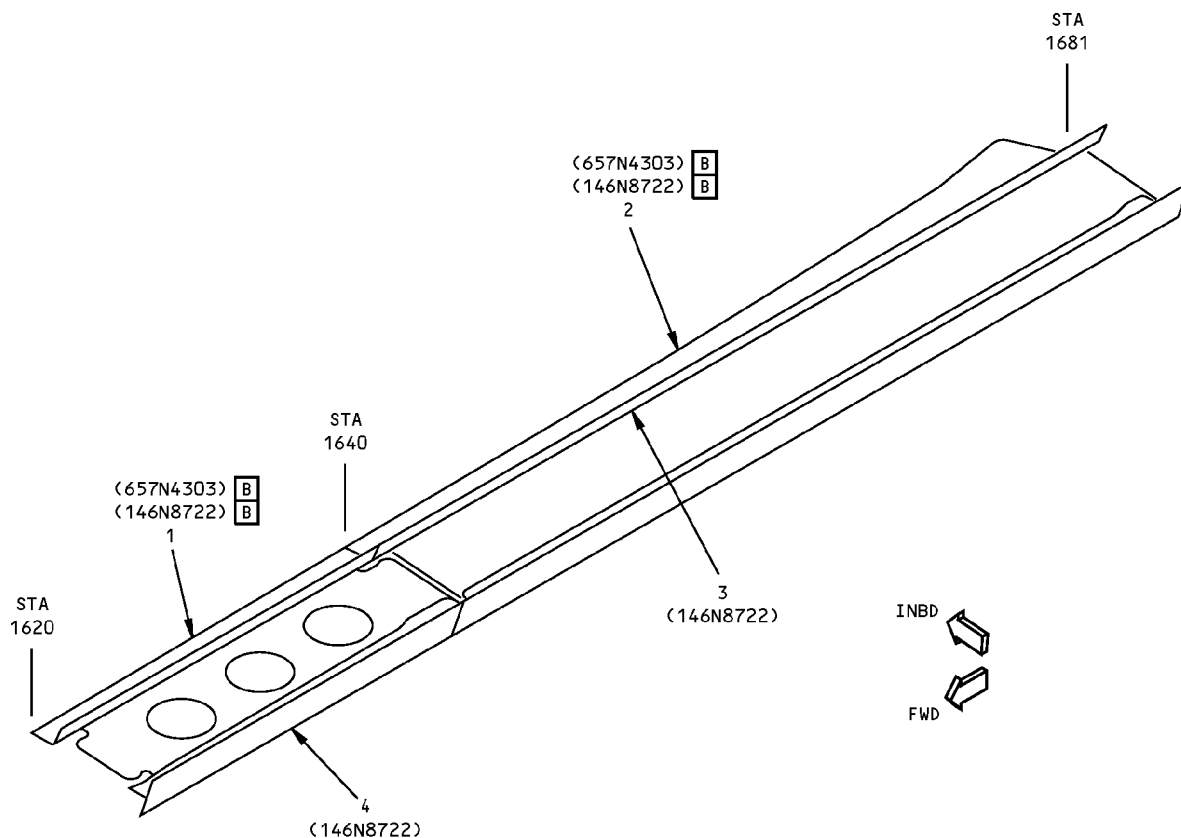
Ref Dwg
146N8722
657N4303

DETAIL VII
LEFT AND RIGHT HAND

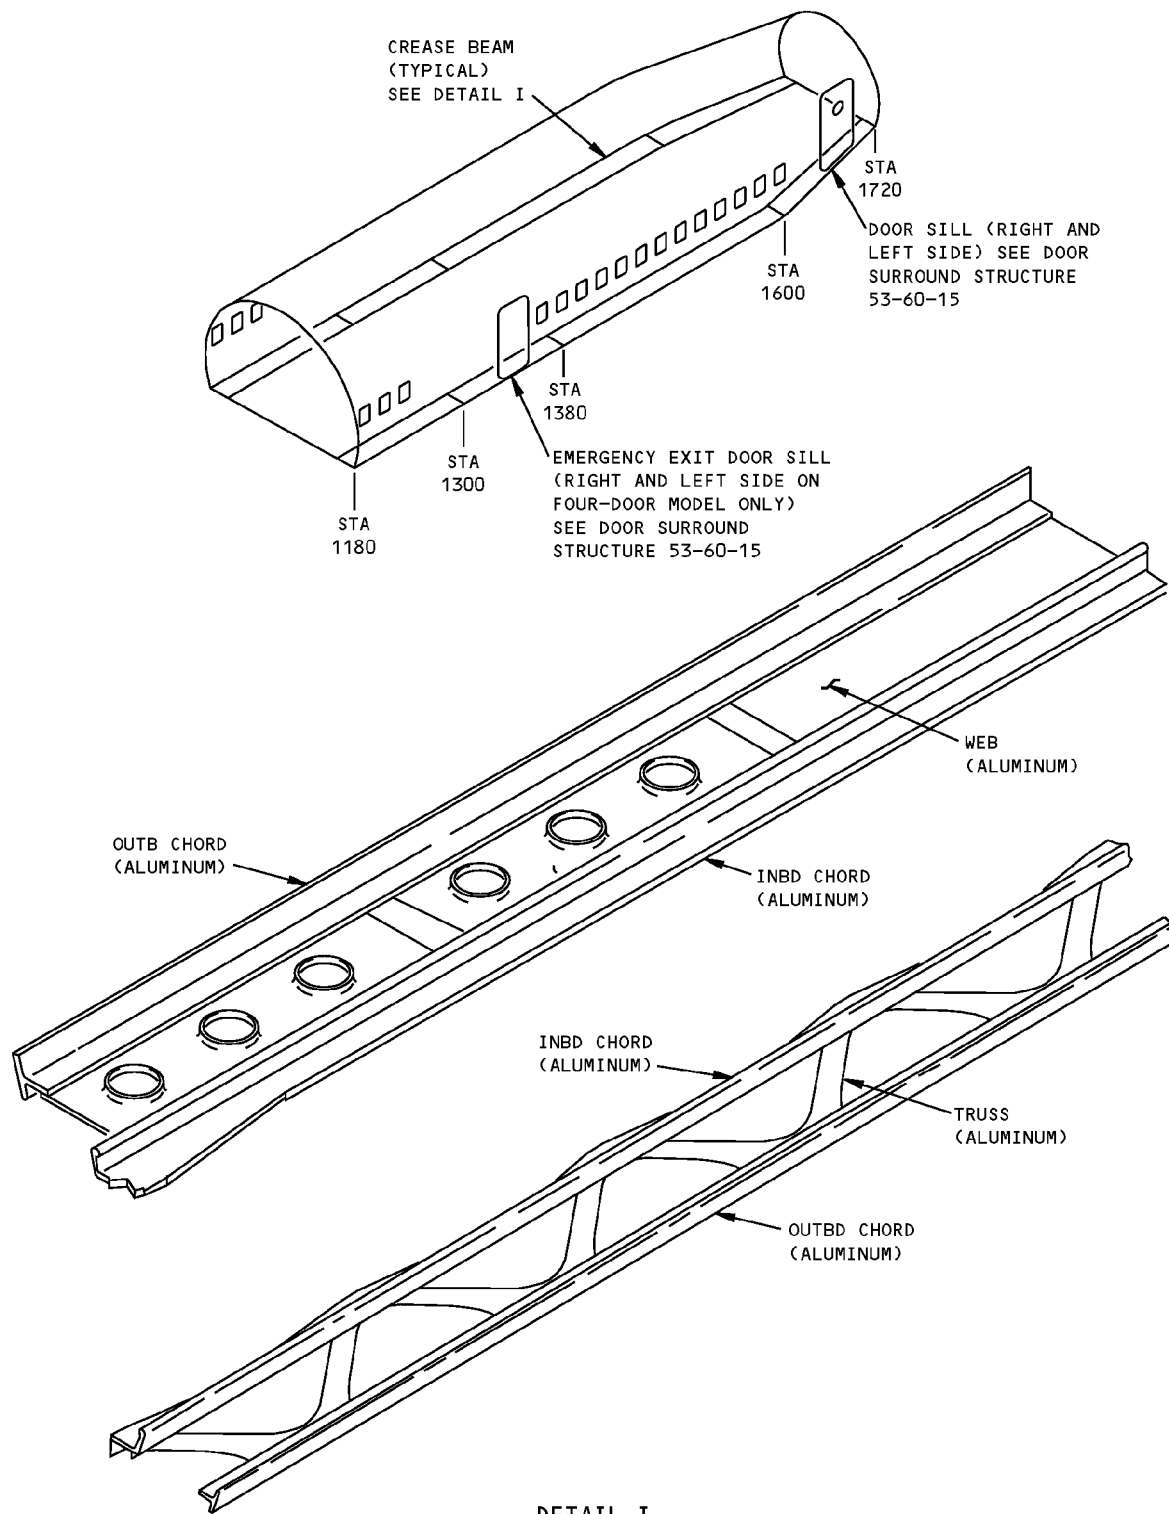
Section 46 Crease Beam Allowable Damage
Figure 101 (Sheet 1 of 5)

ALLOWABLE DAMAGE 1 - SECTION 46 - CREASE BEAM

DETAIL I

- THIS ALLOWABLE DAMAGE DATA IS APPLICABLE TO PASSENGER AIRPLANES ONLY.
- REFER TO IDENTIFICATION 1 FOR CREASE BEAM LOCATIONS
- REFINISH REWORKED AREAS AS SHOWN IN AMM 51-20
- REFER TO 51-10-02 FOR INSPECTION AND REMOVAL OF DAMAGE

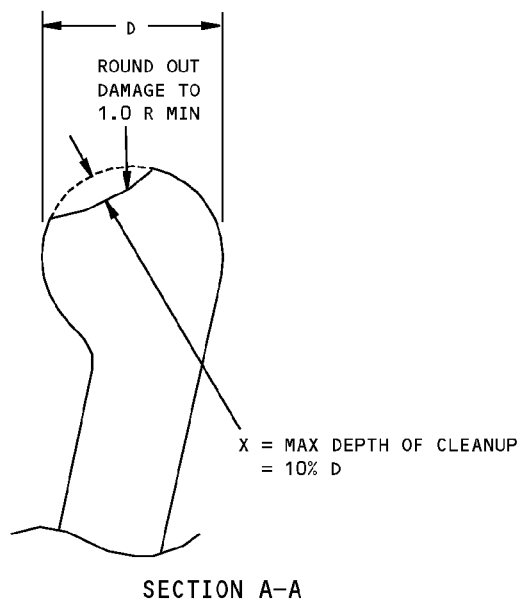
SECTION A-A

DAMAGE CLEANUP MUST NOT
REDUCE CROSS-SECTIONAL
AREA BY MORE THAN 10%

SECTION THRU EXTRUSION

DAMAGE CLEANUP OF BULB ANGLE
DETAIL VIII

- F** REMOVE DAMAGE AS SHOWN IN DETAILS II AND III
- G** CRACKS ARE NOT PERMITTED EXCEPT FOR EDGE CRACKS WHICH MUST BE REMOVED AS SHOWN IN DETAILS II AND VIII
- H** CRACKS ARE NOT PERMITTED EXCEPT FOR EDGE CRACKS WHICH MUST BE REMOVED AS SHOWN IN DETAILS II AND III
- J** REMOVE EDGE DAMAGE AS SHOWN IN DETAILS II AND V. BLEND OUT SURFACE DAMAGE PER DETAIL VII
- K** CLEAN OUT DAMAGE TO WEB PORTION OF TRUSS ONLY UP TO 0.25 INCH (6 mm) DIA AND NOT CLOSER THAN 1.0 INCH (25 mm) TO FASTENER HOLE, MATERIAL EDGE, OR OTHER DAMAGE. FILL HOLE WITH 2117-T3 OR T4 ALUMINUM RIVET INSTALLED WET WITH BMS 5-95 SEALANT. ALL OTHER HOLES TO BE REPAIRED

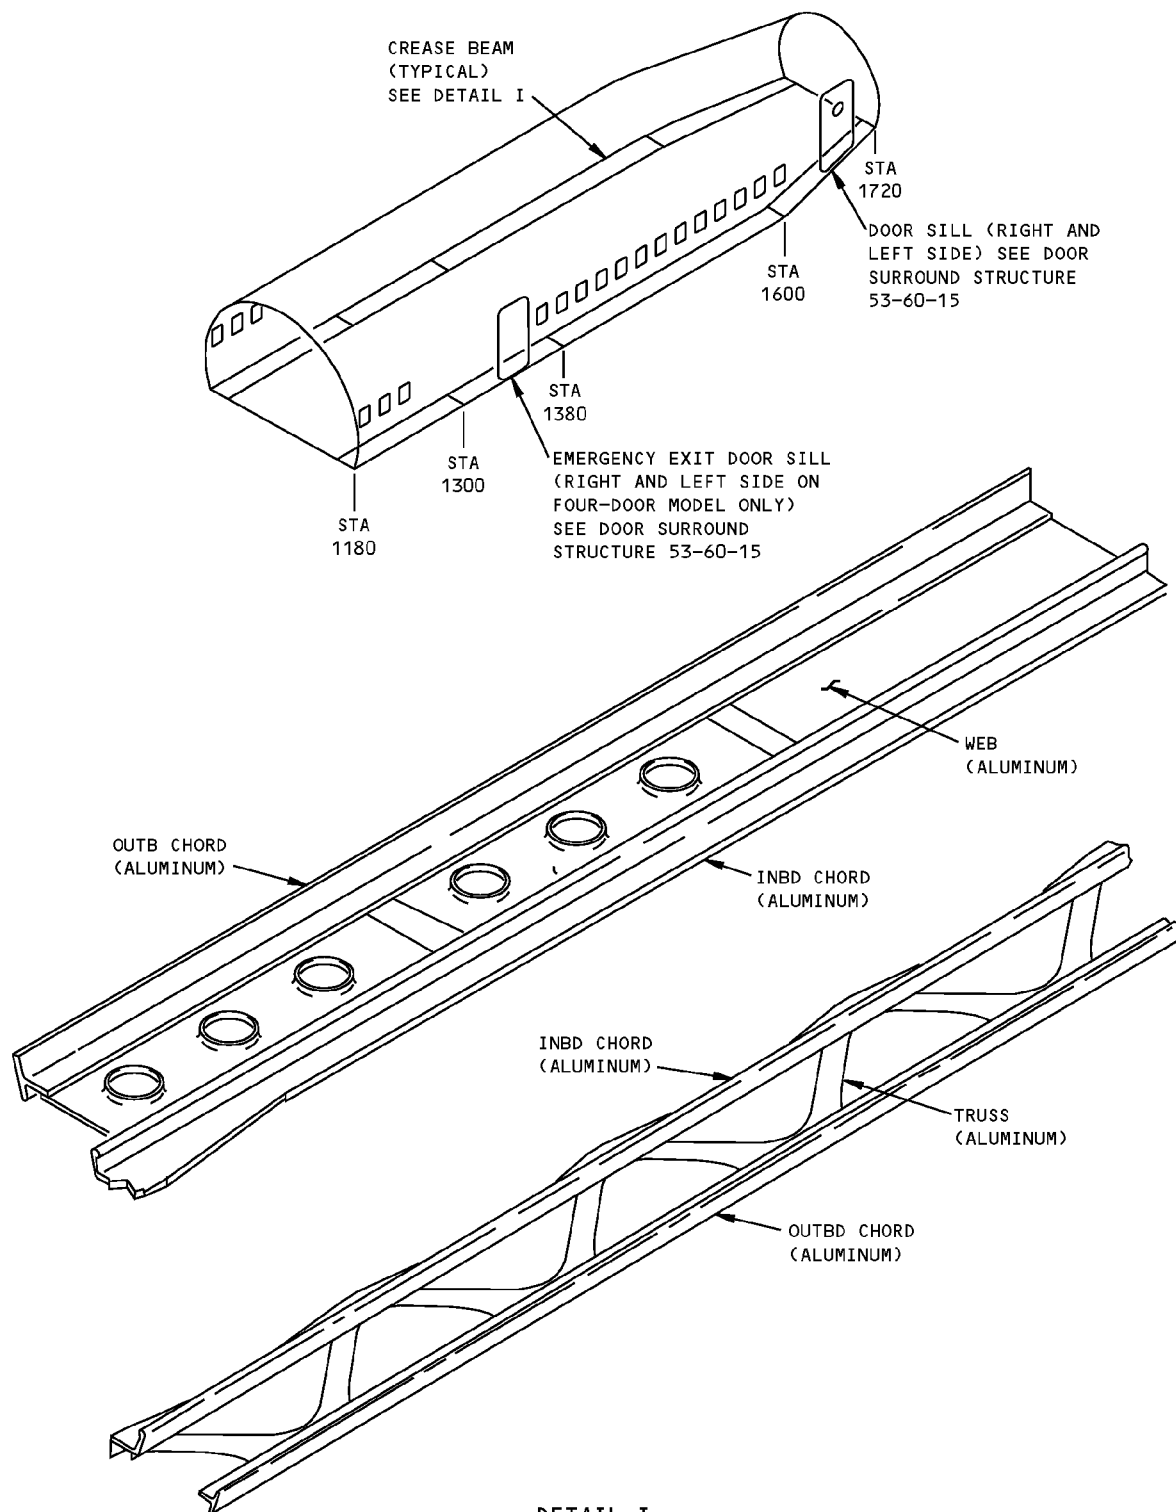
Section 46 Crease Beam Allowable Damage - 757-SF
Figure 101 (Sheet 1 of 5)

ALLOWABLE DAMAGE 2 - SECTION 46 - CREASE BEAM - 757-SF

DETAIL I

- THIS ALLOWABLE DAMAGE DATA IS APPLICABLE TO 757-SF AIRPLANES ONLY
- THIS ALLOWABLE DAMAGE IS A CATEGORY A REPAIR FOR 757-SF AIRPLANES. THE INSPECTIONS GIVEN IN THE MAINTENANCE PLANNING DATA (MPD) AND ASSOCIATED SUPPLEMENT ARE SUFFICIENT TO MAINTAIN THE DAMAGE TOLERANCE OF THE INITIAL STRUCTURE WITH THIS ALLOWABLE DAMAGE. REFER TO SRM 51-00-06 FOR REPAIR CATEGORIES AND DEFINITIONS.
- REFER TO IDENTIFICATION 1 FOR CREASE BEAM LOCATIONS
- ALL DIMENSIONS ARE IN INCHES
- REFINISH REWORKED AREAS IN AS GIVEN IN AMM 51-21
- REFER TO SRM 51-10-02 FOR INSPECTION AND REMOVAL OF DAMAGE

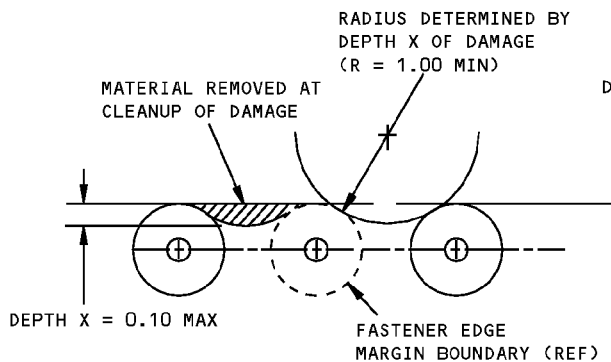
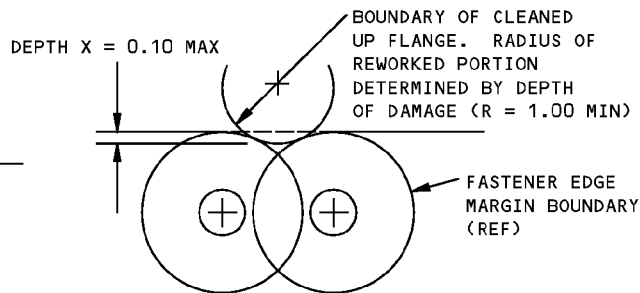
DETAIL II

DAMAGE CLEANUP OF EDGES WHERE
FASTENER EDGE MARGINS DO NOT OVERLAP

DAMAGE CLEANUP OF EDGES WHERE
FASTENER EDGE MARGINS OVERLAP

- A** REMOVE DAMAGE AS SHOWN IN DETAILS II, III, AND V.
- B** FOR EDGE CRACKS SEE DETAILS II AND V. FOR LIGHTENING HOLE EDGE CRACKS SEE DETAIL VI.
- C** REMOVE DAMAGE AS SHOWN IN DETAILS III, V, AND VI.
- D** CLEAN OUT DAMAGE UP TO 0.25 INCH (6 mm) MAX DIA AND NOT CLOSER THAN 1.5 INCHES (38 mm) TO FASTENER HOLE, MATERIAL EDGE, OR OTHER DAMAGE. FILL HOLE WITH 2117-T3 OR T4 ALUMINUM RIVET INSTALLED WET WITH BMS 5-95 SEALANT. ALL OTHER HOLES TO BE REPAIRED.
- E** CRACKS ARE NOT PERMITTED EXCEPT FOR EDGE CRACKS WHICH CAN BE REMOVED AS SHOWN IN DETAILS II AND V.

- F** REMOVE DAMAGE AS SHOWN IN DETAILS II AND III.
- G** CRACKS ARE NOT PERMITTED EXCEPT FOR EDGE CRACKS WHICH MUST BE REMOVED AS SHOWN IN DETAILS II AND VIII.

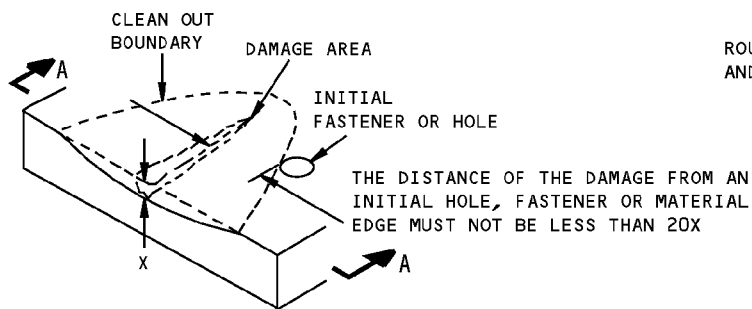
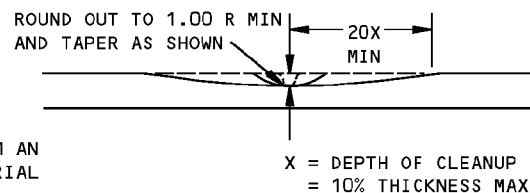
SECTION A-A

REMOVAL OF NICK, GOUGE AND SCRATCH DAMAGE ON A SURFACE

DETAIL III L M

- L** DAMAGE REMOVAL AS SHOWN IN DETAIL III NOT PERMITTED BETWEEN STA. 1320 AND STA. 1350.
- M** DAMAGE REMOVAL AS SHOWN IN DETAIL III NOT PERMITTED BETWEEN:

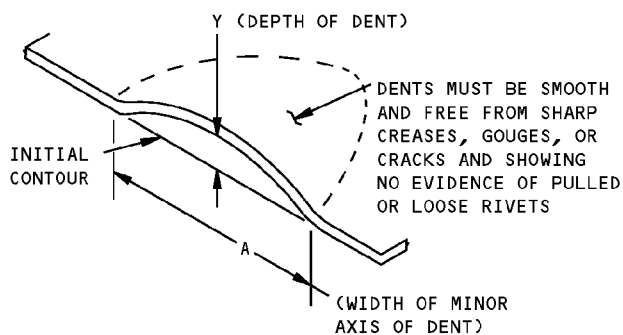
$\frac{A}{Y}$ MUST NOT BE LESS THAN 30
 $Y (MAX) = 0.125$

ALLOWABLE DAMAGE FOR DENT
DETAIL IV

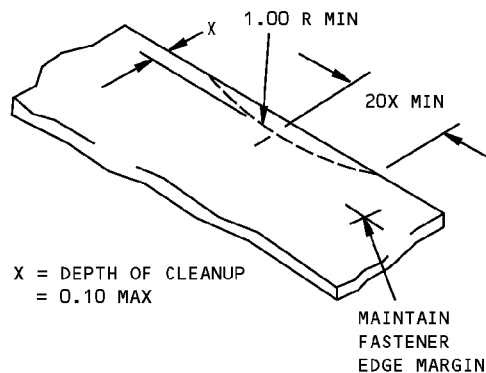
REMOVAL OF NICK OR CRACK
DAMAGE ON AN EDGE
DETAIL V

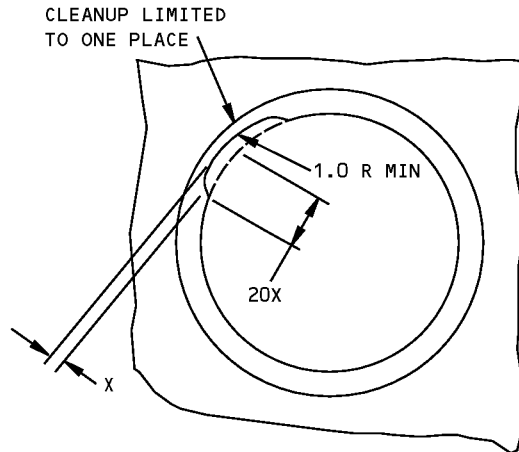
X = DEPTH OF CLEANUP = 0.10 MAX OR
1/2 FLANGE WIDTH WHICHEVER IS LESS

**FLANGED HOLE EDGE DAMAGE CLEANUP
DETAIL VI**

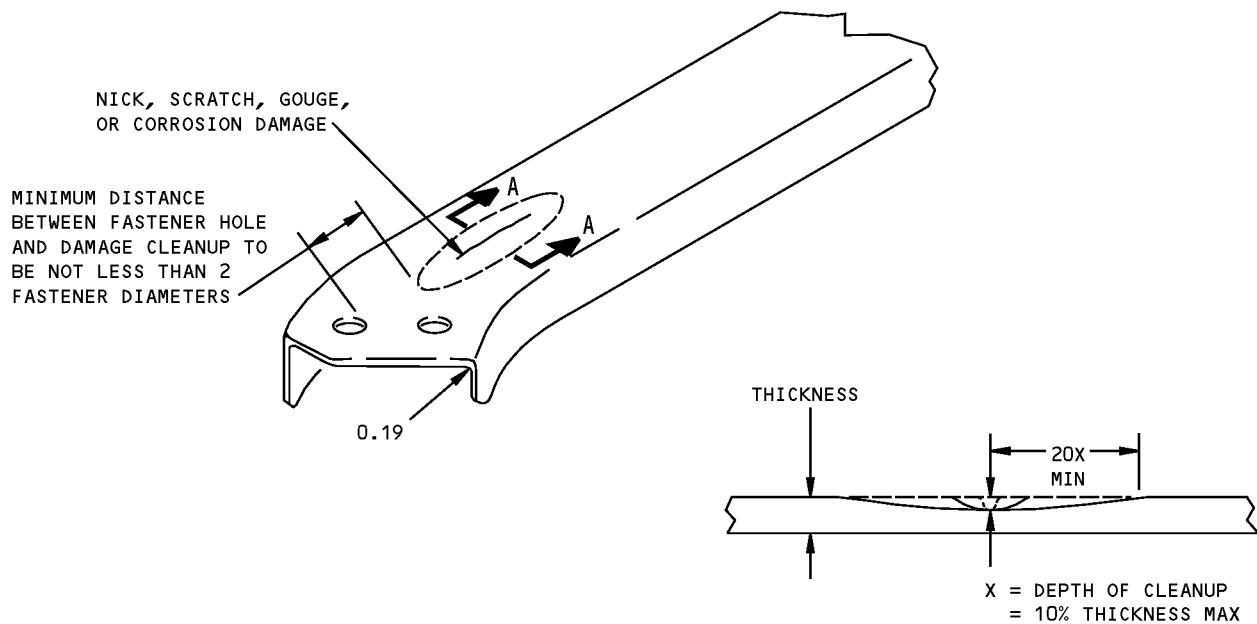
SECTION A-A

**NICK, GOUGE, AND SCRATCH REMOVAL
FROM SURFACE OF CREASE BEAM TRUSS
DETAIL VII**

- H** CRACKS ARE NOT PERMITTED EXCEPT FOR EDGE CRACKS WHICH MUST BE REMOVED AS SHOWN IN DETAILS II AND III.
- J** REMOVE EDGE DAMAGE AS SHOWN IN DETAILS II AND V. BLEND OUT SURFACE DAMAGE AS SHOWN IN DETAIL VII.

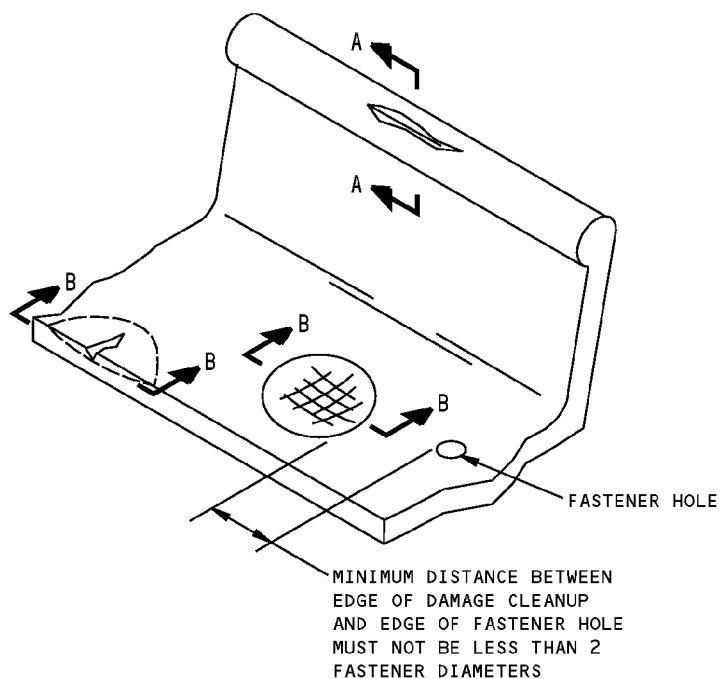
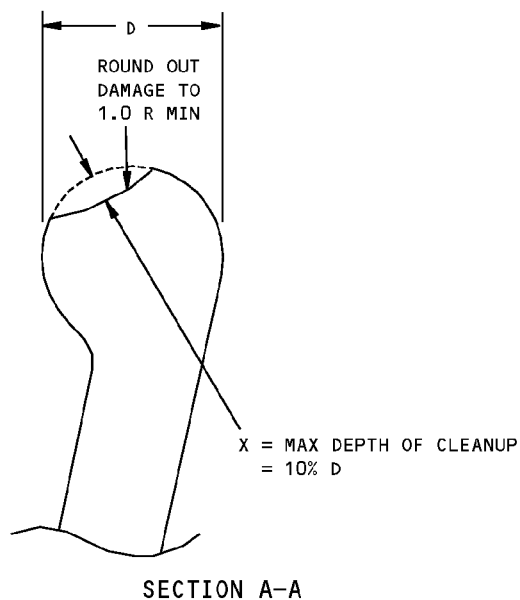
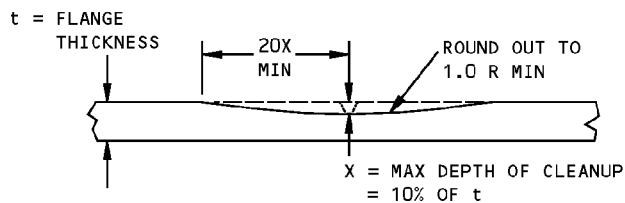
DAMAGE CLEANUP MUST NOT
REDUCE CROSS-SECTIONAL
AREA BY MORE THAN 10%

SECTION THRU EXTRUSION

SECTION A-A

SECTION B-B

DAMAGE CLEANUP OF BULB ANGLE
DETAIL VIII

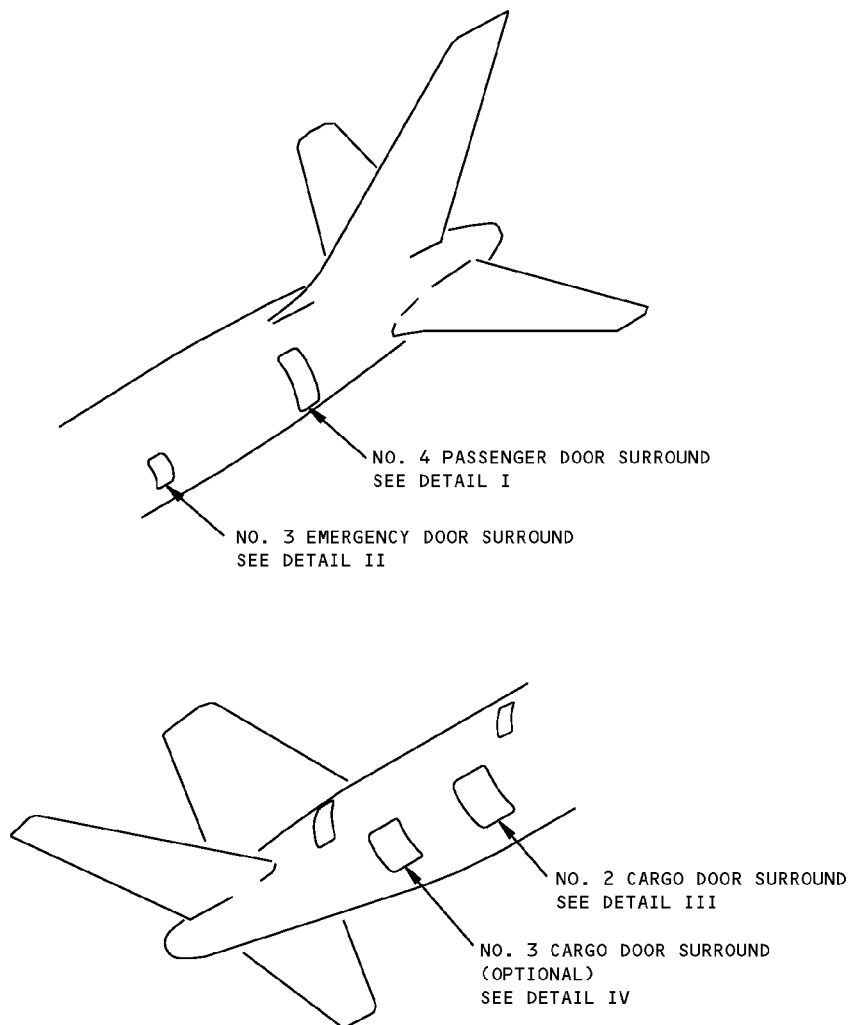
**Section 46 Door Surround Structure Identification
Figure 1 (Sheet 1 of 9)**

IDENTIFICATION 1 - SECTION 46 - DOOR SURROUND STRUCTURE

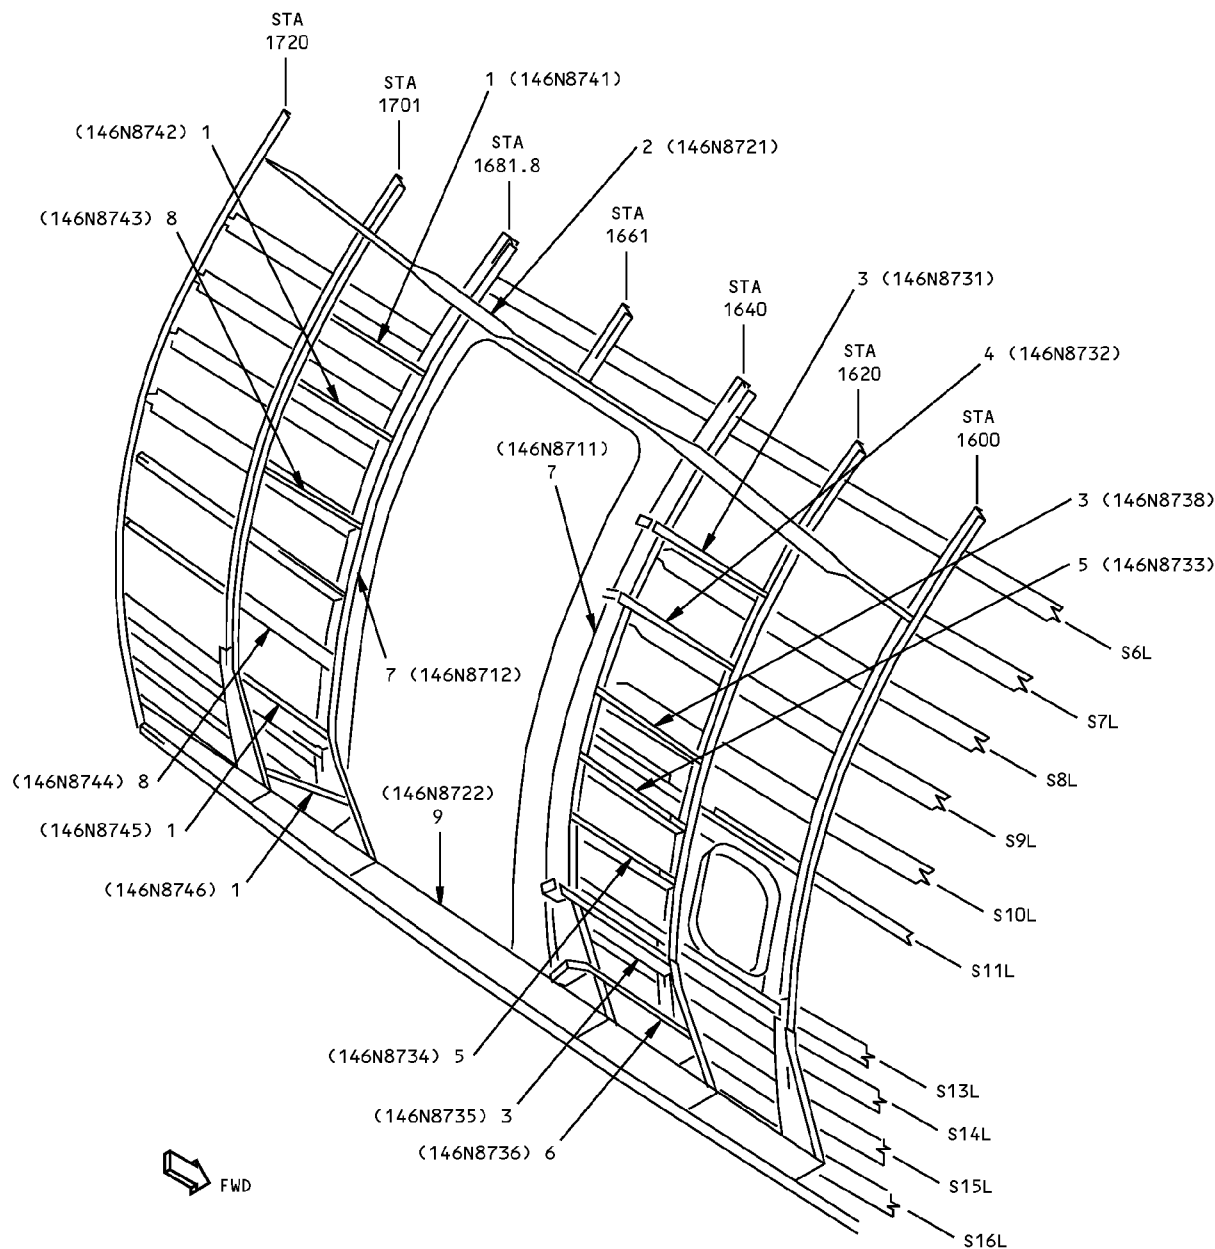
DETAIL I

No. 4 PASSENGER DOOR
LEFT SIDE AS SHOWN
RIGHT SIDE OPPOSITE
