FUSELAGE

757-200 STRUCTURAL REPAIR MANUAL

CHAPTER 53 FUSELAGE

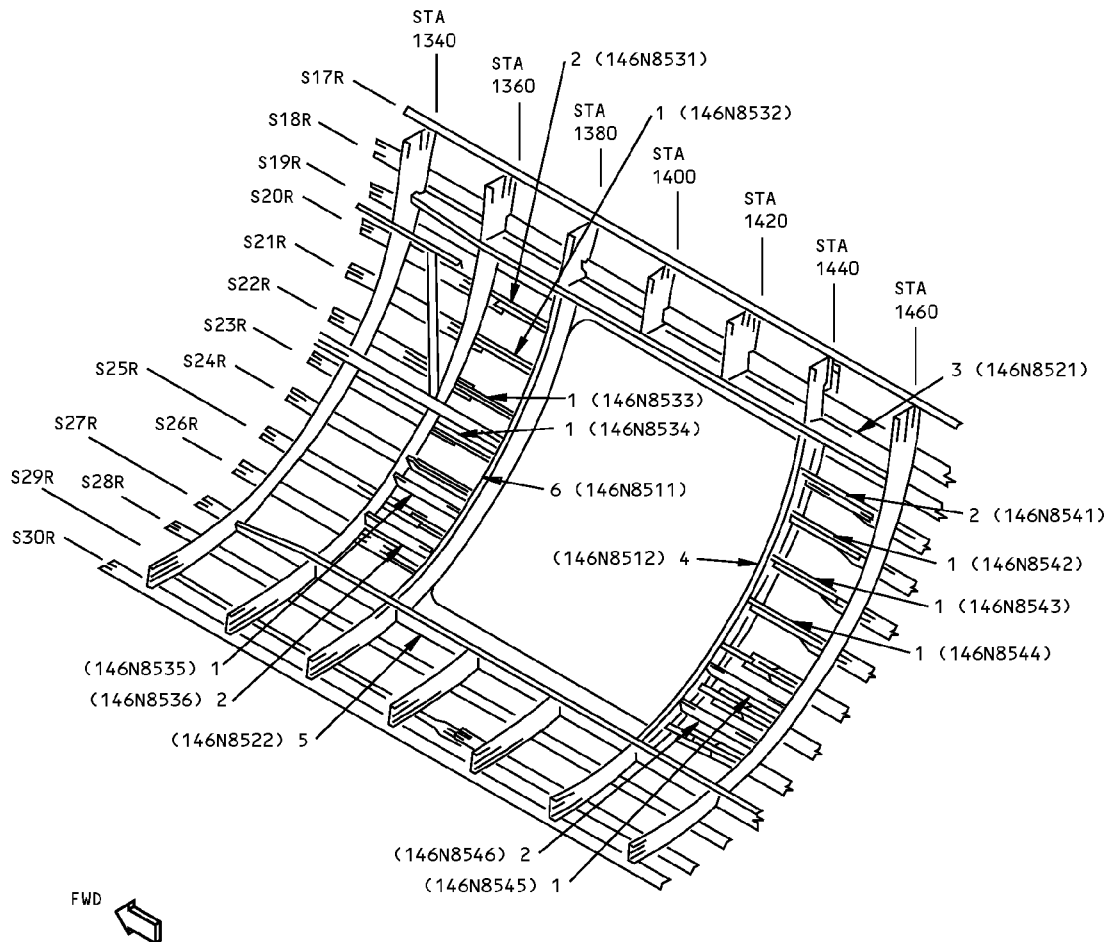
NO. 2 CARGO DOOR SURROUND STRUCTURE

RIGHT SIDE ONLY

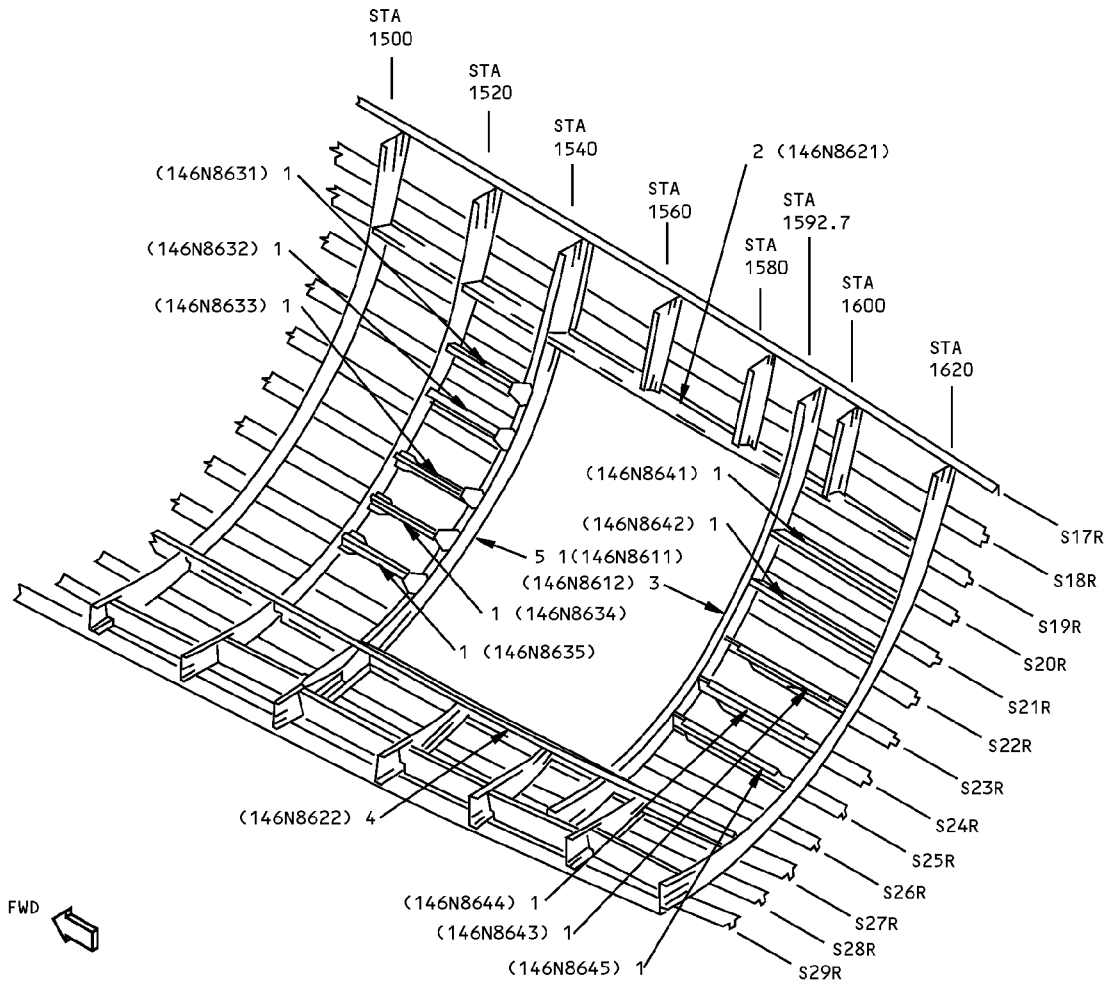
DETAIL IV

REF DWG
143N5520

NO. 3 CARGO DOOR SURROUND STRUCTURE
(RIGHT SIDE ONLY)

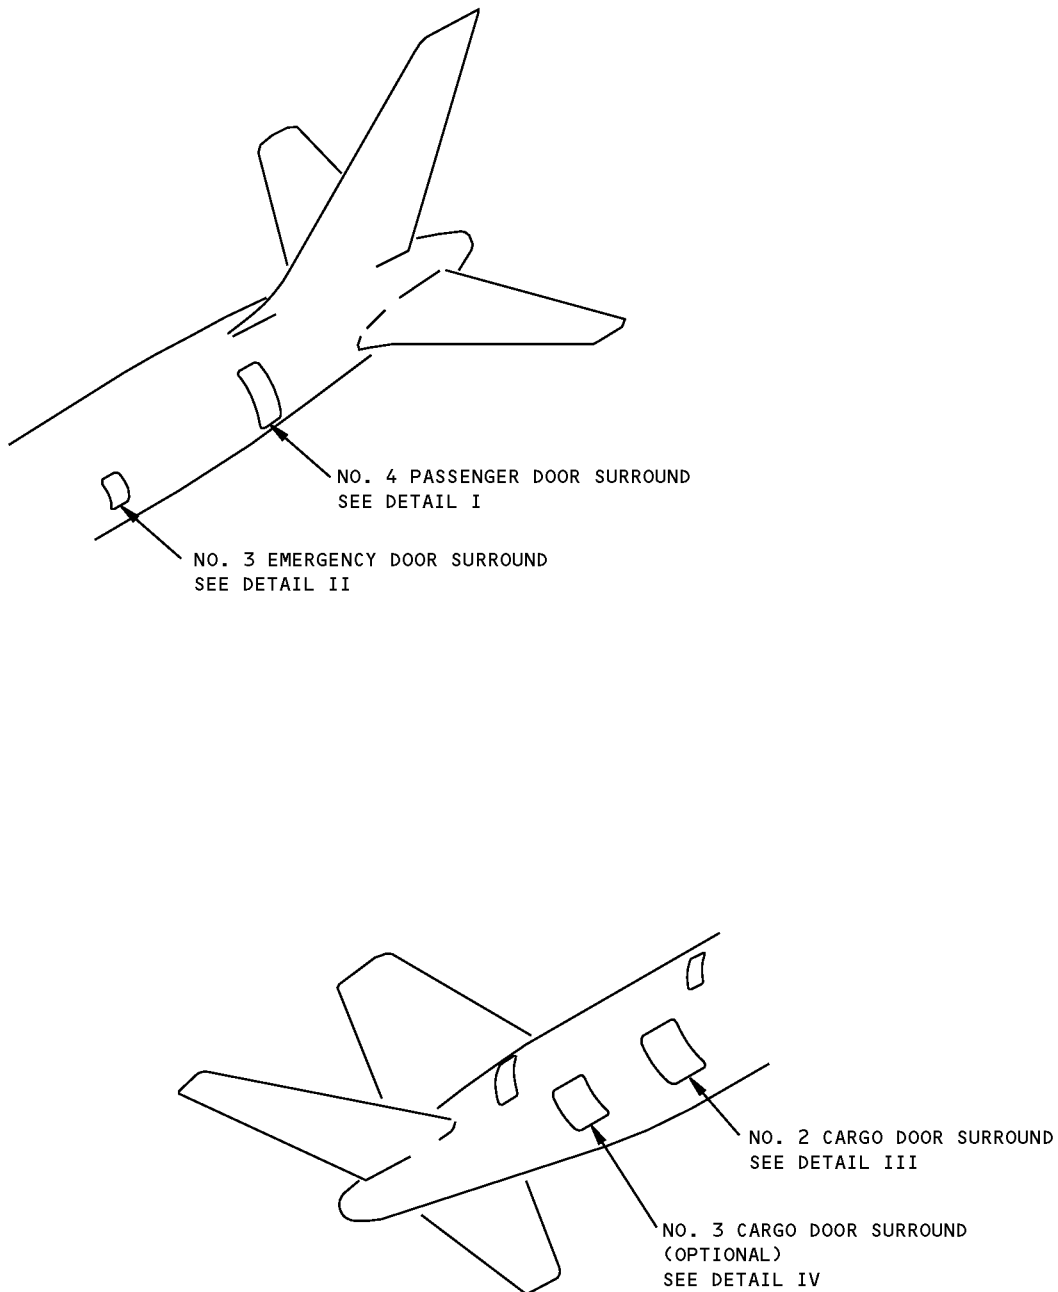
Section 46 Door Surround Structure Allowable Damage
Figure 101 (Sheet 1 of 7)

ALLOWABLE DAMAGE 1 - SECTION 46 - DOOR SURROUND STRUCTURE

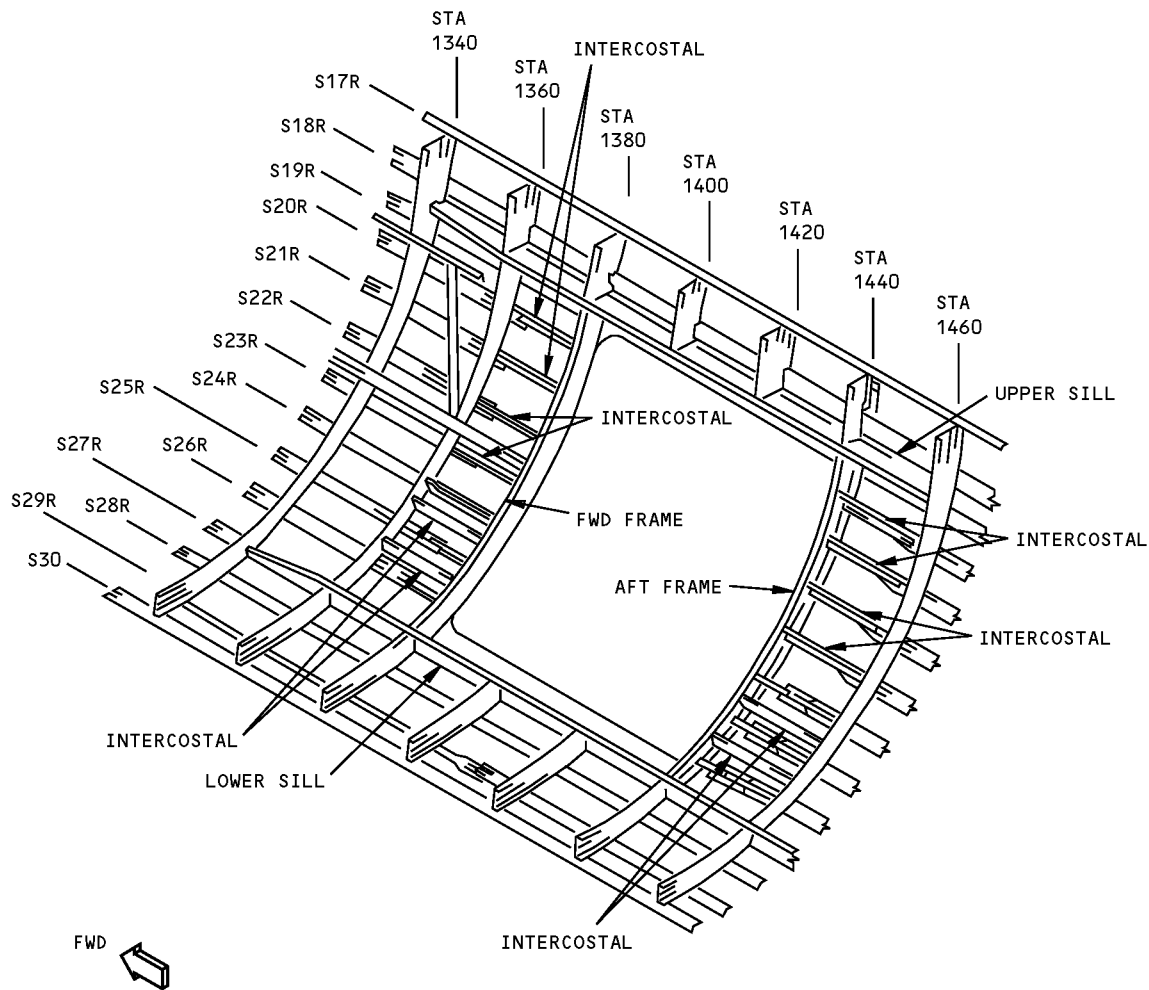
RIGHT SIDE ONLY
DETAIL III

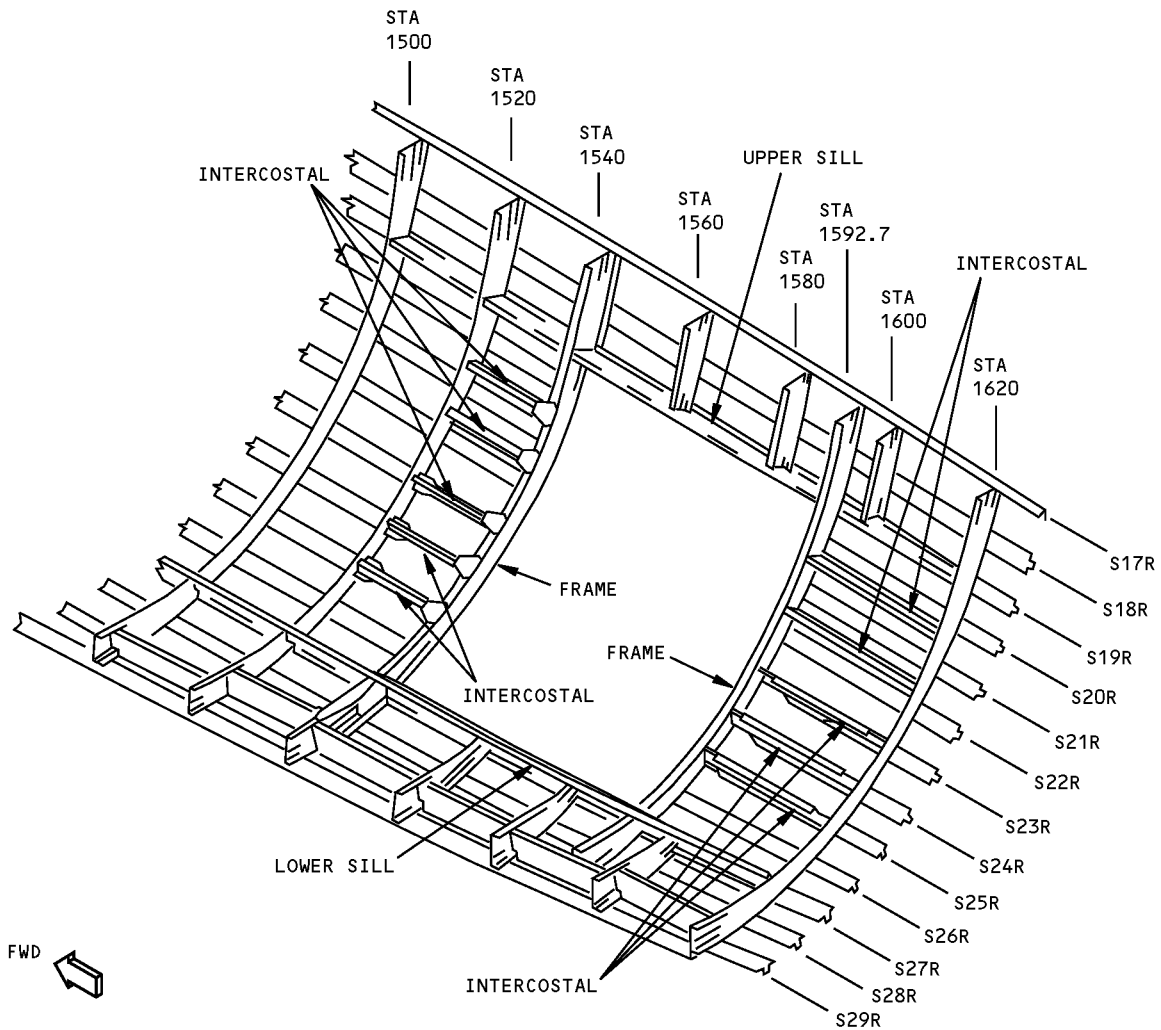
RIGHT SIDE ONLY
DETAIL IV

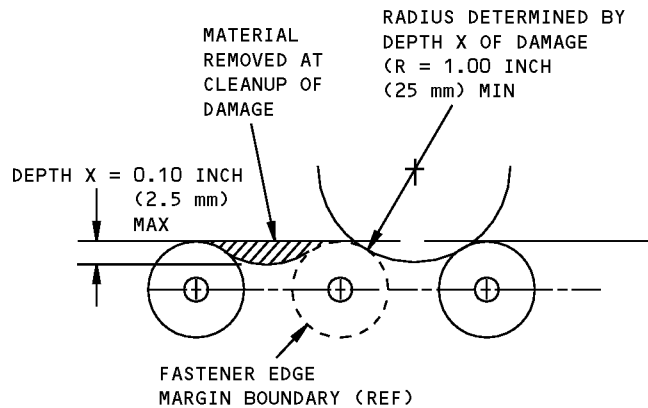
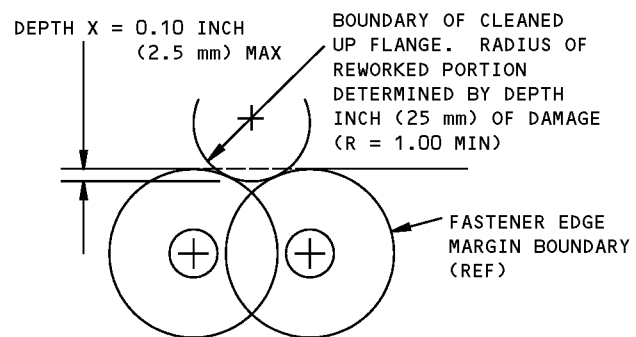
DETAIL V

DAMAGE CLEANUP OF EDGES WHERE
FASTENER EDGE MARGINS DO NOT OVERLAP

DAMAGE CLEANUP OF EDGES WHERE
FASTENER EDGE MARGINS OVERLAP

A CRACKS ARE NOT PERMITTED EXCEPT FOR EDGE CRACKS WHICH MUST BE REMOVED AS GIVEN IN DETAILS V AND IX.

B REMOVE DAMAGE AS GIVEN IN DETAILS V, VI, VIII, AND IX.

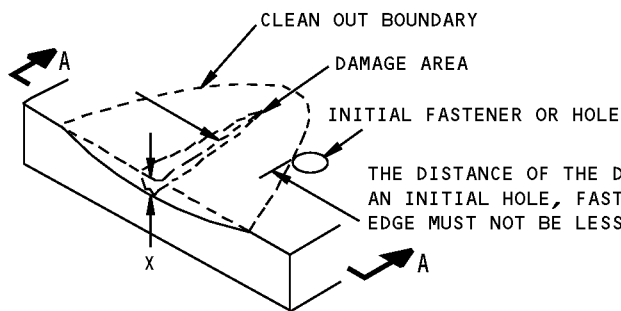
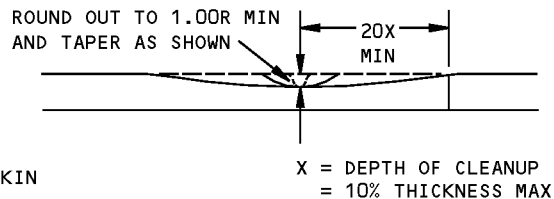
SECTION A-A

REMOVAL OF NICK, GOUGE AND SCRATCH DAMAGE ON A SURFACE DETAIL VI

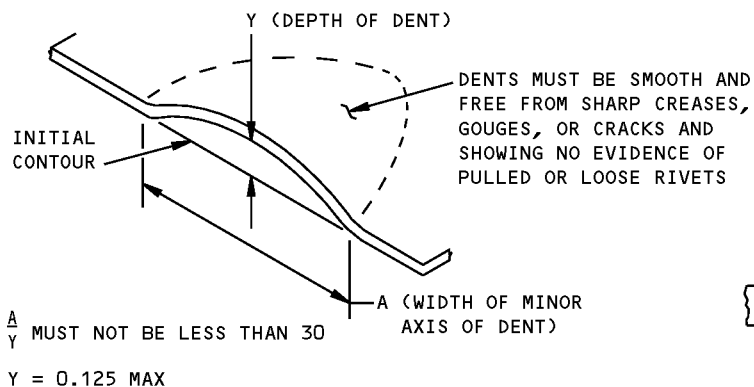
ALLOWABLE DAMAGE FOR DENT DETAIL VII

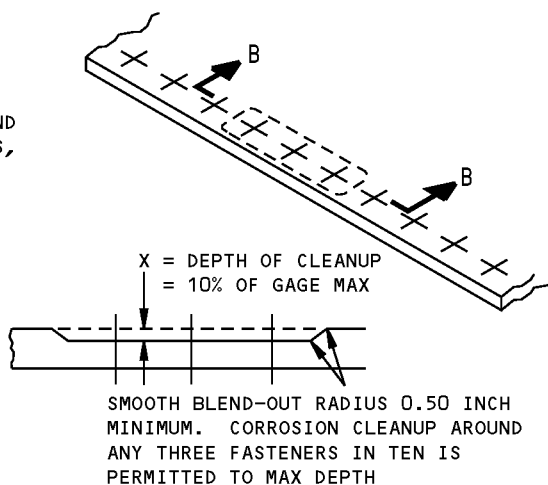
SECTION B-B

CORROSION CLEANUP DETAIL VIII

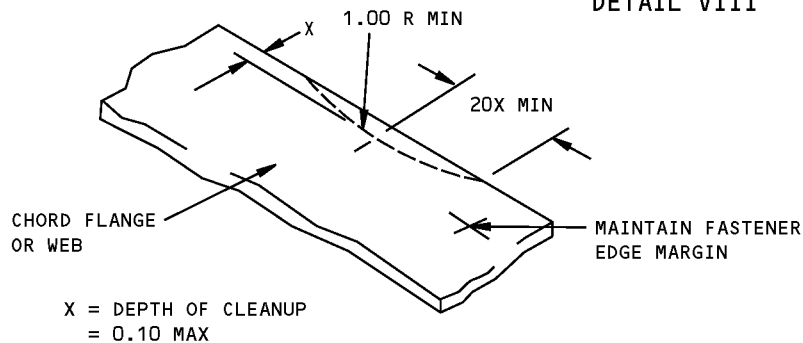
REMOVAL OF NICK OR CRACK DAMAGE ON AN EDGE DETAIL IX

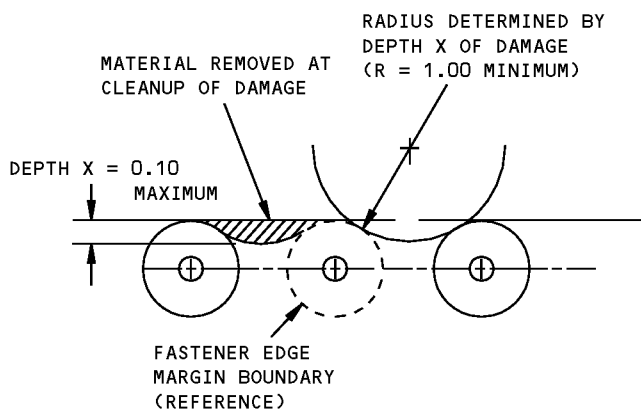
DETAIL I

DAMAGE CLEANUP OF EDGES WHERE
FASTENER EDGE MARGINS DO NOT OVERLAP

DAMAGE CLEANUP OF EDGES WHERE
FASTENER EDGE MARGINS OVERLAP

- A** CRACKS ARE NOT PERMITTED EXCEPT FOR EDGE CRACKS WHICH MUST BE REMOVED PER DETAILS I AND V.
- B** REMOVE DAMAGE PER DETAILS I, II, III OR IV, AND V. SURFACE FINISH REQUIRED 63 MICRO-INCHES R_a OR BETTER.

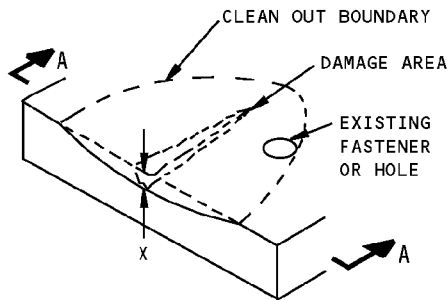
REMOVAL OF NICK, GOUGE AND SCRATCH
DAMAGE ON A SURFACE
DETAIL II

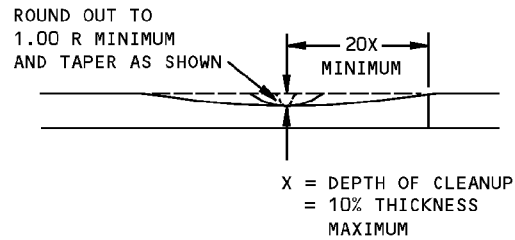
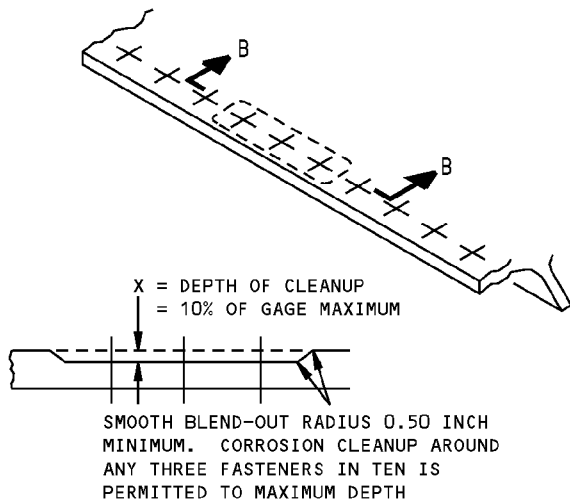
SECTION A-A

SECTION B-B

CORROSION CLEANUP
SEE DETAIL IV; EXPANDED DEPTH CLEANUP
LOCATION FOR STATION 1378 TO 1442
DETAIL III

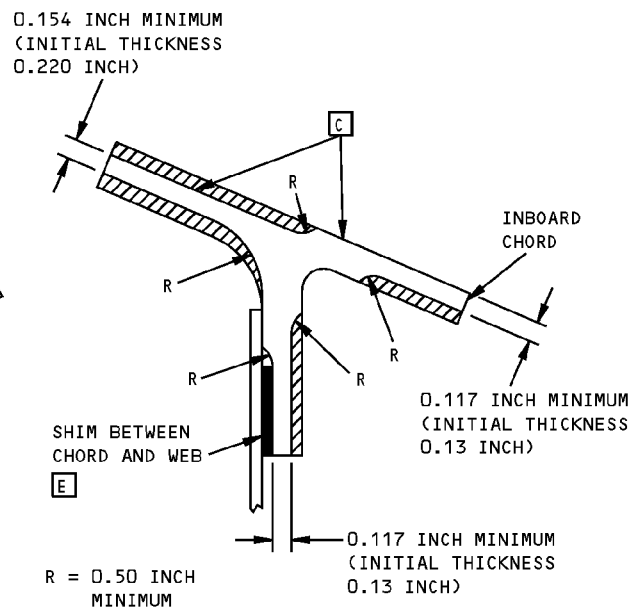
STATION 1378 TO 1442 ONLY
(TYPICAL)
DETAIL IV D

- D** THE THICKNESS SHOWN ARE THE MINIMUM REQUIRED THICKNESS REMAINING AFTER CORROSION REMOVAL FROM EITHER ONE OR BOTH SURFACES ON A FLANGE.
- E** SOLID OR LAMINATED SHIM. MAKE THE MATERIAL AND THICKNESS FOR THE SHIM THE SAME AS THE REMOVED MATERIAL.

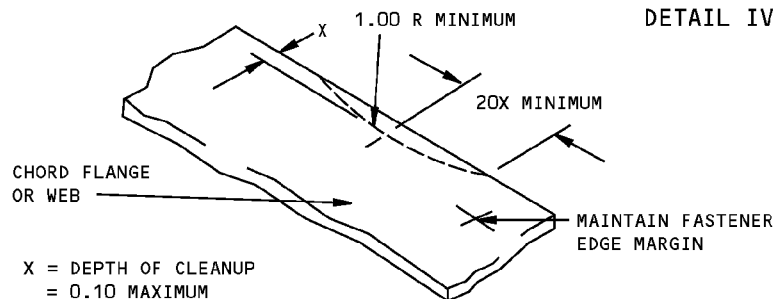
REMOVAL OF NICK OR CRACK DAMAGE ON AN EDGE
DETAIL V

Section 46 Cargo Door Number 2 Lower Sill, Inboard Chord Stations 1378 - 1442 Allowable Damage
Figure 101 (Sheet 2 of 2)

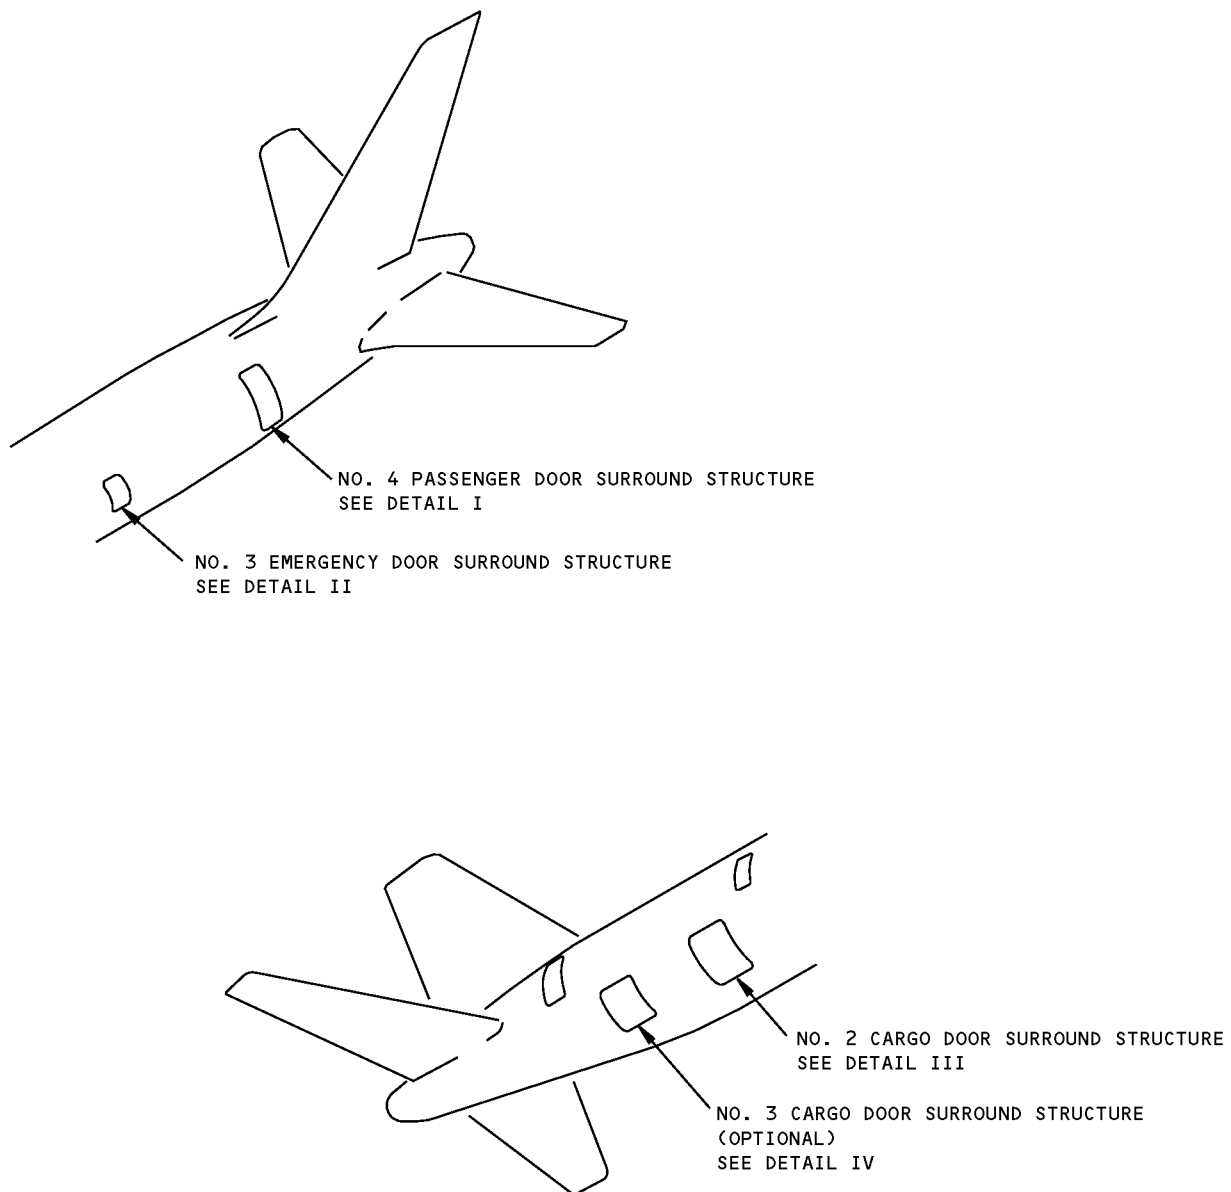
Section 46 Door Surround Structure Repair Figure 201 (Sheet 1 of 5)

- THIS REPAIR DATA IS APPLICABLE TO PASSENGER AIRPLANES ONLY
- DAMAGED COMPONENTS IN DOOR SURROUND STRUCTURE MAY BE REPLACED OR REPAIRED. IF REPAIRS ARE TO BE MADE, REFER TO SRM 51-70 FOR TYPICAL WEB, AND EXTRUDED SECTION REPAIRS

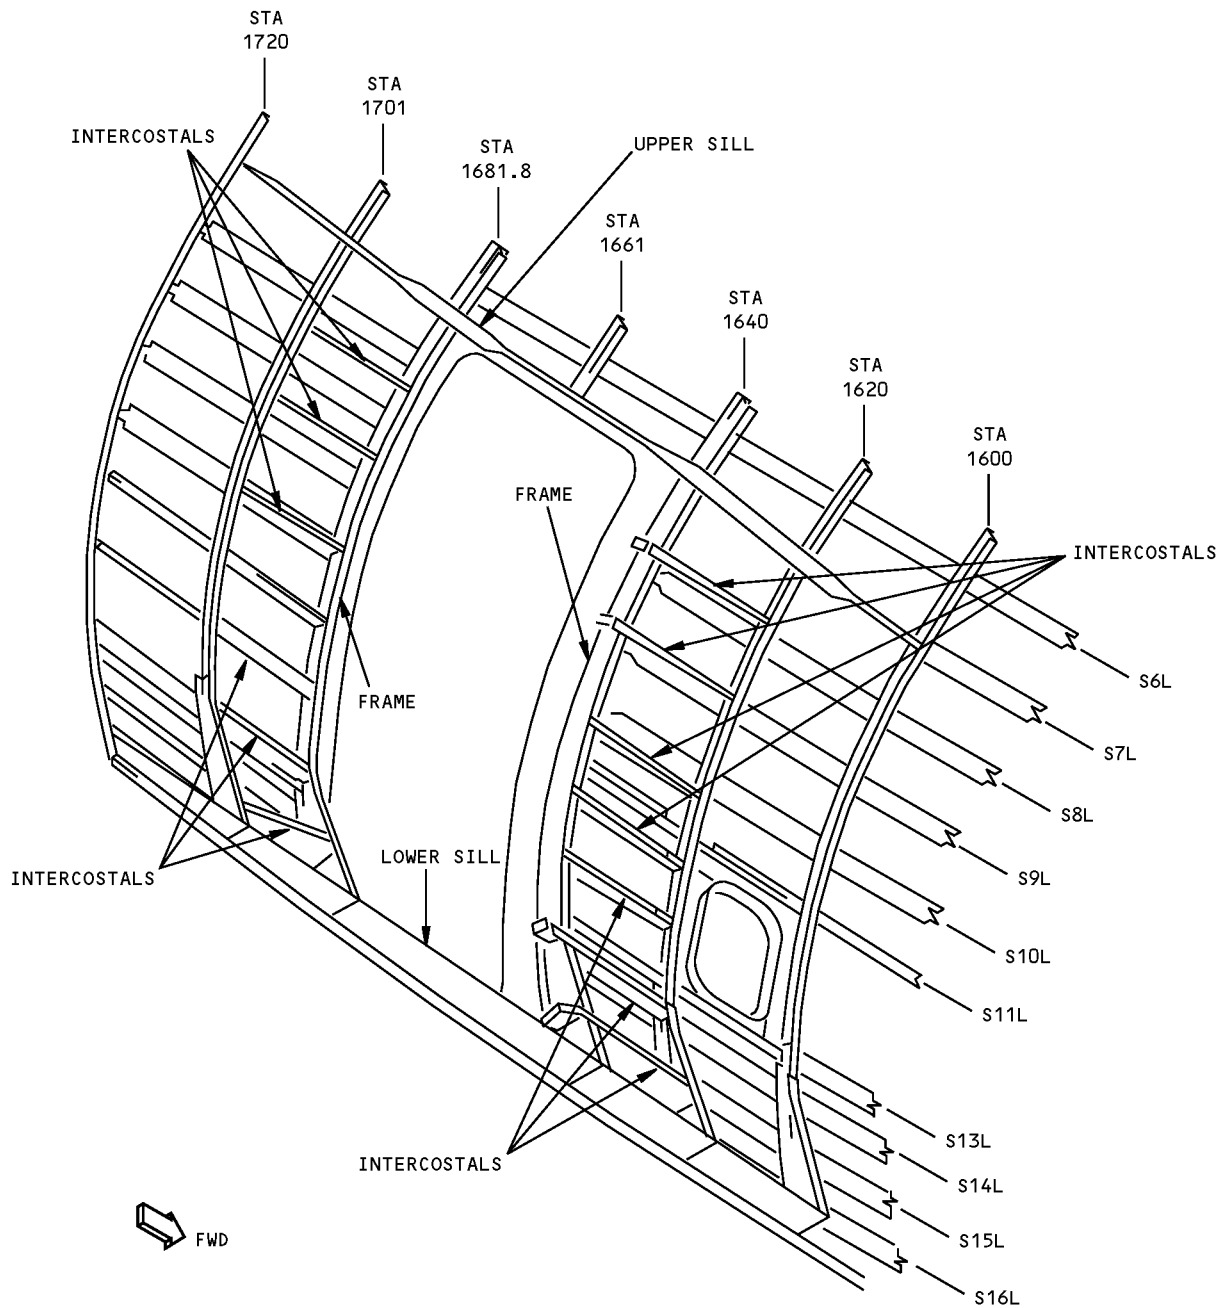
Section 46 Door Surround Structure Repair Figure 201 (Sheet 2 of 5)

LEFT SIDE AS SHOWN
RIGHT SIDE OPPOSITE

DETAIL I

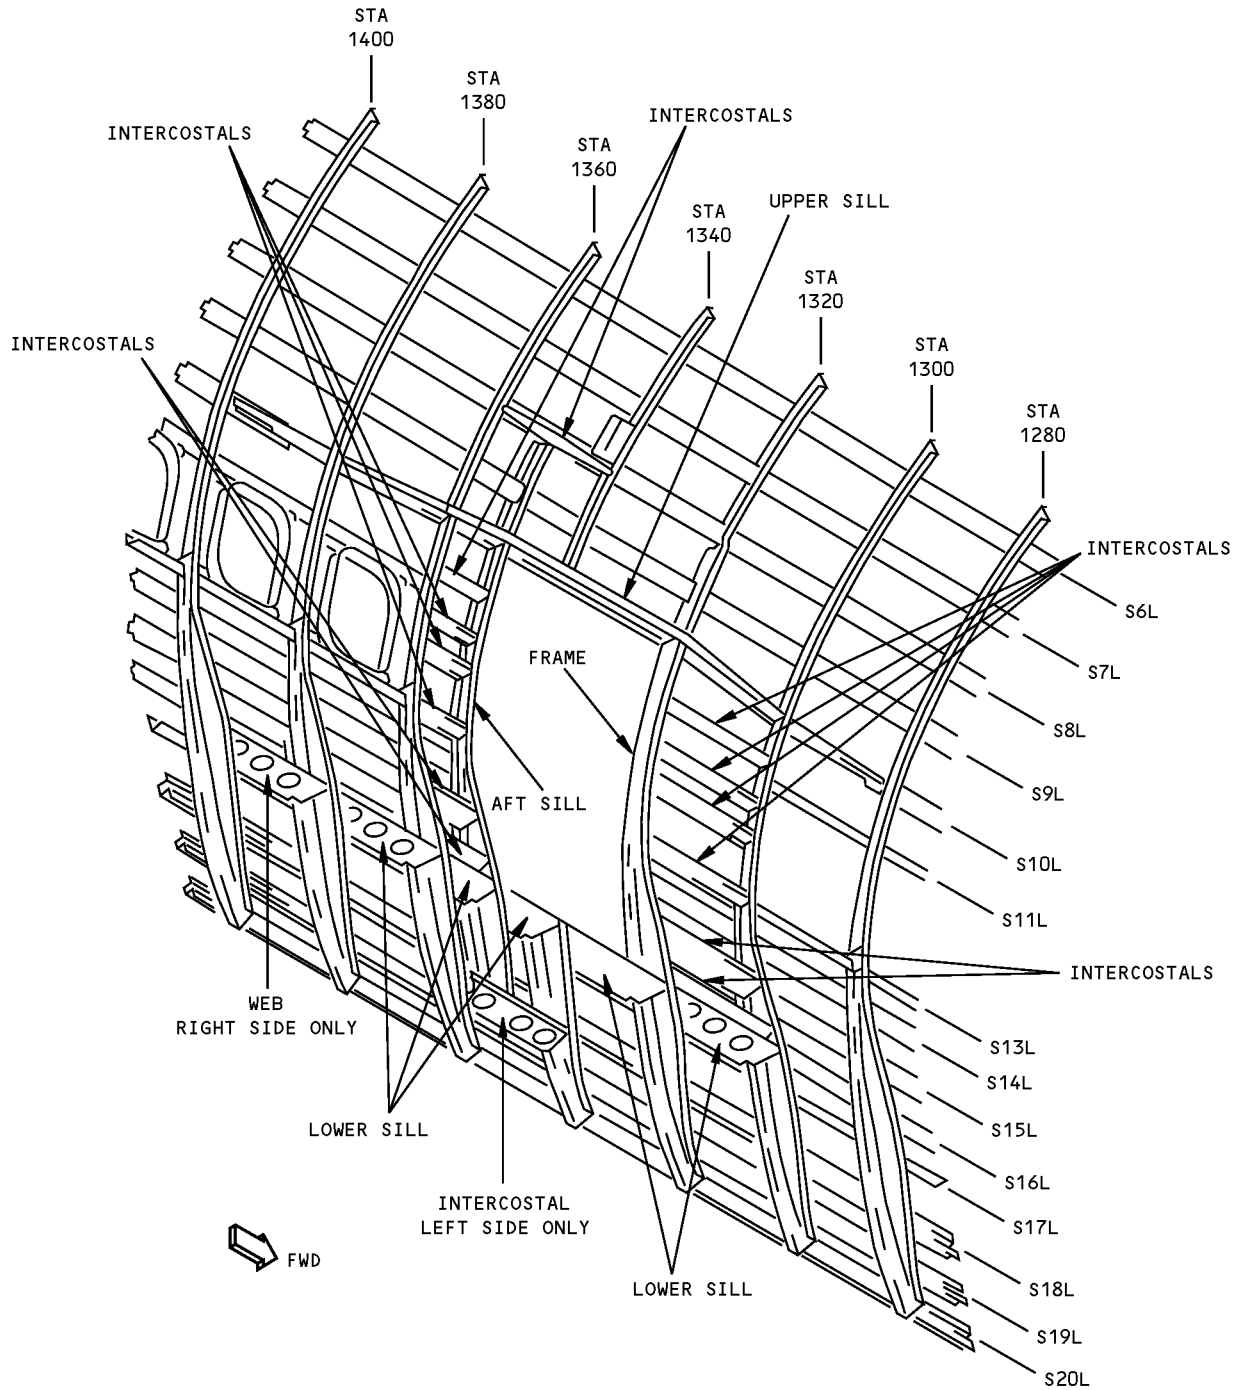
Section 46 Door Surround Structure Repair Figure 201 (Sheet 3 of 5)

LEFT SIDE SHOWN
RIGHT SIDE OPPOSITE

DETAIL II

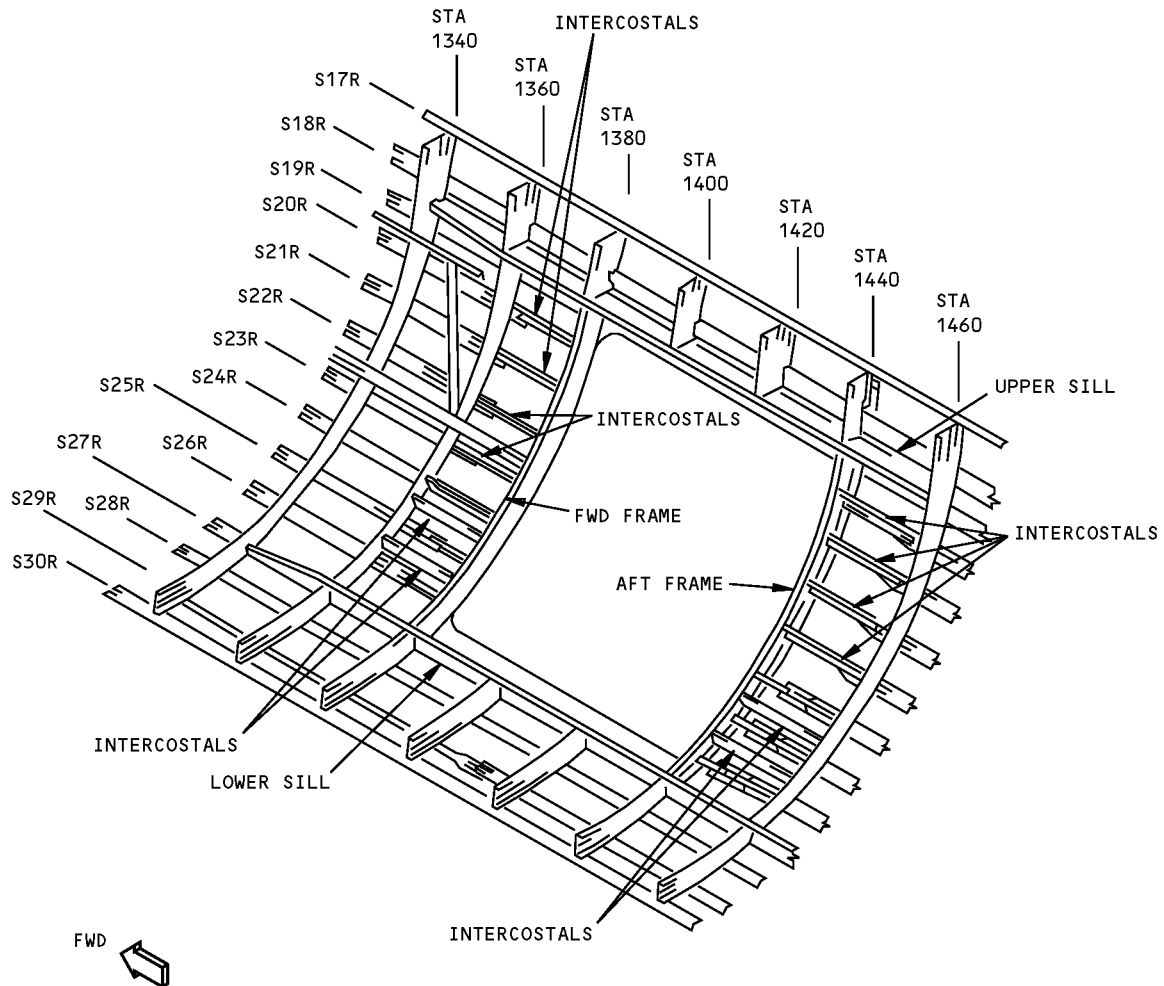
**Section 46 Door Surround Structure Repair
Figure 201 (Sheet 4 of 5)**

RIGHT SIDE ONLY
DETAIL III

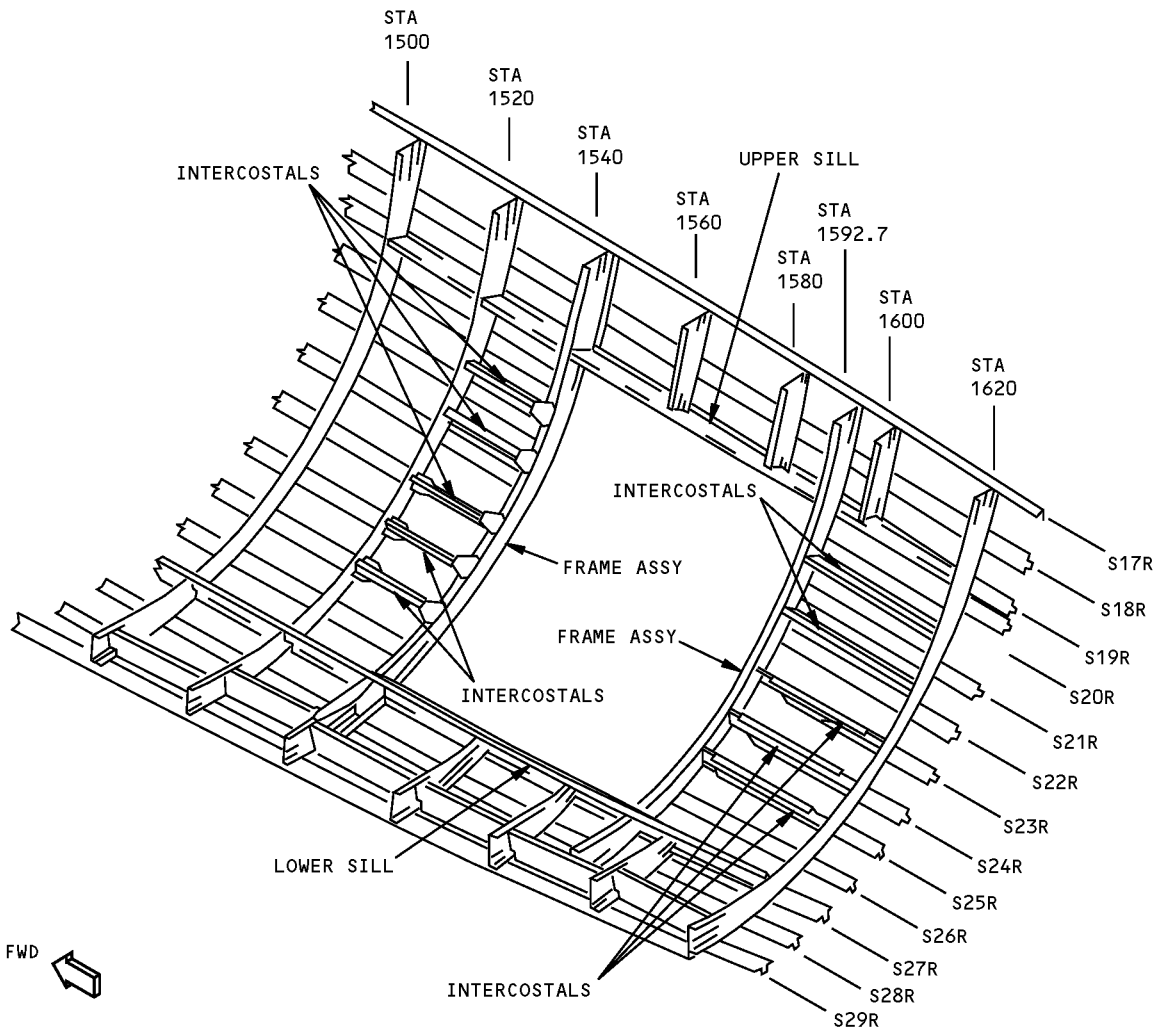
Section 46 Door Surround Structure Repair
Figure 201 (Sheet 5 of 5)

RIGHT SIDE ONLY
DETAIL IV

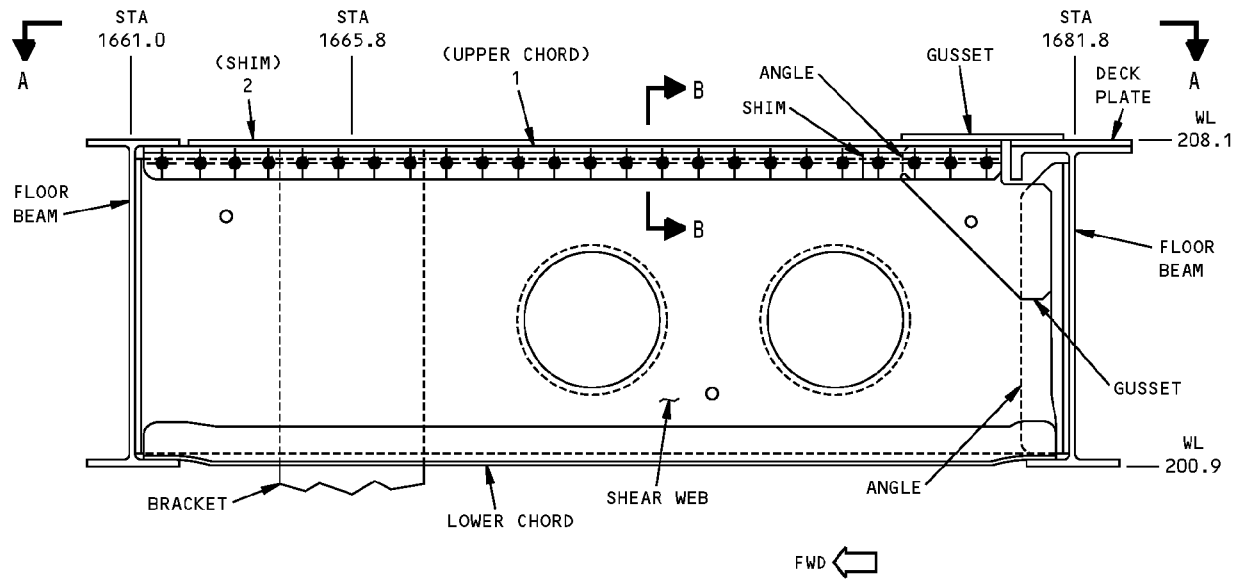
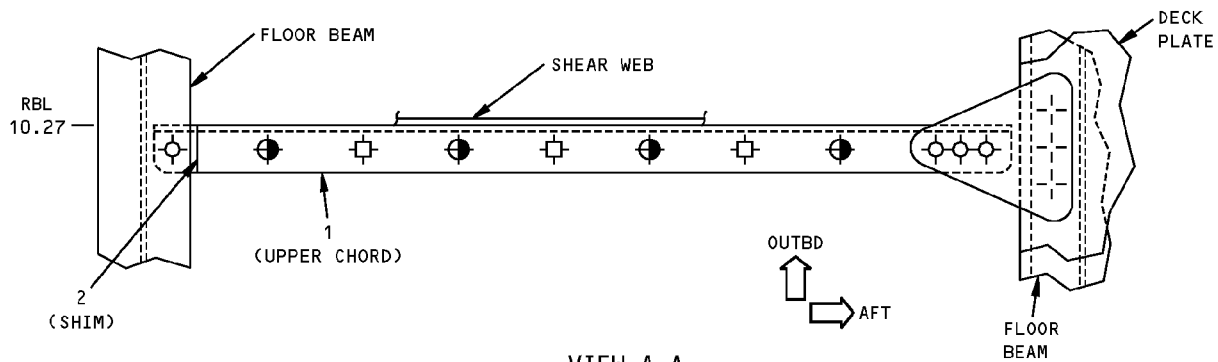
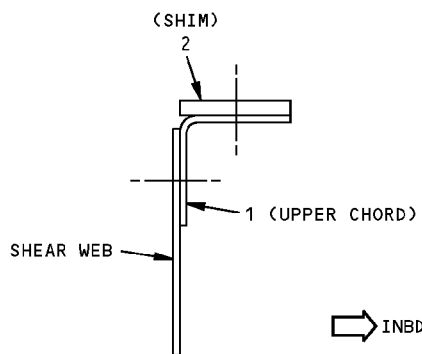
Section 46 Floor Structure - Intercostal Upper Chord Repair Between Station 1661 and 1681.8
Figure 201 (Sheet 2 of 2)

DETAIL I

VIEW A-A

SECTION B-B

1. Remove the floor panels and other structure to get access to the floor beams, gusset and intercostal angle.
2. Remove all the initial fasteners from the repair area. See Detail I.

3. Remove and discard the damaged angle.
4. Make the repair parts. See Table I.
5. Assemble the repair parts and drill the initial fastener hole locations and the repair fastener locations. [A] [B]

- [A] MAKE SURE THE INITIAL FASTENER HOLE LOCATIONS IN THE REPAIR ANGLE ARE LOCATED BY THE FASTENER HOLES IN THE FLOOR PANEL. MAKE SURE THE REPAIR FASTENER EDGE MARGIN IS A MINIMUM OF 2D AND FASTENER SPACING IS A MAXIMUM OF 2.0 INCHES (50 mm).
- [B] DRILL THE FASTENER HOLES FOR THE BACR15DR3 RIVETS THROUGH THE REPAIR ANGLE ONLY.
- [C] IF NECESSARY, INSTALL A 1/32 INCH OVERSIZE FASTENER OF THE SAME TYPE AS THE INITIAL FASTENER.

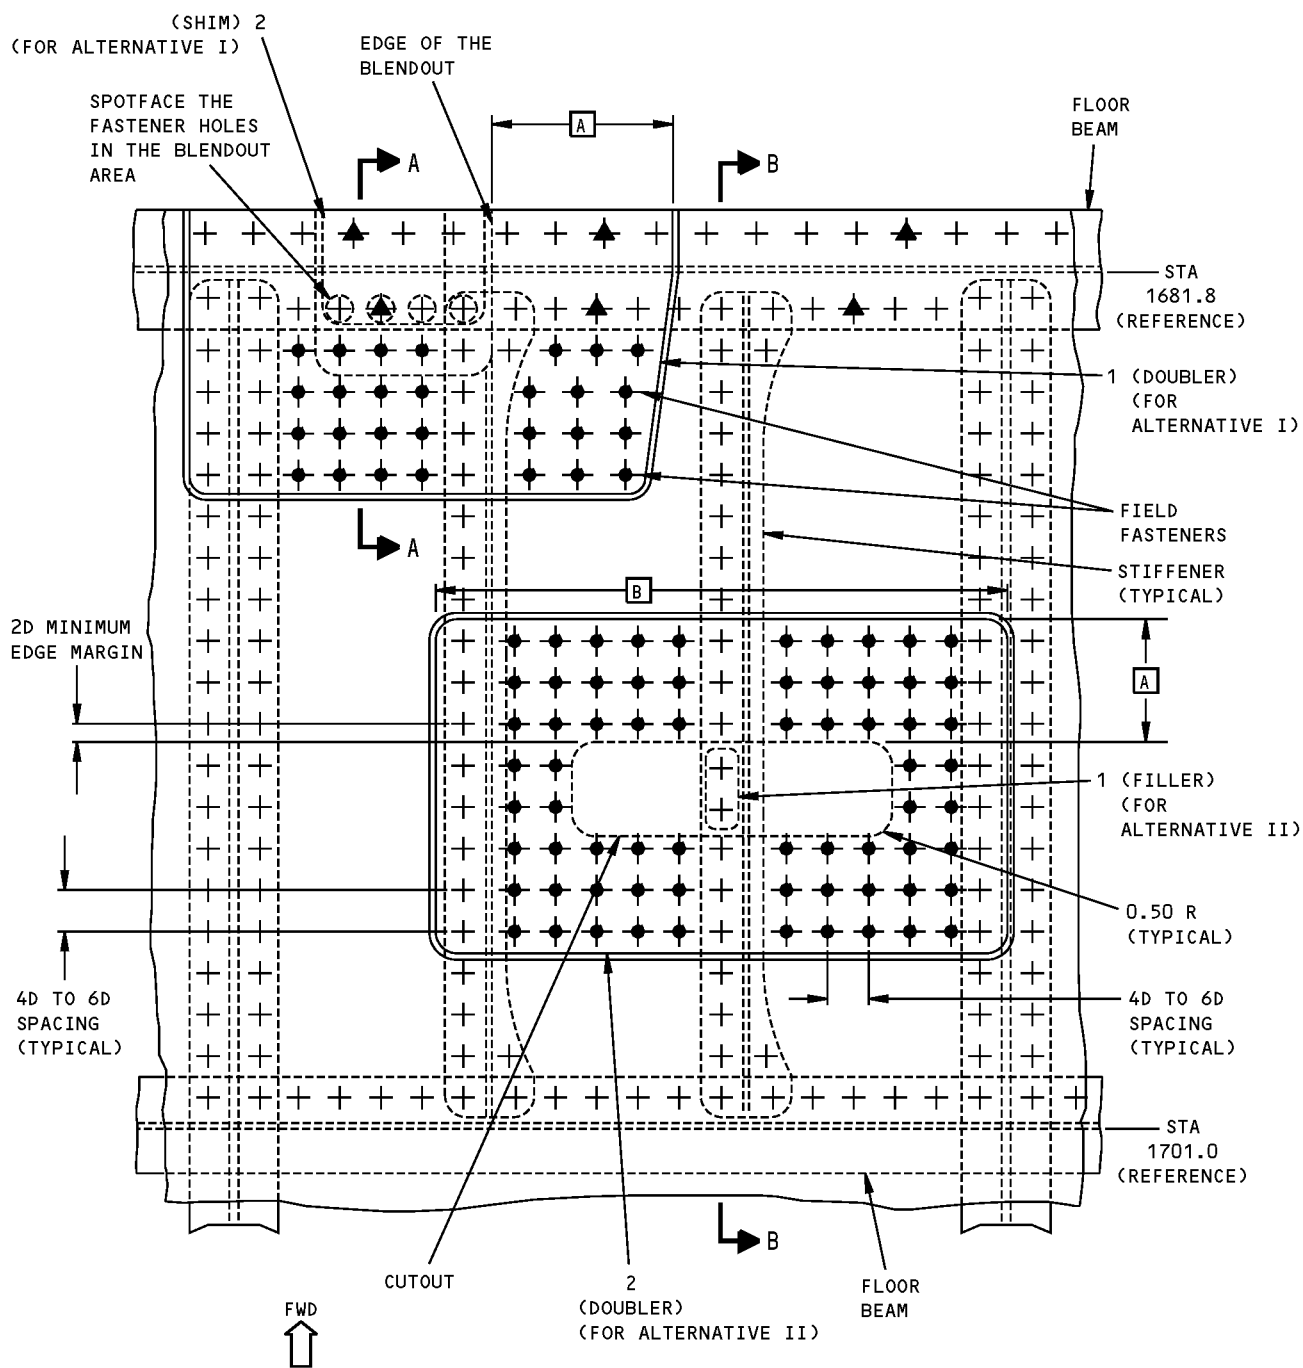
Section 46 Aft Deck Plate Repair
Figure 201 (Sheet 4 of 5)

TYPICAL REPAIR INSTALLATION
DETAIL I

1. Make the repair parts as shown in Table I and Detail I. Where the blendout intersects the fastener locations, and the gaps between the deck plate and the part 1 doubler are more than 0.01 deep, do one of the steps that follow:

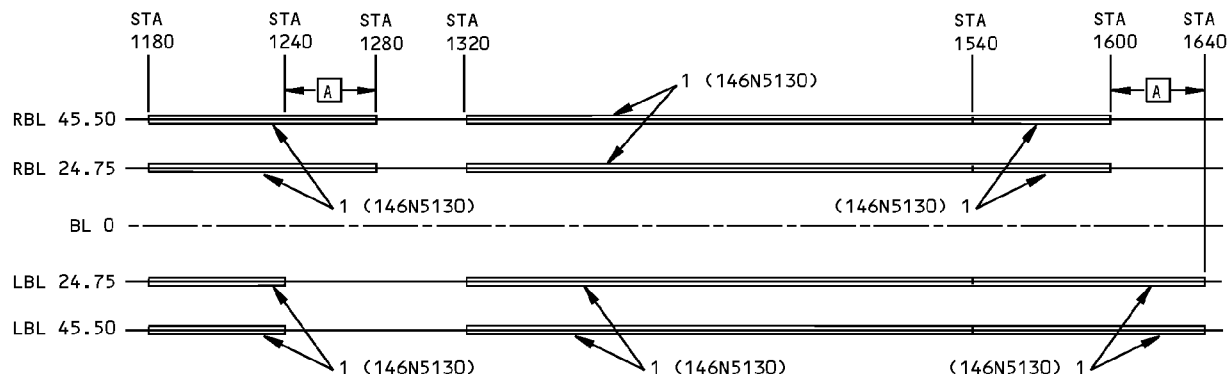
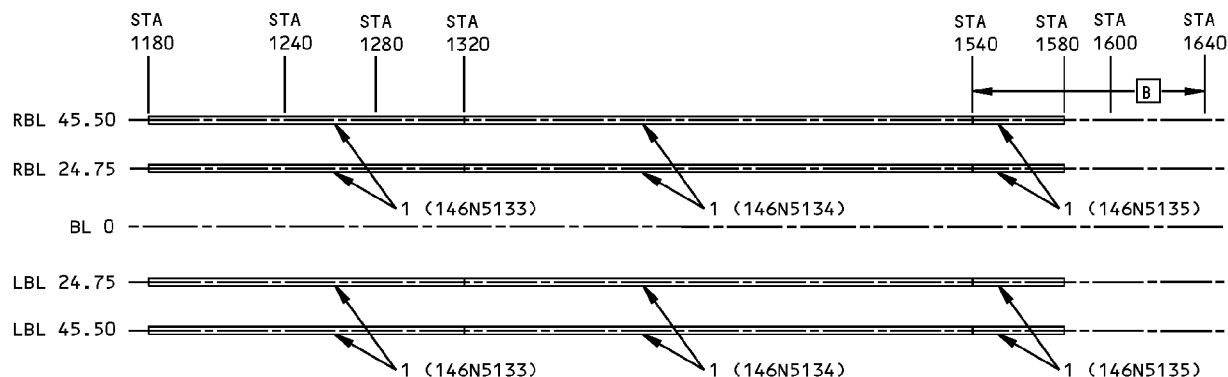
DETAIL I

AIRPLANES WITH NO. 3 EMERGENCY EXIT DOORS
BASIC CONFIGURATION

AIRPLANES WITH OVERWING EXITS
BASIC CONFIGURATION

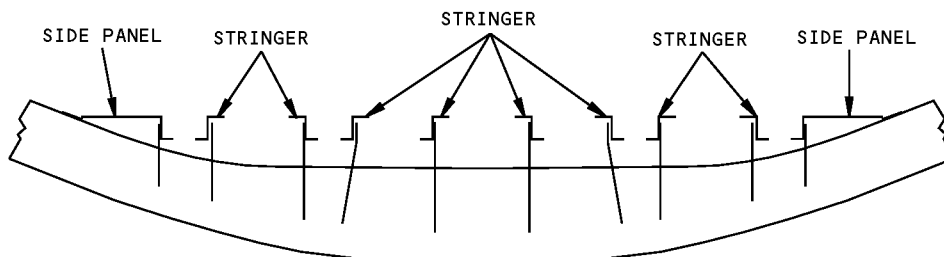
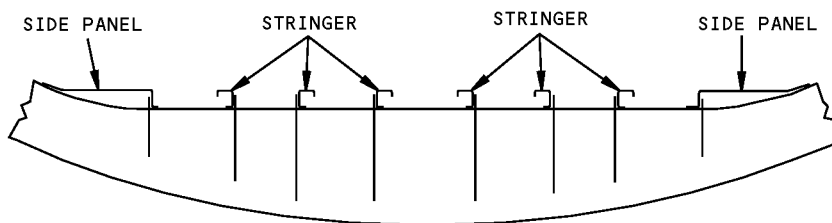
SECTION A-A
(ROTATED 90° CW)

SECTION B-B
(ROTATED 90° CW)

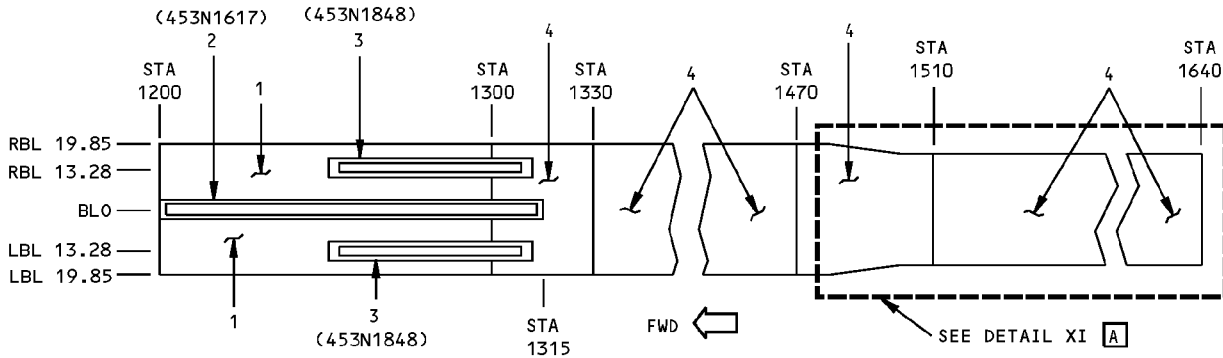
DECK PLATE LOCATIONS FOR AIRPLANES WITH ACE BAGGAGE LOADER
DETAIL X

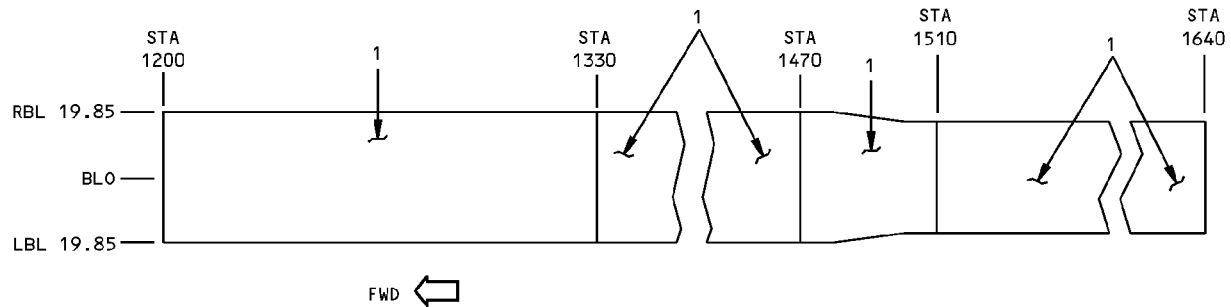
DECK PLATE LOCATIONS FOR AIRPLANES WITHOUT ACE BAGGAGE LOADER
DETAIL XIII
