FUSELAGE

757-200 STRUCTURAL REPAIR MANUAL

CHAPTER 53 FUSELAGE

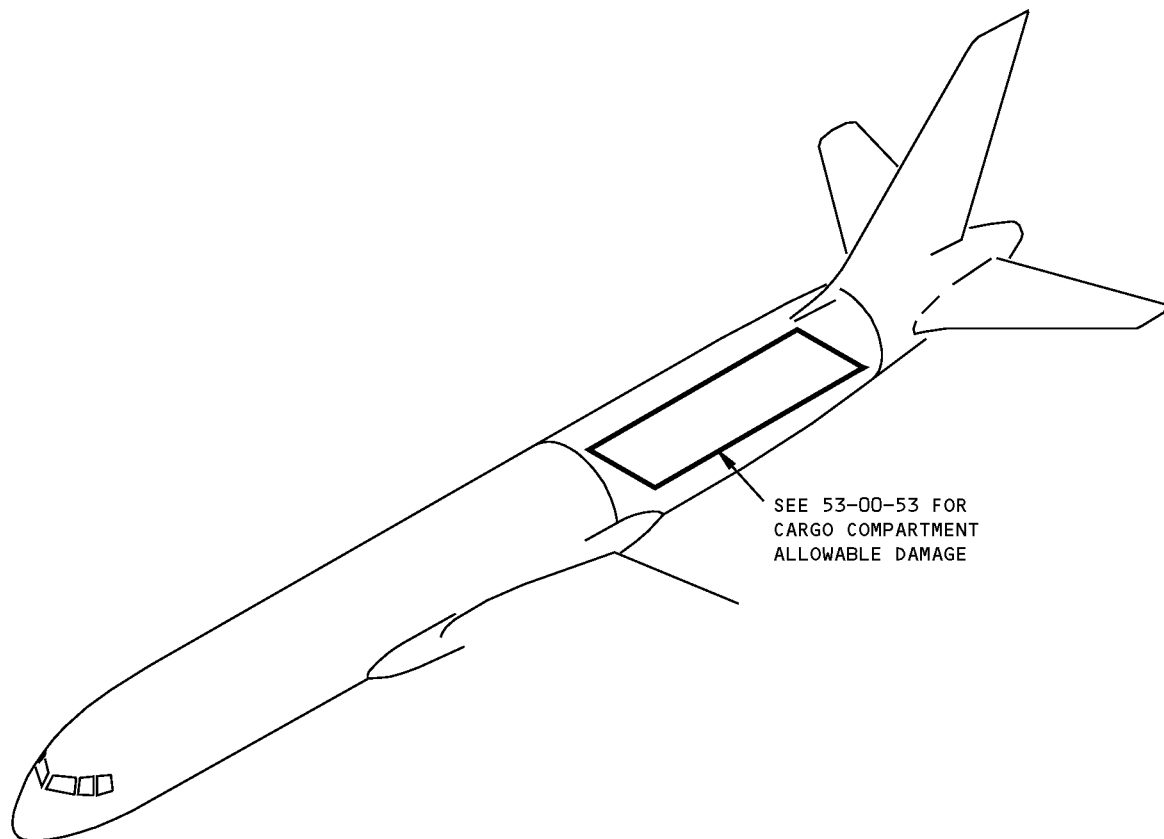
Section 46 Cargo Compartment Floor Structure Allowable Damage
Figure 101

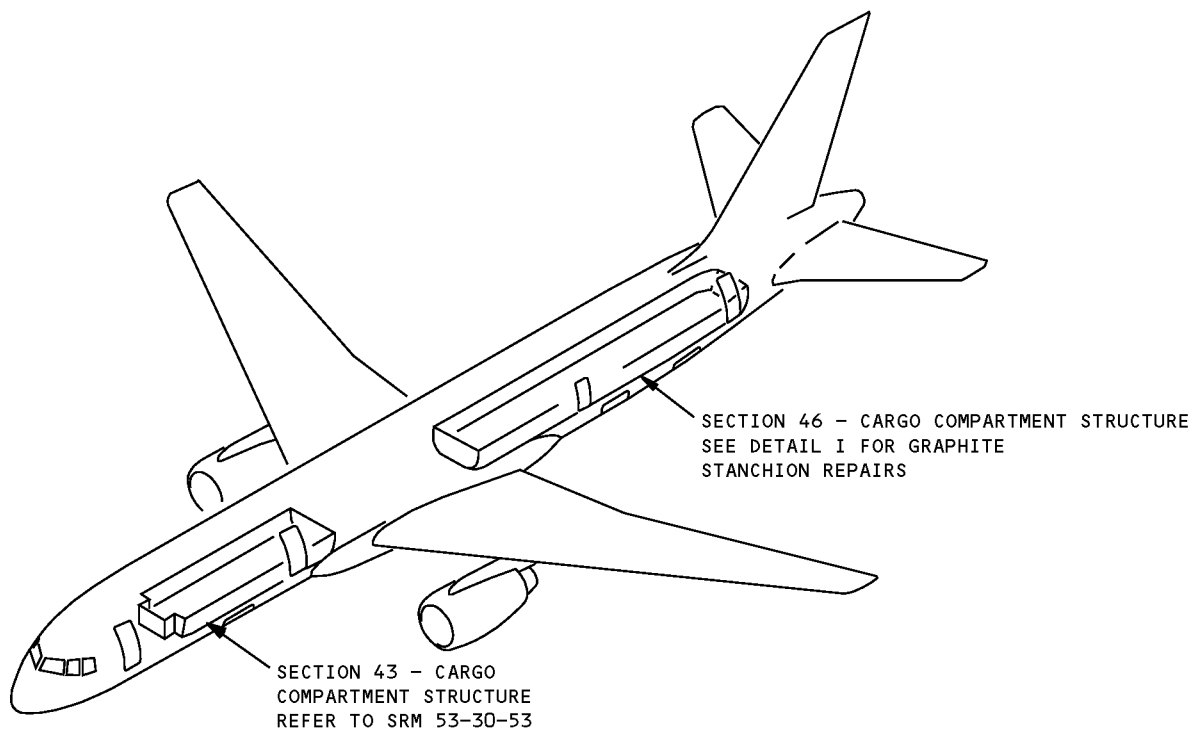
- THIS REPAIR DATA IS APPLICABLE TO PASSENGER AIRPLANES ONLY
- REFER TO AMM 25-50-09 FOR REPAIRS TO THE CARGO SIDEWALL LINER. THE LINERS PROVIDE A FIRE AND SMOKE BARRIER
- REFER TO SRM 51-70-11 FOR FORMED SECTION REPAIR
- REFER TO SRM 51-70-12 FOR EXTRUDED SECTION REPAIR
- REFER TO SRM 51-70-13 FOR WEB REPAIRS
- FITTING REPAIRS ARE NOT PERMITTED
- A CRACK REPAIR TO GRAPHITE STANCHIONS IS PERMITTED IF, THE CRACK IS LOCATED IN A CORNER AND THE CRACK LENGTH IS NOT MORE THAN A MAXIMUM OF 3.0 INCHES (75 mm)
- REPAIR GRAPHITE STANCHIONS AS GIVEN IN SRM 51-70-03, PARAGRAPH 5.P. ONLY IF THESE CONDITIONS ARE MET
- AT THE NEXT "C" CHECK, REPLACE ANY DAMAGED GRAPHITE STANCHION WITH A NEW STANCHION MADE OF GRAPHITE OR ALUMINUM MATERIAL
- STANCHIONS WITH DAMAGE EXCEEDING THE LIMITS AS GIVEN MUST BE REPLACED

Section 46 Cargo Compartment Floor Structure Repair
Figure 201 (Sheet 1 of 2)

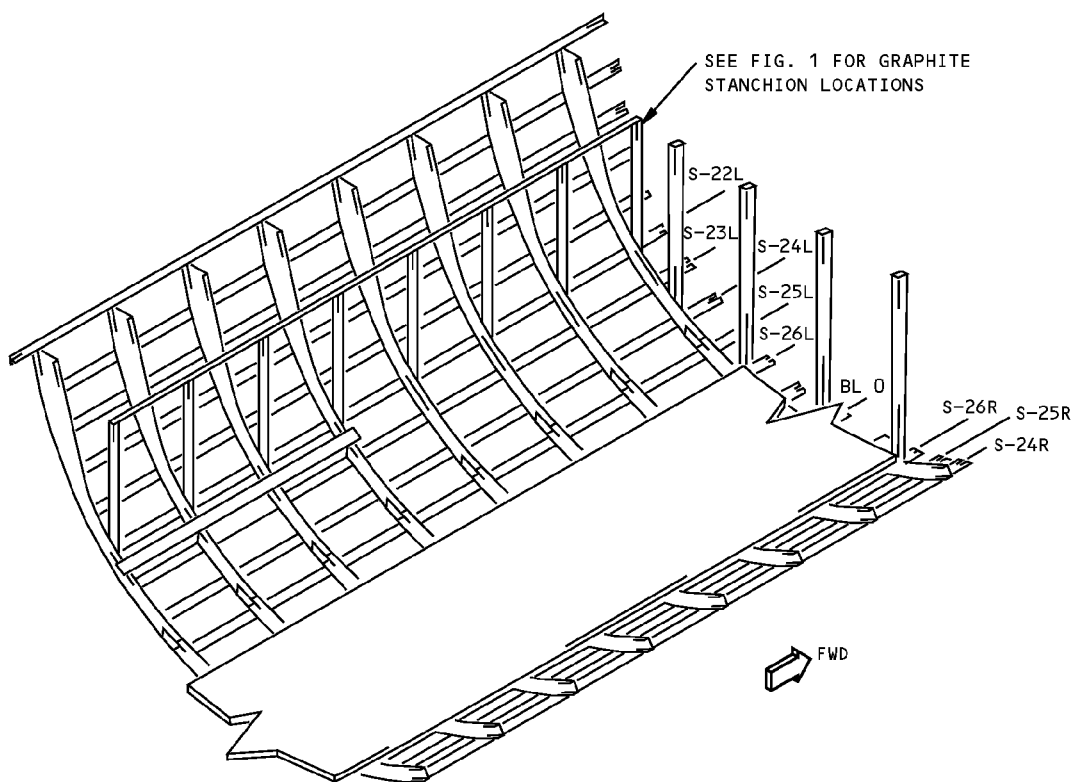
TYPICAL CARGO COMPARTMENT STRUCTURE

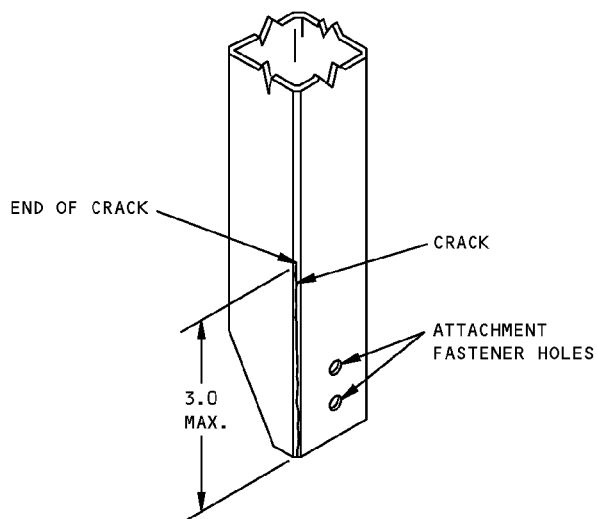
TYPICAL GRAPHITE STANCHION

GRAPHITE STANCHION REPAIR
DETAIL I

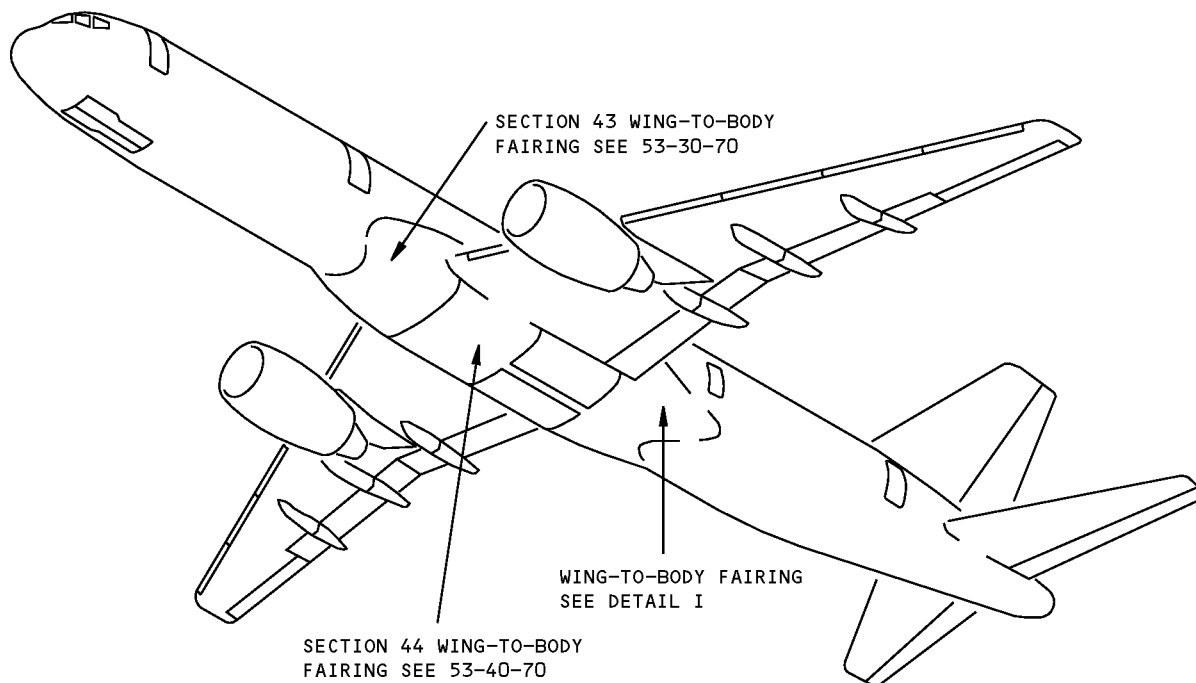
IDENTIFICATION 1 - SECTION 46 - WING-TO-BODY FAIRING SKINS

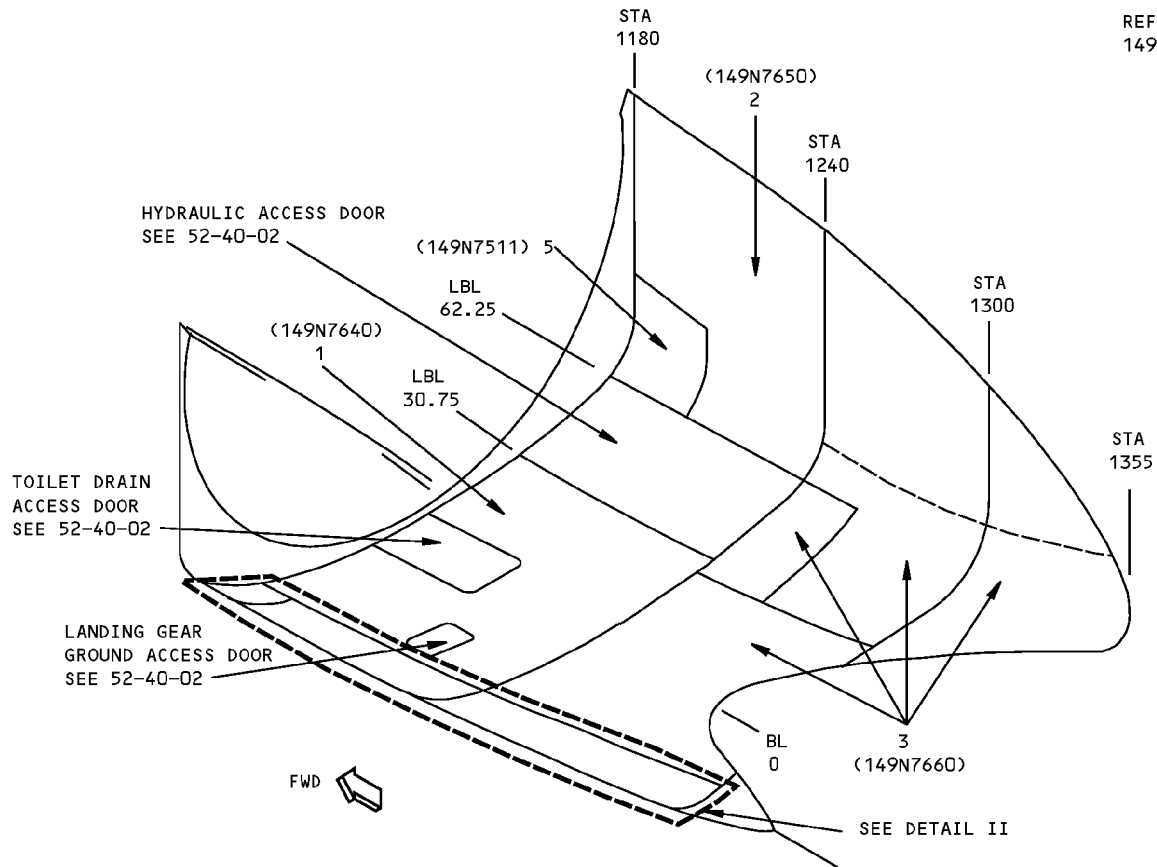
LEFT SIDE SHOWN
RIGHT SIDE OPPOSITE
EXCEPT AS NOTED
DETAIL I

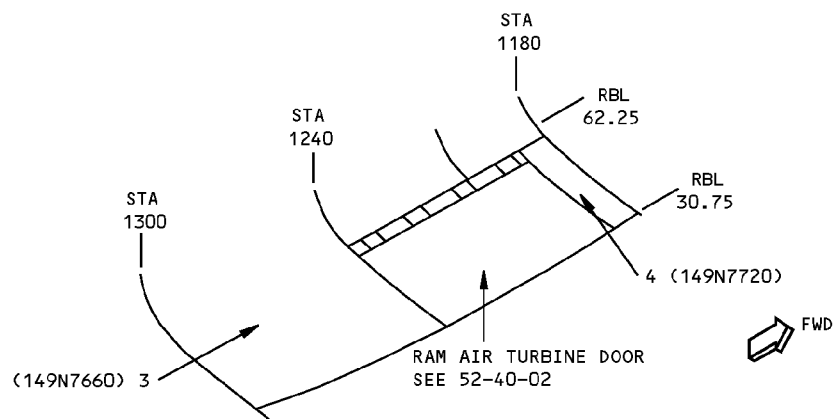
RIGHT SIDE ONLY
DETAIL II

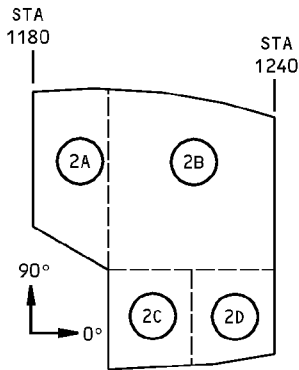
VIEW ON PANEL **G**

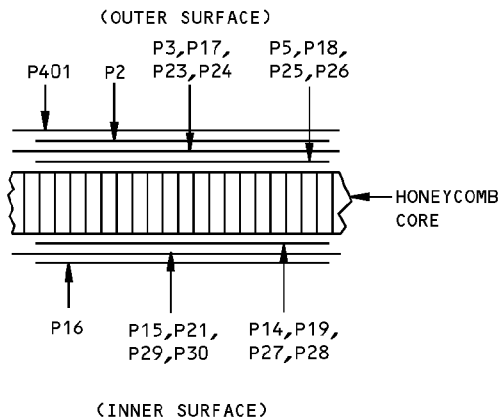
SECTION THRU HONEYCOMB PANEL

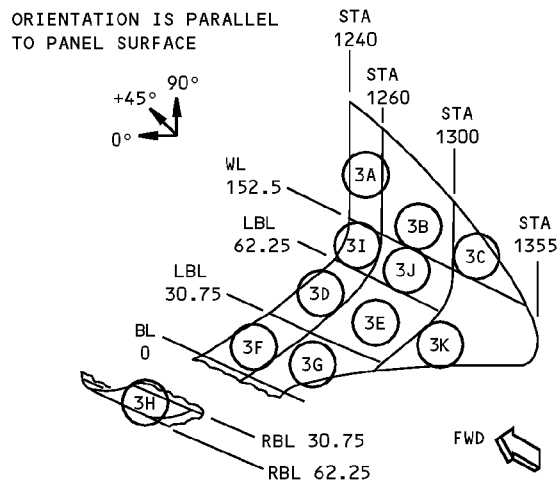
VIEW ON PANELS [G]

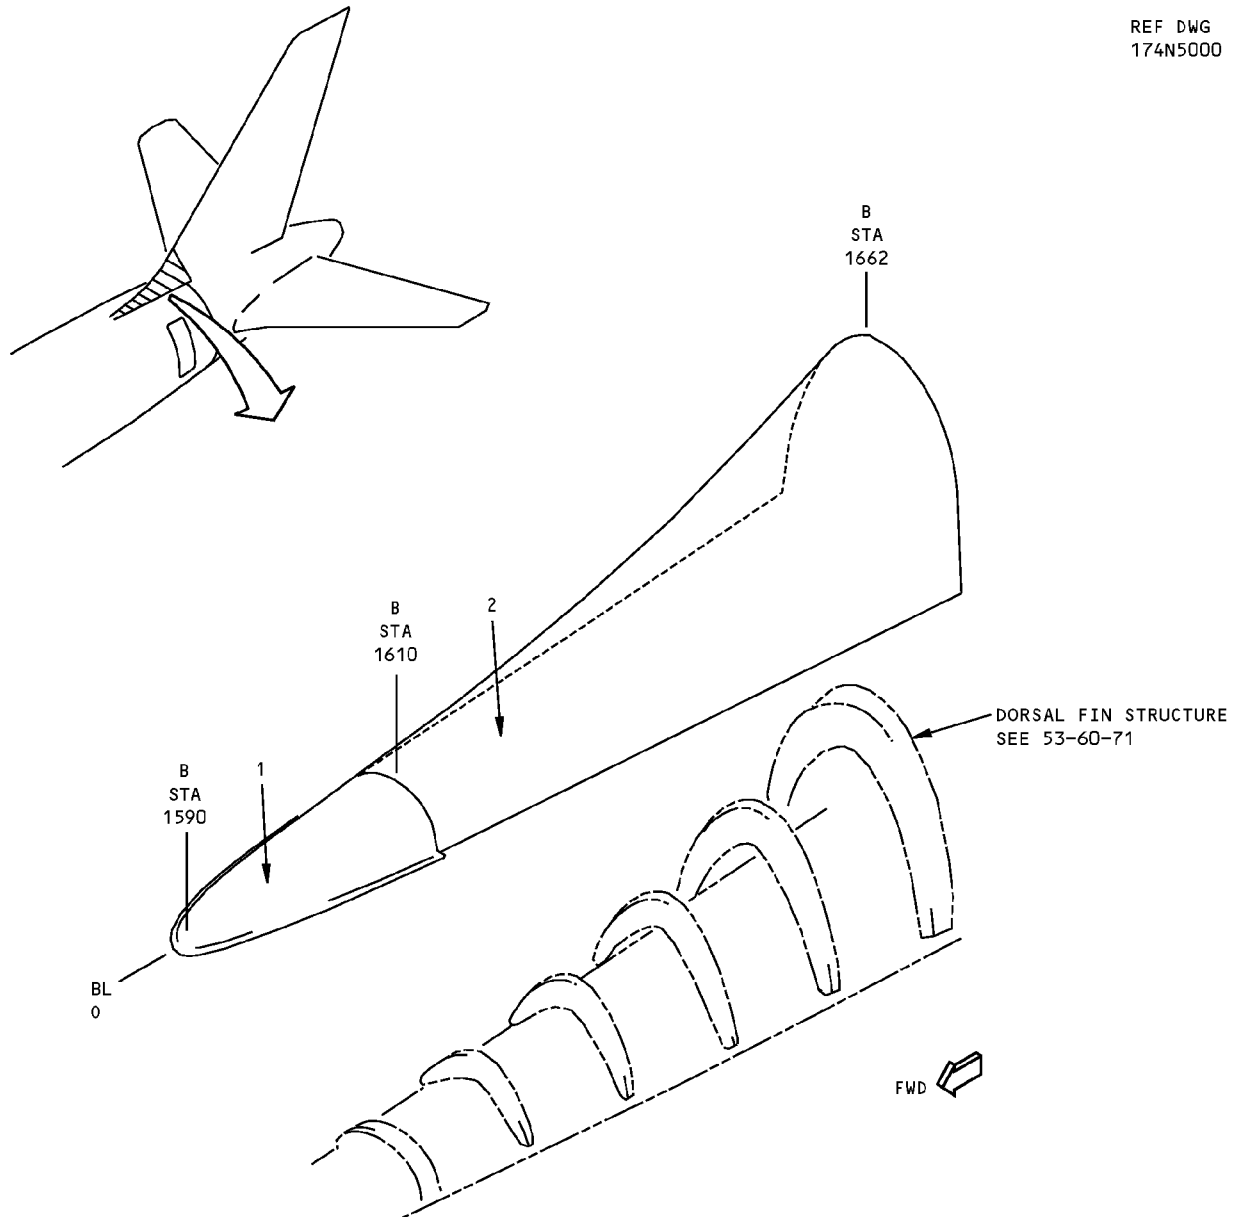
IDENTIFICATION 2 - DORSAL FIN SKIN

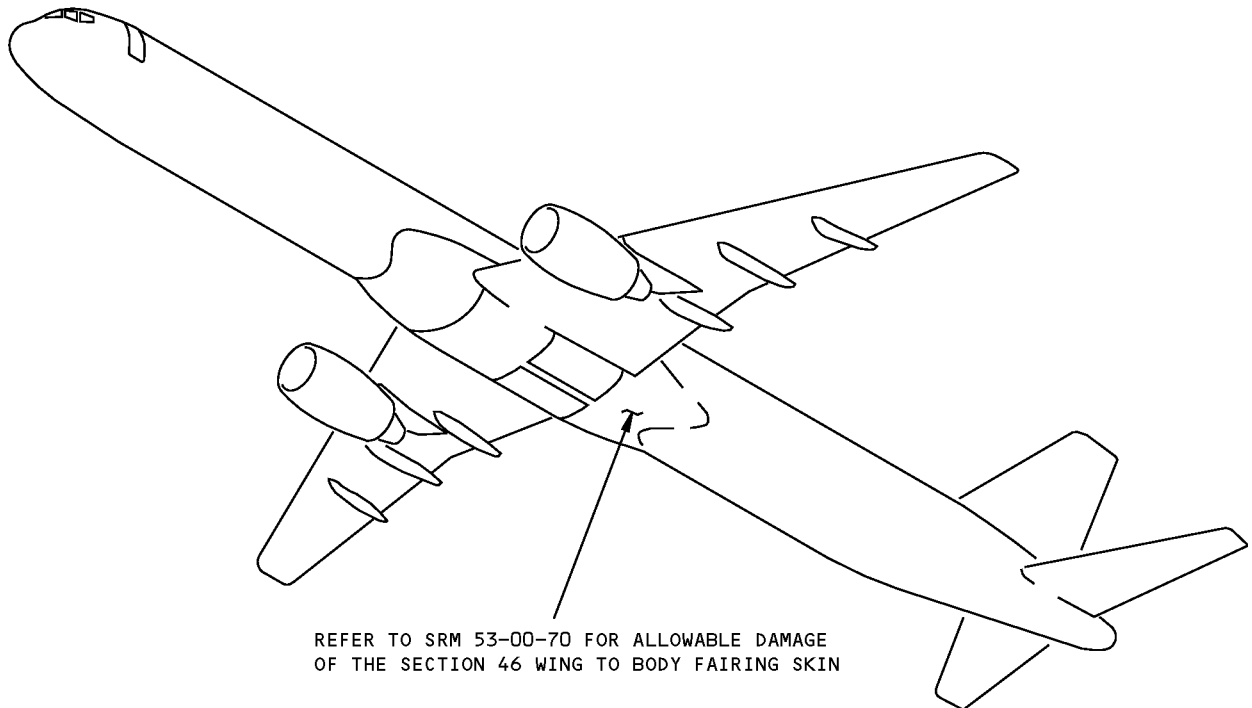
Section 46 Wing-to-Body Fairing Skin Allowable Damage
Figure 101

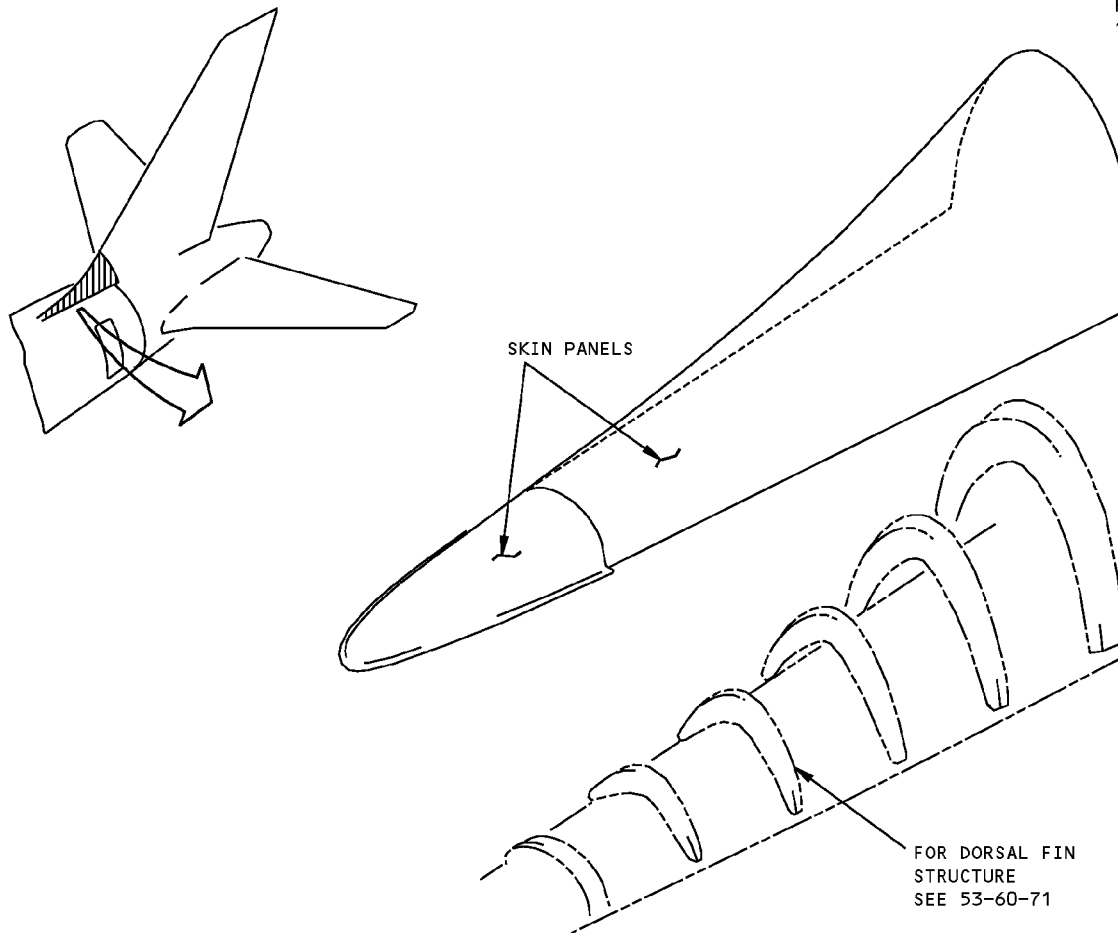
A REMOVE EDGE CRACKS PER DETAIL I. FOR OTHER CRACKS UP TO 0.25 SEE **C**

B REMOVE DAMAGE PER DETAILS I, II AND IV

C CLEAN OUT DAMAGE UP TO 0.25 MAX DIA AND NOT CLOSER THAN 1.0 INCH TO FASTENER HOLE, MATERIAL EDGE, OR OTHER DAMAGE. FILL HOLE WITH 2117-T3 OR T4 ALUMINUM RIVET INSTALLED WET WITH BMS 5-95 SEALANT. ALL OTHER HOLES TO BE REPAIRED

**Dorsal Fin Skin Allowable Damage
Figure 101 (Sheet 1 of 2)**

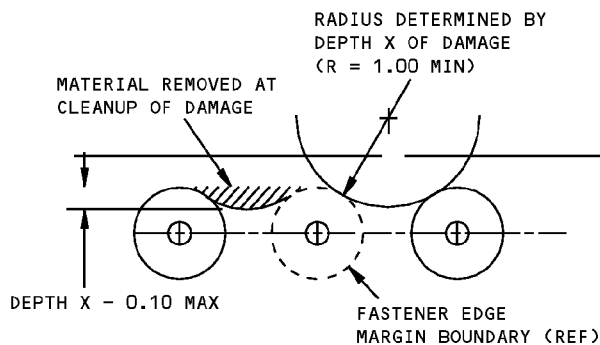
DETAIL I

DAMAGE CLEANUP OF EDGES WHERE FASTENER EDGE MARGINS DO NOT OVERLAP

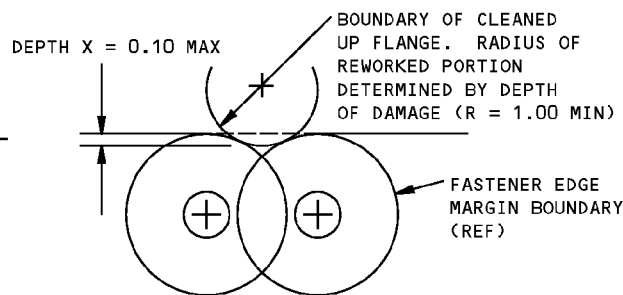
DAMAGE CLEANUP OF EDGES WHERE FASTENER EDGE MARGINS OVERLAP

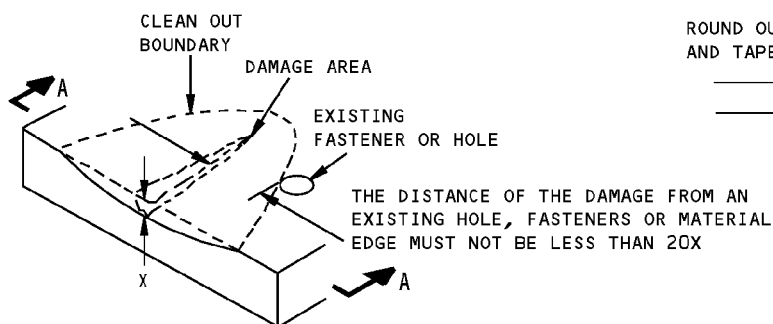
DETAIL II

REMOVAL OF NICK, GOUGE AND SCRATCH DAMAGE ON A SURFACE

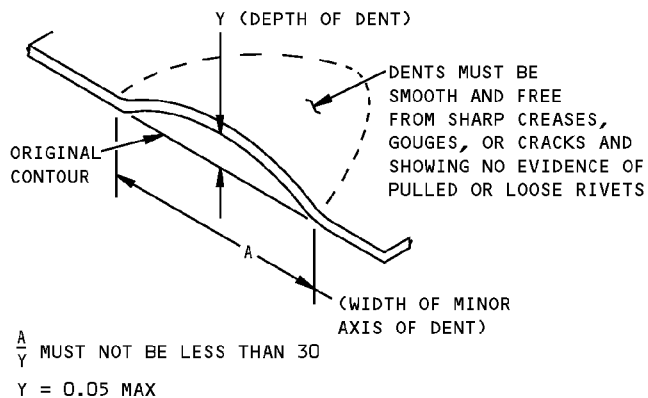
DETAIL III

ALLOWABLE DAMAGE FOR DENT

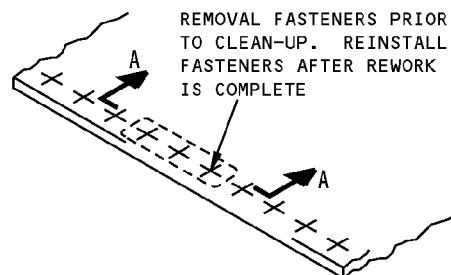
SECTION B-B
CORROSION CLEANUP
DETAIL IV

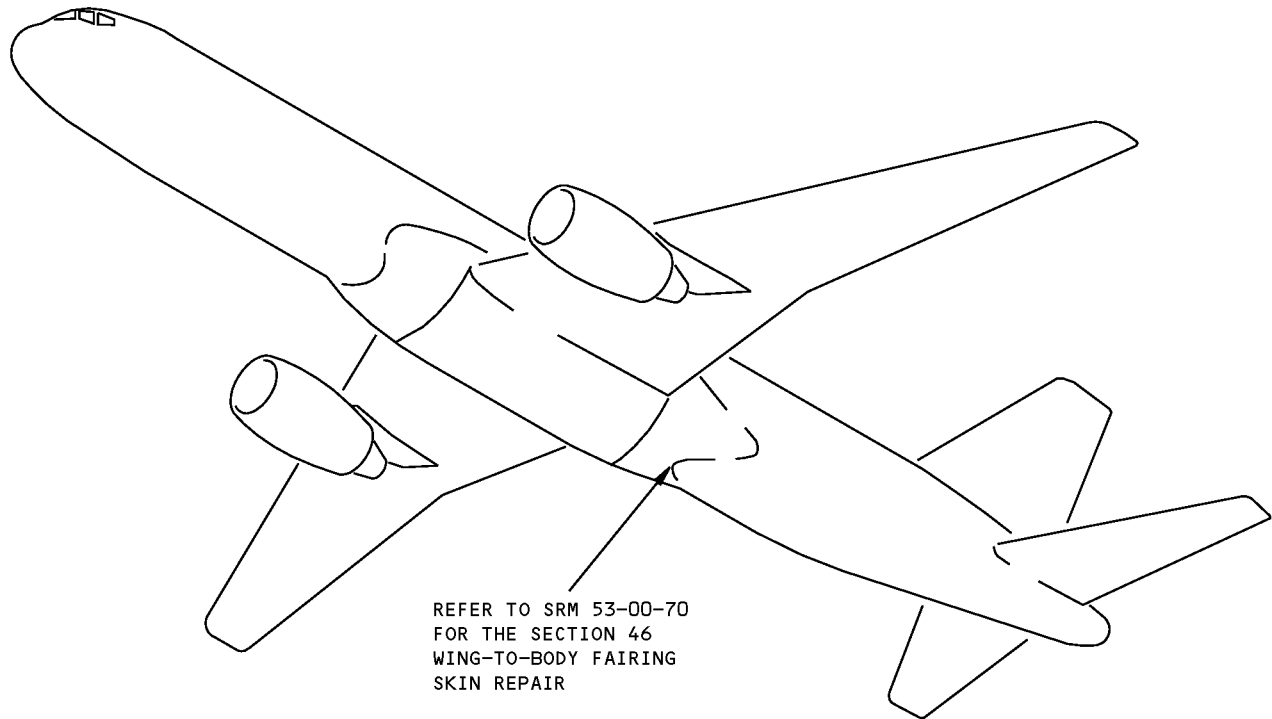
Section 46 Wing to Body Fairing Skin Repairs
Figure 201

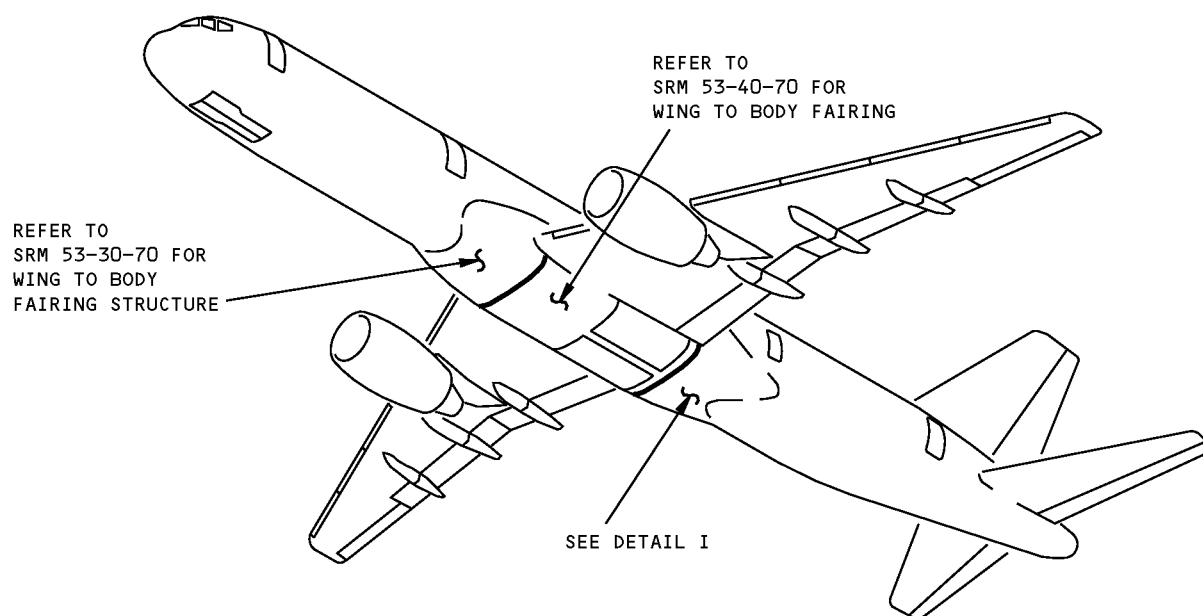
IDENTIFICATION 1 - SECTION 46 - WING-TO-BODY FAIRING STRUCTURE

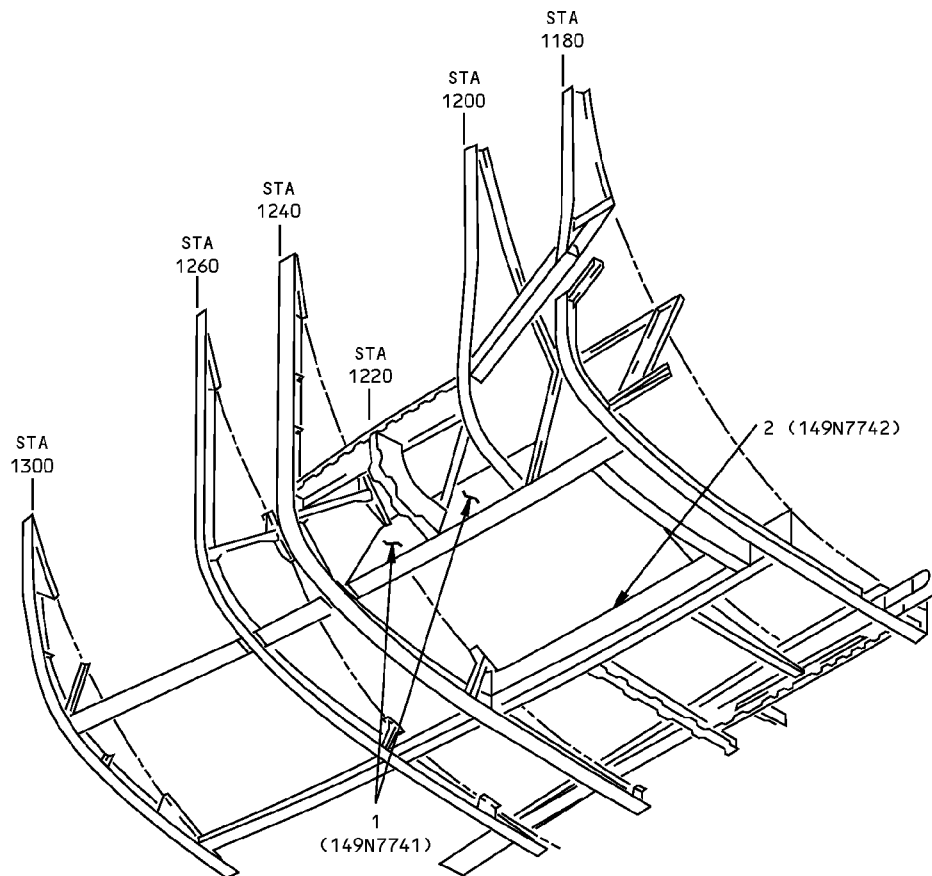
RIGHT SIDE ONLY
DETAIL II

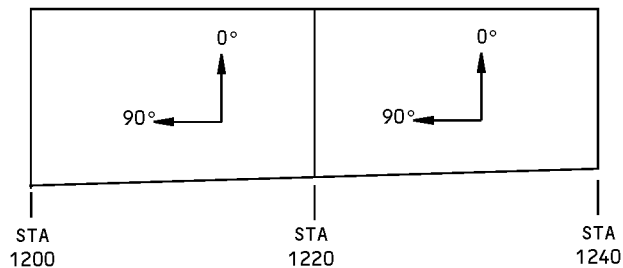
PLY ORIENTATION DIAGRAM

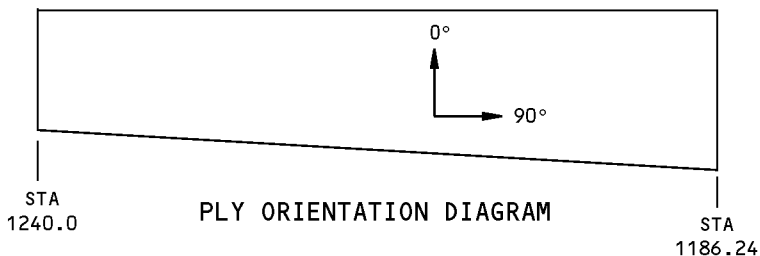
PLY ORIENTATION DIAGRAM

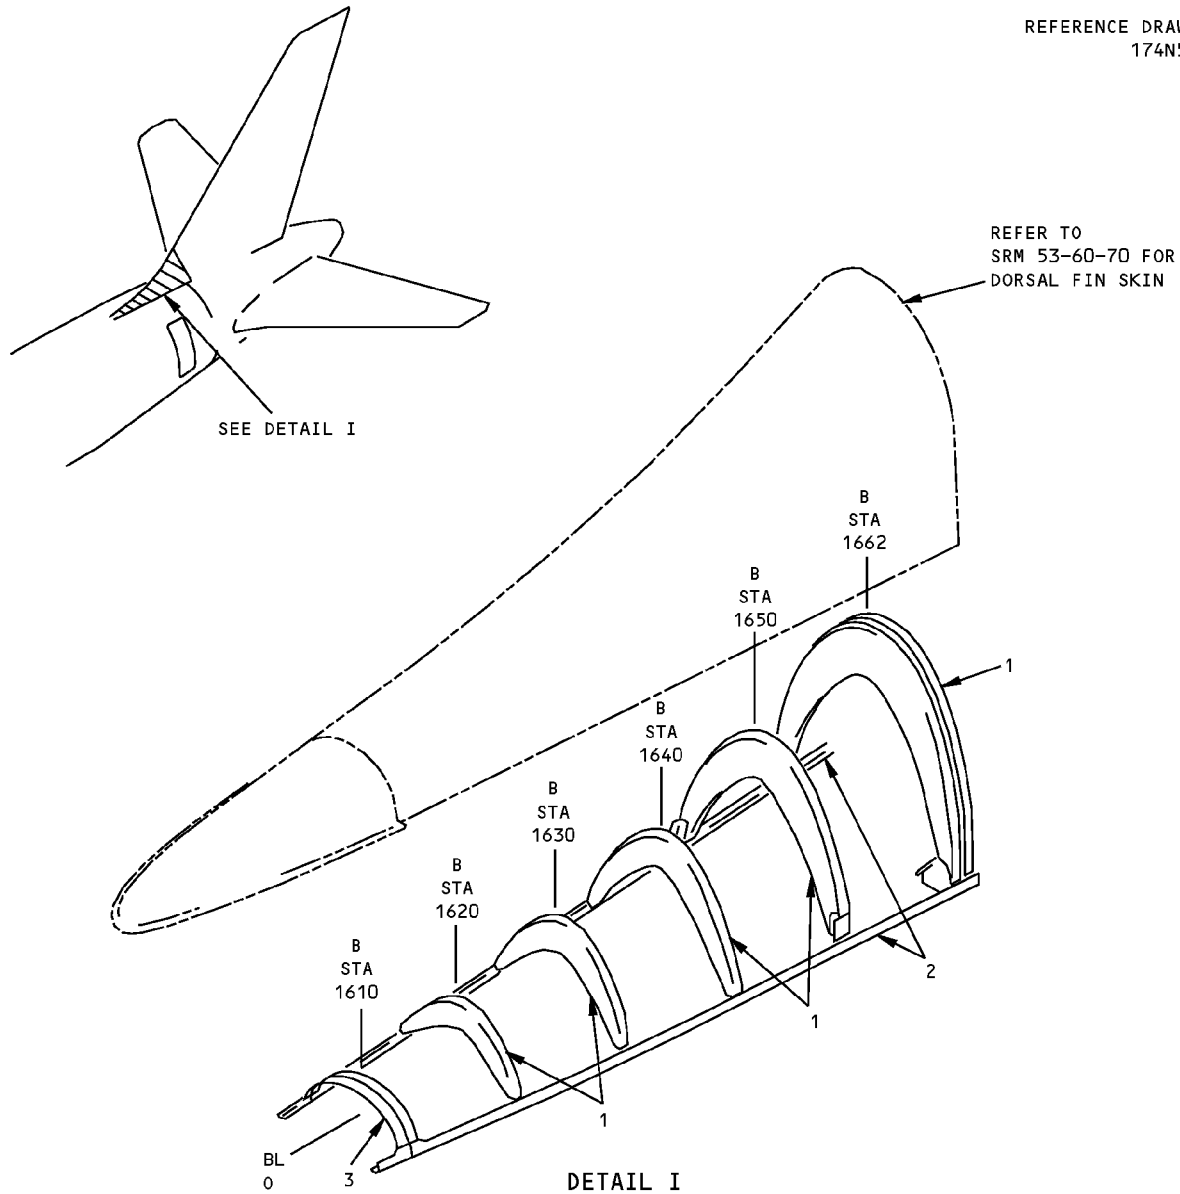
IDENTIFICATION 2 - DORSAL FIN STRUCTURE

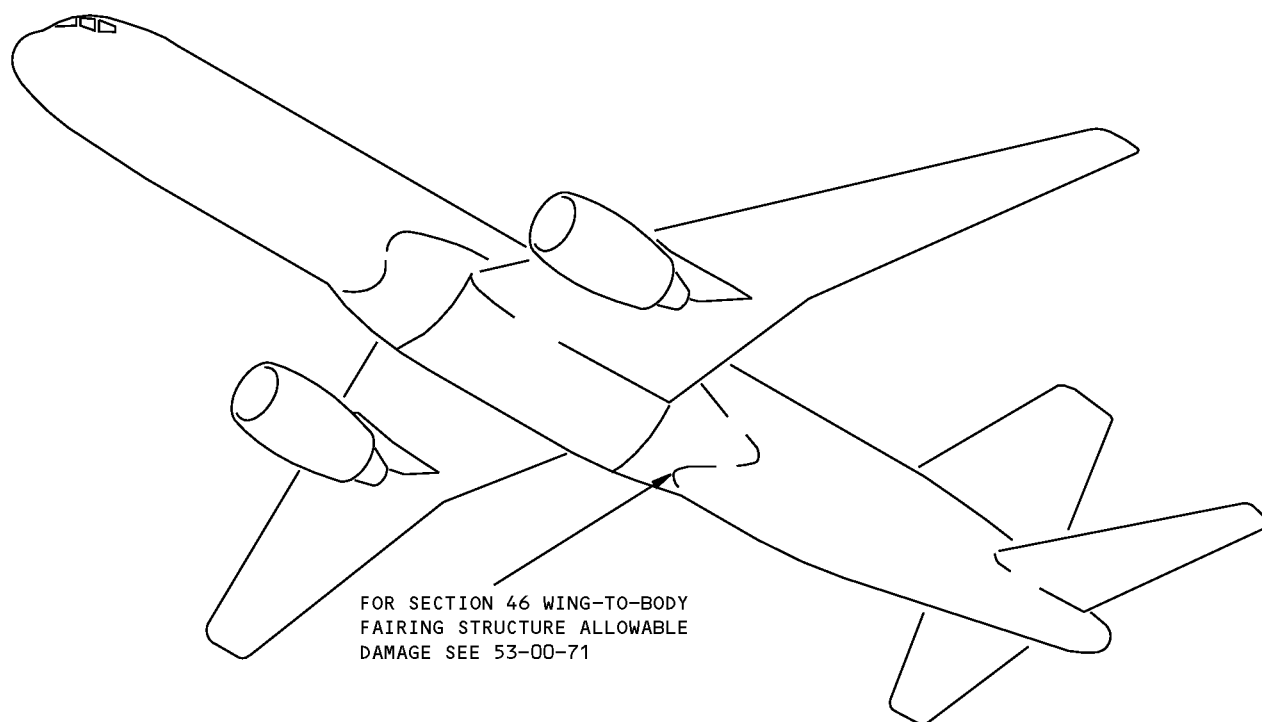
Section 46 Wing-to-Body Fairing Structure Allowable Damage
Figure 101

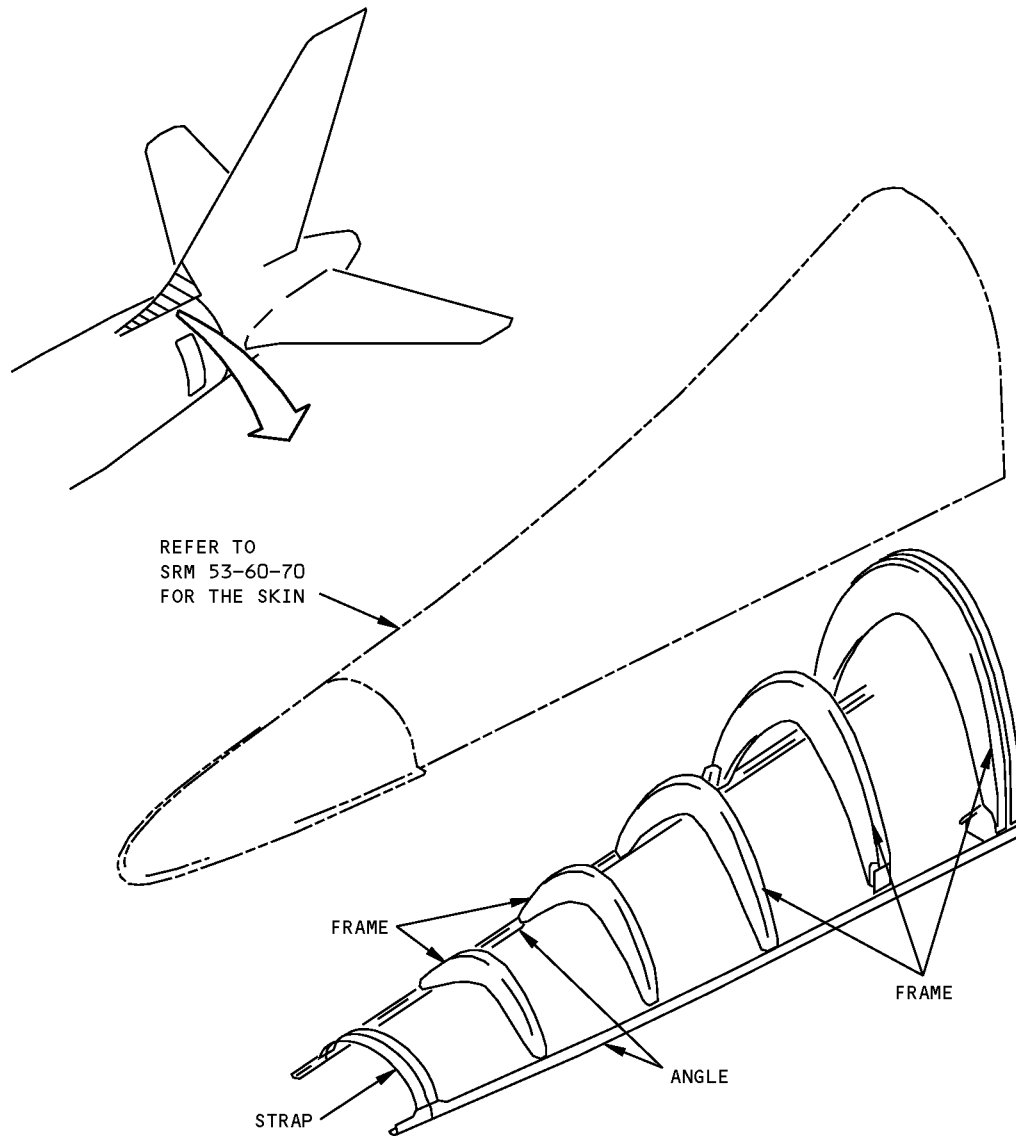
ALLOWABLE DAMAGE 1 - DORSAL FIN STRUCTURE - SECTION 46

Dorsal Fin Structure - Section 46 - Allowable Damage
Figure 101 (Sheet 1 of 3)

- REFINISH REWORKED AREAS PER 51-20 OF THE MAINTENANCE MANUAL
- A** CRACKS NOT ALLOWED EXCEPT FOR EDGE CRACKS WHICH MUST BE REMOVED PER DETAILS I AND IV
- B** REMOVED DAMAGE PER DETAILS I, II, IV AND V
- C** CLEAN OUT DAMAGE UP TO 0.25 MAX DIA AND NOT CLOSER THAN 1.0 INCH TO FASTENER HOLE OR OTHER DAMAGE. FILL HOLE WITH A 2117-T3 OR T4 ALUMINUM RIVET INSTALLED WET WITH BMS 5-95 SEALANT. ALL OTHER HOLES TO BE REPAIRED. MAINTAIN 2.0 D EDGE MARGIN.

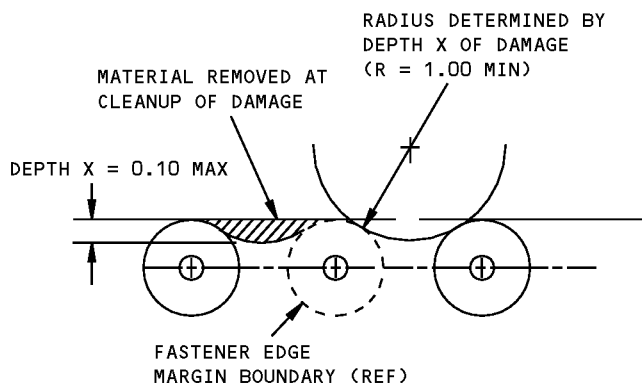
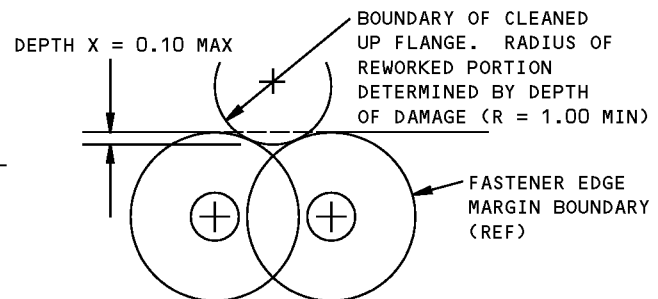
DETAIL I

DAMAGE CLEANUP OF EDGES WHERE FASTENER EDGE MARGINS DO NOT OVERLAP

DAMAGE CLEANUP OF EDGES WHERE FASTENER EDGE MARGINS OVERLAP

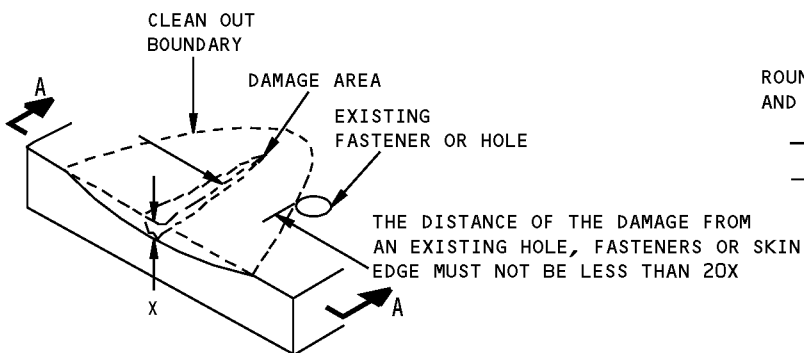
REMOVAL OF NICK, GOUGE AND SCRATCH DAMAGE ON A SURFACE
DETAIL II

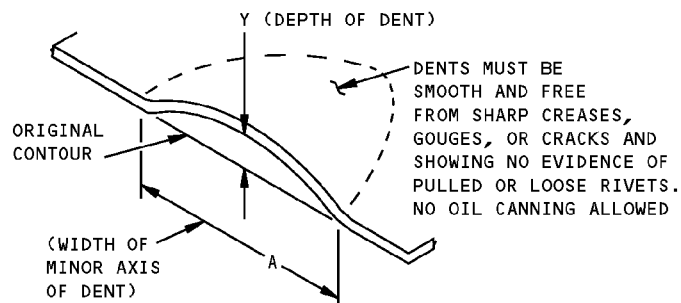
$\frac{A}{Y}$ MUST NOT BE LESS THAN 30
Y MAX = 0.05

ALLOWABLE DAMAGE FOR DENT (WEB ONLY) DETAIL III

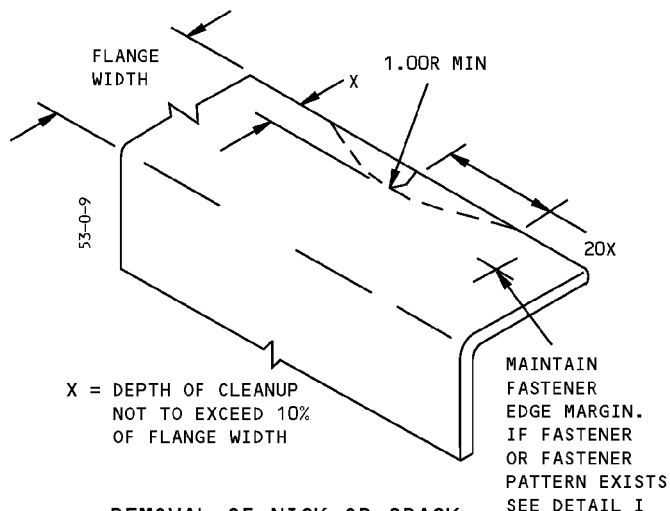
REMOVAL OF NICK OR CRACK DAMAGE ON AN EDGE DETAIL IV

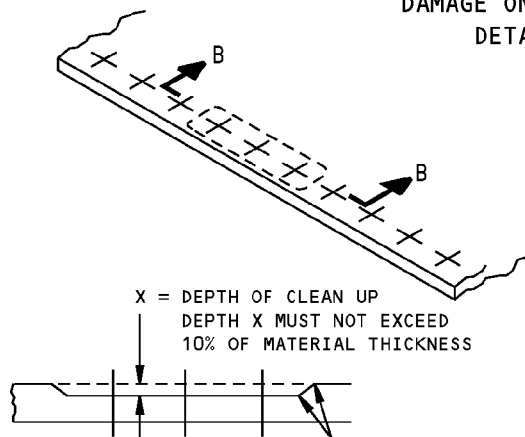
SMOOTH BLEND-OUT RADIUS 0.50 INCH
MINIMUM. CORROSION CLEANUP AROUND
ANY THREE FASTENERS IN TEN IS
PERMITTED TO MAX DEPTH

SECTION B-B CORROSION CLEANUP DETAIL V

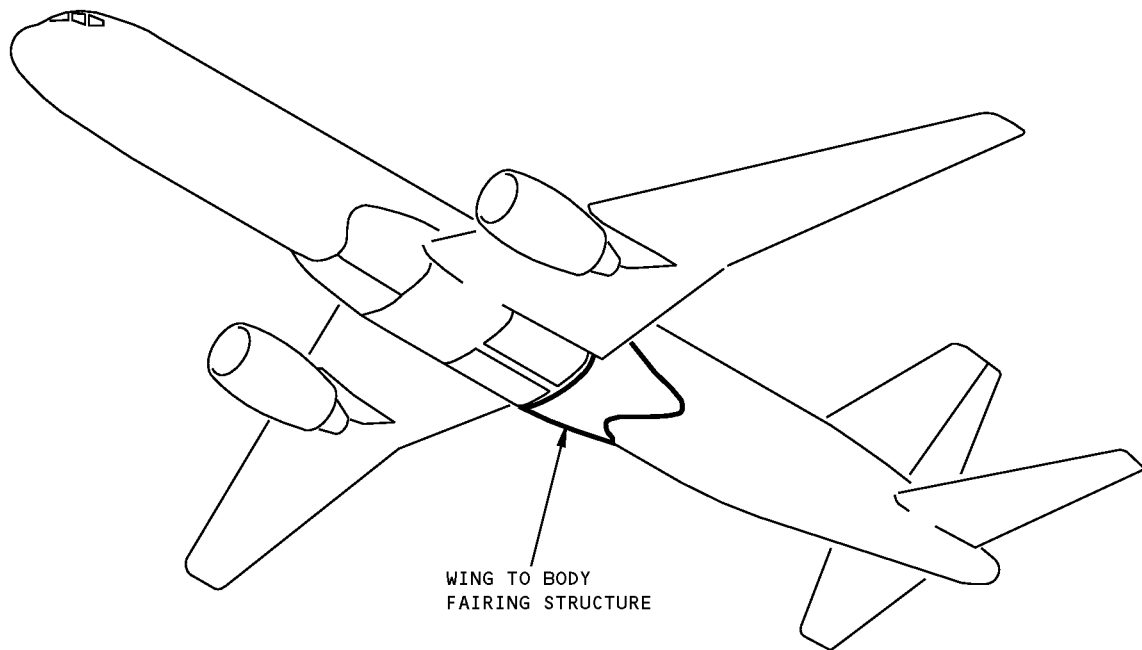
Section 46 Wing-to -Body Fairing Structure Repair
Figure 201

- REFER TO SRM 51-70-11 FOR FORMED SECTION REPAIR
- REFER TO SRM 51-70-12 FOR EXTRUDED SECTION REPAIR
- REFER TO SRM 51-70-13 FOR WEB REPAIRS

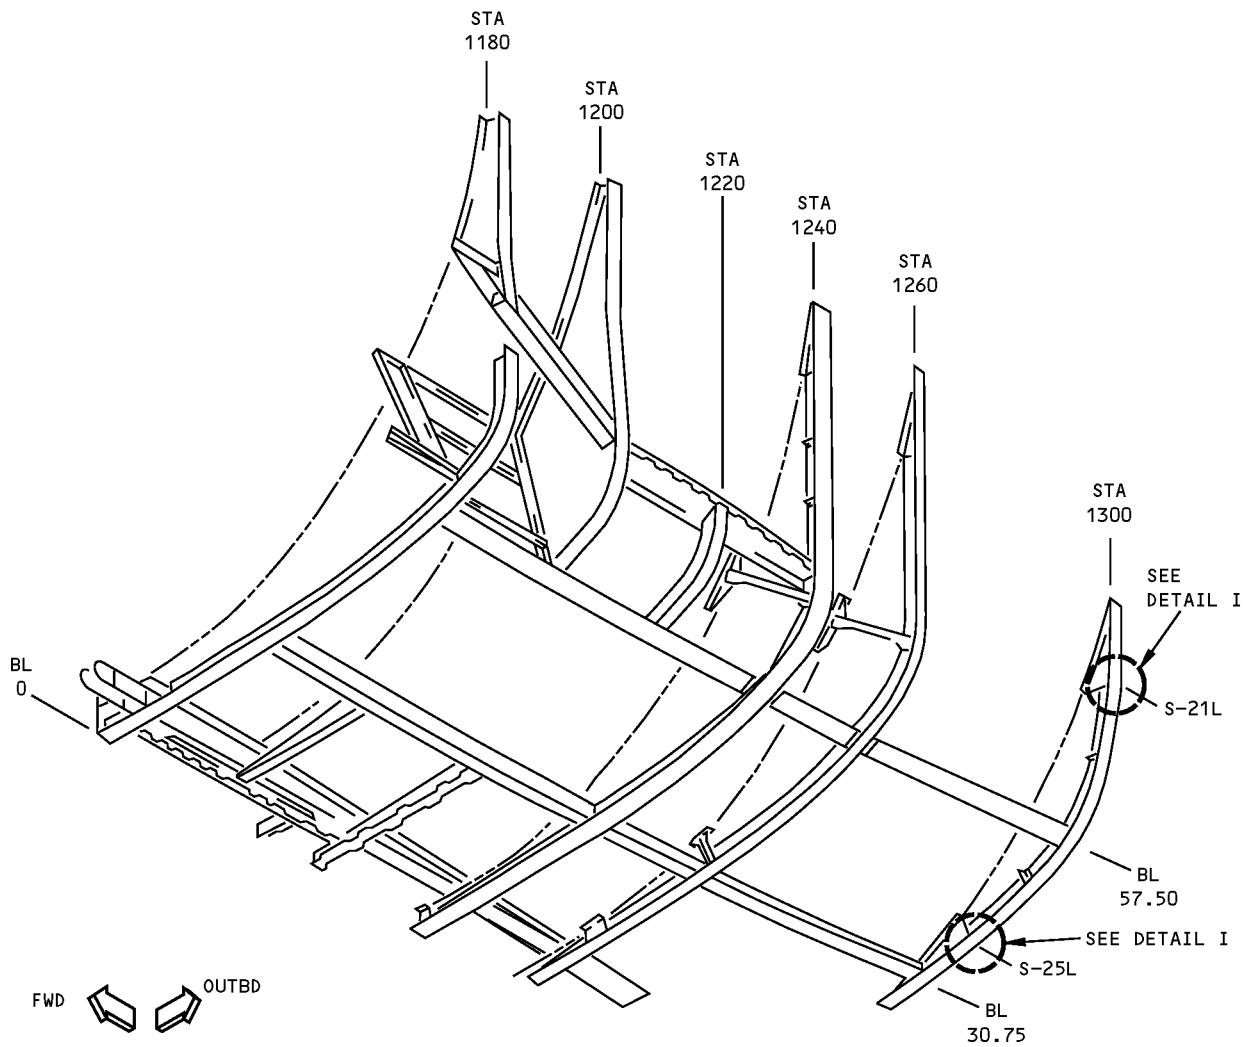
**Section 46 - Wing-to-Body Fairing - Frame Support Angle Repair
Figure 201 (Sheet 2 of 3)**

LEFT SIDE SHOWN
RIGHT SIDE OPPOSITE

THIS REPAIR IS APPLICABLE TO THE SUPPORT ANGLE AT STRINGERS S-25 OR S-21 ON THE WING TO BODY FAIRING FRAME AT STATION 1300.

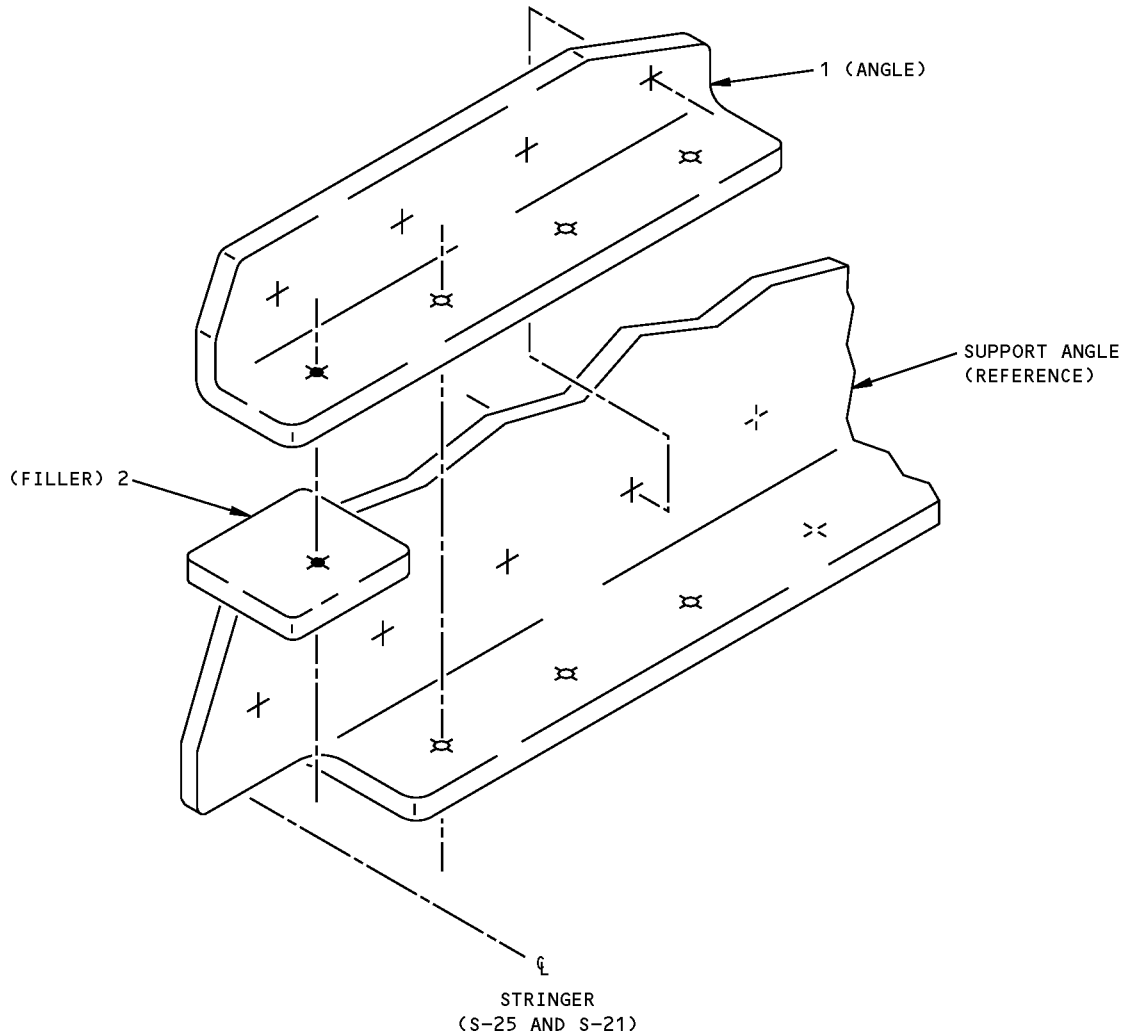
DETAIL I

Section 46 - Wing-to-Body Fairing - Frame Support Angle Repair
Figure 201 (Sheet 3 of 3)

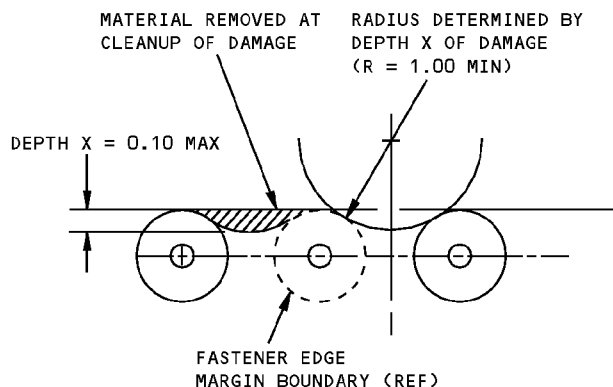
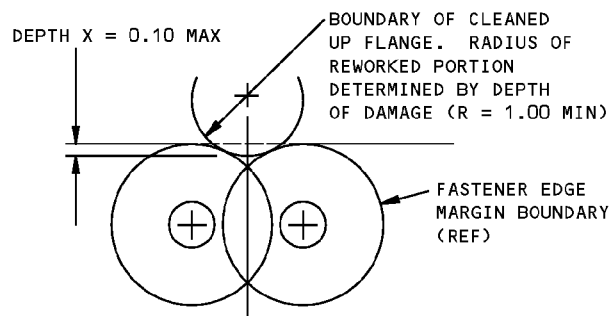
DETAIL II

DAMAGE CLEANUP OF EDGES WHERE
FASTENER EDGE MARGINS DO NOT OVERLAP

DAMAGE CLEANUP OF EDGES WHERE
FASTENER EDGE MARGINS OVERLAP

A CLEAN UP EDGE CRACKS AS SHOWN IN DETAILS II AND VI. 0.50 INCH (12.7 mm) MAX LENGTH CRACK PERMITTED IN HONEYCOMB AREA. STOP DRILL ENDS OF CRACK WITH 0.25 INCH (6 mm) DIAMETER HOLE. **F**

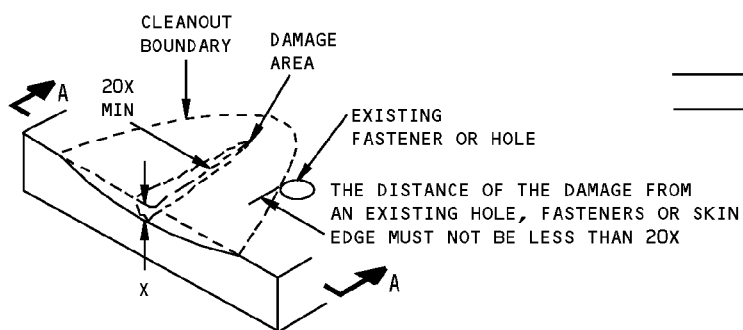
REMOVAL OF NICK, GOUGE AND SCRATCH DAMAGE ON A SURFACE
DETAIL III

B REMOVE DAMAGE AS SHOWN IN DETAILS III AND V.
