FUSELAGE

757-200 STRUCTURAL REPAIR MANUAL

CHAPTER 53 FUSELAGE

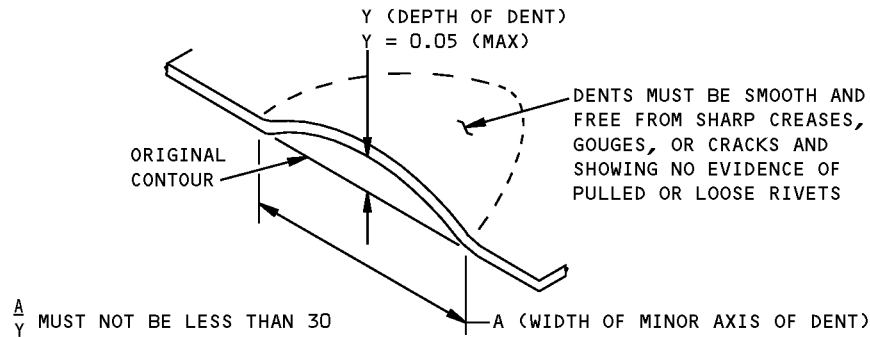
ALLOWABLE DAMAGE FOR DENT
DETAIL IV

- C**
- DENTS THAT ARE LESS THAN OR EQUAL TO 0.05 INCH (1.27 mm) IN DEPTH (Y) ARE PERMITTED AS GIVEN IN DETAIL IV.
 - DENTS THAT ARE MORE THAN 0.05 INCH (1.27 mm) BUT LESS THAN OR EQUAL TO 0.100 INCH (2.5 mm) IN DEPTH (Y) ARE PERMITTED AS GIVEN IN DETAIL IV IF:
 - IT IS FILLED WITH POTTING COMPOUND AS GIVEN IN SRM 51-70-01
 - IT IS SEALED WITH ALUMINUM FOIL TAPE (SPEED TAPE) 3M-Y436 OR ITS EQUIVALENT. KEEP A RECORD OF THE LOCATION WHERE THE SPEED TAPE IS APPLIED
 - AT EACH "2A" CHECK, AN INSPECTION IS MADE OF THE LOCATION WHERE THE SPEED TAPE IS APPLIED. REPLACE THE TAPE IF DETERIORATION IS FOUND. IT IS POSSIBLE THAT THERE WILL BE DETERIORATION OF THE SPEED TAPE IN SOME AREAS OF THE SKIN BEFORE THE NEXT NECESSARY INSPECTION. IF DETERIORATION IS FOUND, INSPECT THE TAPE MORE FREQUENTLY.
 - A PERMANENT REPAIR IS MADE NO LATER THAN THE NEXT "C" CHECK. REFER TO SRM 51-70-10.

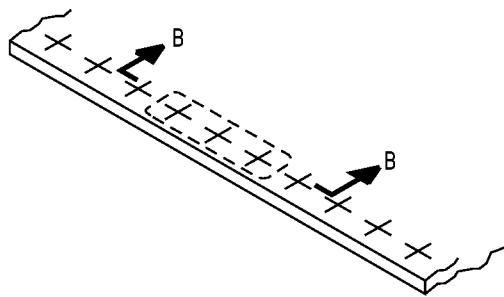
SMOOTH BLEND-OUT RADIUS 0.50 INCH MINIMUM.
CORROSION CLEANUP AROUND ANY THREE FASTENERS
IN TEN IS PERMITTED TO MAX DEPTH

CORROSION CLEANUP
DETAIL V

B REMOVE DAMAGE AS SHOWN IN DETAILS III AND V.

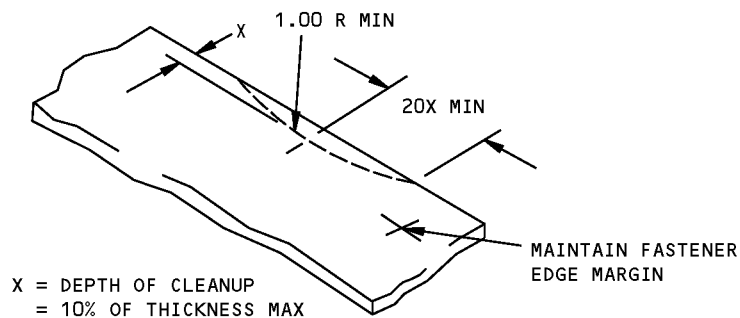
REMOVAL OF NICK OR CRACK DAMAGE ON AN EDGE
DETAIL VI

A CLEAN UP EDGE CRACKS AS SHOWN IN DETAILS II AND VI. 0.50 INCH (12.7 mm) MAX LENGTH CRACK PERMITTED IN HONEYCOMB AREA. STOP DRILL ENDS OF CRACK WITH 0.25 INCH (6 mm) DIAMETER HOLE. **F**

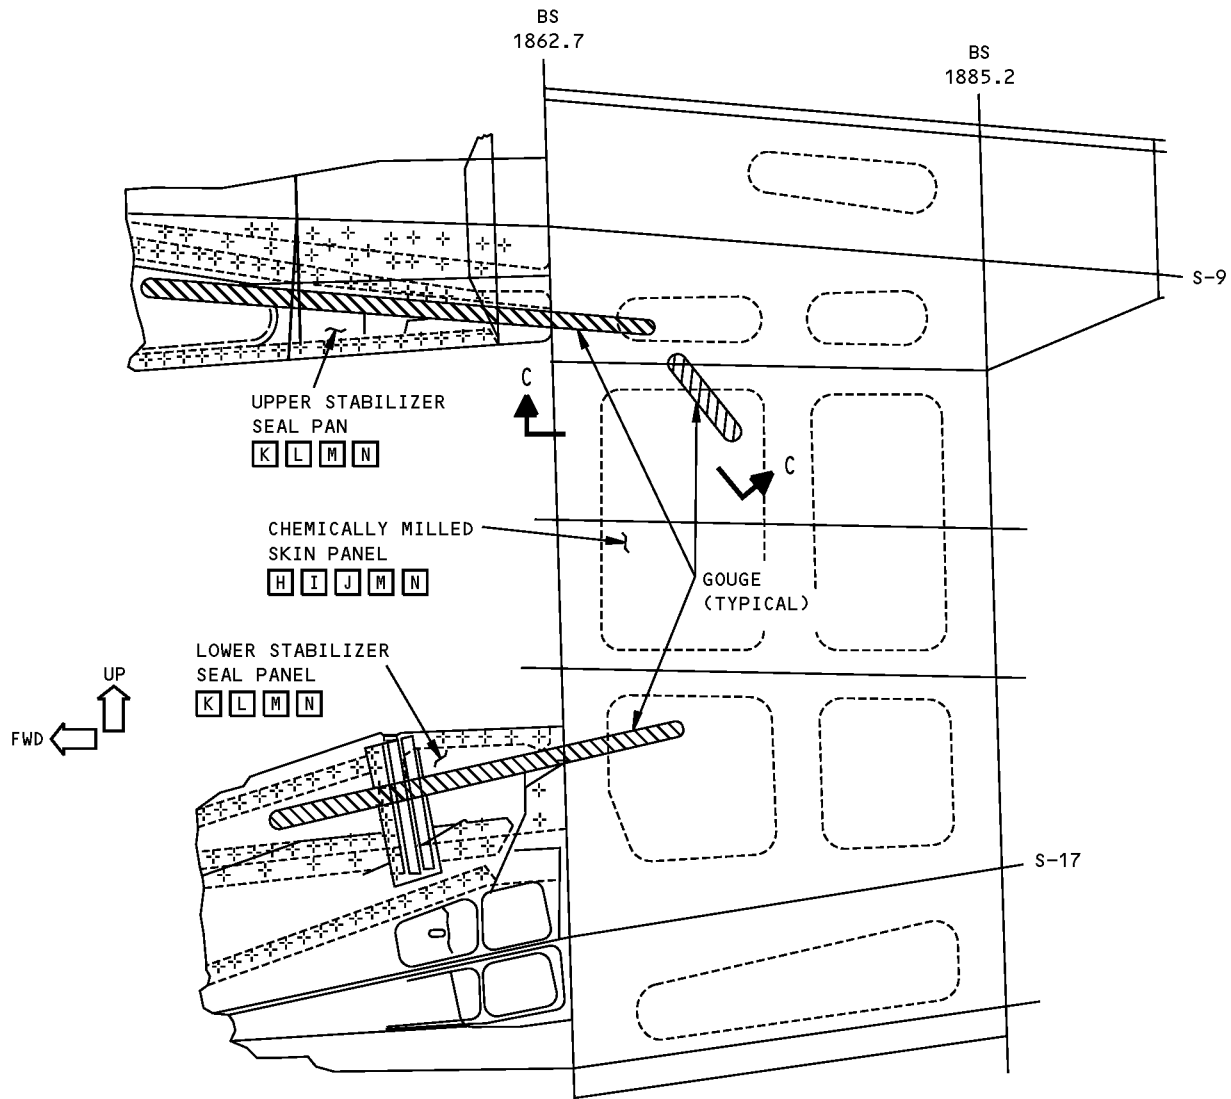
**TYPICAL SKIN WEAR PATTERNS CAUSED BY THE STABILIZER BLADE SEAL
DETAIL VII**

- G** THESE ALLOWABLE DAMAGE LIMITS HAVE FAA APPROVAL CONTINGENT UPON ACCOMPLISHMENT OF THE INSPECTIONS CONTAINED HEREIN.
- H** THE MAXIMUM GOUGE LENGTH PERMITTED IS 7 INCHES (178 mm). GOUGE WIDTH MUST NOT BE MORE THAN THE PITCH OF THE FASTENERS. REFER TO DETAIL VII FOR THE GOUGE DEPTH PERMITTED.

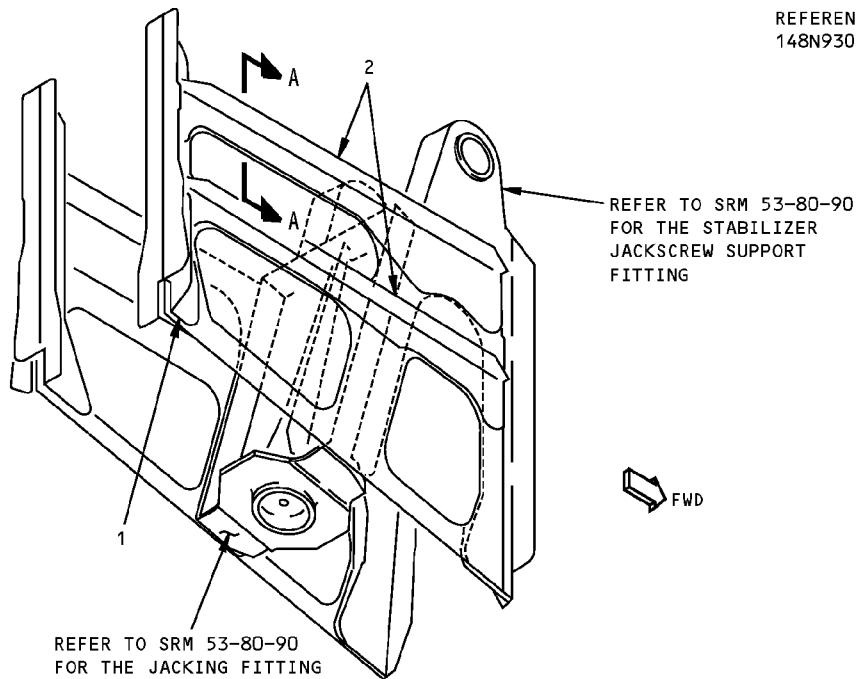
STABILIZER JACKSCREW SUPPORT FITTING STRUCTURE
DETAIL II

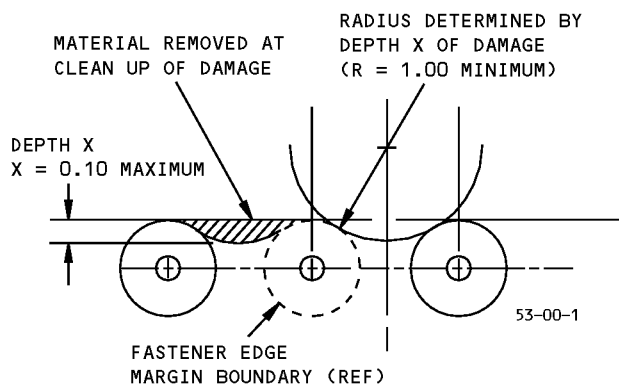
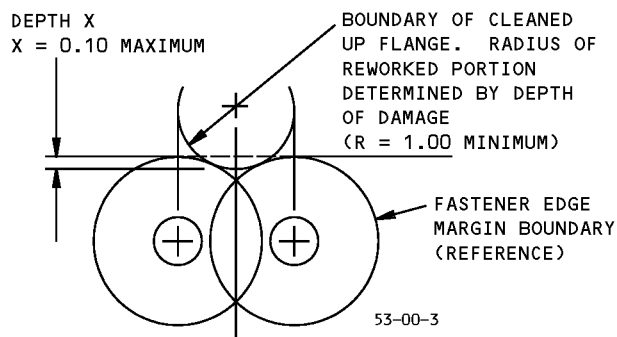
DETAIL III

DAMAGE CLEAN UP OF EDGES WHERE FASTENER EDGE MARGINS DO NOT OVERLAP

DAMAGE CLEAN UP OF EDGES WHERE FASTENER EDGE MARGINS OVERLAP

- REFINISH REWORKED AREAS AS GIVEN IN AMM 51-20
- A** CRACKS NOT ALLOWED EXCEPT FOR EDGE CRACKS WHICH MUST BE REMOVED AS GIVEN IN DETAILS III AND VII
- B** CRACKS NOT ALLOWED EXCEPT FOR EDGE CRACKS WHICH MUST BE REMOVED AS GIVEN IN DETAILS III AND VI
- C** CLEAN OUT DAMAGE UP TO 0.25 MAXIMUM DIA AND NOT CLOSER THAN 1.0 INCH TO FASTENER HOLE. FILL HOLE WITH A 2117-T3 OR T4 ALUMINUM RIVET INSTALLED WET WITH BMS 5-95 SEALANT. ALL OTHER HOLES TO BE REPAIRED
- D** REMOVE THE DAMAGE AS GIVEN IN DETAIL IV

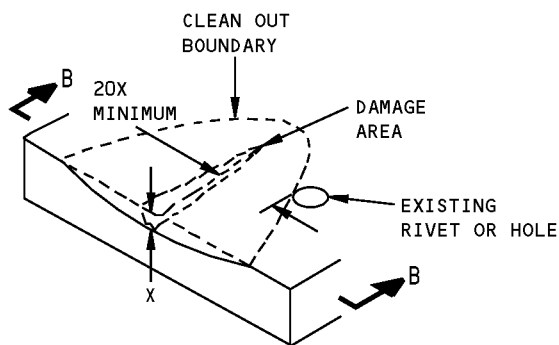
REMOVAL OF NICK, GOUGE AND SCRATCH DAMAGE ON A SURFACE
DETAIL IV

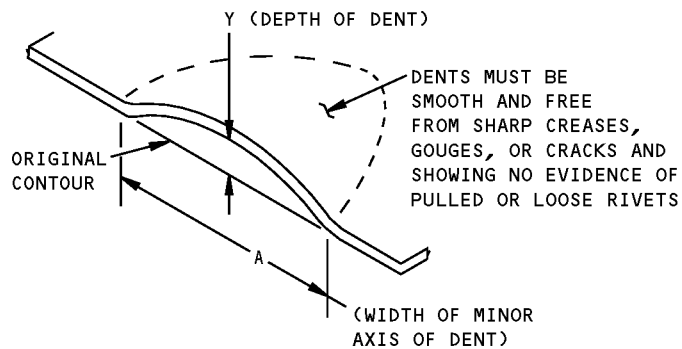
$\frac{A}{Y}$ MUST NOT BE LESS THAN 30

Y MAXIMUM = 0.05 OR WEB THICKNESS,
WHICHEVER IS LESS

ALLOWABLE DAMAGE FOR DENT DETAIL V

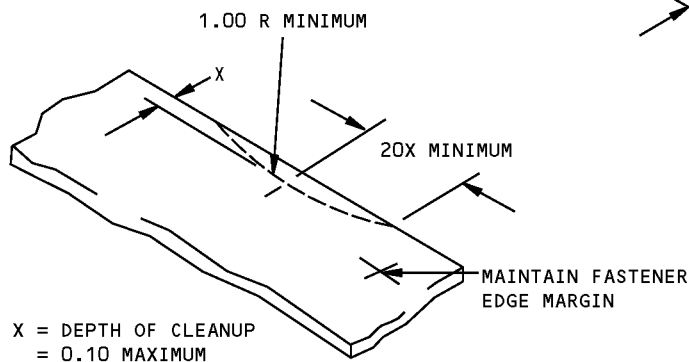
REMOVAL OF NICK OR CRACK
DAMAGE ON AN EDGE
DETAIL VI

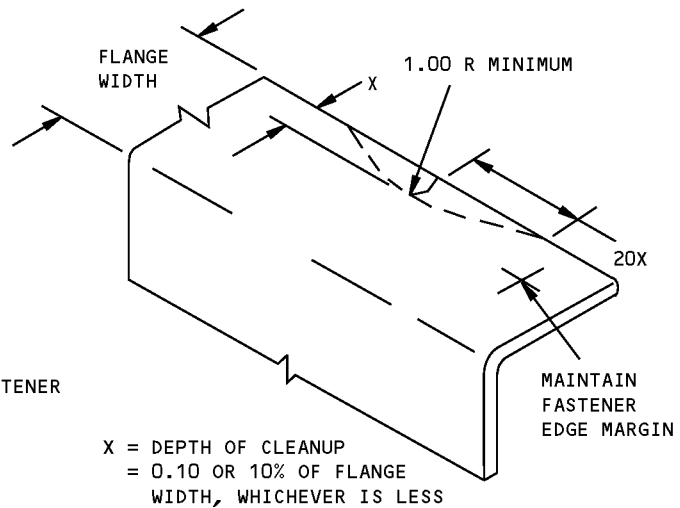
REMOVAL OF NICK OR CRACK
DAMAGE ON AN EDGE
DETAIL VII

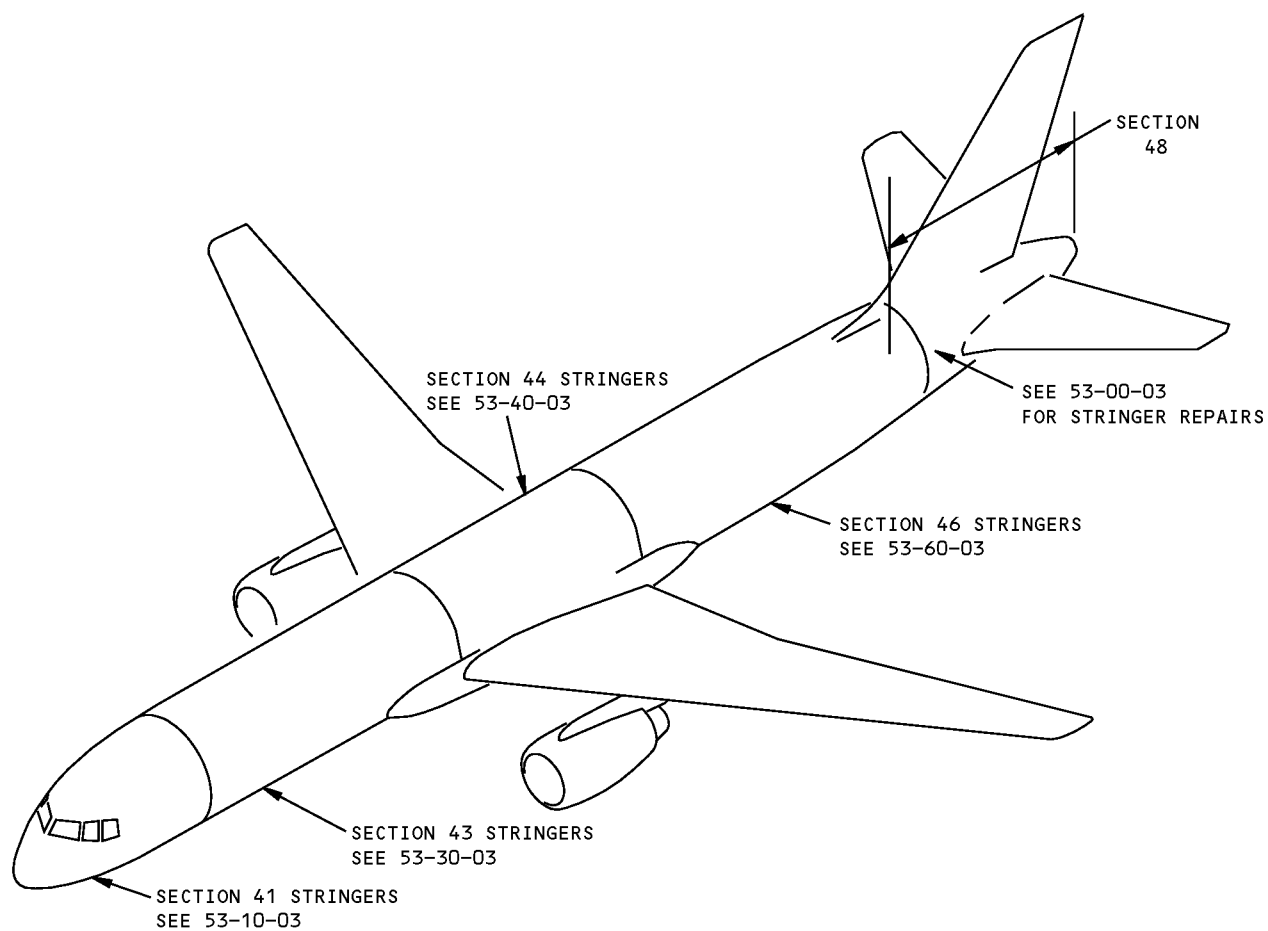
Section 48 Stringer Repair
Figure 201

REPAIR GENERAL - SECTION 48 - STRINGERS

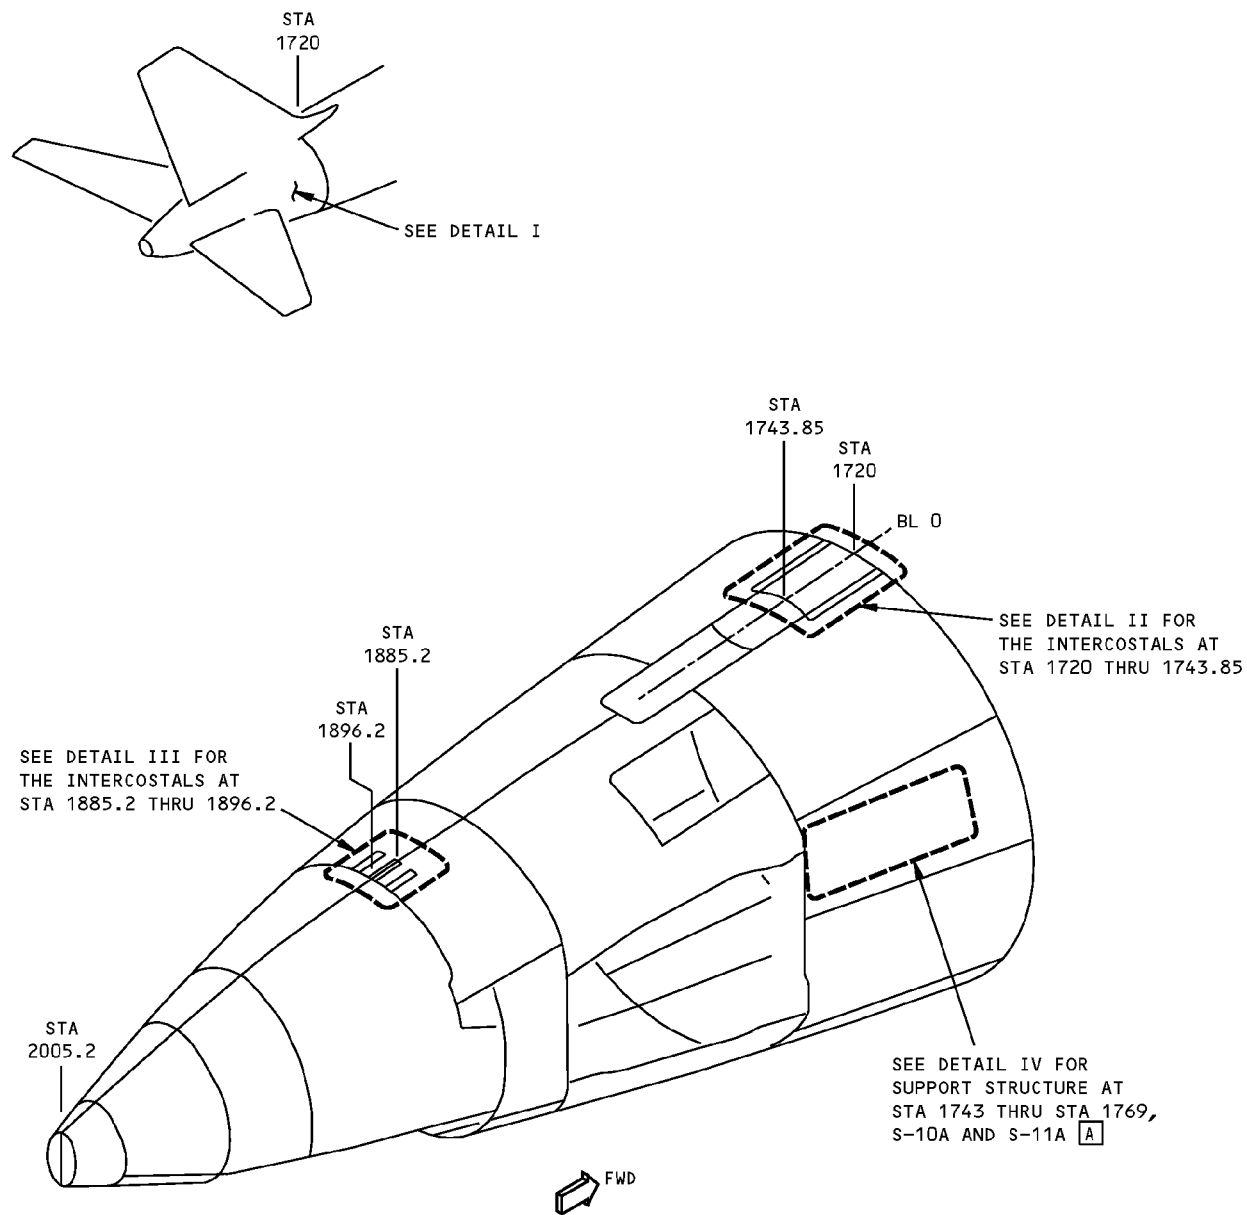
DETAIL I

IDENTIFICATION 1 - SECTION 48 - INTERCOSTALS

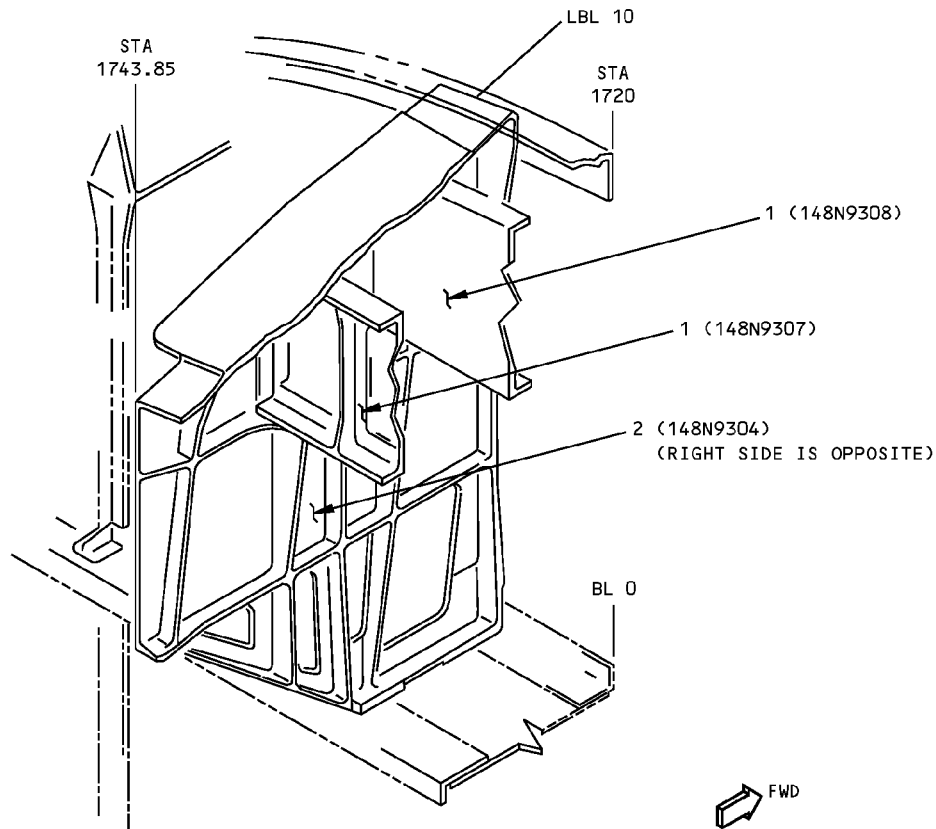
DETAIL II

REFERENCE DRAWING
148N9301

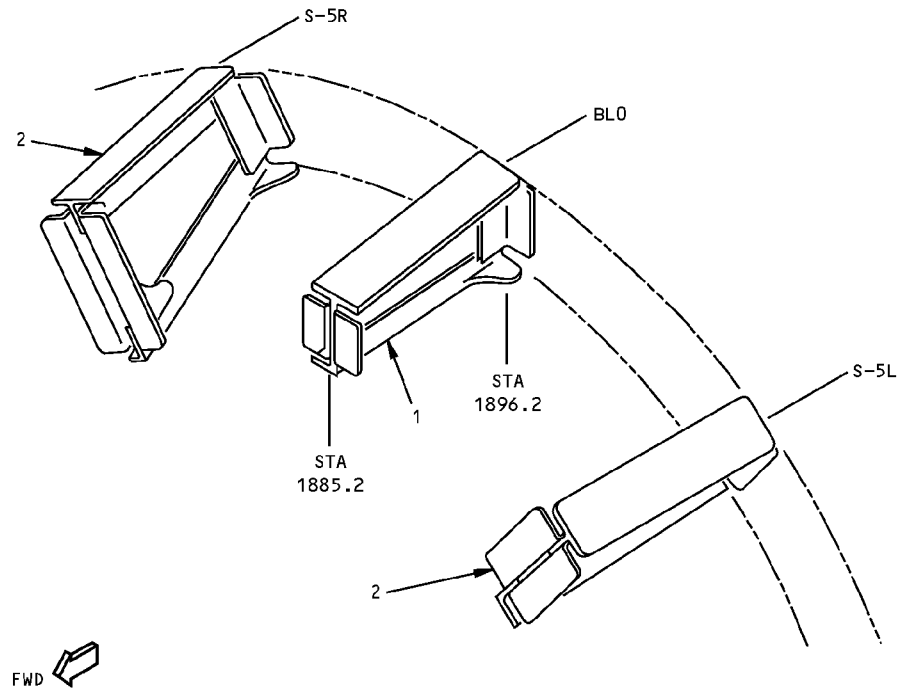
DETAIL III

REFERENCE DRAWING
148N8501

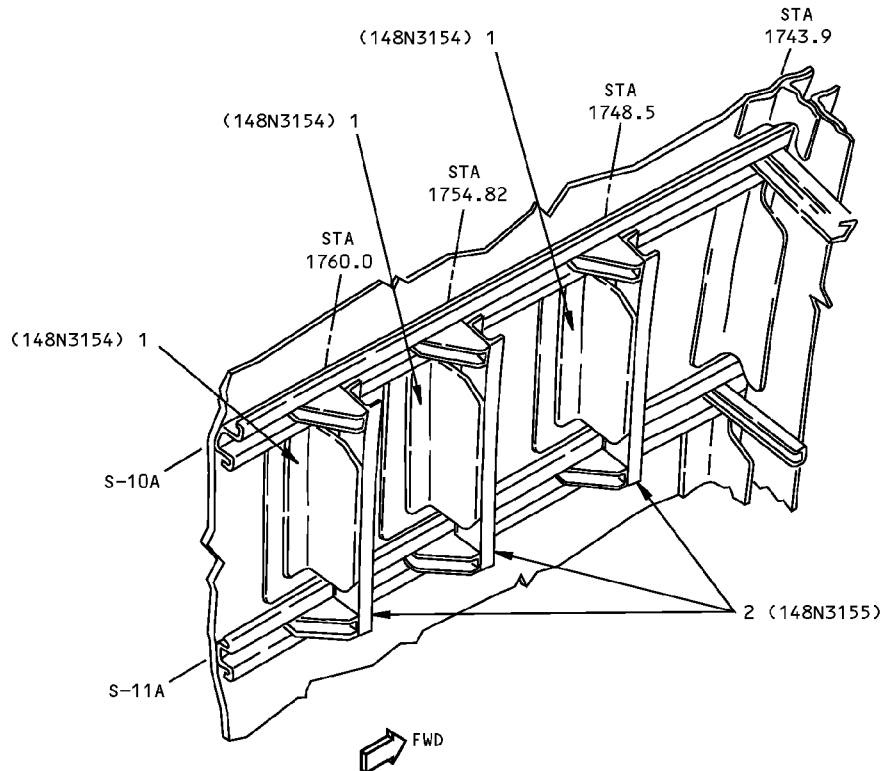
LEFT SIDE IS SHOWN, RIGHT SIDE IS OPPOSITE
DETAIL IV

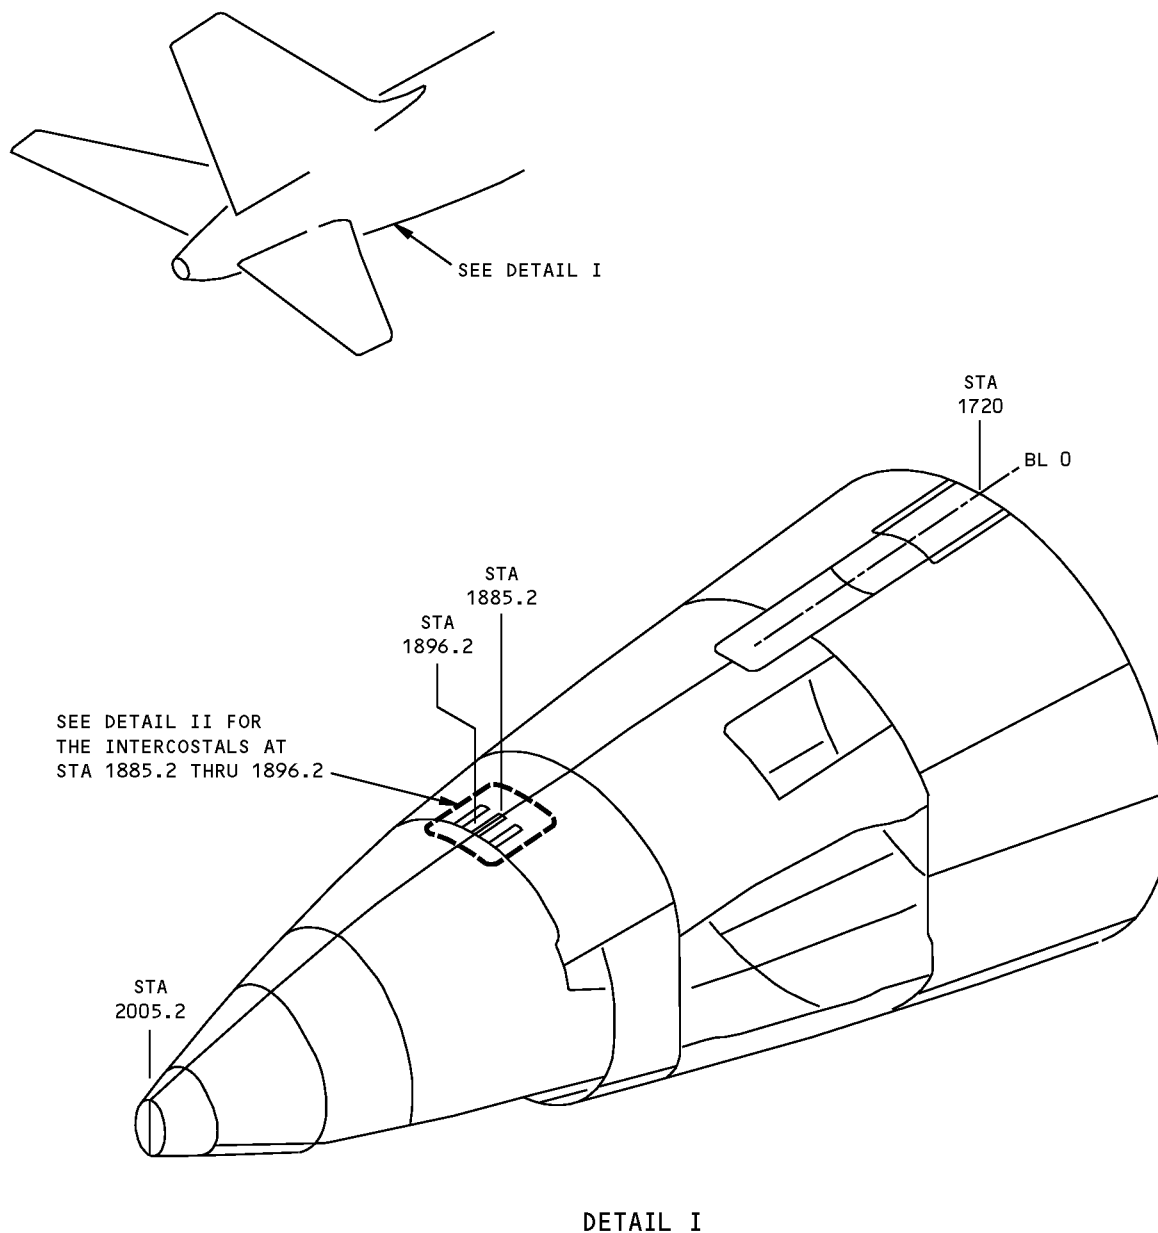
Section 48 Intercostal Allowable Damage
Figure 101 (Sheet 1 of 2)

ALLOWABLE DAMAGE GENERAL - SECTION 48 - INTERCOSTALS

- REFER TO SRM 53-00-04 FOR THE INTERCOSTAL ALLOWABLE DAMAGE DATA

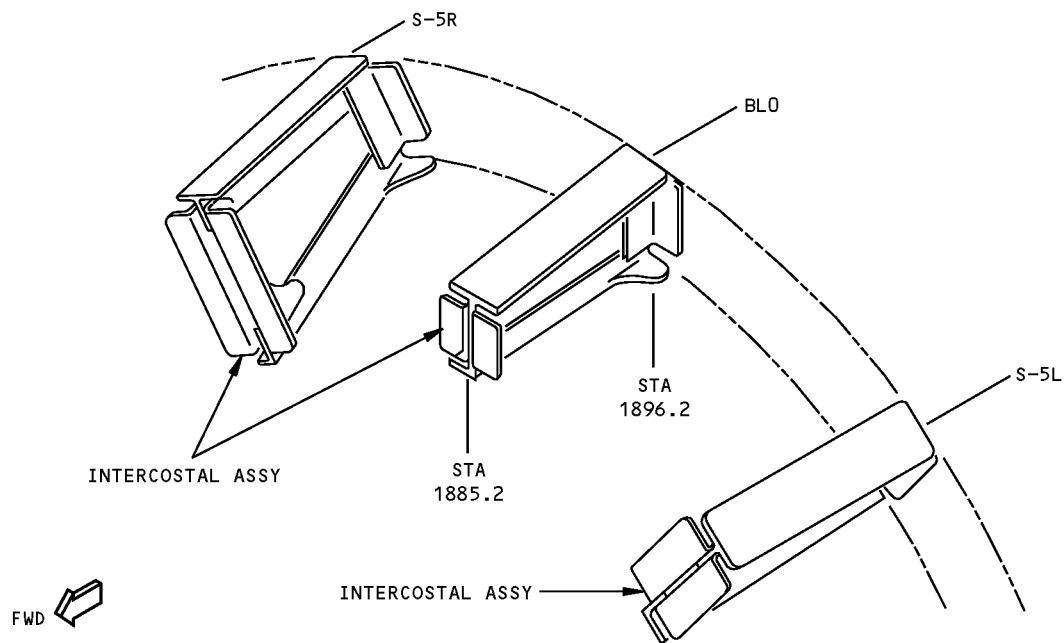
DETAIL II

Section 48 Intercostal Allowable Damage
Figure 101 (Sheet 2 of 2)

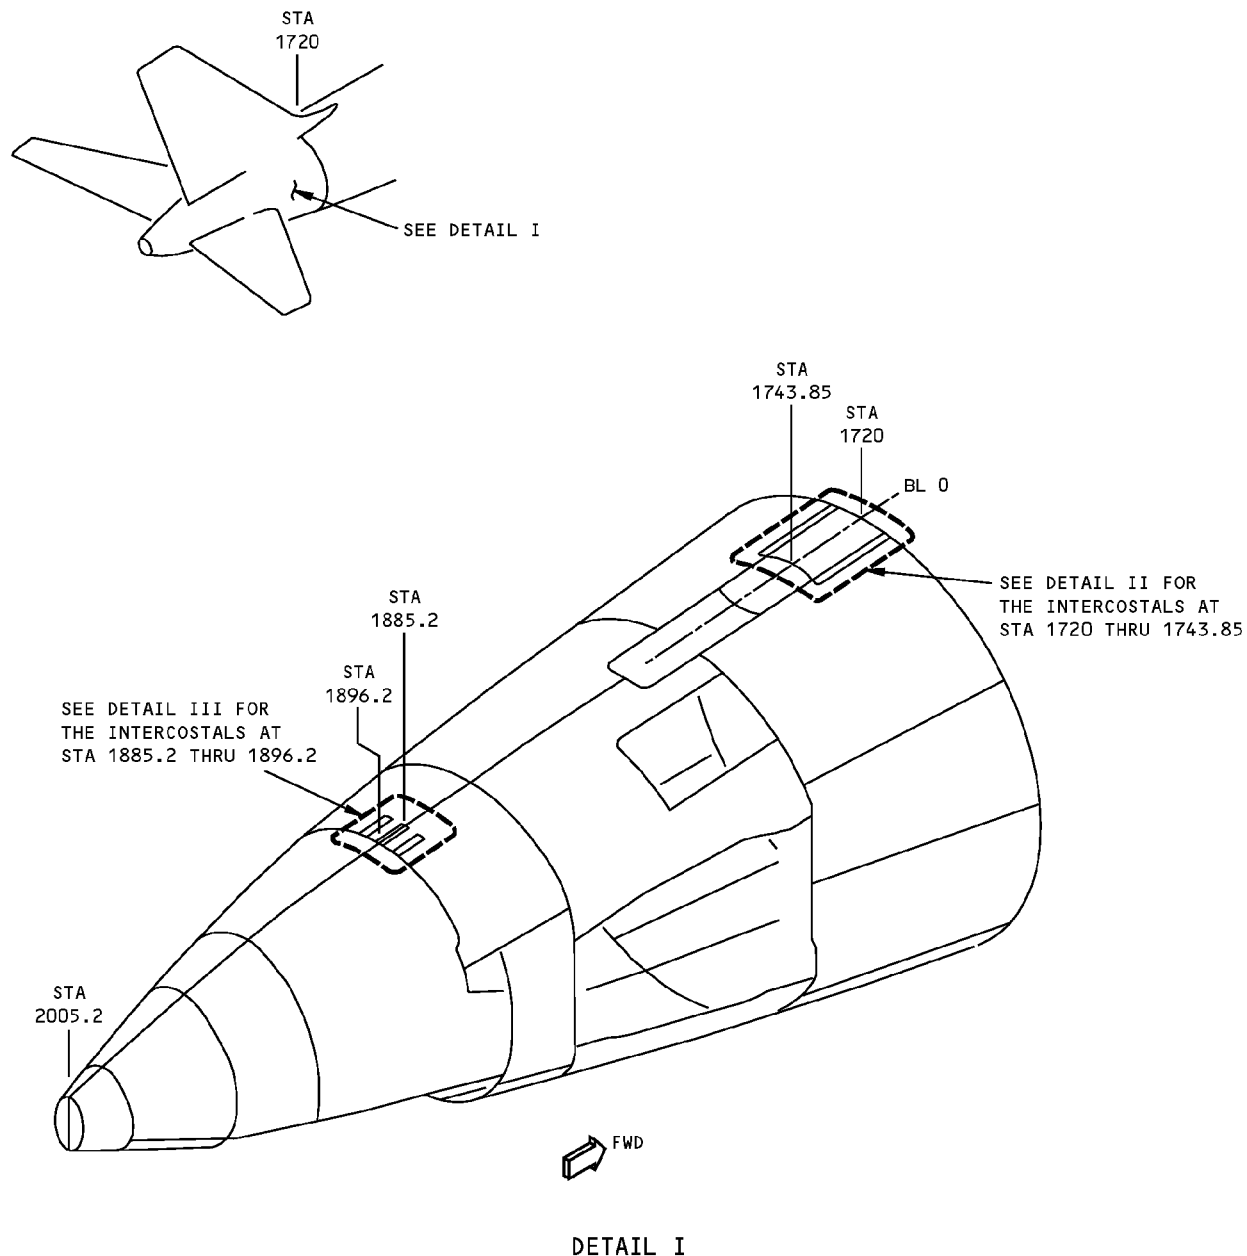
**Section 48 Fuselage Intercostal Repair
Figure 201 (Sheet 1 of 2)**

REPAIR GENERAL - SECTION 48 - INTERCOSTAL

A NO TYPICAL REPAIR TO FITTINGS APPLICABLE. SPECIFIC REPAIRS TO FITTINGS WILL BE PROVIDED BASED ON SERVICE EXPERIENCE.

B DAMAGED COMPONENTS MAY BE REPLACED OR REPAIRED. IF REPAIRS ARE TO BE MADE, REFER TO SRM 51-70 FOR TYPICAL WEB, FORMED SECTION, OR EXTRUDED SECTION REPAIR.

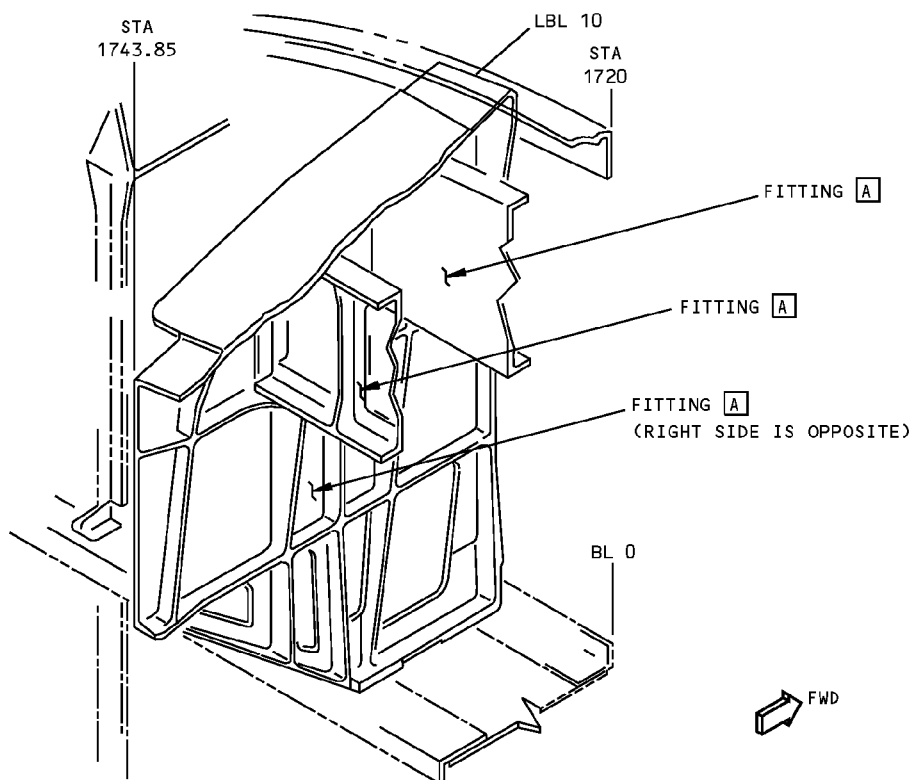
DETAIL II

REFERENCE DRAWING
148N9301

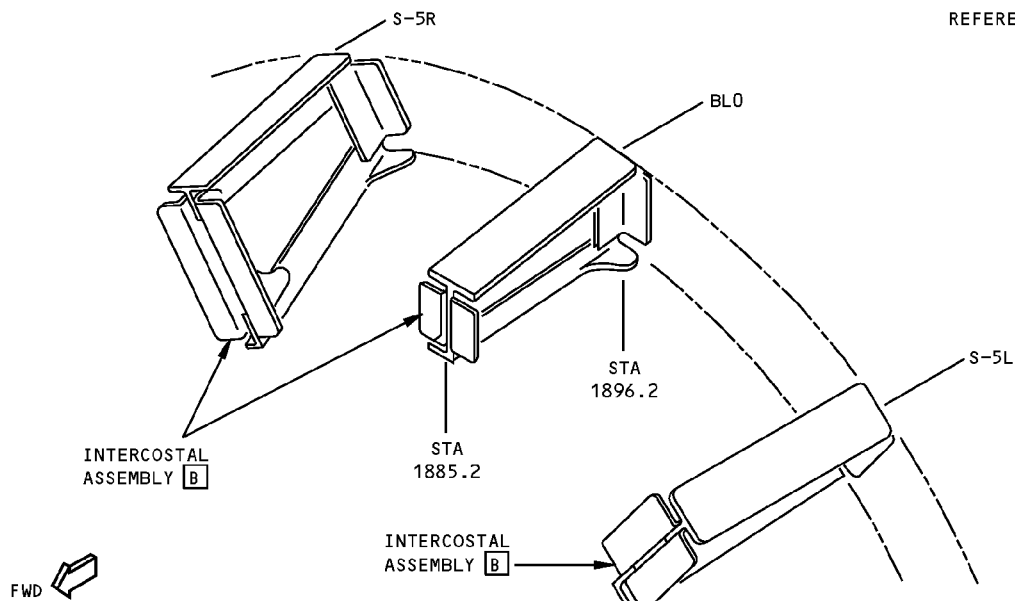
DETAIL III

REFERENCE DRAWING
148N8501

Section 48 Fuselage Intercostal Repair Figure 201 (Sheet 2 of 2)

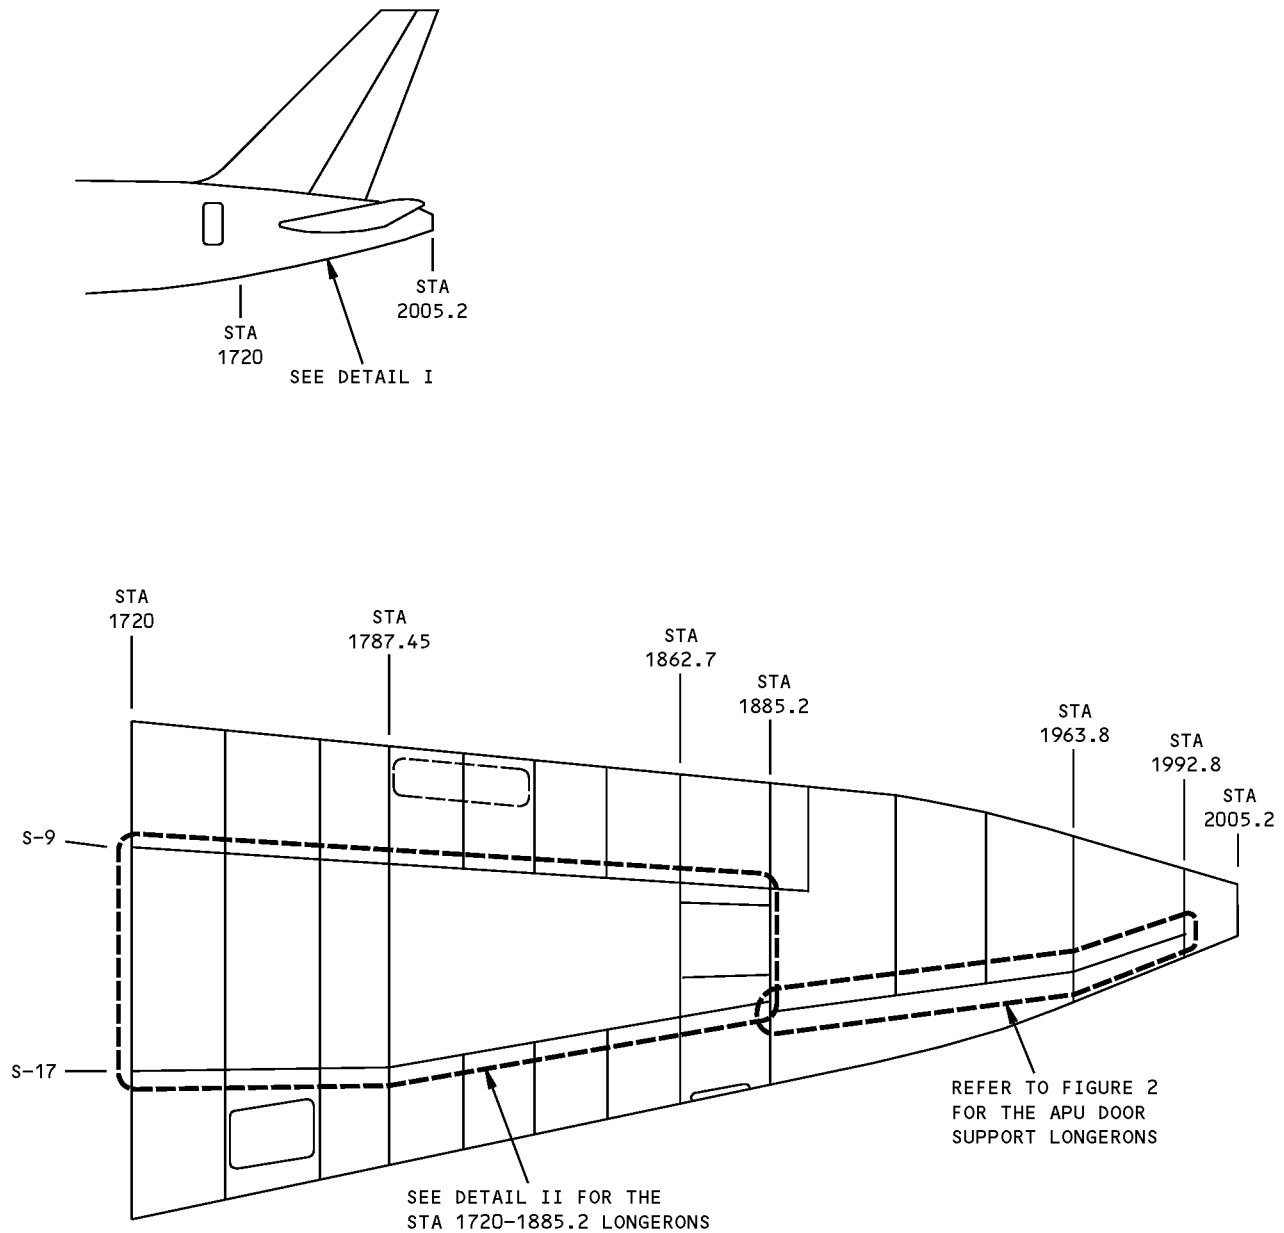
Section 48 Longerons Identification
Figure 1 (Sheet 1 of 3)

IDENTIFICATION 1 - SECTION 48 - LONGERONS

LEFT SIDE VIEW
SECTION 48

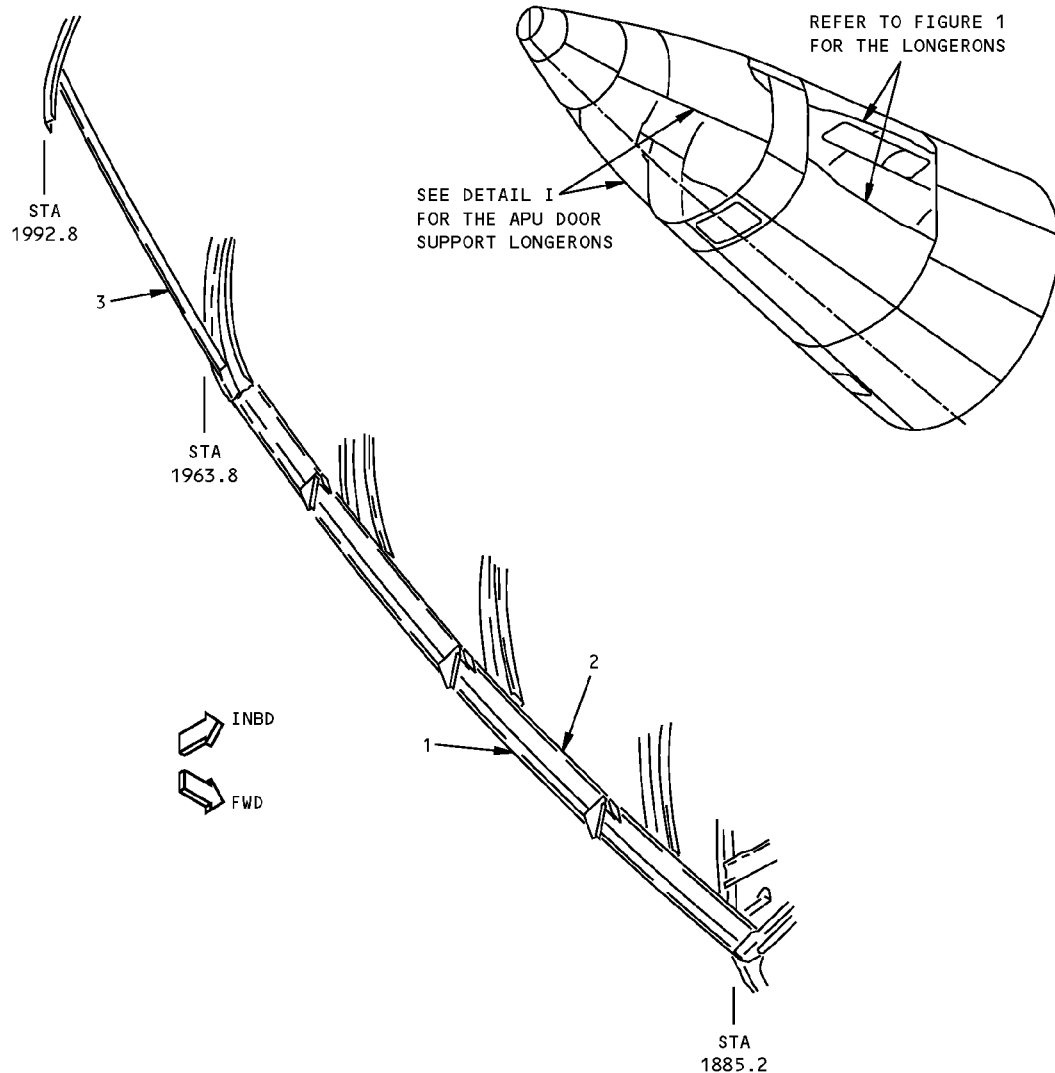
DETAIL I

IDENTIFICATION 2 - SECTION 48 - APU DOOR SUPPORT LONGERON

REFERENCE DRAWING
148N8201

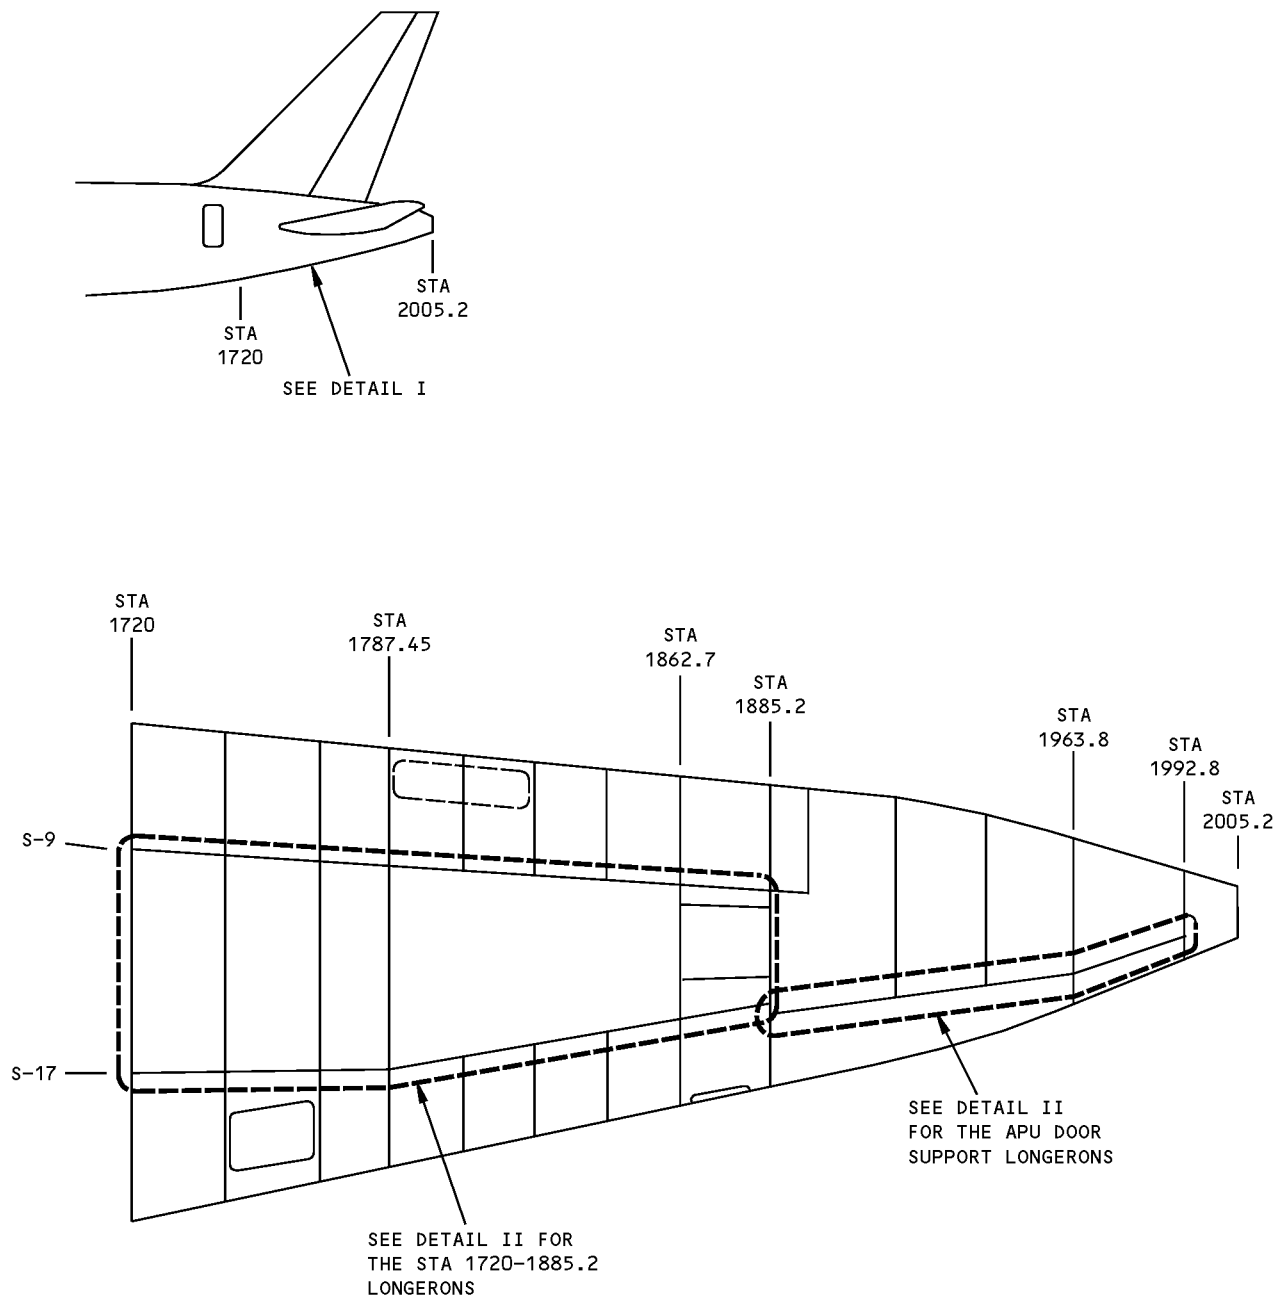
Section 48 Longerons Allowable Damage
Figure 101 (Sheet 1 of 7)

ALLOWABLE DAMAGE 1 - SECTION 48 - LONGERONS

LEFT SIDE VIEW
SECTION 48

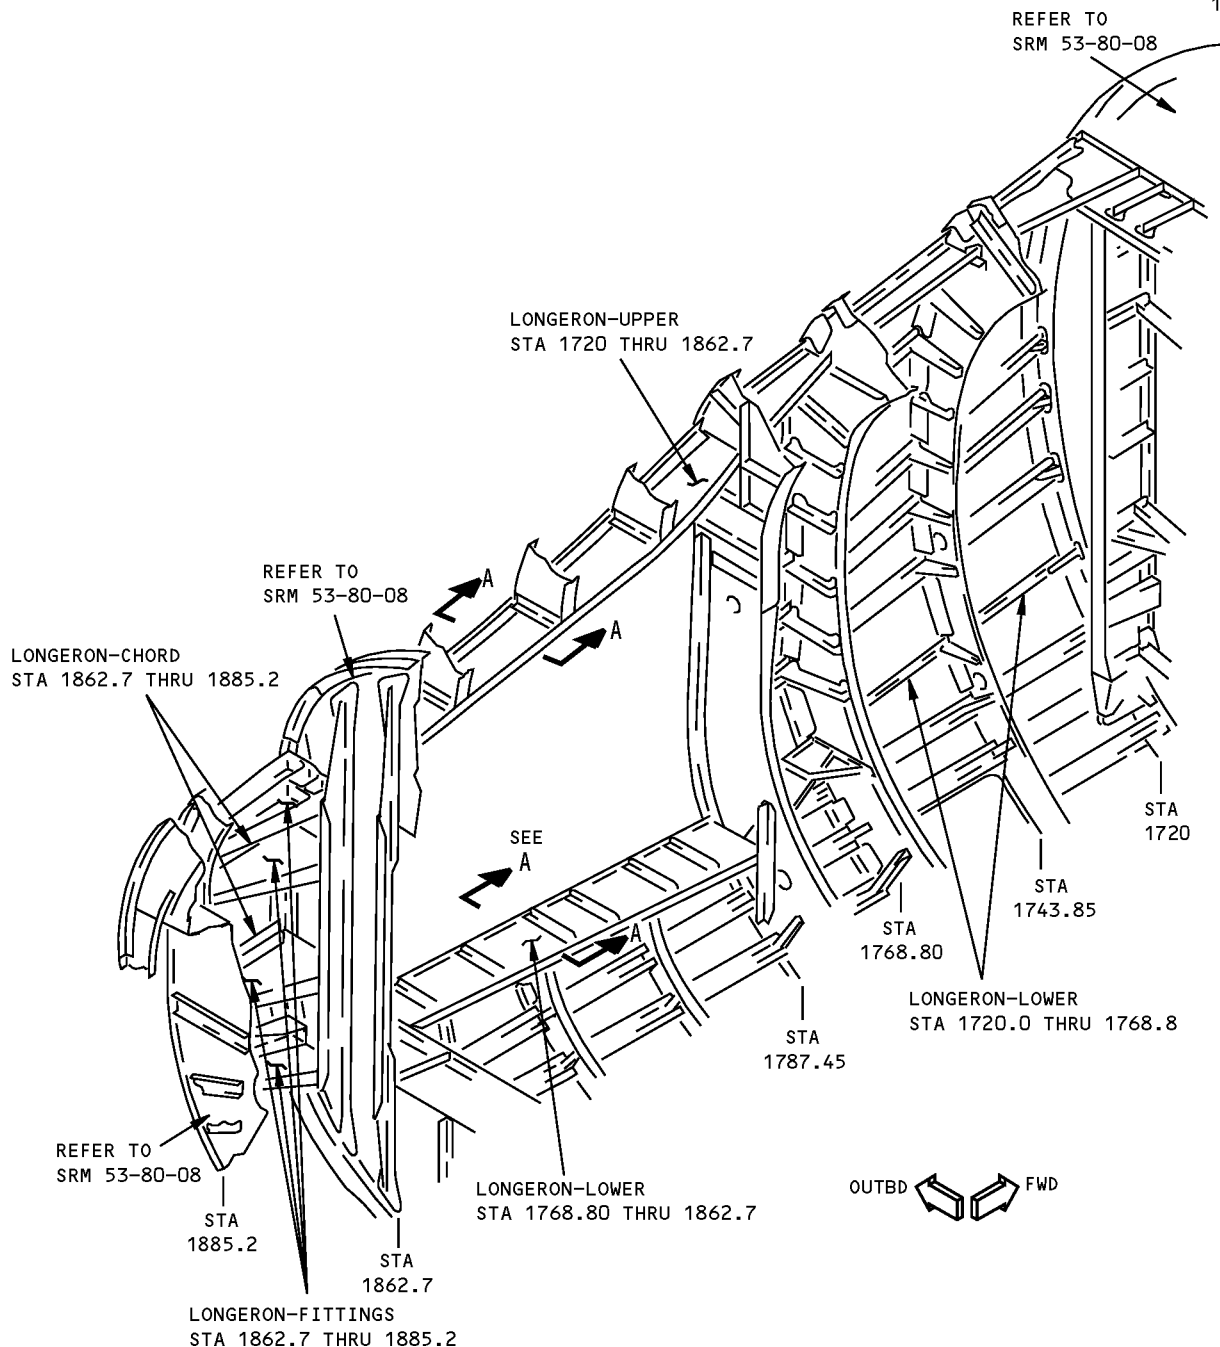
Section 48 Longeron Allowable Damage Figure 101 (Sheet 2 of 7)

REFERENCE DRAWINGS
148N9102
148N9103
148N9202

MATERIAL: ALUMINUM

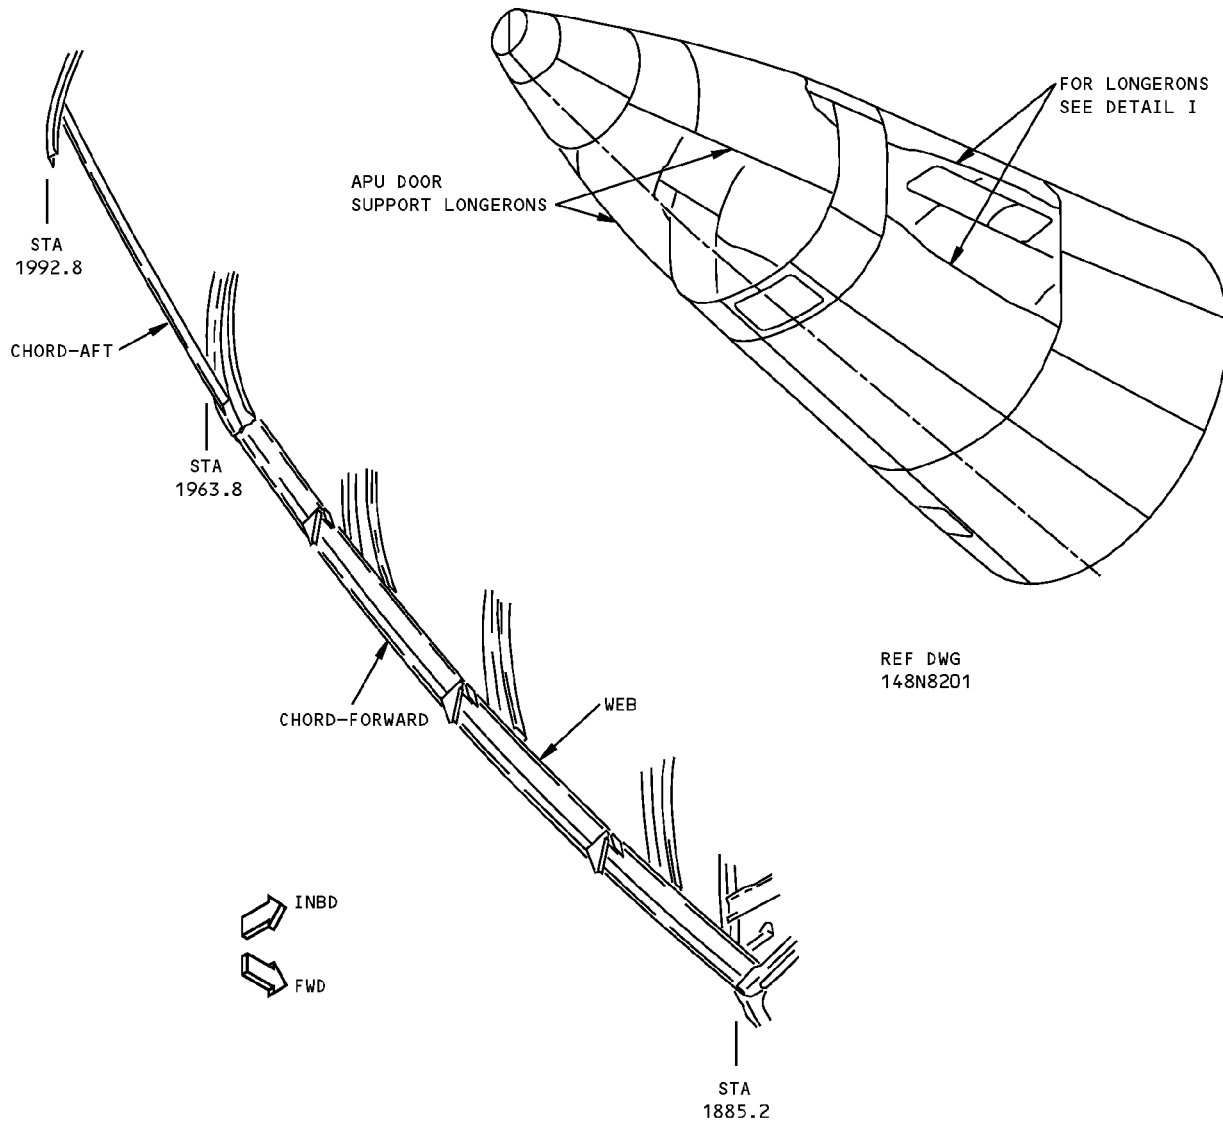
Section 48 Longerons Allowable Damage
Figure 101 (Sheet 4 of 7)

MATERIAL: ALUMINUM

DETAIL III

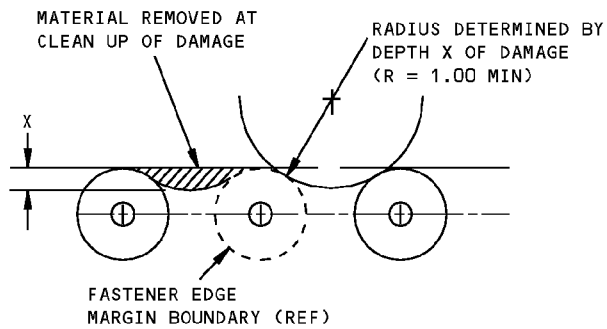
DETAIL IV

DEPTH X = 0.10 MAX OR 10% OF FLANGE WIDTH, WHICHEVER IS LESS

DAMAGE CLEAN UP OF EDGES WHERE FASTENER EDGE MARGINS DO NOT OVERLAP

DAMAGE CLEAN UP OF EDGES WHERE FASTENER EDGE MARGINS OVERLAP

- REFER TO AMM 51-20 TO APPLY THE FINISH TO THE REWORKED AREA.
- [A]** CRACKS ARE NOT PERMITTED EXCEPT FOR EDGE CRACKS WHICH MUST BE REMOVED AS SHOWN ON DETAILS IV AND X.

- [B]** CRACKS ARE NOT PERMITTED EXCEPT FOR EDGE CRACKS WHICH MUST BE REMOVED AS SHOWN ON DETAILS IV AND IX.
- [C]** CRACKS ARE NOT PERMITTED EXCEPT FOR EDGE CRACKS WHICH MUST BE REMOVED AS SHOWN ON DETAILS IV AND VIII.

- [D]** REMOVE DAMAGE AS SHOWN ON DETAILS IV, V AND IX.
- [E]** REMOVE THE DAMAGE AS SHOWN ON DETAILS IV, V, VII, AND X.
- [F]** REMOVE THE DAMAGE AS SHOWN ON DETAILS IV, V, VII, AND VIII.
