FUSELAGE

757-200 STRUCTURAL REPAIR MANUAL

CHAPTER 53 FUSELAGE

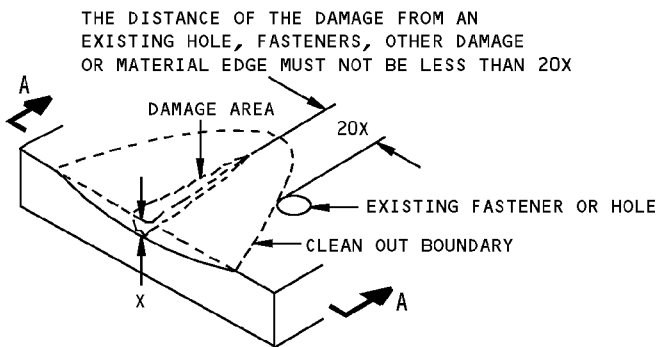
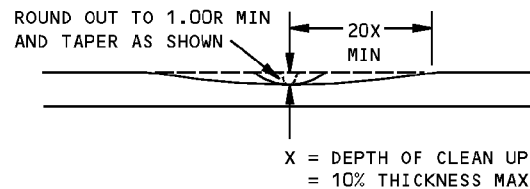
REMOVAL OF NICK, GOUGE AND SCRATCH DAMAGE ON A SURFACE
DETAIL V

THE MAXIMUM AREA REMOVED FOR DAMAGE CLEANUP SHALL NOT EXCEED 4% OF THE ORIGINAL CROSS-SECTIONAL AREA

SECTION A-A

- [D]** REMOVE DAMAGE AS SHOWN ON DETAILS IV, V AND IX.
- [E]** REMOVE THE DAMAGE AS SHOWN ON DETAILS IV, V, VII, AND X.
- [F]** REMOVE THE DAMAGE AS SHOWN ON DETAILS IV, V, VII, AND VIII.

- [G]** REMOVE THE DAMAGE AS SHOWN IN DETAILS IV, V, AND IX. SHOT PEEN REWORKED AREAS AS GIVEN IN SOPM 20-10-03 AND SRM 51-20-06 WITH SHOT NO. 230-550. SHOT PEEN INTENSITIES WILL VARY WITH THE THICKNESS REMAINING AFTER REWORK.

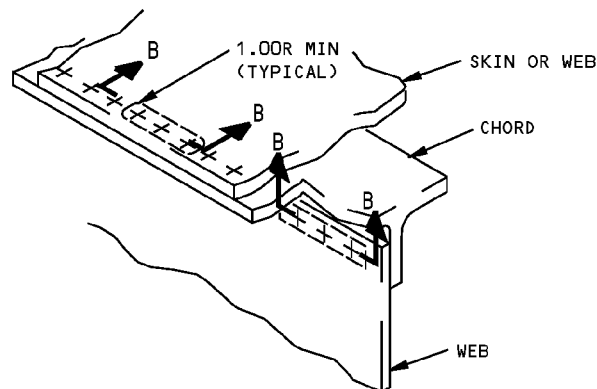
CORROSION CLEANUP
DETAIL VII

SMOOTH BLEND-OUT RADIUS 0.50 INCH MINIMUM. CORROSION CLEANUP AROUND ANY THREE FASTENERS IN TEN IS PERMITTED TO MAX DEPTH 10% OF MATERIAL THICKNESS

SECTION B-B

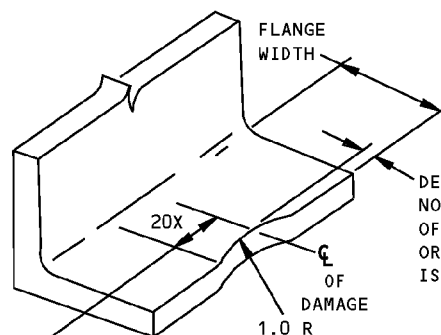
REMOVAL OF EDGE DAMAGE FROM
FREE FLANGE WITHOUT FASTENERS
DETAIL IX

THE DISTANCE OF THE DAMAGE
FROM AN EXISTING HOLE, FASTENERS,
OTHER DAMAGE OR EDGE MUST NOT BE
LESS THAN 20X

- [B]** CRACKS ARE NOT PERMITTED EXCEPT FOR EDGE CRACKS WHICH MUST BE REMOVED AS SHOWN ON DETAILS IV AND IX.
- [C]** CRACKS ARE NOT PERMITTED EXCEPT FOR EDGE CRACKS WHICH MUST BE REMOVED AS SHOWN ON DETAILS IV AND VIII.

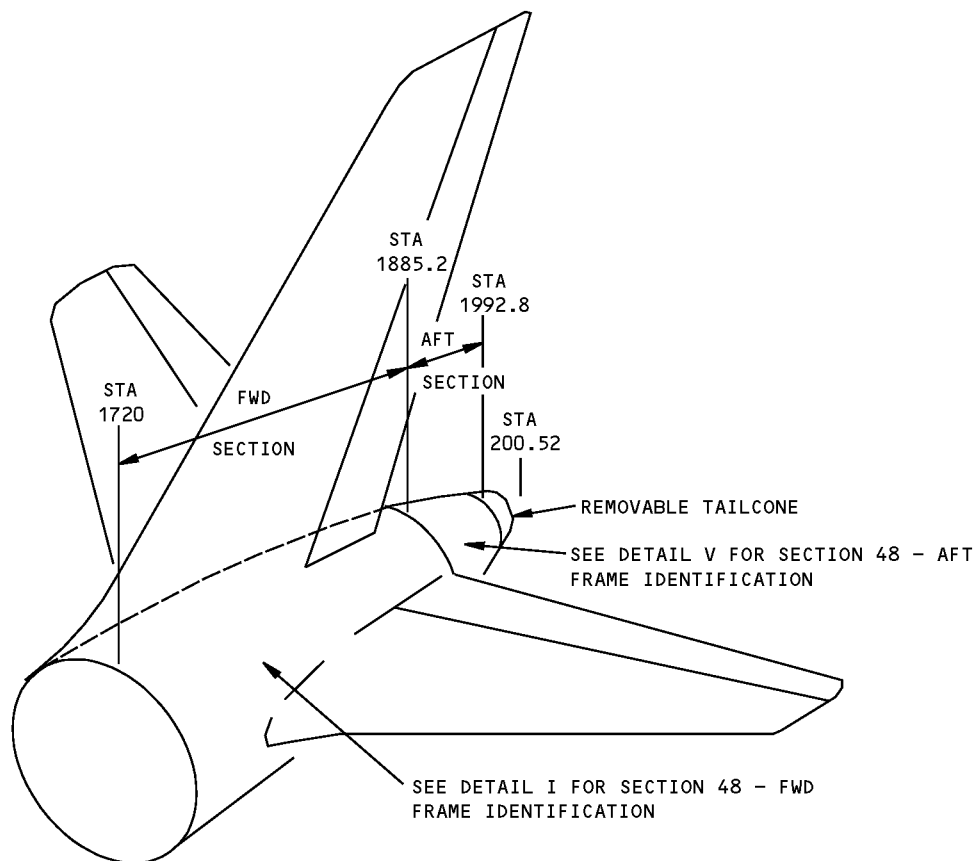
Section 48 Frame Identification
Figure 1 (Sheet 1 of 8)

IDENTIFICATION 1 - SECTION 48 - FRAMES

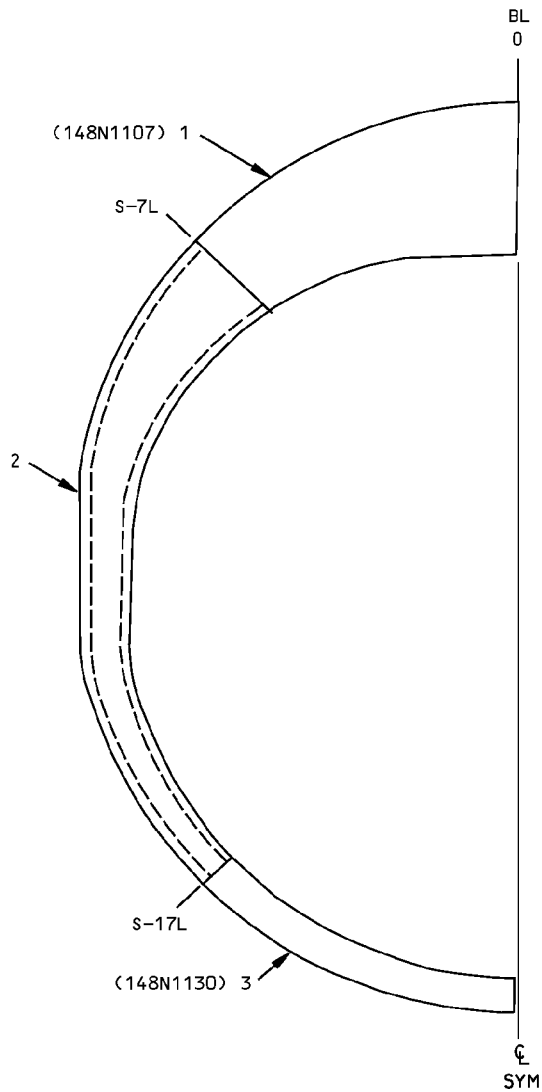
FRAME - STA 1743.85
REAR VIEW
DETAIL II

REF DWG
148N1101

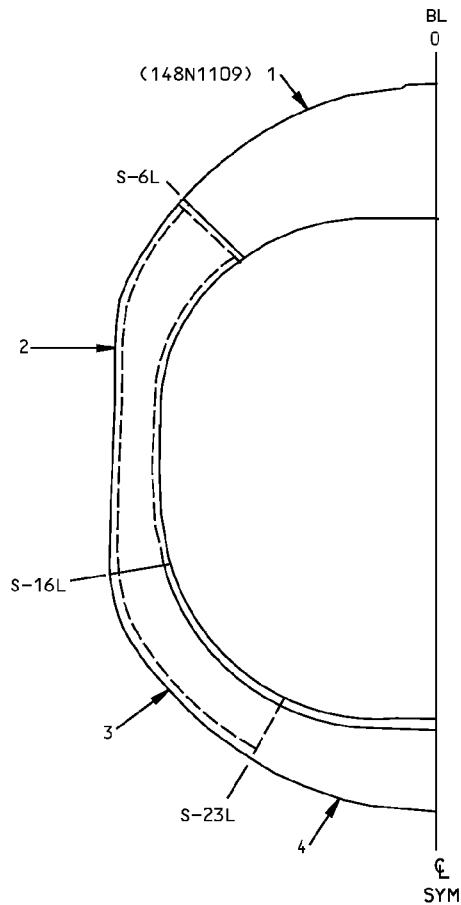
FRAME - STA 1768.80
REAR VIEW
DETAIL III

REF DWG
148N1102

| ITEM | DESCRIPTION | GAGE | MATERIAL | EFFECTIVITY |
|---|--|---|--|---|
| 3 | FRAME ASSY OUTER CHORD WEB WEB INNER CHORD FAILSAFE CHORD | 0.063 0.100 | AND10134-2404 7075-T73 7075-T6 7075-T6 AND10136-3006 7075-T73 AND10133-2004 7075-T73 | |
| 4 | FRAME ASSY FITTING WEB FAILSAFE CHORD | 1.80 0.063 | 7075-T7351 7075-T6 AND10133-2004 7075-T73 | |

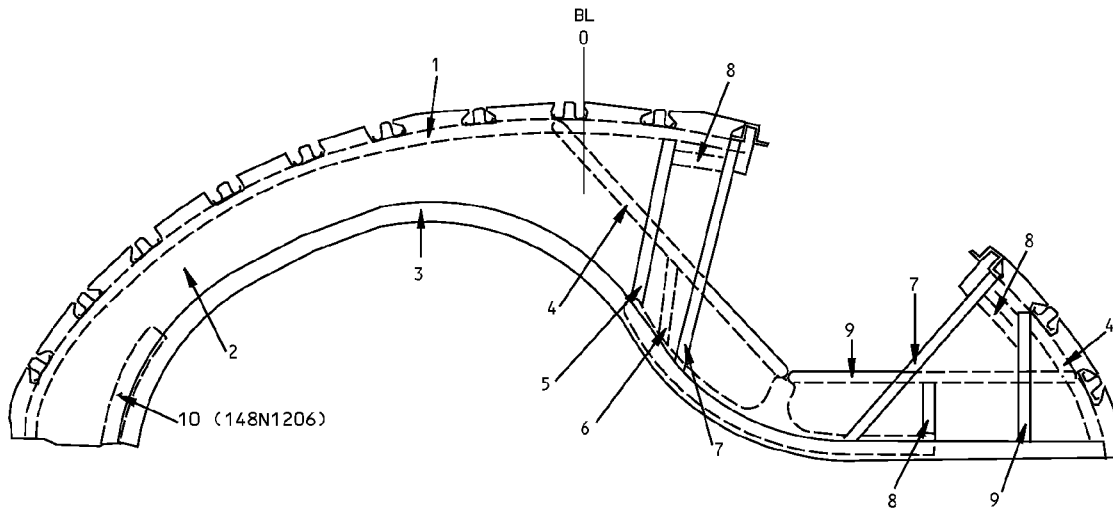
FRAME - STA 1806
REAR VIEW
DETAIL IV

REF DWG
148N1103

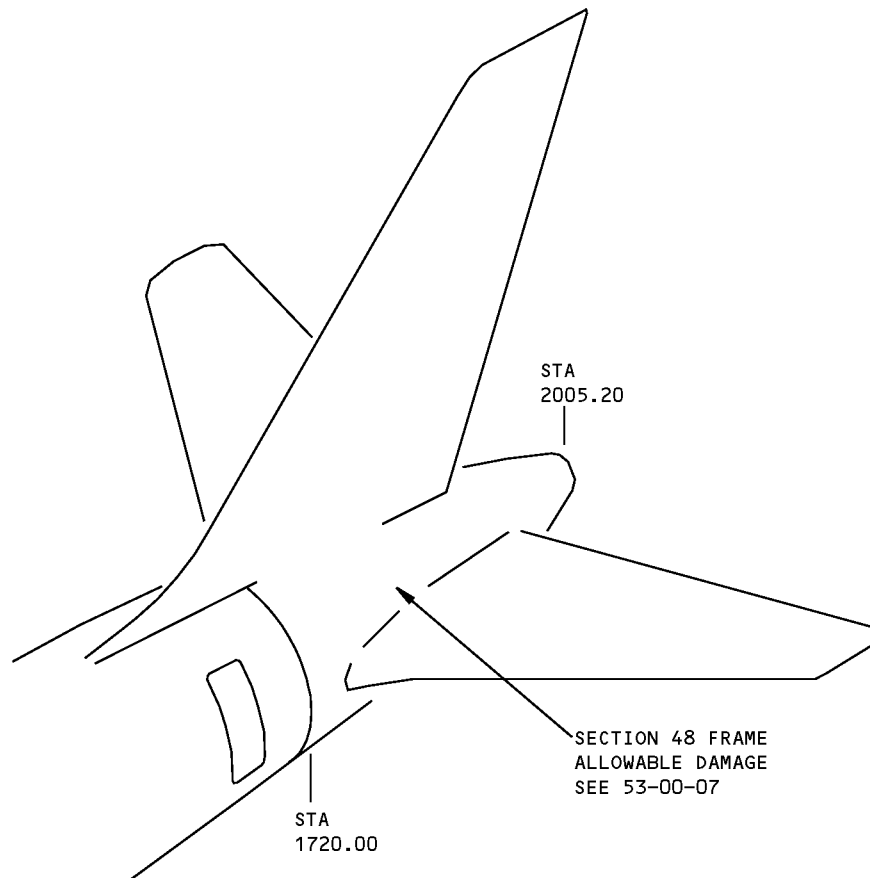
Section 48 Fuselage Frames Allowable Damage
Figure 101

ALLOWABLE DAMAGE GENERAL - SECTION 48 - FRAMES

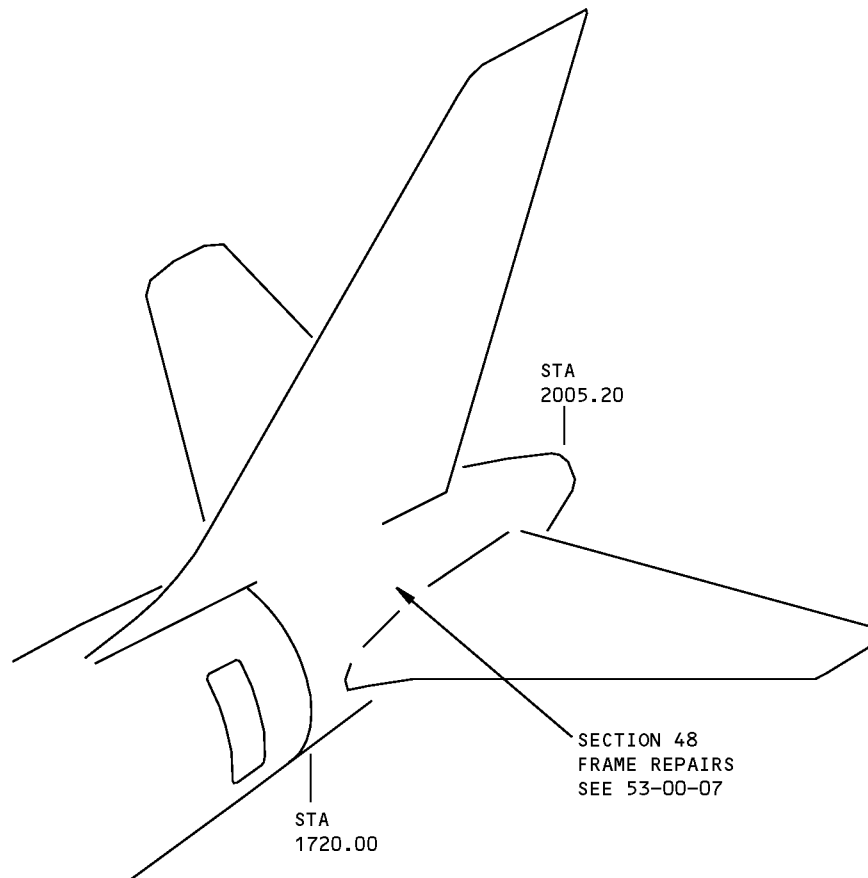
Section 48 Frame Repairs
Figure 201

REPAIR GENERAL - SECTION 48 - FRAMES

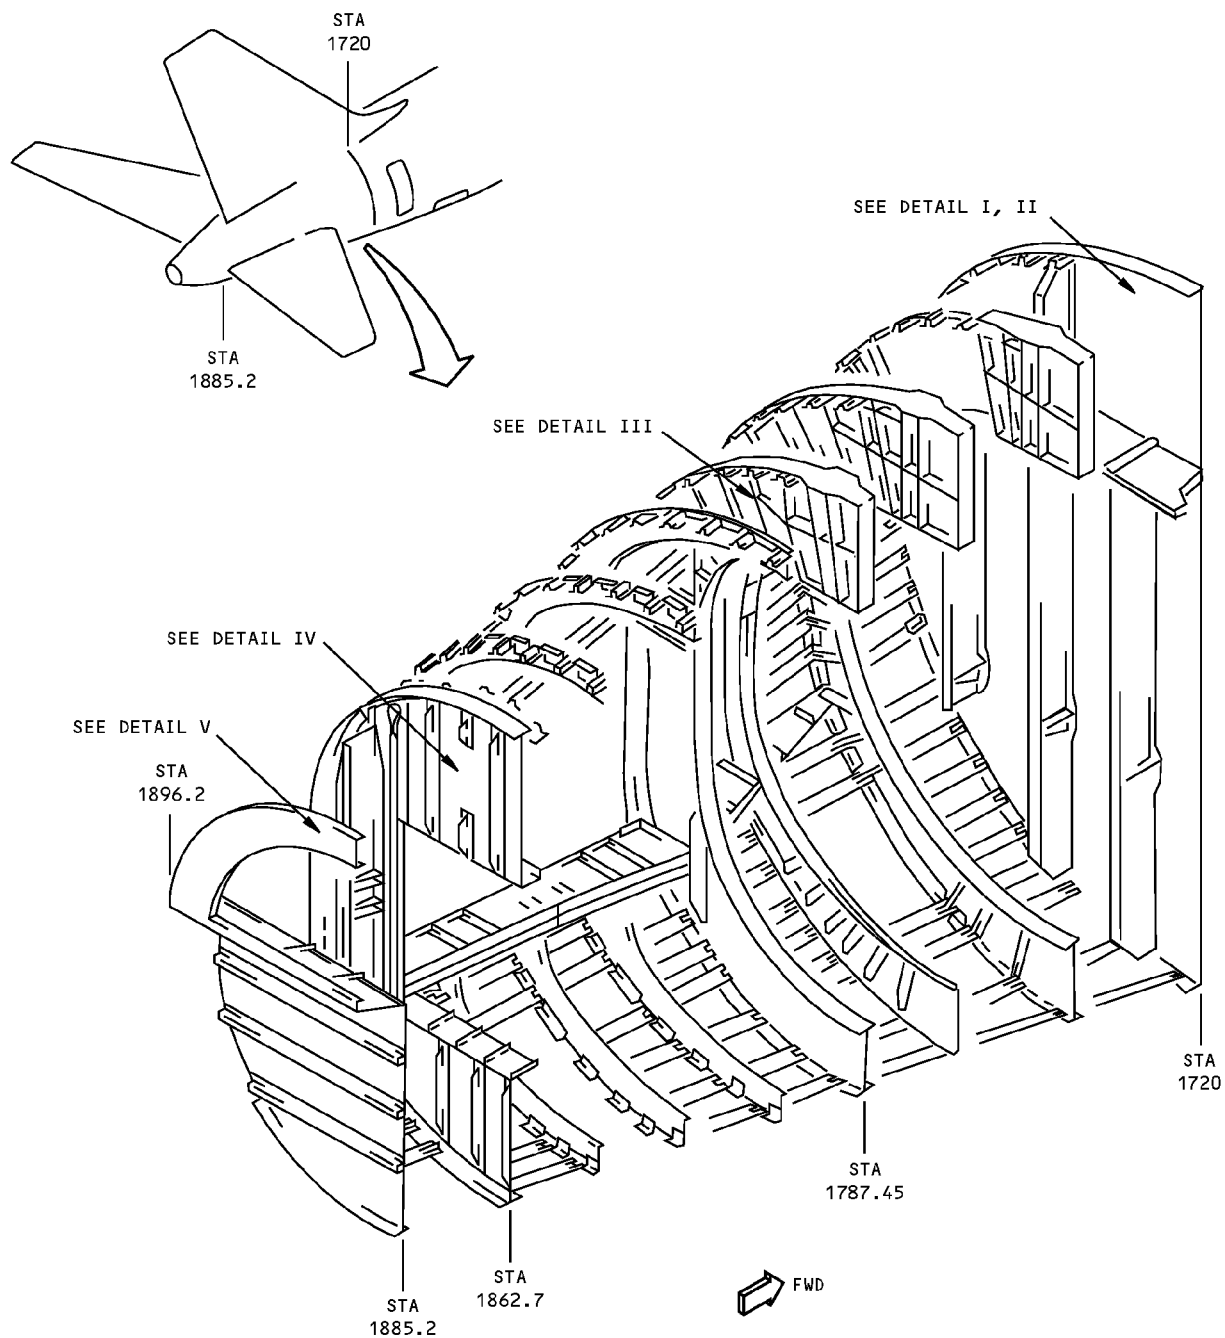
IDENTIFICATION 1 - SECTION 48 - BULKHEADS

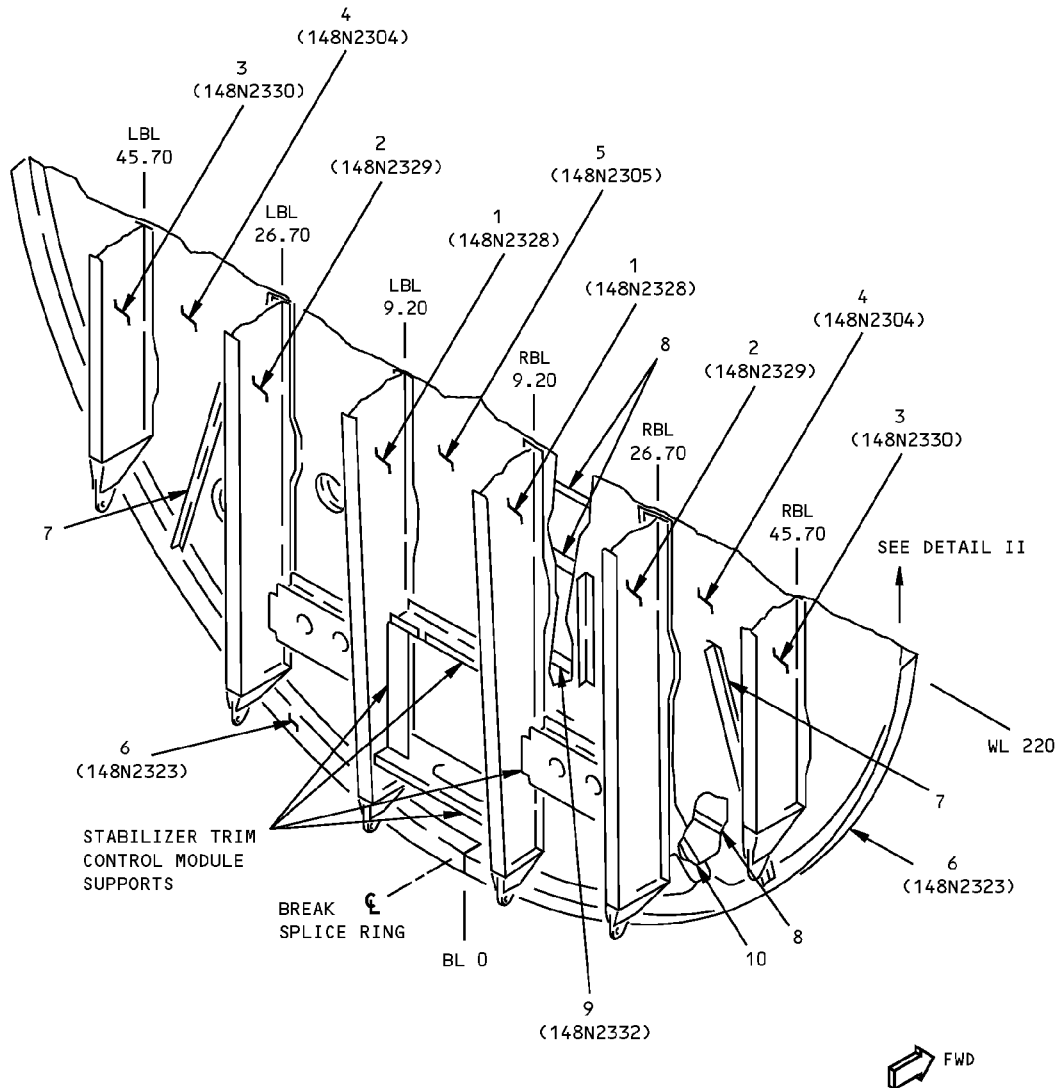
AFT PRESSURE BULKHEAD STA 1720
DETAIL I

REF DWG
148N2301

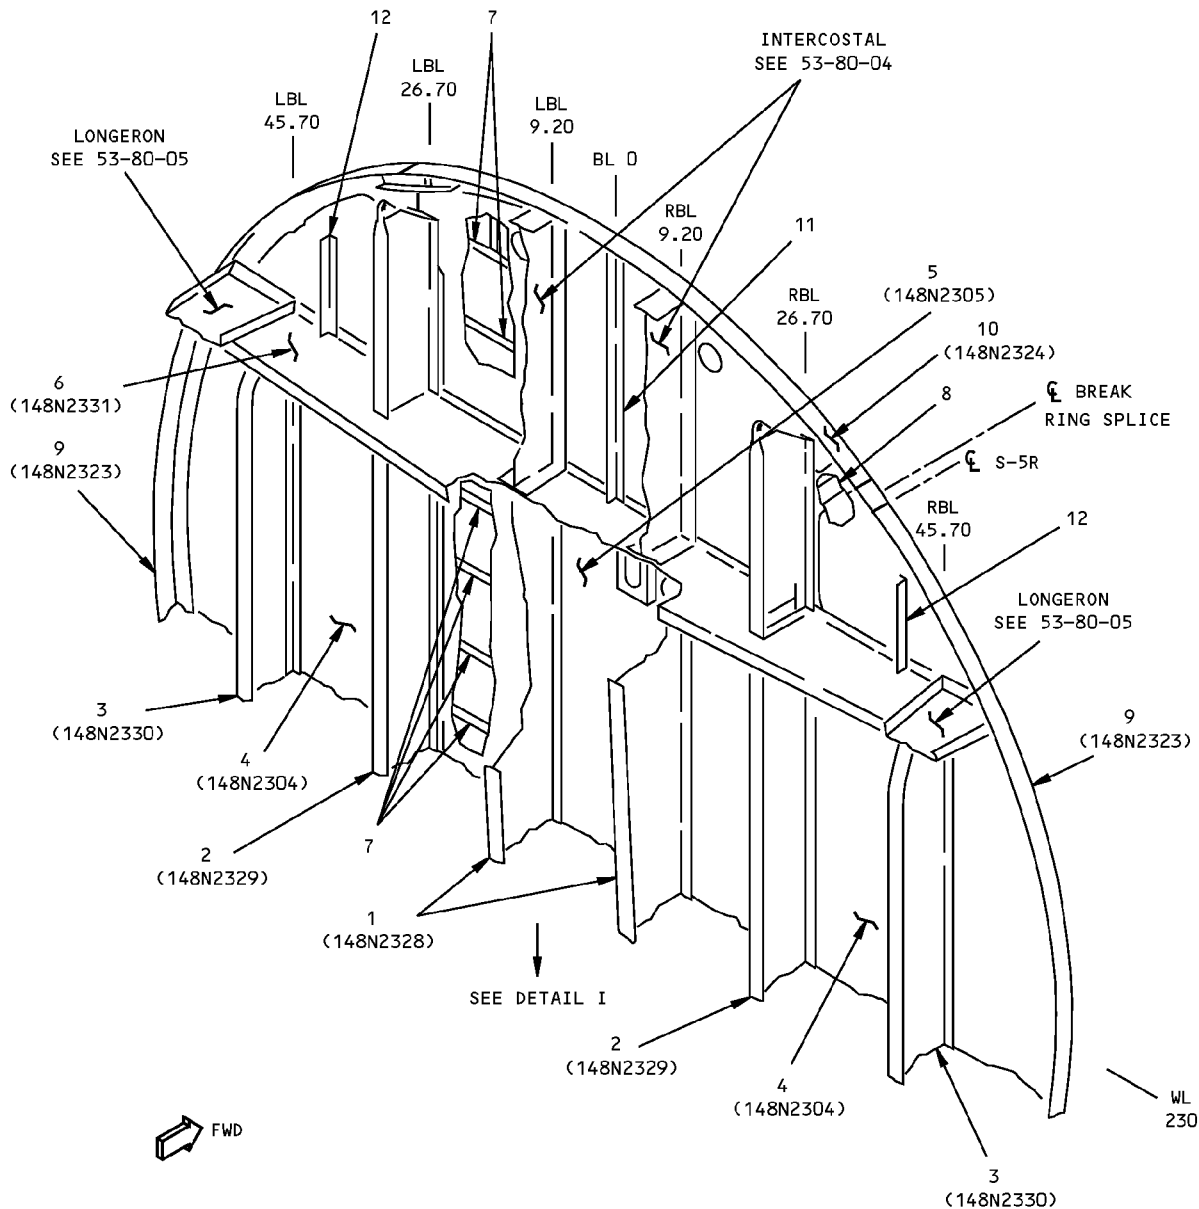
AFT PRESSURE BULKHEAD
STA 1720
DETAIL II

REF DWG
148N2301

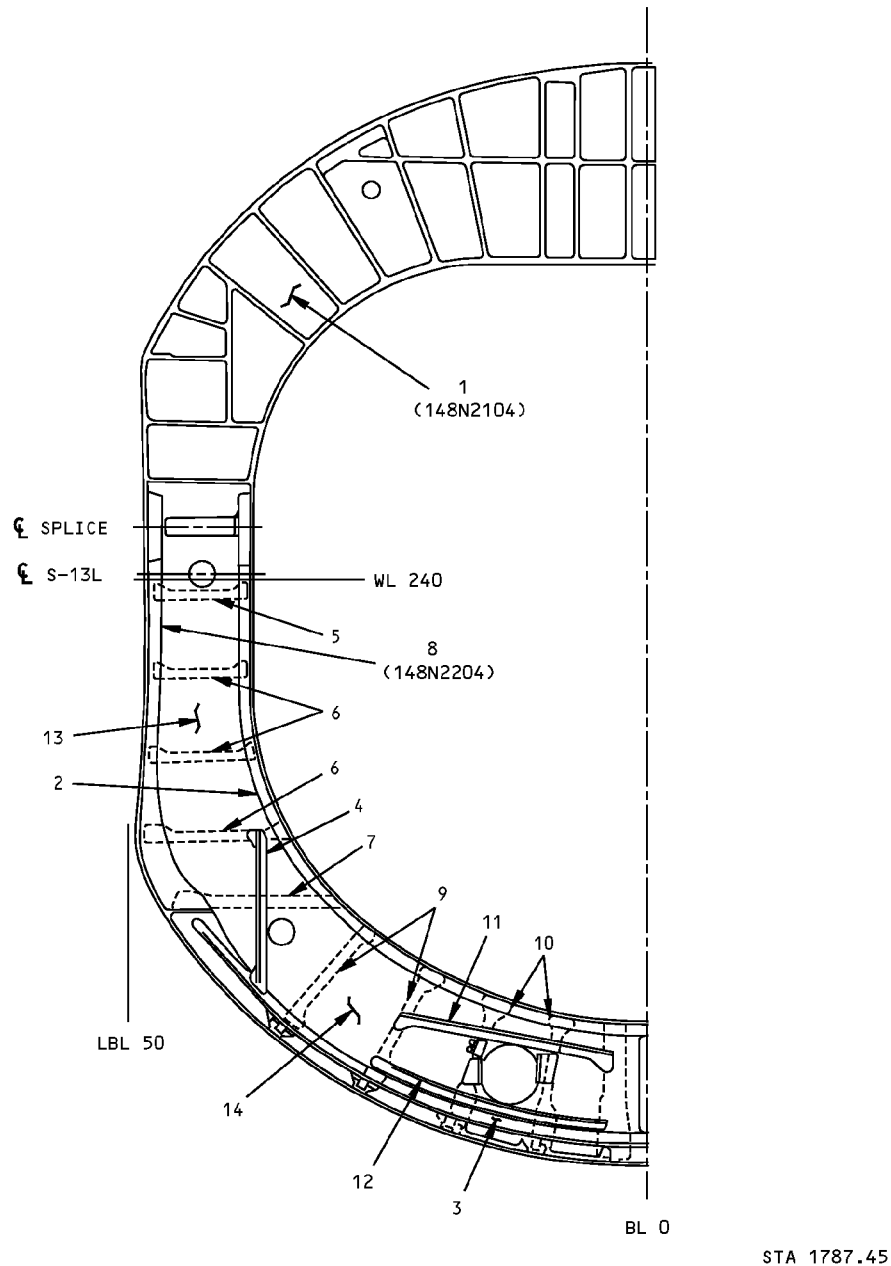
REAR VIEW
STA 1787.45 BULKHEAD
DETAIL III

REF DWGS:
148N2201
148N2101

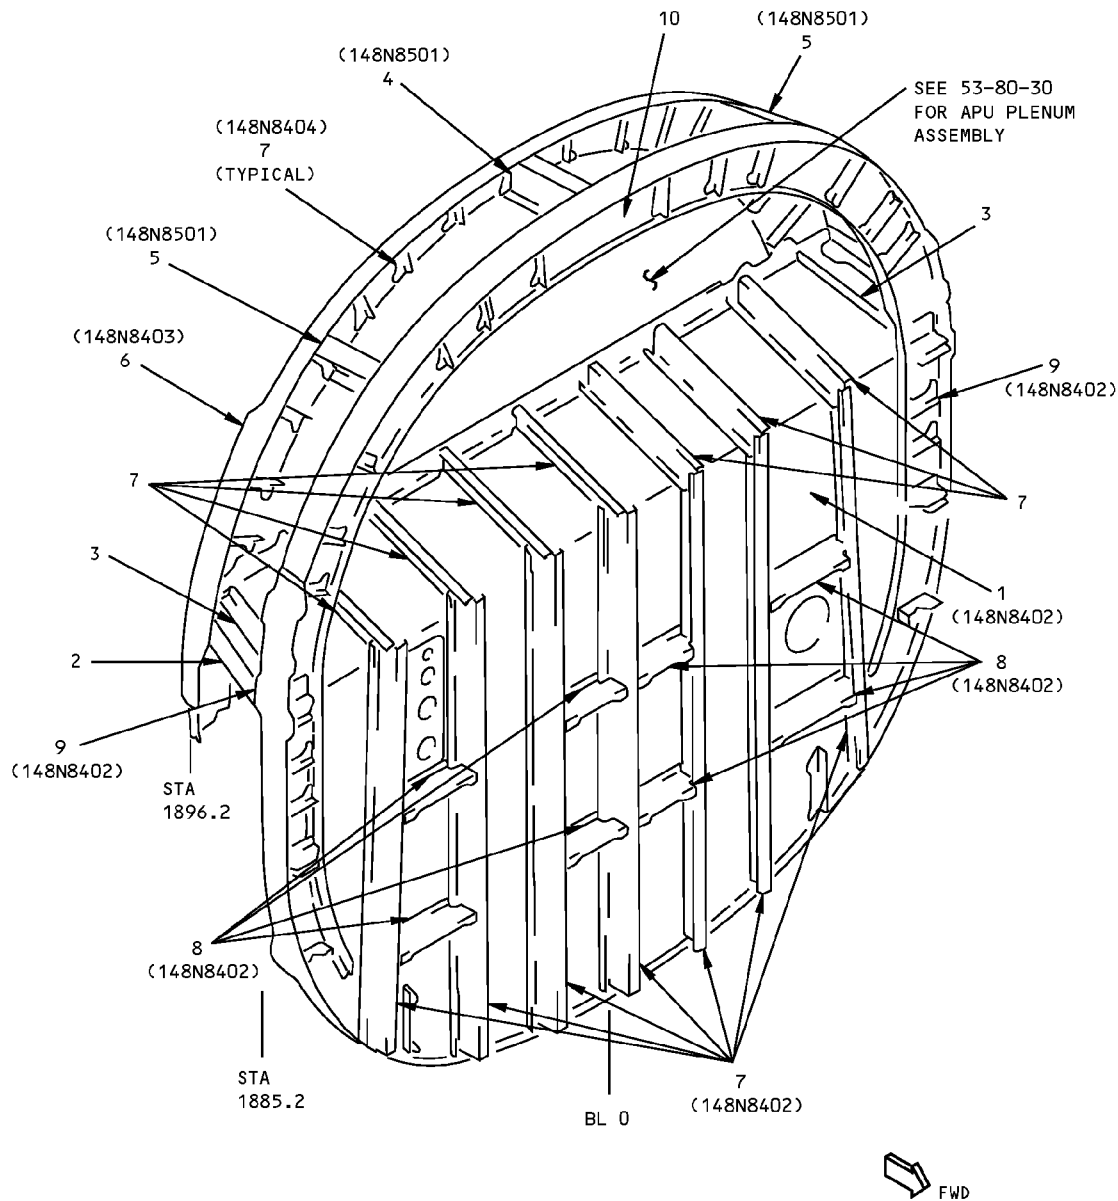
FIREWALL AND STA 1885.2 BULKHEAD
FRONT VIEW
DETAIL V

REF DWG
148N8401

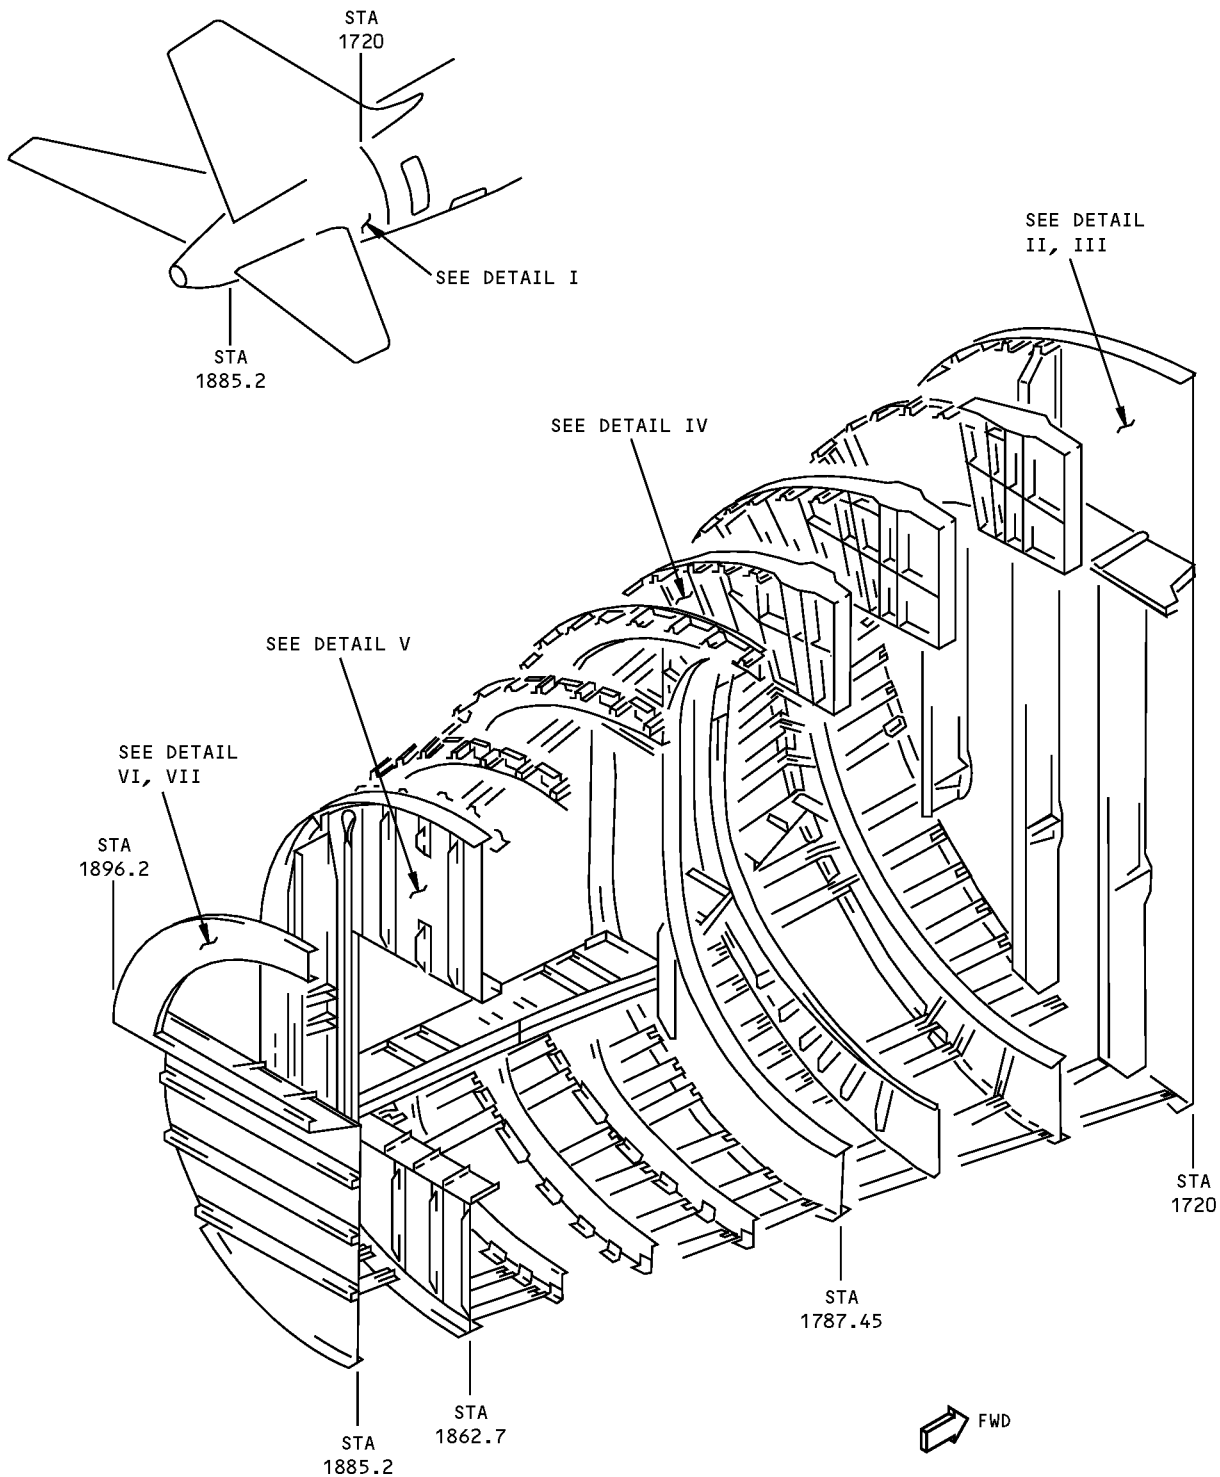
**Section 48 Bulkhead Allowable Damage
Figure 101 (Sheet 1 of 11)**

ALLOWABLE DAMAGE 1 - SECTION 48 - BULKHEADS

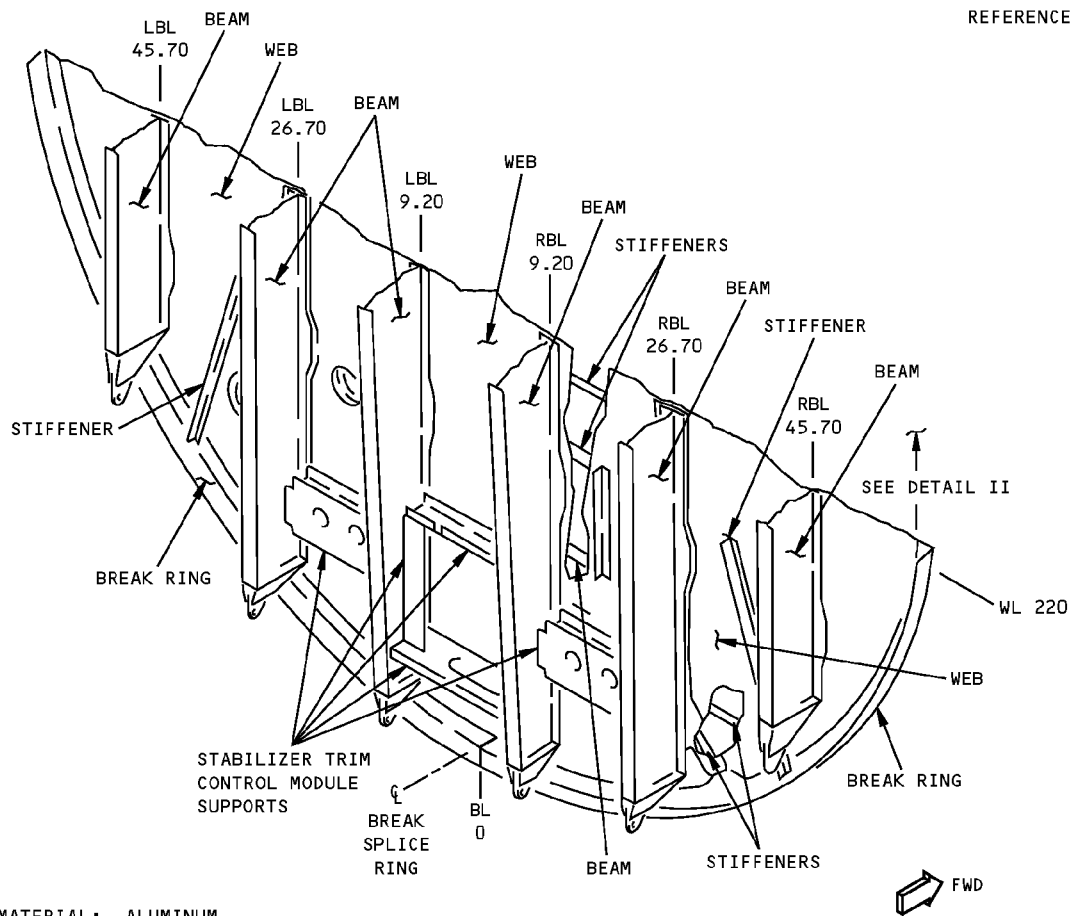
Section 48 Bulkhead Allowable Damage
Figure 101 (Sheet 2 of 11)

MATERIAL: ALUMINUM

AFT PRESSURE BULKHEAD STA 1720
DETAIL II

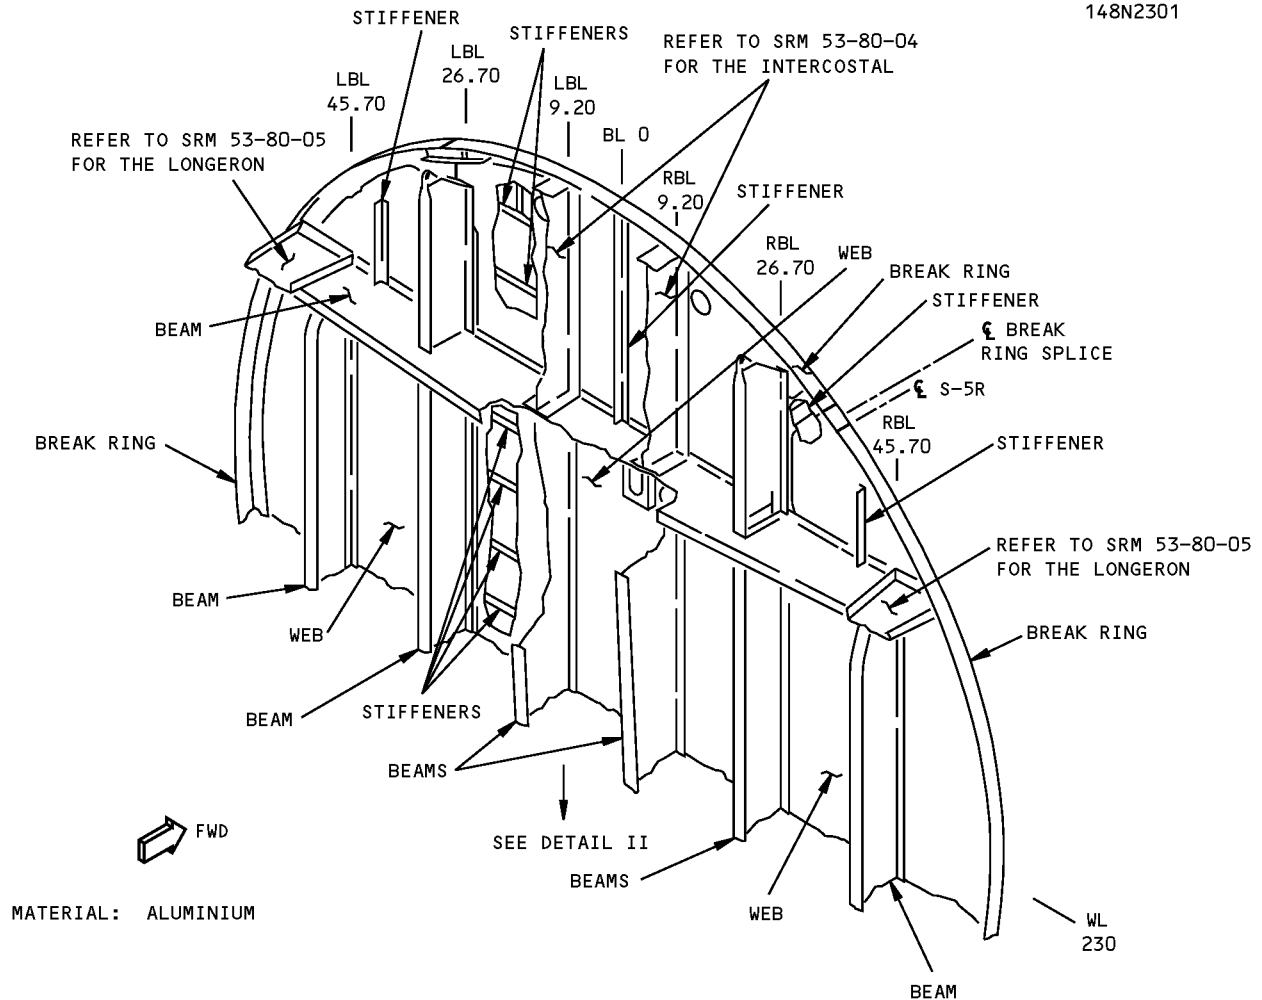
Section 48 Bulkhead Allowable Damage
Figure 101 (Sheet 3 of 11)

AFT PRESSURE BULKHEAD
STA 1720
DETAIL III

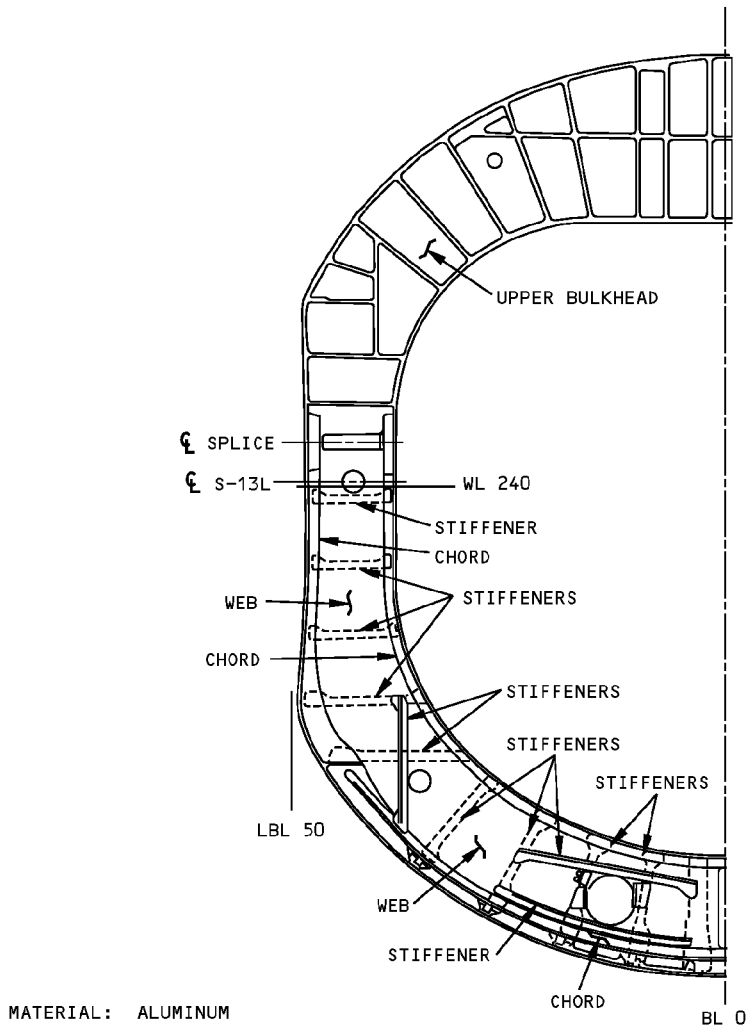
Section 48 Bulkhead Allowable Damage
Figure 101 (Sheet 4 of 11)

REAR VIEW
STA 1787.45 BULKHEAD
DETAIL IV

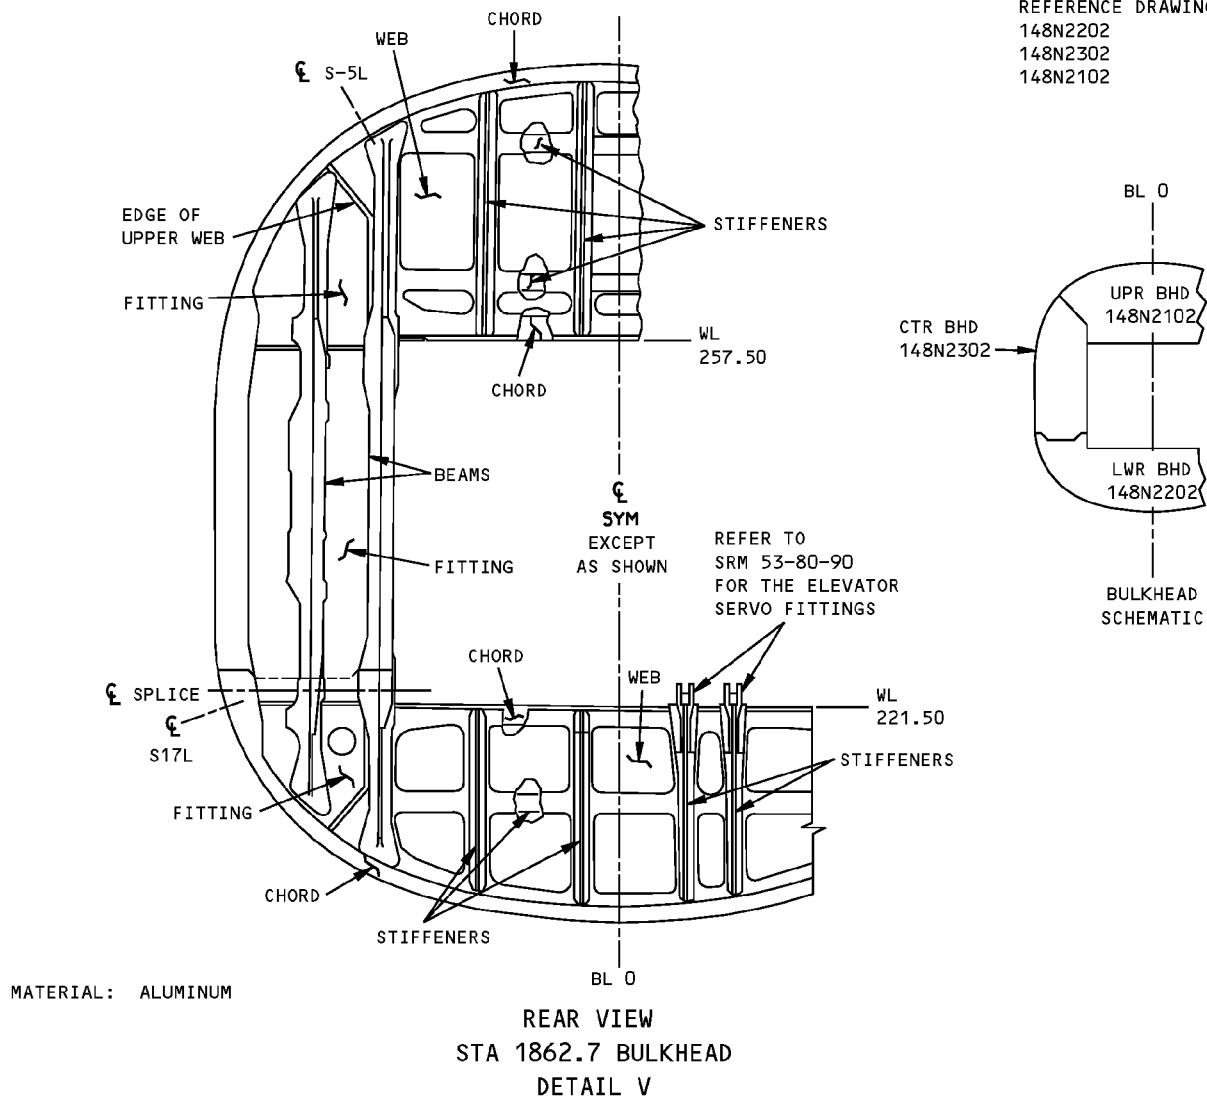
Section 48 Bulkhead Allowable Damage
Figure 101 (Sheet 5 of 11)

| DESCRIPTION | CRACKS | NICKS, GOUGES AND CORROSION | DENTS | HOLES AND PUNCTURES |
|---|---|---|---|---|
| STIFFENERS | A | F | NOT PERMITTED | NOT PERMITTED |

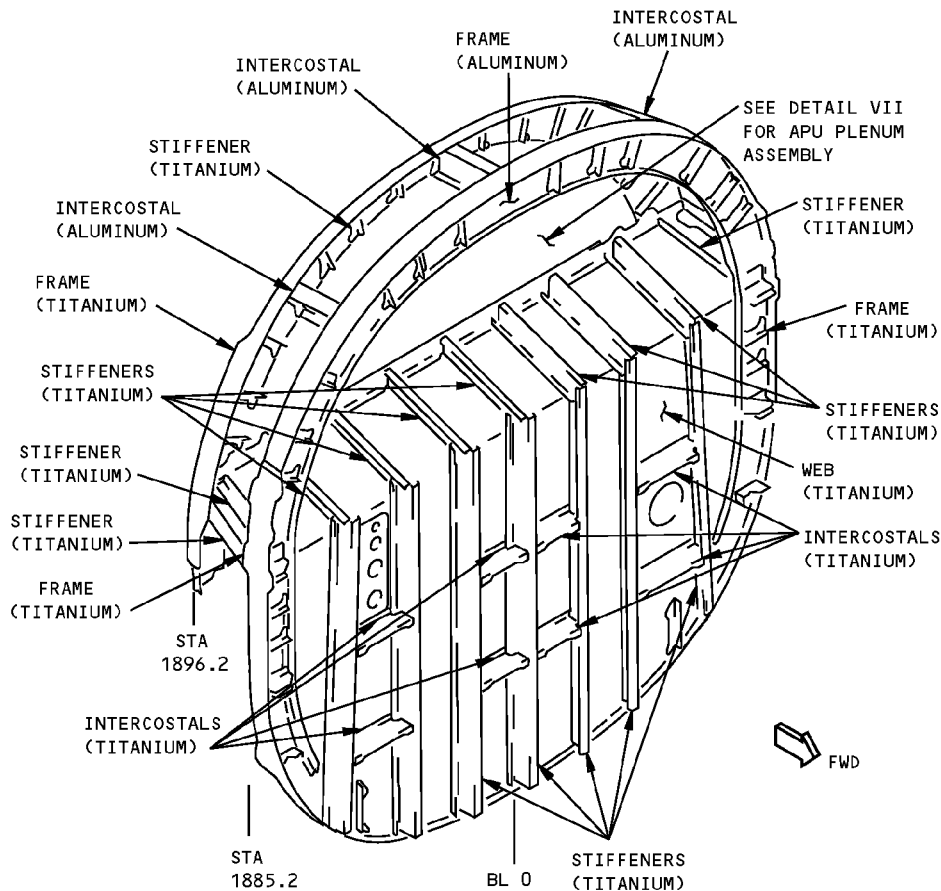
Section 48 Bulkhead Allowable Damage
Figure 101 (Sheet 6 of 11)

FIREWALL AND STA 1885.2 BULKHEAD
FRONT VIEW
DETAIL VI

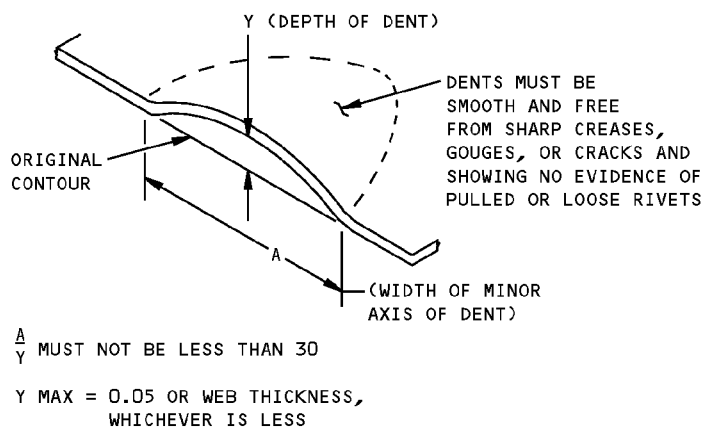
ALLOWABLE DAMAGE FOR DENT
DETAIL X

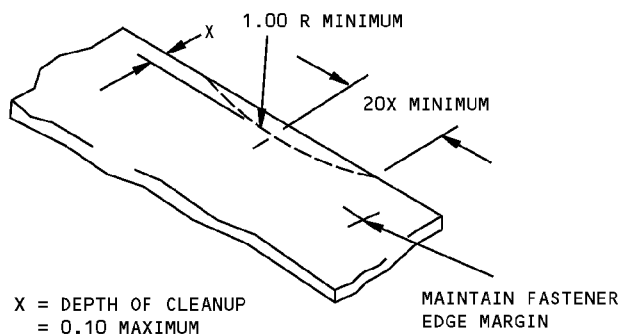
DETAIL XI

REMOVAL OF NICK OR CRACK
DAMAGE ON AN EDGE

- B** FOR EDGE DAMAGE SEE DETAIL XIV. FOR LUG DAMAGE SEE DETAIL XIII. FOR OTHER DAMAGE SEE DETAIL IX. DAMAGE NOT PERMITTED IN VICINITY OF BUSHINGS
- C** CRACKS NOT PERMITTED EXCEPT FOR EDGE CRACKS WHICH MUST BE REMOVED AS SHOWN IN DETAILS VIII AND XI. REFER TO **L** FOR SHOT PEEN REQUIREMENTS.

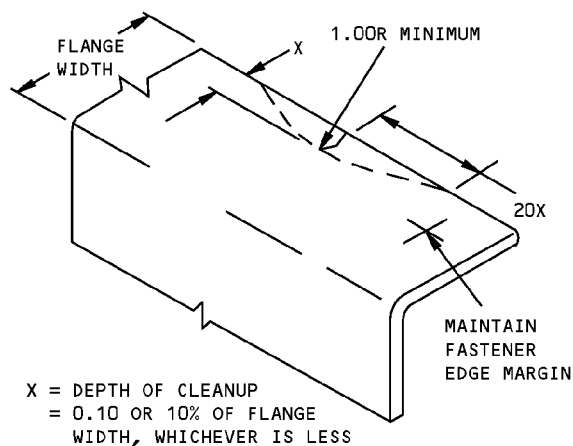
DETAIL XII

REMOVAL OF NICK OR CRACK
DAMAGE ON AN EDGE

- REFINISH REWORKED AREAS AS GIVEN IN AMM 51-20.
- A** CRACKS NOT PERMITTED EXCEPT FOR EDGE CRACKS WHICH MUST BE REMOVED AS SHOWN IN DETAILS VIII AND XII.

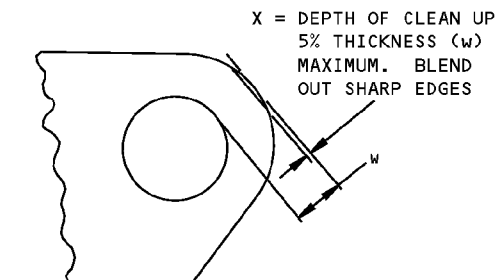
DETAIL XIII

DAMAGE CLEAN UP FOR EDGES OF LUG

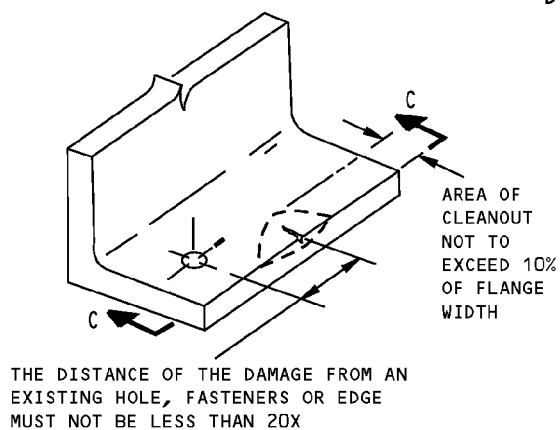
DETAIL XIV

REMOVAL OF NICK OR CRACK
DAMAGE ON AN EDGE

- K** CRACKS NOT PERMITTED EXCEPT FOR EDGE CRACKS WHICH MUST BE REMOVED AS SHOWN IN DETAIL XIV. REFER TO **L** FOR SHOT PEEN REQUIREMENTS.
- L** SHOT PEEN REWORKED AREA AS GIVEN IN CMM 20-10-03. REFER TO SRM 51-20-06 FOR SHOT PEEN REQUIREMENTS.

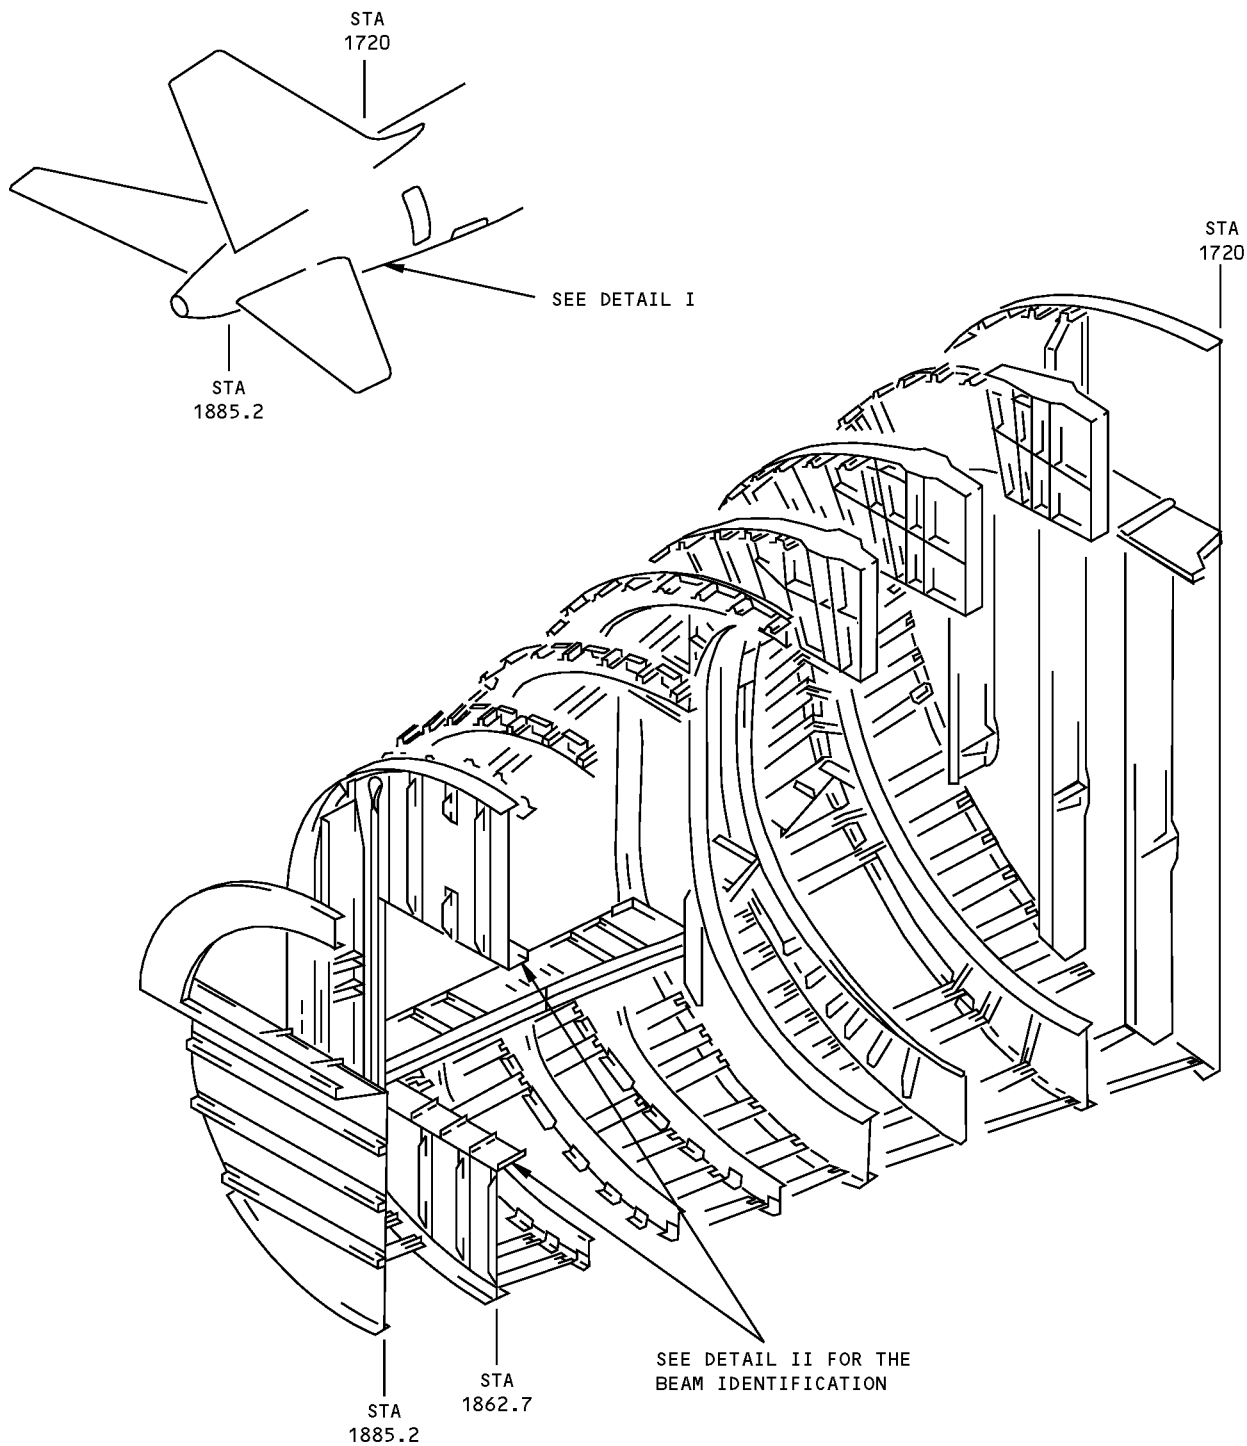
**Section 48 Beam Identification
Figure 1 (Sheet 1 of 3)**

IDENTIFICATION 1 - SECTION 48 - BEAMS
