FUSELAGE

757-200 STRUCTURAL REPAIR MANUAL

CHAPTER 53 FUSELAGE

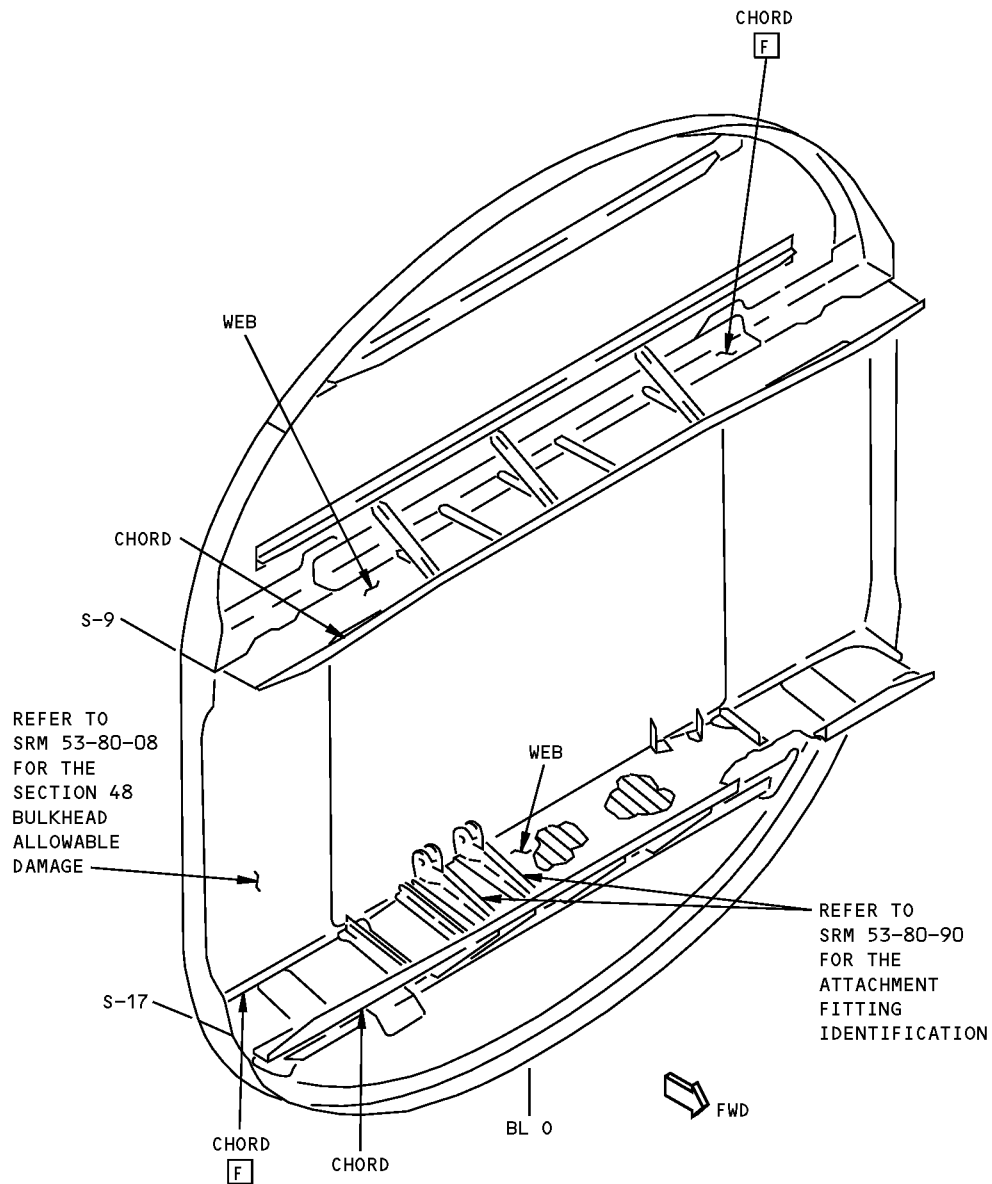
REAR VIEW BULKHEAD
STA 1862.7
DETAIL II

MATERIAL: ALUMINUM

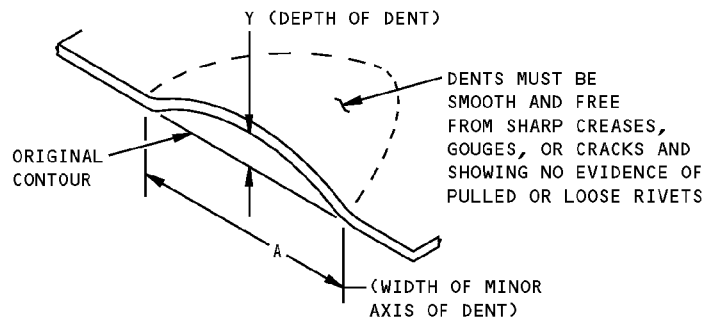
$\frac{A}{Y}$ MUST NOT BE LESS THAN 30

Y MUST BE NO GREATER THAN THE MATERIAL THICKNESS

ALLOWABLE DAMAGE FOR DENT DETAIL V

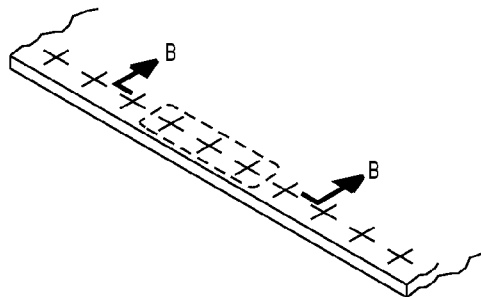
CORROSION CLEANUP
DETAIL VI

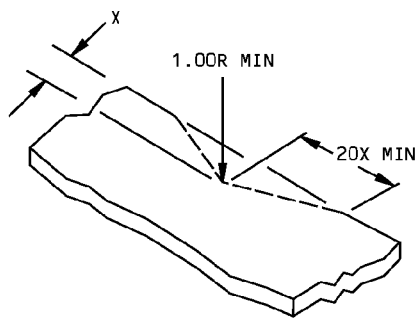
DETAIL VII

X = DEPTH OF CLEANUP = 0.10 MAX

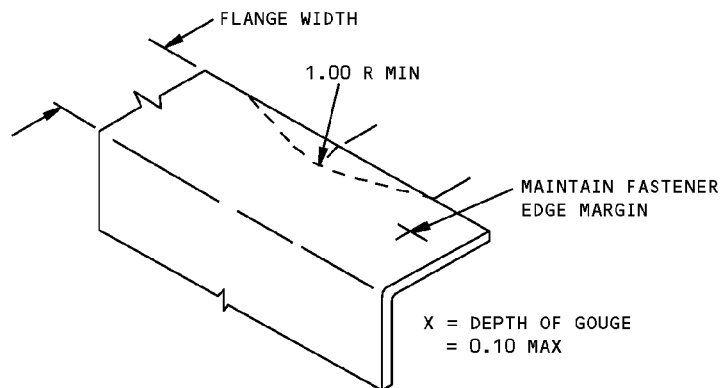
REMOVAL OF NICK OR CRACK
DAMAGE ON AN EDGE
DETAIL VIII

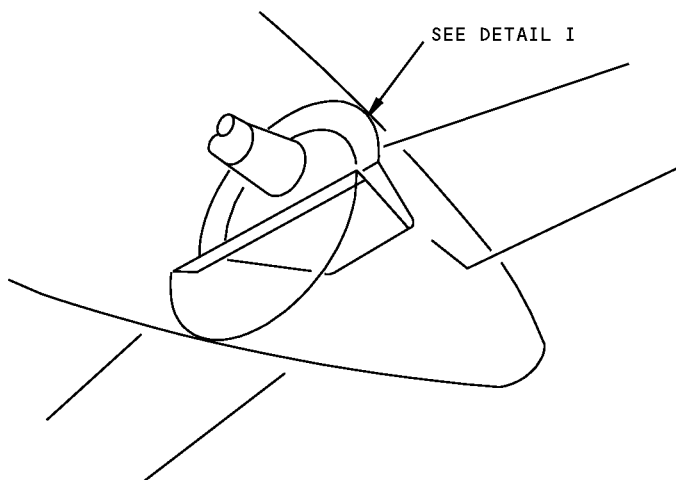
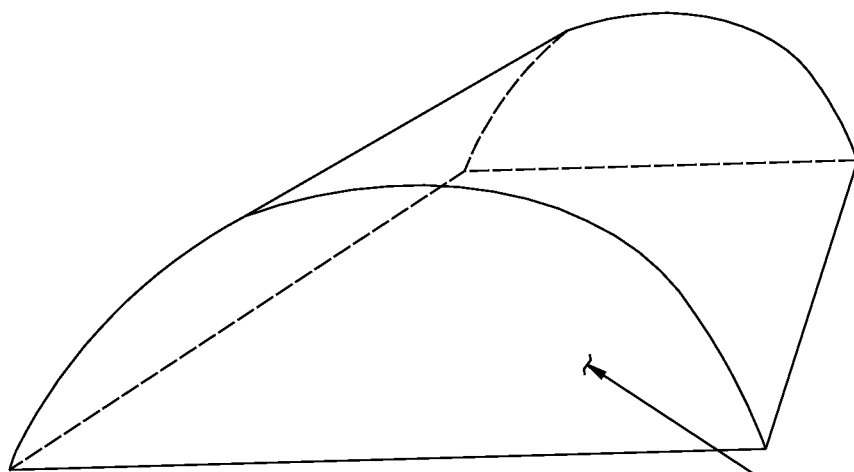
DETAIL I

SEE 53-80-08, FIGURE 101
FOR ALLOWABLE DAMAGE
LIMITS FOR THE APU
PLENUM ASSEMBLY
BULKHEAD AT
STA 1896.2

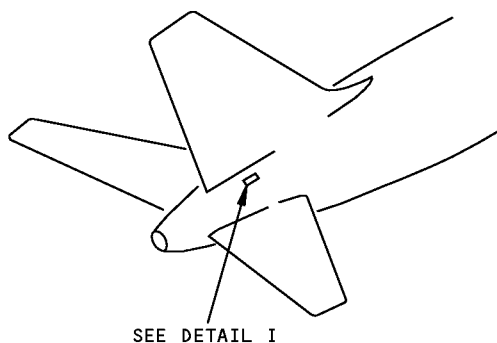
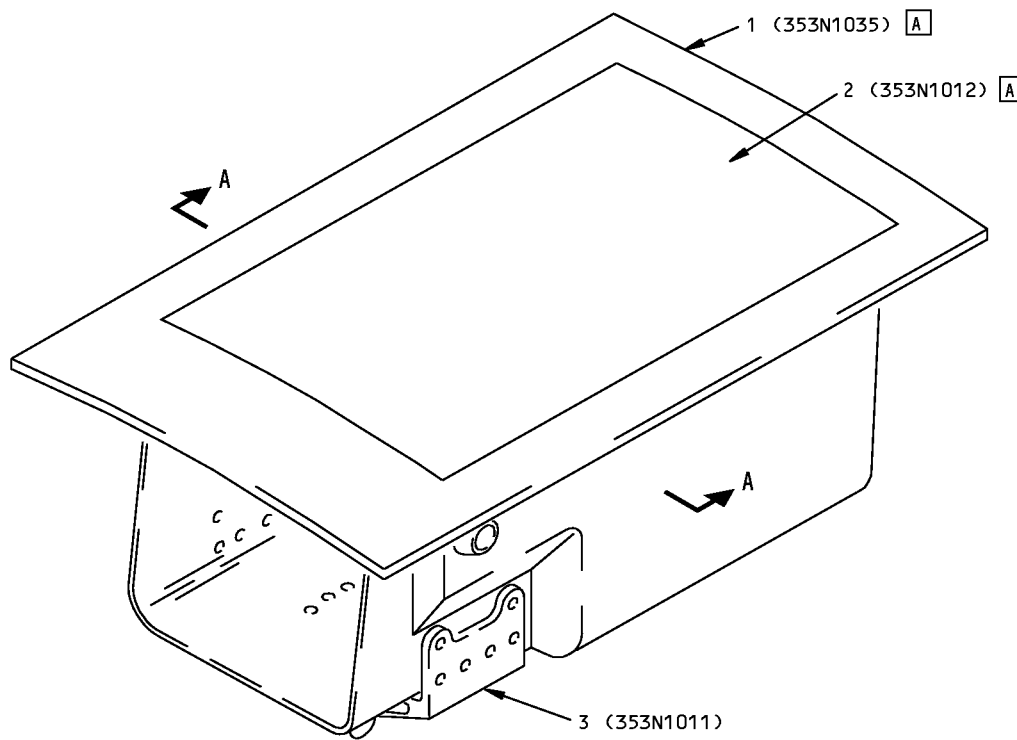
DETAIL I

IDENTIFICATION 1 - AUXILIARY POWER UNIT AIR INLET DOOR

REFERENCE DRAWINGS
353N1001
353N1010
353N1020
353N1035

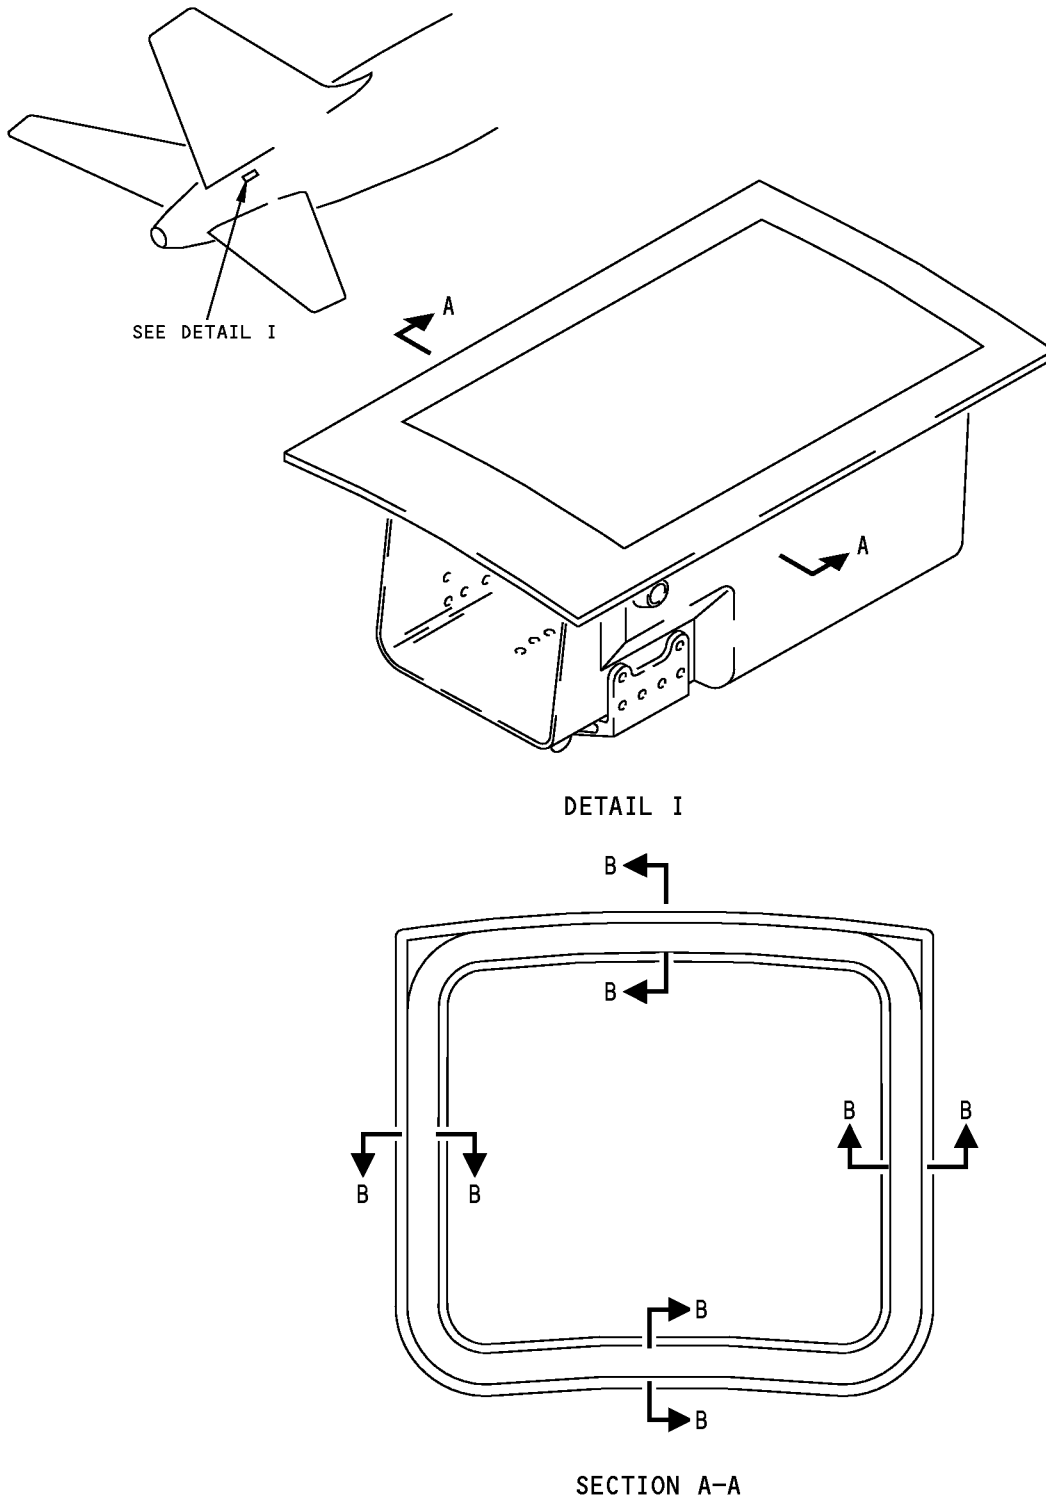
ALLOWABLE DAMAGE 1 - AUXILIARY POWER UNIT AIR INLET DOOR

APU Intake Port - Frame/Door Structure Allowable Damage
Figure 101 (Sheet 1 of 2)

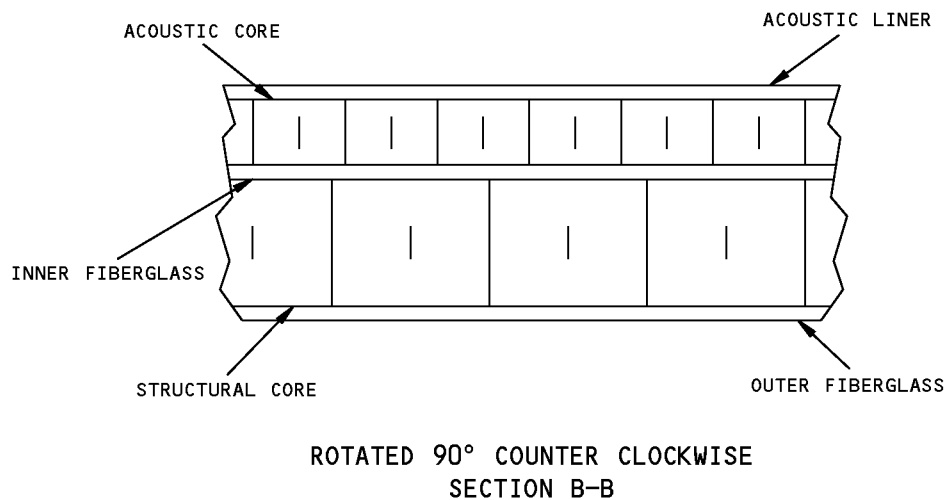
- NO DAMAGE IS PERMITTED.

APU Intake Port - Frame/Door Structure Allowable Damage
Figure 101 (Sheet 2 of 2)

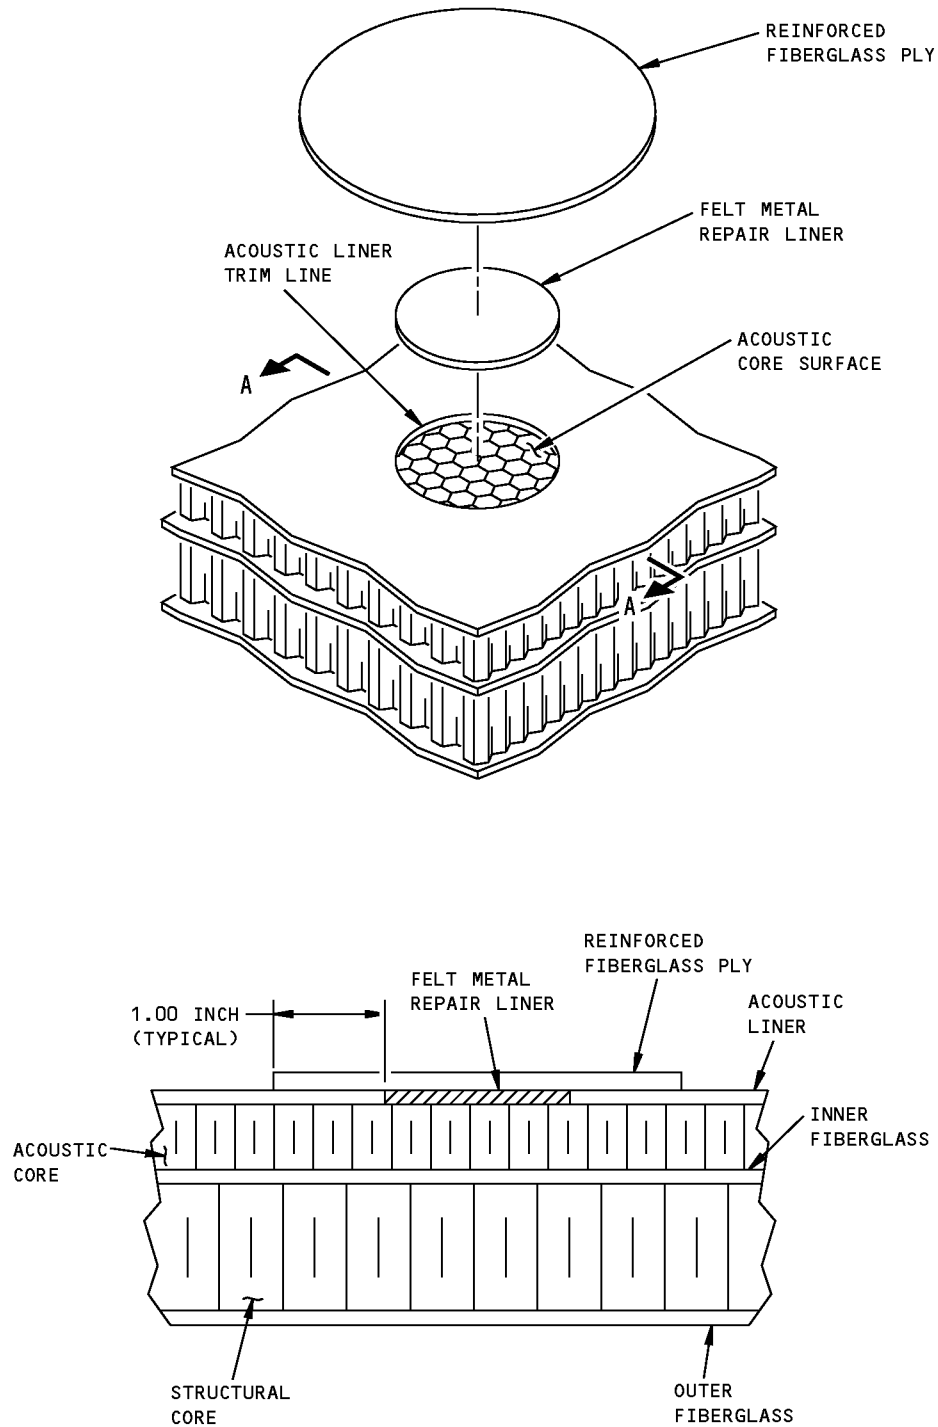
SECTION A-A

**Acoustic Liner Damage Between 0.5 Inches and 3.0 Inches in Diameter
Figure 201**

- F. Remove the damaged section of the acoustic liner. Make the trim the minimum dimensions possible. For damage between 0.5 in. (12.7 mm) and 1.0 in. (25.4 mm) in diameter, make a circular trim. For damage between 1.0 in. (25.4 mm) and 3.0 in. (76.2 mm) in diameter, make the trim a smooth shape with a minimum corner trim radius of 0.5 in. (12.7 mm). Sand the area of the trim to remove sharp edges.

NOTE: Make sure that the repair liner is flush with the initial liner. A gap of 0.06 in. (1.52 mm) or less is allowed between the repair liner and the initial liner.

- M. Apply the potting resin to the bond surface of the felt metal repair liner and the initial acoustic liner.
- N. Align the reinforcement fiberglass ply on the felt metal repair liner. See Figure 201/REPAIR 1.

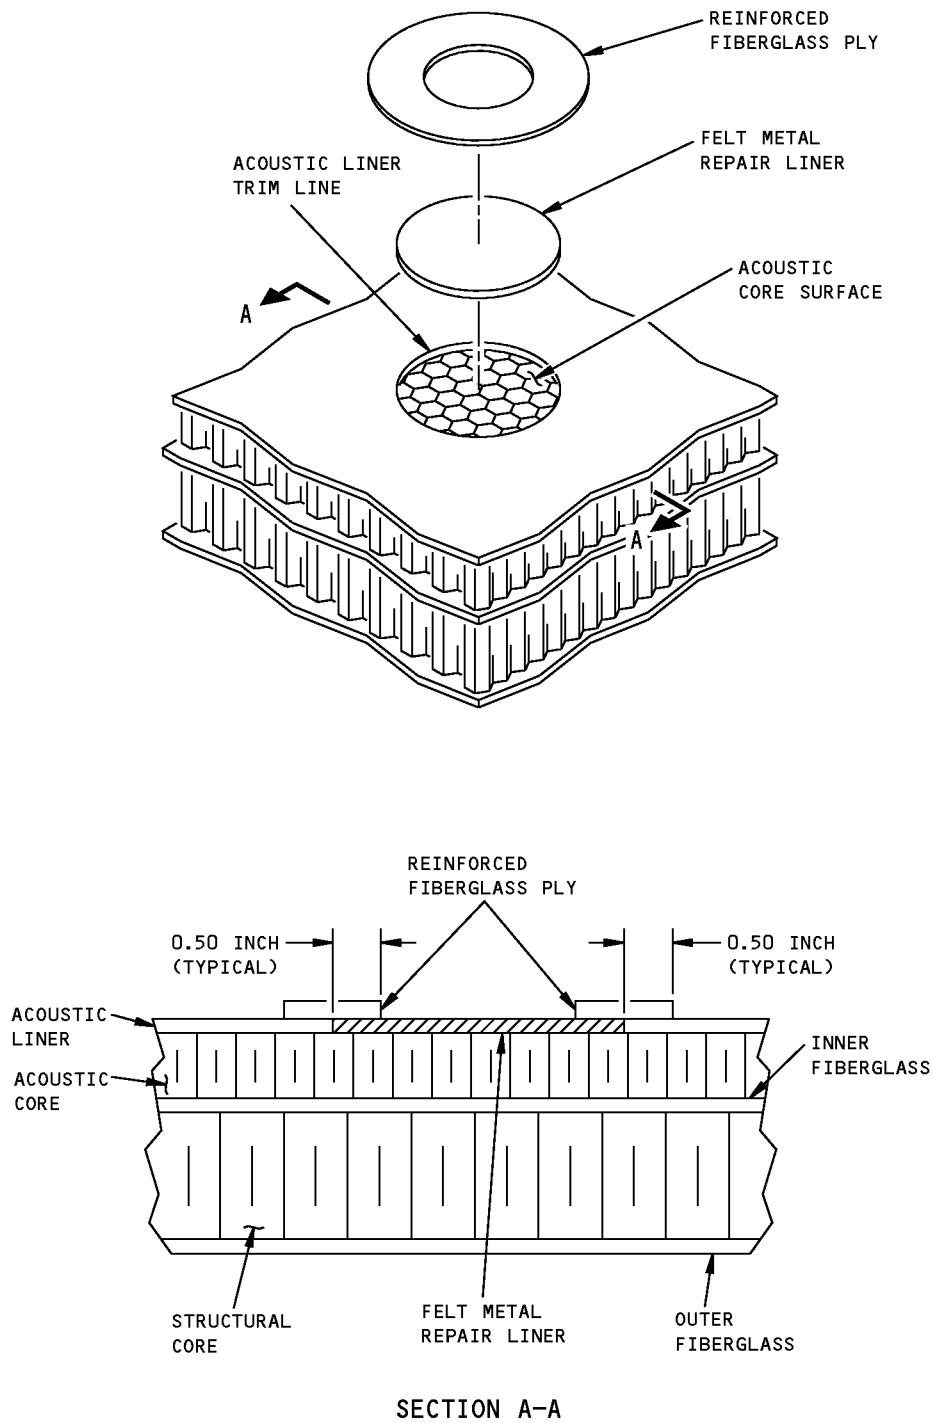
Acoustic Liner Damage Larger Than 3.0 Inches in Diameter
Figure 201

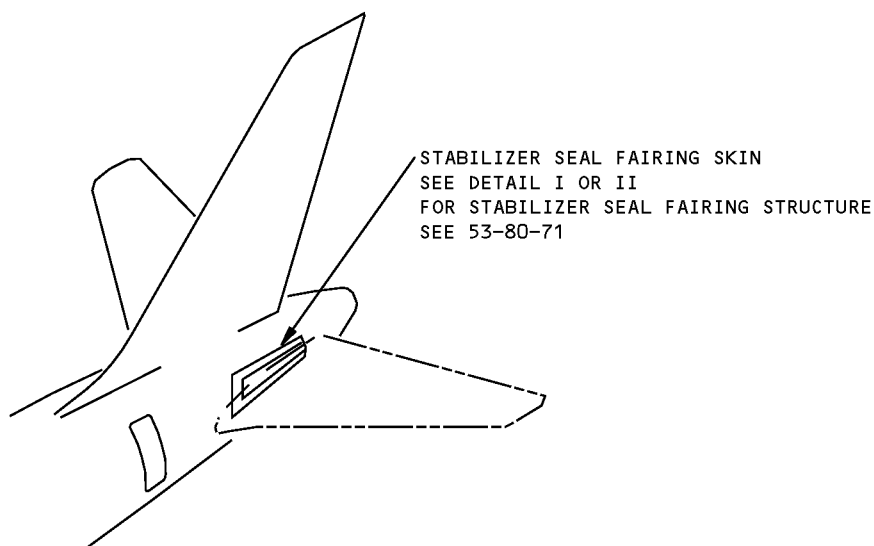
IDENTIFICATION 1 - SECTION 48 - SEAL FAIRING SKIN

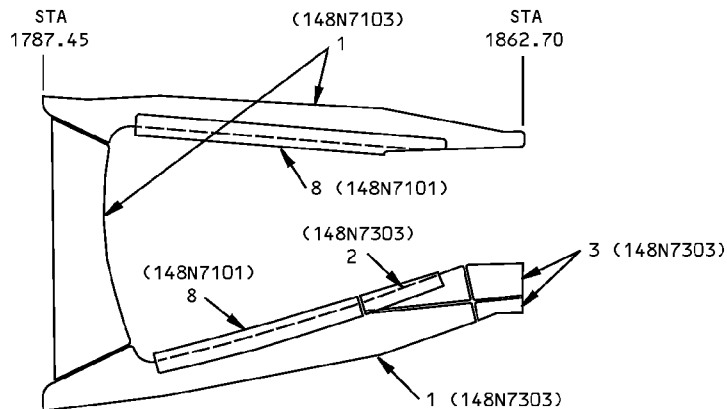
SEAL FAIRING SKIN
(CUM LINE NUMBERS 1 THRU 3)
DETAIL I

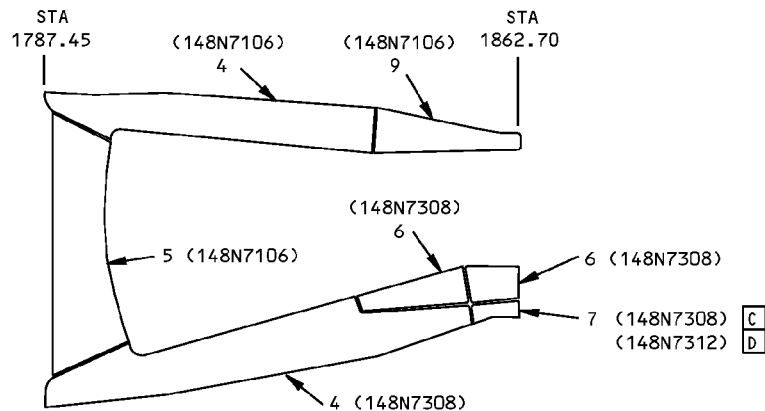
SEAL FAIRING SKIN
(CUM LINE NUMBERS 4 AND ON)
DETAIL II

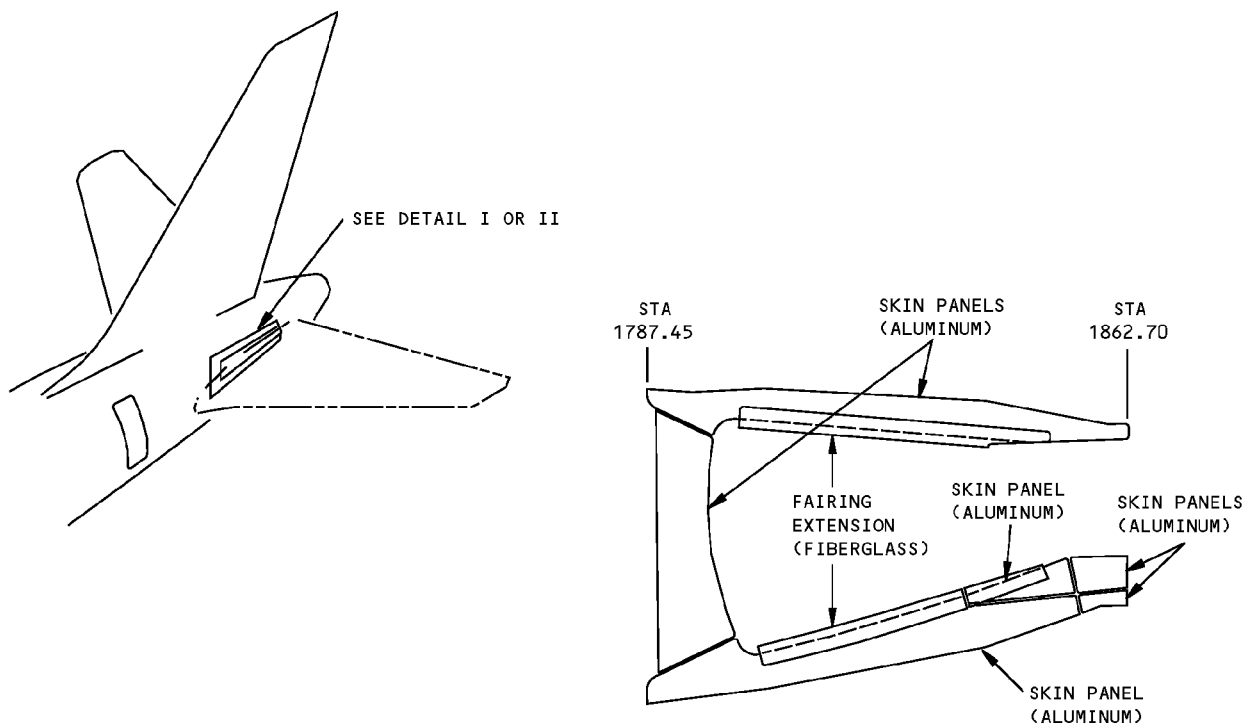
**SEAL FAIRING SKIN
(CUM LINE NUMBERS 1 THRU 3)
DETAIL I**

**Section 48 Seal Fairing Skin Allowable Damage
Figure 101 (Sheet 1 of 4)**

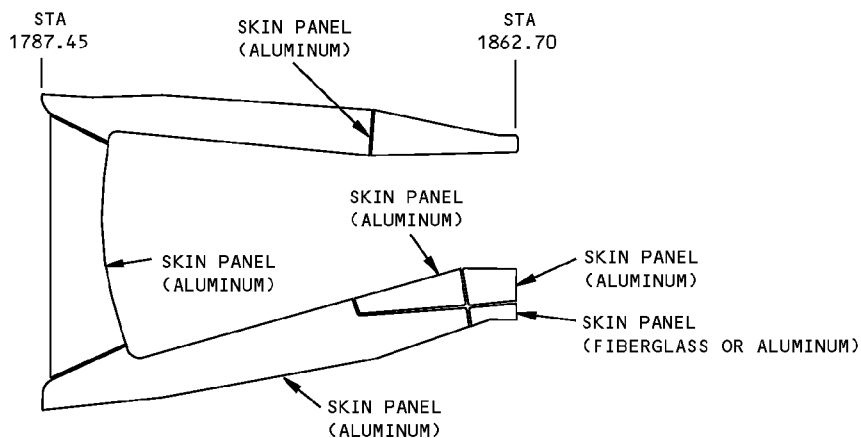
**SEAL FAIRING SKIN
(CUM LINE NUMBERS 4 AND ON)
DETAIL II**

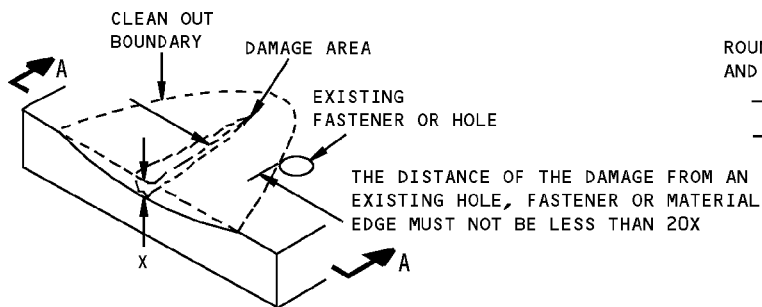
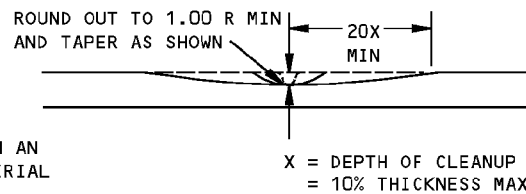
SECTION A-A

REMOVAL OF NICK, GOUGE AND SCRATCH DAMAGE ON A SURFACE
DETAIL IV

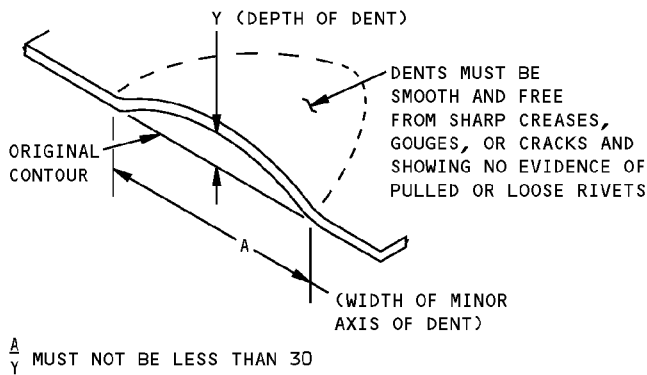
ALLOWABLE DAMAGE FOR DENT
DETAIL V

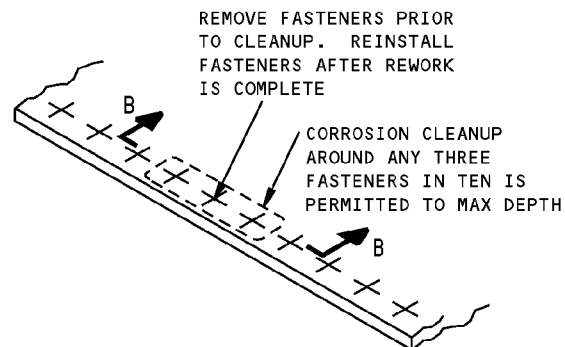
SECTION B-B
CORROSION CLEANUP
DETAIL VI

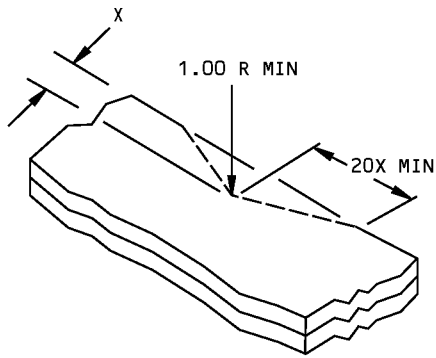
$X = \text{DEPTH OF CLEANUP} = 0.10 \text{ MAX}$

**REMOVAL OF NICK OR CRACK
DAMAGE ON AN EDGE
DETAIL VII**

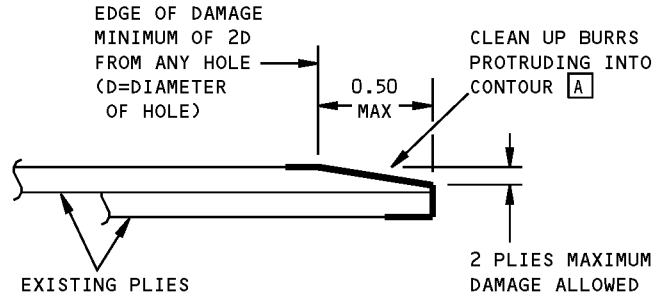
**DAMAGE CLEANUP AND SEALING
OF EDGE EROSION
DETAIL VIII**

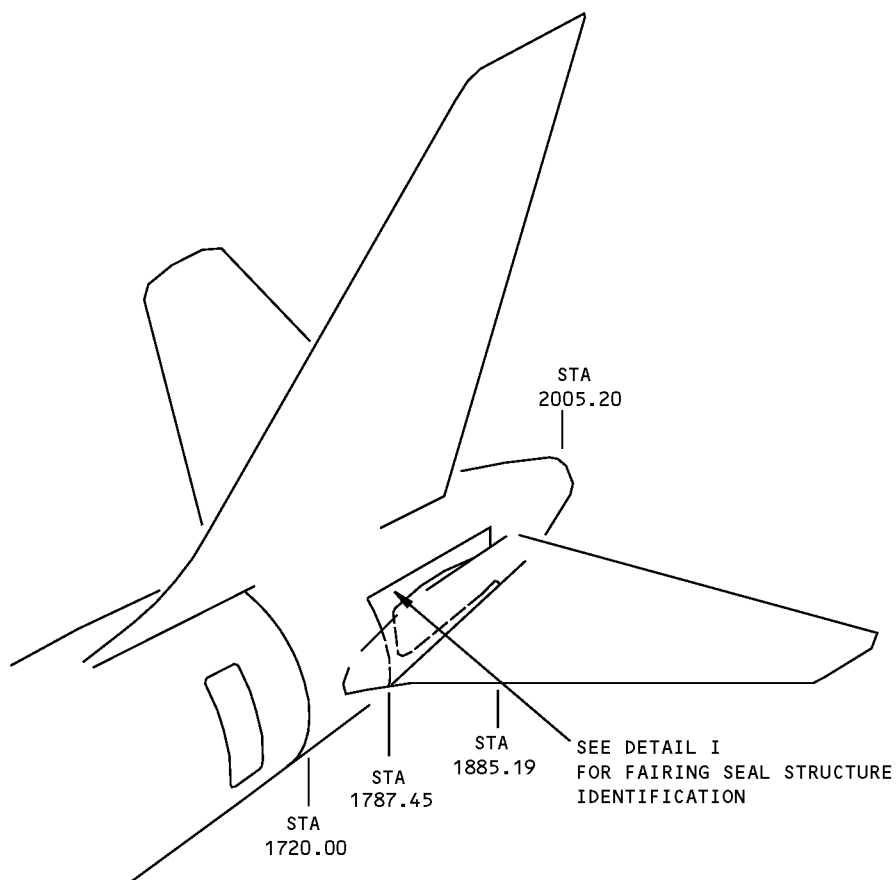
IDENTIFICATION 1 - SECTION 48 - SEAL FAIRING STRUCTURE

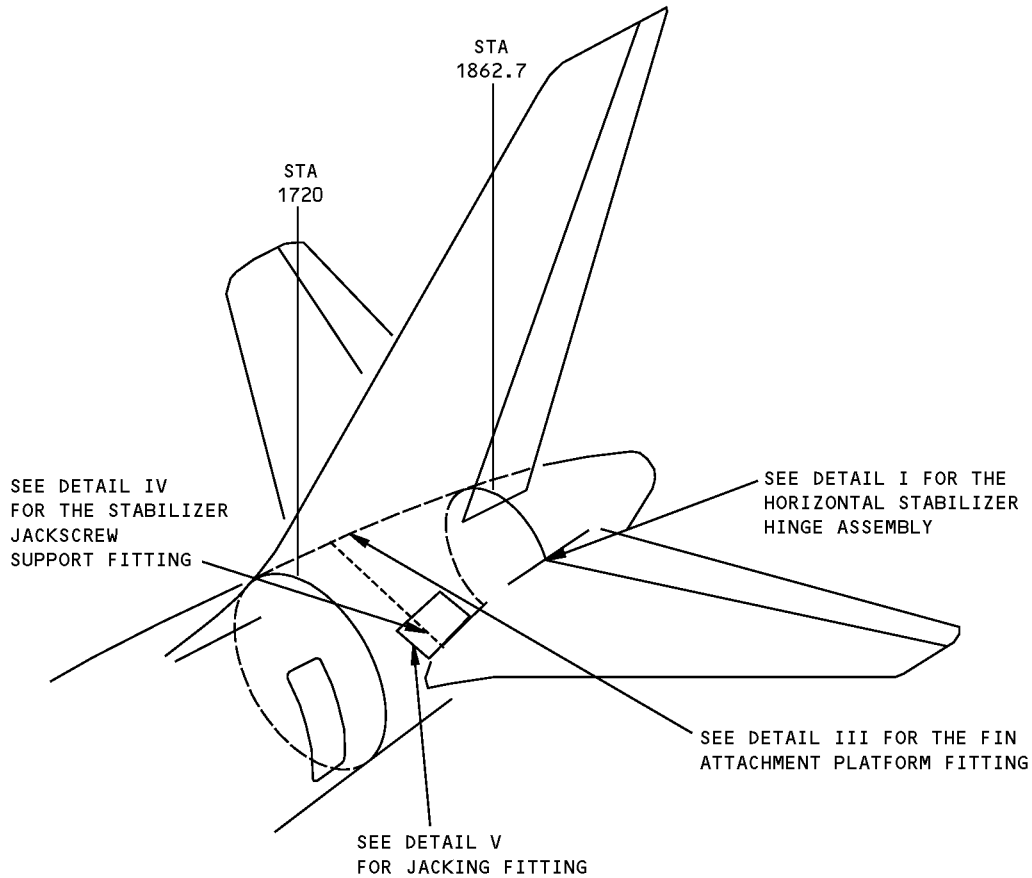
Section 48 Attachment Fitting Identification
Figure 1 (Sheet 1 of 6)

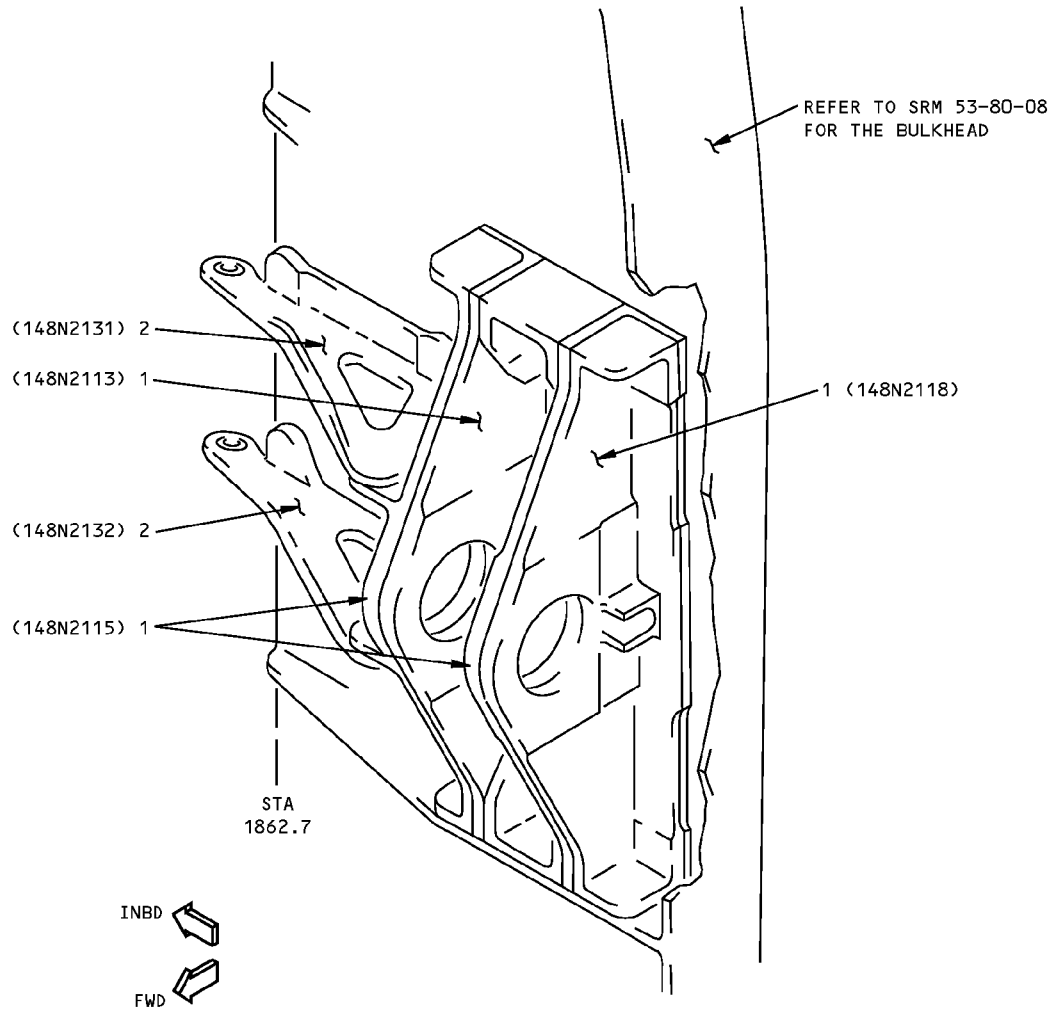
HORIZONTAL STABILIZER HINGE ASSEMBLY
DETAIL I

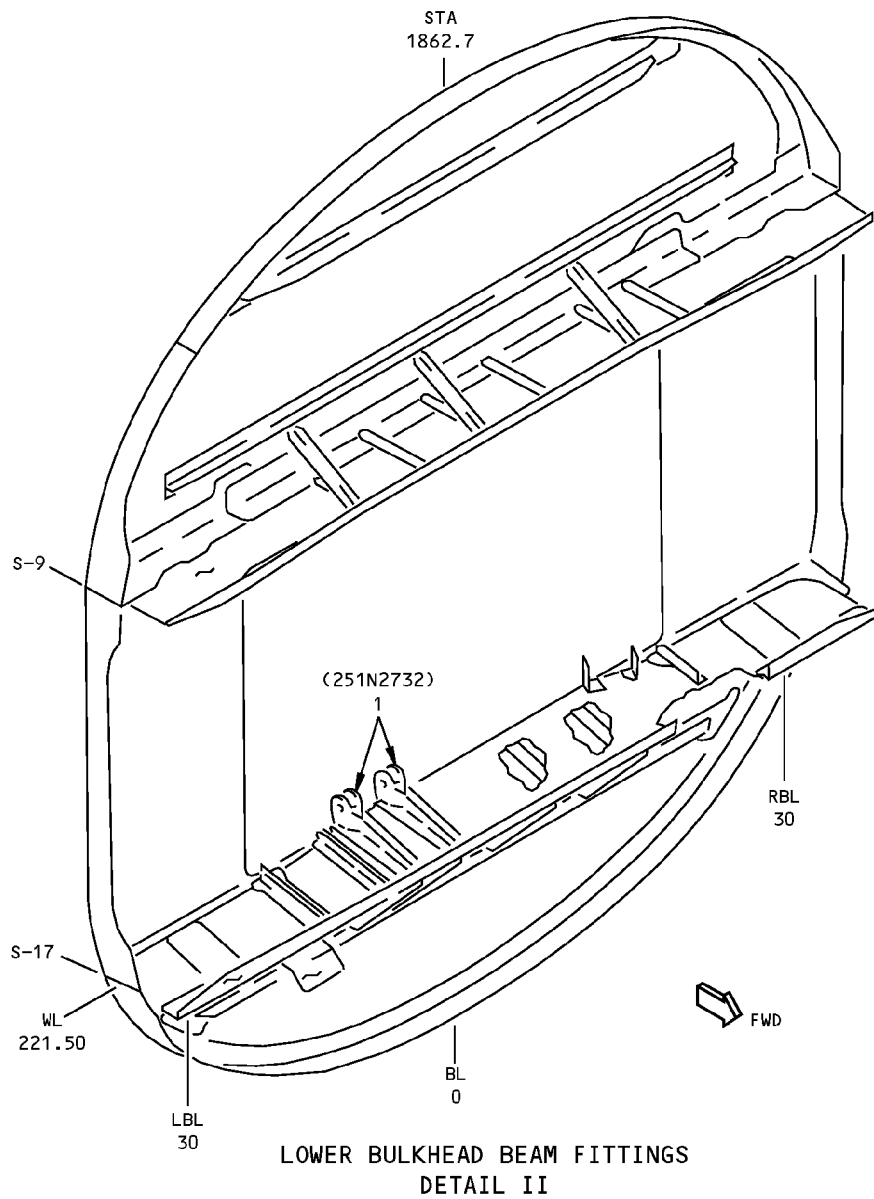
| ITEM | DESCRIPTION | GAGE | MATERIAL | EFFECTIVITY |
|---|---|---|---|---|
| 1 | ELEVATOR SERVO FITTING | 2.00 | 7075-T73 DIE FORGING | |

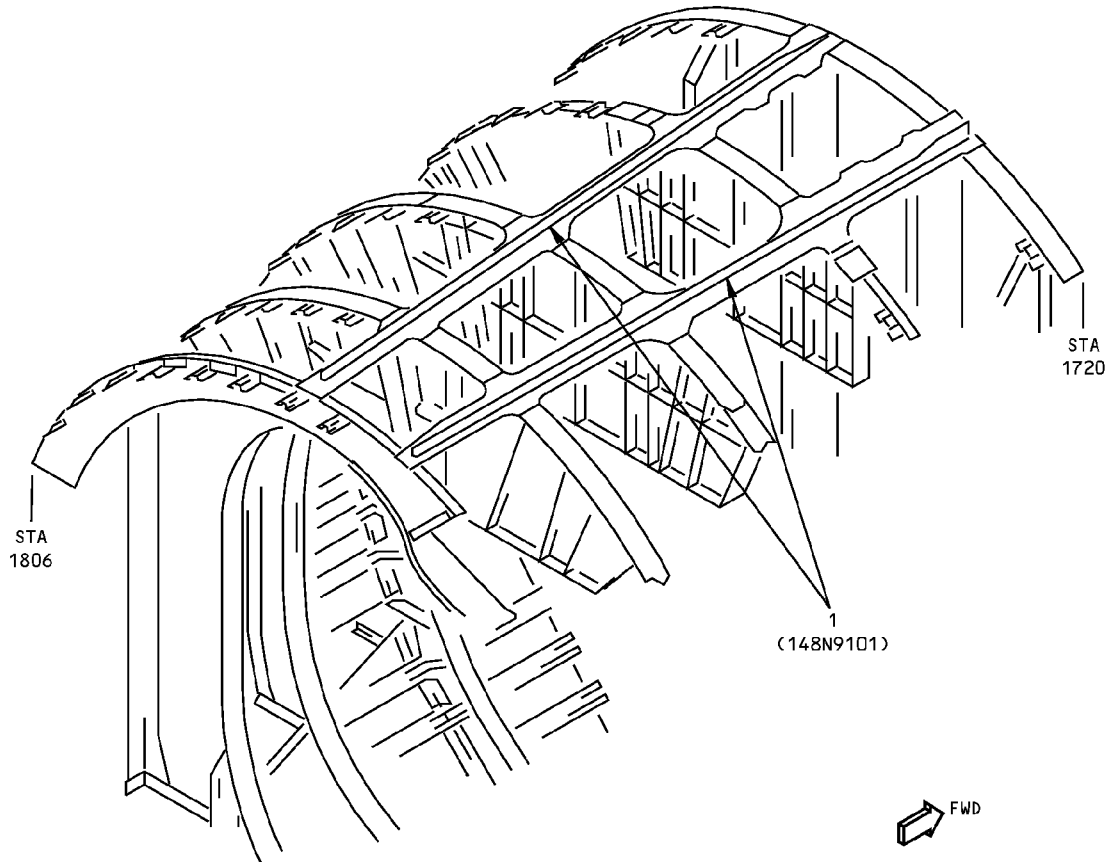
**FIN ATTACHMENT PLATFORM FITTING
DETAIL III**

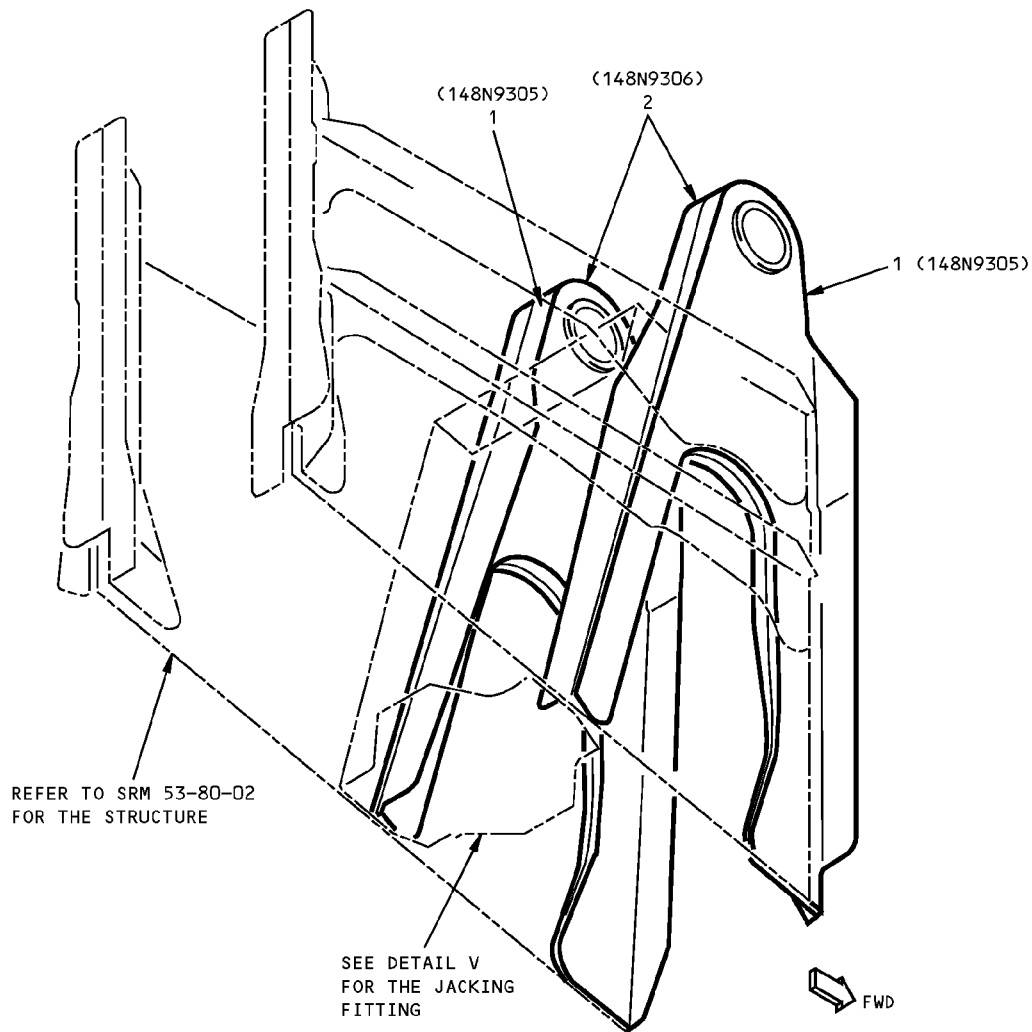
STABILIZER JACKSCREW SUPPORT FITTING
DETAIL IV

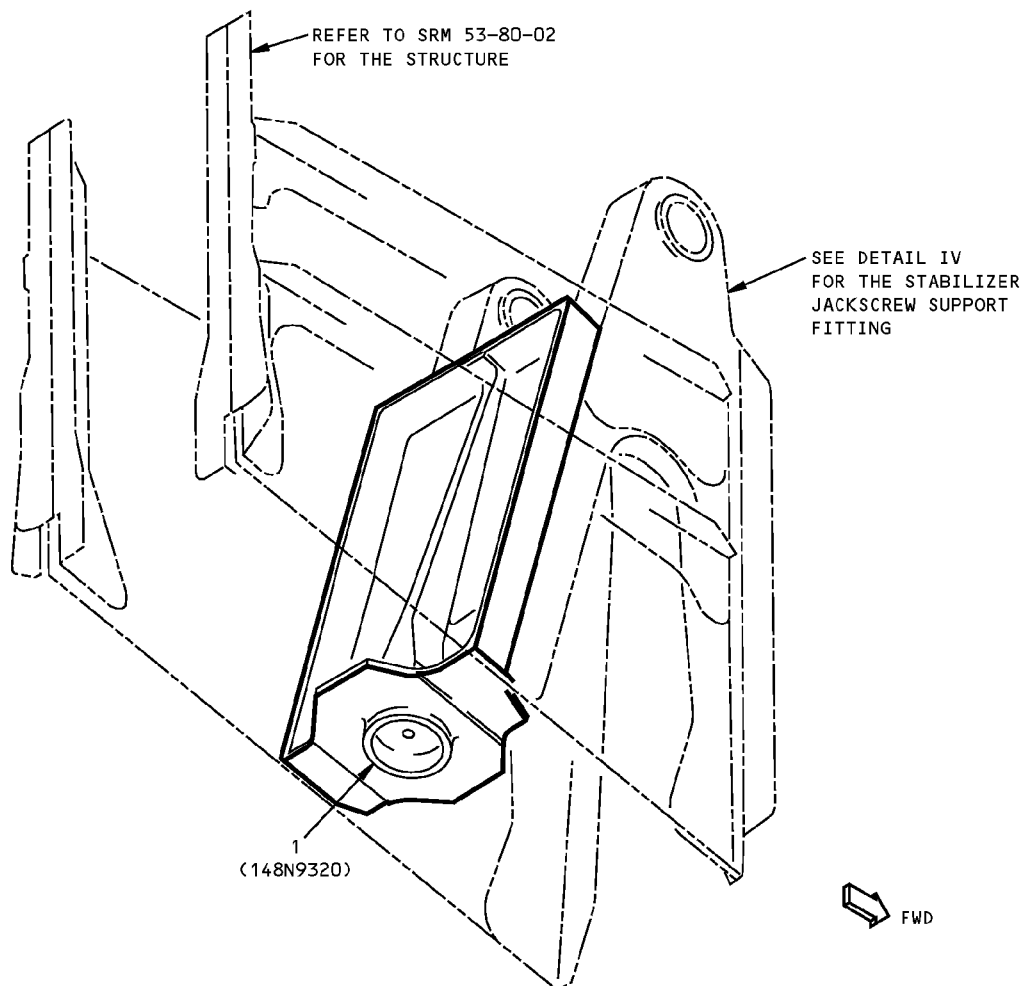
JACKING STABILIZATION SUPPORT FITTING
DETAIL V

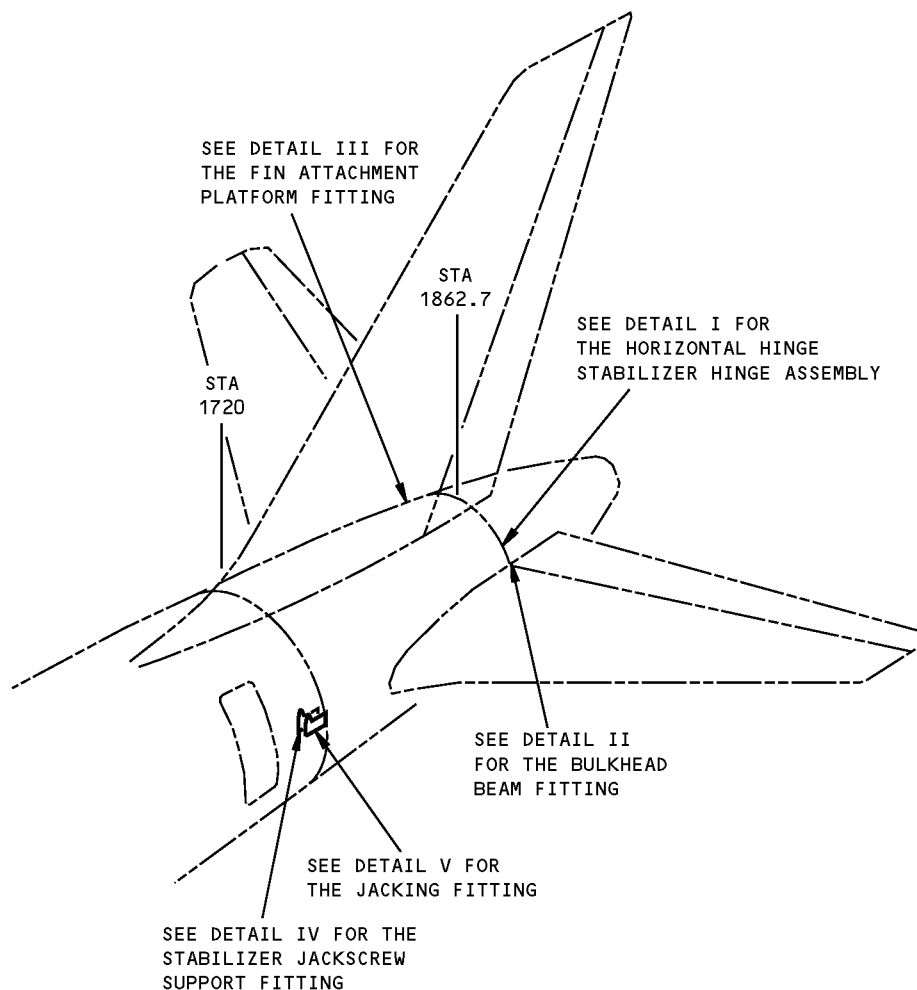
Section 48 Attachment Fitting Allowable Damage
Figure 101 (Sheet 1 of 7)

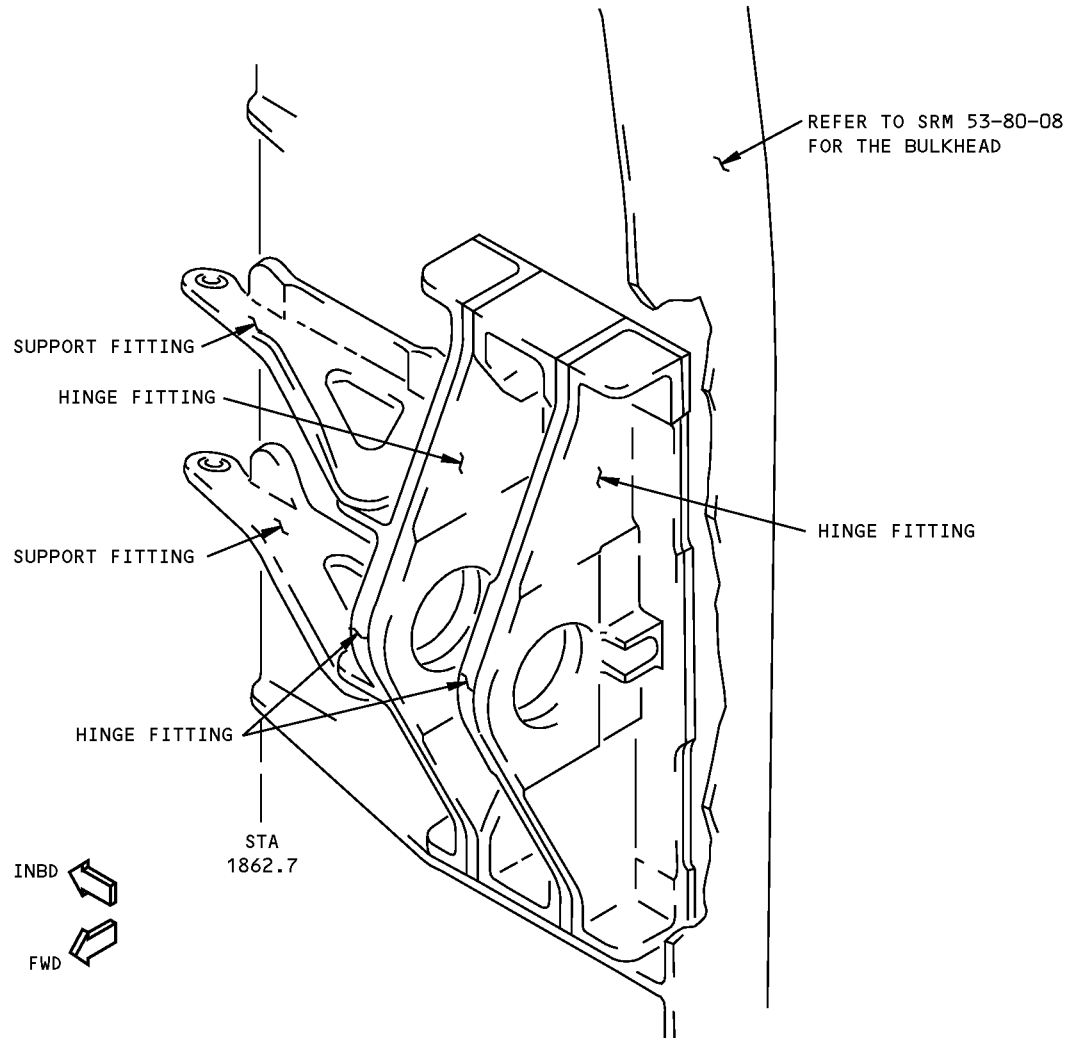
MATERIAL: FORGED ALUMINUM

HORIZONTAL STABILIZER HINGE ASSEMBLY
DETAIL I

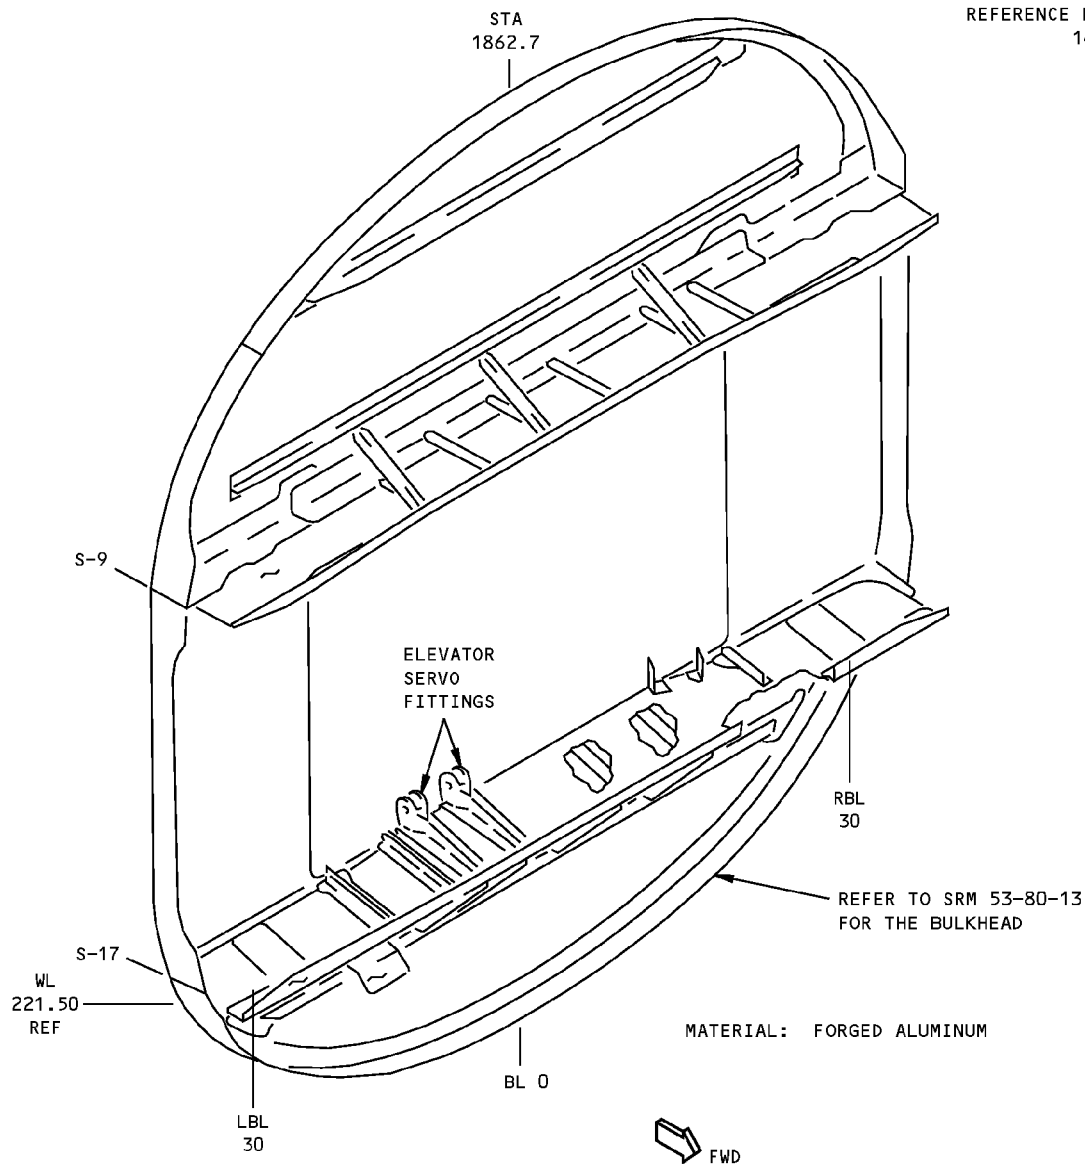
NOTE: SHOT PEENING IS NECESSARY FOR THE REWORKED AREA OF THESE PARTS.

LOWER BULKHEAD BEAM FITTING
DETAIL II
