FUSELAGE

757-200 STRUCTURAL REPAIR MANUAL

CHAPTER 53 FUSELAGE

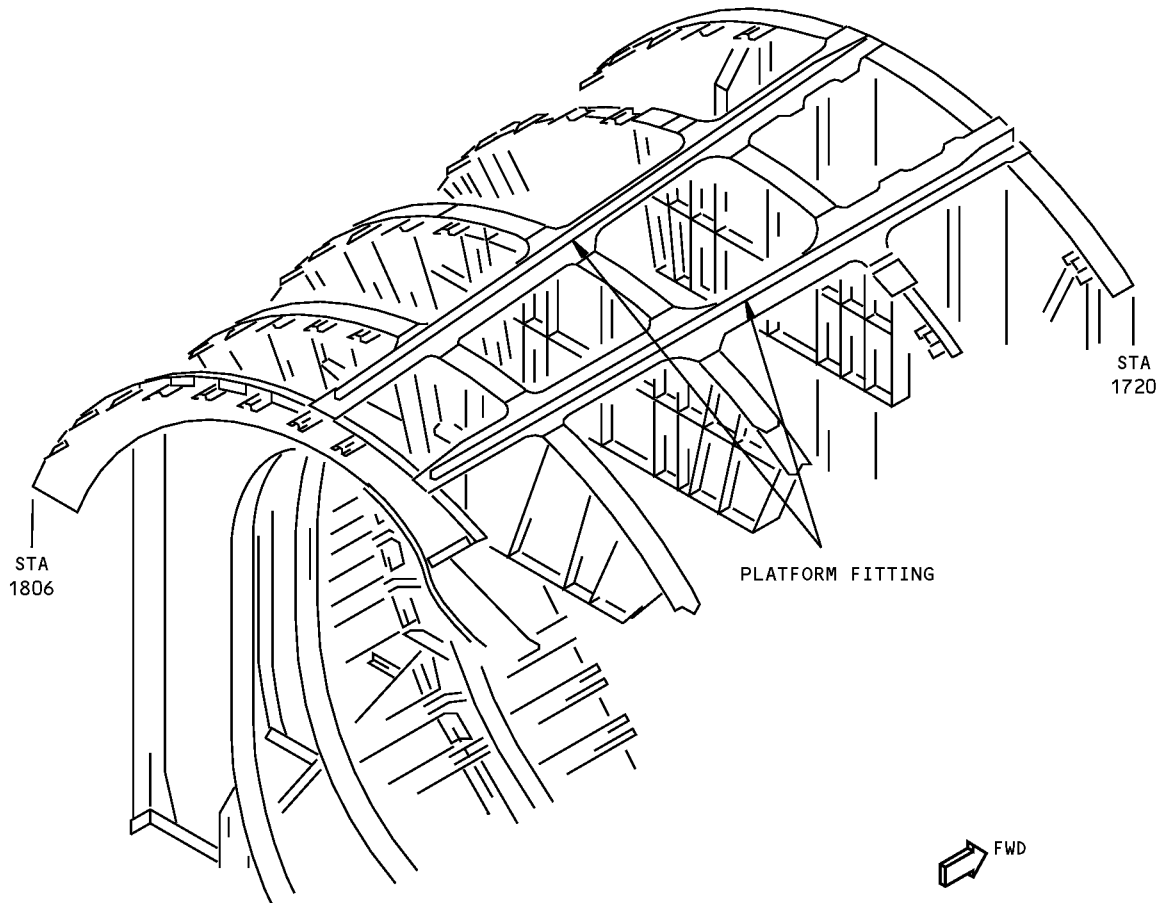
MATERIAL: MACHINED ALUMINUM

**FIN ATTACHMENT PLATFORM FITTING
DETAIL III**

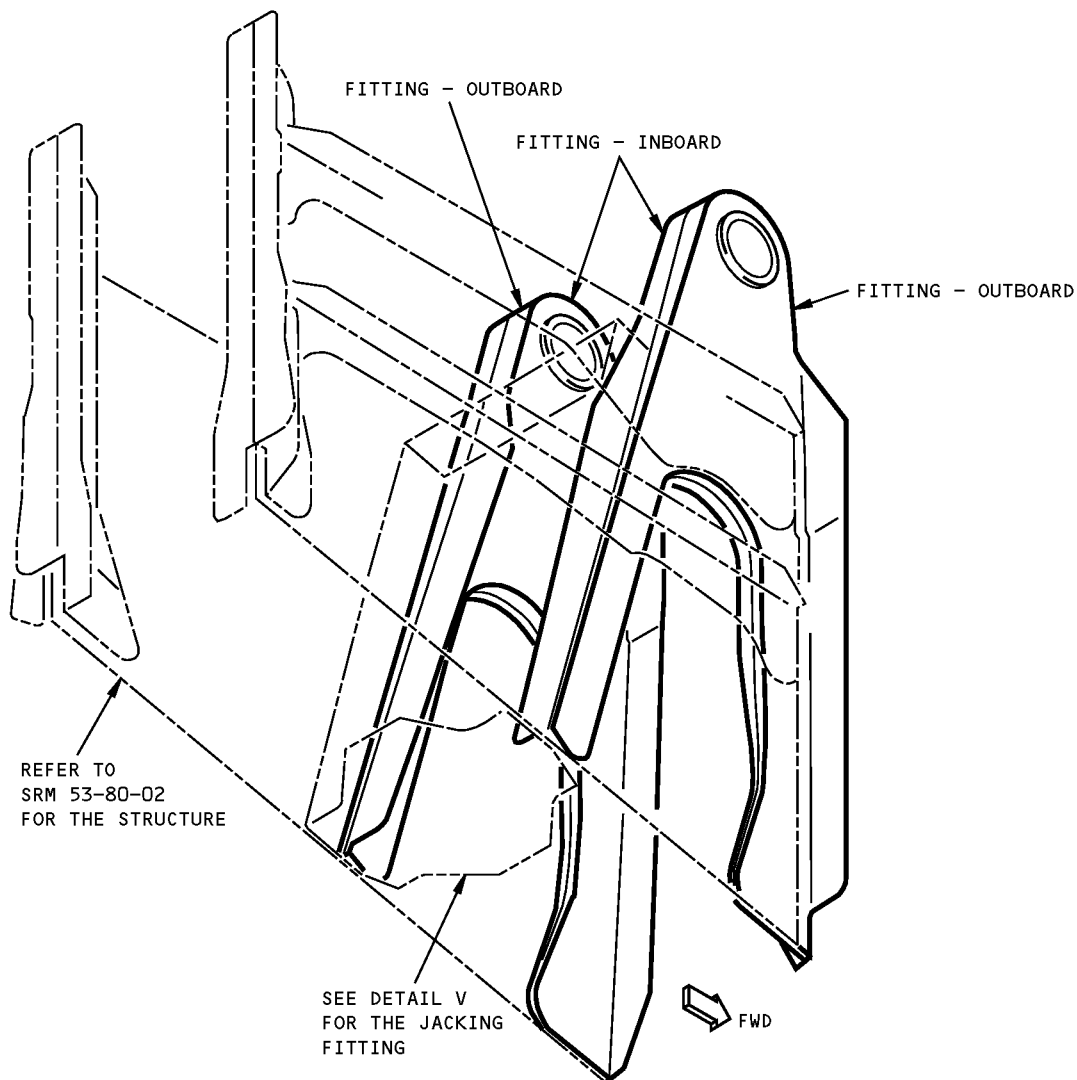
MATERIAL: FORGED ALUMINUM OR ALUMINUM PLATE

STABILIZER JACKSCREW SUPPORT FITTING
DETAIL IV

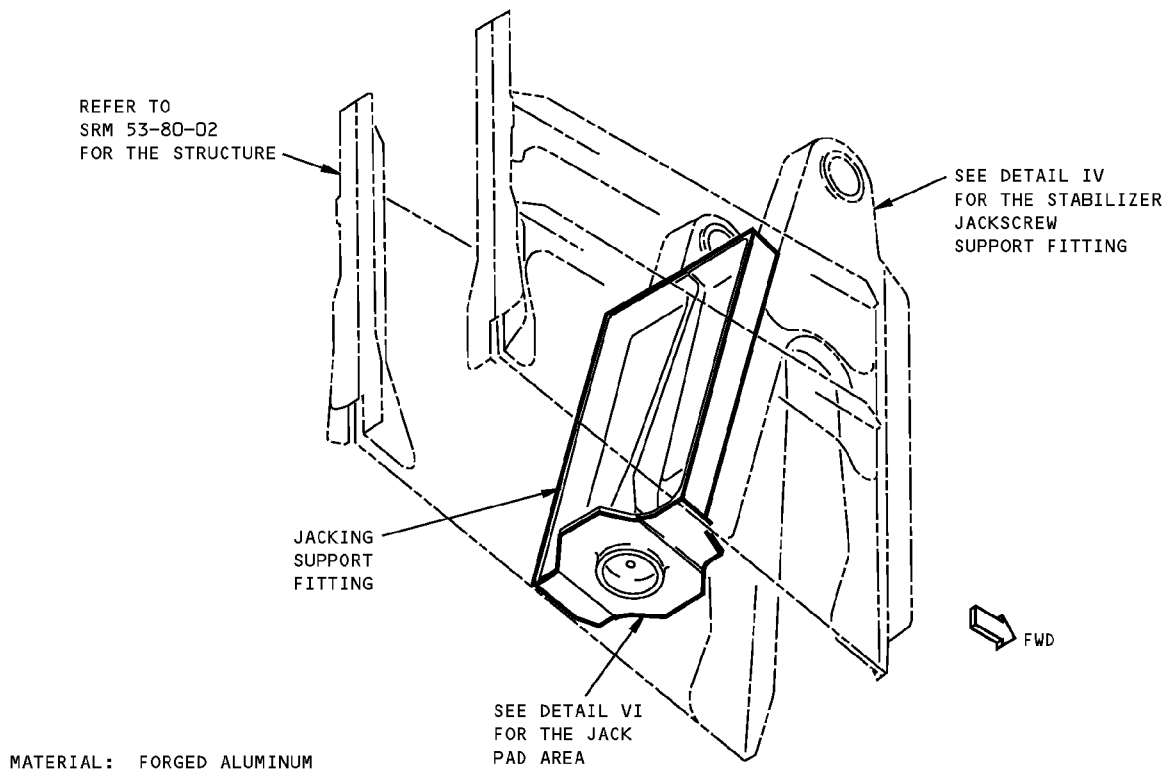
JACKING STABILIZATION SUPPORT FITTING DETAIL V

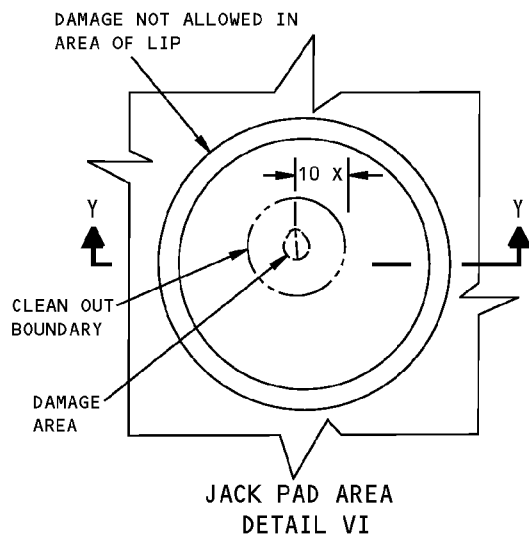
REWORK MAY BE MADE IN MORE THAN ONE PLACE ON JACK PAD SURFACE PROVIDED PAD SURFACE AREA LOSS DOES NOT EXCEED 20% OF ORIGINAL SURFACE AREA

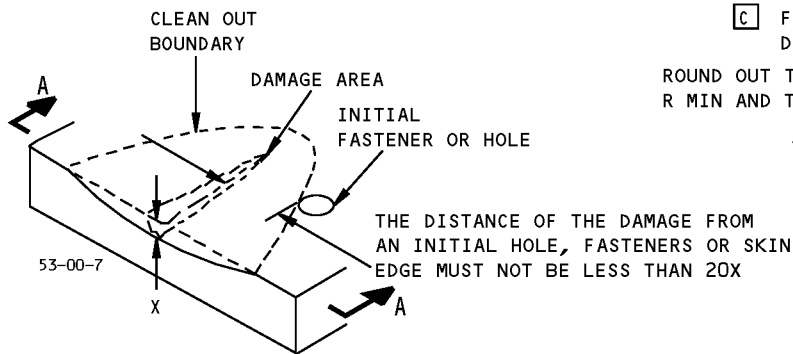
REMOVAL OF NICK, GOUGE AND SCRATCH DAMAGE ON A SURFACE
DETAIL VIII

- A** CRACKS ARE NOT PERMITTED EXCEPT FOR EDGE CRACKS WHICH MUST BE REMOVED AS GIVEN IN DETAIL VIII
- B** FOR EDGE DAMAGE SEE DETAIL VIII. FOR LUG DAMAGE SEE DETAIL VII. FOR OTHER DAMAGE SEE DETAIL VI. DAMAGE IS NOT PERMITTED IN VICINITY OF BUSHINGS
- C** FOR EDGE DAMAGE SEE DETAIL VIII FOR OTHER DAMAGE SEE DETAIL VI

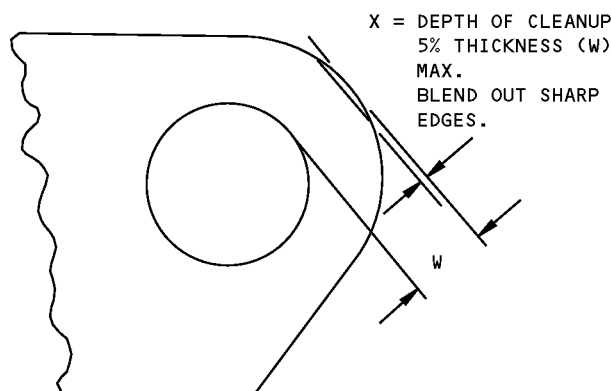
DETAIL IX

DAMAGE CLEANUP FOR EDGES OF LUG

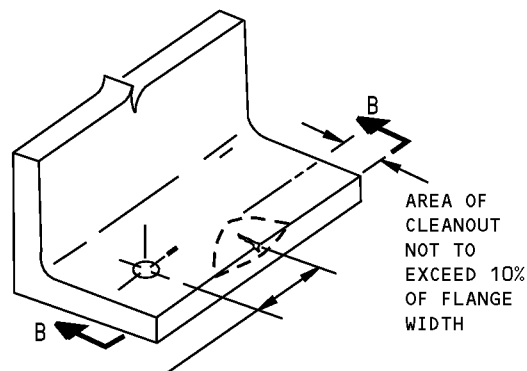
THE DISTANCE OF THE DAMAGE FROM AN EXISTING HOLE, FASTENERS OR EDGE MUST NOT BE LESS THAN 20X

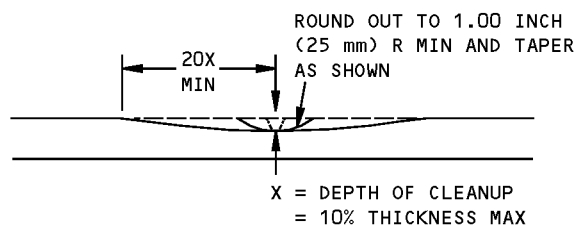
SECTION B-B

REMOVAL OF NICK OR CRACK
DAMAGE ON AN EDGE

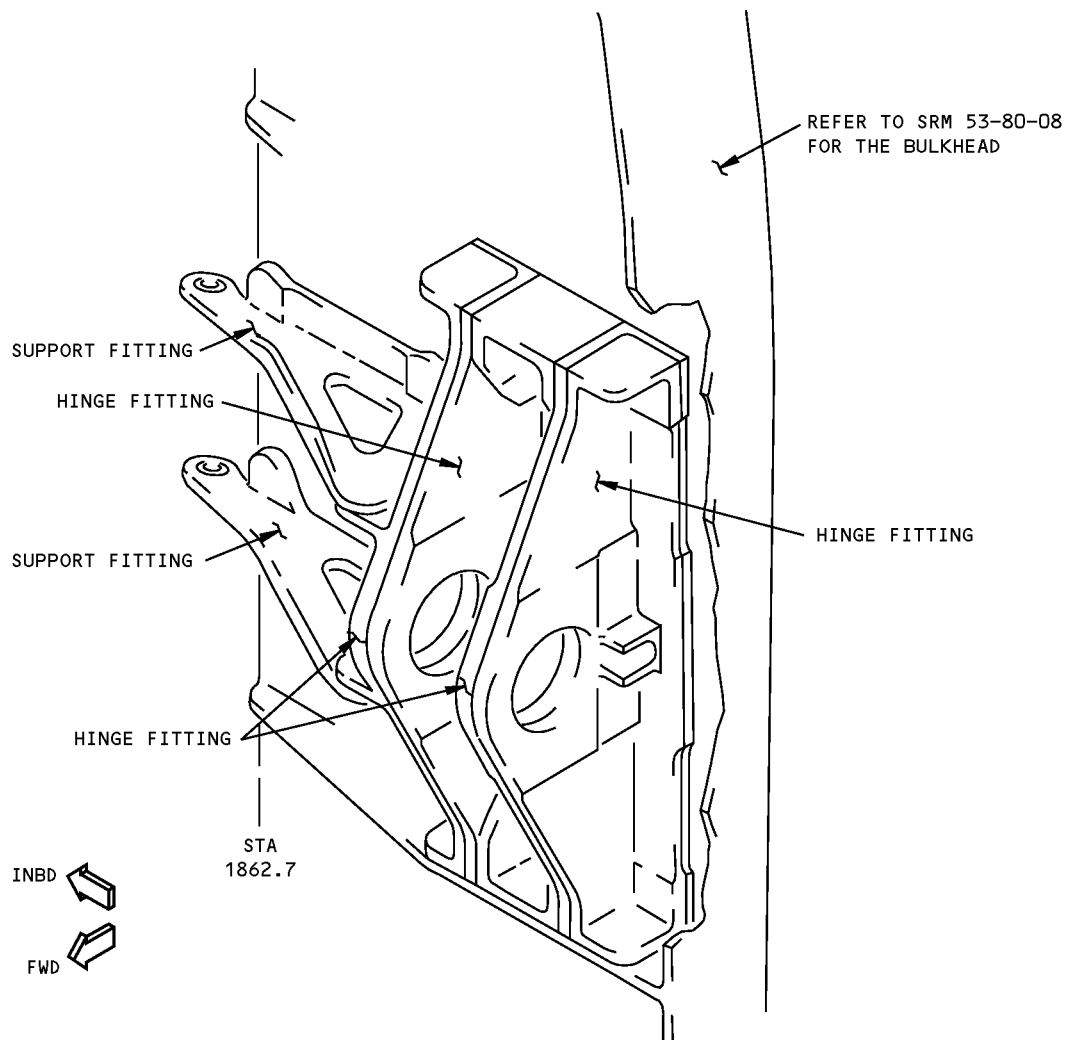
Section 48 Attachment Fittings Repair
Figure 201 (Sheet 2 of 6)

REFERENCE DRAWING
148N2112

**HORIZONTAL STABILIZER HINGE ASSEMBLY
DETAIL I**

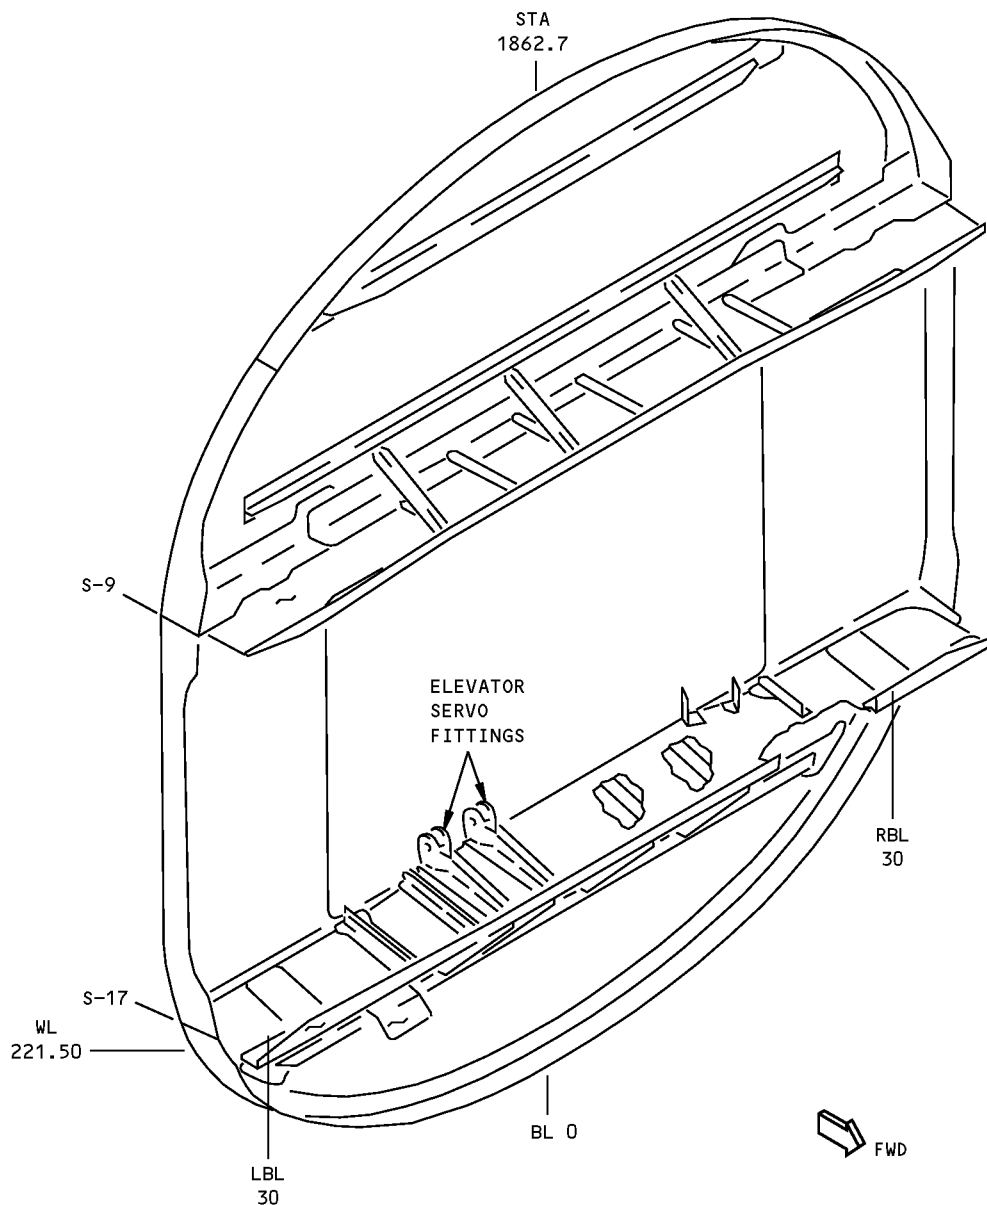
Section 48 Attachment Fittings Repair Figure 201 (Sheet 3 of 6)

REFERENCE DRAWING
148N2202

LOWER BULKHEAD BEAM FITTINGS
DETAIL II

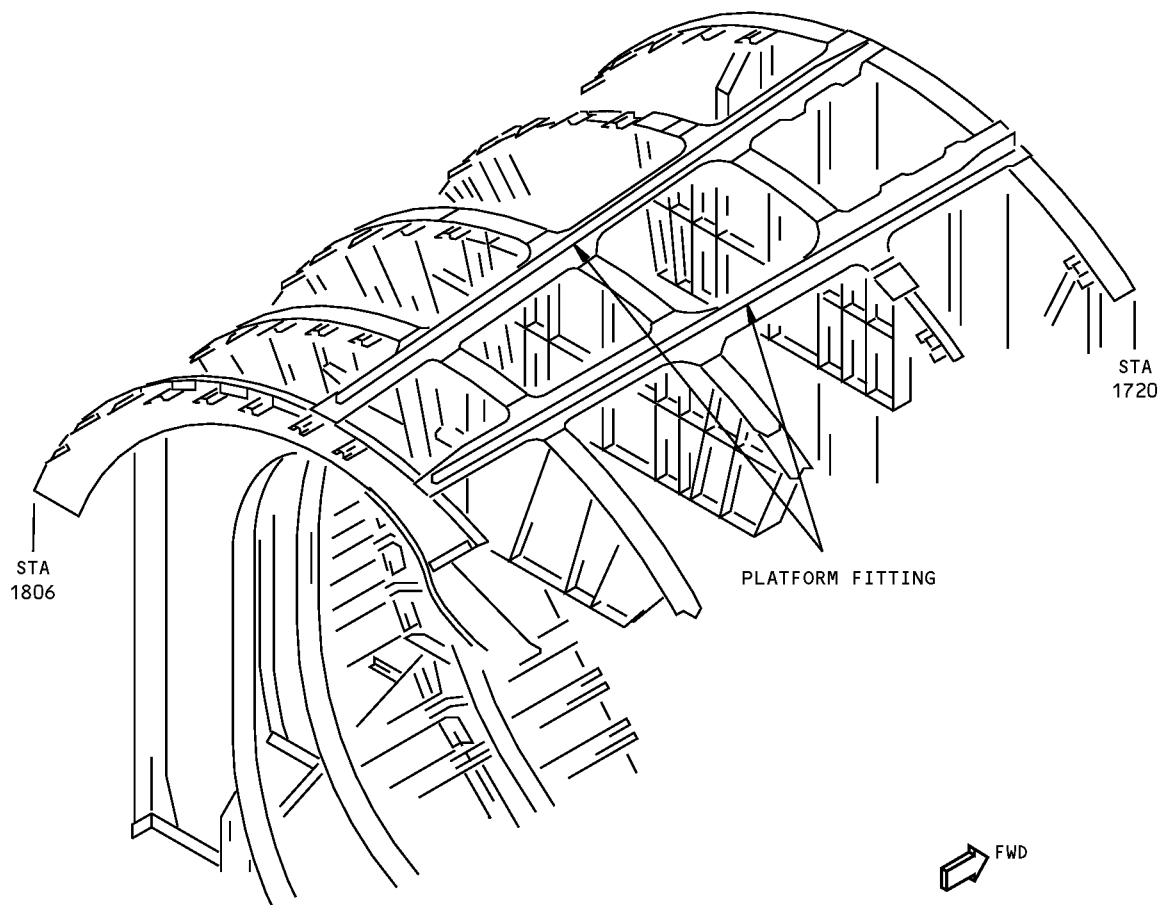
**Section 48 Attachment Fittings Repair
Figure 201 (Sheet 4 of 6)**

REFERENCE DRAWING
148N3101

**FIN ATTACHMENT PLATFORM FITTING
DETAIL III**

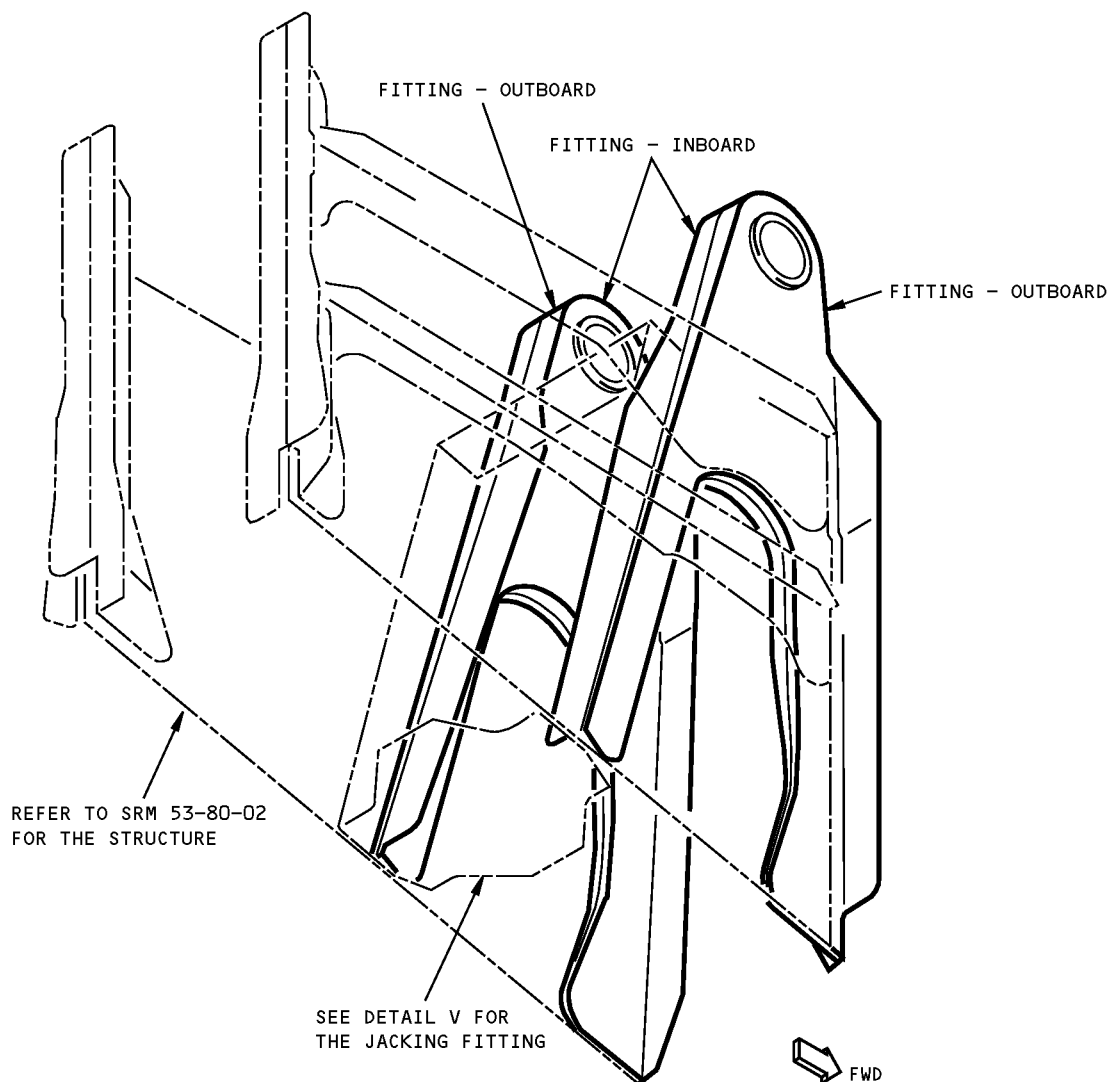
Section 48 Attachment Fittings Repair
Figure 201 (Sheet 5 of 6)

**STABILIZER JACKSCREW SUPPORT FITTING
DETAIL IV**

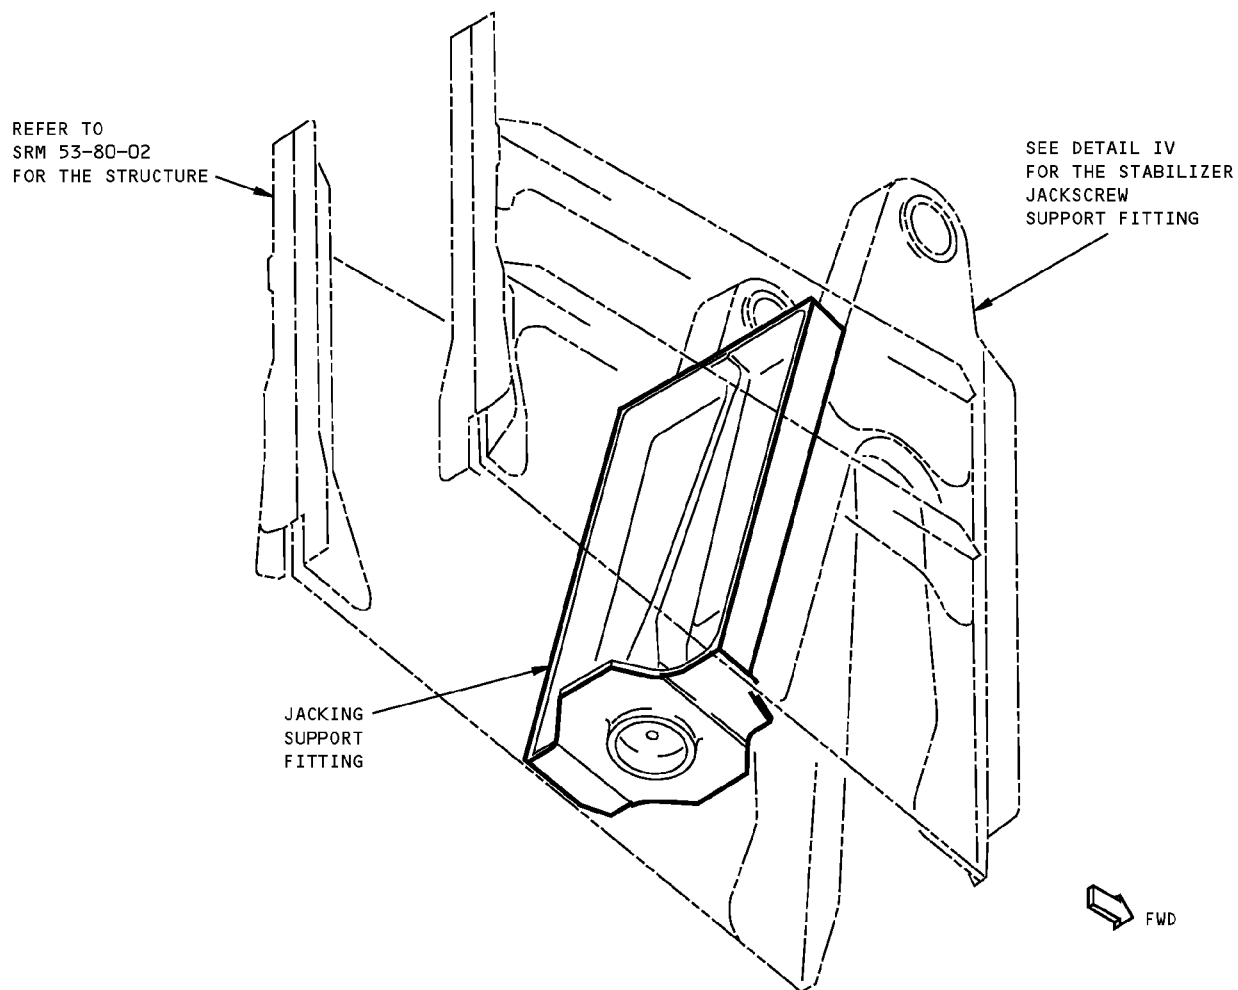
**Section 48 Attachment Fittings Repair
Figure 201 (Sheet 6 of 6)**

**JACKING STABILIZATION SUPPORT FITTING
DETAIL V**
