# **CHAPTER**

**FUSELAGE**

### CHAPTER 53 FUSELAGE

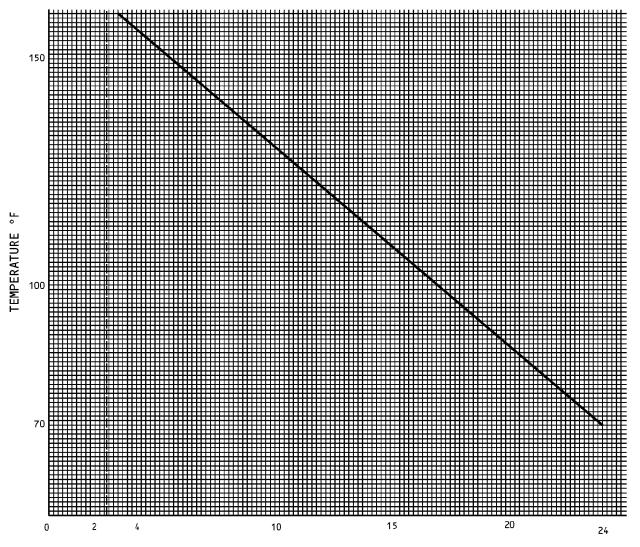
Resin Cure Cycle Figure 209 (Sheet 2 of 2)

TIME IN HOURS
(CURE CURVE FOR EA 9330 A/B ADHESIVE)

DETAIL II

(j) Cure the repair as given in Figure 209/REPAIR GENERAL.
