**NACELLES AND
PYLONS**

**757-200
STRUCTURAL REPAIR MANUAL**

**CHAPTER 54
NACELLES AND PYLONS**

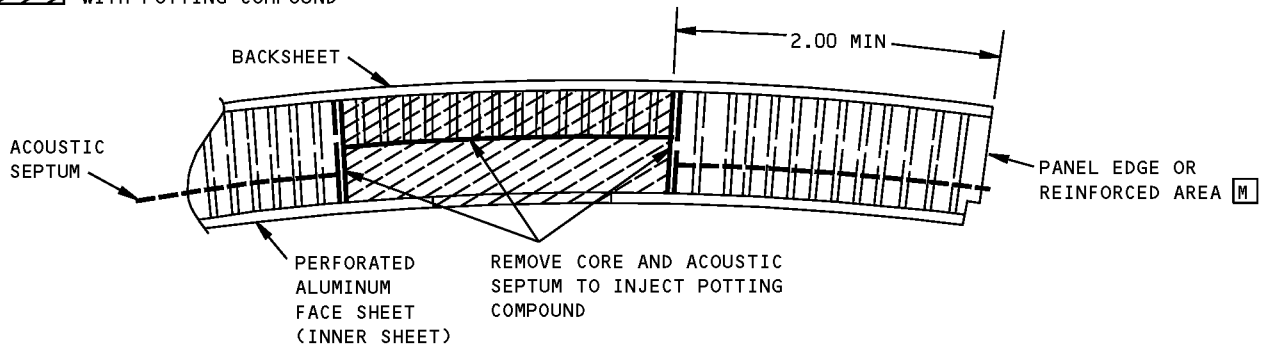
**REPAIR OF LIMITED DAMAGE BY POTTING
DETAIL II**

THIS REPAIR IS FOR DAMAGE THAT IS NOT MORE THAN 3 INCHES (75 mm) IN DIAMETER. REFER TO DETAIL III FOR DAMAGE ADJACENT TO PANEL EDGE AND DETAIL IV FOR LARGE DAMAGE.

1. Cut out the damaged skin, leaving the core intact. Undercut the core and septum at perimeter of cutout as shown to allow for injection of resin into one further row of cells around cutout.

NOTE: REMOVAL OF DAMAGED CORE IS NOT REQUIRED WHEN USING A POTTED RESIN REPAIR, HOWEVER THE DAMAGED CORE MUST EITHER BE CLEANED OR CUT OUT.

4. When potting compound has cured sufficiently, sand down the surplus resin flush with the surrounding skin.

2. Clean out all particles from exposed core.

PORTION OF CORE FILLED WITH POTTING COMPOUND

SECTION A-A

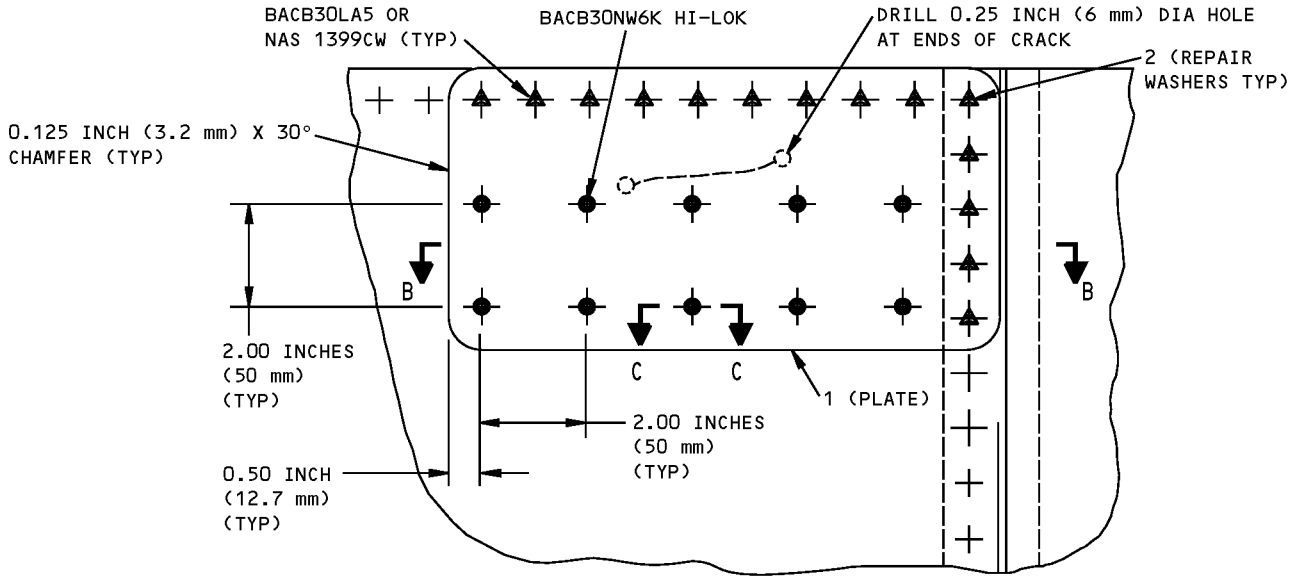
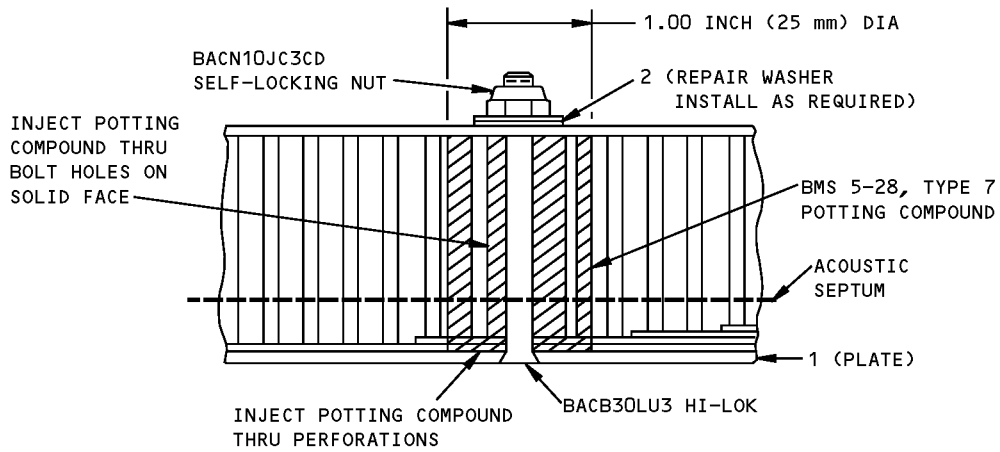
**REPAIR OF LARGE CRACKS OR DAMAGE NEAR PANEL EDGE
DETAIL III**

APPLICABILITY
THIS REPAIR IS FOR CRACKS WITHIN 2 INCHES (50 mm) OF PANEL EDGE AND/OR CORE DAMAGE THAT IS NOT MORE THAN 3 INCHES (75 mm) IN DIAMETER. REFER TO DETAILS II AND IV FOR REPAIRS OUTSIDE OF THIS AREA.

REPAIR MATERIAL			
PART		QTY	MATERIAL
1	REPAIR PLATE	1	0.080 INCH 2024-T3
2	REPAIR WASHER	AS REQ'D	IN ACCORDANCE WITH SRM 51-40-08

1. Drill a 0.25-inch (6.4 mm) diameter hole at each end of the crack.

2. Drill out sufficient edge fasteners to permit installation of the repair plate 1.
3. Locate repair plate on panel and drill holes to match existing edge fastener holes.

4. Drill additional repair fasteners holes in the repair plate 1 as shown.
5. Solvent clean the faying surfaces of the original panel and repair plate 1 as detailed in SRM 51-70-10.

6. Apply Alodine to all bare surfaces and raw edges of existing and repair parts per SRM 51-20-01.
7. Prime faying surfaces of initial panel and repair doubler with Courtaulds Aerospace 515X346 corrosion inhibiting adhesive primer.

**REPAIR FASTENER INSTALLATION
SECTION C-C**

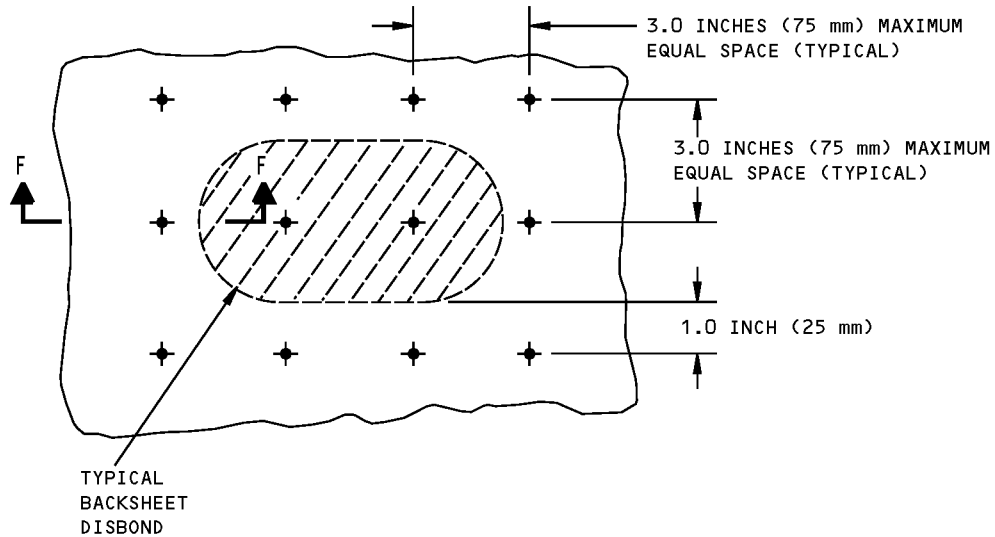
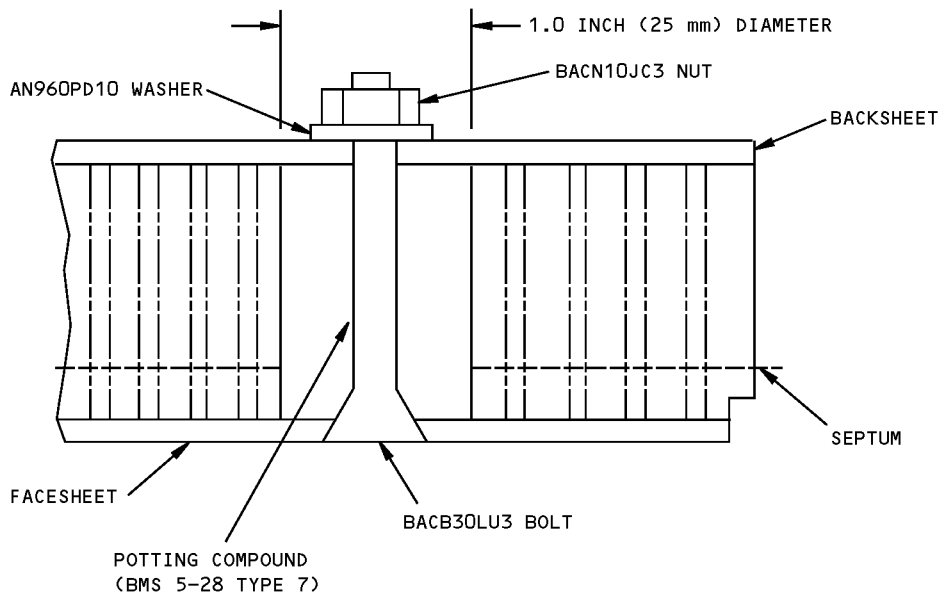
PANEL SHOWN WITH OUTER SKIN PANEL LOWER HALF REMOVED
DETAIL VI

APPLICABILITY
<p>THIS REPAIR IS LIMITED TO INLET COWL ACOUSTIC PANEL ONLY. THIS REPAIR IS FOR BACKSHEET. DISBOND LIMITED TO AN AREA OF 100 SQUARE INCHES (645 SQUARE cm) FOR EACH PANEL. MAXIMUM DISBOND SHALL NOT BE MORE THAN 30 INCHES (760 mm) IN THE CIRCUMFERENTIAL DIRECTION AND 10 INCHES (250 mm) IN THE FORE AND AFT DIRECTION. A CIRCUMFERENTIAL SEPARATION OF A MINIMUM OF 12 INCHES (300 mm) IS REQUIRED BETWEEN ADJACENT DISBONDS GREATER THAN 20 INCHES (500 mm) IN LENGTH. NO DISBOND ALONG PANEL EDGE IS PERMITTED. IN NO CASE SHALL THE NOISE SUPPRESSION CAPABILITIES OF THE ACOUSTICAL PANELS BE COMPROMISED. REFER TO DETAIL I FOR REPAIR LIMITS.</p>

- ✦ REPAIR FASTENER LOCATION.
INSTALL BACB30LU3 BOLT WITH BACN10JC3 NUT AND AN96OPD10 WASHER.

SECTION F-F

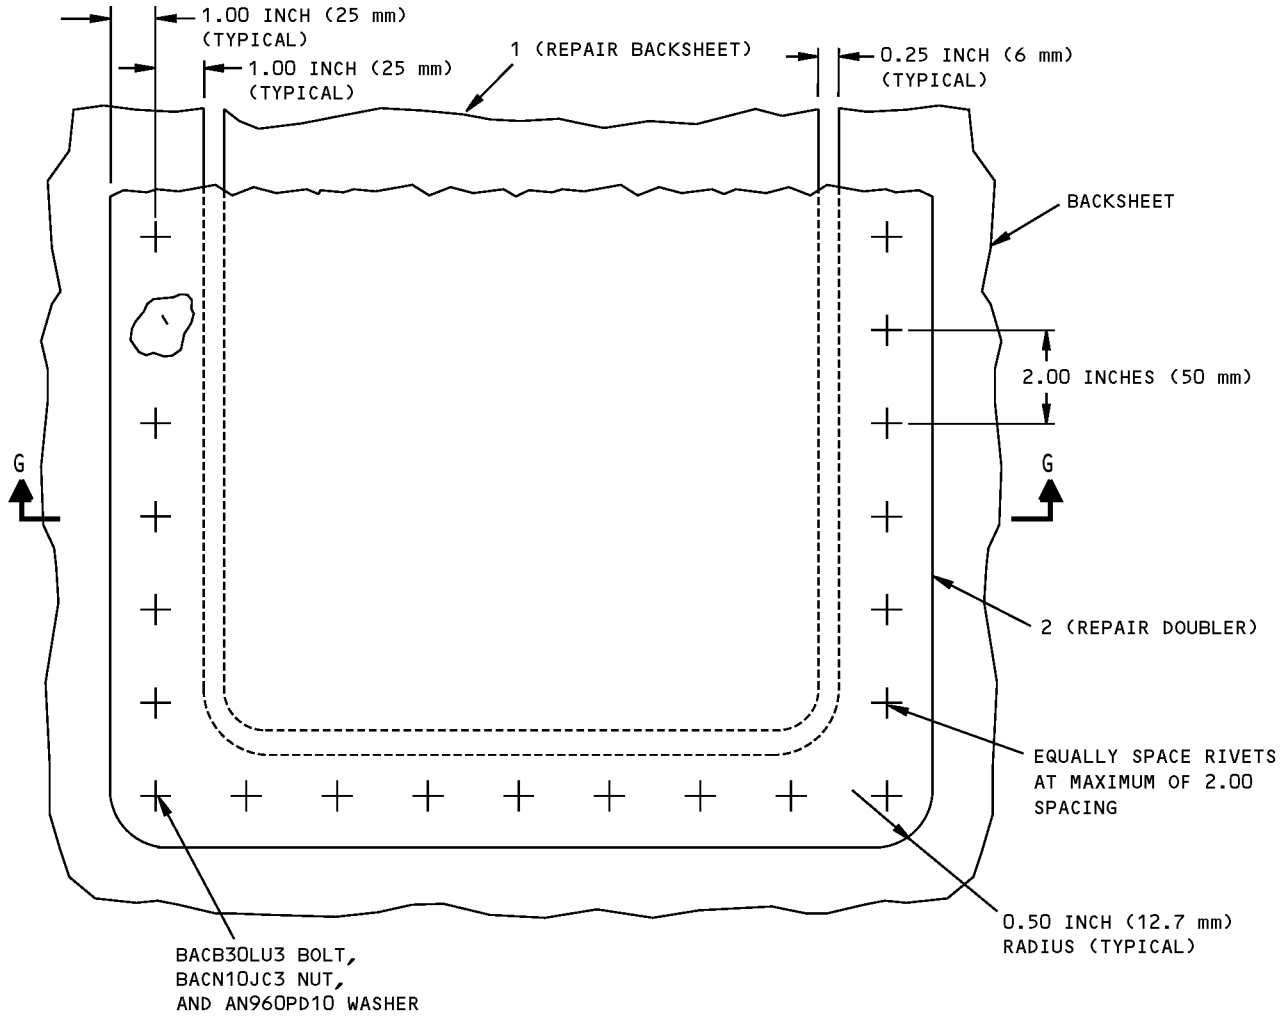
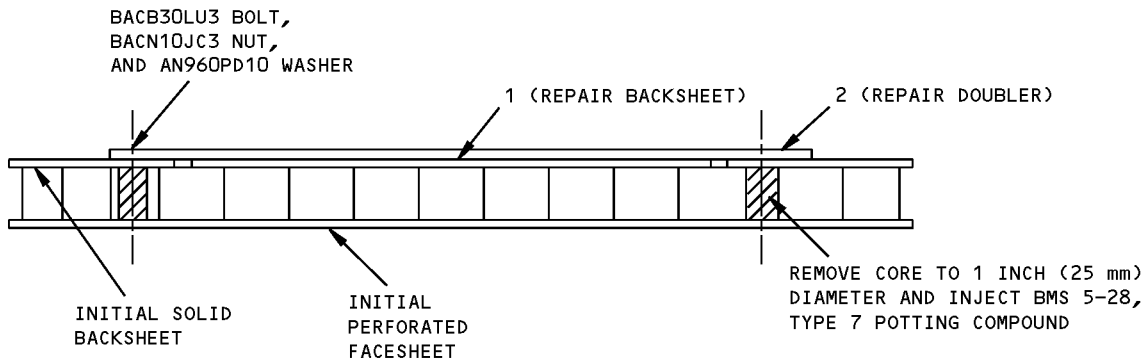
DETAIL VII

SECTION G-G

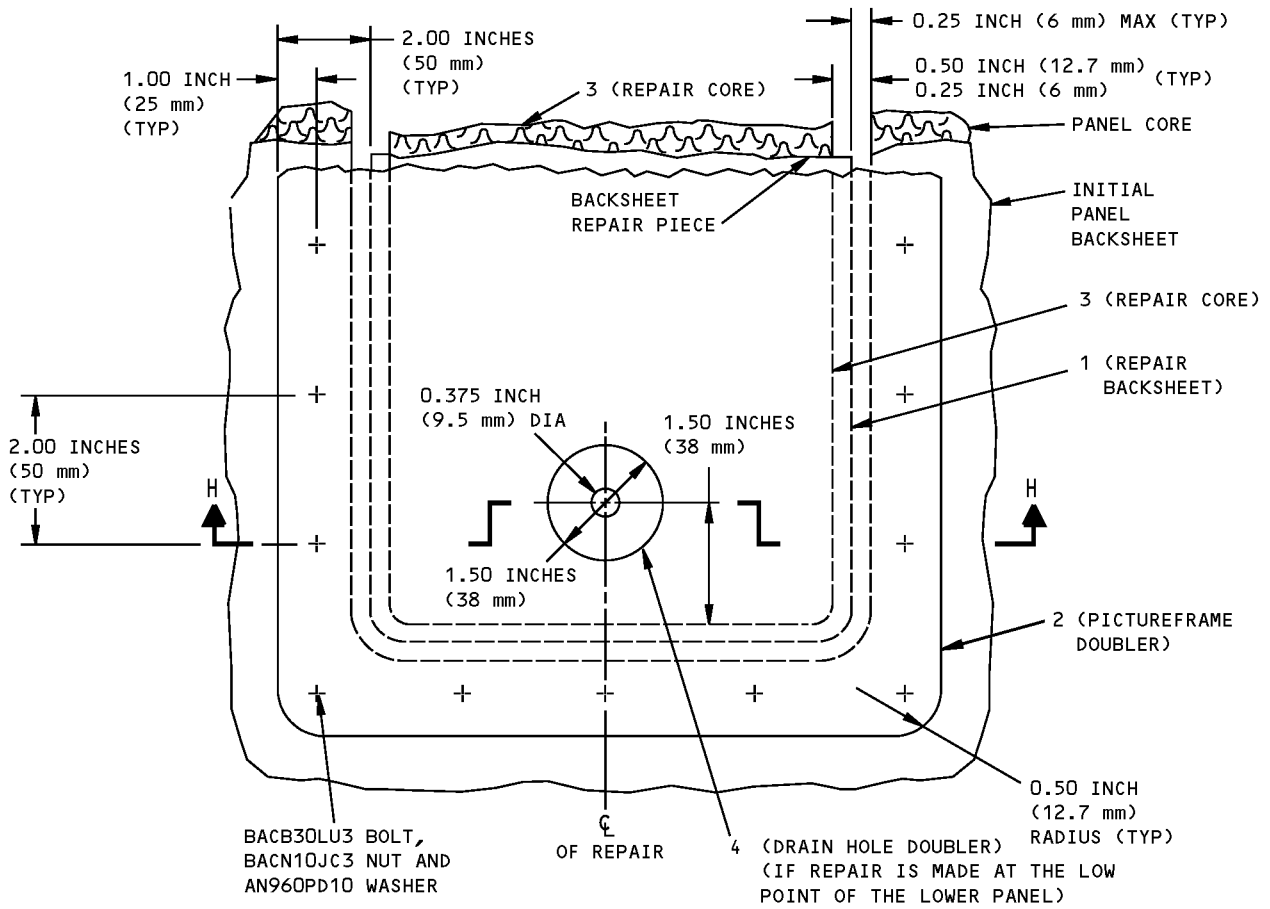
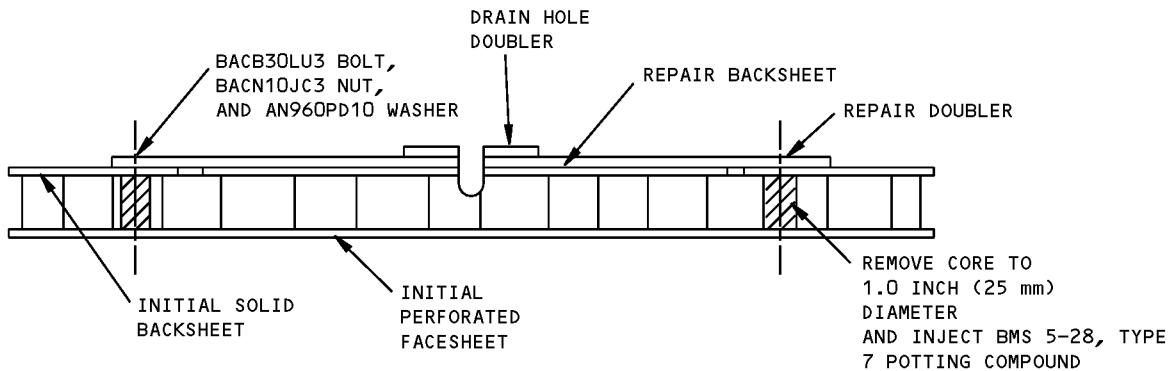
DETAIL VIII

SECTION H-H

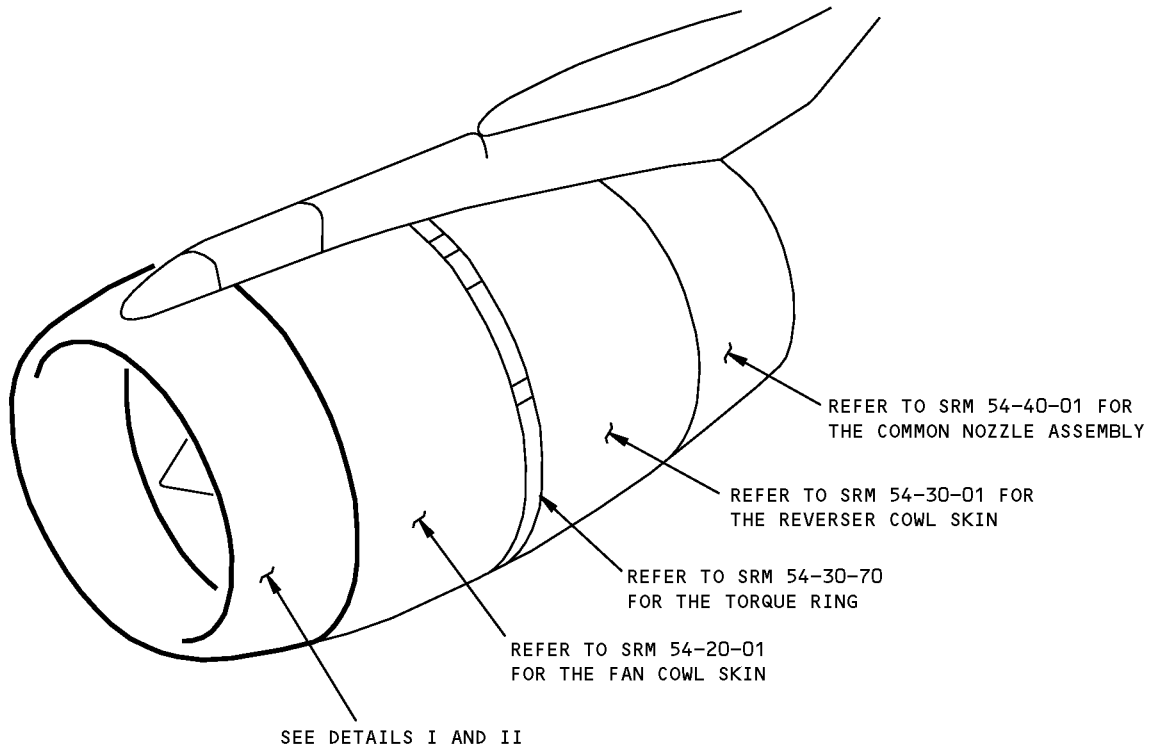
Inlet Cowl Skin Identification - RB211-535E4 Engine
Figure 1 (Sheet 1 of 5)

IDENTIFICATION 1 - INLET COWL SKIN - RB211-535E4 ENGINE

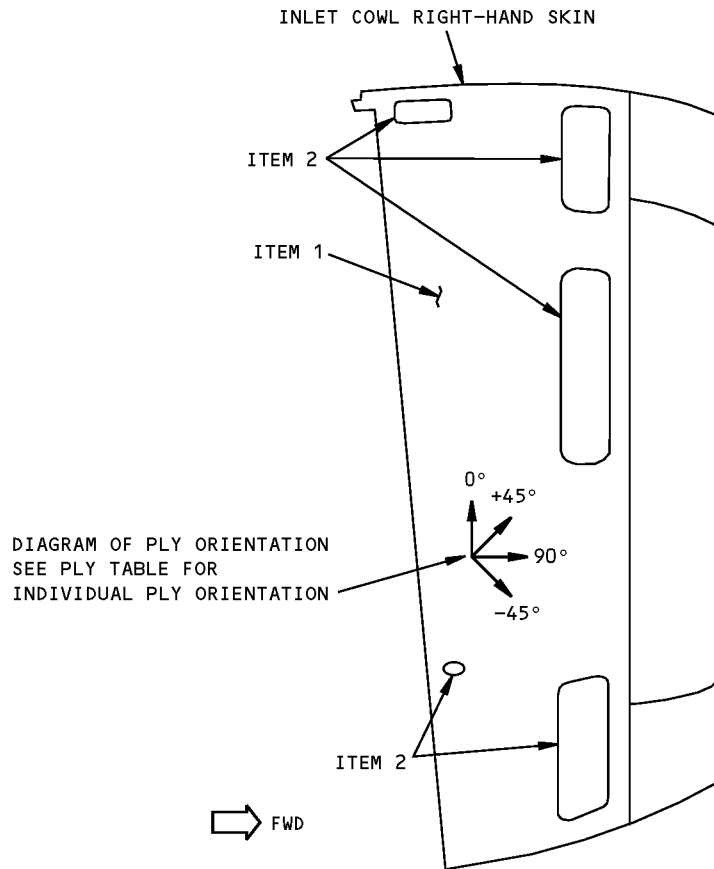
DETAIL V

PLY ORIENTATION DIAGRAM FOR
RIGHT-HAND INLET COWL SKIN

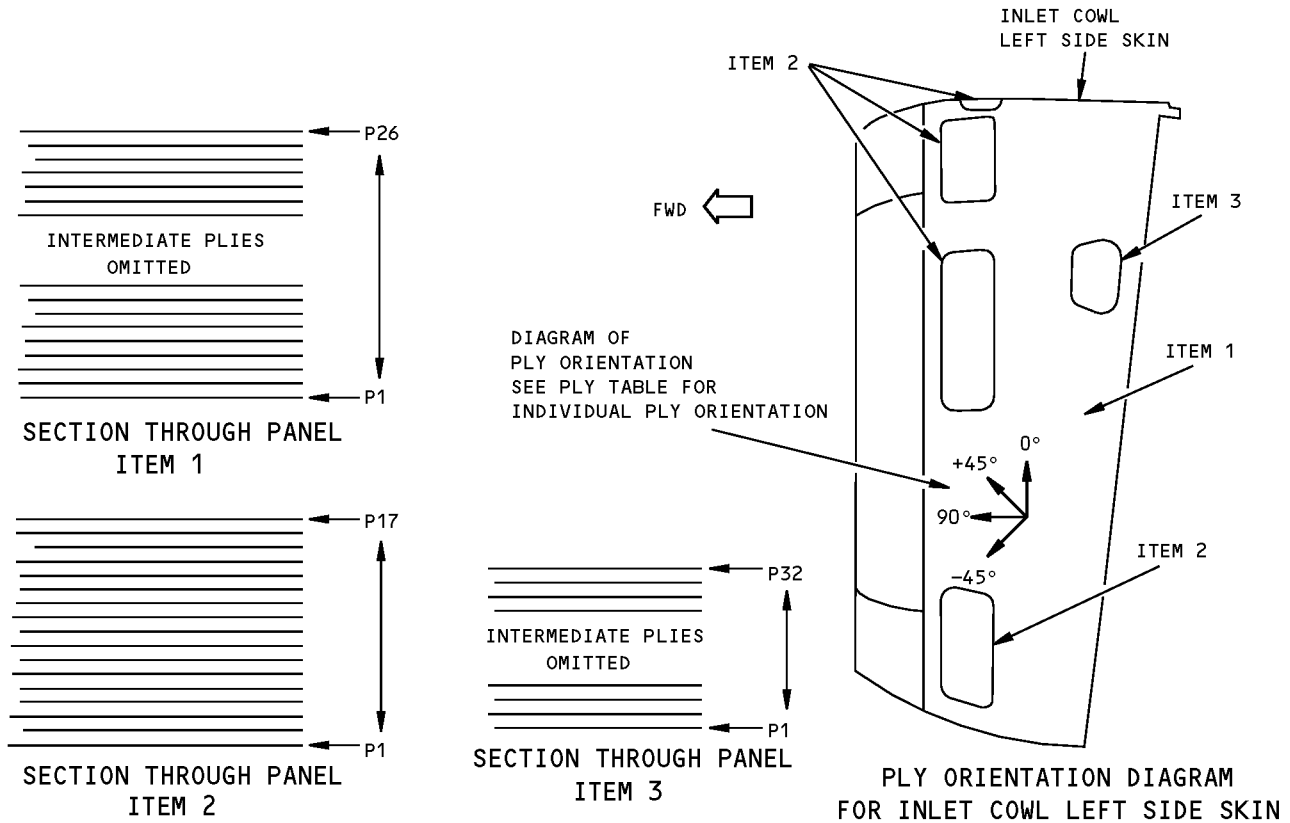
DETAIL VI

ITEM NO.	PLY NO.	MATERIAL	PLY ORIENTATION	NOTE REFER SHEET 1
1	P1,P5,P14 AND P26	B	±45°	A E
	P2 TO P4 AND P6 TO P8 P11 TO P13 AND P15 TO P17	C	0°	A E
	P9 AND P10	C	±45°	A E
	P18,P21,P22 AND P25	D	±45°	A E
	P19,P20, P23 AND P24	D	0° OR 90°	A E
2	P1,P2,P5 AND P8 TO P17	D	±45°	A F
	P3,P4,P6 AND P7	D	0° OR 90°	A F
3 G	P1,P5 AND P6,P10,P17 AND P18,P25 AND P26 P31 AND P32	D	±45°	A F
	P2 TO P4,P7 TO P9,P11 TO P16 P19 TO P24,P27 TO P30	D	0° OR 90°	A F

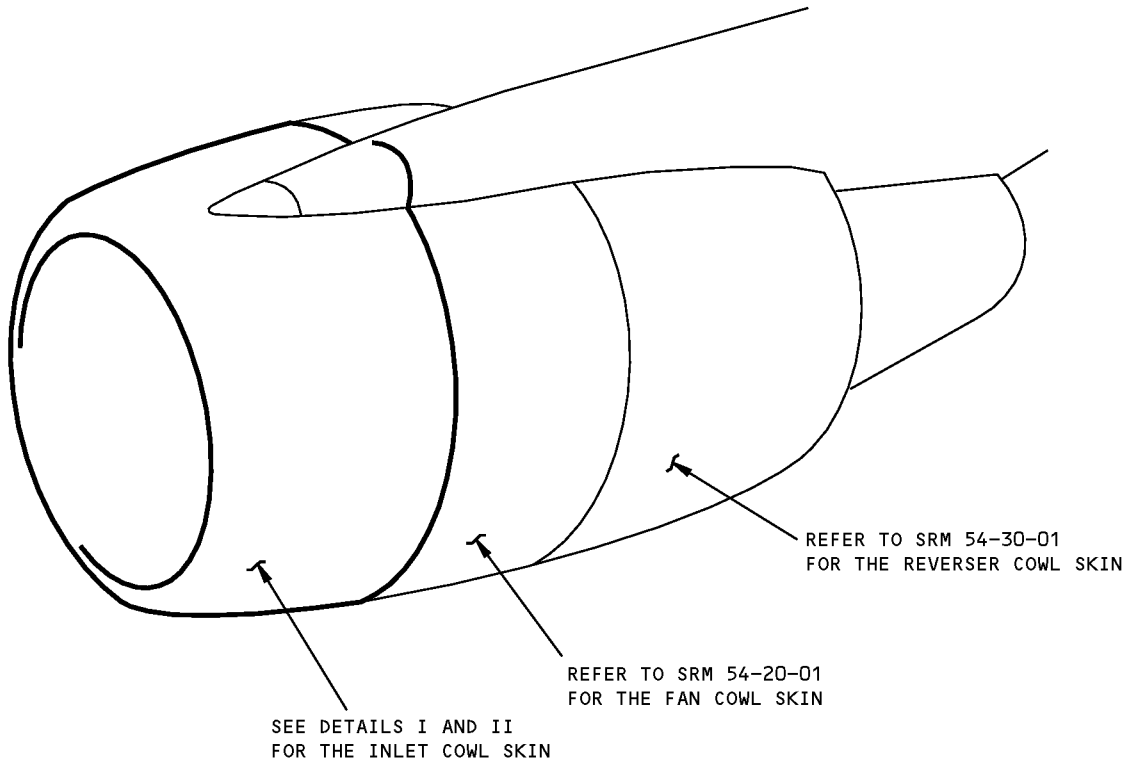
Inlet Cowl Skin Identification - RB211-535C Engine
Figure 1 (Sheet 1 of 3)

IDENTIFICATION 2 - INLET COWL SKIN - RB211-535C ENGINE

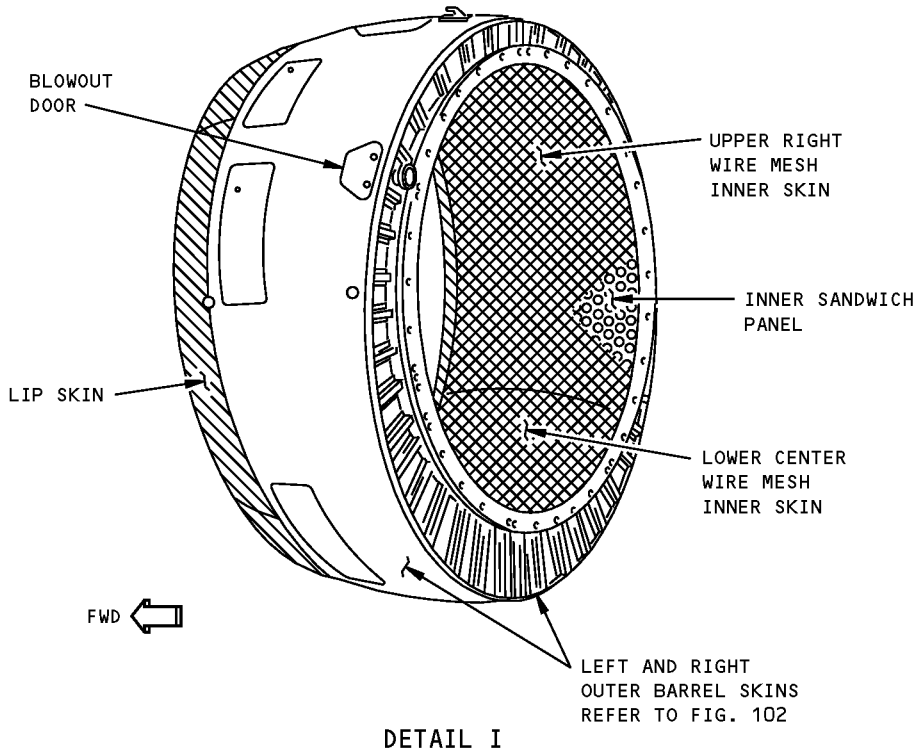
Inlet Cowl Skin Allowable Damage - RB211-535E4 Engine
Figure 101 (Sheet 1 of 3)

ALLOWABLE DAMAGE 2 - INLET COWL SKIN - RB211-535E4 ENGINE

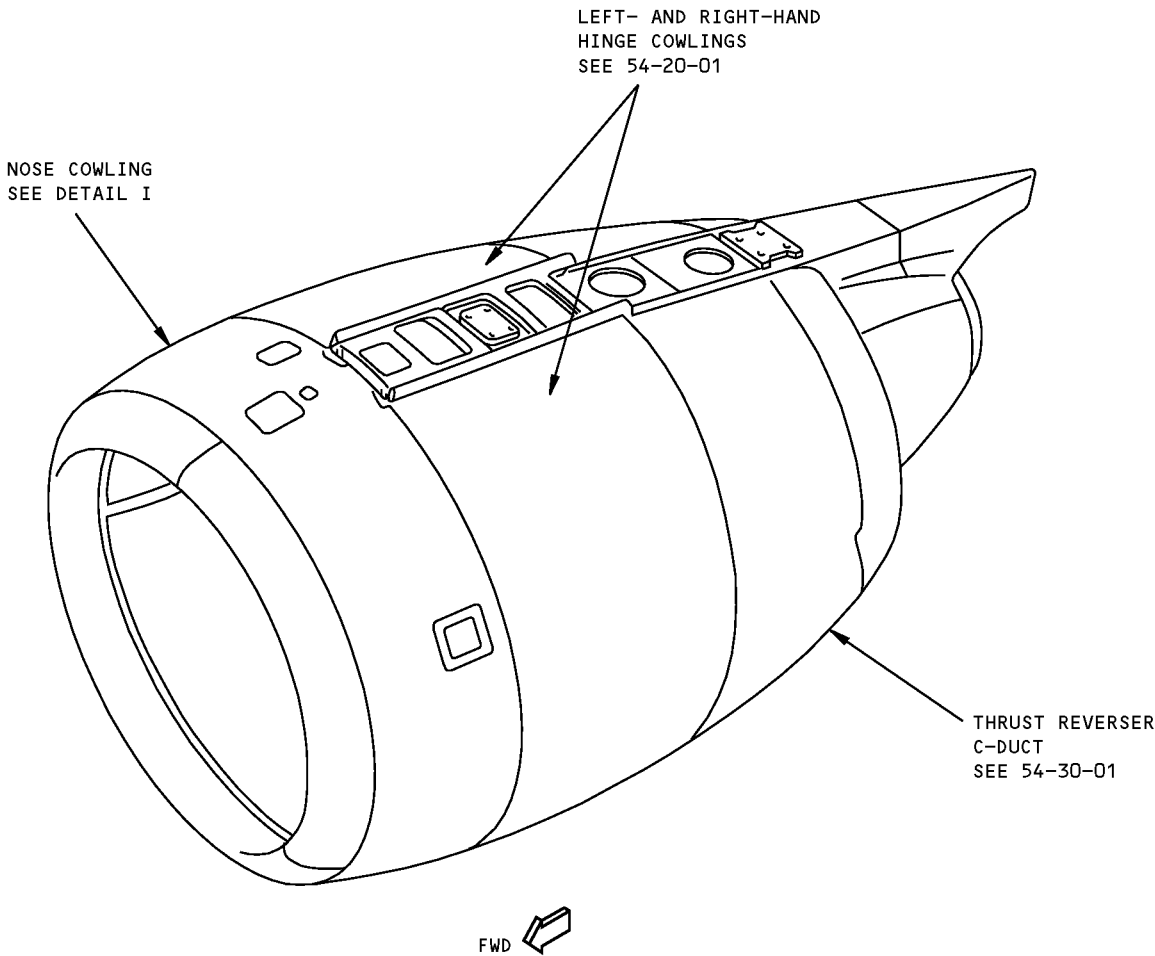
**Plates and Skins, Nose Cowl Allowable Damage - RB211-535C Engine
Figure 101 (Sheet 1 of 4)**

ALLOWABLE DAMAGE 3 - PLATES AND SKINS, NOSE COWL - RB211-535C ENGINE

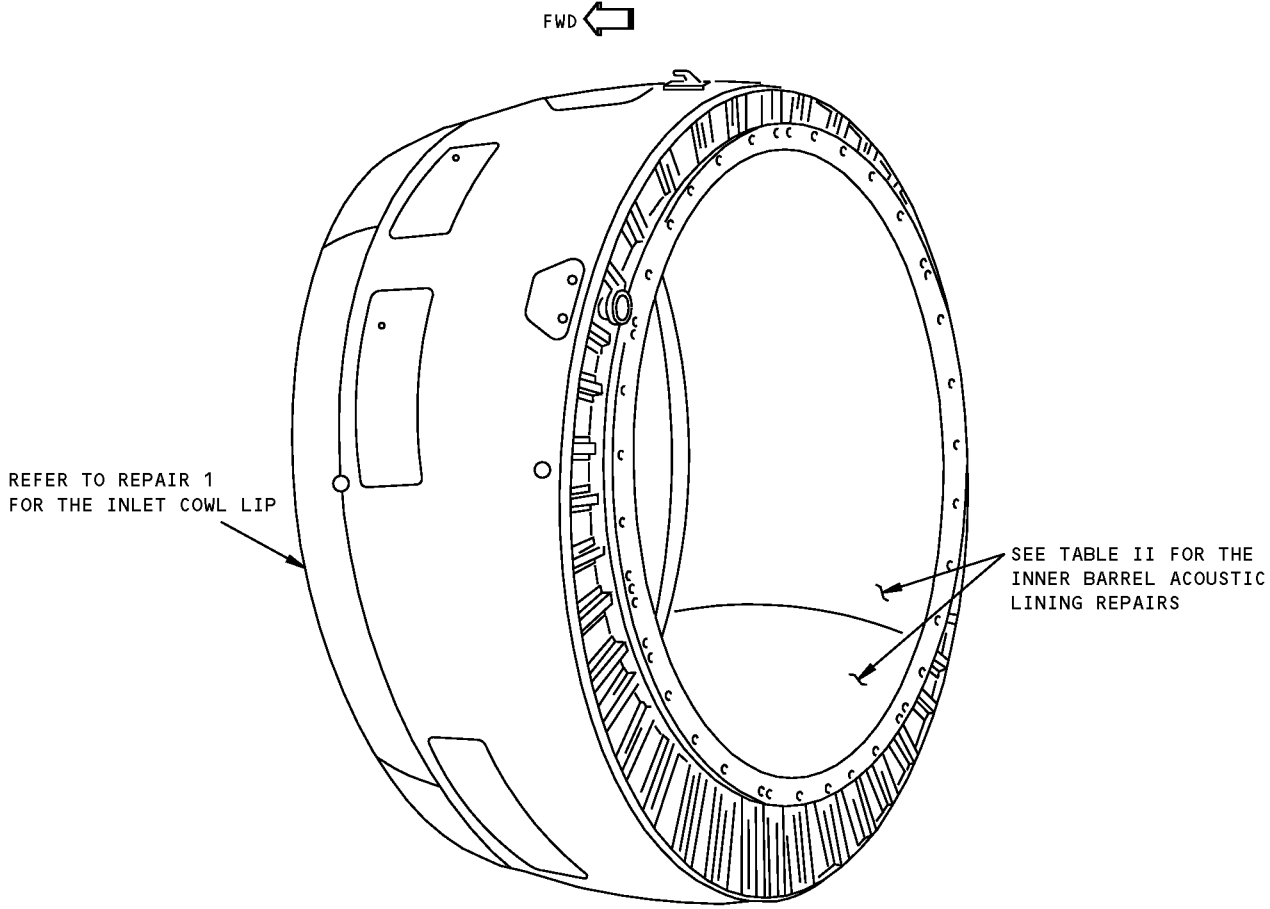
RB211-535E4 INLET COWL
DETAIL II

REPAIR GENERAL - INLET COWL REPAIRS - RB211-535 ENGINE

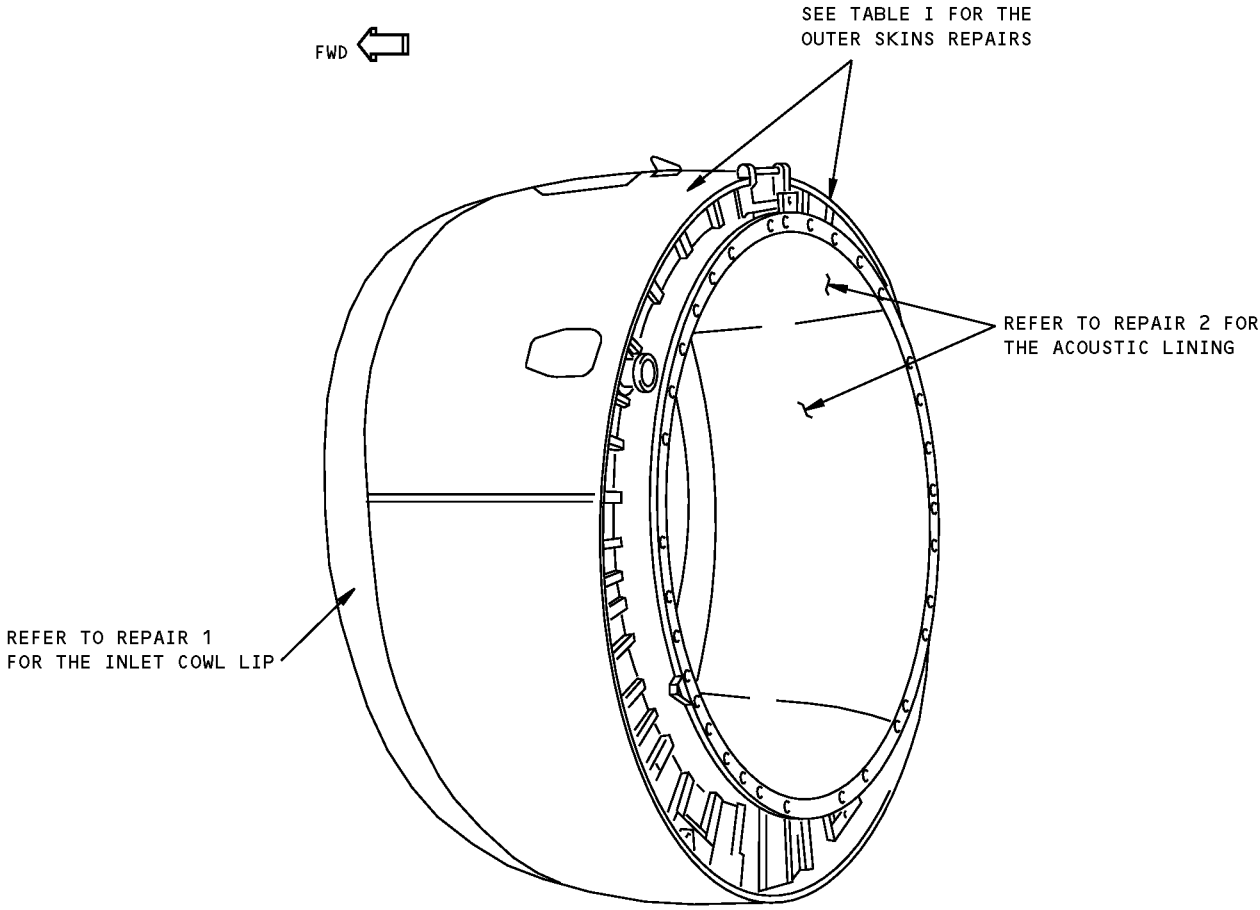
RB211-535C INLET COWL
DETAIL I

Inlet Cowl Skin Repairs - RB211-535C Engine
Figure 202

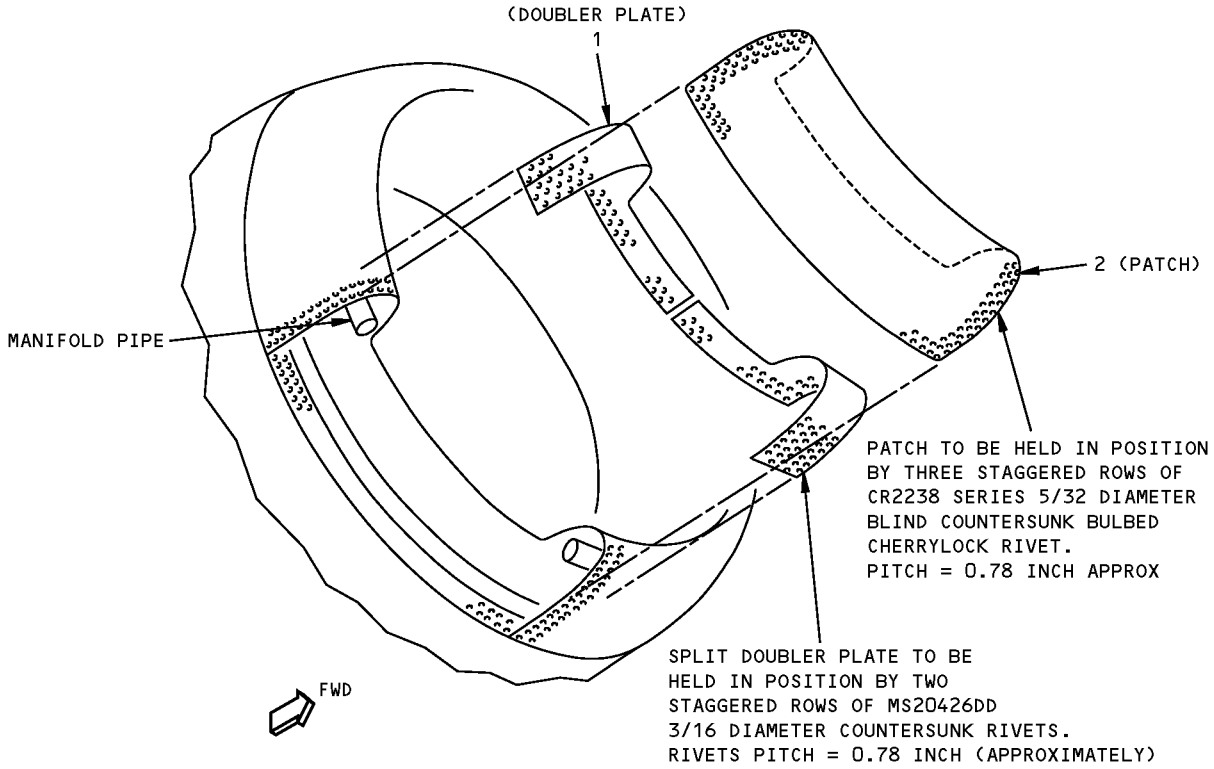
(SEE DETAILS I AND II)
VIEW ON INLET COWLING ASSEMBLY

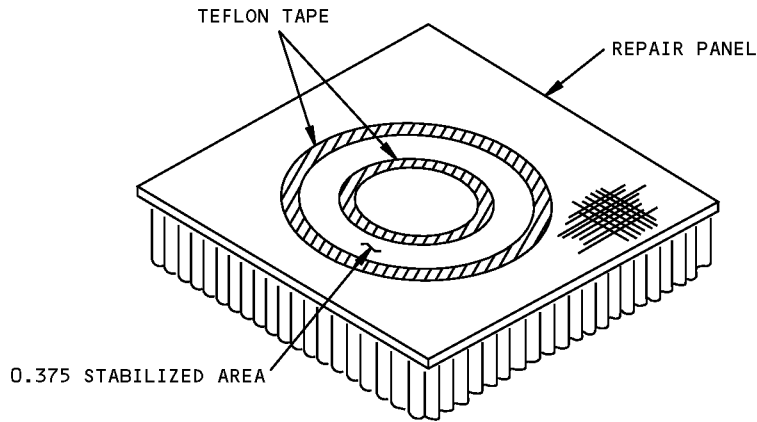
USING CUTTING DISC,
CUT THROUGH FACE SKIN
USING CENTER OF STABILIZED
AREA AS A GUIDE

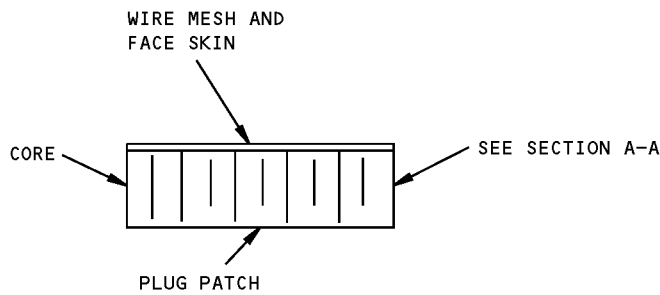
A7627

AFTER CUTTING WIRE MESH AND
FACE SKIN USE A KNIFE AND
CUT THROUGH CORE

Inlet Cowl - Inner Barrel - Repair for Partial Penetration of Perforated Skin - RB211-535E4 Engine
Figure 201 (Sheet 3 of 4)

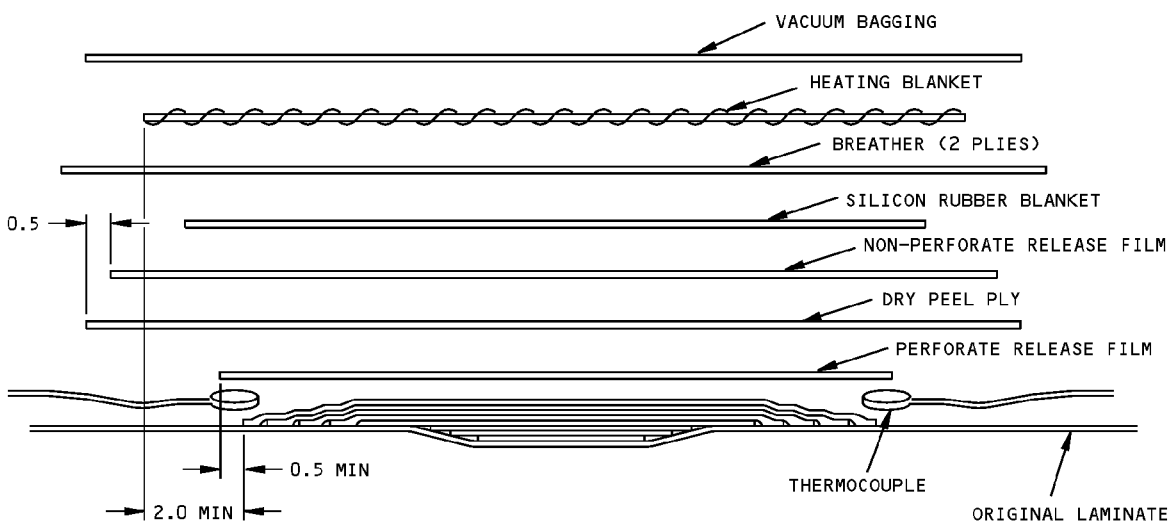
HEATER BLANKET AND VACUUM BAGGING
SET UP SEQUENCE
DETAIL II

Inlet Cowl Outer Skin - Repair to Damage Not Extending Through Laminate - RB211-535E4 Engine
Figure 201 (Sheet 3 of 4)

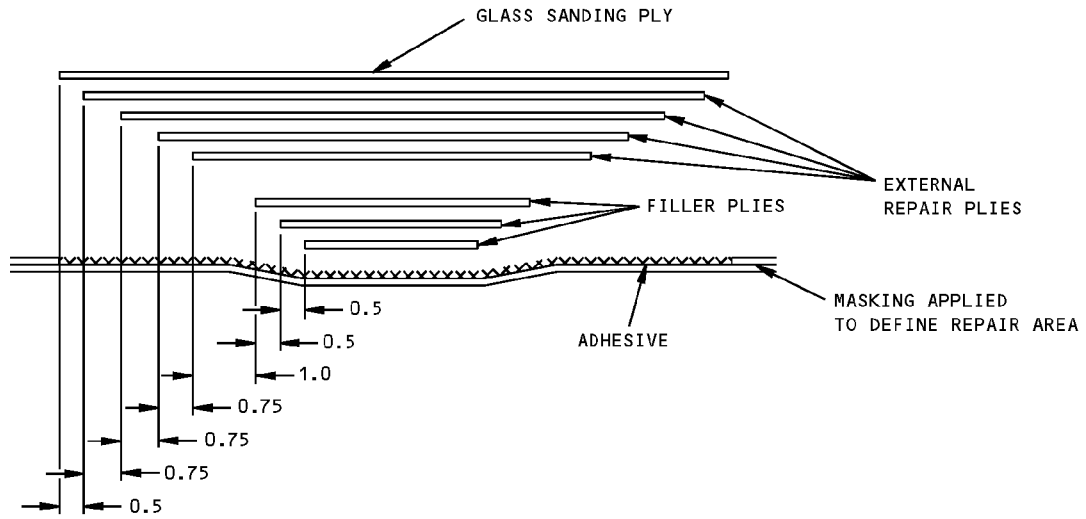
**Inlet Cowl Outer Skin - Repair to Damage Extending Through Laminate - RB211-535E4 Engine
Figure 201 (Sheet 2 of 3)**

VIEW SHOWING PARENT LAMINATE
WITH THREE DAMAGED PLYS
DETAIL I

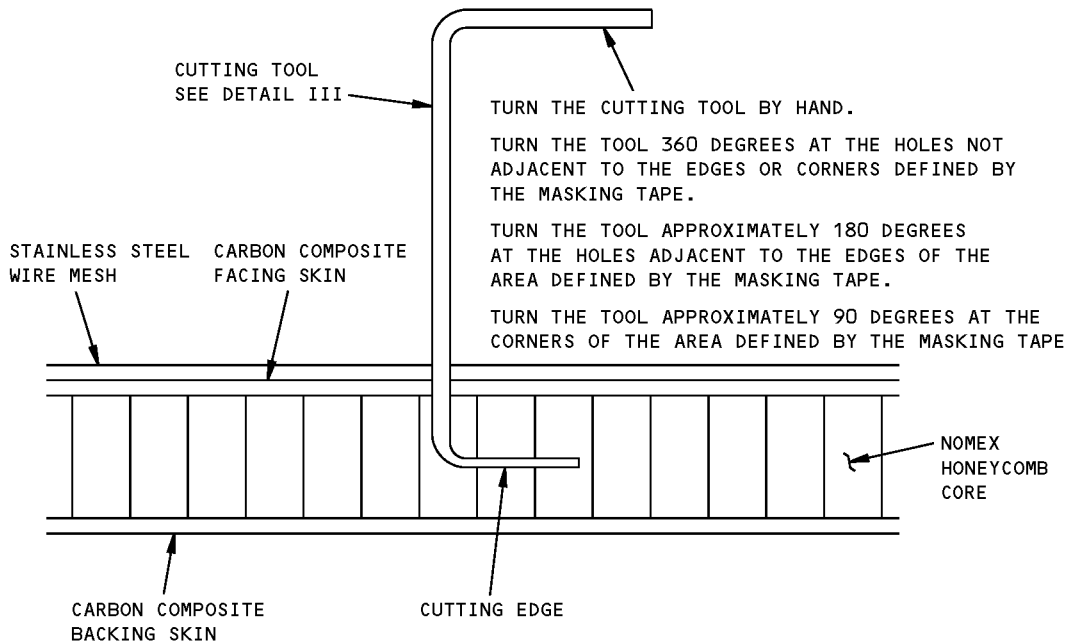
DETAIL II

Intake Acoustic Liner - Repair for Disbonded Honeycomb Core - RB211-535E4 and RB211- 535E4B Engine
Figure 201 (Sheet 3 of 4)

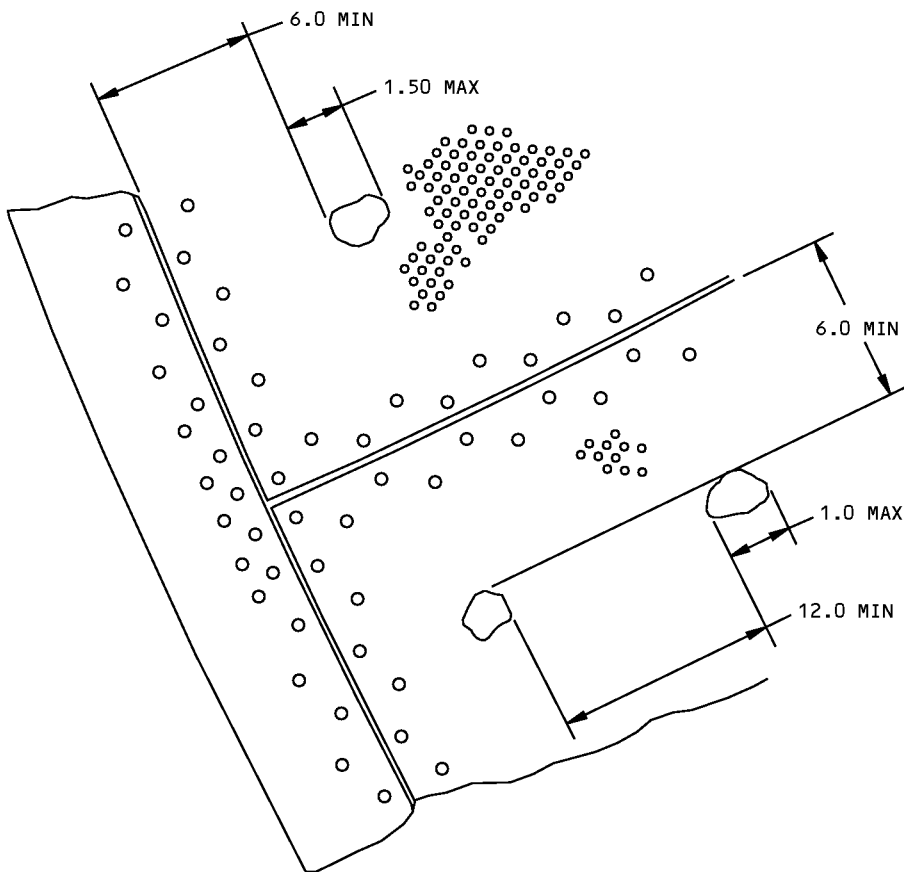
**Inlet Cowl - Repair to Local Damage of Acoustic Linings - RB211-535C Engine
Figure 201 (Sheet 1 of 2)**

VIEW ON COWLING ASSEMBLY, SHOWING ACOUSTIC LINING

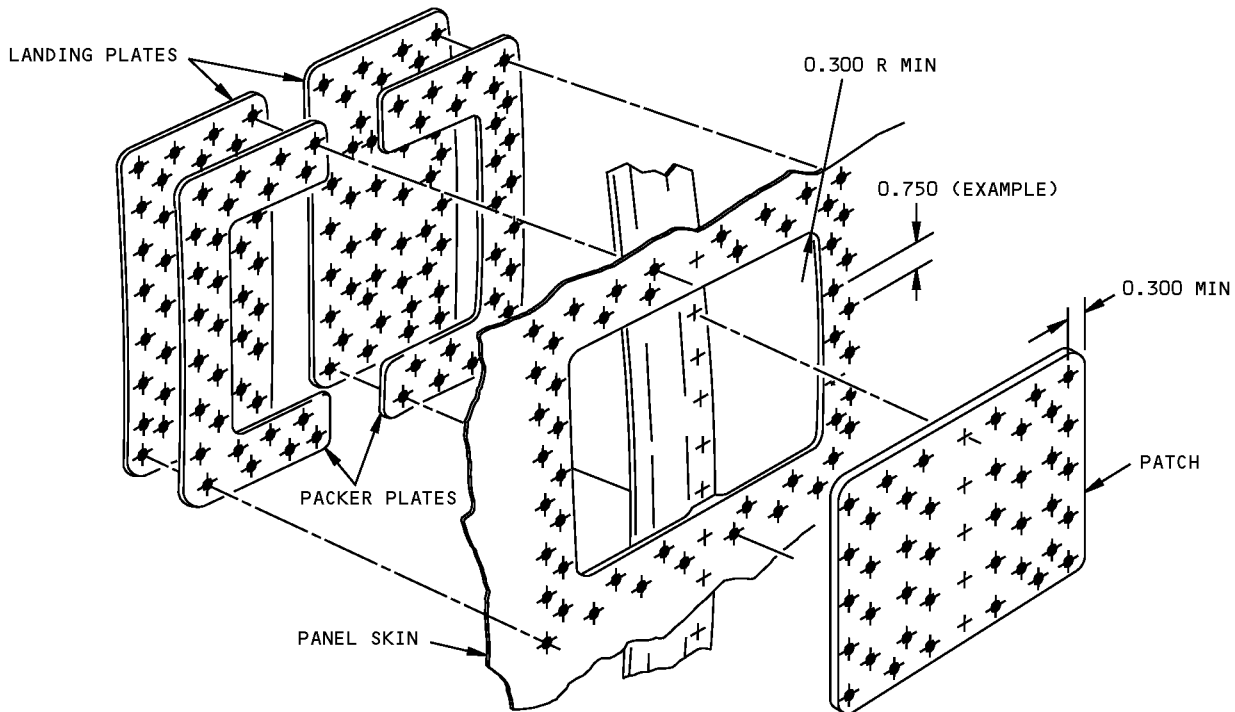
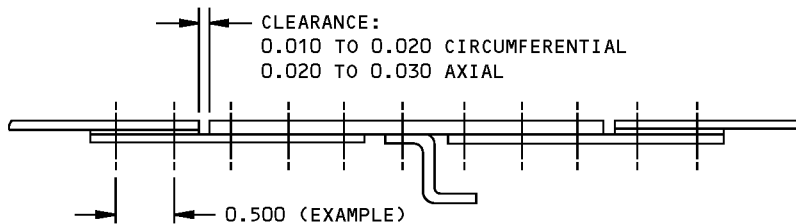
A3605

**Inlet Cowl Outer Skin Repair - Permanent Patch Adjacent to Stiffener - RB211-535C Engine
Figure 201 (Sheet 1 of 2)**

SECTION THROUGH INLET COWLING ASSEMBLY SHOWING EXAMPLE REPAIR

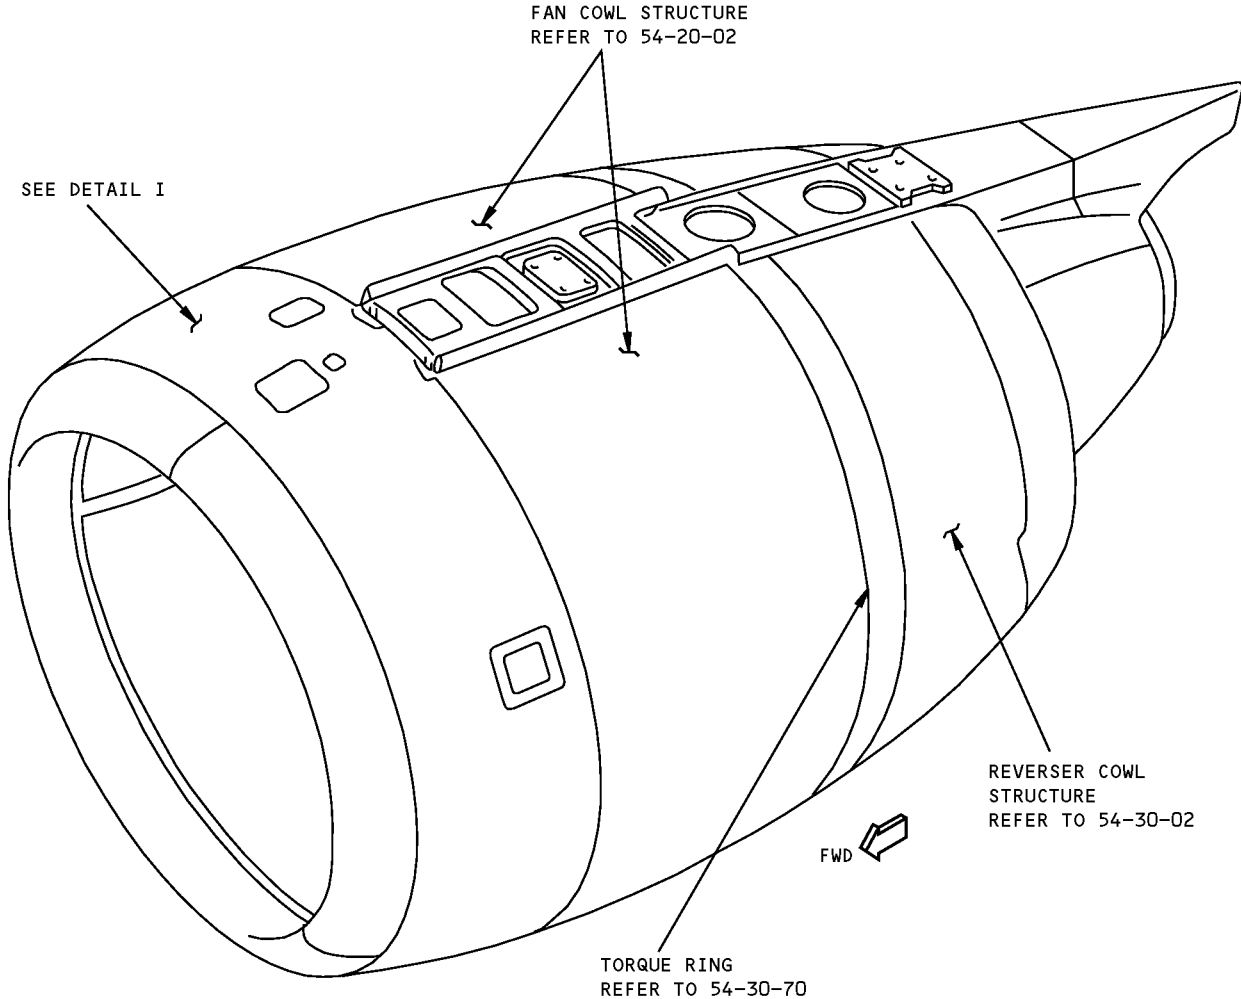
ALLOWABLE DAMAGE 2 - INLET COWL STRUCTURE - RB211-535C ENGINE

Allowable Damage - Inlet Cowl Structure - RB211-535C Engine
Figure 101 (Sheet 1 of 5)

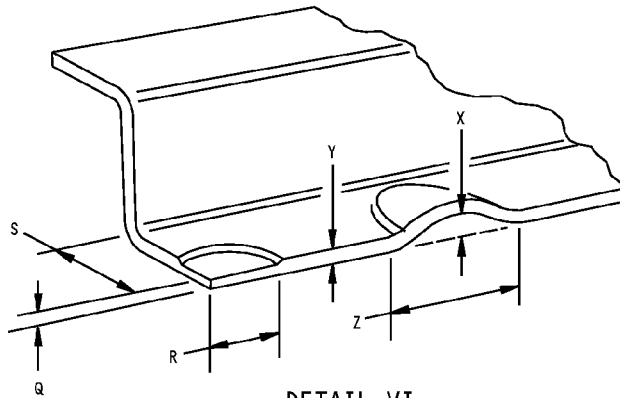
DETAIL VI

Allowable Damage - Inlet Cowl Structure - RB211-535C Engine
Figure 101 (Sheet 4 of 5)

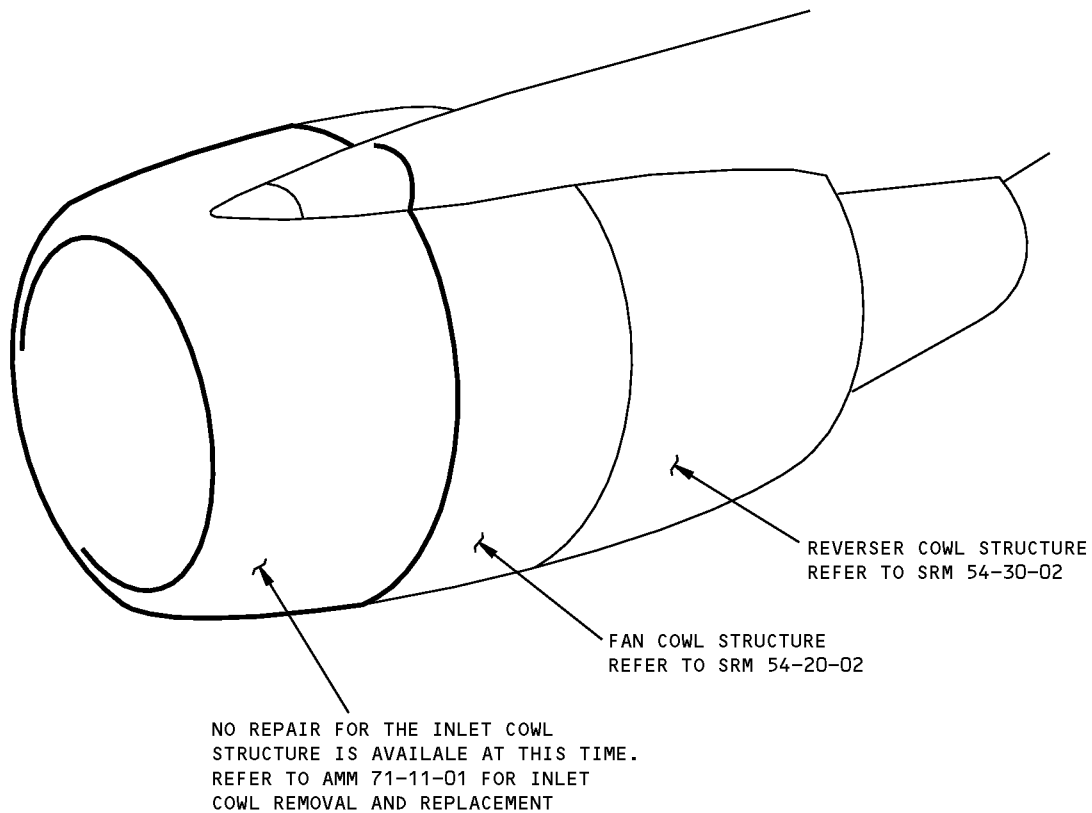
REPAIR 2 - INLET COWL STRUCTURE - RB211-535C ENGINE

Inlet Cowl Structure - RB211-535C Engine
Figure 201
