**NACELLES AND
PYLONS**

**757-200
STRUCTURAL REPAIR MANUAL**

**CHAPTER 54
NACELLES AND PYLONS**

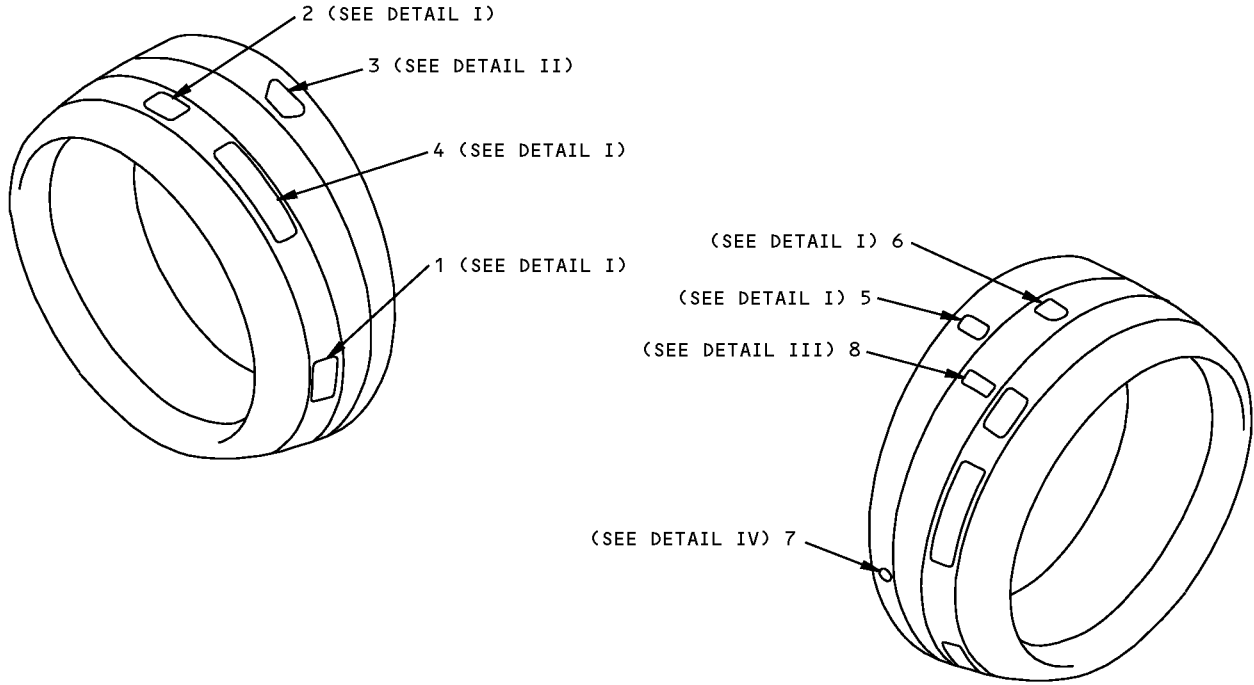
DETAIL I

TYPICAL ACCESS PANEL SURROUND
STRUCTURE FOR ITEMS 1, 2, 4, 5, AND 6 **A**

**Inlet Cowl Door and Access Panel Surround Structure Identification - RB211-535E4 Engine
Figure 1 (Sheet 1 of 2)**

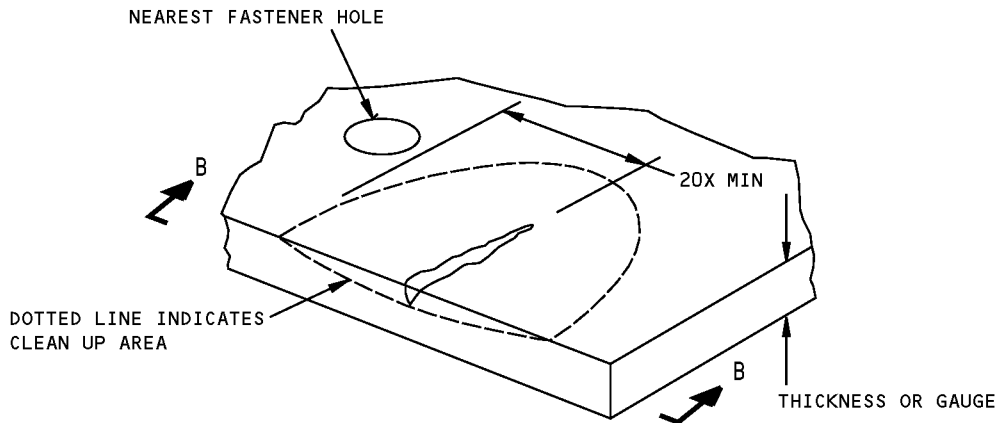
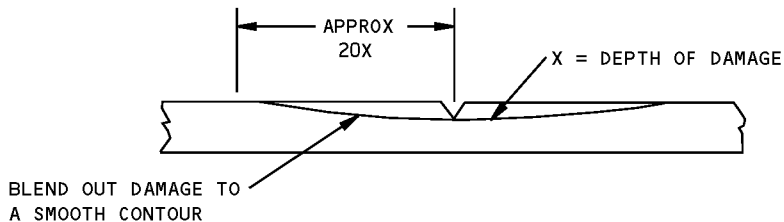
SECTION B-B

Allowable Damage - Door Surround Structure, Nose Cowl - RB211-535C Engine
Figure 101 (Sheet 2 of 3)

- REFINISH REWORKED AREAS AS SHOWN IN SRM 51-21-01
- A** DAMAGE IS PERMITTED UP TO 4% OF MATERIAL THICKNESS AND 2.00 INCHES (50 mm) LONG. REMOVE DAMAGE AS SHOWN IN DETAIL I
- B** SMOOTH DENTS ARE PERMITTED PROVIDING "V" (DETAIL II) DOES NOT EXCEED 0.10 INCH (2.5 mm), AREA OF DAMAGE "W" DOES NOT EXCEED 2.00 INCHES (50 mm) DIAMETER, AND THERE IS A MINIMUM OF 4.00 INCHES (100 mm) SEPARATING EACH DAMAGED AREA

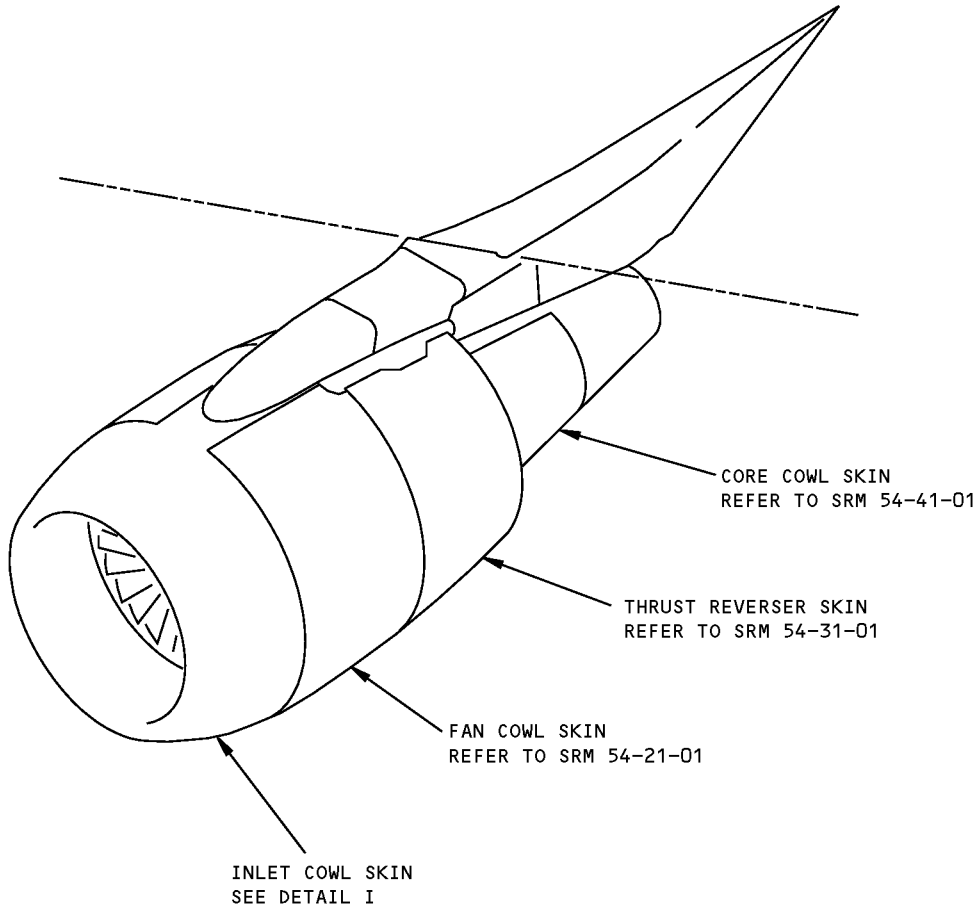
Inlet Cowl Skin Identification - PW2000 Engine
Figure 1 (Sheet 1 of 4)

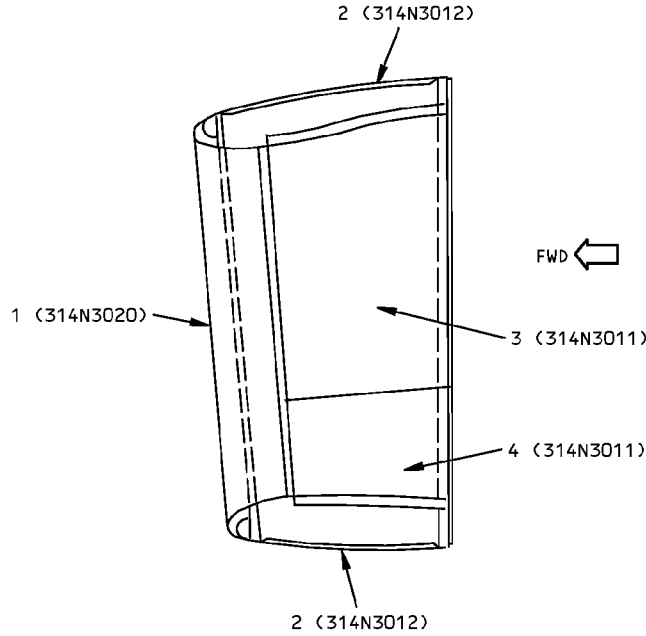
SECTION THRU COWL
DETAIL II

**Inlet Cowl Skin Identification - PW2000 Engine
Figure 1 (Sheet 3 of 4)**

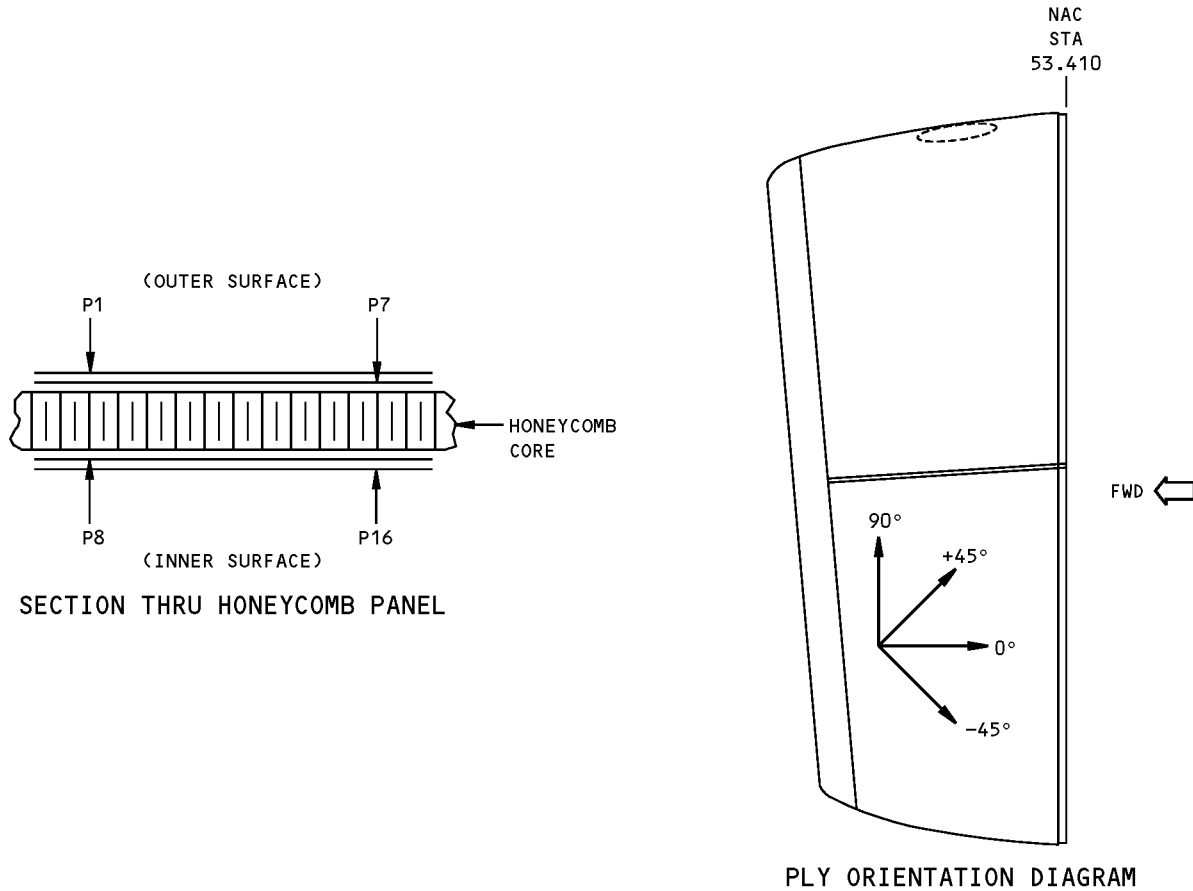
ITEM NO.	PLY NO.	MATERIAL	PLY ORIENTATION ^[A]
2	P1,P16	[C]	0°
	P7,P8	[D]	± 45°

PLY TABLE ^[B]
DETAIL III

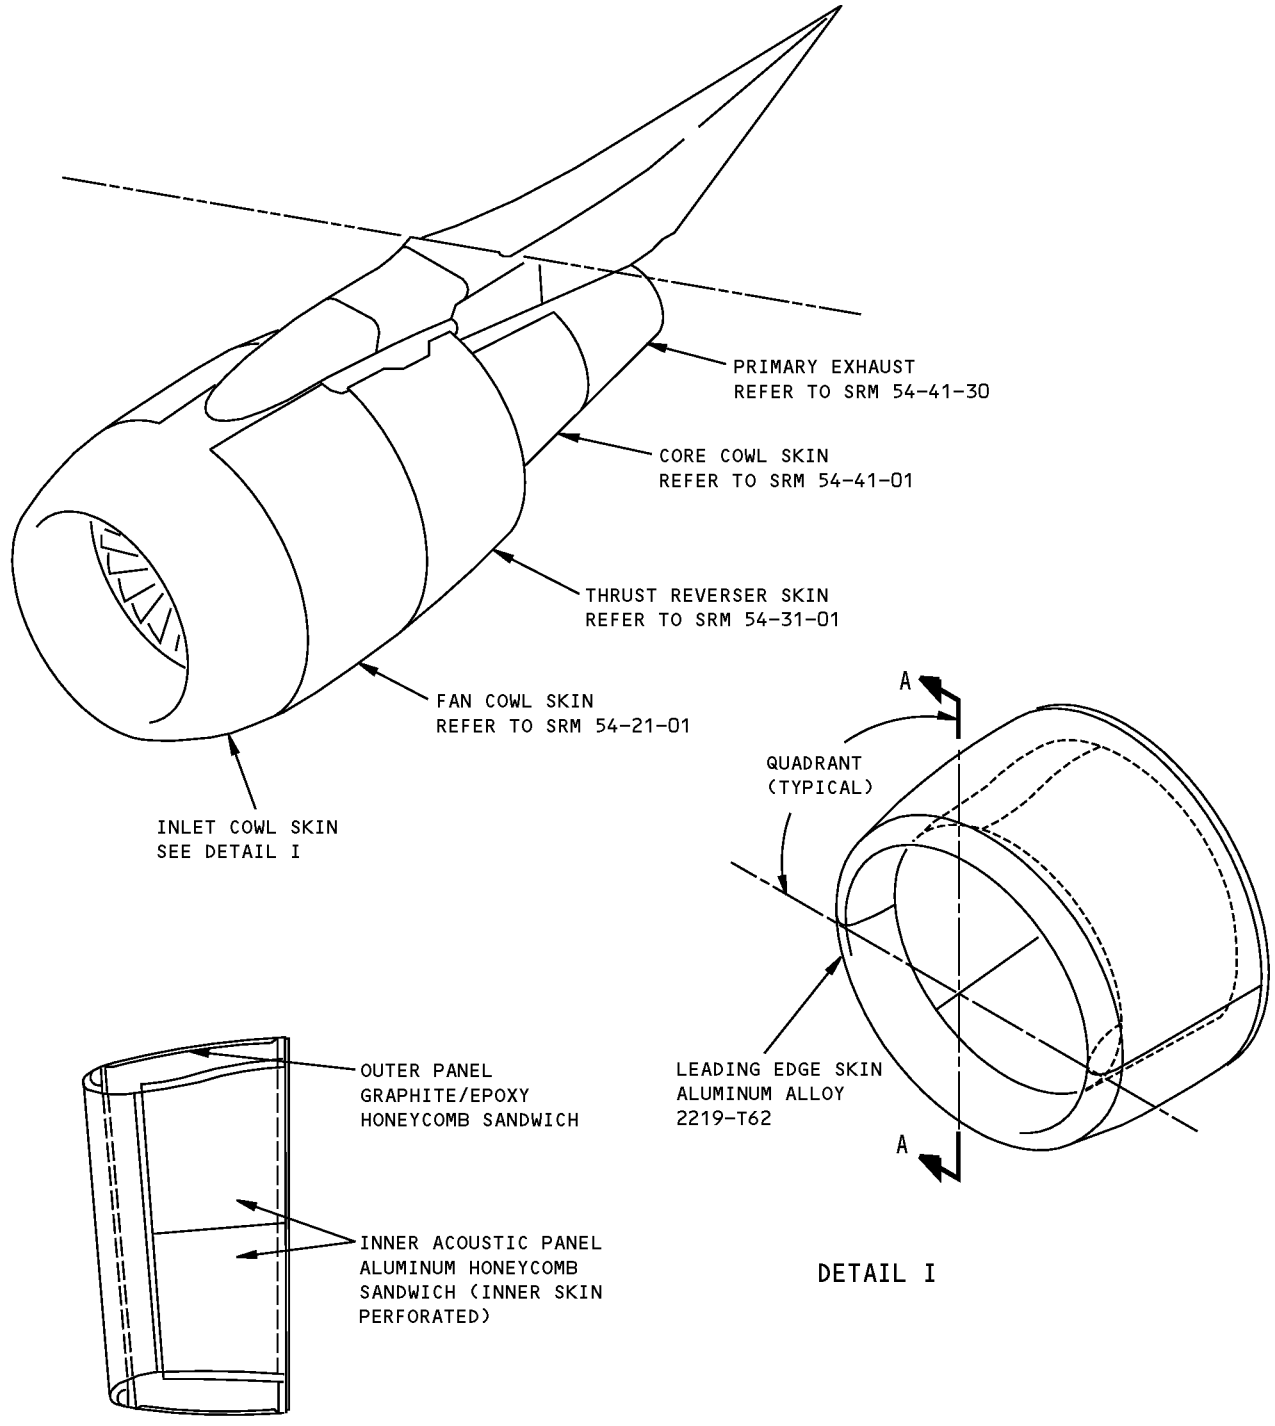
**Inlet Cowl Skin Allowable Damage - PW2000 Engine
Figure 101 (Sheet 1 of 6)**

DESCRIPTION	CRACKS	NICKS, GOUGES, CORROSION, AND SCRATCHES	DENTS	HOLES AND PUNCTURES	PANEL DELAMINATION
LEADING EDGE SKIN	A	B	J	C	--
OUTER PANEL	F	G	H	I	E
INNER PANEL—PERFORATED FACESHEET, SOLID BACK-FACE	A	B	J	NOT PERMITTED	K

- J** MAXIMUM OF TWO DENTS ARE PERMITTED FOR EACH QUADRANT (SEE DETAIL I), WITH NO LESS THAN 15.0 INCHES (380 mm) BETWEEN DENTS. SEE DETAIL IV
- K** SEE DETAIL VIII FOR DELAMINATION (DISBONDING) OF PERFORATED FACESHEET. SEE DETAIL IX FOR SOLID BACKFACE. DAMAGE NOT EXCEEDING THESE LIMITS ARE ALLOWED, PROVIDING THAT PANELS ARE INSPECTED EVERY 300 FLIGHT HOURS UNTIL PANEL IS REPAIRED OR REPLACED

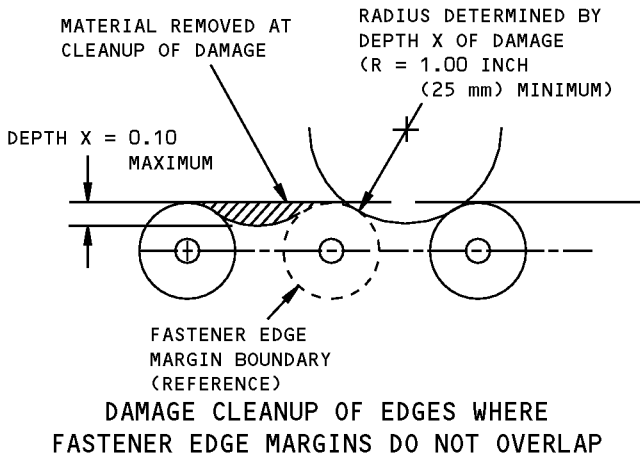
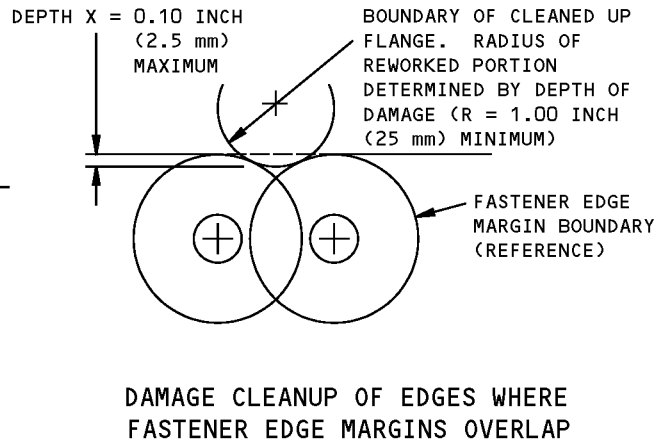
DETAIL II

Inlet Cowl Skin Allowable Damage - PW2000 Engine
Figure 101 (Sheet 3 of 6)

- A** CRACKS ARE NOT PERMITTED EXCEPT FOR EDGE CRACKS, WHICH MUST BE REMOVED AS SHOWN IN DETAILS II AND VI.
- B** REMOVE DAMAGE AS SHOWN IN DETAILS II, III, AND V.
- C** CLEAN PUNCTURES UP TO 0.25 INCH (6.3 mm) DIAMETER MAXIMUM. HOLES ALLOWED UP TO 0.25 INCH (6.3 mm) DIAMETER, NOT CLOSER THAN 4D TO ANY ADJACENT HOLE. HOLE IS TO BE FILLED WITH A NAS 1399D BLIND RIVET FOR HOLE UP TO 0.16 INCH (4.0 mm) DIAMETER AND NAS 1398D BLIND RIVET FOR HOLE 0.19 TO 0.25 INCH (4.8 TO 6.3 mm) DIAMETER, INSTALLED WET WITH BAC5710, TYPE 51 (DESOTO HI-TEMP) PRIMER. OTHER HOLES TO BE REPAIRED

F CRACKS IN FASTENER HOLES ALONG LONGITUDINAL SPLICE PERMITTED AS SHOWN IN DETAIL VII **D**. FOR DAMAGE OTHER THAN LONGITUDINAL SPLICE: CLEAN UP EDGE CRACKS AS SHOWN IN DETAILS II AND VI. NOT MORE THAN ONE FASTENER HOLE IN SIX MAY BE CRACKED OR DAMAGED. DAMAGE IS NOT MORE THAN 2 PERCENT OF EDGE BAND LENGTH. 0.50 INCH (12.7 mm) MAXIMUM DIMENSION IN EDGE BAND AND 2.00 INCHES (50 mm) MAXIMUM DIMENSION (D) IN HONEYCOMB AREA IS PERMITTED FOR EACH SQUARE FOOT (930 SQUARE cm) OF AREA AND A MINIMUM OF 3D (EDGE TO EDGE) FROM ANY OTHER DAMAGE, FASTENER HOLE OR PANEL EDGE. **D**

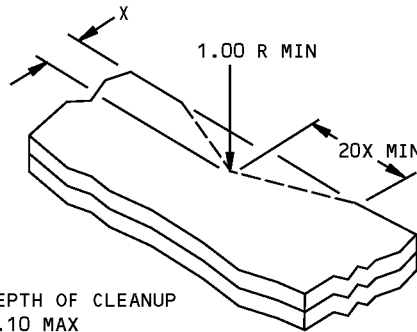
DETAIL VI

**Inlet Cowl Skin Allowable Damage - PW2000 Engine
 Figure 101 (Sheet 4 of 6)**

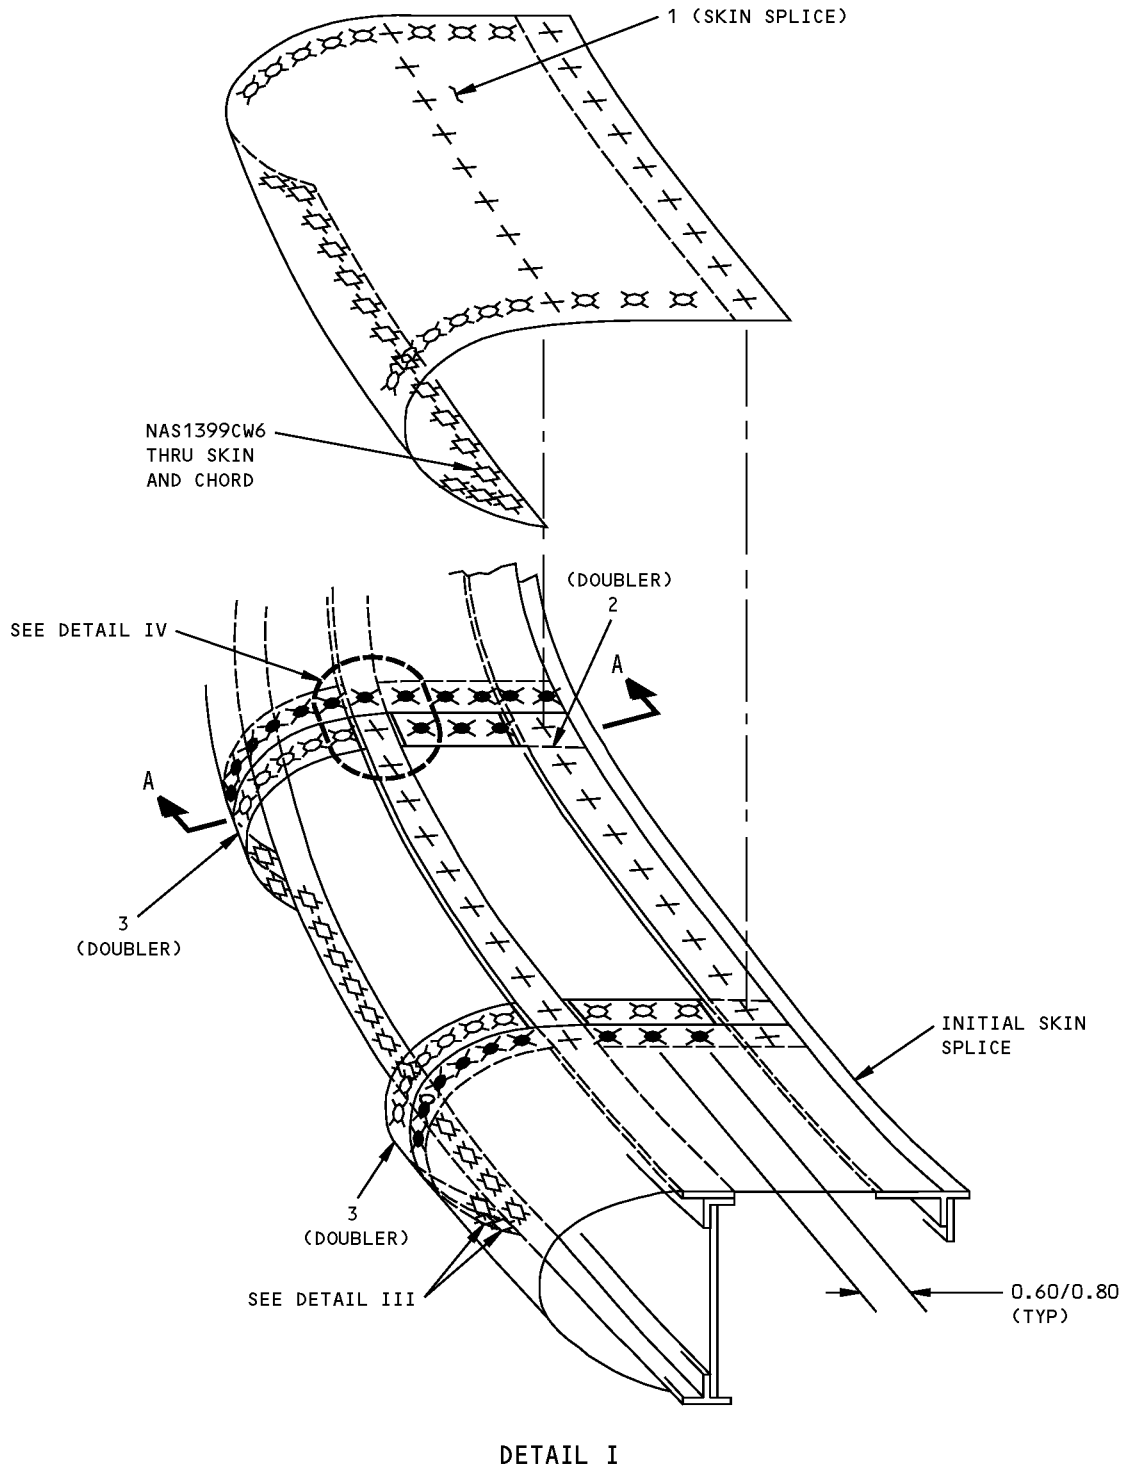
**Inlet Cowl - Leading Edge Skin Repair - PW2000 Engine
Figure 201 (Sheet 2 of 4)**

3. Make the repair parts. See Detail I thru IV and Table I.

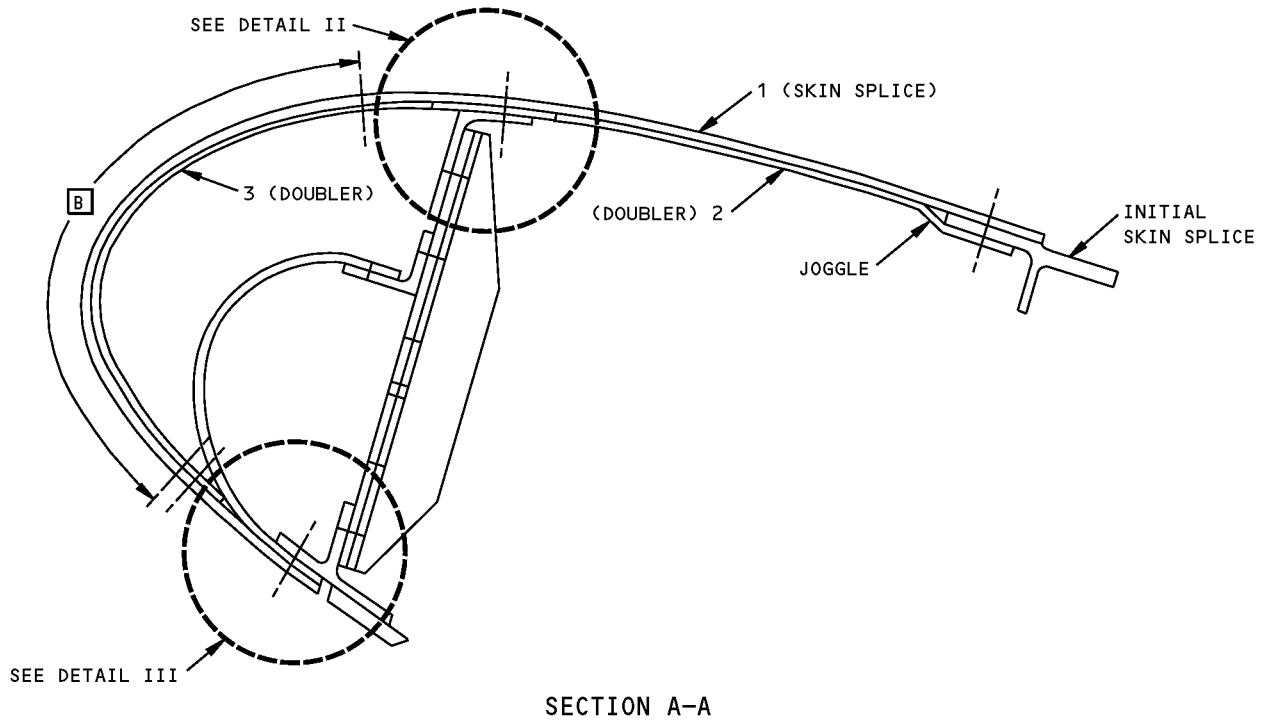
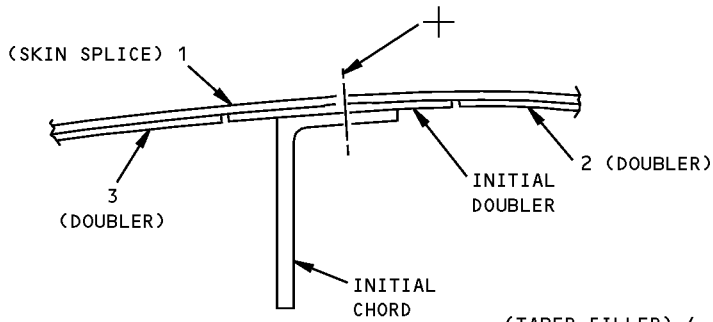
DETAIL II

**Inlet Cowl - Leading Edge Skin Repair - PW2000 Engine
Figure 201 (Sheet 3 of 4)**

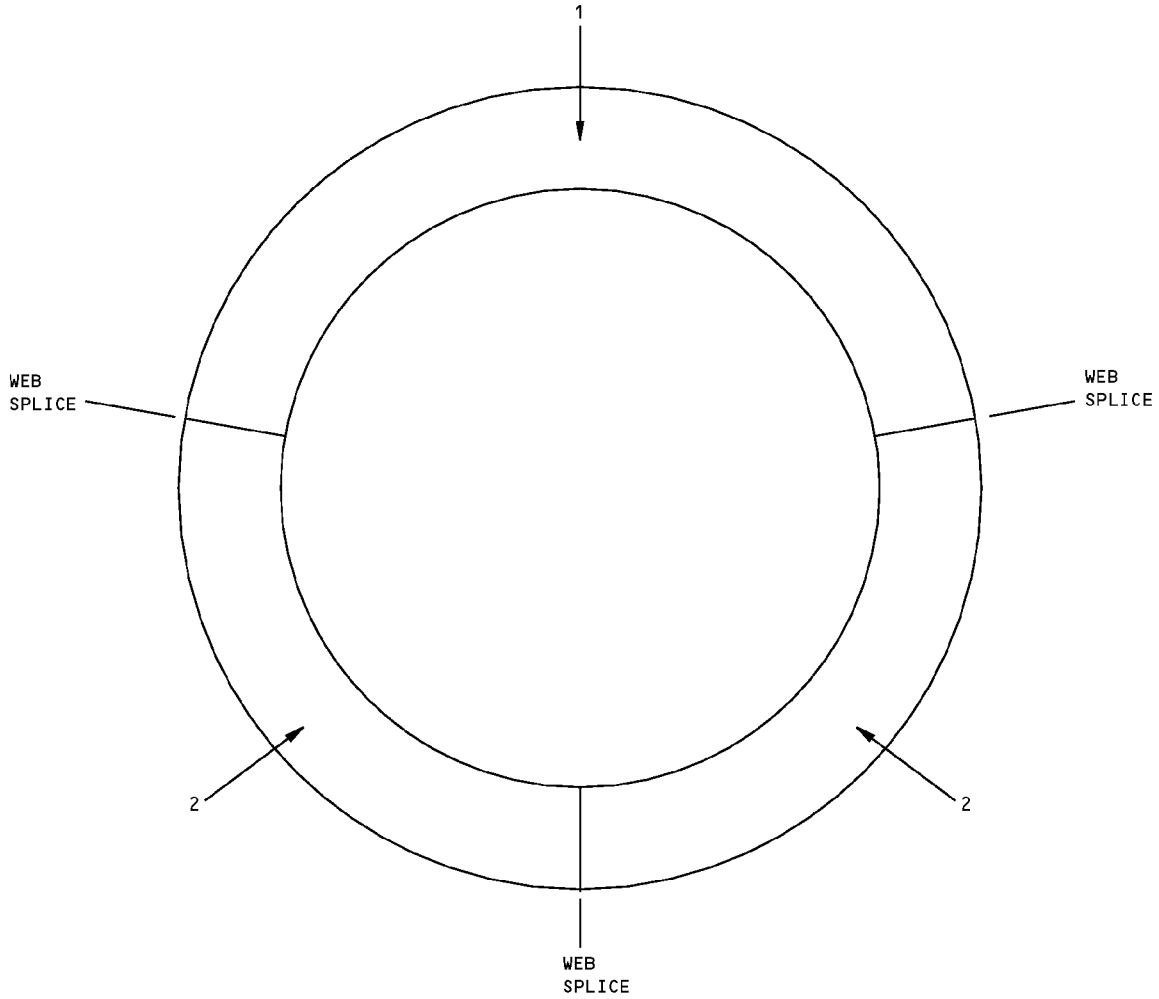
DETAIL II

ITEM	DESCRIPTION	GAGE	MATERIAL	EFFECTIVITY
1	WEB	0.100	CLAD 2024-T81	
2	WEB	0.125	CLAD 2024-T81

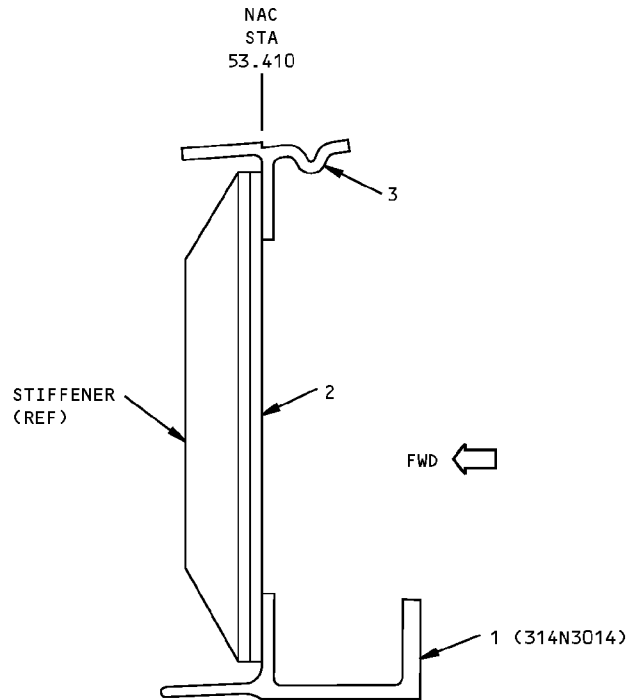
SECTION THRU AFT INLET COWL STRUCTURE
DETAIL III

ITEM	DESCRIPTION	GAGE	MATERIAL	EFFECTIVITY
1	INLET ATTACH RING		7075-T73 FORGED RING	
2	WEB	0.040	CHEM MILLED TI-6AL-4V	
3	CHORD		BAC1506-3551 2024-T42

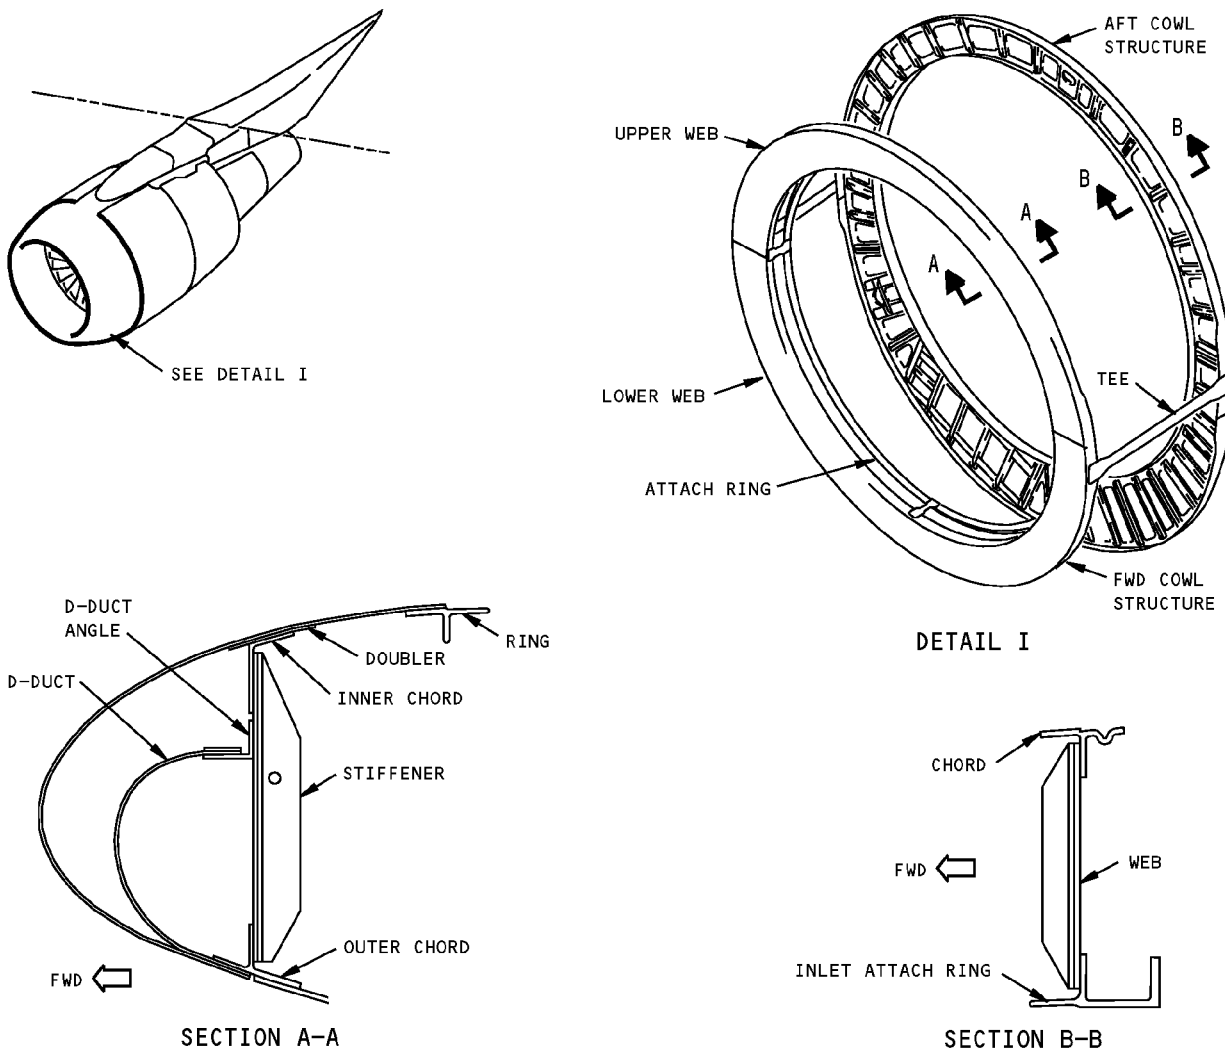
DESCRIPTION		CRACKS	NICKS, GOUGES AND CORROSION	DENTS	HOLES AND PUNCTURES
AFT COWL STRUCTURE	OUTER CHORD	A	B	NOT ALLOWED	NOT ALLOWED
	WEB	A	B	SEE DETAIL III	E
	INLET ATTACH RING F	C	D	NOT ALLOWED	NOT ALLOWED
TEE		A	B	NOT ALLOWED	E STEM ONLY
FWD COWL STRUCTURE	ATTACH RING	A	B	NOT ALLOWED	NOT ALLOWED
	OUTER CHORD	A	B	NOT ALLOWED	NOT ALLOWED
	D-DUCT	A	B	NOT ALLOWED	NOT ALLOWED
	D-DUCT ANGLE	A	B	NOT ALLOWED	NOT ALLOWED
	WEB	A	B	SEE DETAIL III	E

**Inlet Cowl Structure Allowable Damage - PW2000 Engine
Figure 101 (Sheet 1 of 3)**

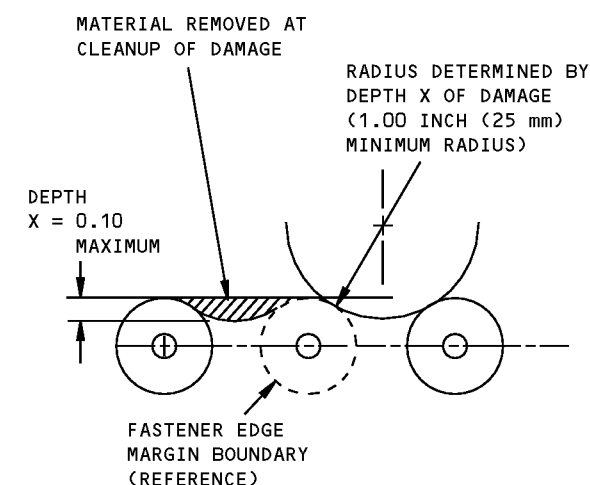
DETAIL II

DAMAGE CLEANUP OF EDGES WHERE FASTENER EDGE MARGINS DO NOT OVERLAP

DAMAGE CLEANUP OF EDGES WHERE FASTENER EDGE MARGINS OVERLAP

Inlet Cowl Structure Allowable Damage - PW2000 Engine
Figure 101 (Sheet 2 of 3)

- REFER TO AMM 51-20 TO REFINISH THE REWORKED AREAS
- REFER TO SRM 51-10-02 FOR INSPECTION AND REMOVAL OF DAMAGE.
- A** CRACKS ARE NOT PERMITTED EXCEPT FOR EDGE CRACKS WHICH MUST BE REMOVED AS SHOWN IN DETAILS II AND VI.
- B** REMOVE DAMAGE AS SHOWN IN DETAILS II, III AND V.
- C** CRACKS ARE NOT PERMITTED EXCEPT FOR EDGE CRACKS WHICH MUST BE REMOVED AS SHOWN IN DETAILS II AND VI.
- D** REMOVE DAMAGE AS SHOWN IN DETAILS II, III AND V.
- E** CLEAN OUT DAMAGE UP TO 0.25 INCH (6.3 mm) MAXIMUM DIAMETER AND NOT CLOSER THAN 1.0 INCH (25 mm) TO FASTENER HOLE OR OTHER DAMAGE. FILL HOLE WITH A 2117-T3 OR T4 ALUMINUM RIVET INSTALLED WET WITH BMS 5-63 SEALANT. ALL OTHER HOLES TO BE REPAIRED.
- F** REFER TO SRM 51-20-06 TO SHOT PEEN THE REWORKED AREAS.

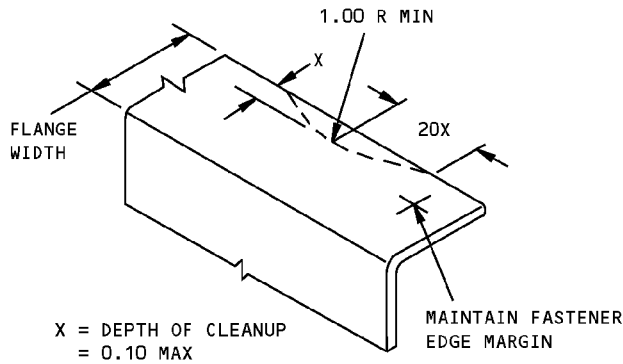
**REMOVAL OF NICK OR CRACK DAMAGE ON AN EDGE
DETAIL VI**

**Inlet Cowl Structure Allowable Damage - PW2000 Engine
Figure 101 (Sheet 3 of 3)**

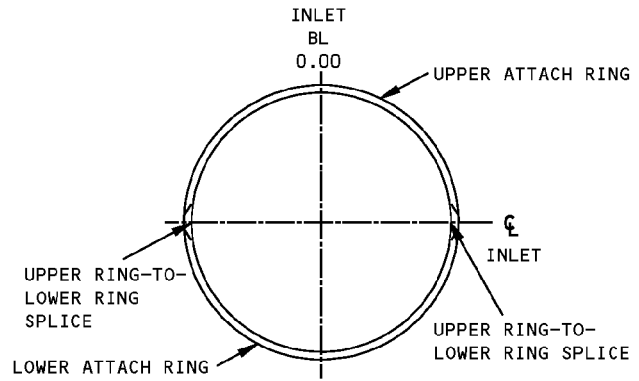
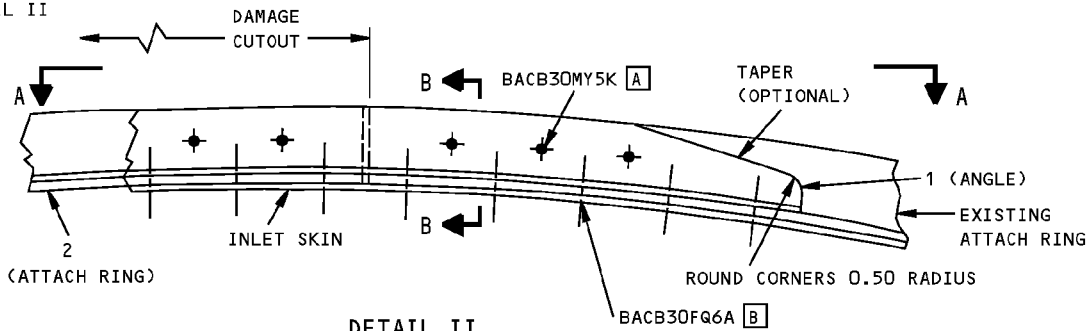
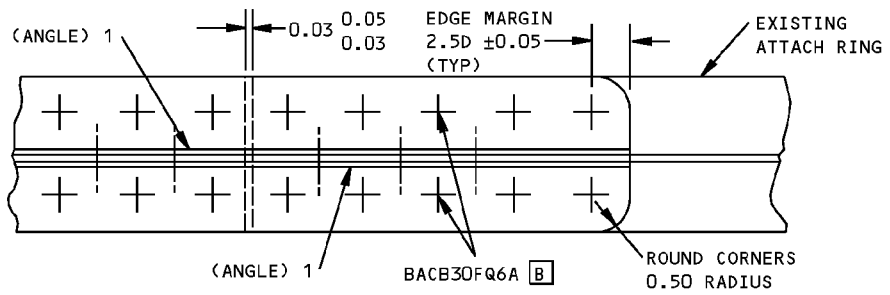
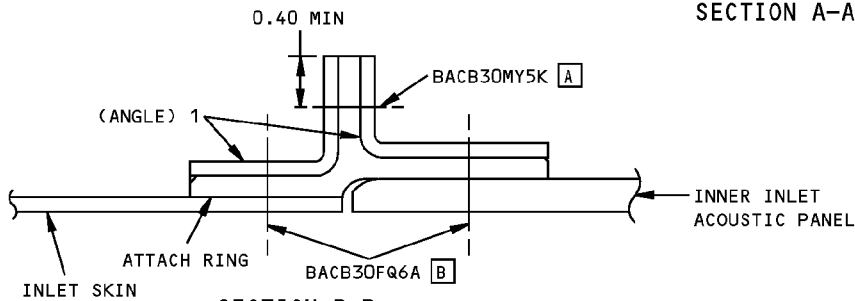
**Inlet Cowl Structure - Attach Ring Repair - PW2000 Engine
Figure 201 (Sheet 2 of 2)**

FOR SPLICE LOCATIONS
SEE DETAIL I
FOR ATTACH RING
SEE DETAIL II

DETAIL I

DETAIL II

SECTION A-A

SECTION B-B

APPLICABILITY
THIS REPAIR APPLIES TO PW2000 SERIES ENGINE INLET COWL UPPER AND LOWER ATTACH RING ONLY. THIS REPAIR DOES NOT APPLY TO THE UPPER AND LOWER RING SPLICE AREA (SEE DETAIL I).

1. Remove inlet lip skin and acoustic panel as required to gain access to the inlet attach ring. If skin is damaged, refer to SRM 54-11-01.
2. Cut out the damaged portion of attach ring. Center the cut between initial fastener locations.
3. Make repair parts using the repair material table.
4. Drill fastener holes by fitting parts together and using initial fastener locations in the inlet lip skin and the acoustic panel.
5. Remove all sharp edges, nicks, burrs, and scratches from initial and repair parts.
6. Alodize raw edges and initial surfaces and repair parts.
7. Apply one coat of BMS 10-11, type 1 primer to alodize surfaces of initial and repair parts.
8. Install repair parts and fasteners wet with BMS 5-79 or BMS 5-95.
9. Restore initial finish in accordance with AMM 51-21.

- A** 3 REQUIRED ON EACH SIDE OF REPAIR SPLICE. CENTER THESE REPAIR FASTENERS BETWEEN THE SKIN ATTACH FASTENER LOCATIONS. INSTALL WET WITH BMS 5-79 OR BMS 5-95. USE WITH BACC30M COLLAR.
- B** 5 REQUIRED ON EACH SIDE OF REPAIR SPLICE. USE INITIAL FASTENER LOCATIONS. INSTALL WET WITH BMS 5-79 OR BMS 5-95. USE WITH BACC30M COLLAR.
- C** THE OUTSIDE BEND RADIUS OF THE REPAIR ANGLE MUST BE LARGER THAN THE RADIUS OF THE NESTING PART. INSIDE BEND RADIUS OF REPAIR ANGLE MUST BE 0.12 INCH (3.0 mm) MINIMUM TO 0.16 INCH (4.0 mm) MAXIMUM.

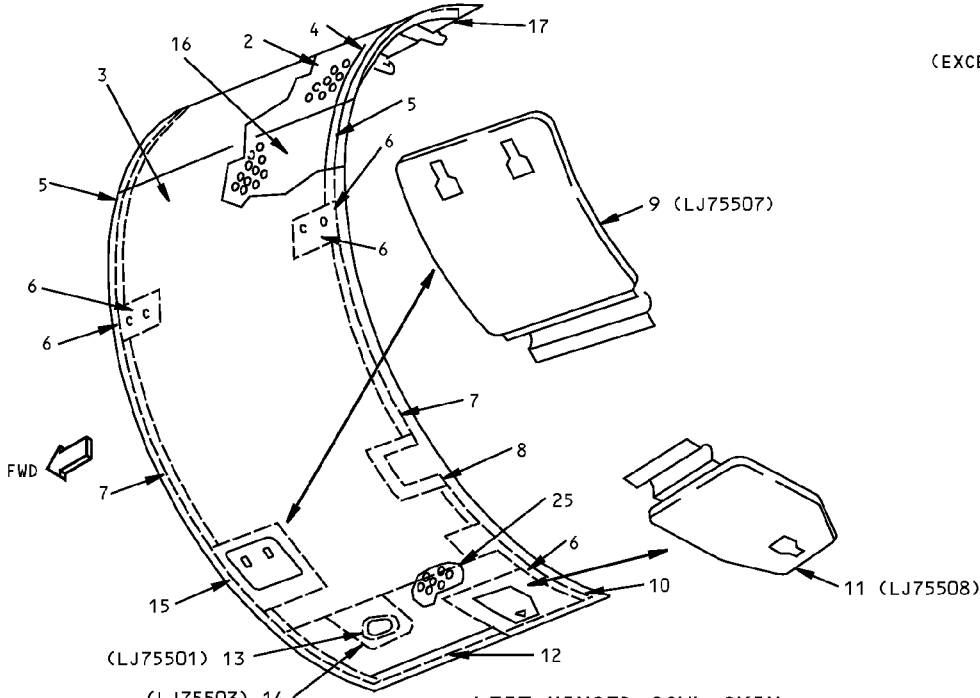
REF DWG
LJ75503
(EXCEPT AS NOTED)

**LEFT HINGED COWL SKIN
DETAIL I**

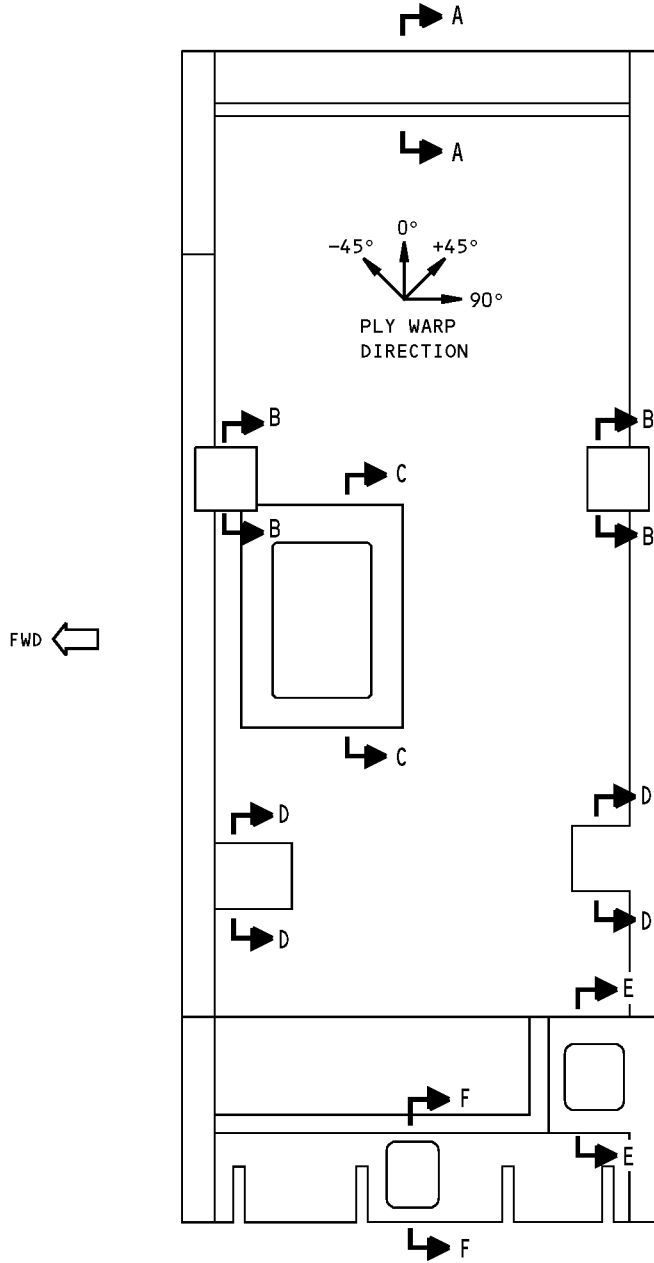
OUTER SKIN LOOKING INBOARD
DETAIL III

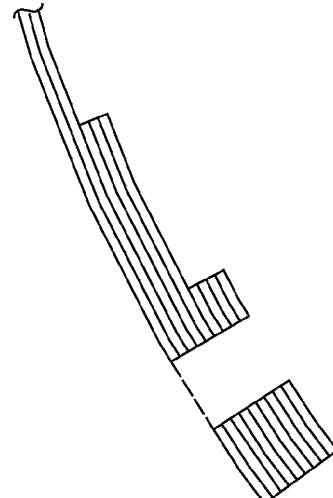
SECTION A-A

SECTION B-B

SECTION D-D

SECTION E-E

SECTION F-F

ITEM	GAGE	MATERIAL	WARP DIRECTION
SKIN PANEL			
6	0.014	GRAPHITE FABRIC A370-5H/3501-5A	0°

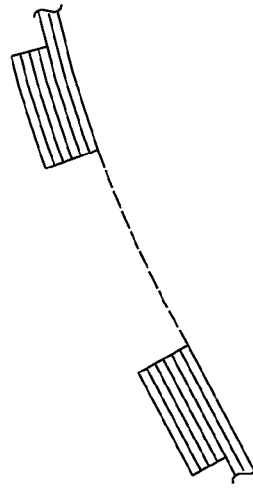
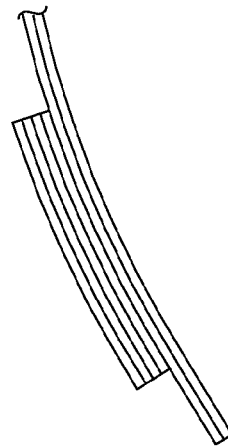
SECTION K-K

SECTION L-L

SECTION M-M

SECTION N-N

ITEM	GAGE	MATERIAL	WARP DIRECTION
SKIN PANEL			
6	0.014	GRAPHITE FABRIC A370-5H/3501-5A	0°

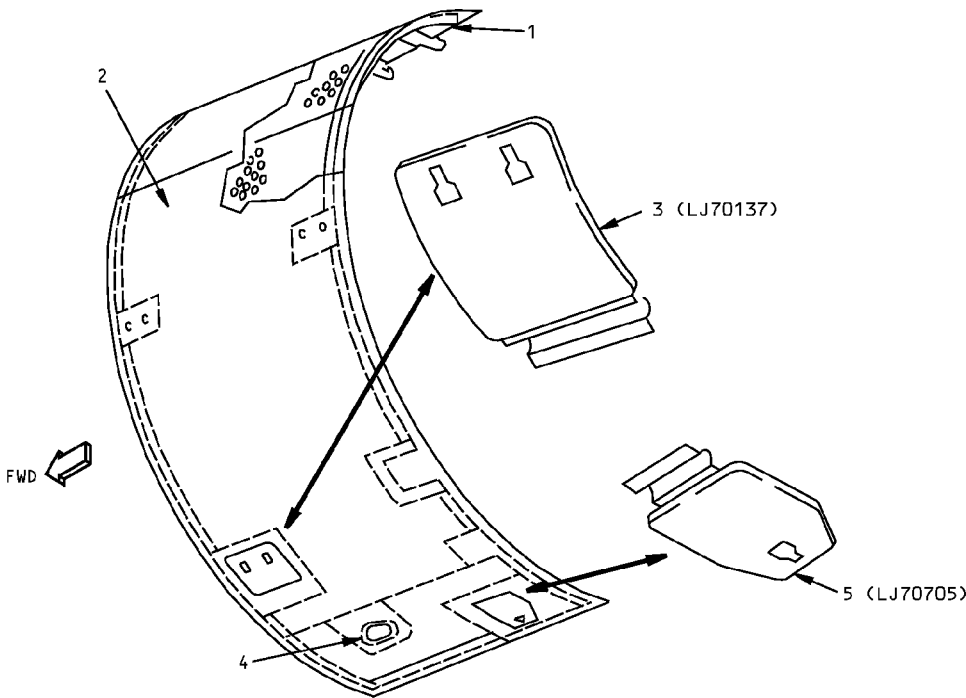
REF DWG
LJ71465
(EXCEPT AS NOTED)

LEFT HINGED COWL SKIN
DETAIL I

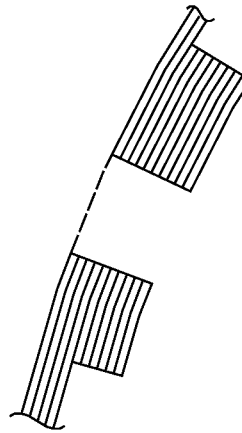
SECTION L-L

ITEM	GAGE	MATERIAL	WARP DIRECTION
SKIN PANEL			
6	0.014	GRAPHITE FABRIC A370-5H/3501-5A	0°

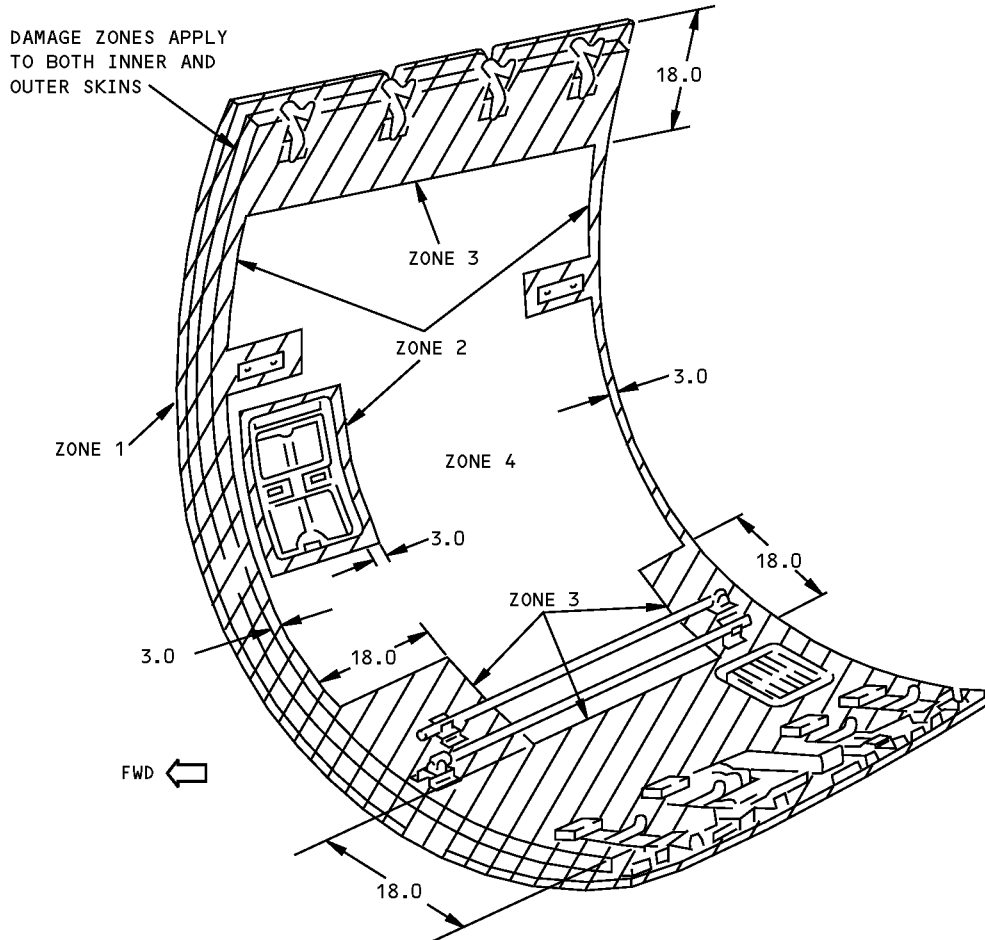
Fan Cowl Skin Allowable Damage - RB211-535 Engine
Figure 101 (Sheet 1 of 2)

ALLOWABLE DAMAGE 1 - FAN COWL SKIN - RB211-535 ENGINE

- (1) Apparent surface damage or surface imperfections that do not extend into graphite fibers.
- (2) Surface abrasion with a maximum depth of 0.005 inch to an area not greater than 28 sq. inches.
- (3) A maximum of two cuts at a minimum spacing of 10 inches not more than 15 inches in length and 0.005 inch in depth.
- (4) A maximum of two holes at a minimum spacing of 10 inches and 1 inch maximum diameter that pierce the graphite composite skin through to the honeycomb core.

NOTE: The hole or holes must be temporarily covered with aluminum foil tape (Speed Tape) 3M-436 or equivalent. After a maximum of 25 hours, the damaged area must be repaired.

CAUTION: ANY PENETRATION OF INNER OR OUTER SKIN IN FIREPROOF ZONE MUST BE REPAIRED PRIOR TO RETURNING PANEL TO FLIGHT STATUS

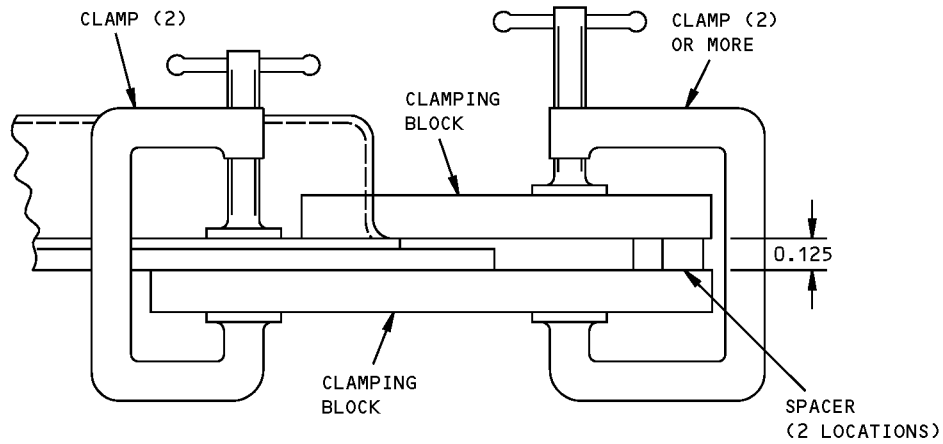
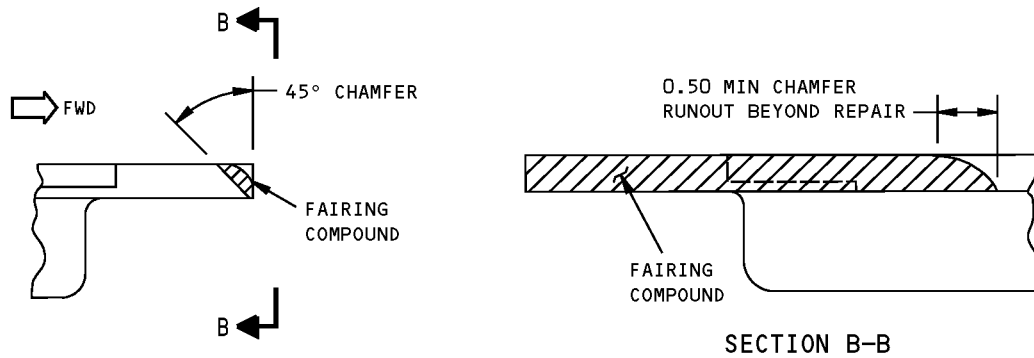
Fan Cowl - Repair to Corners - Erosion and Impact Damage - RB211-535 Engine
Figure 201 (Sheet 5 of 5)

CLAMPUP CONFIGURATION DURING CURE
DETAIL IV

FORWARD CORNERS ONLY
DETAIL V

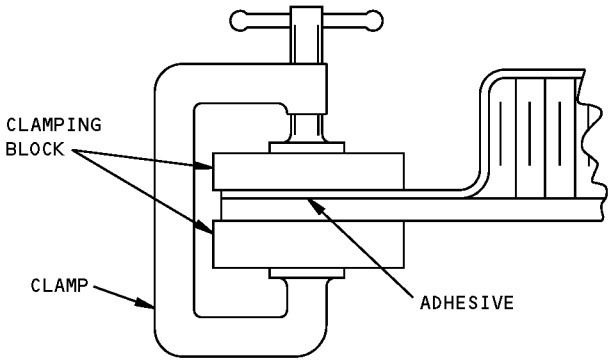
**Fan Cowl - Repair to Corners - Delamination Damage - RB211-535 Engine
Figure 201 (Sheet 1 of 2)**

SECTION A-A

TYPICAL ALL CORNERS
MAXIMUM EXTENT OF REPAIRABLE DELAMINATION
DETAIL I

CLAMPUP CONFIGURATION
DURING DELAMINATION CURE
DETAIL II

APPLICABILITY
THIS REPAIR IS FOR DELAMINATION ON FAN COWL CORNERS. THE DAMAGE MUST NOT EXCEED THE LIMITS SHOWN IN DETAIL I.

3. Position clamping blocks (0.190 ins thick aluminum plate) and secure. See Detail II.
4. Cure adhesive for 2 hrs while applying heat and pressure at 65-120°C (150-250°F). Use heater lamps (explosion proof).
5. Remove clamping blocks.
6. **WARNING:** SANDING OR CUTTING OF COMPOSITE MATERIALS PRODUCES DUST AND FLYING PARTICLES WHICH ARE POTENTIAL HEALTH HAZARD. WEAR PROTECTIVE CLOTHING, GLOVES, DUST MASKS, AND SAFETY GLASSES. AVOID BREATHING OF DUST OR PROLONGED CONTACT OF DUST ON SKIN.

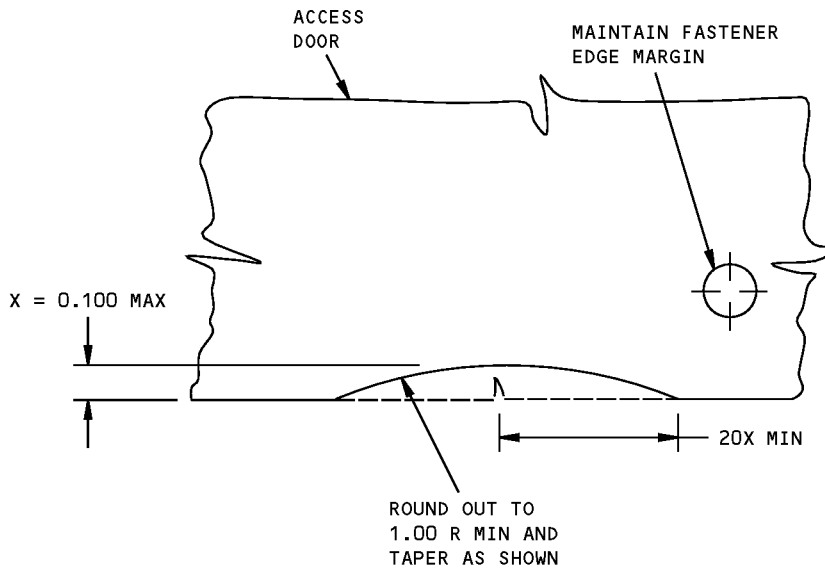
Fan Cowl - Repair of Access Panel - RB211-535 Engine
Figure 201 (Sheet 2 of 3)

DETAIL OF NICK OR CRACK REMOVED
DETAIL I

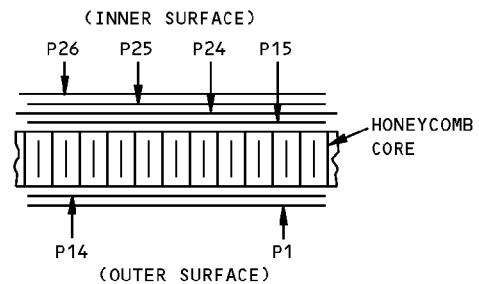
REF DWG
314N3111

LEFT COWL PANEL SHOWN
RIGHT PANEL SIMILAR

ITEM	DESCRIPTION	GAGE	MATERIAL	EFFECTIVITY
1	PANEL ASSY SKIN CORE		SEE PLY TABLE FOR MATERIAL NONMETALLIC HONEYCOMB PER BMS 8-124, CLASS IV, TYPE I, GRADE 4.0

SECTION THRU HONEYCOMB PANEL

DETAIL I

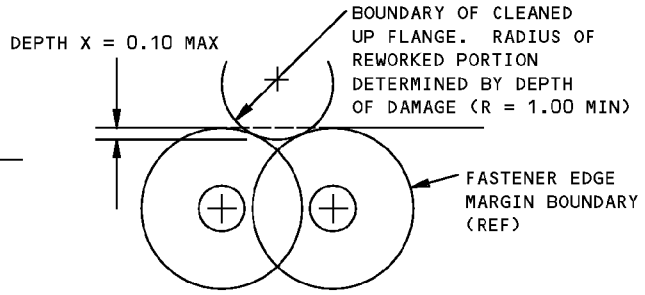
DETAIL I

DAMAGE CLEANUP OF EDGES WHERE FASTENER EDGE MARGINS DO NOT OVERLAP

DAMAGE CLEANUP OF EDGES WHERE FASTENER EDGE MARGINS OVERLAP

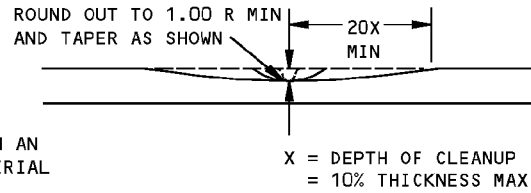
DETAIL II

SECTION A-A

REMOVAL OF NICK, GOUGE AND SCRATCH DAMAGE ON A SURFACE

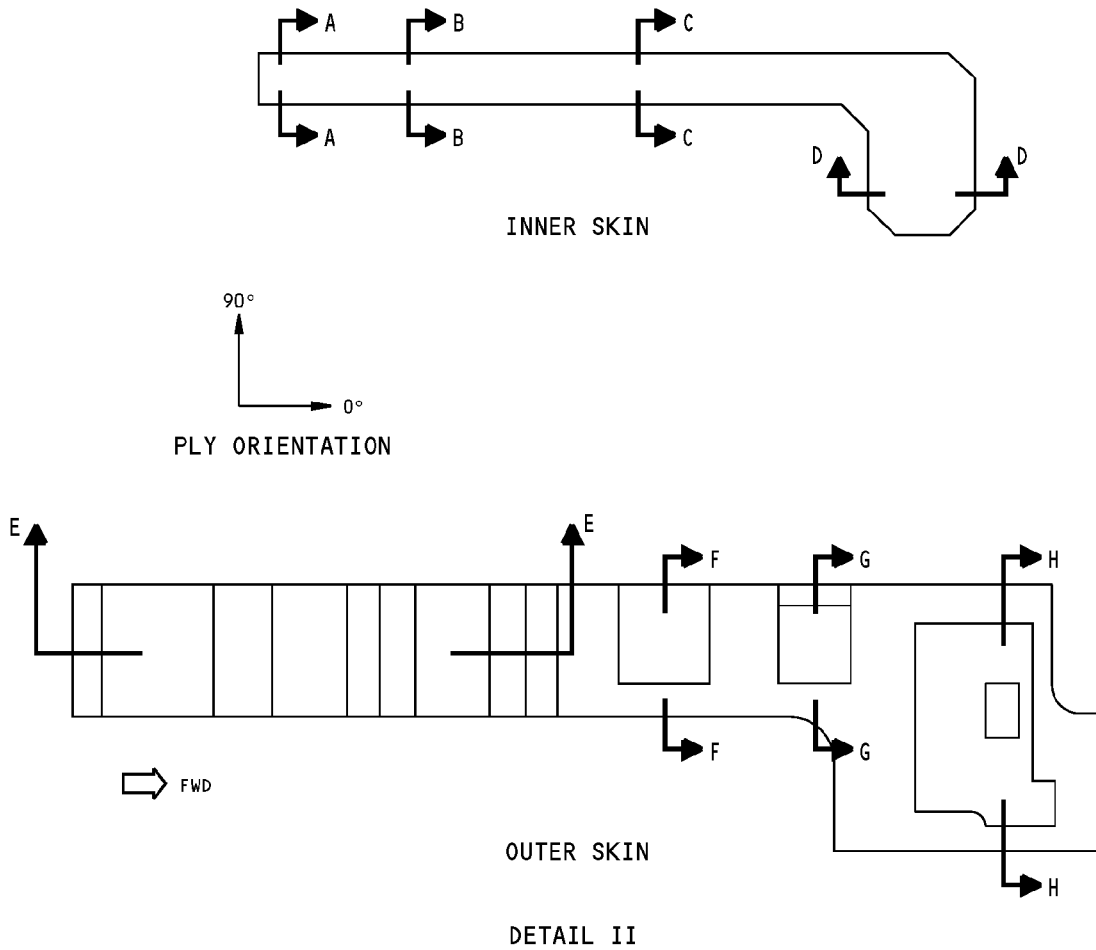
Reverser Cowl Hinge Access Door Identification - All RB211-535 Engines
Figure 1 (Sheet 3 of 5)

ITEM NO.	PLY NO.	MATERIAL	PLY ORIENTATION ^A
1	F1, F2, F3, F4, F5, F6, F7, F8, F9, F10, F11, F12, F13	^B	0°
	P2	^C	—
	T1, T2, T3, T4, T5, T6, T7, T8, T9, T10, T11, T12	^D	0° AND 90°

PLY TABLE FOR DETAIL II
