**NACELLES AND
PYLONS**

**757-200
STRUCTURAL REPAIR MANUAL**

**CHAPTER 54
NACELLES AND PYLONS**

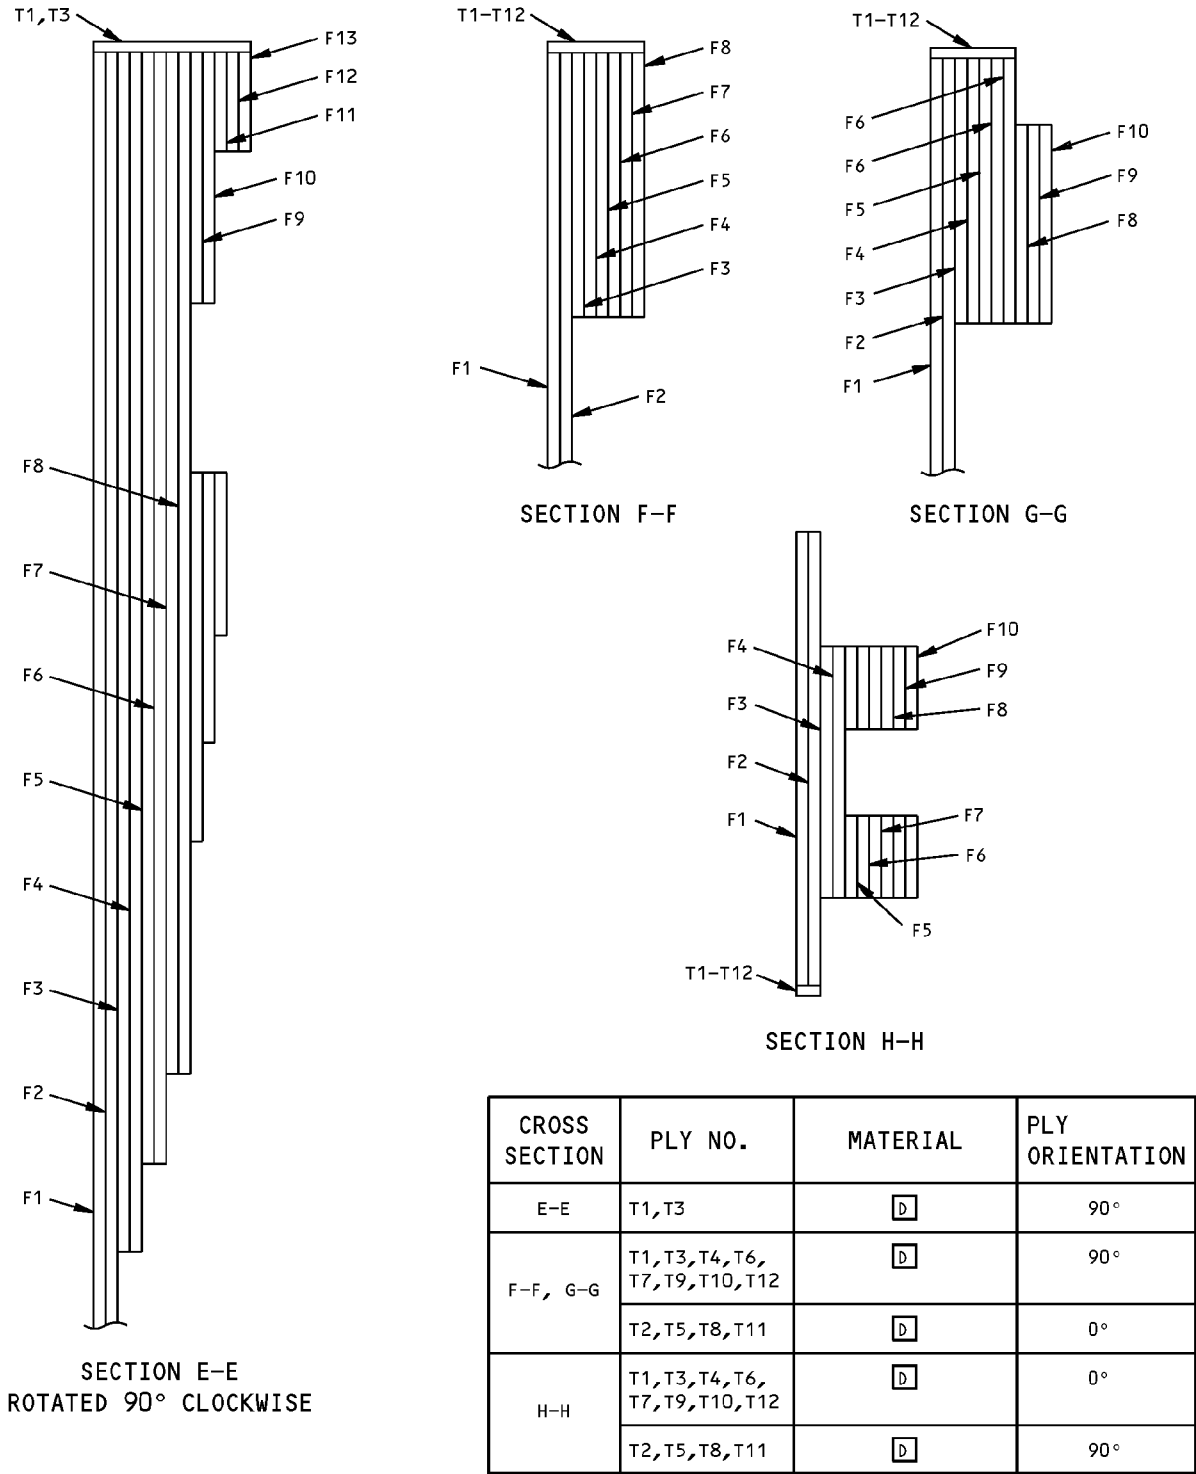
Reverser Cowl Hinge Access Door Identification - All RB211-535 Engines
Figure 1 (Sheet 5 of 5)

PLY TABLE FOR SECTIONAL VIEWS OF DETAIL II

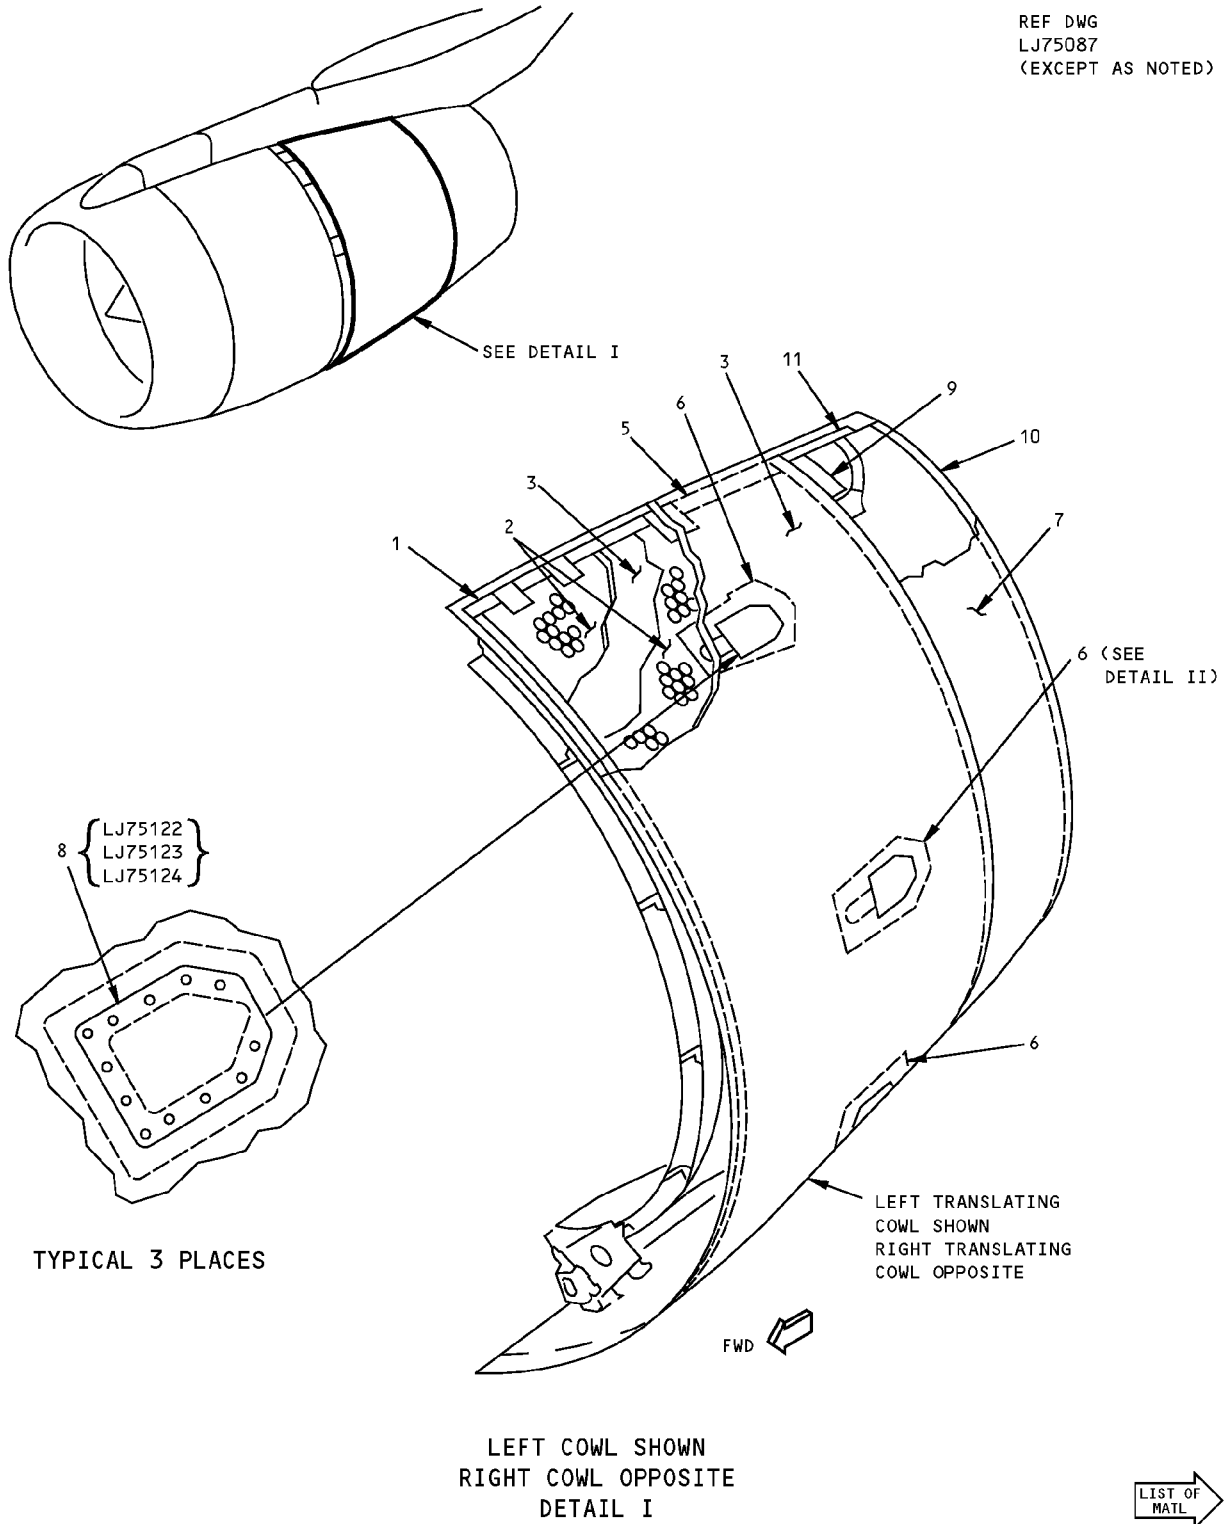
Reverser Cowl Skin Panel Identification - RB211-535E4 Engine
Figure 1 (Sheet 2 of 4)

REF DWG
LJ75087
(EXCEPT AS NOTED)

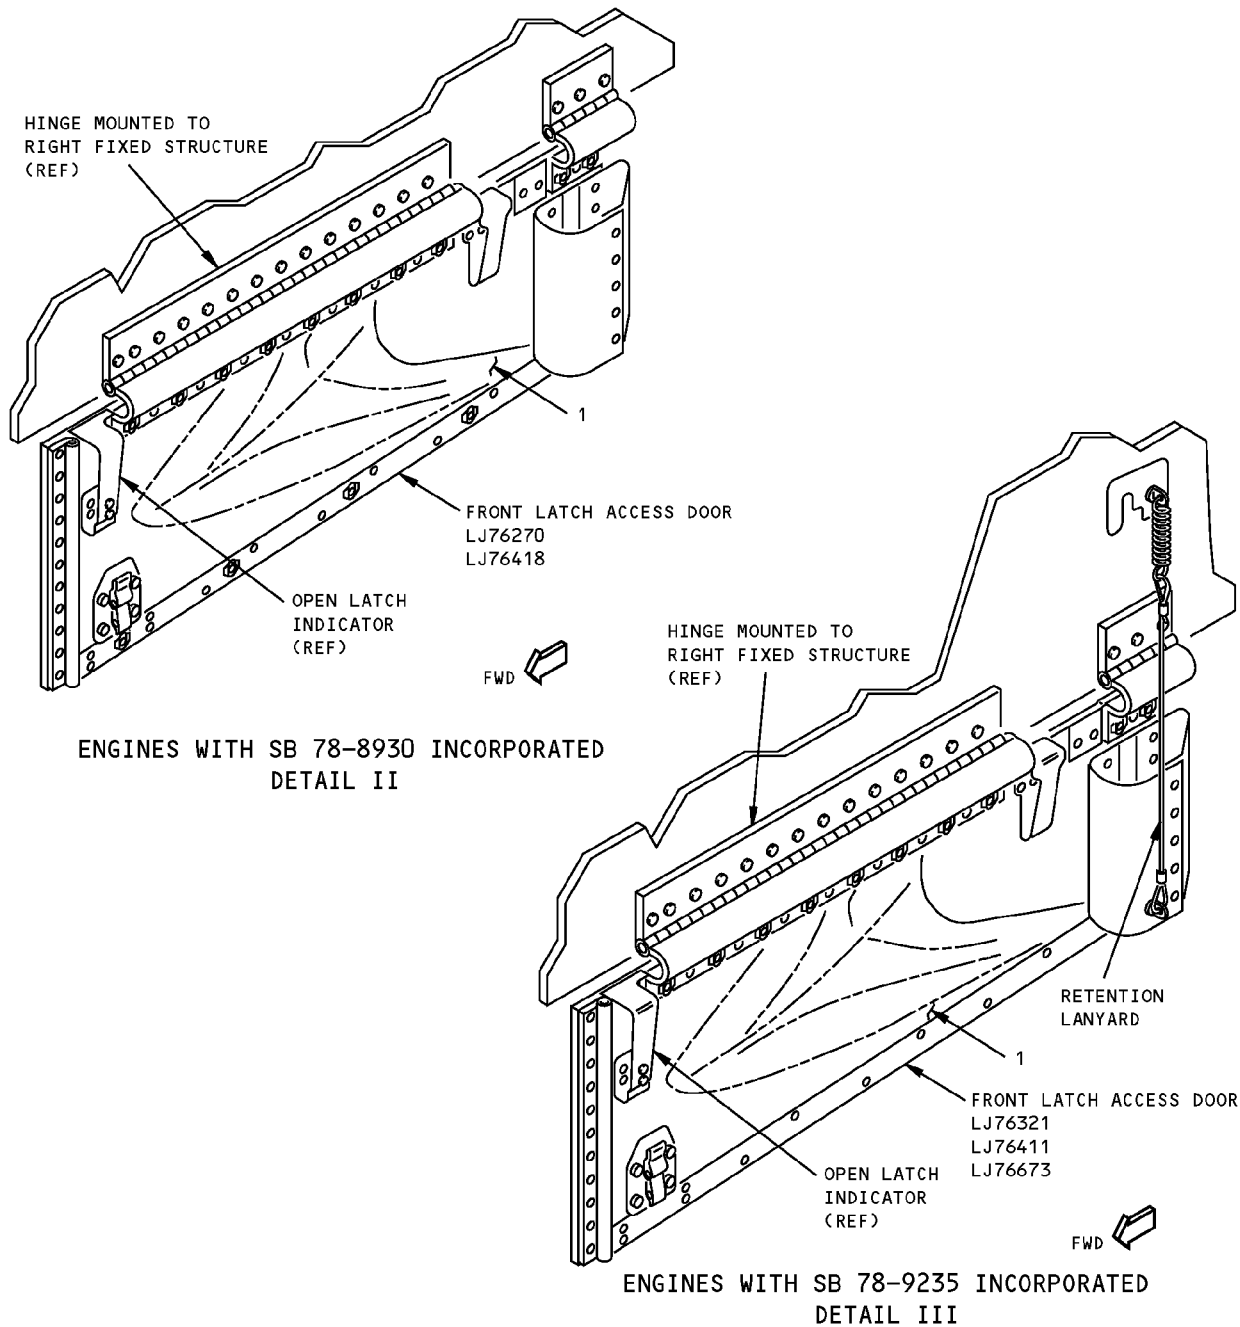
Reverser Cowl Latch Access Doors Identification - RB211-535E4 Engine
Figure 1 (Sheet 3 of 5)

ENGINES WITH SB 78-8930 INCORPORATED
DETAIL II

ENGINES WITH SB 78-9235 INCORPORATED
DETAIL III

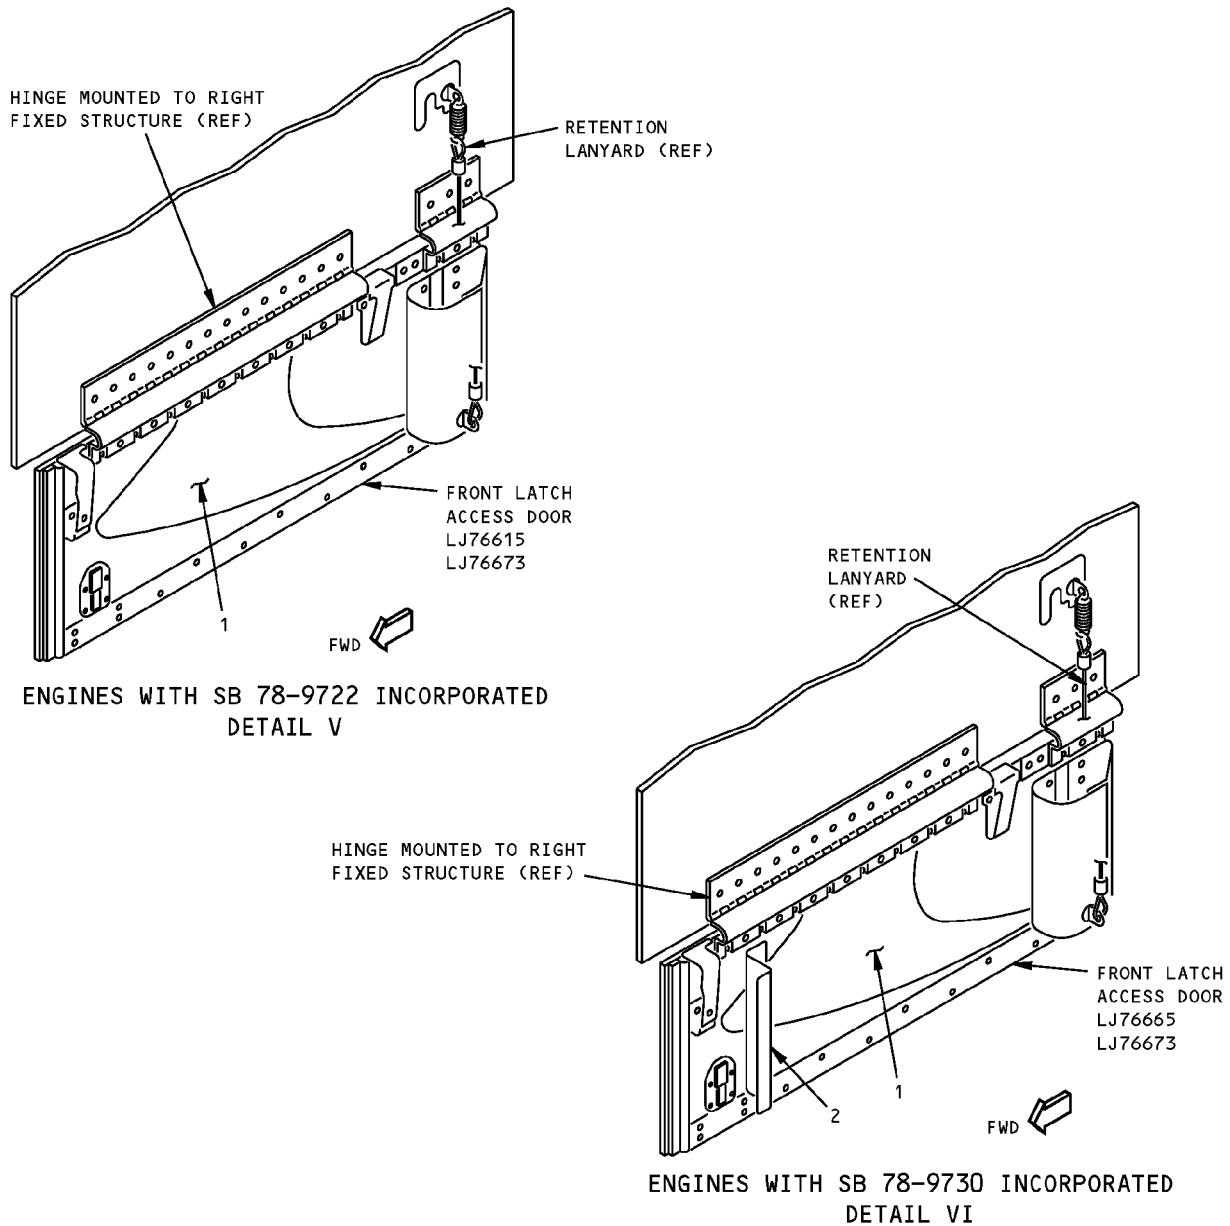
LIST OF MATERIALS FOR DETAILS V AND VI

ITEM	DESCRIPTION	GAGE	MATERIAL	EFFECTIVITY
1	INNER AND OUTER SKIN PANEL	0.063	2219-0 ALUMINUM SHEET PER QQ-A-250/30 (HEAT TREAT TO -T62)	
2	STIFFENER		2219-0 ALUMINUM SHEET PER QQ-A-250/30 (HEAT TREAT TO -T62)

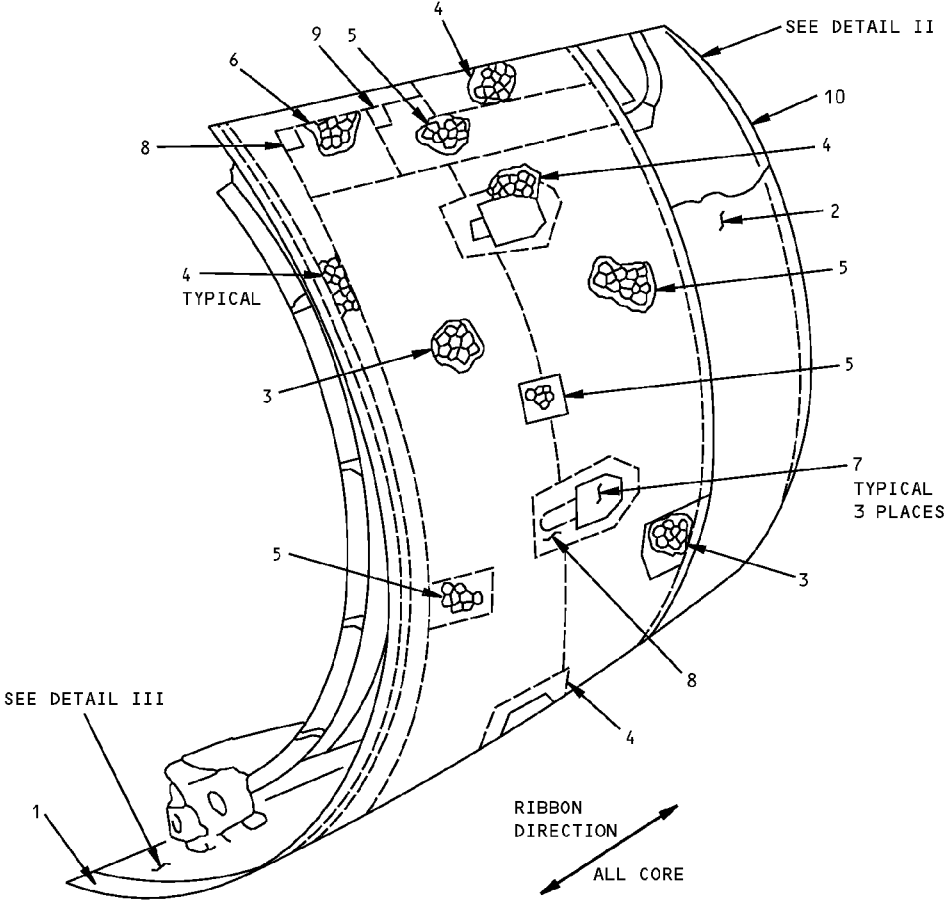
REF DWG
LJ70087
(EXCEPT AS NOTED)

LEFT COWL SHOWN
RIGHT COWL OPPOSITE
DETAIL I

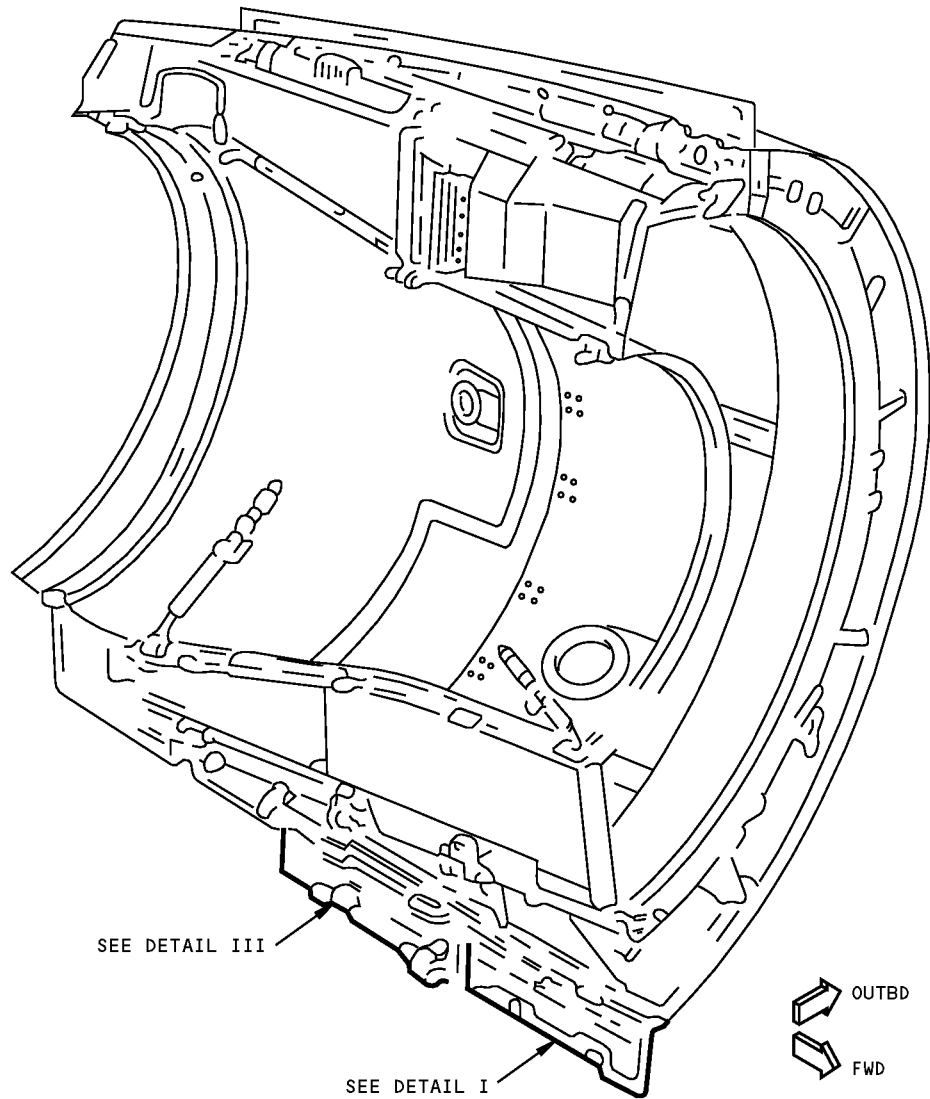
Reverser Cowl Latch Access Doors - RB211-535C Engine
Figure 1 (Sheet 1 of 5)

IDENTIFICATION 5 - REVERSER COWL LATCH ACCESS DOORS - RB211-535C ENGINE

- A** PLY ORIENTATION CONVENTION DEGREES INDICATED IS PARALLEL TO THE FABRIC WARP DIRECTION.
- B** GRAPHITE FABRIC, A-370-5H/3501-5A
- C** GRAPHITE TAPE, 3501-5A-AS-4
- D** POTTING COMPOUND PRO SEAL 828 AND PRO SEAL 840

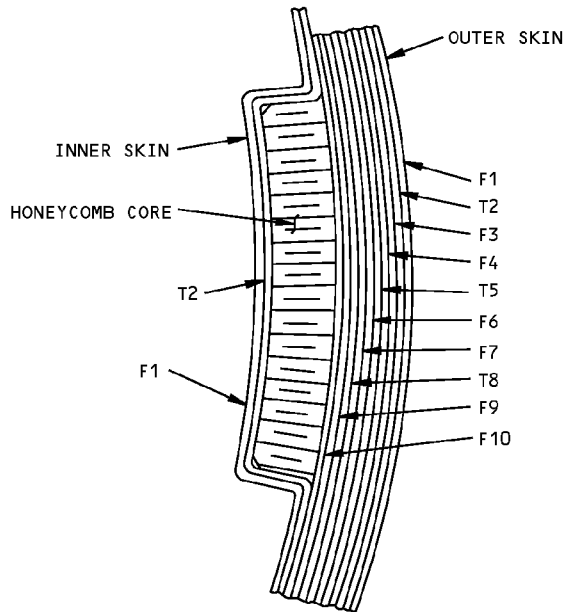
SECTION THRU HONEYCOMB

ITEM NO.	PLY NO.	MATERIAL	PLY ORIENTATION ^[A]
1	F1, F3, F4, F6, F7, F9, F10	[B]	0°
	T2, T5, T8	[C]	0°

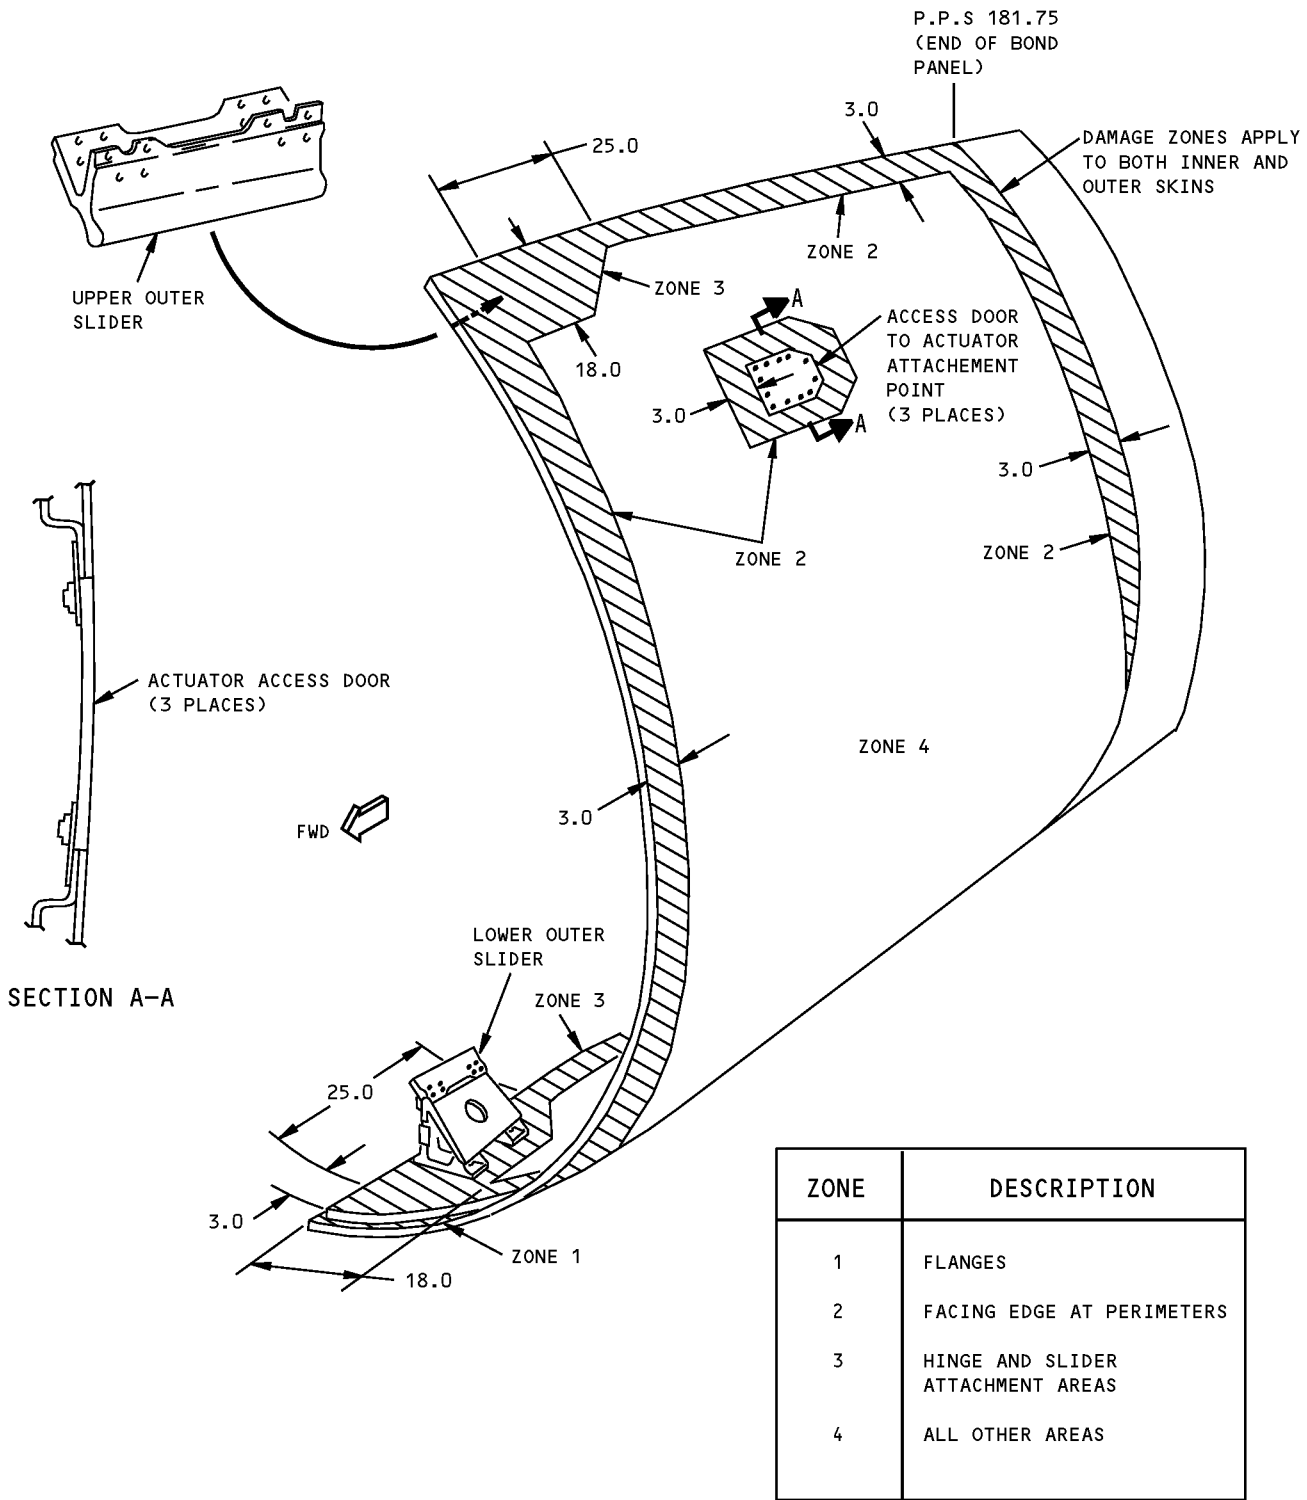
Reverser Cowl Skin Allowable Damage - RB211-535 Engine
Figure 101

ALLOWABLE DAMAGE 1 - REVERSER COWL SKIN - RB211-535 ENGINE

- (1) Superficial surface damage not extending into graphite fibers.
- (2) Surface abrasion with a maximum depth of 0.005 inch to an area not greater than 28 sq. inches.
- (3) A maximum of two cuts at a minimum spacing of 10 inches not more than 15 inches in length and 0.005 inch in depth.
- (4) A maximum of two holes at a minimum spacing of 10 inches and 1 inch maximum diameter that pierce the graphite composite skin through to the honeycomb core.

NOTE: The hole or holes must be temporarily covered with aluminum foil tape (Speed Tape) 3M-436 or equivalent. After a maximum of 25 hours, the damaged area must be repaired.

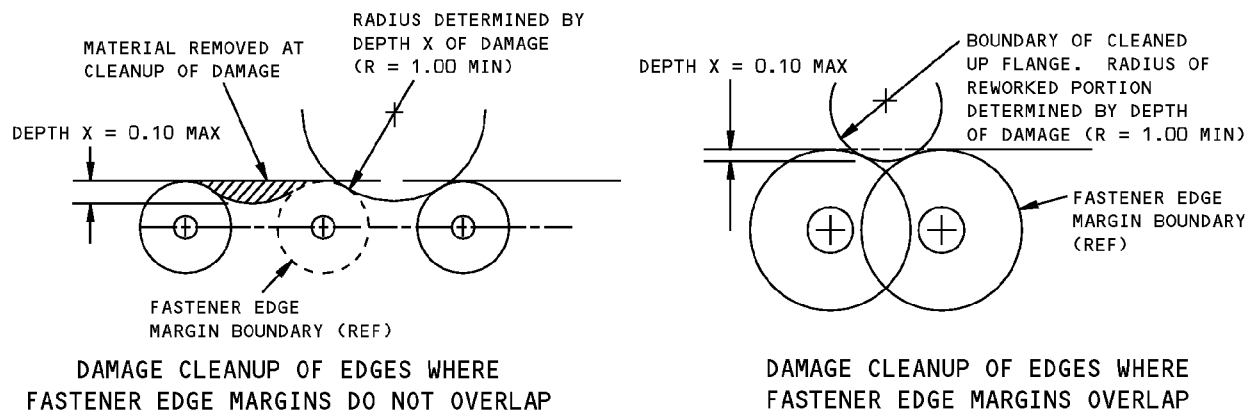
DETAIL I

- REFINISH REWORKED AREAS PER 51-20 OF THE MAINTENANCE MANUAL
- A** CRACKS NOT ALLOWED EXCEPT FOR EDGE CRACKS WHICH MUST BE REMOVED PER DETAILS I AND V
- B** REMOVE DAMAGE PER DETAILS I, II, IV, AND V
- C** CLEAN OUT DAMAGE UP TO 0.25 INCH MAXIMUM DIAMETER AND NOT CLOSER THAN 1.0 INCH TO FASTENER HOLE, MATERIAL EDGE, OR OTHER DAMAGE. FILL HOLE WITH A 2117-T3 OR T4 ALUMINUM RIVET INSTALLED WET WITH BMS 5-95 SEALANT. ALL OTHER HOLES MUST BE REPAIRED

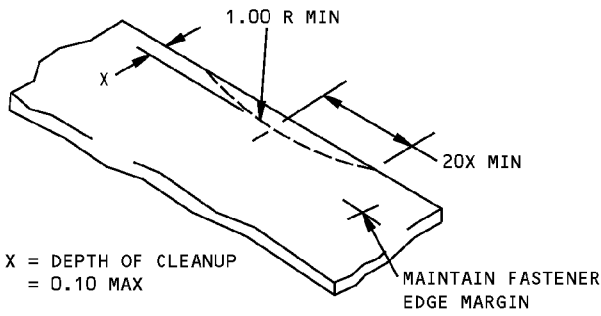
DETAIL V

REMOVAL OF NICK OR CRACK DAMAGE ON AN EDGE

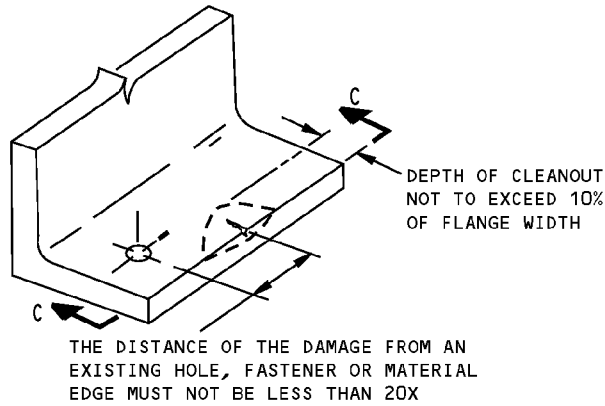
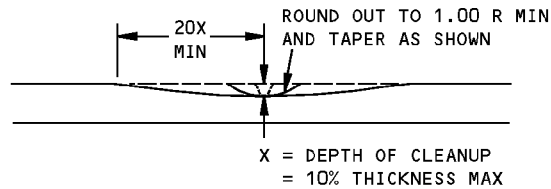
DETAIL VI

REMOVAL OF NICK OR CRACK DAMAGE ON AN EDGE

SECTION C-C

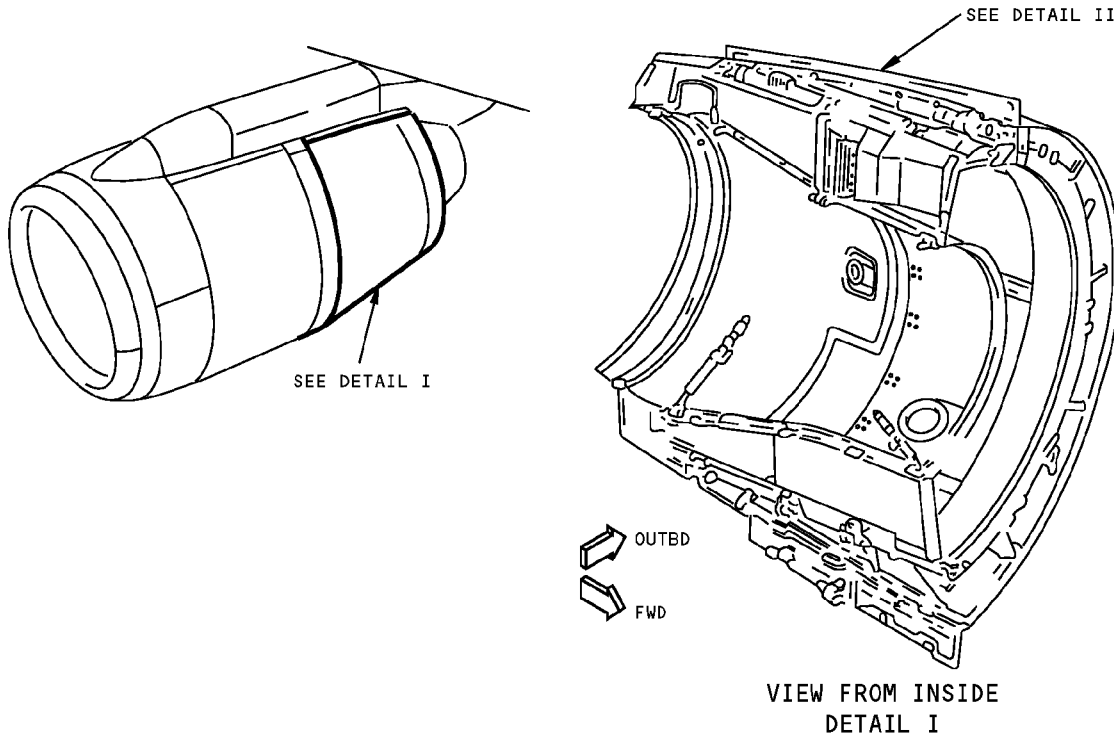
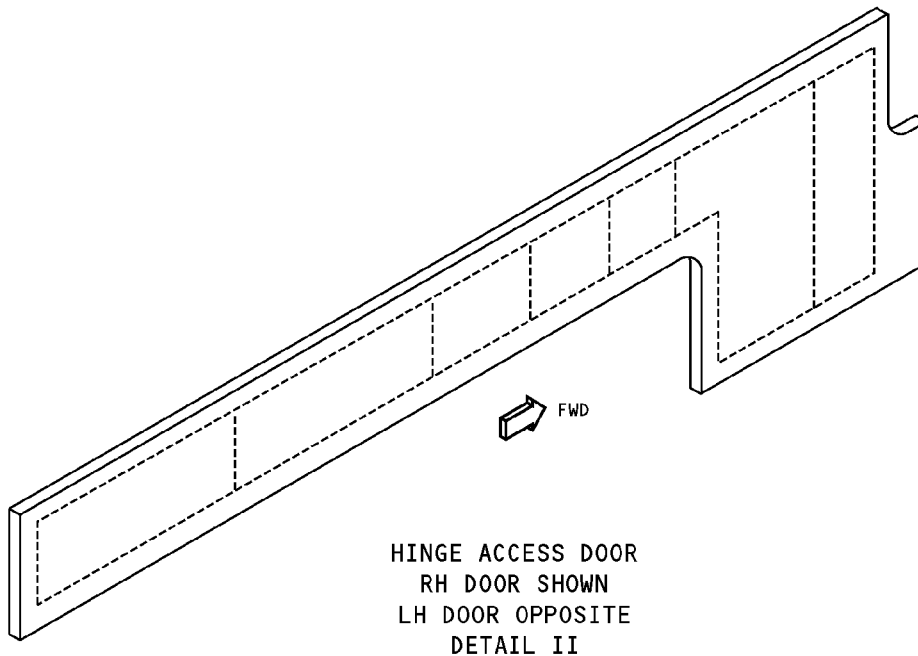
**Reverser Cowl Hinge Access Doors Allowable Damage - RB211-535 Engine
Figure 101 (Sheet 1 of 2)**

ALLOWABLE DAMAGE 3 - REVERSER COWL HINGE ACCESS DOORS - RB211-535 ENGINE

REF DWG
LJ75087
(EXCEPT AS NOTED)

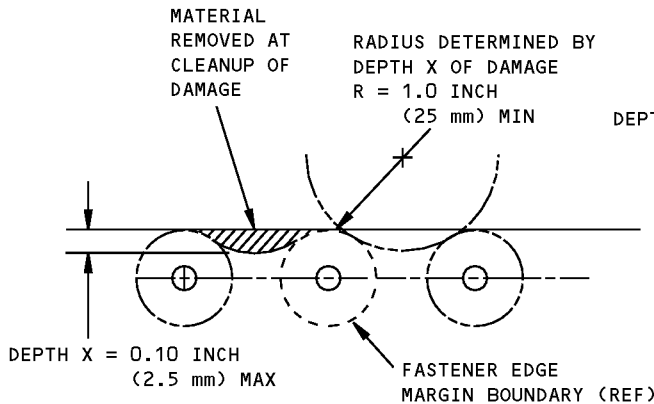
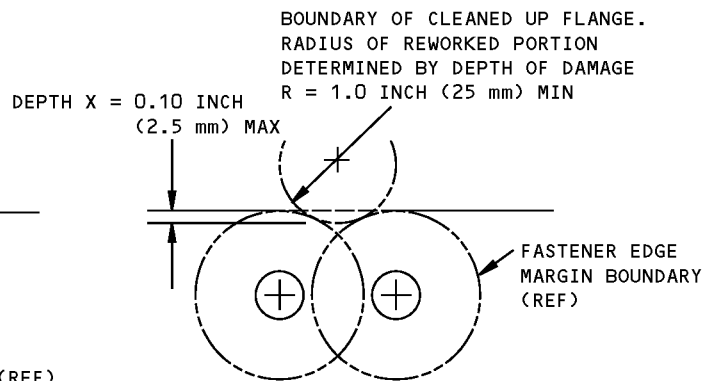
DETAIL III

DAMAGE CLEANUP OF EDGES WHERE FASTENER EDGE MARGINS DO NOT OVERLAP

DAMAGE CLEANUP OF EDGES WHERE FASTENER EDGE MARGINS OVERLAP

- A** REMOVE MOISTURE FROM DAMAGE AREA. USE OF VACUUM AND HEAT (MAX OF 125°F (52°C)) TO REMOVE MOISTURE FROM HONEYCOMB CELLS IS RECOMMENDED. PROTECT DAMAGE FROM ENTRANCE OF WATER, SUNLIGHT OR OTHER FOREIGN MATTER BY SEALING WITH ALUMINUM FOIL TAPE (SPEED TAPE) 3M-Y346. RECORD THE LOCATION AND INSPECT EACH AIRPLANE 'A' CHECK. REPLACE THE ALUMINUM FOIL TAPE IF ANY PEELING OR DETERIORATION IS EVIDENT. REPAIR NO LATER THAN NEXT AIRPLANE 'C' CHECK.
- B** DAMAGE IS PERMITTED ON SURFACE RESIN ONLY WITH NO FIBER DAMAGE. CLEAN UP EDGE DAMAGE AS SHOWN IN DETAIL III.

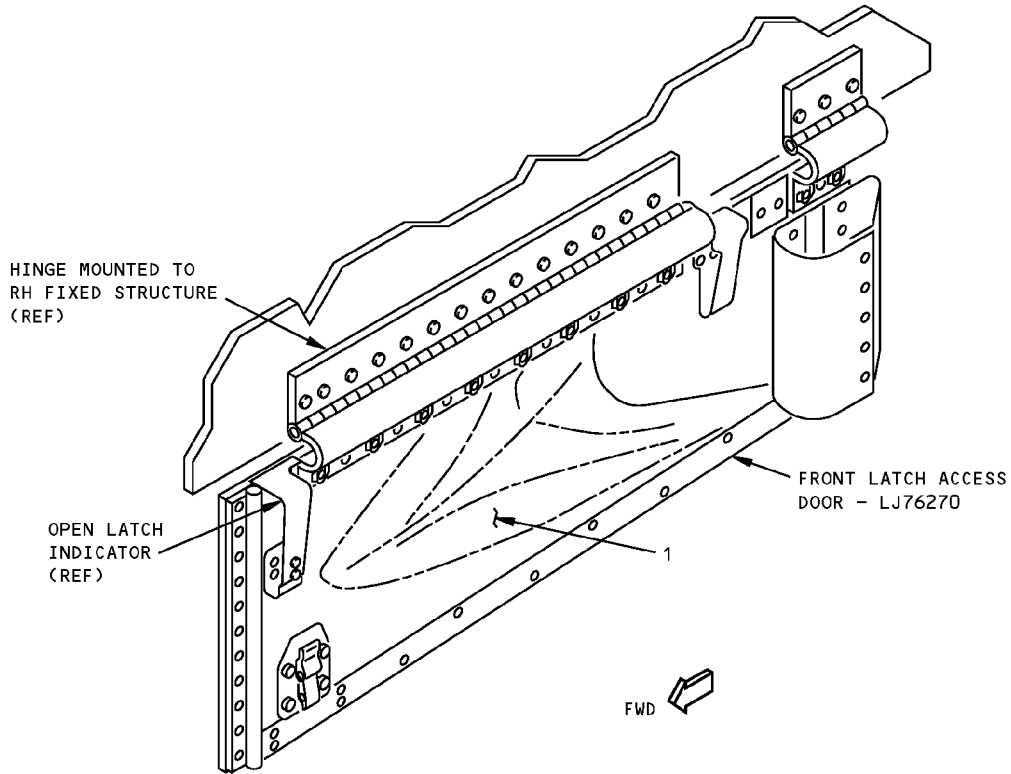
FOR AIRPLANES WITH ROLLS-ROYCE SB 78-8930 INCORPORATED
DETAIL III

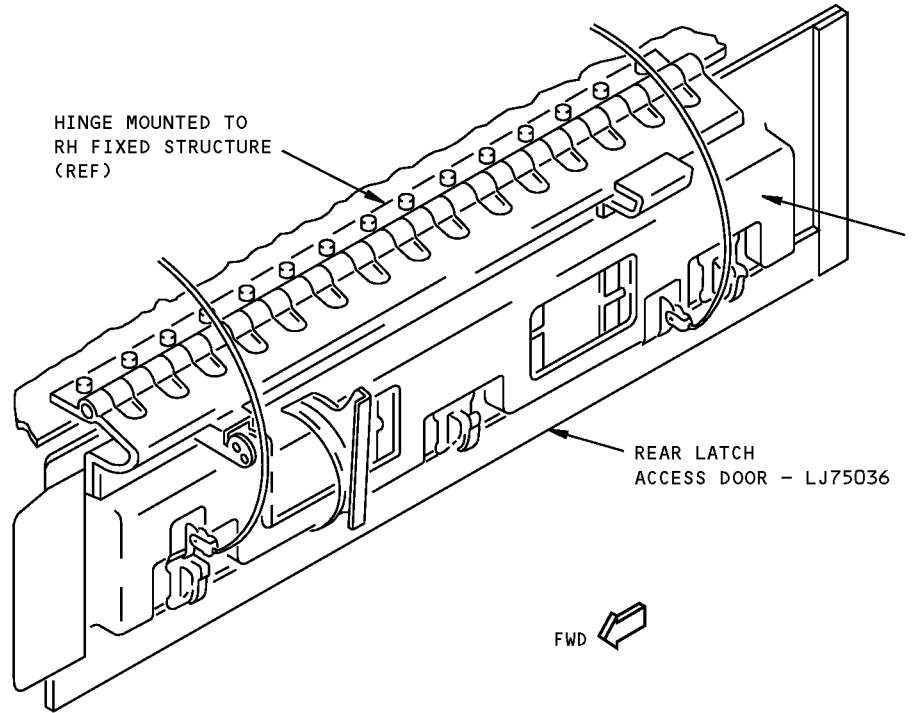
DETAIL IV

Reverser Cowl Latch Access Doors Allowable Damage - RB211-535E4 Engine
Figure 101 (Sheet 3 of 4)

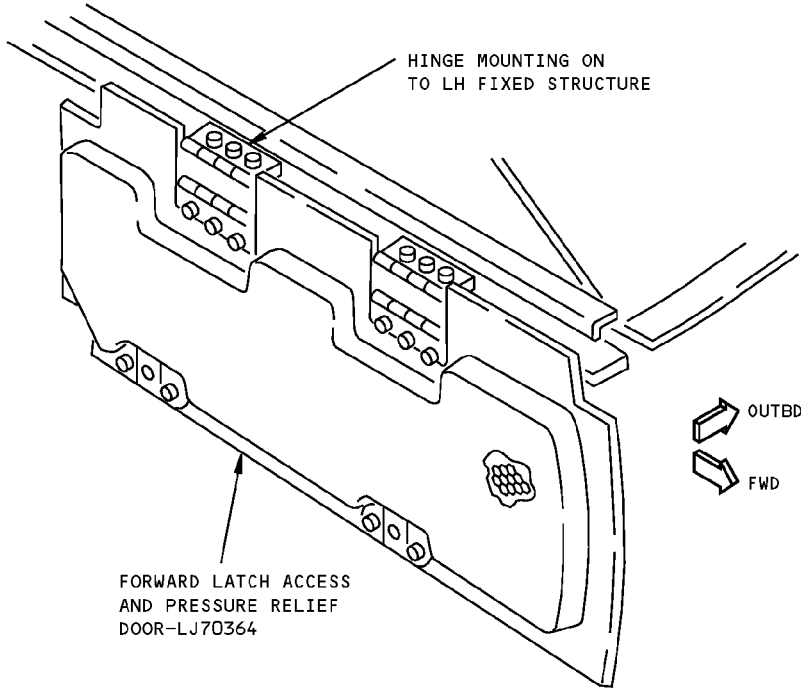
FWD LATCH ACCESS DOOR
DETAIL II

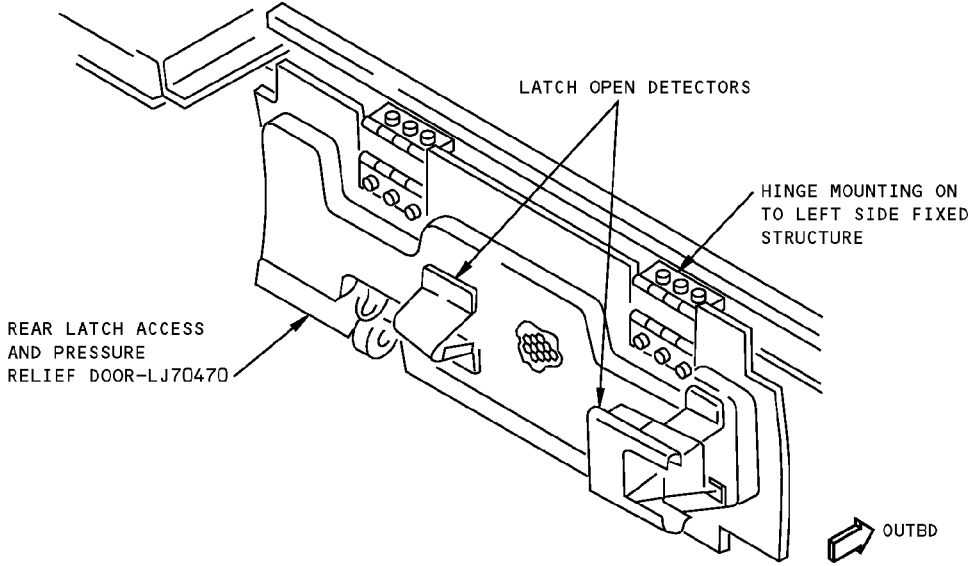
REAR LATCH ACCESS DOOR
DETAIL III

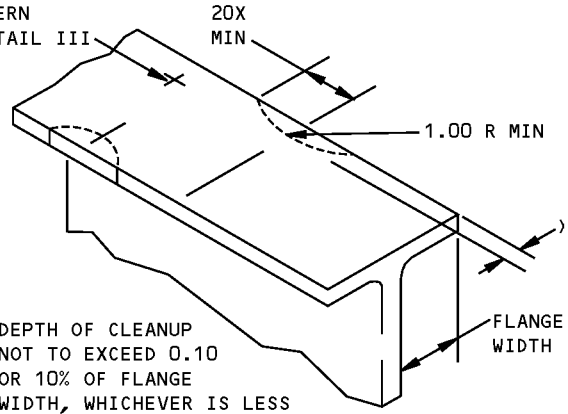
REMOVAL OF DAMAGE ON AN EDGE
DETAIL VII

- [G] CLEAN UP EDGE CRACKS AS GIVEN IN DETAILS IV AND VII. CLEAN UP CORNER CRACKS AS GIVEN IN DETAIL VIII. OTHER CRACKS NOT ALLOWED
- [H] CLEAN UP EDGE DAMAGE PER DETAILS IV AND VI. CLEAN UP CORNER DAMAGE PER DETAIL VIII. CLEAN UP LUG DAMAGE PER DETAIL IX. CLEAN UP OTHER DAMAGE PER DETAIL V.

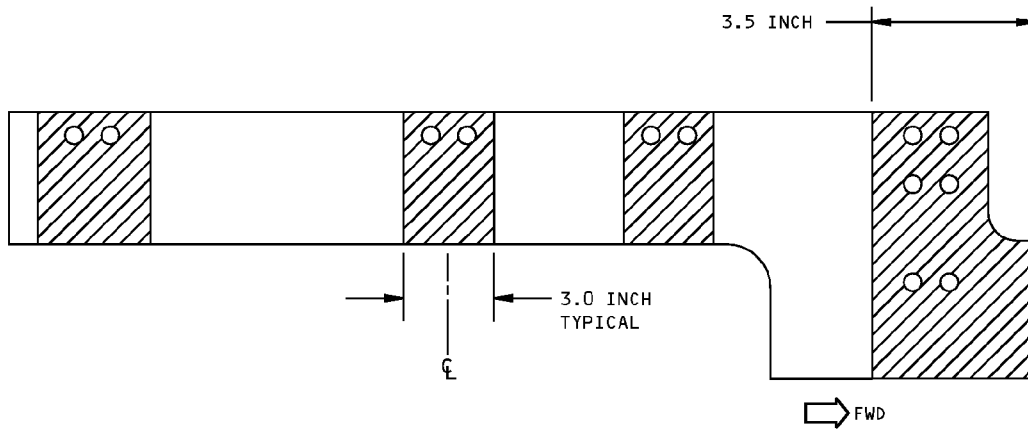
OUTER SKIN
DETAIL I

REPAIR 2 - REVERSER COWL HINGE DOOR - RB211-535 ENGINE

Reverser Cowl Hinge Door Repair - RB211-535 Engine
Figure 201 (Sheet 1 of 2)

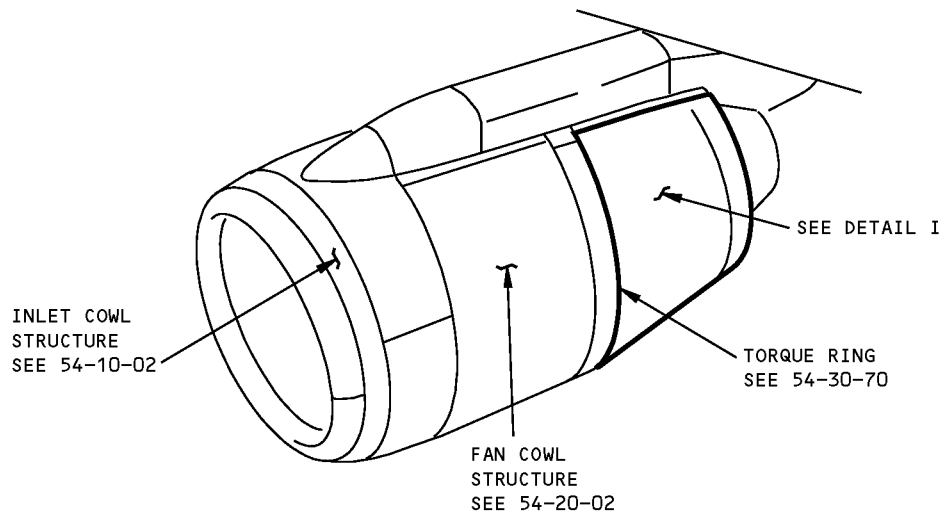
IDENTIFICATION 2 - REVERSER COWL RIBS AND STRINGERS - RB211-535C ENGINE

Reverser Cowl Ribs and Stringers Identification - RB211-535C Engine
Figure 1 (Sheet 1 of 5)

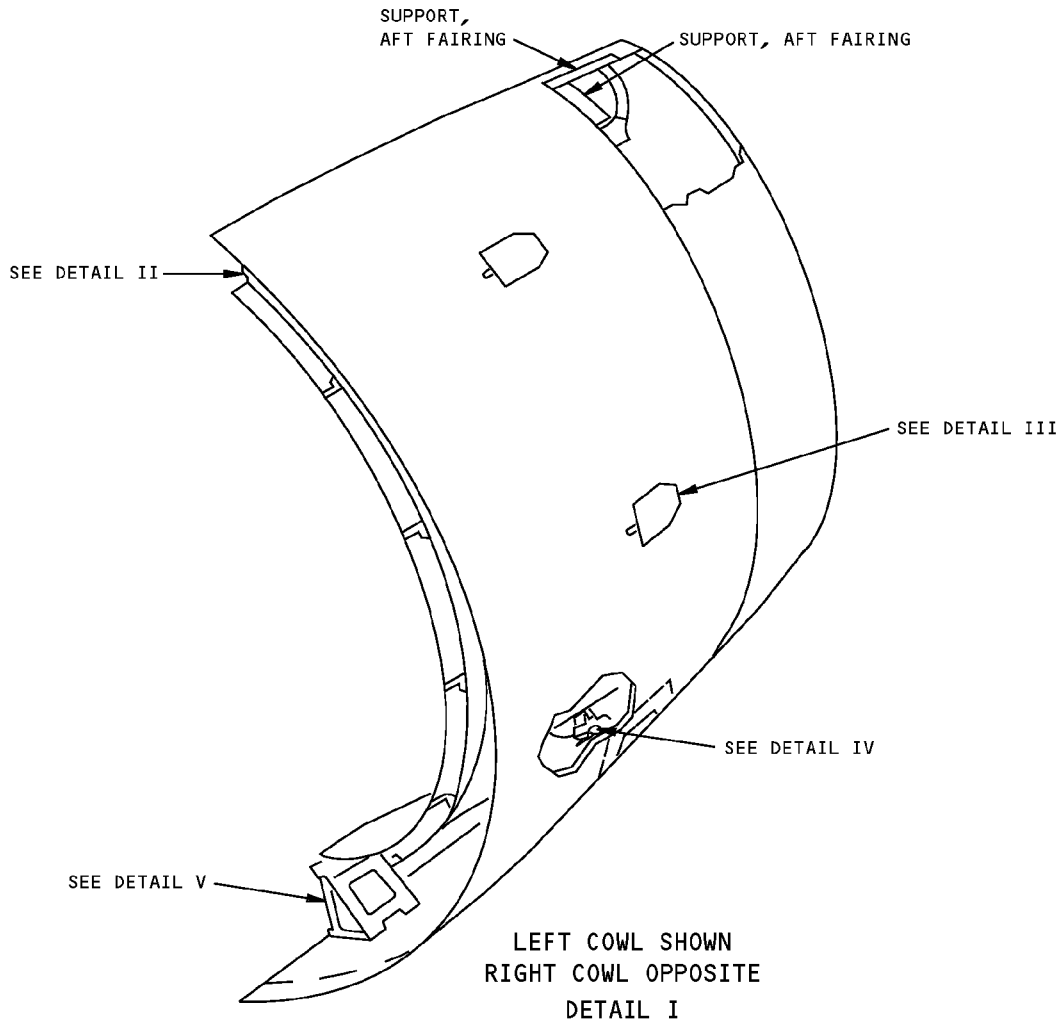
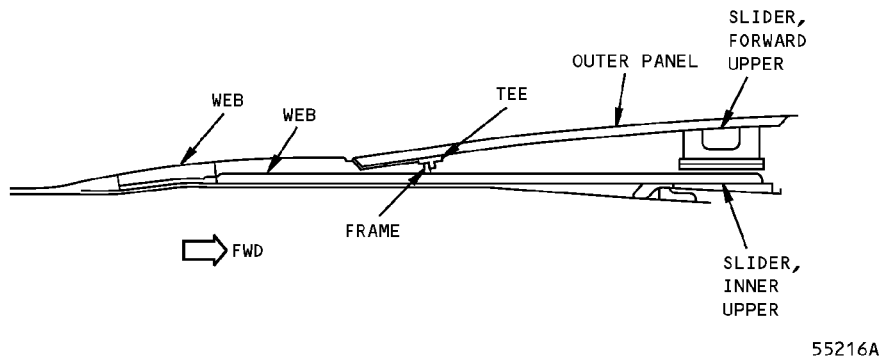
Reverser Cowl Ribs and Stringers Allowable Damage - RB211-535E4 Engine
Figure 101 (Sheet 2 of 5)

DETAIL II

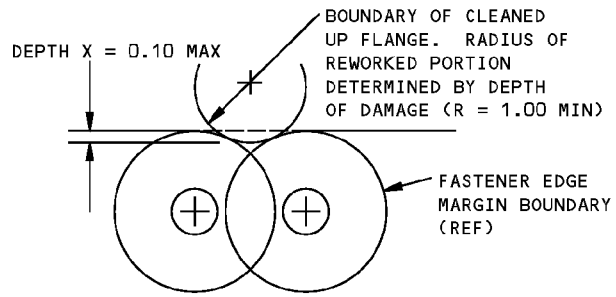
DAMAGE CLEANUP OF EDGES WHERE FASTENER EDGE MARGINS DO NOT OVERLAP

DAMAGE CLEANUP OF EDGES WHERE FASTENER EDGE MARGINS OVERLAP

- A** CRACKS NOT ALLOWED EXCEPT FOR EDGE CRACKS WHICH MUST BE REMOVED PER DETAIL VI AND XI
- B** REMOVE DAMAGE PER DETAILS VI, VII, AND IX
- C** CRACKS NOT ALLOWED EXCEPT FOR EDGE CRACKS WHICH MUST BE REMOVED PER DETAILS VI AND X

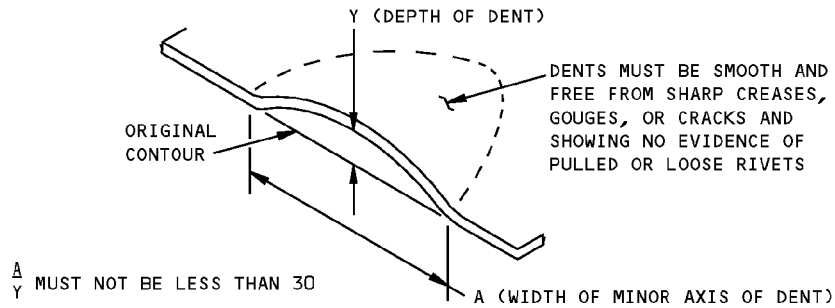
DETAIL VIII

ALLOWABLE DAMAGE FOR DENT

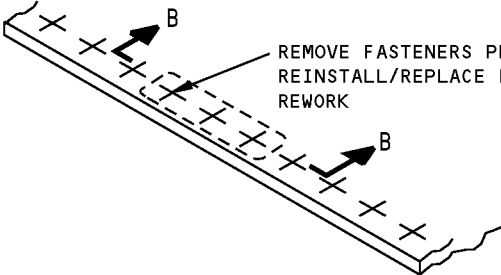
CORROSION CLEANUP
DETAIL XI

SMOOTH BLENDOUT RADIUS 0.50 INCH MINIMUM. CORROSION CLEANUP AROUND ANY THREE FASTENERS IN TEN IS PERMITTED TO MAX DEPTH

SECTION B-B

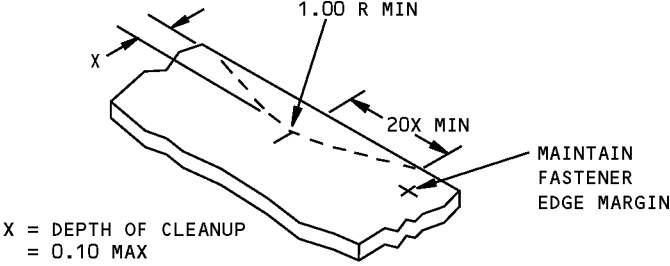
REMOVAL OF NICK OR CRACK DAMAGE ON AN EDGE
DETAIL X

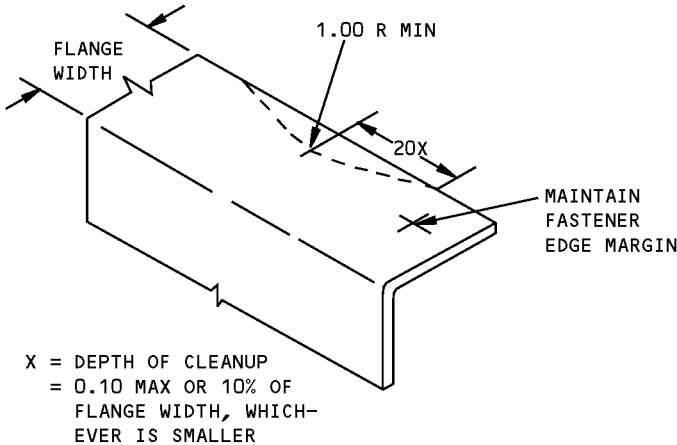
REMOVAL OF NICK OR CRACK DAMAGE ON AN EDGE
DETAIL XI

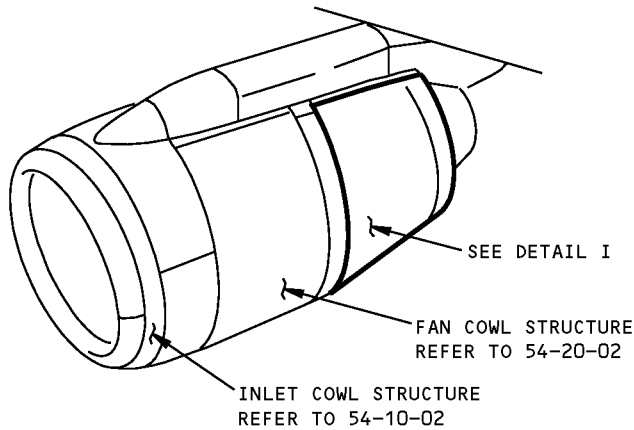
Reverser Cowl Ribs and Stringers Allowable Damage - RB211-535C Engine
Figure 101 (Sheet 1 of 5)

ALLOWABLE DAMAGE 2 - REVERSER COWL RIBS AND STRINGERS - RB211-535C ENGINE

- A** CRACKS NOT ALLOWED EXCEPT FOR EDGE CRACKS WHICH MUST BE REMOVED PER DETAIL VI.
- B** REMOVE DAMAGE PER DETAILS VI, VII, AND IX.
- C** CRACKS NOT ALLOWED EXCEPT FOR EDGE CRACKS WHICH MUST BE REMOVED PER DETAILS VI AND X.
- D** CRACKS NOT ALLOWED EXCEPT FOR EDGE CRACKS WHICH MUST BE REMOVED PER DETAILS VI AND XI.

DESCRIPTION	CRACKS	NICKS, GOUGES AND CORROSION	DENTS	HOLES AND PUNCTURES
CLOSURE	C	B	NOT ALLOWED	NOT ALLOWED
UPPER CLOSURE	C	B	NOT ALLOWED	NOT ALLOWED
FILLER	B	B	NOT ALLOWED	NOT ALLOWED
UPPER SLUG	D	B	NOT ALLOWED	NOT ALLOWED
TRAILING EDGE	B	B	NOT ALLOWED	NOT ALLOWED
INTERCOSTAL	A	B	NOT ALLOWED	NOT ALLOWED
WEB	D	B	SEE DETAIL VIII	NOT ALLOWED
ANGLE	D	B	NOT ALLOWED	NOT ALLOWED
INNER SLIDER	C	B	NOT ALLOWED	NOT ALLOWED
AFT SLIDER BRACKET	D	B	NOT ALLOWED	NOT ALLOWED
FORWARD SLIDER BRACKET	D	B	NOT ALLOWED	NOT ALLOWED
OUTER SLIDER	C	B	NOT ALLOWED	NOT ALLOWED
LEADING EDGE	B	B	NOT ALLOWED	NOT ALLOWED
DOUBLER	B	B	NOT ALLOWED	NOT ALLOWED
BRACKET	D	B	NOT ALLOWED	NOT ALLOWED
LOWER SLIDER	C	B	NOT ALLOWED	NOT ALLOWED

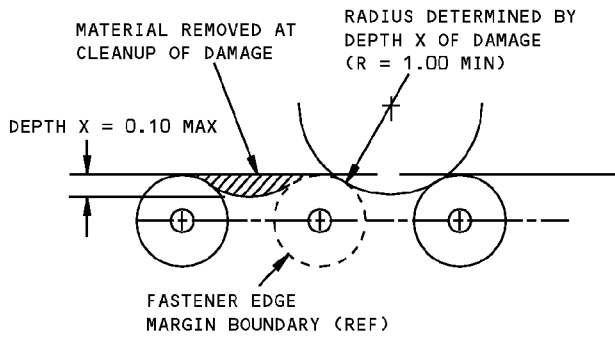
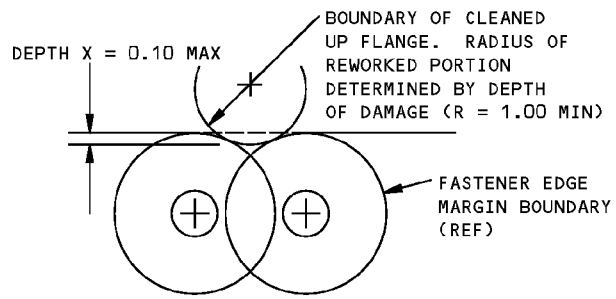
DETAIL VI

DAMAGE CLEANUP OF EDGES WHERE FASTENER EDGE MARGINS DO NOT OVERLAP

DAMAGE CLEANUP OF EDGES WHERE FASTENER EDGE MARGINS OVERLAP

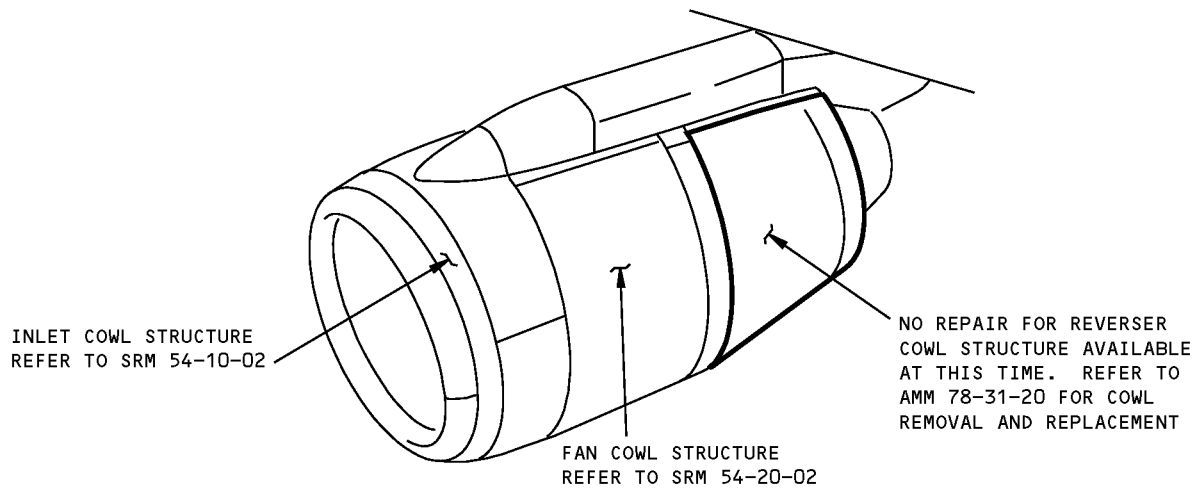
Reverser Cowl Ribs and Stringers Repair - RB211-535C Engine
Figure 201

REPAIR 2 - REVERSER COWL RIBS AND STRINGERS - RB211-535C ENGINE
