**NACELLES AND
PYLONS**

**757-200
STRUCTURAL REPAIR MANUAL**

**CHAPTER 54
NACELLES AND PYLONS**

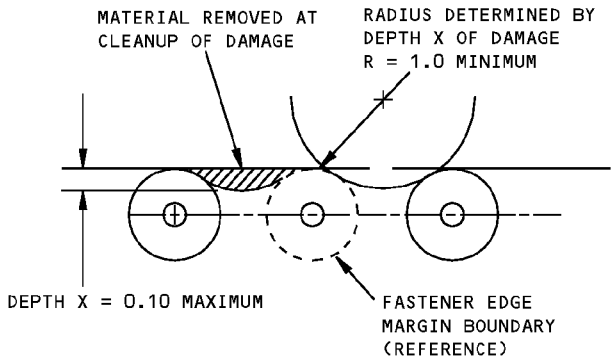
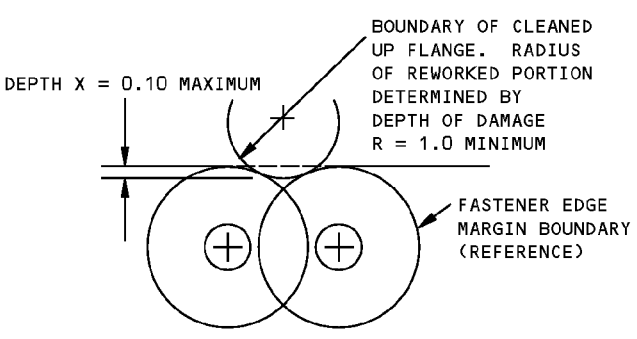
DETAIL III

DAMAGE CLEANUP OF EDGES WHERE FASTENER EDGE MARGINS DO NOT OVERLAP

DAMAGE CLEANUP OF EDGES WHERE FASTENER EDGE MARGINS OVERLAP

- B** 0.125 INCH (3.18 mm) MAXIMUM LENGTH FOR EACH SQUARE FOOT OF AREA AND A MINIMUM OF 10.0 INCHES (250 mm) FROM ANY OTHER DAMAGE. CLEAN UP EDGE CRACKS AS SHOWN IN DETAIL III. CRACKS THROUGH TWO CONSECUTIVE HOLES THROUGH EDGE BAND ARE PERMITTED, PROVIDED SUCH CRACKS ARE NOT LESS THAN 12.0 INCHES (300 mm) APART. **A**

- E** 1.0 INCH (25 mm) MAXIMUM DIAMETER SMOOTH WITH NO CRACKS. **A**
- F** 0.015 INCH (0.38 mm) MAXIMUM DEPTH, 5.0 INCHES (125 mm) MAXIMUM LENGTH. CLEAN UP EDGE DAMAGE AS AS SHOWN IN DETAIL III. **A**

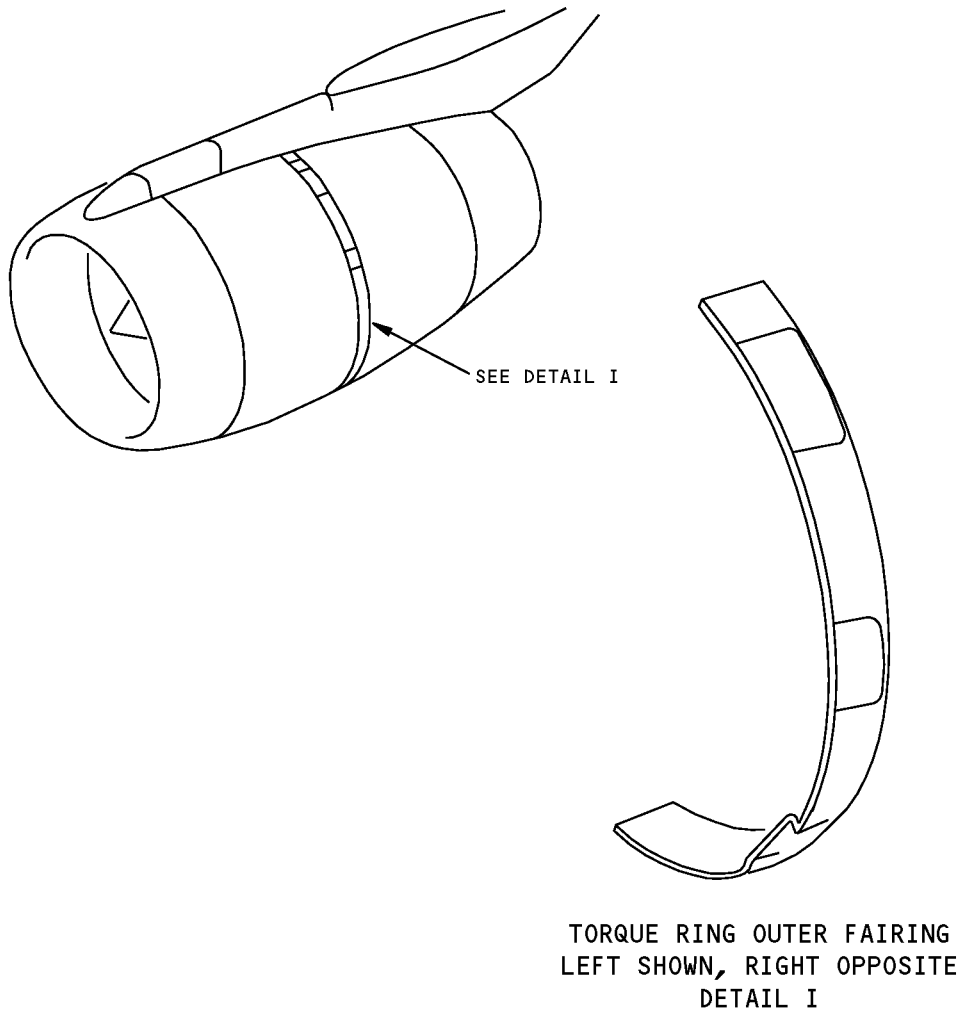
Torque Ring Outer Fairing - Patch Repair- All RB211-535 Engines
Figure 201 (Sheet 1 of 7)

REPAIR 2 - TORQUE RING OUTER FAIRING - PATCH REPAIR - ALL RB211-535 ENGINES

1. Prepare the damaged area by removing the metal parts which are closer than 1.25 inches from the edge of the damage. Drill out the fasteners and retain parts for refitment.
2. **WARNING:** PROTECTIVE GLOVES MUST BE WORN WHEN USING DEGREASERS. USE ONLY IN WELL VENTILATED AREAS. VERY INFLAMMABLE. KEEP AWAY FROM IGNITION SOURCES.

Cut away the damaged fairing. Refer to Details II, III, and IV. If necessary, peel down the edge of the reinforcing plies in the area of the repair.

4. Cut the repair patch from the repair parts for the fairing and rub strip. Refer to Details V and VI.
5. Position the repair patch on the inner surface over the damage cut-out and mark out for fasteners. Refer to Details VI and VII.
6. Drill the fastener holes and deburr.
7. Lightly abrade the faying surfaces using 180 grit abrasive paper in a back and forth motion to matt the surface.
8. **WARNING:** PROTECTIVE GLOVES MUST BE WORN WHEN USING DEGREASERS. USE ONLY IN WELL VENTILATED AREAS. VERY INFLAMMABLE. KEEP AWAY FROM IGNITION SOURCES.

10. Clamp the repair patch into position and wet install the blind rivets NAS1739M4-3 and washers AN960C6 using PR-1431-GB-2 sealant. Rivet heads should be flush to 0.004 underflush. Rivet shaving is not allowed.

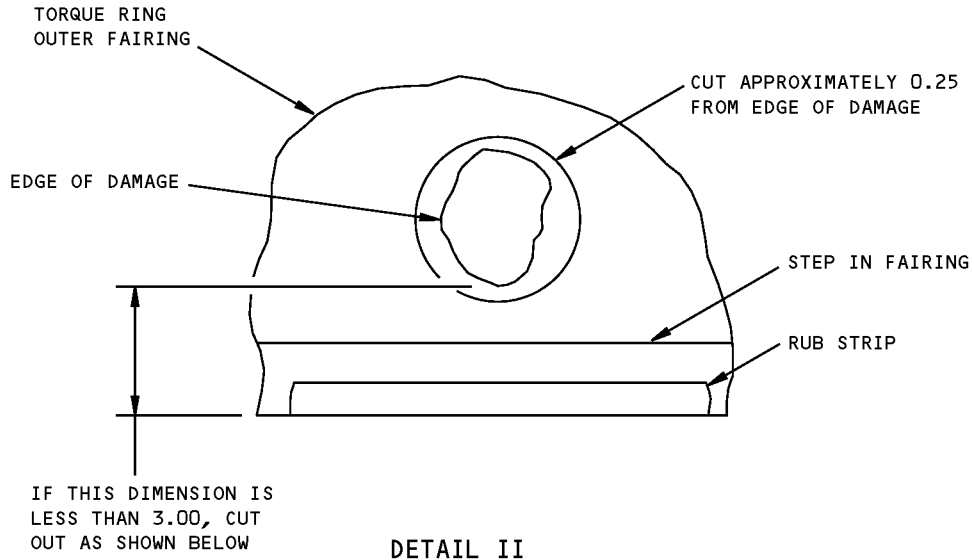
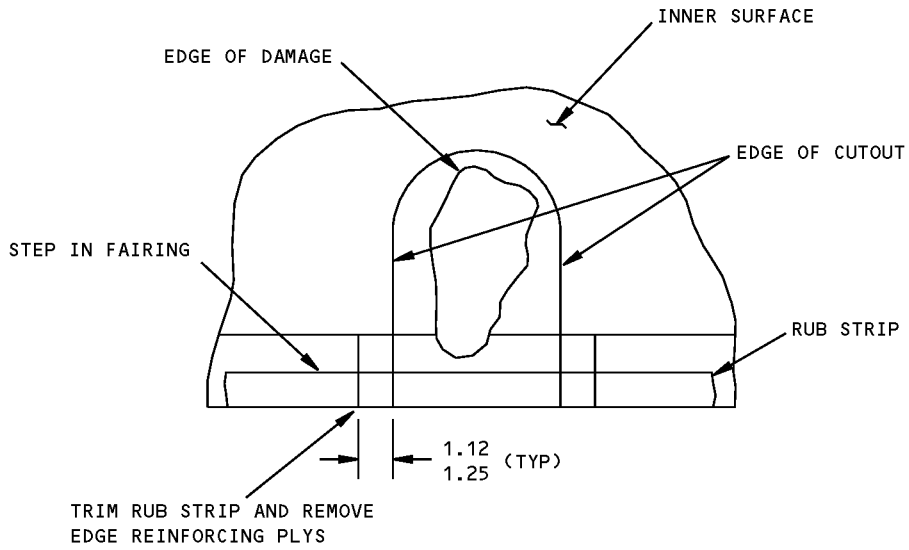
DETAIL III

**Torque Ring Outer Fairing - Patch Repair- All RB211-535 Engines
Figure 201 (Sheet 4 of 7)**

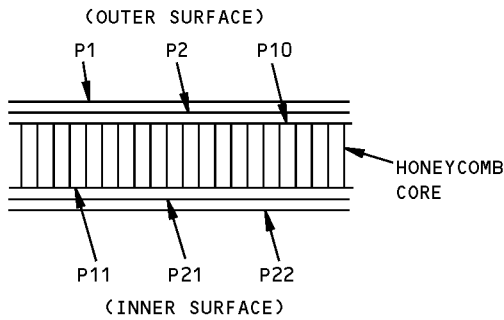
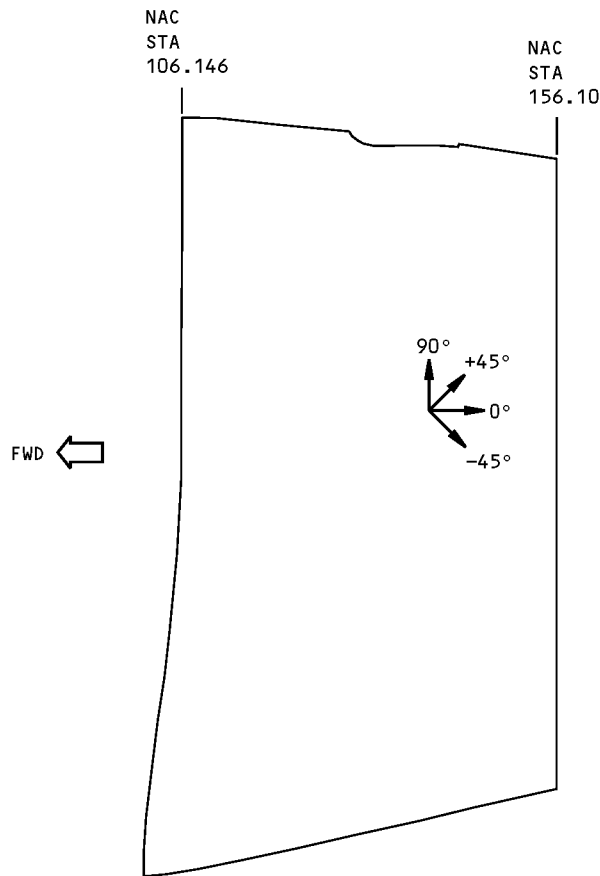
ITEM NO.	PLY NO.	MATERIAL	PLY ORIENTATION ^A
1	P1,P22	^B	0°
	P2,P21	^B	+45°
	P10,P11	^C	-45°

SECTION THRU HONEYCOMB PANEL

PLY ORIENTATION DIAGRAM ^A
DETAIL II

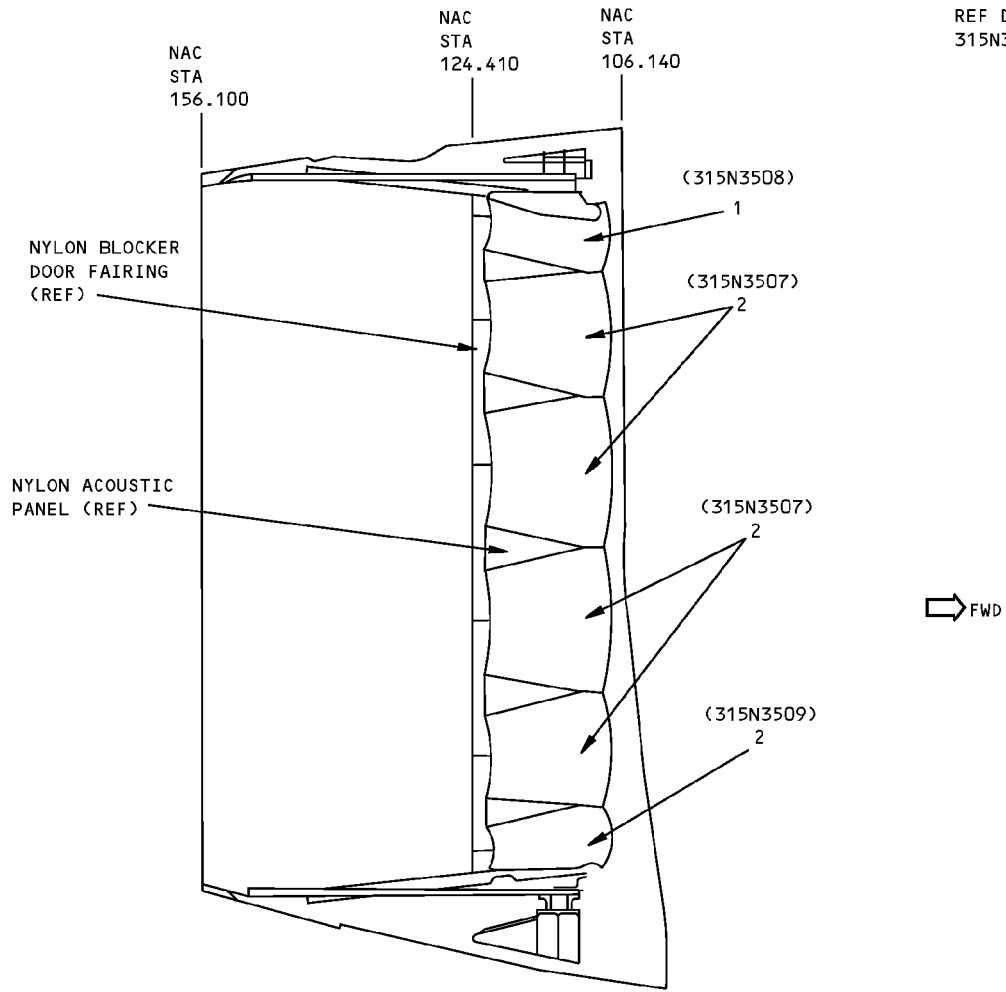
LEFT SIDE SHOWN
RIGHT SIDE OPPOSITE
DETAIL IV

ITEM	DESCRIPTION	GAGE	MATERIAL	EFFECTIVITY
1	BLOCKER DOOR ASSY - UPPER			
	OUTER SKIN CORE	0.025	2024-T81 ALUMINUM HONEYCOMB PER BMS 4-4, TYPE 6-40N, FORM B	
	INNER SKIN	0.025	2024-T62	
2	BLOCKER DOOR ASSY			
	OUTER SKIN CORE	0.025	2024-T81 ALUMINUM HONEYCOMB PER BMS 4-4, TYPE 6-40N, FORM B	
	INNER SKIN	0.050	PERFORATED SHEET CLAD 2024-T62 PER BMS 7-209, TYPE 1B-50, GRADE 1B, CLASS 50-109

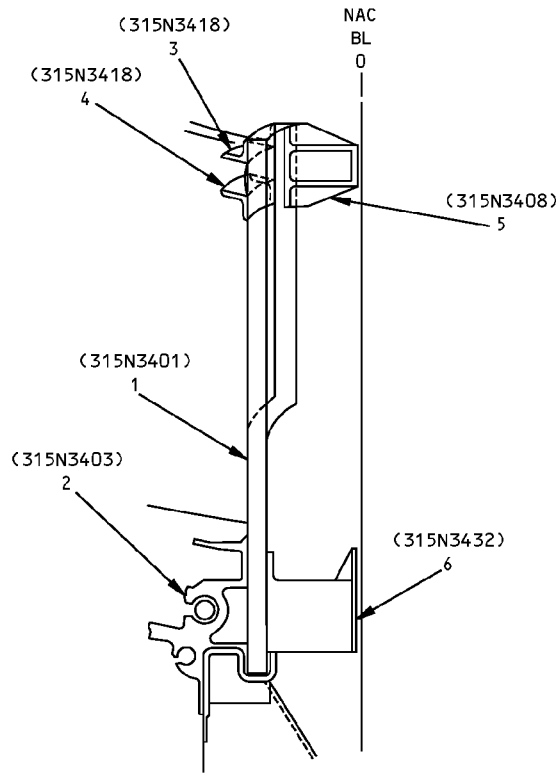
**LOWER BIFURCATION PANEL - REAR VIEW
LEFT SIDE SHOWN, RIGHT SIDE OPPOSITE
DETAIL VI**

ITEM	DESCRIPTION	GAGE	MATERIAL	EFFECTIVITY
1	PANEL ASSY OUTER SKIN CENTER CORE EDGE CORES INNER SKIN	0.025 0.040	PERFORATED CLAD SHEET 2024-T62 PER BMS 7-209, TYPE 1B-25, GRADE 1B, CLASS 50-187 ALUMINUM HONEYCOMB PER BMS 4-4, TYPE 6-30N ALUMINUM HONEYCOMB PER BMS 4-4, TYPE 3-60N, GRADE 2 CHEM MILLED 2024-T81	
2	BEAM FITTING		A357-T61 PREMIUM QUALITY CASTING PER MIL-A-21180 OPTIONAL: HT TR T62	
3	UPPER ATTACH ANGLE		BAC1517-2298 7075-T73	
4	LOWER ATTACH ANGLE		BAC1517-2299 7075-T73	
5	COMPRESSION PAD		7075-T73 FORGED BLOCK	
6	CLOSE OUT FITTING		A357 PREMIUM QUALITY CASTING PER MIL-A-21180, CLASS 10

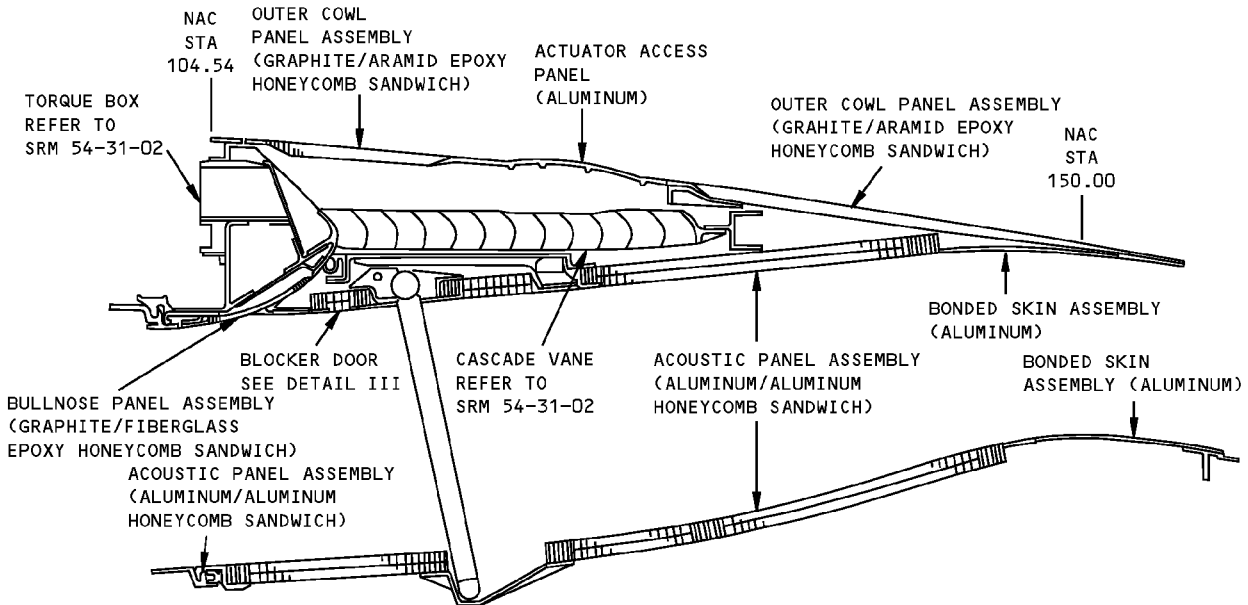
DETAIL II

CROSS SECTION THRU THRUST REVERSER COWL

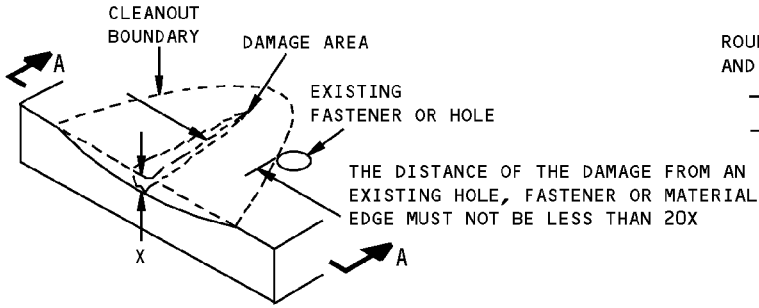
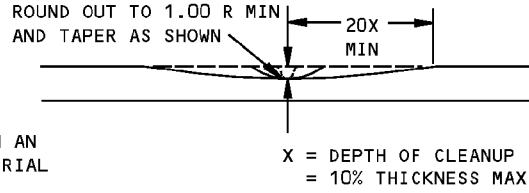
SECTION A-A

**REMOVAL OF NICK, GOUGE AND SCRATCH DAMAGE ON A SURFACE
DETAIL VII**

- B** CRACKS ARE NOT PERMITTED EXCEPT FOR EDGE CRACKS WHICH MUST BE REMOVED AS SHOWN IN DETAILS VI AND X.
- C** REMOVE DAMAGE AS SHOWN IN DETAILS VI, VII AND IX.

- M** FOR EDGE DAMAGE SEE DETAIL VI. FOR OTHER DAMAGE SEE DETAILS VII AND IX.
- N** 2.25 INCH MAX DIA ALLOWED. A MAXIMUM OF 0.50 DELAMINATION FROM EDGE IS ALLOWED.

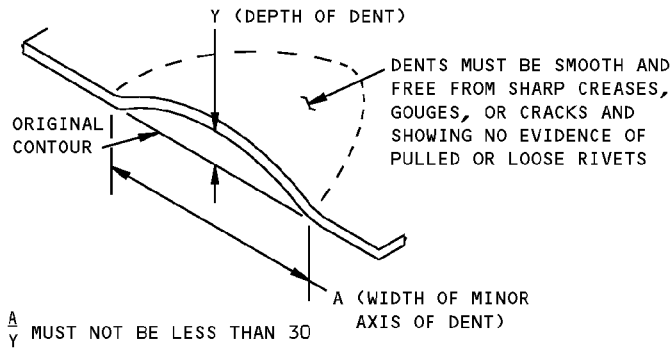
**ALLOWABLE DAMAGE FOR DENT
DETAIL VIII**

- H** DENTS GENERALLY RESULT IN FIBER DAMAGE OR DELAMINATION. HOWEVER, PROVIDED THAT THERE IS NO FIBER DAMAGE OR DELAMINATION, DENTS UP TO 1.50 DIA MAX ARE ALLOWED. ONE DENT PER SQUARE FOOT OF AREA ALLOWED WHICH MUST BE A MINIMUM OF 6 INCHES FROM ANY OTHER DAMAGE, FASTENER HOLE, OR PANEL EDGE. IF FIBER DAMAGE OR DELAMINATION IS PRESENT, REFER TO APPLICABLE DAMAGE DATA IN TABLE.

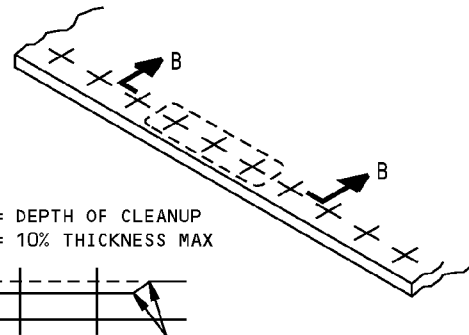
BLEND OUT WITH 0.50 INCH RADIUS MINIMUM. CORROSION CLEANUP AROUND ANY THREE FASTENERS IN TEN IS PERMITTED TO MAX DEPTH

SECTION B-B

**CORROSION CLEANUP
DETAIL IX**

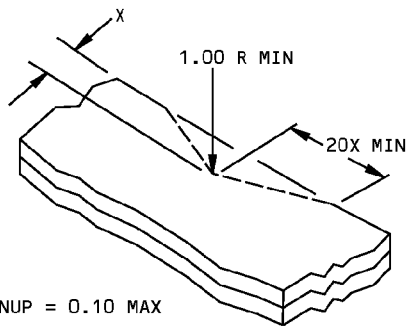
X = DEPTH OF CLEANUP = 0.10 MAX

**REMOVAL OF NICK OR CRACK DAMAGE ON AN EDGE
DETAIL X**

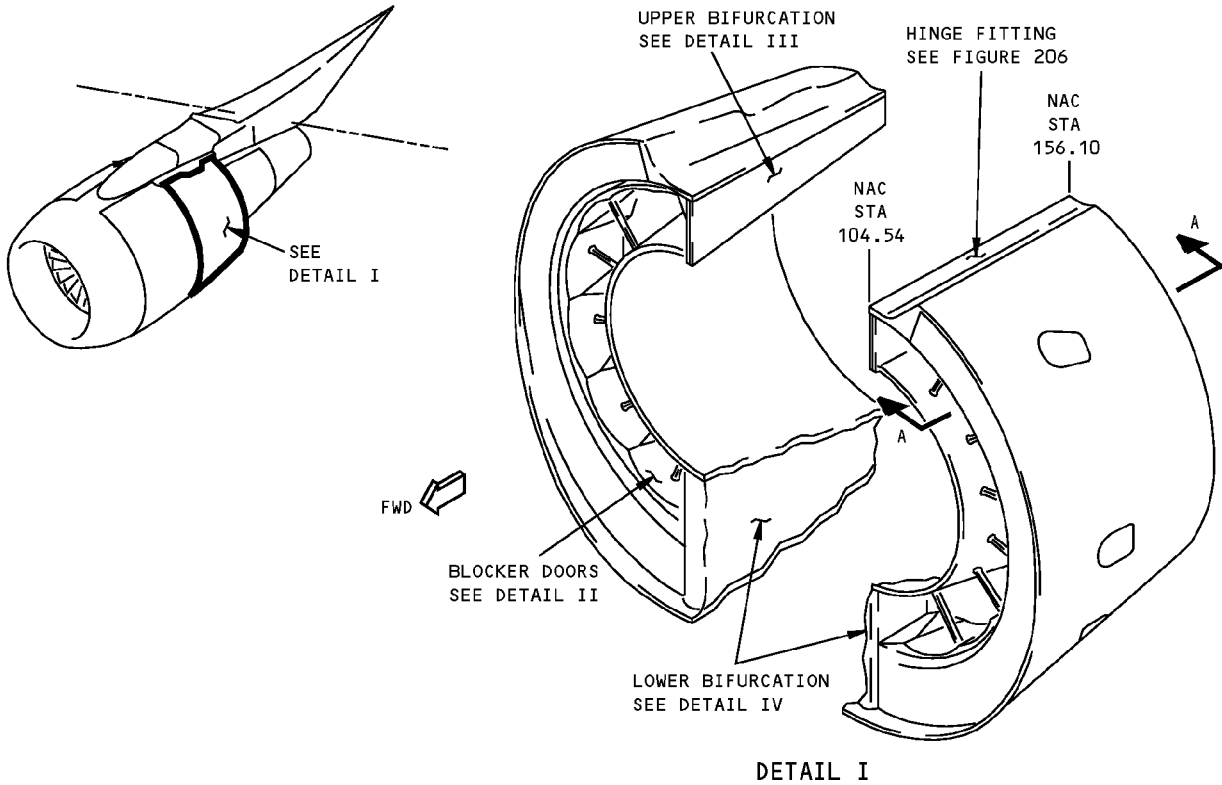
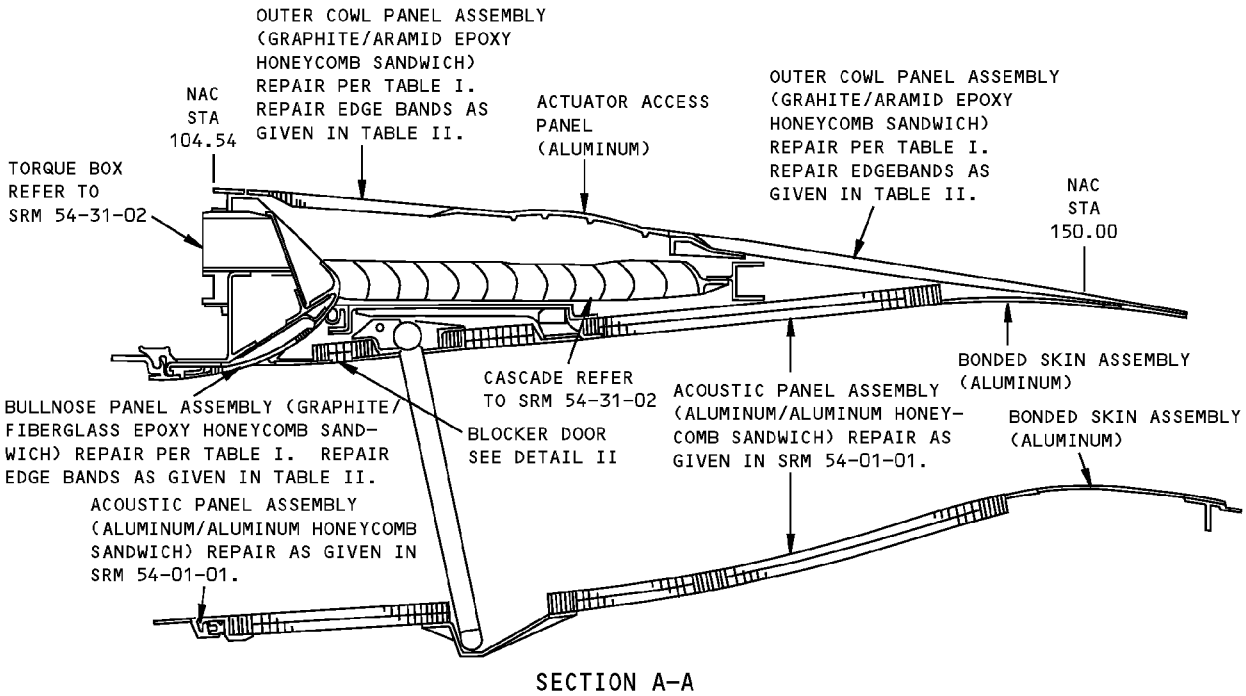
**Fan Duct Cowl and Thrust Reverser Skin Repair - PW2000 Engine
Figure 201 (Sheet 1 of 5)**

REPAIR 1 - FAN DUCT COWL AND THRUST REVERSER SKIN - PW2000 ENGINE

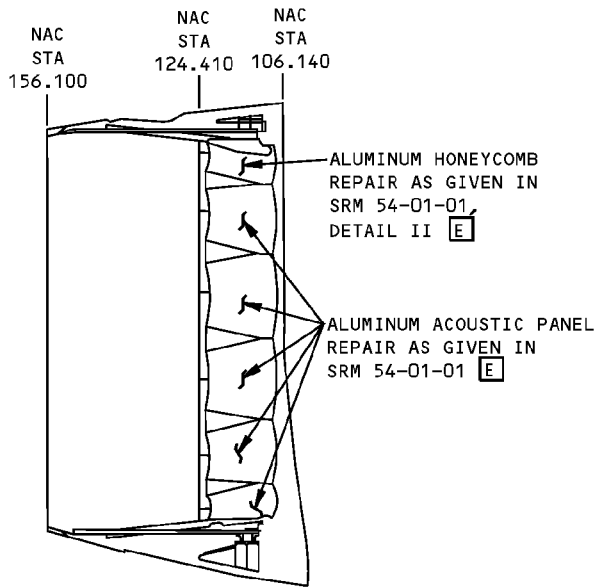
**BLOCKER DOOR ASSY
(ALUMINUM/ALUMINUM HONEYCOMB SANDWICH)
DETAIL II**

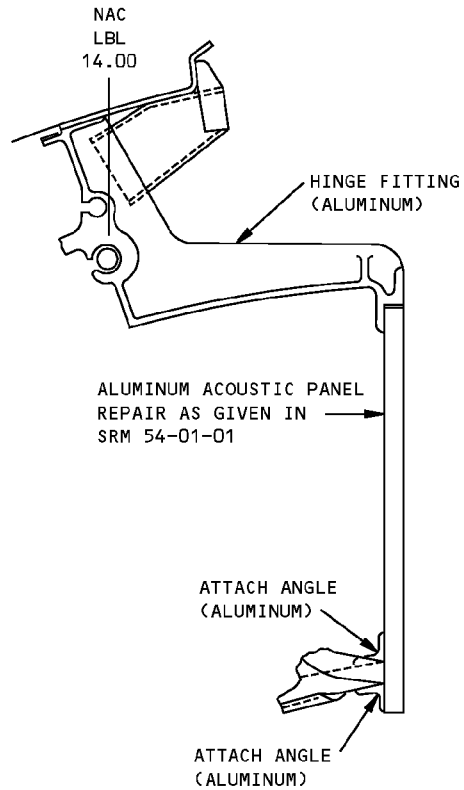
**UPPER BIFURCATION PANEL
REAR VIEW
LEFT SIDE SHOWN - RIGHT SIDE OPPOSITE
DETAIL III**

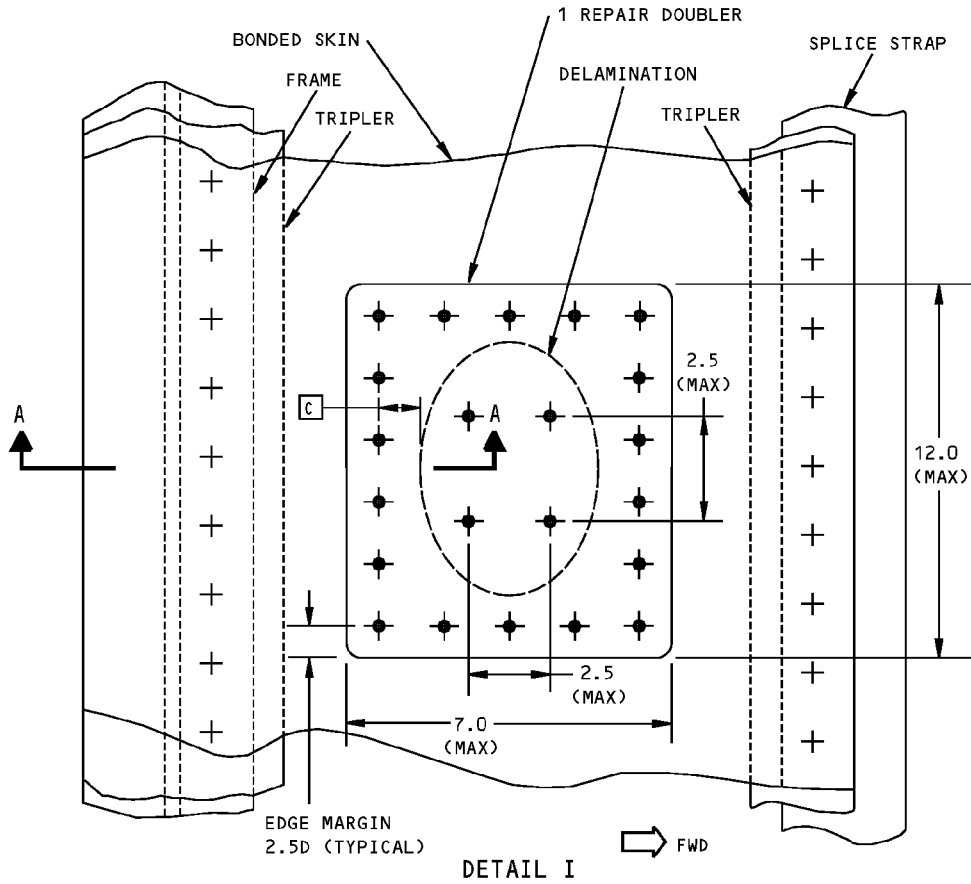
**Fan Duct Inner Wall Bonded Skin Repair - PW2000 Engine
Figure 201 (Sheet 2 of 3)**

REPAIR MATERIAL			
PART	QTY	MATERIAL	
1	REPAIR DOUBLER	1	0.020 2024-T3

1. Get access to the inside of the fan duct at the location of damage.
2. Make the repair doubler as shown in Detail I or Detail II. **B** **D**
3. Locate and mark the fastener holes on the repair doubler.

- A** USE UP TO 1/32 OVERSIZE FASTENER.
- B** USE DETAIL I TO REPAIR SMALL AREAS OF DELAMINATION. USE DETAIL II TO REPAIR LARGER AREAS OF DELAMINATION WHERE REPAIR DOUBLER EXTENDS TO FRAME AND SPLICE STRAP.
- C** MAINTAIN 2.5D EDGE MARGIN TO ENSURE CONTAINMENT OF DELAMINATION.
- D** THE REPAIR DOUBLER IN DETAIL II WILL NOT BE SQUARE DUE TO OFFSET FASTENER SPACING IN FRAME AND SPLICE STRAP.
- E** THE CRES FIRESHIELD IS LOCATED ONLY ABOVE THE 45° RADIALS ON THE RIGHT AND LEFT SIDES OF THE FAN DUCT.

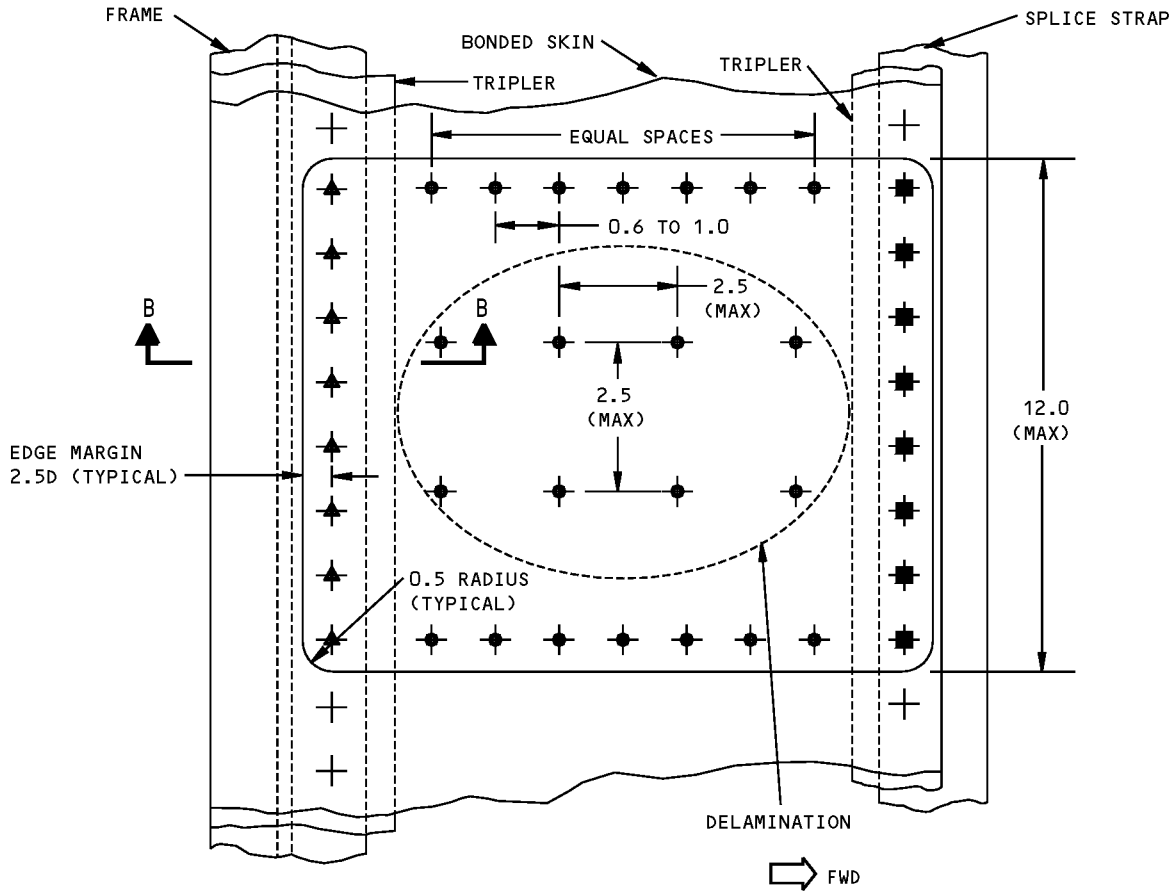
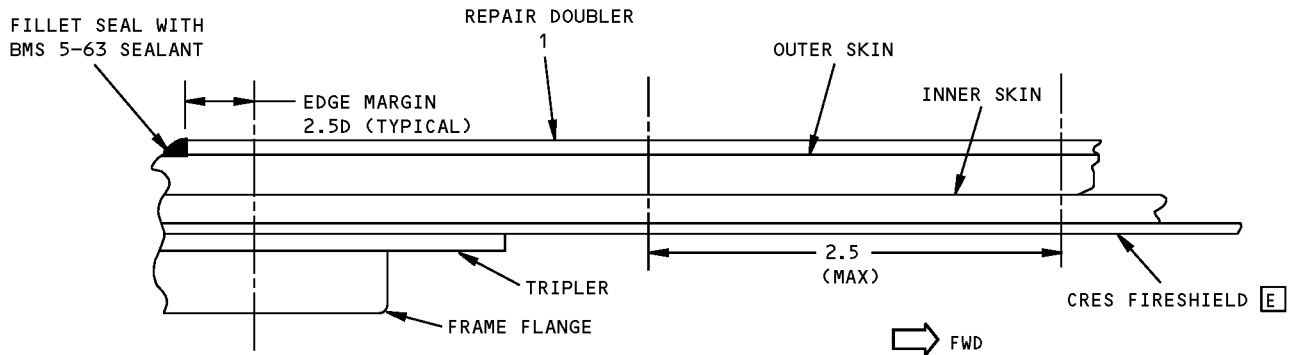
**Fan Duct Inner Wall Bonded Skin Repair - PW2000 Engine
Figure 201 (Sheet 3 of 3)**

DETAIL II

SECTION B-B

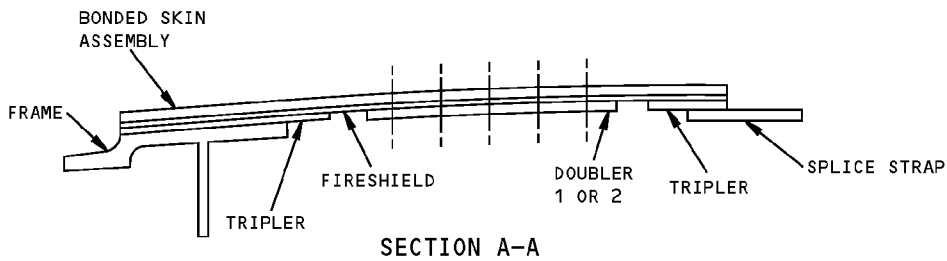
**Fan Duct Cowl Inner Wall Fireshield Delamination Repair - PW2000 Engine
Figure 201 (Sheet 2 of 2)**

LEFT SIDE OF ENGINE SHOWN
DETAIL I

1. Make doubler 1. Refer to Table I and Detail I. Make the repair doubler fit the contour of the cowl.
2. Put doubler 1 in place on the cowl and drill the fastener holes.
3. Remove the nicks, burrs, scratches, gouges, and sharp edges from the cowl and doubler 1.
4. Apply Alodine to the repair doubler.
5. Apply one layer of BAC5710, Type 51 (DeSoto Hi-Temp) primer to the repair doubler and the bare edges of the cowl. Refer to AMM 51-21.
6. Install doubler 1. Make a fay surface seal with BMS 5-63, Type I sealant. Install fasteners wet with BMS 5-63, Type I sealant.
7. Apply a fillet seal all the way around the repair doubler edge with BMS 5-63, Type I sealant.

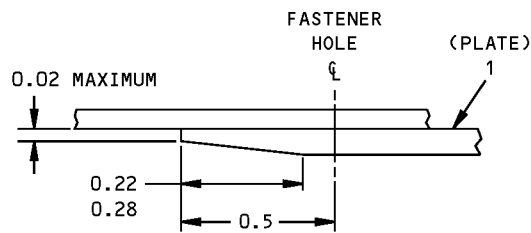
**Thrust Reverser Inner Wall Aft Cowl External Repair - PW2000 Engine
Figure 201 (Sheet 4 of 4)**

SECTION B-B

SECTION C-C

SECTION D-D

**EDGE CHAMFER TYPICAL ALL EDGES
DETAIL III**

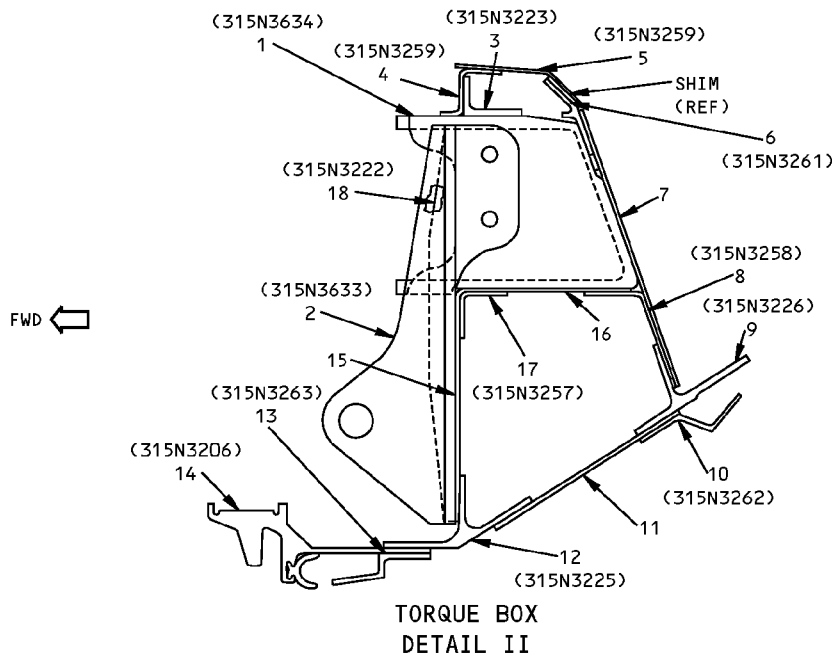
LIST OF MATERIALS FOR DETAIL II

REF DWG
315N3202

ITEM	DESCRIPTION	GAGE	MATERIAL	EFFECTIVITY
1	ACTUATOR FITTING		7075-T73 FORGING	
2	BRACKET		BAC1505-101231 7075-T73511	
3	FRAME		AND10133-1203 7075-T73	
4	CHORD	0.050	2024-T42 OR INCONEL 625 PER AMS 5599	
5	CHORD	0.040	INCONEL 625 PER AMS 5599	
6	STIFFENER		TI-6AL-4V MACHINED BAR	
7	FIREWALL	0.040	TI-6AL-4V	
8	CHORD	0.063	CLAD 2024-T42	
9	CHORD		BAC1506-3538 2024-T3511	
10	SUPPORT ZEE		BAC1517-2315 7075-T73511	
11	WEB ASSY			
	DOUBLER	0.020	2024-T3	
	DOUBLER	0.020	2024-T3	
	WEB	0.025	2024-T3	
12	CHORD		BAC1506-3513 2024-T3511	
13	SUPPORT ZEE		BAC1517-2304 7075-T73511	
14	VEE GROOVE FITTING		BAC1506-3516 7075-T73511	
15	WEB ASSY			
	DOUBLER	0.016	2024-T3	
	WEB	0.040	2024-T3	
16	WEB	0.040	CLAD 2024-T3	
17	CHORD		BAC1514-2741 2024-T42	
18	STIFFENER		BAC1505-100120 7075-T73511

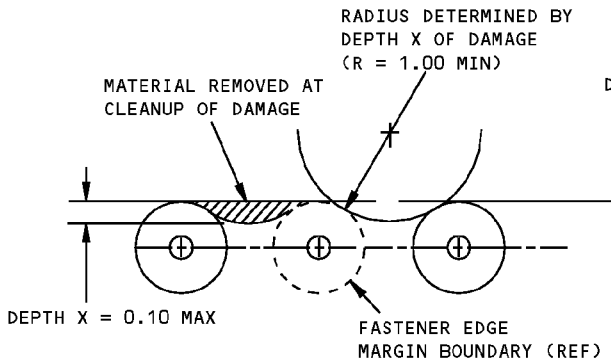
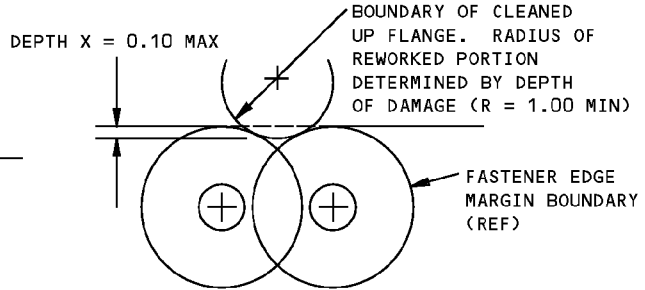
DETAIL III

**DAMAGE CLEANUP OF EDGES WHERE
FASTENER EDGE MARGINS DO NOT OVERLAP**

**DAMAGE CLEANUP OF EDGES WHERE
FASTENER EDGE MARGINS OVERLAP**

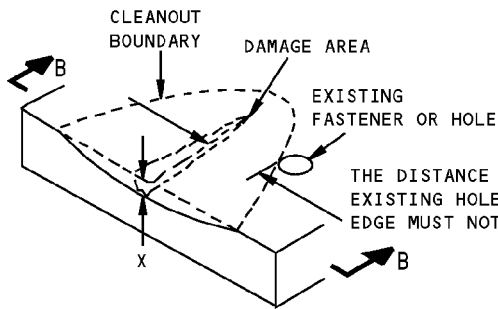
SECTION B-B

REMOVAL OF NICK, GOUGE AND SCRATCH DAMAGE ON A SURFACE

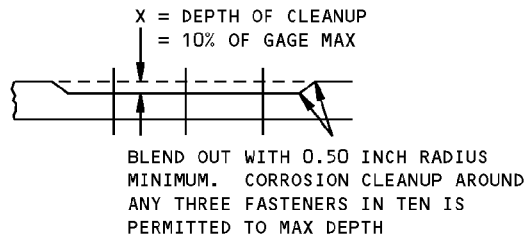
SECTION C-C

**CORROSION CLEANUP
DETAIL VI**

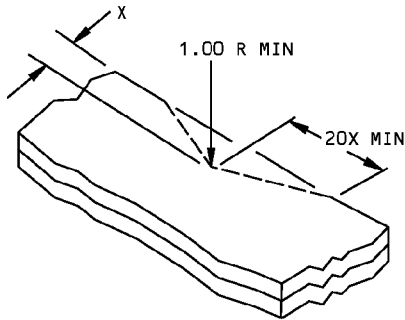
DETAIL VII

X = DEPTH OF CLEANUP = 0.10 MAX

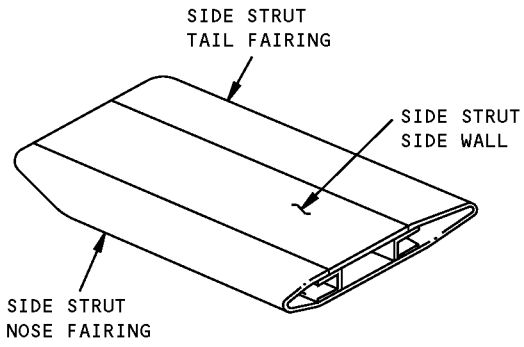
**SIDE SUPPORT STRUT
DETAIL II**

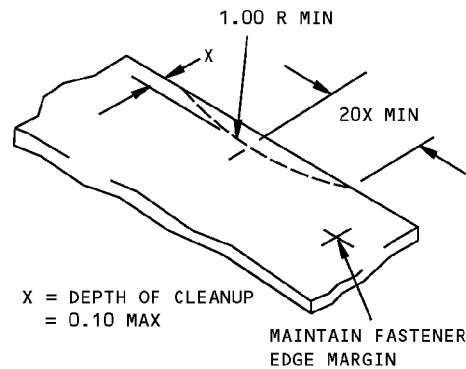
REMOVAL OF NICK OR CRACK
DAMAGE ON AN EDGE
DETAIL VI

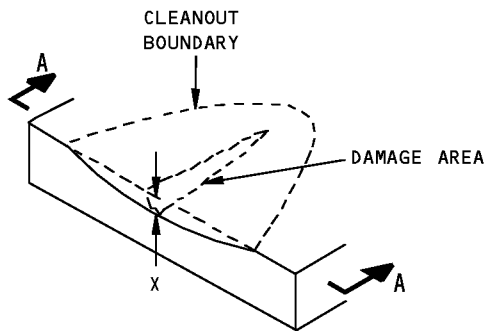
Common Nozzle Assembly Scratch Repair - RB211-535E4 Engine
Figure 201

REMOVAL OF NICK, GOUGE, AND SCRATCH DAMAGE ON A SURFACE
DETAIL I

1. If the gouge, nick or scratch is no larger than 10.0 inches (250 mm) long, 0.10 inch (2.5 mm) wide or 0.010 (0.25 mm) inch deep then repair as shown in Detail I.
2. If the gouge, nick or scratch does not meet the conditions in Step 1 then repair the damage as a crack. Refer to Repair 1.

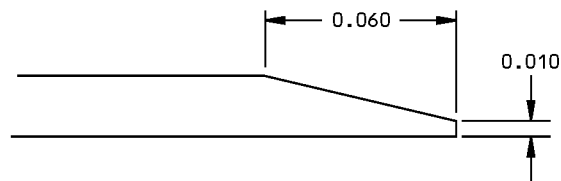
DOUBLER EDGE CHAMFER
DETAIL II

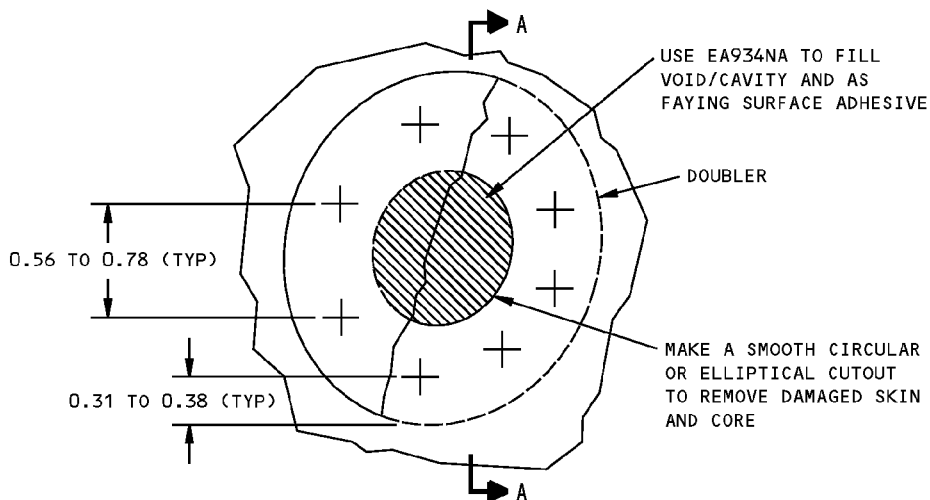
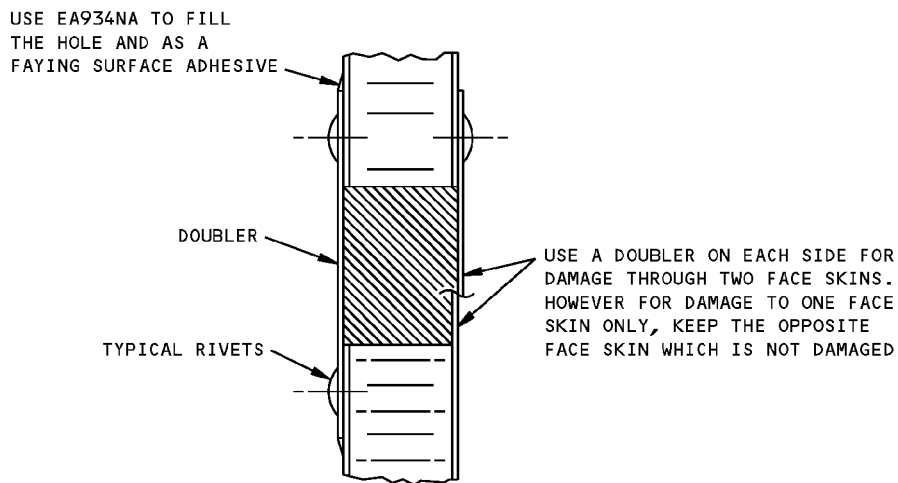
SECTION A-A

- + REPAIR FASTENER LOCATION. INSTALL A CR3555-4-1 UNISINK BLIND RIVET
- ⊕ REPAIR FASTENER LOCATED IN A PERFORATION. INSTALL A CR3555-4-1 UNISINK BLIND RIVET
- ◆ REPAIR FASTENER LOCATION. INSTALL A BACB30ND6A REPAIR HI-LOK

REPAIR MATERIAL			
PART		QTY	MATERIAL
1	DOUBLER	A	0.020 TI 6AL-4V
2	FILLER	1	0.020 TI 6AL-4V
3	CORE	1	CRES HONEYCOMB

POTTING REPAIR
DETAIL I

1. Damage to honeycomb core panels can be repaired by potting or by honeycomb core replacement.
 - A. The limits for repair by potting are as follows (refer to Detail I):
 - (1) Damage that extends through both face skins and honeycomb core can be repaired if 1.60 inches (40 mm) dia or less.
 - (2) Damage that extends through one face skin and honeycomb core can be repaired if 2.0 square inches (13 square cm) or less or if narrower than 0.75 inch (19 mm).
 - B. The limit for repair by honeycomb core replacement for one face skin and honeycomb core only is up to 20.0 square inches (130 square mm). Refer to Detail II.
2. Remove the damaged skin and honeycomb core with a router and saw.

For repair by potting, the removal of damaged core is not necessary. Fill the damaged core with adhesive.

8. For repair by potting, fill the damaged core with EA934NA adhesive.

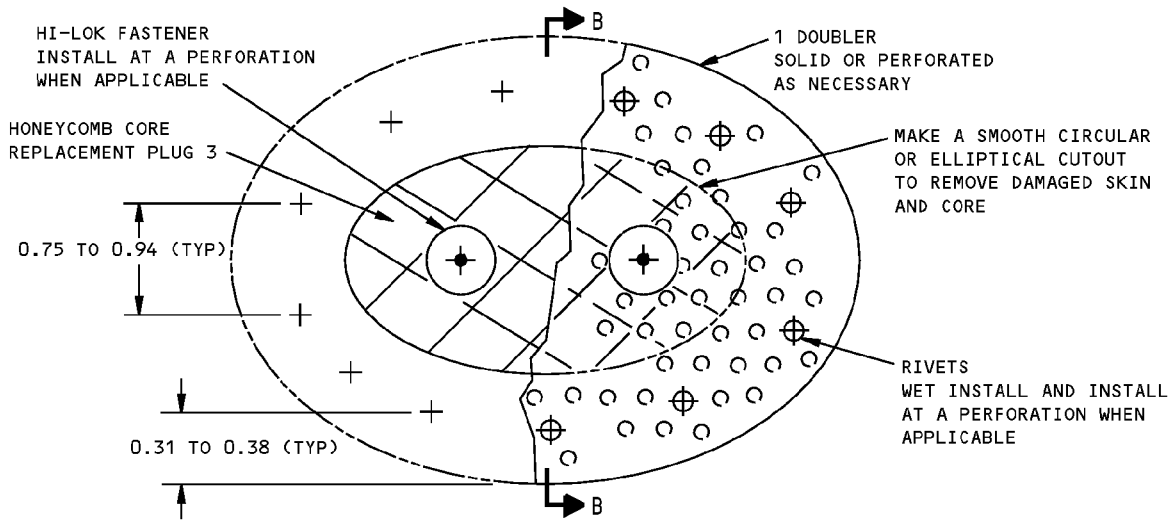
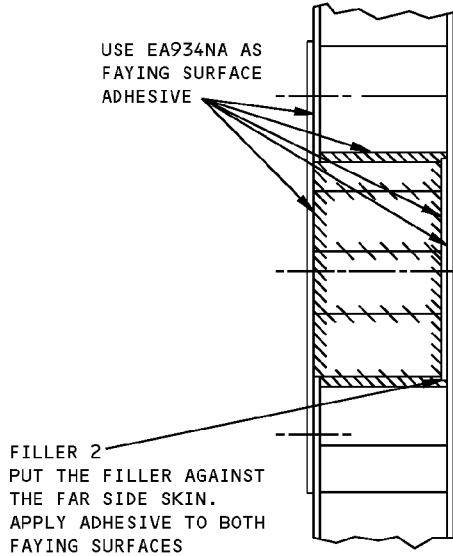
SECTION B-B

HONEYCOMB CORE REPLACEMENT REPAIR
DETAIL II

For repair by honeycomb core replacement, remove the adhesive fillets on the far side skin but do not damage the skin itself. Refer to SRM 51-10-00.
3. Make the repair part(s).

For honeycomb core replacement, the core should fit in the repair hole with contact on all sides.
4. Put the doubler in place and drill the fastener holes.
5. Remove the doubler.
6. Remove all the nicks, scratches, gouges, sharp edges, and burrs from the nozzle and the repair part(s).
7. Wipe the repair area on the nozzle and the repair parts with methyl isobutyl ketone (MIBK), methyl ethyl ketone (MEK) or acetone and a clean cotton cloth. Wipe the surfaces dry before the solvent evaporates.

For repair by honeycomb core replacement, vapor degrease the core. Refer to 20-30-03 of the Standard Overhaul Practices Manual, D6-51702.

For repair by honeycomb core replacement, install the filler and replacement core. Install the filler with EA934NA adhesive between the faying surfaces. Apply the adhesive to the bottom and sides of the replacement core and install the plug.
9. For repair by potting, install the repair doubler with EA934NA adhesive between the faying surfaces.

For repair by honeycomb core replacement, apply the adhesive to both the top of the replacement core and to the faying surface of the repair doubler and install the doubler.

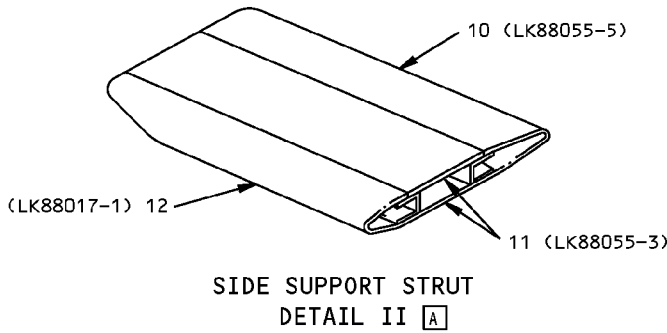
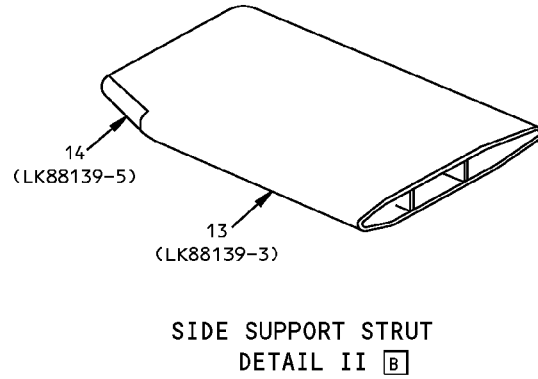
LIST OF MATERIALS FOR DETAILS I,II AND III

ITEM	DESCRIPTION	GAGE	MATERIAL	EFFECTIVITY
1	SEAL	0.080	AL CLAD 2024-0	
2	PYLON SEAL LOCATION BUSH		AMS 5630	
3	SEAL RETAINER BRACKET		AMS 5646	
4	EXIT NOZZLE FAIRING	0.050	2024-T3	
5	EXIT NOZZLE TRAILING EDGE		EXTRUDED 2024-T4 2024-T4	
6	LID BOND PANEL	0.020	T1-6AL-4V	
7	FAIRING FRAME		2024-0 ALUMINUM	B
8	RUBBING BLOCK		TEFLON AMS 3651	
9	TRANSLATING COWL REAR SEAL		ARM 834 ARM 835	
10	SIDE STRUT TAIL FAIRING	0.063	2024-T42	A
11	SIDE STRUT SIDE WALL	0.063	2024-T3	A
12	SIDE STRUT NOSE FAIRING	0.063	2024-T3	A
13	SIDE STRUT	0.110	6061-0 ALUMINUM SHEET	B
14	SIDE STRUT NOSE EXTENSION	0.100	6061-0 ALUMINUM SHEET	B

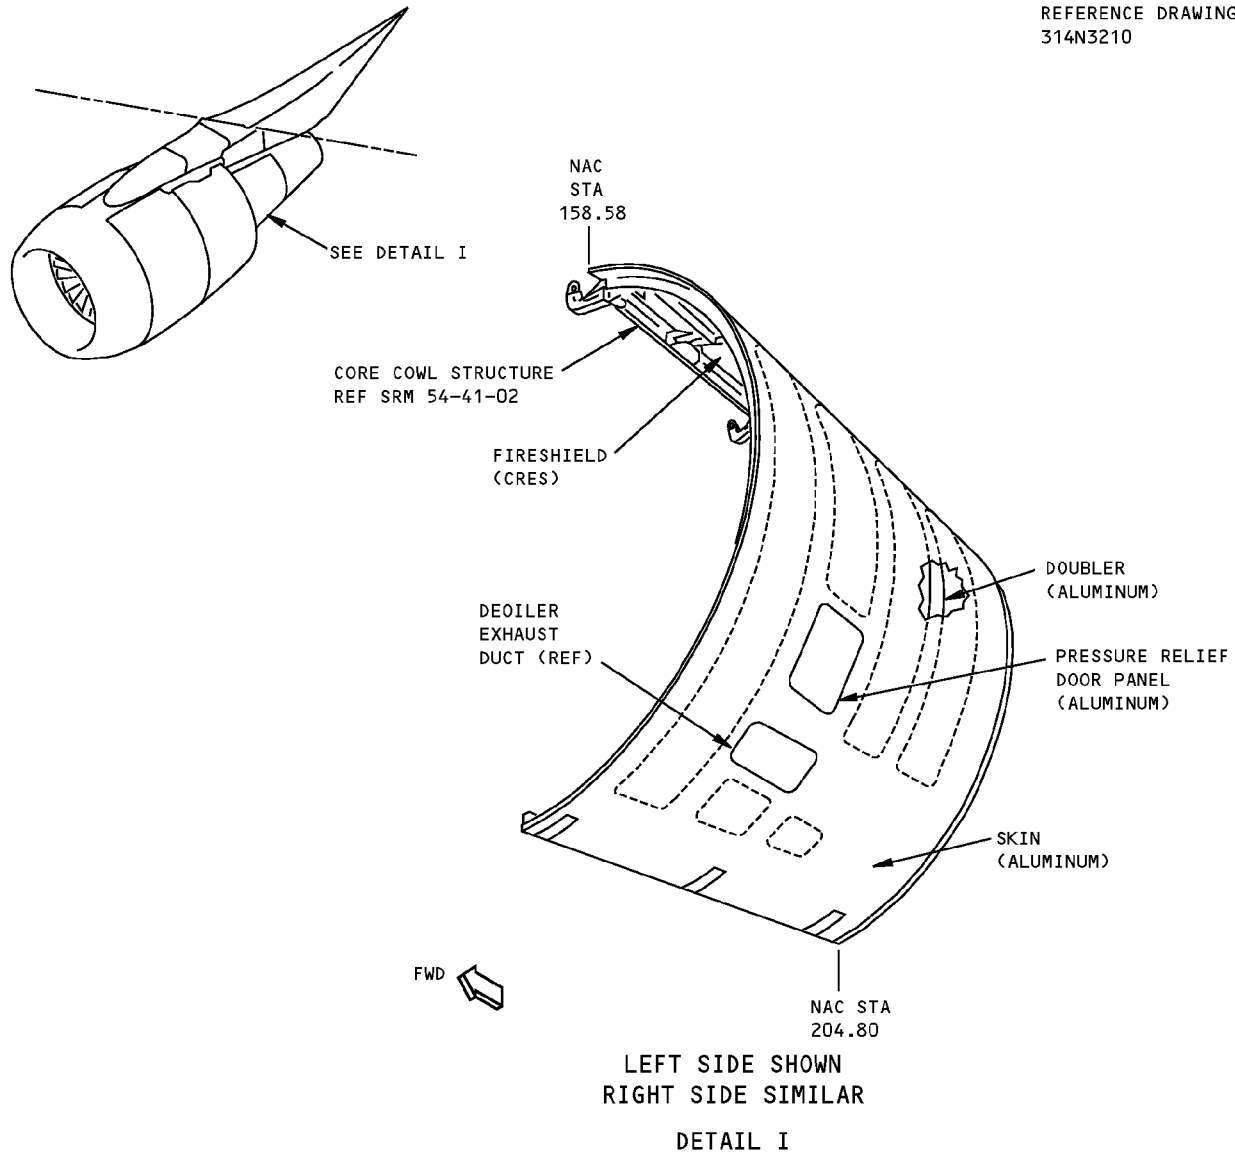
**Core Cowl Skin Allowable Damage - PW2000 Engine
Figure 101 (Sheet 1 of 3)**

ALLOWABLE DAMAGE 1 - CORE COWL SKIN - PW2000 ENGINE

DESCRIPTION	CRACKS	NICKS, GOUGES AND CORROSION	DENTS	HOLES AND PUNCTURES
FIRESHIELD (CRES)	F	B	SEE DETAIL IV	C
DOOR PANEL (ALUMINUM)	E	B	SEE DETAIL IV	D
DOUBLER (ALUMINUM)	A	B	SEE DETAIL IV	D
SKIN (ALUMINUM)	E	B	SEE DETAIL IV	D

- A** CRACKS ARE NOT PERMITTED EXCEPT FOR EDGE CRACKS WHICH MUST BE REMOVED AS SHOWN IN DETAILS II AND VI.
- B** REMOVE DAMAGE AS SHOWN IN DETAILS II, III AND V.
- C** CLEAN OUT DAMAGE UP TO 0.25 INCH (6 mm) MAXIMUM, AND NOT CLOSER THAN 1.0 INCH (25 mm) TO FASTENER HOLE, MATERIAL EDGE, OR OTHER DAMAGE.

- D** CLEAN OUT DAMAGE UP TO 0.25 INCH (6 mm) MAXIMUM DIA AND NOT CLOSER THAN 1.0 INCH (25 mm) TO FASTENER HOLE, MATERIAL EDGE, OR OTHER DAMAGE. FILL HOLE WITH A 2117-T3 OR T4 ALUMINUM RIVET INSTALLED WET WITH BMS 5-95 SEALANT. ALL OTHER HOLES TO BE REPAIRED.
- E** 1.00 (25 mm) MAXIMUM LENGTH CRACK PERMITTED PROVIDED CRACK IS MINIMUM 6.00 INCHES (150 mm) FROM HINGE OR LATCH FITTINGS AND MINIMUM 3.00 INCHES (80 mm) FROM PANEL EDGE OR ADJACENT DAMAGE. DRILL 0.19 INCH (3 mm) STOP HOLES AT ENDS OF CRACK AND REPAIR AT NEXT AIRPLANE "A" CHECK. REMOVE EDGE CRACKS AS SHOWN IN DETAILS II AND VI.
- F** DRILL 0.25 INCH (6 mm) DIA HOLES AT ENDS OF CRACK.

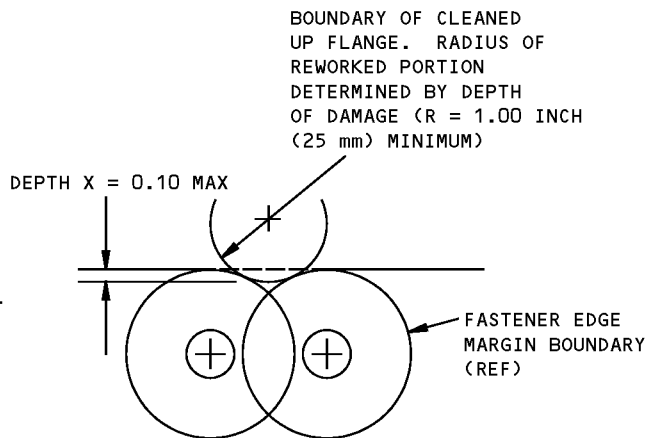
DETAIL II

DAMAGE CLEANUP OF EDGES WHERE FASTENER EDGE MARGINS DO NOT OVERLAP

DAMAGE CLEANUP OF EDGES WHERE FASTENER EDGE MARGINS OVERLAP

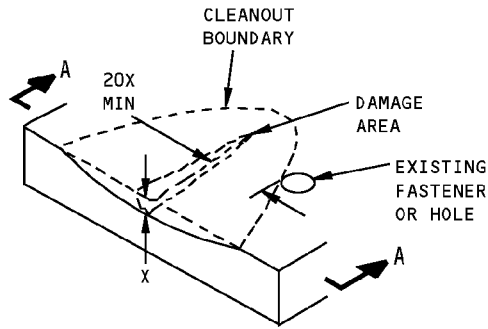
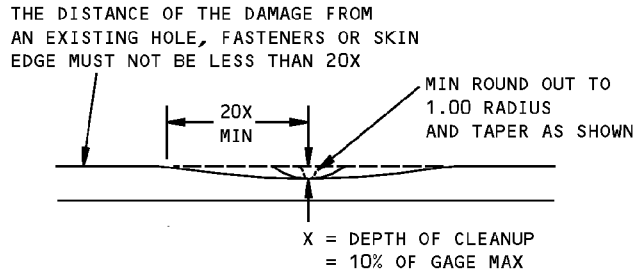
SECTION A-A

**REMOVAL OF NICK, GOUGE OR SCRATCH DAMAGE ON A SURFACE
DETAIL III**

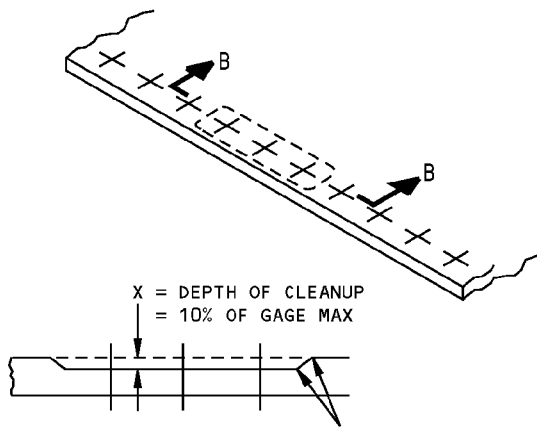
SECTION B-B

SMOOTH BLEND-OUT RADIUS 0.50 INCH MINIMUM. CORROSION CLEANUP AROUND ANY THREE FASTENERS IN TEN IS PERMITTED TO MAX DEPTH

**CORROSION CLEANUP
DETAIL V**

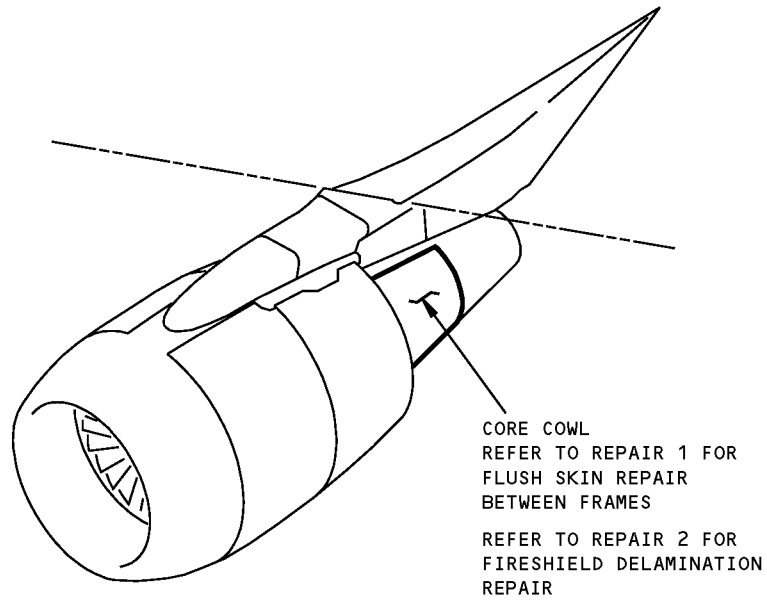
Core Cowl Skin Repair - PW2000 Engine
Figure 201

REPAIR GENERAL - CORE COWL SKIN - PW2000 ENGINE

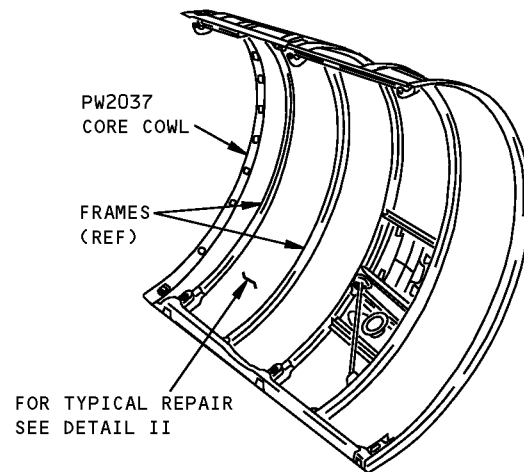
DETAIL I

REPAIR MATERIAL			
	PART	QTY	MATERIAL
1	REPAIR PLATE	1	0.050 INCH (1.3mm) 2024-T3
2	FILLER	1	0.040 INCH (1.0 mm) CLAD 2024-T3

Core Cowl Skin - Flush Repair Between Frames - PW2000 Engine
Figure 201 (Sheet 1 of 2)

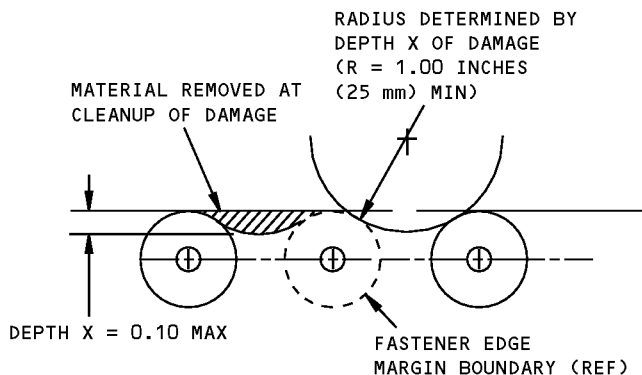
DAMAGE CLEANUP OF EDGES WHERE FASTENER EDGE MARGINS DO NOT OVERLAP

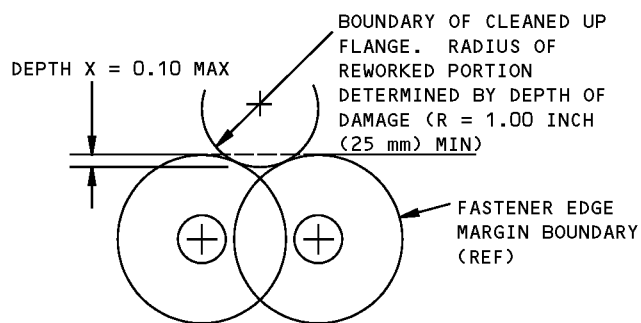
DAMAGE CLEANUP OF EDGES WHERE FASTENER EDGE MARGINS OVERLAP

DETAIL II
