**NACELLES AND
PYLONS**

**757-200
STRUCTURAL REPAIR MANUAL**

**CHAPTER 54
NACELLES AND PYLONS**

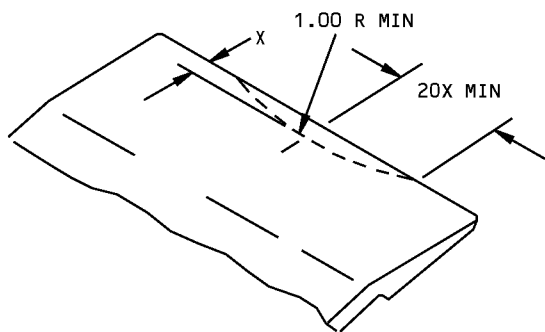
DETAIL III

X = DEPTH OF CLEANUP = 0.10 MAX

REMOVAL OF NICK OR CRACK DAMAGE ON AN EDGE

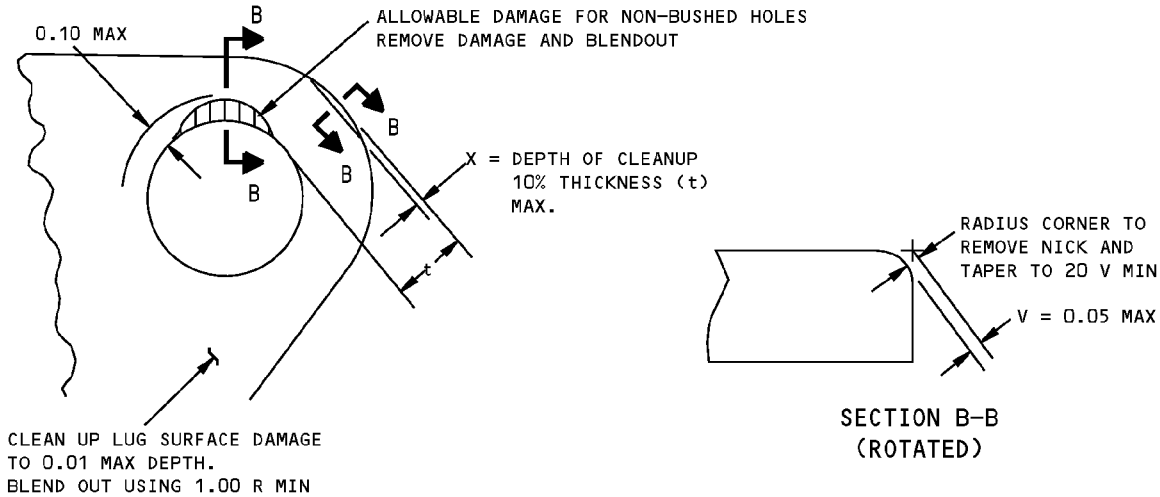
DAMAGE CLEANUP FOR EDGES AND SURFACES OF A LUG
DETAIL VII

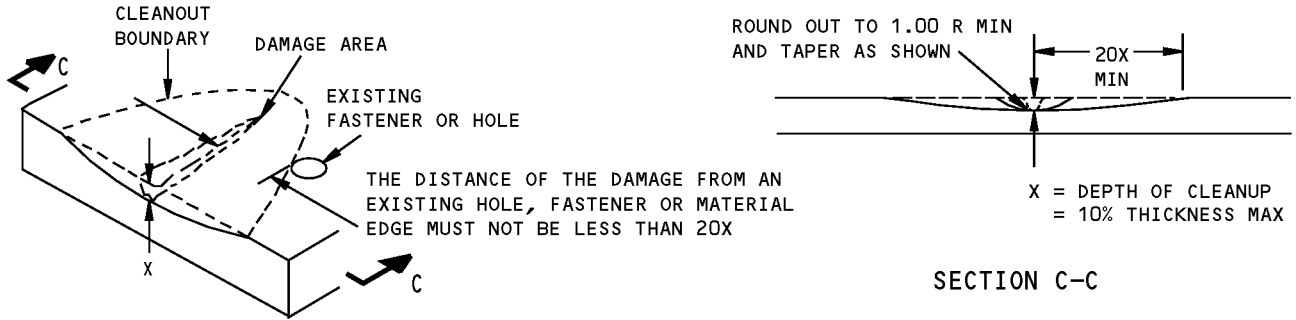
**REMOVAL OF NICK, GOUGE AND SCRATCH DAMAGE ON A SURFACE
DETAIL VIII**

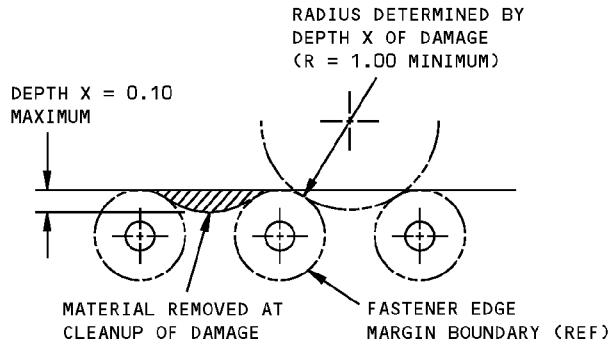
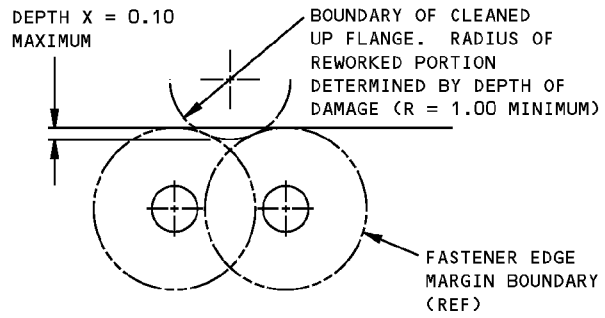
DAMAGE CLEANUP OF EDGES WHERE FASTENER EDGE MARGINS DO NOT OVERLAP

DAMAGE CLEANUP OF EDGES WHERE FASTENER EDGE MARGINS OVERLAP

- A** NO CRACKS ARE PERMITTED EXCEPT FOR EDGE CRACKS WHICH MUST BE REMOVED AS GIVEN IN DETAILS II AND IV.
- B** NICKS AND GOUGES ON EDGES MUST BE REMOVED AS GIVEN IN DETAILS III AND IV.
- C** DENTS NOT CLOSER THAN 2.00 INCHES TO EDGE OF PANEL AND WITHOUT CRACKS, SHARP CREASES, WRINKLES, DELAMINATIONS OR HOLES (OTHER THAN MANUFACTURED PERFORATIONS OF ACOUSTIC PANEL) ARE PERMITTED AS GIVEN IN DETAIL V. Y = 0.05 INCH MAXIMUM.

- M** REMOVE DAMAGE FROM NICKS, GOUGES AND SCRATCHES AS GIVEN IN DETAIL III.
- N** DAMAGE CLEANUP AND REMOVAL OF EDGE CRACKS ARE PERMITTED AS GIVEN IN DETAILS II AND IV.

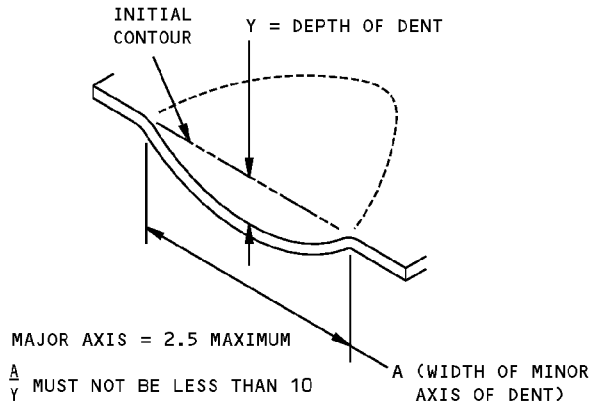
ALLOWABLE DAMAGE FOR A DENT
DETAIL V

- F** SURFACE NICKS AND GOUGES UP TO 0.10 INCH IN LENGTH OR DIAMETER ARE PERMITTED. CLEAN UP DAMAGE AS GIVEN IN DETAIL III.
- G** DENTS WITHOUT CRACKS, SHARP CREASES, WRINKLES, DELAMINATIONS, OR HOLES ARE PERMITTED AS GIVEN IN DETAIL V.

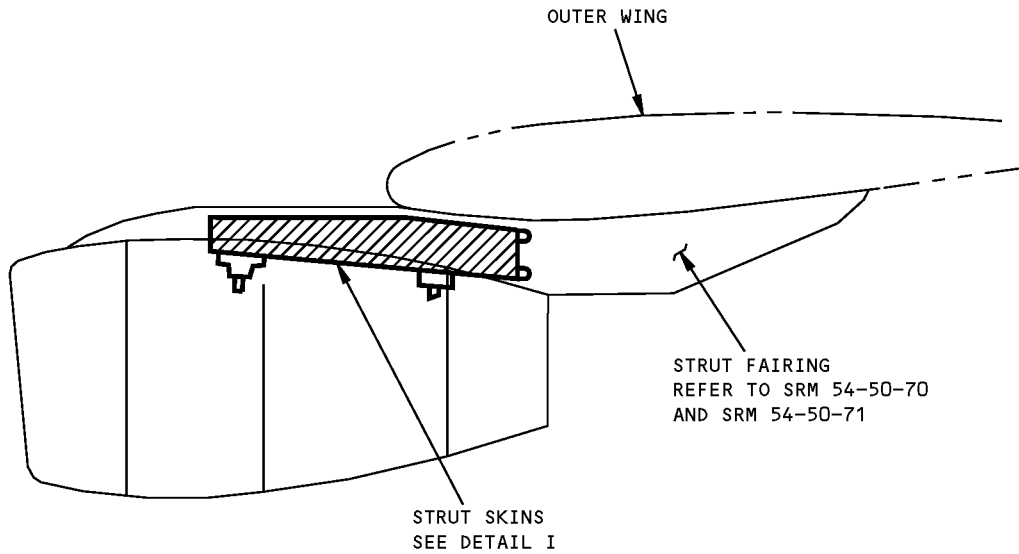
**Strut Skin Identification - RB211-535E4 Engine
Figure 1 (Sheet 1 of 3)**

IDENTIFICATION 1 - STRUT SKIN - RB211-535E4 ENGINE

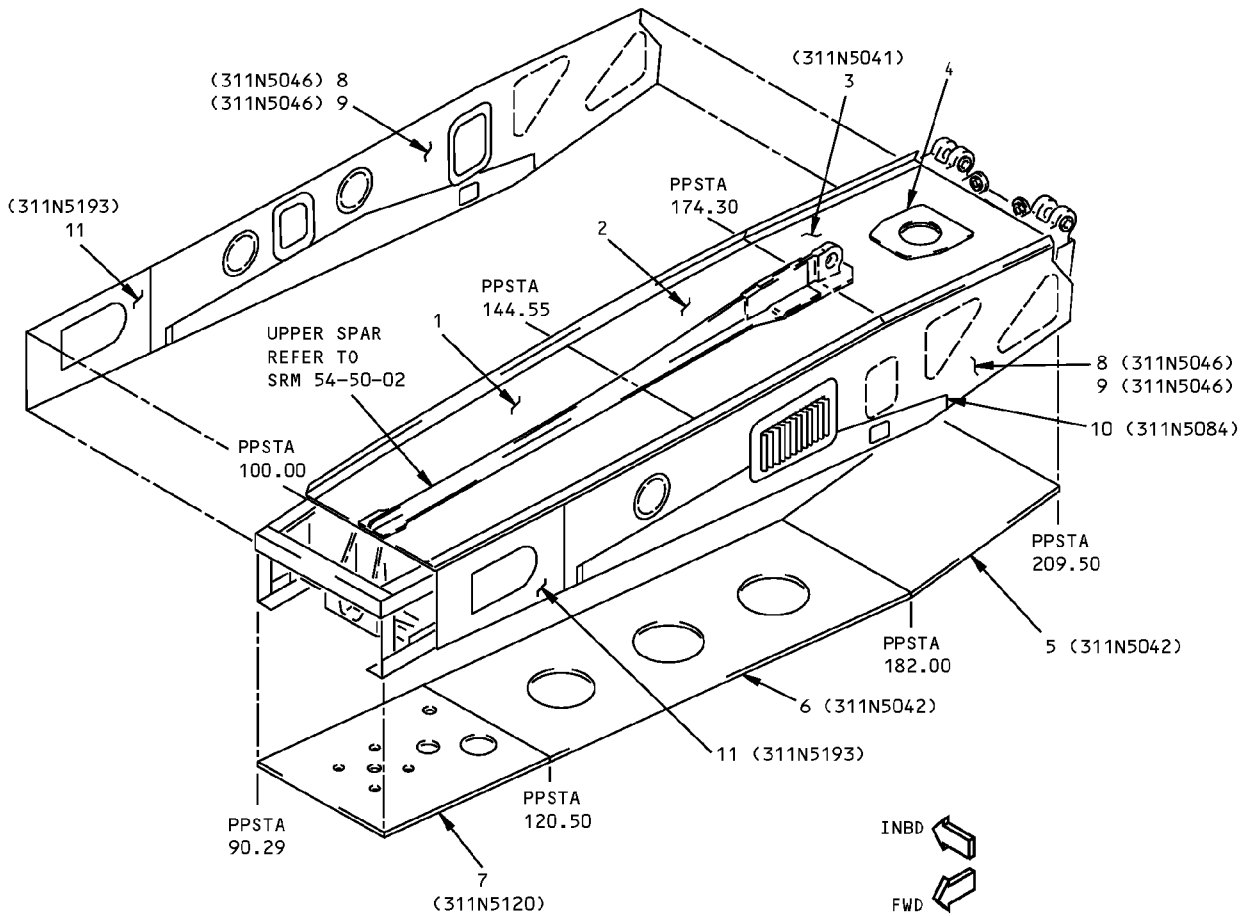
REF DWG
311N5002
311N5040
311N5041

ITEM	DESCRIPTION	GAGE	MATERIAL	EFFECTIVITY
1	FORWARD WEB	0.080	2024-T81	
2	CENTERLINE	0.063	15-5PH CRES HT-TR 180-200 KSI	
3	AFT WEB	0.071	2024-T3	
4	DOUBLER	0.063	2024-T62	
5	LOWER WEB - AFT	0.080	15-5PH CRES HT-TR 180-200 KSI	
6	LOWER WEB - CENTER	0.063	15-5PH CRES HT-TR 180-200 KSI	
7	LOWER WEB - FORWARD	0.063	6AL-4V TITANIUM TYPE III, COMP C	
8	SIDE SKIN	0.090	CLAD 2024-T42	
9	DOUBLER	0.090	2024-T42	
10	HEAT SHIELD	0.057	FIBERGLASS/EPOXY LAMINATE PER BMS 8-139, TYPE 181	
11	SIDE SKIN	1.80	MACHINED TO 0.130 2024-T351

LIST OF MATERIALS FOR DETAIL I

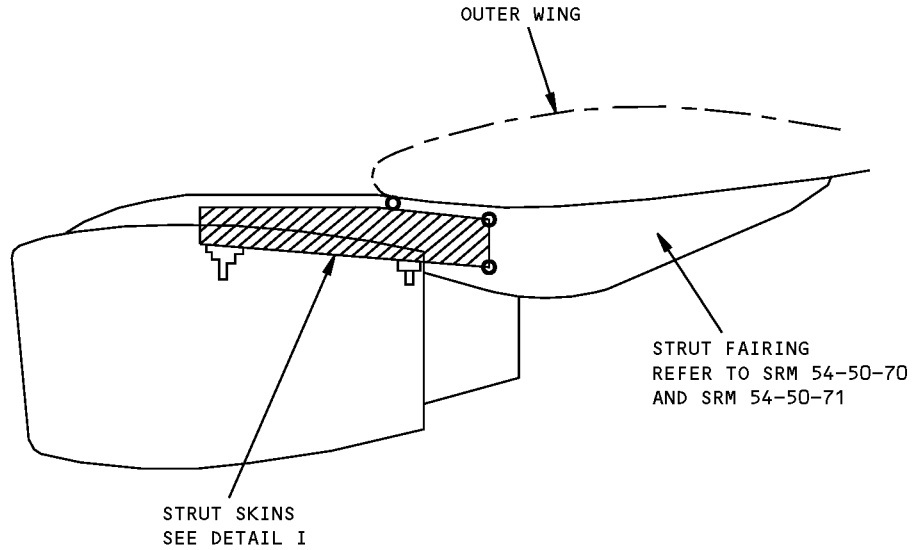
IDENTIFICATION 2 - STRUT SKIN - RB211-535C ENGINE

- A** FOR AIRPLANES WITH CUM LINE NUMBERS 1 THRU 18
- B** FOR AIRPLANES WITH CUM LINE NUMBERS 19 AND ON
- C** FOR AIRPLANES WITH CUM LINE NUMBERS 1 THRU 30, 32, 33, 34, 36, 50, 51, 52, 54, 56, 57, 58, 63, 77, 78, 81, 89, 90, 93, 98
- D** FOR AIRPLANES NOT INCLUDED IN **C**

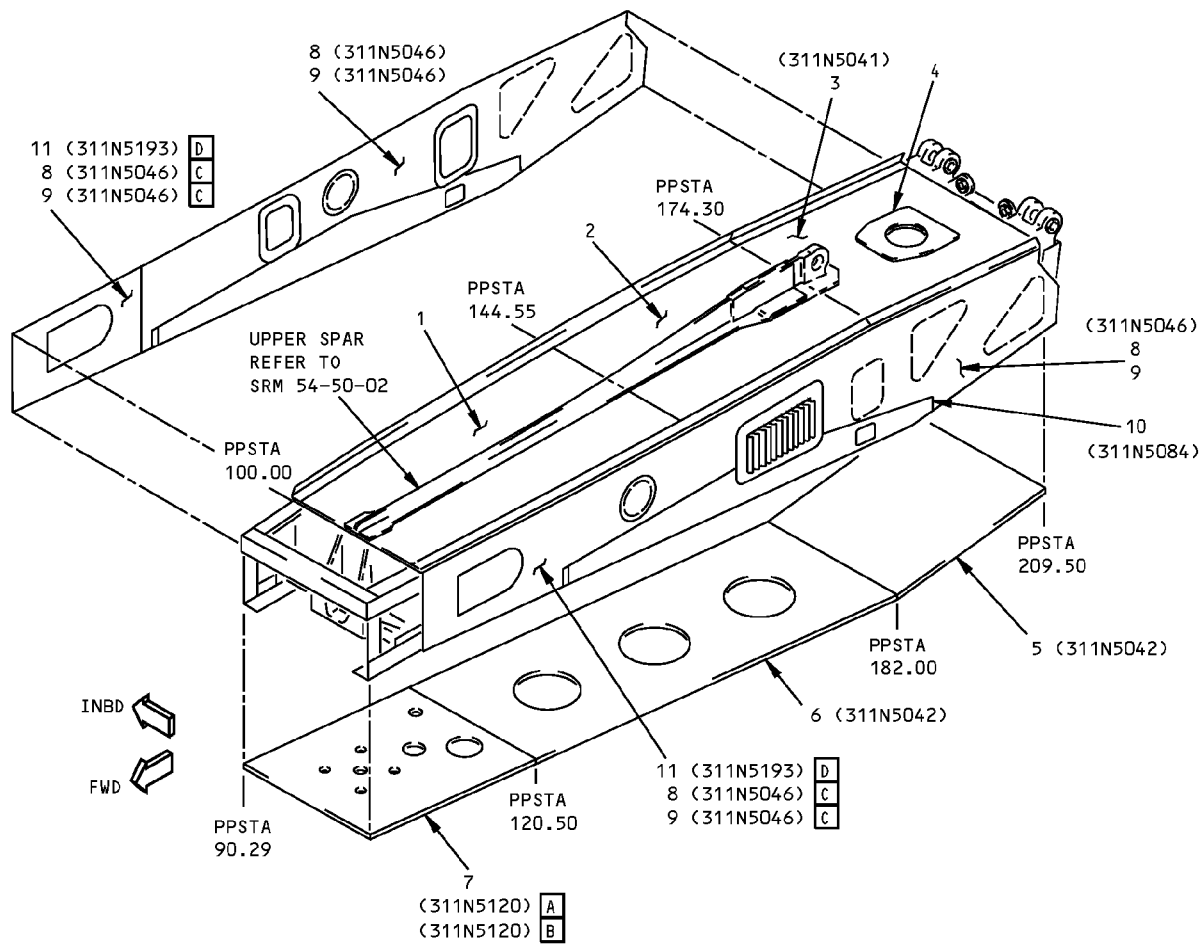
REF DWG
311N5002
311N5040
311N5041

ITEM	DESCRIPTION	GAGE	MATERIAL	EFFECTIVITY
1	FORWARD WEB	0.080	2024-T81	
2	CENTERLINE	0.063	15-5PH CRES HT-TR 180-200 KSI	
3	AFT WEB	0.071	2024-T3	
4	DOUBLER	0.063	2024-T62	
5	LOWER WEB - AFT	0.080	15-5PH CRES HT-TR 180-200 KSI	
6	LOWER WEB - CENTER	0.063	15-5PH CRES HT-TR 180-200 KSI	
7	LOWER WEB - FORWARD	0.063	6AL-4V TITANIUM TYPE III, COMP C	
8	SIDE SKIN	0.090	CLAD 2024-T42	C
9	DOUBLER	0.090	2024-T42	C
10	HEAT SHIELD	0.057	FIBERGLASS/EPOXY LAMINATE PER BMS 8-139, TYPE 181	
11	SIDE SKIN	1.80	MACHINED TO 0.130 2024-T351	D

LIST OF MATERIALS FOR DETAIL I

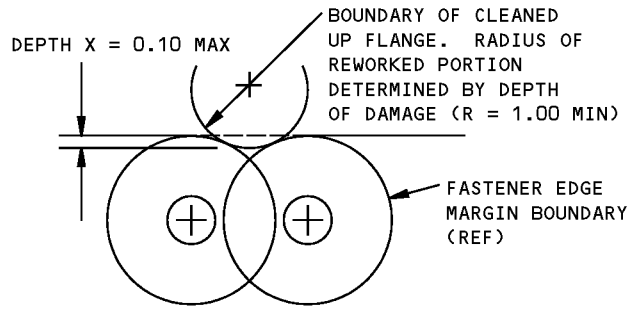
DETAIL II

DAMAGE CLEANUP OF EDGES WHERE FASTENER EDGE MARGINS DO NOT OVERLAP

DAMAGE CLEANUP OF EDGES WHERE FASTENER EDGE MARGINS OVERLAP

A CRACKS NOT ALLOWED EXCEPT FOR EDGE CRACKS WHICH MUST BE REMOVED PER DETAILS II AND VI.

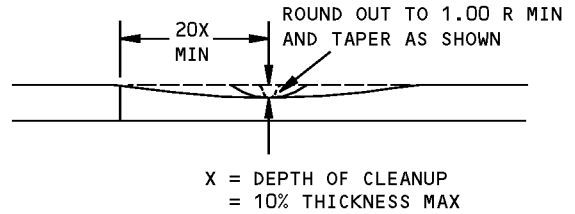
SECTION A-A

REMOVAL OF NICK, GOUGE AND SCRATCH DAMAGE ON A SURFACE

B REMOVE DAMAGE PER DETAILS II, III, AND V.

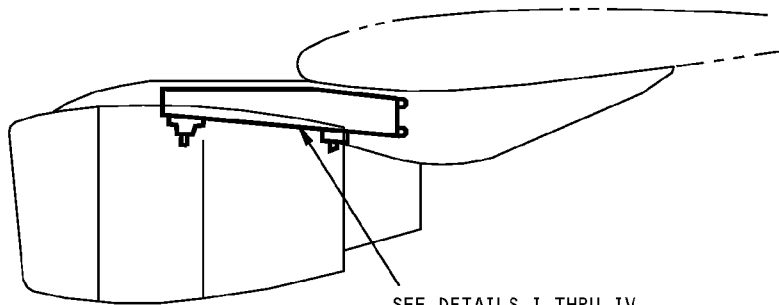
IDENTIFICATION 1 - STRUT STRUCTURE - RB211-535 ENGINE

REFERENCE DRAWING
311N0506
311N5040
311N5002

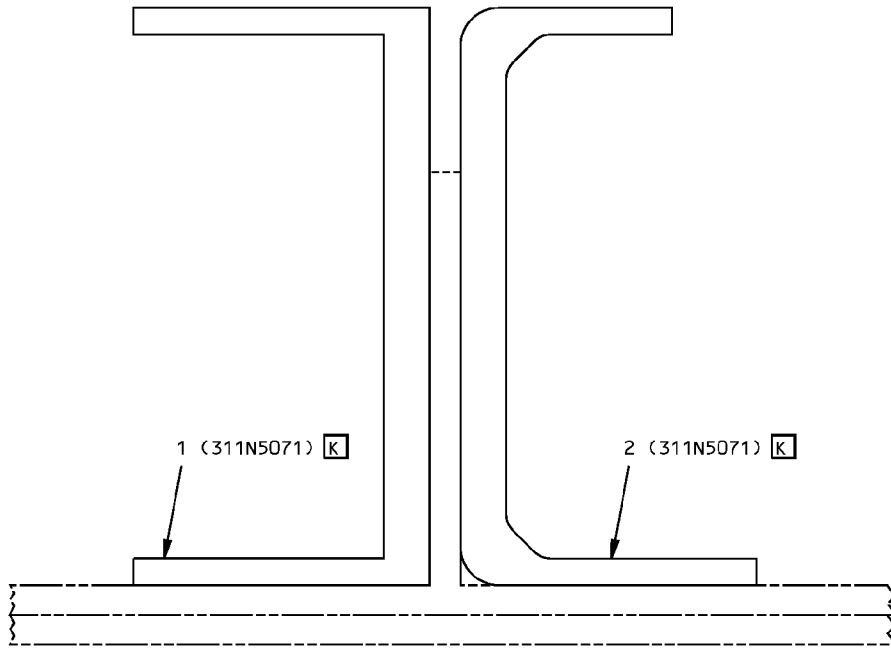
DETAIL V

ITEM	DESCRIPTION	GAGE	MATERIAL	EFFECTIVITY
1	BATHTUB FITTING		15-5PH CRES BAR HT TR 180-200 KSI	[K]
2	CHANNEL-MID CHORD		15-5PH CRES BAR HT TR 180-200 KSI	[K]

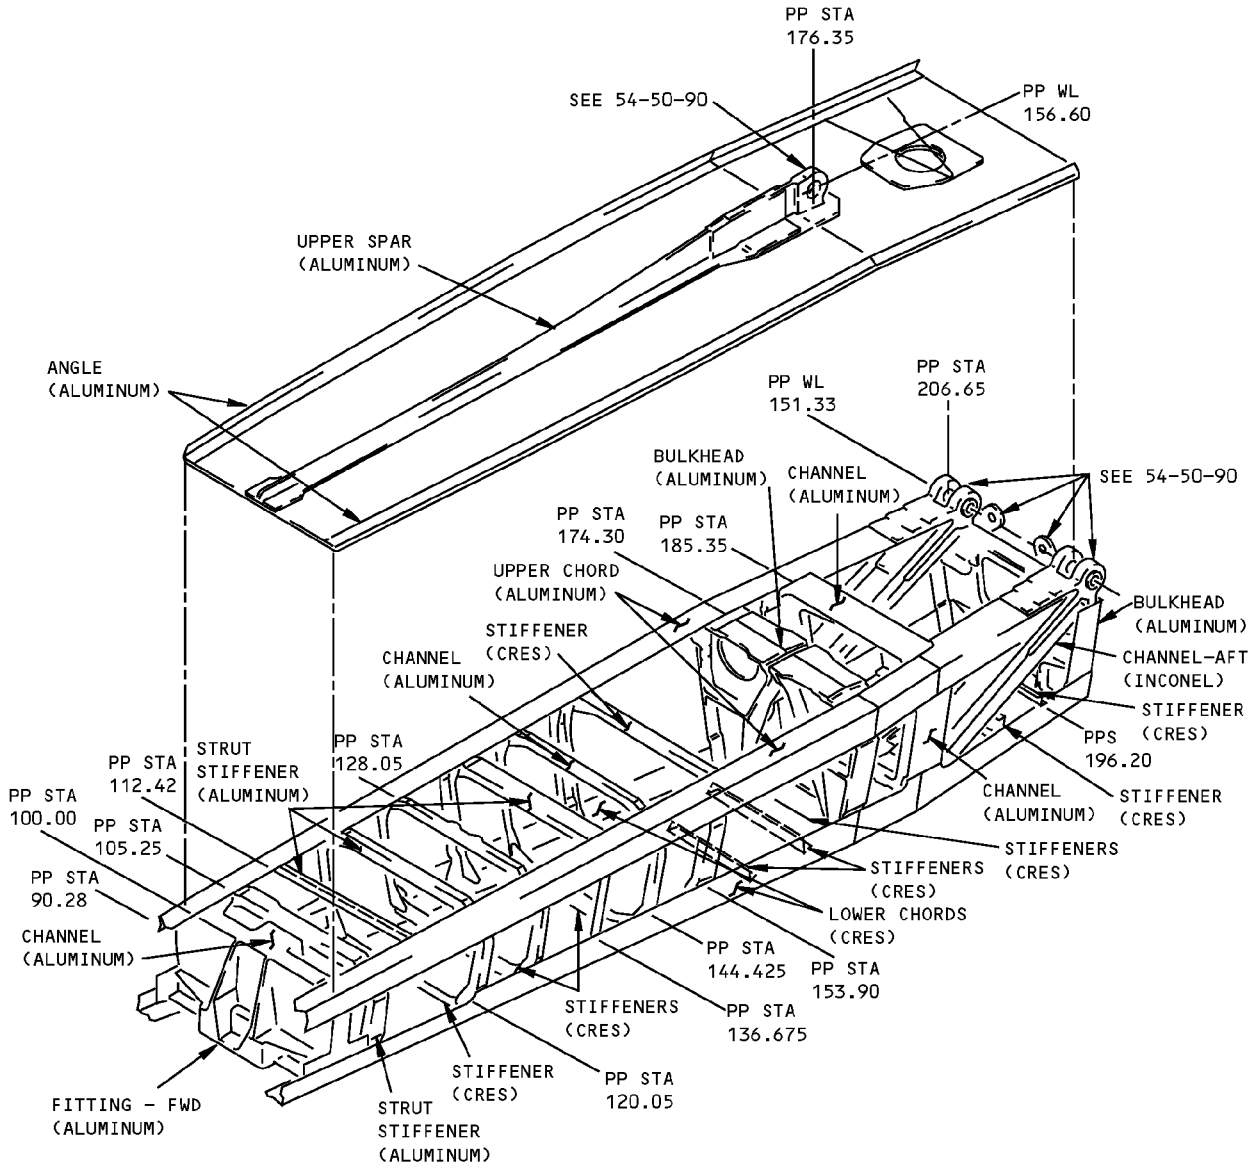
**Strut Structure Allowable Damage - RB211-535 Engine
Figure 101 (Sheet 2 of 6)**

DETAIL II

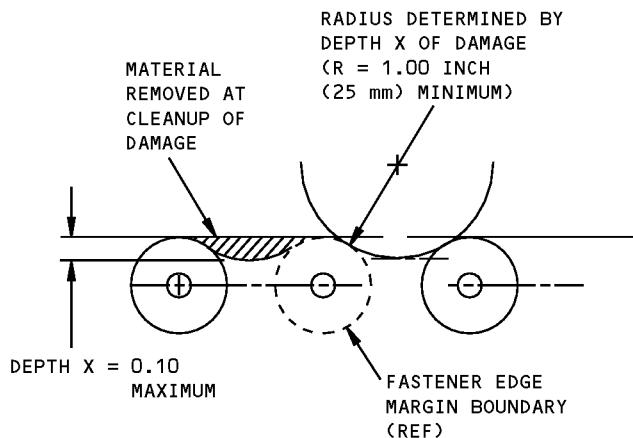
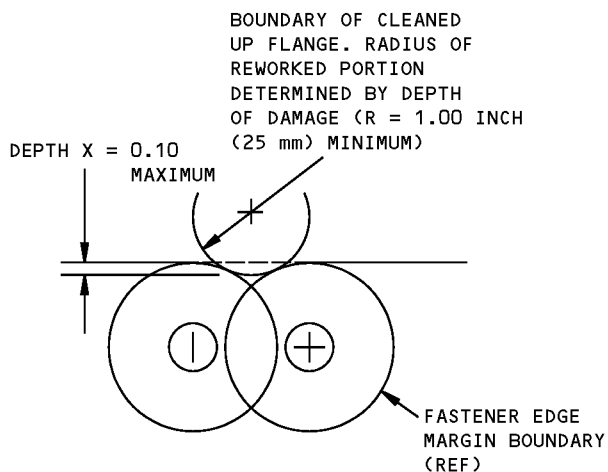
DETAIL III

DAMAGE CLEANUP OF EDGES WHERE FASTENER EDGE MARGINS DO NOT OVERLAP

DAMAGE CLEANUP OF EDGES WHERE FASTENER EDGE MARGINS OVERLAP

- REFINISH REWORKED AREAS AS SHOWN IN AMM 51-20
 - REFER TO SRM 51-10-02 FOR INSPECTION AND REMOVAL OF DAMAGE
- A** CRACKS ARE NOT PERMITTED EXCEPT FOR EDGE CRACKS WHICH MUST BE REMOVED AS SHOWN IN DETAILS III AND VIII.

- E** CRACKS ARE NOT PERMITTED EXCEPT FOR EDGE CRACKS WHICH MUST BE REMOVED AS SHOWN IN DETAILS III AND VIII.
- F** REMOVE DAMAGE AS SHOWN IN DETAILS III, IV, AND VIII

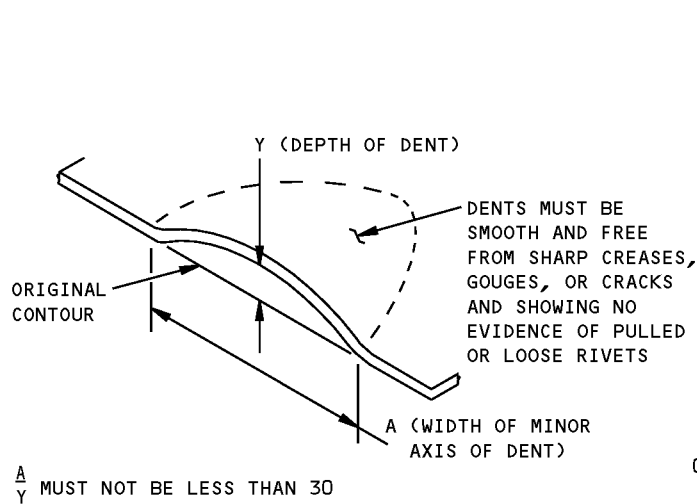
**ALLOWABLE DAMAGE FOR DENT
DETAIL V**

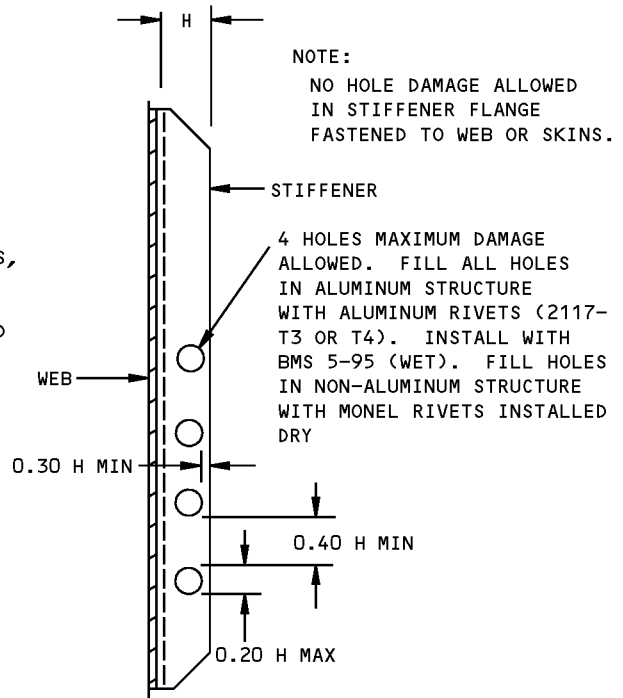
DETAIL VI

ALLOWABLE DAMAGE LIMITS FOR HOLES IN STIFFENERS

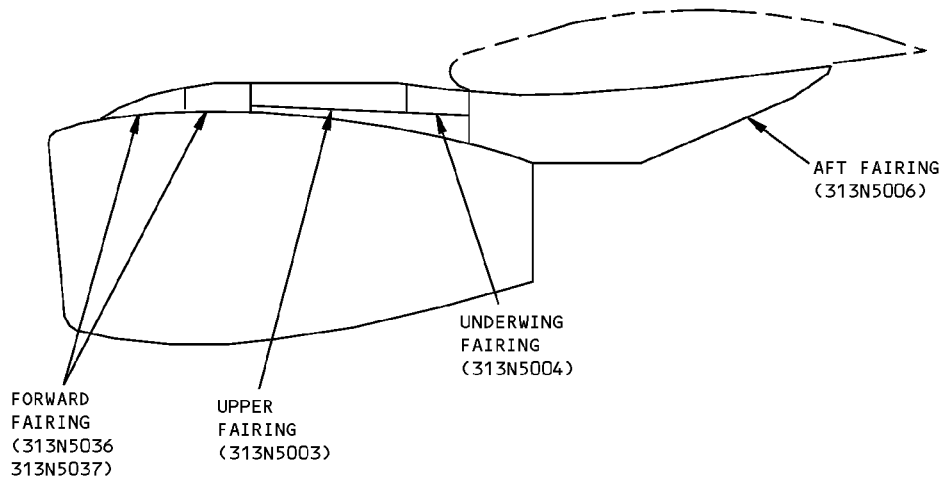
**Strut Fairing Skin Identification - RB211-535E4 Engine
Figure 1 (Sheet 1 of 10)**

IDENTIFICATION 1 - STRUT FAIRING SKIN - RB211-535E4 ENGINE

REF DWG
311N5001

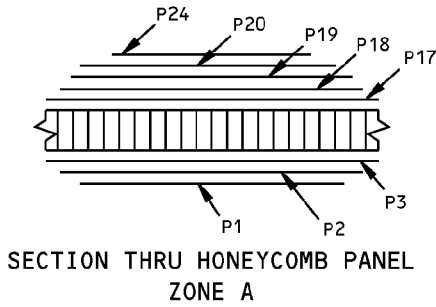
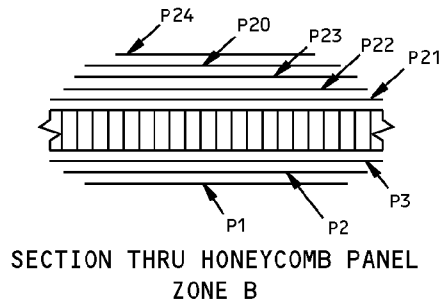
DETAIL I

REF DWG
313N5037

ITEM NO.	PLY NUMBER	MATERIAL	PLY ORIENTATION A
2	P2,P17,P18,P19	C	0° OR 90° D
	P3	H	0° OR 90° D
	P21,P22,P23	B	0° OR 90° D
	P1	E	0° OR 90° D
	P24	I	0° OR 90° D
	P20	H	0° OR 90° D

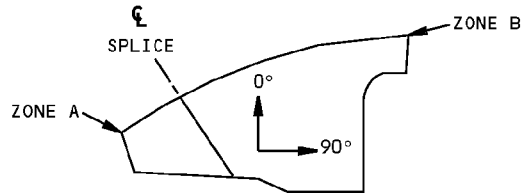
DIAGRAM OF PLY ORIENTATION, SEE TABLE I FOR PLY ORIENTATION AND MATERIAL A

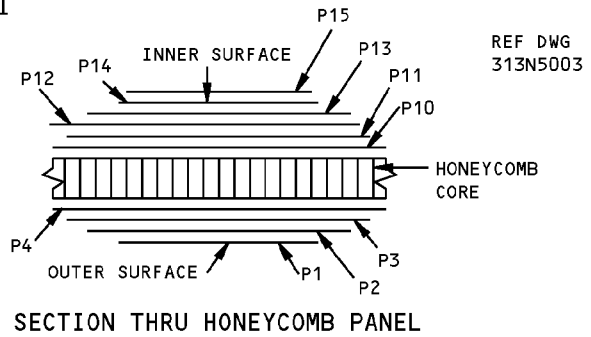
DETAIL II

ITEM NO.	PLY NUMBER	MATERIAL	PLY ORIENTATION A
3	1	F	90°
	4,11,13	B	0°
	10,12	B	90°
	2	C	0°
	3,14	H	90°
	15	I	---

DIAGRAM OF PLY ORIENTATION, SEE TABLE II FOR PLY ORIENTATION AND MATERIAL A

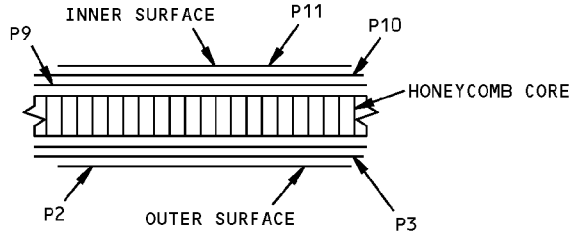
REF DWG
313N5020

SECTION THRU HONEYCOMB PANEL

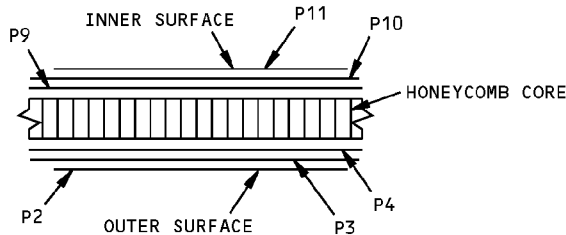
REF DWG
313N5018

SECTION THRU HONEYCOMB PANEL

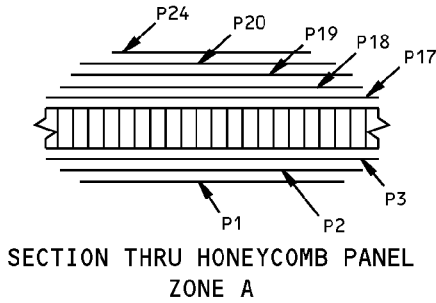
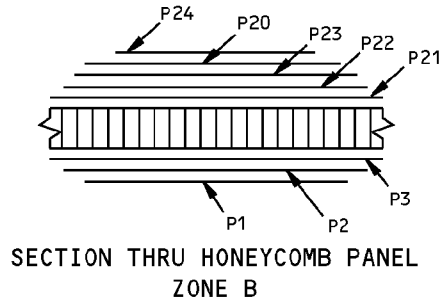
ITEM NO.	PLY NUMBER	MATERIAL	PLY ORIENTATION ^A
2	P2, P17, P18, P19	C	0° OR 90° ^D
	P3	H	0° OR 90° ^D
	P21, P22, P23	B	0° OR 90° ^D
	P1 ^K	E	0° OR 90° ^D
	P1 ^L	O	0° OR 90° ^D
	P24	M	0° OR 90° ^D
	P20 ^K	N	0° OR 90° ^D
	P20 ^L	H	0° OR 90° ^D

TABLE I ^G

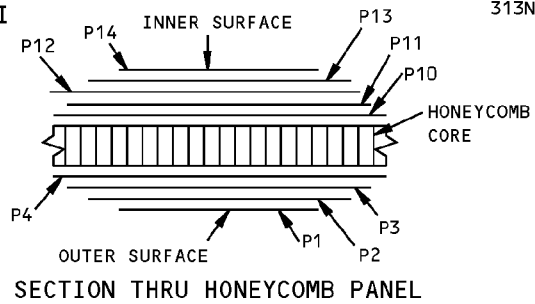
DETAIL II

DIAGRAM OF PLY ORIENTATION, SEE TABLE II FOR PLY ORIENTATION AND MATERIAL ^A

**Strut Fairing Skin Identification - RB211-535C Engines
Figure 1 (Sheet 4 of 10)**

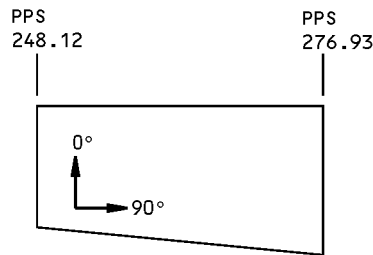
DIAGRAM OF PLY ORIENTATION, SEE
TABLE IX FOR PLY ORIENTATION
AND MATERIAL A

ITEM NO.	PLY NUMBER	MATERIAL	PLY ORIENTATION A
12	P2,P3	C	0° OR 90°
	P9,P10,P11	B	0° OR 90° OPTIONAL

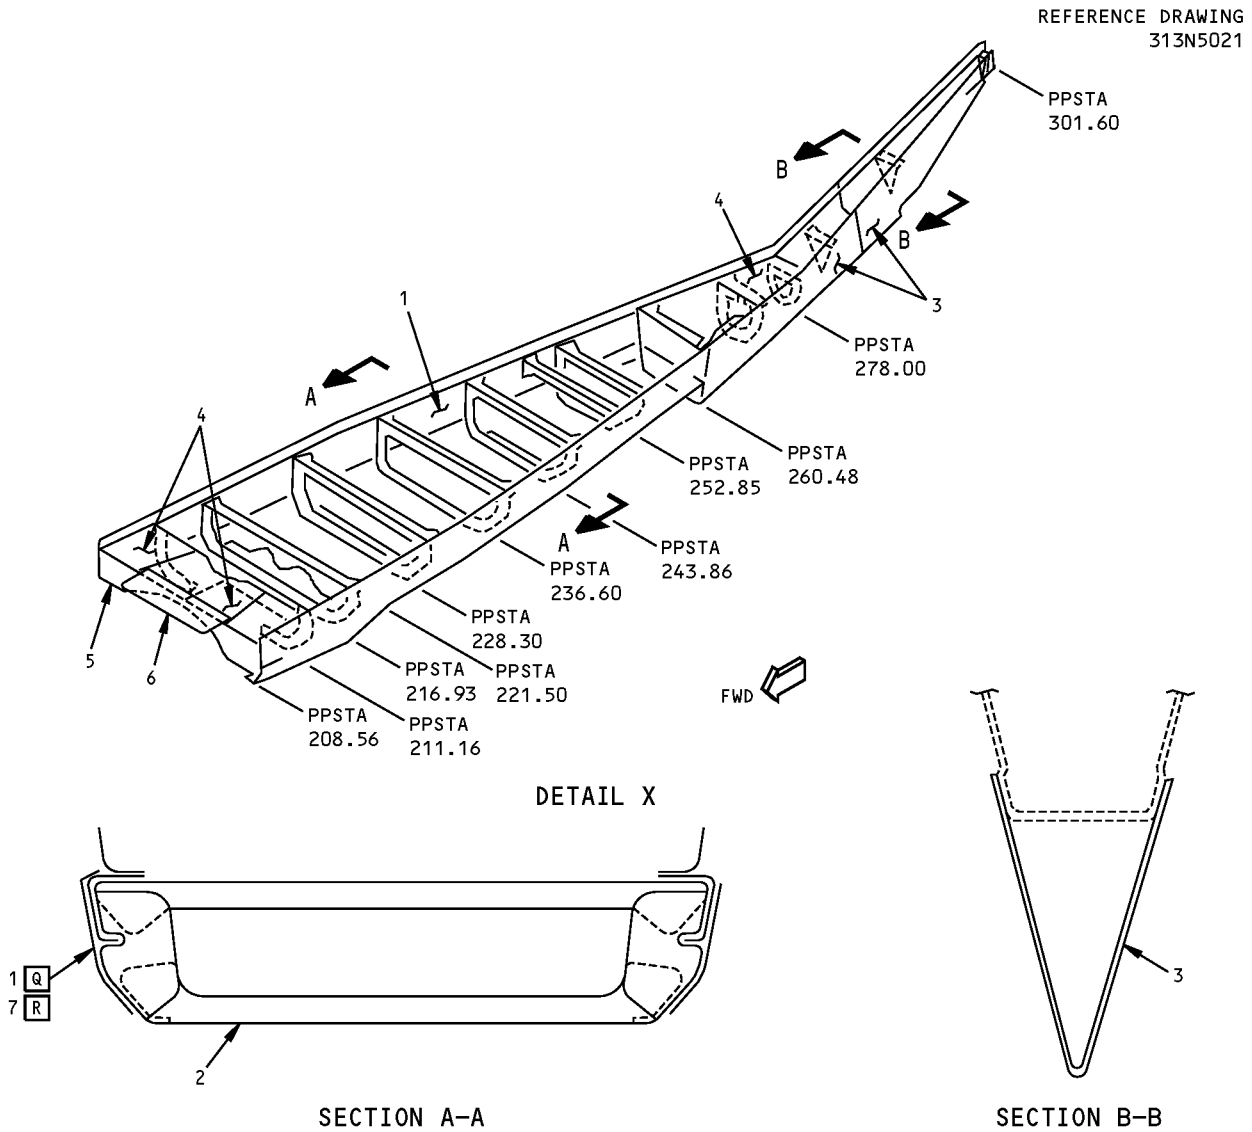
ITEM	DESCRIPTION	GAGE	MATERIAL	EFFECTIVITY
1	SKIN	0.040	STEEL 17-7PH HEAT TREATMENT 150-170 KSI	Q
2	SKIN	0.050	CLAD 7075-T6	
3	SKIN	0.040	INCONEL 625	
4	COVER	0.040	CLAD 7075-T6	
5	CHANNEL	0.080	CLAD 7075-T6	
6	PLATE	0.090	CLAD 7075-T6	
7	SKIN	0.040	CLAD 2024-T42	R

LIST OF MATERIALS FOR DETAIL X

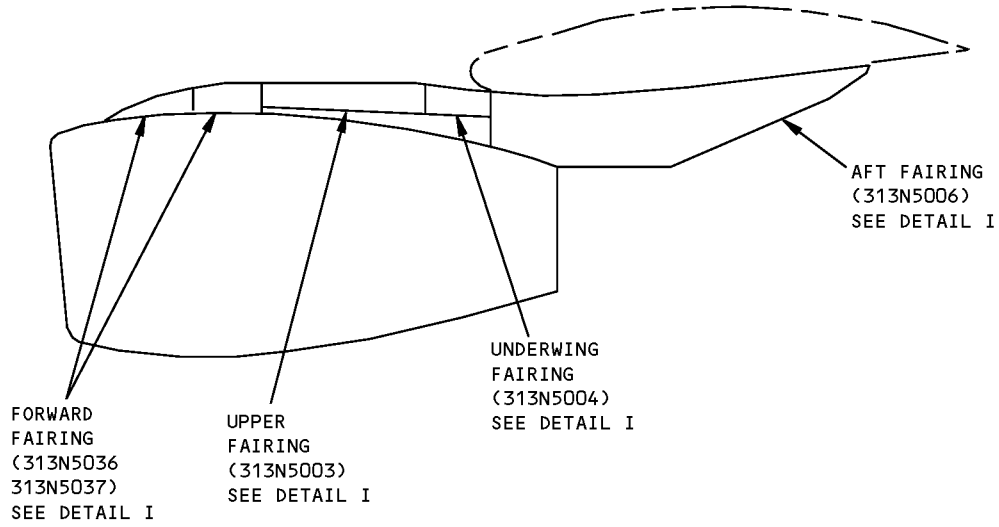
REF DWG
311N5001

ALLOWABLE DAMAGE 1 - SRUT FAIRING SKIN - RB211-535E4 ENGINE

Strut Fairing Skin Allowable Damage - RB211-535E4 Engine
Figure 101 (Sheet 1 of 6)

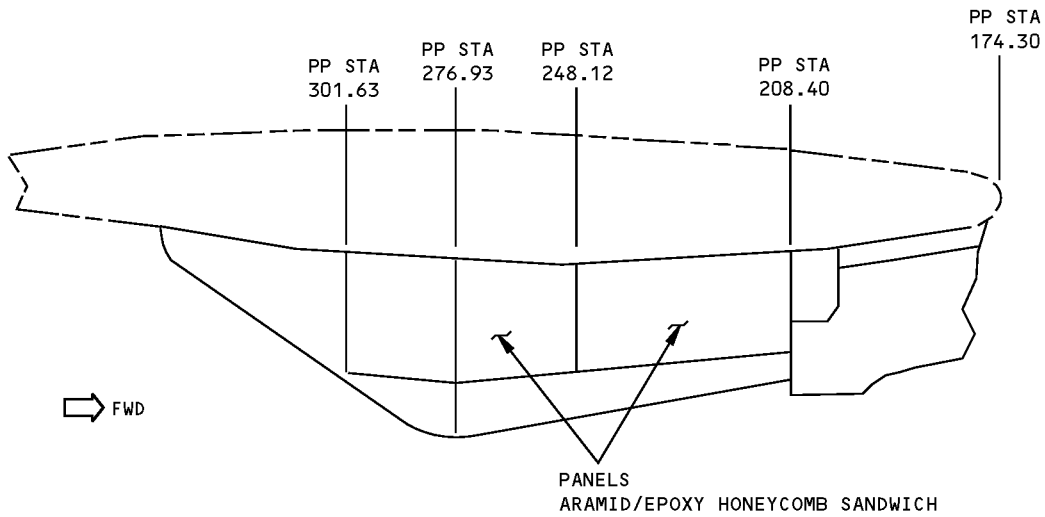
REF DWG
311N0506

VIEW ON LEFT SIDE OF LEFT AND RIGHT STRUTS
RIGHT SIDE SAME EXCEPT AS NOTED

VIEW ON RIGHT SIDE OF LEFT AND RIGHT STRUTS
DETAIL I

**Strut Fairing Skin Allowable Damage - RB211-535C Engine
Figure 101 (Sheet 2 of 6)**

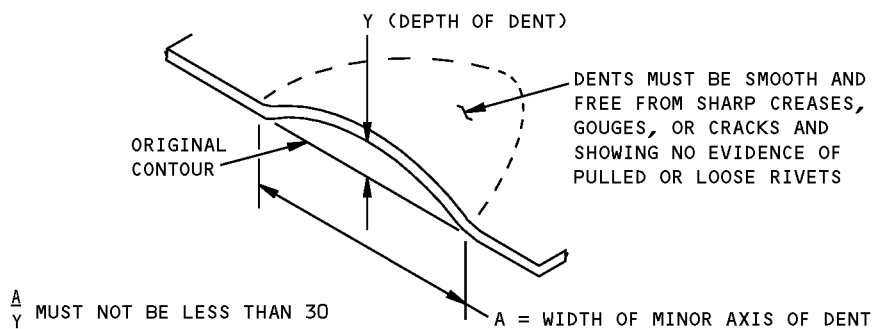
**ALLOWABLE DAMAGE FOR DENT
DETAIL V**

DESCRIPTION	CRACKS	NICKS, GOUGES AND CORROSION	DENTS	HOLES AND PUNCTURES	DELAMINATION
ALUMINUM SKIN	B	C	SEE DETAIL V	D	---
PANELS	E	F	G	H	I
FAIRING	E	F	G	H	I
DOOR	E	F	G	H	I
PAN SKIN- AFT	B	C	SEE DETAIL V	J	---
WEB	B	C	SEE DETAIL V	D	---
PAN SKIN - FWD	B	C	SEE DETAIL V	J	---
PAN - ALUMINUM	B	C	SEE DETAIL V	D	---
PAN - STEEL	B	C	SEE DETAIL V	J	---

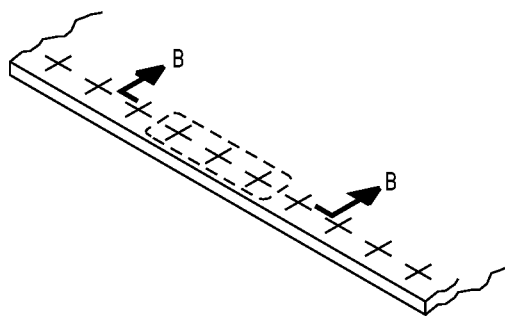
SMOOTH BLENDOUT RADIUS 0.50 INCH MINIMUM. CORROSION CLEANUP AROUND ANY THREE FASTENERS IN TEN IS PERMITTED TO MAX DEPTH

SECTION B-B

**CORROSION CLEANUP
DETAIL VI**

C REMOVE DAMAGE PER DETAILS III, IV, AND VI.

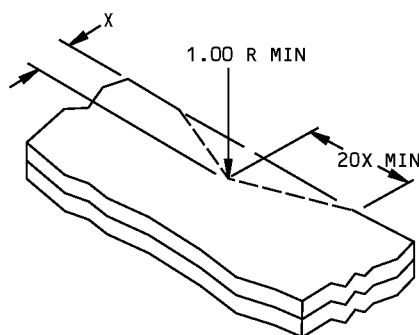
DETAIL VII

X = DEPTH OF CLEANUP = 0.10 MAX

B CRACKS NOT ALLOWED EXCEPT FOR EDGE CRACKS WHICH MUST BE REMOVED PER DETAILS III AND VII.

E 2.0 MAX LENGTH IN HONEYCOMB AREA. CLEAN UP EDGE CRACKS PER DETAIL VII. CRACKS THROUGH CONSECUTIVE FASTENERS OR THROUGH THE PANEL EDGE-BAND ARE ALLOWED PROVIDED DAMAGE DOES NOT EXCEED 10% OF EDGE-BAND LENGTH PER SIDE. **A**

F DAMAGE ALLOWED ON SURFACE RESIN ONLY. DAMAGE TO FIBERS NOT ALLOWED. CLEAN UP EDGE DAMAGE PER DETAIL VII. **A**

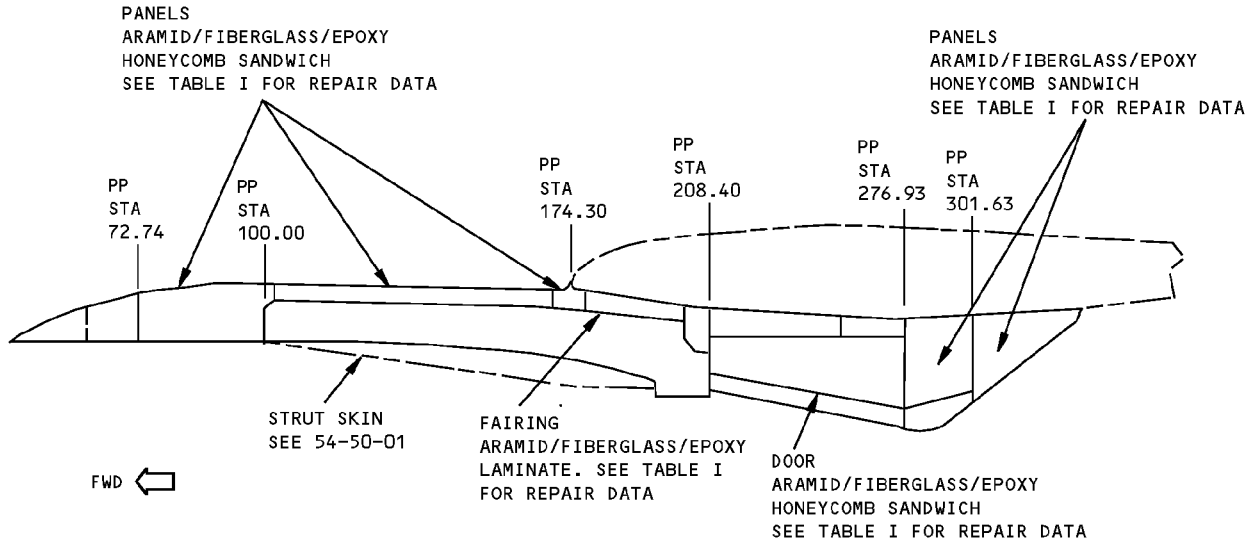
REF DWG
311N0506

VIEW ON LEFT SIDE OF LEFT AND RIGHT STRUTS
RIGHT SIDE SAME EXCEPT AS NOTED

VIEW ON RIGHT SIDE OF LEFT AND RIGHT STRUTS
DETAIL I

**Strut Fairing Skin Repairs - RB211-535 Engine
Figure 201 (Sheet 2 of 3)**

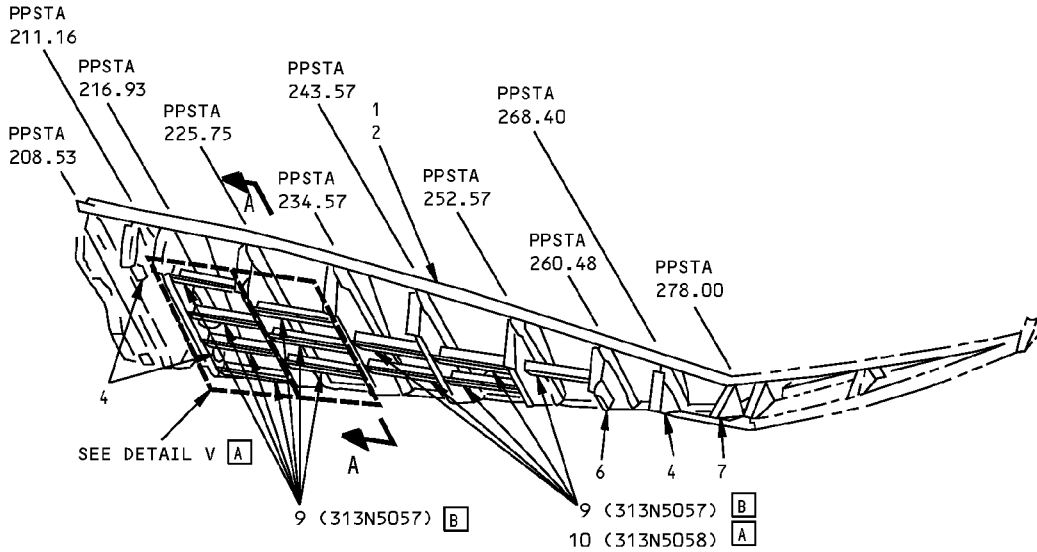
REF DWG
313N5021
313N5058
313N5059

**LOWER PAN - RB211-535C ENGINE
DETAIL III**

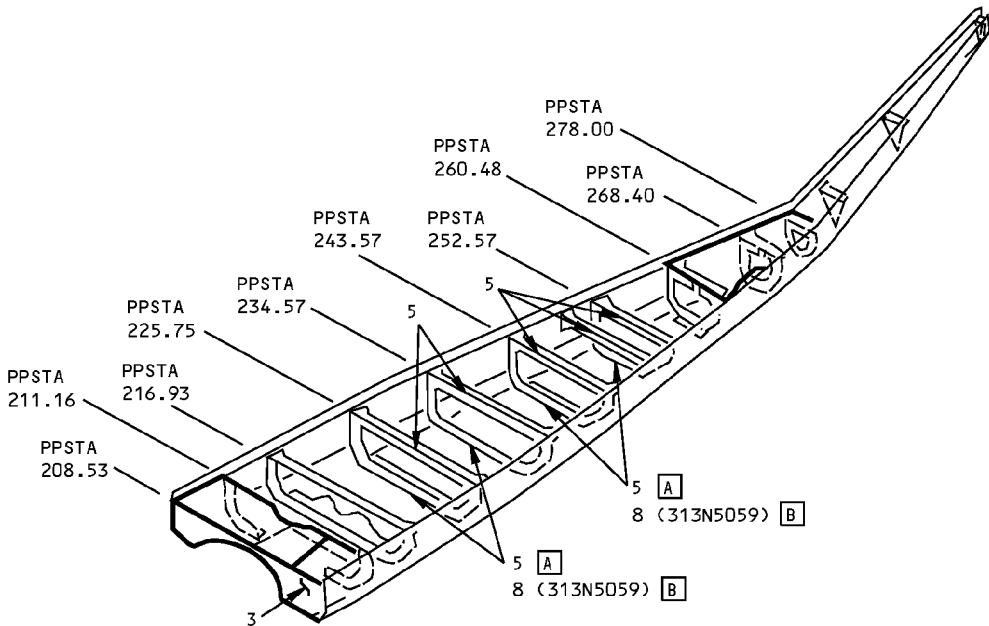
**LOWER PAN - RB211-535C ENGINE
DETAIL IV**

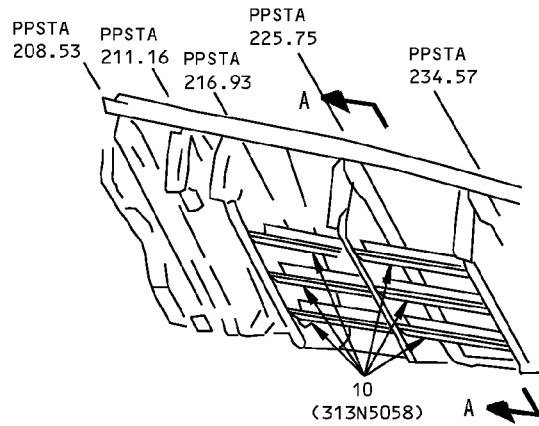
**LOWER PAN - RB211-535C ENGINE
DETAIL V [A]**

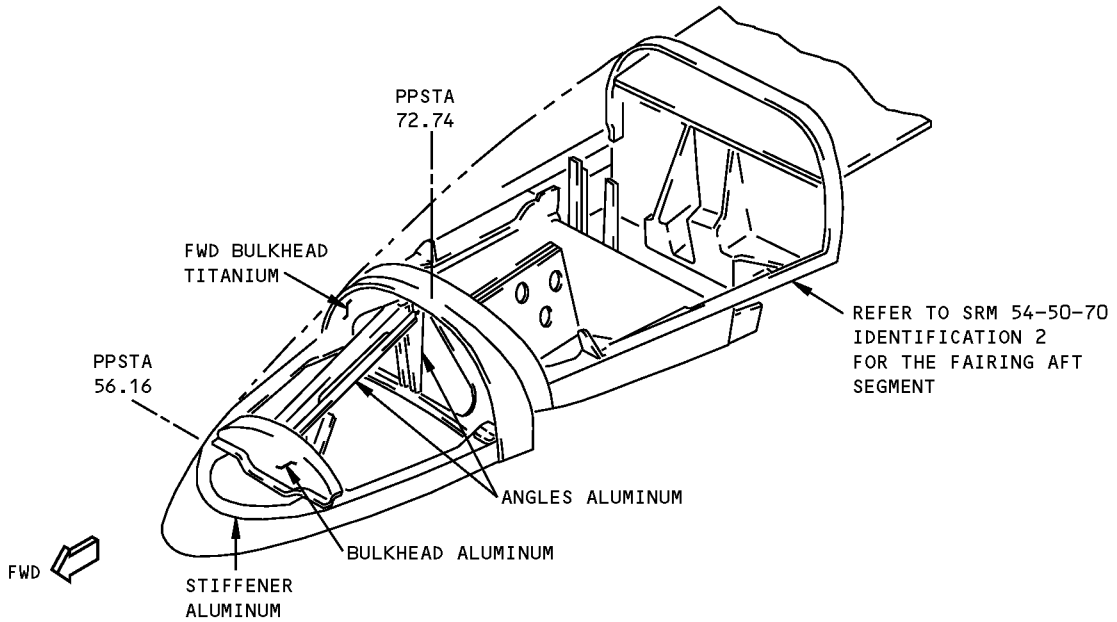
**Strut Fairing Structure Allowable Damage - RB211-535 Engine
Figure 101 (Sheet 1 of 5)**

ALLOWABLE DAMAGE 1 - STRUT FAIRING STRUCTURE - RB211-535 ENGINE

DETAIL I

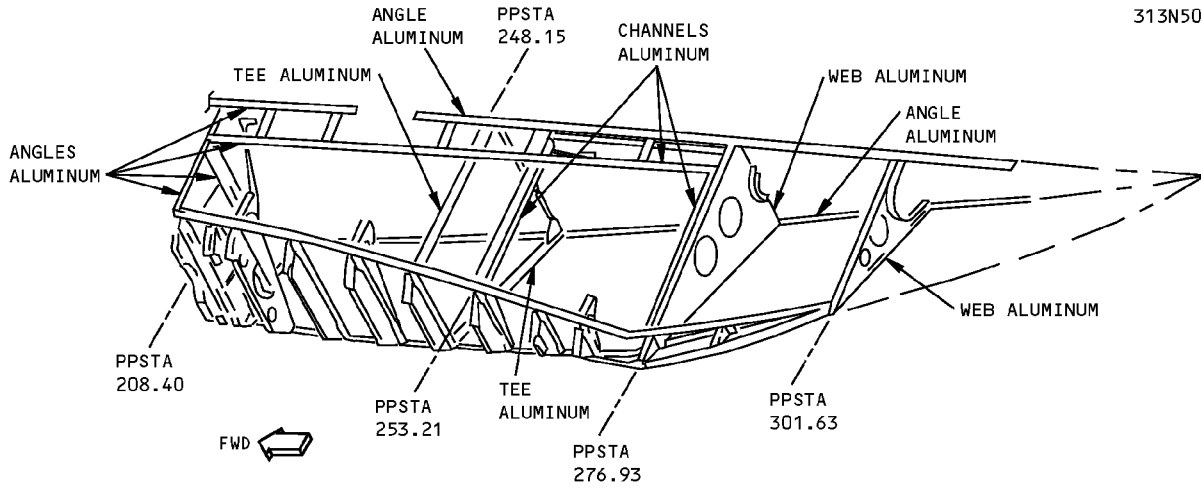
**Strut Fairing Structure Allowable Damage - RB211-535 Engine
Figure 101 (Sheet 2 of 5)**

DETAIL II

SECTION AT PPSTA 225.75
(TYPICAL)
SECTION A-A
DETAIL III

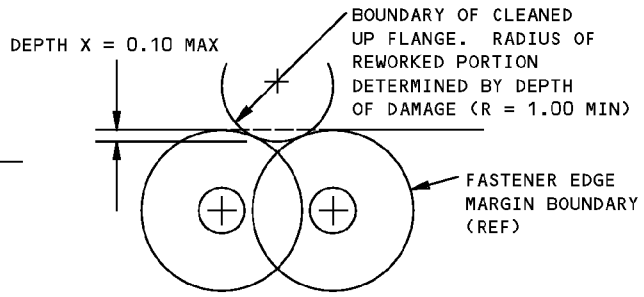
DETAIL IV

DAMAGE CLEANUP OF EDGES WHERE FASTENER EDGE MARGINS OVERLAP

- REFINISH REWORKED AREAS PER 51-20 OF THE MAINTENANCE MANUAL
- A CRACKS NOT ALLOWED EXCEPT FOR EDGE CRACKS WHICH MUST BE REMOVED PER DETAILS IV AND IX
- B REMOVE DAMAGE PER DETAILS IV, V, AND VII
- C CRACKS NOT ALLOWED EXCEPT FOR EDGE CRACKS WHICH MUST BE REMOVED PER DETAILS IV AND VIII
- D CLEAN OUT DAMAGE UP TO 0.25 MAX DIA AND NOT CLOSER THAN 1.0 INCH TO FASTENER HOLE OR OTHER DAMAGE. FILL HOLE WITH A 2117-T3 OR T4 ALUMINUM RIVET INSTALLED WET WITH BMS 5-95 SEALANT. ALL OTHER HOLES TO BE REPAIRED
- E CLEAN OUT DAMAGE UP TO 0.25 MAX DIA AND NOT CLOSER THAN 1.0 INCH TO FASTENER HOLE OR OTHER DAMAGE. FILL HOLE WITH A MONEL RIVET INSTALLED DRY. ALL OTHER HOLES TO BE REPAIRED

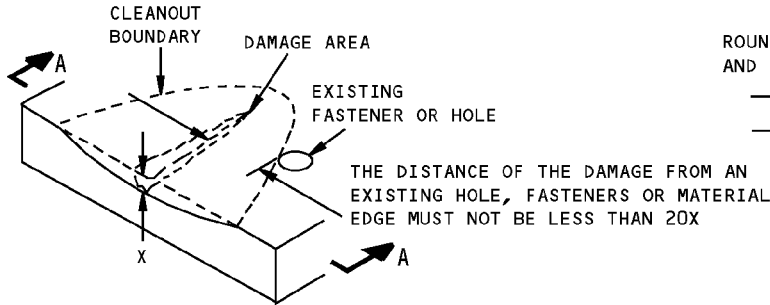
REMOVAL OF NICK, GOUGE AND SCRATCH DAMAGE ON A SURFACE
DETAIL V

SECTION A-A

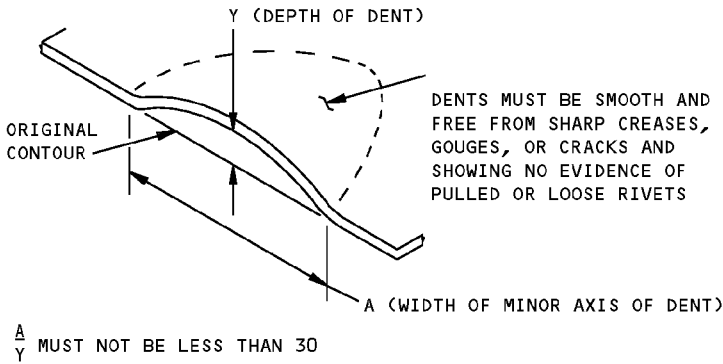
ALLOWABLE DAMAGE FOR DENT
DETAIL VI

DESCRIPTION	CRACKS	NICKS, GOUGES AND CORROSION	DENTS	HOLES AND PUNCTURES
FWD BULKHEAD	A	B	SEE DETAIL VI	E
STIFFENER	A	B	SEE DETAIL VI	SEE DETAIL X
ANGLES	A	B	SEE DETAIL VI	SEE DETAIL X
BULKHEADS	A	B	SEE DETAIL VI	D
TEES	A	B	SEE DETAIL VI	SEE DETAIL X
CHANNELS	A	B	SEE DETAIL VI	D
WEBS	C	B	SEE DETAIL VI	D
FRAMES	A	B	SEE DETAIL VI	D
CROSS TIE	A	B	SEE DETAIL VI	D
FITTING	A	B	NOT ALLOWED	NOT ALLOWED
CHORD	A	B	SEE DETAIL VI	D

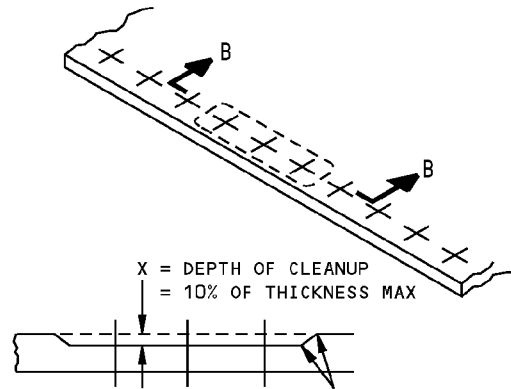
SMOOTH BLENDOUT RADIUS 0.50 INCH MINIMUM. CORROSION CLEANUP AROUND ANY THREE FASTENERS IN TEN IS PERMITTED TO MAX DEPTH

SECTION B-B

CORROSION CLEANUP
DETAIL VII

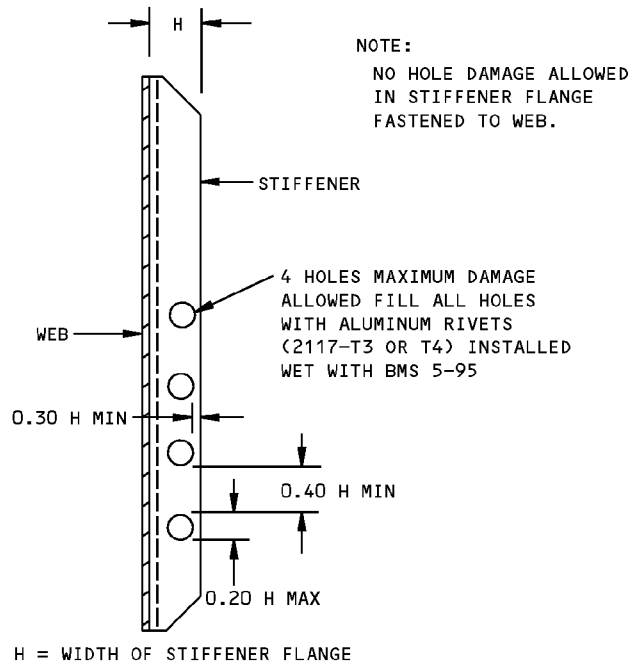
DETAIL X

**ALLOWABLE DAMAGE LIMITS FOR
HOLES IN WEB STIFFENERS**

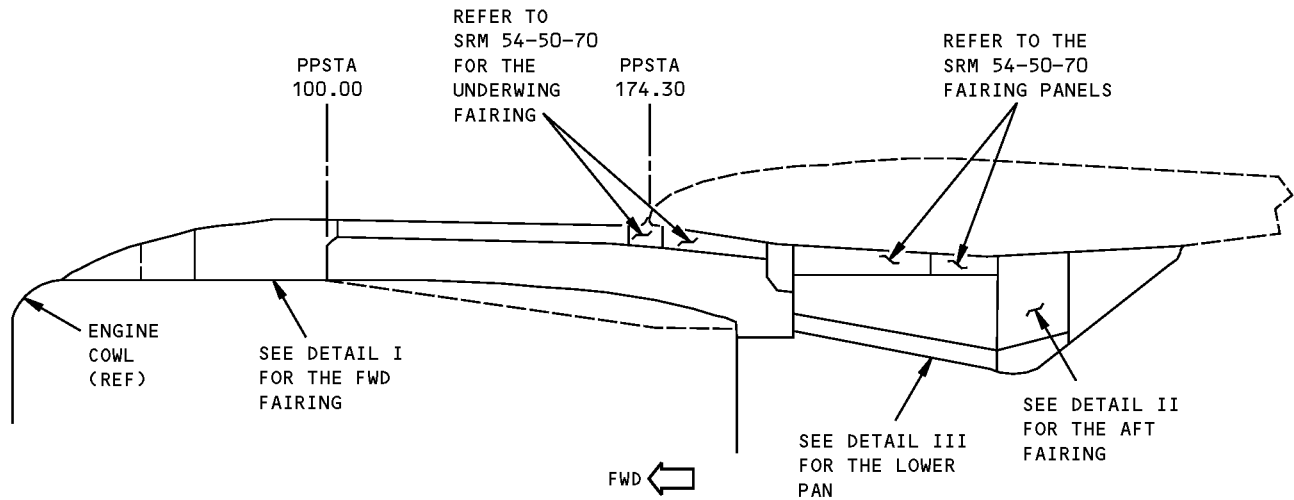
**Strut Fairing Structure Repair - RB211-535 Engine
Figure 201 (Sheet 1 of 3)**

REPAIR 1 - STRUT FAIRING STRUCTURE - RB211-535 ENGINE

- A** REFER TO SRM 51-70-11 FOR FORMED SECTION REPAIR
- B** REFER TO SRM 51-70-12 FOR EXTRUDED SECTION REPAIR
- C** REFER TO SRM 51-70-13 FOR WEB REPAIR
- D** NO TYPICAL REPAIRS APPLICABLE. REPAIRS WILL BE BASED ON SERVICE EXPERIENCE

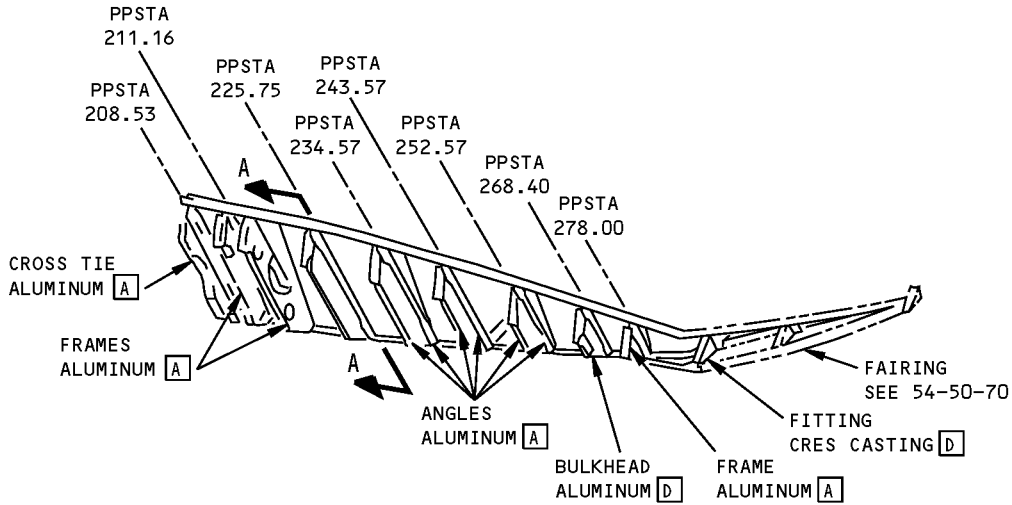
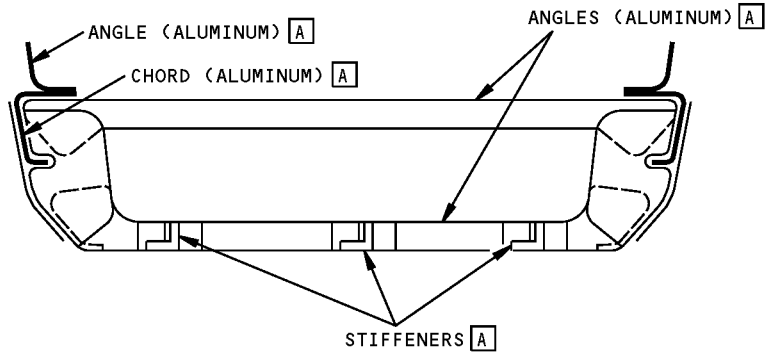
**Strut Fairing Structure Repair - RB211-535 Engine
Figure 201 (Sheet 3 of 3)**

DETAIL III

**SECTION AT PPSTA 225.75
OTHER SECTIONS SIMILAR
SECTION A-A**
