**NACELLES AND
PYLONS**

**757-200
STRUCTURAL REPAIR MANUAL**

**CHAPTER 54
NACELLES AND PYLONS**

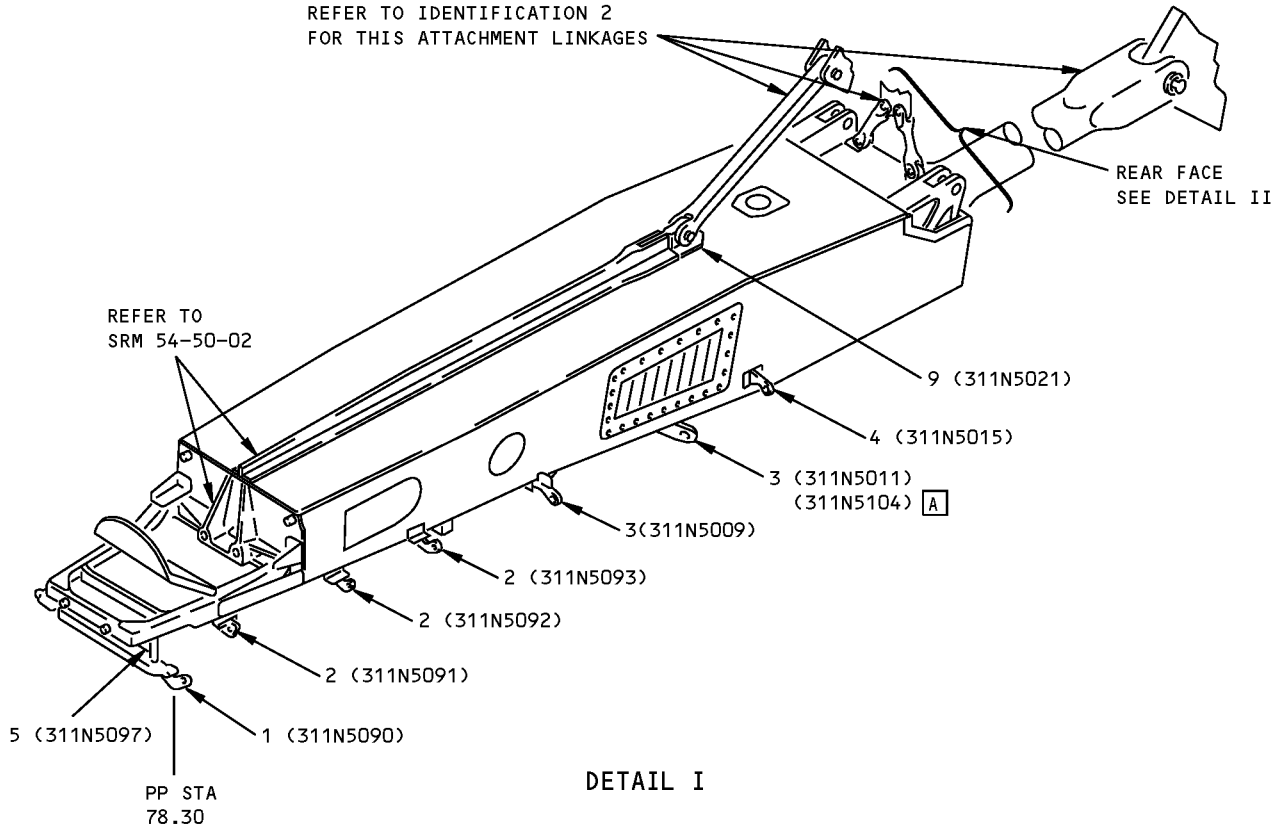
IDENTIFICATION 1 - STRUT FITTING - RB211-535 ENGINE

REFER TO IDENTIFICATION 2
FOR THIS ATTACHMENT LINKAGES

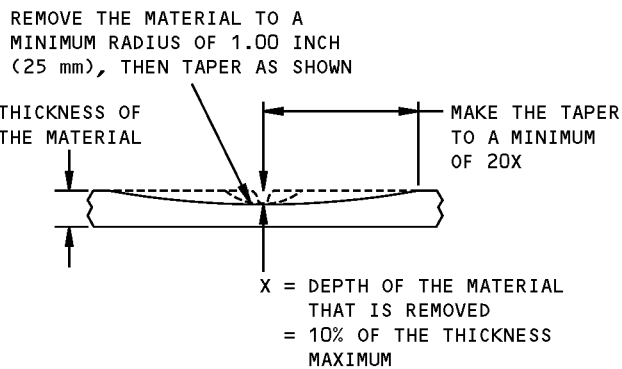
SECTION A-A

REMOVAL OF NICK, GOUGE, CORROSION AND SCRATCH DAMAGE ON A SURFACE
DETAIL III

- A** FOR EDGE DAMAGE REFER TO DETAIL VI. FOR LUG DAMAGE REFER TO DETAIL V. FOR OTHER DAMAGE REFER TO DETAIL III. DAMAGE NOT ALLOWED IN VICINITY OF BUSHINGS.

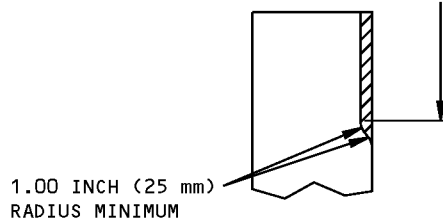
**Links and Fittings Allowable Damage - RB211-535 Engine
Figure 101 (Sheet 5 of 5)**

BUSHING FLANGE DIAMETER
+0.01 INCH (0.25 mm)
MAXIMUM

X = 0.010 INCH (25 mm) MAXIMUM

DAMAGE ON LUG FACE
SECTION D-D

REMOVAL OF DAMAGE ON THE LUG FACE UNDER THE FLANGE OF THE BUSHING

SHADED AREA SHOWS WHERE DAMAGE HAS BEEN REMOVED

- D** REMOVE DAMAGE AS GIVEN IN DETAIL VII.
- E** SHOT PEEN REWORKED AREAS AS GIVEN IN SRM 51-20-06.
- F** CORROSION OR ABRASIONS ON THE FACE OF THE LUG UNDER THE FLANGE OF THE BUSHING MUST BE REMOVED AS GIVEN IN DETAIL VIII. WHEN YOU REMOVE THE DAMAGE, MAKE SURE THE SPOTFACE IS PERPENDICULAR TO THE BORE. AS A RESULT OF THE SPOTFACE, TRIM 0.01 TO 0.02 INCH (0.25 TO 0.50 mm) FROM THE NON-FLANGED END OF THE BUSHING BEFORE INSTALLATION.

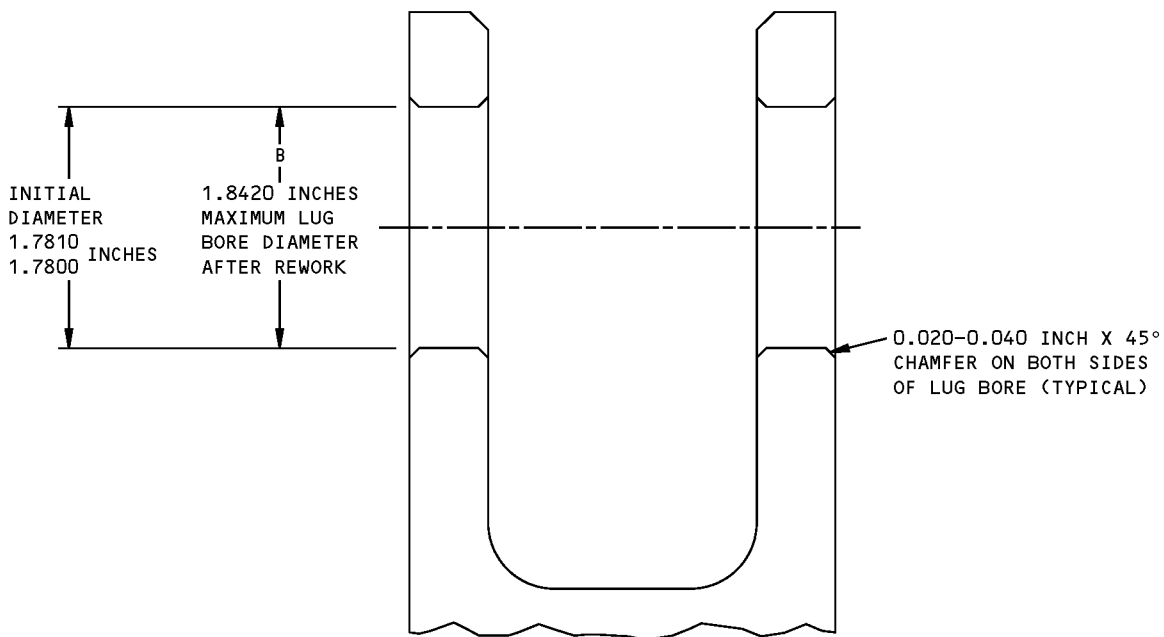
SECTION THROUGH ONE OF THE MIDSPAR CLEVIS FOR FITTINGS WITH 15-5PH MATERIAL

2. The maximum diameter of each hole is 1.8420 inches, see DETAIL III, SECTION A-A. If the diameter of the hole is larger than the maximum, you must get alternative repair instructions from Boeing.

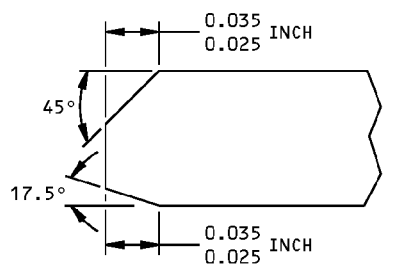
DETAIL VII

FLANGED BUSHING CHAMFERS

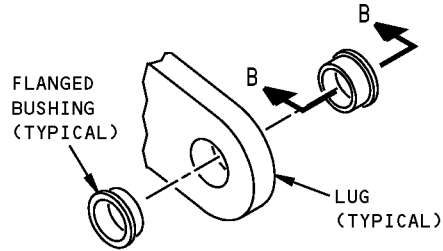
DETAIL III

LOWER SPAR FITTING ASSEMBLY

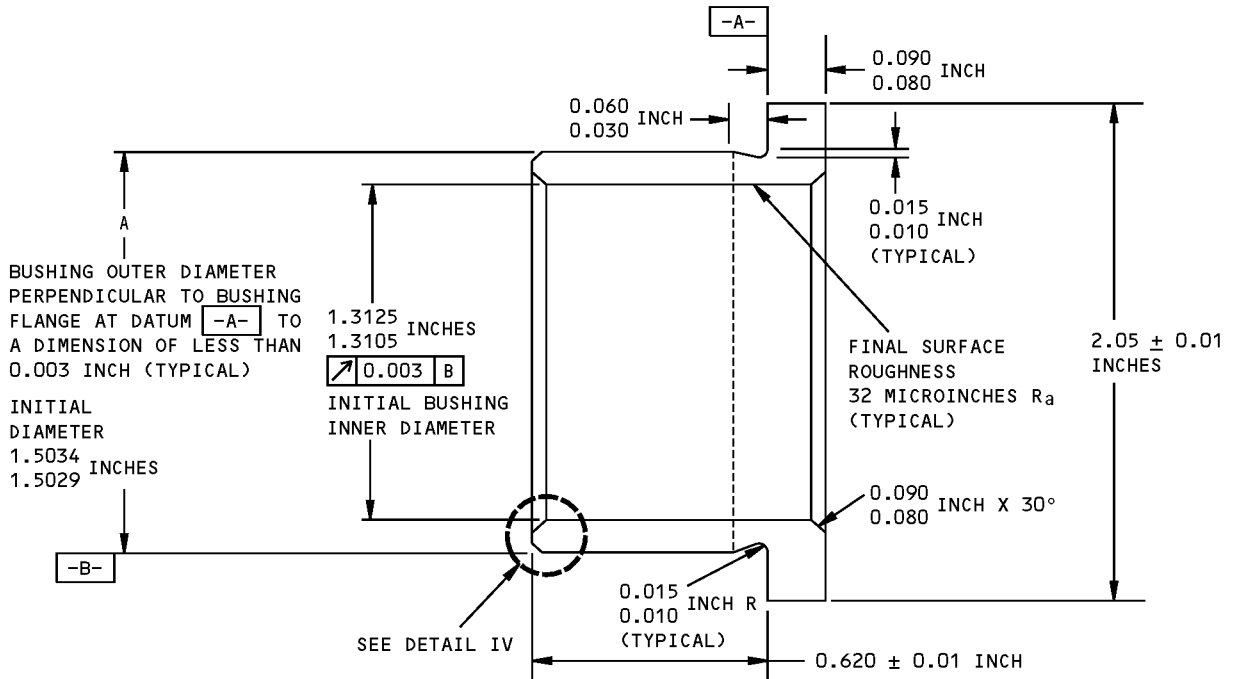
SECTION B-B

FLANGED BUSHING (TYPICAL)

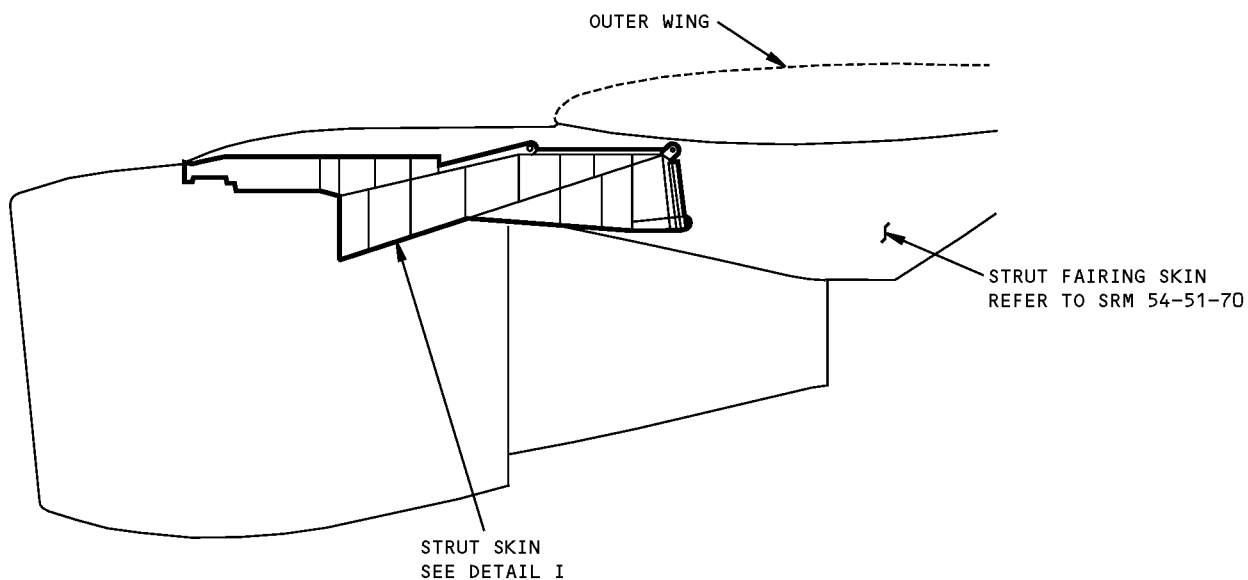
Strut Skin Identification - PW2000 Engine
Figure 1 (Sheet 1 of 3)

IDENTIFICATION 1 - STRUT SKIN - PW2000 ENGINE

REFERENCE DRAWING
311N3000

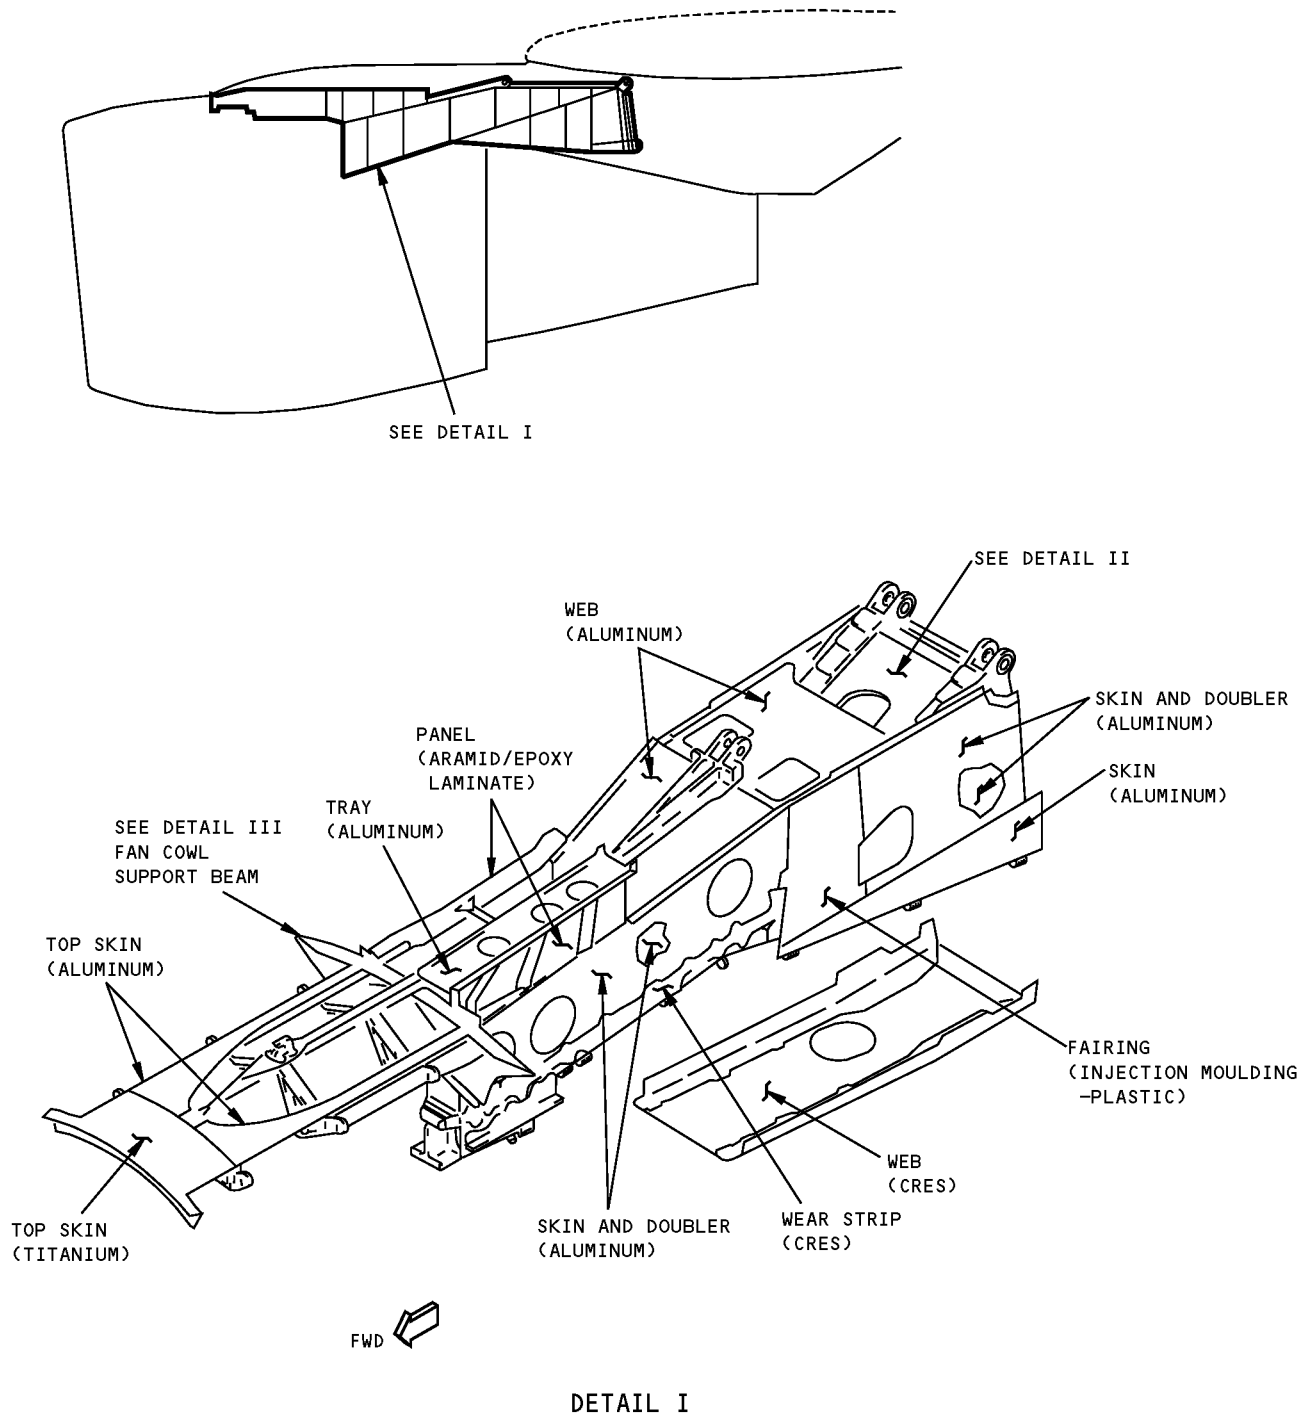
**Strut Skin Allowable Damage- PW2000 Engine
Figure 101 (Sheet 1 of 7)**

ALLOWABLE DAMAGE 1 - STRUT SKIN - PW2000 ENGINE

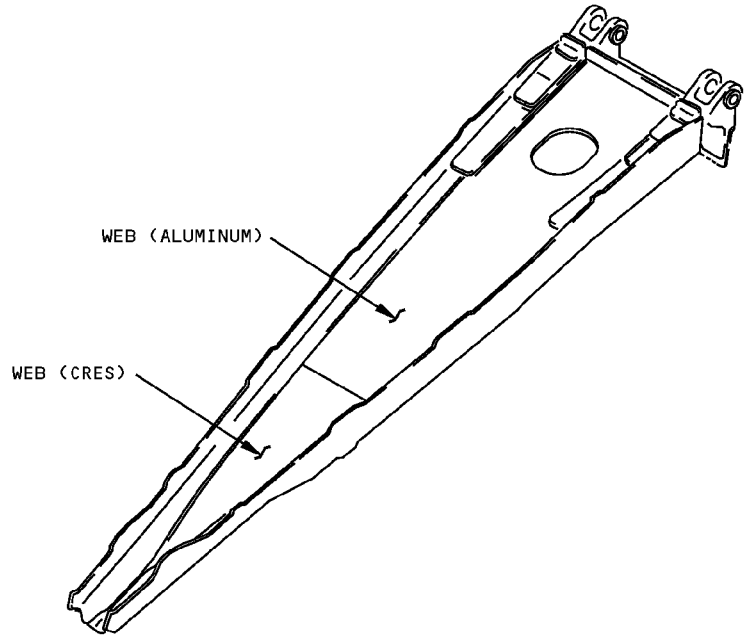
DETAIL II

DESCRIPTION	CRACKS	NICKS, GOUGES AND CORROSION	DENTS	HOLES AND PUNCTURES	DELAMINATION
SKINS AND DOUBLERS	A	B	SEE DETAIL VI	C	—
WEBS	A	B	SEE DETAIL VI	C	—
TRAY AND WEAR STRIP	D	B	SEE DETAIL VI	C	—
FAIRING	D	B	NOT PERMITTED	G	—
PANEL (ARAMID/EPOXY LAMINATE)	A AND H	I	F	E	J

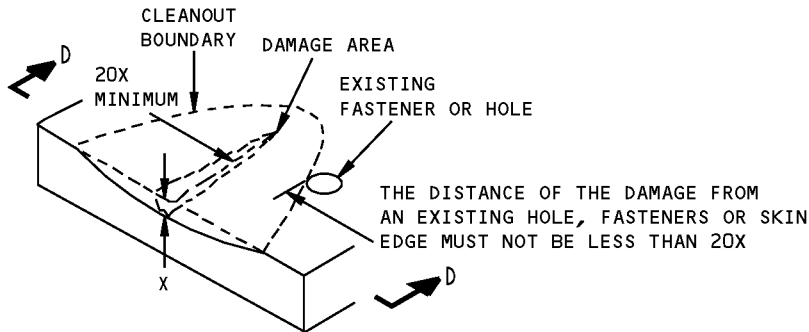
REMOVAL OF NICK, GOUGE AND SCRATCH DAMAGE ON A SURFACE
DETAIL V

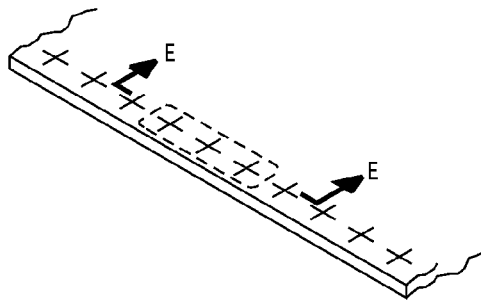
DETAIL VII

SMOOTH BLENDOUT RADIUS 0.50 INCH MINIMUM.
CORROSION CLEANUP AROUND ANY THREE FASTENERS
IN TEN IS PERMITTED TO MAXIMUM DEPTH

SECTION E-E

CORROSION CLEANUP

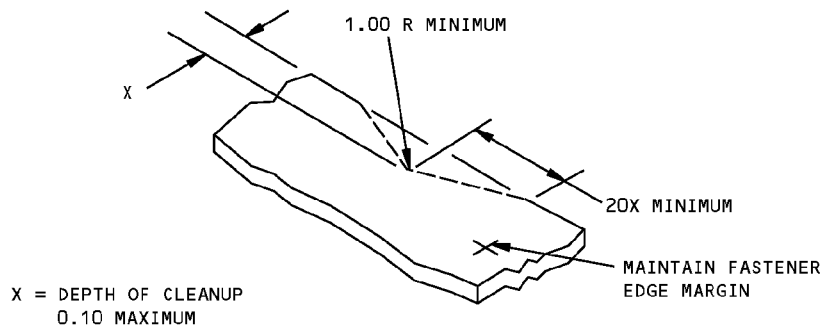
DETAIL VIII

**Strut Skin Allowable Damage- PW2000 Engine
Figure 101 (Sheet 7 of 7)**

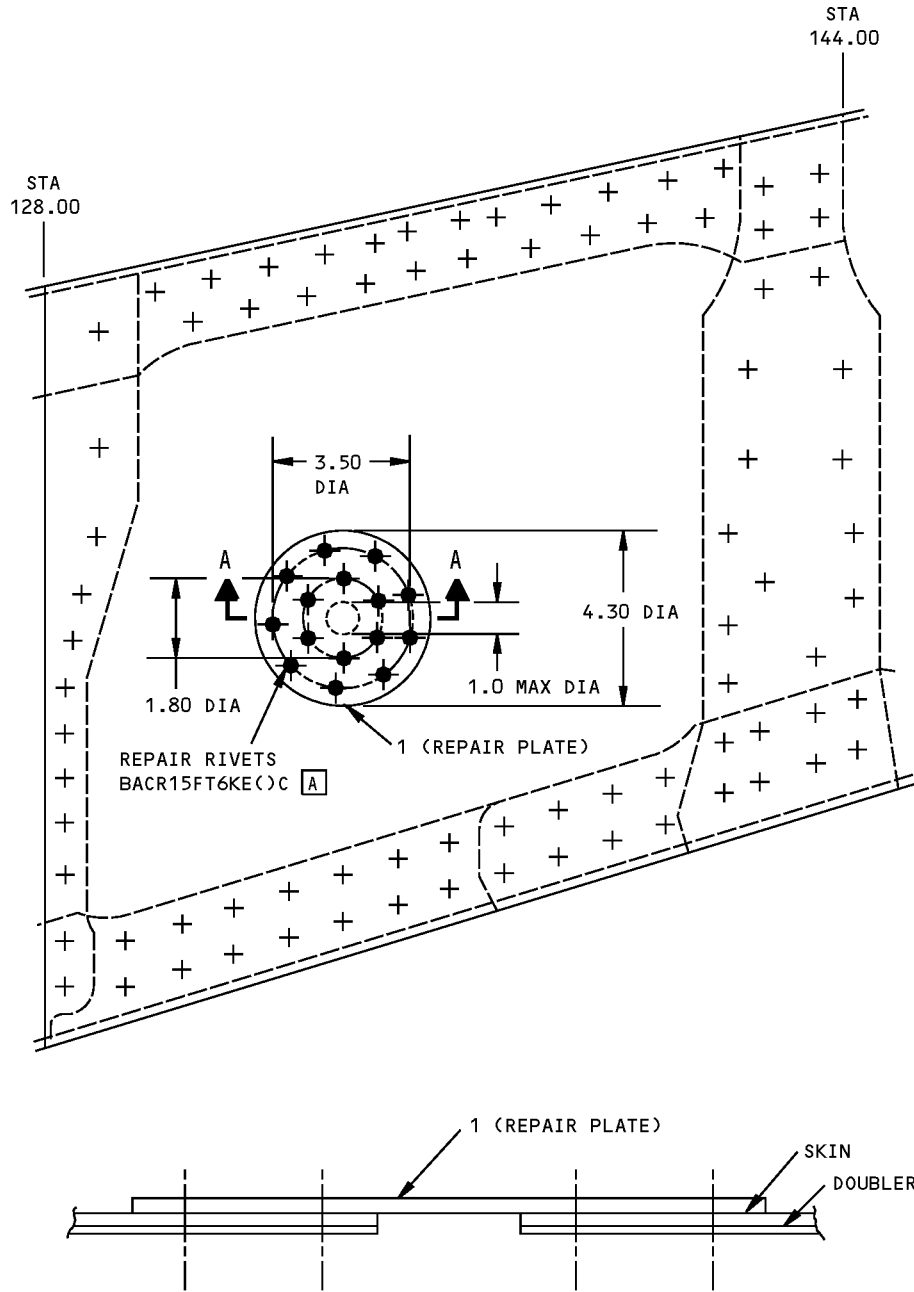
**Strut Side Skin Small Hole or Crack Repair - PW2000 Engine
Figure 201 (Sheet 3 of 3)**

SECTION A-A

**SMALL HOLE OR CRACK REPAIR
DETAIL II**

REPAIR MATERIAL			
PART		QTY	MATERIAL
1	PLATE	1	0.10 CLAD 2024-T3

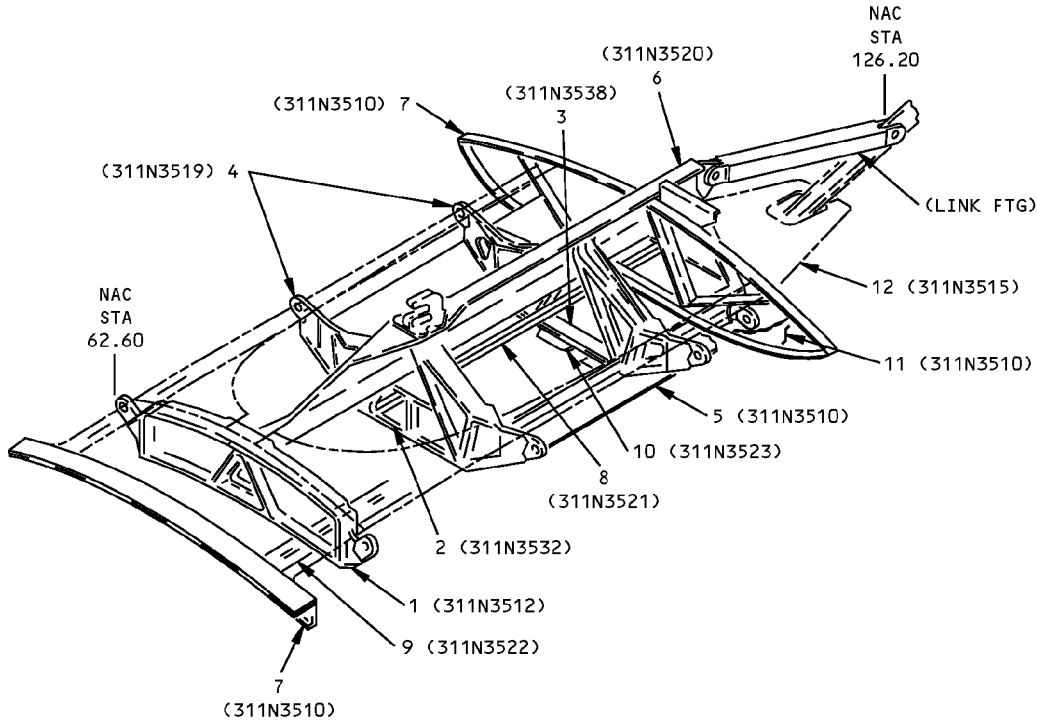
**FAN COWL SUPPORT BEAM
DETAIL III**

REF DWG
311N3510

ITEM	DESCRIPTION	GAGE	MATERIAL	EFFECTIVITY
1	HINGE FTG		FORGING TI-6AL-4V ANNEALED	
2	HINGE, BACK UP FTG		FORGING TI-6AL-4V ANNEALED	
3	HINGE, BACK UP FTG		FORGING 7075-T73	
4	HINGE FTG		CASTING TI-6AL-4V PER BMS 7-181B TYPE I, COND B GRADE B	
5	FIREWALL	0.063	TI-6AL-4V TYPE III, COMP C	
6	UPR CHORD		BAC1520-2386 7075-T73	
7	ANGLE	0.050	TI-6AL-4V TYPE III, COMP C	
8	LWR CHORD		BAC514-1514 7075-T73	
9	RAIL		BAC1671-201 TI-6AL-4V ANNEALED	
10	DRAIN PAN	0.040	INCONEL 625 ANNEALED	
11	WEB	0.050	TI-6AL-4V TYPE III, COMP C	
12	AFT MOUNT FTG		FORGING 7075-T73

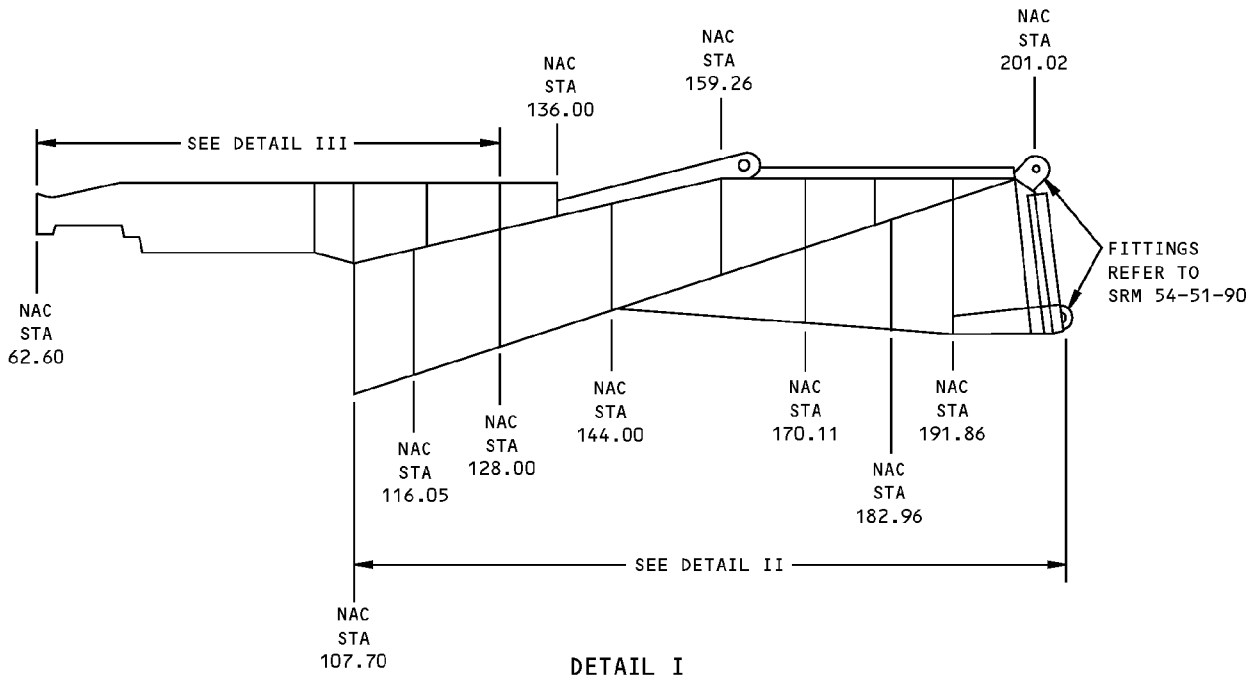
**Strut Structure Allowable Damage- PW2000 Engine
Figure 101 (Sheet 1 of 5)**

ALLOWABLE DAMAGE 1 - STRUT STRUCTURE - PW2000 ENGINE

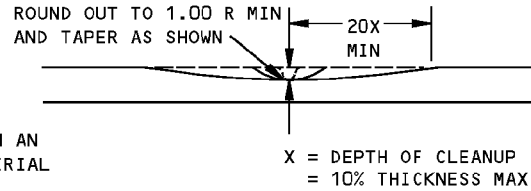
**REMOVAL OF NICK, GOUGE AND SCRATCH DAMAGE ON A SURFACE
DETAIL V**

SECTION A-A

[B] REMOVE DAMAGE AS SHOWN IN DETAILS IV, V AND VII.

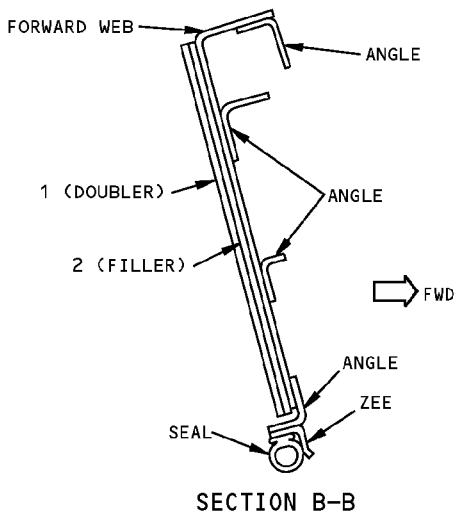
**Fan Cowl Support Beam Web Repair - PW2000 Engine
Figure 201 (Sheet 4 of 4)**

RIGHT SIDE IS SHOWN, LEFT SIDE IS OPPOSITE
VIEW IS LOOKING AFT
SECTION A-A [A]

3. Carefully cut and remove the damaged aft web as shown in Detail III, Section A-A. Maintain a minimum of 2D edge margin along the edge of the trim to the initial fastener locations. Make the corner radii a minimum of 0.50 inch (12.7 mm). If the damage is larger than the cutout shown in Detail III, Section A-A, get alternate repair instructions from the Boeing Company.

- A** THIS REPAIR IS SYMMETRICAL ON EACH SIDE OF THE FAN COWL SUPPORT BEAM.
- B** CUT AND REMOVE 0.05 INCH (1.27 mm) OFF THIS FLANGE AND APPLY THE FINISH.

INITIAL FASTENER LOCATION. INSTALL A COUNTERSINK REPAIR WASHER AND INSTALL A BACB30NW5K() HEX DRIVE BOLT WITH A BACC30M COLLAR.

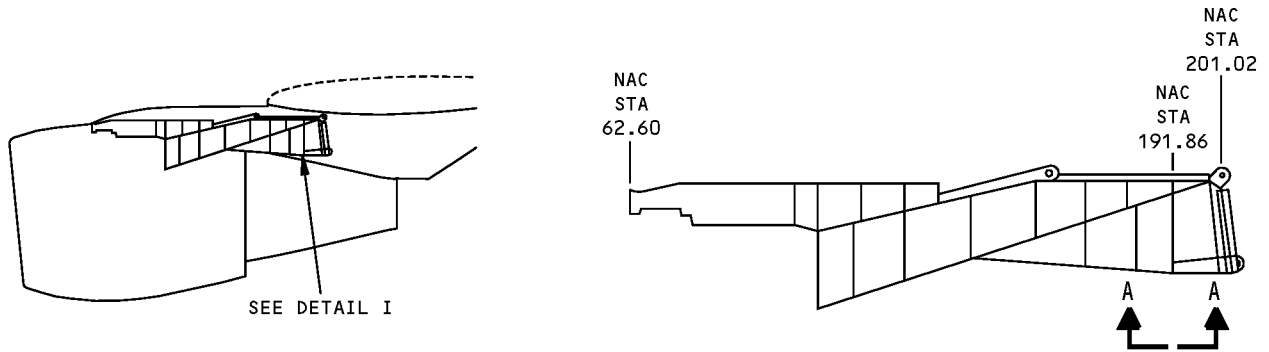
DETAIL I

FWD ←

VIEW LOOKING UP

REPAIR 2 - AFT ENGINE MOUNT ALIGNMENT PIN HOLE - PW2000 ENGINE

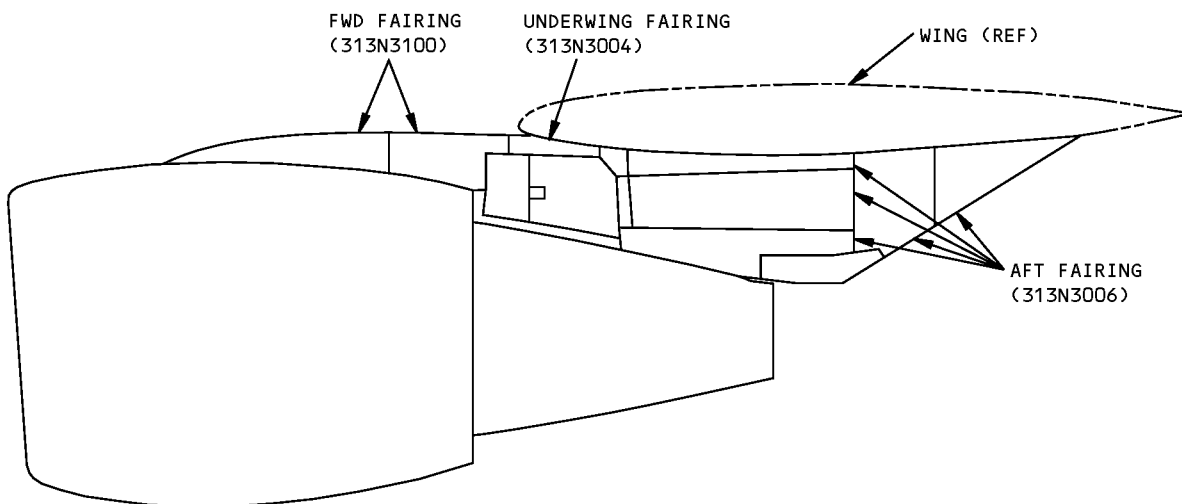
**Strut Fairing Skin Identification - PW2000 Engine
Figure 1 (Sheet 1 of 8)**

IDENTIFICATION 1 - STRUT FAIRING SKIN - PW2000 ENGINE

- MATERIAL AND PLY ORIENTATION SHOWN FOR FIELD AREAS ONLY. SEE BOEING DRAWINGS FOR EDGE BANDS AND AREAS WITH DOUBLERS

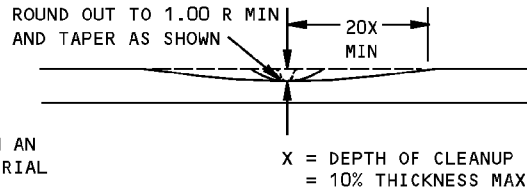
**REMOVAL OF NICK, GOUGE AND SCRATCH DAMAGE ON A SURFACE
DETAIL IV**

- A** CRACKS ARE NOT PERMITTED EXCEPT FOR EDGE CRACKS WHICH MUST BE REMOVED AS SHOWN IN DETAILS V AND VIII.
- B** REMOVE DAMAGE AS SHOWN IN DETAILS IV, V, AND VII.

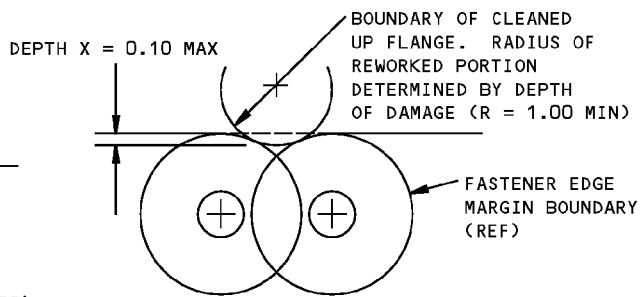
**DAMAGE CLEANUP OF EDGES WHERE
FASTENER EDGE MARGINS OVERLAP**

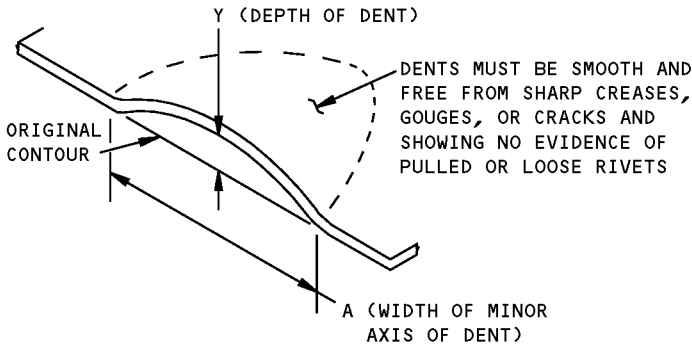
$\frac{A}{Y}$ MUST NOT BE LESS THAN 30
CONTACT BOEING FOR $\frac{A}{Y}$ LESS THAN 30

**ALLOWABLE DAMAGE FOR DENT
DETAIL VI**

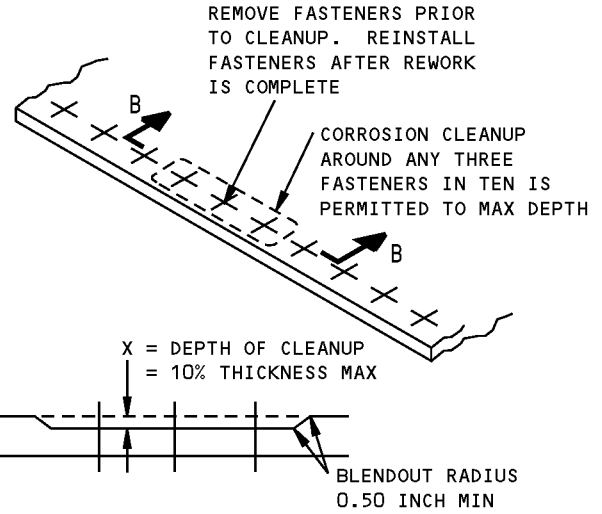
**SECTION B-B
CORROSION CLEANUP
DETAIL VII**

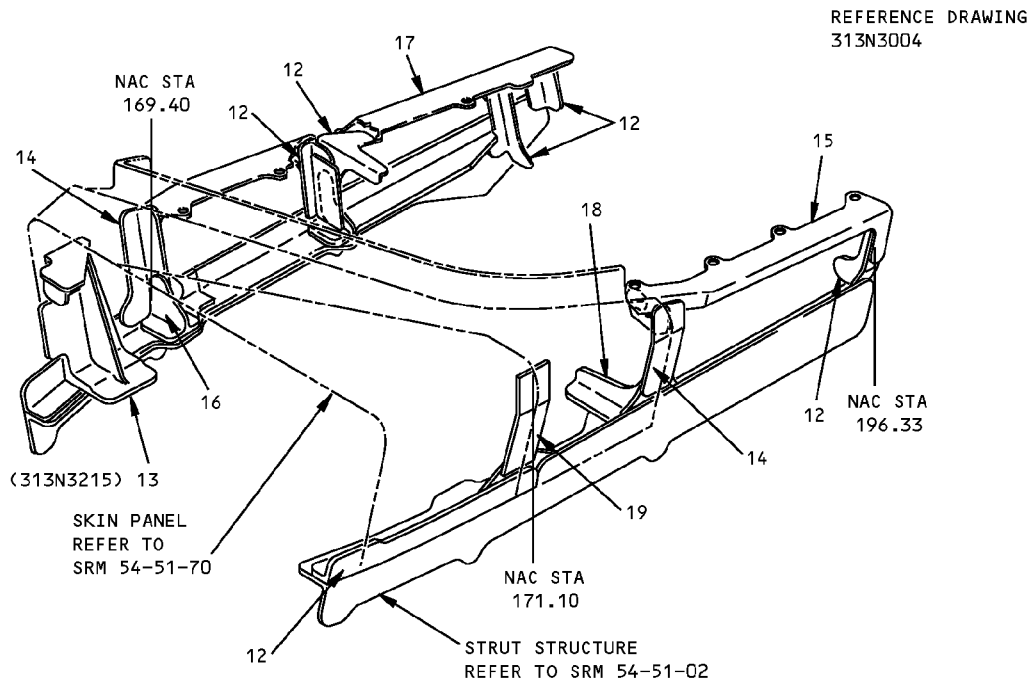
**UNDERWING FAIRING STRUCTURE
DETAIL II**

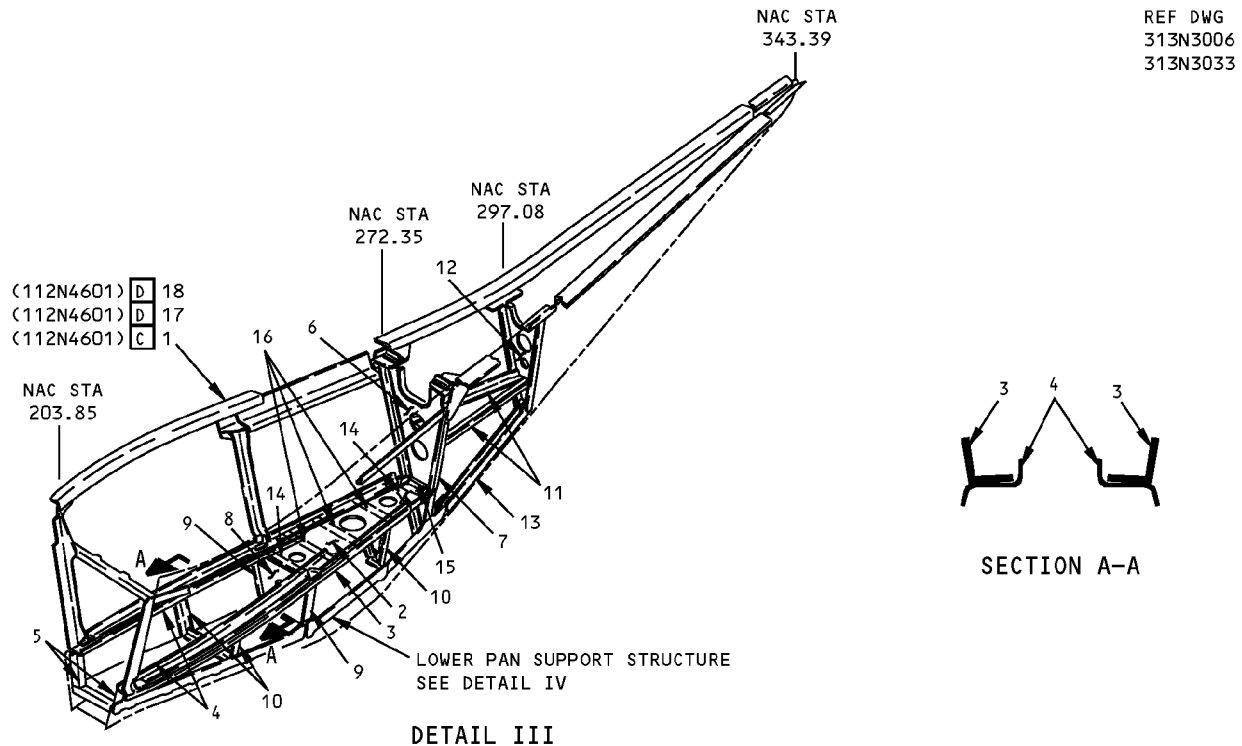
DETAIL III

ITEM	DESCRIPTION	GAGE	MATERIAL	EFFECTIVITY
1	SKATE ANGLE	0.125	2024-T42	C
2	WEB	0.063	CLAD 2024-T42	
3	LATCH STRIKER		BAC1503-100515 7075-T73511	
4	CHORD	0.100	7075-T62	
5	CHANNEL	0.063	2024-T42	
6	WEB	0.063	7075-T62	
7	CHANNEL		BAC1510-1151 7075-T62	
8	WEB	0.050	CLAD 2024-T42	
9	TEE		BAC1506-2643 2024-T42	
10	ANGLE	0.063	CLAD 2024-T42	
11	CHANNEL	0.063	7075-T6	
12	WEB	0.050	CLAD 7075-T6	
13	CLOSURE		BAC1520-2414 2024-T42	
14	ANGLE		BAC1505-100569 2024-T42	
15	ANGLE	0.063	CLAD 7075-T62	
16	CROSS TIE		BAC1505-100913 2024-T42	
17	SKATE ANGLE		AND10133-2401 EXTRUSION 2024-T42	D
18	SKATE ANGLE		BAC1506-588 EXTRUSION 2024-T3511	D

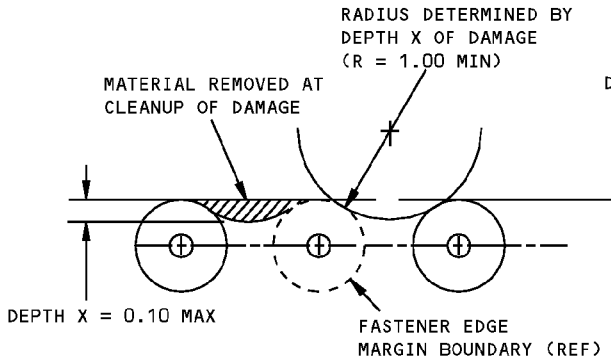
DAMAGE CLEANUP OF EDGES WHERE FASTENER EDGE MARGINS DO NOT OVERLAP

- REFINISH REWORKED AREAS AS SHOWN IN AMM 51-20.
 - REFER TO SRM 51-10-02 FOR INSPECTION AND REMOVAL OF DAMAGE
- A** CRACKS ARE NOT PERMITTED EXCEPT FOR EDGE CRACKS WHICH MUST BE REMOVED AS SHOWN IN DETAILS V, IX AND X.
- B** REMOVE DAMAGE AS SHOWN IN DETAILS V, VI, VIII, IX AND X.
- C** CLEAN OUT DAMAGE UP TO 0.25 INCH (6 mm) MAX DIA AND NOT CLOSER THAN 1.0 INCH (25 mm) TO FASTENER HOLE OR OTHER DAMAGE. FILL HOLE WITH A 2117-T3 OR T4 ALUMINUM RIVET INSTALLED WET WITH BMS 5-95 SEALANT. ALL OTHER HOLES TO BE REPAIRED.

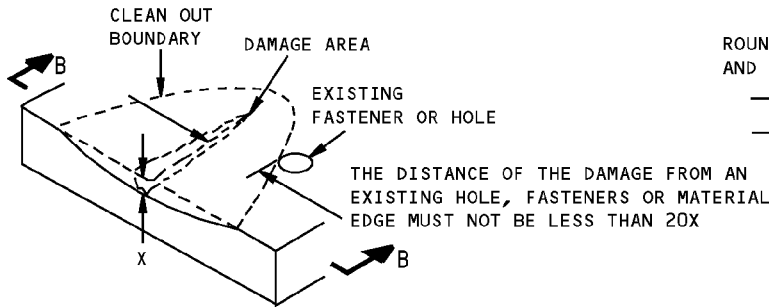
REMOVAL OF NICK, GOUGE AND SCRATCH DAMAGE ON A SURFACE
DETAIL VI

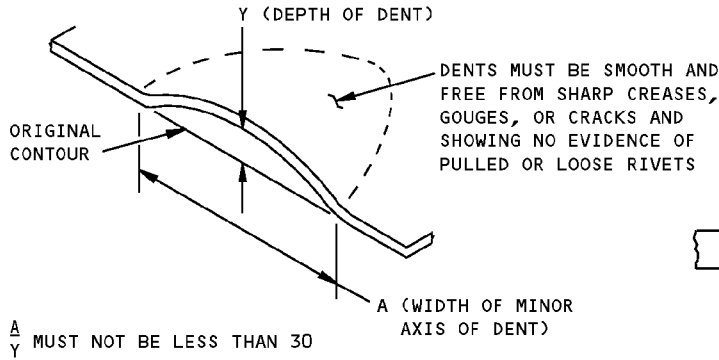
ALLOWABLE DAMAGE FOR DENT
DETAIL VII

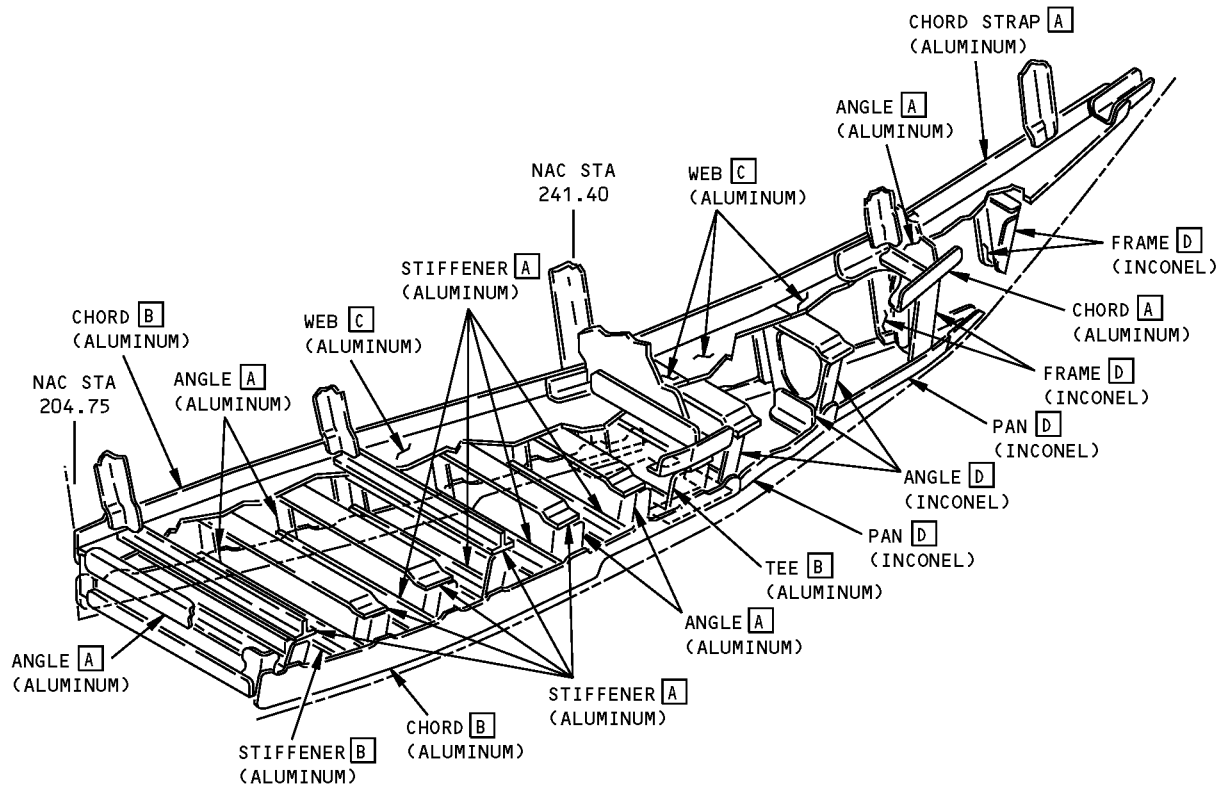
DETAIL IV

**Strut Fairing Support Structure Repair - PW2000 Engine
Figure 201 (Sheet 4 of 4)**

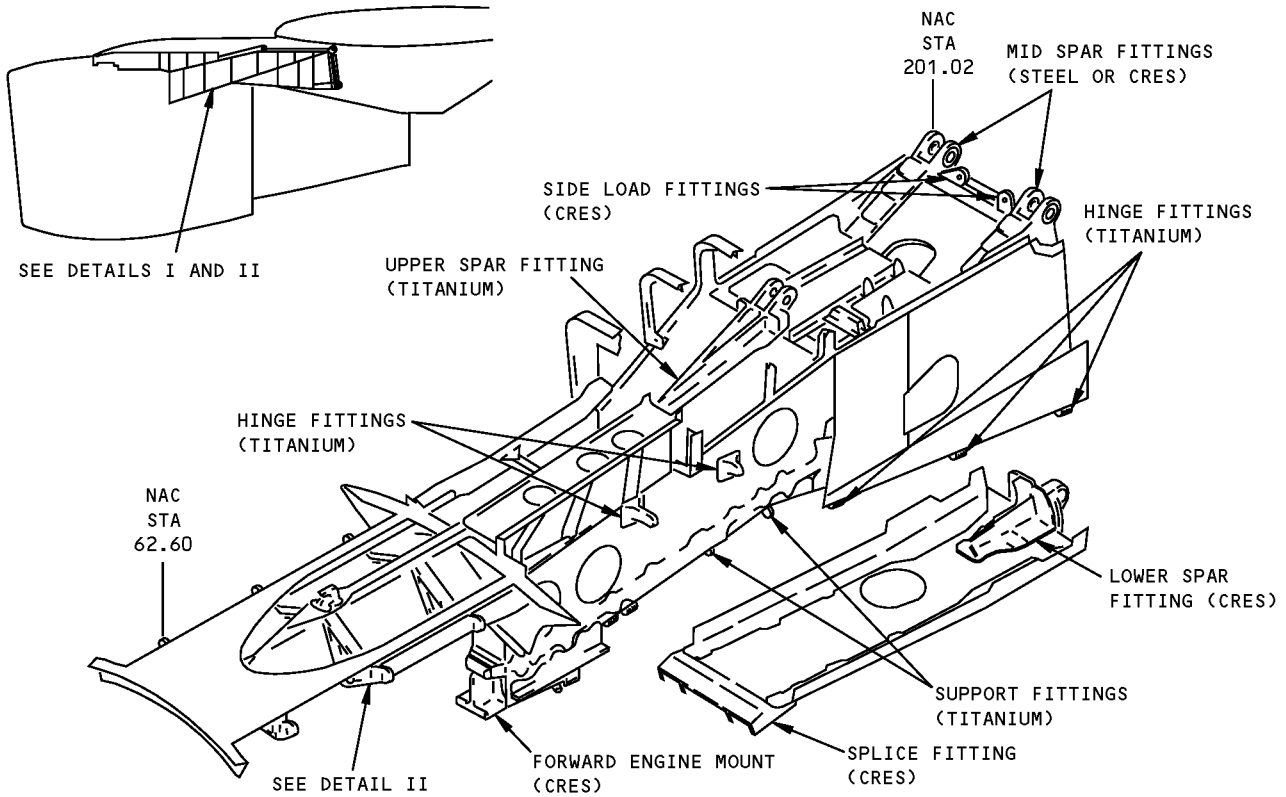
ALLOWABLE DAMAGE 1 - STRUT FITTINGS - PW2000 ENGINE

**Strut Fittings Allowable Damage - PW2000 Engine
Figure 101 (Sheet 1 of 5)**

- A** CRACKS ARE NOT PERMITTED EXCEPT FOR EDGE CRACKS WHICH MUST BE REMOVED AS GIVEN IN DETAIL VIII.
- B** REMOVE DAMAGE AS GIVEN IN DETAILS V, VI AND VII.
- C** FOR EDGE DAMAGE REFER TO DETAIL VIII. FOR LUG DAMAGE REFER TO DETAIL IX. FOR OTHER DAMAGE REFER TO DETAIL IV. DAMAGE IS NOT PERMITTED IN VICINITY OF BUSHINGS.
- D** SHOT PEEN REWORKED AREAS AS GIVEN IN SRM 51-20-06.
- E** CORROSION OR ABRASIONS ON THE FACE OF THE LUG UNDER THE FLANGE OF THE BUSHING MUST BE REMOVED AS GIVEN IN DETAIL X. WHEN YOU REMOVE THE DAMAGE, MAKE SURE THE SPOTFACE IS PERPENDICULAR TO THE BORE. AS A RESULT OF THE SPOTFACE, TRIM 0.01 TO 0.02 INCH (0.25 TO 0.5 mm) FROM THE NON-FLANGED END OF THE BUSHING BEFORE INSTALLATION.

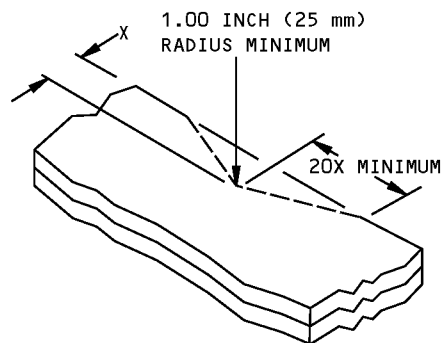
DETAIL IV

X = DEPTH OF CLEANUP
= 0.10 INCH (2.5 mm) MAXIMUM

**Strut Fittings Allowable Damage - PW2000 Engine
Figure 101 (Sheet 2 of 5)**

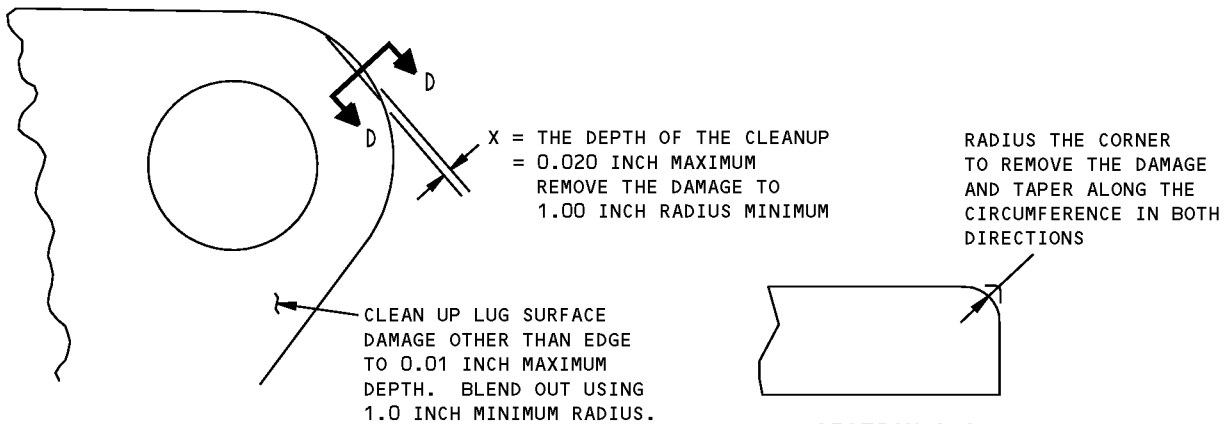
**SECTION D-D
(ROTATED)**

**REMOVAL OF DAMAGE ON A LUG EDGE AND SURFACE
DETAIL IX**

**Strut Fittings Allowable Damage - PW2000 Engine
Figure 101 (Sheet 4 of 5)**

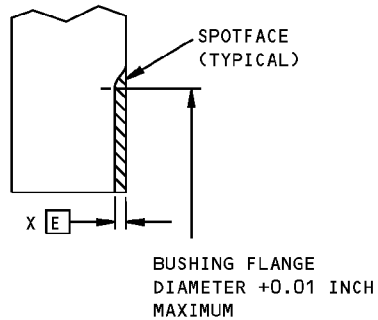
X = 0.010 INCH MAXIMUM

**DAMAGE ON LUG FACE
SECTION D-D**

**REMOVAL OF DAMAGE ON THE LUG FACE UNDER THE FLANGE OF THE BUSHING
DETAIL X**

SHADED AREA SHOWS WHERE DAMAGE HAS BEEN REMOVED

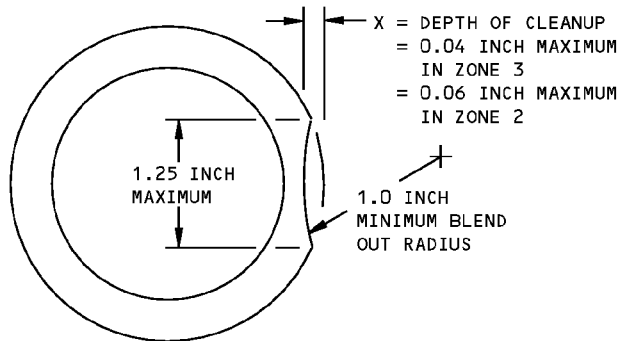
**REMOVAL OF DAMAGE ON A SURFACE
DETAIL VIII**

D REMOVE DAMAGE AS GIVEN IN DETAIL VIII.

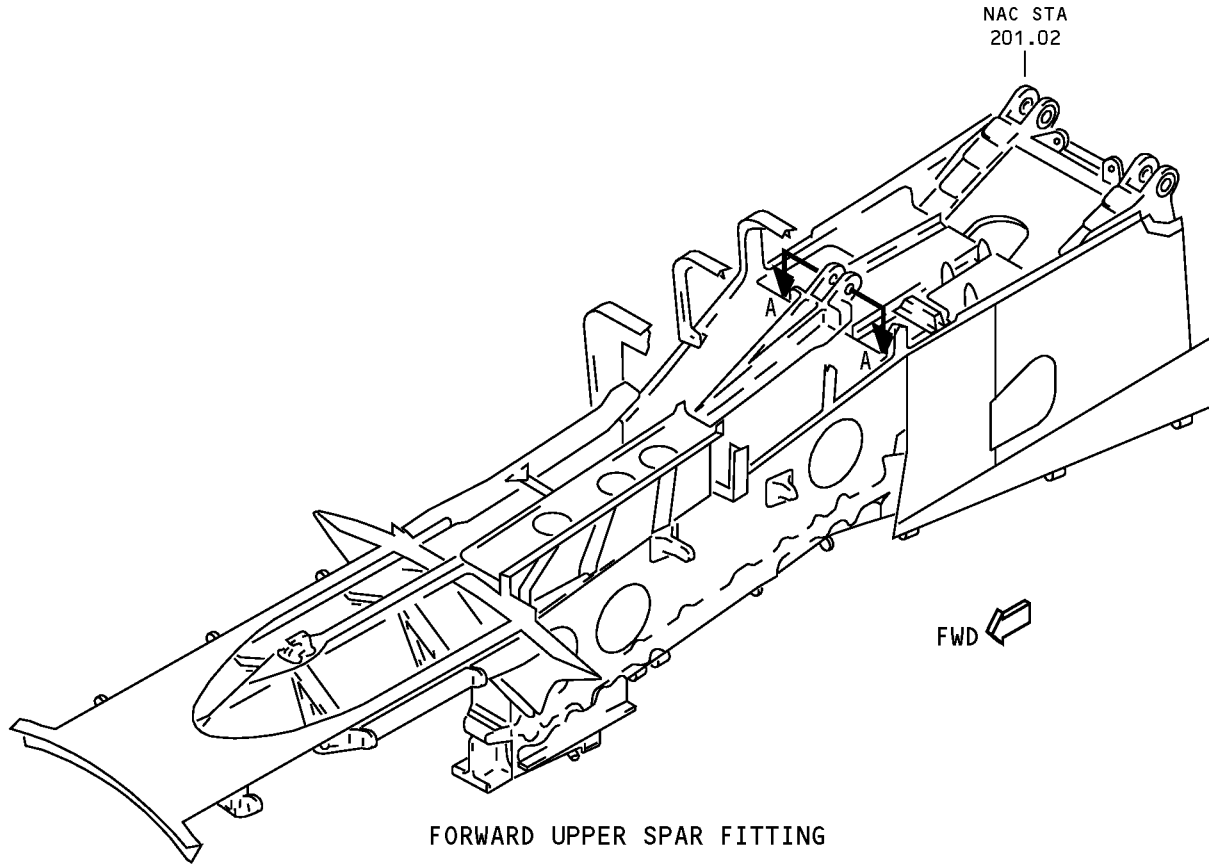
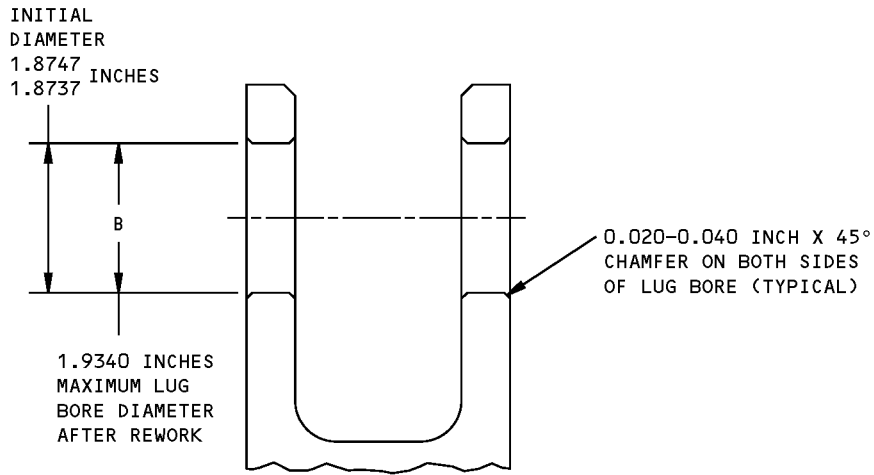
DETAIL II

FORWARD UPPER SPAR FITTING

SECTION THROUGH THE FITTING CLEVIS

LUG BORE DIMENSIONS

- C. The maximum diameter of the hole is 1.9340 inches, see DETAIL II, SECTION A-A. If the diameter of the hole(s) is larger than the maximum, you must get alternative repair instructions from Boeing.
3. Put a 0.020 to 0.040 inch by 45 degree chamfer on the edges of the hole. As an alternative to the chamfer, you can make an equivalent radius.
4. Remove the tools.
5. Remove the sharp edges and burrs from the cut surfaces.
6. Do a flap peen procedure to each hole. Use a 3M flapwheel that is 9/16 inch by 1.25 inch to get an Almen intensity of 0.012A and a coverage of 2.0. Refer to SOPM 20-10-03.
7. Hone each hole to the final diameter. Make the finish on the inner surface of the hole 32 microinches R_a or smoother. You can remove a maximum of 0.0012 inch from the radius of the hole to get the necessary surface finish. The maximum diameter of the hole is 1.9340 inches.

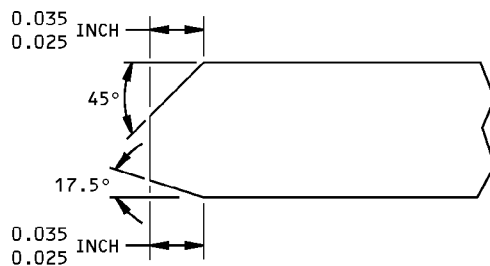
**FLANGED BUSHING CHAMFERS
DETAIL IV**
