**NACELLES AND
PYLONS**

**757-200
STRUCTURAL REPAIR MANUAL**

**CHAPTER 54
NACELLES AND PYLONS**

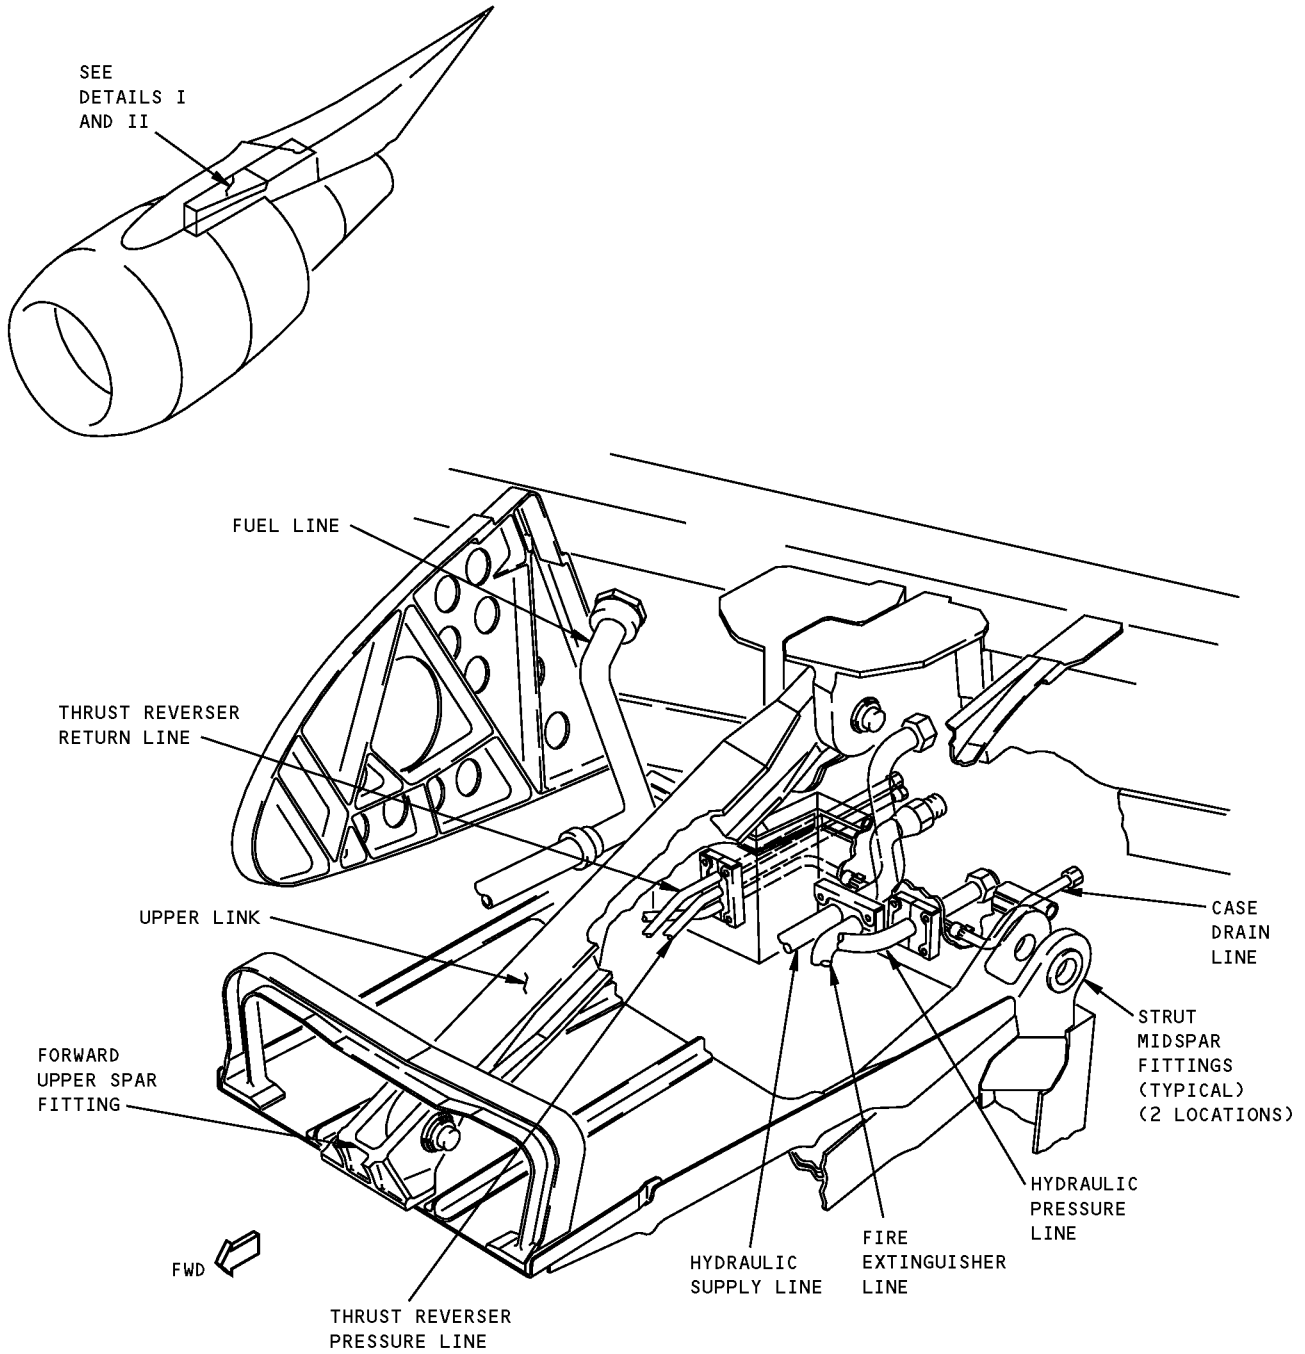
**TUBING, DUCT AND FITTING LOCATIONS
DETAIL I**

**Midspar Fitting, Lug Hole Repair with Interference Fit Bushing Procedure - PW2000 Engine
Figure 201 (Sheet 5 of 10)**

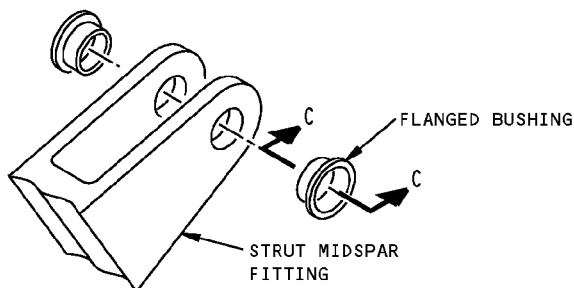
DETAIL III

**MIDSPAR CLEVIS FOR AIRPLANE CUM LINE NUMBERS 37 THRU 732
WITHOUT SB 757-54-0034 DONE (TWO LOCATIONS ON EACH STRUT)**

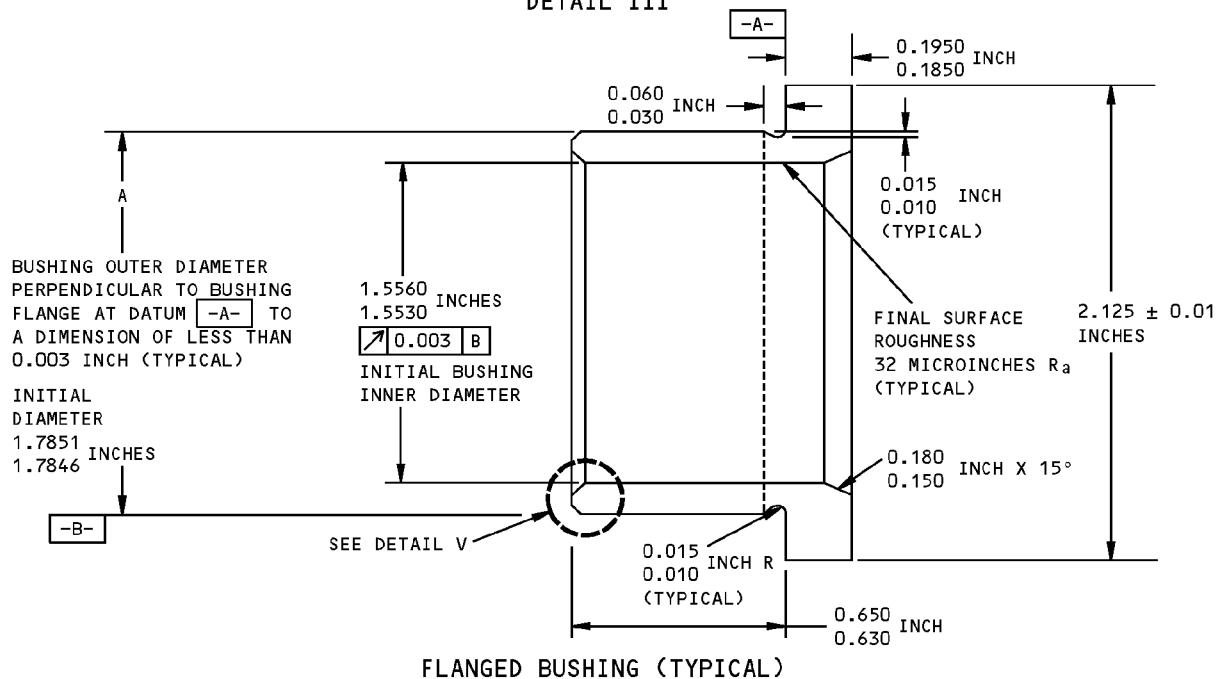
SECTION C-C

FLANGED BUSHING (TYPICAL)

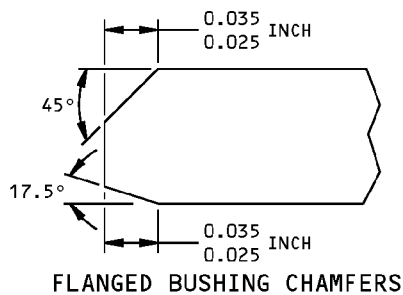
DETAIL IV

FLANGED BUSHING CHAMFERS

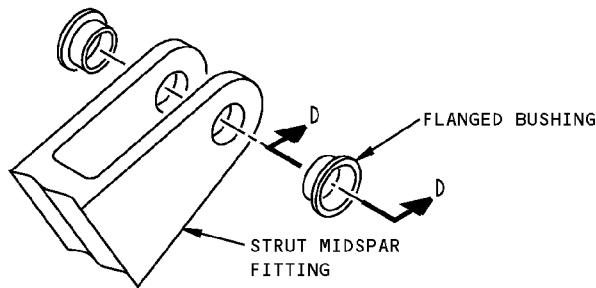
DETAIL V

MIDSPAR CLEVIS FOR AIRPLANE CUM LINE NUMBERS 736 AND ON OR AIRPLANES WITH SB 757-54-0034 DONE (TWO LOCATIONS ON EACH STRUT)

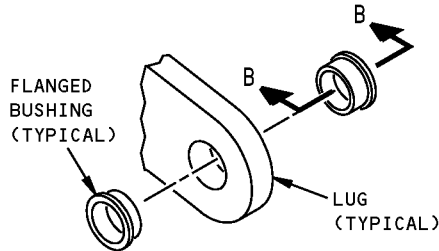
DETAIL III

LOWER SPAR FITTING ASSEMBLY

1. If no damage is found and the airplane age is 15 years or less, use the same diameter dimensions as the initial bushings. Refer to Table I and Detail III. Continue with the steps given in Procedure VIII.
2. Machine the oversized bushings to the necessary outer diameter that you found in Procedure V and the other dimensions given in Detail III.
3. Make the surface finish of the outer diameter of the bushings 32 microinches R_a or smoother. Make the surface finish on the other surfaces 63 microinches R_a or smoother.
4. Remove the sharp edges and burrs from the cut surfaces.

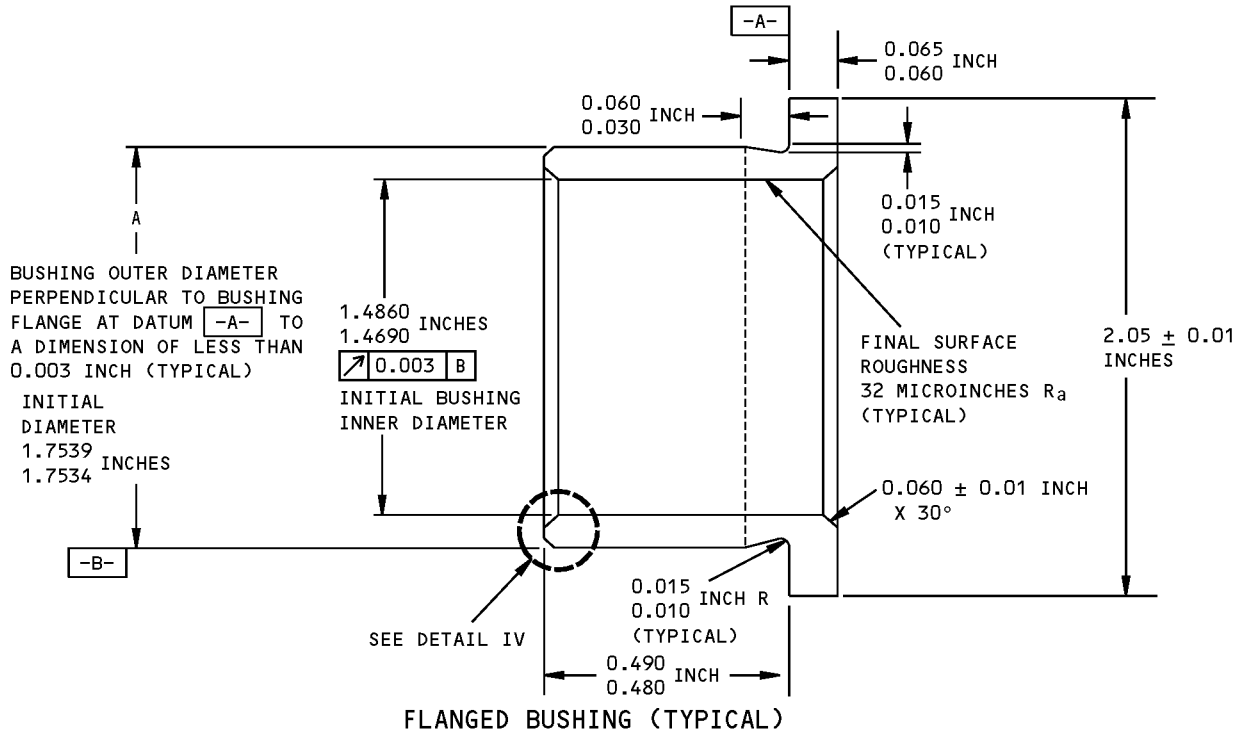
SECTION B-B

FLANGED BUSHING (TYPICAL)

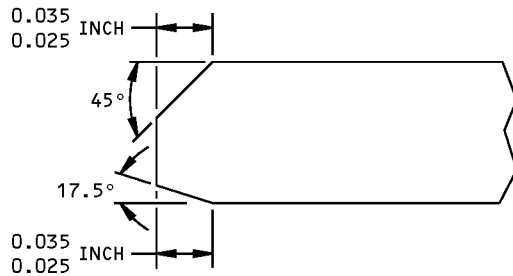
DETAIL IV

FLANGED BUSHING CHAMFERS
