**757-200  
STRUCTURAL REPAIR MANUAL**

**CHAPTER 54  
NACELLES AND PYLONS**

REPAIR GENERAL - ACOUSTIC PANEL AREA LOSS LIMITS - RB211-535 ENGINE

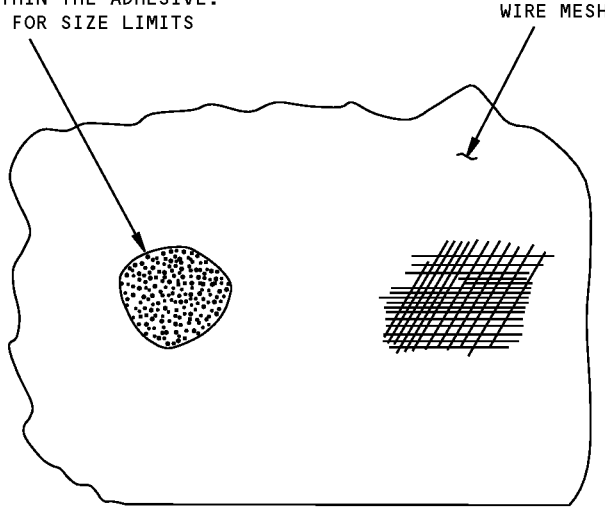
DETAIL I

THE LOSS OF ACOUSTIC LINING AREA FOR THIS REPAIR IS THE TOTAL AREA COVERED BY OR ENCLOSED WITHIN THE ADHESIVE. REFER TO 54-00-01 FOR SIZE LIMITS

**Inlet Cowl - Acoustic Barrel - Repair for Wire Mesh - RB211-535E4 Engine  
Figure 201 (Sheet 2 of 2)**

- Trim all loose wire from damaged mesh using finger nail scissors.
- Repair area less than 1.0 inches dia, mask around damage using Teflon tape leaving 0.25 inch of exposed mesh. Areas greater than 1.0 inches dia, mask around damage using Teflon tape leaving 0.25 inch of exposed mesh, and mask within area leaving 0.25 inch between edge of mesh and Teflon tape.
- WARNING:** PROTECTIVE GLOVES SHOULD BE WORN WHEN USING DEGREASERS. USE ONLY IN WELL VENTILATED AREAS. VERY FLAMMABLE, KEEP AWAY FROM IGNITION SOURCES.

- THE TOTAL AREA OF ACOUSTIC LINING REPAIR IS LIMITED, REFER TO 54-00-01.
- THE LOSS OF ACOUSTIC LINING AREA FOR THIS REPAIR IS THE TOTAL AREA COVERED BY OR ENCLOSED WITHIN ADHESIVE.

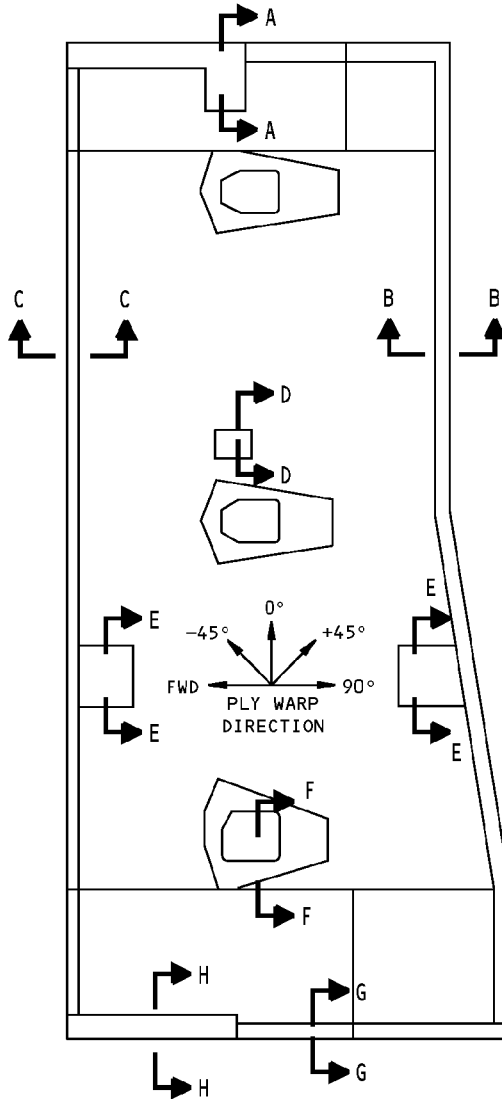
Reverser Cowl Skin Panel Identification - RB211-535C Engine  
Figure 1 (Sheet 4 of 8)

NOTE: SECTION VIEWS DO NOT NECESSARILY REPRESENT ACTUAL PANEL CONTOURS

OUTER SKIN LOOKING INBOARD  
DETAIL II

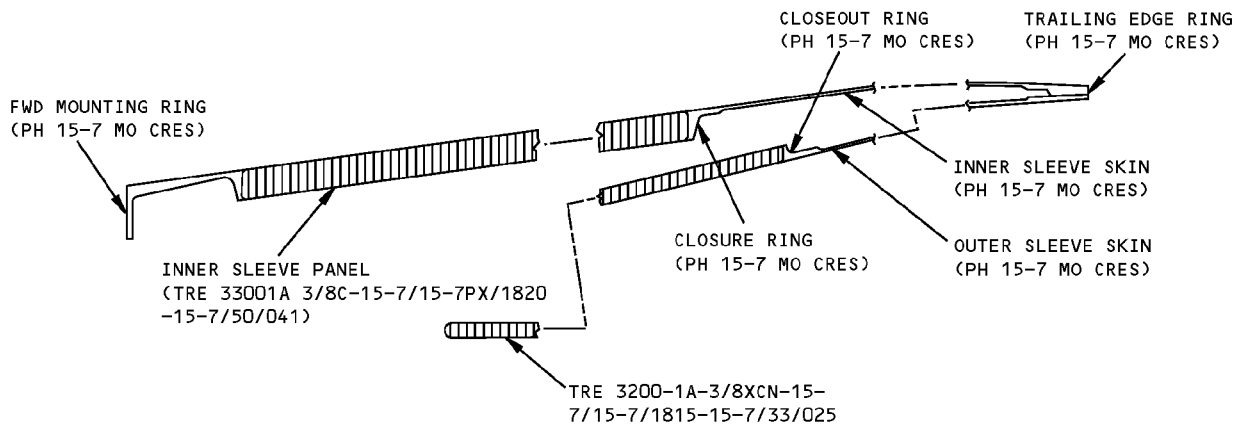
**CROSS-SECTIONAL VIEW THRU EXHAUST ASSEMBLY**

**Primary Exhaust Allowable Damage - PW2000 Engine  
Figure 101 (Sheet 1 of 4)**

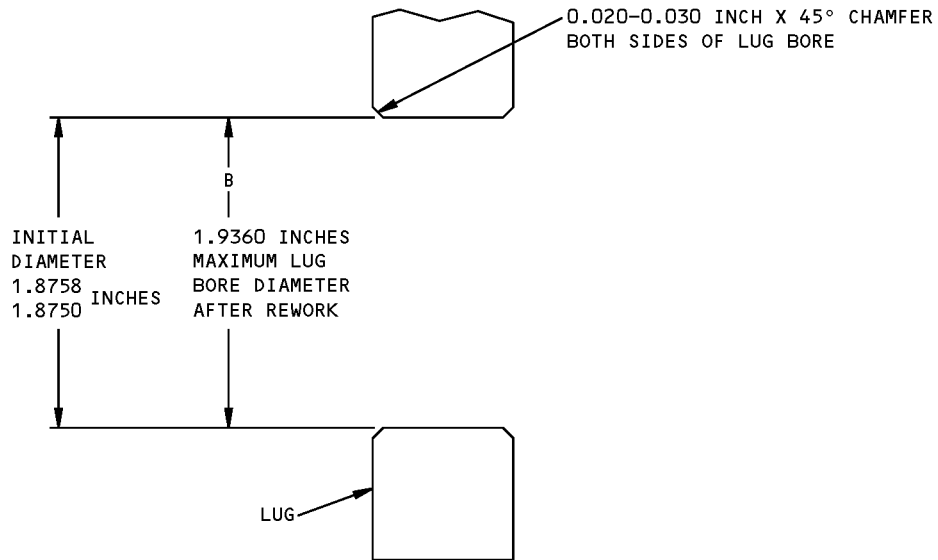
**LUG BORE DIMENSIONS  
SECTION A-A**

**Forward Upper Spar Fitting, Lug Hole Repair with Interference Fit Bushing Procedure - RB211-535 Engine  
Figure 201 (Sheet 6 of 8)**

2. Machine the hole as necessary to remove the damage.
  - A. The material of the fitting is 15-5PH corrosion resistant steel.
  - B. Do a magnetic particle inspection to make sure all of the damage is removed. If the inspection shows that there is no more damage, machine an insurance cut that is a minimum of 0.010 inch on the diameter.
  - C. The maximum diameter of the hole is 1.9360 inches, see DETAIL II, SECTION A-A. If the diameter of the hole is larger than the maximum, you must get alternative repair instructions from Boeing.
3. Put a 0.020 to 0.030 inch by 45 degree chamfer on the edges of the hole. As an alternative to the chamfer, you can make an equivalent radius.
4. Remove the tools.
5. Remove the sharp edges and burrs from the cut surfaces.

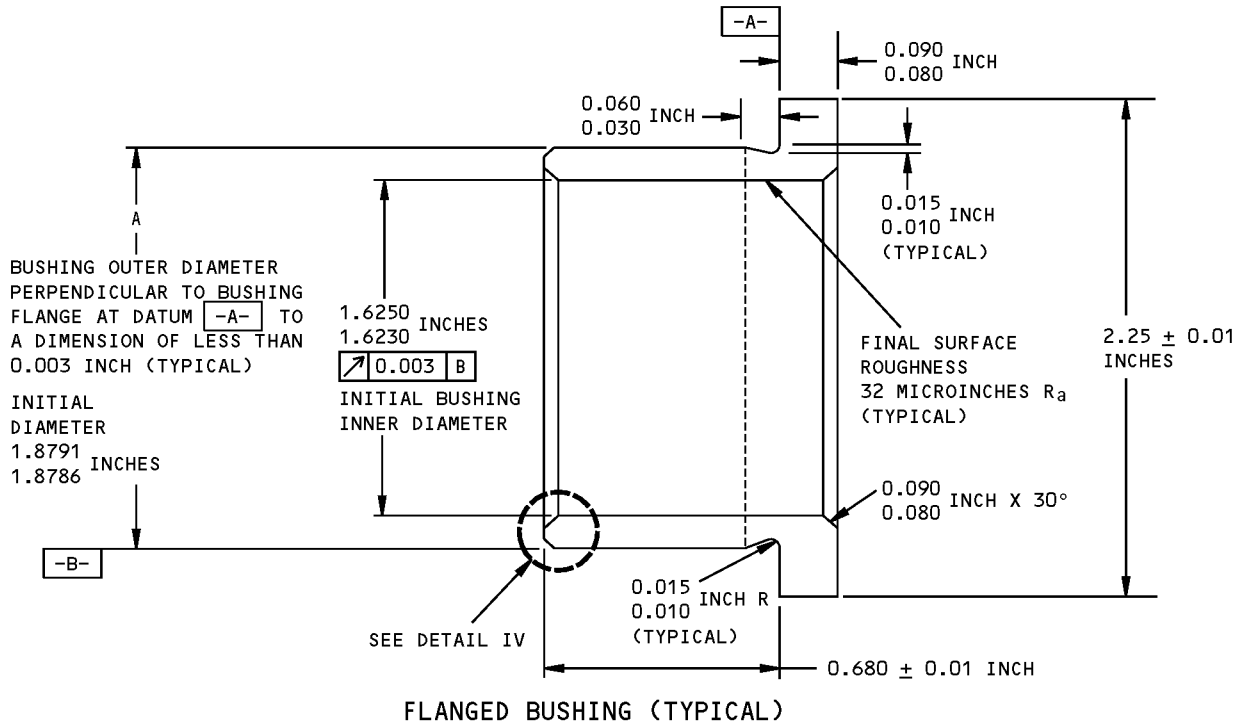
**SECTION B-B**

**FLANGED BUSHING (TYPICAL)**

REPAIR MATERIAL			
PART		QTY	MATERIAL
1	OVERSIZED BUSHING	2	2.30 INCHES DIAMETER BY 0.80 INCH LONG ALUMINUM-NICKEL-BRONZE BAR AS SPECIFIED IN AMS 4640

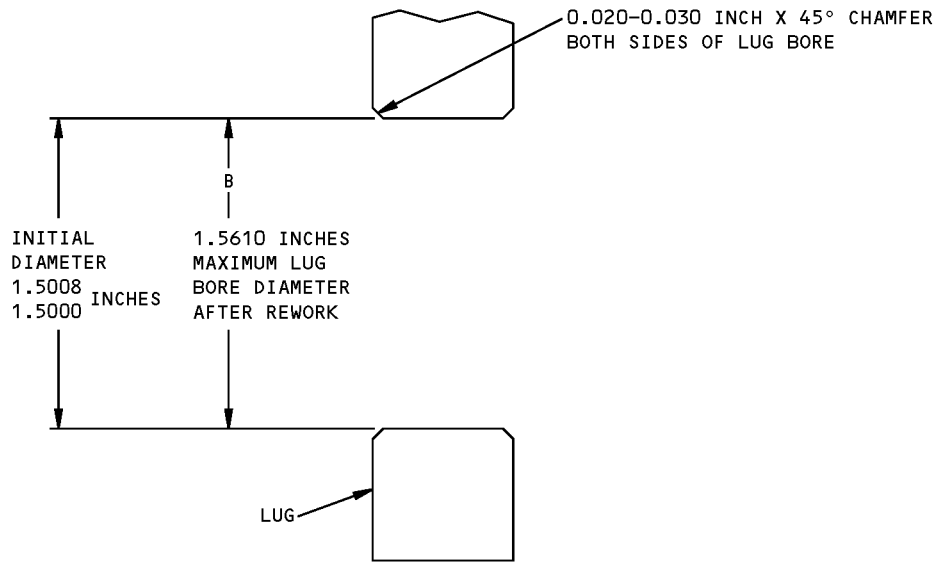
**LUG BORE DIMENSIONS  
SECTION A-A**

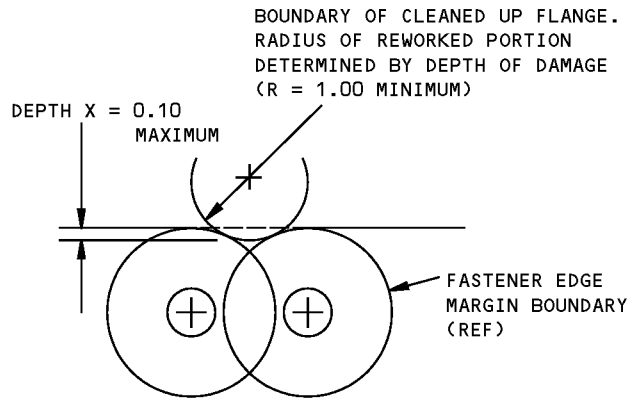
DAMAGE CLEANUP OF EDGES WHERE FASTENER EDGE MARGINS OVERLAP

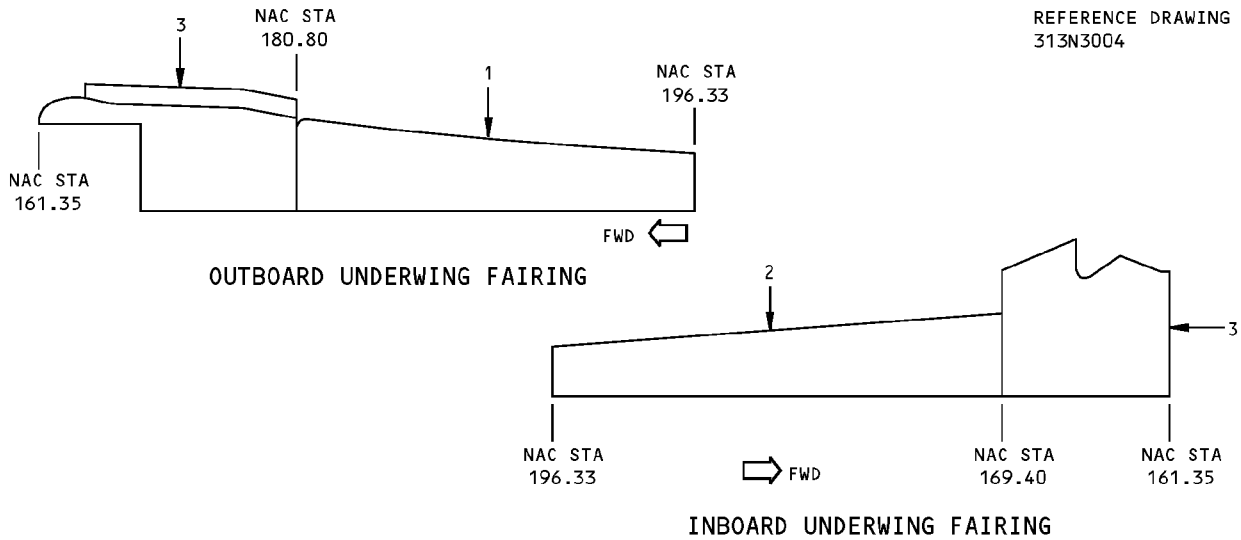
DETAIL IX

REFERENCE DRAWING  
313N3004

ITEM	DESCRIPTION	GAGE	MATERIAL	EFFECTIVITY
1	OUTBOARD SKIN PANEL	0.10	CLAD 2024-T42	
2	INBOARD SKIN PANEL	0.10	CLAD 2024-T3	
3	SKIN PANEL		SEE DETAIL X

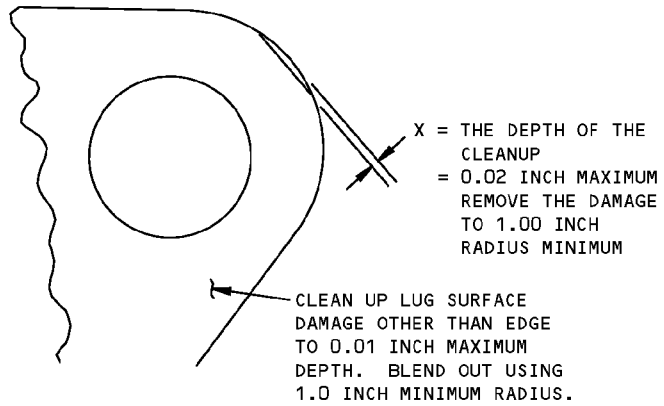
**DAMAGE CLEANUP FOR LUG SURFACE  
DETAIL VI**

**A** FOR EDGE DAMAGE REFER TO DETAIL VII. FOR LUG DAMAGE REFER TO DETAIL VI. FOR OTHER DAMAGE REFER TO DETAIL IV. DAMAGE NOT ALLOWED IN THE VICINITY OF BUSHINGS.
