CHAPTER 56 WINDOWS

IDENTIFICATION 1 - FLIGHT COMPARTMENT WINDOW STRUCTURE

Flight Compartment Window Structure Figure 1 (Sheet 1 of 3)

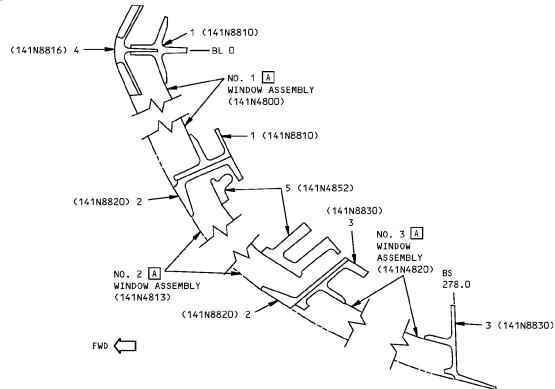
LEFT SIDE SHOWN RIGHT SIDE OPPOSITE

SECTION A-A

LIST OF MATERIALS FOR SECTION A-A

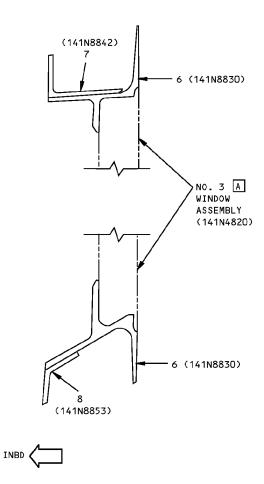
Flight Compartment Window Structure Figure 1 (Sheet 3 of 3)

ITEM	DESCRIPTION	GAGE	MATERIAL	EFFECTIVITY
1	SILL FITTING		FORGING TI-6AL-4V	
2	SILL FITTING		FORGING 7075-T73	
3	OPENABLE FRAME		FORGING 7075-T73	
4	NO. 1 WINDOW FRAME		FORGING TI-6AL-4V	
5	NO. 2 WINDOW FRAME		FORGING 7075-T73	
6	NO. 3 WINDOW FRAME		FORGING 7075-T73	
7	ANGLE		BAC1503-100327 7075-T73511	
8	CHORD		BAC1514-2610 7075-T6

D-D

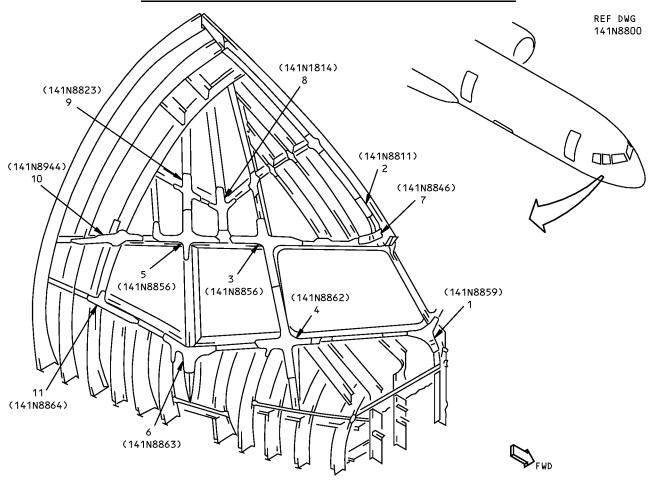
Flight Compartment Splice Straps Identification Figure 1

ITEM	DESCRIPTION	GAGE	MATERIAL	EFFECTIVITY
1	SPLICE PLATES PLATE PLATE	0.500 0.200	TI-6AL-4V TI-6AL-4V	
2	SPLICE PLATE	0.080	2024-T3	
3	SPLICE PLATE	0.375	TI-6AL-4V	
4	SPLICE PLATE	0.220	TI-6AL-4V	
5	SPLICE PLATE	0.200	TI-6AL-4V	
6	SPLICE PLATE	0.250	TI-6AL-4V	
7	SPLICE PLATE	0.180	TI-6AL-4V	
8	SPLICE PLATE	0.125	CLAD 7075-T6	
9	SPLICE PLATE	0.08	CLAD 7075-T6	
10	SPLICE PLATE	0.150	TI-6AL-4V	
11	SPLICE PLATE	0.19	TI-6AL-4V

LIST OF MATERIALS

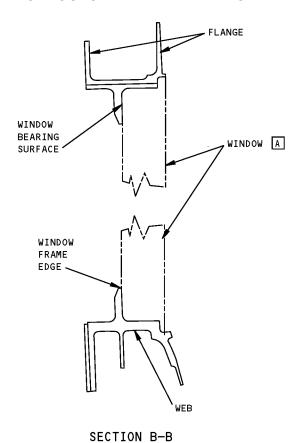
Allowable Damage - Flight Compartment Window Structure Figure 101 (Sheet 2 of 5)

DESCRIPTION	CRACKS	NICKS, GOUGES, SCRATCHES AND CORROSION	DENTS	HOLES AND PUNCTURES
WINDOW BEARING SURFACE	В	0.010 C	F	G
WINDOW FRAME EDGE	В	0.050 D	F	NOT ALLOWED
WEB	В	15% C	F	G
FLANGE SURFACE OR EDGE	В	15% C D E	F	G
OPENABLE FRAME	В	15% C D E	F	G

TABLE I

- A REPAIR IS REQUIRED WHEN THE DAMAGE EXCEEDS THE ALLOWABLE DAMAGE LIMITS OF TABLE I
- THE ALLOWABLE DAMAGE LIMITS OF TABLE I ARE A MAXIMUM AFTER ALL DAMAGE HAS BEEN REMOVED

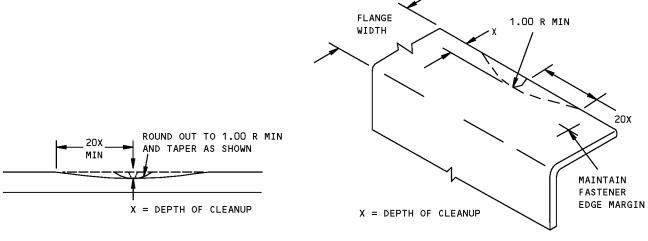
SECTION THROUGH GOUGE REMOVAL OF NICK, OR GOUGE OR SCRATCH DAMAGE ON AN EDGE DETAIL I

REMOVAL OF NICK OR GOUGE DAMAGE ON AN EDGE DETAIL II

- B ALL CRACKED PARTS MUST BE REPAIRED. CRACKS
 ON FLANGE EDGES AND SURFACES MUST BE REWORKED AS SHOWN IN DETAIL I, II OR III.
 THE DEPTH OF DAMAGE AFTER REWORK MUST NOT
 EXCEED THE REQUIREMENTS OF TABLE I FOR A
 NICK, GOUGE OR SCRATCH DAMAGE

- C NICKS, GOUGES OR SCRATCH DAMAGE REMOVED ACCORDING TO DETAIL I OR III ARE ALLOWABLE PROVIDED THE MAXIMUM PERMISSIBLE DEPTH IS NOT EXCEEDED. AFTER REWORK FINISH TO 125 MICROINCHES Ra.

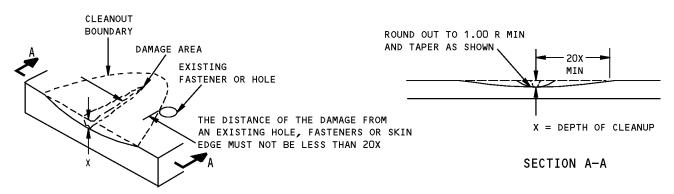
Allowable Damage - Flight Compartment Window Structure Figure 101 (Sheet 5 of 5)

REMOVAL OF NICK, GOUGE AND SCRATCH DAMAGE ON A SURFACE DETAIL III

- E ALLOWABLE DAMAGE DEPTH BETWEEN FASTENERS MUST NOT EXCEED 15 PERCENT OF ORIGINAL MATERIAL THICKNESS. SEE DETAIL III
- F MINOR DENTS AND SURFACE DEPRESSIONS WHICH
 DO NOT PENETRATE ANY DEEPER THAN THE
 LIMITS OF TABLE I FOR NICK, GOUGE OR
 SCRATCH DAMAGE AND WHICH DO NOT DISTORT THE
 OPPOSITE SURFACE OF THE MEMBER MAY BE
 REWORKED AS SHOWN IN DETAIL I OR III

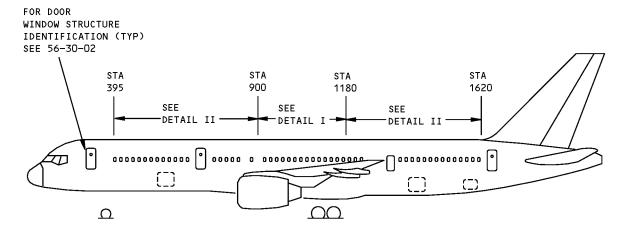
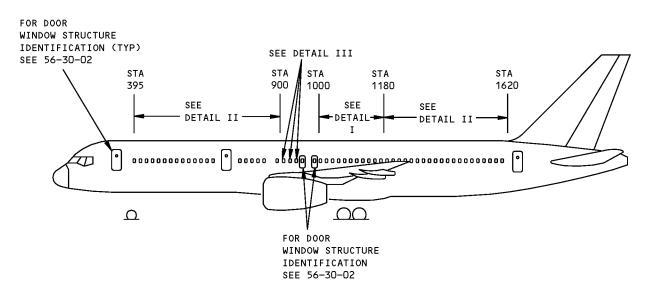
> **Cabin Window Structure Identification** Figure 1 (Sheet 1 of 2)

FOR AIRPLANES WITH NO. 3 EMERGENCY EXIT DOOR

FOR AIRPLANES WITH OVERWING EMERGENCY EXIT DOORS

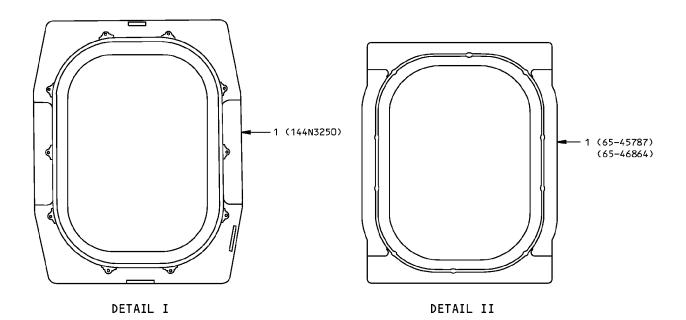
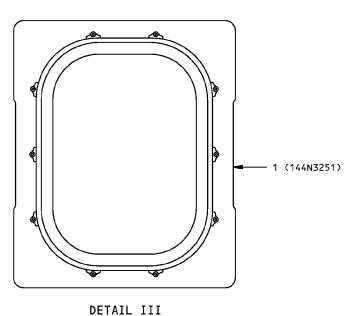
Cabin Window Structure Identification Figure 1 (Sheet 2 of 2)

ITEM	DESCRIPTION	GAGE	MATERIAL	EFFECTIVITY
1	FRAME		FORGING 7075-T73

LIST OF MATERIALS FOR DETAILS I, II AND III

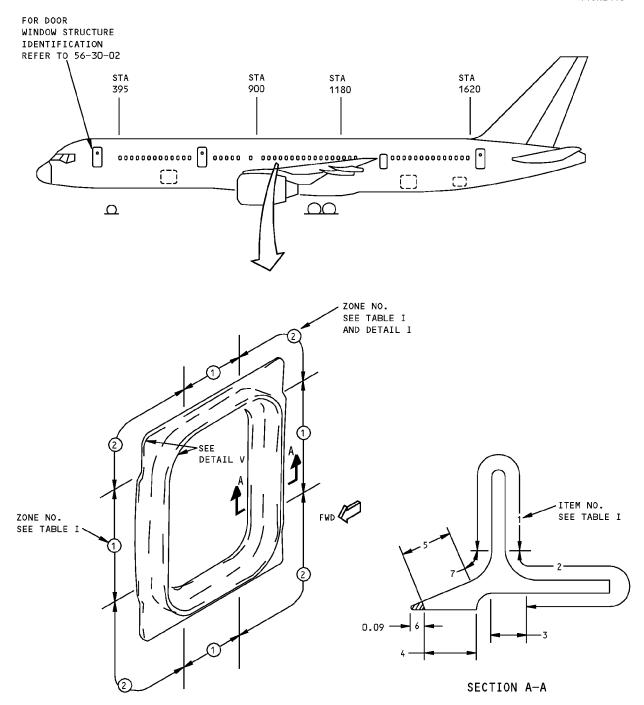
Allowable Damage - Cabin Window Frames Figure 101 (Sheet 1 of 4)

TYPICAL WINDOW FRAME

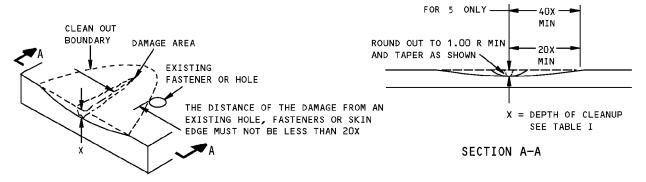
Allowable Damage - Cabin Window Frames Figure 101 (Sheet 3 of 4)

REMOVAL OF NICK, GOUGE AND SCRATCH DAMAGE ON A SURFACE DETAIL IV

- B DAMAGE REMOVED PER DETAIL IV IS ALLOWED PROVIDED THE MAXIMUM PERMISSIBLE DEPTH IS NOT EXCEEDED
- C NO CRACKS ALLOWED. REPLACE FRAME
- D DAMAGE ON SURFACES IN THE REGIONS OF FAST-ENER HEADS OR COLLARS IS ALLOWED, PROVIDED THAT THE DAMAGE CAN BE REMOVED BY SPOTFACING AS SHOWN IN DETAIL V
- E REDUCTION IN CROSS-SECTIONAL AREA NOT TO EXCEED 15% OF ORIGINAL AREA
- F DAMAGE OF EDGE OF A FLANGE REMOVED ACCORDING
 TO DETAIL II IS ALLOWED, PROVIDED THE MAXIMUM
 DEPTH IS NOT EXCEEDED. ALL OTHER CRACKS NOT
 ALLOWED

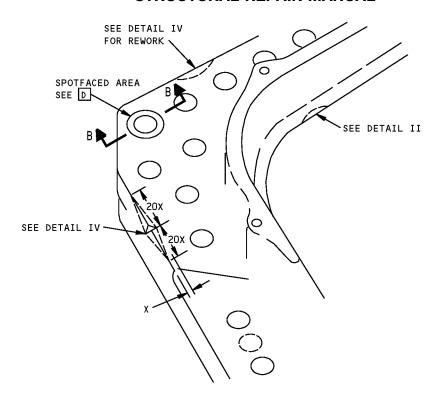
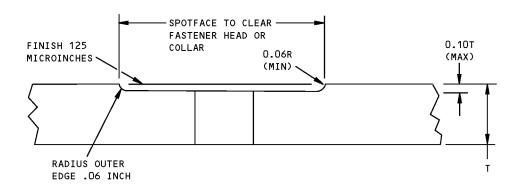
Allowable Damage - Cabin Window Frames Figure 101 (Sheet 4 of 4)

DETAIL V

SECTION B-B

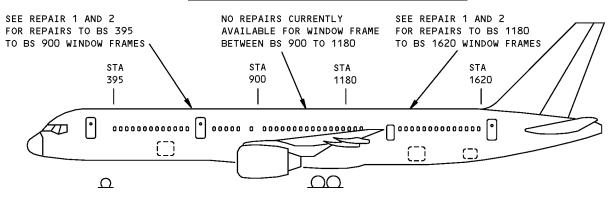
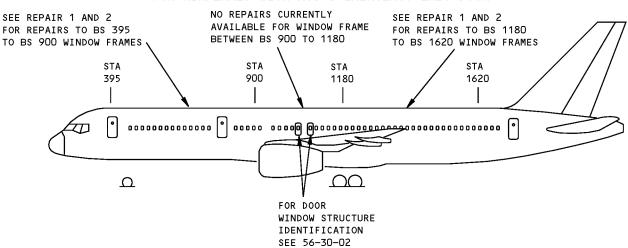
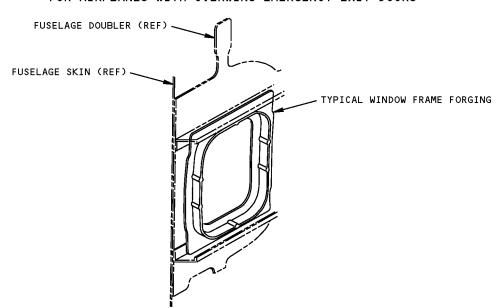
Cabin Window Frame Repair Figure 201

FOR AIRPLANES WITH NO. 3 EMERGENCY EXIT DOOR

FOR AIRPLANES WITH OVERWING EMERGENCY EXIT DOORS

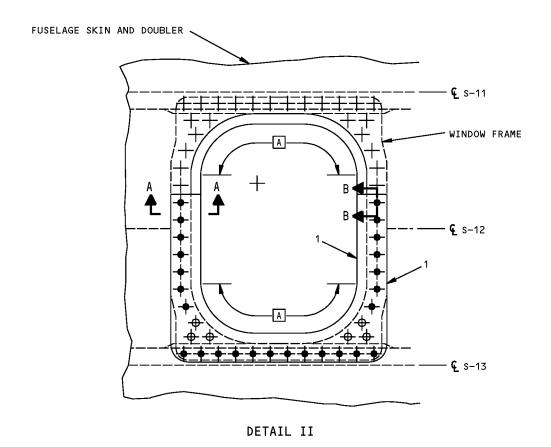
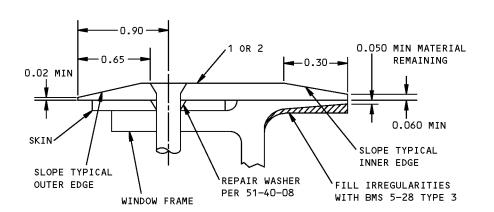
Cabin Window Frame External Repair Figure 201 (Sheet 2 of 3)

SECTION A-A

- 1. This repair is for damage to cabin window frame in excess of that described in Allowable Damage 1 or for damage adjacent to fasteners common to skin. Clean up damage and maintain a minimum of 0.05 of sound material (see section A-A). Where damage is confined to the upper or lower flange only, doubler 1 is required, per detail II. Damage extending farther around the frame requires the use of doubler 2 per detail III. Extensive damage requires window frame replacement.

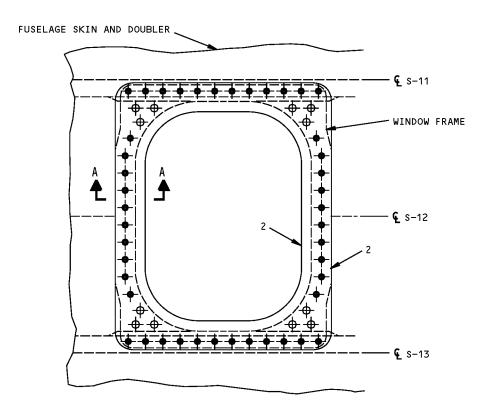
Cabin Window Frame External Repair Figure 201 (Sheet 3 of 3)

DETAIL III

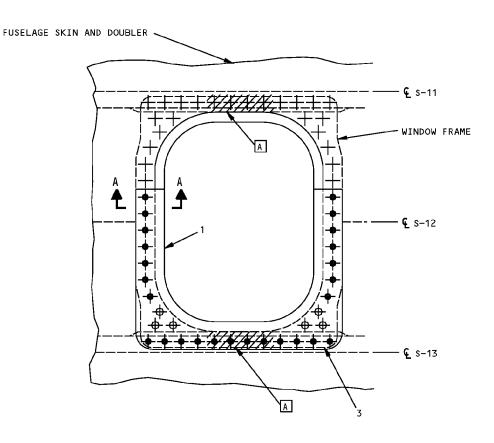
Cabin Window Frame Forging Repair Figure 201 (Sheet 2 of 3)

DETAIL II

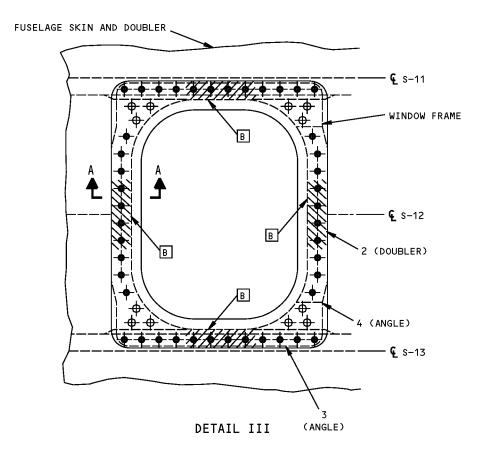
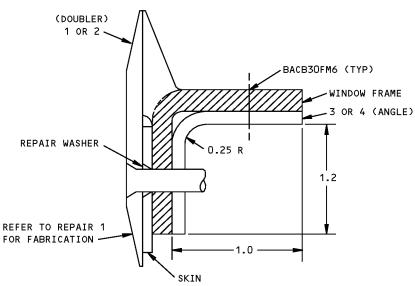
Cabin Window Frame Forging Repair Figure 201 (Sheet 3 of 3)

SECTION A-A (TYPICAL) ROTATED 90° CCW

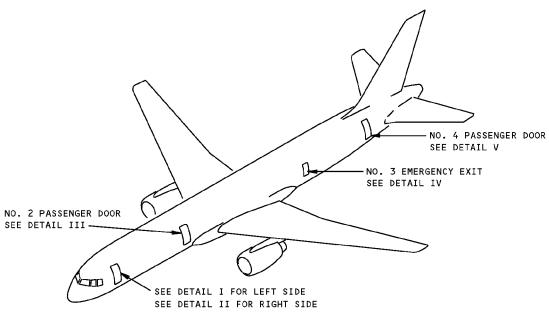
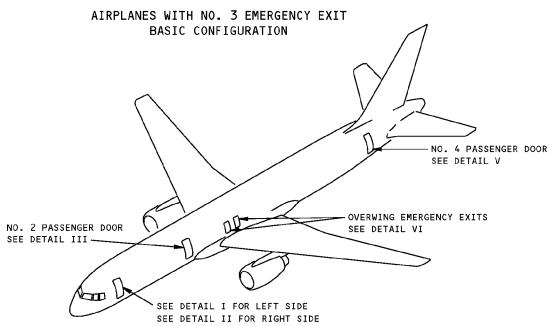
Door Window Structure Identification Figure 1 (Sheet 1 of 2)

AIRPLANES WITH OVERWING EMERGENCY EXITS BASIC CONFIGURATION

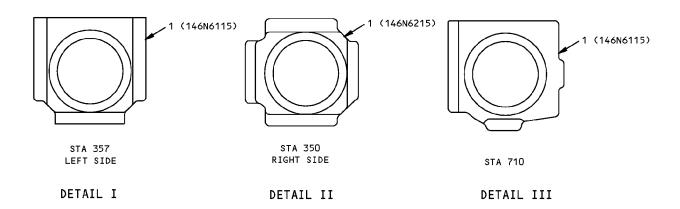
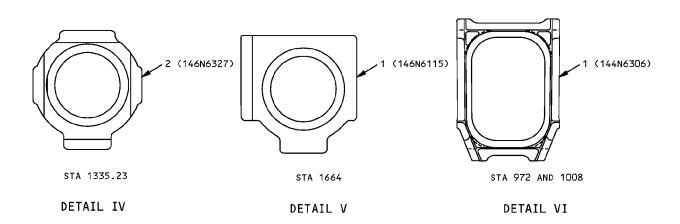
Door Window Structure Identification Figure 1 (Sheet 2 of 2)

ITEM	DESCRIPTION	GAGE	MATERIAL	EFFECTIVITY
1	FRAME	1.50	7075-T7351 7075-T73 FORGING	A B
2	FRAME	1.40	7075-T7351 7075-T73 FORGING	<u>с</u> D
3	FRAME		7075-T73 FORGING

LIST OF MATERIALS FOR DETAILS I THRU VI

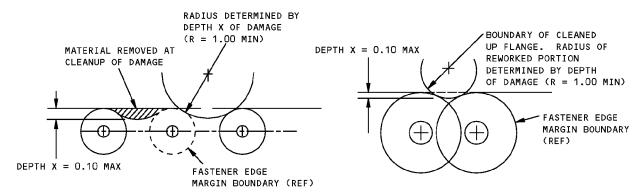
DETAIL I

DAMAGE CLEANUP OF EDGES WHERE FASTENER EDGE MARGINS DO NOT OVERLAP

DAMAGE CLEANUP OF EDGES WHERE FASTENER EDGE MARGINS OVERLAP

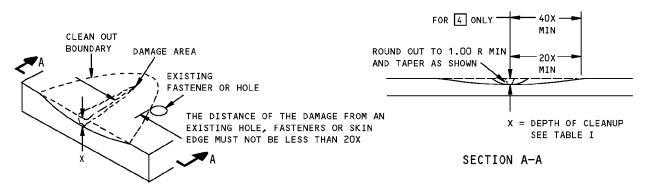
Allowable Damage - Door Window Frames Figure 101 (Sheet 3 of 3)

REMOVAL OF NICK, GOUGE AND SCRATCH DAMAGE ON A SURFACE DETAIL III
