**757-200  
STRUCTURAL REPAIR MANUAL**

**CHAPTER 56  
WINDOWS**

**IDENTIFICATION 1 - FLIGHT COMPARTMENT WINDOW STRUCTURE**

**ALLOWABLE DAMAGE 1 - FLIGHT COMPARTMENT WINDOW STRUCTURE**

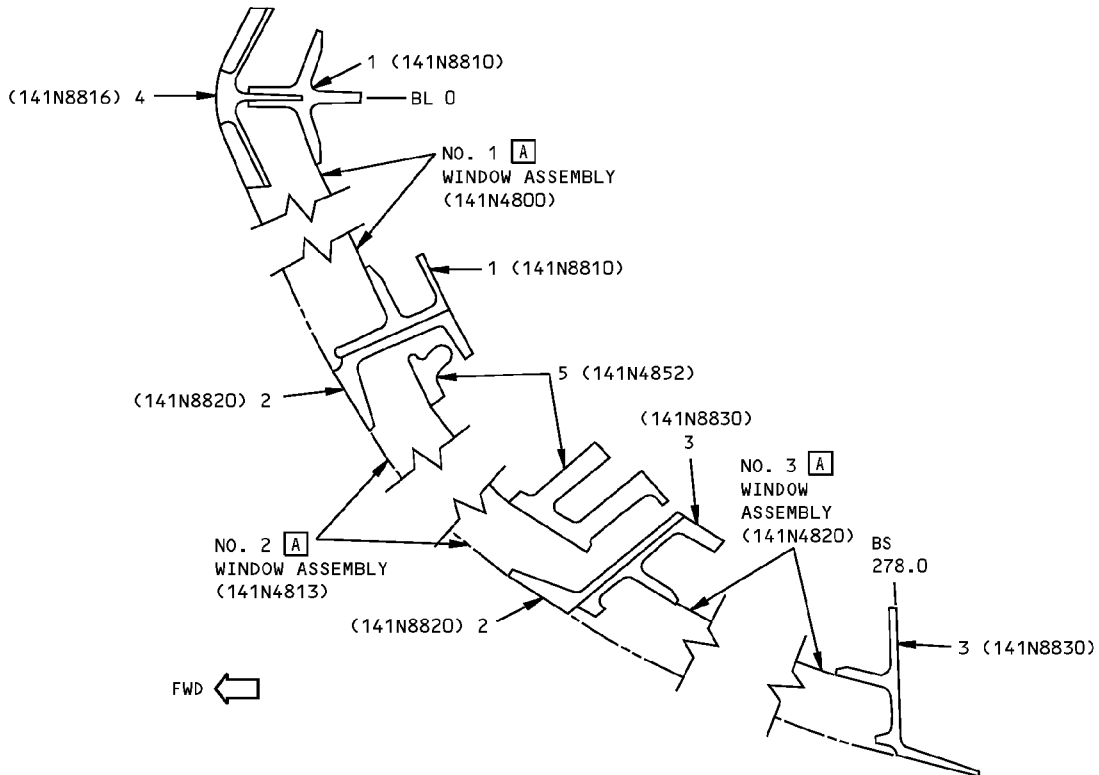
**Flight Compartment Window Structure  
Figure 1 (Sheet 1 of 3)**

LEFT SIDE SHOWN  
RIGHT SIDE OPPOSITE

**SECTION A-A**

ITEM	DESCRIPTION	GAGE	MATERIAL	EFFECTIVITY
1	NO. 1 WINDOW FRAME		FORGING TI-6AL-4V	
2	NO. 2 WINDOW FRAME		FORGING 7075-T73	
3	NO. 3 WINDOW FRAME		FORGING 7075-T73	
4	A-B POST FITTING		FORGING TI-6AL-4V	
5	OPENABLE FRAME		FORGING 7075-T73

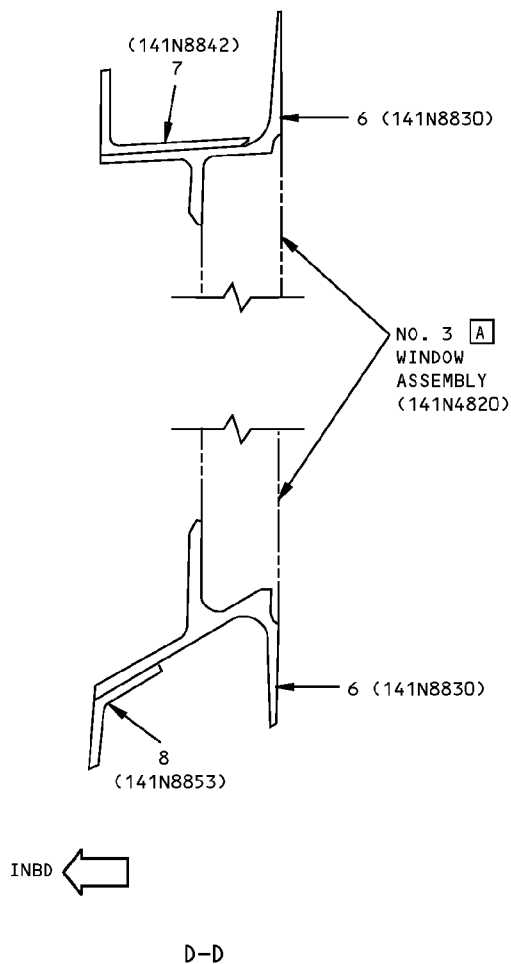
**Flight Compartment Window Structure  
Figure 1 (Sheet 3 of 3)**

ITEM	DESCRIPTION	GAGE	MATERIAL	EFFECTIVITY
1	SILL FITTING		FORGING TI-6AL-4V	
2	SILL FITTING		FORGING 7075-T73	
3	OPENABLE FRAME		FORGING 7075-T73	
4	NO. 1 WINDOW FRAME		FORGING TI-6AL-4V	
5	NO. 2 WINDOW FRAME		FORGING 7075-T73	
6	NO. 3 WINDOW FRAME		FORGING 7075-T73	
7	ANGLE		BAC1503-100327 7075-T73511	
8	CHORD		BAC1514-2610 7075-T6

LIST OF MATERIALS FOR SECTIONS B-B, C-C, D-D

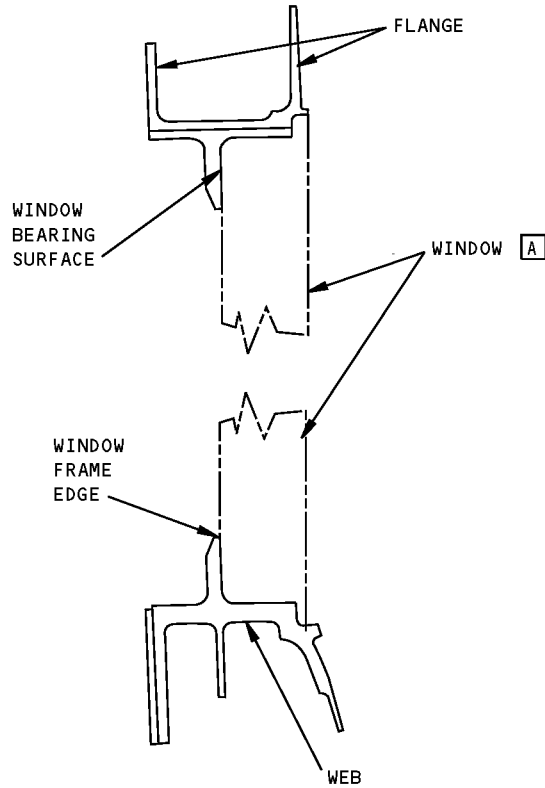
**Allowable Damage - Flight Compartment Window Structure  
Figure 101 (Sheet 2 of 5)**

SECTION B-B

DESCRIPTION	CRACKS	NICKS, GOUGES, SCRATCHES AND CORROSION	DENTS	HOLES AND PUNCTURES
WINDOW BEARING SURFACE	B	0.010 C	F	G
WINDOW FRAME EDGE	B	0.050 D	F	NOT ALLOWED
WEB	B	15% C	F	G
FLANGE SURFACE OR EDGE	B	15% C D E	F	G
OPENABLE FRAME	B	15% C D E	F	G

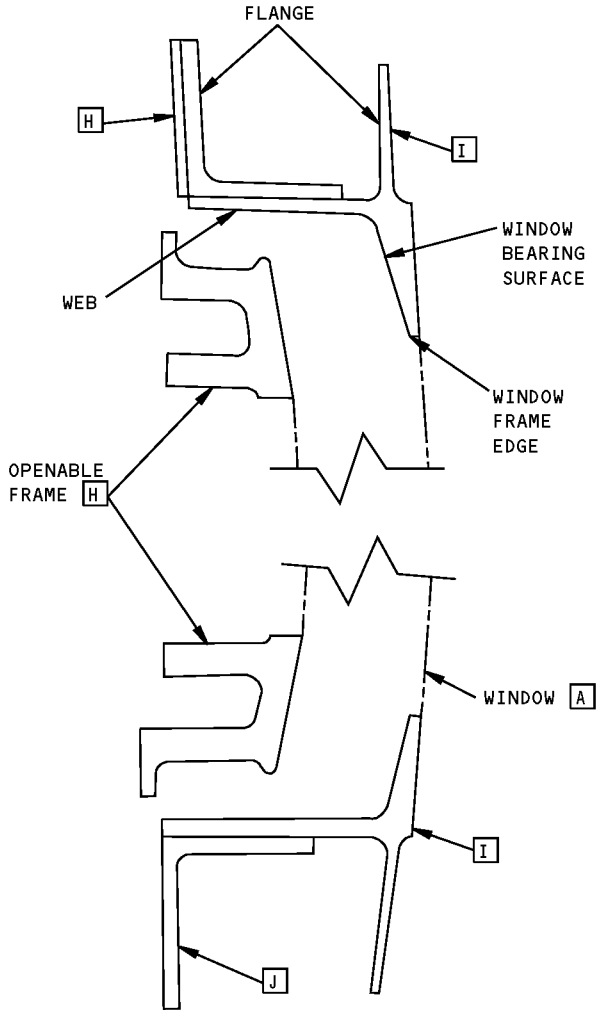
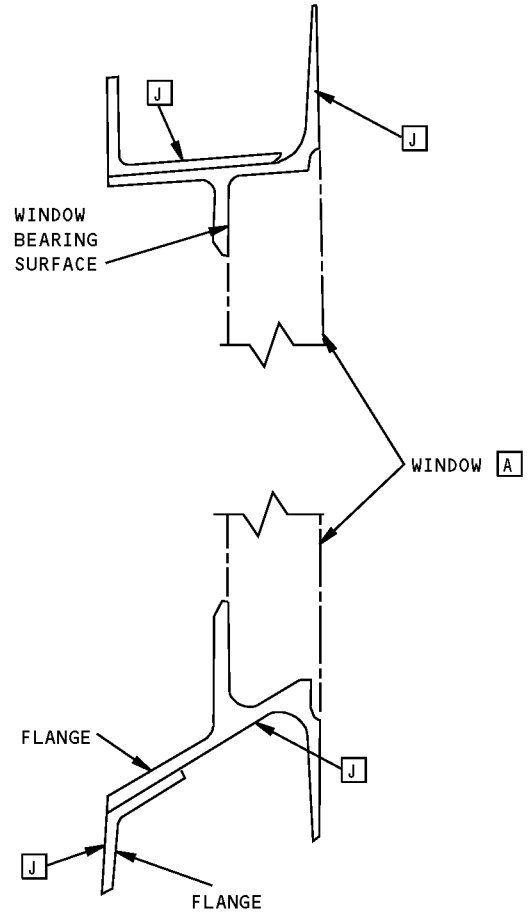
**Allowable Damage - Flight Compartment Window Structure  
Figure 101 (Sheet 3 of 5)**

SECTION C-C

SECTION D-D

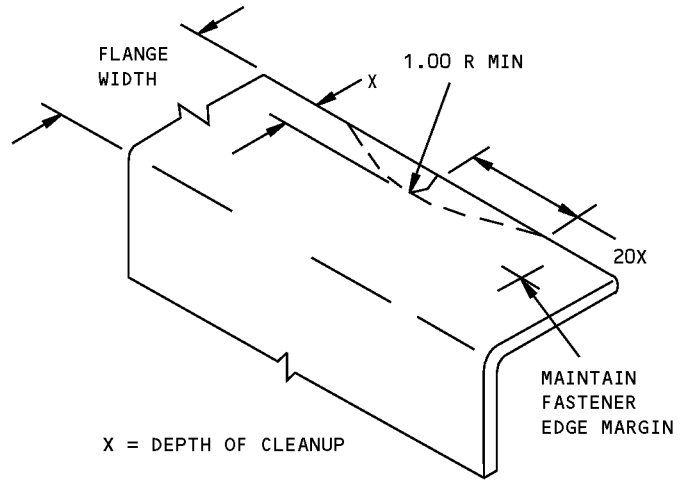
**SECTION THROUGH GOUGE  
REMOVAL OF NICK, OR GOUGE OR  
SCRATCH DAMAGE ON AN EDGE  
DETAIL I**

- B** ALL CRACKED PARTS MUST BE REPAIRED. CRACKS ON FLANGE EDGES AND SURFACES MUST BE REWORKED AS SHOWN IN DETAIL I, II OR III. THE DEPTH OF DAMAGE AFTER REWORK MUST NOT EXCEED THE REQUIREMENTS OF TABLE I FOR A NICK, GOUGE OR SCRATCH DAMAGE

- C** NICKS, GOUGES OR SCRATCH DAMAGE REMOVED ACCORDING TO DETAIL I OR III ARE ALLOWABLE PROVIDED THE MAXIMUM PERMISSIBLE DEPTH IS NOT EXCEEDED. AFTER REWORK FINISH TO 125 MICROINCHES  $R_a$ .

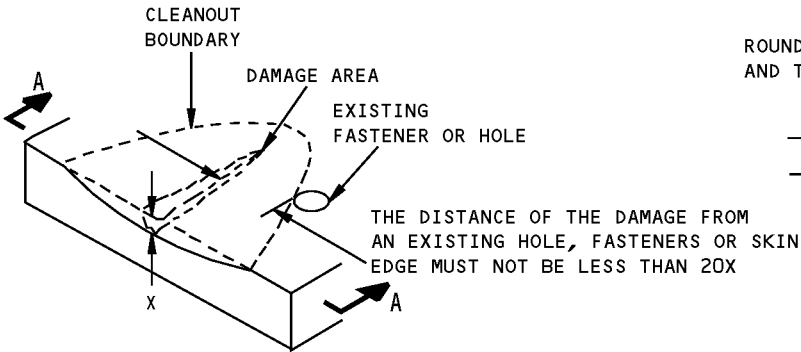
**REMOVAL OF NICK OR GOUGE  
DAMAGE ON AN EDGE  
DETAIL II**

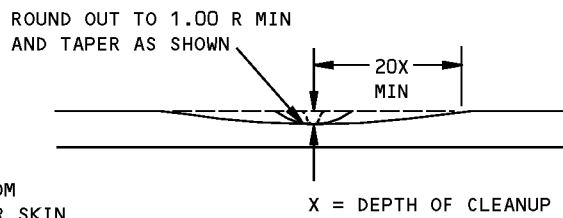
**REMOVAL OF NICK, GOUGE AND SCRATCH DAMAGE ON A SURFACE  
DETAIL III**

**SECTION A-A**

- E** ALLOWABLE DAMAGE DEPTH BETWEEN FASTENERS MUST NOT EXCEED 15 PERCENT OF ORIGINAL MATERIAL THICKNESS. SEE DETAIL III
- F** MINOR DENTS AND SURFACE DEPRESSIONS WHICH DO NOT PENETRATE ANY DEEPER THAN THE LIMITS OF TABLE I FOR NICK, GOUGE OR SCRATCH DAMAGE AND WHICH DO NOT DISTORT THE OPPOSITE SURFACE OF THE MEMBER MAY BE REWORKED AS SHOWN IN DETAIL I OR III

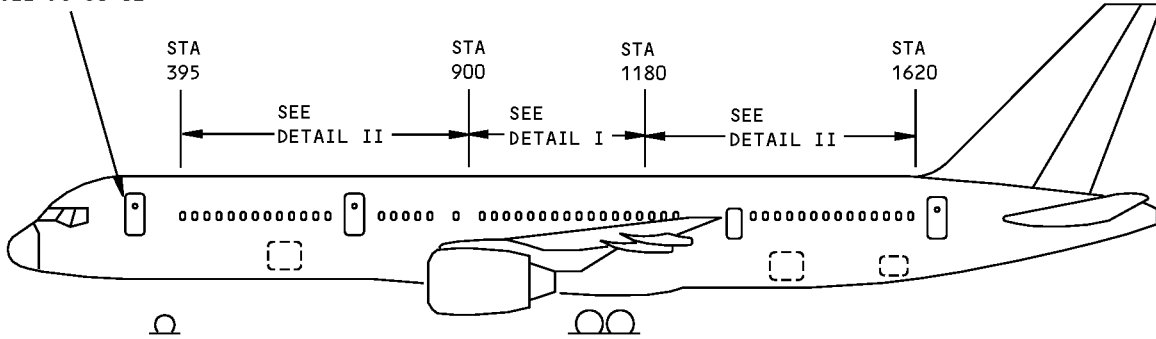
**Cabin Window Structure Identification  
Figure 1 (Sheet 1 of 2)**

FOR AIRPLANES WITH NO. 3 EMERGENCY EXIT DOOR

FOR AIRPLANES WITH OVERWING EMERGENCY EXIT DOORS

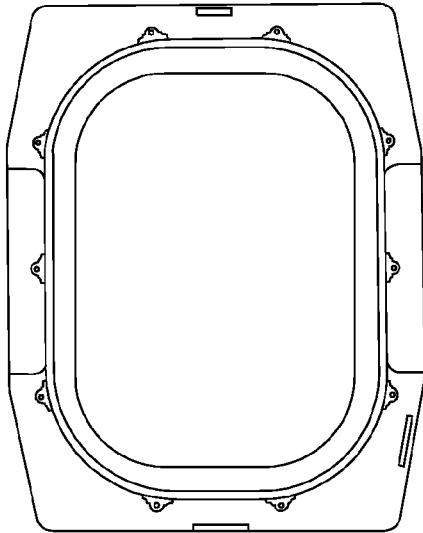
**DETAIL I**

← 1 (144N3250)

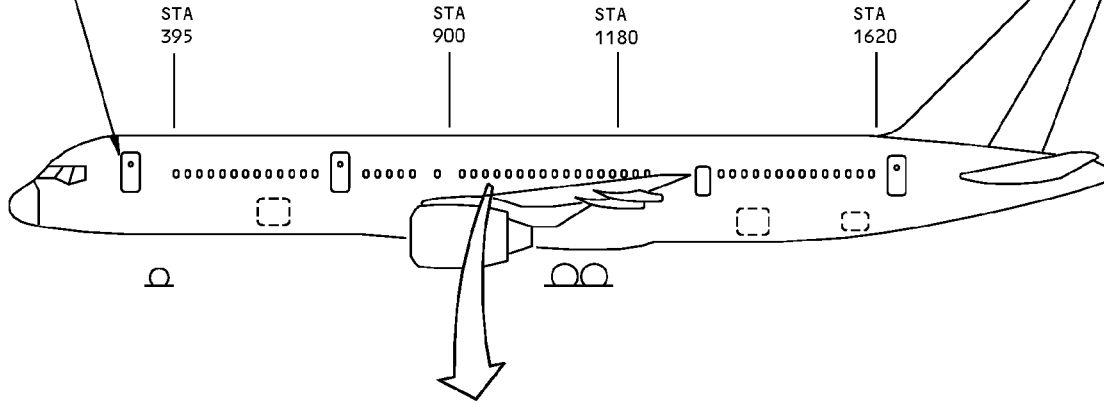
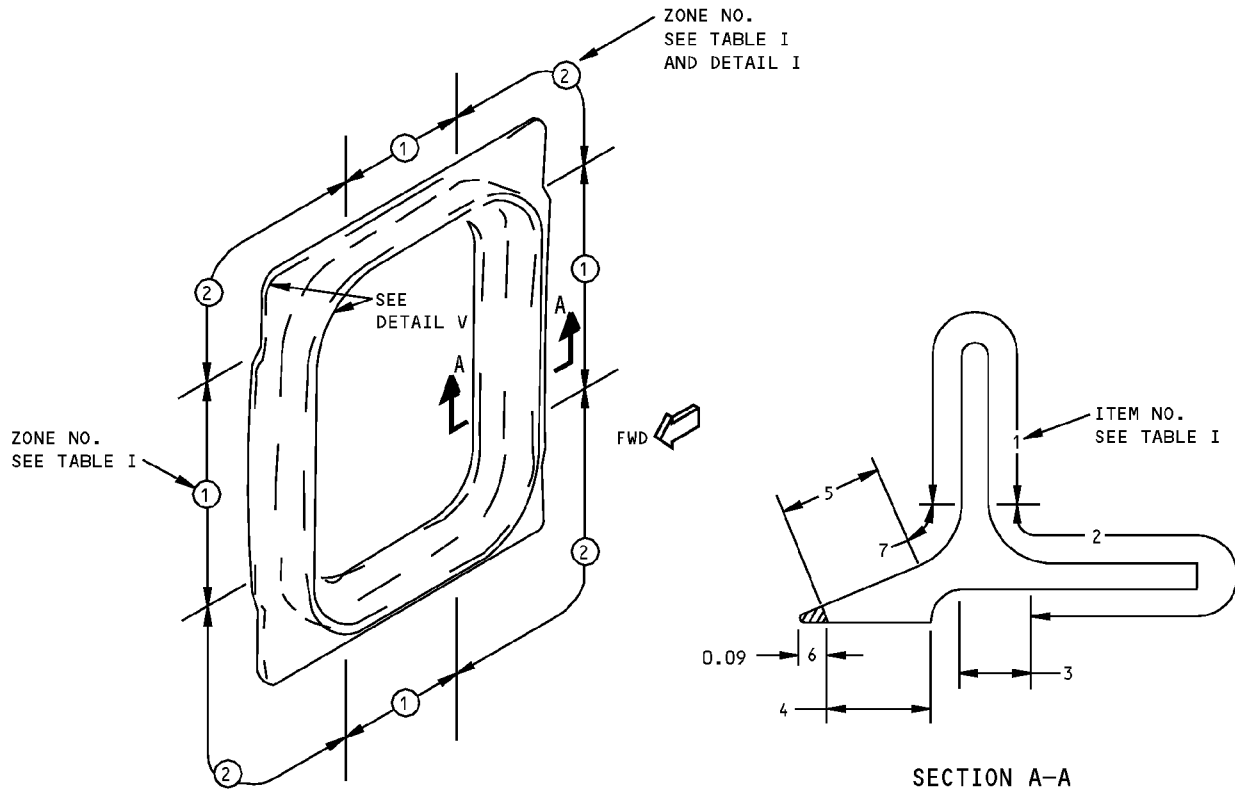
**Allowable Damage - Cabin Window Frames  
Figure 101 (Sheet 1 of 4)**

**ALLOWABLE DAMAGE 1 - CABIN WINDOW FRAMES**

TYPICAL WINDOW FRAME

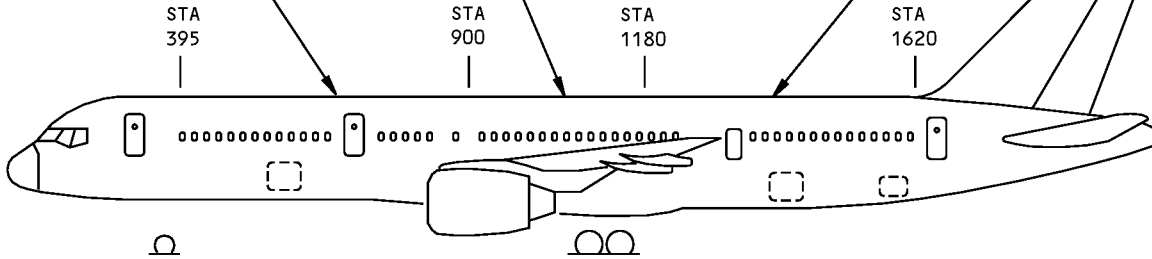
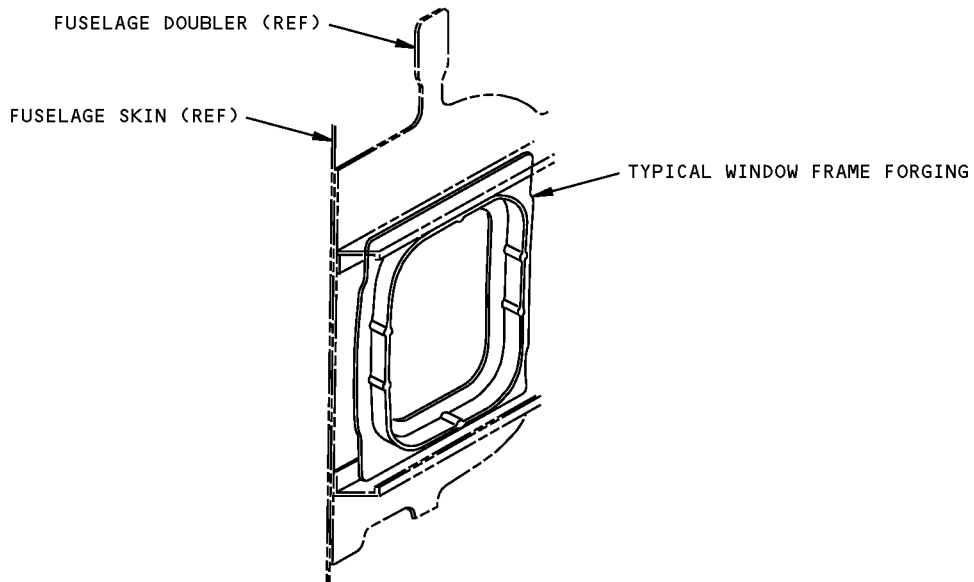
**Cabin Window Frame Repair  
Figure 201**

SEE REPAIR 1 AND 2  
FOR REPAIRS TO BS 395  
TO BS 900 WINDOW FRAMES

NO REPAIRS CURRENTLY  
AVAILABLE FOR WINDOW FRAME  
BETWEEN BS 900 TO 1180

SEE REPAIR 1 AND 2  
FOR REPAIRS TO BS 1180  
TO BS 1620 WINDOW FRAMES

**FOR AIRPLANES WITH NO. 3 EMERGENCY EXIT DOOR**

**FOR AIRPLANES WITH OVERWING EMERGENCY EXIT DOORS**

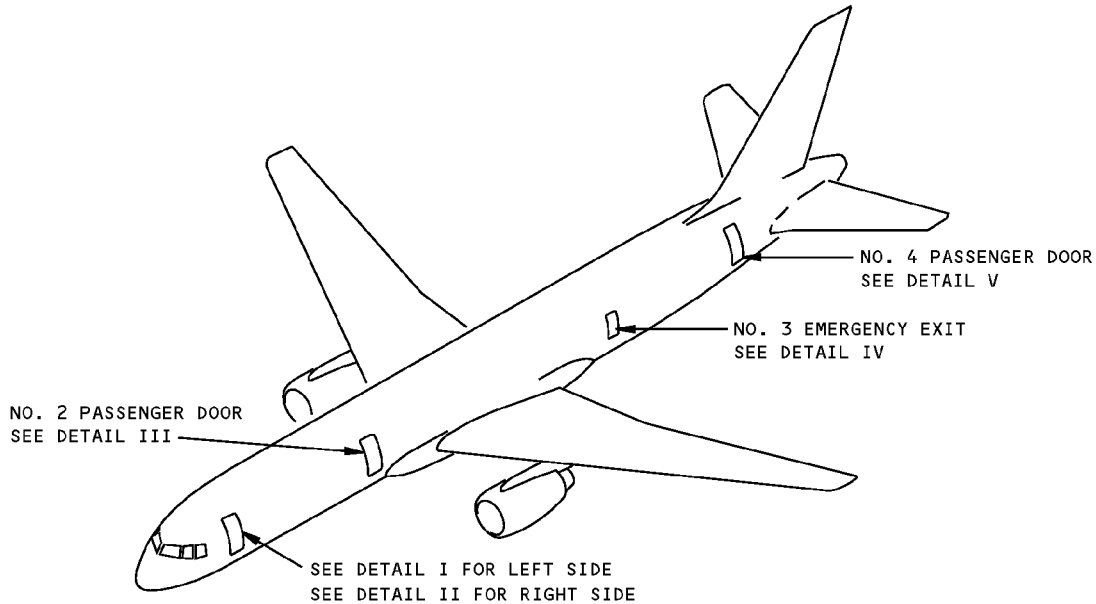
**AIRPLANES WITH NO. 3 EMERGENCY EXIT  
BASIC CONFIGURATION**

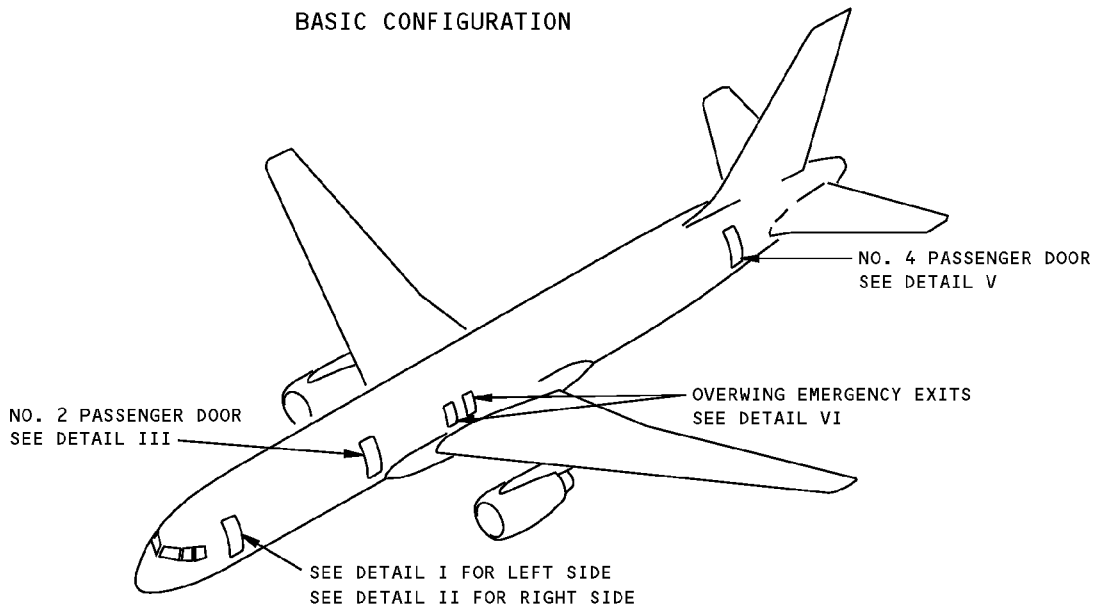
**AIRPLANES WITH OVERWING EMERGENCY EXITS  
BASIC CONFIGURATION**

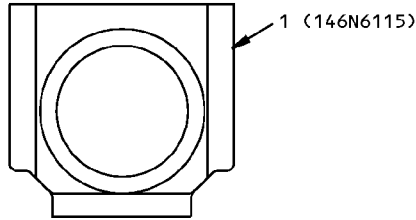
DETAIL I

STA 357  
LEFT SIDE

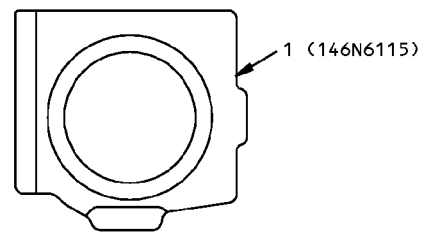
DETAIL II

STA 350  
RIGHT SIDE

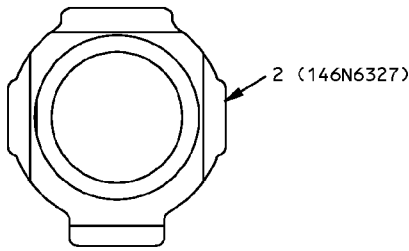
DETAIL III

STA 710

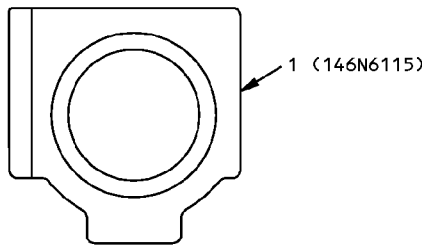
DETAIL IV

STA 1335.23

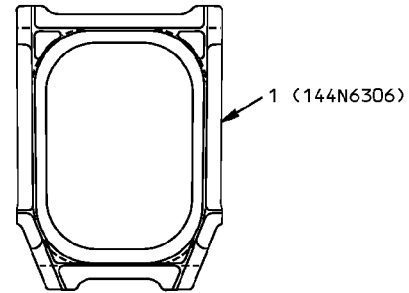
DETAIL V

STA 1664

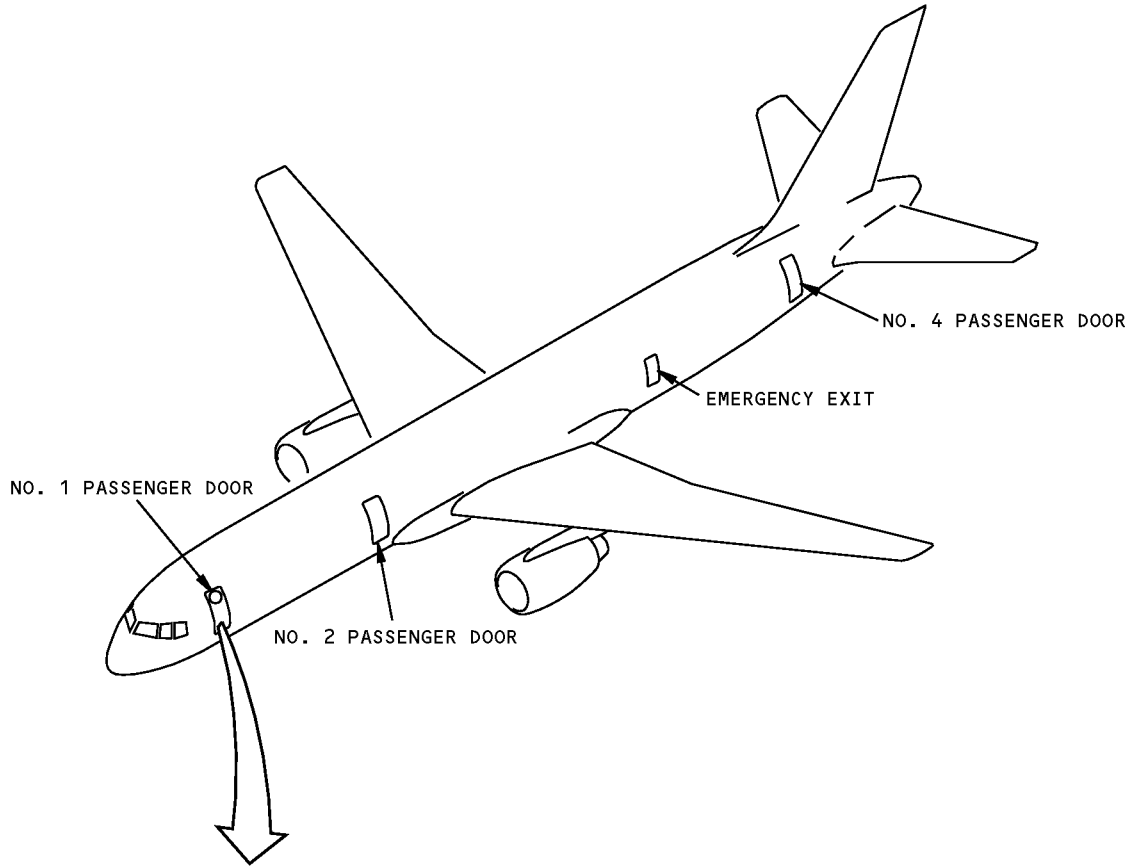
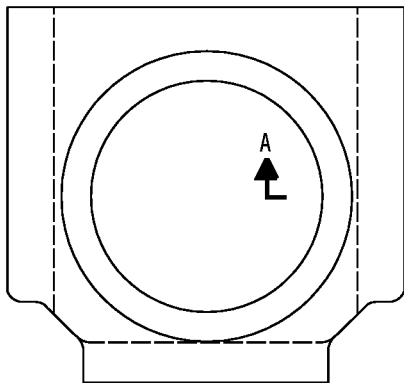
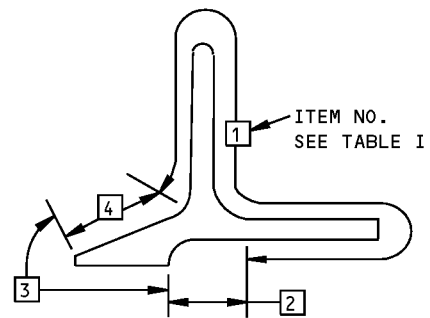
**Allowable Damage - Door Window Frames  
Figure 101 (Sheet 1 of 3)**

**VIEWING PORT FRAME  
NO. 1 DOOR SHOWN  
OTHERS SIMILAR**

**SECTION A-A**

ITEM	CRACKS	NICKS, GOUGES, SCRATCHES AND CORROSION	DENTS	HOLES AND PUNCTURES
1	A	0.020 MAX DEPTH B	NOT ALLOWED	NOT ALLOWED
2	C	0.020 MAX DEPTH B	NOT ALLOWED	NOT ALLOWED
3	A	0.030 MAX DEPTH B	NOT ALLOWED	NOT ALLOWED
4	C	0.030 MAX DEPTH B	NOT ALLOWED	NOT ALLOWED

- A DAMAGE ON EDGE OF A FLANGE REMOVED ACCORDING TO DETAILS I OR II IS ALLOWED PROVIDED THE MAXIMUM DEPTH IS NOT EXCEEDED AND THE MINIMUM FASTENER EDGE MARGIN IS MAINTAINED. ALL OTHER CRACKS NOT ALLOWED
- B DAMAGE REMOVED PER DETAIL III IS ALLOWED PROVIDED THE MAXIMUM PERMISSABLE DEPTH IS NOT EXCEEDED
- C NO CRACKS ALLOWED. REPLACE FRAME

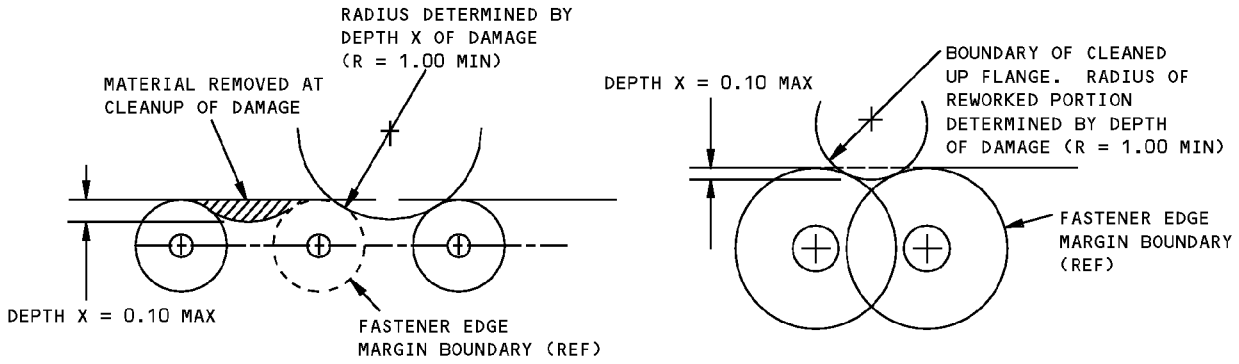
DETAIL I

DAMAGE CLEANUP OF EDGES WHERE FASTENER EDGE MARGINS DO NOT OVERLAP

DAMAGE CLEANUP OF EDGES WHERE FASTENER EDGE MARGINS OVERLAP
