**BOEING**  
 757  
 FAULT ISOLATION/MAINT MANUAL

CHAPTER 24

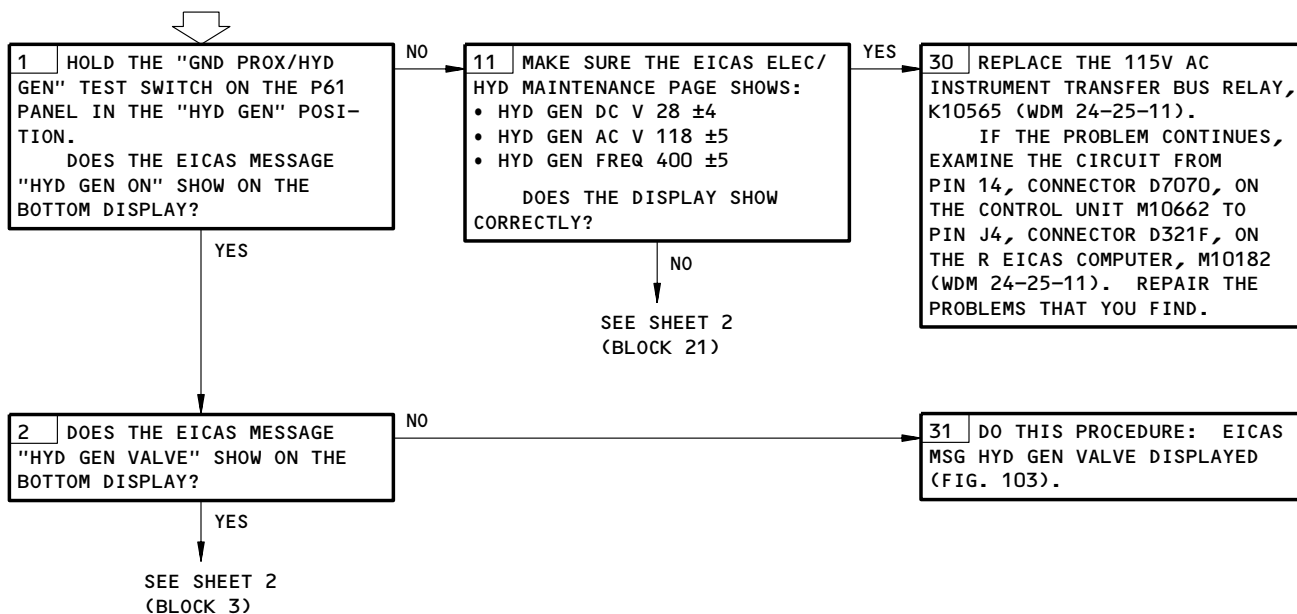
Hydraulic Motor Generator System Fault Isolation Procedure  
Figure 105 (Sheet 1)

**NOTE:** WHEN YOU USE THE ACMPs, PRESSURIZE THE LEFT HYDRAULIC SYSTEM AND THE RIGHT HYDRAULIC SYSTEM (AMM 29-11-00/201). PUT THE PTU SWITCH ON THE P61 PANEL TO THE "ON" POSITION.

**HYDRAULIC MOTOR GENERATOR SYSTEM  
FAULT ISOLATION  
PROCEDURE**

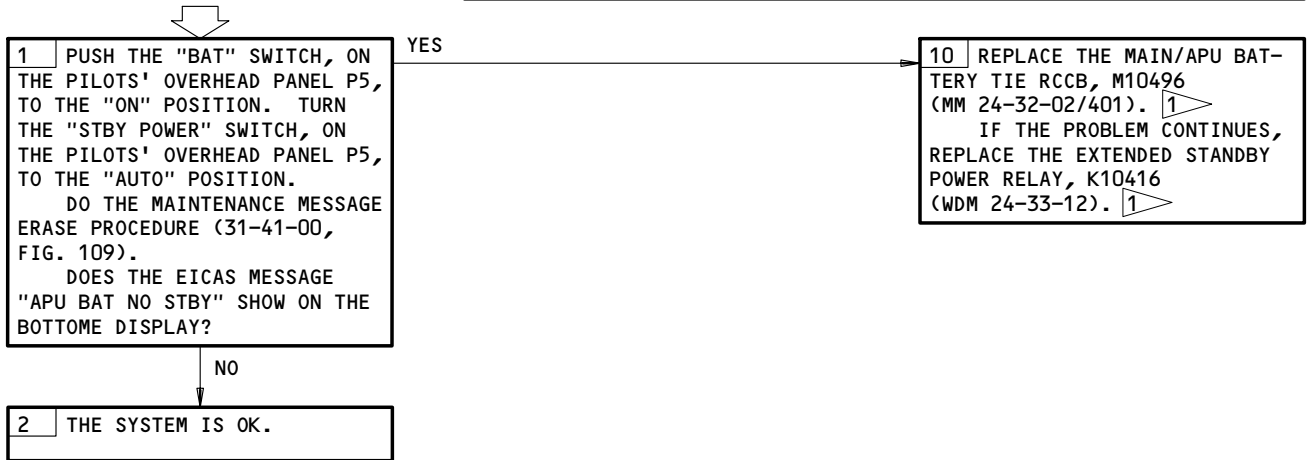
EICAS Msg APU BAT NO STBY Displayed  
Figure 105

MAKE SURE THESE CIRCUIT BREAKERS ARE CLOSED:  
6L7,11A19,11A20

**1** DO THE "MAINTENANCE MESSAGE ERASE PROCEDURE" (31-41-00, FIG. 109)

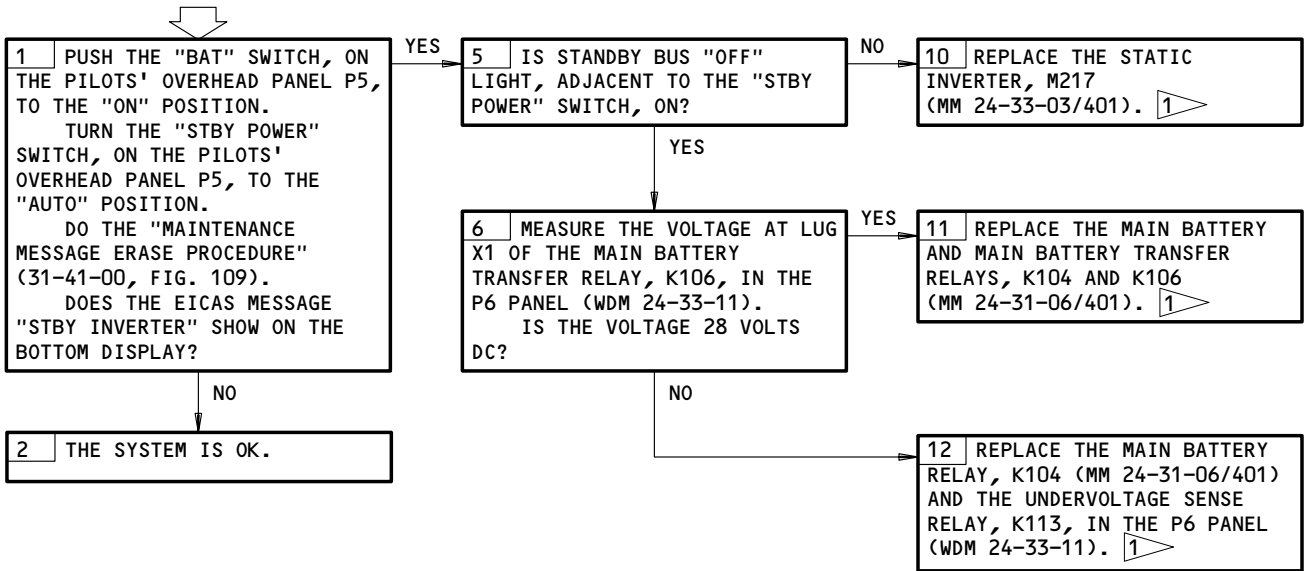
**EICAS MSG "STBY  
 INVERTER" DISPLAYED**

DO THE "MAINTENANCE MESSAGE ERASE PROCEDURE" (31-41-00, FIG. 109).
