D633N632

CHAPTER 73 - ENGINE FUEL AND CONTROL

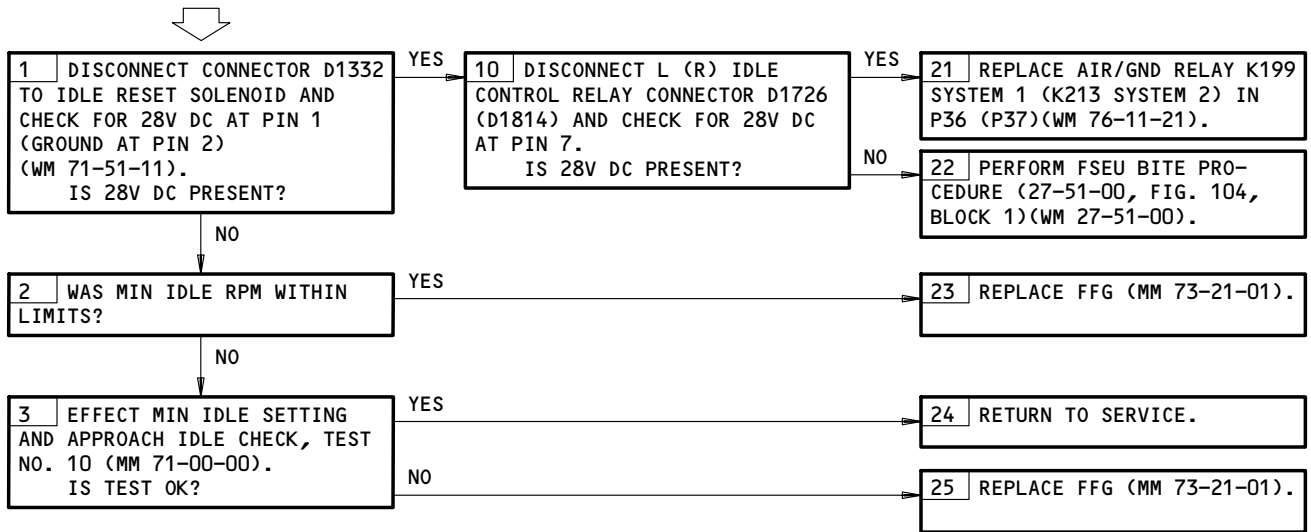
APPROACH IDLE RPM INCORRECT

Approach Idle RPM Incorrect
Figure 111A

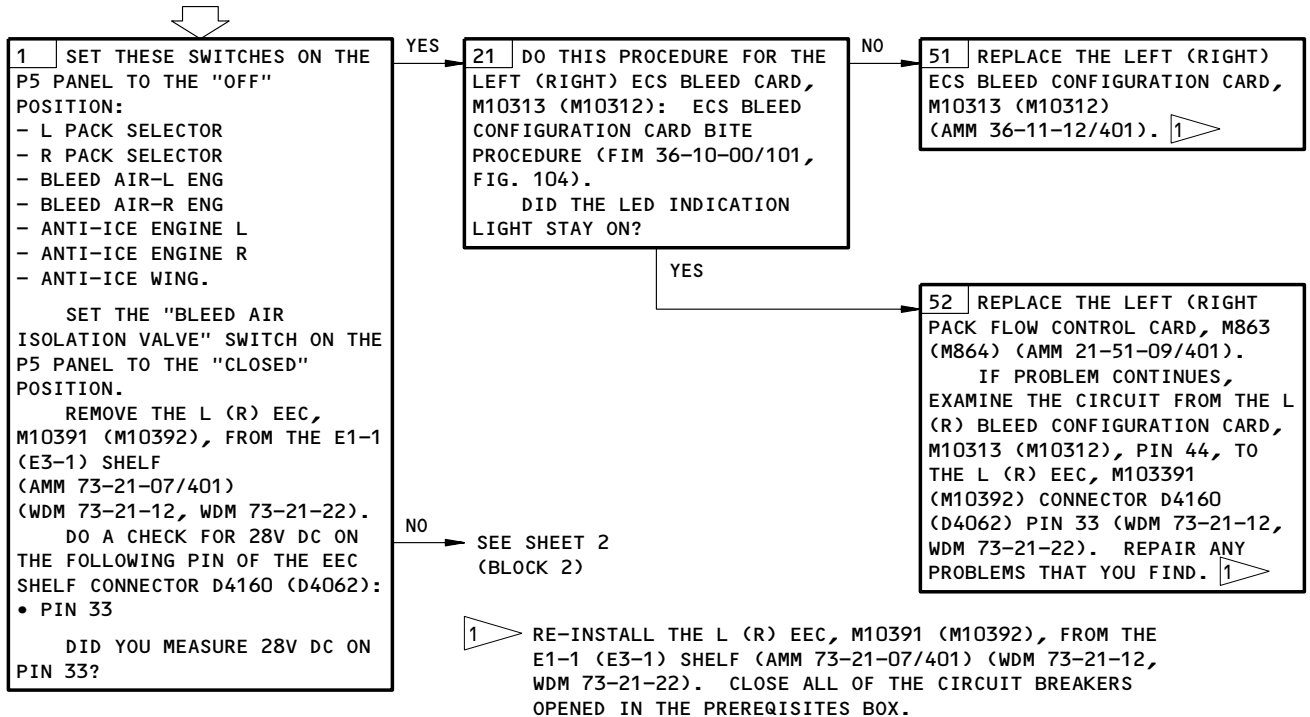
Left (Right) EEC Bleed System Discrete Circuit Test
Figure 119 (Sheet 1)

MAKE SURE THE AIRPLANE IS IN THIS CONFIGURATION:

- ELECTRICAL POWER IS ON (AMM 24-22-00/201)
- PNEUMATIC POWER IS OFF (AMM 36-00-00/201)
