CHAPTER 75 - AIR

<u>Subject</u>	<u>Chapter Section Subject</u>	<u>Page</u>	<u>Effectivity</u>
FAULT ISOLATION	75-FAULT CODE INDEX	1	ALL
<u>AIR</u>	75-00-00		
<u>COMPRESSOR CONTROL</u>	75-30-00		
COMPRESSOR BLEED CONTROL SYSTEM	75-32-00		
Component Location		101	CONFIG 3 [*]
Component Index			
Component Location			
Fault Isolation			
BVCU BITE Procedure (Fig. 103)		107	
EGT Is More Than 30 Degrees C Higher Than Other Engine (Fig. 105)		126	
L (R) ENG SURGE BITE Message Shown on EICAS (Fig. 107)		129	
Not Used (Fig. 106)		128	
TPU BITE Procedure (Fig. 104)		122	
[*] RB211-535E4 ENGINES WITH BVCU C8E38-9 AND POST-SB 757-75-5			
Component Location		101	CONFIG 4 [*]
Component Index			
Component Location			
Fault Isolation			
BVCU BITE Procedure (Fig. 103)		109	
EGT Is More Than 30 Degrees C Higher Than Other Engine (Fig. 105)		113	
L (R) ENG SURGE BITE Message Shown on EICAS (Fig. 106)		115	
TPU BITE Procedure (Fig. 104)		112	
[*] RB211-535E4 ENGINES WITH BVCU C8E38-11, C8E38-12 OR C8E38-15

75-CONTENTS

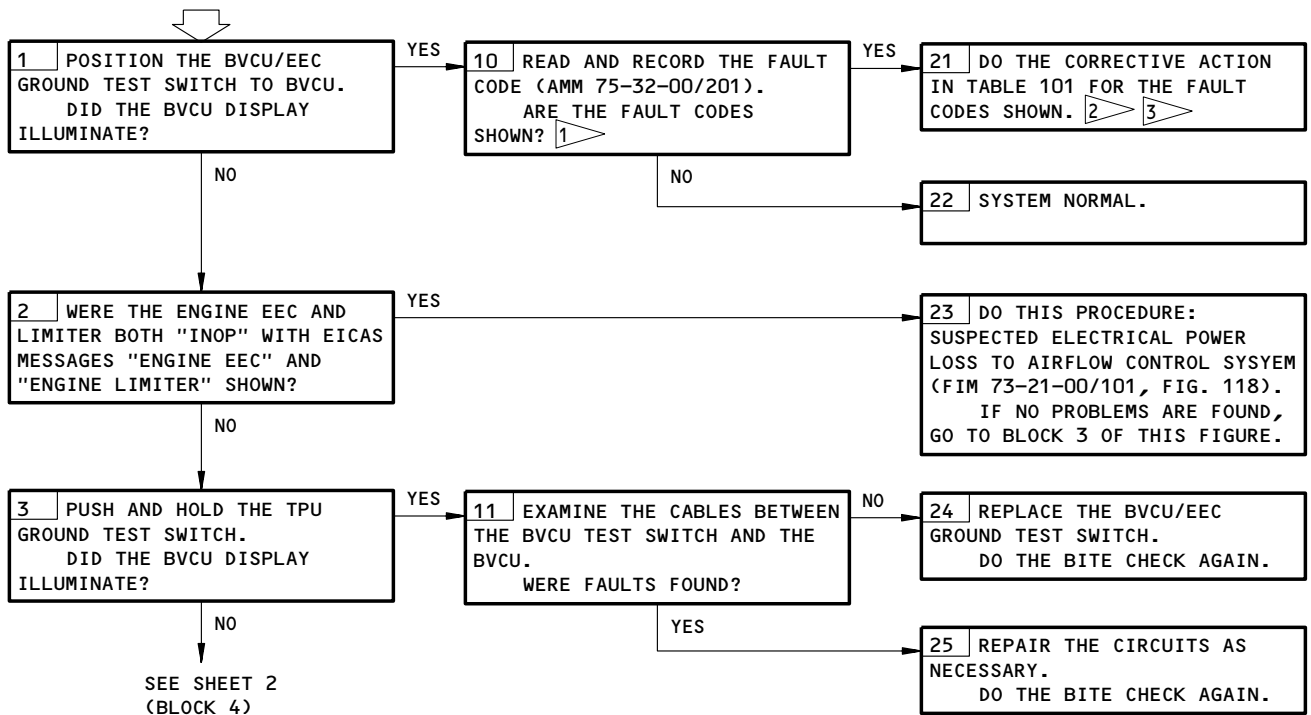
- THE BVCU DISPLAY SHOWS, CONSECUTIVELY, FAULT CODES FOR UP TO THREE FLIGHTS. THE MOST RECENT FLIGHT IS SHOWN FIRST. FLIGHTMARKERS (IF FOLLOWED BY THE NUMBER OF FAULT-FREE FLIGHTS BETWEEN EACH SET OF CODES) ARE SHOWN JUST BEFORE THE FAULT CODES.

BVCU BITE PROCEDURE

- 1 ALL FAULT CODES AND ALL FLIGHT MARKERS THAT APPEAR AFTER THE FLIGHT MARKER F1 OR GREATER CAN BE IGNORED. BVCU REJECTION IS NOT NECESSARY.
- 2 IF FAULT CODES ARE SHOWN THAT ARE NOT LISTED IN TABLE 101, REPLACE BVCU (AMM 75-32-01/401).
- 3 IF NO FAULT IS FOUND AFTER YOU TROUBLESHOOT, DO AN INSPECTION OF THE MODULAR TERMINAL BLOCK/TERMINAL BLOCK FOR A POSSIBLE WIRING FAULT (AMM 71-51-01/601).

BVCU BITE Procedure
Figure 103 (Sheet 1)

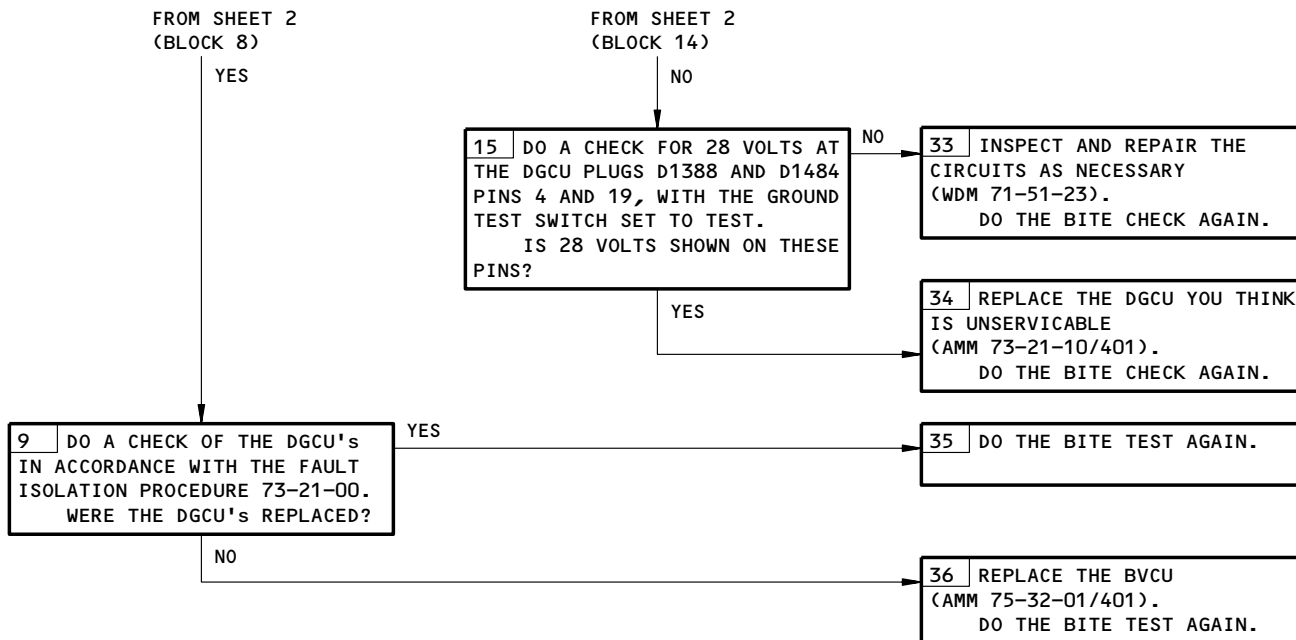
BVCU BITE Procedure
Figure 103 (Sheet 3)
