CHAPTER 75 - AIR

<u>Subject</u>	<u>Chapter Section Subject</u>	<u>Page</u>	<u>Effectivity</u>
FAULT ISOLATION	75-FAULT CODE INDEX	1	ALL
<u>AIR</u>	75-00-00		
<u>COMPRESSOR CONTROL</u>	75-30-00		
COMPRESSOR BLEED CONTROL SYSTEM	75-32-00		
Component Location		101	CONFIG 3 [*]
Component Index			
Component Location			
Fault Isolation			
BVCU BITE Procedure (Fig. 103)		107	
EGT Is More Than 30 Degrees C Higher Than Other Engine (Fig. 105)		126	
L (R) ENG SURGE BITE Message Shown on EICAS (Fig. 107)		129	
Not Used (Fig. 106)		128	
TPU BITE Procedure (Fig. 104)		122	
[*] RB211-535E4 ENGINES WITH BVCU C8E38-9 AND POST-SB 757-75-5			
Component Location		101	CONFIG 4 [*]
Component Index			
Component Location			
Fault Isolation			
BVCU BITE Procedure (Fig. 103)		109	
EGT Is More Than 30 Degrees C Higher Than Other Engine (Fig. 105)		113	
L (R) ENG SURGE BITE Message Shown on EICAS (Fig. 106)		115	
TPU BITE Procedure (Fig. 104)		112	
[*] RB211-535E4 ENGINES WITH BVCU C8E38-11, C8E38-12 OR C8E38-15

Compressor Bleed Control System - Component Location
Figure 102 (Sheet 1)

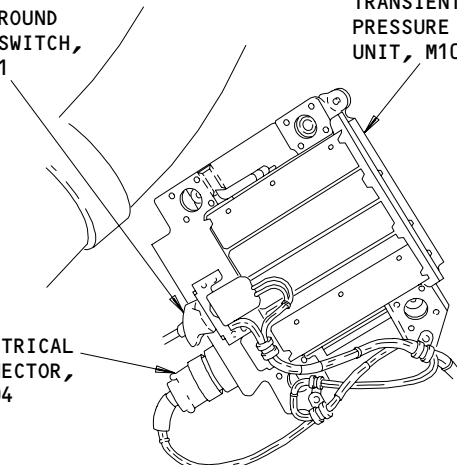
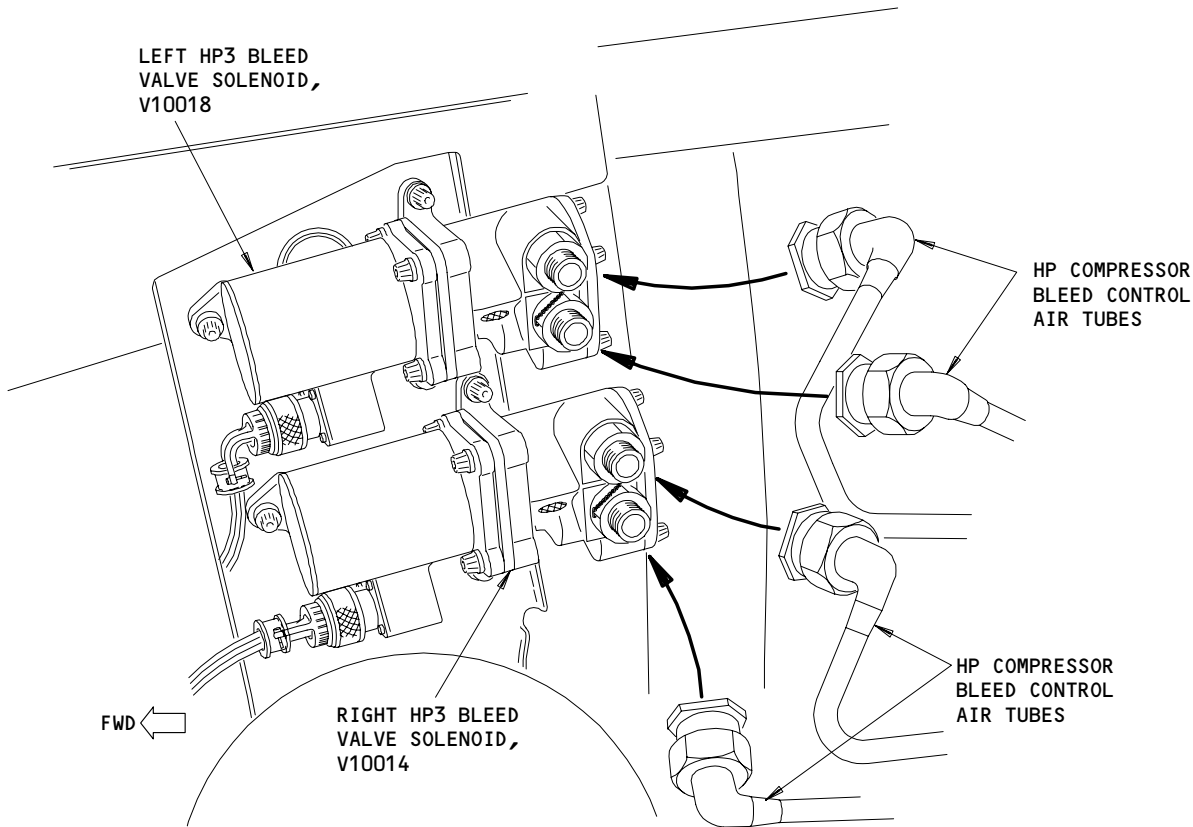
Compressor Bleed Control System - Component Location (Details from Sht 1)
Figure 102 (Sheet 2)

TRANSIENT PRESSURE UNIT (TPU)

HP2 SOLENOID

LEFT HP3 BLEED VALVE SOLENOID, V10018

HP COMPRESSOR BLEED CONTROL AIR TUBES

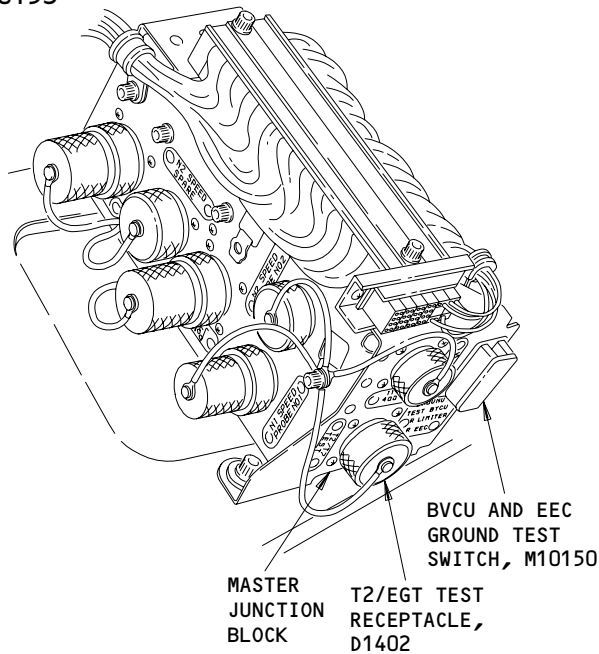
Compressor Bleed Control System - Component Location
Figure 102 (Sheet 3)

BLEED VALVE CONTROL UNIT (BVCU), M10153

ALTITUDE SWITCH, S10142

MASTER JUNCTION BLOCK
