GPA Group plc

CHAPTER 76 - ENGINE CONTROLS

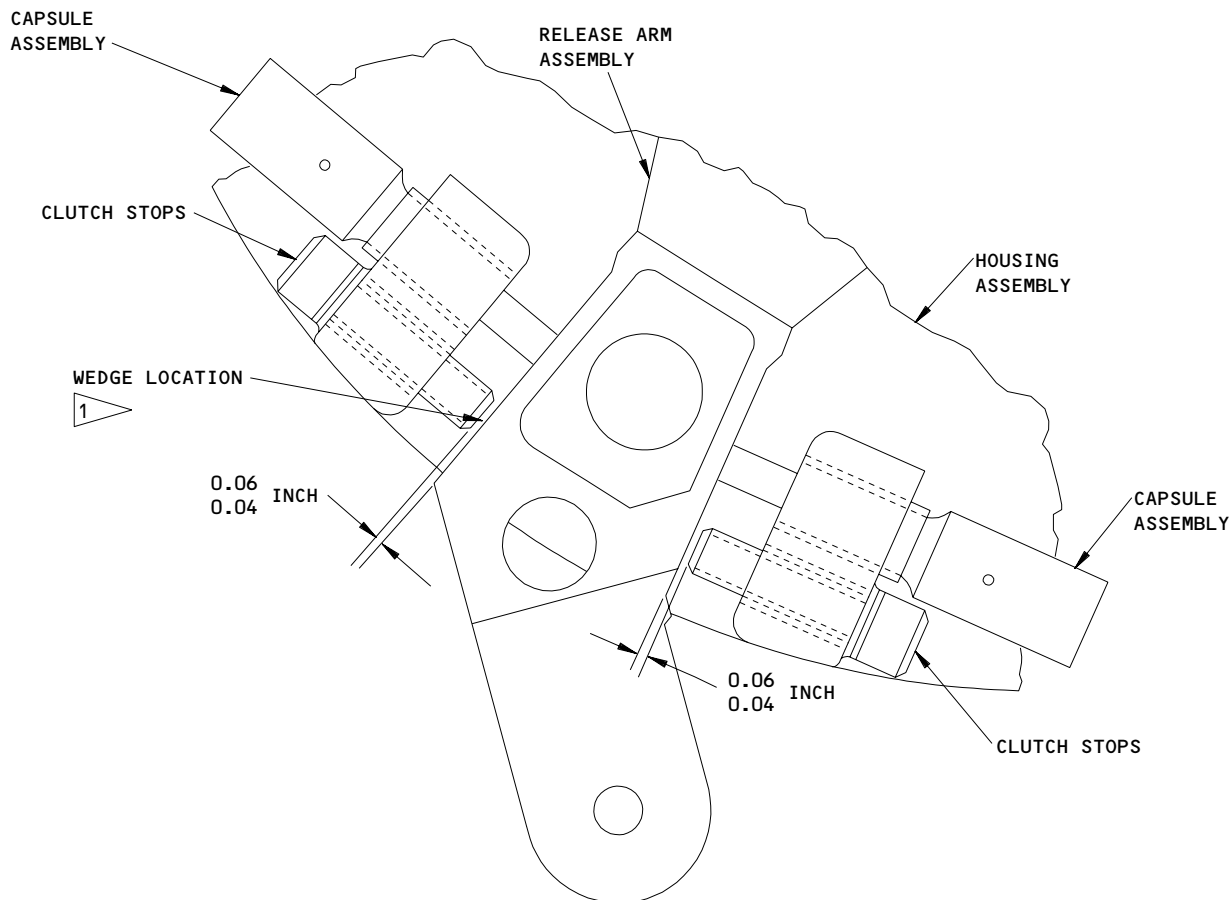
Engine Control System - Component Location  
Figure 102 (Sheet 4)

1 THE WEDGE IS USED TO HOLD THE RELEASE ARM ASSEMBLY AGAINST THE OPPOSITE CLUTCH STOP AND RELEASE THE CLUTCH. THE WEDGE CAN BE MADE OF ANY MATERIAL WHICH WILL NOT DAMAGE THE RELEASE ARM OF THE CLUTCH STOPS (PHENOLIC, BRASS, PLASTIC...ETC.)
