CHAPTER 52 DOORS

- A. This chapter contains information about the passenger/crew entry doors (both sides), escape hatches, cargo doors (forward and aft including optional forward large cargo door and bulk cargo door), service doors (elec/elex access door, ram air turbine access door, potable water access door, controls bay access door, service access door, waste disposal access door, forward access door and auxiliary power unit access door) and landing gear doors.
- B. All major structural components are located and identified through the use of detailed illustrations with corresponding tabulated material lists.
- C. Allowable damage to doors is defined in this chapter.
- D. Approved repairs are described and illustrated in this chapter.

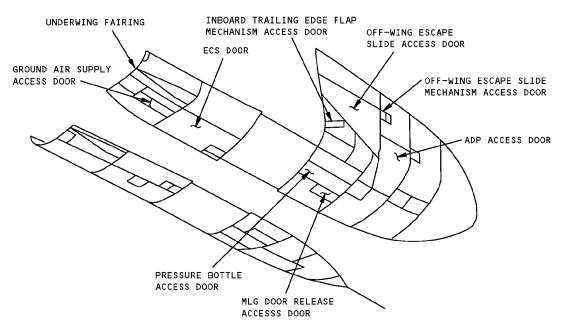
LEFT SIDE
SECTION 46 WING-TO-BODY FAIRING AND UNDERWING FAIRING

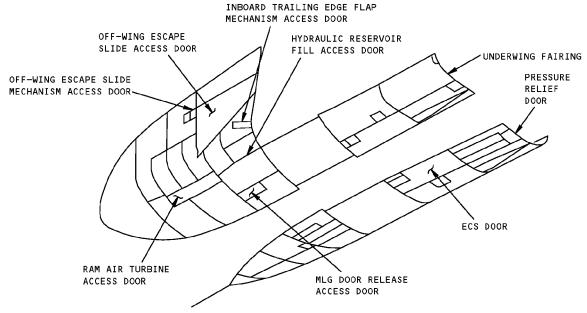
RIGHT SIDE
SECTION 46 WING-TO-BODY FAIRING AND UNDERWING FAIRING

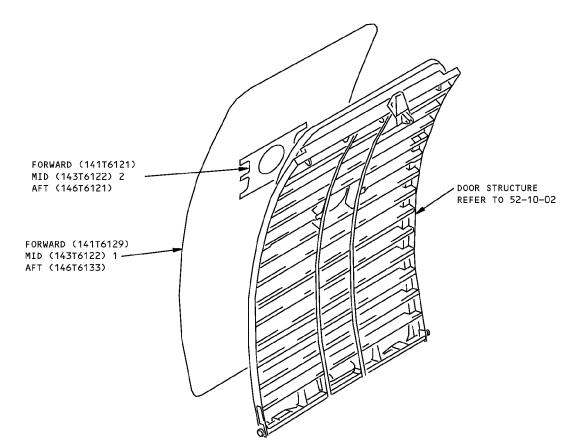
IDENTIFICATION 1 - ENTRY DOOR SKIN

ITEM	DESCRIPTION	GAGE	MATERIAL	EFFECTIVITY
1	OUTER SKIN	0.071	CLAD 2024-T3 (CHEM-MILLED TO 0.050 MIN)	
2	DOUBLER	0.080	CLAD 2024-T3

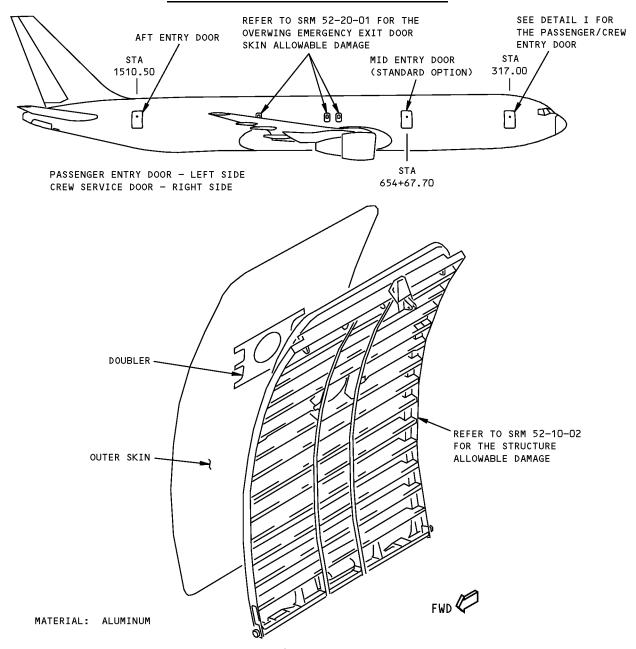
Passenger / Crew Entry Door Skin Allowable Damage Figure 101 (Sheet 1 of 3)

PASSENGER/CREW ENTRY DOOR DETAIL I

DESCRIPTION	CRACKS	NICKS, GOUGES AND CORROSION	DENTS	HOLES AND PUNCTURES
OUTER SKIN A	B F	C F	G	DF
DOUBLER	В	С	SEE DETAIL IV	E

- REFER TO SRM 51-10-02 FOR INSPECTION AND REMOVAL OF DAMAGE.
- REFINISH REWORKED AREAS AS SHOWN IN AMM 51-21
- REFER TO SRM 51-20-01 FOR PROTECTIVE TREATMENT OF METAL

- A REFER TO SRM 51-10-01 FOR AERODYNAMIC SMOOTH-NESS REQUIREMENTS. WHERE THE DAMAGE IS MORE THAN THE LIMITS SHOWN IN SRM 51-10-01, CONSIDERATION SHOULD BE GIVEN TO THE LOSS OF PERFORMANCE INVOLVED

- B CRACKS ARE NOT PERMITTED EXCEPT FOR EDGE CRACKS WHICH MUST BE REMOVED AS SHOWN IN DETAILS II AND VI
- C REMOVE DAMAGE AS SHOWN IN DETAILS II, III, V AND VI

- D CLEAN OUT DAMAGE UP TO 0.25 INCH (6.35mm)
 MAXIMUM DIAMETER NOT CLOSER THAN 1.0 INCH
 (25.4 mm) TO FASTENER HOLE, MATERIAL EDGE,
 OR OTHER DAMAGE. FILL HOLE WITH 2117-T3
 OR T4 ALUMINUM RIVET INSTALLED WET WITH
 BMS 5-95 SEALANT. ALL OTHER HOLES TO BE
 REPAIRED

- E CLEAN OUT DAMAGE UP TO 0.25 INCH (6.35mm)
 MAXIMUM DIAMETER AND NOT CLOSER THAN
 1.0 INCH (25.4 mm) TO FASTENER HOLE,
 MATERIAL EDGE, OR OTHER DAMAGE
- F REFER TO FIGURE 102 FOR THE PASSENGER/CREW ENTRY DOOR SKIN OPERATING LIMITS AFTER DAMAGE HAS BEEN REMOVED.

- G DENTS THAT ARE MORE THAN THE LIMITS SHOWN IN DETAIL IV SHOULD BE PERMANENTLY REPAIRED. HOWEVER, A REPAIR CAN BE DELAYED IF THE CONDITIONS THAT FOLLOW ARE MET:

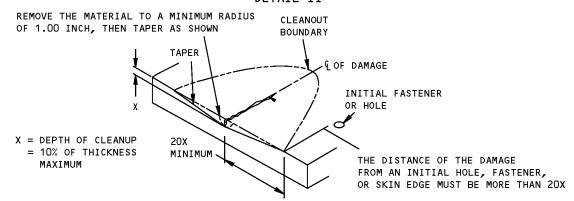
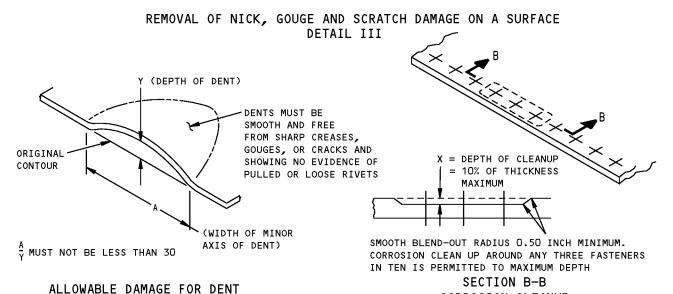
Passenger / Crew Entry Door Skin Allowable Damage Figure 101 (Sheet 2 of 3)

DEPTH X
= 0.10 INCH MAXIMUM
FLANGE. RADIUS OF REWORKED
PORTION DETERMINED BY DEPTH
OF DAMAGE R = 1.0 INCH
MINIMUM

DAMAGE CLEAN UP OF EDGES WHERE FASTENER EDGE MARGINS DO NOT OVERLAP

DAMAGE CLEAN UP OF EDGES WHERE FASTENER EDGE MARGINS OVERLAP

DETAIL II

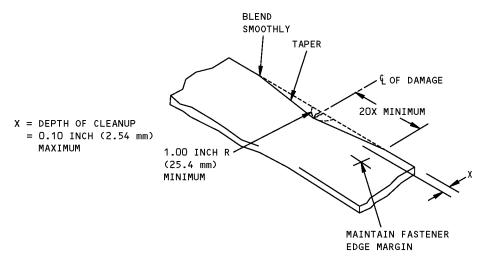
Passenger / Crew Entry Door Skin Allowable Damage Figure 101 (Sheet 3 of 3)

CORROSION CLEANUP

DETAIL V

REMOVAL OF NICK OR CRACK DAMAGE ON AN EDGE DETAIL VI

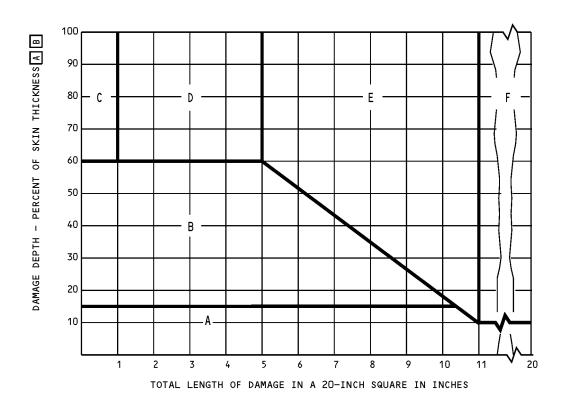
ALLOWABLE DAMAGE 2 - OPERATING LIMITS FOR PASSENGER / CREW ENTRY DOOR SKIN

- A SKIN THICKNESS DOES NOT INCLUDE THE THICKNESS OF THE DOUBLERS, TRIPLERS, OR STRAPS.
- B DAMAGE INCLUDES HOLES, PUNCTURES, NICKS, GOUGES, SCRATCHES, CORROSION AND CRACKS. DAMAGE DOES NOT INCLUDE DENTS.
- C CABIN PRESSURE LIMITS ARE FOR SKIN DAMAGE IN THE PRESSURIZED FUSELAGE CAVITY ONLY.

CHART AREA	DAMAGE TREATMENT	ALLOWABLE AIRPLANE OPERATIONS
A	CLEAN UP AS SPECIFIED IN ALLOWABLE DAMAGE 1	NO FLIGHT RESTRICTIONS
В	CLEAN UP AS SPECIFIED IN ALLOWABLE DAMAGE 1 TO DAMAGE DEPTH.	LIMITED TO 50 HOURS OF FLIGHT INCLUDING REVENUE FLIGHTS.
	DO AN APPLICABLE REPAIR AS GIVEN IN SRM 52-10-01.	REFER TO THE APPLICABLE REPAIR FOR THE LIMITS.
c	CLEAN UP AS SPECIFIED IN ALLOWABLE DAMAGE 1 TO DAMAGE DEPTH. STOP DRILL 0.25 INCH (6 mm) DIAMETER HOLES AT THE ENDS OF CRACKS.	A NON-REVENUE FLIGHT TO A REPAIR STATION IS PERMITTED IF THE APPLICABLE REGULATORY AUTHORITY GIVES APPROVAL BEFORE THE FLIGHT. IT IS RECOMMENDED THAT THE PROPOSED REPAIR PROCEDURE BE PROVIDED TO BOEING.
		THE MAXIMUM CABIN PRESSURE DIFFERENTIAL LIMITED C TO 6.0 PSIG UNLESS REPAIRED.
	DO AN APPLICABLE REPAIR AS GIVEN IN SRM 52-10-01.	REFER TO THE APPLICABLE REPAIR FOR THE LIMITS.
D	CLEAN UP AS SPECIFIED IN ALLOWABLE DAMAGE 1 TO DAMAGE DEPTH. STOP DRILL 0.25 INCH (6 mm) DIAMETER HOLES AT THE ENDS OF CRACKS.	A NON-REVENUE FLIGHT TO A REPAIR STATION IS PERMITTED IF THE APPLICABLE REGULATORY AUTHORITY GIVES APPROVAL BEFORE THE FLIGHT. IT IS RECOMMENDED THAT THE PROPOSED REPAIR PROCEDURE BE PROVIDED TO BOEING.

THE MAXIMUM CABIN PRESSURE DIFFERENTIAL LIMITED C TO 6.0 PSIG UNLESS REPAIRED.
	DO AN APPLICABLE REPAIR AS GIVEN IN SRM 52-10-01.	REFER TO THE APPLICABLE REPAIR FOR THE LIMITS.
E	CLEAN UP AS SPECIFIED IN ALLOWABLE DAMAGE 1 TO DAMAGE DEPTH. STOP DRILL 0.25 INCH (6 mm) DIAMETER HOLES AT THE ENDS OF CRACKS.	A NON-REVENUE FLIGHT TO A REPAIR STATION IS PERMITTED IF THE APPLICABLE REGULATORY AUTHORITY GIVES APPROVAL BEFORE THE FLIGHT. IT IS RECOMMENDED THAT THE PROPOSED REPAIR PROCEDURE BE PROVIDED TO BOEING.
		THE MAXIMUM CABIN PRESSURE DIFFERENTIAL LIMITED [] IS NOT MORE THAN ZERO PSIG.
	DO AN APPLICABLE REPAIR AS GIVEN IN SRM 52-10-01.	REFER TO THE APPLICABLE REPAIR FOR THE LIMITS.
F	CLEAN UP AS SPECIFIED IN ALLOWABLE DAMAGE 1 TO DAMAGE DEPTH. STOP DRILL 0.25 INCH (6 mm) DIAMETER HOLES AT THE ENDS OF CRACKS.	OPERATION IS NOT PERMITTED BEFORE BOEING AND APPLICABLE REGULATORY AUTHORITY GIVES APPROVAL.

DO AN APPLICABLE REPAIR AS GIVEN IN SRM 52-10-01.	REFER TO THE APPLICABLE REPAIR FOR THE LIMITS.

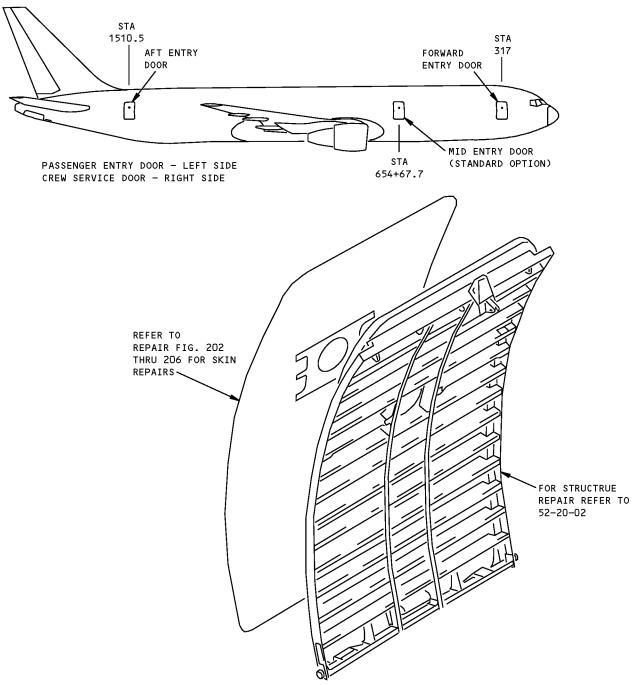
Passenger / Crew / Service Doors - Skin Repair References Figure 201

REPAIR GENERAL - ENTRY DOOR SKIN

SKIN REPAIR FIGURES:

REFER TO FIG. 202 FOR FLUSH SKIN REPAIR BETWEEN BEAMS

REFER TO FIG. 203 FOR FLUSH SKIN REPAIR AT BEAM REFER TO FIG. 204 FOR SMALL HOLE-FLUSH REPAIR REFER TO FIG. 205 FOR SMALL HOLE-EXTERNAL REPAIR REFER TO FIG. 206 FOR EXTERNAL REPAIR

REFER TO FIG. 207 FOR EXTERNAL SKIN REPAIR AT A BEAM

REFER TO FIG. 208 FOR EXTERNAL SKIN REPAIR BETWEEN BEAMS

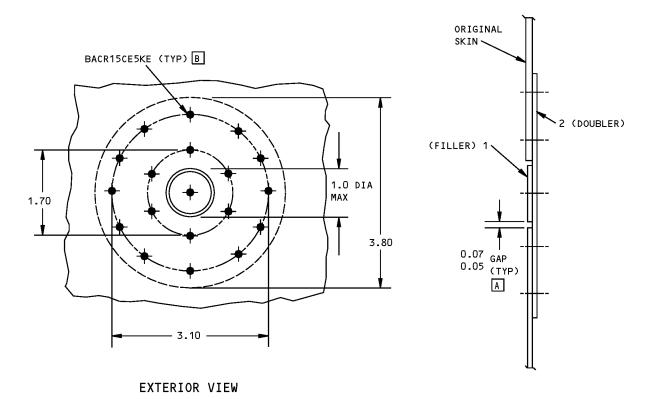
Passenger / Crew Entry Doors - Small Hole Flush Repair Figure 201 (Sheet 2 of 2)

SECTI	ON	THROUGH	REPAIR

REPAIR MATERIAL				
	PART	QTY	MATERIAL		
1	FILLER	1	SAME MATERIAL AND GAGE AS ORIGINAL SKIN		
2	DOUBLER	1	SAME MATERIAL, ONE GAGE HEAVIER THAN ORIGINAL SKIN

→ REPAIR FASTENER LOCATIONS

- Remove the inner skin panel for access if required.
- Clean out the damaged hole to 1-inch diameter maximum. The center of the hole to an edge or cutout must not be less than 1.90.

- 3. Make repair parts 1 and 2.
- Assemble repair parts in installed postions and drill fastener holes.
- 5. Remove repair parts.
- 6. Break sharp edges of original and repair parts 0.015 to 0.030.

- Remove all nicks, scratches, burrs, sharp edges and corners from original and repair parts.
- 8. Alodize all raw edges of existing and repair parts per 51-20-01.

- 10. Install repair parts, making a faying surface seal with BMS 5-95 sealant as described in 51-20-05.
- 11. Form a fillet seal around the edge of the repair parts, using the sealant squeezed out duing installation. Apply additional sealant where necessary.

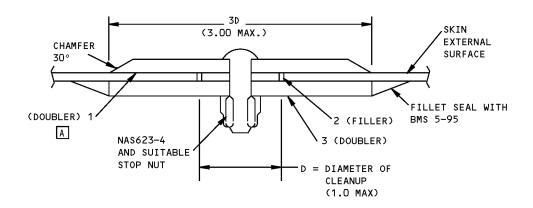
Passenger / Crew Entry Doors - Small Hole External Repair Figure 201 (Sheet 2 of 2)

OPTIONAL METHOD

- Remove the inner skin panel for access if required.
- Clean out the damaged hole to 1.00 diameter maximum. The center of the hole to an edge or cutout must not be less than 4D.

- 3. Fabricate repair parts.
- 4. Break sharp edges of original and repair parts 0.015 to 0.030.
- Remove all nicks, scratches, burrs, sharp edges and corners from original and repair parts.

- Alodize all raw edges of existing and repair parts per 51-20-01.
- 7. Apply one coat of BMS 10-11, type 1, primer to all of part 1 and to the edges and inner surface of part 2 in accordance with 51-21 of the 767 Maintenance Manual.

- Install repair parts, making a faying surface seal with BMS 5-95 sealant as described in 51-20-05.
- Form a fillet seal around the edge of the repair parts, using the sealant squeezed out during installation. Apply additional sealant where necessary.

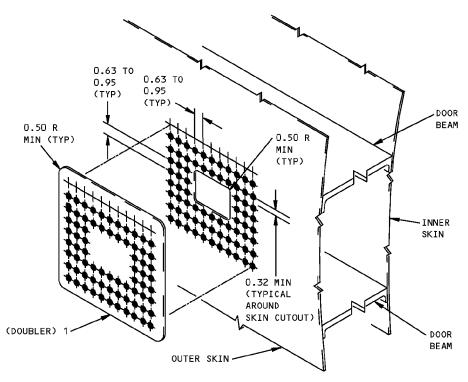
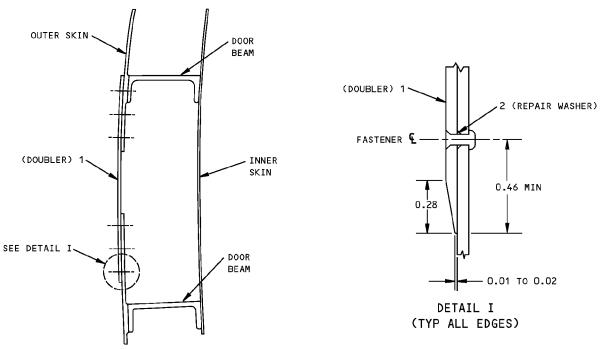
Passenger / Crew Service Doors - External Skin Repair Between Beams Figure 201 (Sheet 2 of 2)

REPAIR BETWEEN BEAMS

SECTION THRU REPAIR

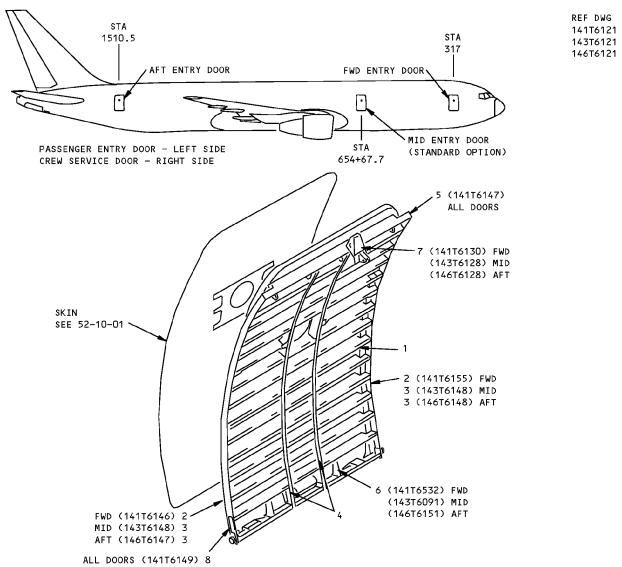
IDENTIFICATION 1 - ENTRY DOOR STRUCTURE

ITEM	DESCRIPTION	GAGE	MATERIAL	EFFECTIVITY
1	BEAM		FORGING 7075-T73	
2	EDGE MEMBER		BAC1520-2160 7050-T76	
3	EDGE MEMBER		BAC1520-2390 7050-T76 OPTIONAL: BAC1520-2160 7050-T76	
4	TENSION STRAP		BAC1511-3711 2024-T42	
5	CONTINUOUS STOP		BAC1522-379 TORLON 4301	
6	INTERCOSTAL	0.063	7075 – T62	
7	UPPER GUIDE SUPPORT		FORGING 7075-T73 OR PLATE 7075-T7351	
8	SUPPORT FTG	0.300	PLATE 15-5PH CRES HT-TR 150-170 KSI

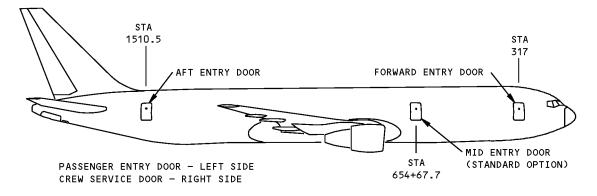
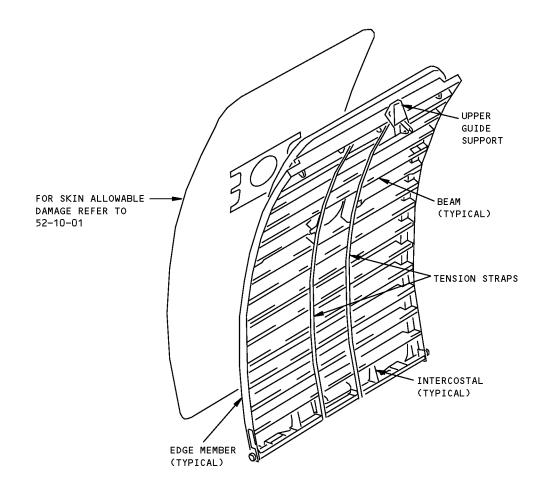
Entry Door Structure - Allowable Damage Figure 101 (Sheet 1 of 4)

ALLOWABLE DAMAGE 1 - ENTRY DOOR STRUCTURE

MATERIAL: ALUMINUM

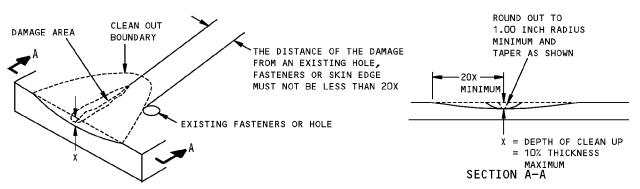
DAMAGE CLEAN UP OF EDGES WHERE FASTENER EDGE MARGINS OVERLAP

DETAIL I

REMOVAL OF NICK, GOUGE AND SCRATCH DAMAGE ON A SURFACE DETAIL II

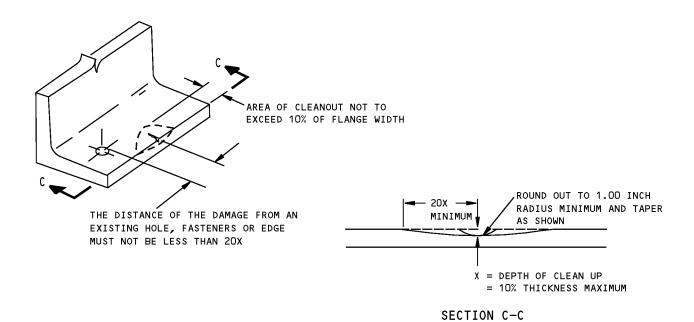
Entry Door Structure - Allowable Damage Figure 101 (Sheet 4 of 4)

REMOVAL OF NICK OR CRACK DAMAGE ON AN EDGE DETAIL V

REMOVAL OF NICK OR CRACK DAMAGE ON AN EDGE DETAIL VI

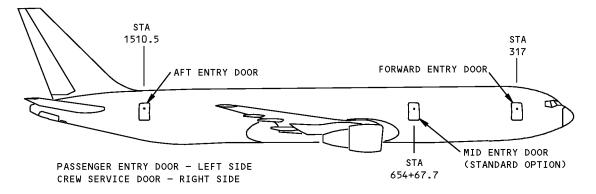
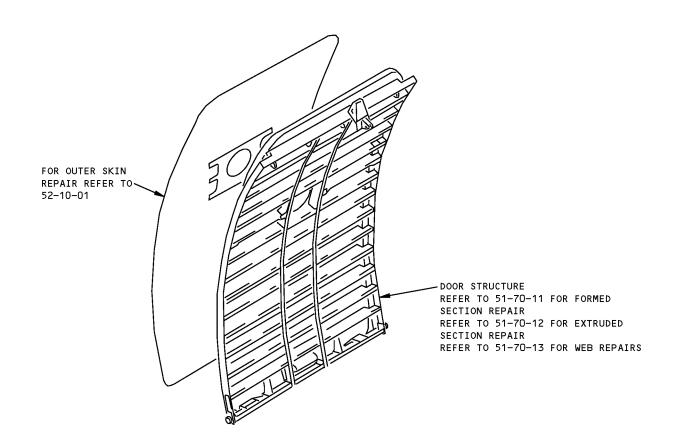
Passenger / Crew Service Doors Structure Repair Figure 201

REPAIR GENERAL - ENTRY DOOR STRUCTURE

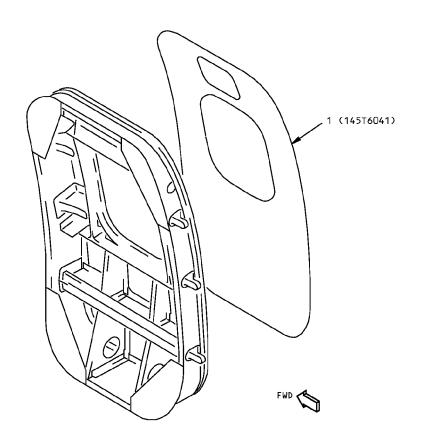
REF DWG 145T6016

ITEM	DESCRIPTION	GAGE	MATERIAL	EFFECTIVITY
1	OUTER SKIN	0.071	CLAD 2024-T3 (CHEM-MILLED TO 0.050 MIN)

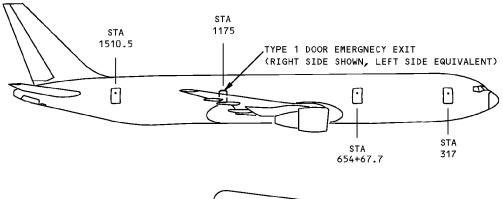
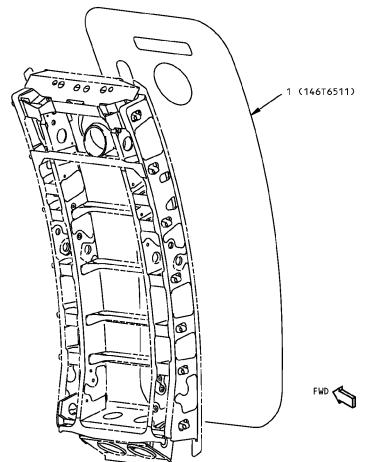
REF DWG 146T6505

IDENTIFICATION 2 - TYPE 1 DOOR (EMERGENCY EXIT) SKIN

ITEM	DESCRIPTION	GAGE	MATERIAL	EFFECTIVITY
1	SKIN	0.14	CLAD 2024-T3 (MACHINED TO 0.05)

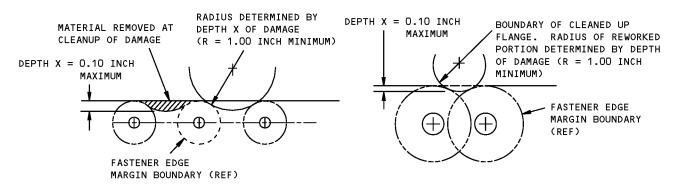
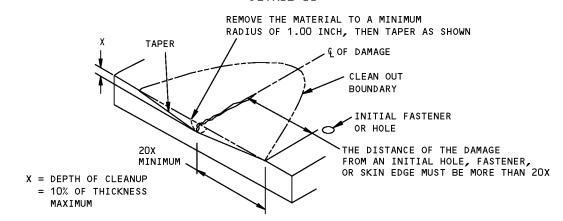
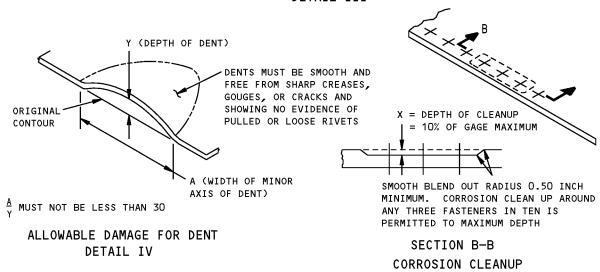
Overwing Emergency Exit Door Skin Allowable Damage Figure 101 (Sheet 1 of 2)

ALLOWABLE DAMAGE 1 - EMERGENCY EXIT DOOR SKIN

DAMAGE CLEAN UP OF EDGES WHERE FASTENER EDGE MARGINS DO NOT OVERLAP

DAMAGE CLEAN UP OF EDGES WHERE FASTENER EDGE MARGINS OVERLAP

DETAIL II

REMOVAL OF NICK, GOUGE, CORROSION, AND SCRATCH DAMAGE ON A SURFACE DETAIL III

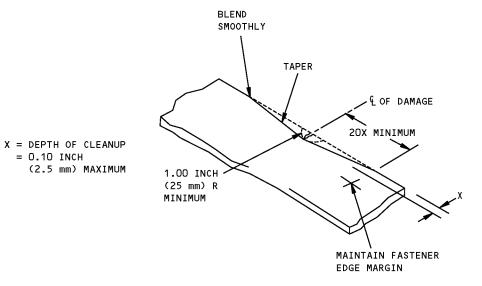
DETAIL V

REMOVAL OF NICK OR CRACK DAMAGE ON AN EDGE DETAIL VI

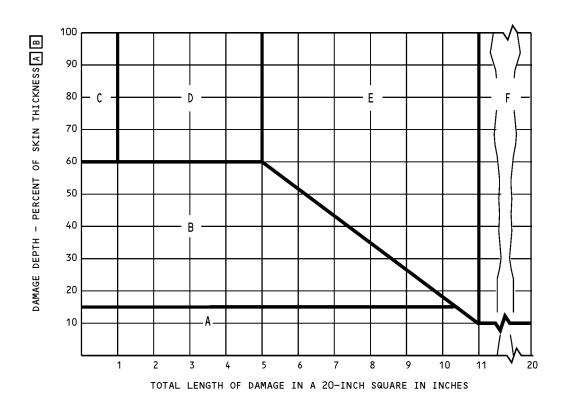
ALLOWABLE DAMAGE 2 - OPERATING LIMITS FOR OVERWING / TYPE I EMERGENCY EXIT DOOR SKIN

- A SKIN THICKNESS DOES NOT INCLUDE THE THICKNESS OF THE DOUBLERS, TRIPLERS, OR STRAPS.
- B DAMAGE INCLUDES HOLES, PUNCTURES, NICKS, GOUGES, SCRATCHES, CORROSION AND CRACKS.

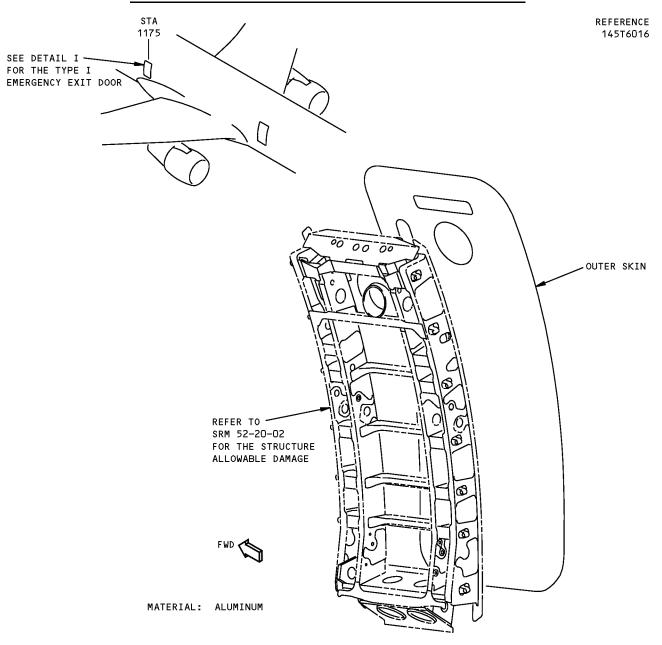
ALLOWABLE DAMAGE 3 - TYPE I EMERGENCY EXIT DOOR SKIN

RIGHT SIDE IS SHOWN, LEFT SIDE IS SIMILAR

TYPE I EMERGENCY EXIT DOOR

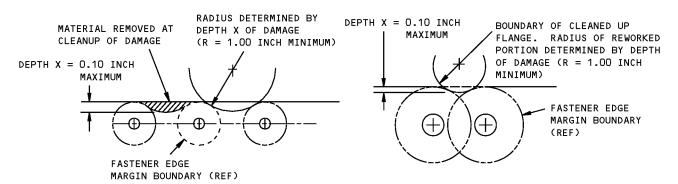
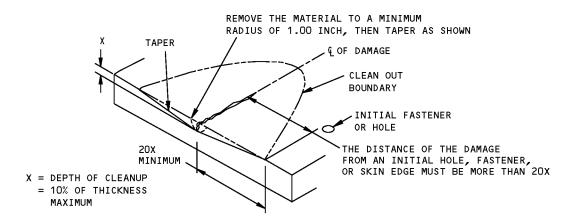
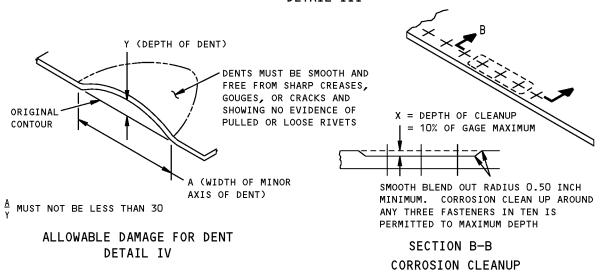
Type I Emergency Exit Door Skin Allowable Damage Figure 101 (Sheet 2 of 3)

DAMAGE CLEAN UP OF EDGES WHERE FASTENER EDGE MARGINS DO NOT OVERLAP

DAMAGE CLEAN UP OF EDGES WHERE FASTENER EDGE MARGINS OVERLAP

DETAIL II

REMOVAL OF NICK, GOUGE, CORROSION, AND SCRATCH DAMAGE ON A SURFACE DETAIL III

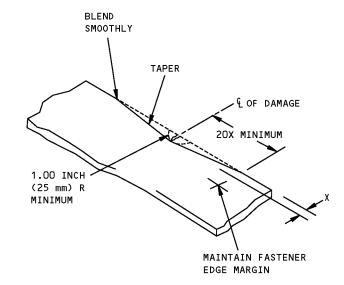
DETAIL V

REMOVAL OF NICK OR CRACK DAMAGE ON AN EDGE
DETAIL VI

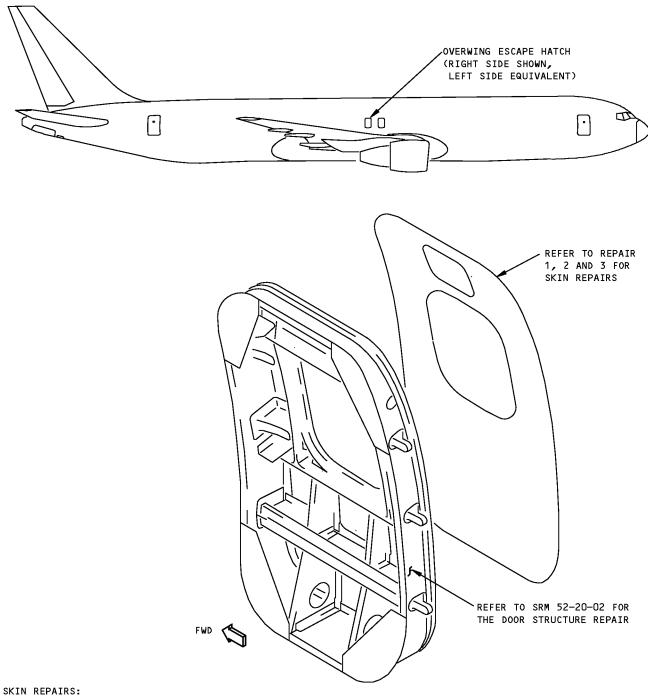
> Overwing Escape Hatch (Emergency Exit) Door Skin Repair References Figure 201

REPAIR GENERAL - EMERGENCY EXIT DOOR SKIN

REFER TO REPAIR 1 FOR THE FLUSH SKIN REPAIR BETWEEN BEAMS REFER TO REPAIR 3 FOR THE SMALL HOLE-FLUSH REPAIR REFER TO REPAIR 4 FOR THE SMALL HOLE-EXTERNAL REPAIR

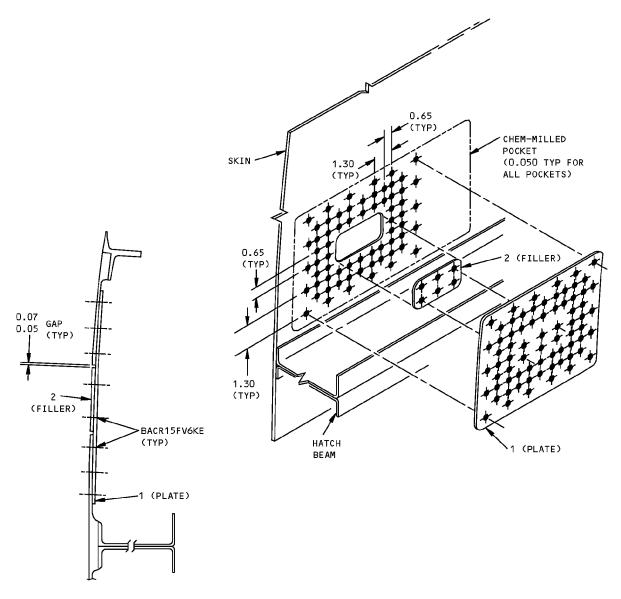
REPAIR 1 Page 201 Apr 01/2005

SECTION THRU REPAIR

REPAIR MATERIAL							
	PART	QTY	MATERIAL					
1	PLATE	1	SAME MATERIAL ONE GAGE HEAVIER THAN ORIGINAL SKIN					
2	FILLER	1	SAME MATERIAL AND GAGE AS ORIGINAL SKIN

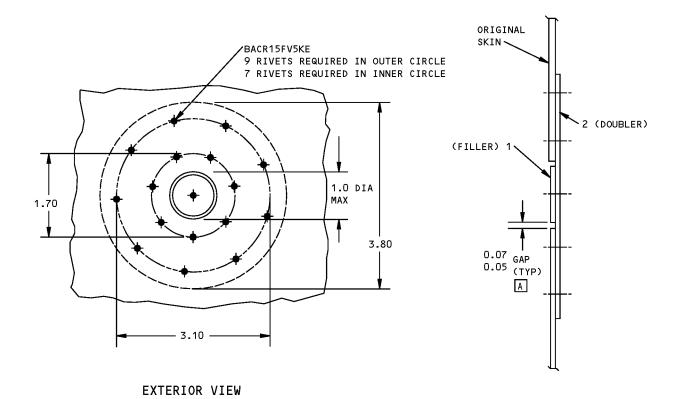
REPAIR 3 Page 201 Apr 01/2005

SECTION	THROUGH	REPAIR

REPAIR MATERIAL							
	PART	QTY	MATERIAL				
1	FILLER	1	SAME MATERIAL AND GAGE AS ORIGINAL SKIN				
2	DOUBLER	1	SAME MATERIAL, ONE GAGE HEAVIER THAN ORIGINAL SKIN

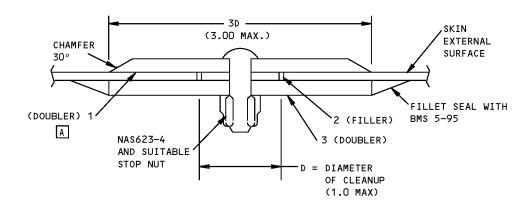
Overwing Escape Hatch Door - Small Hole - External Repair Figure 201 (Sheet 2 of 2)

OPTIONAL METHOD

REPAIR MATERIAL							
	PART	QTY	MATERIAL					
1	DOUBLER	1	2024-T3, -T4 OR -T42 TWICE SKIN GAGE					
2	FILLER	1	2024-T3, -T4 OR -T42 SAME GAGE AS SKIN					
3	DOUBLER	1	2024-T3, -T4 OR -T42 TWICE SKIN GAGE

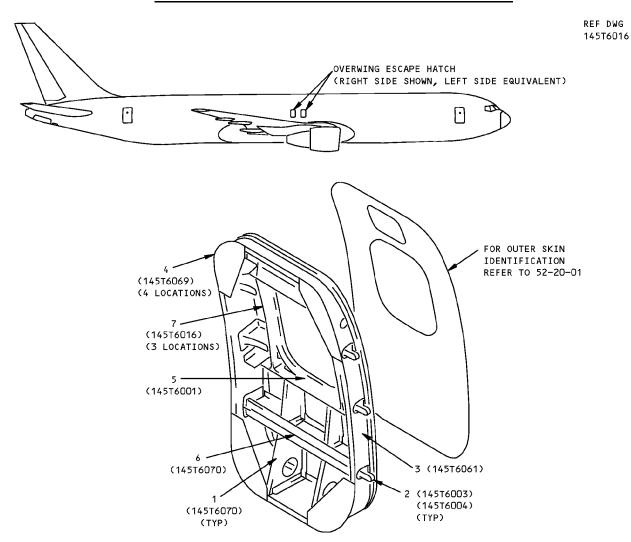
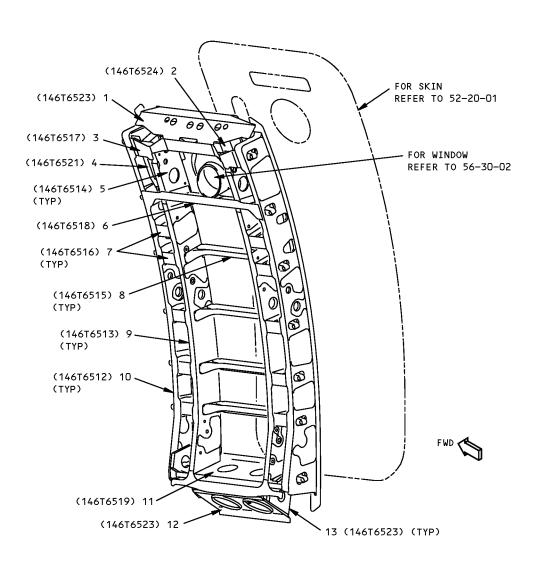
Type 1 Emergency Exit Door Structure Identification Figure 1 (Sheet 1 of 2)

IDENTIFICATION 1 - EMERGENCY EXIT DOOR STRUCTURE

ITEM	DESCRIPTION	GAGE	MATERIAL	EFFECTIVITY
1	INTERCOSTAL WEB CHORD	0.071	CLAD 2024-T42 AND10136-1701 7075-T6511	
2	DOOR STOP		FORGING 7075 T73	
3	FRAME	0.071	CLAD 2024-T42	
4	GUSSET	0.063	CLAD 7075-T62	
5	WINDOW SUPPORT FRAME		FORGING 7075-T73	
6	BEAM	0.071	CLAD 2024-T42	
7	FAIL SAFE STRAP	0.150	7075-T6

REF DWG 146T6505

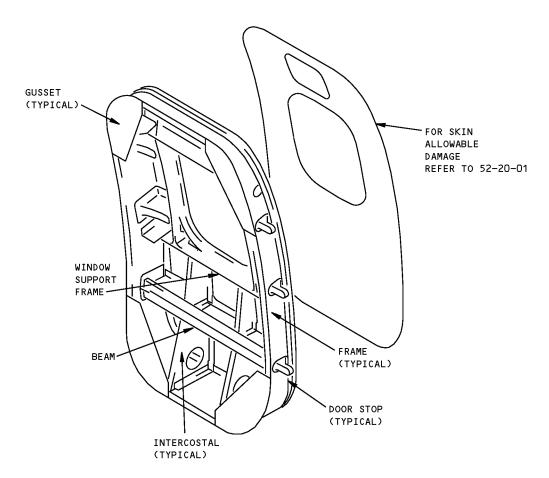
Overwing Emergency Exit Door Structure Allowable Damage Figure 101 (Sheet 1 of 4)

ALLOWABLE DAMAGE 1 - EMERGENCY EXIT DOOR STRUCTURE

OVERWING EMERGENCY EXIT DOOR

MATERIAL: ALUMINUM

DESCRIPTION	CRACKS	NICKS, GOUGES AND CORROSION	DENTS	HOLES AND PUNCTURES
BEAM	Α	D	SEE DETAIL III	H
FRAME	А	D	SEE DETAIL III	H
INTERCOSTAL	В	E	SEE DETAIL III	H
GUSSET	В	E	SEE DETAIL III	H
DOOR STOP	CI	FΙ	NOT PERMITTED	NOT PERMITTED
WINDOW SUPPORT FRAME	С	G	NOT PERMITTED	HOLES PERMITTED IN WEBS ONLY H

- REFER TO SRM 51-10-02 FOR INSPECTION AND REMOVAL OF DAMAGE
- REFINISH REWORKED AREAS AS SHOWN IN AMM 51-20
- A CRACKS ARE NOT PERMITTED EXCEPT FOR EDGE CRACKS WHICH MUST BE REMOVED AS SHOWN IN DETAILS I AND VI
- B CRACKS ARE NOT PERMITTED EXCEPT FOR EDGE CRACKS WHICH MUST BE REMOVED AS SHOWN IN DETAILS I AND V
- C CRACKS ARE NOT PERMITTED EXCEPT FOR EDGE CRACKS WHICH MUST BE REMOVED AS SHOWN IN DETAILS I AND VII. J
- D REMOVE DAMAGE AS SHOWN IN DETAILS I, II, IV AND VI
- E REMOVE DAMAGE AS SHOWN IN DETAILS I, II, IV AND V
- F FOR EDGE DAMAGE SEE DETAILS I AND VII. FOR LUG DAMAGE, SEE DETAIL VIII. FOR OTHER DAMAGE, SEE DETAIL II. DAMAGE IS NOT PERMITTED IN VICINITY OF BUSHINGS.

- G REMOVE DAMAGE AS SHOWN IN DETAILS I, II, IV AND VII.
- H CLEAN OUT DAMAGE UP TO 0.25 INCH (6 mm) MAX DIA AND NOT CLOSER THAN 1.0 INCH (25 mm) TO FASTENER HOLE, MATERIAL EDGE, OR OTHER DAMAGE. FILL HOLE WITH 2117-T3 OR T4 ALUMINUM RIVET INSTALLED WET WITH BMS 5-95 SEALANT. ALL OTHER HOLES TO BE REPAIRED
- BOEING APPROVAL REQUIRED FOR ALLOWABLE DAMAGE ON OUTBOARD EDGES OF STOP OVERHANGS
- J SHOT PEEN ALL REWORKED SURFACES AS SHOWN IN SRM 51-20-06. SHOT PEEN INTENSITIES WILL VARY WITH THE THICKNESS REMAINING AFTER REWORK

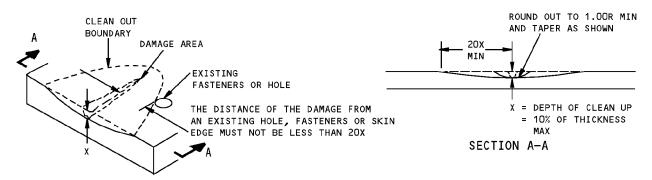
DETAIL I

DAMAGE CLEAN UP OF EDGES WHERE FASTENER EDGE MARGINS DO NOT OVERLAP

UP FLANGE. RADIUS OF REWORKED PORTION DETERMINED BY DEPTH OF DAMAGE (R = 1.00 MIN)

DAMAGE CLEAN UP OF EDGES WHERE FASTENER EDGE MARGINS OVERLAP

REMOVAL OF NICK, GOUGE AND SCRATCH DAMAGE ON A SURFACE DETAIL II

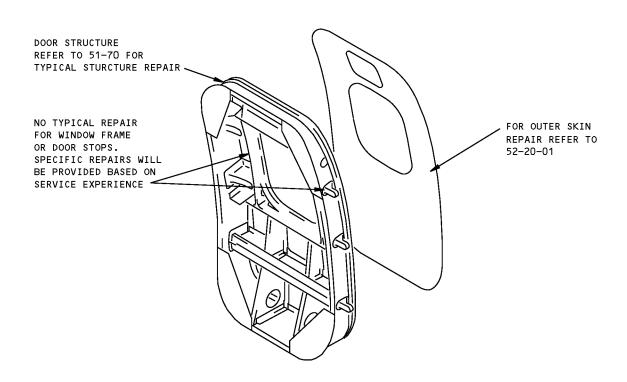
Overwing Escape Hatch (Emergency Exit) Structure Repair Figure 201

REPAIR GENERAL - EMERGENCY EXIT DOOR STRUCTURE REPAIR

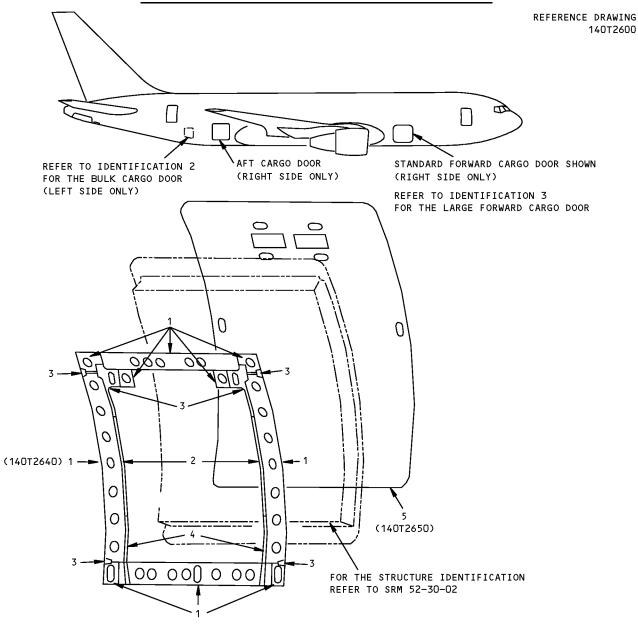
IDENTIFICATION 1 - FORWARD / AFT CARGO DOOR SKIN

ITEM	DESCRIPTION	GAGE	MATERIAL	EFFECTIVITY
1	SKIN (INNER)	0.040	CLAD 7075-T6	
2	DOUBLER	0.050	CLAD 7075-T6	
3	DOUBLER	0.063	CLAD 7075-T6	
4	DOUBLER	0.090	CLAD 7075-T6	
5	OUTER SKIN	0.071	CLAD 2024-T3 (CHEM-MILLED TO 0.051 MINIMUM)

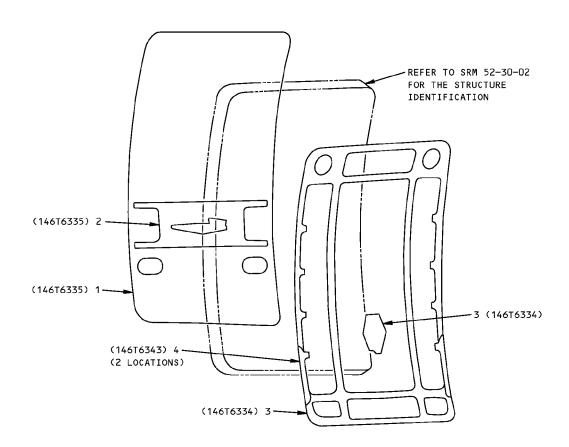
IDENTIFICATION 2 - BULK CARGO DOOR SKIN

ITEM	DESCRIPTION	GAGE	MATERIAL	EFFECTIVITY
1	OUTER SKIN	0.071	CLAD 2024-T3 (CHEM-MILLED TO 0.051 MINIMUM)	
2	DOUBLER	0.063	CLAD 2024-T3	
3	INNER SKIN	0.063	CLAD 7075-T62	
4	DOUBLER	0.063	CLAD 7075-T6

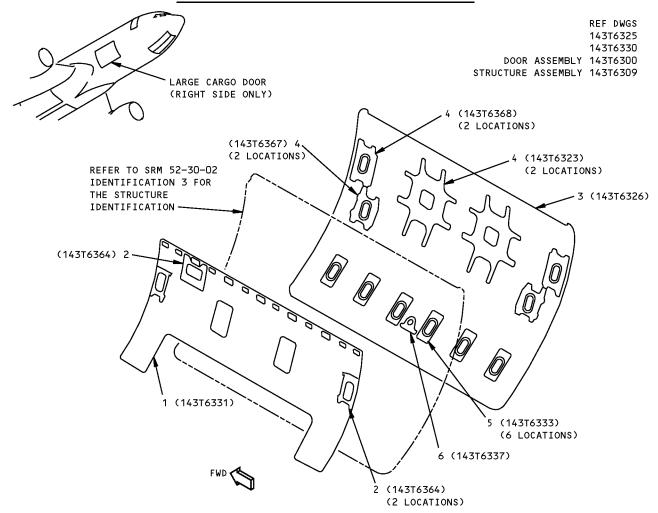
IDENTIFICATION 3 - LARGE CARGO DOOR SKIN

ITEM	DESCRIPTION	GAGE	MATERIAL	EFFECTIVITY
1	INNER SKIN	0.056	CLAD OR BARE 2024-T3 THE SKIN IS CHEM-MILLED AND MACHINED AND VARIES IN THICKNESS. REFER TO THE BOEING DRAWING TO DETERMINE THE LOCAL THICKNESS.	
2	DOUBLER	0.050	CLAD 2024-T3	
3	OUTER SKIN	0.125	CLAD 2024-T3 THE SKIN IS CHEM-MILLED AND VARIES IN THICKNESS. REFER TO THE BOEING DRAWING TO DETERMINE THE LOCAL THICKNESS.	
4	DOUBLER	0.100	CLAD 2024-T3	
5	DOUBLER	0.250	2024-T351 PLATE	
6	DOUBLER	0.140	CLAD 2024-T3

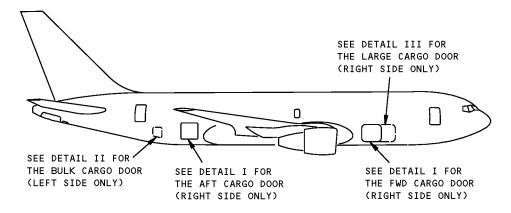
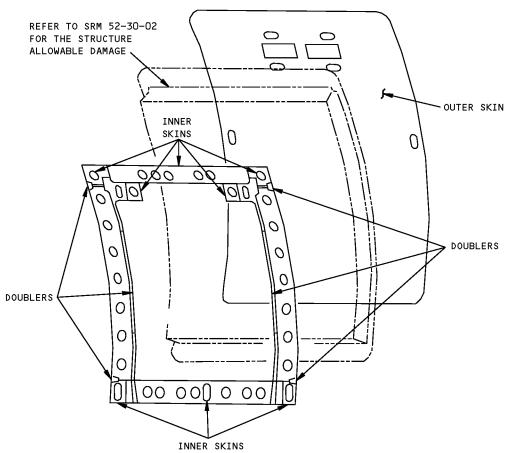
Cargo Doors Skin Allowable Damage Figure 101 (Sheet 1 of 5)

ALLOWABLE DAMAGE 1 - CARGO DOORS SKIN

REF DWG 140T2600

MATERIAL: ALUMINUM

FORWARD/AFT CARGO DOOR DETAIL I

DESCRIPTION	CRACKS	NICKS, GOUGES AND CORROSION	DENTS	HOLES AND PUNCTURES
OUTER SKIN A	вн	HI	J	EΗ
INNER SKIN	С	D	J	F
DOUBLERS	В	D	SEE DETAIL VI	F

- A REFER TO SRM 51-10-01 FOR AERODYNAMIC SMOOTHNESS REQUIREMENTS. WHERE THE DAMAGE IS MORE THAN THE LIMITS SHOWN IN SRM 51-10-01, THOUGHT SHOULD BE GIVEN TO THE LOSS OF PERFORMANCE THAT MAY OCCUR.

- B CRACKS ARE NOT PERMITTED EXCEPT FOR EDGE CRACKS WHICH MUST BE REMOVED AS SHOWN IN DETAILS IV AND VIII.
- FOR EDGE CRACKS SEE DETAILS IV AND VIII,
 FOR LIGHTENING HOLE EDGE CRACKS, SEE
 DETAIL X. FOR OTHER CRACKS SEE DETAIL IX

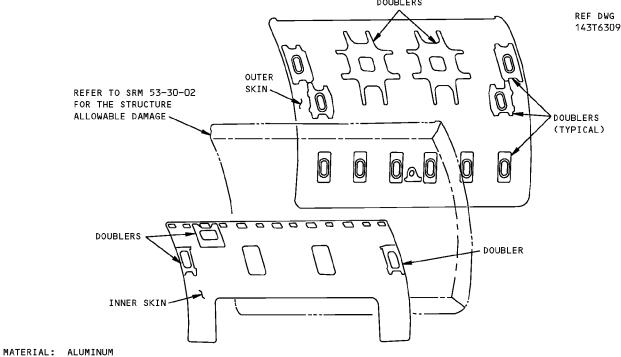
Cargo Doors Skin Allowable Damage Figure 101 (Sheet 2 of 5)

REF DWG 146T6301 REFER TO SRM 52-30-02 FOR THE STRUCTURE ALLOWABLE DAMAGE OUTER SKIN . INNER SKIN DOUBLER - DOUBLER MATERIAL: ALUMINUM DOUBLER-BULK CARGO DOOR DETAIL II DOUBLERS REF DWG 143T6309 OUTER

LARGE CARGO DOOR DETAIL III

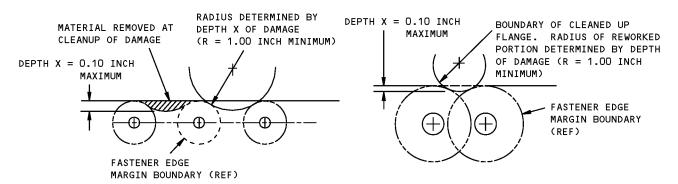
DETAIL IV

DAMAGE CLEAN UP OF EDGES WHERE FASTENER EDGE MARGINS DO NOT OVERLAP

DAMAGE CLEAN UP OF EDGES WHERE FASTENER EDGE MARGINS OVERLAP

- REMOVE DAMAGE AS SHOWN IN DETAILS IV, V, VII AND VIII.
- E CLEAN OUT DAMAGE UP TO 0.25 INCH (6.35 mm)
 MAXIMUM DIAMETER AND NOT CLOSER THAN
 1.0 INCH (25.4 mm) TO FASTENER HOLE,
 MATERIAL EDGE, OR OTHER DAMAGE. FILL HOLE
 WITH 2117-T3 OR T4 ALUMINUM RIVET INSTALLED
 WET WITH BMS 5-95 SEALANT. ALL OTHER HOLES
 TO BE REPAIRED.

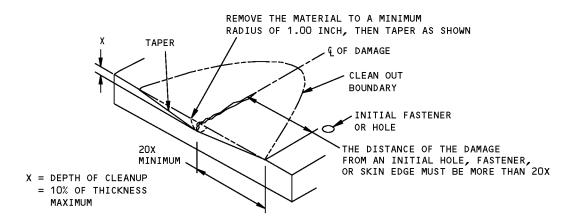
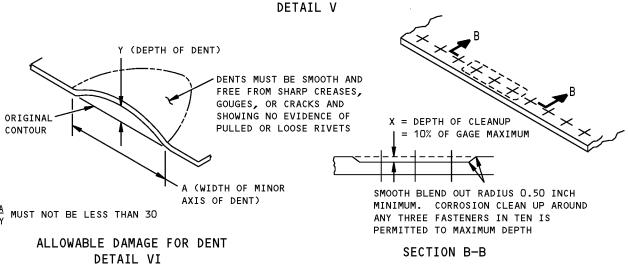
Cargo Doors Skin Allowable Damage Figure 101 (Sheet 4 of 5)

REMOVAL OF NICK, GOUGE, CORROSION, AND SCRATCH DAMAGE ON A SURFACE

CORROSION CLEANUP
DETAIL VII

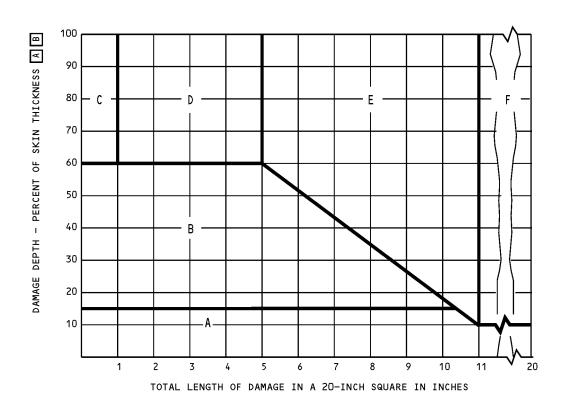
ALLOWABLE DAMAGE 2 - OPERATING LIMITS FOR CARGO DOORS OUTER SKIN

- A SKIN THICKNESS DOES NOT INCLUDE THE THICKNESS OF THE DOUBLERS, TRIPLERS, OR STRAPS.
- B DAMAGE INCLUDES HOLES, PUNCTURES, NICKS, GOUGES, SCRATCHES, CORROSION AND CRACKS DAMAGE DOES NOT INCLUDE DENTS
- C CABIN PRESSURE LIMITS ARE FOR SKIN DAMAGE IN THE PRESSURIZED FUSELAGE CAVITY ONLY.

CHART AREA	DAMAGE TREATMENT	ALLOWABLE AIRPLANE OPERATIONS
A	CLEAN UP AS SPECIFIED IN ALLOWABLE DAMAGE 1	NO FLIGHT RESTRICTIONS
В	CLEAN UP AS SPECIFIED IN ALLOWABLE DAMAGE 1 TO DAMAGE DEPTH.	LIMITED TO 50 HOURS OF FLIGHT INCLUDING REVENUE FLIGHTS.
	DO AN APPLICABLE REPAIR AS GIVEN IN SRM 52-30-01.	REFER TO THE APPLICABLE REPAIR FOR THE LIMITS.
С	CLEAN UP AS SPECIFIED IN ALLOWABLE DAMAGE 1 TO DAMAGE DEPTH. STOP DRILL 0.25 INCH (6 mm) DIAMETER HOLES AT THE ENDS OF CRACKS.	A NON-REVENUE FLIGHT TO A REPAIR STATION IS PERMITTED IF THE APPLICABLE REGULATORY AUTHORITY GIVES APPROVAL BEFORE THE FLIGHT. IT IS RECOMMENDED THAT THE PROPOSED REPAIR PROCEDURE BE PROVIDED TO BOEING.
		THE MAXIMUM CABIN PRESSURE DIFFERENTIAL LIMIT C TO 6.0 PSIG UNLESS REPAIRED.
	DO AN APPLICABLE REPAIR AS GIVEN IN SRM 52-30-01.	REFER TO THE APPLICABLE REPAIR FOR THE LIMITS.
D	CLEAN UP AS SPECIFIED IN ALLOWABLE DAMAGE 1 TO DAMAGE DEPTH. STOP DRILL 0.25 INCH (6 mm) DIAMETER HOLES AT THE ENDS OF CRACKS.	A NON-REVENUE FLIGHT TO A REPAIR STATION IS PERMITTED IF THE APPLICABLE REGULATORY AUTHORITY GIVES APPROVAL BEFORE THE FLIGHT. IT IS RECOMMENDED THAT THE PROPOSED REPAIR PROCEDURE BE PROVIDED TO BOEING.

THE MAXIMUM CABIN PRESSURE DIFFERENTIAL LIMIT C TO 6.0 PSIG UNLESS REPAIRED.
	DO AN APPLICABLE REPAIR AS GIVEN IN SRM 52-30-01.	REFER TO THE APPLICABLE REPAIR FOR THE LIMITS.
E	CLEAN UP AS SPECIFIED IN ALLOWABLE DAMAGE 1 TO DAMAGE DEPTH. STOP DRILL 0.25 INCH (6 mm) DIAMETER HOLES AT THE ENDS OF CRACKS.	A NON-REVENUE FLIGHT TO A REPAIR STATION IS PERMITTED IF THE APPLICABLE REGULATORY AUTHORITY GIVES APPROVAL BEFORE THE FLIGHT. IT IS RECOMMENDED THAT THE PROPOSED REPAIR PROCEDURE BE PROVIDED TO BOEING.
		THE MAXIMUM CABIN PRESSURE DIFFERENTIAL LIMIT C IS NOT MORE THAN ZERO PSIG.
	DO AN APPLICABLE REPAIR AS GIVEN IN SRM 52-30-01.	REFER TO THE APPLICABLE REPAIR FOR THE LIMITS.
F	CLEAN UP AS SPECIFIED IN ALLOWABLE DAMAGE 1 TO DAMAGE DEPTH. STOP DRILL 0.25 INCH (6 mm) DIAMETER HOLES AT THE ENDS OF CRACKS.	OPERATION IS NOT PERMITTED BEFORE BOEING AND APPLICABLE REGULATORY AUTHORITY GIVES APPROVAL.

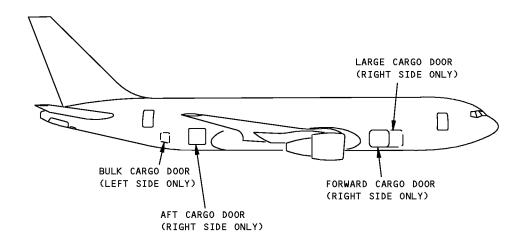
Cargo Door Outer Skin Repair References Figure 201

REPAIR GENERAL - CARGO DOOR OUTER SKIN

- FOR TYPICAL FORWARD/AFT/BULK CARGO DOOR OUTER SKIN REPAIRS:
 - REFER TO REPAIR 1 FOR FLUSH SKIN REPAIR BETWEEN BEAMS
 - REFER TO REPAIR 4 FOR SMALL HOLE-FLUSH REPAIR
 - REFER TO REPAIR 5 FOR SMALL HOLE-EXTERNAL REPAIR
 - REFER TO REPAIR 6 FOR EXTERNAL REPAIR
- FOR TYPICAL LARGE CARGO DOOR OUTER SKIN REPAIRS:
 - REFER TO REPAIR 2 FOR FLUSH SKIN REPAIR BETWEEN BEAMS
 - REFER TO REPAIR 4 FOR SMALL HOLE-FLUSH REPAIR
 - REFER TO REPAIR 5 FOR SMALL HOLE-EXTERNAL REPAIR
 - REFER TO REPAIR 6 FOR EXTERNAL REPAIR

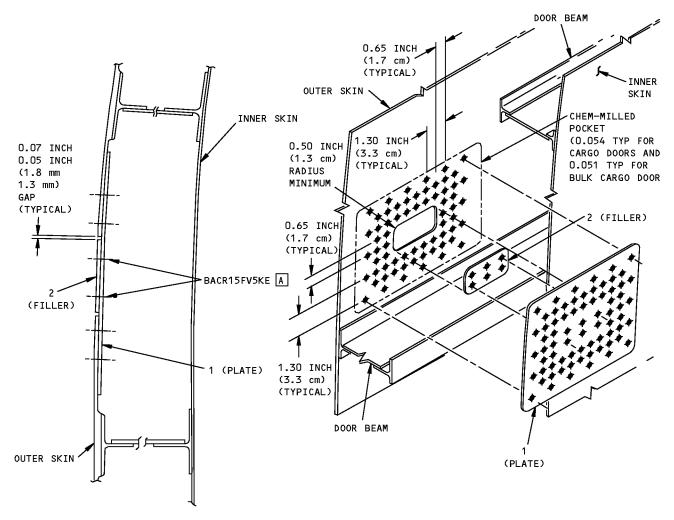
REPAIR 1 - FORWARD / AFT / BULK CARGO DOOR - FLUSH SKIN REPAIR BETWEEN BEAMS

SECTION THRU REPAIR

REPAIR MATERIAL						
P.	PART QTY GAGE MATERIAL					
1	PLATE	1	0.063	CLAD 2024-T3		
2 FILLER 1 0.054 CLAD 2024-T3

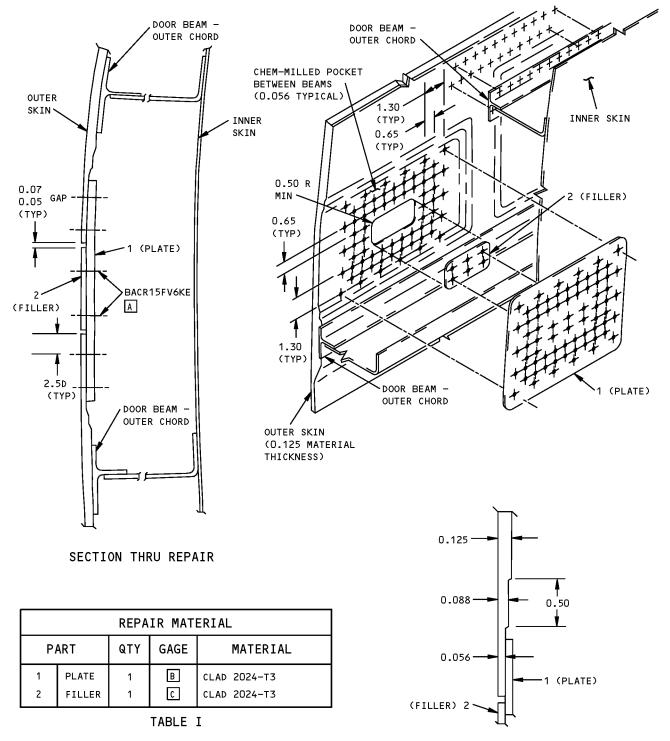
Large Cargo Door - Flush Skin Repair Between Beams Figure 201 (Sheet 2 of 2)

SECTION THRU CHEM-MILLED SKIN (TYPICAL FOR ALL 0.056 CHEM-MILLED POCKETS)

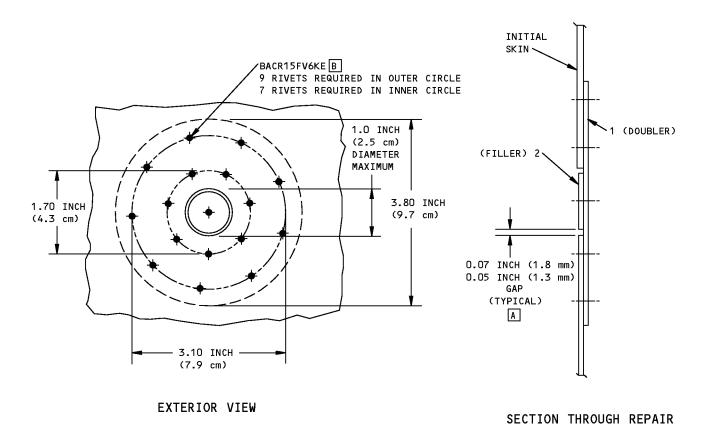
Cargo Doors - Small Hole - Flush Repair Figure 201 (Sheet 1 of 2)

REPAIR MATERIAL						
P	PART QTY GAGE MATERIAL						
1	DOUBLER	1	С	CLAD 2024-T3			
2 FILLER 1 D CLAD 2024-T3

TABLE I

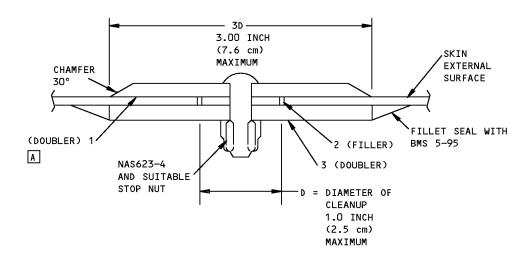
OPTIONAL METHOD

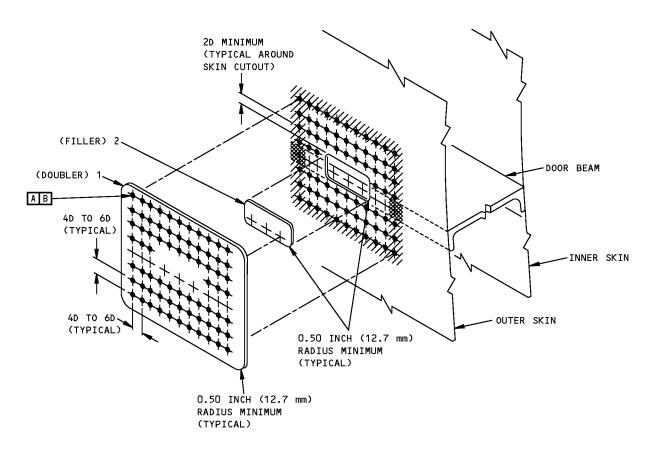
DETAIL II

SKIN INSPECTION AREA

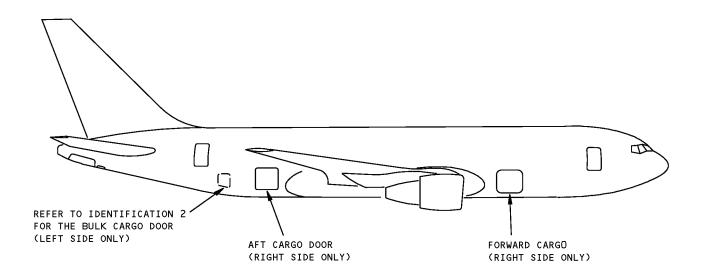
Forward / Aft Cargo Door Structure Identification Figure 1 (Sheet 1 of 3)

IDENTIFICATION 1 - FORWARD / AFT CARGO DOOR STRUCTURE

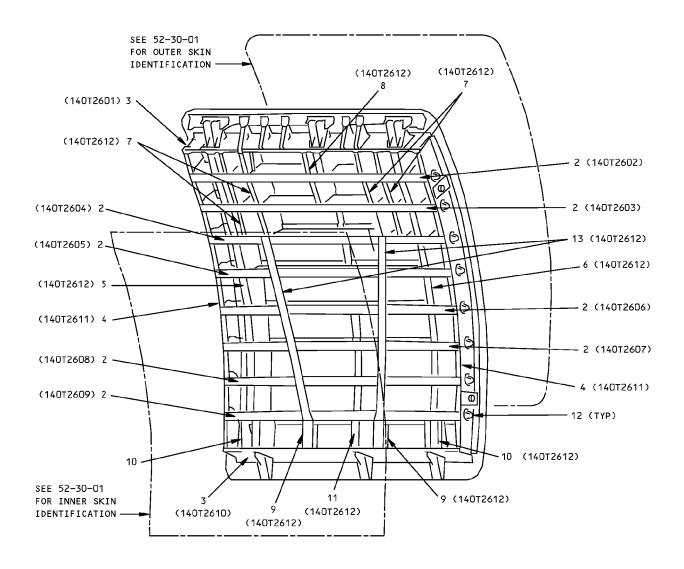
DETAIL I

REF DWG 140T2600

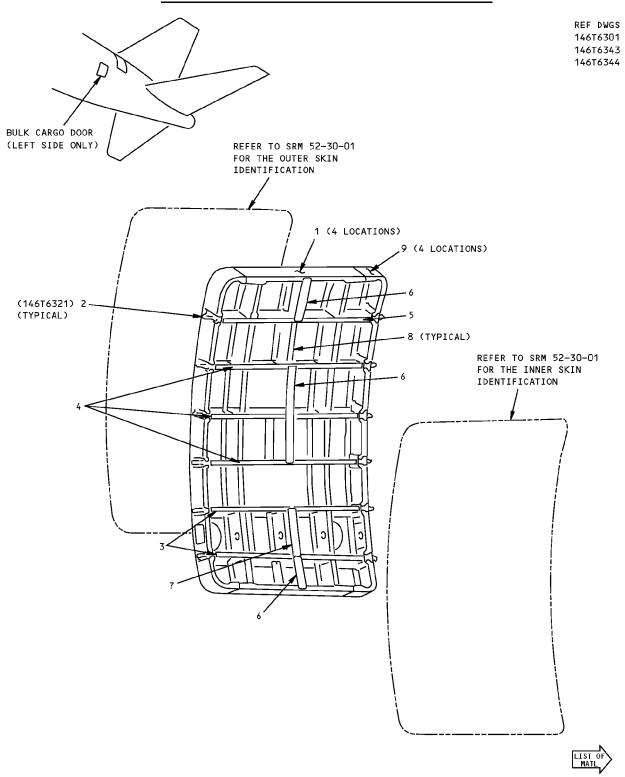
Bulk Cargo Door Structure Identification Figure 1 (Sheet 1 of 2)

IDENTIFICATION 2 - BULK CARGO DOOR STRUCTURE

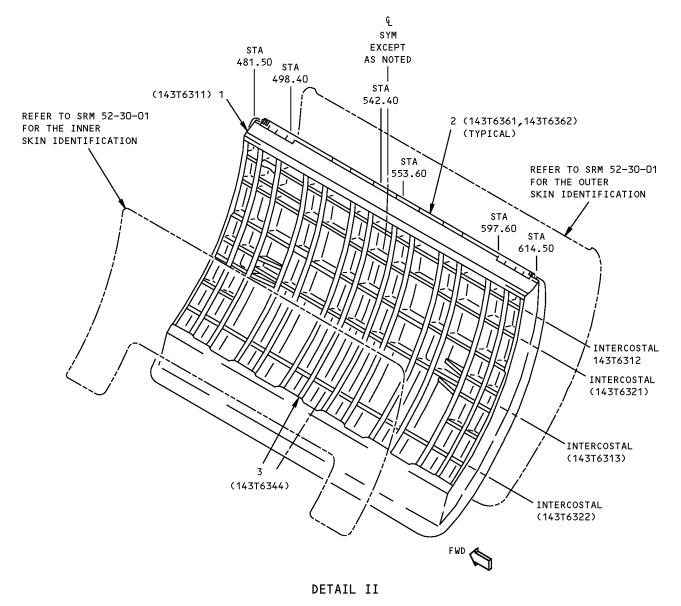
Large Cargo Door Structure Identification Figure 1 (Sheet 3 of 4)

REFERENCE DRAWING 143T6309

LIST OF MATL

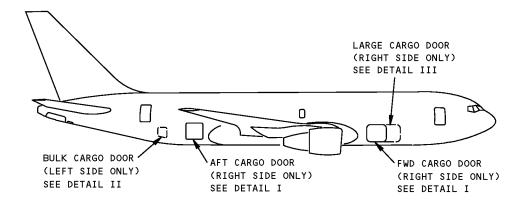
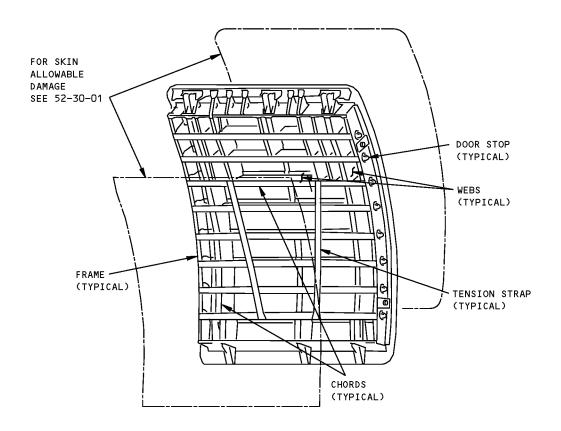
FORWARD/AFT CARGO DOOR DETAIL I

ALLOWABLE DAMAGE 1 - CARGO DOORS STRUCTURE

REF DWG 140T2600

MATERIAL: ALUMINUM

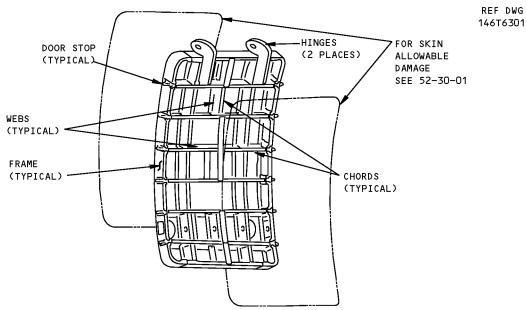
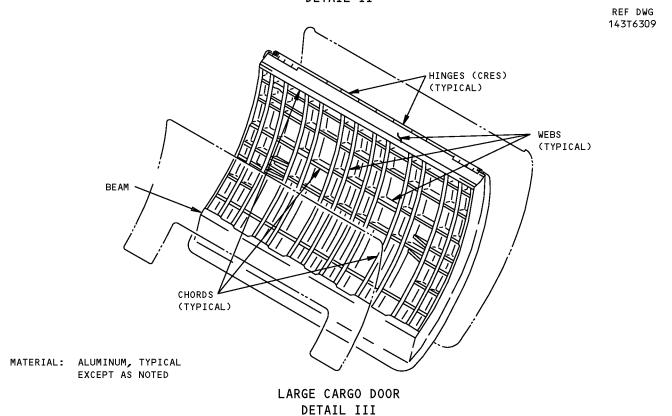
Cargo Doors Structure Allowable Damage Figure 101 (Sheet 2 of 5)

MATERIAL: ALUMINUM

BULK CARGO DOOR DETAIL II

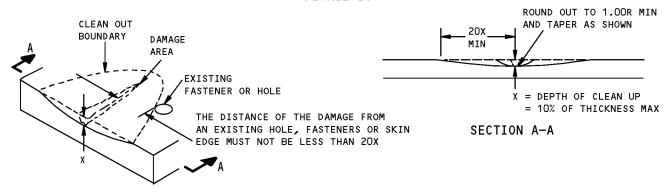
DETAIL IV

DAMAGE CLEAN UP OF EDGES WHERE FASTENER EDGE MARGINS OVERLAP

REMOVAL OF NICK, GOUGE AND SCRATCH DAMAGE ON A SURFACE DETAIL V

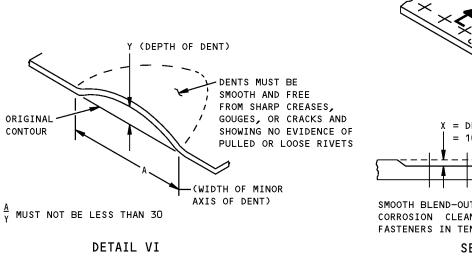
CORROSION CLEAN UP AROUND ANY THREE FASTENERS IN TEN IS PERMITTED TO MAX DEPTH

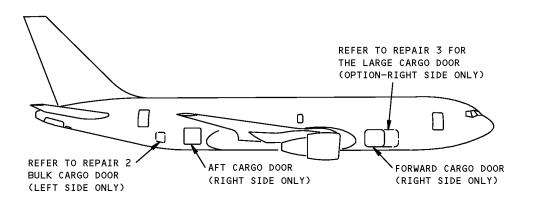
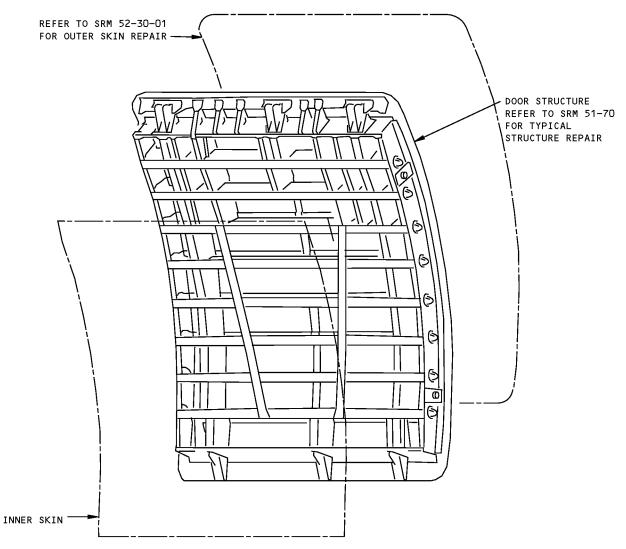
Forward / Aft Cargo Door Structure Repair Figure 201

REPAIR 1 - FORWARD / AFT CARGO DOOR STRUCTURE

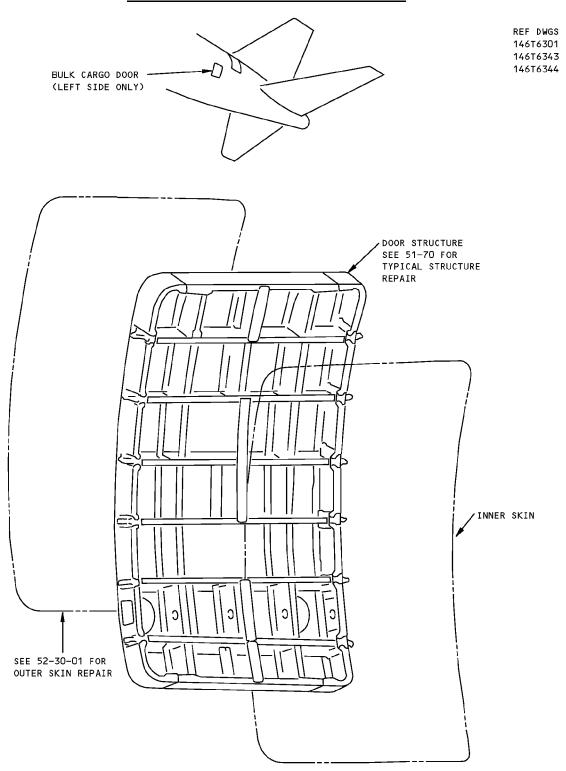
Bulk Cargo Door Structure Repair Figure 201

REPAIR 2 - BULK CARGO DOOR STRUCTURE
