CHAPTER 52 DOORS

- A. This chapter contains information about the passenger/crew entry doors (both sides), escape hatches, cargo doors (forward and aft including optional forward large cargo door and bulk cargo door), service doors (elec/elex access door, ram air turbine access door, potable water access door, controls bay access door, service access door, waste disposal access door, forward access door and auxiliary power unit access door) and landing gear doors.
- B. All major structural components are located and identified through the use of detailed illustrations with corresponding tabulated material lists.
- C. Allowable damage to doors is defined in this chapter.
- D. Approved repairs are described and illustrated in this chapter.

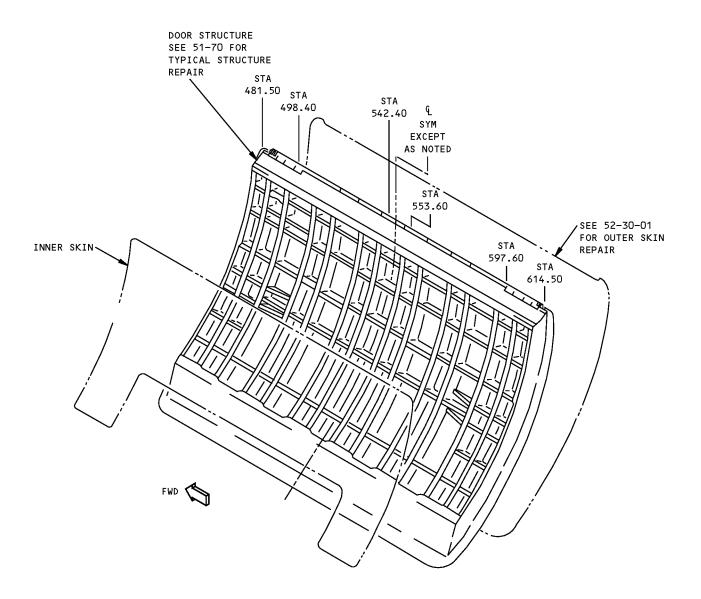
Large Cargo Door Structure Repair Figure 201

REF DWG 143T6309

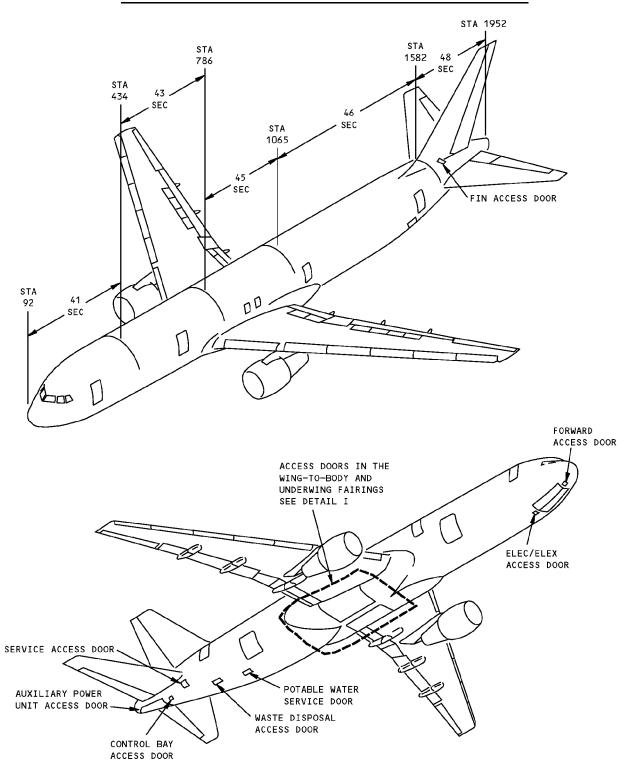
Service Door Location Diagram Figure 1 (Sheet 1 of 2)

IDENTIFICATION GENERAL - SERVICE DOOR LOCATION DIAGRAM

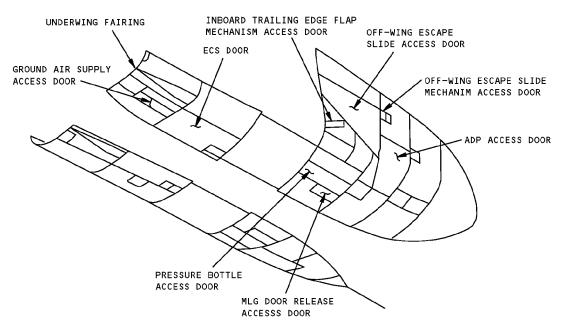
LEFT SIDE
SECTION 46 WING-TO-BODY FAIRING AND UNDERWING FAIRING

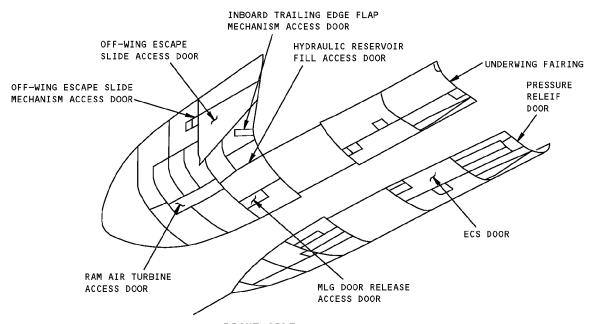
RIGHT SIDE
SECTION 46 WING-TO-BODY FAIRING AND UNDERWING FAIRING

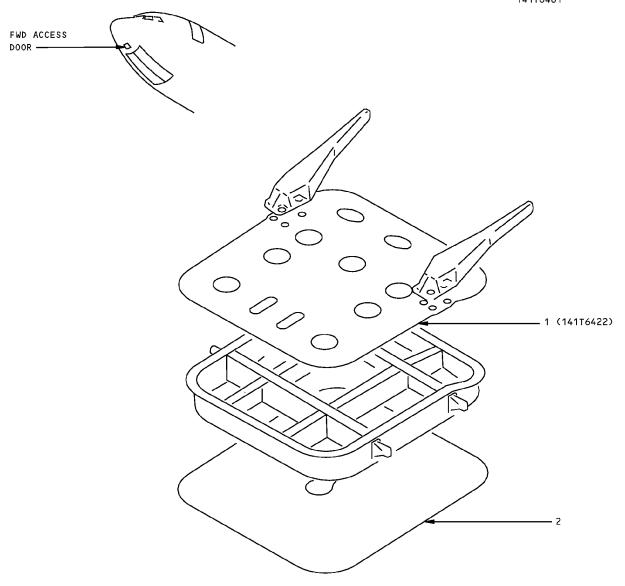
IDENTIFICATION 1 - FORWARD ACCESS DOOR SKIN

ITEM	DESCRIPTION	GAGE	MATERIAL	EFFECTIVITY
1	INNER SKIN	0.032	CLAD 2024-T42	
2	OUTER SKIN	0.050	CLAD 2024-T3

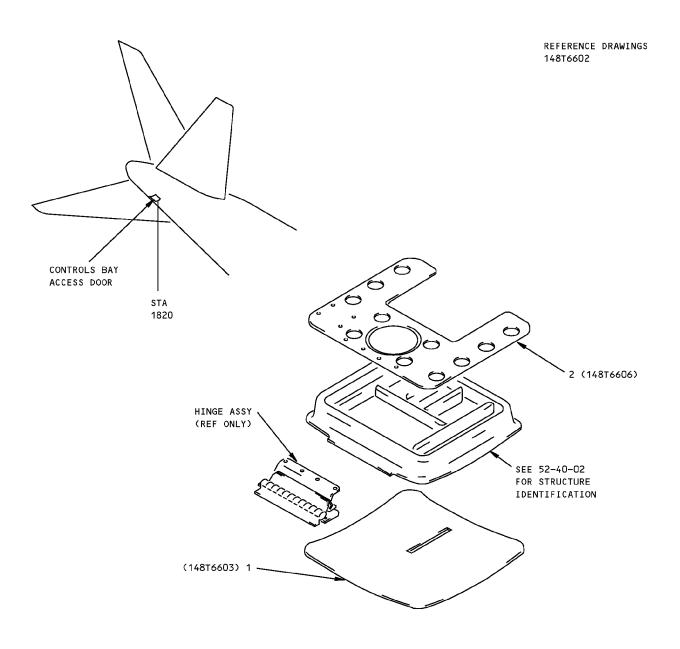
IDENTIFICATION 2 - CONTROLS BAY ACCESS DOOR SKIN

ITEM	DESCRIPTION	GAGE	MATERIAL	EFFECTIVITY
1	OUTER SKIN	0.056	CLAD 7075-T6	
2	INNER SKIN	0.025	CLAD 7075-T6

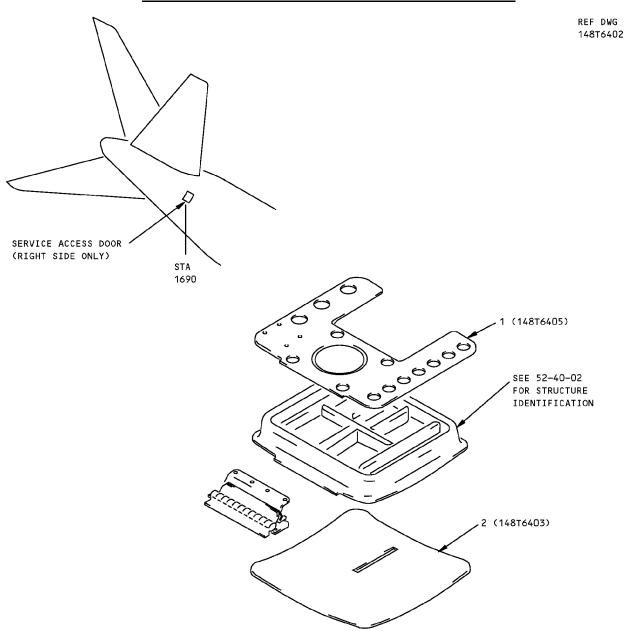
IDENTIFICATION 3 - SERVICE ACCESS DOOR SKIN- STA 1690

ITEM	DESCRIPTION	GAGE	MATERIAL	EFFECTIVITY
1	INNER SKIN	0.025	CLAD 7075-T6	
2	OUTER SKIN	0.063	CLAD 7075-T6

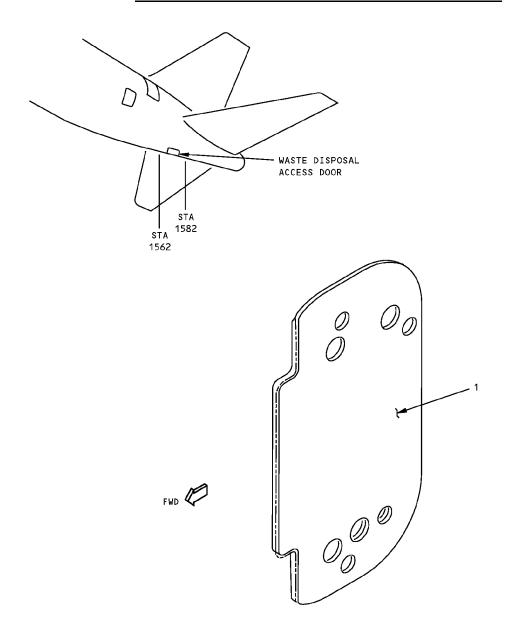
IDENTIFICATION 4 - WASTE DISPOSAL ACCESS DOOR SKIN

ITEM	DESCRIPTION	GAGE	MATERIAL	EFFECTIVITY
1	DOOR	0.140	CLAD 2024-T3 (CHEM-MILLED TO 0.063 MIN)

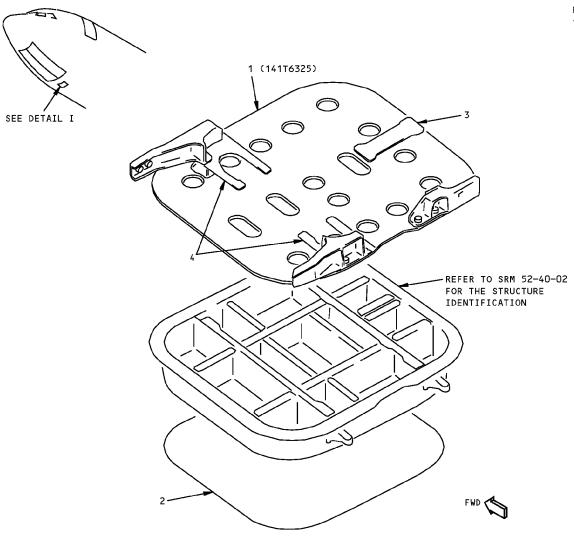
IDENTIFICATION 5 - ELEC/ELEX ACCESS DOOR SKIN

ITEM	DESCRIPTION	GAGE	MATERIAL	EFFECTIVITY
1	INNER SKIN	0.032	CLAD 2024-T3	
2	OUTER SKIN	0.050	CLAD 2024-T3	
3	SPACER	0.080	CLAD 2024-T3	
4	SPACER	0.050	CLAD 2024-T3

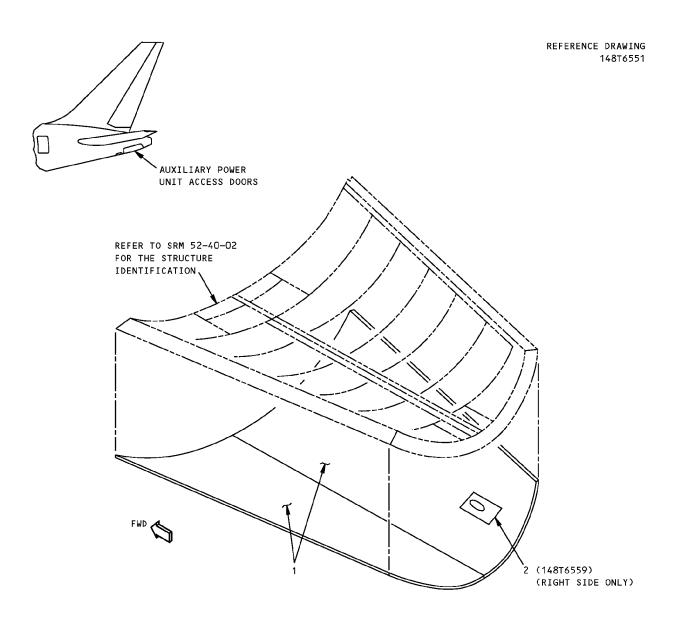
IDENTIFICATION 6 - AUXILIARY POWER UNIT ACCESS DOOR SKIN

ITEM	DESCRIPTION	GAGE	MATERIAL	EFFECTIVITY
1	BONDED SKIN PANEL ASSEMBLY	0.016 (EACH PLY)	TWO-PLY CLAD 2024-T3 LAMINATION AS GIVEN IN BMS 5-69, TYPE I, CLASS 3, GRADE B	
2	DOUBLER	0.040	CLAD 7075-T62

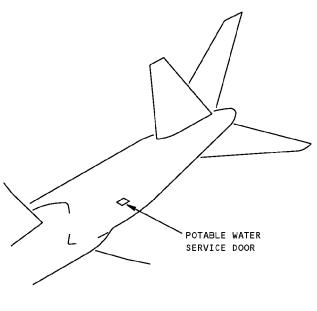
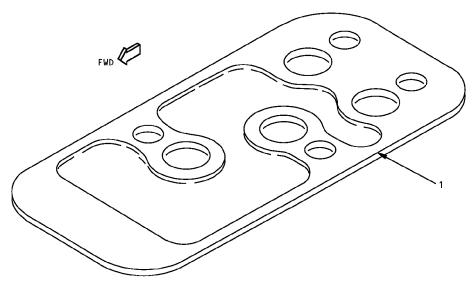
IDENTIFICATION 7 - POTABLE WATER SERVICE DOOR SKIN

ITEM	DESCRIPTION	GAGE	MATERIAL	EFFECTIVITY
1	DOOR	0.140	CLAD 2024-T3 (CHEM-MILLED OR MACHINE MILLED TO 0.063 MIN)

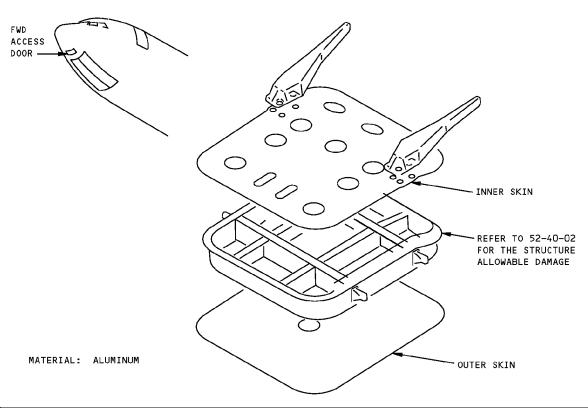
Forward Access Door Allowable Damage Figure 101 (Sheet 1 of 3)

ALLOWABLE DAMAGE 1 - FORWARD ACCESS DOOR

ITEM	CRACKS	NICKS, GOUGES AND CORROSION	DENTS	HOLES AND PUNCTURES
OUTER SKIN A	В	D	SEE DETAIL IV	E
INNER SKIN	C	G	SEE DETAIL IV	F

- REFINISH REWORK AREAS PER AMM 51-20.
- Α REFER TO SRM 51-10-01 FOR THE AERODYNAMIC SMOOTHNESS REQUIREMENTS. WHERE THE DAMAGE EXCEEDS THE LIMITS SHOWN IN SRM 51-10-01, CONSIDERATION SHOULD BE GIVEN TO THE LOSS OF PERFORMANCE INVOLVED
- B | CRACKS NOT ALLOWED EXCEPT FOR EDGE CRACKS WHICH MUST BE REMOVED PER DETAILS I AND III
- CRACKS WITHIN THE LIMITS SHOWN IN DETAIL VI ARE ALLOWED. REMOVE EDGE CRACKS PER DETAILS I AND III AND FLANGED HOLE EDGE CRACKS PER DETAIL VII
- D REMOVE DAMAGE PER DETAILS I, II, III AND V

- E | CLEAN OUT DAMAGE UP TO 0.25 MAXIMUM DIAMETER AND NOT CLOSER THAN 1.0 INCH TO FASTENER HOLE, MATERIAL EDGE, OR OTHER DAMAGE. FILL HOLE WITH 2117-T3 OR T4 ALUMINUM RIVET INSTALLED WET WITH BMS 5-95 SEALANT. ALL OTHER HOLES TO BE REPAIRED
- | F | CLEAN OUT DAMAGE UP TO 0.25 MAXIMUM DIAMETER AND NOT CLOSER THAN 1.0 INCH TO FASTENER HOLE, MATERIAL EDGE, OR OTHER DAMAGE
- REMOVE DAMAGE PER DETAILS I, II, III, AND V. CORROSION MAY BE DRILLED OUT UP TO 0.5 MAXIMUM DIAMETER PROVIDED FASTENER EDGE MARGINS ARE MAINTAINED
- Н 1.50 MINIMUM TO EDGE OF EXISTING FASTENER HOLE, TO EDGE OF FLANGED HOLE, OR TO EDGE OF CUTOUT

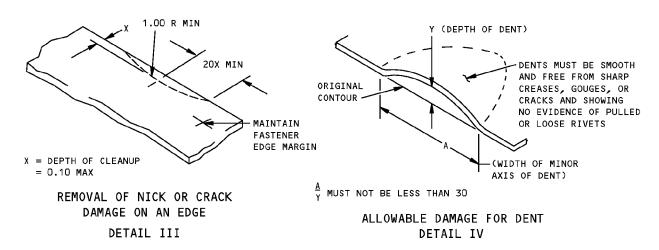
Forward Access Door Allowable Damage Figure 101 (Sheet 2 of 3)

REMOVAL OF NICK, GOUGE AND SCRATCH DAMAGE ON A SURFACE DETAIL II

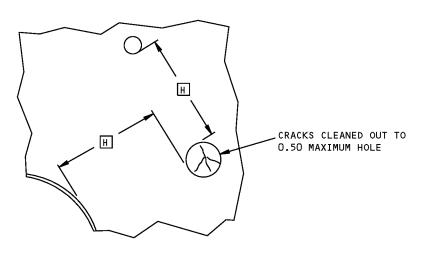
Forward Access Door Allowable Damage Figure 101 (Sheet 3 of 3)

SMOOTH BLEND-OUT RADIUS 0.50 INCH MINIMUM. CORROSION CLEAN UP AROUND ANY THREE FASTENERS IN TEN IS PERMITTED TO MAX DEPTH

CORROSION CLEANUP DETAIL V

SURFACE CRACKS
DETAIL VI

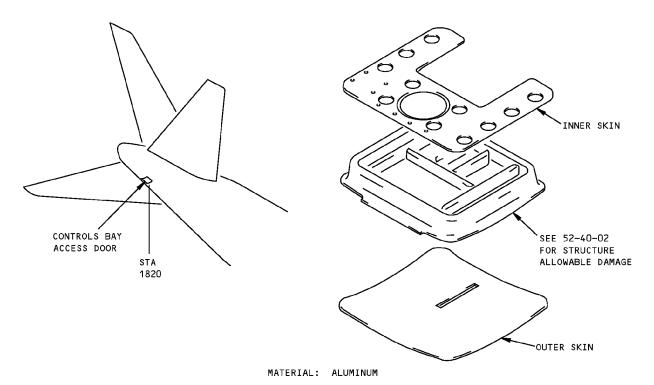
Controls Bay Access Door Allowable Damage Figure 101 (Sheet 1 of 3)

ALLOWABLE DAMAGE 2 - CONTROLS BAY ACCESS DOOR

DESCRIPTION	CRACKS	NICKS, GOUGES	DENTS	HOLES AND
7 2001121 1 2011		AND CORROSION		PUNCTURES
OUTER SKIN A	В	D	SEE DETAIL III	D
INNER SKIN	С	G	SEE DETAIL III	F

- REFINISH REWORKED AREAS PER 51-20 OF THE MAINTENANCE MANUAL
- A REFER TO 51-10-01 FOR AERODYNAMIC SMOOTH-NESS REQUIREMENTS. WHERE THE DAMAGE EXCEEDS THE LIMITS SHOWN IN 51-10-01, CONSIDERATION SHOULD BE GIVEN TO THE LOSS OF PERFORMANCE INVOLVED
- B CRACKS NOT ALLOWED EXCEPT FOR EDGE CRACKS
 WHICH MUST BE REMOVED PER DETAILS I AND III
- C 1.00 MAX LENGTH SURFACE CRACKS ALLOWED,
 PROVIDED CRACKS ARE WITHIN LIMITS SHOWN IN
 DETAIL VI. REMOVE EDGE CRACKS PER DETAILS
 I AND V AND FLANGED HOLE EDGE CRACKS PER
 DETAIL VII
- D REMOVE DAMAGE PER DETAILS I, II, IV AND V

- E CLEAN OUT DAMAGE UP TO 0.25 MAX DIA AND NOT CLOSER THAN 1.0 INCH TO FASTENER HOLE, MATERIAL EDGE, OR OTHER DAMAGE. FILL HOLE WITH 2117-T3 OR T4 ALUMINUM RIVET INSTALLED WET WITH BMS 5-95 SEALANT. ALL OTHER HOLES TO BE REPAIRED
- F CLEAN OUT DAMAGE UP TO 0.25 MAX DIA AND NOT CLOSER THAN 1.0 INCH TO FASTENER HOLE, MATERIAL EDGE, OR OTHER DAMAGE
- G REMOVE DAMAGE PER DETAILS I, II, IV, AND V.
 CORROSION MAY BE DRILLED OUT UP TO 0.5 MAX
 DIA PROVIDED FASTENER EDGE MARGINS ARE
 MAINTAINED
- H 1.50 MIN TO EDGE OF EXISTING FASTENER HOLE, TO EDGE OF FLANGED HOLE, OR TO EDGE OF CUTOUT

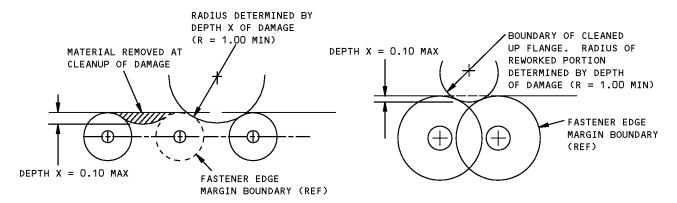
DAMAGE CLEANUP OF EDGES WHERE FASTENER EDGE MARGINS DO NOT OVERLAP

DAMAGE CLEANUP OF EDGES WHERE FASTENER EDGE MARGINS OVERLAP

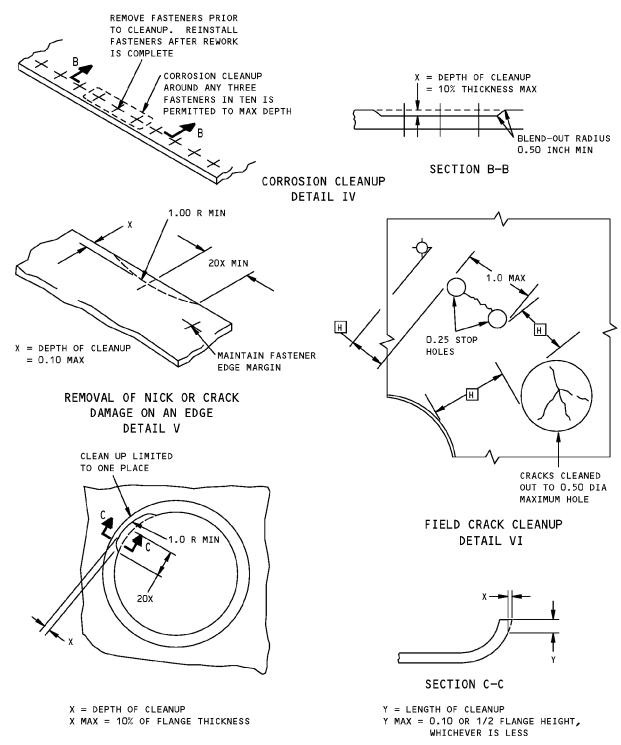
Controls Bay Access Door Allowable Damage Figure 101 (Sheet 3 of 3)

FLANGED HOLE EDGE DAMAGE CLEANUP
DETAIL VII

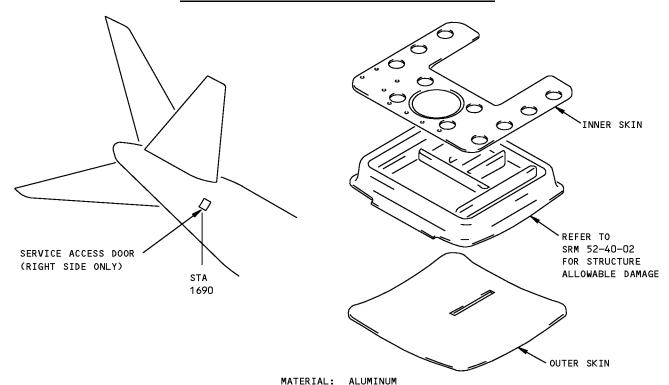
Service Access Door Allowable Damage Figure 101 (Sheet 1 of 3)

ALLOWABLE DAMAGE 3 - SERVICE ACCESS DOOR

DESCRIPTION	CRACKS	NICKS, GOUGES AND CORROSION	DENTS	HOLES AND PUNCTURES
OUTER SKIN A	В	D	SEE DETAIL III	D
INNER SKIN	С	G	SEE DETAIL III	F

- REFINISH REWORKED AREAS AS SHOWN IN AMM 51-20
- A REFER TO SRM 51-10-01 FOR AERODYNAMIC SMOOTH-NESS REQUIREMENTS. WHERE THE DAMAGE IS MORE THAN THE LIMITS SHOWN IN SRM 51-10-01, CONSIDERATION SHOULD BE GIVEN TO THE LOSS OF PERFORMANCE INVOLVED
- B CRACKS NOT ARE NOT PERMITTED EXCEPT FOR EDGE CRACKS WHICH MUST BE REMOVED AS SHOWN IN DETAILS I AND V
- C 1.00 INCH MAXIMUM LENGTH SURFACE CRACKS
 PERMITTED, PROVIDED CRACKS ARE WITHIN LIMITS
 SHOWN IN DETAIL VI. REMOVE EDGE CRACKS AS
 SHOWN IN DETAILS I AND V AND FLANGED HOLE
 EDGE CRACKS AS SHOWN IN DETAIL VII
- D REMOVE DAMAGE AS SHOWN IN DETAILS I, II, IV AND V

- E CLEAN OUT DAMAGE UP TO 0.25 INCH MAXIMUM DIAMETER AND NOT CLOSER THAN 1.0 INCH TO FASTENER HOLE, MATERIAL EDGE, OR OTHER DAMAGE. FILL HOLE WITH 2117-T3 OR T4 ALUMINUM RIVET INSTALLED WET WITH BMS 5-95 SEALANT. ALL OTHER HOLES TO BE REPAIRED
- F CLEAN OUT DAMAGE UP TO 0.25 INCH MAXIMUM DIAMETER AND NOT CLOSER THAN 1.0 INCH TO FASTENER HOLE, MATERIAL EDGE, OR OTHER DAMAGE
- G REMOVE DAMAGE AS SHOWN IN DETAILS I, II,
 IV, AND V. CORROSION MAY BE DRILLED OUT UP
 TO 0.5 INCH MAXIMUM DIAMETER PROVIDED
 FASTENER EDGE MARGINS ARE MAINTAINED
- H 1.50 INCH MINIMUM TO EDGE OF THE INITIAL FASTENER HOLE, TO EDGE OF FLANGED HOLE, OR TO EDGE OF CUTOUT

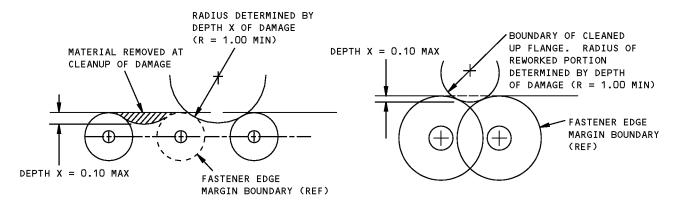
DAMAGE CLEANUP OF EDGES WHERE FASTENER EDGE MARGINS DO NOT OVERLAP

DAMAGE CLEANUP OF EDGES WHERE FASTENER EDGE MARGINS OVERLAP

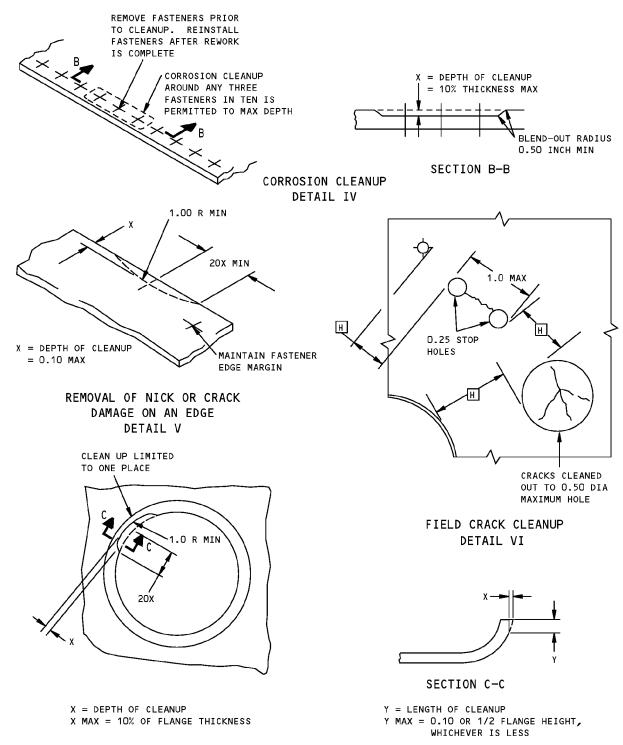
Service Access Door Allowable Damage Figure 101 (Sheet 3 of 3)

FLANGED HOLE EDGE DAMAGE CLEANUP
DETAIL VII

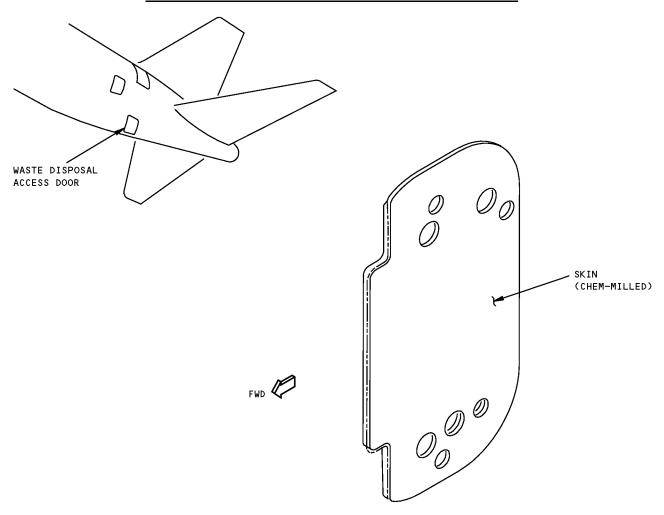
Waste Disposal Access Door Allowable Damage Figure 101 (Sheet 1 of 2)

ALLOWABLE DAMAGE 4 - WASTE DISPOSAL ACCESS DOOR

DESCRIPTION	CRACKS	NICKS, GOUGES AND CORROSION	DENTS	HOLES AND PUNCTURES
SKIN (CHEM-MILLED) A	В	С	SEE DETAIL III	D

- MATERIAL: ALUMINUM
- REFINISH REWORKED AREAS PER 51-20 OF THE MAINTENANCE MANUAL
- A REFER TO 51-10-01 FOR AERODYNAMIC SMOOTH-NESS REQUIREMENTS. WHERE THE DAMAGE EXCEEDS THE LIMITS SHOWN IN 51-10-01, CONSIDERATION SHOULD BE GIVEN TO THE LOSS OF PERFORMANCE INVOLVED
- B CRACKS NOT ALLOWED EXCEPT FOR EDGE CRACKS
 WHICH MUST BE REMOVED PER DETAILS I AND V
- REMOVE DAMAGE PER DETAILS I, II, IV AND V
- D CLEAN OUT DAMAGE UP TO 0.25 MAX DIA AND NOT CLOSER THAN 1.0 INCH TO FASTENER HOLE, MATERIAL EDGE, OR OTHER DAMAGE. FILL HOLE WITH 2117-T3 OR T4 ALUMINUM RIVET INSTALLED WET WITH BMS 5-95 SEALANT. ALL OTHER HOLES TO BE REPAIRED

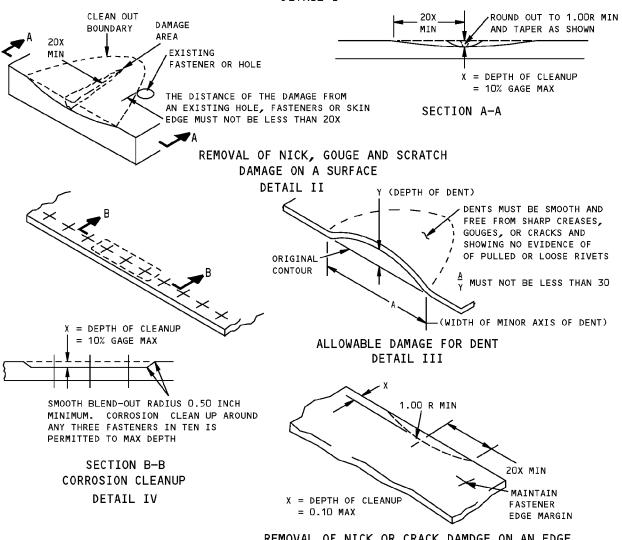
Waste Disposal Access Door Allowable Damage Figure 101 (Sheet 2 of 2)

REMOVAL OF NICK OR CRACK DAMDGE ON AN EDGE
DETAIL V

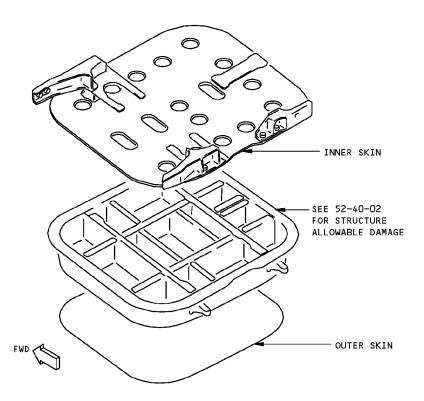
Elec/Elex Access Door Allowable Damage Figure 101 (Sheet 1 of 3)

ALLOWABLE DAMAGE 5 - ELEC/ELEX ACCESS DOOR

ITEM	CRACKS	NICKS, GOUGES AND CORROSION	DENTS	HOLES AND PUNCTURES
OUTER SKIN A	В	D	SEE DETAIL IV	E
INNER SKIN	С	G	SEE DETAIL IV	F

- REFINISH REWORK AREAS PER 51-20 OF THE MAINTENANCE MANUAL
- REFER TO 51-10-01 FOR AERODYNAMIC SMOOTH-NESS REQUIREMENTS. WHERE THE DAMAGE EXCEEDS THE LIMITS SHOWN IN 51-10-01, CONSIDERATION SHOULD BE GIVEN TO THE LOSS OF PERFORMANCE INVOLVED
- CRACKS NOT ALLOWED EXCEPT FOR EDGE CRACKS WHICH MUST BE REMOVED PER DETAILS I AND III
- C THE CRACKS WITHIN LIMITS SHOWN IN DETAIL VI ARE ALLOWED. REMOVE EDGE CRACKS PER DETAILS I AND III AND FLANGED HOLE EDGE CRACKS PER DETAIL VII
- D REMOVE DAMAGE PER DETAILS I, II, III AND V

- E | CLEAN OUT DAMAGE UP TO 0.25 MAX DIA AND NOT CLOSER THAN 1.0 INCH TO FASTENER HOLE, MATERIAL EDGE, OR OTHER DAMAGE. FILL HOLE WITH 2117-T3 OR T4 ALUMINUM RIVET INSTALLED WET WITH BMS 5-95 SEALANT. ALL OTHER HOLES TO BE REPAIRED
- F | CLEAN OUT DAMAGE UP TO 0.25 MAX DIA AND NOT CLOSER THAN 1.0 INCH TO FASTENER HOLE, MATERIAL EDGE, OR OTHER DAMAGE
- G REMOVE DAMAGE PER DETAILS I, II, III, AND V. CORROSION MAY BE DRILLED OUT UP TO 0.5 MAX DIA PROVIDED FASTENER EDGE MARGINS ARE MAINTAINED
- 1.50 MIN TO EDGE OF EXISTING FASTENER HOLE, TO EDGE OF FLANGED HOLE, OR TO EDGE OF CUTOUT

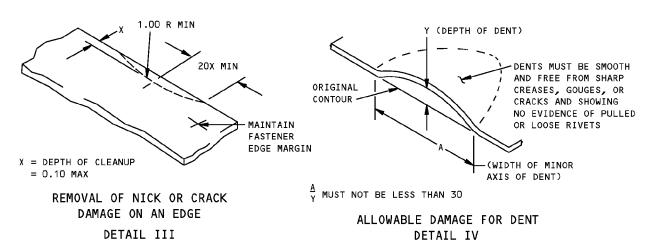
Elec/Elex Access Door Allowable Damage Figure 101 (Sheet 2 of 3)

REMOVAL OF NICK, GOUGE AND SCRATCH DAMAGE ON A SURFACE DETAIL II

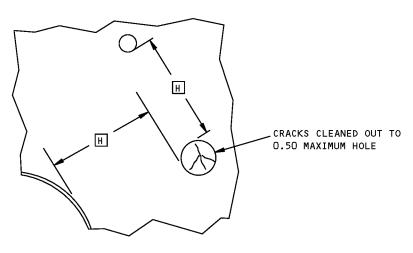
Elec/Elex Access Door Allowable Damage Figure 101 (Sheet 3 of 3)

SMOOTH BLEND-OUT RADIUS 0.50 INCH MINIMUM. CORROSION CLEAN UP AROUND ANY THREE FASTENERS IN TEN IS PERMITTED TO MAXIMUM DEPTH

CORROSION CLEANUP DETAIL V

SURFACE CRACKS
DETAIL VI

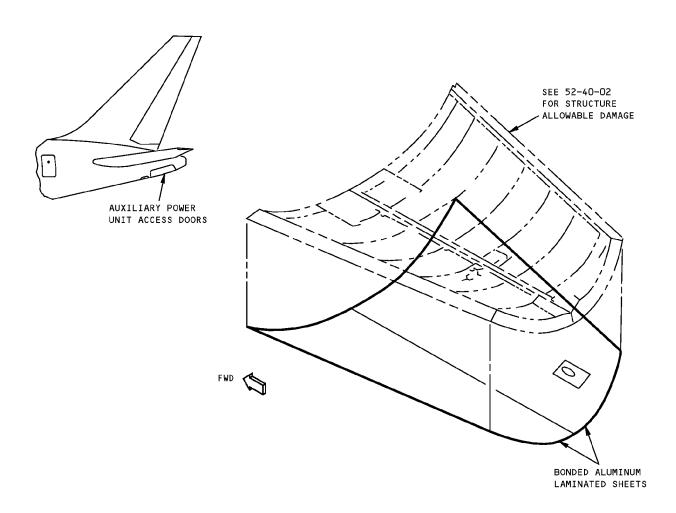
Auxiliary Power Unit Access Door Allowable Damage Figure 101 (Sheet 1 of 3)

ALLOWABLE DAMAGE 6 - AUXILIARY POWER UNIT ACCESS DOOR

DESCRIPTION	CRACKS	NICKS, GOUGES AND CORROSION	DENTS	HOLES AND PUNCTURES	DELAMINATION
BONDED ALUMINUM LAMINATED SHEETS	В	С	SEE DETAIL IV	D	E

- REFINISH REWORKED AREAS PER 51-20 OF THE MAINTENANCE MANUAL
- A REFER TO 51-10-01 FOR AERODYNAMIC SMOOTH-NESS REQUIREMENTS. WHERE THE DAMAGE EXCEEDS THE LIMITS SHOWN IN 51-10-01, CONSIDERATION SHOULD BE GIVEN TO THE LOSS OF PERFORMANCE INVOLVED
- B CRACKS NOT ALLOWED EXCEPT FOR EDGE CRACKS
 WHICH MUST BE REMOVED PER DETAILS I AND III
- C REMOVE DAMAGE PER DETAILS I, II, III AND V
- D CLEAN OUT DAMAGE UP TO 0.25 MAX DIA AND NOT CLOSER THAN 1.0 INCH TO FASTENER HOLE, MATERIAL EDGE, OR OTHER DAMAGE. FILL HOLE WITH 2117-T3 OR T4 ALUMINUM RIVET INSTALLED WET WITH BMS 5-95 SEALANT. ALL OTHER HOLES TO BE REPAIRED
- E 2.0 DIA DELAMINATION ALLOWED PROVIDED NOT NEAR AN EDGE. ANY DELAMINATION ON PANEL EDGE MUST BE CLEANED AND RESEALED PER 51-20-05

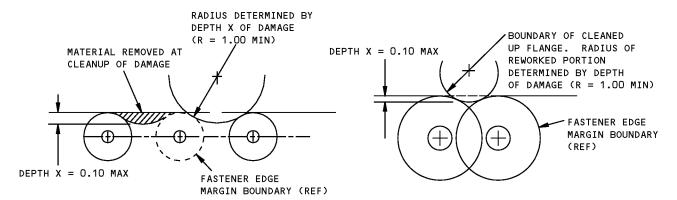
DAMAGE CLEANUP OF EDGES WHERE FASTENER EDGE MARGINS DO NOT OVERLAP

DAMAGE CLEANUP OF EDGES WHERE FASTENER EDGE MARGINS OVERLAP

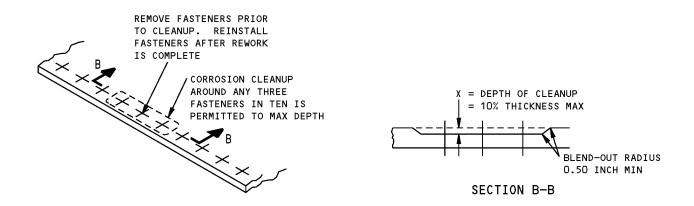
Auxiliary Power Unit Access Door Allowable Damage Figure 101 (Sheet 3 of 3)

ALLOWABLE DAMAGE FOR DENT DETAIL IV

CORROSION CLEANUP
DETAIL V

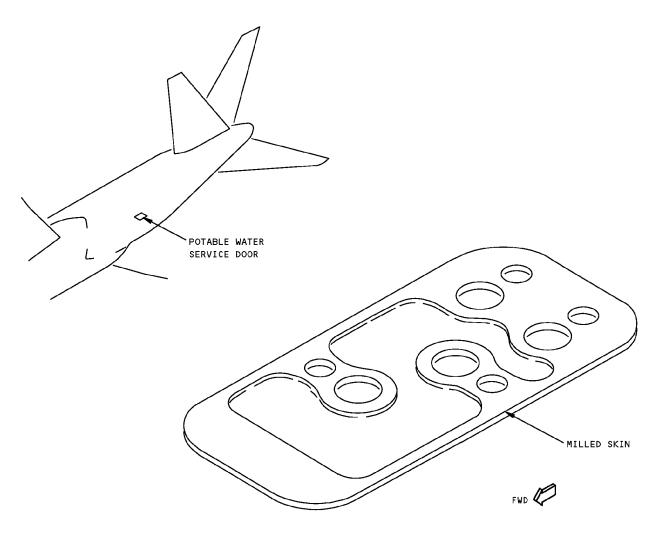
Potable Water Service Door Allowable Damage Figure 101 (Sheet 1 of 2)

ALLOWABLE DAMAGE 7 - POTABLE WATER SERVICE DOOR

DESCRIPTION	CRACKS	NICKS, GOUGES AND CORROSION	DENTS	HOLES AND PUNCTURES
MILLED SKIN A	В	С	SEE DETAIL III	D

- MATERIAL: ALUMINUM
- REFINISH REWORKED AREAS PER 51-20 OF THE MAINTENANCE MANUAL
- A REFER TO 51-10-01 FOR AERODYNAMIC SMOOTH-NESS REQUIREMENTS. WHERE THE DAMAGE EXCEEDS THE LIMITS SHOWN IN 51-10-01, CONSIDERATION SHOULD BE GIVEN TO THE LOSS OF PERFORMANCE INVOLVED
- B CRACKS NOT ALLOWED EXCEPT FOR EDGE CRACKS WHICH MUST BE REMOVED PER DETAILS I AND V
- C REMOVE DAMAGE PER DETAILS I, II, IV AND V
- D CLEAN OUT DAMAGE UP TO 0.25 MAX DIA AND NOT CLOSER THAN 1.0 INCH TO FASTENER HOLE, MATERIAL EDGE, OR OTHER DAMAGE. FILL HOLE WITH 2117-T3 OR T4 ALUMINUM RIVET INSTALLED WET WITH BMS 5-95 SEALANT. ALL OTHER HOLES TO BE REPAIRED

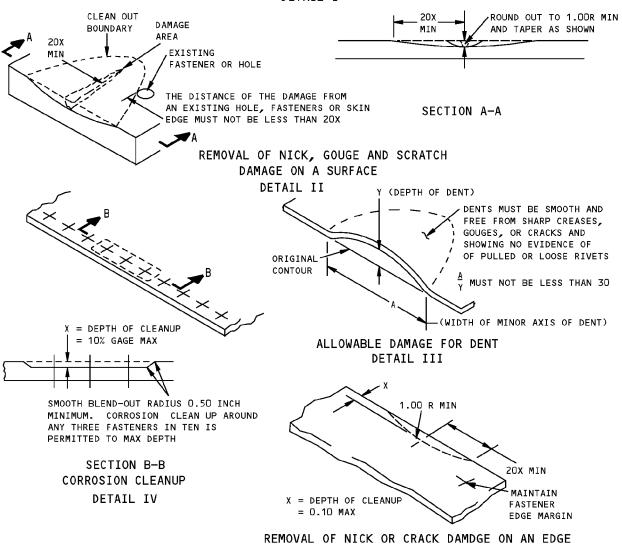
Potable Water Service Door Allowable Damage Figure 101 (Sheet 2 of 2)

DETAIL V

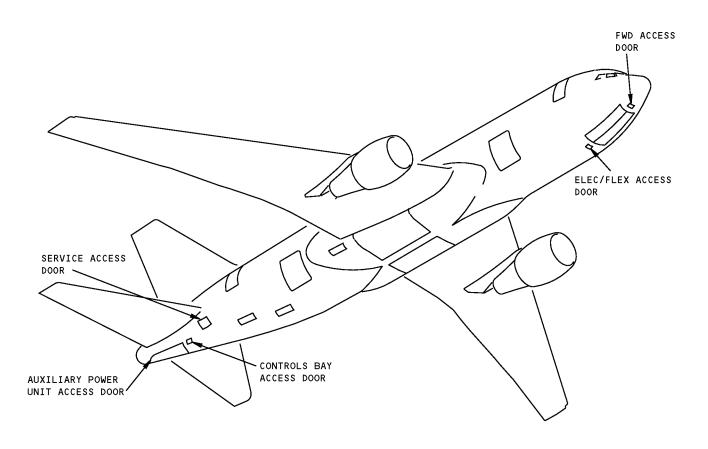
Typical Skin Repairs for Access Doors with Aluminum Outer Skins Figure 201

REPAIR GENERAL - TYPICAL SKIN REPAIRS FOR ACCESS DOORS WITH ALUMINUM OUTER SKINS

- REPAIR 1 FOR FLUSH SKIN REPAIR BETWEEN BEAMS
- REPAIR 2 FOR FLUSH SKIN REPAIR AT BEAM
- REPAIR 3 FOR SMALL HOLE-FLUSH REPAIR
- REPAIR 4 FOR SMALL HOLE-EXTERNAL REPAIR
- REPAIR 5 FOR EXTERNAL REPAIR.

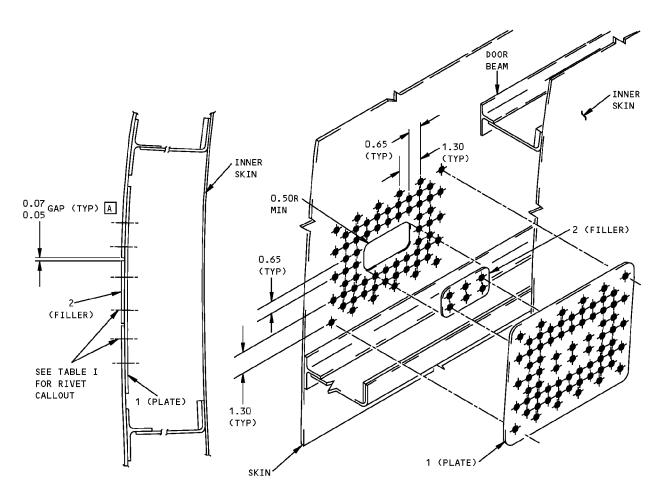
REPAIR 1 - FLUSH SKIN REPAIR BETWEEN BEAMS

- Remove the inner skin panel for access if required.
- Clean out the damage to the skin to a rectangular shape with a minimum of 0.50 radius at the corners. The cutout should be parallel to the centerline of the adjacent beam.

- 3. Make repair parts 1 and 2.
- Assemble repair parts in installed positions and drill fastener holes.
- 5. Remove repair parts.
- Break sharp edges of original and repair parts 0.015 to 0.030.

- Remove all nicks, scratches, burrs, sharp edges and corners from original and repair parts.
- 8. Alodize all raw edges of existing and repair parts per 51-20-01.

- 10. Install repair parts, making a faying surface seal with BMS 5-95 sealant as described in 51-20-05.
- 11. Form a fillet seal around the edge of the repair parts, using the sealant squeezed out during installation. Apply additional sealant where necessary.

SECTION THROUGH REPAIR

REPAIR MATERIAL				
P	ART	QTY	MATERIAL		
1	PLATE	1	SAME MATERIAL ONE GAGE HEAVIER THAN ORIGINAL SKIN		
2	FILLER	1	SAME MATERIAL AND GAGE AS ORIGINAL SKIN

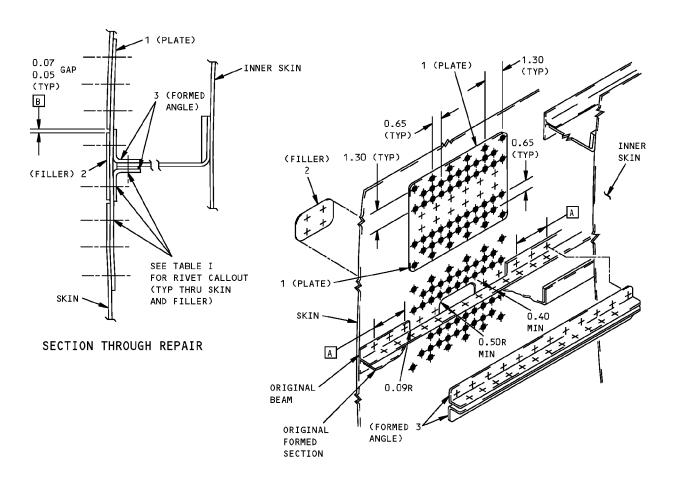
REPAIR MATERIAL				
PART		QTY	MATERIAL		
1	DOUBLER	1	SAME MATERIAL, ONE GAGE HEAVIER THAN ORIGINAL SKIN		
2	FILLER	1	SAME MATERIAL AND GAGE AS ORIGINAL SKIN		
3	FORMED ANGLE	2	SAME MATERIAL, ONE GAGE HEAVIER THAN SKIN SIDE LEG OF ORIGINAL SECTION

RIVET CALLOUT				
ACCESS DOOR	RIVET THRU SKIN	RIVET THRU 3 ANGLE		
FORWARD ACCESS	BACR15CE5KE C	BACR15FT5KE()C		
CONTROLS BAY ACCESS	BACR15FT5AD	BACR15FT5AD		
SERVICE ACCESS	BACR15BA5AD	BACR15FT5AD		
ELEC/ELEX ACCESS	BACR15CE5KE C	BACR15FT5KE		
APU ACCESS	BACR15FT5AD	BACR15FT5AD

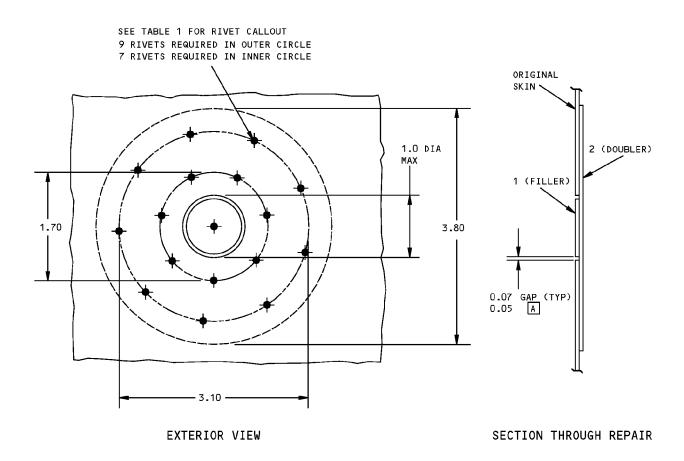
Small Hole - Flush Repair Figure 201 (Sheet 1 of 2)

+ REPAIR FASTENER LOCATIONS

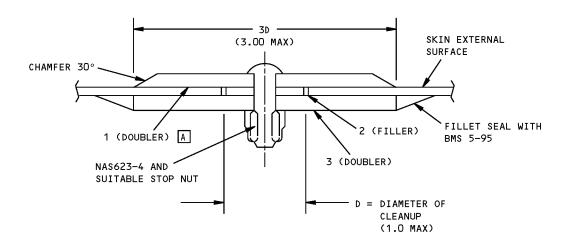
Small Hole - External Repair Figure 201 (Sheet 1 of 2)

OPTIONAL METHOD

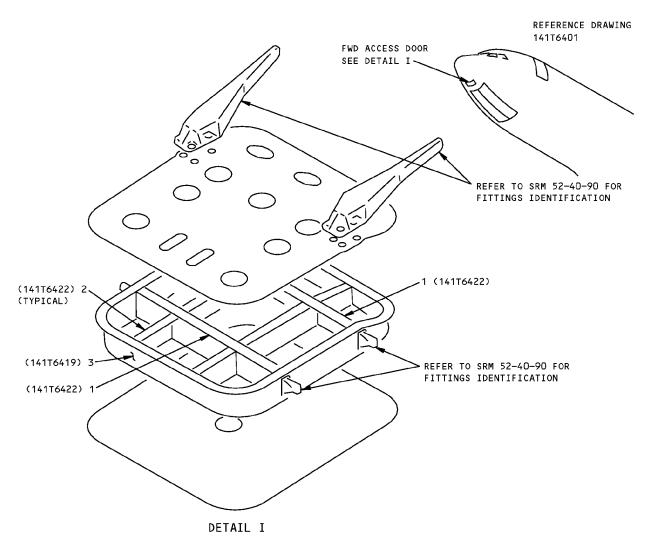
IDENTIFICATION 1 - FORWARD ACCESS DOOR STRUCTURE

ITEM	DESCRIPTION	GAGE	MATERIAL	EFFECTIVITY
1	BEAM WEB CHORD	0.063	CLAD 2024-T42 BAC1505-100261 2024-T42	
2	INTERCOSTAL WEB, FORWARD AND AFT WEB, CENTER CHORD	0.040 0.040	CLAD 2024-T42 CLAD 2024-T3 BAC1506-2195 2024-T42	
3	FRAME	0.050	CLAD 2024-T42

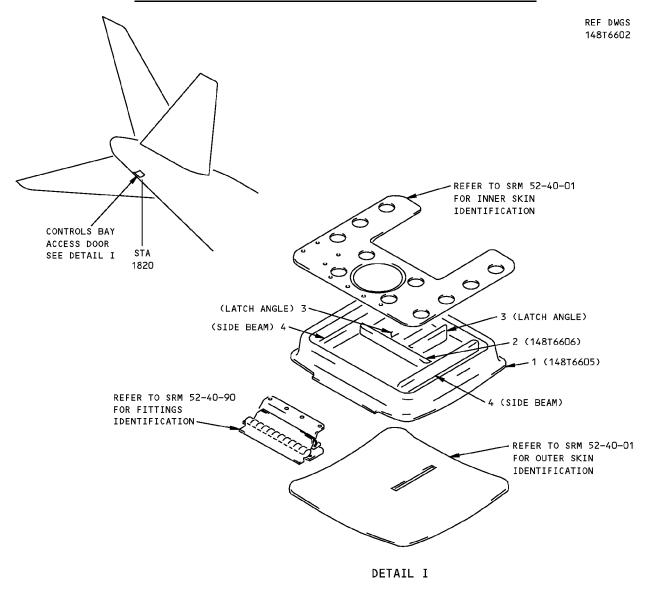
IDENTIFICATION 2 - CONTROLS BAY ACCESS DOOR STRUCTURE

ITEM	DESCRIPTION	GAGE	MATERIAL	EFFECTIVITY
1	FRAME	0.050	CLAD 2024-T42	
2	CENTER BEAM	0.050	CLAD 7075-T62	
3	LATCH ANGLE	0.063	CLAD 7075-T62	
4	SIDE BEAM	0.040	CLAD 7075-T62

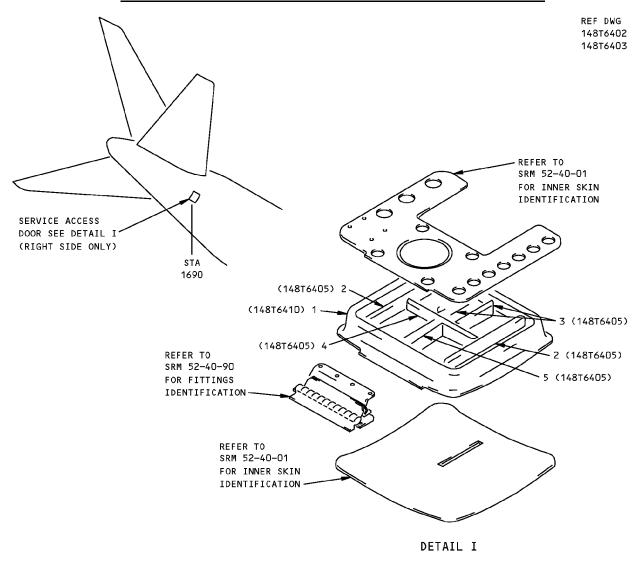
IDENTIFICATION 3 - SERVICE ACCESS DOOR STRUCTURE - STA 1690

ITEM	DESCRIPTION	GAGE	MATERIAL	EFFECTIVITY
1	FRAME	0.050	CLAD 2024-T42	
2	SIDE BEAM	0.040	CLAD 7075-T62	
3	LATCH ANGLE	0.063	CLAD 7075-T62	
4	CENTER BEAM	0.050	CLAD 7075-T62	
5	STIFFENER	0.040	CLAD 7075-T62

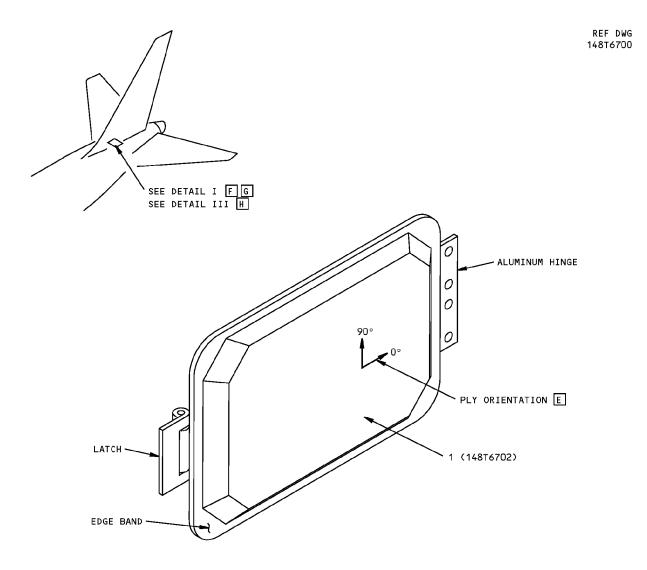
IDENTIFICATION 4 - FIN ACCESS DOOR

ITEM	DESCRIPTION	GAGE	MATERIAL	EFFECTIVITY
1	DOOR PANEL SKIN CORE		FIBERGLASS/EPOXY HONEYCOMB SANDWICH SEE DETAIL II NONMETALLIC HONEYCOMB PER BMS 8-124 CLASS IV, TYPE I, GRADE 4.0

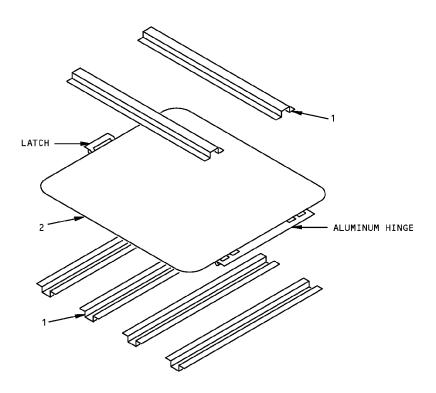
REF DWG 148T6702

DETAIL III H

I.	TEM	DESCRIPTION	GAGE	MATERIAL	EFFECTIVITY
	1	STIFFENER		BAC1500-6056 7075-T62	
	2	WEB	0.080	CLAD 7075-T6

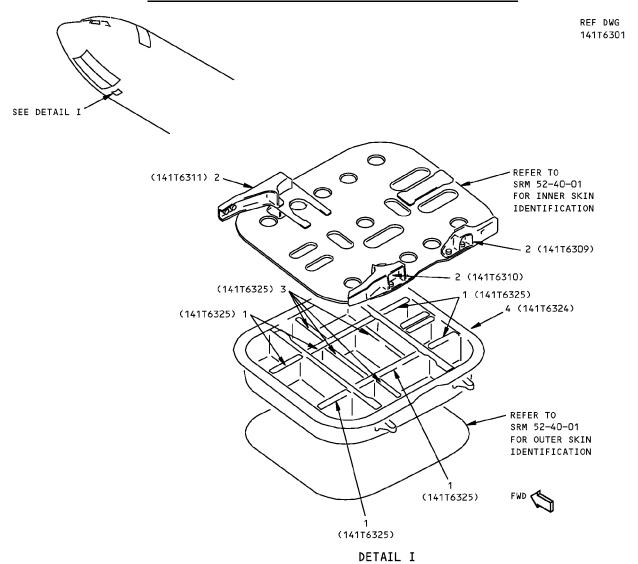
IDENTIFICATION 5 - ELEC/ELEX ACCESS DOOR STRUCTURE

ITEM	DESCRIPTION	GAGE	MATERIAL	EFFECTIVITY
1	WEB	0.040	CLAD 2024-T42	
2	ROLLER SUPPORT		FORGING 7075-T73	
3	WEB	0.063	CLAD 2024-T42	
4	FRAME	0.050	CLAD 2024-T42

LIST OF MATERIALS FOR DETAIL I

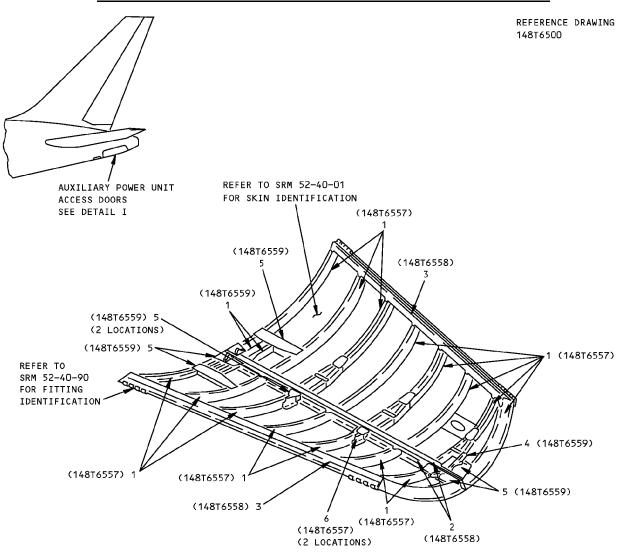
IDENTIFICATION 6 - AUXILIARY POWER UNIT ACCESS DOOR STRUCTURE

DETAIL I

ITEM	DESCRIPTION	GAGE	MATERIAL	EFFECTIVITY
1	FRAME	0.050	CLAD 7075-T62	
2	CHANNEL	0.063	clad 7075-T62	
3	HINGE MEMBER	0.063	CLAD 7075-T62	
4	PIVOT MEMBER	0.071	CLAD 7075-T62	
5	GUSSET	0.050	clad 7075-T62	
6	STIFFENER	0.050	CLAD 7075-T62

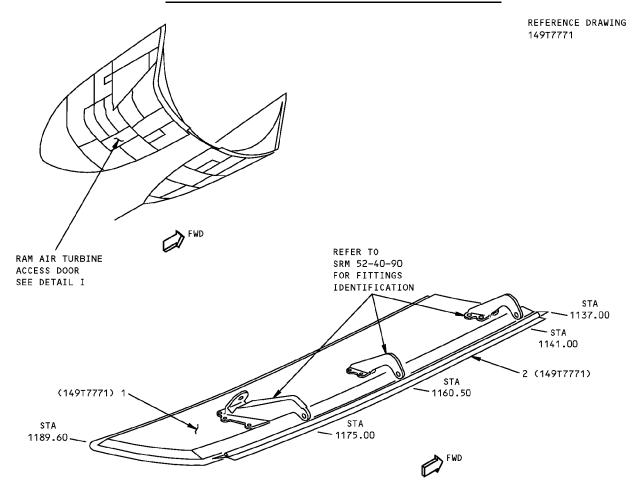
IDENTIFICATION 7 - RAM AIR TURBINE ACCESS DOOR

DETAIL I

ITEM	DESCRIPTION	GAGE	MATERIAL	EFFECTIVITY
1	DOOR PANEL SKIN CORE CORE (AT FASTENER		GRAPHITE, ARAMID, FIBERGLASS HONEYCOMB SANDWICH SEE DETAIL II NOMEX HONEYCOMB PER BMS 8-124, CLASS IV, TYPE V, GRADE 3.0 FIBERGLASS HONEYCOMB PER BMS 8-124, CLASS I, TYPE I, GRADE 8.0	
2	LOCATIONS) SEAL ASSEMBLY SEAL SEAL DEPRESSOR	0.032	DACRON FABRIC BONDED OVER SILICONE CORE CLAD 2024-T42

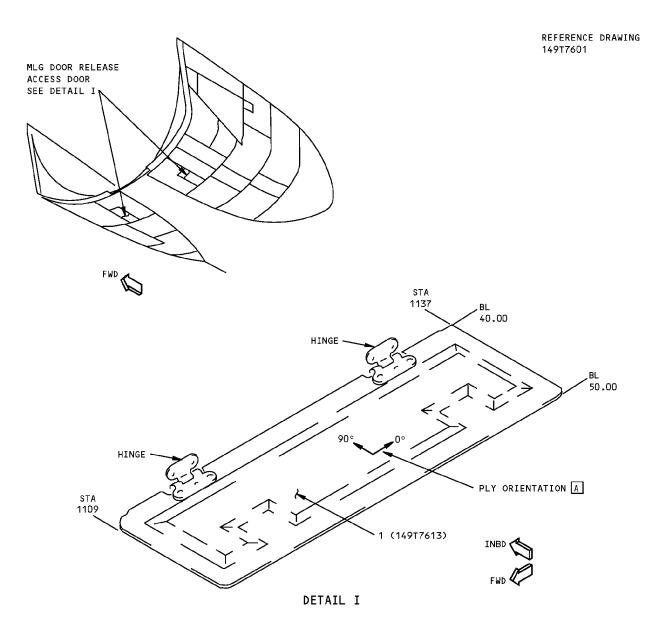
IDENTIFICATION 8 - MLG DOOR RELEASE ACCESS DOOR

ITEM	DESCRIPTION	GAGE	MATERIAL	EFFECTIVITY
1	DOOR PANEL SKIN CORE		ARAMID/GRAPHITE/EPOXY HONEYCOMB SANDWICH SEE DETAIL II NOMEX HONEYCOMB PER BMS 8-124, CLASS IV, TYPE V, GRADE 3.0

LIST OF MATERIALS FOR DETAIL I

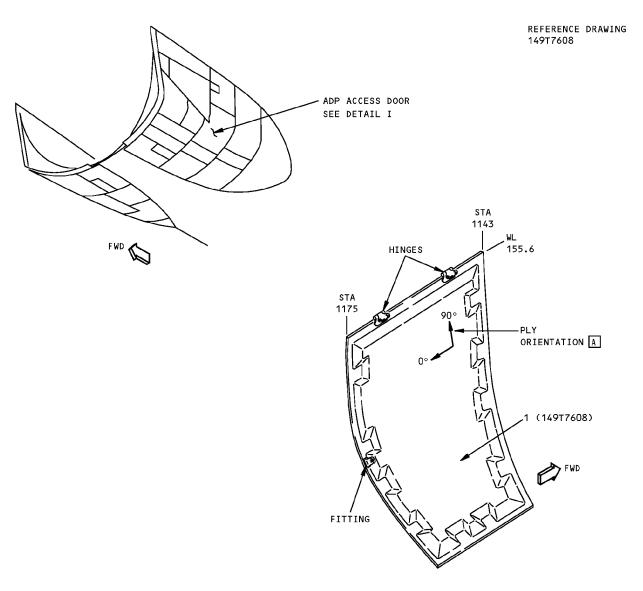
IDENTIFICATION 9 - ADP ACCESS DOOR

DETAIL I

ITEM	DESCRIPTION	GAGE	MATERIAL	EFFECTIVITY
1	DOOR PANEL SKIN CORE		ARAMID/GRAPHITE/EPOXY HONEYCOMB SANDWICH SEE DETAIL II FIBERGLASS HONEYCOMB PER BMS 8-124, CLASS I, TYPE I, GRADE 4.0

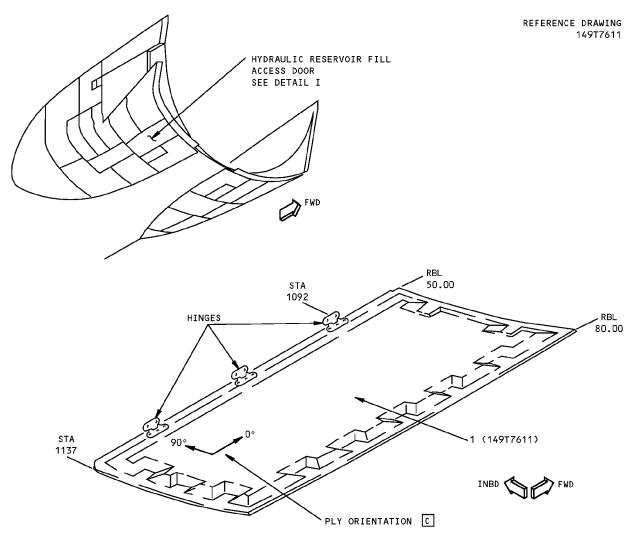
IDENTIFICATION 10 - HYDRAULIC RESERVOIR FILL ACCESS DOOR

DETAIL I

ITEM	DESCRIPTION	GAGE	MATERIAL	EFFECTIVITY
1	DOOR PANEL SKIN CORE		ARAMID/GRAPHITE/EPOXY HONEYCOMB SANDWICH SEE DETAIL II FIBERGLASS HONEYCOMB PER BMS 8-124, CLASS I, TYPE I, GRADE 4.0

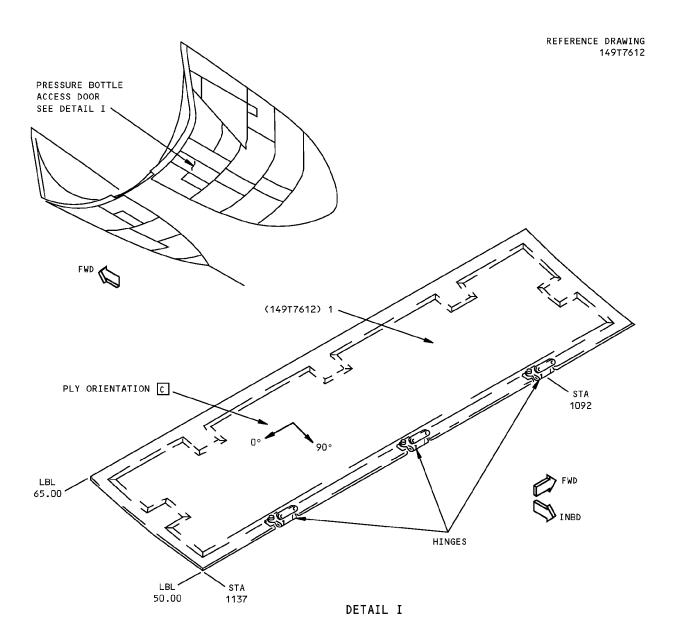
IDENTIFICATION 11 - PRESSURE BOTTLE ACCESS DOOR

ITEM	DESCRIPTION	GAGE	MATERIAL	EFFECTIVITY
1	DOOR PANEL SKIN CORE		ARAMID/GRAPHITE/EPOXY HONEYCOMB SANDWICH SEE DETAIL II FIBERGLASS HONEYCOMB PER BMS 8-124, CLASS I, TYPE I, GRADE 4.0

LIST OF MATERIALS FOR DETAIL I

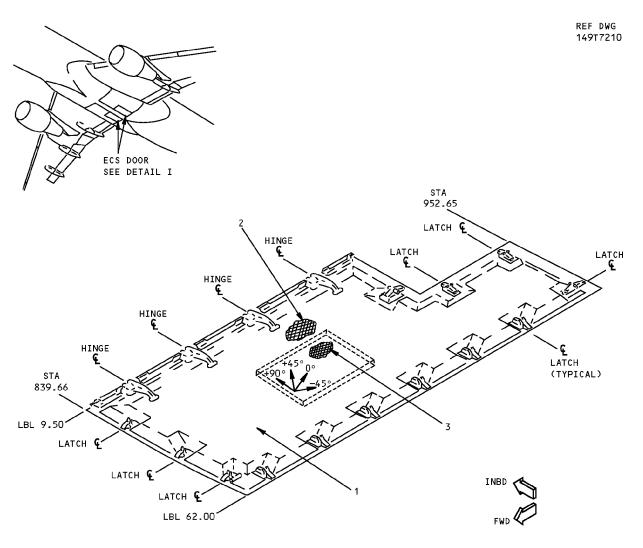
IDENTIFICATION 12 - ECS DOOR

ECS DOOR DETAIL I

ITEM	DESCRIPTION	GAGE	MATERIAL	EFFECTIVITY
1	DOOR PANEL SKIN		ARAMID/GRAPHITE/EPOXY HONEYCOMB SANDWICH SEE DETAIL I	
2	CORE		NOMEX HONEYCOMB PER BMS 8-124, CLASS I, TYPE I GRADE 5.5	
3	CORE		NOMEX HONEYCOMB PER BMS 8-124, CLASS IV, TYPE V, GRADE 3.0

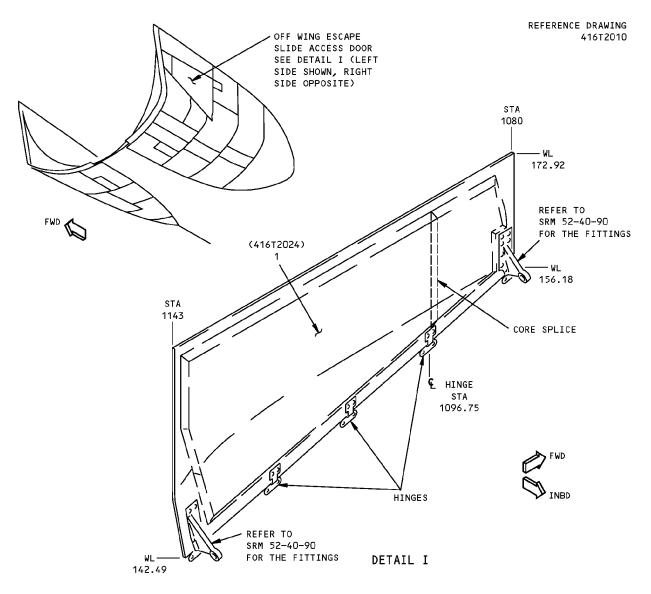
IDENTIFICATION 13 - ACCESS DOOR

ITEM	DESCRIPTION	GAGE	MATERIAL	EFFECTIVITY
1	DOOR PANEL SKIN FWD CORE AFT CORE		ARAMID/GRAPHITE EPOXY HONEYCOMB SANDWICH SEE DETAIL II NOMEX HONEYCOMB PER BMS 8-124, CLASS IV, TYPE V, GRADE 8.0 NOMEX HONEYCOMB PER BMS 8-124, CLASS IV, TYPE V, GRADE 3.0

LIST OF MATERIALS FOR DETAIL I

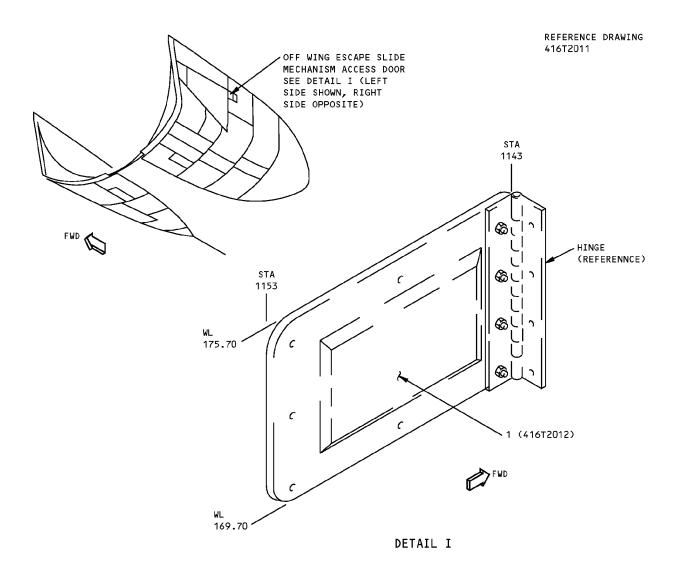
IDENTIFICATION 14 - MECHANISM ACCESS DOOR

ITEM	DESCRIPTION	GAGE	MATERIAL	EFFECTIVITY
1	DOOR PANEL SKIN CORE		ARAMID/GRAPHITE/EPOXY HONEYCOMB SANDWICH SEE DETAIL II NOMEX HONEYCOMB PER BMS 8-124, CLASS IV, TYPE V, GRADE 3.0

LIST OF MATERIALS FOR DETAIL I

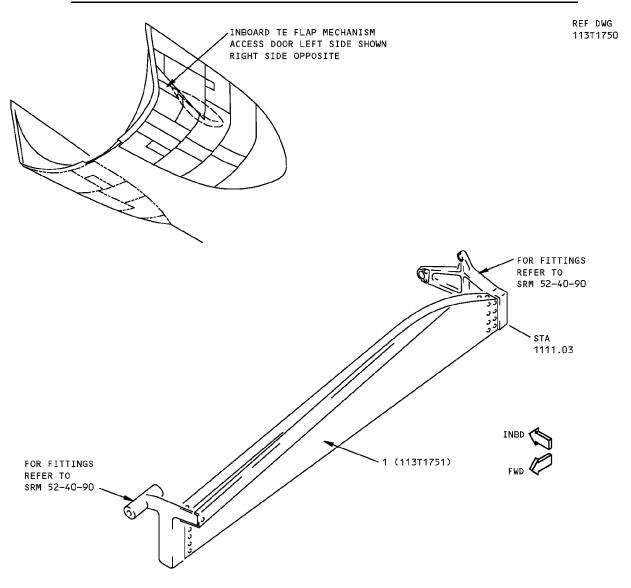
IDENTIFICATION 15 - INBOARD TRAILING EDGE FLAP MECHANISM ACCESS DOOR

ITEM	DESCRIPTION	GAGE	MATERIAL	EFFECTIVITY
1	DOOR PANEL OUTER SKIN INNER SKIN UPPER CHANNEL LOWER CHANNEL ANGLE	0.063 0.063 0.020	ARAMID/FIBERGLASS LAMINATE SEE DETAIL I SEE DETAIL I CLAD 7075-T62 CLAD 7075-T62 CLAD 7075-T62

LIST OF MATERIALS

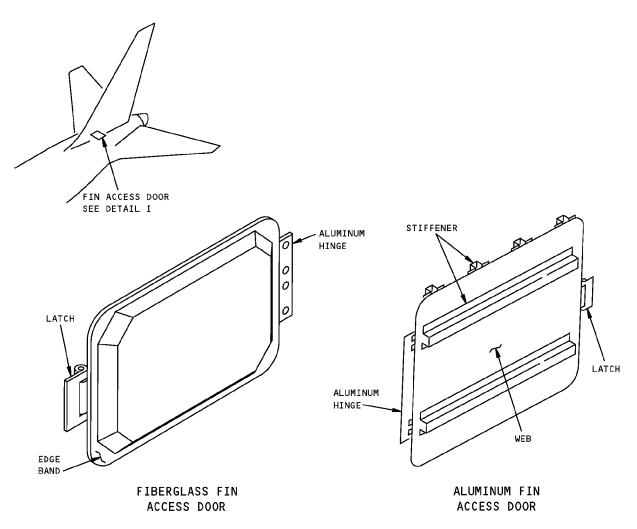
ALLOWABLE DAMAGE 1 - FIN ACCESS DOOR

DETAIL I

LOCATION	CRACKS	NICKS, GOUGES AND CORROSION	DENTS	HOLES	DELAMINATION
FIBERGLASS FIN ACCESS DOOR	В	C	D	E	F
ALUMINUM FIN ACCESS DOOR					
WEB	G	Н	M	I	
STIFFENER	JL	K	NOT ALLOWED	Ī	
HINGE/LATCH	NOT ALLOWED	N	NOT ALLOWED	NOT ALLOWED

Fin Access Door Allowable Damage Figure 101 (Sheet 1 of 4)

- A REMOVE MOISTURE FROM DAMAGE AREA. USE OF VACUUM AND HEAT (MAX OF 125°F (52°C)) TO REMOVE MOISTURE FROM HONEYCOMB CELLS IS RECOMMENDED. PROTECT DAMAGE FROM ENTRANCE OF WATER, SUNLIGHT OR OTHER FOREIGN MATTER BY SEALING WITH ALUMINUM FOIL TAPE (SPEED TAPE). RECORD THE LOCATION AND INSPECT EACH AIRPLANE "ALUMINUM FOIL TAPE IF ANY PEELING OR DETERIORATION IS EVIDENT. REPAIR NO LATER THAN NEXT AIRPLANE "C" CHECK

- B 0.50 INCH (13 mm) MAXIMUM LENGTH FOR EACH SQUARE FOOT OF AREA IS PERMITTED IN THE HONEYCOMB AREA. MINIMUM OF 6.0 INCHES (150 mm) FROM ANY OTHER CRACK. EDGE CRACKS MUST BE REMOVED AS GIVEN IN DETAILS II AND VI. MAINTAIN EDGE MARGIN SHOWN. REFINISH OR A.

- F 0.50 INCH (13 mm) MAX DIA IS PERMITTED IN HONEYCOMB AREA. A MAXIMUM OF 0.10 INCH (2.5 mm) DELAMINATION FROM EDGE IS PERMITTED. REPAIR DELAMINATION IN HONEYCOMB AREA AS GIVEN IN SRM 51-70 NO LATER THAN THE NEXT AIRPLANE "C" CHECK. PROTECT EDGE DAMAGE AS GIVEN IN A.

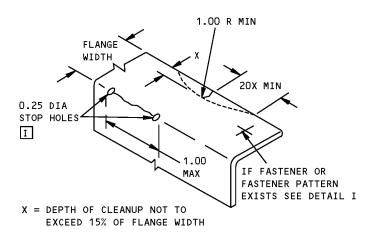
FORMED MEMBER

Fin Access Door Allowable Damage Figure 101 (Sheet 4 of 4)

- J FOR EDGE CRACKS SEE DETAIL II AND VII. FOR RADIUS CRACKS NOT EXCEEDING 1.00 INCH (25 mm) SEE DETAIL VII
- REMOVE DAMAGE AS GIVEN IN DETAILS II, III, V AND VII

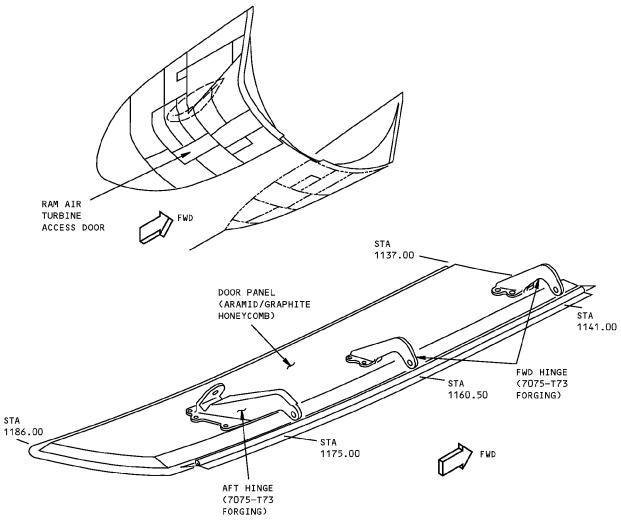
ALLOWABLE DAMAGE 2 - RAM AIR TURBINE ACCESS DOOR

ITEMS	CRACKS	NICKS, GOUGES, AND SCRATCHES	DENTS	PUNCTURES AND HOLES	DELAMINATIONS
DOOR PANEL	А	c	G	E	ONE SQUARE INCH ALLOWED IN HONEYCOMB AREAS ONLY.
FWD HINGE STA. 1141.00 AND STA. 1160.00	D	FOR CORNER DAMAGE SEE DETAIL II FOR OTHERS B	NOT ALLOWED	NOT ALLOWED	
AFT HINGE STA. 1175.00	D	FOR CORNER DAMAGE SEE DETAIL II FOR OTHERS B	NOT ALLOWED	NOT ALLOWED

Ram Air Turbine Access Door Allowable Damage Figure 101 (Sheet 1 of 3)

- A NONE ALLOWED EXCEPT FOR EDGE CRACKS WHICH ARE AT LEAST 2.5 INCHES (63 mm) DIA'S FROM FASTENER HOLES. CLEAN UP EDGE DAMAGE AS GIVEN IN DETAIL I
- B NICK, GOUGE, OR SCRATCH DAMAGE REMOVED ACCORDING TO DETAIL III IS ALLOWED

- C DAMAGE IS PERMITTED ON SURFACE RESIN ONLY.
 DAMAGE TO FIBERS ARE NOT PERMITTED | H
- D CLEAN UP CORNER CRACKS AS GIVEN IN DETAIL II.
 ALL OTHER CRACKS MUST BE REPAIRED

- G DENTS GENERALLY RESULT IN FIBER DAMAGE OR DELAMINATION. HOWEVER, PROVIDED THAT THERE IS NO FIBER DAMAGE OR DELAMINATION, DENTS UP TO 2.25 INCHES (56 mm) DIA MAX ARE PERMITTED. ONE DENT PER SQUARE FOOT OF AREA PERMITTED WHICH MUST BE A MINIMUM OF 6 INCHES (150 mm) FROM ANY OTHER DENT, PUNCTURE OR DELAMINATION. SEE DETAIL IV. DENTS ALLOWED IN HONEYCOMB AREAS ONLY
