CHAPTER 52 DOORS

- A. This chapter contains information about the passenger/crew entry doors (both sides), escape hatches, cargo doors (forward and aft including optional forward large cargo door and bulk cargo door), service doors (elec/elex access door, ram air turbine access door, potable water access door, controls bay access door, service access door, waste disposal access door, forward access door and auxiliary power unit access door) and landing gear doors.
- B. All major structural components are located and identified through the use of detailed illustrations with corresponding tabulated material lists.
- C. Allowable damage to doors is defined in this chapter.
- D. Approved repairs are described and illustrated in this chapter.

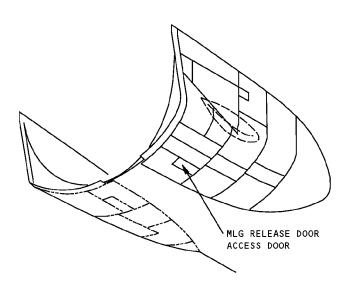
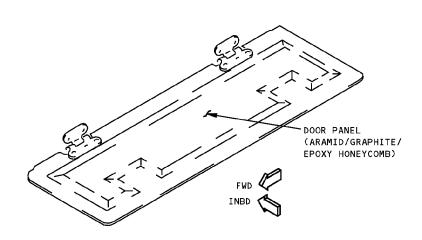
ALLOWABLE DAMAGE 3 - MLG DOOR RELEASE ACCESS DOOR

REF DWG 149T7613

ITEM	CRACKS	NICKS AND GOUGES	DENTS	HOLES AND PUNCTURES	DELAMINATION
DOOR PANEL	В	С	D	E	규

MLG Door Release Access Door Allowable Damage Figure 101 (Sheet 1 of 2)

- B 2.0 INCHES (50 mm) MAX LENGTH IN HONEYCOMB AREA IS PERMITTED FOR EACH SQUARE FOOT OF AREA AND MINIMUM OF 6.0 INCHES (150 mm) FROM ANY OTHER CRACK. CLEAN UP EDGE CRACKS AS GIVEN IN DETAIL I. CRACKS THROUGH CONSECUTIVE FASTENERS OR THROUGH THE PANEL EDGE-BAND ARE PERMITTED PROVIDED DAMAGE DOES NOT EXCEED 10% OF EDGEBAND LENGTH FOR EACH SIDE. A
- DAMAGE IS PERMITTED ON SURFACE RESIN ONLY.

- E 1.0 INCH (25 mm) MAX DIA PERMITTED IN
 HONEYCOMB AREA ONLY PROVIDED DAMAGE IS MIN
 OF 2.5 D FROM OTHER DAMAGE, NEAREST HOLE,
 OR MATERIAL EDGE. DO NOT CLEAN UP DAMAGE
 EXCEPT TO REMOVE RESIN BURRS EXTENDING INTO
 SURFACE CONTOUR. A

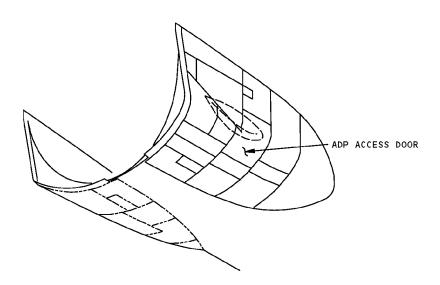
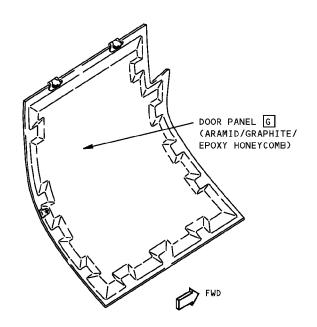
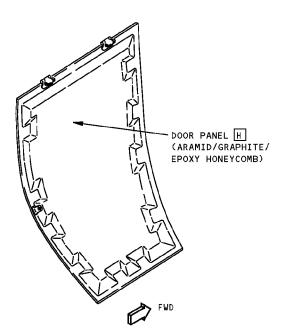
ALLOWABLE DAMAGE 4 - ADP ACCESS DOOR

REF DWG 149T7608 149T7610

ITEM	CRACKS	NICKS AND GOUGES	DENTS	HOLES AND PUNCTURES	DELAMINATION
DOOR PANEL	R	С	٥	E	F

ADP Access Door Allowable Damage Figure 101 (Sheet 1 of 2)

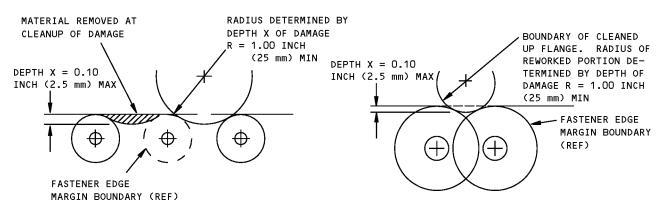
DETAIL I

DAMAGE CLEANUP OF EDGES WHERE FASTENER EDGE MARGINS DO NOT OVERLAP

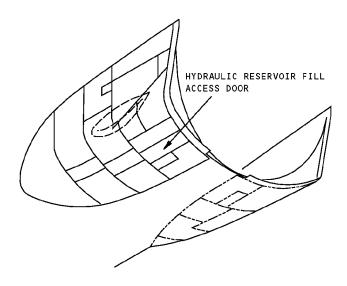
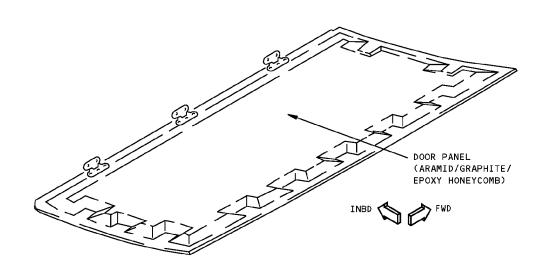
ALLOWABLE DAMAGE 5 - HYDRAULIC RESERVOIR FILL ACCESS DOOR

REF DWG 149T7611

ITEM	CRACKS	NICKS AND GOUGES	DENTS	HOLES AND PUNCTURES	DELAMINATION
DOOR PANEL	В	C	D	E	F

Hydraulic Reservoir Fill Access Door Allowable Damage Figure 101 (Sheet 1 of 2)

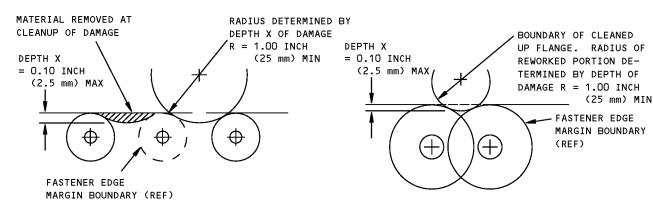
DAMAGE CLEANUP OF EDGES WHERE FASTENER EDGE MARGINS DO NOT OVERLAP

DAMAGE CLEANUP OF EDGES WHERE FASTENER EDGE MARGINS OVERLAP

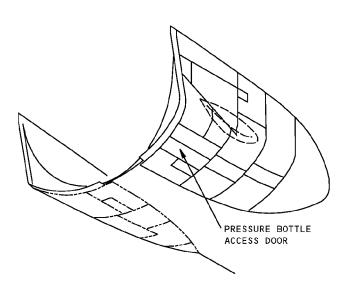
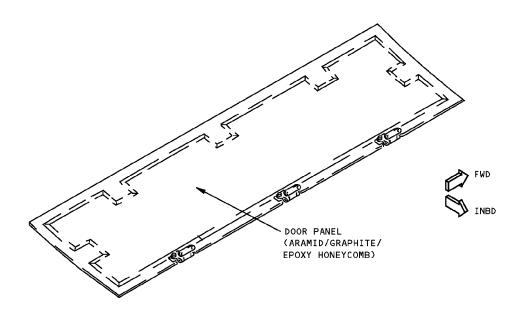
ALLOWABLE DAMAGE 6 - PRESSURE BOTTLE ACCESS DOOR

REF DWG 149T7612

ITEM	CRACKS	NICKS AND GOUGES	DENTS	HOLES AND PUNCTURES	DELAMINATION
DOOR PANEL	В	٥	D	E	F

Pressure Bottle Access Door Allowable Damage Figure 101 (Sheet 1 of 2)

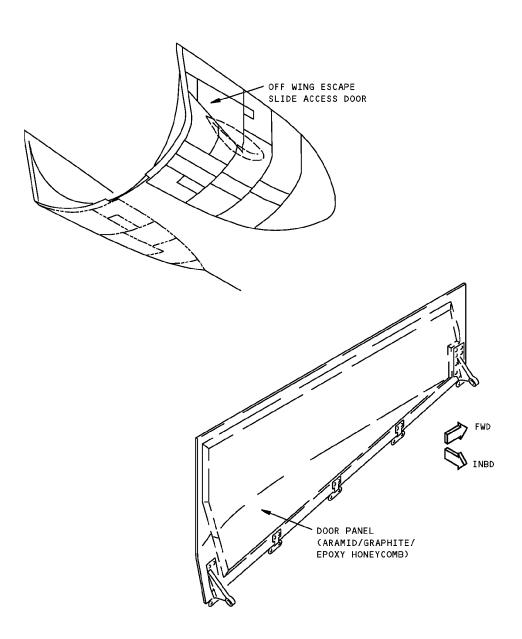
ALLOWABLE DAMAGE 7 - ACCESS DOOR

REF DWG 416T2010

ITEM	CRACKS	NICKS AND GOUGES	DENTS	HOLES AND PUNCTURES	DELAMINATION
DOOR PANEL	В	C	D	E	F

Off-Wing Escape Slide Access Door Allowable Damage Figure 101 (Sheet 1 of 2)

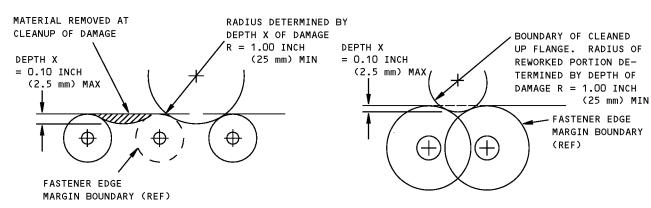
DAMAGE CLEANUP OF EDGES WHERE FASTENER EDGE MARGINS DO NOT OVERLAP

DAMAGE CLEANUP OF EDGES WHERE FASTENER EDGE MARGINS OVERLAP

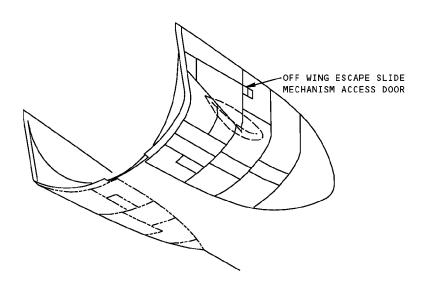
ALLOWABLE DAMAGE 8 - MECHANISM ACCESS DOOR

REF DWG 416T2012

ITEM	CRACKS	NICKS AND GOUGES	DENTS	HOLES AND PUNCTURES	DELAMINATION
DOOR PANEL	В	С	D	E	F

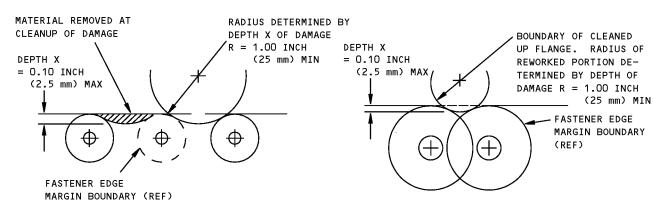
DAMAGE CLEANUP OF EDGES WHERE FASTENER EDGE MARGINS DO NOT OVERLAP

DAMAGE CLEANUP OF EDGES WHERE FASTENER EDGE MARGINS OVERLAP

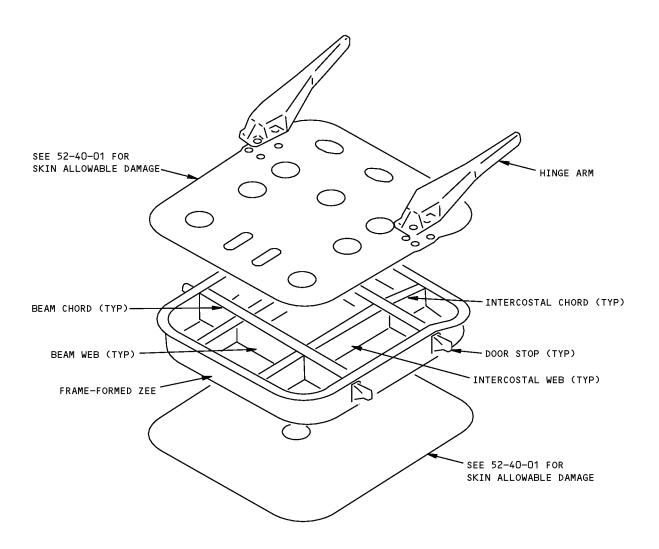
ALLOWABLE DAMAGE 9 - FORWARD ACCESS DOOR STRUCTURE

MATERIAL: ALUMINUM

Forward Access Door Structure Allowable Damage Figure 101 (Sheet 1 of 5)

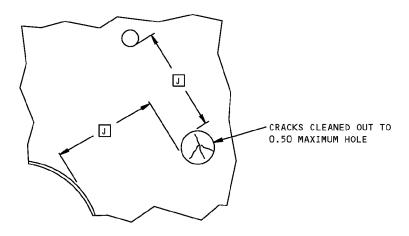
SURFACE CRACKS
DETAIL IX

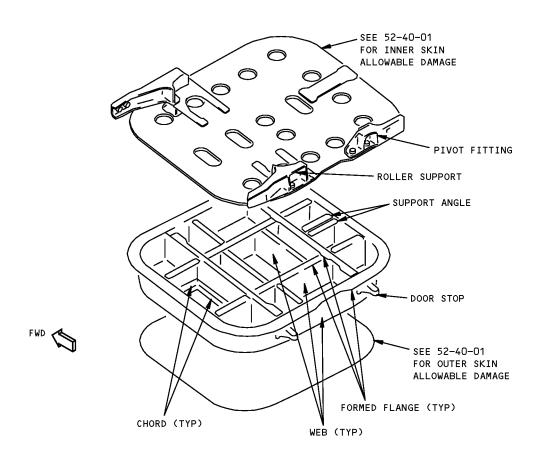
ALLOWABLE DAMAGE 10 - ELEC/ELEX ACCESS DOOR STRUCTURE

MATERIAL: ALUMINUM

Elec/Elex Access Door Structure Allowable Damage Figure 101 (Sheet 1 of 5)

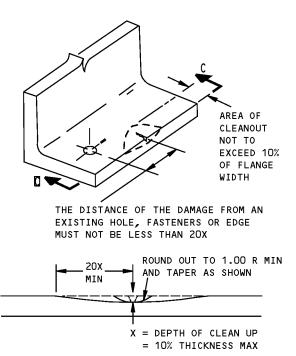
REMOVAL OF NICK OR CRACK DAMAGE ON AN EDGE DETAIL V

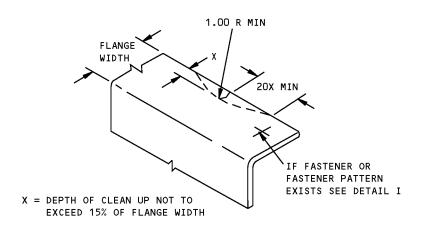
REMOVAL OF NICK OR CRACK DAMAGE ON AN EDGE DETAIL VI

FORMED MEMBER
DETAIL VII

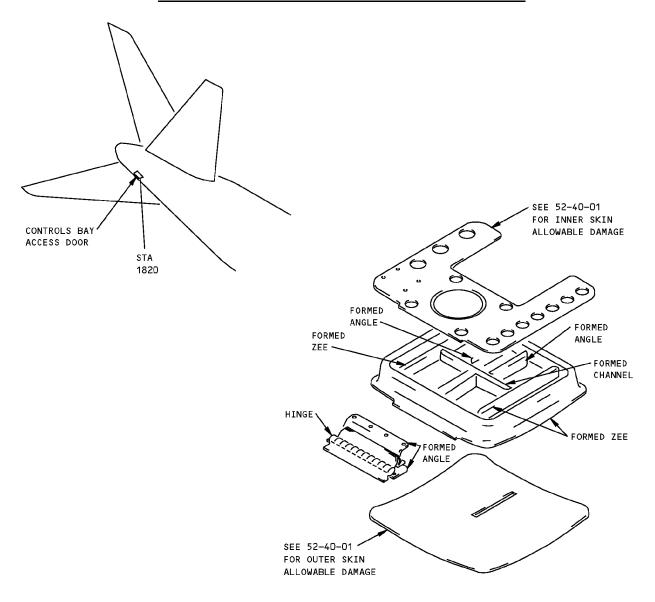
ALLOWABLE DAMAGE 11 - CONTROLS BAY ACCESS DOOR

ITEM	CRACKS	NICKS, GOUGES AND CORROSION	DENTS	HOLES AND PUNCTURES
FORMED FLANGE	В	E	SEE DETAIL III	G
WEB	С	F	SEE DETAIL III	G
HINGE	Α	D	NOT ALLOWED	NOT ALLOWED

Controls Bay Access Door Allowable Damage Figure 101 (Sheet 1 of 4)

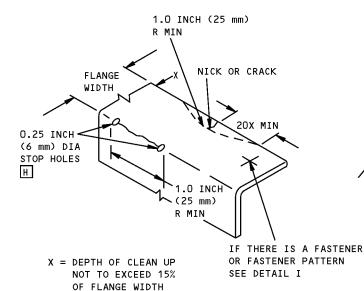
(FORMED MEMBER)
DETAIL VIII

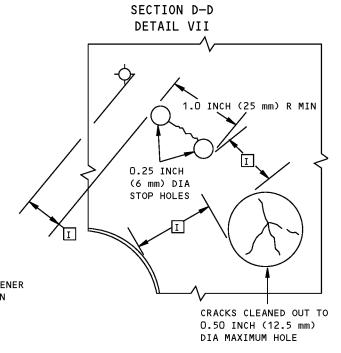
Controls Bay Access Door Allowable Damage Figure 101 (Sheet 4 of 4)

THE DISTANCE OF THE DAMAGE FROM AN INITIAL HOLE, FASTENERS OR SKIN EDGE

SURFACE CRACKS
DETAIL IX

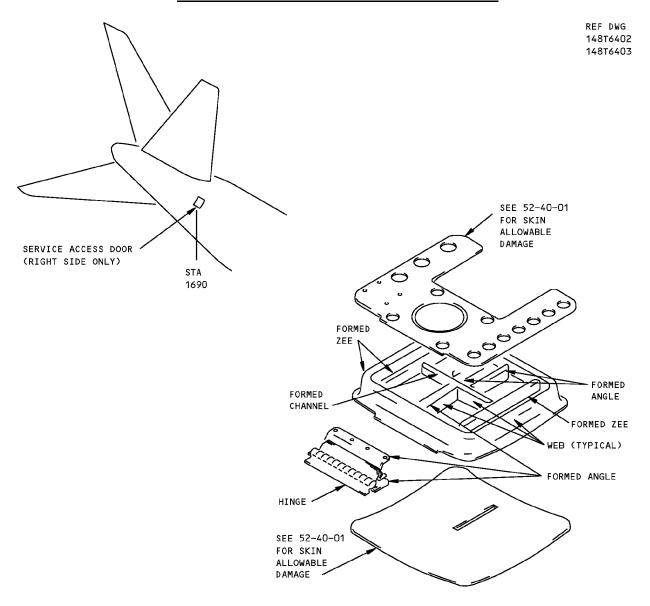
Service Access Door Allowable Damage Figure 101 (Sheet 1 of 4)

ALLOWABLE DAMAGE 12 - SERVICE ACCESS DOOR

ITEM	CRACKS	NICKS, GOUGES AND CORROSION	DENTS	HOLES AND PUNCTURES
FORMED FLANGE	В	E	SEE DETAIL III	G
WEB	С	F	SEE DETAIL III	G
HINGE	Α	D	NOT ALLOWED	NOT ALLOWED

- REFINISH REWORKED AREAS AS GIVEN IN AMM 51-21
- A CRACKS ARE NOT PERMITTED EXCEPT FOR EDGE CRACKS WHICH MUST BE REMOVED AS GIVEN IN DETAILS I AND VI
- B FOR EDGE CRACKS SEE DETAILS I AND VIII. FOR RADIUS CRACKS NOT EXCEEDING 1.00 INCH (25 mm) SEE DETAIL VIII

- C 1.00 INCH (25 mm) MAX LENGTH SURFACE CRACKS ARE PERMITTED, PROVIDED CRACKS ARE WITHIN LIMITS SHOWN IN DETAIL IX, REMOVE EDGE CRACKS AS GIVEN IN DETAILS I AND V

- D REMOVE DAMAGE AS GIVE IN DETAILS I, II, IV
- E REMOVE DAMAGE AS GIVEN IN DETAILS I, II, IV
 AND VIII
- F REMOVE DAMAGEAS GIVEN INR DETAILS I, II, IV, V AND VII

- G CLEAN OUT DAMAGE UP TO 0.25 INCH (6 mm) MAX
 DIA AND NOT CLOSER THAN 1.0 INCH (25 mm) TO
 FASTENER HOLE, MATERIAL EDGE, OR OTHER DAMAGE.
 FILL HOLE WITH 2117-T3 OR T4 ALUMINUM RIVET
 INSTALLED WET WITH BMS 5-95 SEALANT. ALL
 OTHER HOLES TO BE REPAIRED

- H ACCUMULATED LENGTH OF CRACKS MUST NOT BE MORE THAN 10% OF FLANGE LENGTH. DISTANCE BETWEEN STOP HOLES OF ADJACENT CRACKS MUST NOT BE LESS THAN 4.0 INCHES (100 mm)

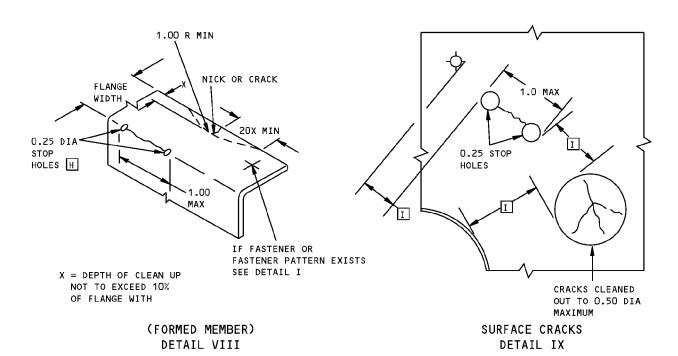
Service Access Door Allowable Damage Figure 101 (Sheet 4 of 4)

THE DISTANCE OF THE DAMAGE FROM AN EXISTING HOLE, FASTENERS OR SKIN EDGE MUST NOT BE LESS THAN 20X

SECTION D-D DETAIL VII

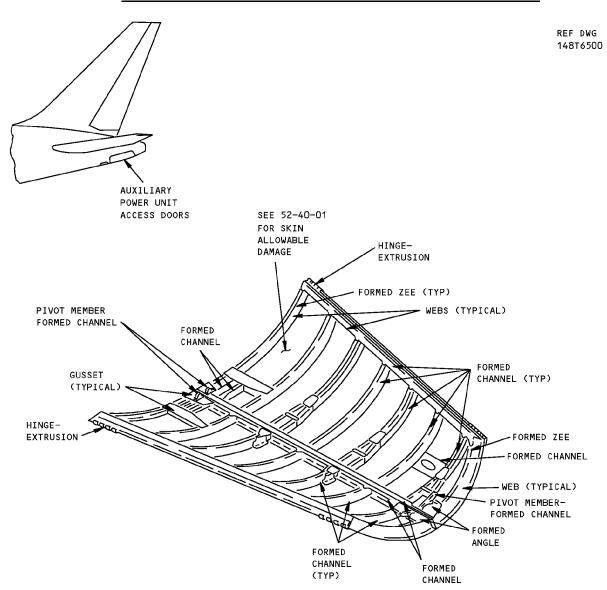
Auxiliary Power Unit Access Door Allowable Damage Figure 101 (Sheet 1 of 5)

ALLOWABLE DAMAGE 13 - AUXILIARY POWER UNIT ACCESS DOOR

ITEM	CRACKS	NICKS, GOUGES AND CORROSION	DENTS	HOLES AND PUNCTURES
FORMED FLANGE	В	E	SEE DETAIL IV	Н
WEB	С	F	SEE DETAIL IV	H
PIVOT MEMBER FORMED FLANGE	В	E G	SEE DETAIL IV	H
GUSSET	С	F	SEE DETAIL IV	H
HINGE	A	D	NOT ALLOWED	NOT ALLOWED

- REFINISH REWORKED AREAS AS GIVEN IN AMM 51-20
- A CRACKS ARE NOT PERMITTED EXCEPT FOR EDGE CRACKS WHICH MUST BE REMOVED AS GIVEN IN DETAILS I AND VI
- B FOR EDGE CRACKS SEE DETAILS I AND VIII. FOR RADIUS CRACKS NOT EXCEEDING 1.00 INCH (25 mm) SEE DETAIL VIII

- C 1.00 INCH (25 mm) MAX LENGTH SURFACE CRACKS
 ARE PERMITTED, PROVIDED CRACKS ARE WITHIN
 LIMITS SHOWN IN DETAIL IX, REMOVE EDGE
 CRACKS AS GIVEN IN DETAILS I AND III

- D REMOVE DAMAGE AS GIVEN IN DETAILS I, II, V
- E REMOVE DAMAGE AS GIVEN IN DETAILS I, II, V AND VIII
- F REMOVE DAMAGE AS GIVEN IN DETAILS I, II, III, V AND X

- G FOR LUG DAMAGE SEE DETAIL VII
- H CLEAN OUT DAMAGE UP TO 0.25 INCH (6 mm) MAX
 DIA AND NOT CLOSER THAN 1.0 INCH (25 mm) TO
 FASTENER HOLE, MATERIAL EDGE, OR OTHER DAMAGE.
 FILL HOLE WITH 2117-T3 OR T4 ALUMINUM RIVET
 INSTALLED WET WITH BMS 5-95 SEALANT. ALL
 OTHER HOLES TO BE REPAIRED

- ACCUMULATED LENGTH OF CRACKS MUST NOT BE MORE THAN 10% OF FLANGE LENGTH. DISTANCE BETWEEN STOP HOLES OF ADJACENT CRACKS MUST NOT BE LESS THAN 4.0 INCHES (100 mm)

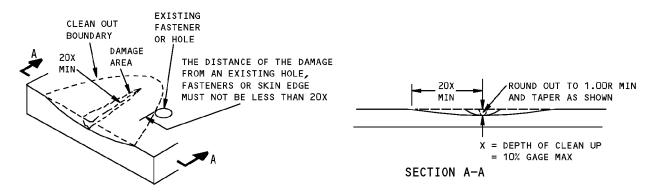
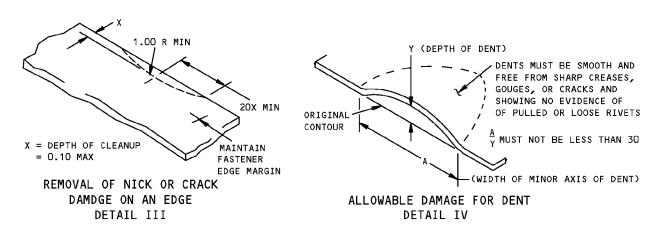
Auxiliary Power Unit Access Door Allowable Damage Figure 101 (Sheet 3 of 5)

DETAIL I

REMOVAL OF NICK GOUGES AND SCRATCH DAMAGE ON A SURFACE DETAIL II

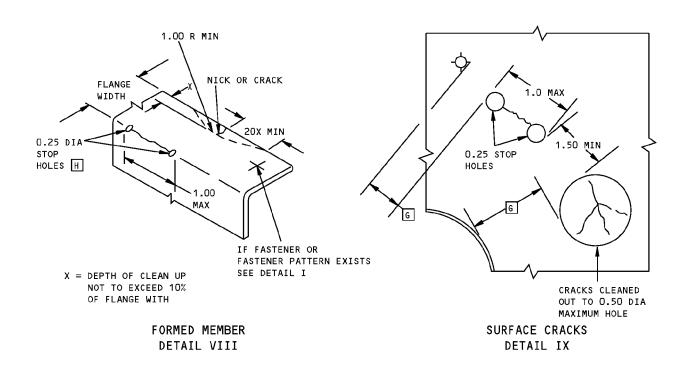
Auxiliary Power Unit Access Door Allowable Damage Figure 101 (Sheet 5 of 5)

THE DISTANCE OF THE DAMAGE FROM AN EXISTING HOLE, FASTENERS OR SKIN EDGE MUST NOT BE LESS THAN 20X

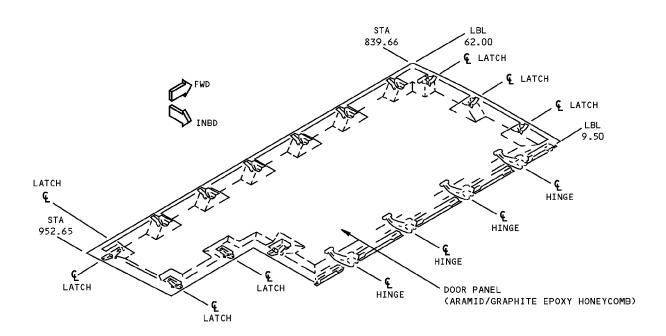
ECS Door Allowable Damage Figure 101 (Sheet 1 of 2)

ALLOWABLE DAMAGE 14 - ECS DOOR

REF DWG 149T7210

LEFT SIDE SHOWN RIGHT SIDE OPPOSITE

ITEM	CRACKS	NICKS AND GOUGES	DENTS	HOLES AND PUNCTURES	DELAMINATION
DOOR PANEL	R	С	D	E	F

- REFINISH REWORKED AREAS AS GIVEN IN AMM 51-20
- DAMAGE TO PANEL EDGES MAY BE CONFINED TO DELAMINATION OR MAY TAKE A FORM WHICH RESULTS IN DAMAGE TO FIBERS AND A LOSS OF EFFECTIVE CROSS-SECTIONAL AREA. THIS TYPE OF DAMAGE SHOULD BE REMOVED AND THE LIMITATIONS GIVEN FOR CRACKS APPLIED

- A REMOVE MOISTURE FROM DAMAGE AREA. USE OF VACUUM AND HEAT (MAX OF 125°F [52°C]) TO REMOVE MOISTURE FROM HONEYCOMB CELLS IS RECOMMENDED. PROTECT DAMAGE FROM ENTRANCE OF WATER, SUNLIGHT OR OTHER FOREIGN MATTER BY SEALING WITH ALUMINUM FOIL TAPE (SPEED TAPE). RECORD THE LOCATION AND INSPECT EACH AIRPLANE "A" CHECK. REPLACE THE ALUMINUM FOIL TAPE IF ANY PEELING OR DETERIORATION IS EVIDENT. REPAIR NO LATER THAN NEXT AIRPLANE "C" CHECK

- B 2.0 INCHES (50 mm) MAX LENGTH IN HONEYCOMB
 AREA IS PERMITTED FOR EACH SQUARE FOOT OF
 AREA AND MINIMUM OF 6.0 INCHES (150 mm)
 FROM ANY OTHER CRACK. CLEAN UP EDGE CRACKS
 AS GIVEN IN DETAIL I. CRACKS THROUGH
 CONSECUTIVE FASTENERS OR THROUGH THE PANEL
 EDGE-BAND ARE PERMITTED PROVIDED DAMAGE IS
 NOT MORE THAN 10% OF EDGEBAND LENGTH FOR
 EACH SIDE. A
- C DAMAGE IS PERMITTED ON SURFACE RESIN ONLY.

DAMAGE TO FIBERS NOT PERMITTED. CLEAN UP
 EDGE DAMAGE AS GIVEN IN DETAIL I. A
- D DENTS GENERALLY RESULT IN FIBER DAMAGE OR DELAMINATION. HOWEVER, PROVIDED THAT THERE IS NO FIBER DAMAGE OR DELAMINATION, DENTS UP TO 1.50 INCHES (38 mm) DIA MAX ARE ALL PERMITTED. ONE DENT FOR EACH SQUARE FOOT OF AREA PERMITTED WHICH MUST BE A MINIMUM OF 6 INCHES (150 mm) FROM ANY OTHER DAMAGE, FASTENER HOLE, OR PANEL EDGE. IF FIBER DAMAGE OR DELAMINATION IS PRESENT REFER TO E OR F

- E 1.0 INCH (25 mm) MAX DIA IS PERMITTED IN HONEYCOMB AREA ONLY PROVIDED DAMAGE IS MIN OF 2.5 D FROM OTHER DAMAGE, NEAREST HOLE, OR MATERIAL EDGE. DO NOT CLEAN UP DAMAGE EXCEPT TO REMOVE RESIN BURRS EXTENDING INTO SURFACE CONTOUR.

- F 1.0 INCH (25 mm) MAX DIA IS PERMITTED IN HONEYCOMB AREA. A MAXIMUM OF 0.10 INCH (2.5 mm) DELAMINATION FROM EDGE IS PERMITTED. REPAIR DELAMINATION IN HONEYCOMB AREA AS GIVEN IN SRM 51-70 NO LATER THAN THE NEXT "C" CHECK. PROTECT EDGE DAMAGE AS GIVEN IN A

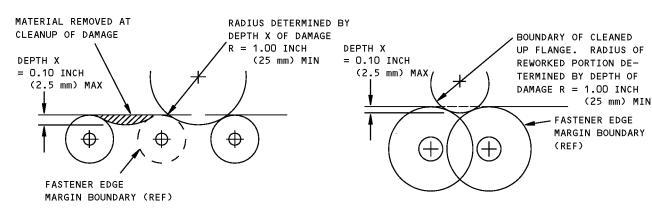
DAMAGE CLEANUP OF EDGES WHERE FASTENER EDGE MARGINS DO NOT OVERLAP

DAMAGE CLEANUP OF EDGES WHERE FASTENER EDGE MARGINS OVERLAP

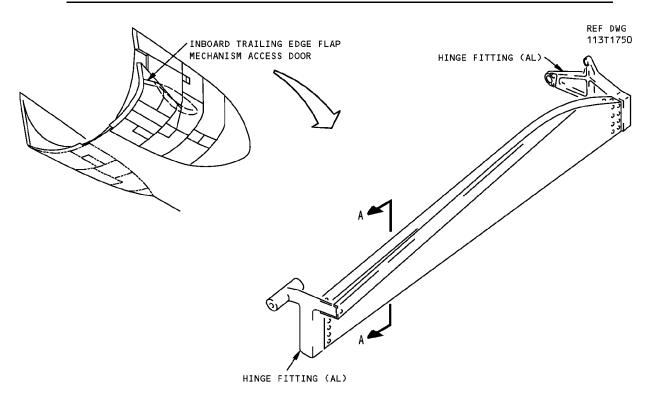
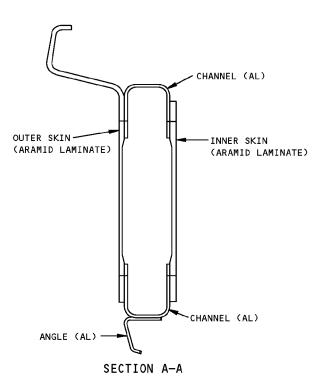
Inboard Trailing Edge Flap Mechanism Access Door - Allowable Damage Figure 101 (Sheet 1 of 4)

ALLOWABLE DAMAGE 15 - INBOARD TRAILING EDGE FLAP MECHANISM ACCESS DOOR

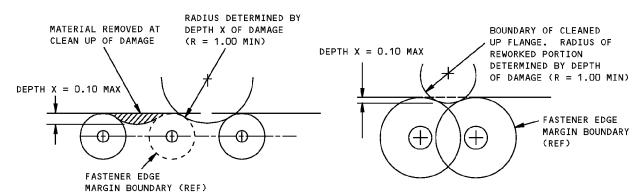
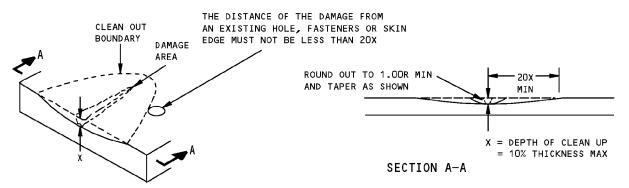
Inboard Trailing Edge Flap Mechanism Access Door - Allowable Damage Figure 101 (Sheet 2 of 4)

DAMAGE CLEAN UP OF EDGES WHERE FASTENER EDGE MARGINS DO NOT OVERLAP

DAMAGE CLEAN UP OF EDGES WHERE FASTENER EDGE MARGINS OVERLAP

DETAIL I

REMOVAL OF NICK, GOUGE AND SCRATCH DAMAGE ON A SURFACE

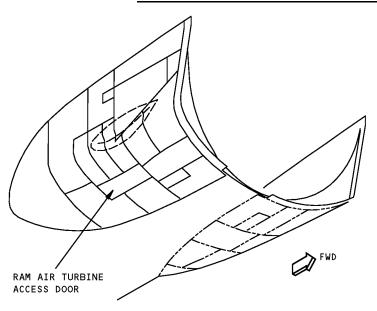
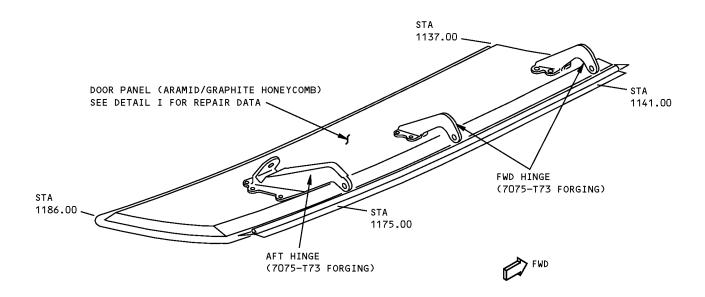
Ram Air Turbine Access Door Repair Figure 201 (Sheet 1 of 2)

REPAIR 1 - RAM AIR TURBINE ACCESS DOOR

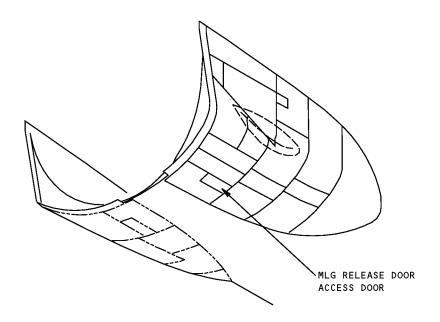
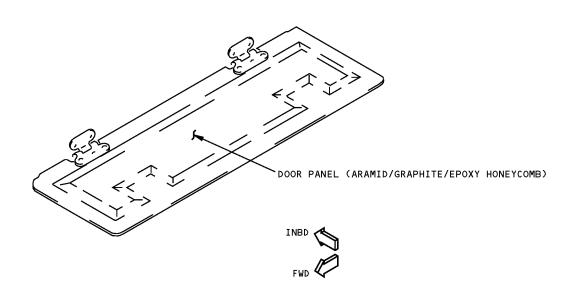
MLG Door Release Access Door Repair Figure 201 (Sheet 1 of 2)

REPAIR 2 - MLG DOOR RELEASE ACCESS DOOR

REF DWG 149T7613

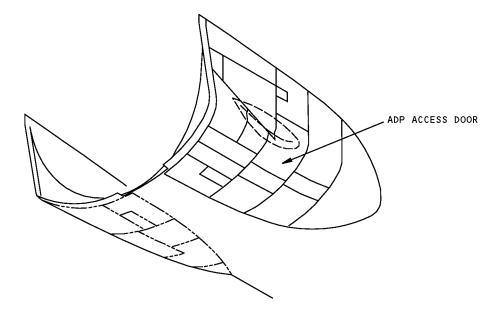
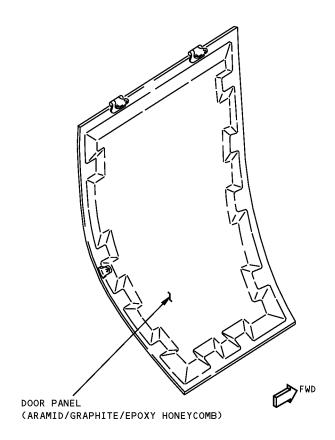
ADP Access Door Repair Figure 201 (Sheet 1 of 2)

REPAIR 3 - ADP ACCESS DOOR

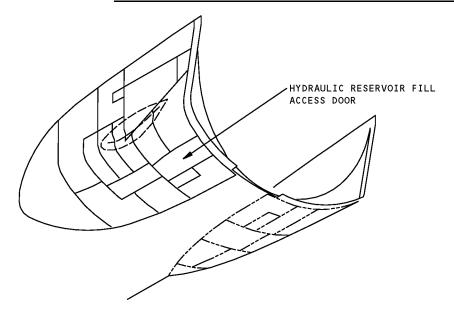
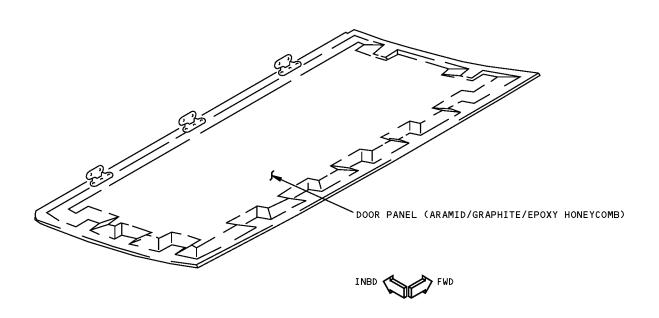
Hydraulic Reservoir Fill Access Door Repair Figure 201 (Sheet 1 of 2)

REPAIR 4 - HYDRAULIC RESERVOIR FILL ACCESS DOOR

REF DWG 149T7611

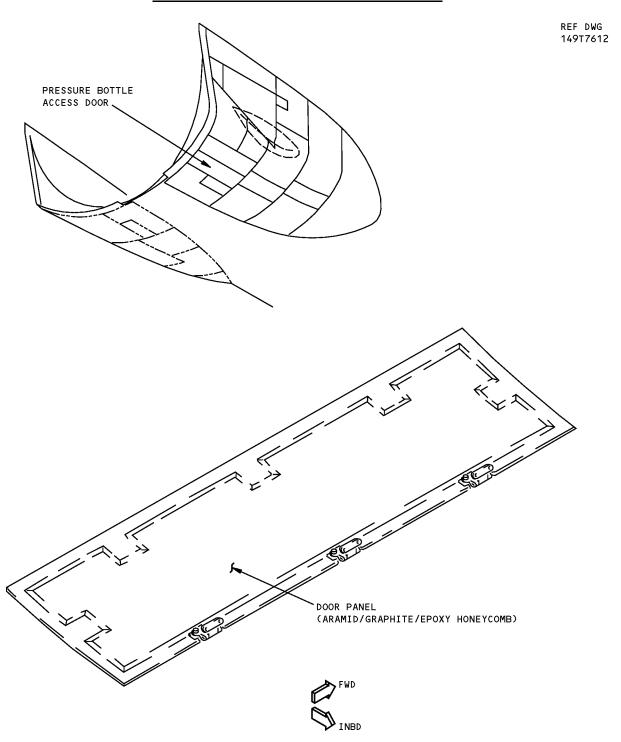
Pressure Bottle Access Door Repair Figure 201 (Sheet 1 of 2)

REPAIR 5 - PRESSURE BOTTLE ACCESS DOOR

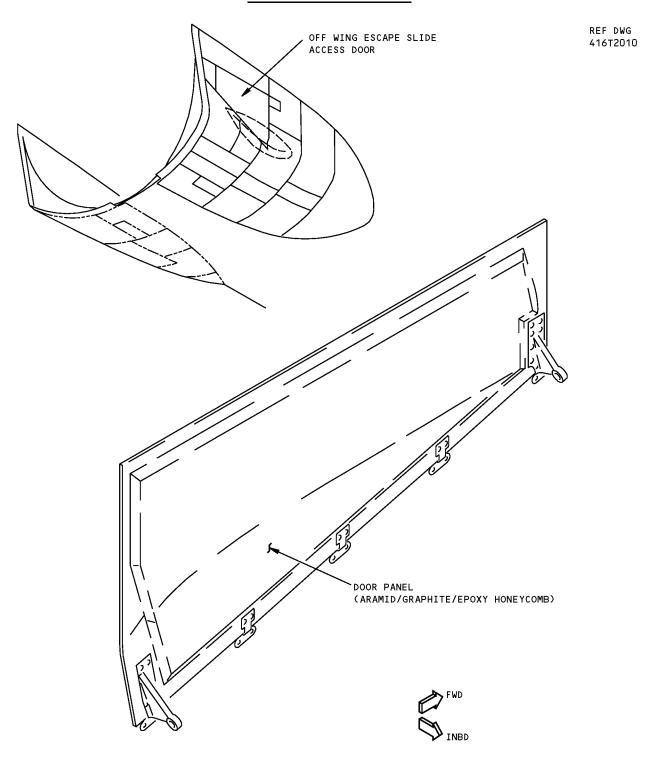
Off-Wing Escape Slide Access Door Repair Figure 201 (Sheet 1 of 2)

REPAIR 6 - ACCESS DOOR

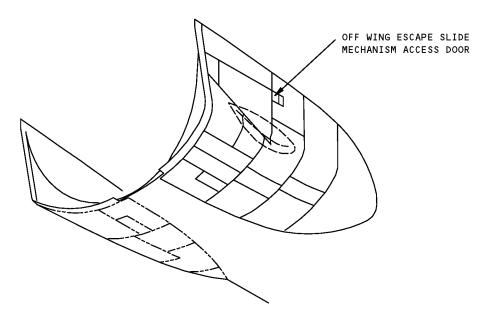
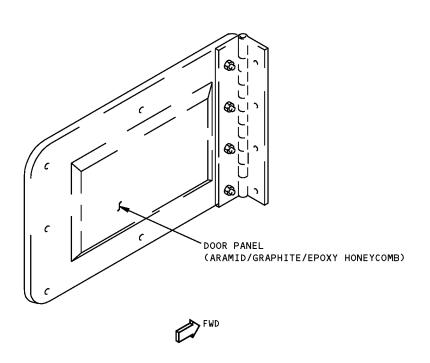
Off-Wing Escape Slide Mechanism Access Door Repair Figure 201 (Sheet 1 of 2)

REPAIR 7 - MECHANISM ACCESS DOOR

REF DWG 416T2012

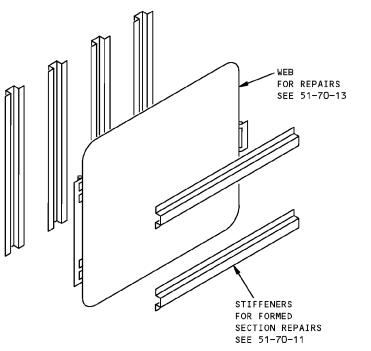
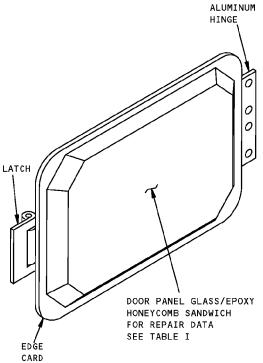
REPAIR 8 - FIN ACCESS DOOR

ALUMINUM FIN ACCESS DOOR

COMPOSITE FIN ACCESS DOOR

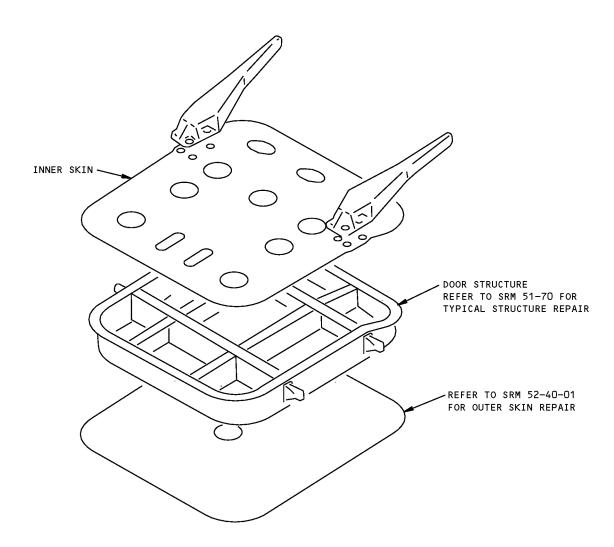
Forward Access Door Structure Repair Figure 201

REFERENCE DRAWING 141T6401

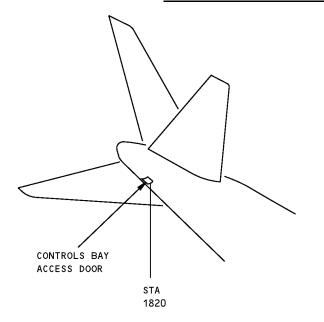
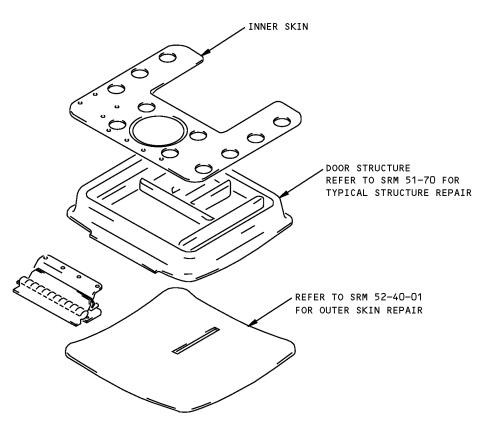
Controls Bay Access Door Repair Figure 201

REPAIR 10 - CONTROLS BAY ACCESS DOOR STRUCTURE

REFERENCE DRAWINGS 148T6602 148T6404

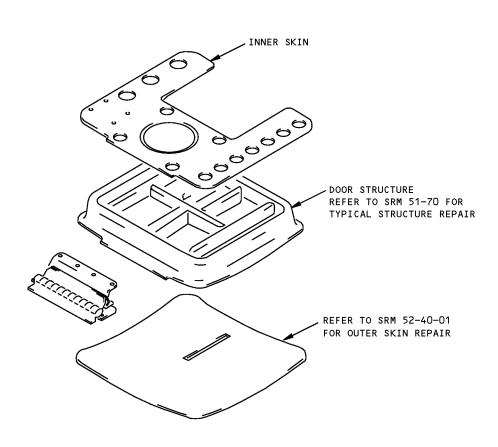
Service Access Door Structure Repair - Sta 1690 Figure 201

SERVICE ACCESS DOOR
(RIGHT SIDE ONLY)
STA
1690

REFERENCE DRAWING 148T6402 148T6403

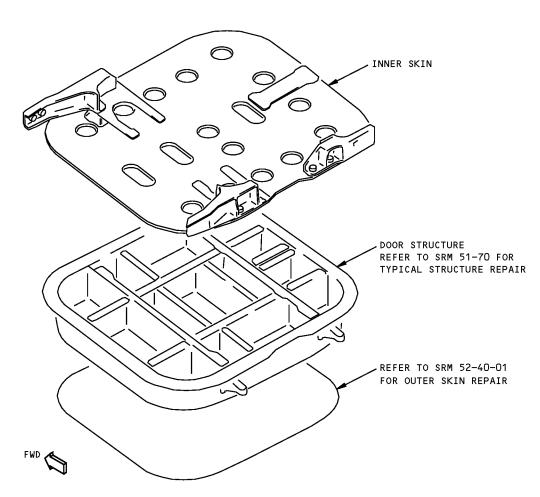
Elec/Elex Access Door Structure Repair Figure 201

REFERENCE DRAWING 141T6301

DETAIL I

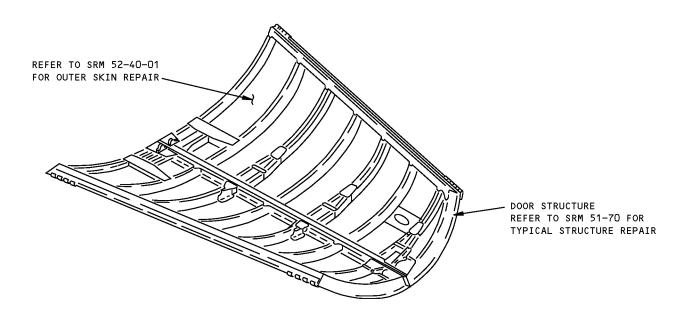
Auxiliary Power Unit Access Door Structure Repair Figure 201

REFERENCE DRAWING 148T6500

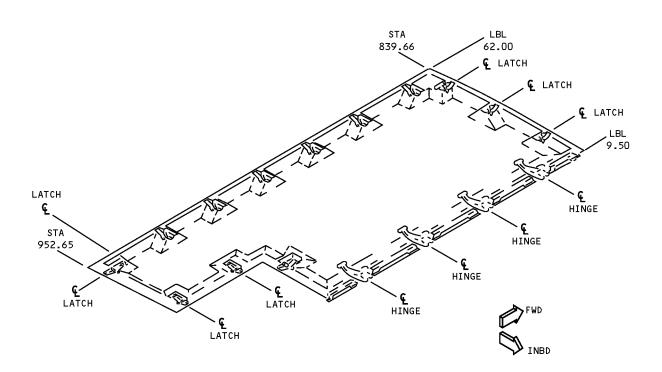
ECS Door Repair Figure 201 (Sheet 1 of 2)

REF DWG 149T7210

LEFT SIDE SHOWN RIGHT SIDE OPPOSITE

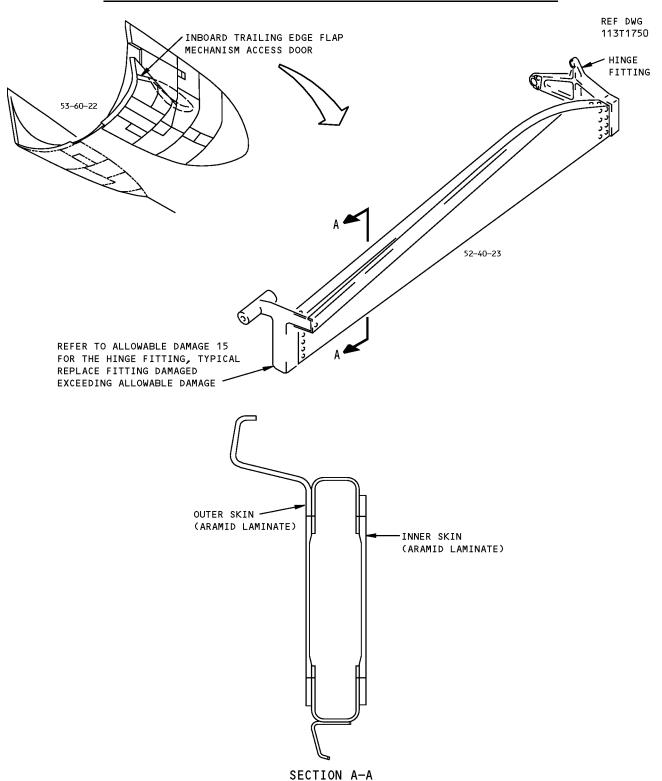
Inboard Trailing Edge Flap Mechanism Access Door Repair Figure 201 (Sheet 1 of 2)

REPAIR 15 - INBOARD TRAILING EDGE FLAP MECHANISM ACCESS DOOR

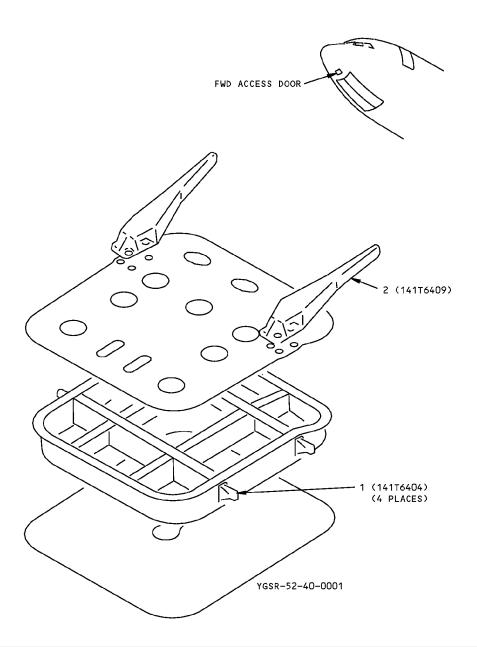
IDENTIFICATION 1 - FORWARD ACCESS DOOR FITTINGS

REF DWG 141T6401

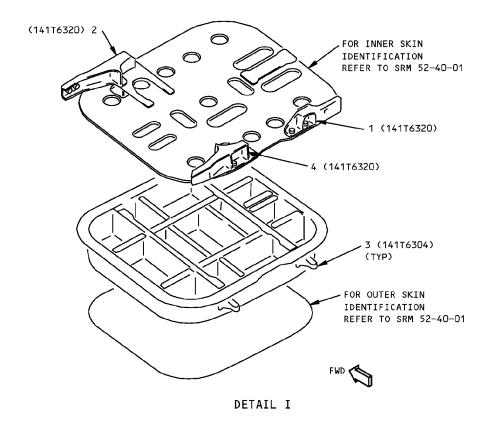
REF DWG 141T6301

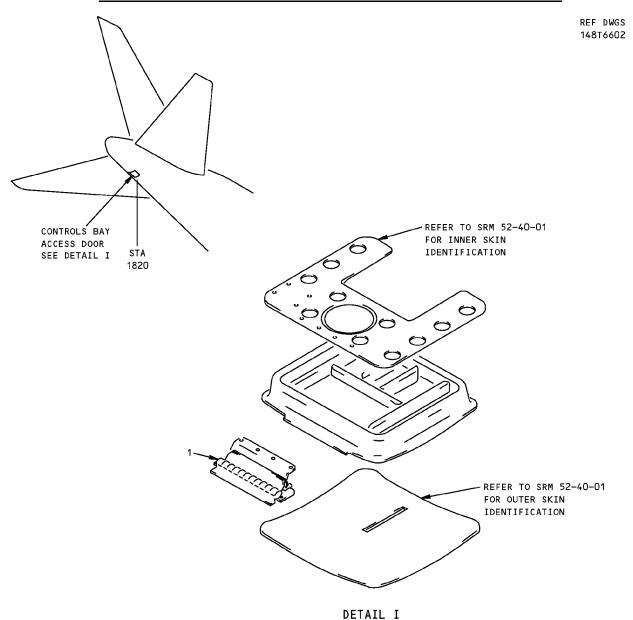
IDENTIFICATION 4 - CONTROLS BAY ACCESS DOOR STRUCTURE FITTINGS

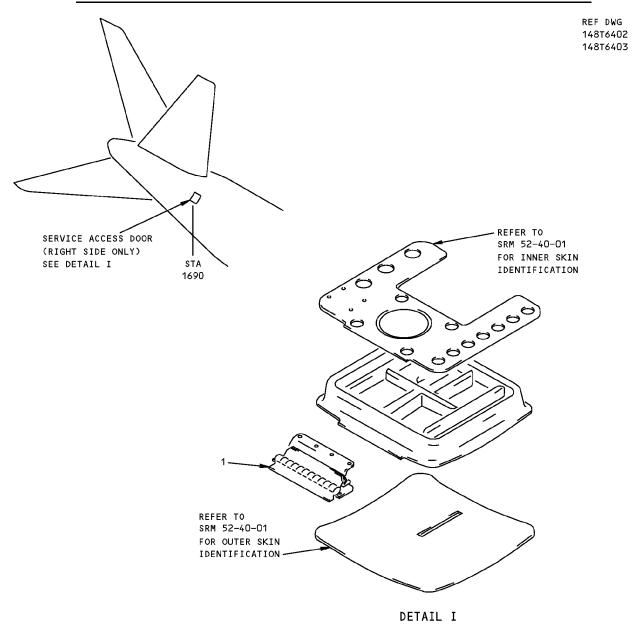
IDENTIFICATION 5 - SERVICE ACCESS DOOR STRUCTURE FITTINGS - STATION 1690

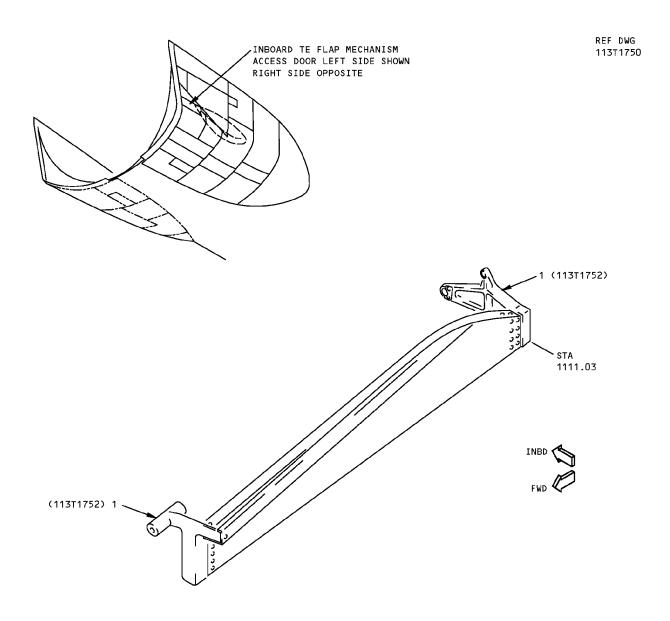
IDENTIFICATION 8 - INBOARD TRAILING EDGE FLAP MECHANISM ACCESS DOOR FITTINGS

ITEM	DESCRIPTION	GAGE	MATERIAL	EFFECTIVITY
1	HINGE FITTING		FORGING 7075-T73

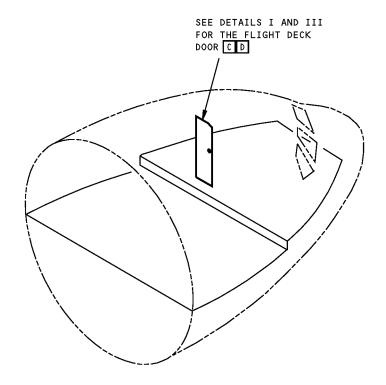
IDENTIFICATION 1 - FIXED INTERIOR DOOR

- ALL DIMENSIONS ARE IN INCHES
- A 320°F (160°C) CURE MATERIAL
- B 260°F (127°C) CURE MATERIAL
- FOR AIRPLANES WITHOUT AN ENHANCED SECURITY DOOR
- FOR AIRPLANES WITH AN ENHANCED SECURITY DOOR (REFERENCE: BOEING CONFIGURATION A AND B)

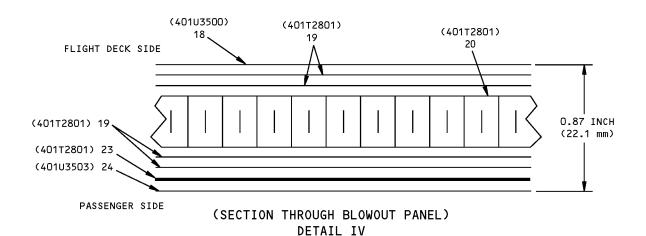
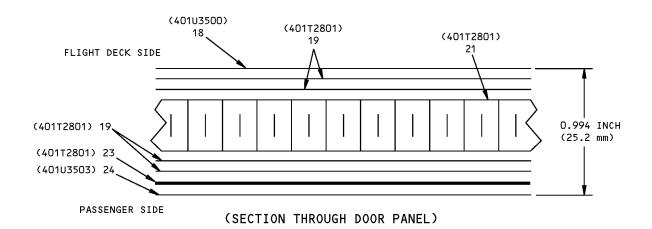
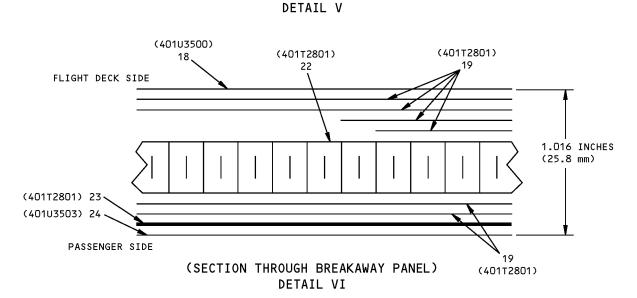
Flight Deck Door Identification Figure 1 (Sheet 5 of 6)

ITEM	DESCRIPTION	GAGE	MATERIAL	EFFECTIVITY
1	TRIM RING	0.160	AMS-T-9046, Ti-6AL-4V, CONDITION A	
2	ARMOR PLATE	0.160	AMS-T-9046, Ti-6AL-4V, CONDITION A, PLATE	
3	LOWER GRILL	0.250	2024-T351 PLATE	
4	UPPER GRILL	0.250	2024-T351 PLATE	
5	ARMOR PLATE	0.160	AMS-T-9046, Ti-6AL-4V, CONDITION A, PLATE	
6	UPPER TRIM	0.050	7075-T62 BARE SHEET	
7	LOWER BREAKAWAY BRACKET		7075-T7351 PLATE	
8	UPPER BREAKAWAY BRACKET		7075-T7351 PLATE	
9	KICK PLATE	0.032	7075-T6 BARE SHEET	
10	LOWER INTERNAL ARMOR PLATE	0.100	AMS-T-9046, Ti-6AL-4V, CONDITION A, SHEET	
11	LOWER TRIM	0.050	7075-T62 BARE SHEET	
12	LOWER ARMOR PLATE	0.080	AMS-T-9046, Ti-6AL-4V, CONDITION A, SHEET	
13	HINGE CHANNEL	0.050	7075-T62 BARE SHEET	
14	LATCH CHANNEL	0.050	7075-T62 BARE SHEET	
15	COVER PLATE	0.500	AMS-T-9046, Ti-6AL-4V, CONDITION A, PLATE	
16	VIEWER		C AND D AEROSPACE	
17	HINGE		2024-T3511	
18	DECORATIVE SURFACE (FLIGHT DECK SIDE)		BMS 5-91, TYPE IV; BMS 8-254,TYPE V, CLASS IV; BMS 8-356, TYPE I, CLASS I, GRADE 0.7, FORM B, FILM

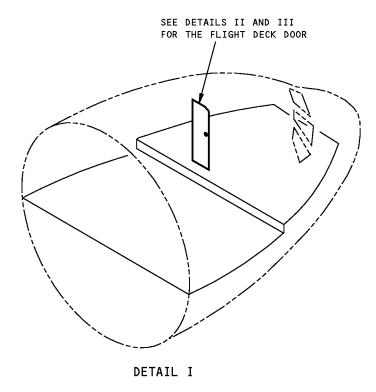
Flight Deck Door Allowable Damage Figure 101 (Sheet 1 of 3)

ALLOWABLE DAMAGE 1 - FIXED INTERIOR DOOR

- FOR THE DOORS IN DETAIL II, ANY AMOUNT OF DAMAGE TO THE STRUCTURE IS PERMITTED UP TO THE LIMITS SPECIFIED IN A, PROVIDED THAT THE FUNCTIONAL UTILITY OF THE DOOR IS NOT IMPAIRED B.
- FOR THE DOORS IN DETAIL III, NO DAMAGE TO THE STRUCTURE IS PERMITTED EXCEPT C AND D. ALSO, THE FUNCTIONAL UTILITY OF THE DOOR MAY NOT BE IMPAIRED B.
- REFER TO SRM 51-10-02 FOR THE INSPECTION AND REMOVAL OF DAMAGE.
- FOR REWORKED ALUMINUM SURFACES, APPLY A CHEMICAL CONVERSION COATING AS GIVEN IN SRM 51-20-01.
- REFINISH REWORKED AREAS AS GIVEN IN AMM 51-20-00.
- A REFER TO AMM 25-00-00 FOR THE REPAIR OF NICKS AND SCRATCHES; FOR GOUGES NOT EXCEEDING 1.5 INCHES (38 mm); AND FOR REPAIRS TO BMS 8-133 URETHANE FOAM.

- B MAINTAIN THE FOLLOWING FUNCTIONAL REQUIREMENTS: DEPRESSURIZATION FEATURE, EMERGENCY EXIT FEATURE, ELECTRIC AND KEYED DOOR LOCK FUNCTION. REFER TO AMM 52-51-00.
- C NICKS, GOUGES AND SCRATCHES ON THE EXTERNAL SURFACE AREAS AS SHOWN WITH SHADED AREAS IN DETAIL III ARE PERMITTED TO A MAXIMUM DEPTH OF 0.020 INCH (0.508 mm)
- D DAMAGE TO THE DECORATIVE LAMINATE IS PERMITTED. REFER TO AMM 25-00-00 FOR THE DECORATIVE LAMINATE REMOVAL/INSTALLATION INSTRUCTIONS. IF THE DECORATIVE LAMINATE IS REMOVED, BEFORE INSTALLATION OF THE NEW DECORATIVE LAMINATE, DO A DETAILED VISUAL INSPECTION OF THE KEVLAR BALLISTIC SHIELD TO MAKE SURE THAT NO OTHER DAMAGE HAS OCCURED. REPLACE THE DOOR IF THERE IS ANY DAMAGE TO THE BALLISTIC SHIELD.
- E DAMAGE IS NOT PERMITTED ON TITANIUM, KEVLAR AND SOME ALUMINUM COMPONENTS.

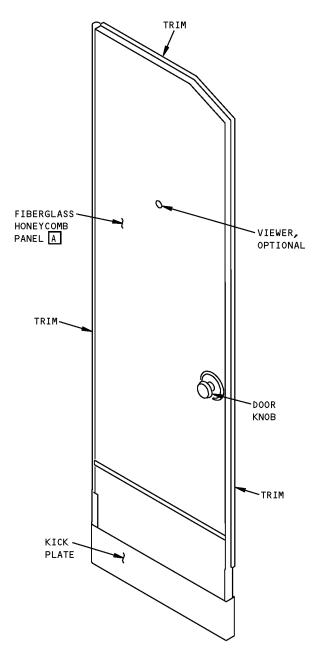
Flight Deck Door Allowable Damage Figure 101 (Sheet 2 of 3)

(TYPICAL FIBERGLASS DOOR)
DETAIL II

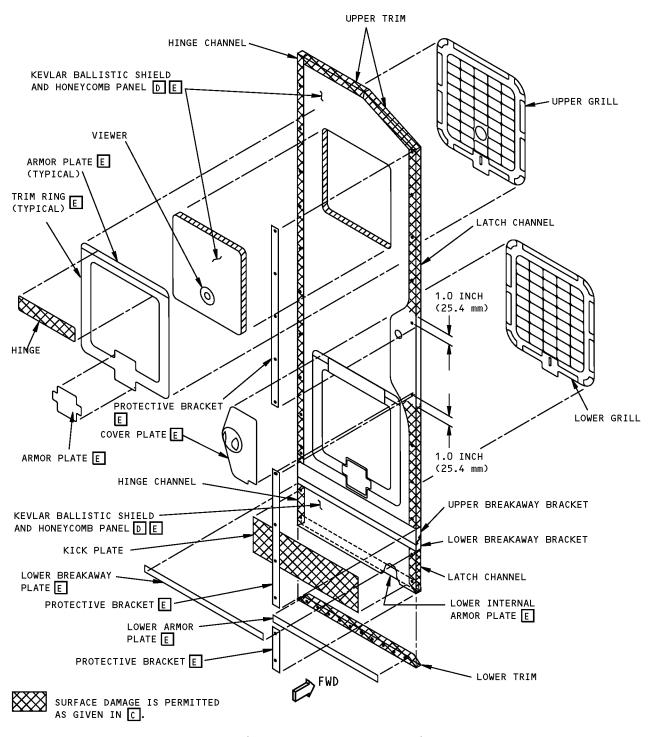
Flight Deck Door Allowable Damage Figure 101 (Sheet 3 of 3)

(ENHANCED SECURITY DOOR)
DETAIL III

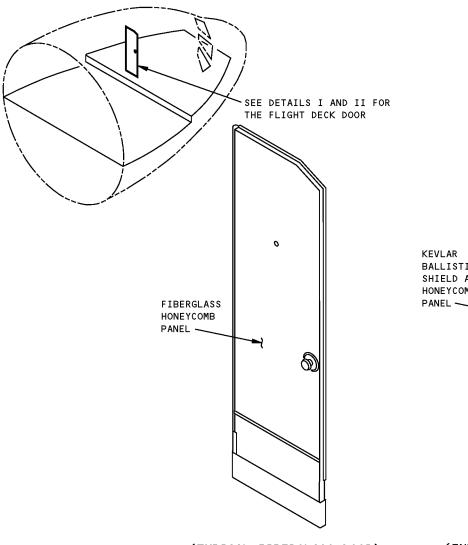
Flight Deck Door Repair Figure 201

REPAIR 1 - FLIGHT DECK DOOR

(ENHANCED SECURITY DOOR)
DETAIL II

• REPAIRS TO THE KEVLAR BALLISTIC SHIELD OF THE DOORS SHOWN IN DETAIL II ARE NOT PERMITTED. DAMAGE TO THE DECORATIVE LAMINATE IS PERMITTED. REFER TO AMM 25-00-00 FOR THE DECORATIVE LAMINATE REMOVAL/INSTALLATION INSTRUCTIONS. IF THE DECORATIVE LAMINATE IS REMOVED, BEFORE INSTALLATION OF THE NEW DECORATIVE LAMINATE, DO A DETAILED VISUAL INSPECTION OF THE KELVAR BALLISTIC SHIELD TO MAKE SURE THAT NO OTHER DAMAGE HAS OCCURED. REPLACE THE DOOR IF THERE IS ANY DAMAGE TO THE BALLISTIC SHIELD. CONTACT THE BOEING COMPANY FOR MORE INFORMATION.

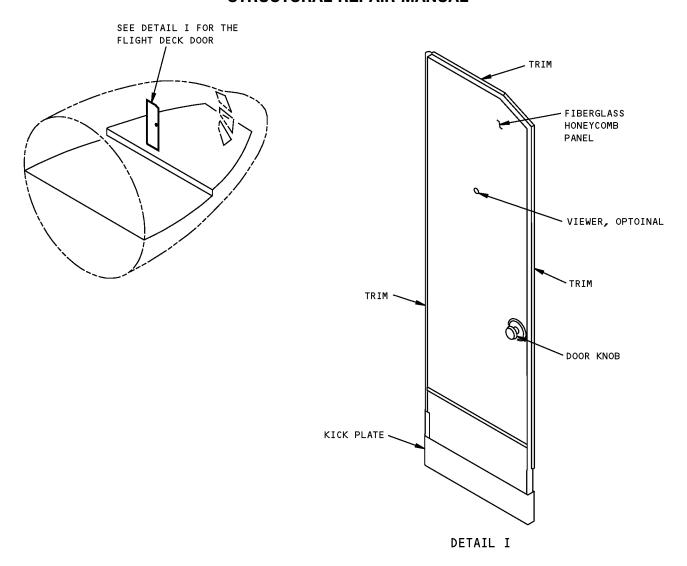
Flight Deck Door Repair - Fiberglass Panels Figure 201 (Sheet 2 of 4)

- Refer to AMM 25-00-00 for the repair of nicks and scratches, for the gouges not exceeding 1.5 inches, and for the repairs to BMS 8-133 urethane foam.
- Refer to SRM 51-70-06, Figure 19 for the repair of cracks up to 6.0 inches. Restore the decorative surface as given in AMM 25-00-00.
- 3. Refer to Details II and III for the repair to BMS 8-143 and BMS 8-151 fiberglass plies and for the repair to NOMEX honeycomb core. Use BMS 9-3 Type H-2 or Type H-3 glass fabric. Extra plies are not required. Restore the decorative surface as given in AMM 25-00-00.

NOTE: The total repaired surface area must not exceed 100 square inch. If the repair area is larger than 100 square inch, you must replace the door panel.

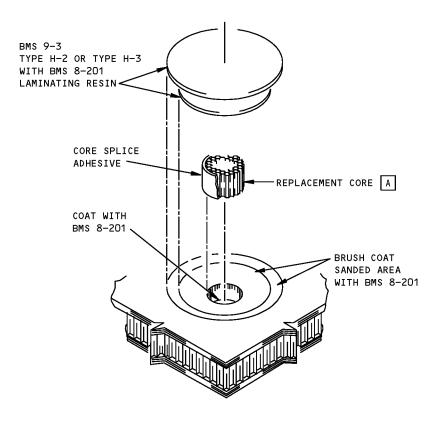
Flight Deck Door Repair - Fiberglass Panels Figure 201 (Sheet 3 of 4)

REPAIR OF DAMAGE TO ONE PANEL SIDE DETAIL II

PASSENGER SIDE

SECTION THRU REPAIR

- REFER TO SRM 51-70-06 FOR THE CLEANUP OF DAMAGE AND THE WET LAYUP CURE PROCEDURE.
- A CELL WALLS MUST BE ALIGNED IN THE SAME DIRECTION AS THE ORIGINAL HONEYCOMB

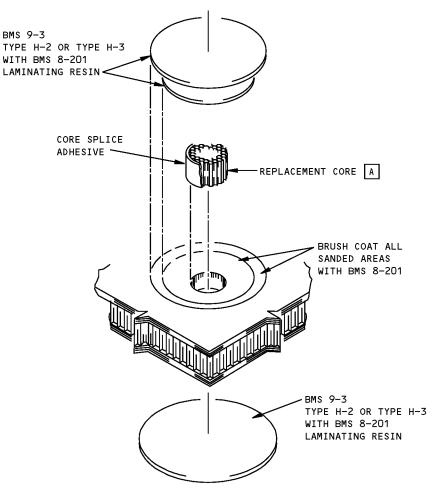
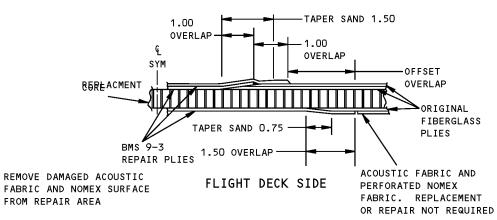
Flight Deck Door Repair - Fiberglass Panels Figure 201 (Sheet 4 of 4)

REPAIR OF DAMAGE TO BOTH PANEL SIDES
DETAIL III

PASSENGER SIDE

SECTION THRU REPAIR

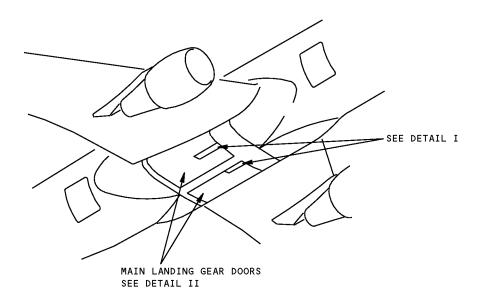
IDENTIFICATION 1 - MAIN LANDING GEAR DOOR

- A PLY ORIENTATION CONVENTION, DEGREES INDICATED IS PARALLEL TO THE FABRIC WARP DIRECTION
- B ARAMID/EPOXY FABRIC PER BMS 8-219, STYLE 120, 250°F (121°C) CURE
- C GRAPHITE/EPOXY FABRIC PER BMS 8-168, TYPE II, CLASS 2, STYLE 3K-70-PW, 250°F (121°C) CURE

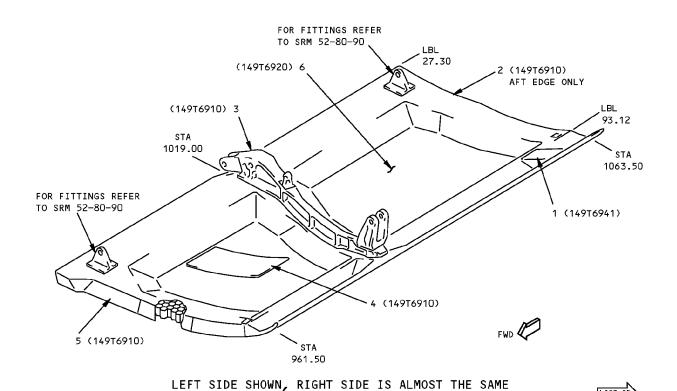
Main Landing Gear Door Identification Figure 1 (Sheet 2 of 3)

DETAIL II

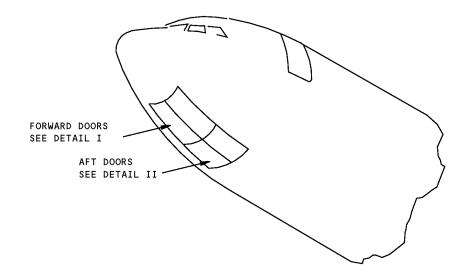
IDENTIFICATION 2 - NOSE LANDING GEAR DOOR

- A PLY ORIENTATION CONVENTION, DEGREES INDICATED IS PARALLEL TO THE FABRIC WARP DIRECTION
- B MATERIAL AND PLY ORIENTATION SHOWN FOR FIELD AREAS ONLY. SEE BOEING DRAWINGS FOR EDGE BAND AND AREAS WITH DOUBLERS
- FIBERGLASS/EPOXY FABRIC PER BMS 8-169, STYLE 120, 275°F (135°C) CURE
- D GRAPHITE/EPOXY FABRIC PER BMS 8-258, CLASS 2, STYLE 3K-70-PW, 275°F (135°C) CURE

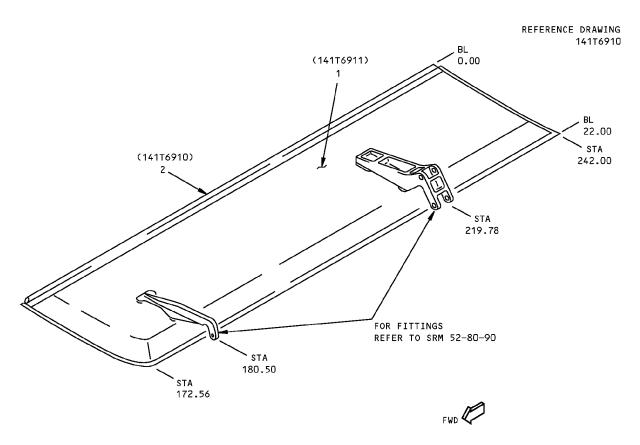
LEFT SIDE IS SHOWN, RIGHT SIDE IS EQUIVALENT FORWARD DOOR DETAIL I

ITEM	DESCRIPTION	GAGE	MATERIAL	EFFECTIVITY
1	DOOR PANEL SKIN CORE		FIBERGLASS/GRAPHITE/EPOXY HONEYCOMB SANDWICH SEE DETAIL III NONMETALLIC HONEYCOMB AS GIVEN IN BMS 8-124, CLASS I, TYPE I, GRADES 4.0 AND 12.0	
2	SEAL ASSEMBLY SEAL SEAL RETAINER	0.040	BAC 1530-44 G , OR BAC 1530-212 H CLAD 2024-T42	σН

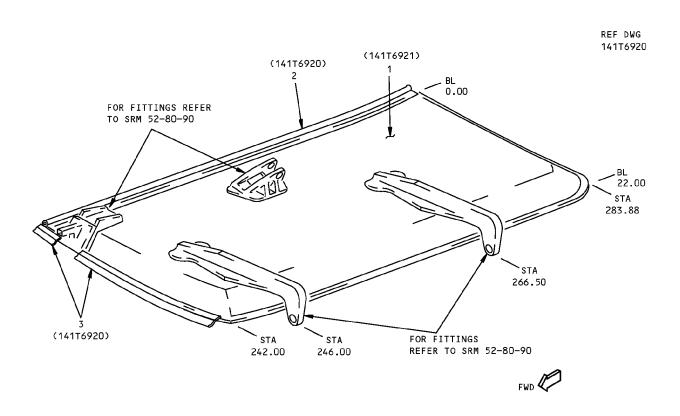
LEFT SIDE IS SHOWN, RIGHT SIDE IS EQUIVALENT AFT DOOR DETAIL II

ITEM	DESCRIPTION	GAGE	MATERIAL	EFFECTIVITY
1	DOOR PANEL SKIN CORE		FIBERGLASS/GRAPHITE/EPOXY HONEYCOMB SANDWICH SEE DETAIL IV NONMETALLIC HONEYCOMB AS GIVEN IN BMS 8-124, CLASS I,TYPE I, GRADES 4.0 AND 12.0	
2	SEAL ASSEMBLY SEAL SEAL RETAINER	0.040	BAC1530-44 CLAD 2024-T42 CLAD SHEET AS GIVEN IN QQ-A-250/5	
3	SEAL ASSEMBLY SEAL SEAL RETAINER	0.050	BAC1530-109 CLAD 2024-T3

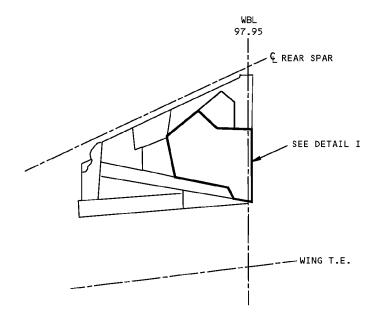
REF DWG 113T8201

IDENTIFICATION 3 - SHOCK STRUT DOOR

- A PLY ORIENTATION CONVENTION DEGREES INDICATED IS PARALLEL TO THE FABRIC WARP DIRECTION
- B MATERIAL AND PLY ORIENTATION SHOWN FOR FIELD AREAS ONLY. SEE BOEING DRAWINGS FOR EDGE BAND AND AREAS WITH DOUBLERS
- GRAPHITE/EPOXY FABRIC PER BMS 8-168, TYPE II, CLASS 2 STYLE 3K-70-PW, 250°F (121°C) CURE
- D GRAPHITE/EPOXY TAPE PER BMS 8-168, CLASS I, TYPE II, GRADE 190, 250°F (121°C) CURE
- FIBERGLASS/EPOXY FABRIC PER BMS 8-79, TYPE 120, 250°F (121°C) CURE
- F NONMETALLIC HONEYCOMB CORE PER BMS 8-124, CLASS I, TYPE I, GRADE 12.0

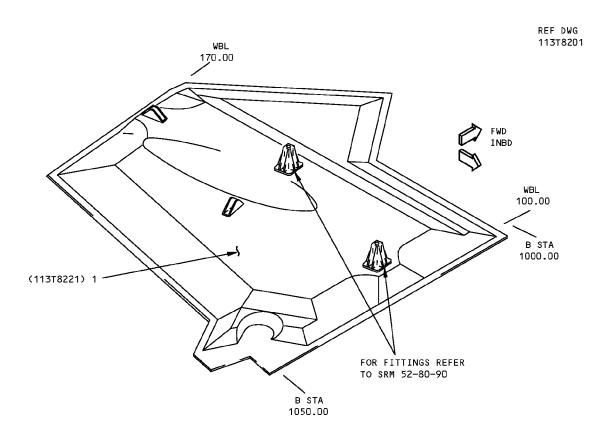
DETAIL I

ITEM	DESCRIPTION	GAGE	MATERIAL	EFFECTIVITY
1	DOOR PANEL SKIN CORE		GRAPHITE/EPOXY, FIBERGLASS HONEYCOMB SANDWICH SEE DETAIL II NOMEX HONEYCOMB PER BMS 8-124, CLASS IV, TYPE V, GRADE 3.0 (EXCEPT WHERE INDICATED IN DETAIL II)

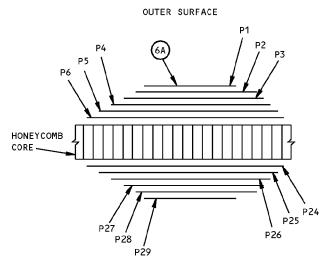
INNER SURFACE

SECTION THRU HONEYCOMB DOOR PANEL ITEM NO. 6A

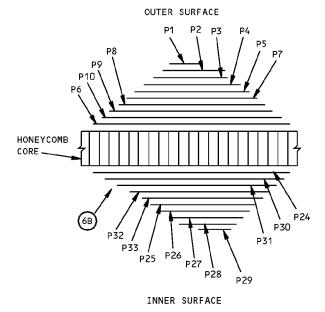
SECTION THRU HONEYCOMB DOOR PANEL ITEM NO. 6B

SECTIONS THRU HONEYCOMB DOOR PANEL DETAIL II
