CHAPTER 52 DOORS

- A. This chapter contains information about the passenger/crew entry doors (both sides), escape hatches, cargo doors (forward and aft including optional forward large cargo door and bulk cargo door), service doors (elec/elex access door, ram air turbine access door, potable water access door, controls bay access door, service access door, waste disposal access door, forward access door and auxiliary power unit access door) and landing gear doors.
- B. All major structural components are located and identified through the use of detailed illustrations with corresponding tabulated material lists.
- C. Allowable damage to doors is defined in this chapter.
- D. Approved repairs are described and illustrated in this chapter.

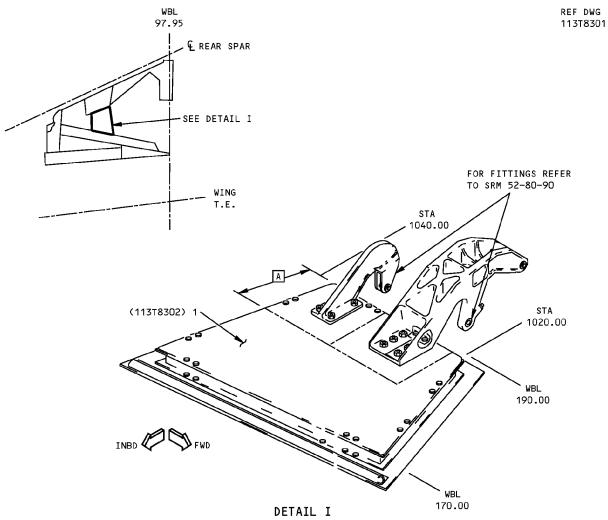
IDENTIFICATION 4 - TRUNNION DOOR

- A HEAVIER DENSITY HONEYCOMB CORES
 INSTALLED IN AREAS UNDER FITTINGS
- B THE SKIN IS CHEM-MILLED AND VARIES IN THICKNESS.
 REFER TO THE BOEING DRAWING TO DETERMINE THE LOCAL
 THICKNESS

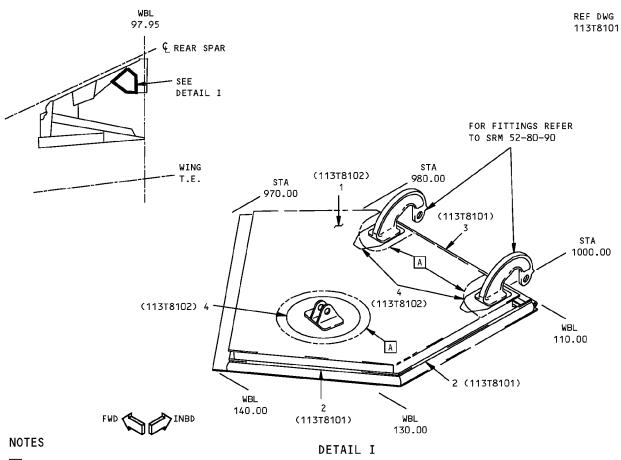
IDENTIFICATION 5 - DRAG STRUT DOOR

A HEAVIER DENSITY HONEYCOMB CORES
INSTALLED IN AREAS UNDER FITTINGS

ITEM	DESCRIPTION	GAGE	MATERIAL	EFFECTIVITY
1	DOOR PANEL ASSY OUTER SKIN CORE	0.080	CLAD 2024-T3 ALUMINUM HONEYCOMB PER BMS 4-4 3-10N	
	INNER SKIN	0.025	2024-T3	
2	SEAL RETAINER		BAC1510-1074 2024-T3511	
3	SEAL RETAINER		BAC1512-330 2024-T3511	
4	DOUBLER	0.025	2024-T3

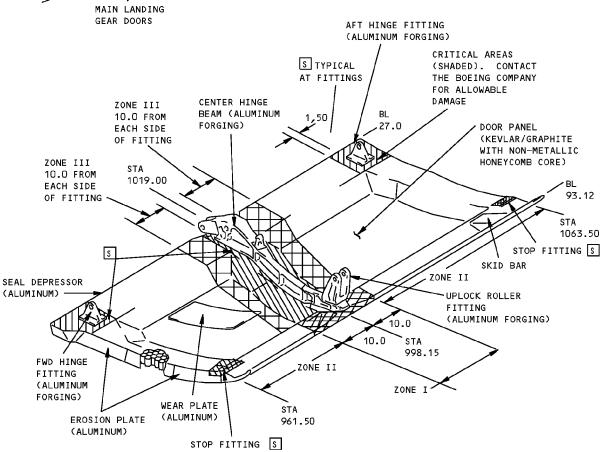
Main Landing Gear Door Allowable Damage Figure 101 (Sheet 1 of 6)

ALLOWABLE DAMAGE 1 - MAIN LANDING GEAR DOOR

ITEMS		CRACKS	NICKS, GOUGES AND CORROSION	DENTS	HOLES AND PUNCTURES	DELAMINATION
DOOR PANEL OUTBD EDGE		А	В		٥	
	OTHER EDGES (NORMAL TO CORE)		В	С	D	E
	FACE SKIN	V	В		D

- THESE ALLOWABLE DAMAGE LIMITS ARE FAA
 APPROVED CONTINGENT ON ACCOMPLISHMENT OF
 THE INSPECTIONS AT THE INTERVALS CONTAINED
 HEREIN
- REFER TO SRM 51-10-02 FOR INSPECTION AND REMOVAL OF DAMAGE
- REFER TO SRM 51-10-01 FOR AERODYNAMIC SMOOTH-NESS REQUIREMENTS. WHERE THE DAMAGE IS MORE THAN THE LIMITS SHOWN IN SRM 51-10-01, CONSIDERATION SHOULD BE GIVEN TO THE LOSS OF PERFORMANCE INVOLVED
- REFINISH REWORKED AREAS AS GIVEN IN SRM 51-20
- DAMAGE TO PANEL EDGES MAY BE CONFINED TO DELAMINATION OR MAY TAKE A FORM WHICH RE-SULTS IN DAMAGE TO FIBERS AND A LOSS OF EFFECTIVE CROSS-SECTIONAL AREA. THIS TYPE OF DAMAGE SHOULD BE REMOVED AND THE LIMITATIONS GIVEN FOR CRACKS APPLIED
- A CRACKS ARE NOT PERMITTED EXCEPT FOR EDGE CRACKS WHICH MUST BE REMOVED PER DETAILS II AND VI. PROTECT EDGE FROM DAMAGE PER W
- B DAMAGE IS PERMITTED ON SURFACE RESIN ONLY.

EDGE DAMAGE PER DETAILS II AND VI. W
- DENTS GENERALLY RESULT IN FIBER DAMAGE OR DELAMINATION. HOWEVER, PROVIDED THAT THERE IS NO FIBER DAMAGE OR DELAMINATION, DENTS UP TO 1.50 INCHES (38 mm) DIA MAX ARE PERMITTED. ONE DENT PER SQUARE FOOT OF AREA IS PERMITTED WHICH MUST BE A MINIMUM OF 6 INCHES (150 mm) FROM ANY OTHER DAMAGE, FASTENER HOLE, OR PANEL EDGE. IF FIBER DAMAGE OR DELAMINATION IS PRESENT, REFER TO APPLICABLE DAMAGE DATA IN TABLE

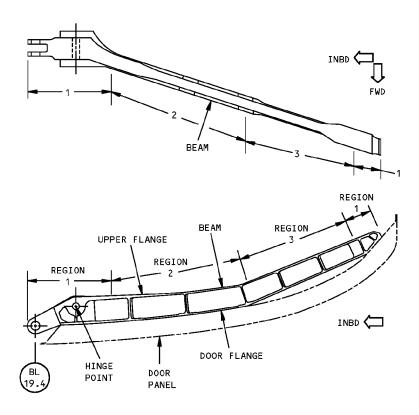
Main Landing Gear Door Allowable Damage Figure 101 (Sheet 2 of 6)

CENTER HINGE BEAM DETAIL I

ITEMS		CRACKS	NICKS, GOUGES AND CORROSION	DENTS	HOLES AND PUNCTURES
CENTER T HINGE BEAM (REGIONS DEFINED IN DETAIL I)	REGION 1	NOT ALLOWED	F		
	REGION 2	G	Н	NOT ALLOWED	NOT ALLOWED
	REGION 3	NOT ALLOWED	I		
FWD AND AFT HINGE		J	K	NOT ALLOWED	NOT ALLOWED
UPLOCK ROLLER FITTING T		J	L	NOT ALLOWED	NOT ALLOWED
EORSION PLATE		М	N	SEE DETAIL VIII	0
WEAR PLATE		M	NO RESTRICTIONS	SEE DETAIL VIII	NO RESTRICTIONS
SEAL DEPRESSOR		М	N	SEE DETAIL VIII	0
SKID BAR		M	P	Q	NO RESTRICTIONS

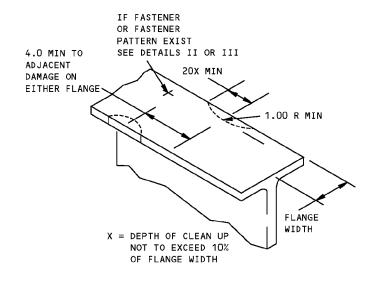
Main Landing Gear Door Allowable Damage Figure 101 (Sheet 5 of 6)

DETAIL V

- T FOR CORNER DAMAGE SEE DETAIL IX. CLEAN UP EDGE DAMAGE PER DETAIL V. NO OTHER DAMAGE IS PERMITTED
- J FOR EDGE CRACKS SEE DETAIL V. FOR CORNER CRACKS SEE DETAIL IX. OTHER CRACKS ARE NOT PERMITTED

- K CLEAN UP EDGE DAMAGE PER DETAIL V AND CORNER DAMAGE PER DETAIL IX. OTHER DAMAGE AS GIVEN IN DETAIL III
- L CLAN UP CORNER DAMAGE PER DETAIL IX. FOR FLANGE GOUGES SEE DETAIL III. NO OTHER DAMAGE IS PERMITTED

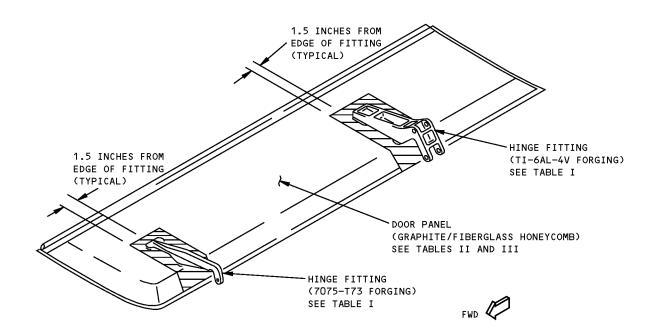
Nose Landing Gear Door Allowable Damage Figure 101 (Sheet 1 of 7)

FORWARD NOSE LANDING GEAR DOOR DETAIL I

ZONE I - CRITICAL AREA

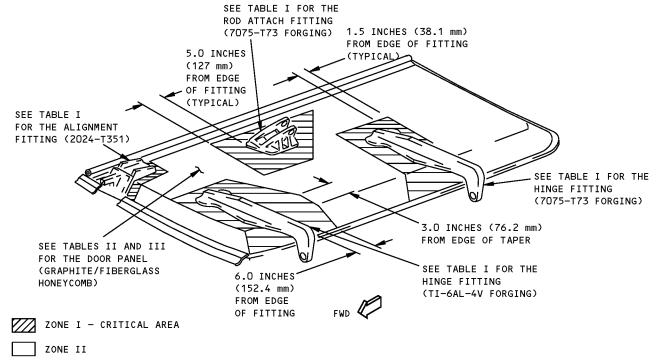
Nose Landing Gear Door Allowable Damage Figure 101 (Sheet 2 of 7)

AFT NOSE LANDING GEAR DOOR DETAIL II

ITEM		CRACKS	NICKS, GOUGES AND SCRATCHES	DENTS	PUNCTURES AND HOLES
FORWARD NOSE LANDING GEAR DOOR	HINGE FITTINGS	А	В	NOT PERMITTED	NOT PERMITTED
AFT	HINGE FITTINGS	А	В	NOT PERMITTED	NOT PERMITTED
NOSE LANDING GEAR DOOR	ROD ATTACH FITTINGS	A C	ВС	NOT PERMITTED	NOT PERMITTED
	ALIGNMENT FITTINGS	А	В	NOT PERMITTED	NOT PERMITTED

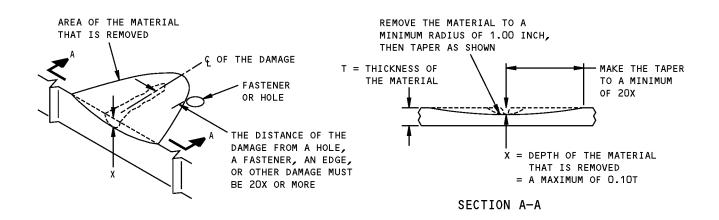
Nose Landing Gear Door Allowable Damage Figure 101 (Sheet 4 of 7)

REMOVAL OF DAMAGED MATERIAL ON A SURFACE DETAIL IV

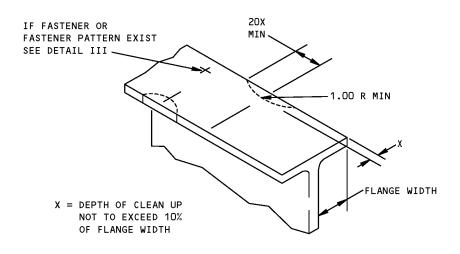
DETAIL V

- A CRACKS NOT PERMITTED. CLEAN UP EDGE
 DAMAGE PER DETAIL V AND CORNER DAMAGE AS
 GIVEN IN DETAIL VI. FOR DAMAGE AT A
 FASTENER LOCATION, SEE DETAIL III.

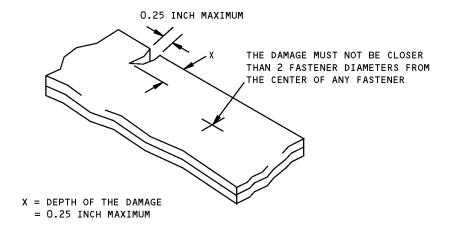
Nose Landing Gear Door Allowable Damage Figure 101 (Sheet 6 of 7)

REMOVAL OF DAMAGE ON AN EDGE DETAIL VIII

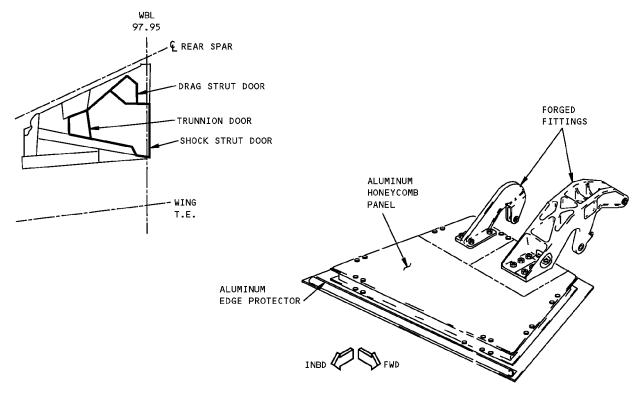
ALLOWABLE DAMAGE 3 - WING LANDING GEAR DOOR

TYPICAL ALUMINUM HONEYCOMB PANEL DOOR

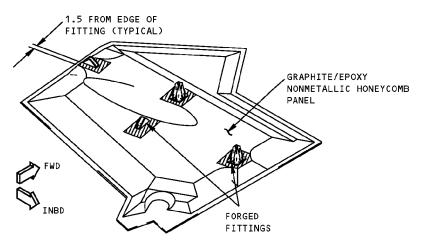
GRAPHITE/EPOXY NONMETALLIC HONEYCOMB
PANEL DOOR

NICKS, GOUGES AND SCRATCHES ARE PERMITTED THAT DO NOT DAMAGE THE FIBERS. ALL OTHER DAMAGE MUST BE REPAIRED.

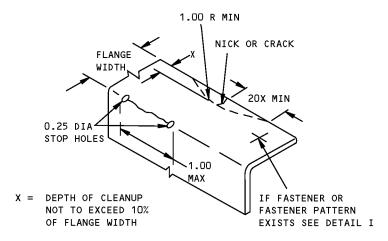
DETAIL VII (FORMED MEMBER)

Wing Landing Gear Door Allowable Damage Figure 101 (Sheet 5 of 5)

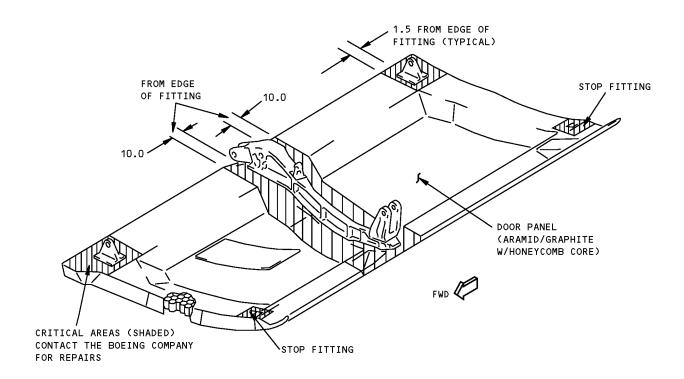
REPAIR 1 - MAIN LANDING GEAR DOOR

REF DWG 149T6910

Main Landing Gear Door Repair Figure 201 (Sheet 1 of 2)

INTERIM REPAIRS B		PERMANENT REPAIRS				
DAMAGE	WET LAYUP ROOM TEMP CURE (SRM 51-70-03)	WET LAYUP 150°F (66°C) CURE (SRM 51-70-03)	WET LAYUP 200°F (93°C) CURE (SRM 51-70-17)	250°F (121°C) CURE (SRM 51-70-05)			
CRACKS	UP TO 3.0 INCHES (75 mm) LONG, REPAIR WITH PATCH AS GIVEN IN SRM 51-70-03 A.	CLEAN UP DAMAGE AND REPAIR AS HOLE.	CLEAN UP DAMAGE AND REPAIR AS HOLE.	CLEAN UP DAMAGE AND REPAIR AS HOLE.			
HOLES	3.0 INCHES (75 mm) MAX DIA NOT TO EXCEED 30% OF SMALLEST DIMENSION OF HONEYCOMB PANEL AT THE DAMAGE LOCATION. FILL WITH BMS 5-28, TYPE 7 POTTING COMPOUND AND PATCH AS GIVEN IN SRM 51-70-03, A.	6.0 INCHES (150 mm) MAX DIA NOT TO EXCEED 50% OF SMALLEST DIMENSION OF HONEYCOMB PANEL AT THE DAMAGE LOCATION. USE TWO EXTRA PLIES FOR EACH FACESHEET REPAIRED A.	12.0 INCHES (300 mm) MAX DIA NOT TO EXCEED 50% OF SMALLEST DIMENSION OF HONEYCOMB PANEL AT THE DAMAGE LOCATION. USE TWO EXTRA PLIES FOR EACH FACESHEET REPAIRED.	NO SIZE LIMIT

- REFER TO 51-10-02 FOR INSPECTION AND REMOVAL OF DAMAGE.
- REFER TO 51-10-01 FOR AERODYNAMIC SMOOTH-NESS REQUIREMENTS. WHERE THE REPAIR IS MORE THAN THE LIMITS SHOWN IN SRM 51-10-01 CONSIDERATION SHOULD BE GIVEN TO THE LOSS OF PERFORMANCE INVOLVED.
- REFINISH REWORKED AREAS AS GIVEN IN AMM 51-21
- A MINIMUM SPACING (EDGE TO EDGE) SHALL BE 6.0 INCHES (150 mm) BETWEEN CORE REPAIRS.

B LIMITED TO REPAIR OF ONE FACESHEET SKIN AND HONEYCOMB CORE. INSPECT INTERIM REPAIR USING INSTRUMENTED NDT METHOS OR "TAP" TEST EVERY AIRPLANE "C" CHECK. FOR "TAP" TEST, USE A SOLID METAL DISK AND TAP THE REPAIR AREA LIGHTLY BUT FIRMLY. VOID AREAS WILL PRODUCE A DULL SOUND AS OPPOSED TO A SHARP RING ON A SOLID BONDED AREA. PERMANENT REPAIR IS REQUIRED IF ANY DETERIORATION IS EVIDENT. REFER TO SRM 51-70-03, PAR. 4.I. AND THE NONDESTRUCTIVE TEST MANUAL, D634T301. THIS REPAIR HAS FAA APPROVAL CONTINGENT ON ACCOMPLISHMENT OF THE INSPECTIONS AT THE INTERVALS CONTAINED HEREIN.

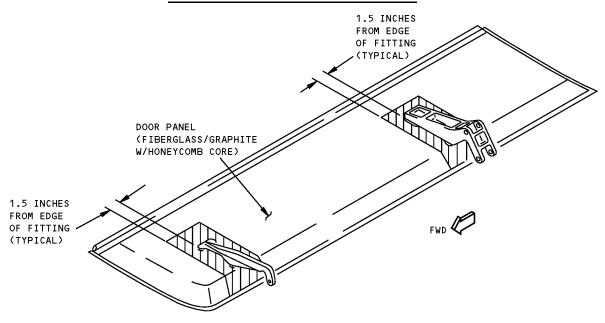
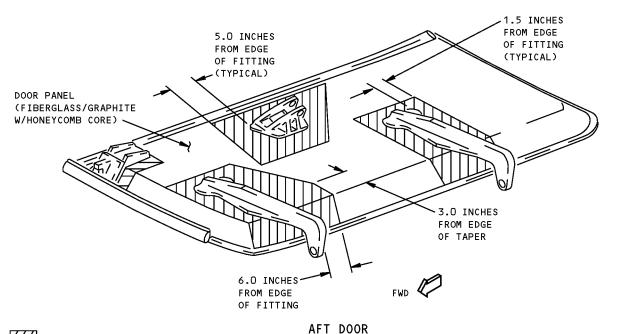
REPAIR 2 - NOSE LANDING GEAR DOOR

FORWARD DOOR

ZONE I - CRITICAL AREA
SEE TABLE I FOR REPAIRS TO THE HONEYCOMB
AREA. SEE TABLE II FOR REPAIRS TO THE
EDGEBAND AREAS

ZONE II
SEE TABLE III FOR REPAIRS TO THE
HONEYCOMB AREAS. SEE TABLE IV FOR
REPAIRS TO THE EDGEBAND AREAS

Nose Landing Gear Door Repair Figure 201 (Sheet 1 of 6)

- NOSE LANDING GEAR DOOR SKINS ARE MADE FROM BMS 8-169 AND BMS 8-258 MATERIALS WHICH ARE 275°F (135°C) CURE MATERIALS. THESE CAN BE REPAIRED WITH 250°F (121°C) CURE MATERIALS, BMS 8-79 AND BMS 8-168.

- A LIMITED TO REPAIR OF DAMAGE TO ONE FACE—
 SHEET SKIN AND HONEYCOMB CORE. KEEP THE
 REPAIR A MINIMUM OF 6.0 INCHES (150 mm)
 (EDGE TO EDGE) FROM ANY OTHER DAMAGE OR
 REPAIRS.

- B INSPECT INTERIM REPAIR USING INSTRUMENTED NDT METHODS OR "TAP" TEST AT THE NEXT AIRPLANE "A" CHECK. CONTINUE TO INSPECT THE REPAIR AT EVERY SUBSEQUENT AIRPLANE "C" CHECK. FOR "TAP" TEST, USE A SOLID METAL DISK AND TAP THE REPAIR AREA LIGHTLY BUT FIRMLY. VOID AREAS WILL PRODUCE A DULL SOUND AS OPPOSED TO A SHARP RING ON A SOLID BONDED AREA. PERMANENT REPAIR IS REQUIRED IF ANY DETERIORATION IS EVIDENT. REFER TO SRM 51-70-03, PAR. 4.1. AND THE NONDESTRUCTIVE TEST MANUAL, D634T301.

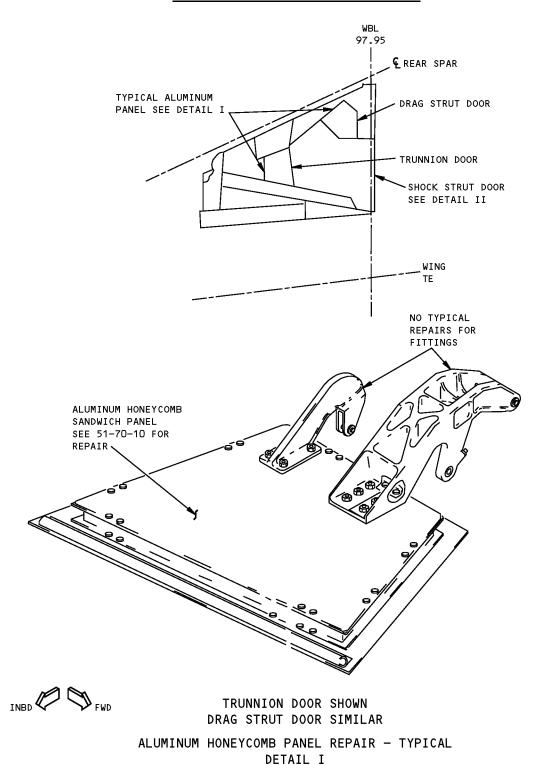
REPAIR 3 - WING LANDING GEAR DOOR

Wing Landing Gear Door Repair Figure 201 (Sheet 1 of 3)

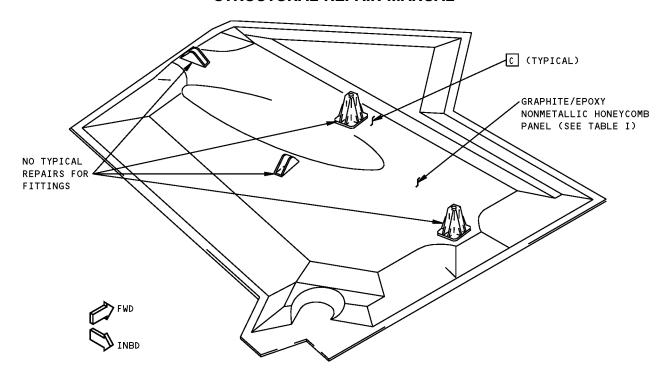
SHOCK STRUT DOOR DETAIL II

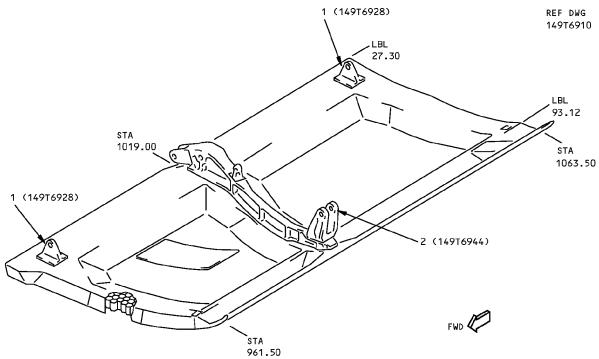
IDENTIFICATION 1 - MAIN LANDING GEAR DOOR FITTINGS

LEFT SIDE SHOWN RIGHT SIDE SIMILAR DETAIL I

ITEM	DESCRIPTION	GAGE	MATERIAL	EFFECTIVITY
1 2	HINGE FITTING UPLOCK FITTING		FORGING 7075-T73 FORGING 7075-T73

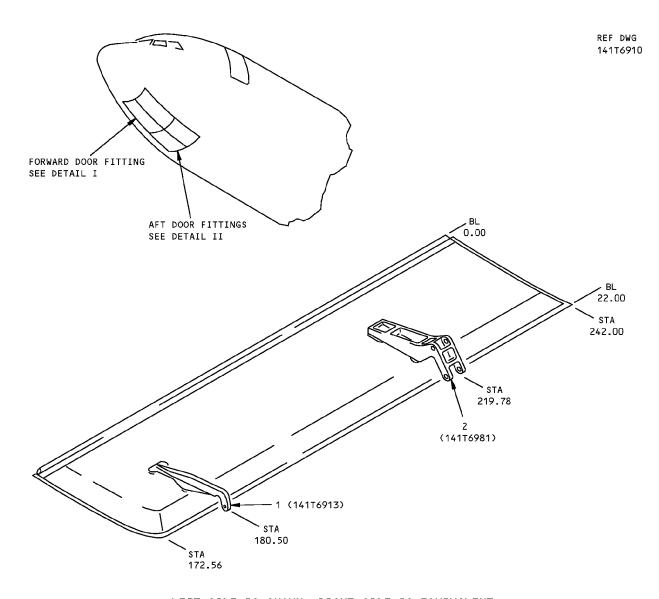
IDENTIFICATION 2 - NOSE LANDING GEAR DOOR FITTINGS

LEFT SIDE IS SHOWN, RIGHT SIDE IS EQUIVALENT FORWARD DOOR DETAIL I

ITEM	DESCRIPTION	GAGE	MATERIAL	EFFECTIVITY
1	HINGE		FORGING 7075-T73	
2	HINGE		FORGING TI-6AL-4V

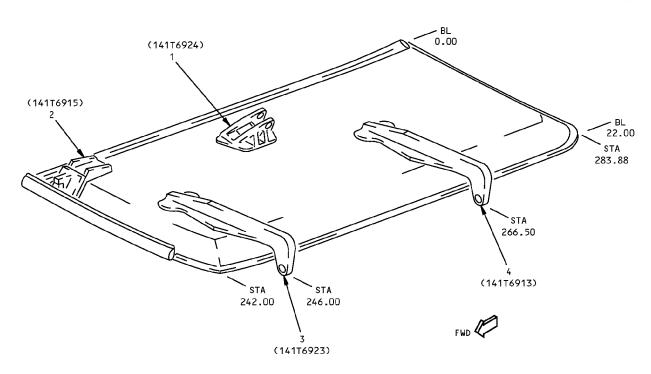
REF DWG 141T6920

LEFT SIDE IS SHOWN, RIGHT SIDE IS EQUIVALENT

AFT DOOR

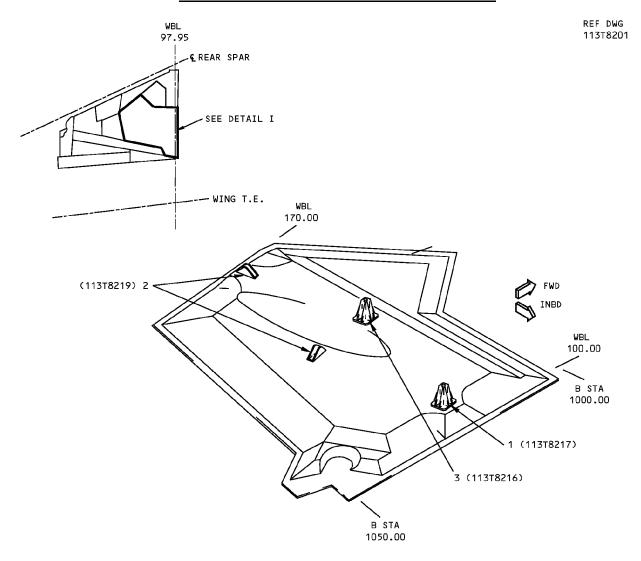
IDENTIFICATION 3 - SHOCK STRUT DOOR FITTINGS

DETAIL I

ITEM	DESCRIPTION	GAGE	MATERIAL	EFFECTIVITY
1	FITTING		FORGING 7075-T73 OPTIONAL: 7075-T7351 PLATE	
2	FITTING		FORGING 7075-T73	
3	FITTING		CASTING 356-T6 OPTIONAL: 6061-T651 PLATE

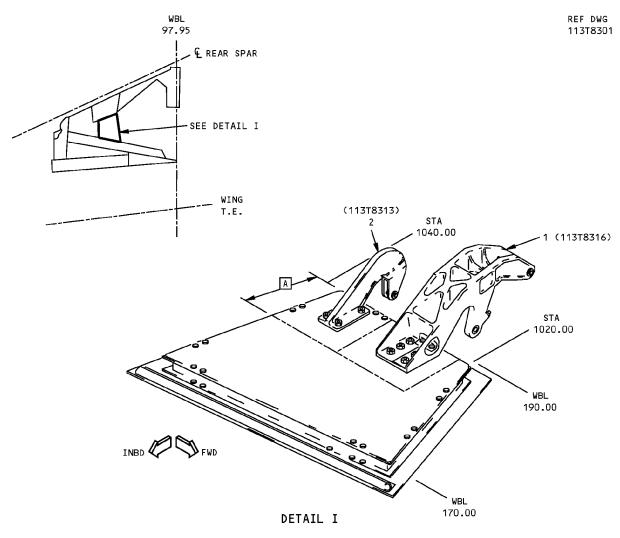
IDENTIFICATION 4 - TRUNNION DOOR FITTINGS

A HEAVIER DENSITY HONEYCOMB CORES
INSTALLED IN AREAS UNDER FITTINGS

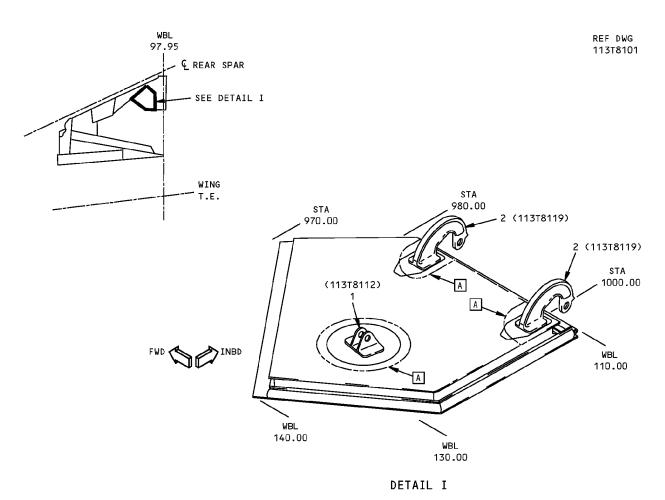
IDENTIFICATION 5 - DRAG STRUT DOOR FITTINGS

A HEAVIER DENSITY HONEYCOMB CORES INSTALLED IN AREAS UNDER FITTINGS
