767

NONDESTRUCTIVE TEST MANUAL

PART 4 - ULTRASONIC

FRONT SPAR EXTERNAL SURFACE ES 139.258 TO ES 212.702 (SKIN-TO-CORE)

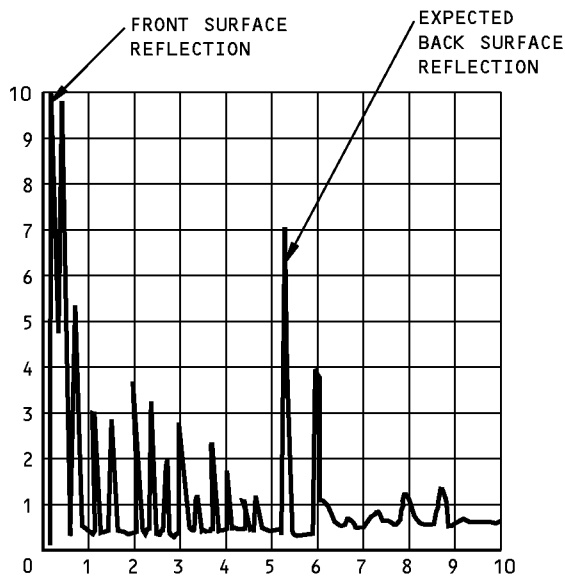
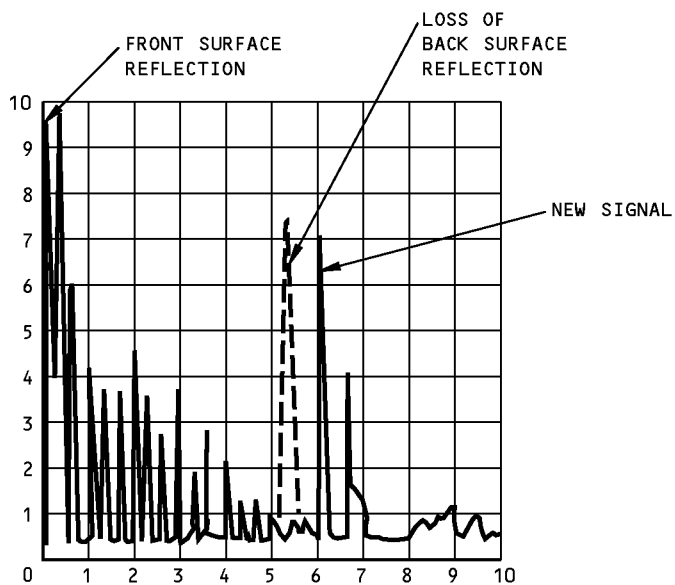
Signal Response Identification
Figure 3

EXPECTED SCREEN RESPONSE
DETAIL I

LAMINATE THICKNESS INCREASE RESPONSE
DETAIL II

- B. A signal response to the right of the expected signal indicates an increase in laminate thickness and is not considered a defect condition (Figure 3, Details I and II).

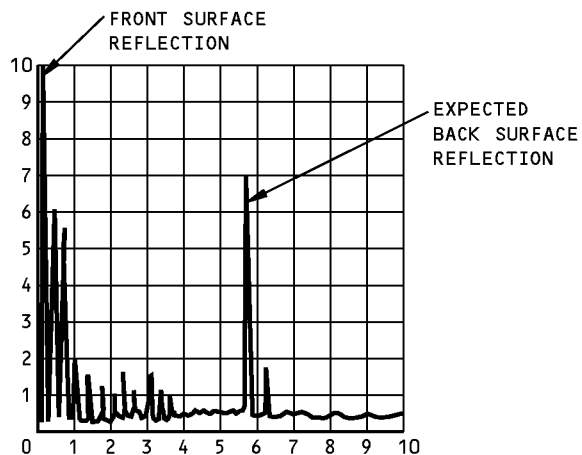
EXPECTED SCREEN RESPONSE
DETAIL I

- 80-100 PERCENT LOSS OF BACK SURFACE REFLECTION AMPLITUDE
- ACCOMPANYING SIGNALS MAY ALSO DECREASE

LOSS OF BACK SURFACE REFLECTION
DETAIL II

- NO IDENTIFIABLE BACK SURFACE REFLECTION WITH INCREASED INSTRUMENT GAIN

- (b) Multiple signals on the CRT screen indicate a fracture in the laminate. See Figure 4, Detail III.
- D. A signal response where back reflection drops below 20 percent of full screen height indicates a potential defect condition (Figure 5, Details I and II) which may be confirmed by the following:
