767

NONDESTRUCTIVE TEST MANUAL

PART 4 - ULTRASONIC

FRONT SPAR EXTERNAL SURFACE RS 106.142 TO RS 181.134 (SKIN-TO-CORE)

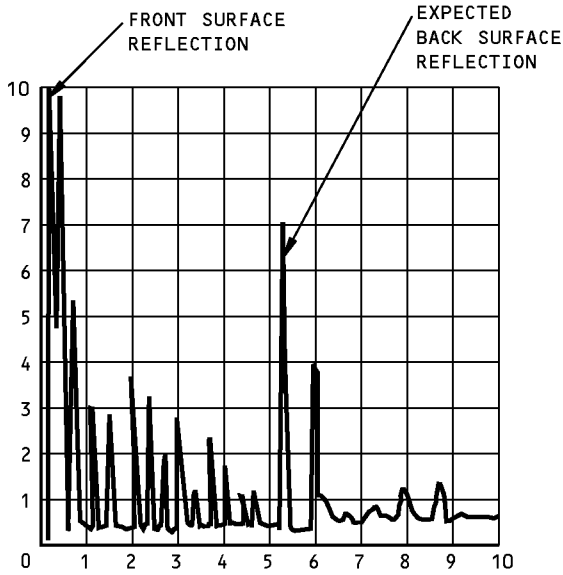
**Signal Response Identification
Figure 3**

**EXPECTED SCREEN RESPONSE
DETAIL I**

**LAMINATE THICKNESS INCREASE RESPONSE
DETAIL II**

- B. A signal response to the right of the expected signal indicates an increase in laminate thickness and is not considered a defect condition (Figure 3, Details I and II).

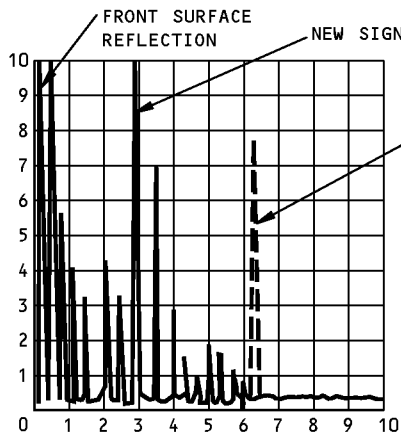
**Signal Response Identification
Figure 4**

**EXPECTED SCREEN RESPONSE
DETAIL I**

**DELAMINATION RESPONSE
DETAIL II**

**FRACTURE RESPONSE
DETAIL III**

- C. A signal response to the left of the expected signal, indicating a decrease in the laminate thickness not noted in Figure 1, is a defect condition. See Figure 4, Details I, II, and III.

- (a) A single signal to the left of the expected signal location indicates a delamination. Note depth by comparison with calibration guide response obtained at the same horizontal position along scope baseline. See Figure 4, Detail II.

- (b) Multiple signals on the CRT screen indicate a fracture in the laminate. See Figure 4, Detail III.
- D. A signal response where back reflection drops below 20 percent of full screen height indicates a potential defect condition (Figure 5, Details I and II) which may be confirmed by the following:

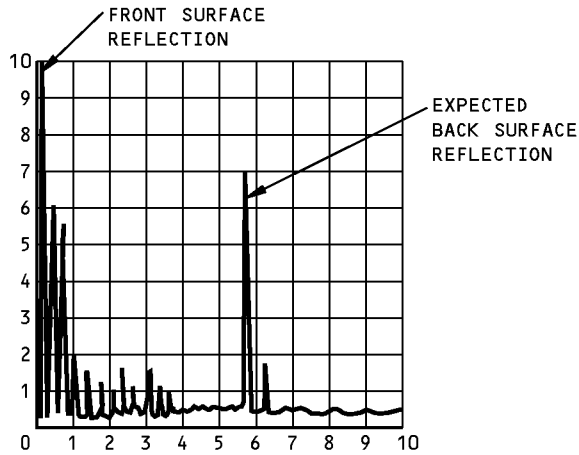
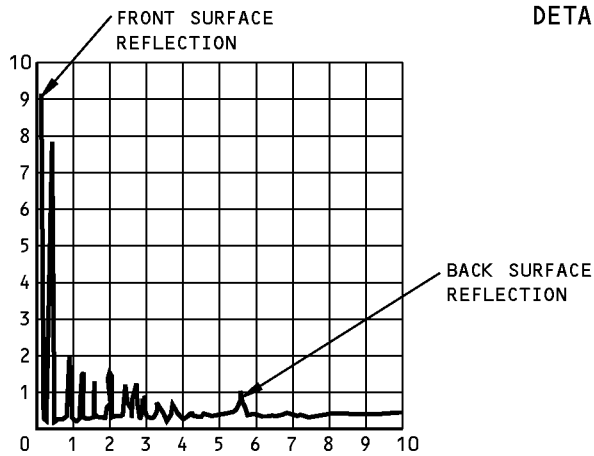
**EXPECTED SCREEN RESPONSE
DETAIL I**

- 80-100 PERCENT LOSS OF BACK SURFACE REFLECTION AMPLITUDE
- ACCOMPANYING SIGNALS MAY ALSO DECREASE

**LOSS OF BACK SURFACE REFLECTION
DETAIL II**

- NO IDENTIFIABLE BACK SURFACE REFLECTION WITH INCREASED INSTRUMENT GAIN

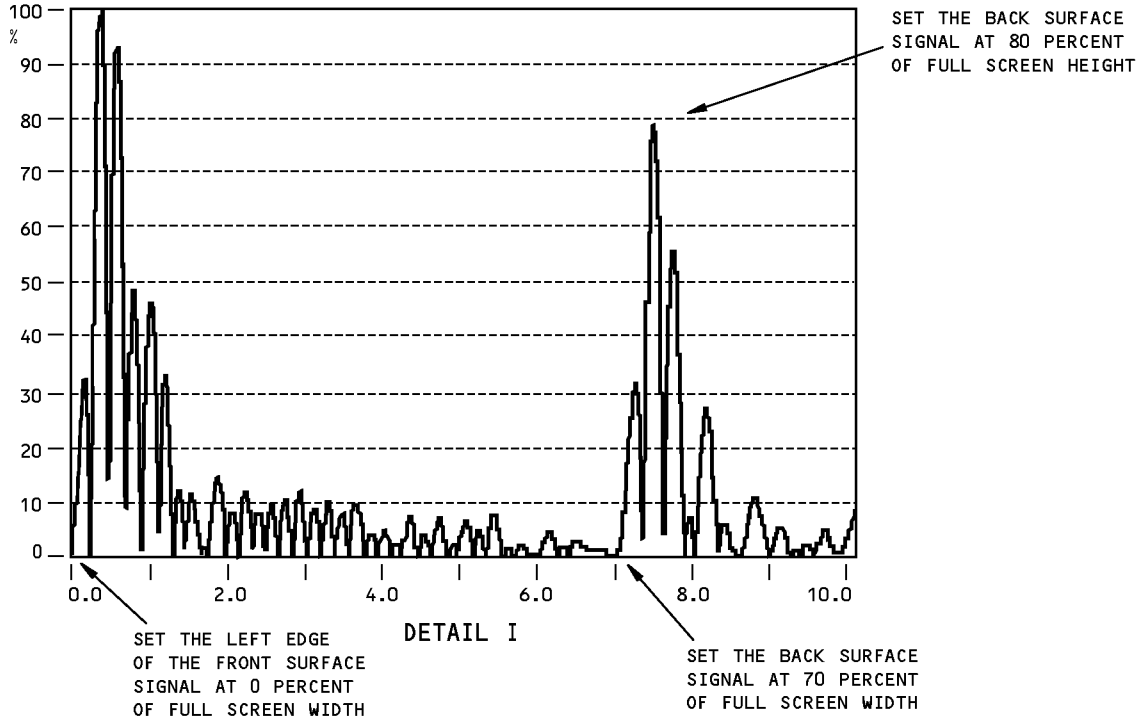
**Pulse Echo Instrument Calibration
Figure 2**

DO A CHECK TO MAKE SURE THAT THERE IS SEPARATION BETWEEN THE FRONT AND THE BACK SURFACE SIGNALS

BACK SURFACE SIGNAL FROM THE STEP OF THE CALIBRATION STANDARD THAT IS EQUAL TO THE MINIMUM SKIN THICKNESS TO BE EXAMINED

- (3) Place transducer on portion of the calibration guide closest to the maximum indicated skin thickness (see Figure 1 for laminate thickness values) of the inspection area.
- (4) Use the delay and range controls to position the front surface reflection at the left edge of screen and the back surface reflection at approximately 70 percent of screen width (see Figure 2, Detail I).

- (5) Adjust back surface signal level to 80 percent of full screen height (Figure 2, Detail I).
- (6) Place transducer on the ply step of the calibration guide that is as near as possible to minimum skin thickness to be examined. Fine tune the instrument adjustments to obtain optimum back surface resolution (Figure 2, Detail II).
- (7) Position transducer along calibration guide from the step equal to the maximum thickness to be inspected through all intermediate steps in the inspection. Make a note of the signal change that occurs when you move the transducer across a ply step.

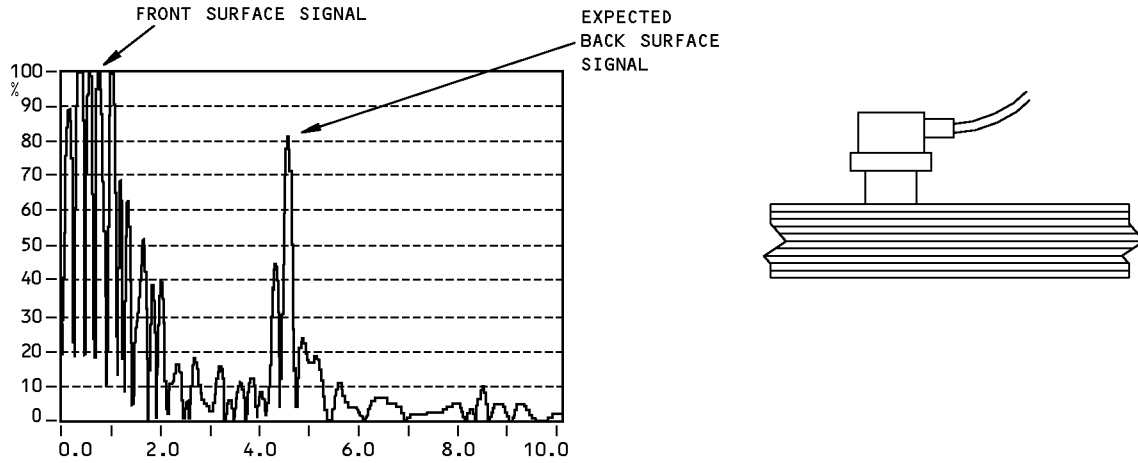
**Signal Response Identification
Figure 5**

**NEAR SURFACE DELAMINATION RESPONSE
DETAIL III**

- (4) If you do not get a definable back surface reflection in a large area, it is possibly due to high signal attenuation. High attenuation graphite/epoxy laminate can create excessive interference signals so that it is not easy to see the back surface reflection. Refer to Figure 5, Detail III. If this occurs, calibrate the instrument with a 5 MHz transducer and do an inspection of the area again. If you cannot get a 50 percent full screen height backwall signal at 5 MHz, calibrate the instrument with a 2.25 MHz transducer or a larger diameter transducer (such as 0.5 inch) and do the inspection again.

- 3) An increase in width of the front surface signal, with a loss of back surface signal, is a sign of a near surface delamination. See Figure 5, Detail III.
