Scandinavian Airlines System

TABLE OF CONTENTS

# 71-HOW TO USE THE FIM

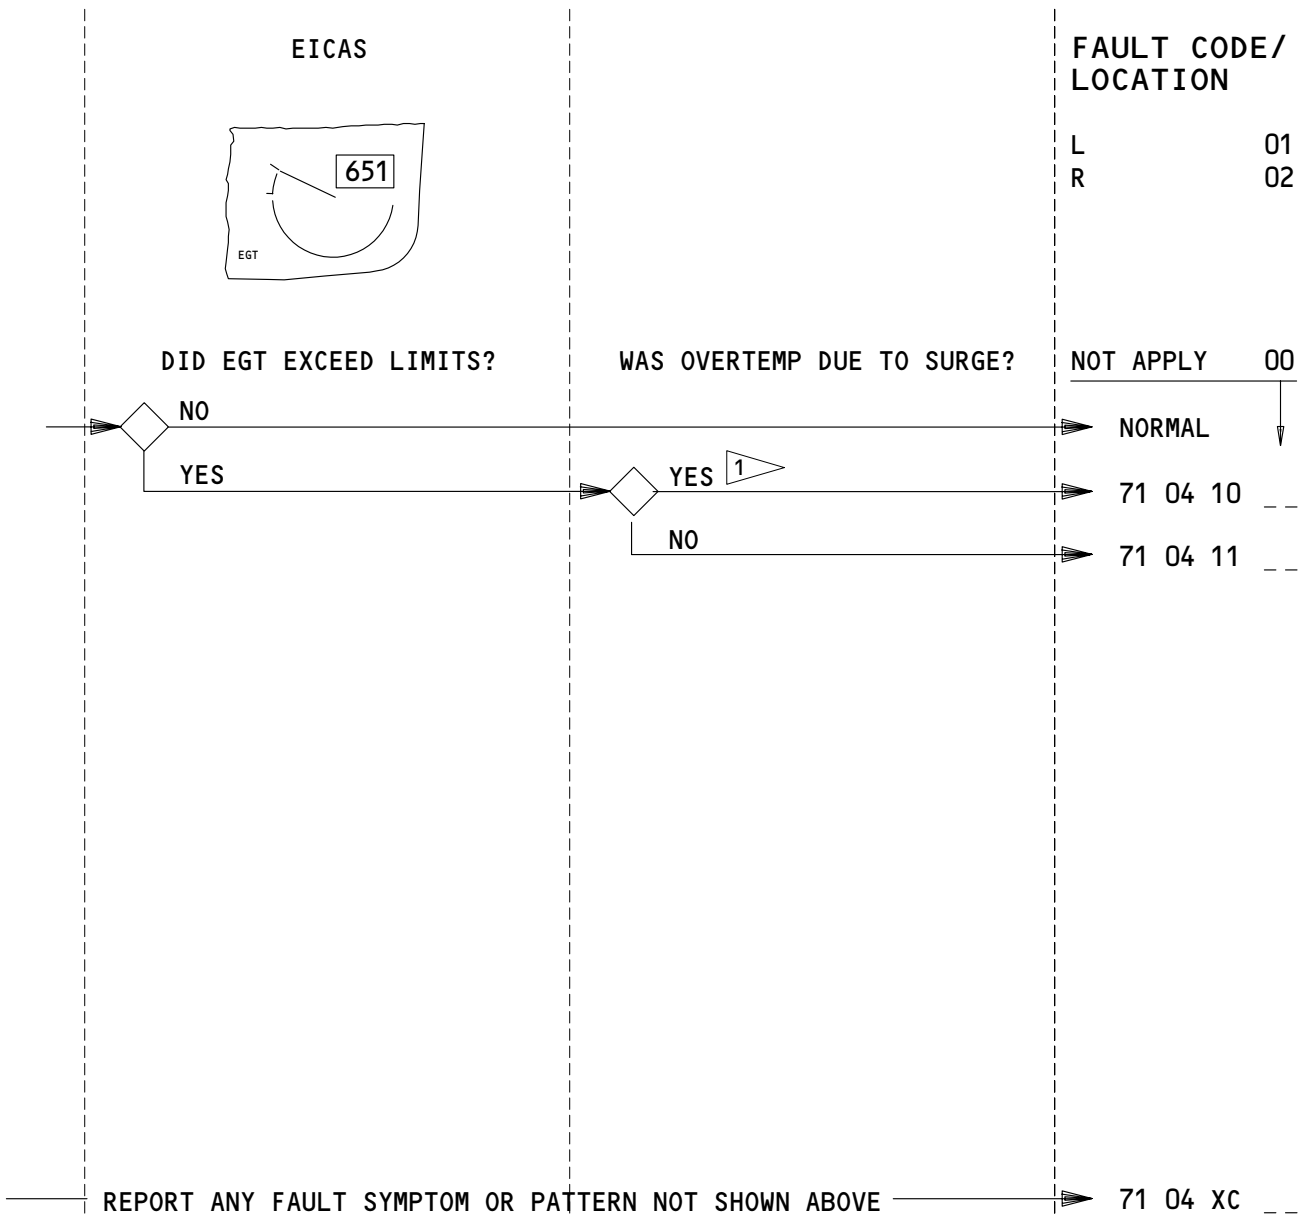
<sup>1</sup> IF OVERTEMP WAS CAUSED BY SURGE, ALSO SEE "SURGE (STALL)" FAULT CODES.

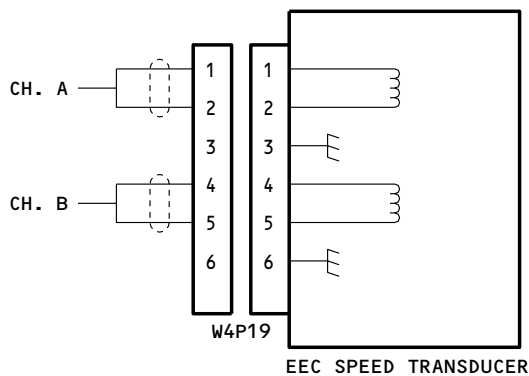
COMPONENT SCHEMATIC

PINS		RESISTANCE
1	2	301-369 OHMS
4	5	301-369 OHMS

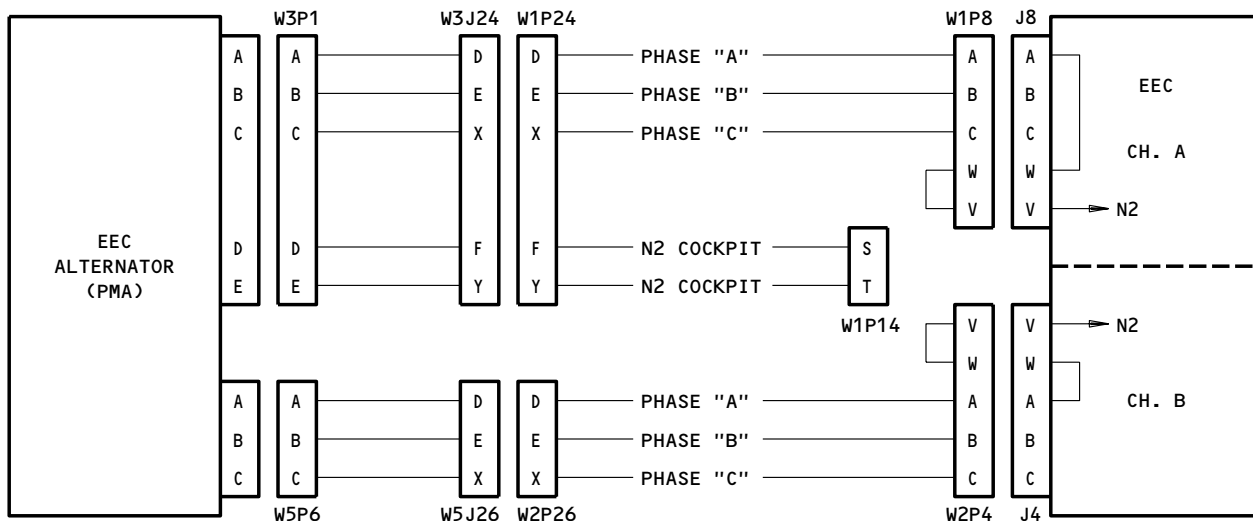
**WIRING HARNESS**

PIMU MESSAGES	
MESSAGES	LABEL-BIT
N2 RANGE FAIL	352-15
LOST POWER	352-29
N2 CROSS-CK FAIL	353-15

CH. A		CH. B	
PMA	EEC	PMA	EEC
W3P1	W1P8	W5P6	W2P4
A	A	A	A
B	B	B	B
C	C	C	C

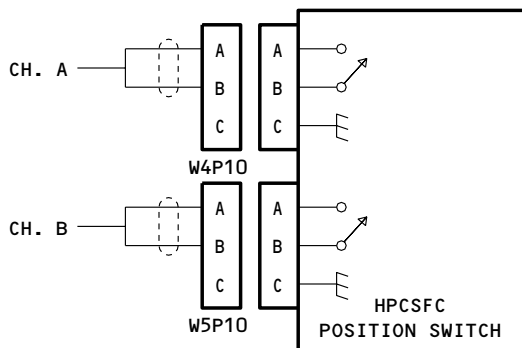
HPC Secondary Flow Control (HPC SFC) Position Switch Schematics  
Figure 16

MESSAGES	LABEL-BIT
TRC EXT W/A FAIL	354-21

CH. A		CH. B	
SWITCH	EEC	SWITCH	EEC
W4P10	W1P6	W5P10	W2P2
A	W	A	W
B	<u>i</u>	B	<u>i</u>

- (a) Do the Repair Confirmation steps at the end of the corrective action.
- (2) If the PIMU message for 354-21 comes back, examine the circuit from the EEC, M7198, to the HPC secondary flow control valve position switch, S1613 (S1614):
  - Channel A, W1P6, pins j,w, to W4P10, pins B,A
  - Channel B, W2P2, pins j,w, to W5P10, pins B,A
 (WDM 71-51-14) (See the simplified schematic that is shown on Fig. 16).
  - (a) Repair the problems that you find.
  - (b) Do the Repair Confirmation steps at the end of the corrective action.

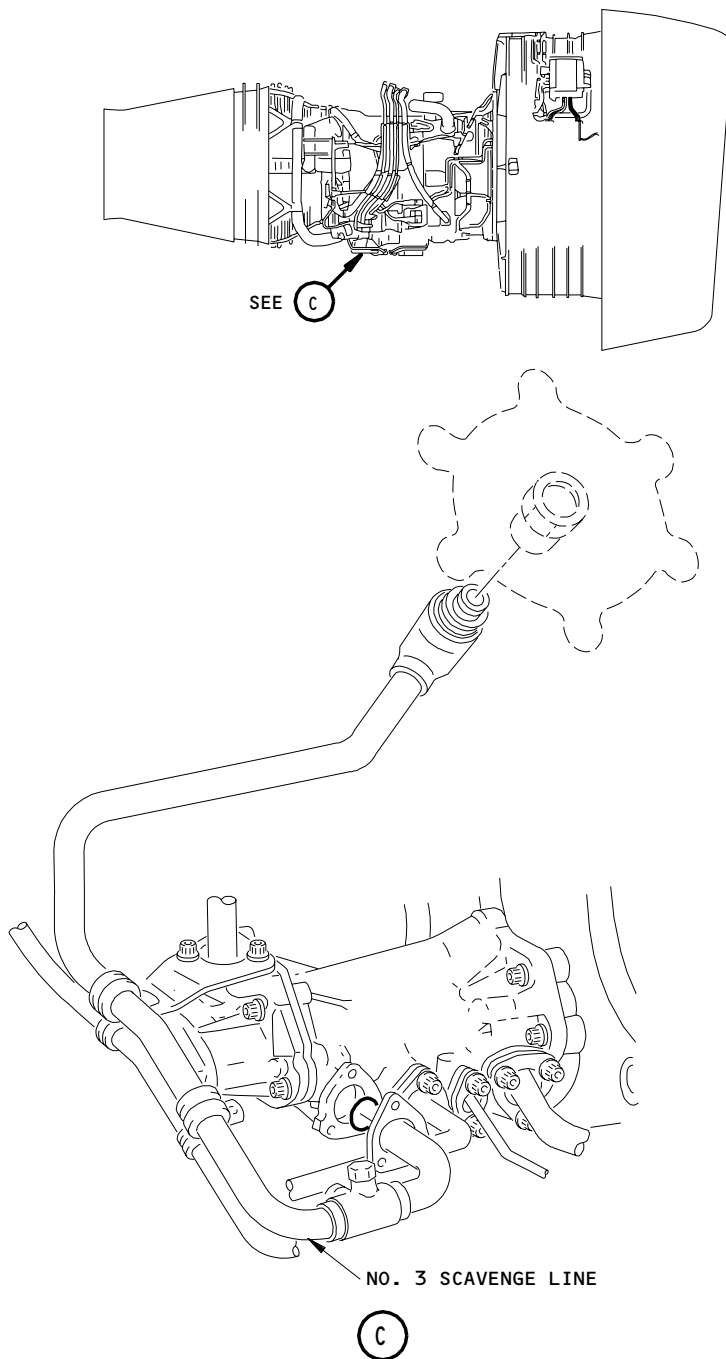
Engine Check 13 - Oil Leak Check  
 Figure 113 (Sheet 4)

- (b) MAKE SURE THE "B" NUT LOCATED AT THE DIFFUSER CASE IS TIGHT.  
 (c) REPAIR AND REPLACE PARTS AS NECESSARY.
