Scandinavian Airlines System

CHAPTER 74 - IGNITION

ENGINE IGNITION SYSTEM

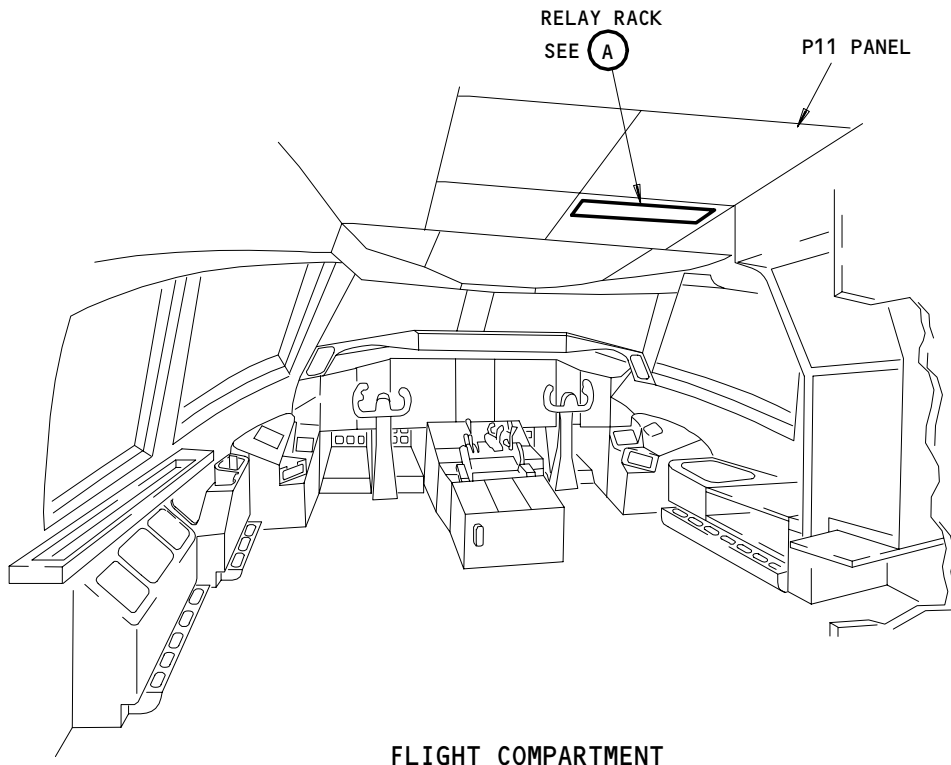
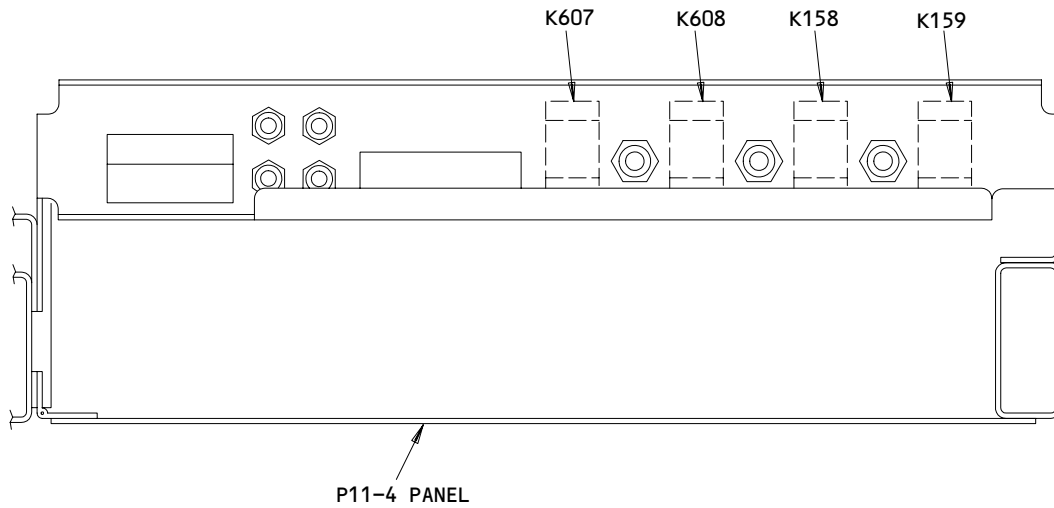
Engine Ignition Systems - Component Location
 Figure 102 (Sheet 1)

FLIGHT COMPARTMENT

RELAY RACK
 (A)

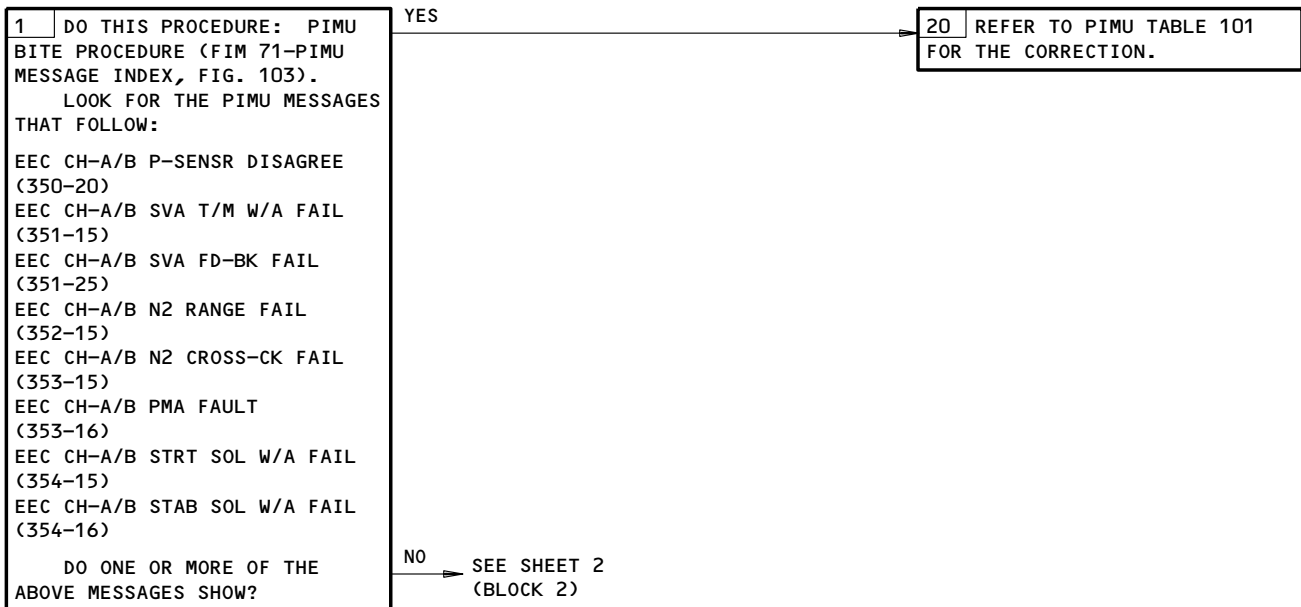
No Engine Lightoff with IGN 1, IGN 2 and Start Normal with BOTH
Figure 103 (Sheet 1)

NO ENGINE LIGHT OFF
WITH "IGN 1, IGN 2"
AND START NORMAL
WITH "BOTH"

ENGINE START IS NOT SUCCESSFUL WITH THE IGNITION SELECT SWITCH TO IGN 1 OR IGN 2, BUT IS SUCCESSFUL WITH THE IGNITION SELECT SWITCH TO BOTH. FUEL FLOW WAS AVAILABLE.

1. FUEL/IGN CONTROL RELAY IS BAD (WDM 74-31-11, -21).
2. CIRCUIT FROM APPLICABLE ENGINE IGN 1 OR IGN 2 IS BAD (WDM 74-31-11, -21).
3. IGNITION SELECT SWITCH, S3, ON THE ENGINE IGNITION AND START CONTROL MODULE, M49, ON P5 IS BAD (WDM 74-31-11, -21).
4. EXCITER-TO-IGNITER PLUG CABLES ARE BAD (AMM 74-21-01/401).
5. IGNITER PLUG IS DAMAGED (AMM 74-21-02/401).
6. IGN 1 OR IGN 2 EXCITER IS BAD (AMM 74-11-01/401).
7. IGNITER PLUG GUIDE IS GONE (AMM 74-21-02/801).
8. BORESCOPE THE 1ST-STAGE HPT BLADES (AMM 72-00-00/601).
9. IGNITER PLUG IMMERSION DEPTH IS INCORRECT (AMM 74-21-02/601).

FAULT CODE	1. LOG BOOK REPORT 2. FAULT ISOLATION REFERENCE
74 03 01 00	1. EICAS msg IGN 1 STBY BUS displayed. (Ref Chapter 31 for fault code diagram). 2. FIM 74-00-00/101, Fig. 104, Block 1
74 03 02 00	1. EICAS msg IGN 2 STBY BUS displayed. (Ref Chapter 31 for fault code diagram). 2. FIM 74-00-00/101, Fig. 104, Block 1
74 03 03 --	1. (01=L, 02=R) eng no lightoff during start with ign selector in (IGN 1, IGN 2). Second start in BOTH was successful. (Ref Chapter 71 for fault code diagram). 2. FIM 74-00-00/101, Fig. 103, Block 1
