Scandinavian Airlines System

CHAPTER 76 - ENGINE CONTROLS

<u>Subject</u>	<u>Chapter Section Subject</u>	<u>Page</u>	<u>Effectivity</u>
FAULT ISOLATION	76-FAULT CODE INDEX	1	ALL
<u>POWER CONTROL</u>	76-10-00		
ENGINE CONTROL SYSTEM	76-11-00		
Component Location		101	ALL
Component Index			
Component Location			
Fault Isolation			
Engine Fuel Conditioning		109	
Control Problem. L (R) ENG			
VALVE Light-On, L (R) ENG			
FUEL VAL EICAS Msg Displayed			
(Fig. 104)			
Forward/Reverse Thrust Lever		105	
Problems (Fig. 103)			
Forward/Reverse Thrust Lever		107	
Problems (Fig. 103A)			
L (R) ENG SHUTDOWN EICAS Msg		112	
Did Not Display. Aural			
Warning and Engine Related			
Msgs Were Not Inhibited.			
Engine Shutdown. (Fig. 105)			
L (R) ENG SHUTDOWN EICAS Msg		113	
Displayed With Engine Running			
(Fig. 106)			
Thrust Lever Has Lost Motion		115	
(Fig. 107)

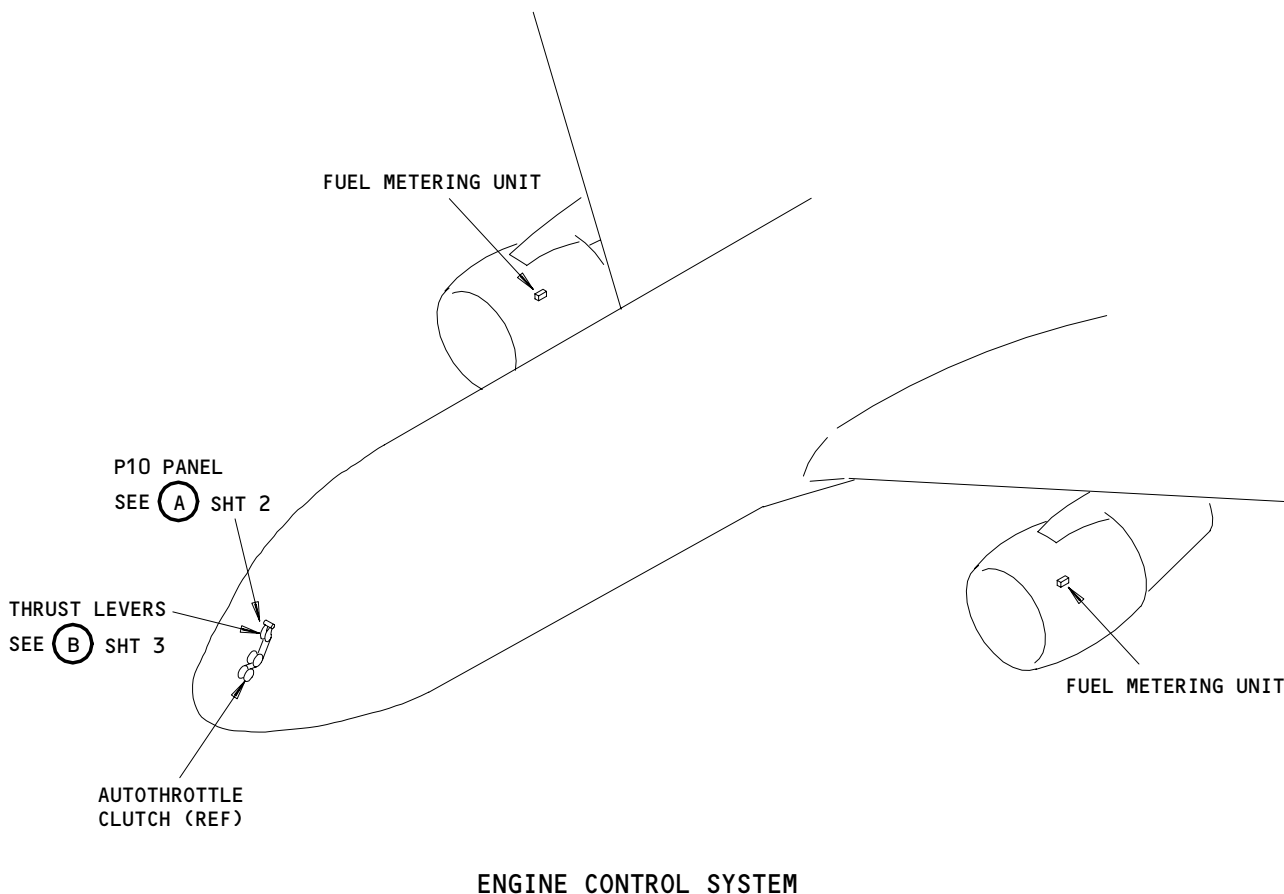
Engine Control System - Component Location
 Figure 102 (Sheet 1)

COMPONENT	FIG. 102 SHT	QTY	ACCESS/AREA	AMM REFERENCE
ACTUATORS - (FIM 78-36-00/101) L THRUST LEVER INTERLOCK, M01440 R THRUST LEVER INTERLOCK, M01441				
CIRCUIT BREAKERS- L ENG FUEL CONT VLV AND CHAN B RESET, C1419 R ENG FUEL CONT VLV AND CHAN B RESET, C1420	1	1	FLT COMPT, P11 11D25	*
COMPUTERS - (FIM 31-41-00/101) L EICAS, M10181 R EICAS, M10182		1	11D26	*
DIODE - (FIM 31-01-33/101) R45				
DIODE - (FIM 31-01-36/101) R297				
DIODES - (FIM 31-01-37/101) R43, R298				
LEVERS - THRUST, M985	2	1	FLT COMPT, P10	76-11-01
LIGHT - L ENG VLV, YAZL2	1	1	FLT COMPT, P10 FUEL CONT PANEL (MODULE), M73	*
LIGHT - R ENG VLV, YAZL4	1	1	FLT COMPT, P10 FUEL CONT PANEL (MODULE), M73	*
PANEL - FUEL CONT (MODULE), M73	1	1	FLT COMPT, P10	76-11-09
PACKS - (FIM 22-31-00/101) AUTOTHROTTLE BRAKE AUTOTHROTTLE MICROSWITCH				
RELAYS - (FIM 31-01-36/101) L FUEL/IGN CONT, K168 L ENG CH B EEC RESET, K1037				
RELAYS - (FIM 31-01-37/101) R FUEL/IGN CONT, K169 R ENG CH B EEC RESET, K1039

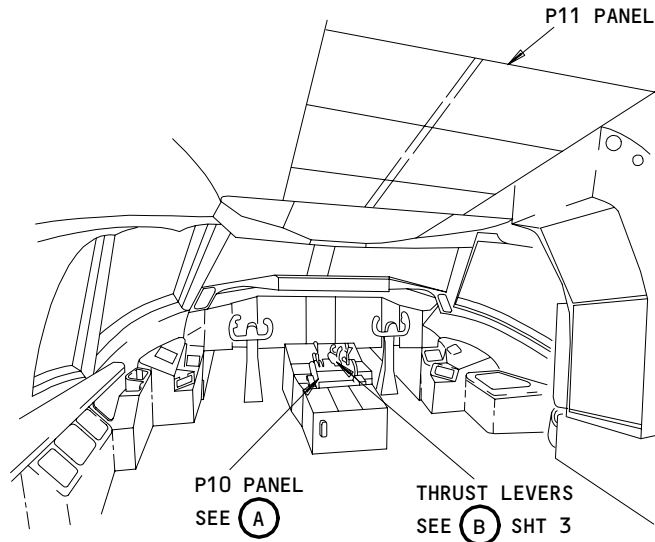
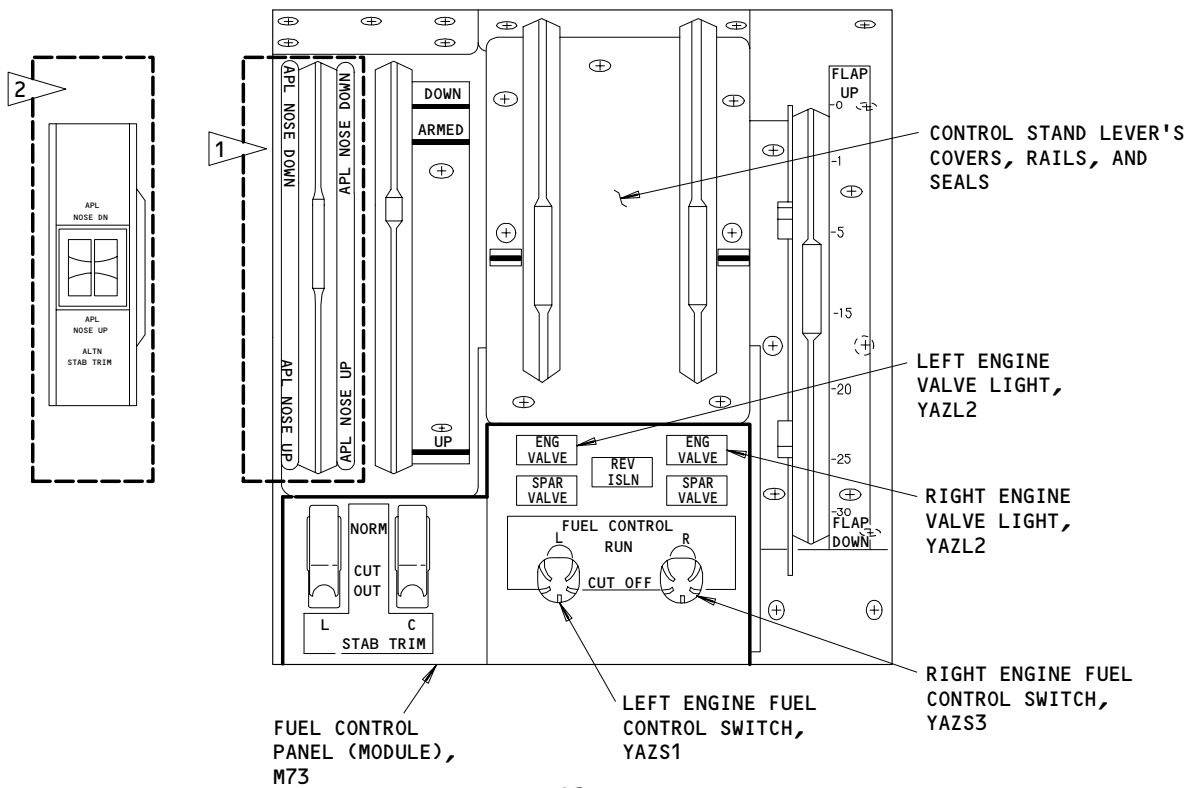
FLIGHT COMPARTMENT

P10 PANEL

- 1 AIRPLANES WITH STABILIZER TRIM LEVERS
- 2 AIRPLANES WITH ALTERNATE STABILIZER TRIM SWITCHES

Engine Control System - Component Location
Figure 102 (Sheet 2)

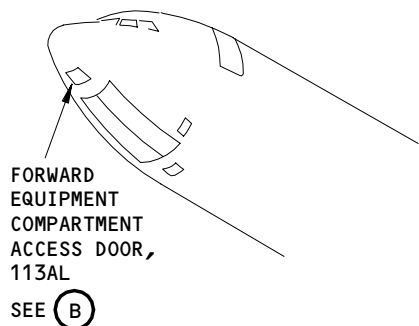
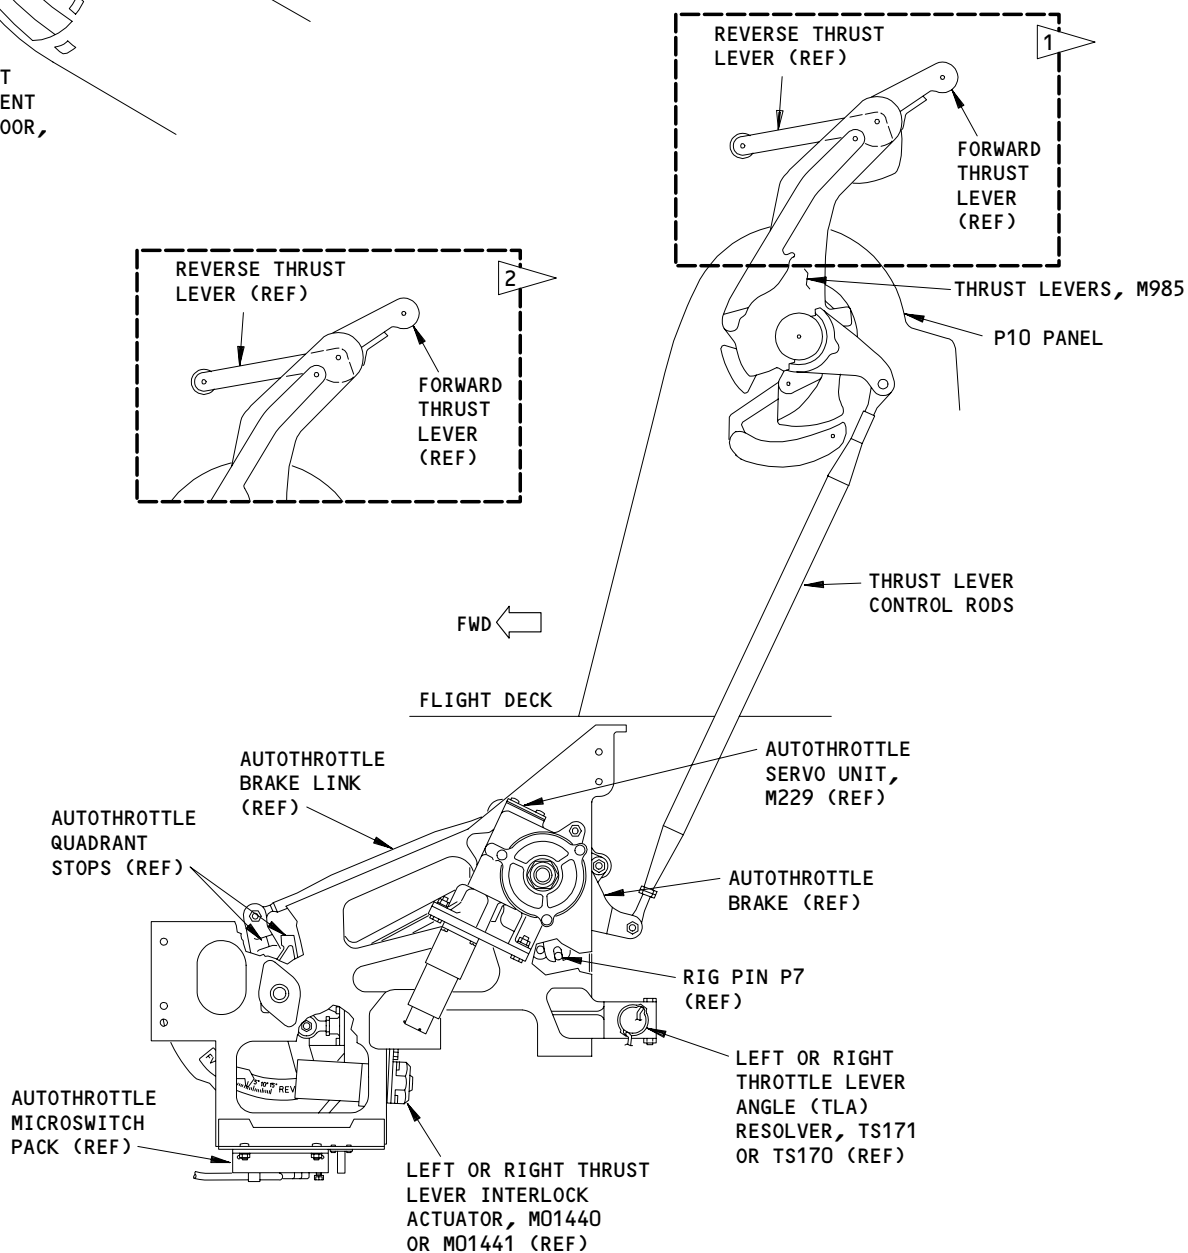
THRUST LEVERS

- 1 AIRPLANES WITH TITANIUM THRUST LEVERS
- 2 AIRPLANES WITH ALUMINUM THRUST LEVERS

Engine Control System - Component Location
Figure 102 (Sheet 3)

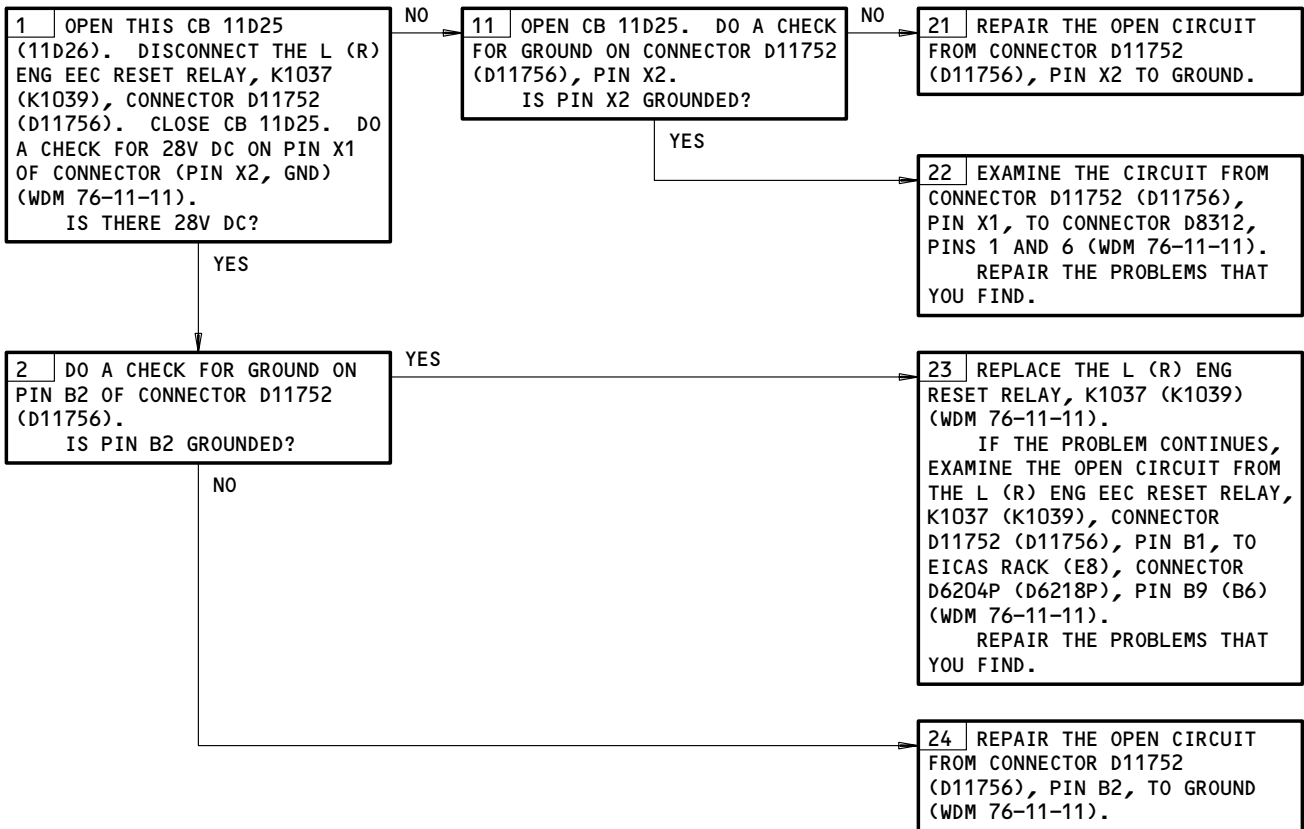
Figure 105

"L (R) ENG SHUT-DOWN" EICAS MSG DID NOT DISPLAY. AURAL WARNING AND ENGINE RELATED MSGS WERE NOT INHIBITED. ENGINE SHUTDOWN.

PREREQUISITES
MAKE SURE THESE CIRCUIT BREAKERS ARE OPEN AND ATTACH THE DO-NOT-CLOSE TAGS:
11D25,11D26

1. BAD WIRING TO FUEL METERING UNIT (WDM 76-11-11)
2. BAD EEC RESET RELAY (WDM 76-11-11).

L (R) ENG SHUTDOWN EICAS Msg Did Not Display. Aural Warning and Engine Related Msgs Were Not Inhibited. Engine Shutdown.

76 03 06 --	1. (O1=L, O2=R) ENG VALVE and SPAR VALVE light illum with fuel control sw in (RUN, CUTOFF) (Ref Chapter 71 for fault code diagram). 2. Replace the L (R) Engine Fuel Control Switch YAZS1 (YAZS3) on the Engine Fuel Control Module M73 (WDM 76-11-11) or replace the Engine Fuel Control Module M73 (AMM 76-11-09/201).
76 03 07 --	1. EICAS msg (O1=L, O2=R) ENG SHUTDOWN did not display and aural warning and appropriate eng related msgs were not inhibited with eng shutdown (Ref Chapter 71 for fault code diagram). 2. FIM 76-11-00/101, Fig. 105, Block 1

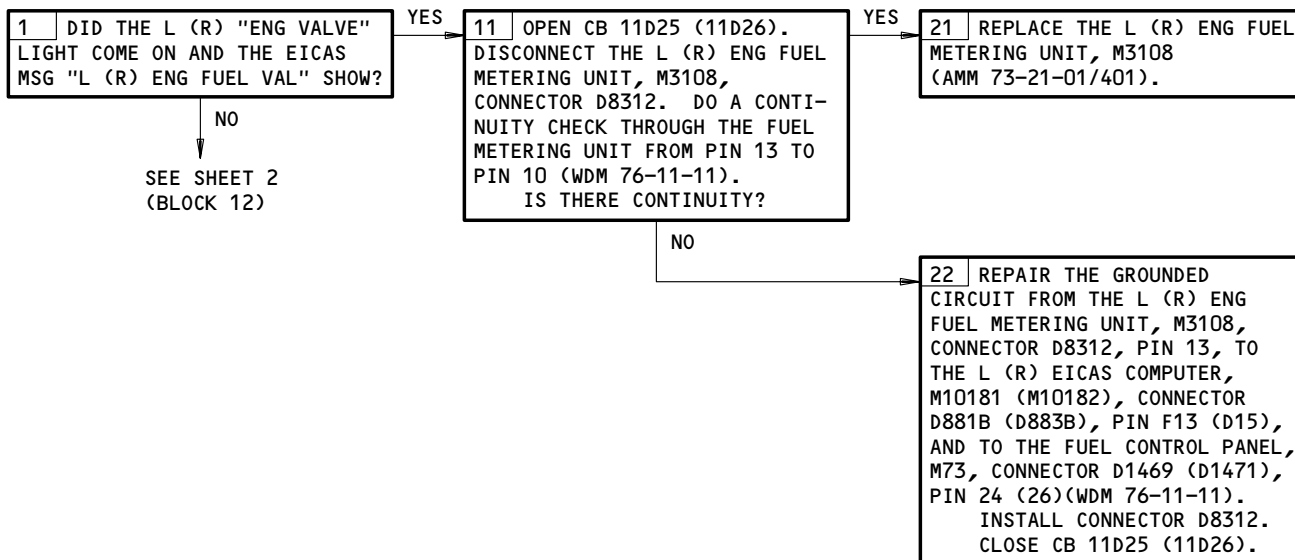
"L (R) ENG SHUT-
DOWN" EICAS MSG
DISPLAYED WITH
ENGINE RUNNING

MAKE SURE THESE SWITCHES ARE IN THESE POSITIONS:
FUEL CONTROL SWITCH - RUN
FIRE SWITCH - NORMAL

1. UNSATISFACTORY WIRE CONNECTIONS (WDM 76-11-11)
2. BAD FUEL METERING UNIT (AMM 73-21-01/401)
3. BAD EEC RESET RELAY (WDM 76-11-11).

L (R) ENG SHUTDOWN EICAS Msg Displayed with Engine Running
Figure 106 (Sheet 1)

12 OPEN CB 11D25 (11D26).
REMOVE THE L (R) ENG EEC RESET
RELAY, K1037 (K1039). DO A
CONTINUITY CHECK FROM PIN B1
TO PIN B2 OF THE RELAY
(WDM 76-11-11).
IS THERE CONTINUITY?

23 REPAIR THE GROUNDED
CIRCUIT FROM TB196, DIODE R45,
ON THE P33 PANEL (TB274, DIODE
R43, ON THE P37 PANEL), TO THE
L (R) EICAS COMPUTER, M10181
(M10182), CONNECTOR D881B
(D883B), PIN D14 (J3)
(WDM 76-11-11).
IF THE PROBLEM CONTINUES,
EXAMINE THE GROUNDED CIRCUIT
FROM THE L (R) ENG FIRE
SWITCH, S37 (S38), CONNECTOR
D836 (D862), PIN 4
(WDM 31-51-33), TO THE L (R)
EICAS COMPUTER, M10181
(M10182), CONNECTOR D881B
(D883B), PINS J11 (K6)
(WDM 31-41-16).
REPAIR THE PROBLEMS THAT
YOU FIND.

24 REPLACE THE L (R) ENG EEC
RESET RELAY (WDM 76-11-11).
