REPLACE THE ENGINE 1 NACELLE ZONE VENTILATION SHUTOFF VALVE.

REPLACE NACELLE ZONE VENT SHUTOFF VALVE

REPLACE THE INTERCOMPRESSOR (2.5) BLEED ACTUATOR.

REPLACE THE ENGINE 2 NACELLE ZONE VENTILATION SHUTOFF VALVE.

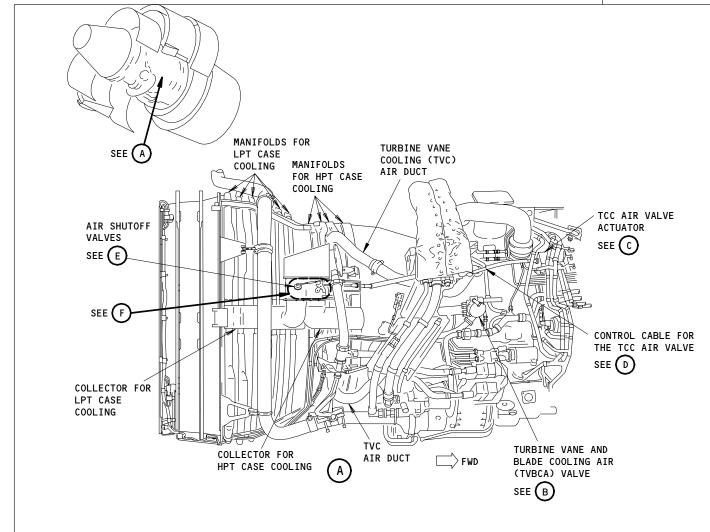
Turbine Cooling System (Right Side) Figure 602 (Sheet 1)

1 ENGINES WITHOUT PHASE 3

- (4) Open the thrust reversers (AMM 78-31-00/201).
- D. Do an Inspection of the Linkage for the Turbine Cooling System (Fig. 602)

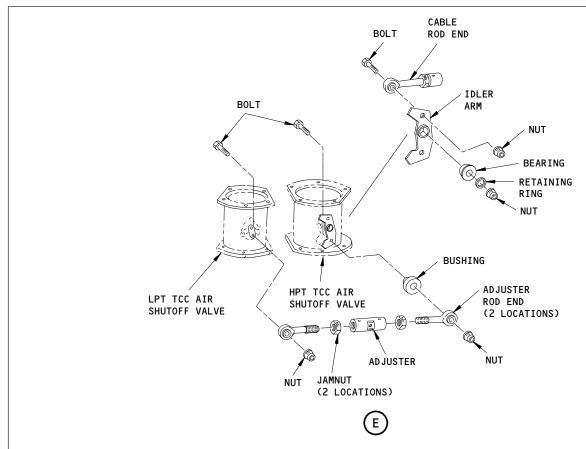
Turbine Cooling System (Right Side) Figure 602 (Sheet 4)

TCC AIR SHUTOFF VALVES FULLY CLOSED POSITION

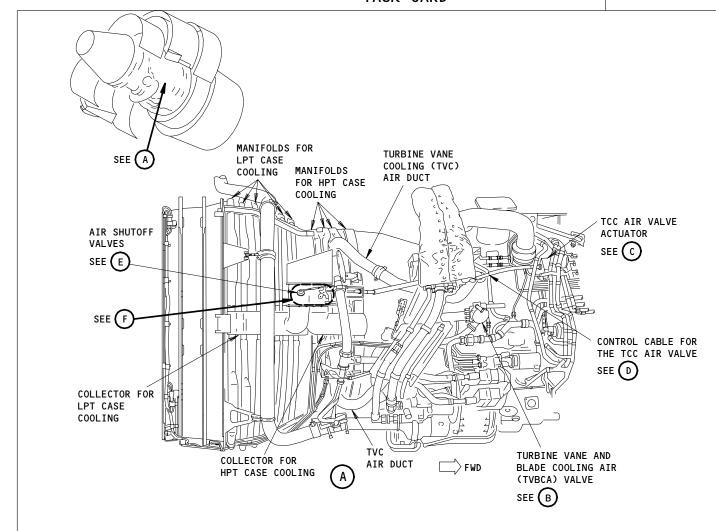
Turbine Cooling System (Right Side) Figure 602 (Sheet 1)

1 ENGINES WITHOUT PHASE 3

- (4) Open the thrust reversers (AMM 78-31-00/201).
- D. Do an Inspection of the Linkage for the Turbine Cooling System (Fig. 602)

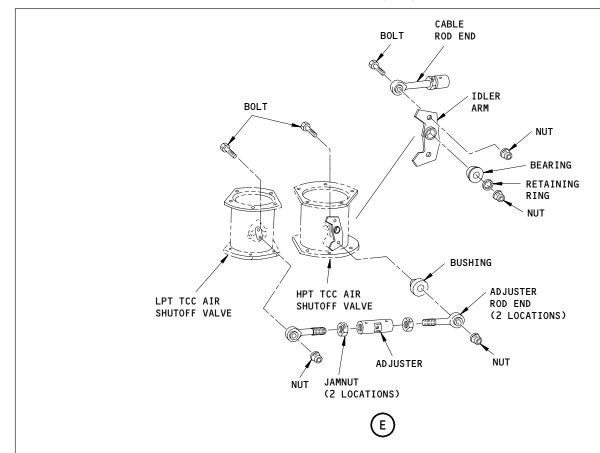
Turbine Cooling System (Right Side) Figure 602 (Sheet 4)

TCC AIR SHUTOFF VALVES FULLY CLOSED POSITION
