SERVICE BULLETIN

## MODEL: CD-4050/CD-4050N

No.: GEN-090 (DP09-0001E) Date: 21.04.00

## SUBJECT: CD-4050/4050N TECHNICAL INFORMATION

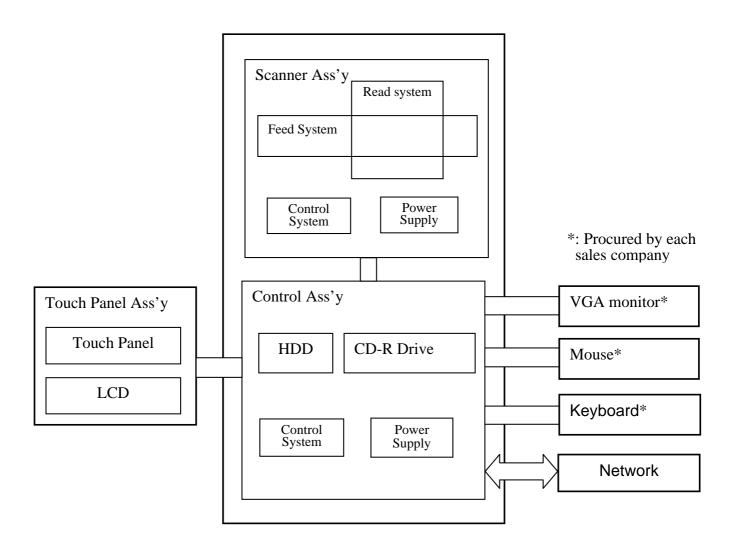
Figure 2-1

The basic configuration of this machine is as follows.

For the additional functions and operational improvement, a VGA monitor, a keyboard, a mouse and I/F for networking have been added.

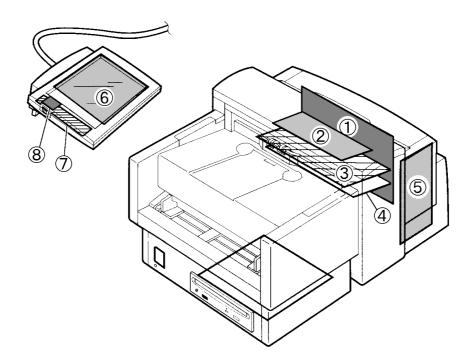
Figure 2-2

The Touch Panel Assembly and Control Assembly, which the new parts have been added to, are as follows.

No.	Description	Function
1	Back Plain PCB	Signal relay and voltage conversion between circuit boards.
2	LAN Card	Interface control for networking.
3	CPU Board	Control of Scanner Assembly and communication with Control Assembly
4	SCSI Board	Interface control for SCSI
5	Power Supply PCB	DC power supply to Control Assembly
6	Display PCB Unit	Operation of LCD & Touch Panel and communication with Control Assembly
7	Inverter PCB	Lighting of LCD back light.
8	Volume PCB	Contrast adjustment of LCD (succeeded from CD-4046)

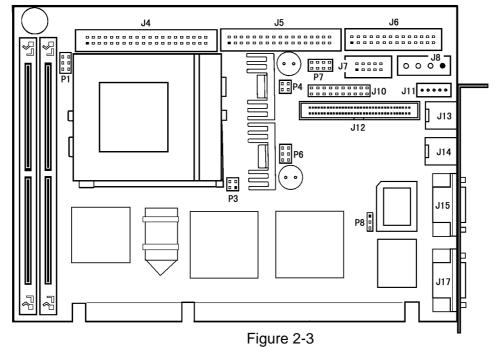
- III. Lists of VR, SW & LED for Each Circuit Board/Unit \* Below shown are the new parts only.
  - 1. CPU Board

●Ju	Jumper pin setting				
	Jumper No.	Drawing	Setting		
	P1	6 <b>1 1</b> 4	1-6, 3-4 shorted		
	P3	4 00 3	1-4 shorted		
	P4	4 <b>00</b> 3 1 <b>00</b> 2	2-3 shorted		
	P6	6 <b>000</b> 4 1 30 3	2-5 shorted		
	P7	8 <b></b> 5 1 <b> 4</b>	2-7, 4-5 shorted		
	P8	3 🗆 🖬 1	opened

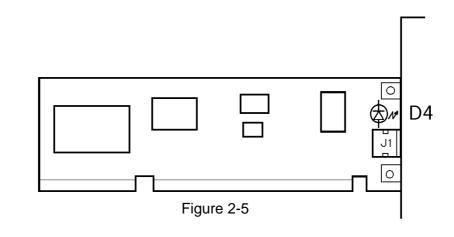
## 3. LAN Card

LED No.	Indication
D4	Lit when LAN cable is connected.

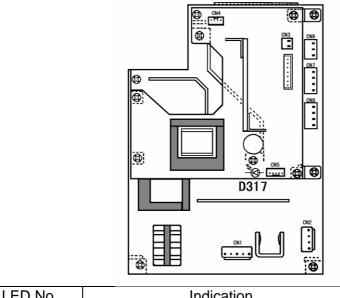
4. Power Supply PCB

LED NO.	Indication
D317	Lit when AC power is supplied.

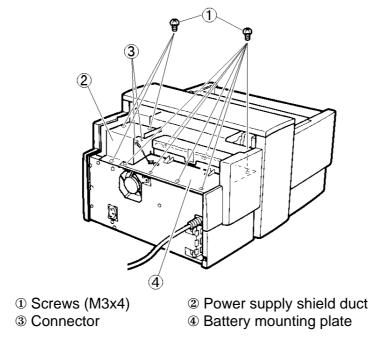
Figure 3-2

2) Remove the screws (①, 7 pcs), and then the power supply shield duct (②). After unplugging the connector (③, 2 spots), remove the battery mounting plate (④).

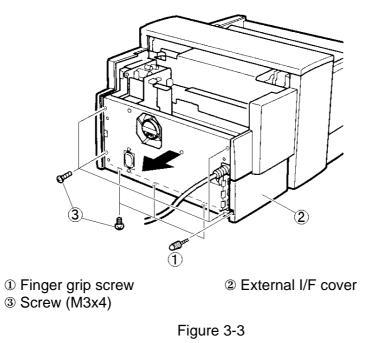
3) Remove the finger grip screw (①) and the external I/F cover(②).

Then, remove the screw (3, 7 pcs) and pull out the Power Supply Unit about 3 cm.

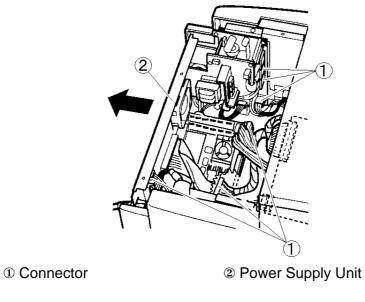
Figure 3-4

4) Unplug the connector(①, 6 spots) and remove the Power Supply Unit (②).

Note: As the Touch Panel Assembly is connected, be cautious not to drop it.

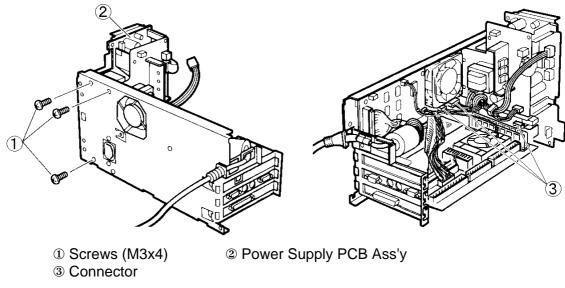
Figure 3-5

2. Power Supply PCB Ass'y

1) Remove the screws (①, 3 pcs), and then the Power Supply PCB Ass'y (②). Unplug the connector (3 spots).

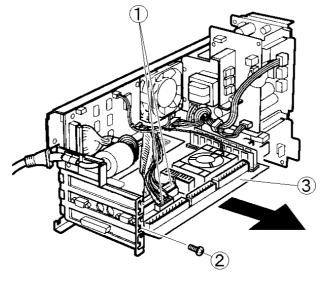
Figure 3-6

3. Control CPU PCB

1) Remove the connector (①, 2 spots). Remove the screw (②, 1 pc), and then the Control CPU PCB.

① Connector
② Screw (TP M3x4, round tip)
③ Control CPU PCB

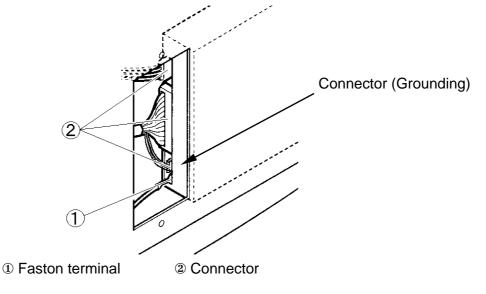
Figure 3-9

\* Below shown is the Connector Assembly only, which a connector for grounding has been added to.

Remove the faston terminal (①) and the connector (@, 3 spots).

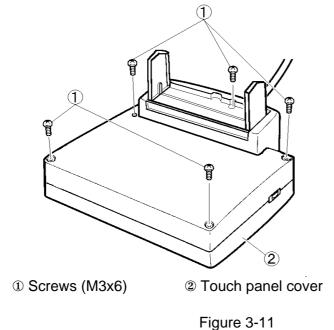
1) Remove the screws (①, 5 pcs), and then the touch panel cover (②).

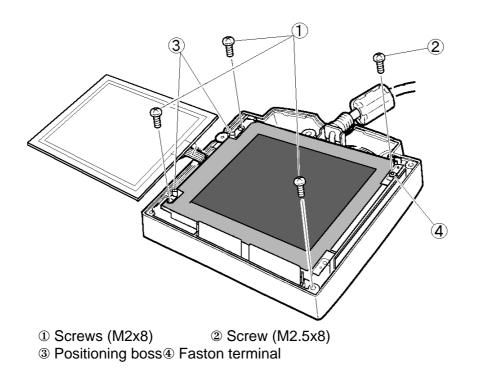
Figure 3-12

2) Remove the screws (M2x8, ①, 3 pcs), and then the positioning boss (③). Also, remove the faston terminal (④) and screws fastened together (M2.5x8, ②, 1 pc).

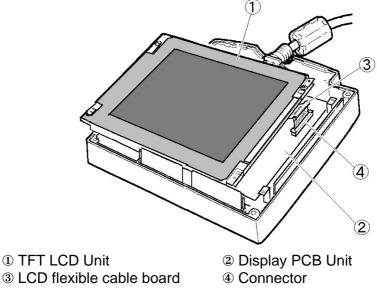
Figure 3-13

3) Lift the TFT LCD Unit (①) up, and unplug the LCD flexible cable board (③) attached to the Display PCB Unit (②) from the connector (④).

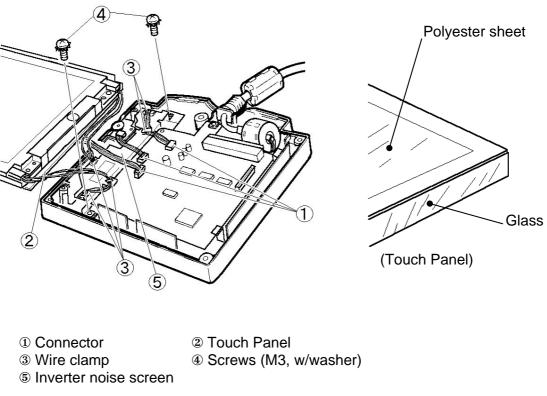
Figure 3-14

4) Remove the connector (①, 3 spots), and then the touch panel (②). Unhook the cable from the wire clamps(③, 5 pcs). Remove the screws (④, 2 pcs), and then the inverter noise screen (⑤).

Note: When mounting the touch panel, be sure to face the polyester sheet on the touch panel (touching side) up.

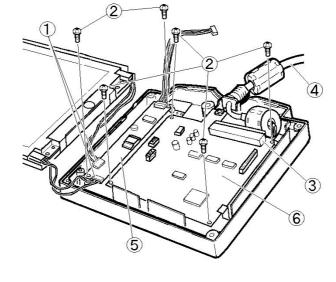
Figure 3-15

5) Unplug the connector (①, 2 spots) and remove the TFT LCD Unit. Also, remove the screws (@, 6 pcs) and the inverter (@). Then, remove the connector of the Display PCB Unit (@), the main relay cable (@) and finally the Display PCB Unit (@).

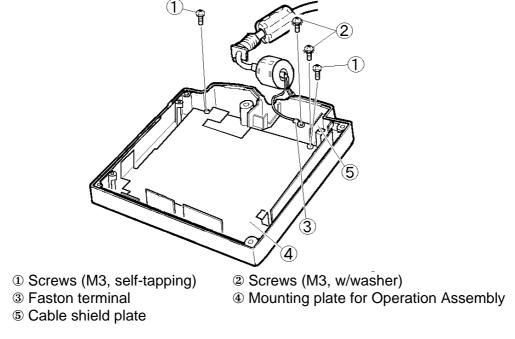
6) Remove the screws (@@, 4 pcs), the faston terminal (@), the mounting plate for the Operation Assembly (@) and the cable shield plate (@).

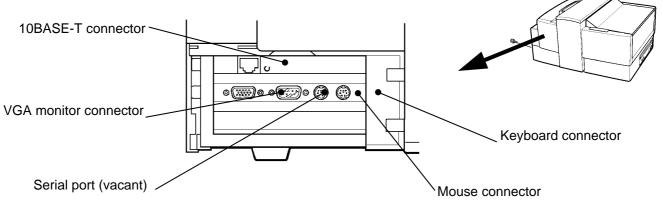
If a user wishes to have a keyboard and a mouse used, each sales company should provide them individually. The keyboard and mouse should satisfy the following specifications.

- Keyboard : IBM PS2 compatible keyboard (101,103 or 106 keyboard)
- Mouse : PS2 compatible mouse
- External monitor : VGA monitor

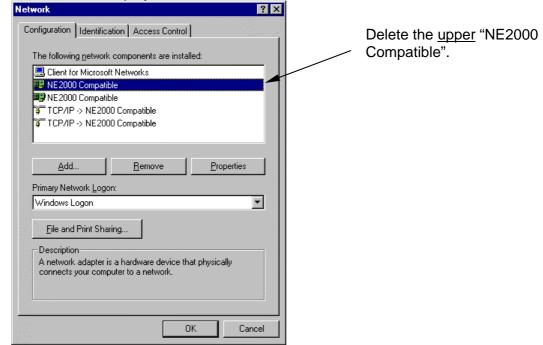
4) The "Network" screen is displayed.

- In case that two "NE2000 Compatible" cards are shown, delete the upper "NE2000 Compatible" card. (The "NE2000 Compatible" card installed should be the lower one.)
- Set other items.
