Service Information

Model: GP605 **Ref. No.:** FF-T01-K1-000007-02

Subject UPDATING THE IMAGE ADJUSTMENT BASIC PROCEDURE

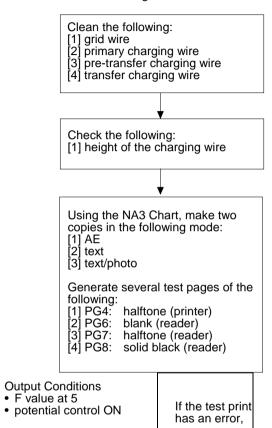
1 Making Pre-Checks

<Making Pre-Checks>

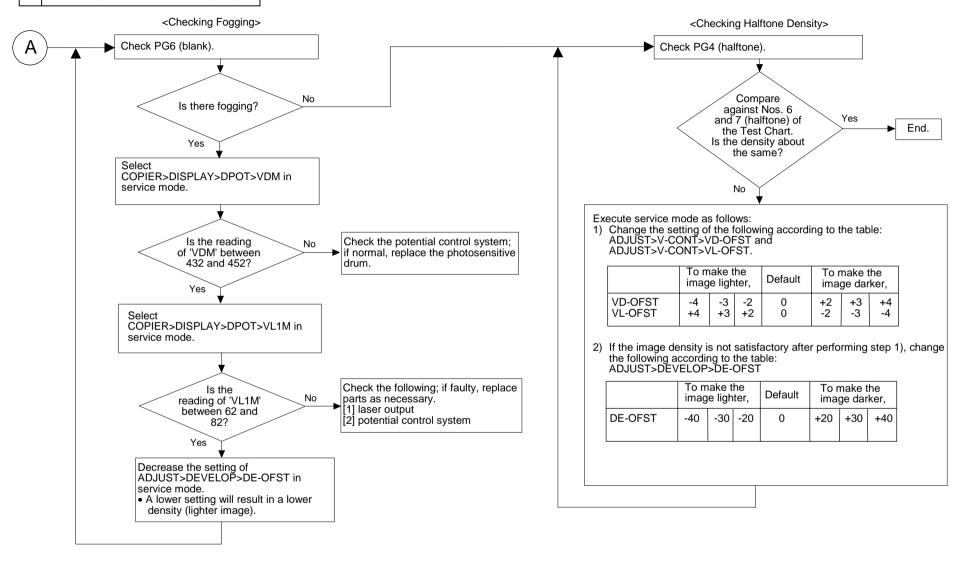
3 Checking the Printer Side (2/2)

Checking the Printer Side (1/2) <Checking the Image> • Use PG4, PG7, and PG8. <Checking the Density Slope> <Checking the Solid Black Density> Are there No vertical lines in Check the image using PG4. Check PG8 (solid black). the image? Yes Is there a Is the image Yes difference in No free of blurring and the Clean the following, and check them density between density optimum? for adhesion of foreign matter: front and [1] dust-proofing glass rear? [2] each charging assembly No Yes Select COPIER>DISPLAY>DPOT>VDM in service mode. No Is the rear side lighter? Are there No vertical lines in Check the primary charging system Is the reading of Yes the image? and the potential control system; if 'VDM' between normal, replace the photosensitive 432 and 452? Turn the adjusting screw at the Turn the adjusting screw at drum. Yes the front of the primary rear of the primary charging charging assembly assembly counterclockwise Yes counterclockwise (maximum (maximum of 2 turns). Select COPIER>DISPLAY>DPOT>VL1M in service mode. of 2 turns). Executina Potential Control Check the following; if faulty, replace Is the reading parts as needed: Turn off and then on the power switch, and of 'VL1M' between [1] laser output generate one test print using PG7 or PG4. 62 and 82? [2] potential control system Caution: Yes [1] If a difference in density remains after giving the adjusting screw 2 turns on one side (a single turn causes a change of about 0.7 mm), check the charging assembly, scanning lamp, and scanner for dirt. Yes Check the following of the Is the test print PG6 When turning the adjusting screw counterclockwise, be sure the developing assembly system: distance between the wire and the grid wire will not be less than (blank) foggy? [1] developing bias 7.5 mm. [2] coating of toner on the sleeve No Reference: Set the following to '2' through '7' in service mode: If the wire is moved away from the photosensitive drum, the image OPTION>BODY>CNT-W/HM density will increase; if it is moved to the drum, the density will • A higher setting will make the density higher (darker). decrease.

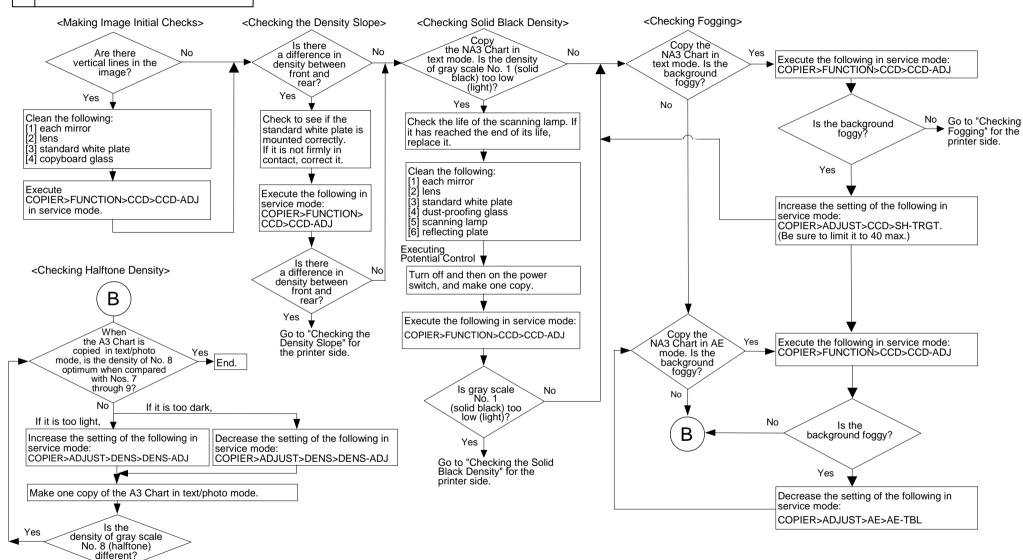
4 Checking the Scanner Side

Go to "Checking the Halftone Density" for the printer side.
