# Portable Manual

FAX Board

**Super G3 FAX Board-T1**

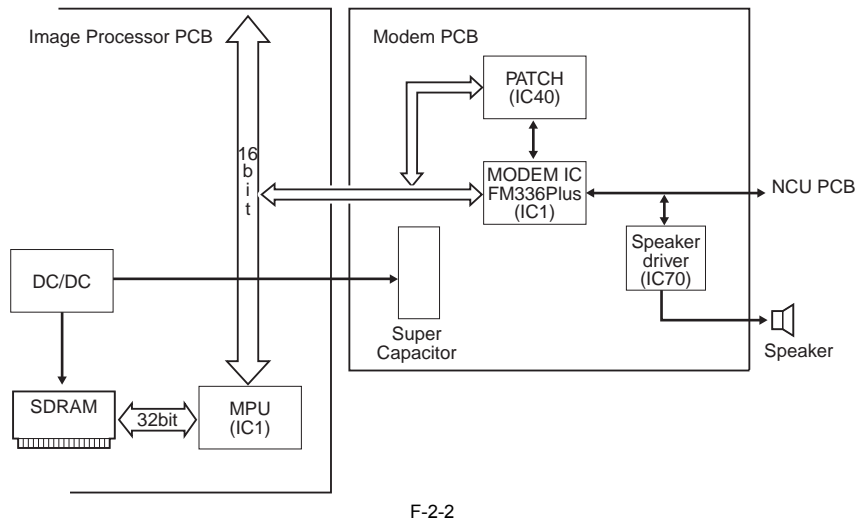
### 2.1.2 Modem PCB

#### MPU (IC1)

It performs JBIG encoding/decoding and control of line communication and SDRAM. SDRAM is connected with a bus of 32bit.

#### PATCH (IC40)

It controls ports, such as those in NCU or speaker.

#### SDRAM

It is used as the memory for encoding/decoding of image data during transmitting/receiving and that for MPU work area.

In addition, it is used for storing the transmitted/received image data.

#### MODEM IC (IC1)

CONEXTANT FM336Plus modem modulates the transmitted data from MPU via line based on the ITU-T V.17, V.21, V.27ter., V.29 and V.34.

In receiving, it demodulates the received data via line based on the ITU-T V.17, V.21, V.27ter., V.29, and V.34.

#### Super Capacitor

It backups the transmitted/received image data stored in SDRAM.

#### DC/DC

It generates the voltage to backup SDRAM by raising the voltage of super capacitor when main power is shut down or fails.
