# **G3/G4 Facsimile Error Code List**

**REVISION 2**

**Canon**

**HY8-23A0-020**

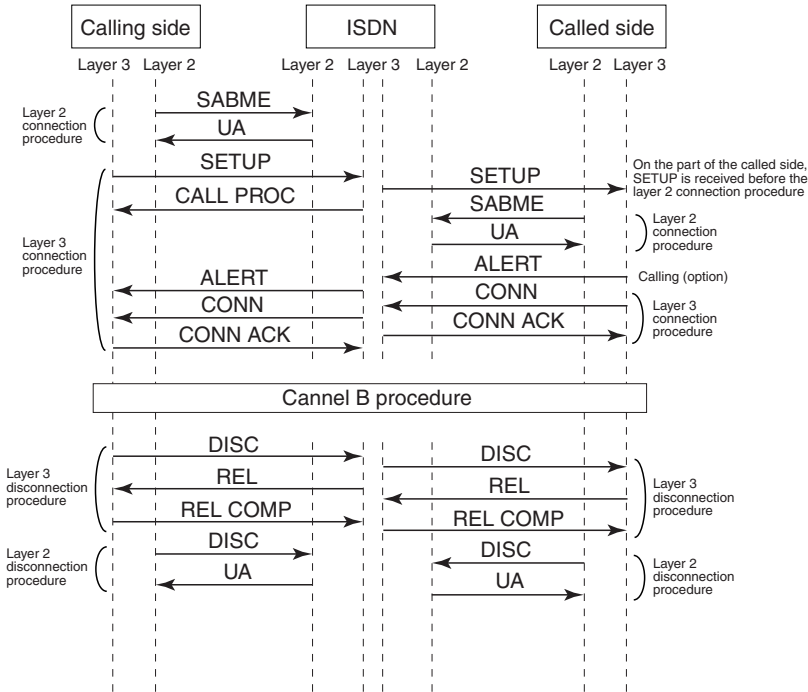
Figure 6 Channel D Control Procedure

A channel D procedure is basically a procedure between an exchange (ISDN network) and a terminal (facsimile machine), not requiring synchronization between signals between the terminal of the machine and that of the other party. Study the following for a channel D control procedure in circuit switching mode:
