SCHEMATIC CHANGES AND EQUIPMENT DIFFERENCES

30S-1 RF Linear Amplifier, Schematic Diagram Figure 7-1 (Sheet A)

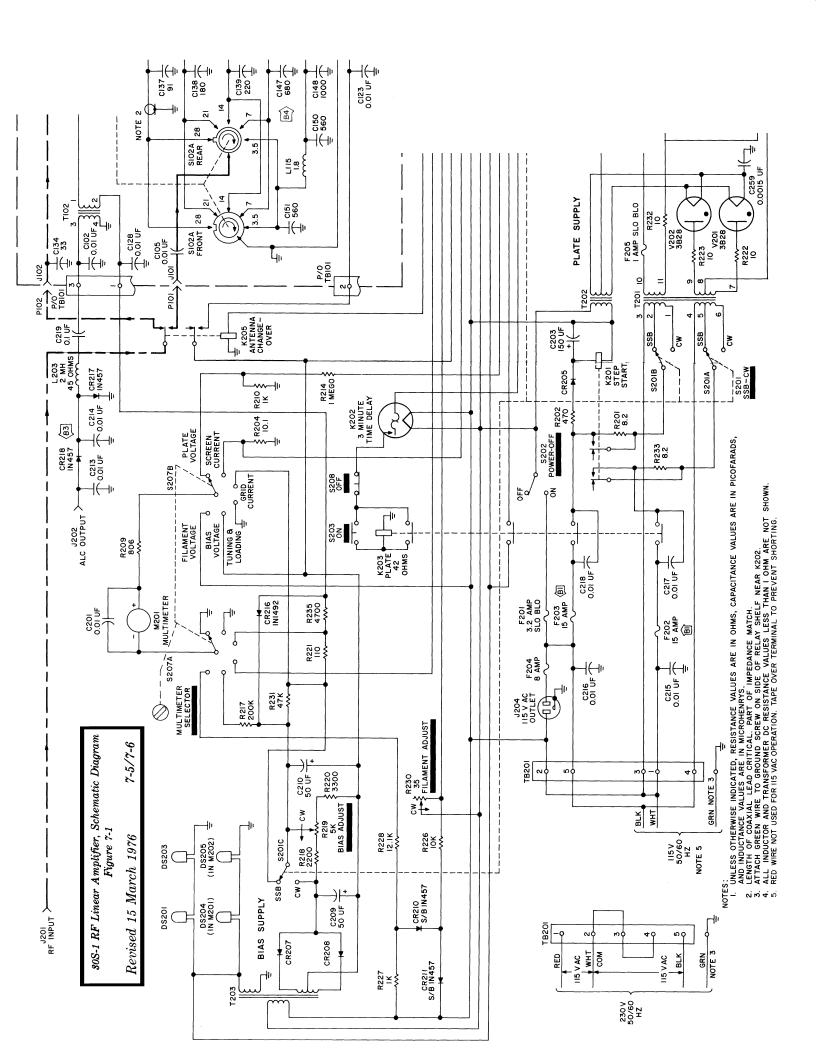
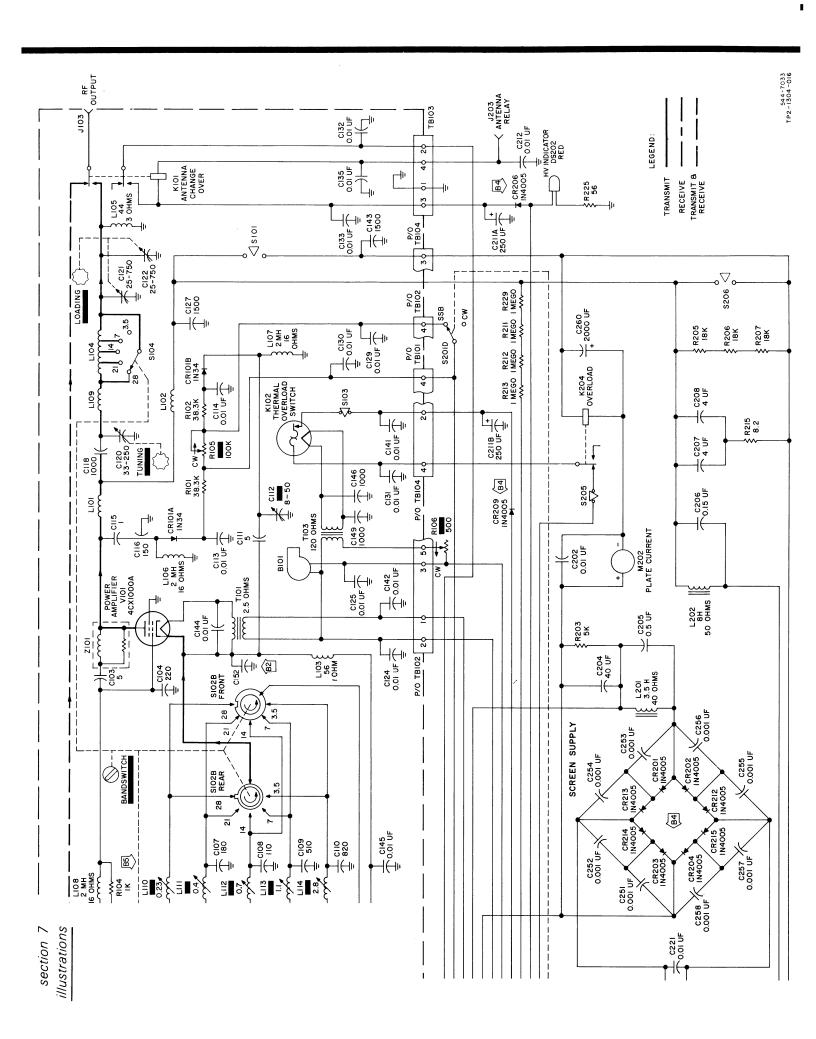
IDENTIFIER	DESCRIPTION
В1	Fuses F202 and F203 were changed from 12 to 15 A. If either fuse needs replacing, it is recommended that both be replaced with the 15-A value.
B2	Capacitor C152 is a factor test select component, from 15 to 47 pF, used in many units. It is selected to provide minimum swr with a 28-MHz input. If this component is in the unit and needs replacing, replace it with the existing value. If it is not in the unit, it should not be added.
В3	Tube V203 (12AL5) was replaced with diodes CR217 and CR218 (1N457). V203 was located between capacitors C213 and C214 with pin 7 connected to connector J202, pins 1 and 2 connected to capacitor C114-choke L203, and pin 5 grounded. If this circuit needs repair, maintain the existing configuration.
B4	Diodes CR201 through CR204 and CR212 through CR215 were changed from 1N1492 to 1N4005. If any of these diodes need replacing, it is recommended that the 1N4005 be used. Diodes CR206 and CR209 were changed from 1N1084 to 1N4005. If one, or both, of these diodes needs replacing, it is recommended that the 1N4005 be used. If the unit originally used 1N1084 diodes, it will contain diode holders for these diodes. The 1N4005 diode leads can be soldered in place without removing the diode holders. When the factory changed to the 1N4005 diodes, terminal board TB211 was elongated to provide space to mount CR206 and CR209. With this change, the Collins part number of TB211 was changed from 545-6150-002 to 609-0691-001.

B5	C147 was changed from 650 to 680 pF.
