G1000[™]

*annunciations and alerts
pilot's guide for the Diamond DA40*

9.1 INTRODUCTION

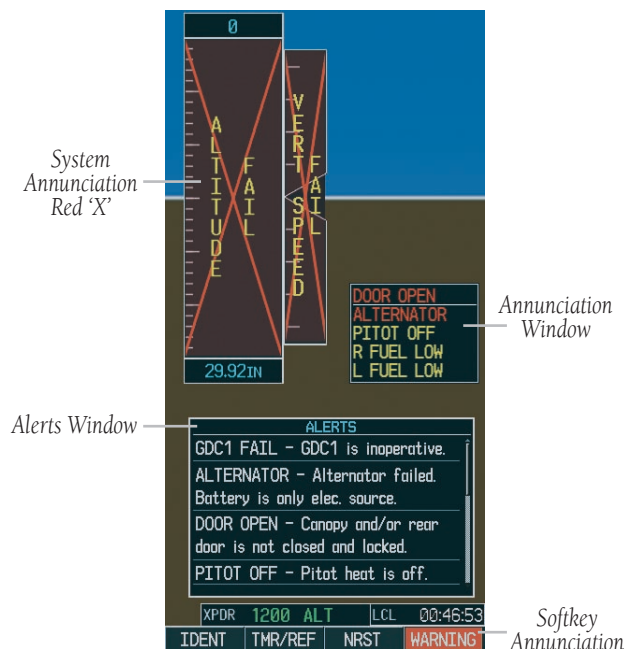
The G1000 Alerting System conveys alerts to the pilot using a combination of the following items:

- **Annunciation Window:** The Annunciation window displays abbreviated annunciation text. Text is colored based on alert levels described in the Alert Level Definitions section. The Annunciation window is located to the right of the Altitude and Vertical Speed windows on the display. Up to 12 DA 40 annunciations can be displayed in the annunciations window simultaneously. A white horizontal line separates the annunciations that are acknowledged from the annunciations that are not yet acknowledged. Higher priority annunciations are displayed towards the top of the window. Lower priority annunciations are displayed towards the bottom of the window.

- **Alerts Window:** The Alerts window displays alert text messages. Up to 64 prioritized alert messages can be displayed in the Alerts window. Pressing the **ALERTS** softkey displays the Alerts window. Pressing the **ALERTS** softkey a second time removes the Alerts window from the display. When the alerts window is displayed, the pilot can use the **large FMS knob** to scroll through the alert message list.

- **Softkey Annunciation:** During certain alerts, the **ALERTS** softkey may appear as a flashing annunciation to accompany an alert. The **ALERTS** softkey assumes a new label consistent with the alert level (WARNING, CAUTION, or ADVISORY). By press-

ing the softkey annunciation, the pilot acknowledges awareness of the alert. If alerts are still present, the **ALERTS** label is displayed in reverse video (white background with black text). The pilot can press the **ALERTS** softkey a second time to view alert text messages.

- **System Annunciations:** Typically, a large red 'X' appears in a window when a failure is detected in the LRU providing the information to the window. See the G1000 System Annunciations section for more information.
- **Audio Alerting System:** The G1000 system issues audio alert tones when specific system conditions are met. See the Alert Level Definitions section for more information.

Figure 9.1.1 G1000 Alerting System

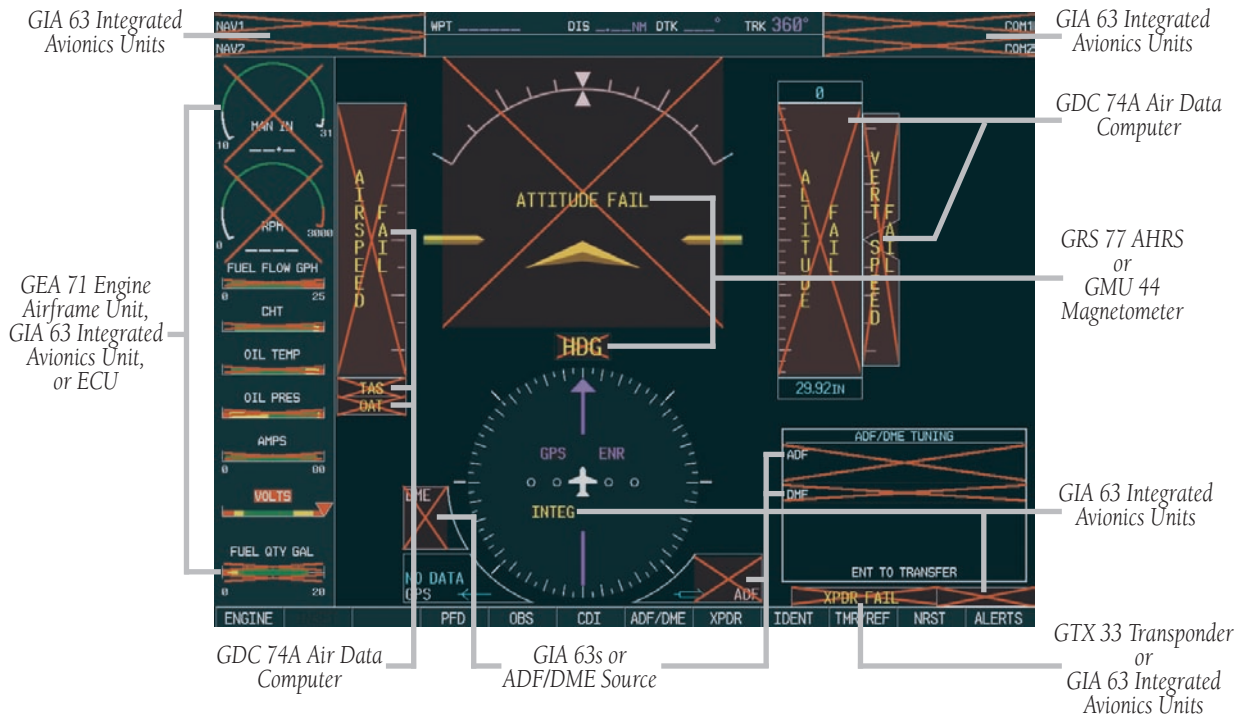
A red 'X' may be the result of an LRU or an LRU function failure. The figure presented below illustrates all possible flags and the responsible LRUs.

Figure 9.4.1 G1000 System Failure Annunciations

When an LRU or an LRU function fails, a large red 'X' is typically displayed on windows associated with the failed data. The following section describes various system annunciations. Refer to the DA 40 Aircraft Flight Manual Supplement (AFMS) for additional information regarding pilot responses to these annunciations.

<p>Display system is not receiving valid transponder information.</p>
<p>Other Various Red "X" Indications</p>	<p>A red 'X' through any other display field (such as engine instrumentation fields) indicates that the field is not receiving valid data.</p>
