# **G1000**<sup>™</sup>

*annunciations and alerts  
for the Diamond DA42*

## 9.1 INTRODUCTION

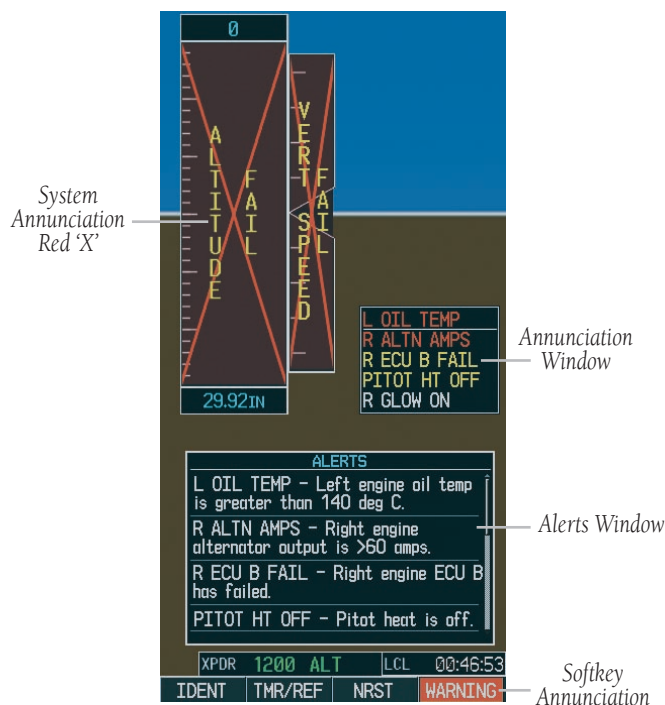
- Annunciation Window:** The Annunciation window displays abbreviated annunciation text. Text is colored based on alert levels described in the Alert Level Definitions section. The Annunciation window is located to the right of the Altitude and Vertical Speed windows on the display. Up to 12 DA42 annunciations can be displayed in the annunciations window simultaneously. A white horizontal line separates annunciations that are acknowledged from annunciations that are not yet acknowledged. Higher priority annunciations are displayed towards the top of the window. Lower priority annunciations are displayed towards the bottom of the window.

- Alerts Window:** The Alerts window displays alert text messages. Up to 64 prioritized alert messages can be displayed in the Alerts window. Pressing the **ALERTS** softkey displays the Alerts window. Pressing the **ALERTS** softkey a second time removes the Alerts window from the display. When the alerts window is displayed, the pilot can use the **large FMS knob** to scroll through the alert message list.

- Softkey Annunciation:** During certain alerts, the **ALERTS** softkey may appear as a flashing annunciation to accompany an alert. The **ALERTS** softkey assumes a new label consistent with the alert level (WARNING, CAUTION, or ADVISORY). By pressing the softkey annunciation, the pilot acknowledges

awareness of the alert. If alerts are still present, the **ALERTS** label will be displayed in inverse video (white background with black text). The pilot can press the **ALERTS** softkey a second time to view alert text messages.

- System Annunciations:** Typically, a large red 'X' appears in windows when a failure is detected in the LRU providing the information to the window. See the G1000 System Annunciations section for more information.
- Audio Alerting System:** The G1000 system issues audio alert tones when specific system conditions are met. See the Alert Level Definitions section for more information.

Figure 9.1.1 G1000 Alerting System

The G1000 Alerting System conveys alerts to the pilot using a combination of the following items:

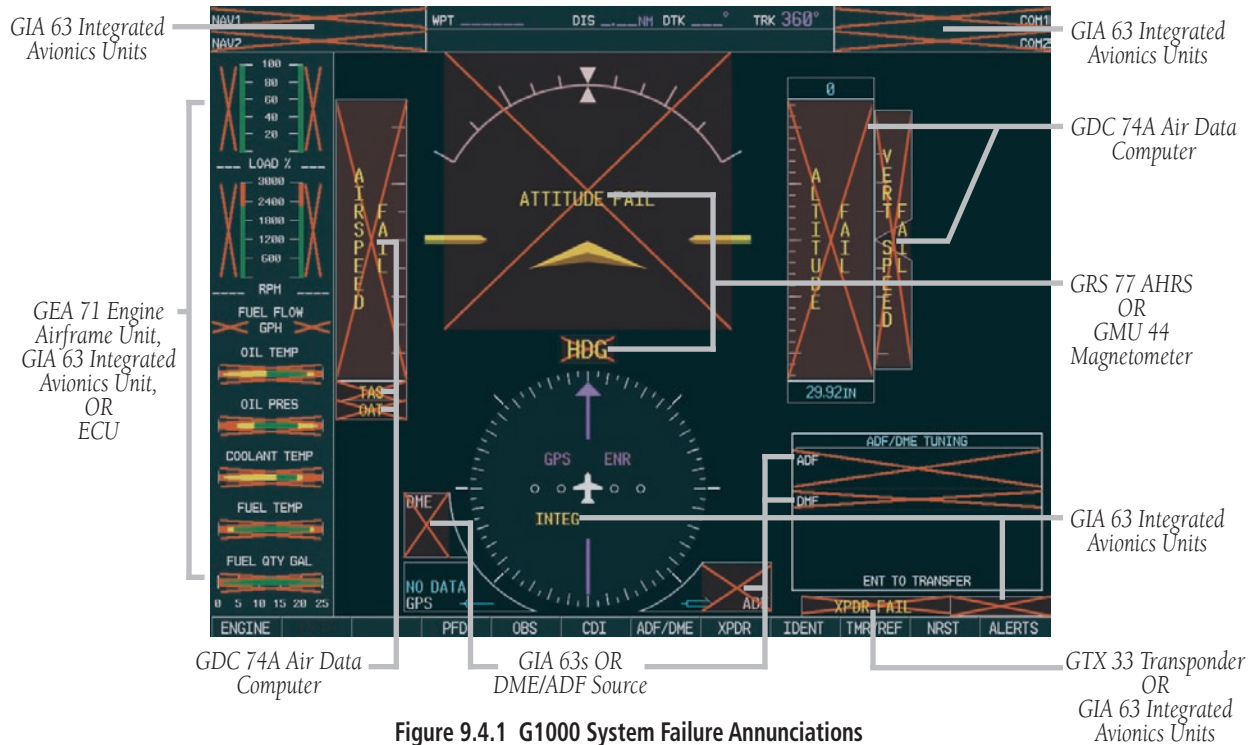
A red 'X' may be the result of an LRU or an LRU function failure. The figure presented below illustrates all possible flags and the responsible LRUs.

Figure 9.4.1 G1000 System Failure Annunciations

When an LRU or an LRU function fails, a large red 'X' is typically displayed on windows associated with the failed data. The following section describes various system annunciations. Refer to the Aircraft Flight Manual for additional information regarding pilot responses to these annunciations.

This section describes various G1000 system message advisories. Certain messages are issued due to an LRU or LRU function failure. Such messages are normally accompanied by a corresponding red 'X' annunciation as shown previously in the G1000 System Annunciations section.
